Environmental Assessment

Project ID: PR-RGRW-03730

Project Name: Apiarios Experiences LLC

Description of the Proposed Project [24 CFR 58.32; 40 CFR 1508.25]:

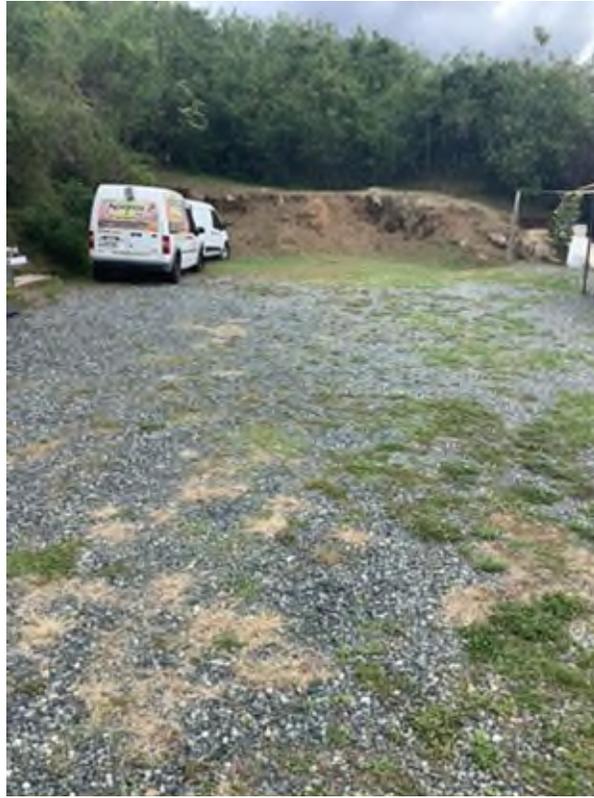
Photo Direction: Northeast

Comments: Techo 60 x 25

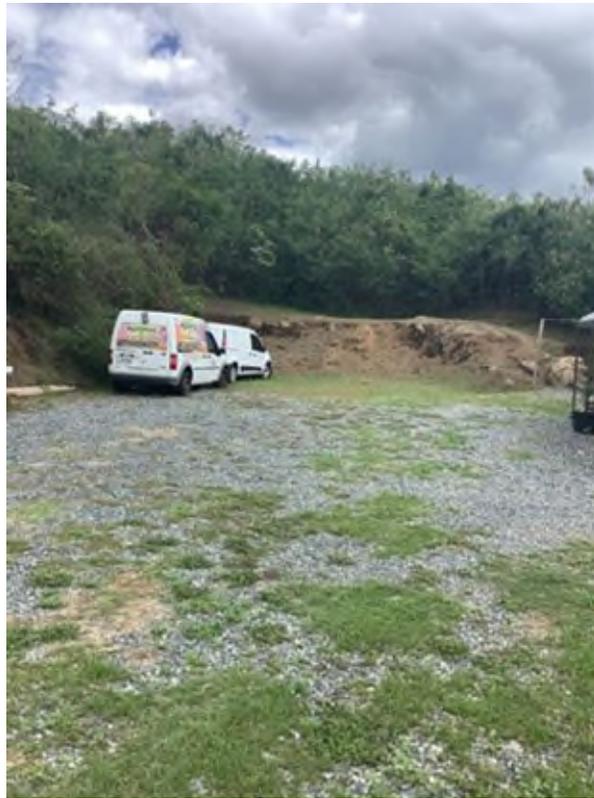
Photo Direction: East

Comments: Techo galvalume y 6 vigas acero (1 viga cada 20 pies)
