Environmental Assessment Determinations and Compliance Findings for HUD-assisted Projects 24 CFR Part 58

Project Name: Estacionamiento Urbano – PR-CRP-000505

Project Location: Parque Street, Bo. Pueblo Rincón, PR 00677

Description of the Proposed Project [24 CFR 50.12 & 58.32; 40 CFR 1508.25]:

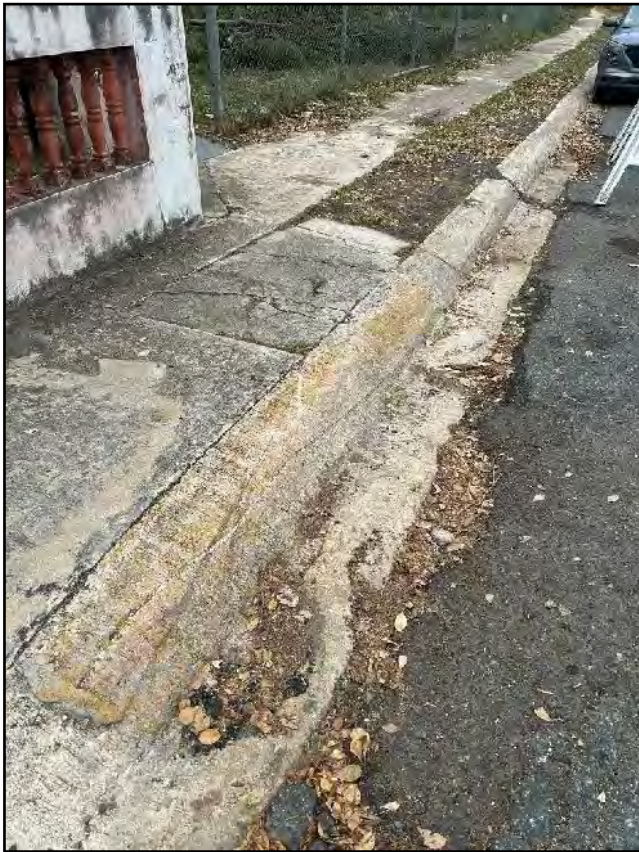
LBP Yellow Concrete Curb,
State Road PR-115

Structure/Room	Components	Substrate	Color	Quantity
<u>Public Parking</u>				
South Park	Bench Support	Metal	Yellow	8 ln.ft.
PR-115	Right Curb	Concrete	Yellow	16 ln.ft.

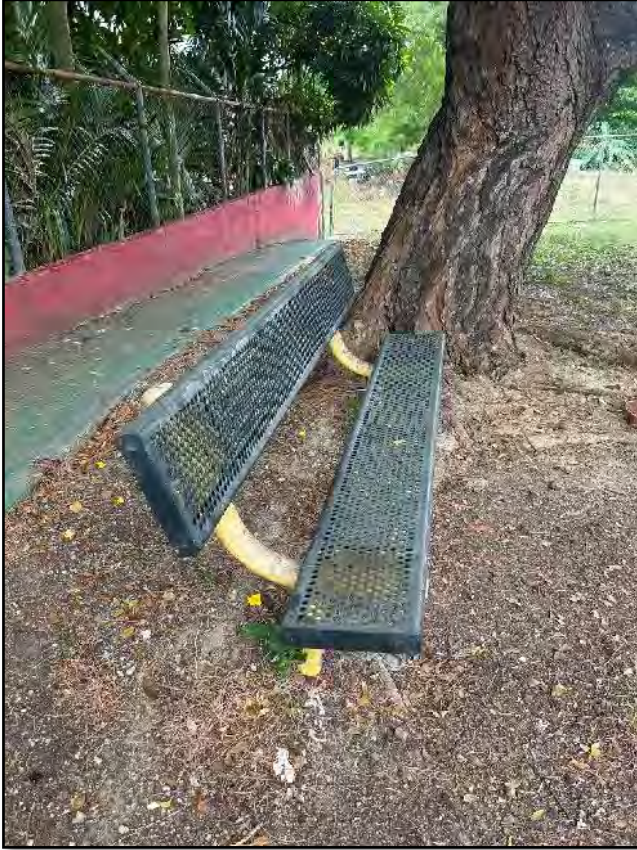
LBP Yellow Metal Bench Support,
South Park

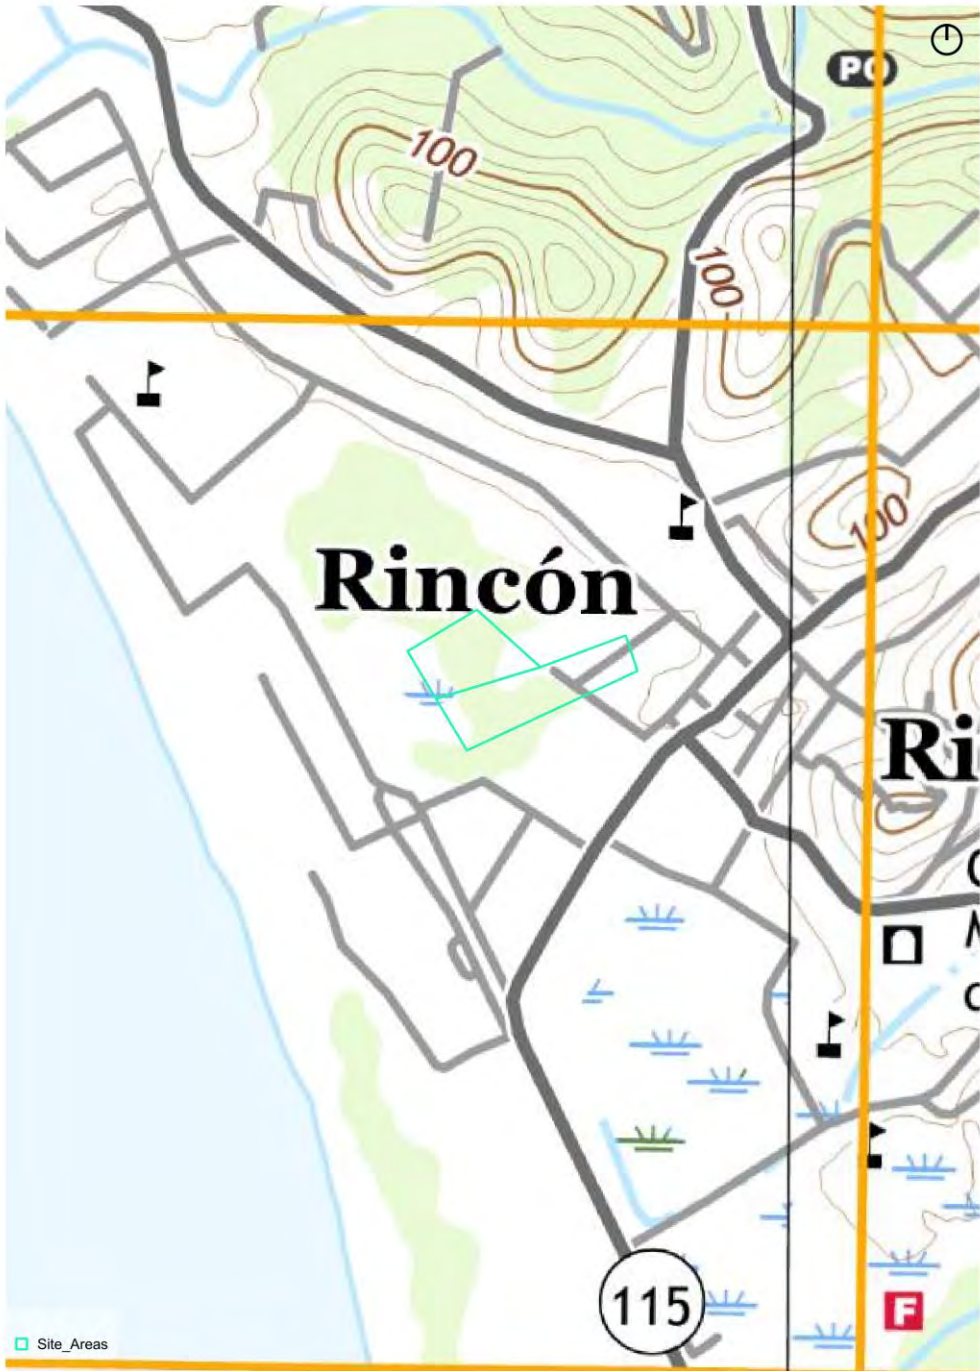
FIGURE 1-1
USGS TOPOGRAPHIC QUADRANGLE

The general composition of the area is mainly vegetation areas and areas occupied by a homemade structure that are located within the project area (See **Figures 1-1, 1-2**). The homemade structures are used for raising chickens and farm animals such as goats. The other main composition in the project area is the main rainwater canal/ditch which travels mainly in the center of the area divides the main site area into two sub-areas.

USGS 2018 Topographic quadrangle “Rincon-OE-W-20181016” (see **Figure 1-1**) shows an identified marsh symbol in the location where NWI locates PEMF1. The topographic quadrangle does not show any waterways or surface waterbodies in the area. Also, floodplain maps were checked via the Federal Emergency Management Agency (FEMA)

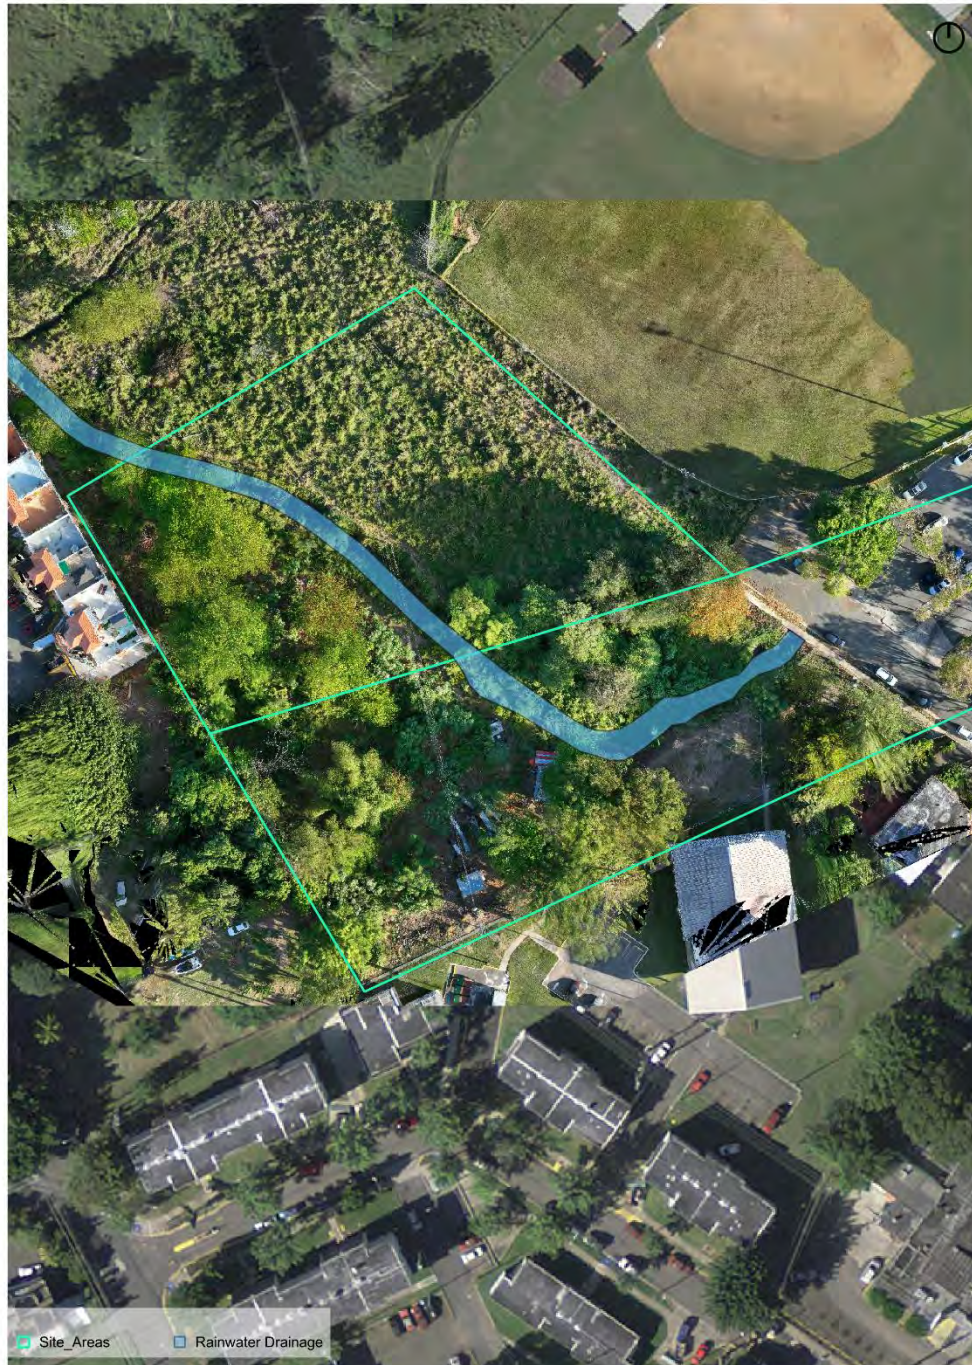
FIGURE 1-2
SITE AREA

Topography for S-A1 ranges from 4 m to 2 m following direction of the rainwater canal/ditch from east to west in reference to the main road (Ojo de Agua Road), lowest point adjoining between canal and wire railing. As mentioned earlier, vegetative debris has impacted the existing topography for S-A1 where deposits seem to be in the process of degradation (See **Figure 1-2**).

To the northwest of S-A2 is located PEM1, approximately 1500 sq m of the total area delimited for PEM1F is located within the boundaries of S-A2. The total coverage area for PM1F is approximately 3298 sq m¹. The area of PEM1F within the proposed project footprint in S-A2 is approximately seventy-eight sq m (see **Figure 1-2**).

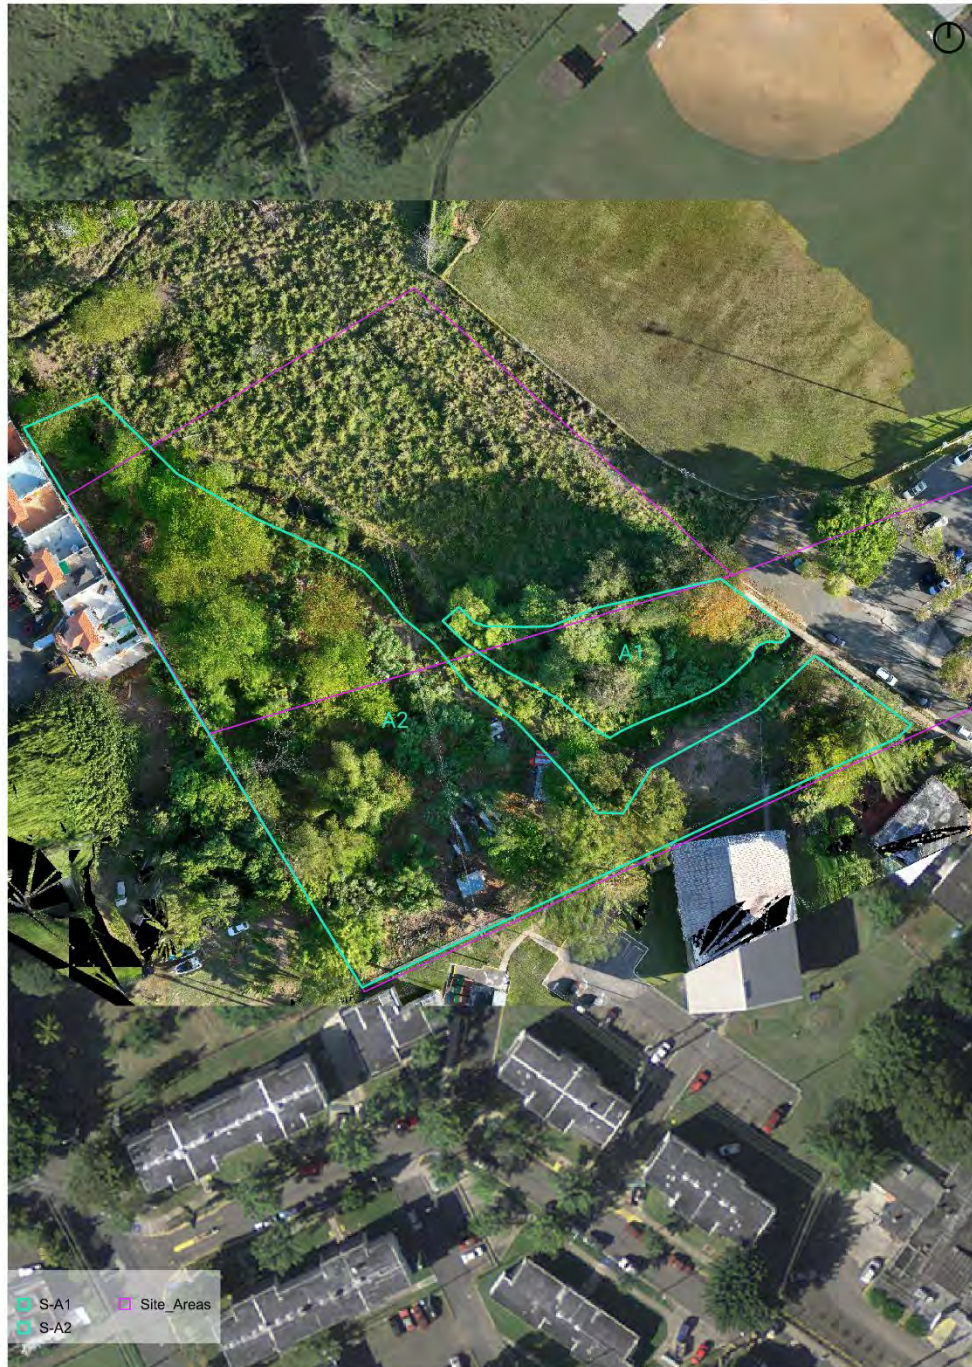
**FIGURE 1-4
SUB-AREAS**

S-A1
S-A2

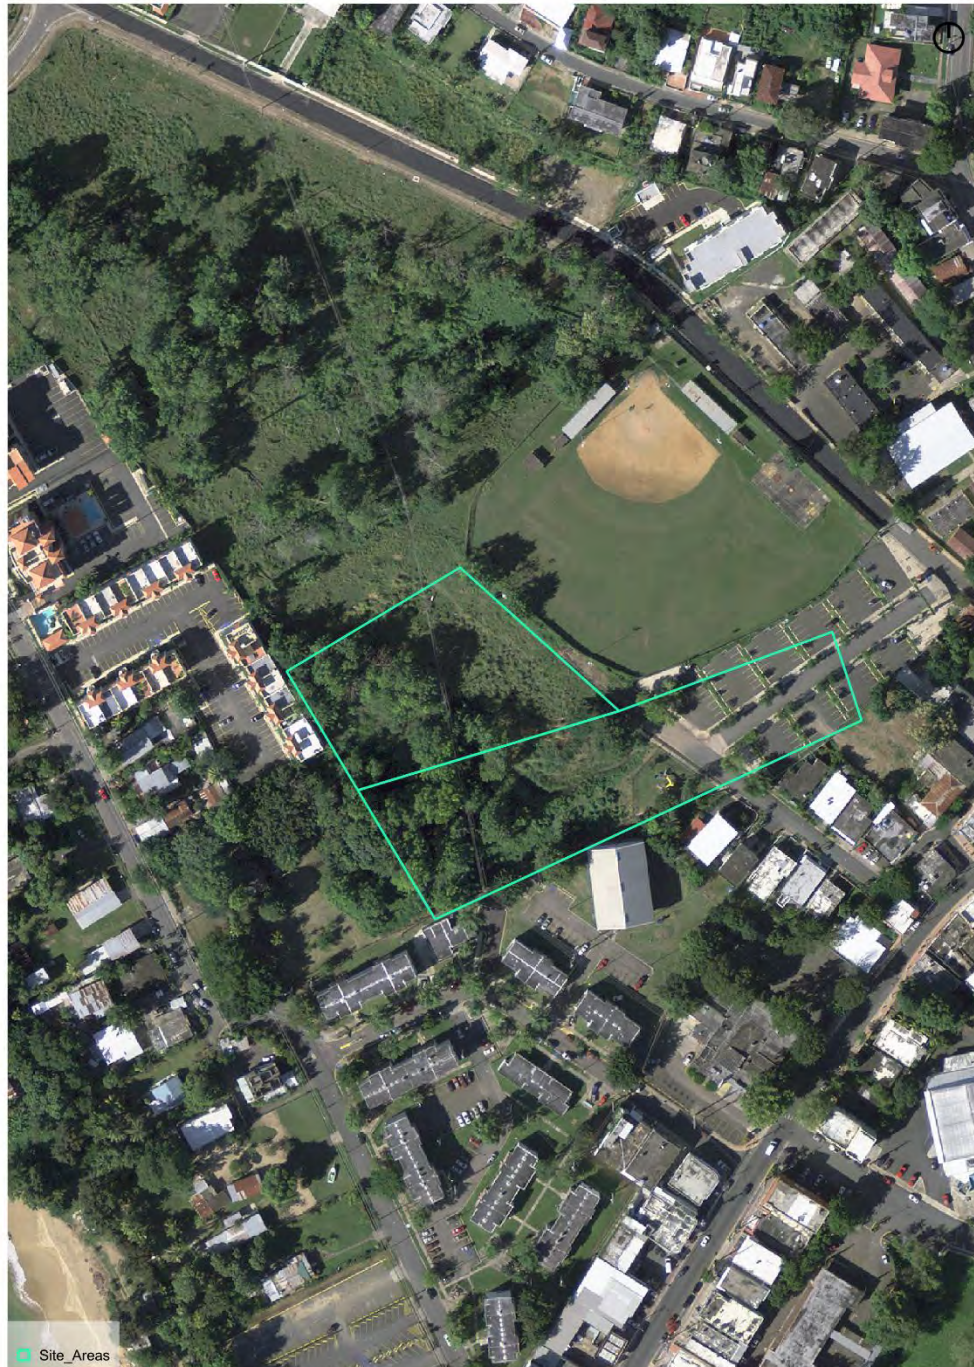
FIGURE 3-1
2016 SITE AERIAL VIEW - HYDROLOGY

Upon review of 2016 aerial imagery for the project site area (**See Figure 3-2**) the rainwater canal / ditch is barely visible and can be observed that the area was populated by low dense vegetations and trees.

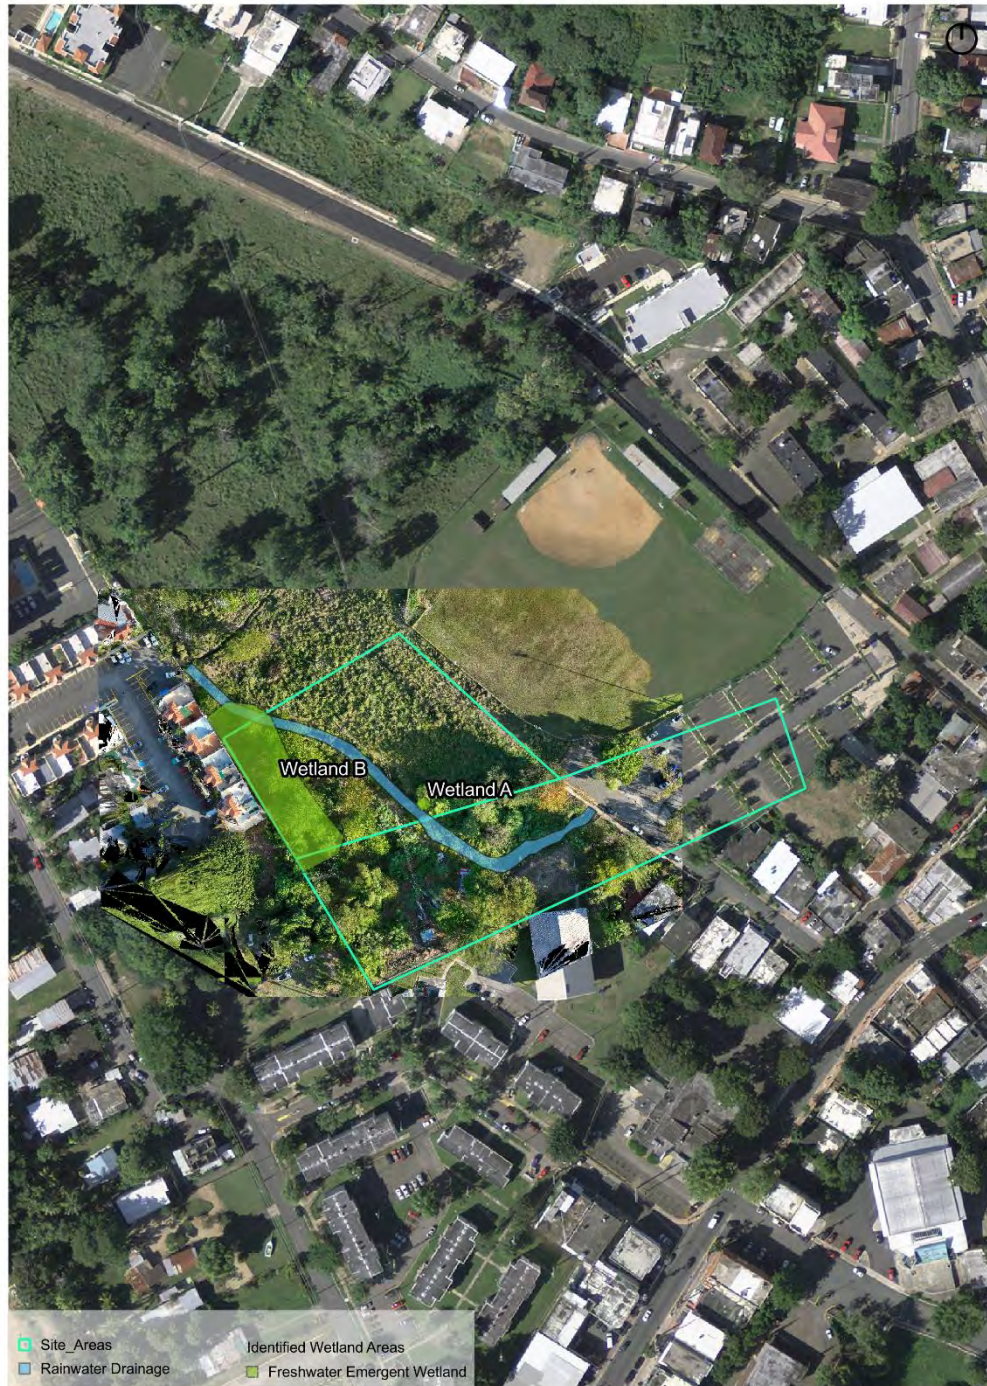
FIGURE 4-1
IDENTIFIED WETLANDS S-A1, S-A2

For S-A1 wetland indicators were identified and delimited this area as Wetland A. Wetland A is not mapped in NWI, Wetland A is shown in **Figure 4-1** and in Sampling point P1 and P2 (see **Attachment 3**). Wetland A is located in in the southwest area of S-A1 and runs perpendicular to the wetland boundary documented for PEM1F located to the west of S-A1, this area appears to be the toe of the rainwater canal/ditch and runs towards the rainwater canal, where elevation for the site is lower and the slope or containment area for the water canal/ditch is reduced to the borderline of the adjacent private property which used for the raising of cattle.

Name	NWI ID	Map (Figure)	Sampling Points (Forms)	NWI Total Area (Acres)	Total Field Area (Acres)	Area within Project (Acres)
Wetland A	-	Figure 4-1	P1	0.0		0.00

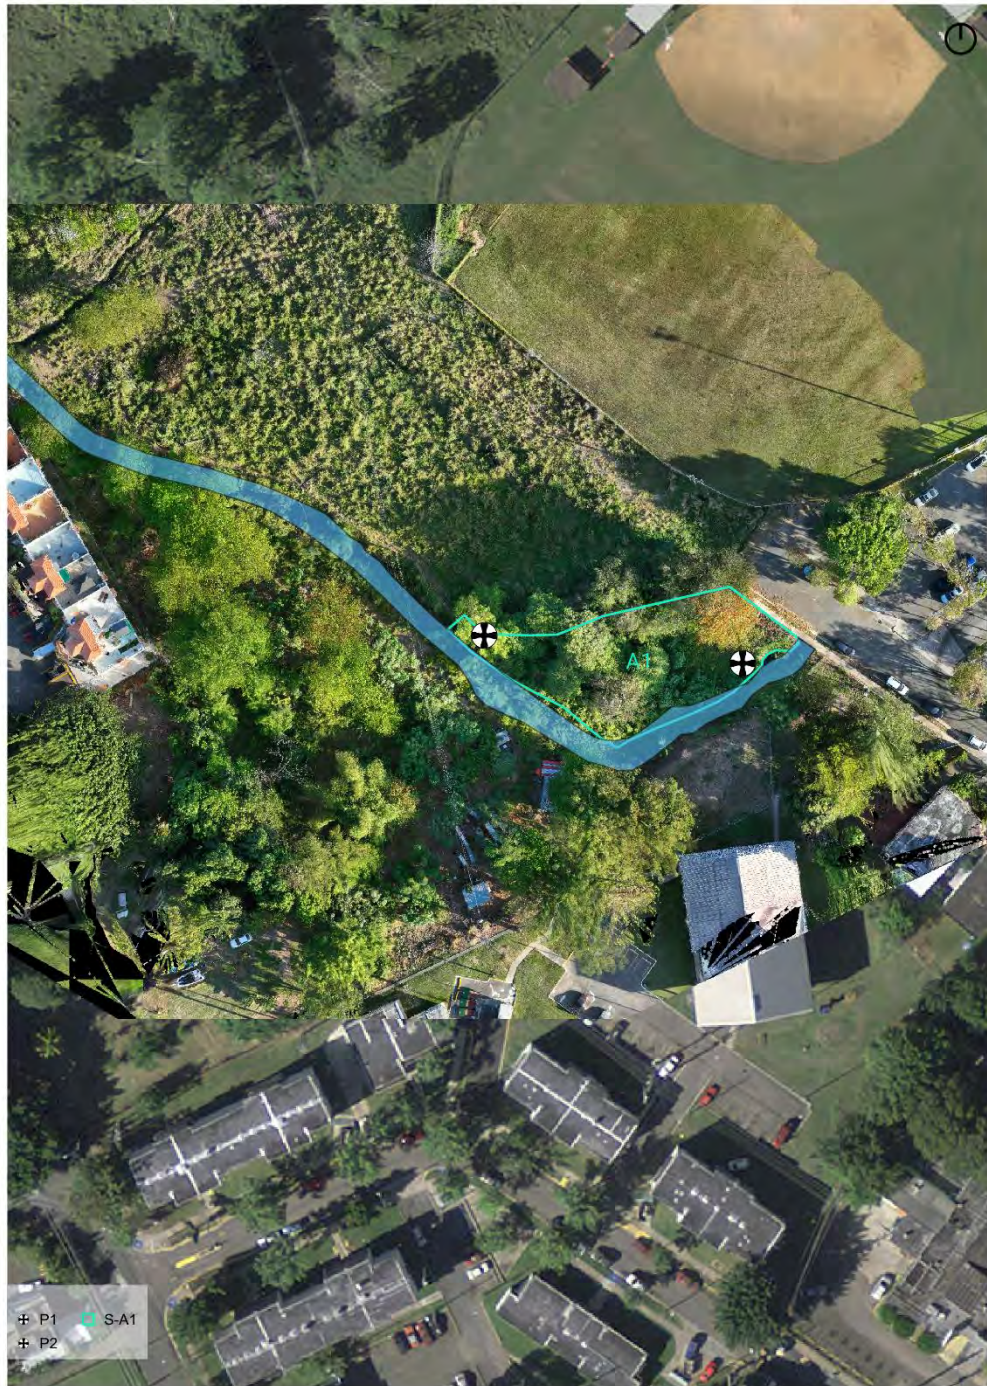
FIGURE 4-4
SAMPLING POINT S-A1

Sampling Point P2 is located to the upper north of area of S-A1 and it is the closest sampling point to the main road “Calle Ojo de Agua”. Dominant plant species observed in this area for the tree stratum were *Terminalia catappa* (UPL), *Ricinus communis* L. (FACU) for the sapling/shrub stratum and *Malvastrum coromandelium* (L.) (FACU) and *Megathyrsus maximus* (Jacq.) (FACU) in the herb stratum. No soil sampling was done in P2, nevertheless visual and color and texture for the soil is consistent with P1 soil sampling. No hydrology indicators were observed in this P2 (see **Attachment 3, P2 Data Form**).

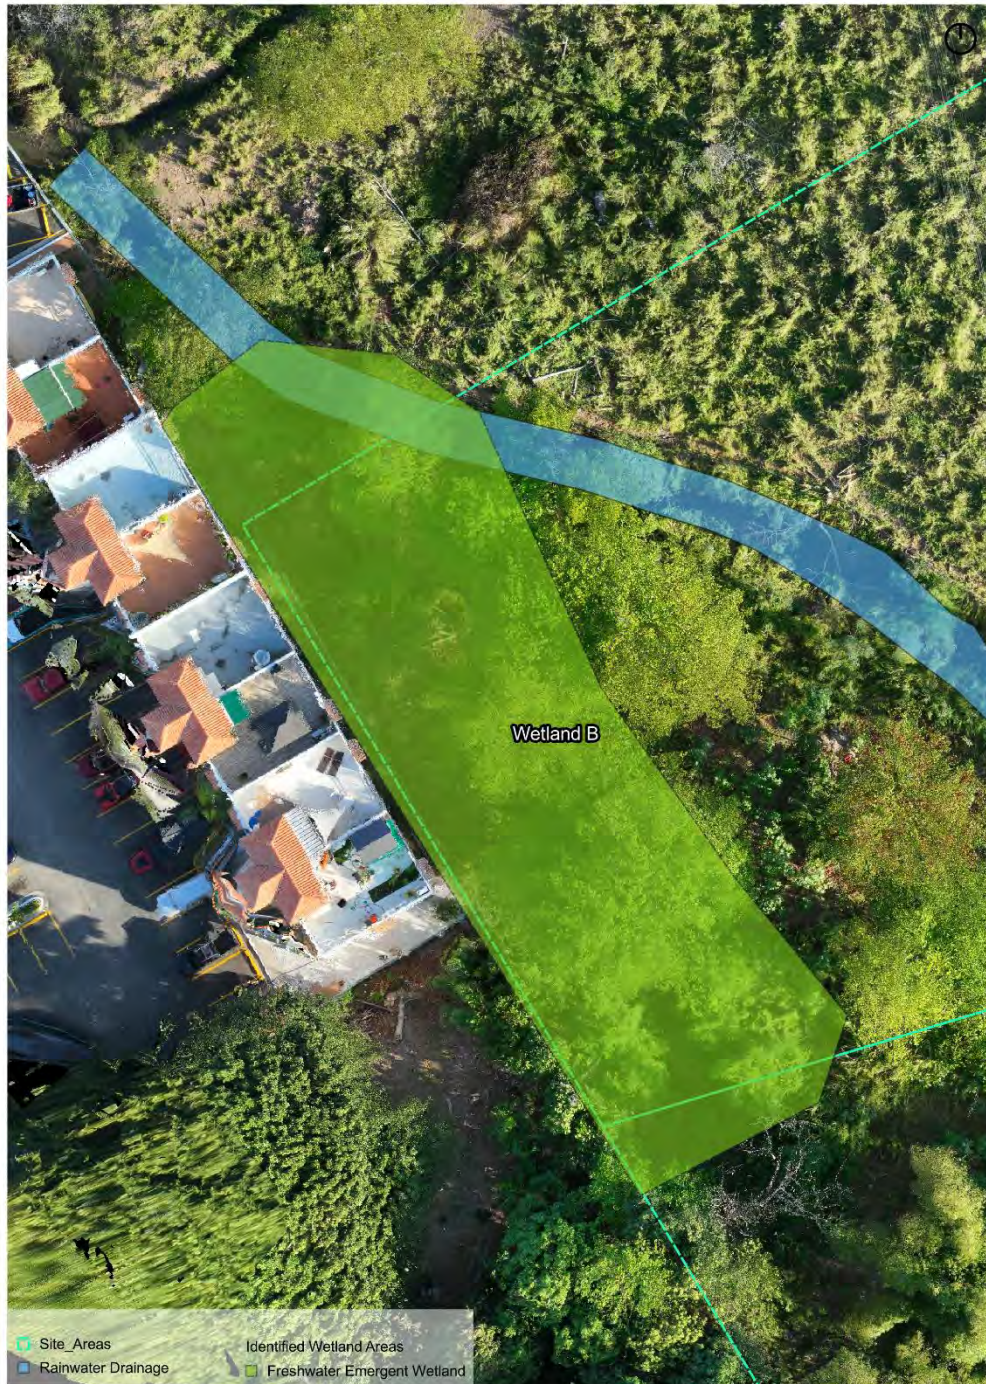
**FIGURE 4-5
WETLAND B S-A2**

For S-A2 is located to the wests of the rainwater canal/ditch and borders with residential public housing facility Santa Rosa and private housing facility Condominium Challet Del Mar. PEM1F footprint was reduced in approximately 1655.64 sq m (51 %) . The remaining Wetland indicators were evaluated for the remaining approximately 1642.46 (49 %) of the original PEM1F footprint. Out of the remaining 49%, approximately seventy-three. 64 (4.4 %) sq m are located within the proposed project area (**See Figure 4-5**).

NWI delineates PEM1F as Freshwater Emergent Wetland, approximately 51 % of PEM1F was lost to construction of Challet Del Mar Condominium and private housing and 49 % of the original footprint delineated in NWI remains in S-A2 as described in the section above (**See Figure 4-5**).

For S-A2 is located to the wests of the rainwater canal/ditch and borders with residential public housing facility Santa Rosa and private housing facility Condominium Challet Del Mar. PEM1F footprint was reduced in approximately 1655.64 sq m (51 %) . The remaining Wetland indicators were evaluated for the remaining approximately 1642.46 (49 %) of the original PEM1F footprint. Out of the remaining 49%, approximately seventy-three. 64 (4.4 %) sq m are located within the proposed project area (**See Figure 4-5**).

NWI delineates PEM1F as Freshwater Emergent Wetland, approximately 51 % of PEM1F was lost to construction of Challet Del Mar Condominium and private housing and 49 % of the original footprint delineated in NWI remains in S-A2 as described in the section above (**See Figure 4-5**).

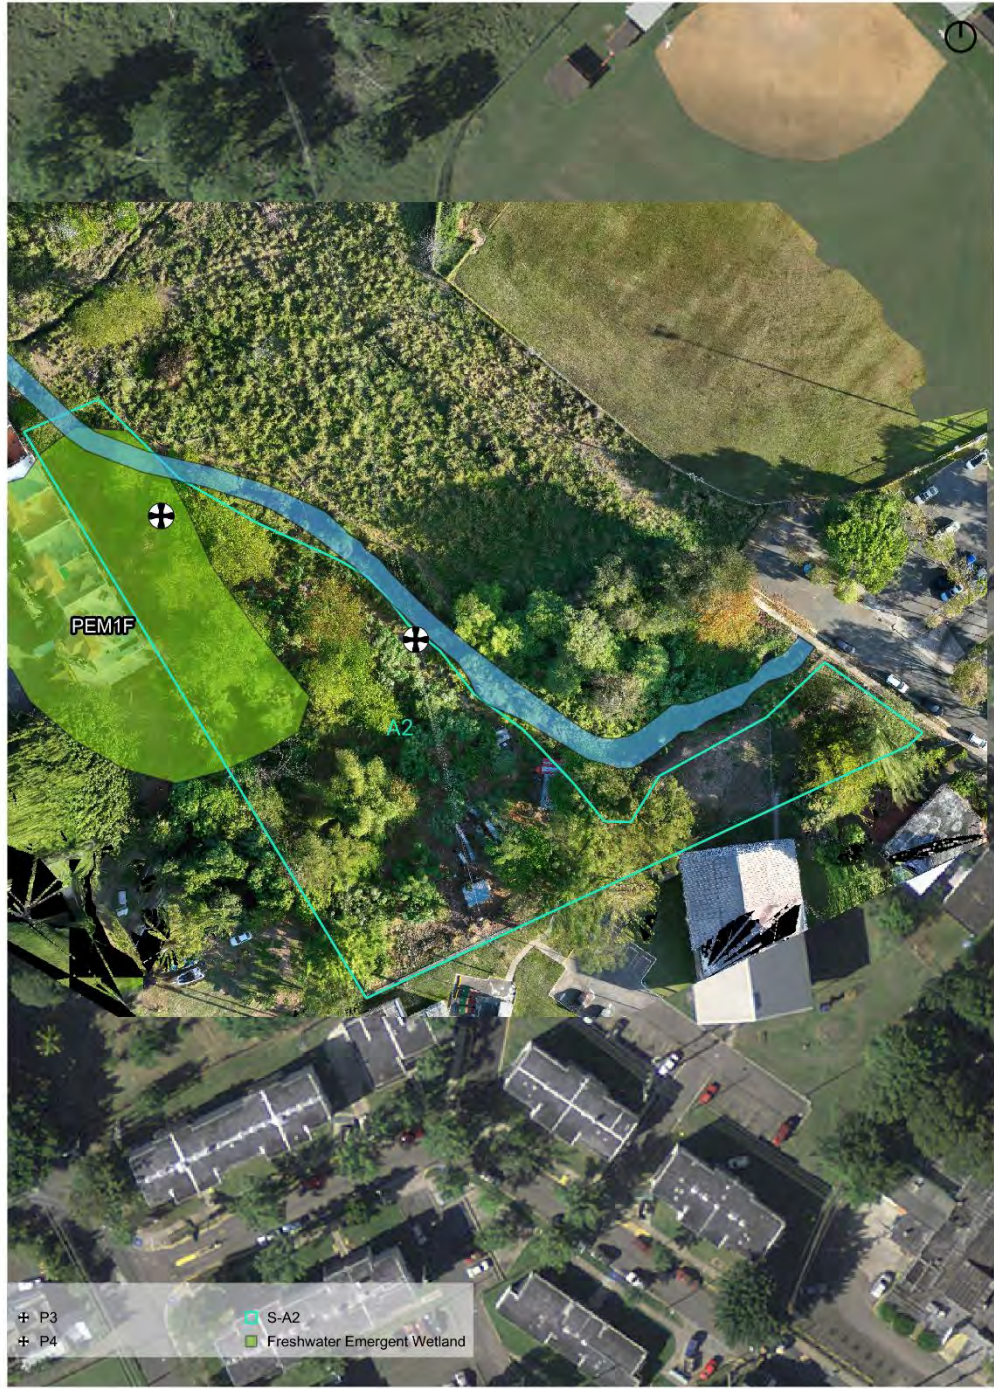
**FIGURE 4-7
SAMPLING POINTS S-A2**

Sampling Point P3 is located in the northeast area of S-A2 within PEM1F boundary, and it is an emergent wetland as delineated in the NWI (see **Attachment 3, P3 Data Form**), dominant plant species in the tree stratum *Terminalia catappa* (FACU) and *Cenchrus echinatus* (UPL) in the herbaceous stratum. No primary or secondary hydrology indicators were observed in P3. Nonetheless, low elevation for the area in combination with the rainwater canal/ditch configuration gives the impression that the area floods during significant rain events, which may present favorable conditions for the emergent wetland to continue developing. No plants for the vine stratum were identified for P3. No soil sample holes were dug in this area due to access limitations, but soil texture and surface color is consistent with P1 soil sample observations.

Sampling Point P4 is located near the center of S-A2 border lining with the rainwater canal/ditch. Dominant species found in P3 include *Ricinus communis* L.(FACU) in the sapling/ shrub stratum and *Cynodon nlemfuensis* (UPL) and *Typha domingensis* (OBL) in the herb stratum. Although *Typha domingensis* (OBL) was identified in a small patch in the area, all specimens are contained within the rainwater canal/ditch at a lower elevation from the upland species. As mentioned in previous sections, topography for the site has been altered and the original toe of the canal/ditch bank is difficult to identify. As a conservative approach species, it has been documented to be considered. No plants for the tree stratum and vine stratum were identified for P4. No soil sample holes were dug in this area due to access limitations, but soil texture and surface color is consistent with P1 soil sample observations (see **Attachment 3, P4 Data Form**).

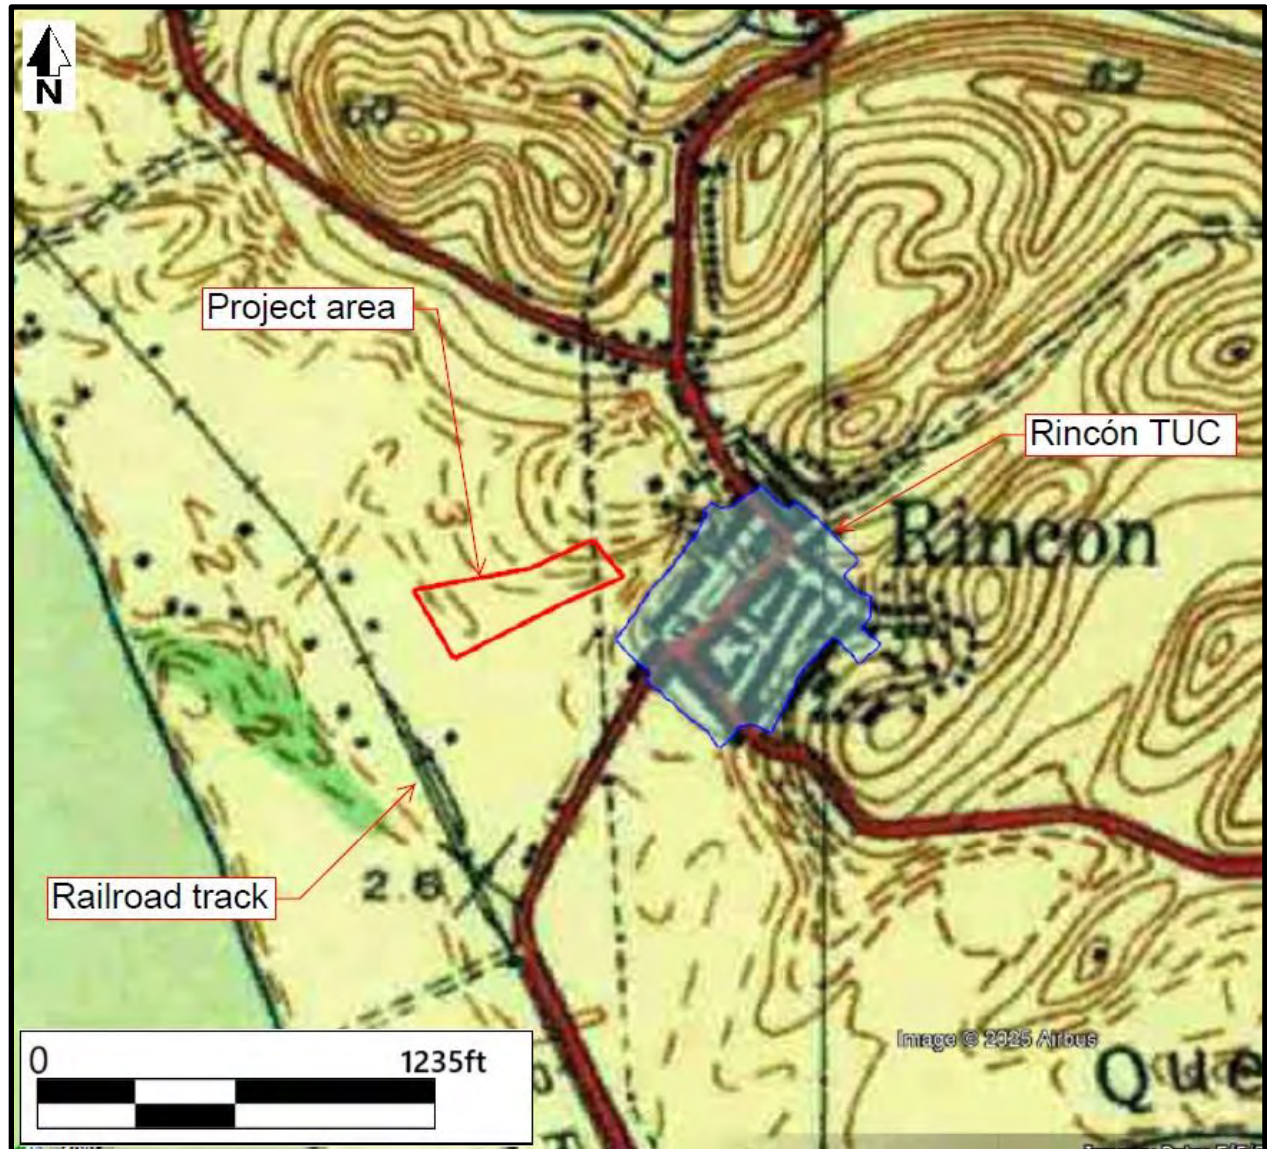
Figure 8. 1941 USGS Topographic Map showing Rincón TUC and Project area perimeter (red polygon). No structures or features can be observed within the project lot. Railroad track located west of the project site.

The next chart is a USGS Rincón topographic map from 1941 which shows the project area west of the Rincón TUC (figure 8). No structures or features can be observed within the project lot. A railroad track is located west of the project parcel.

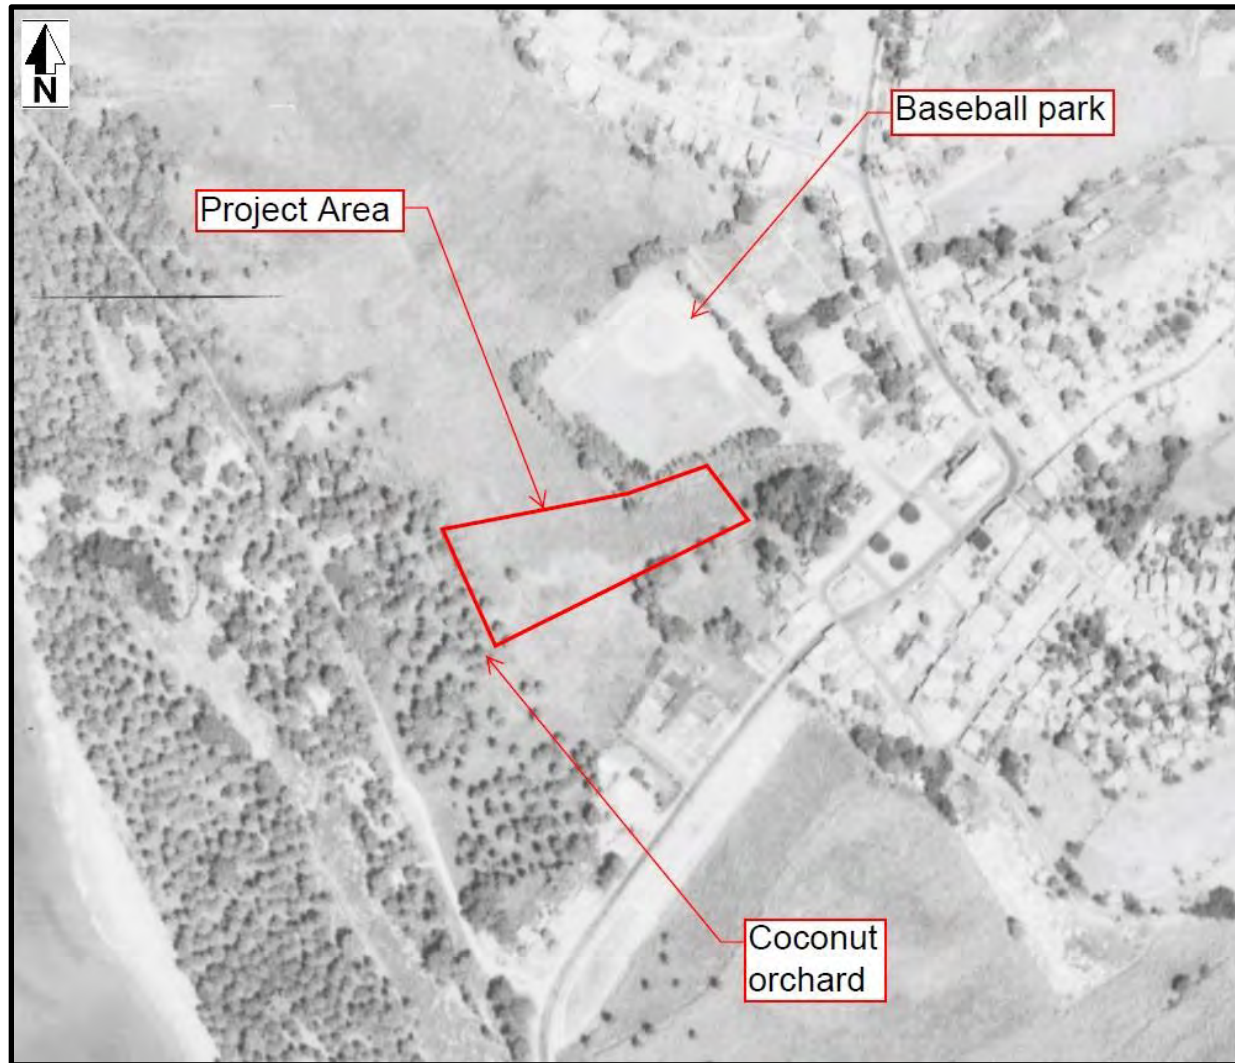
Figure 10. 1963 aerial photo showing project area (red polygon). A coconut orchard can be observed along the coast and the western border of the project lot, and a baseball park is located to the north. Source: DTOP Archives, 2024.

A 1963 aerial photo of the Rincón area shows the project parcel bordered to the west by a large coconut palm orchard (figure 10). No structures or other type of development can be observed within the project area. A new baseball park can also be seen north of the lot.

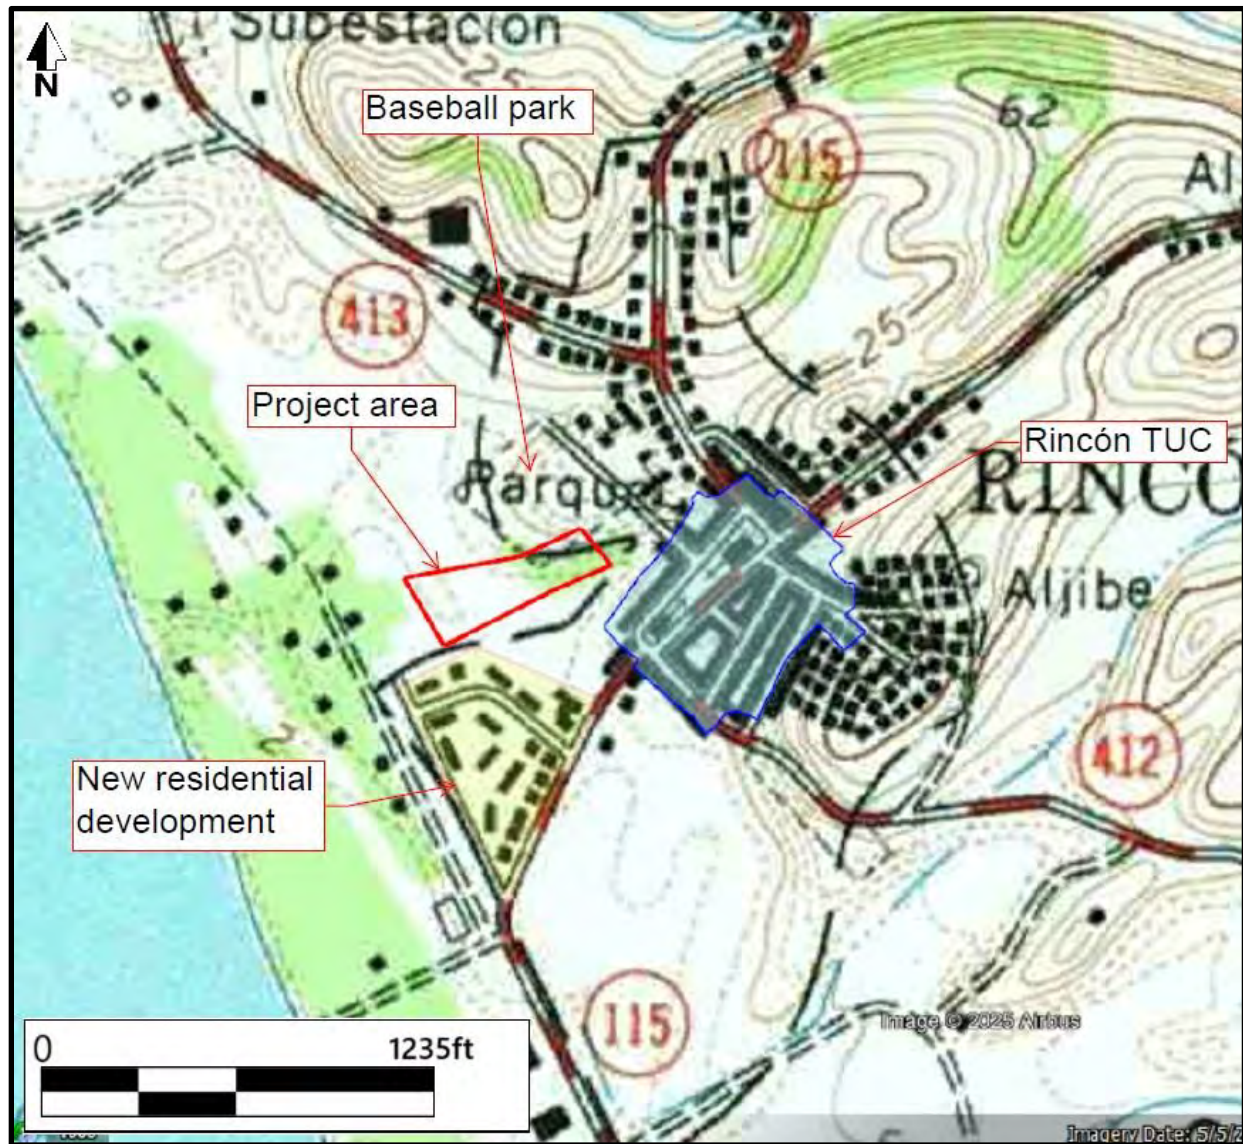
Figure 11. 1966 (edited 1969) Rincón USGS Topographic Map showing new development (light yellow polygon) south of the project area (red polygon).
 Source: <https://ngmdb.usgs.gov/topoview/viewer/#13/18.4431/-66.0730>.

A 1966 (edited 1969) USGS Rincón topographic map shows new development south, near the project parcel (figure 11). No development is observed within the project area.

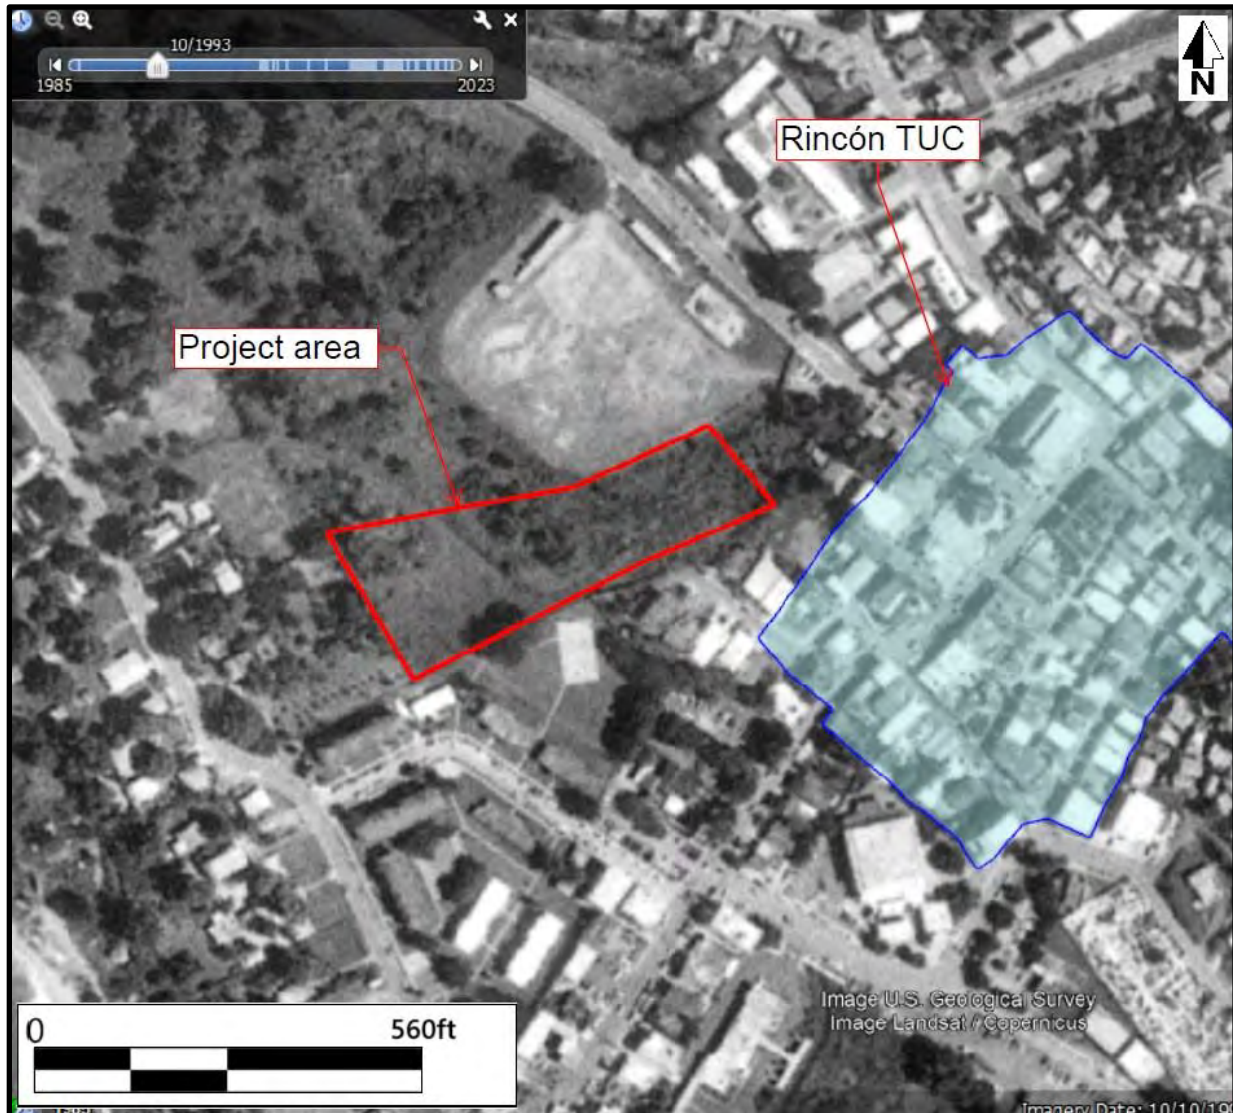
Figure 12. 1993 Google Earth Pro aerial imagery showing project area covered in vegetation. New urban development surrounds the project lot to the south and west.

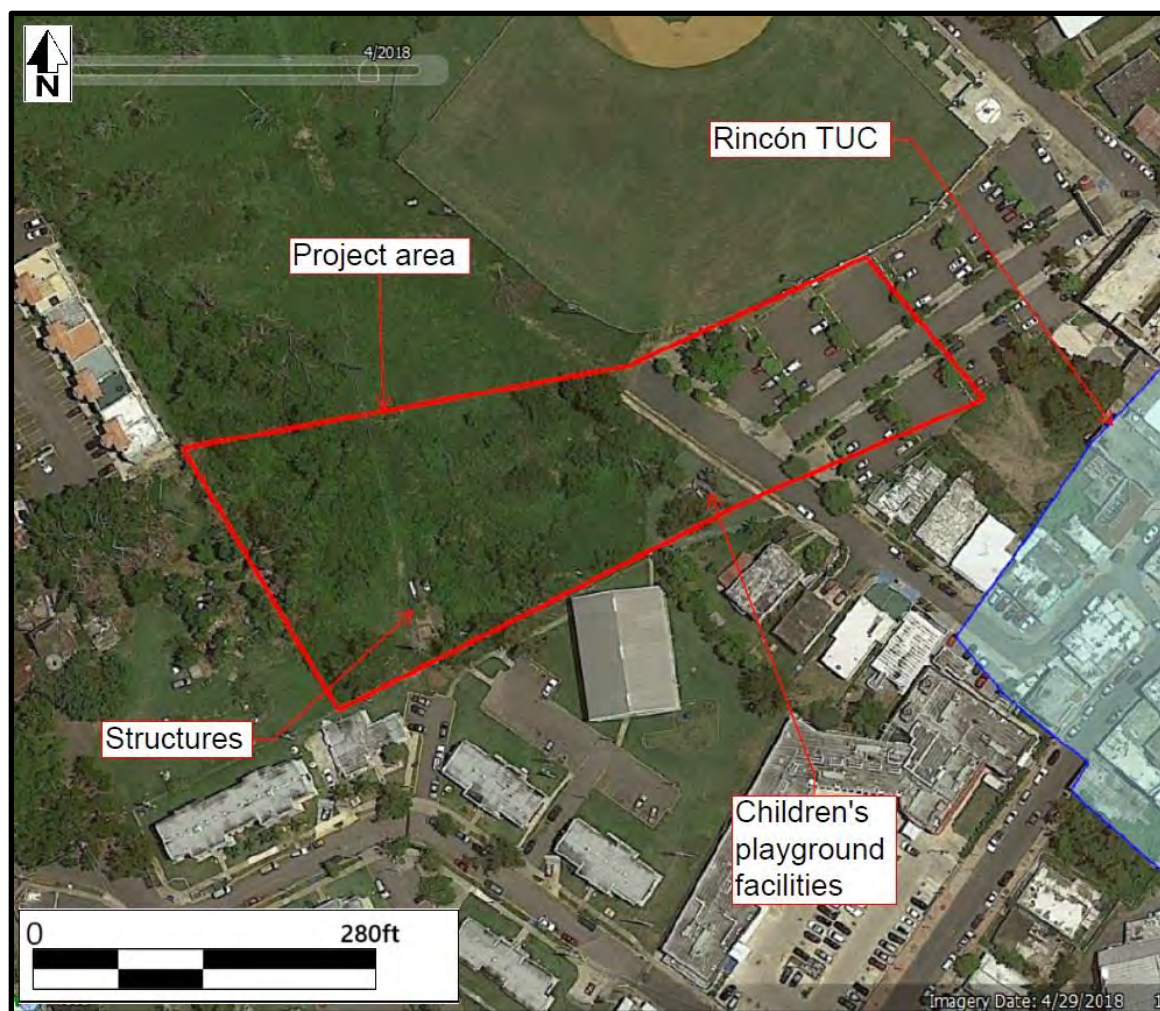
A 2018 Google Earth Pro aerial photograph shows some undetermined structures in the southwestern portion of the project parcel. The children's playground can still be seen in the southern section, and a portion of the existing parking lot in in the east of the lot (figure 15). The remaining area within the property is covered in dense vegetation.

Figure 15. 2018 Google Earth Pro aerial imagery showing undetermined structures in the southwestern portion of the project parcel. The children's playground can still be seen in the southern portion of the lot.

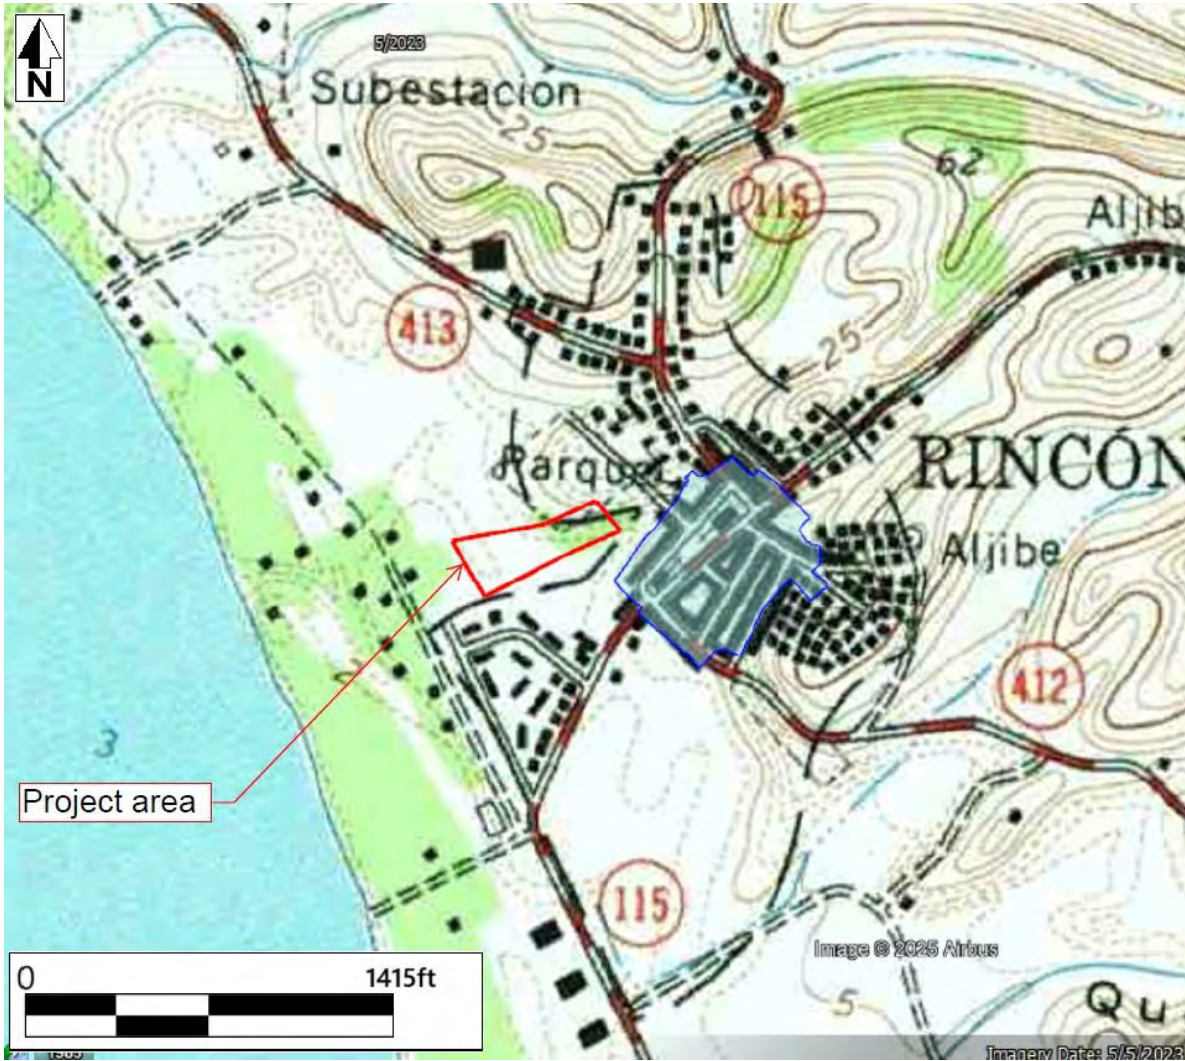
Project (Parcel) Location - USGS Topographic Map

USGS topographic map showing location of direct APE with red polygon.
