Environmental Assessment Determinations and Compliance Findings for HUD-assisted Projects 24 CFR Part 58

Project Name: Estacionamiento Urbano – PR-CRP-000505

Project Location: Parque Street, Bo. Pueblo Rincón, PR 00677

Description of the Proposed Project [24 CFR 50.12 & 58.32; 40 CFR 1508.25]:

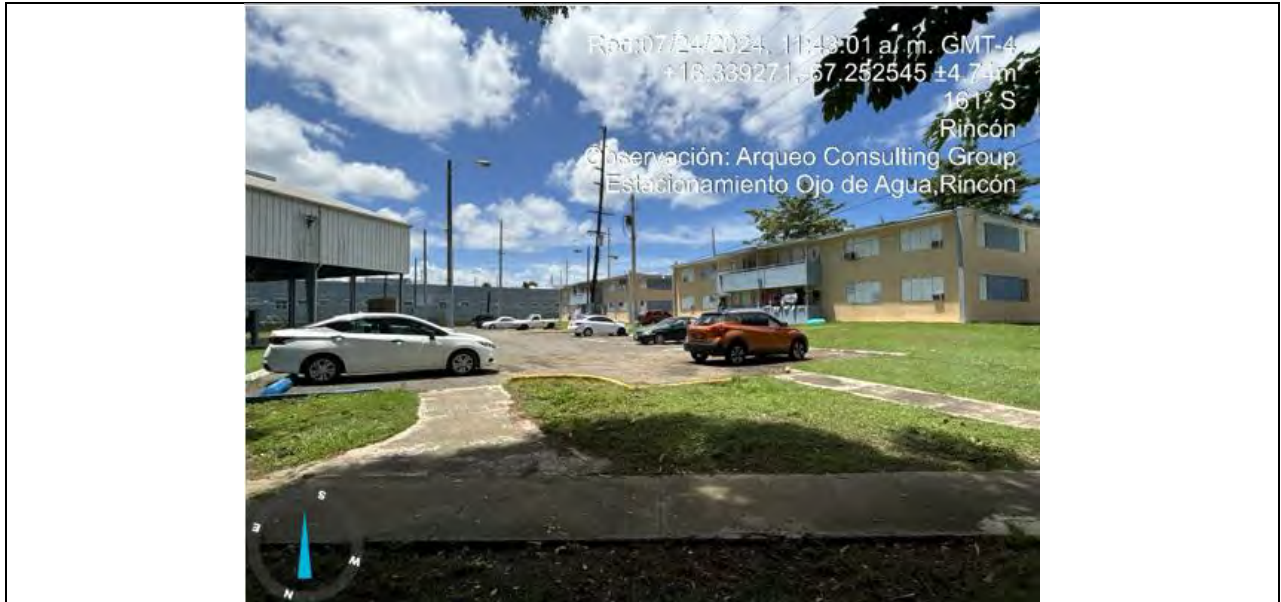
Photo #: 1	Description (South): View from north to south of the lot towards Residencial Santa Rosa.
Date: 7/24/24

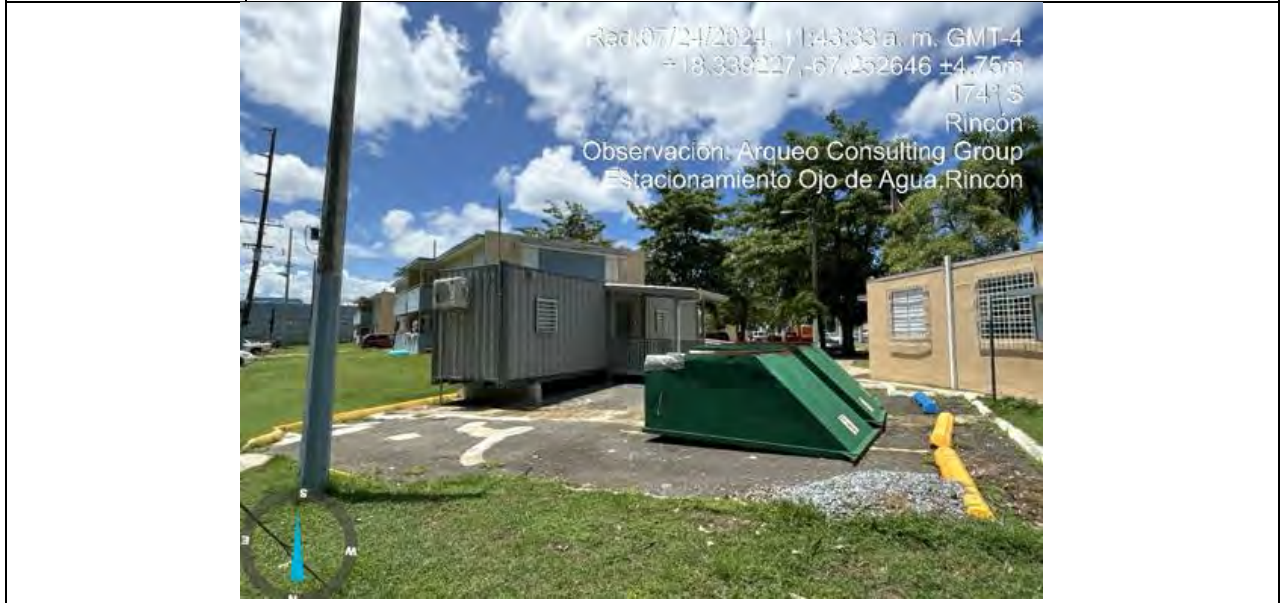
Photo #: 2	Description (South): View from north to south of the lot towards Residencial Santa Rosa.
Date: 7/24/24

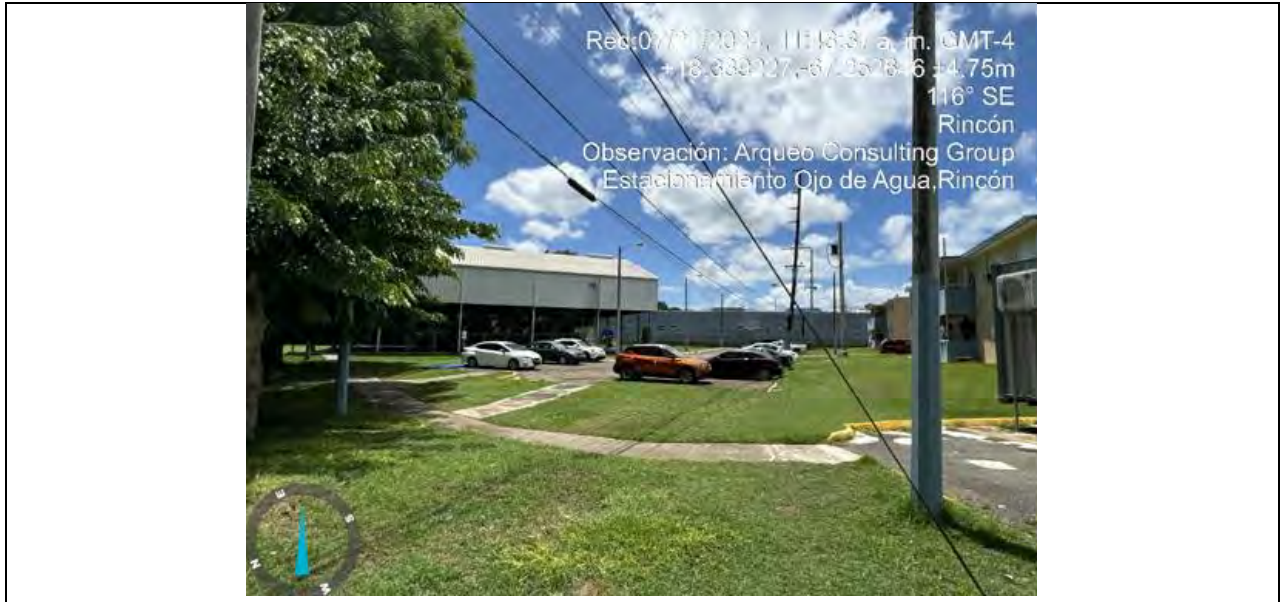
Photo #: 3	Description (East): View to the Residencial Santa Rosa from the southern limit of the lot (cyclone fence) facing east-southeast.
Date: 7/24/24

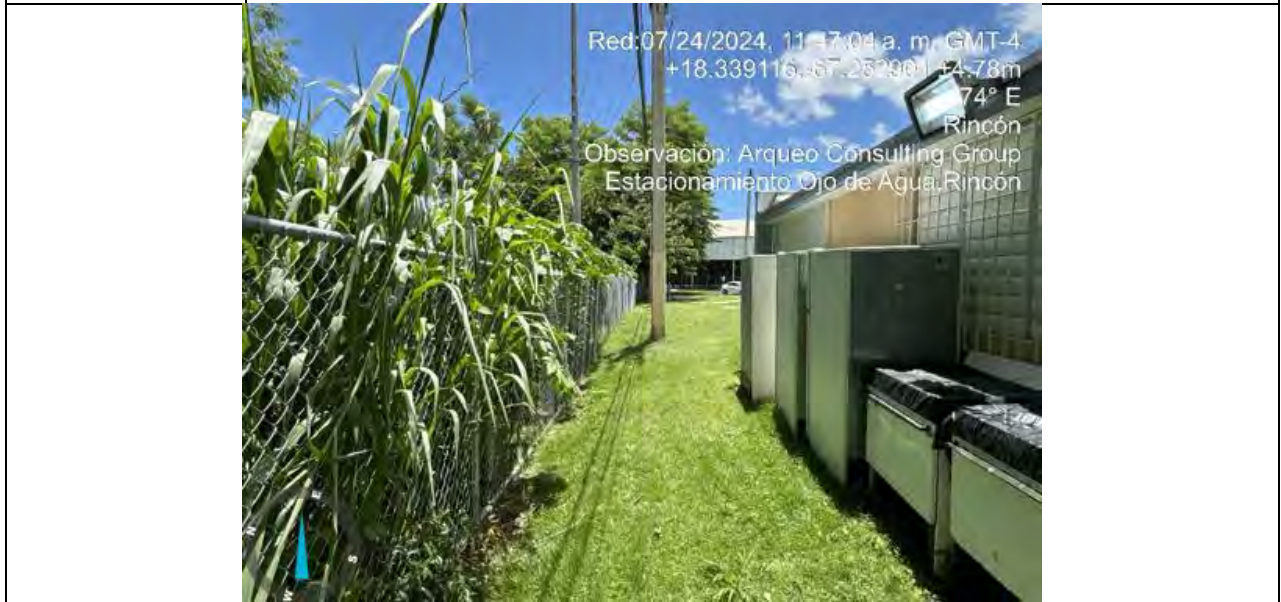
Photo #: 4	Description (East): View of the southern limits of the lot (cyclone fence), west to east vantage point.
Date: 7/24/24

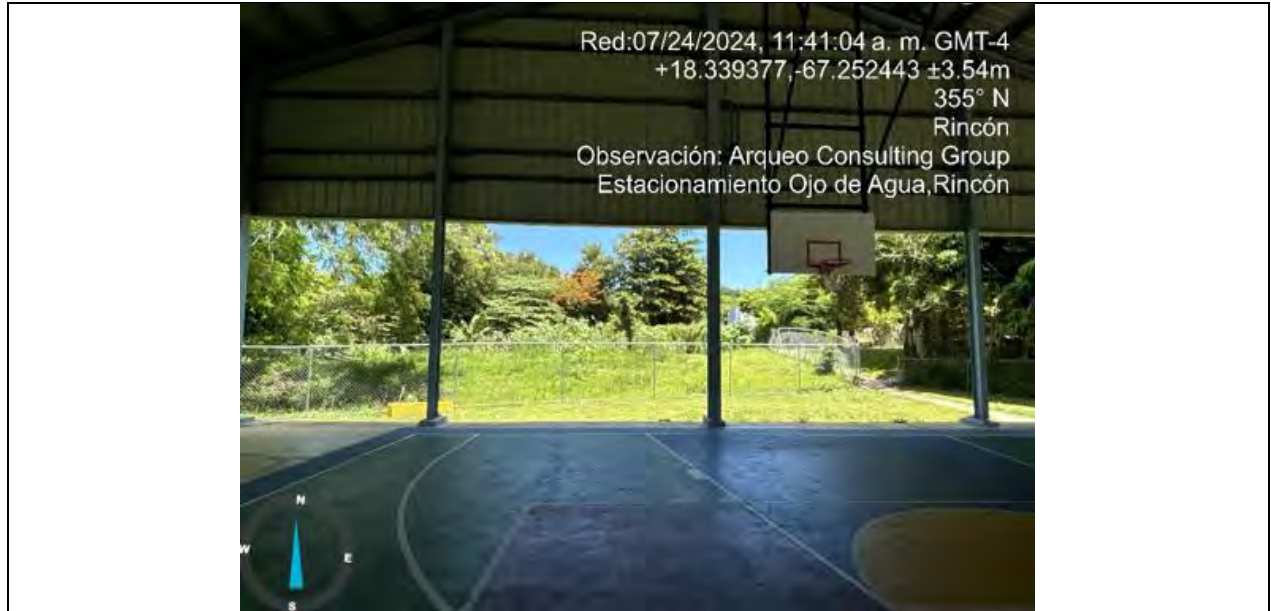
Photo #: 5	Description (North): View of the southwestern limit of the lot, south to north point of view. Yellow concrete drainage system at the center-left of the photo (between cyclone fence and metal post).
Date: /24/24

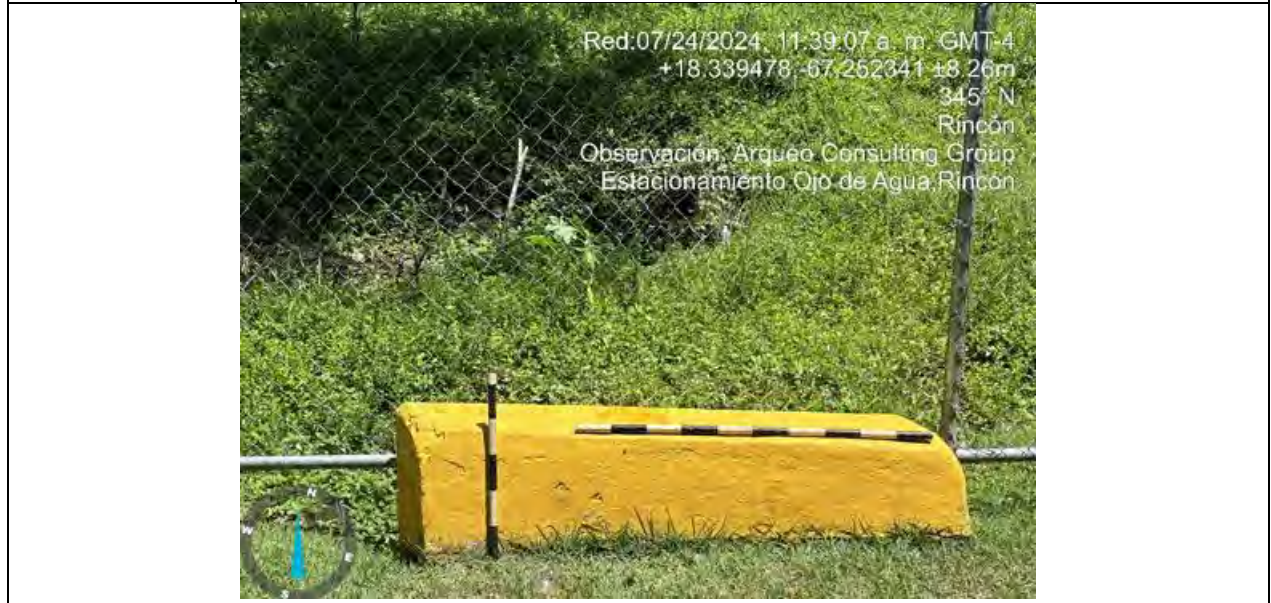
Photo #: 6	Description (North): Concrete drainage system located at the limit of the Residential Santa Rosa and the lot to be developed, near the basketball court. South to north vantage point.
Date: 7/24/24

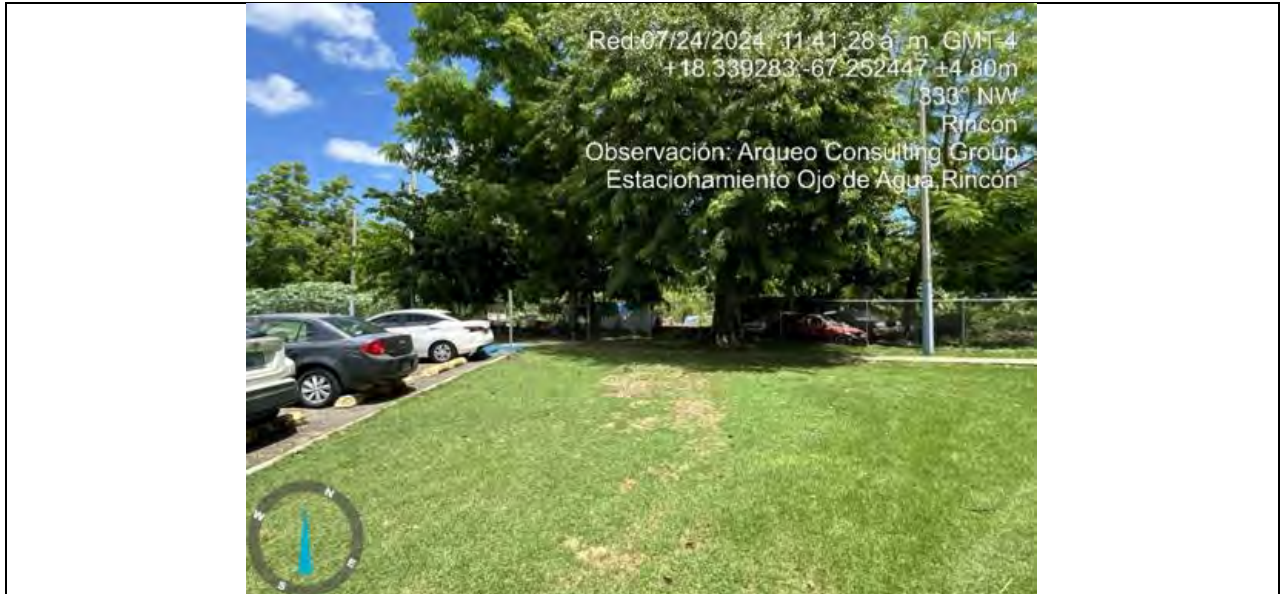
Photo #: 7	Description (Northwest): View towards the southern limit of the lot, south-southeast to north-northwest vantage point, middle section of the limit. Area of makeshift structures described at the site visit paragraph above.
Date: 7/24/24

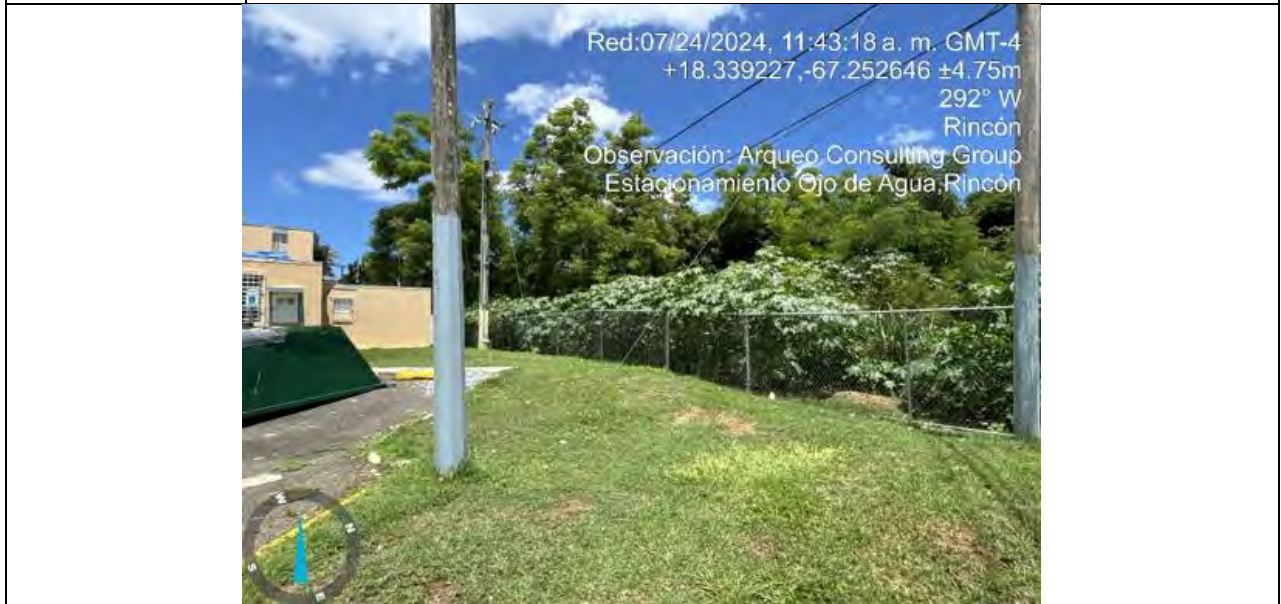
Photo #: 8	Description (West): View towards the southern limit of the lot, facing northwest. Area of makeshift structures described at the site visit paragraph above.
Date: 7/24/24

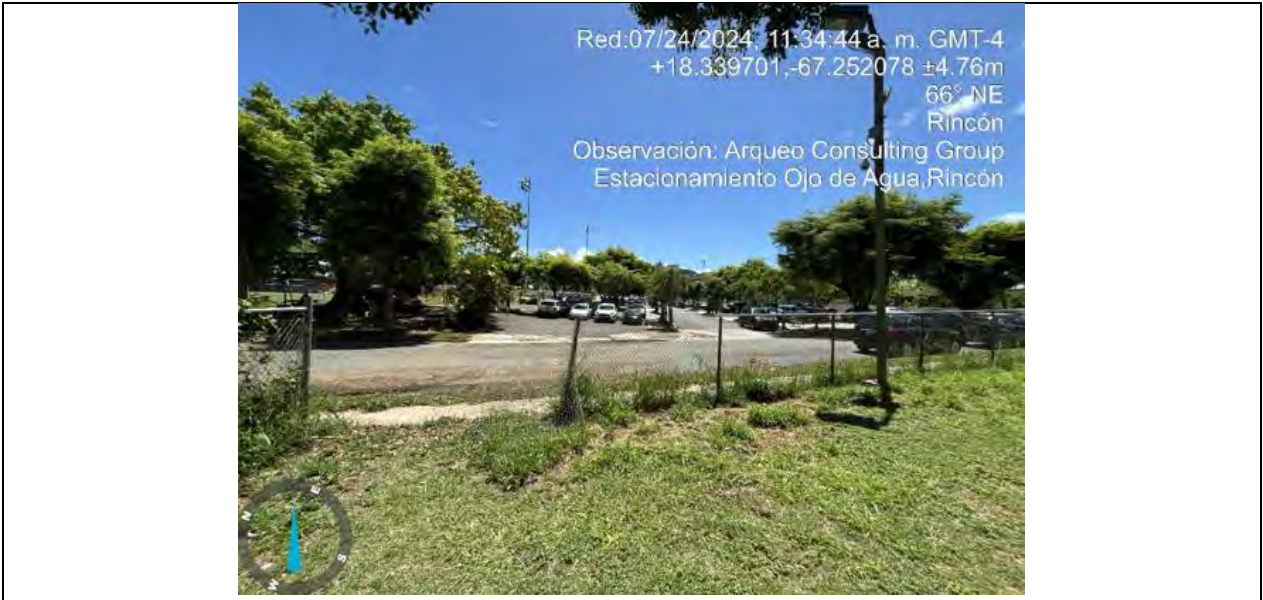
Photo #: 9	Description (Northeast): View towards the existing municipal public parking lot, Ojo de Agua St. and Progreso St., facing west from the eastern limit of the lot.
Date: 7/24/24

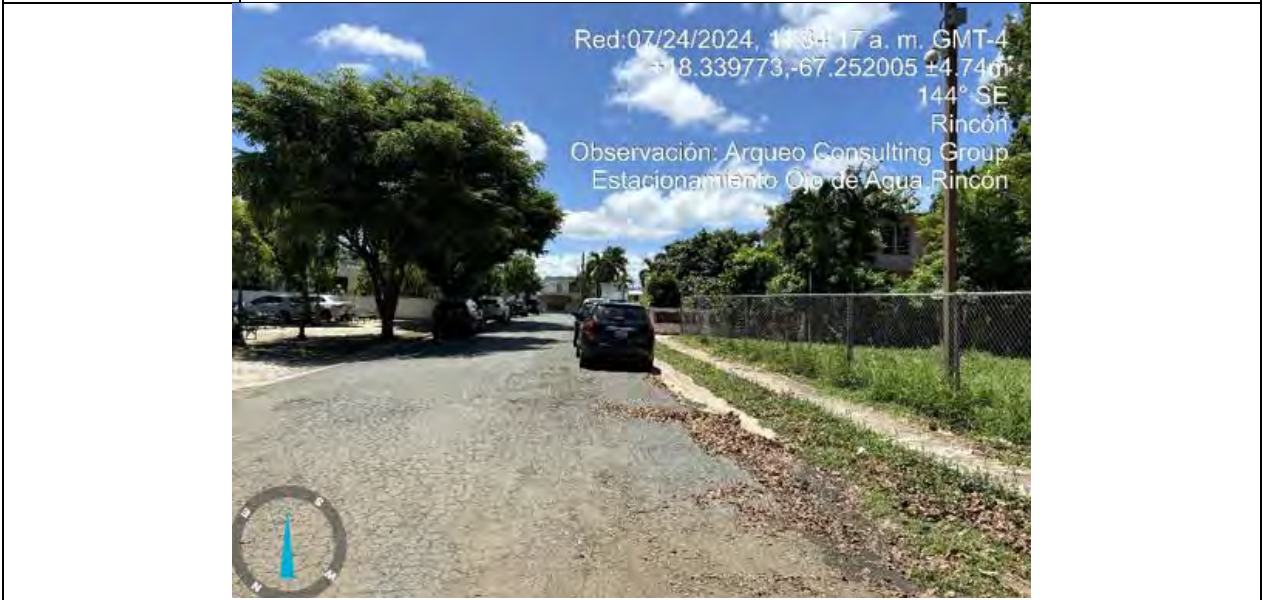
Photo #: 10	Description (Southeast): View towards Progreso St., northwest to southeast vantage point, cyclone fence is the limit of the eastern part of the lot to be developed.
Date: 7/24/24

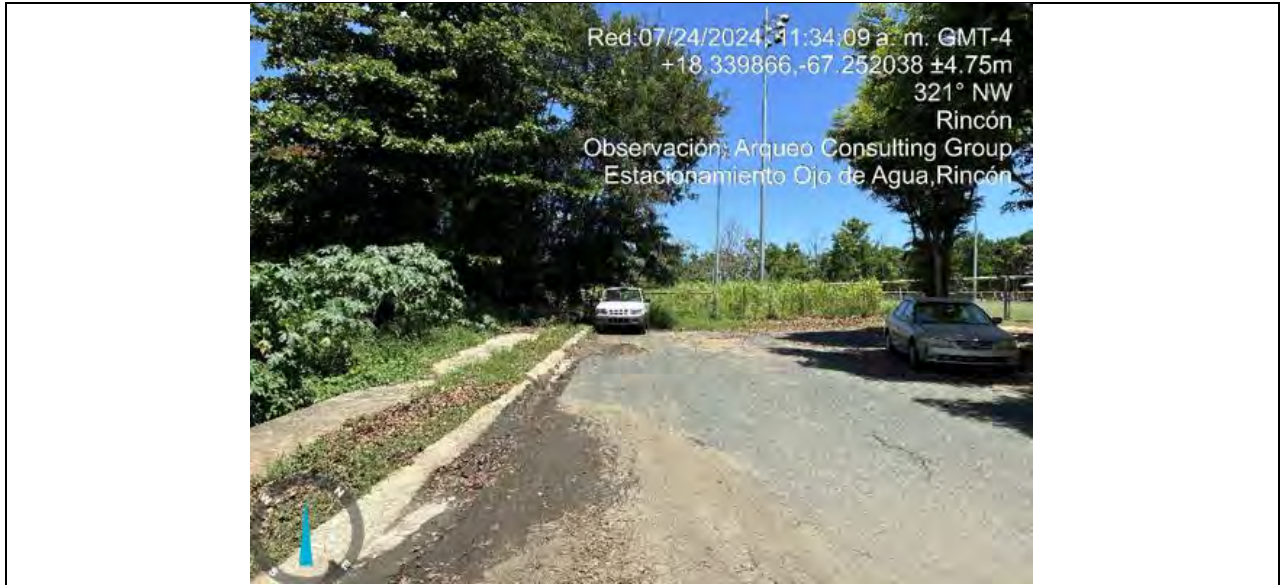
Photo #: 11	Description (Northwest): View towards the baseball field and the end of Progreso St, the northeastern limit of the lot to be developed is behind the white car, south to north vantage point. Side walk and castor bean (<i>ricinus communis</i>) bushes are part of the lot.
Date: 7/24/24

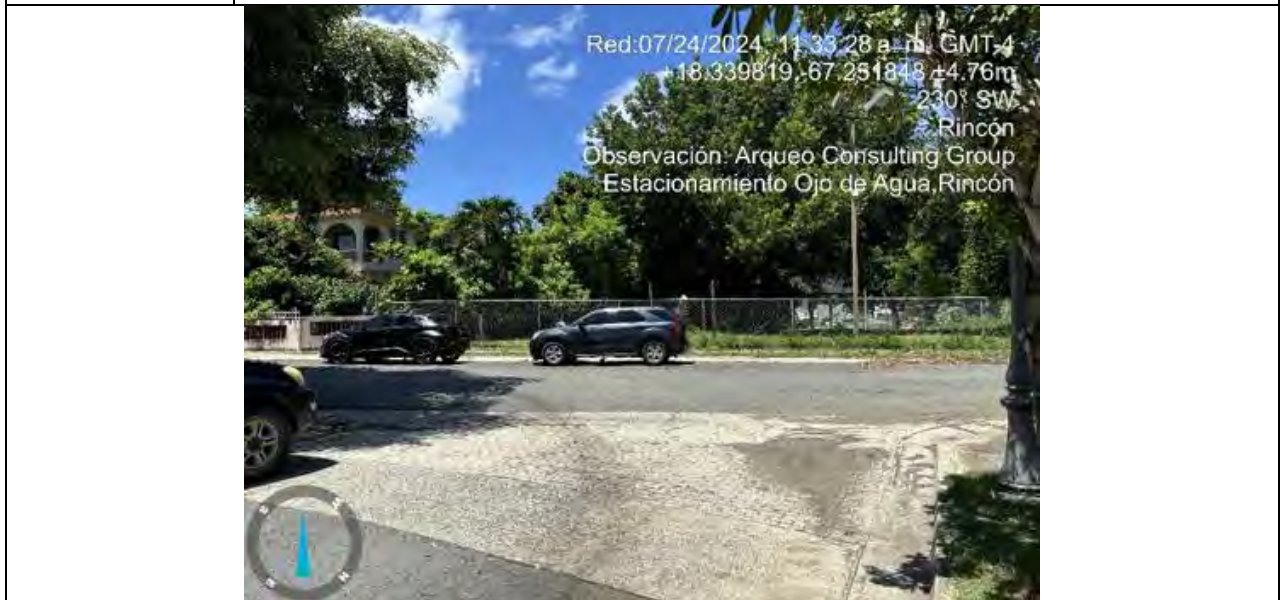
Photo #: 12	Description (Southwest): View of the southeastern limit of the lot to be developed, Progreso St, cyclone fence is the limit of the lot. Picture taken from Ojo de Agua St. corner facing southwest.
Date: 7/24/24

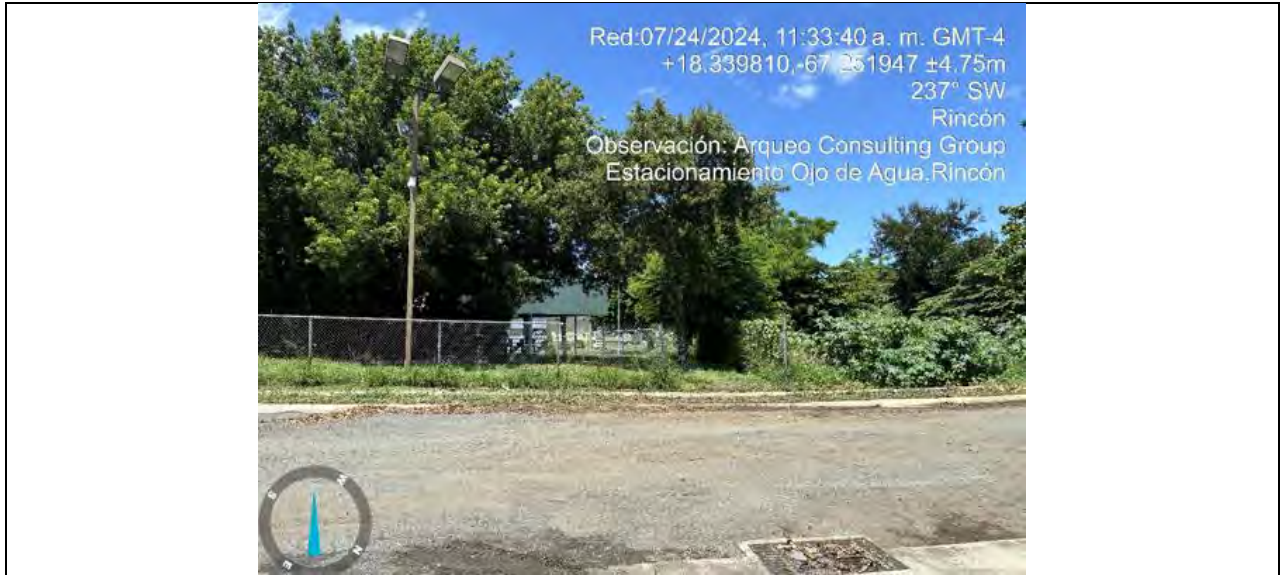
Photo #: 13	Description (Southwest): View towards the eastern limit of the lot to be developed. Cyclone fence and castor bean (<i>ricinus communis</i>) bushes are part of the lot. Facing southwest.
Date: 7/24/24

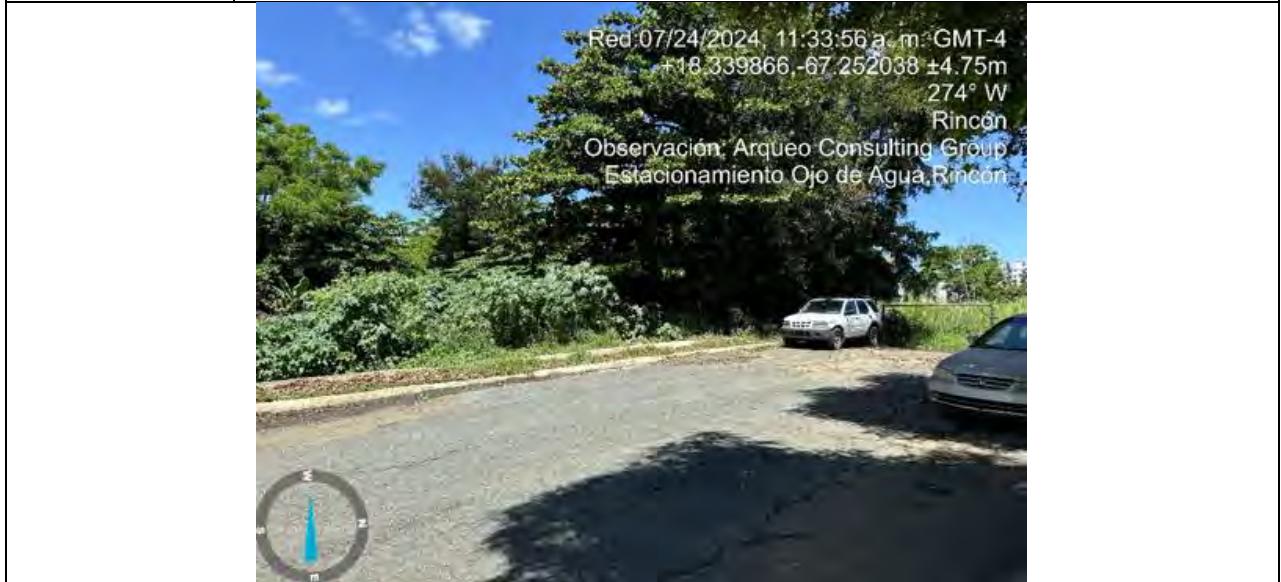
Photo #: 14	Description (West): View towards the northeastern limit of the lot to be developed. Northeastern corner of the lot behind the white car in line with the cyclone fence. Northern end of Progreso St. facing west.
Date: 7/24/24

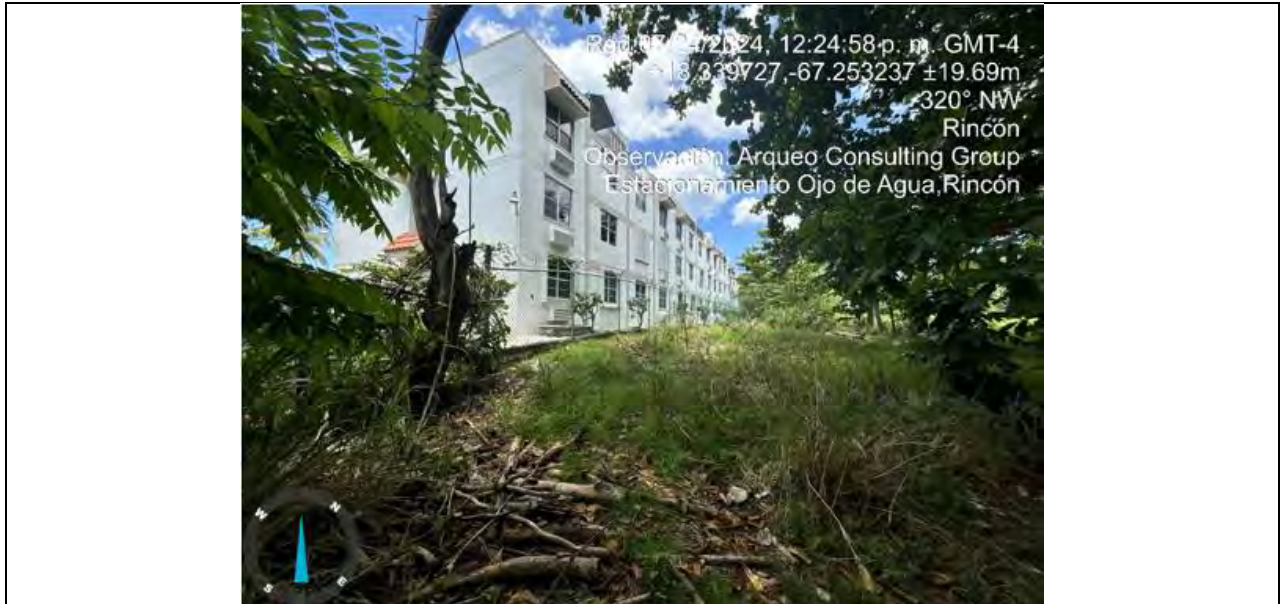
Photo #:15	Description (Northwest): View towards the northwestern limit of the lot to be developed, at the end of the Chalet del Mar Condominium cyclone fence. Facing northwest.
Date: 7/24/24

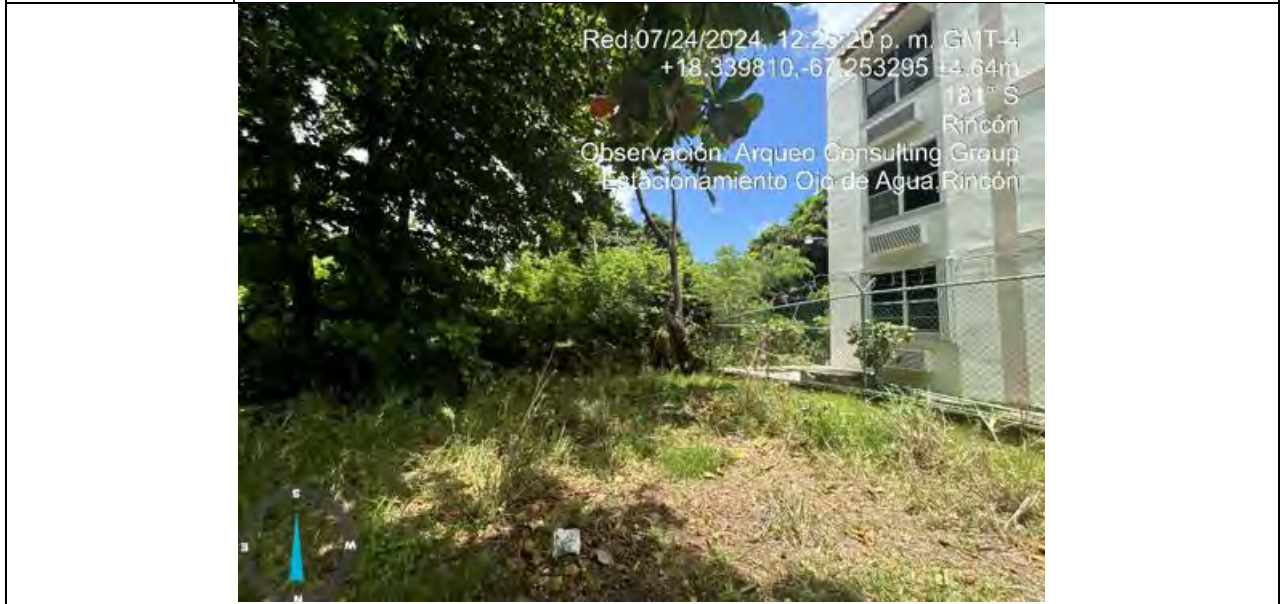
Photo #:16	Description (South): View towards the northwestern limit of the lot to be developed, at the end of the Chalet del Mar Condominium cyclone fence. North to south vantage point.
Date: 7/24/24

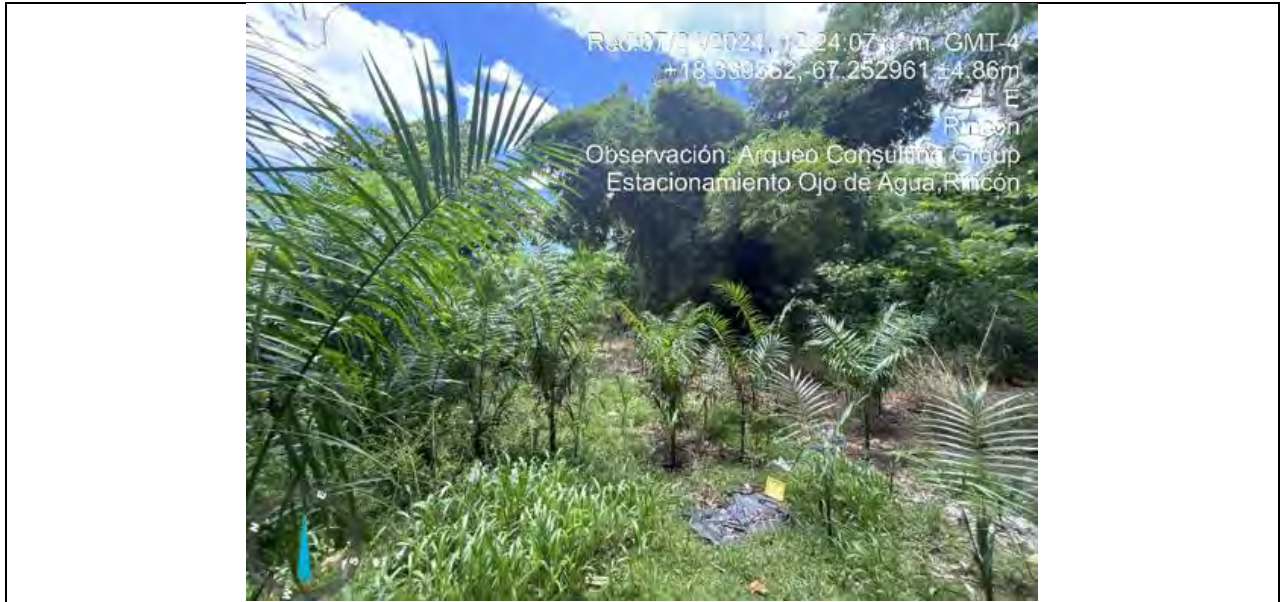
Photo #:17	Description (East): View towards the lot to be developed from the western limit, west to east vantage point, near the middle of the western limit.
Date: 7/24/24

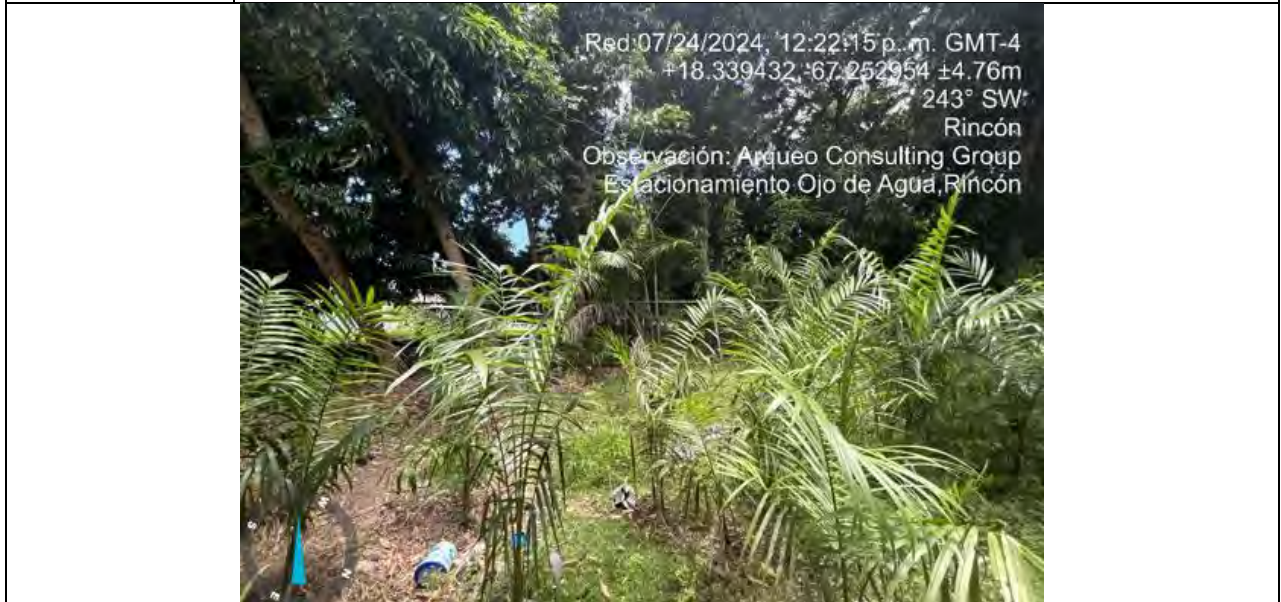
Photo #:18	Description (Southwest): View towards the western limit, east to west vantage point, near the middle of the western limit. Cyclone fence observed is the limit of the lot to be developed.
Date: 7/24/24

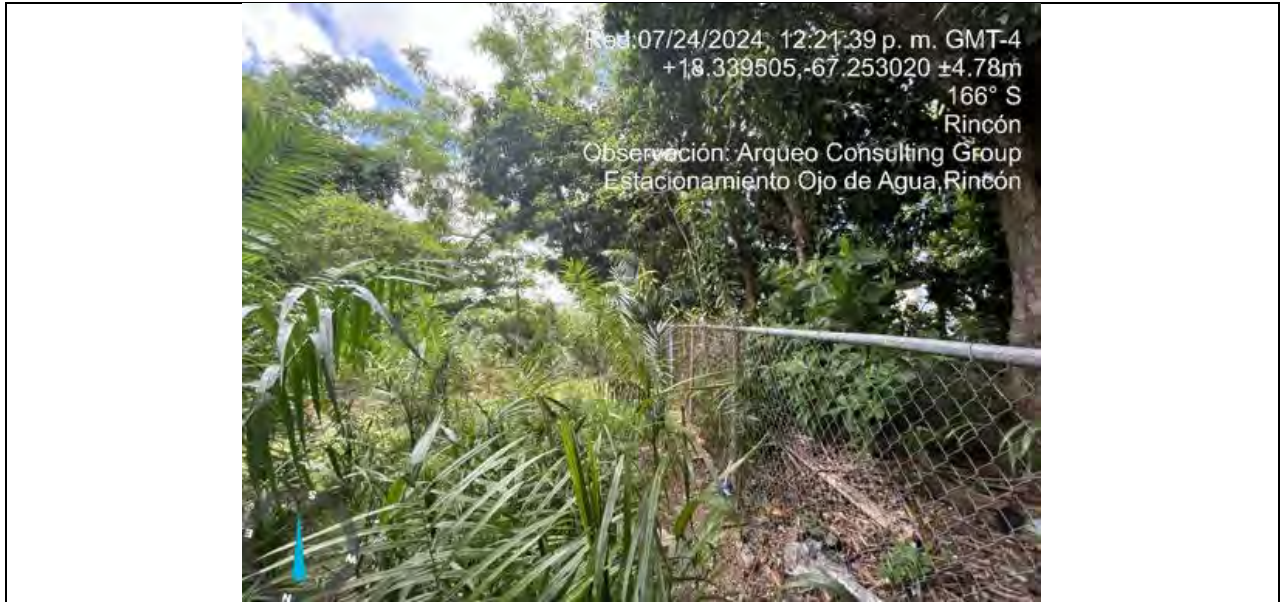
Photo #: 19	Description (South): View of the western limit of the lot, looking towards the south. Cyclone fence is the property limit.
Date: 7/24/24

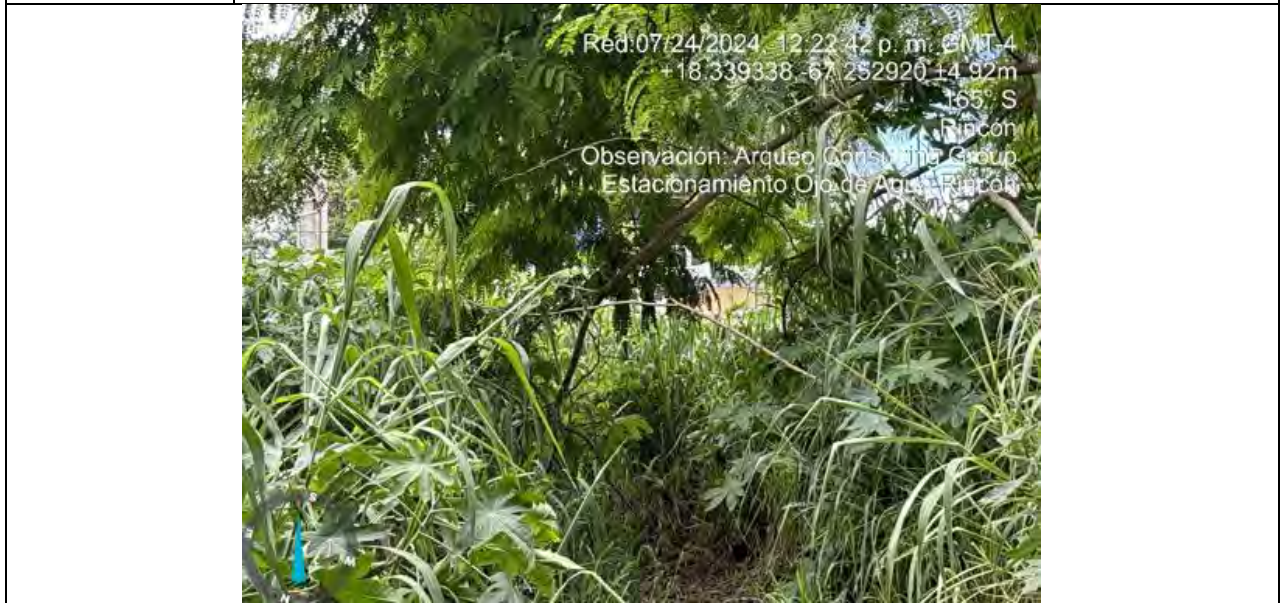
Photo #: 20	Description (South): View towards the southwestern end of the lot to be developed, north to south advantage point. Among the leaves of the acacia trees and tall grass. Residencial Santa Rosa can be seen through the vegetation.
Date: 7/24/24

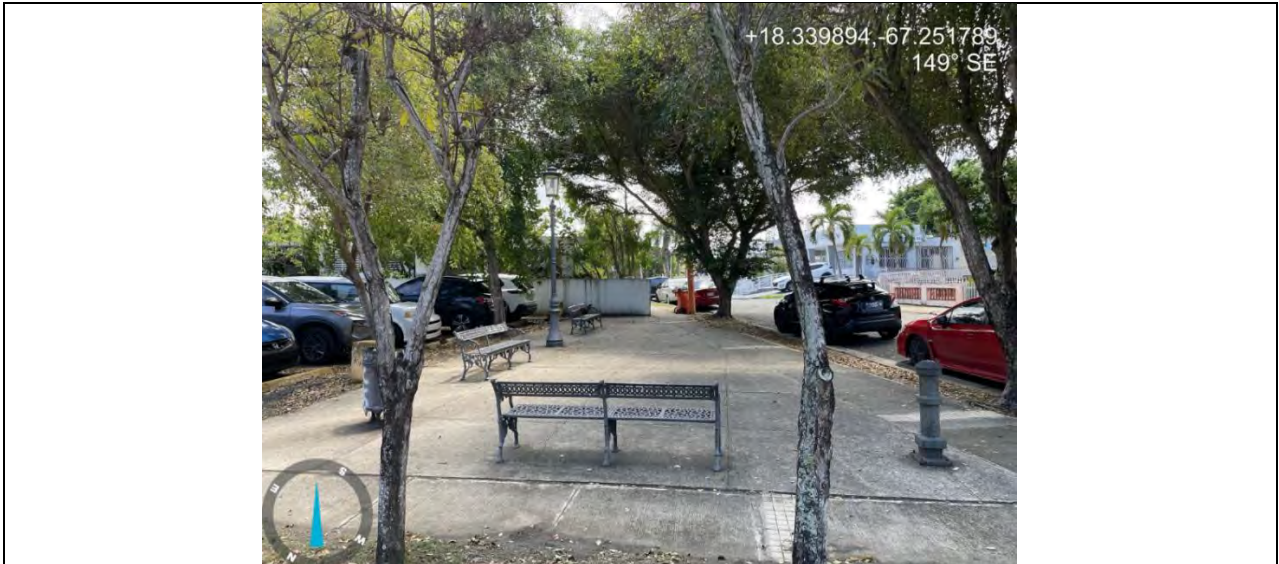
Photo #:25	Description (Southeast): View of park located on the southwest corner of the municipal parking lot (within the project perimeter). The recreation space has a concrete floor and benches, a trash bin, a lamp post and a bollard (all made of metal).
Date: 7/24/24

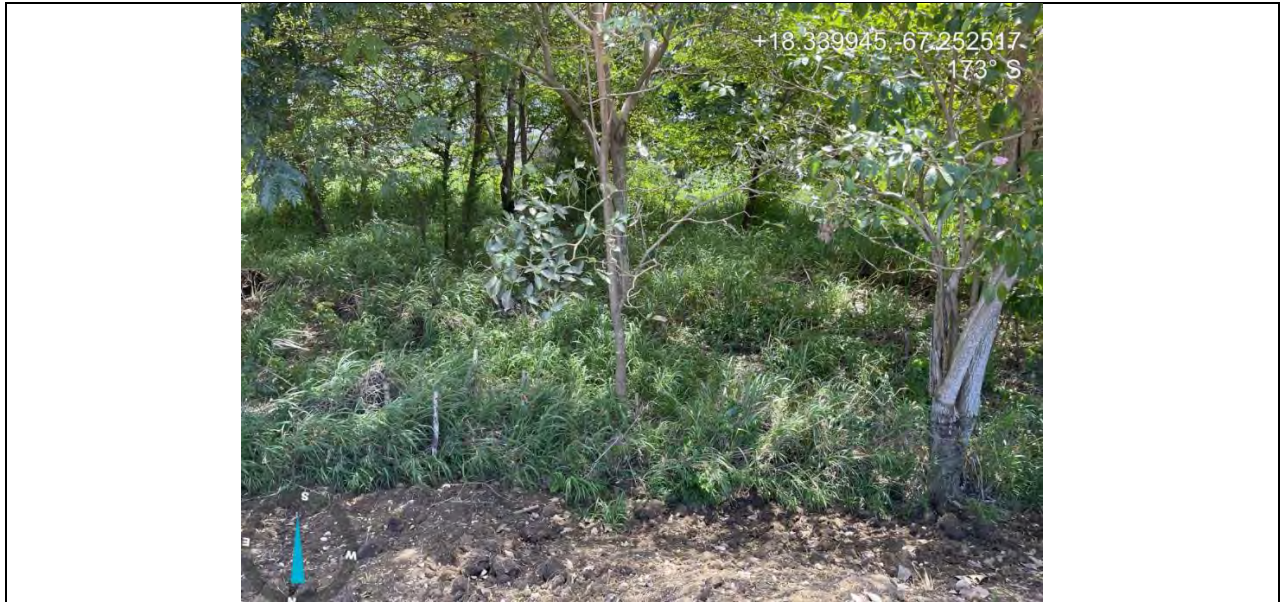
Photo #: 27	Description (South): View of the northern perimeter of the central portion of the project lot, seen from the neighboring lot. Parcel is covered in trees and grasses.
Date: 7/24/24

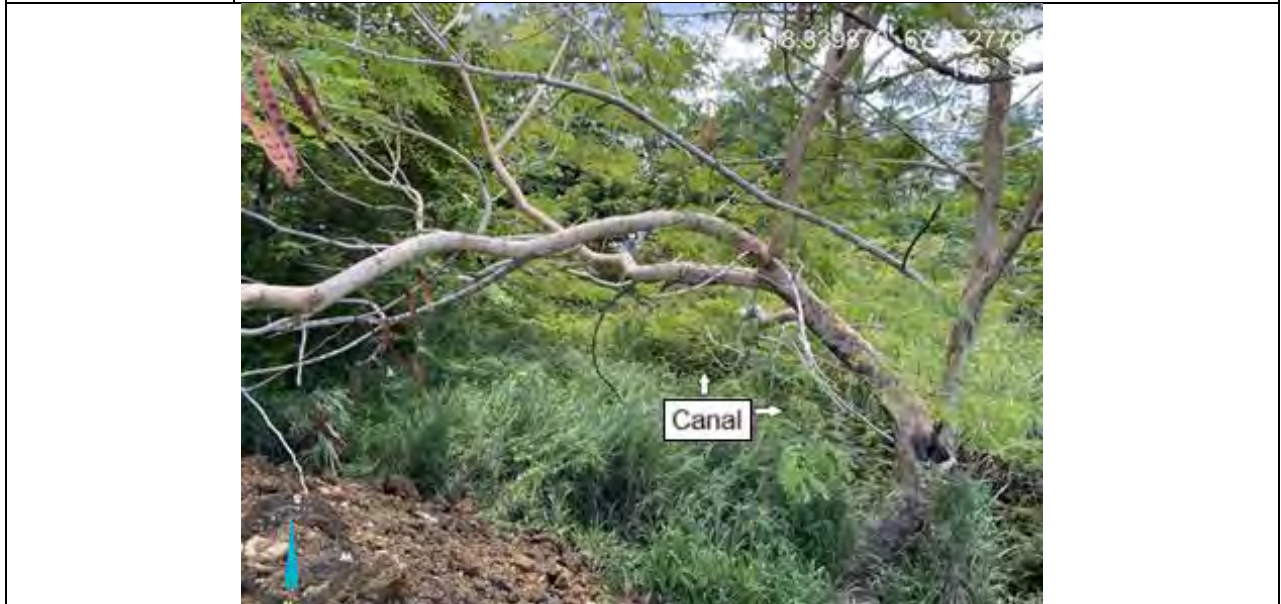
Photo #: 28	Description (South): View of the project area's northern northern perimeter from the neighboring lot. The Ojo de Agua canal can be seen through the vegetation flowing from east to northwest.
Date: 7/24/24

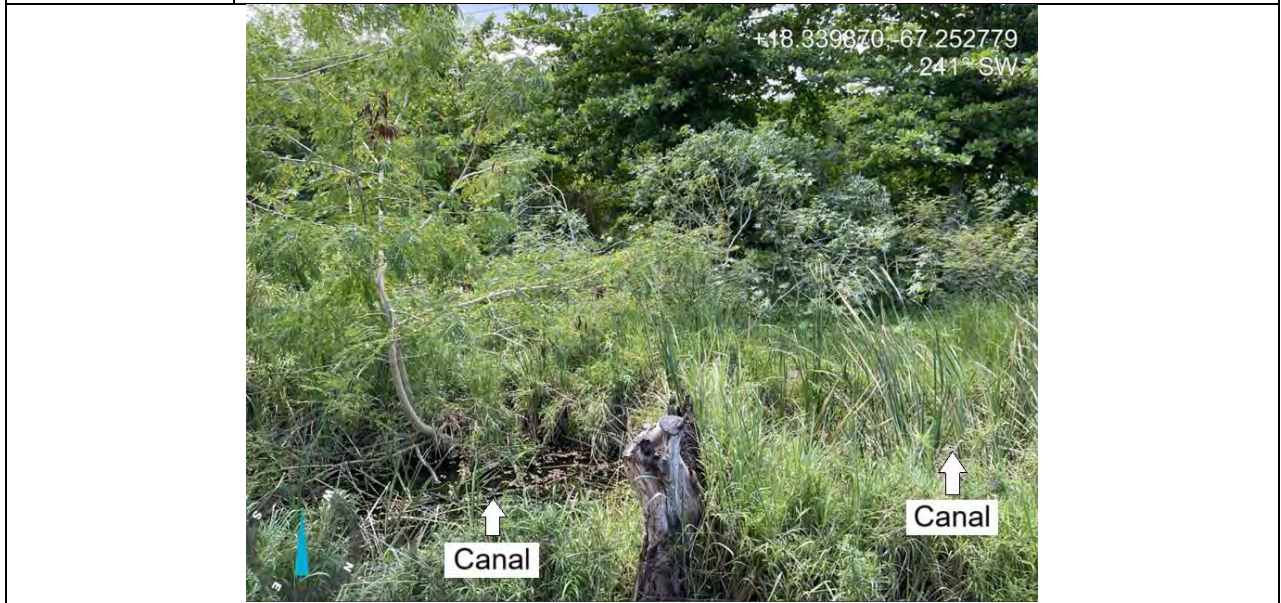
Photo #:30	Description (West-southwest): View of canal as it flows through the northern portion of the project area towards the neighboring lot to the north.
Date: 7/24/24

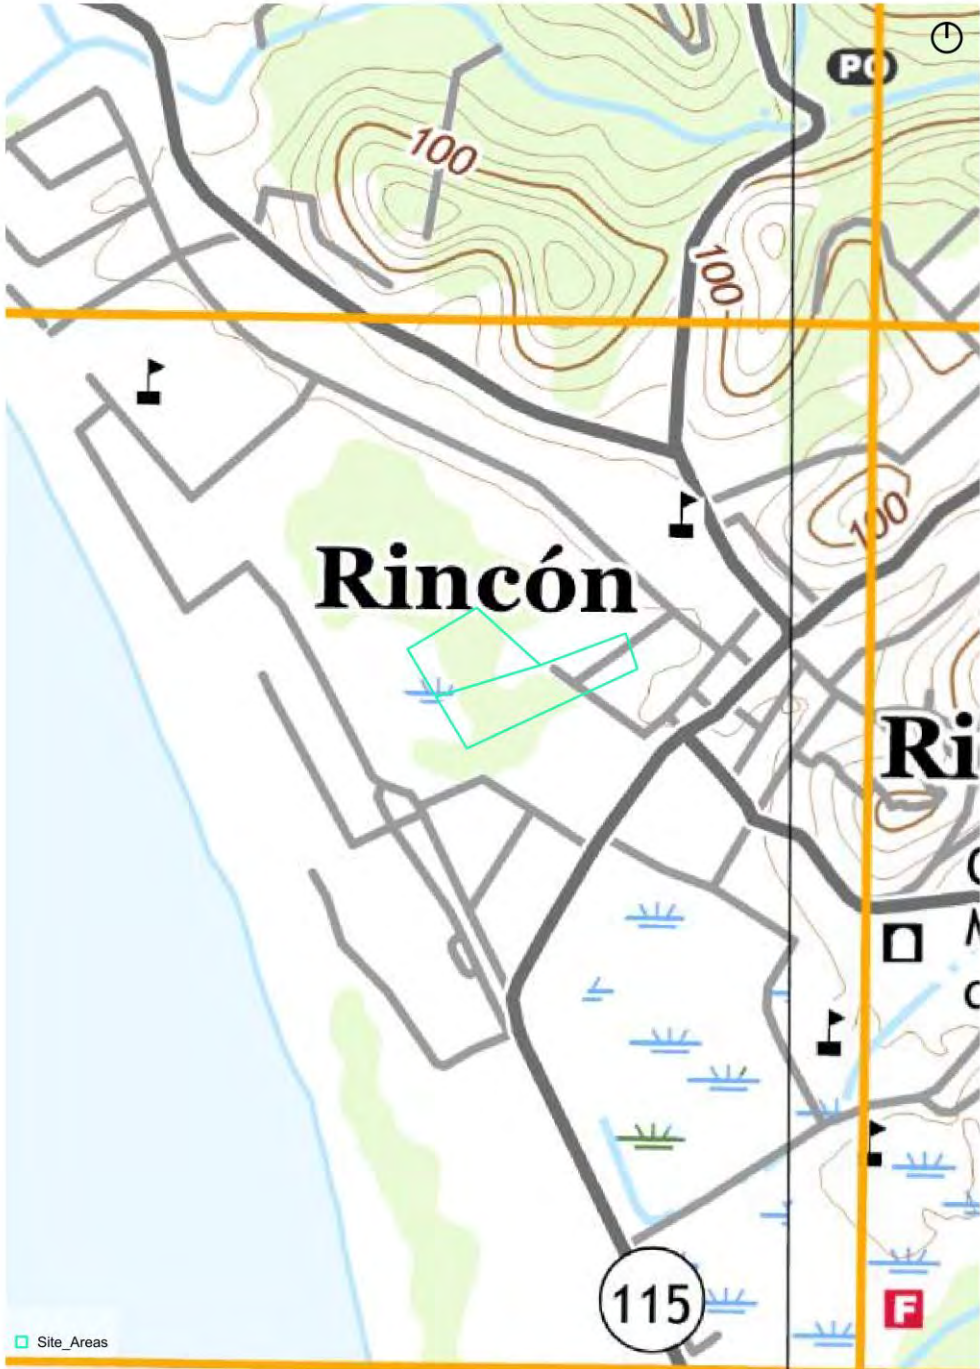
FIGURE 1-1
USGS TOPOGRAPHIC QUADRANGLE

The general composition of the area is mainly vegetation areas and areas occupied by a homemade structure that are located within the project area (See **Figures 1-1, 1-2**). The homemade structures are used for raising chickens and farm animals such as goats. The other main composition in the project area is the main rainwater canal/ditch which travels mainly in the center of the area divides the main site area into two sub-areas.

USGS 2018 Topographic quadrangle “Rincon-OE-W-20181016” (see **Figure 1-1**) shows an identified marsh symbol in the location where NWI locates PEMF1. The topographic quadrangle does not show any waterways or surface waterbodies in the area. Also, floodplain maps were checked via the Federal Emergency Management Agency (FEMA)

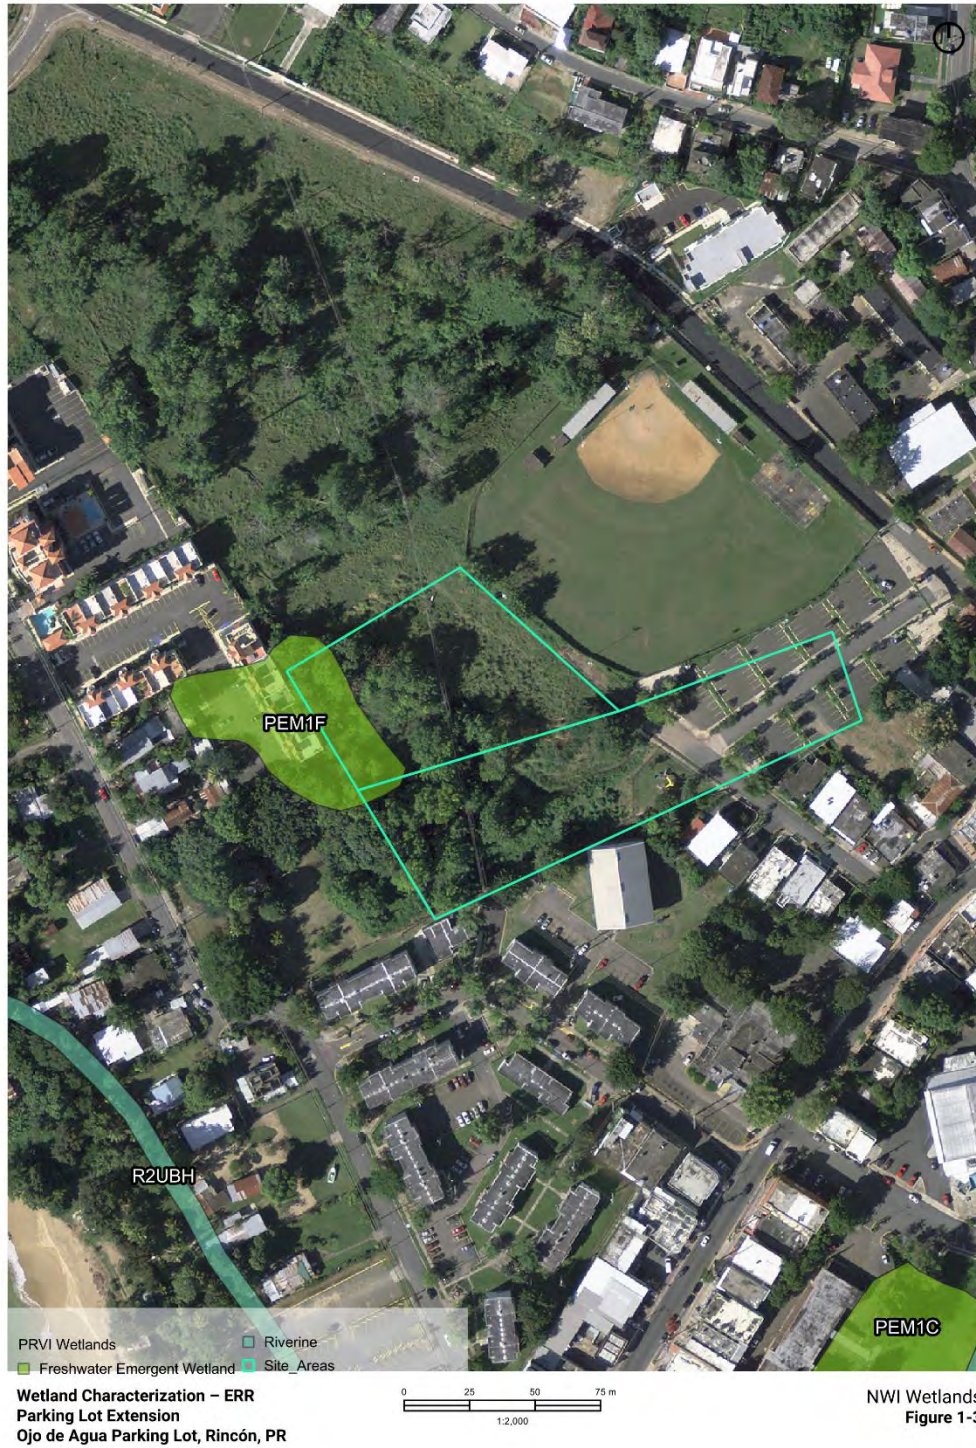
FIGURE 1-3
NWI – PEM1F

The National Wetland Inventory (NWI) identifies an Emergent Freshwater Wetland (EFW) identified as PEM1F to the northwest of the proposed project area.
