Environmental Assessment Determinations and Compliance Findings for HUD-assisted Projects 24 CFR Part 58

Project Name: Estacionamiento Urbano – PR-CRP-000505

Project Location: Parque Street, Bo. Pueblo Rincón, PR 00677

Description of the Proposed Project [24 CFR 50.12 & 58.32; 40 CFR 1508.25]:

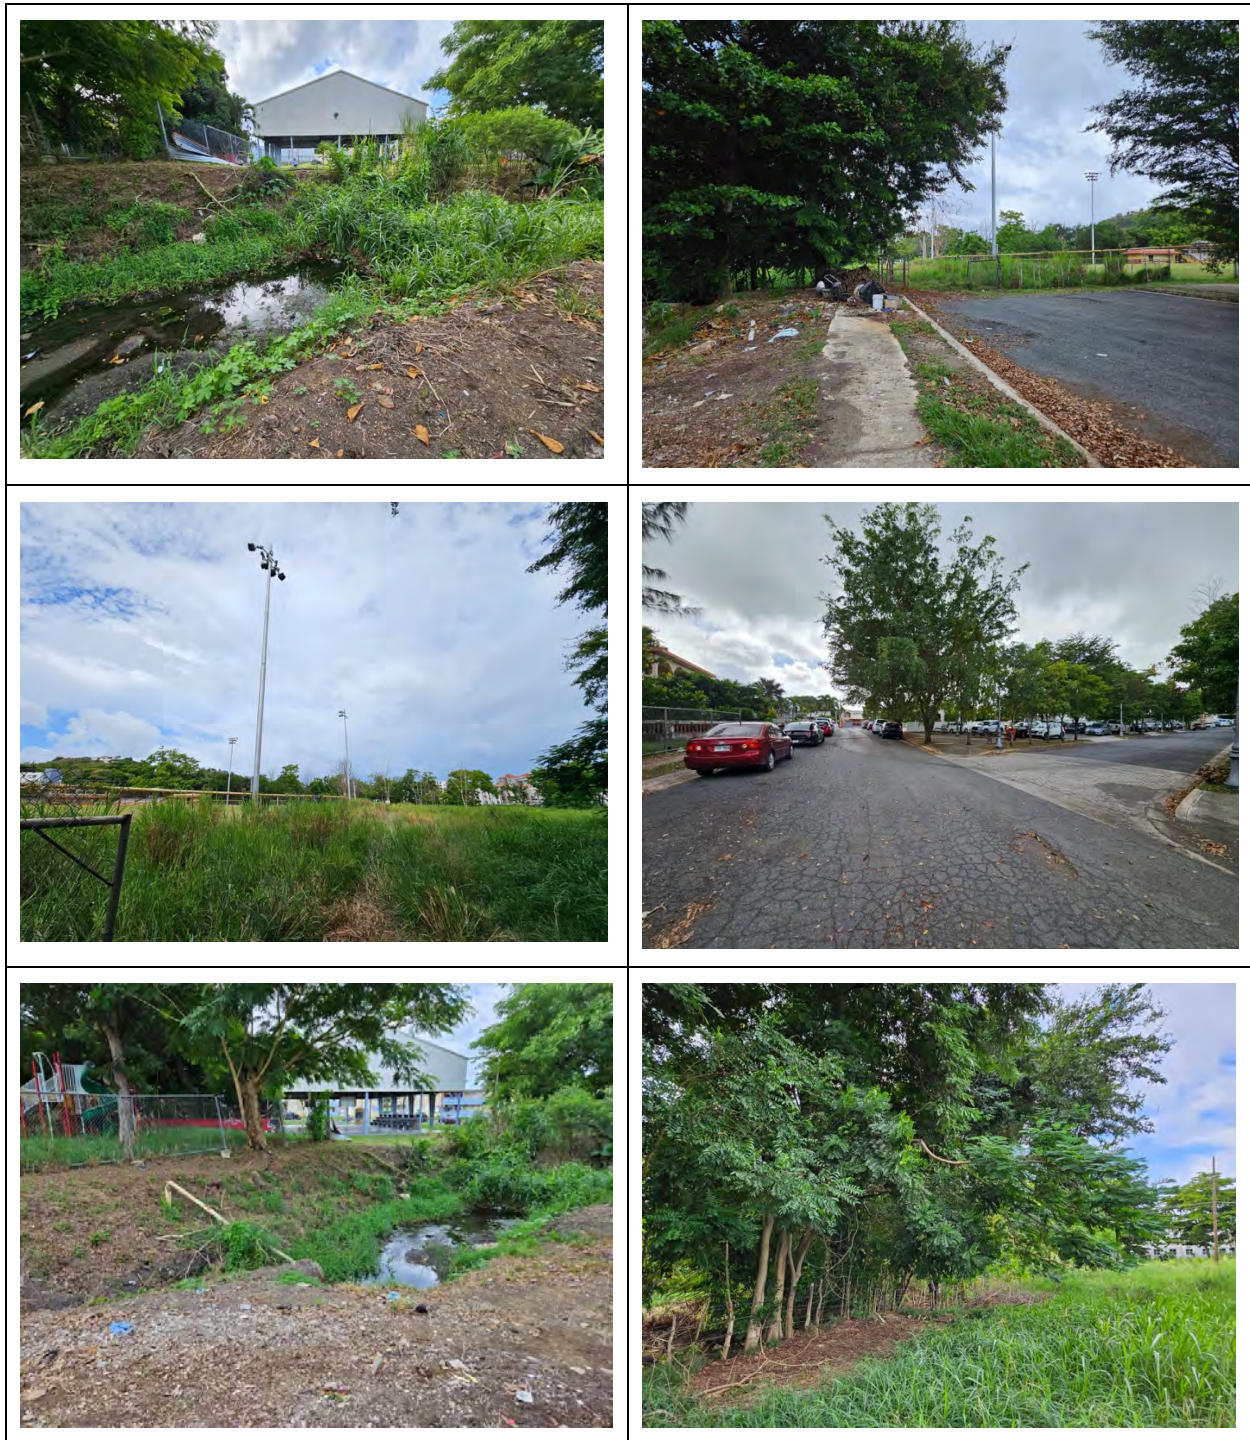
1. Estacionamiento existente y área de expansión
