Environmental Assessment

Determinations and Compliance Findings for HUD-assisted Projects

Project ID: PR-RGRW-00433

Project Name: FINCA GAIA LLC

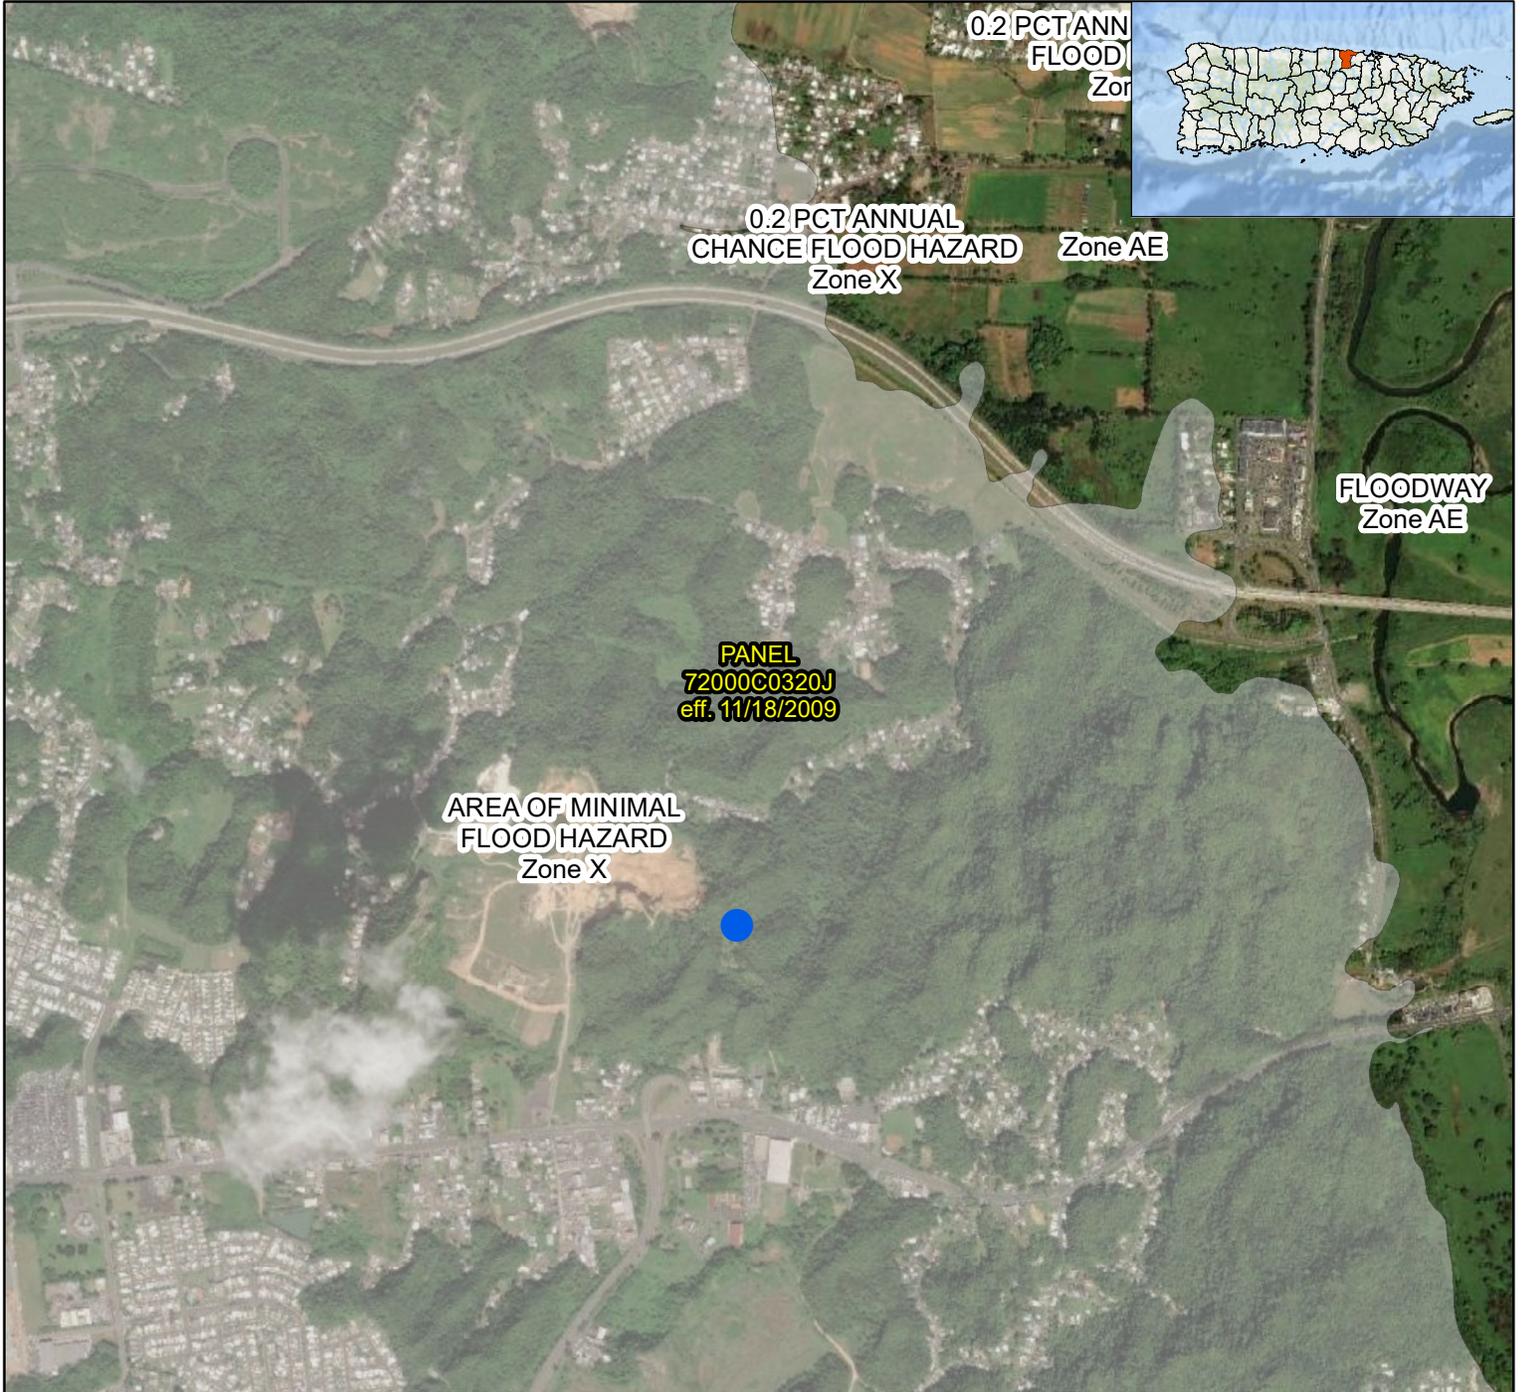
- PR-RGRW-00433
- Area of Minimal Flood Hazard Zone X
- FIRM Panel

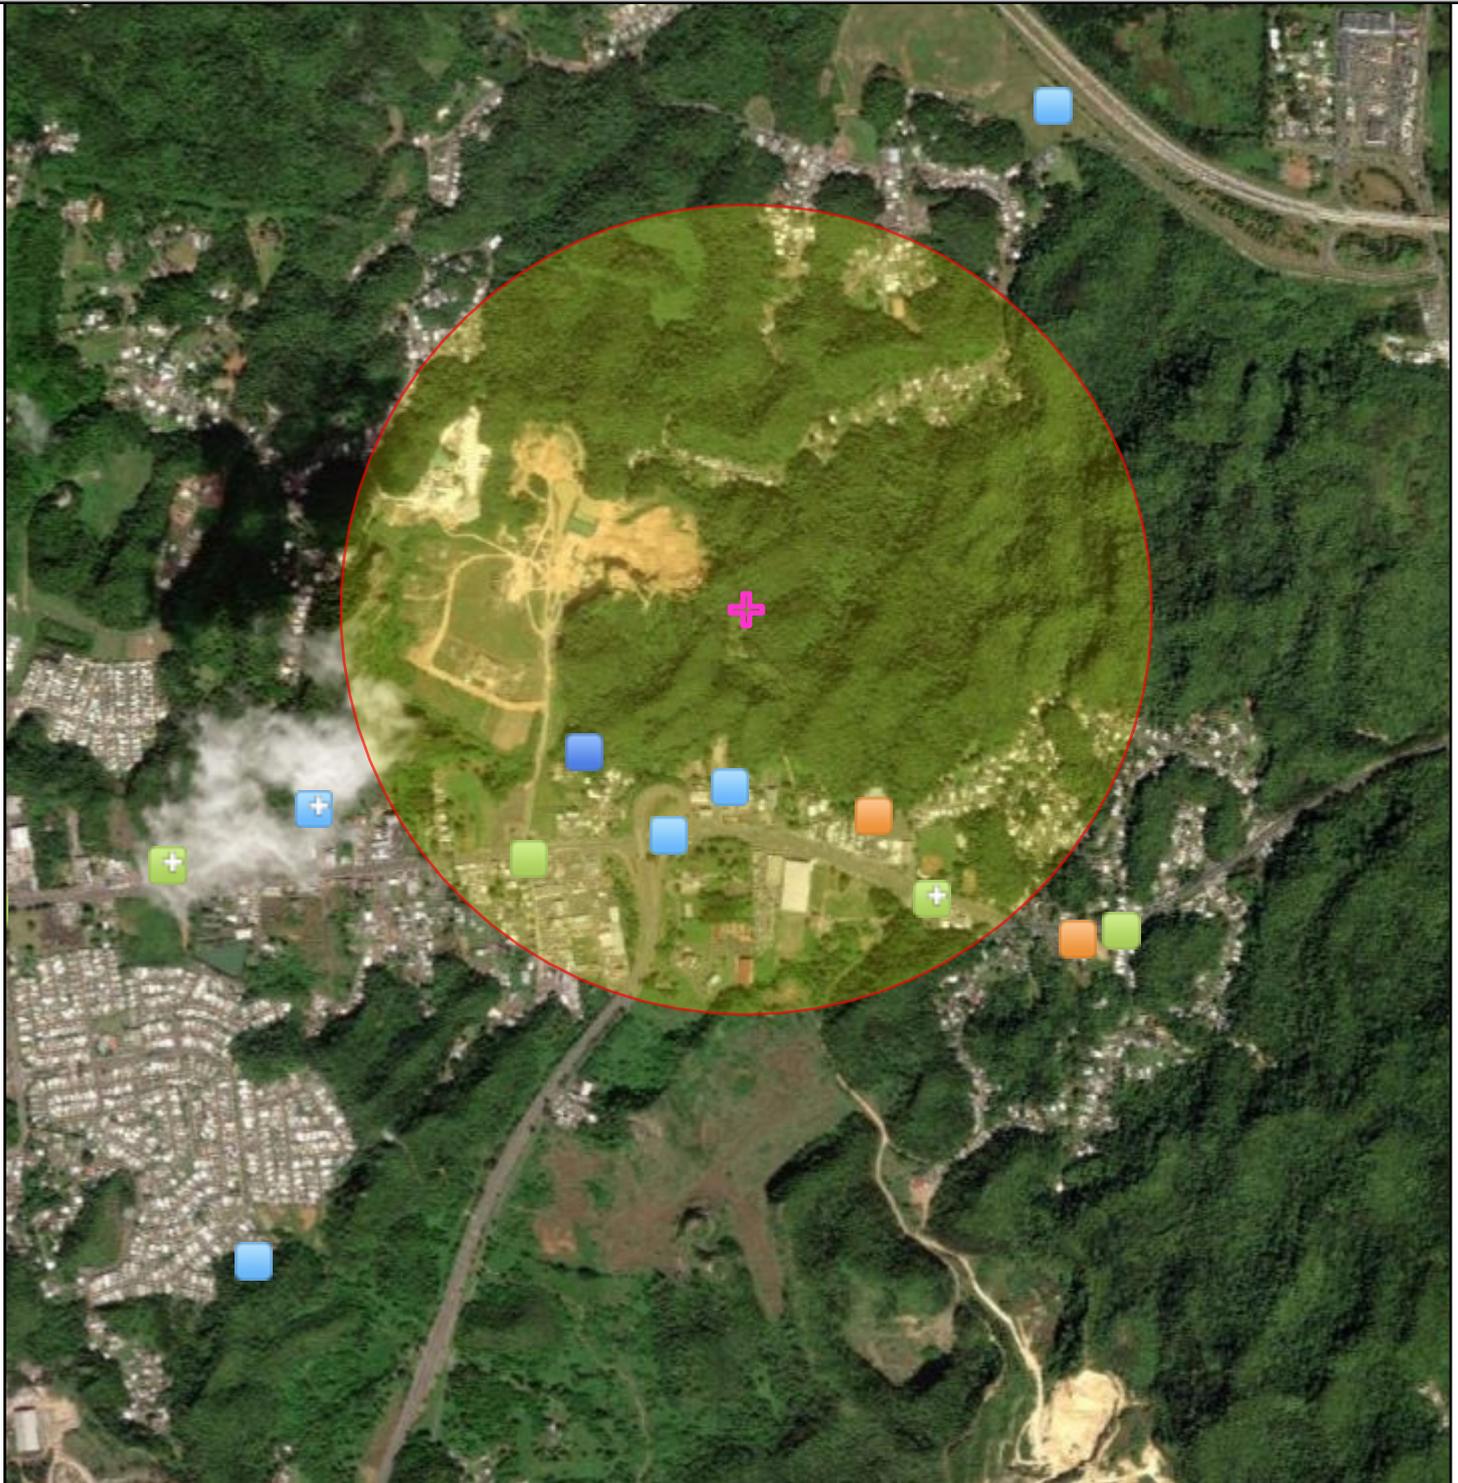
Figure 6: Toxic and Hazardous Facilities

- Superfund (NPL)
- Hazardous Waste (RCRAInfo)
- Water Dischargers (NPDES)
- 3,000 Ft. Buffer
- Air Pollution (ICIS-AIR)
- + PR-RGRW-00433

Based on EPA Enforcement and Compliance History Online (EPA ECHO) there are no violations reported. See Appendix 3.

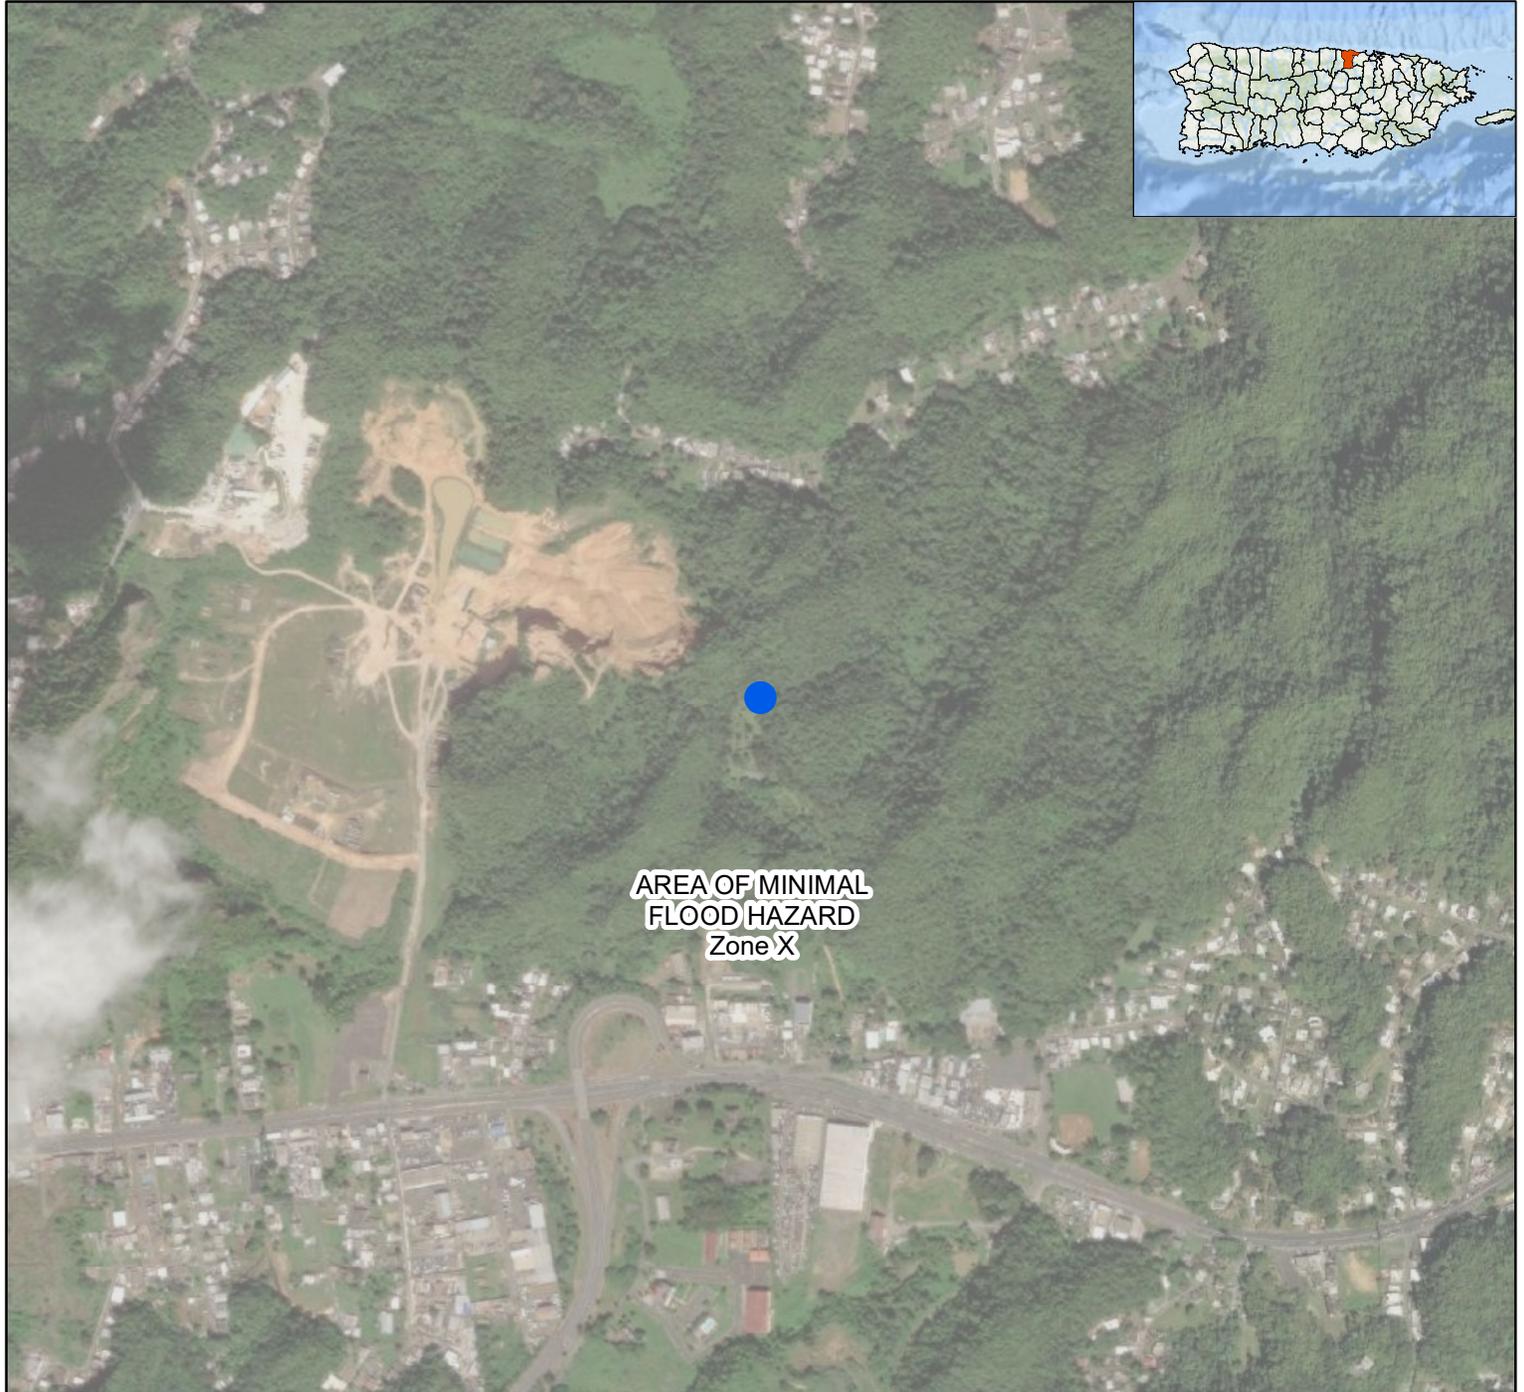
- PR-RGRW-00433
 - 0.2-percent annual chance flood
 - 1-percent annual chance flood
- Flood Zone**
- 0.2% Annual Chance Flood
 - Area of Minimal Flood Hazard Zone X

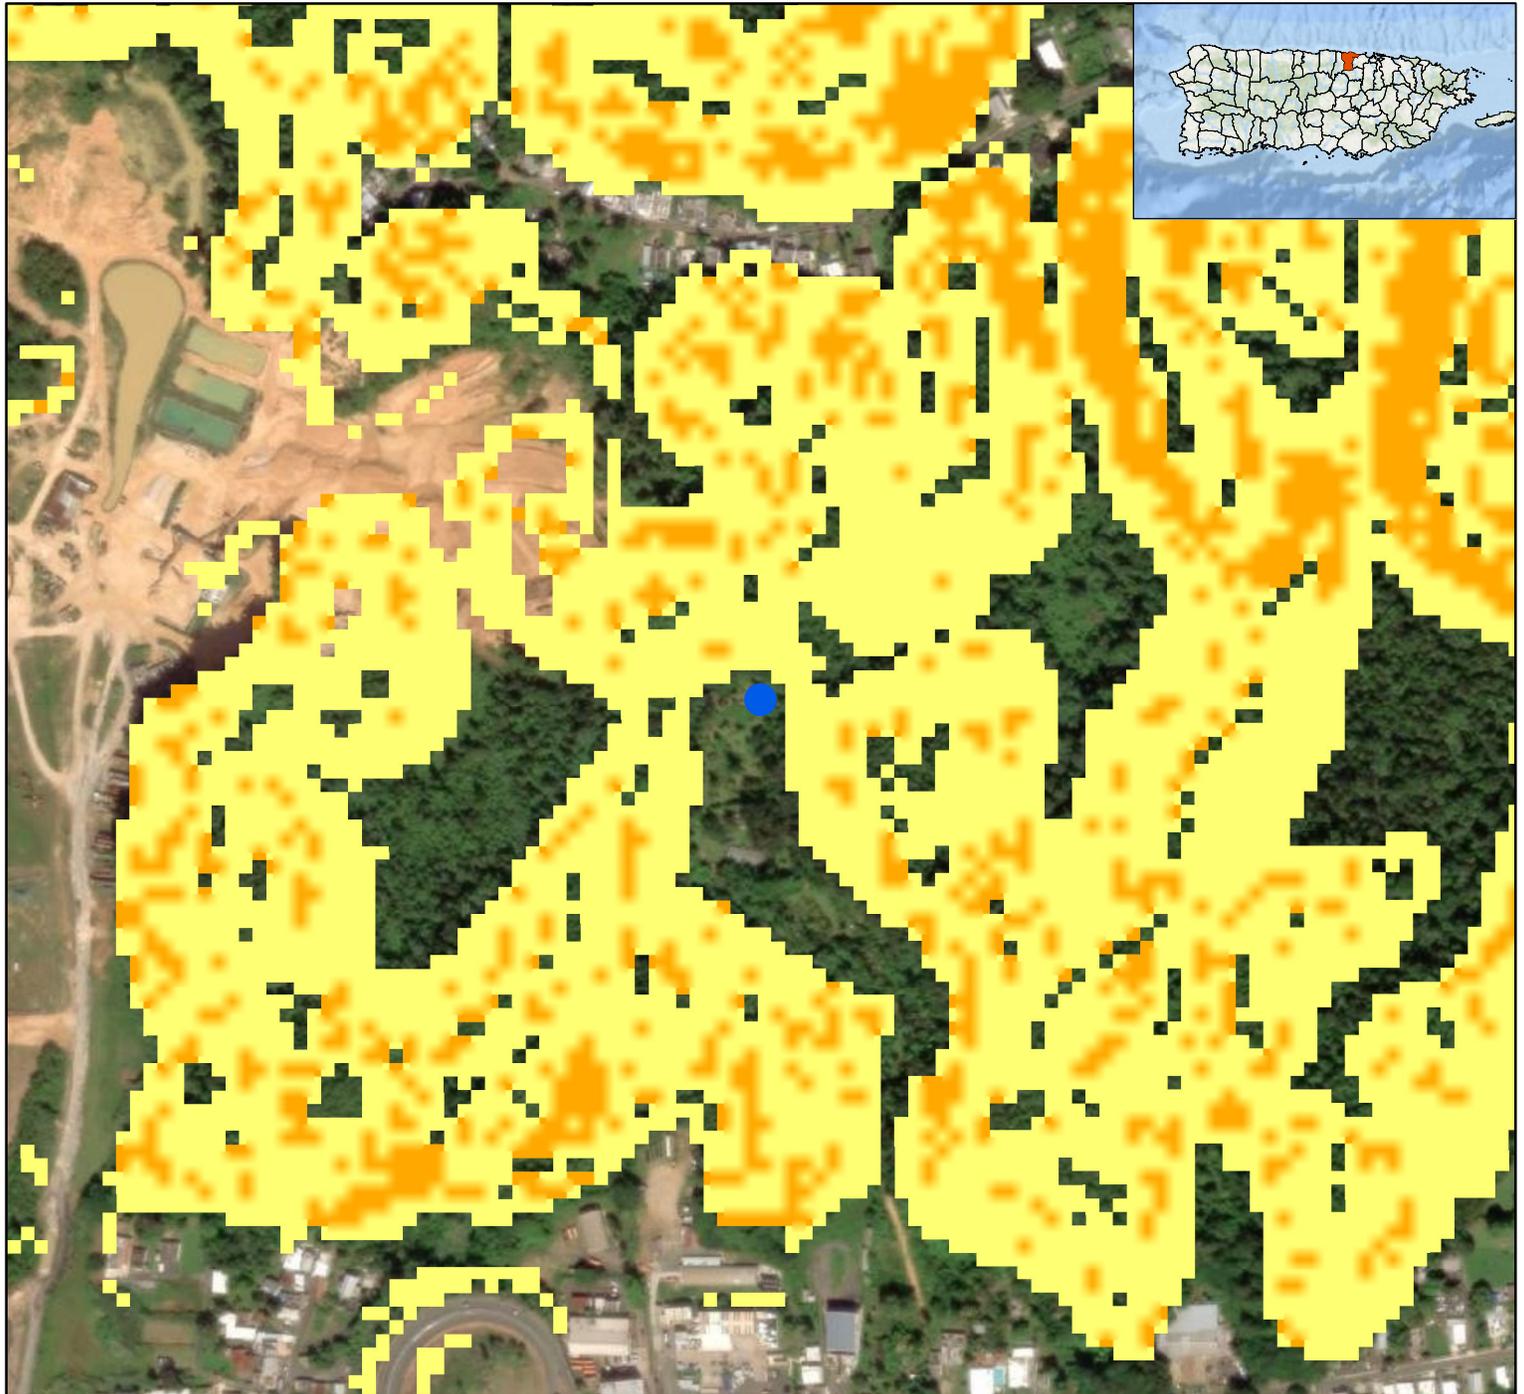
- PR-RGRW-00433
- Low
- Moderate
- High
- Very High
- Extremely High

proposed project activities. There will be no additional runoff associated with the project. See Landslide Susceptibility Map, Figure 14.
Hazards and Nuisances including Site Safety and Noise	2	The project consists of installing/constructing a 400-foot-long water well with a transitional diameter of 12 inches for the initial 40 feet and a subsequent diameter of 10 inches for the remaining 360 feet. There are no specific environmental hazards that have been identified for this site. The site is not in a high Noise Level area. The project does not include housing or such to where inhabitants would be affected.
Energy Consumption	2	The project consists of installing/constructing a 400-foot-long water well with a transitional diameter of 12 inches for the initial 40 feet and a subsequent diameter of 10 inches for the remaining 360 feet on an existing agricultural farm. The power needed to operate the water well pump will come from a portable diesel generator supplied by the applicant. No new connection for power will be necessary.

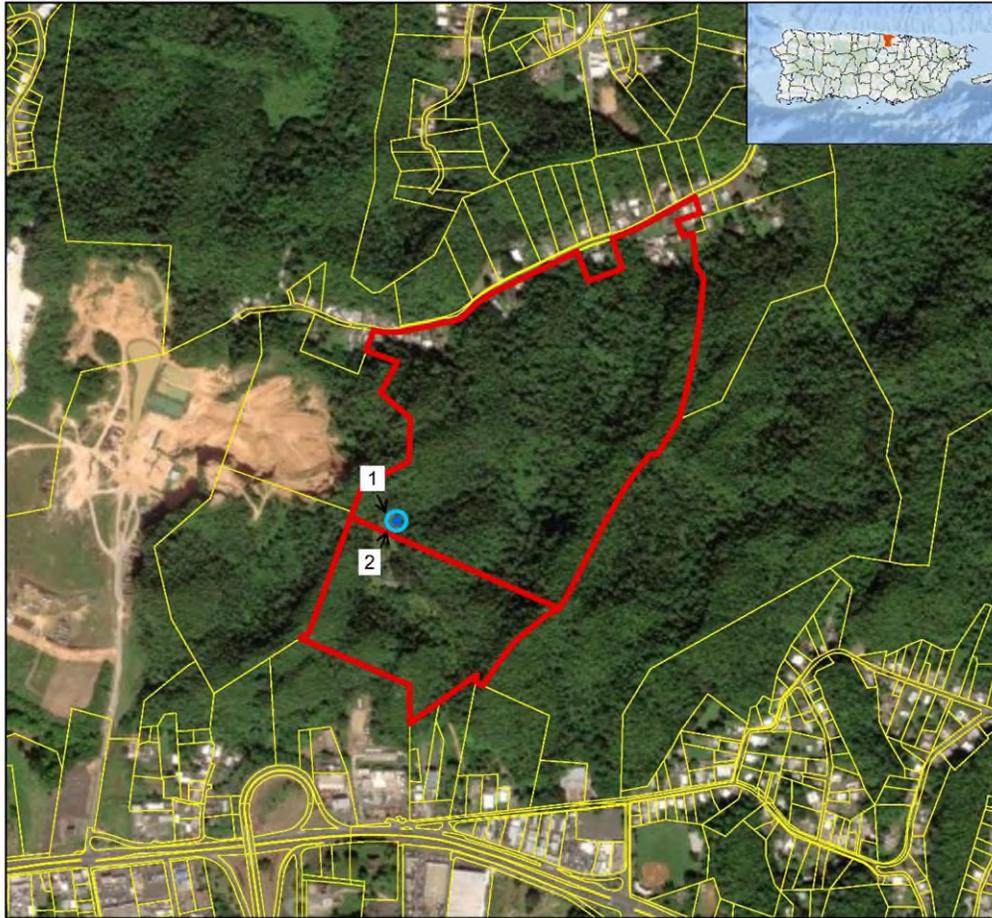
- Area of Potential Effect
- PR-RGRW-00433
- Parcels
- CRIM_PARCELAS_2018

As defined in 36 CFR §800.16(d), the area of potential effects (APE) is the geographic area or areas within which an undertaking may directly or indirectly cause changes in the character or use of historic properties if any such properties exist. Based on this definition and the nature and scope of the Undertaking, the Program has determined that the direct APE for this project is the location of the water well plus a 15-meter buffer and the visual APE is the viewshed of the proposed project.

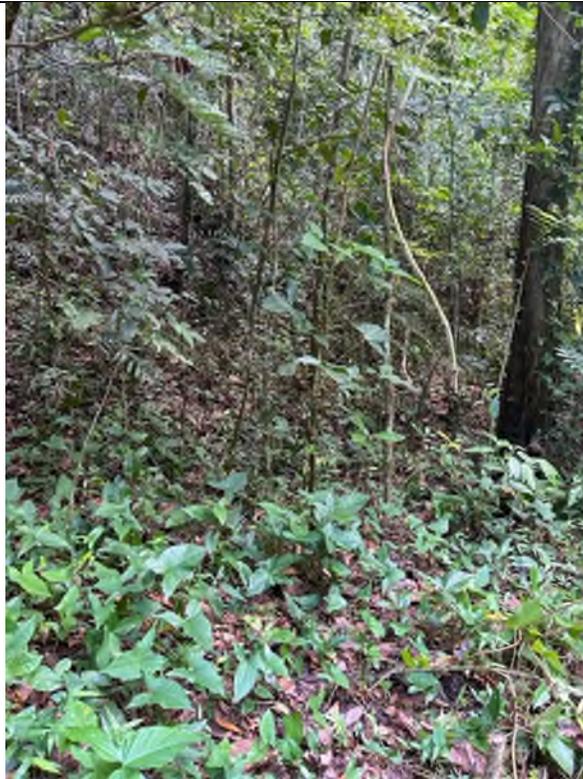
Photo #:1

Description (include direction): Area where the water well will be installed, looking southeast.

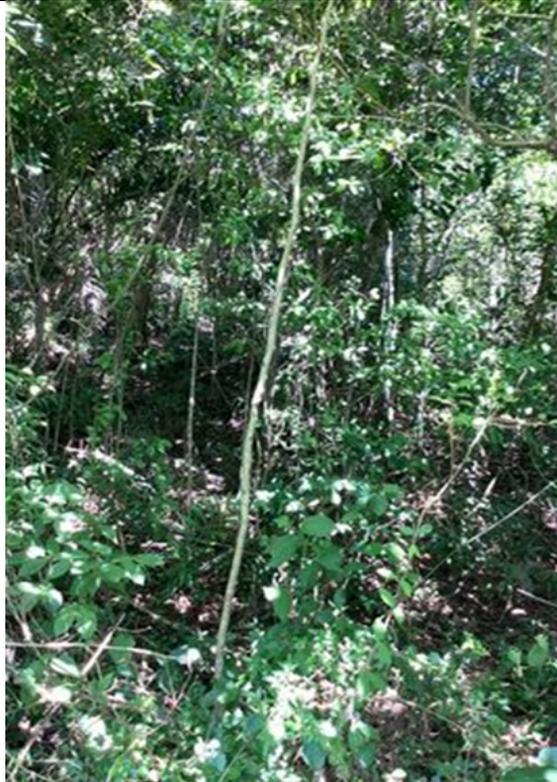
Photo #: 2

Description (include direction): Area where the water well will be installed, looking northeast.

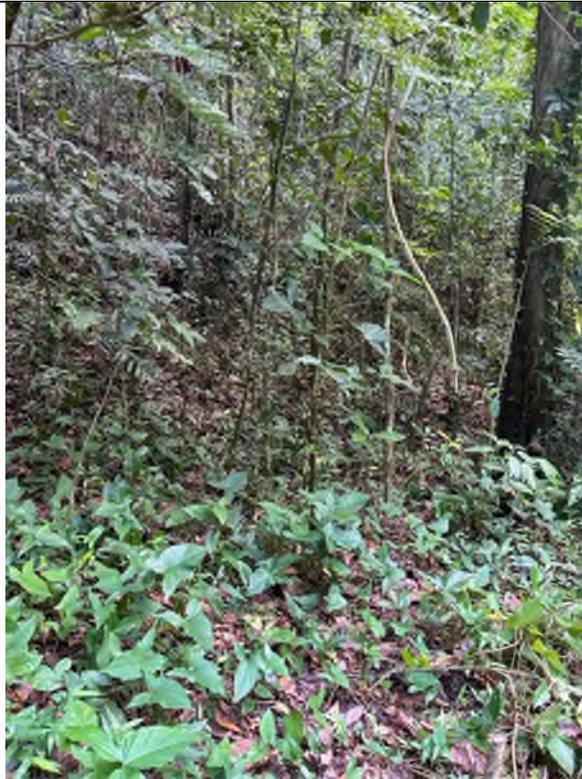
Photo #:1

Description (include direction): Area where the water well will be installed, looking southeast.
