# Environmental Assessment

**Project Name:** Lote A, Guayama - Gonzalez & Cathy Apartments

**Project ID:** PR-SIH-00029B #01

**Responsible Entity:** Puerto Rico Department of Housing

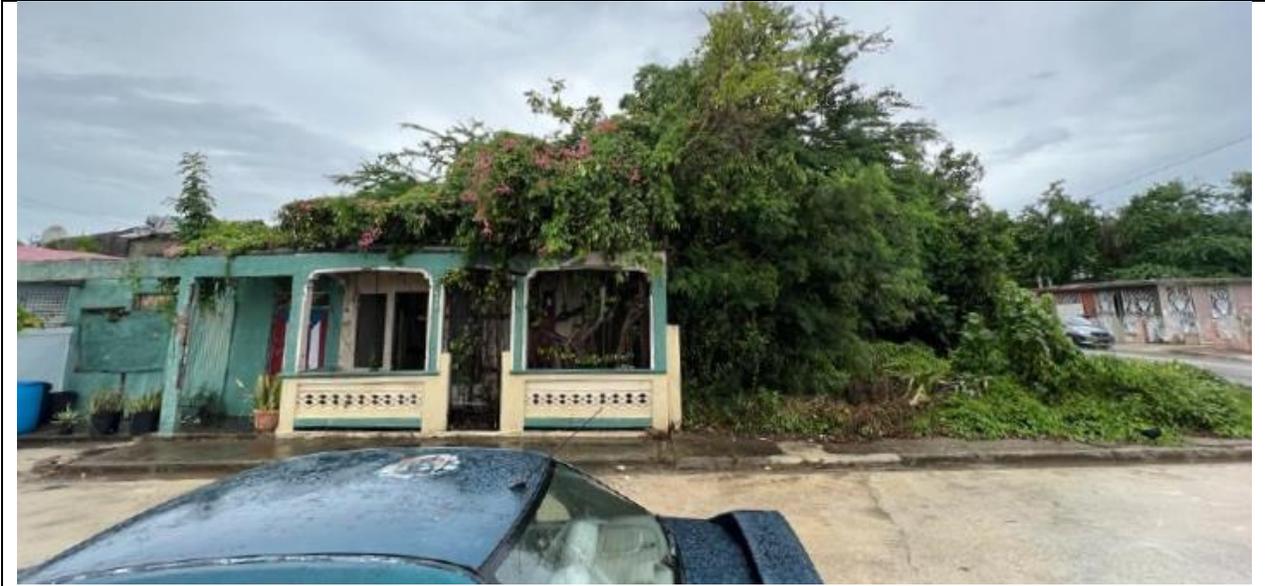
**Photo #:** 1

**Description (include direction):** Overview of both parcels that compose the project APE, looking north from the south side of Calle Enrique González.

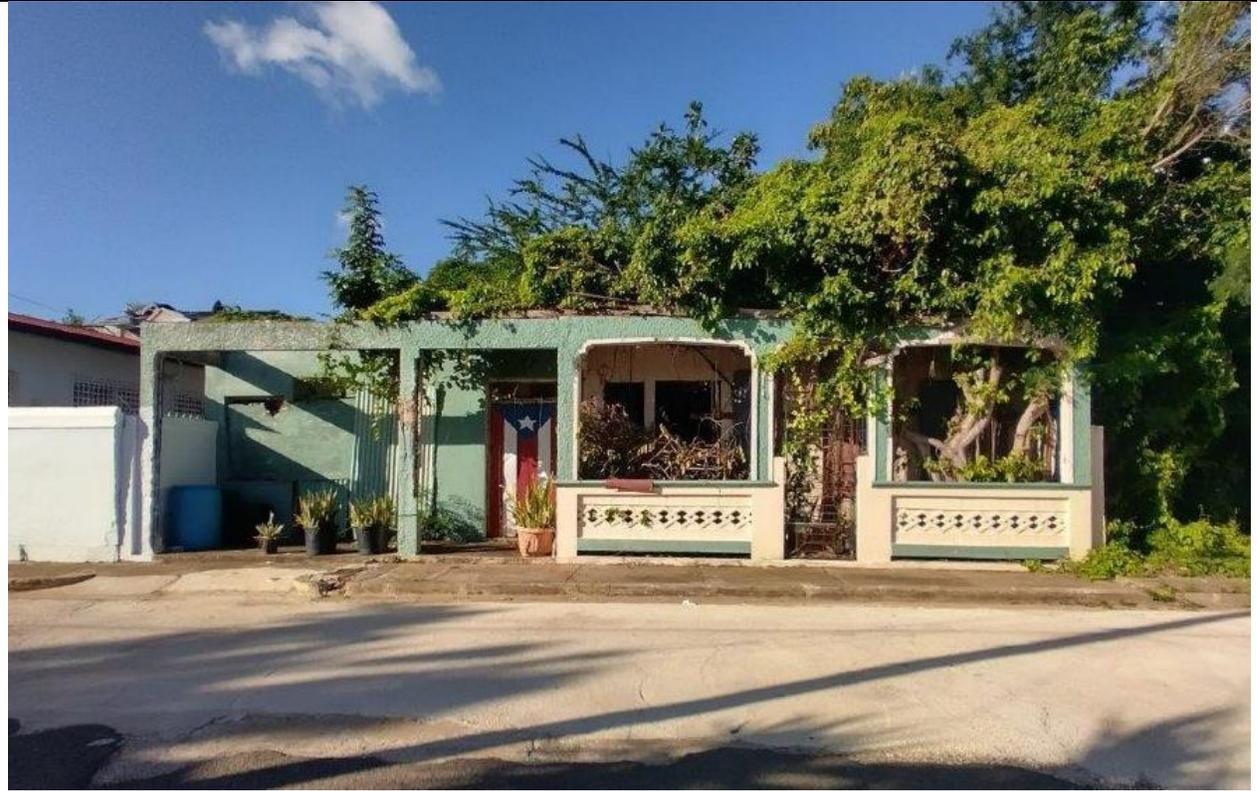
**Photo #:** 2

**Description (include direction):** Overview of the structure on the west half of the APE, facing north.

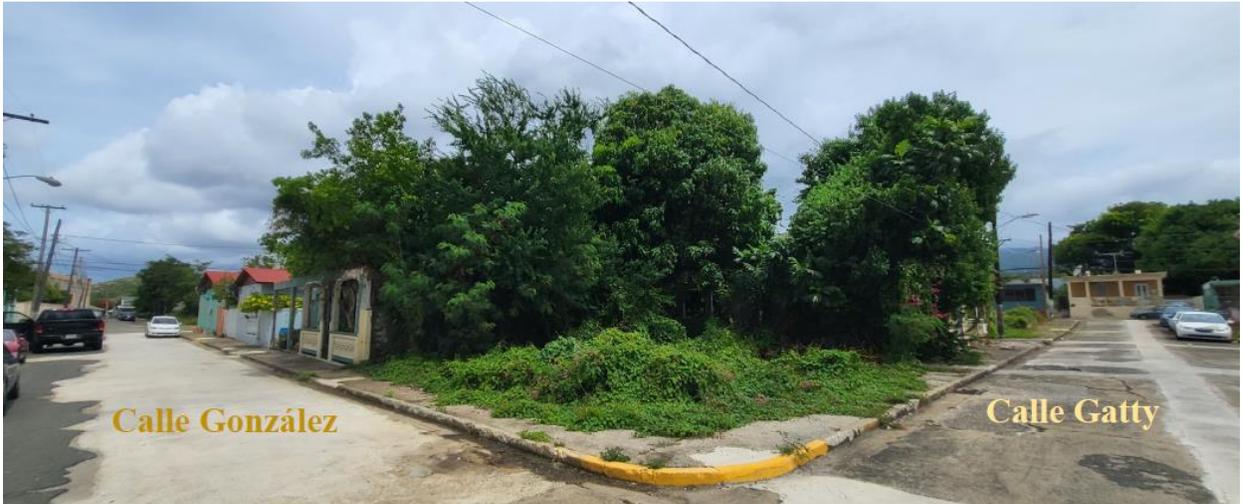
**Photo #:** 3

**Description (include direction):** Overview of the project APE from the intersection of Calles Enrique González and Gatty, looking northwest.

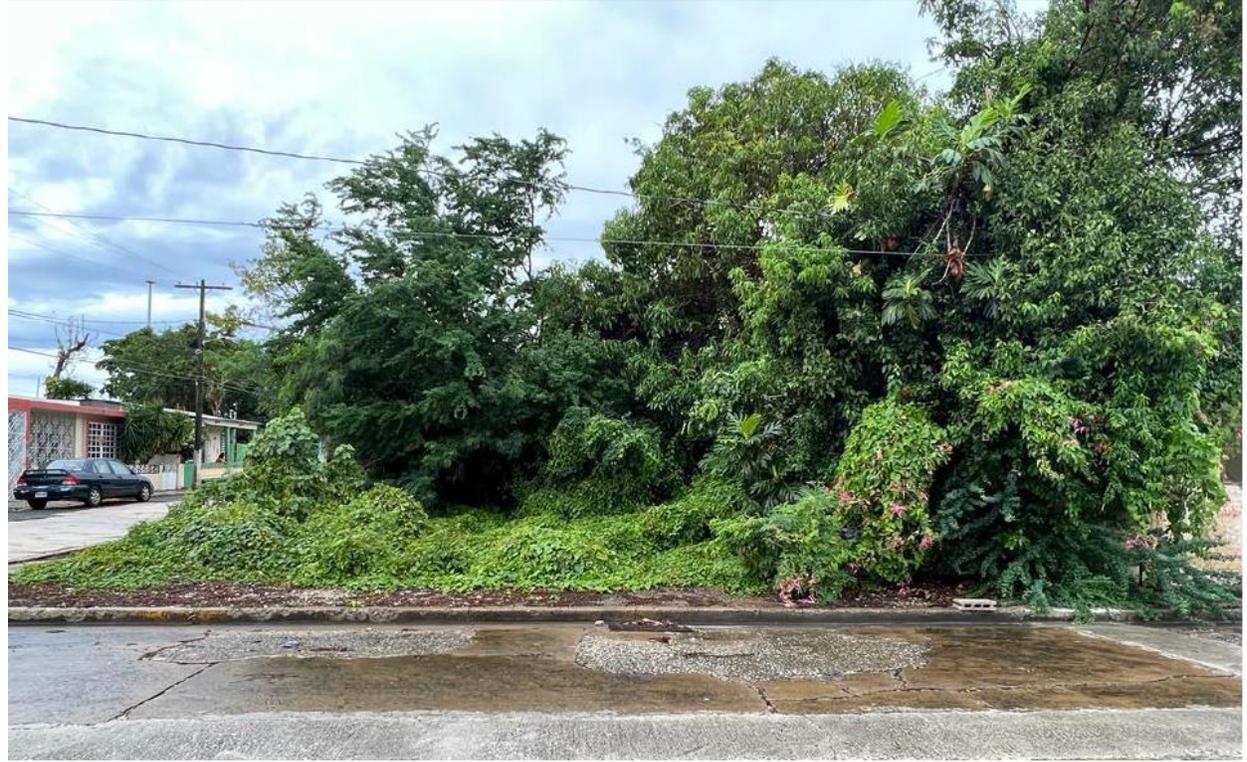
**Photo #:** 4

**Description (include direction):** Overview of the project APE, facing west from the east side of Calle Gatty.

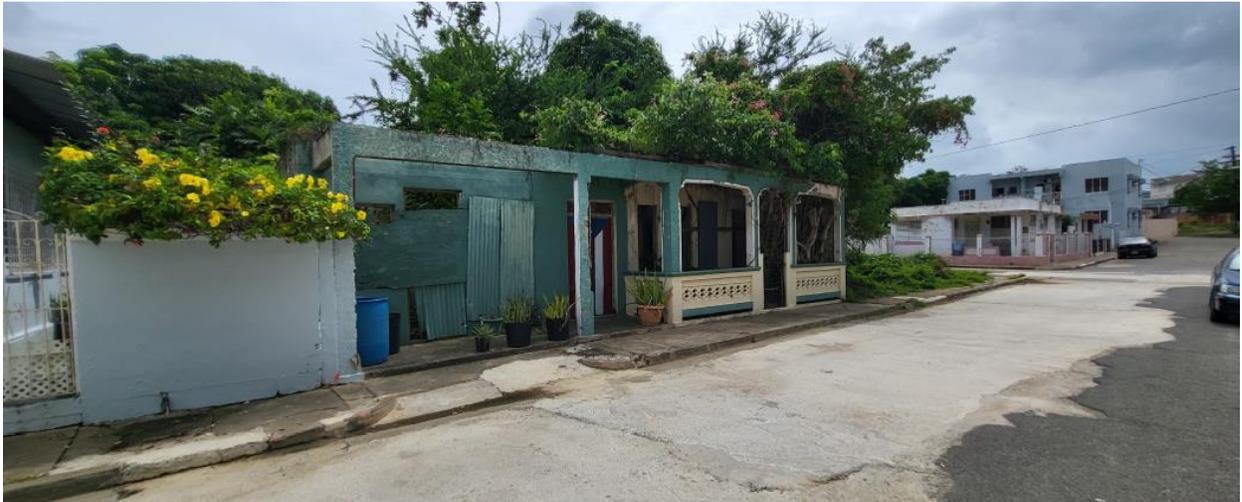
**Photo #:** 5

**Description (include direction):** Overview of the project APE, facing east-northeast from the south side of Calle Enrique González.

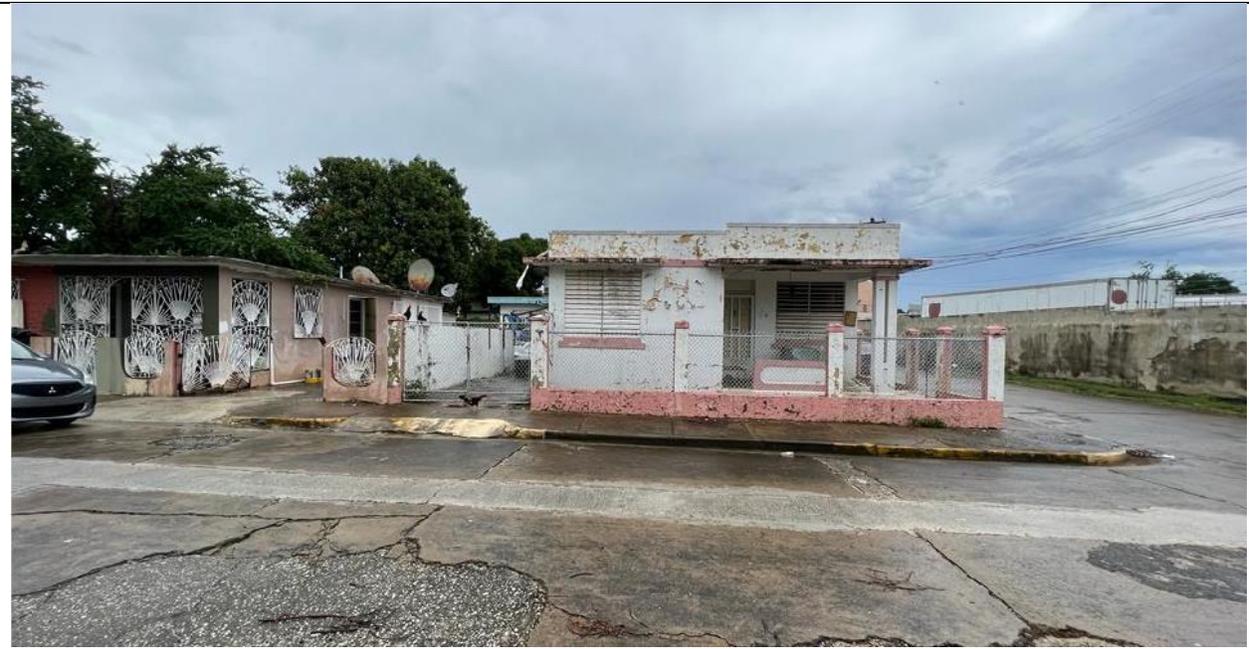
**Photo #:** 6

**Description (include direction):** The Circa 1940 Art Deco residence on the opposite side of Calle Gatty, facing east from the project APE.

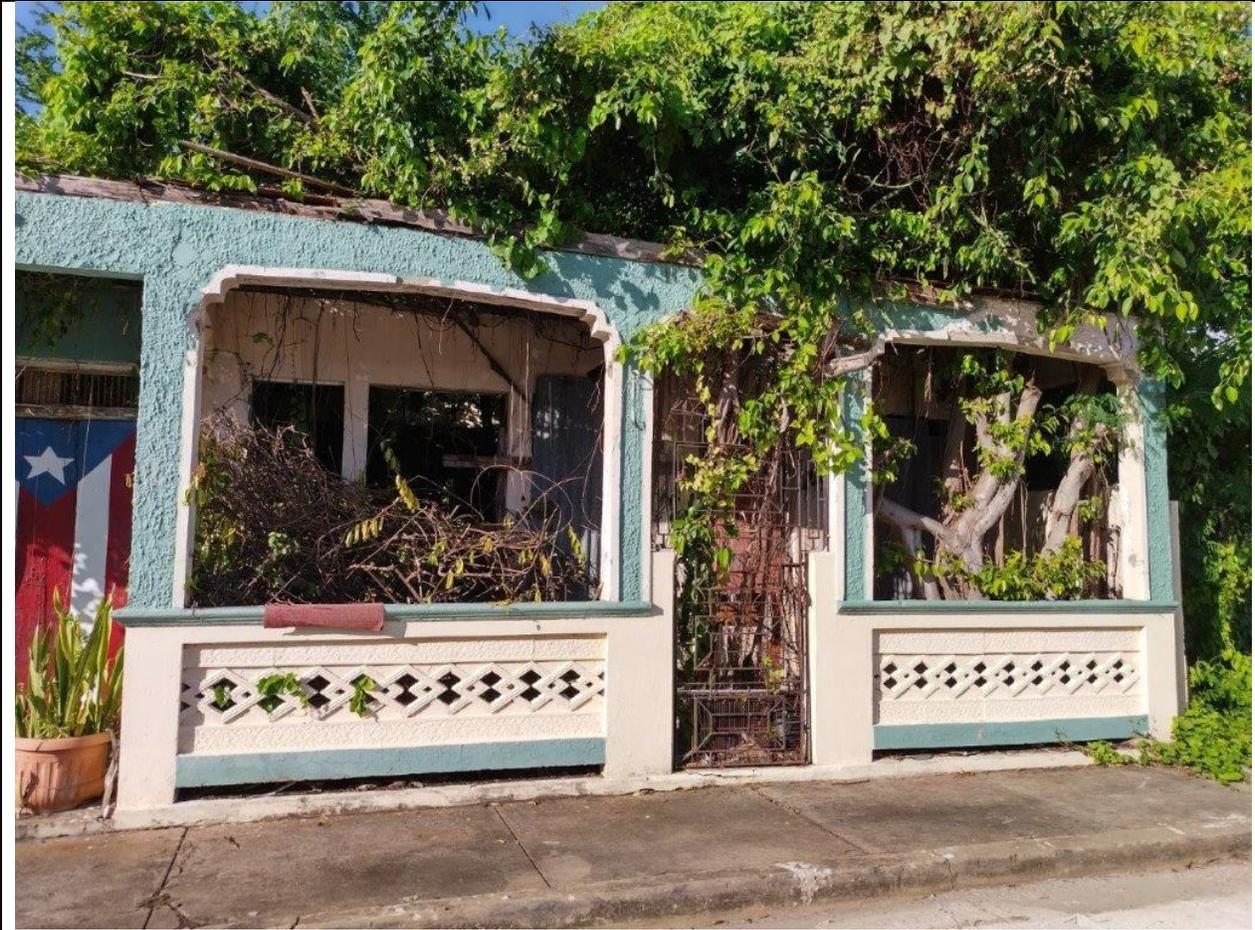
**Photo #:** 12

**Description (include direction):** Overview of the residential portion of the extant structure. Note the invasive vegetation including mature trees that have taken root in the building. Facing north.

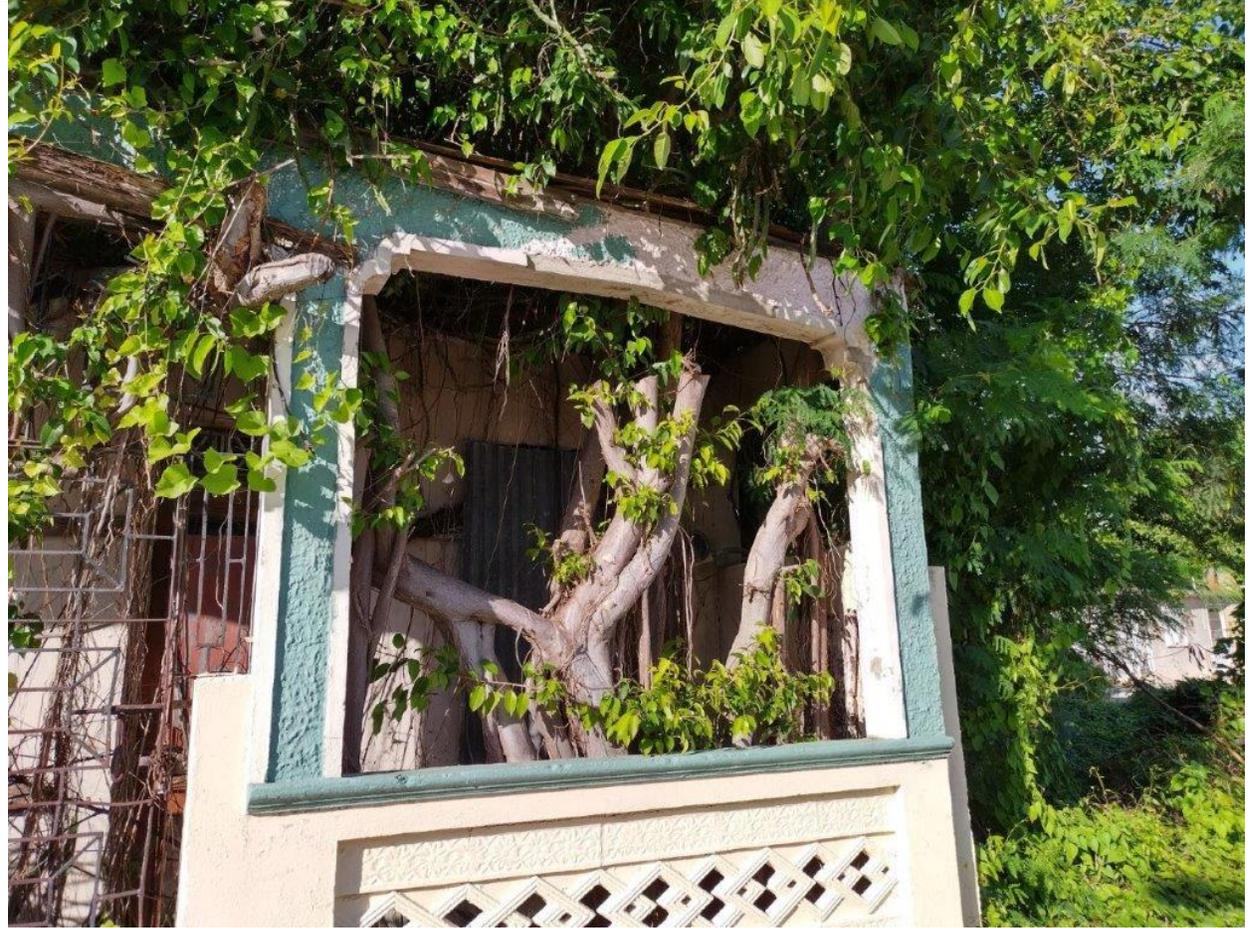
**Photo #:** 13

**Description (include direction):** Closeup of the east side of the front balcony with mature trees that have taken root. Facing north.

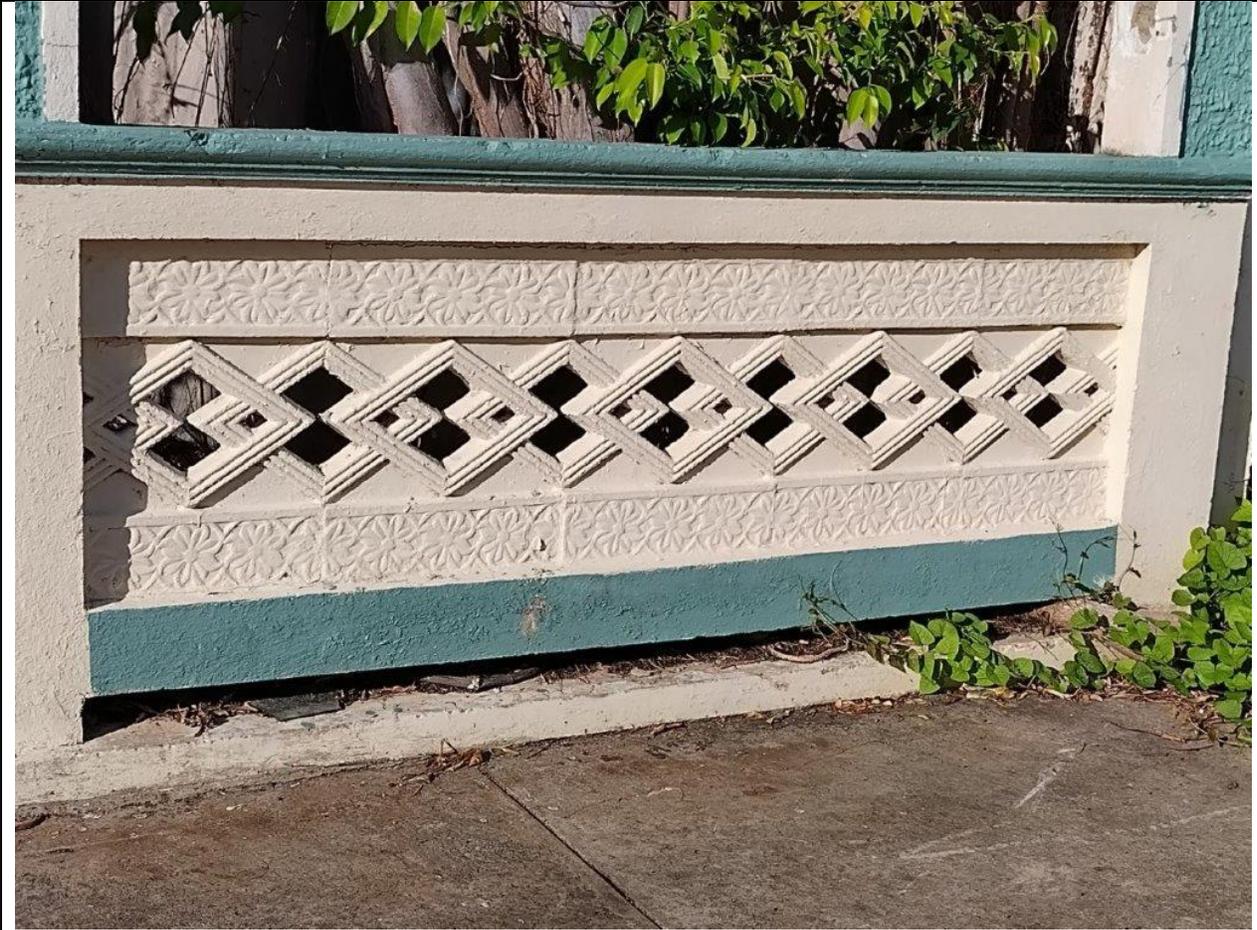
**Photo #:** 14

**Description (include direction):** Details of the decorative concrete balcony railing.

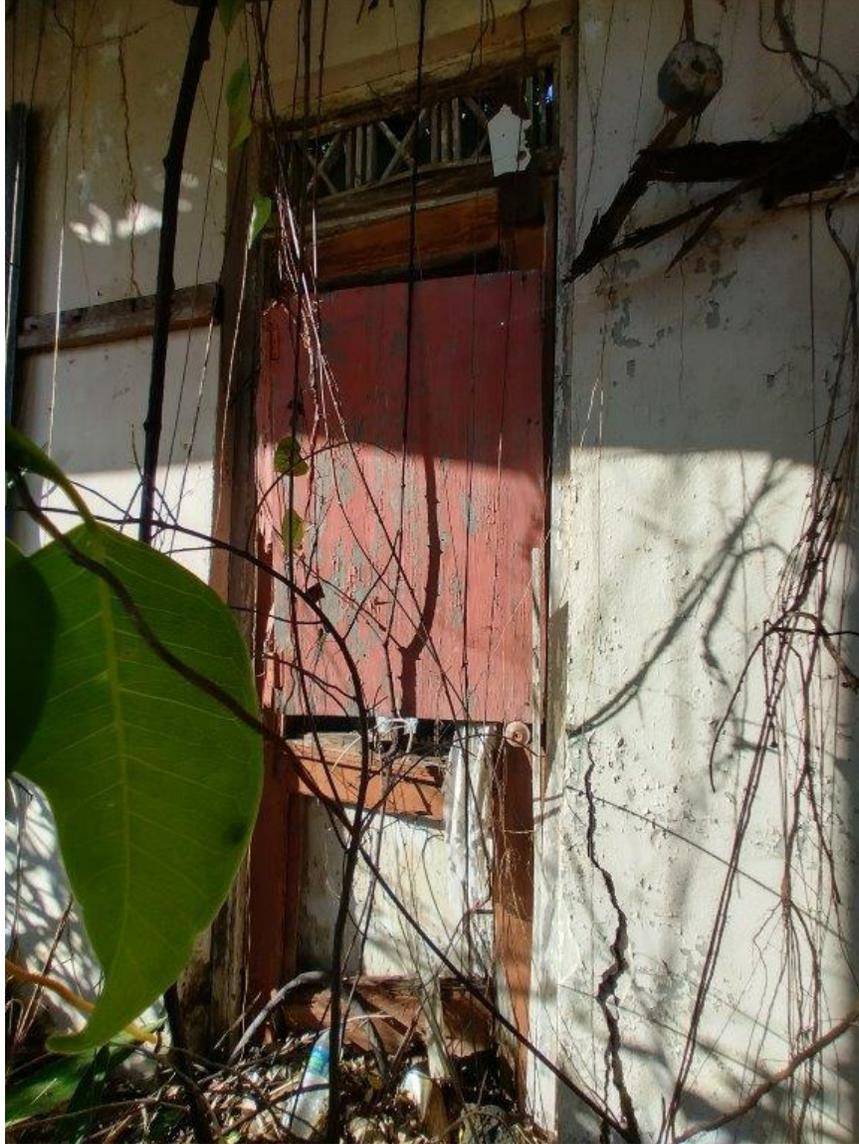
**Photo #:** 15

**Description (include direction):** Detail photograph of the main entrance into the residential portion of the building.

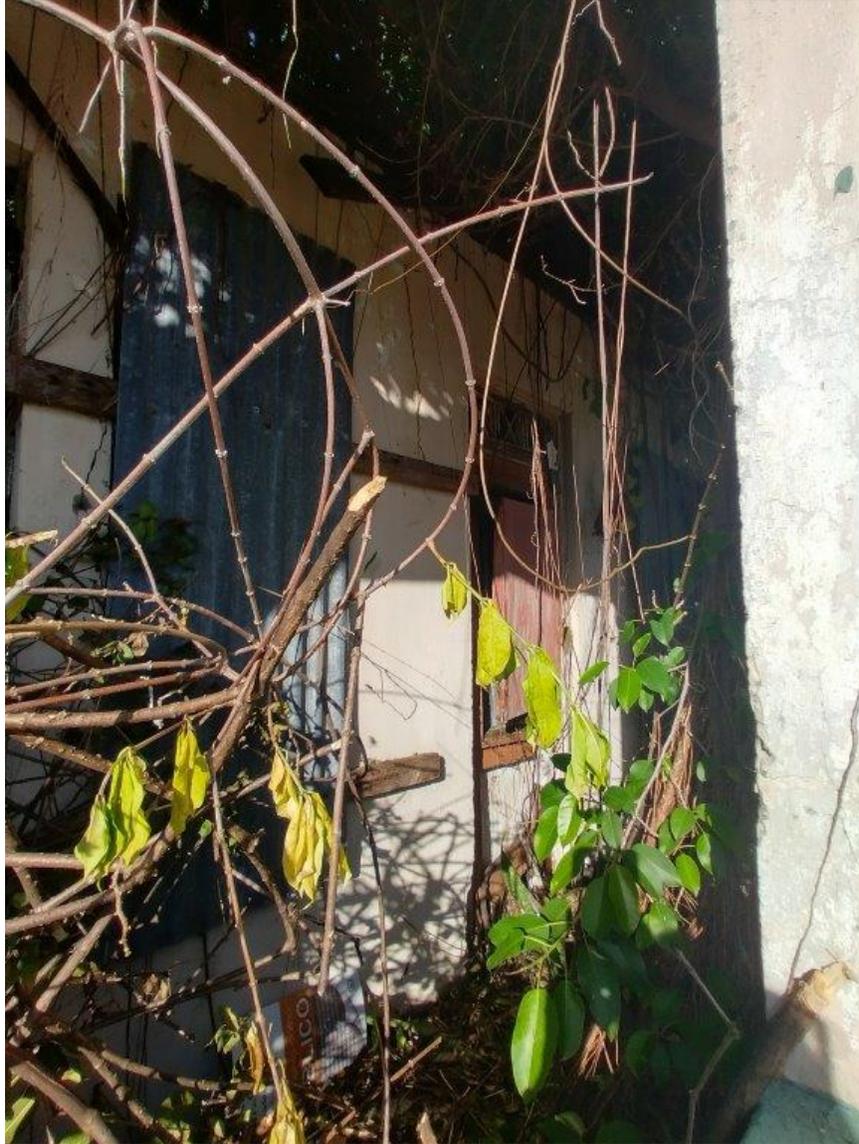
**Photo #:** 16

**Description (include direction):** Close-up of the west side of the back wall of the balcony.

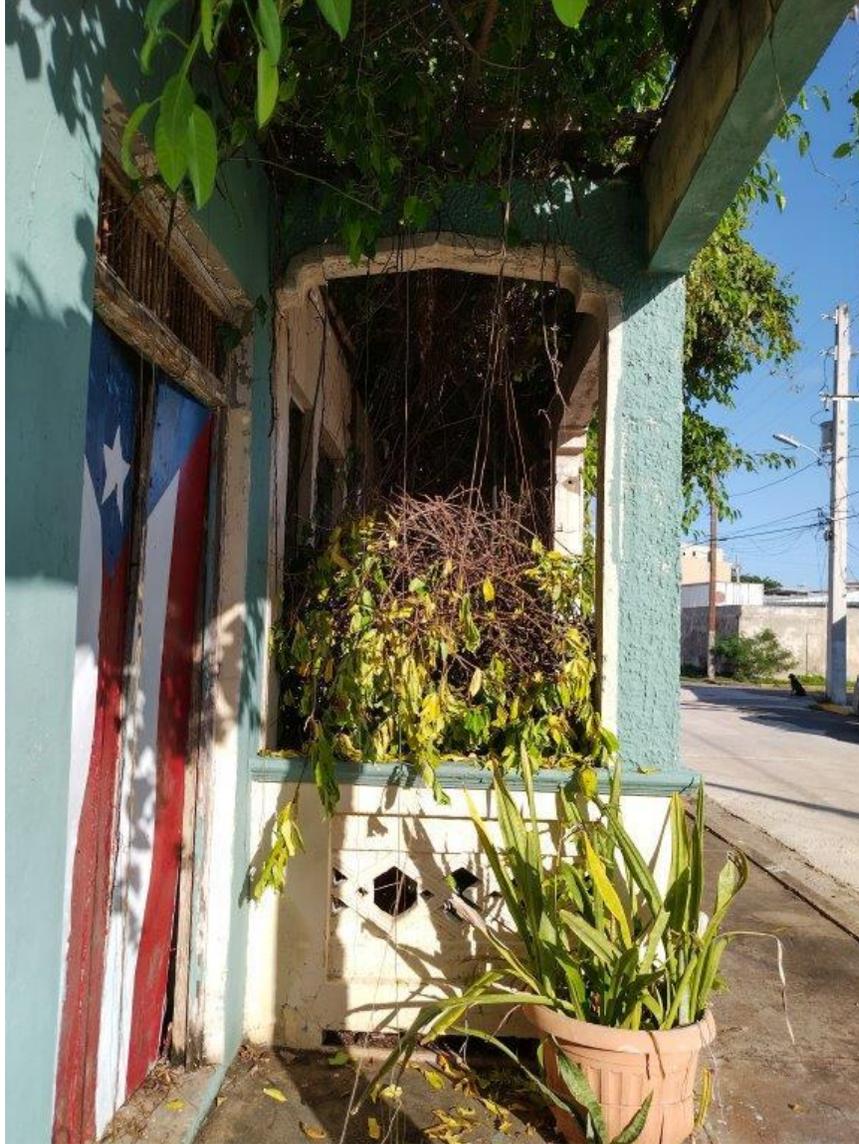
**Photo #:** 17

**Description (include direction):** Side view of the front balcony, featuring Art Deco frets and an existing double door to the left. Facing east.

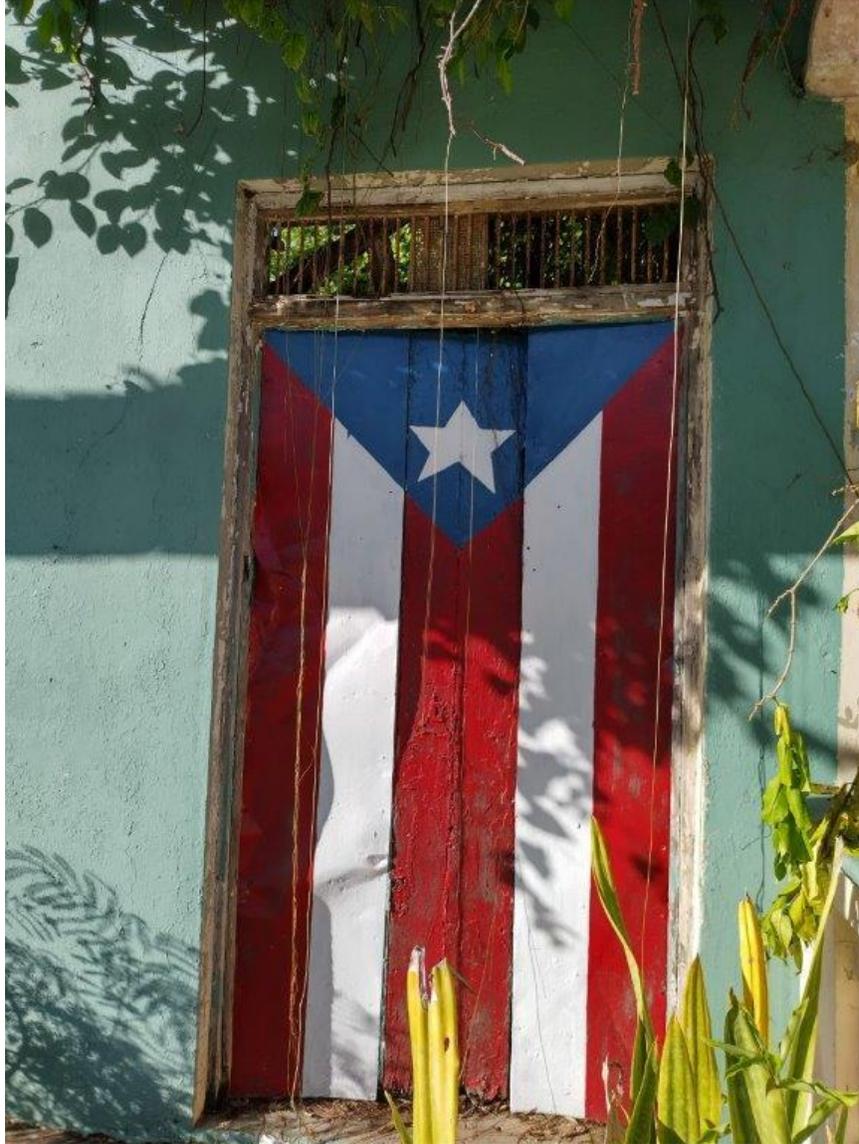
**Photo #:** 18

**Description (include direction):** Existing wood double door, located west of the balcony.

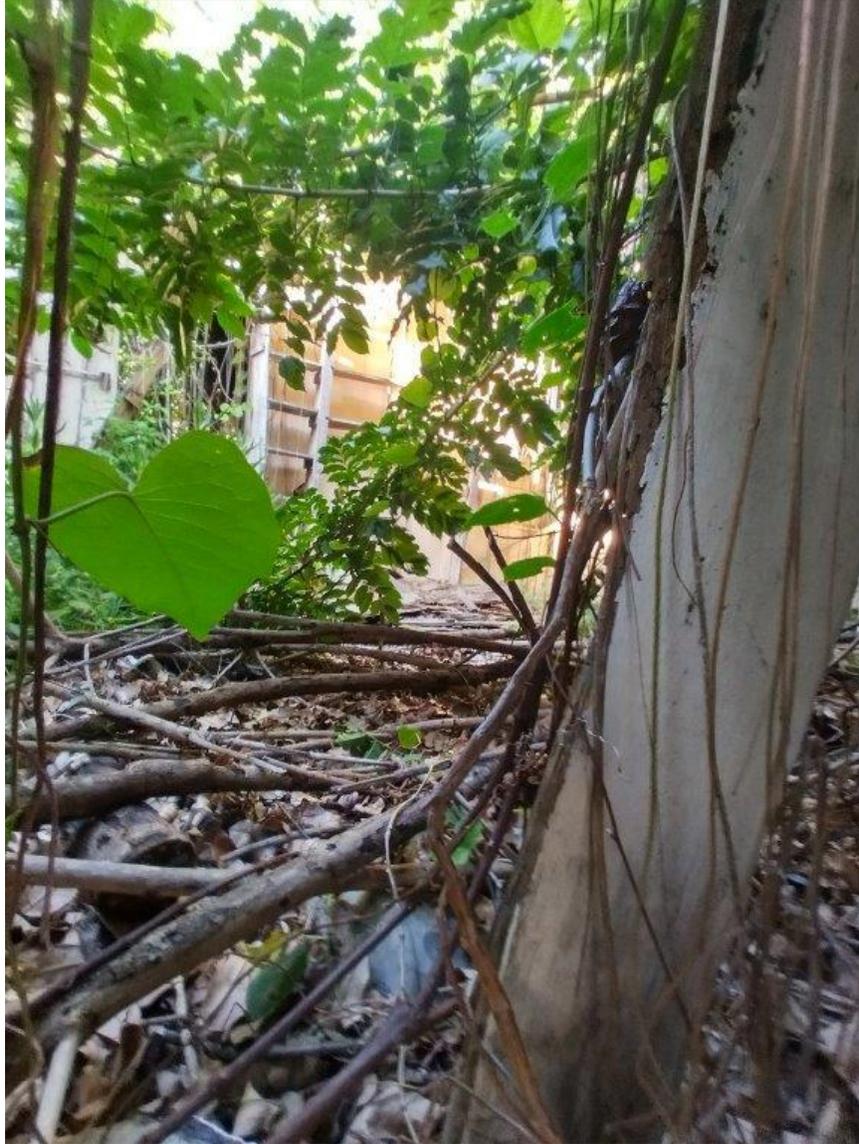
**Photo #:** 19

**Description (include direction):** Interior of the former store. Note the lack of roof and extensive vegetation. Facing north.

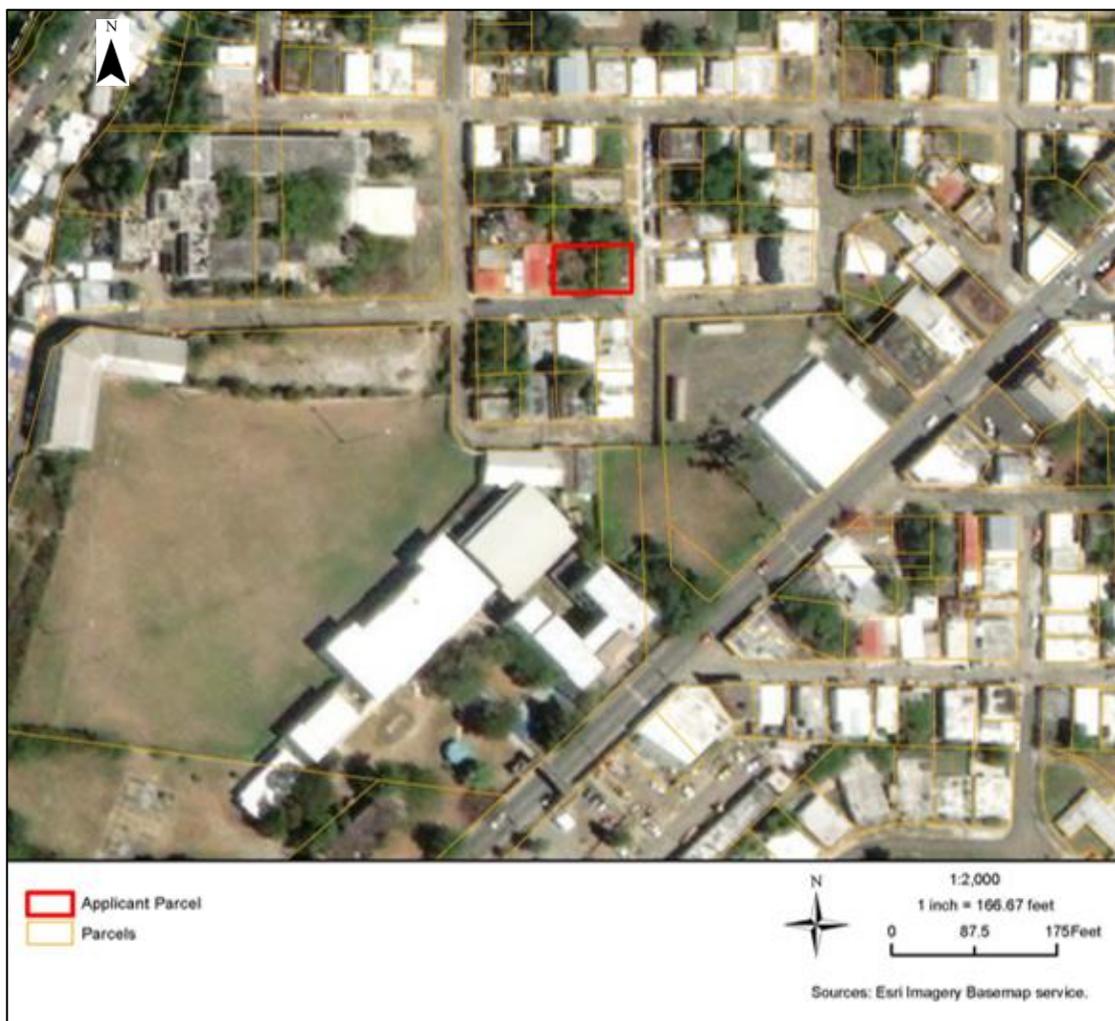
**Figure 1:** Location of the project on the satellite image

The Puerto Rico Department of Housing (PRDOH) is proposing the construction of one, two-story apartment building of four units on two parcels located at #66 Enrique González Street, Guayama, Puerto Rico (Figure 1). The project area is located within the Traditional Urban Center and Historic Zone of Guayama.

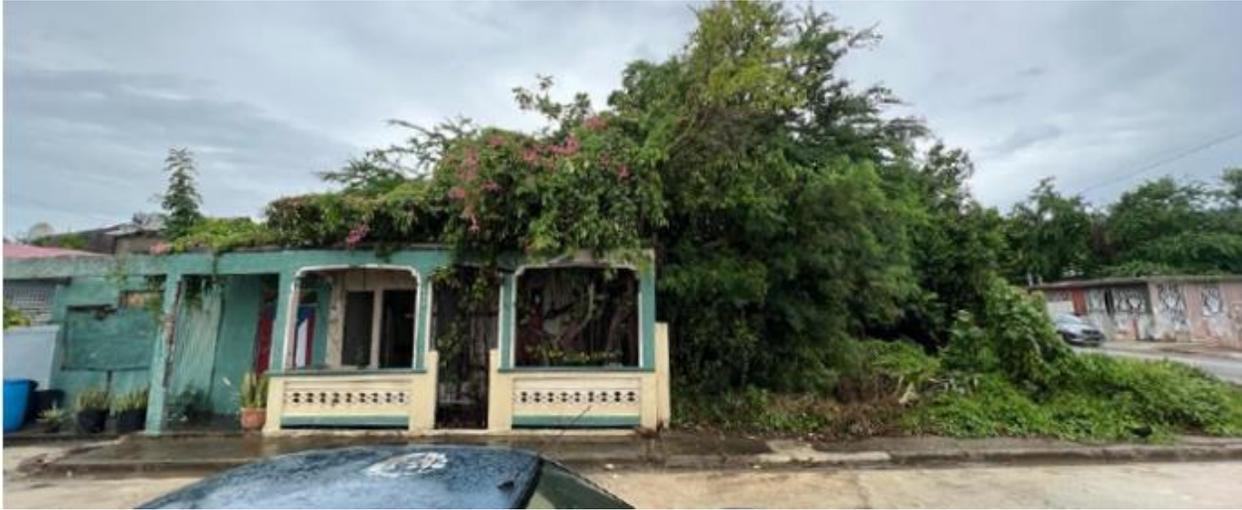
According to the Section 106 NHPA Effect Determination Form, completed by architectural historian Lauren B. Poche and archaeologist Sharon Meléndez Ortiz, on the west parcel there are ruins of a building potentially dating from the early 20th century and on the east parcel there is a high potential to find remnants of occupations from this same period, as there was a building in the 1930s that was demolished in the 21st century.

**Photo 1:** Overview of the parcels that compose the project APE, looking north (10/2022)

The objective of this archaeological monitoring plan is to ensure that the remnants of the building located on the western parcel and any unanticipated discoveries, should they occur, receive appropriate treatment. This document is consistent with the Secretary of the Interior's (SOI) Guidelines for Archeological Documentation and the Advisory Council on Historic Preservation's (ACHP) recommendations on the recovery of significant information from archaeological sites as updated in 2009.

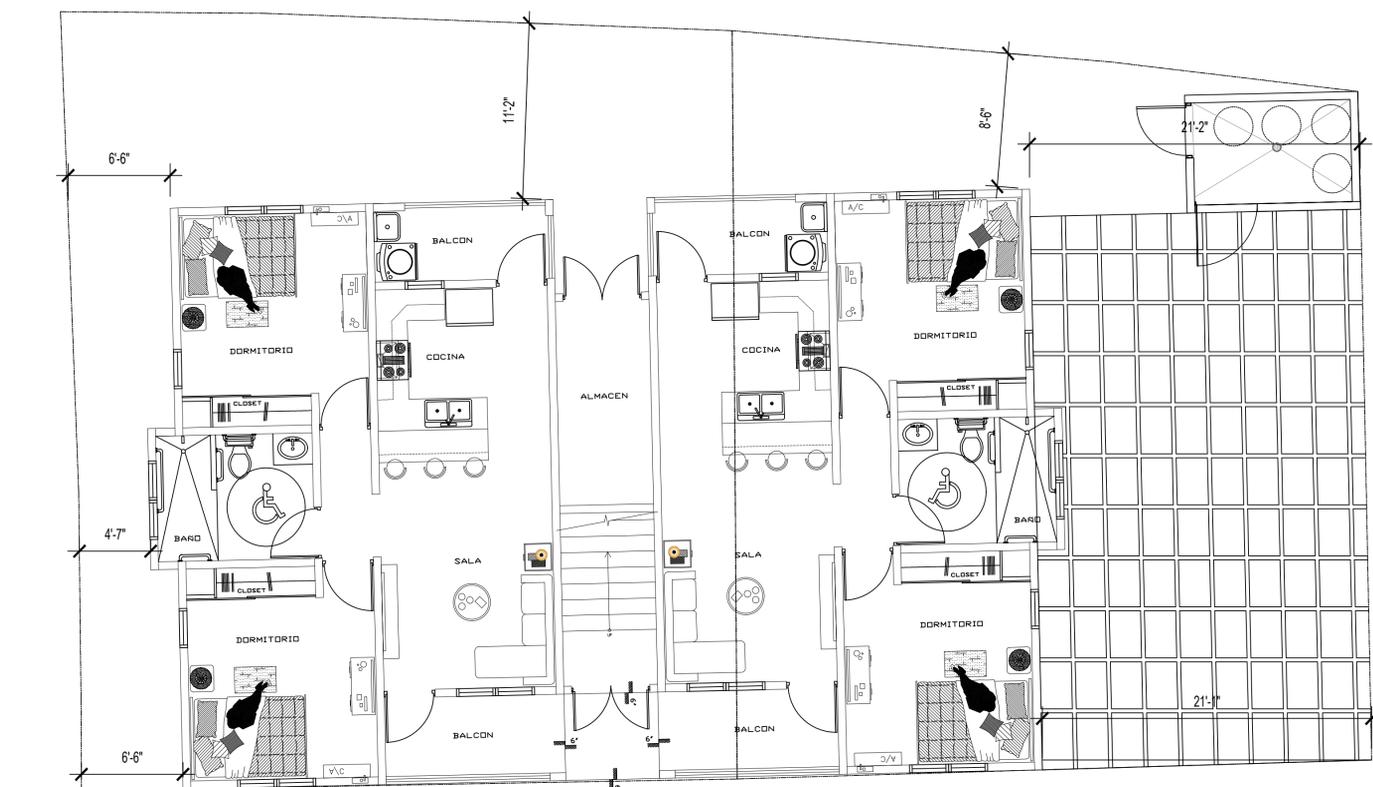
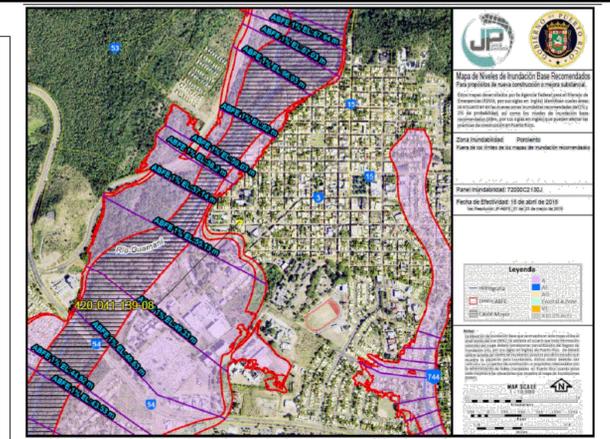
**DATOS DE MENSURA**  
ST. GATTY ST. # 66

PUNTO	LINEA	(Y) NORTE	(X) ESTE	DISTANCIA	RUMBO	DESCRIPCION
301	---	216680.7260	233327.9980	---	---	CDL SDLAR TUBO
302	301-302	216680.1820	233335.3530	7.38	S 85° 18' 19" E	CDL SDLAR TUBO
282	302-282	216679.5470	233340.1980	4.88	S 83° 13' 55" E	CDL SDLAR MURD
279	282-279	216677.6380	233340.2480	1.91	S 01° 30' 01" E	BA
280	279-280	216666.5700	233340.4680	11.07	S 01° 08' 19" E	BA
7	280-7	216666.2008	233328.0959	12.38	S 88° 17' 26" W	VARILLA
301	7-301	216680.7260	233327.9980	14.53	N 00° 23' 10" W	CDL SDLAR TUBO

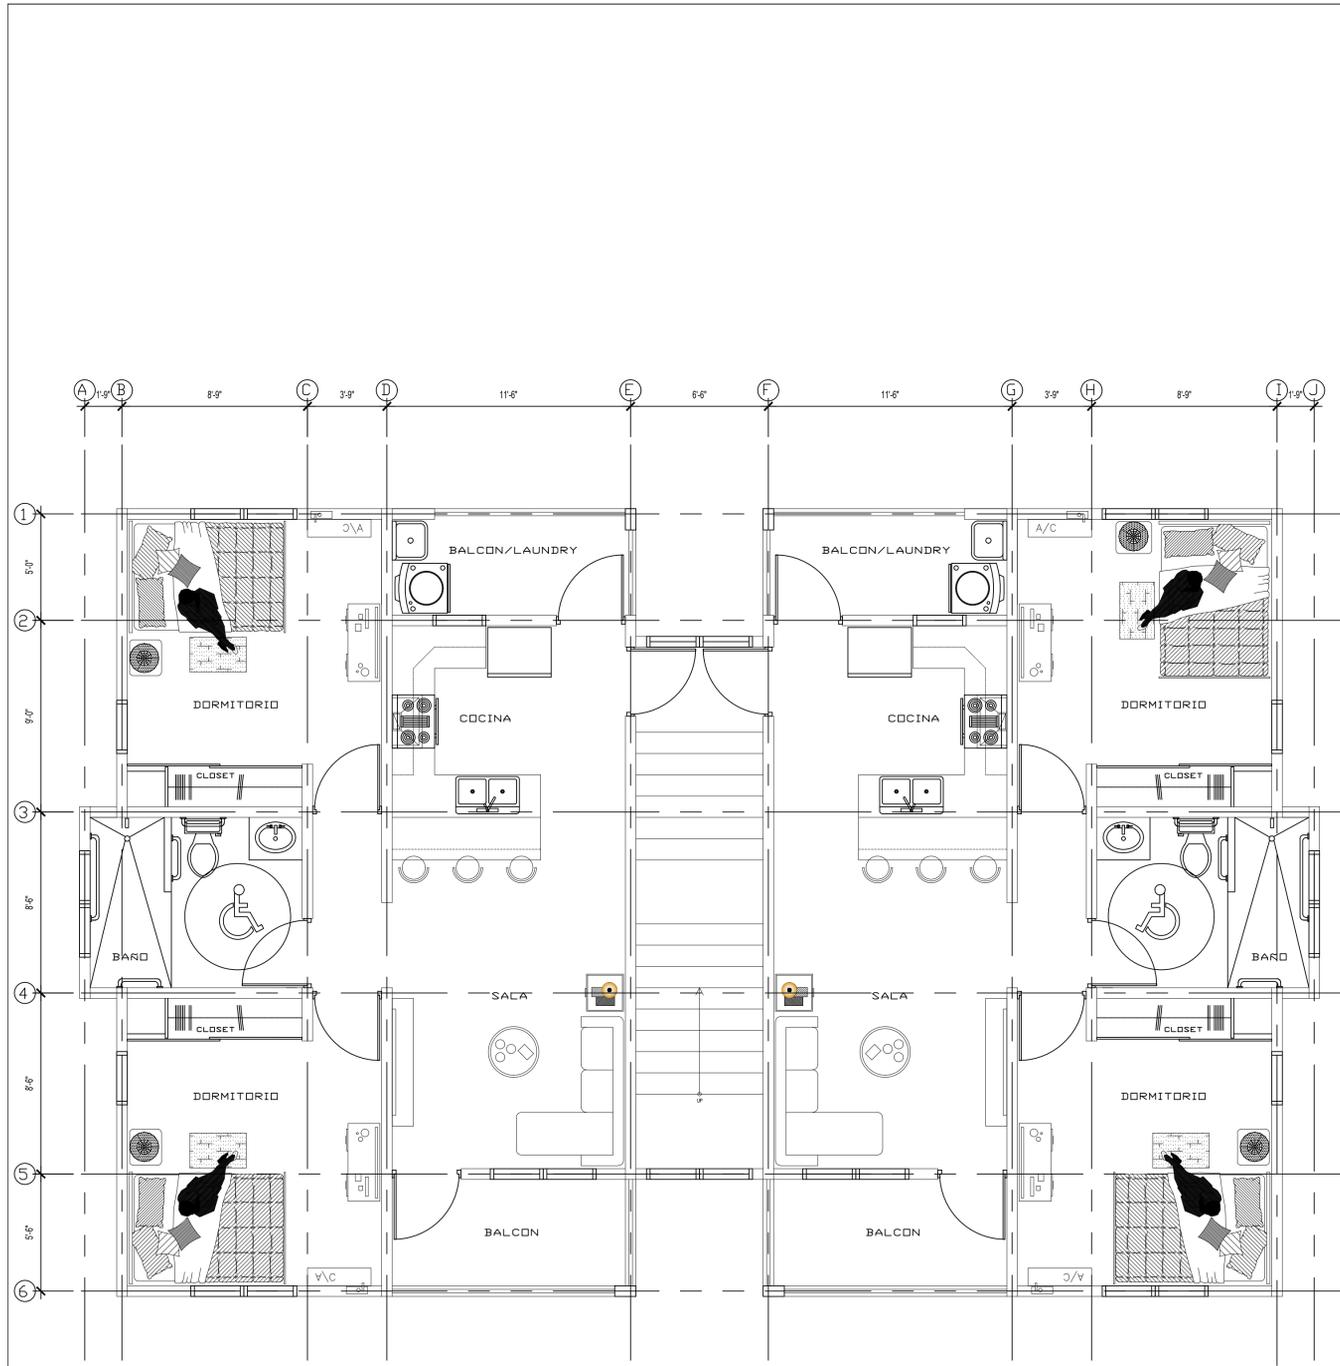
DISEÑO CONCEPTUAL PONCE NHS - LOTE A & B  
 PLANTA DE PISO SEGUNDO NIVEL PROPUESTO  
 ESCALA: 1/4" = 1'-0"

The use of the structure will be housing and it is contemplated from two (2) to four (4) people in occupation per apartment. The development is one (1) building with two (2) levels and two (2) apartments per level. Each apartment has two (2) bedrooms, one (1) bathroom, living room, kitchen, laundry and balcony. The housing area is 775 SQFT (Square Feet) and a balcony area of 58 SQFT (Square Feet), for a total construction area per apartment of 833.00 SQFT (Square Feet). The building has two apartments per level of 833.00 SQFT (Square Feet) each, a warehouse and stair area of 158.50 SQFT (Square Feet), the total area of the

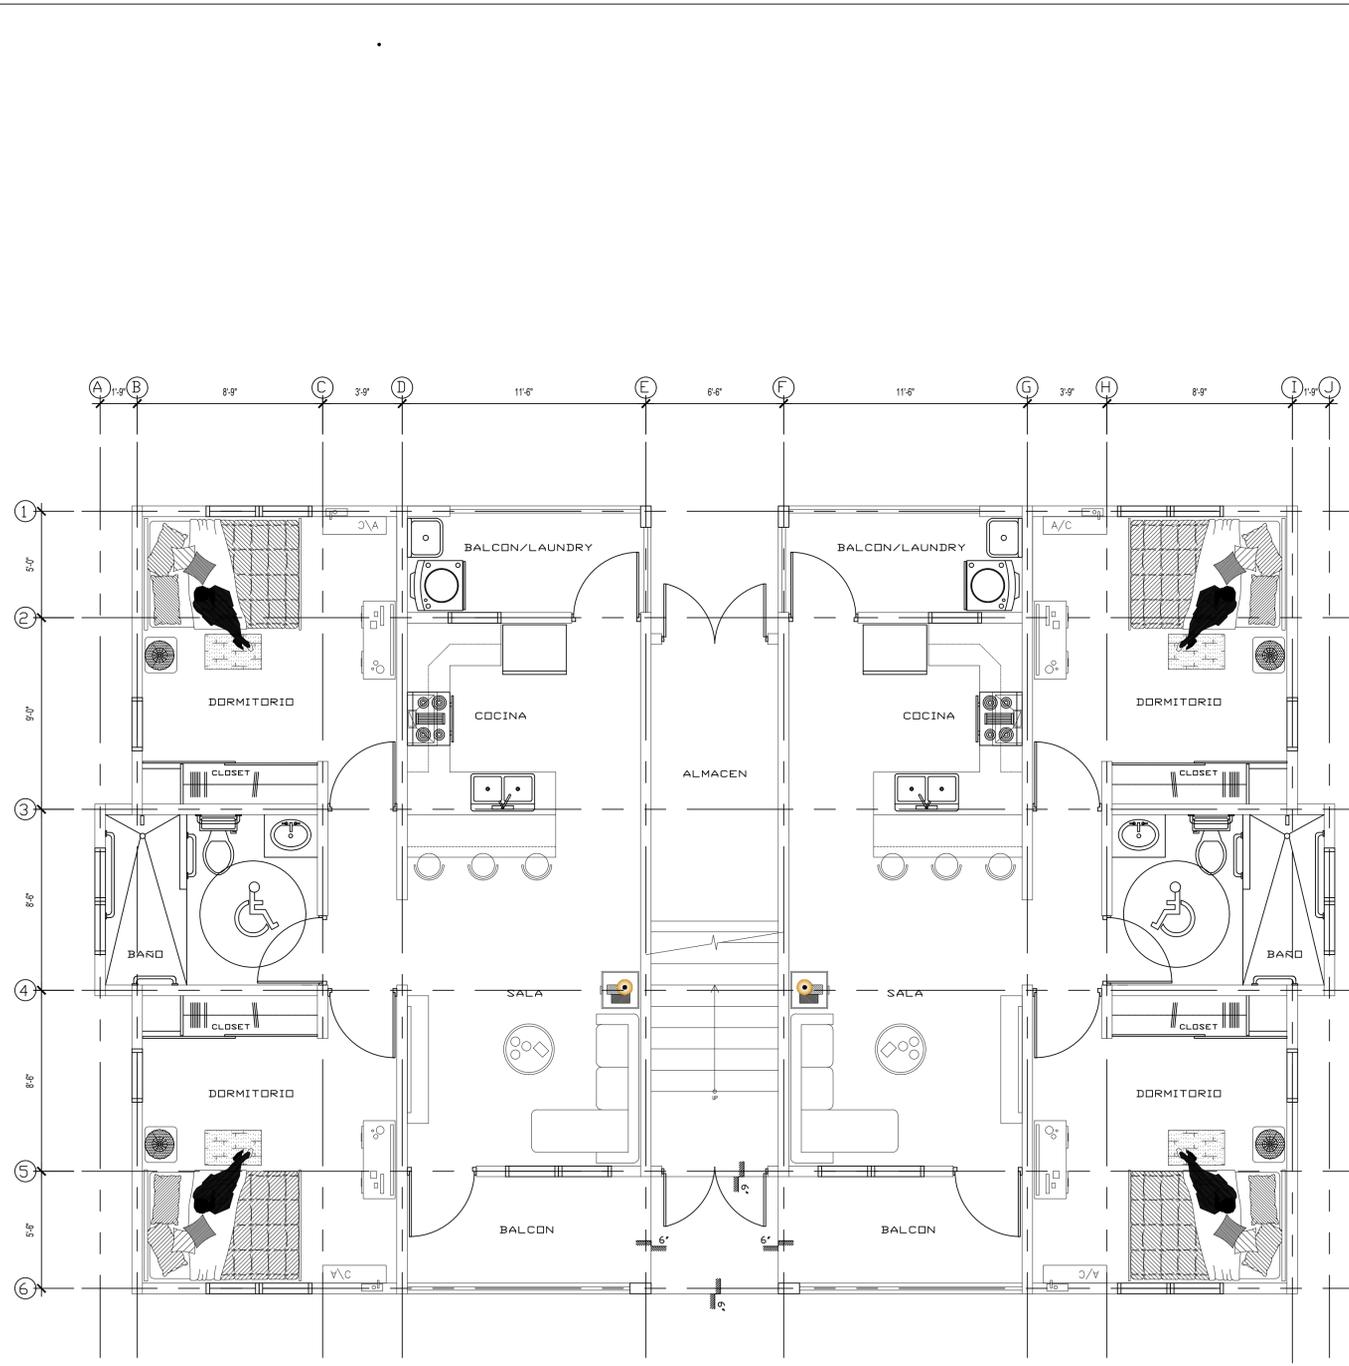
DISEÑO CONCEPTUAL PONCE NHS - LOTE A & B  
 PLANTA DE PISO PRIMER NIVEL PROPUESTO  
 ESCALA: 1/4" = 1'-0"
