# Environmental Assessment

**Project Name:** Lote A, Guayama - Gonzalez & Cathy Apartments

**Project ID:** PR-SIH-00029B #01

**Responsible Entity:** Puerto Rico Department of Housing

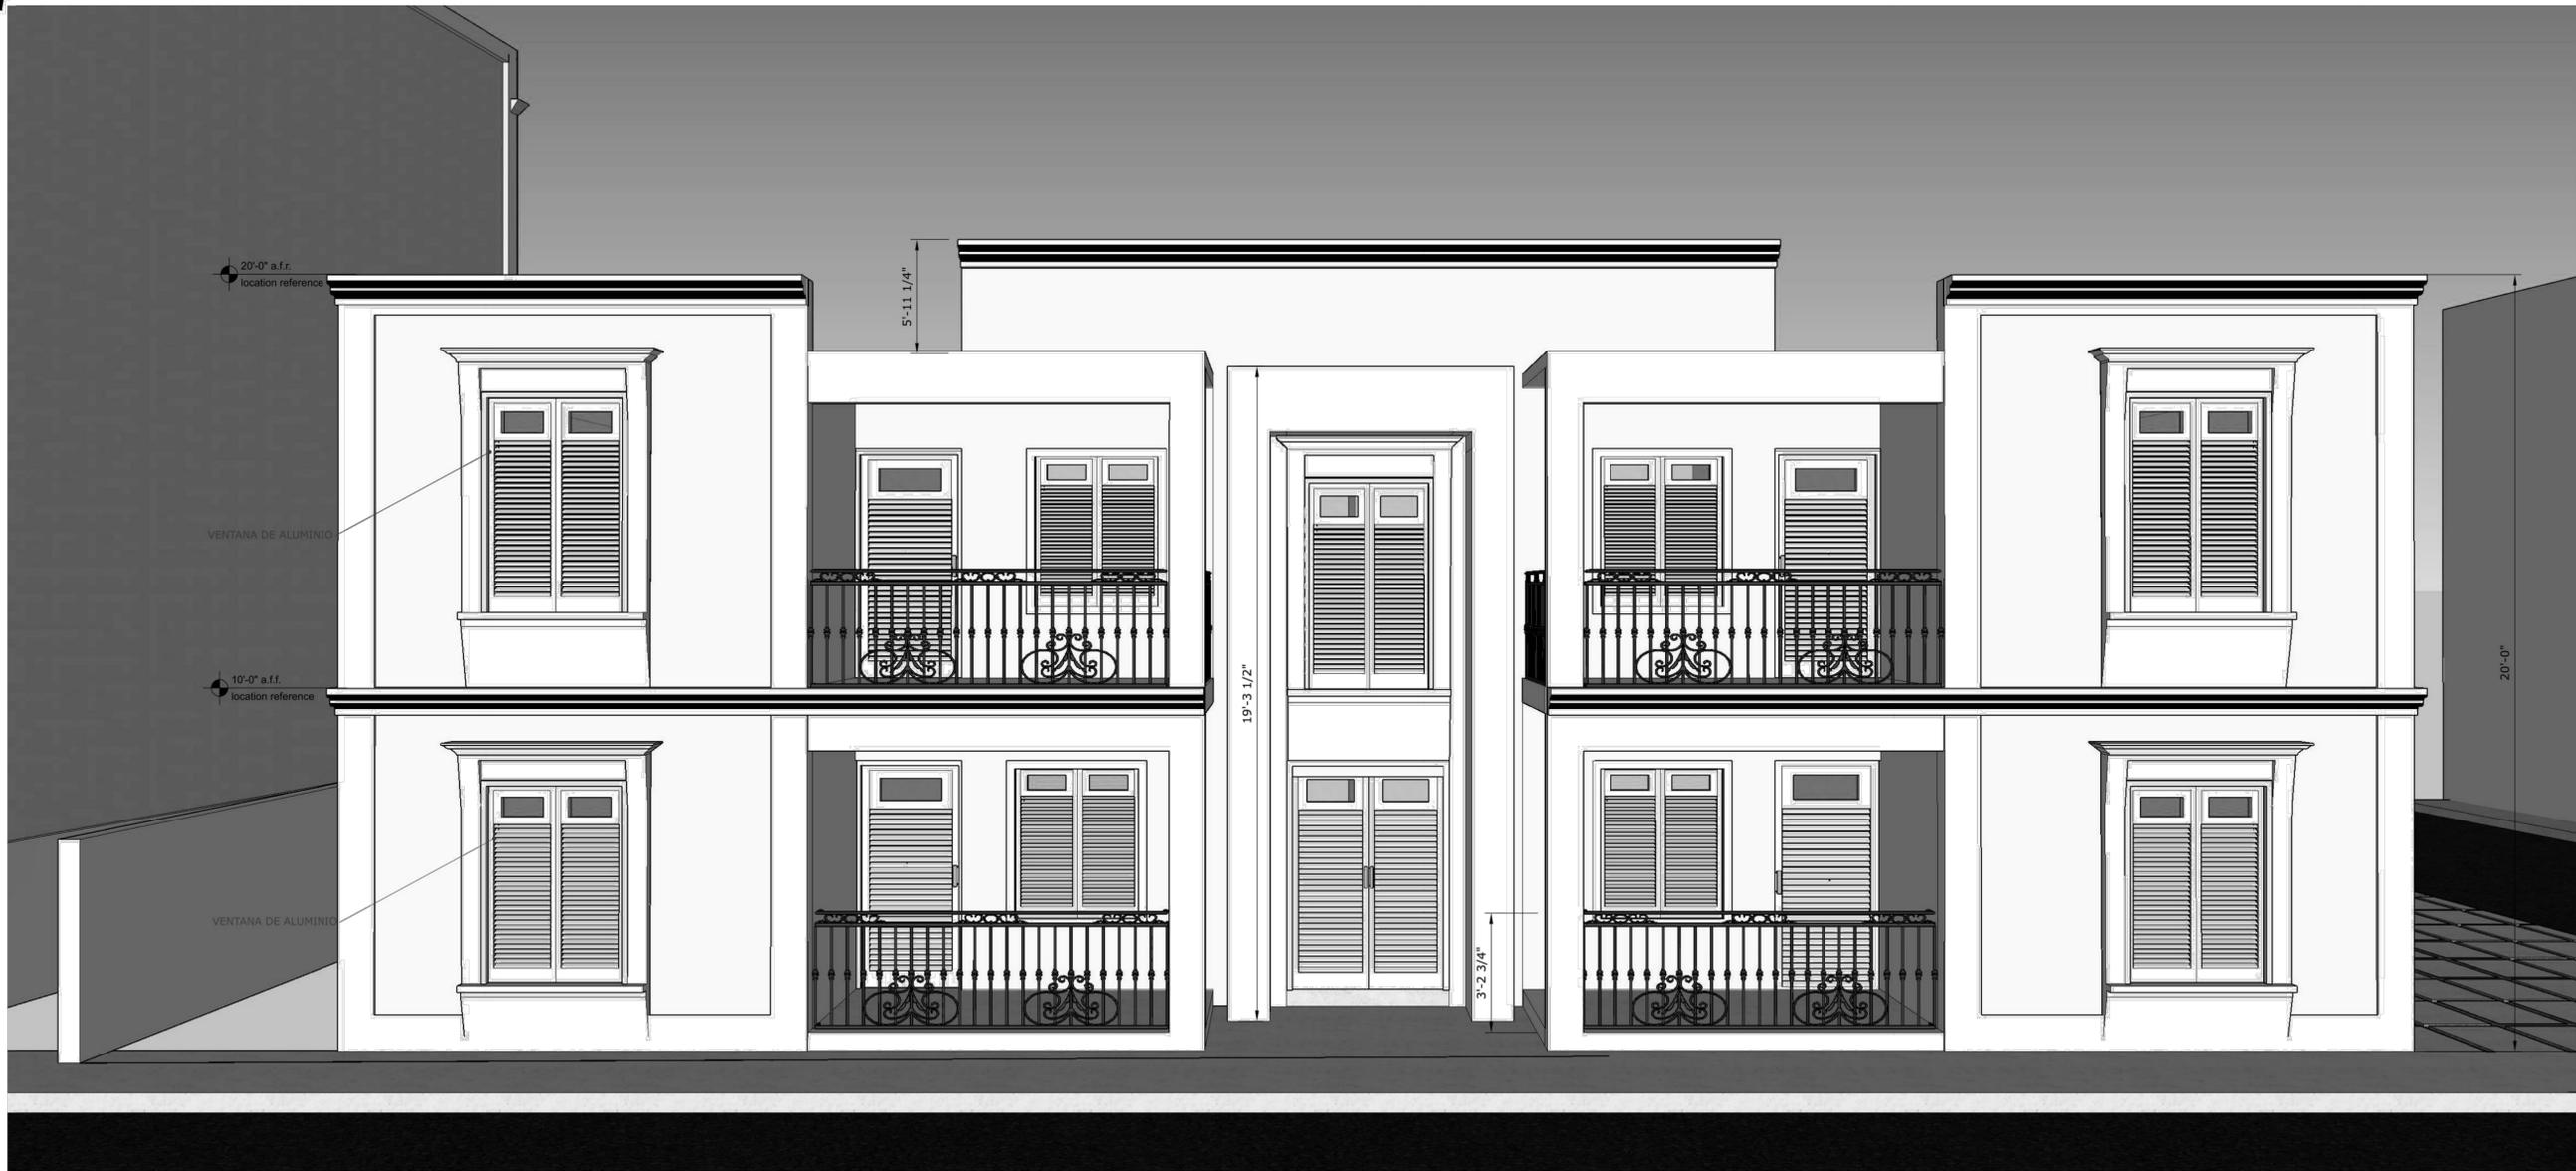
0 ELEVACION CALLE MONSERRATE  
Scale: 1/8" = 1'-0"
