# Environmental Assessment Determinations and Compliance Findings for HUD-assisted Projects 24 CFR Part 58

Project ID: PR-RGRW-04077

Project Name: Komando Inc.

Botijas I Carr 772 KM 5 Parcela 133, Orocovis, PR 00720

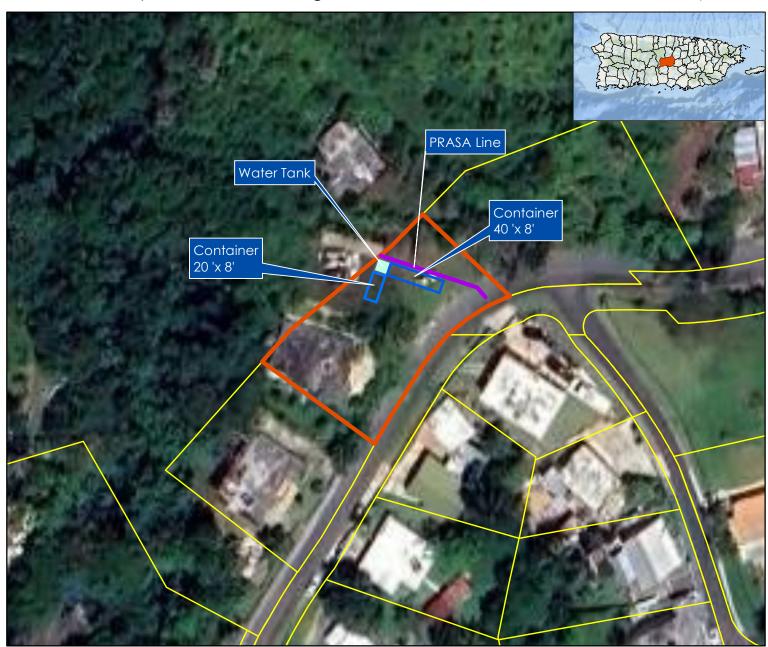
## Figure 1: Location: Aerial Map Puerto Rico Department of Housing ReGrow

A site Map is included in Figure 1, illustrating the location of the two containers, concrete slab for the water tank and power line on the property. Photos of the location are included in Section 106 documentation, Appendix 1. Refer to Appendix 3 for Site Inspection Report.

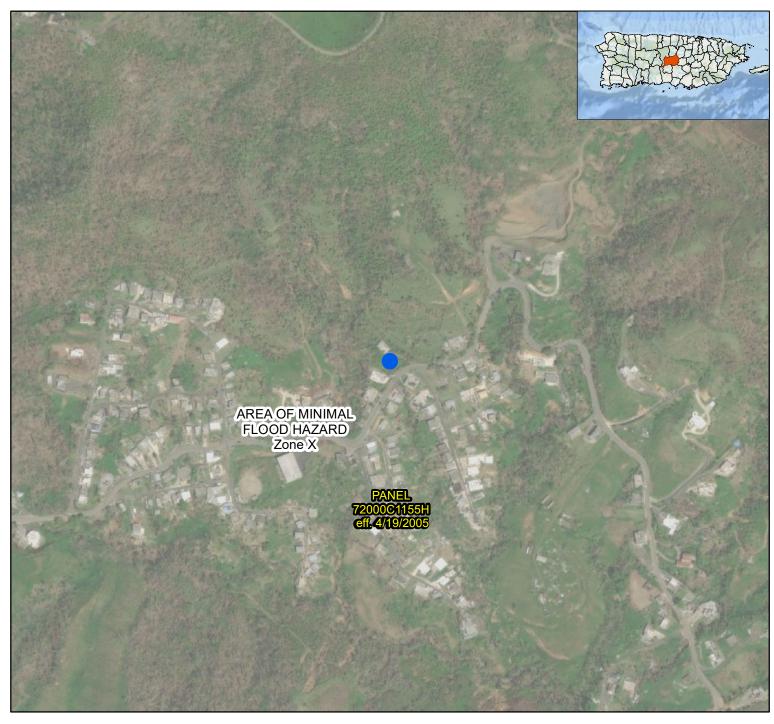
## Figure 4: Flood Insurance Rate Map Puerto Rico Department of Housing ReGrow

Area of Minimal Flood Hazard Zone X

heavy-duty steel garage door will have no impact on any Airports. The site is located 117,100 feet from the nearest major civil airport (Fernando Luis Ribas Dominicci in San Juan) and 138,761 feet from the nearest military airport (Luis Muñoz Marín International Airport in San Juan). This topic is in compliance with the HUD's Airport Hazard regulations without further evaluation. See the attached Airport map Runway Protection Zone, Figure 2.
Coastal Barrier Resources  Coastal Barrier Resources Act, as amended by the Coastal Barrier Improvement Act of 1990 [16 USC 3501]	Yes	No	This project is not located in a CBRS Unit. The project is located 81,782 feet southeast of the nearest Coastal Barrier Resource System, PR-83. Therefore, this project has no potential to impact a CBRS Unit and is in compliance with the Coastal Barrier Resources Act. See the attached CBRS map, Figure 3.
Flood Insurance Flood Disaster Protection Act of 1973 and National Flood Insurance Reform Act of 1994 [42 USC 4001-4128 and 42 USC 5154a]	Yes	No	The project is located in Zone X, Panel 72000C1155H, 4/19/2005 on the FEMA FIRM. The project does not require flood insurance or is excepted from flood insurance. See attached Flood Map, Figure 4. The project is in compliance with the Flood Insurance without further evaluation.

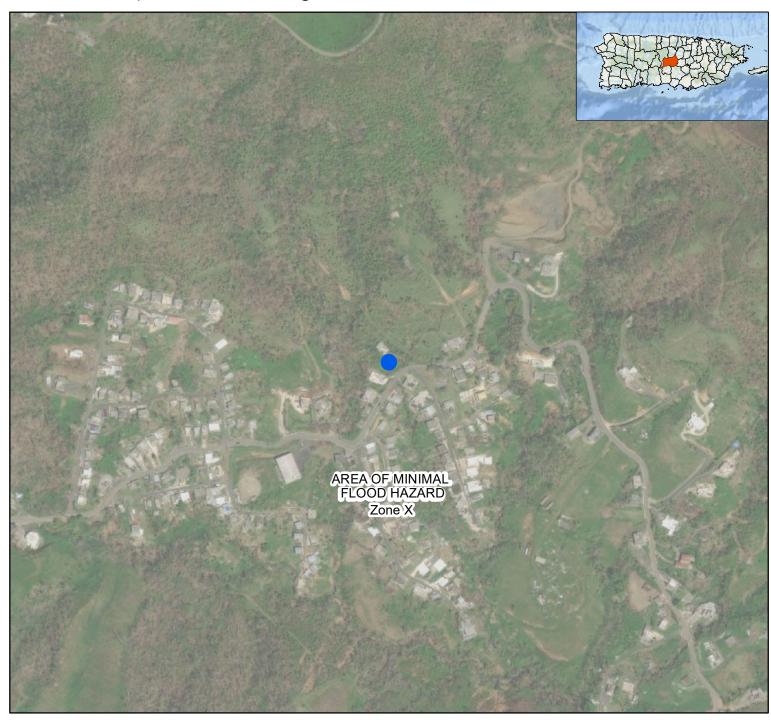
## Figure 9: Advisory Base Flood Elevation Puerto Rico Department of Housing ReGrow

Area of Minimal Flood Hazard Zone X

sections 1504(b) and 1541; 7 CFR Part 658		scope of work includes the installation of the containers and concrete slab for the water tank, and this is a construction limited to on-farm structures needed for farm operations. The project is in compliance with the Farmland Protection Policy Act. See the attached Farmlands map, Figure 8.
Executive Order 11988, particularly section 2(a); 24 CFR Part 55	Yes No	The site is not located in an Advisory Base Flood Elevation special flood hazard area. PFIRMs in Puerto Rico were only developed for certain sections of the municipalities of Carolina, Canovanas, Loiza, San Juan and Trujillo Alto. The proposed project is located in the municipality of Orocovis; therefore, PFIRM information was not available for the area and therefore was not considered in the review. Since the project site does not lies within the 1 percent (100-year) floodplain on the ABFE, it is not within the FFRMS. The project is in compliance with Executive Order 11988, as amended by Executive Order 13690. See attached ABFE Map (Figure 9).

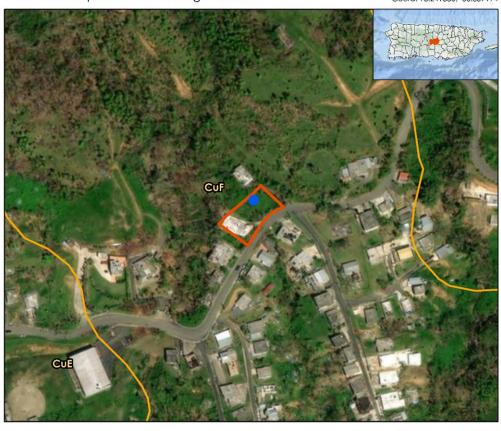
**Soils Map**Puerto Rico Department of Housing ReGrow

The soil in this area has been classified as Consumo clay, 40 to 60 percent slopes (CuF). This is a very steep, well-drained soil on side slopes of maturely dissected humid uplands. Permeability and the available water capacity are moderate. Runoff is very rapid, and erosion is a hazard. Natural fertility is medium.

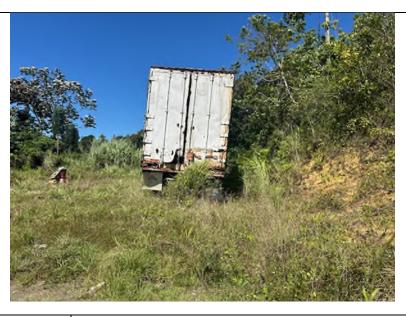
Photo #:1

Description (include direction): Area where the containers will be installed, looking northwest.

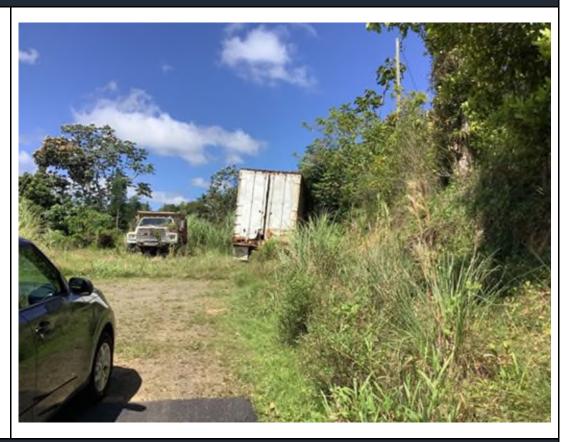
Comments: Trailer 1: 40ft x 8ft :Coordinates:

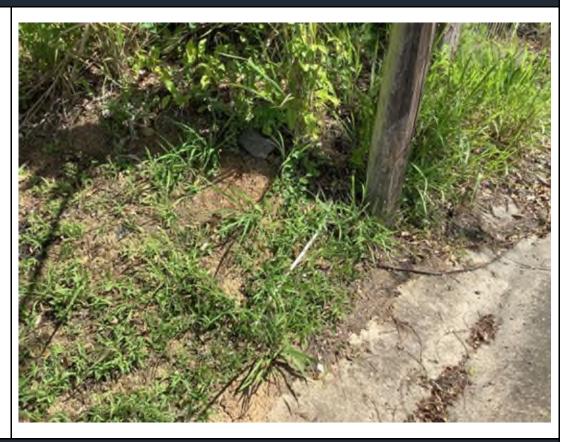
Photo Description: AAA Water line connection

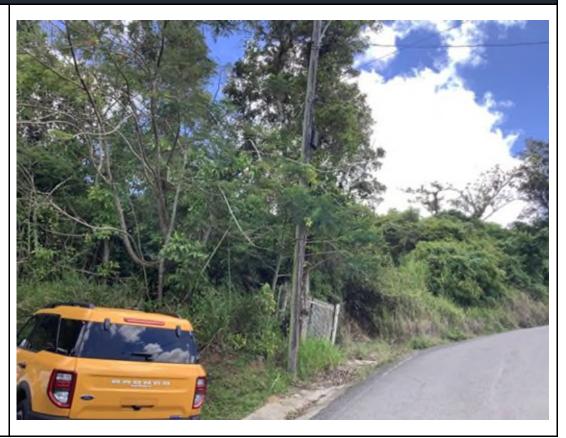
Photo Description: Electricity connection

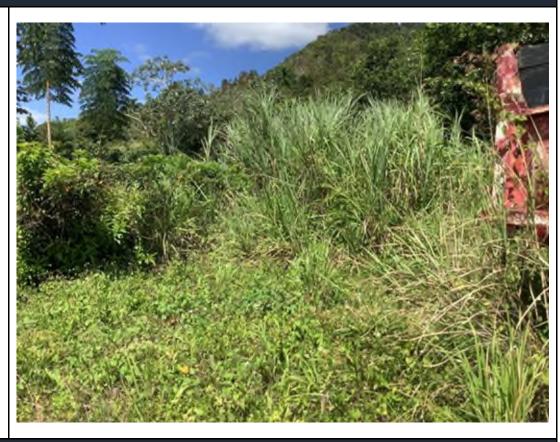
Photo Description: Trailer 2: Front view: Coordinates:

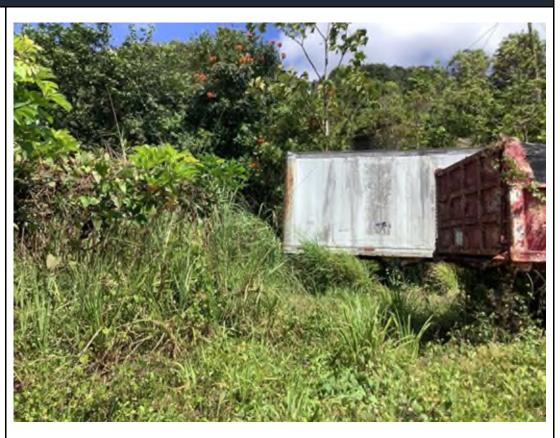
Photo Description: Trailer 2: Left side view

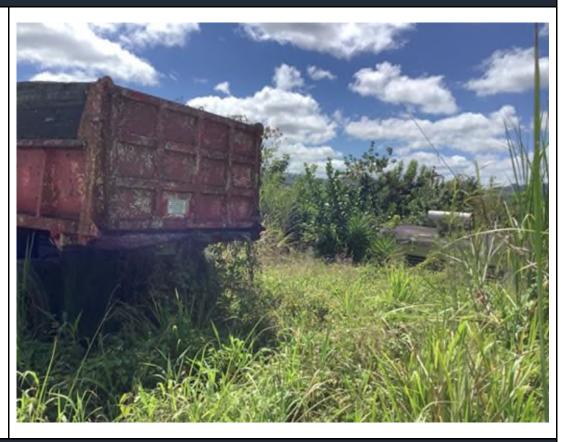
Photo Description: Trailer 2: Back of structure

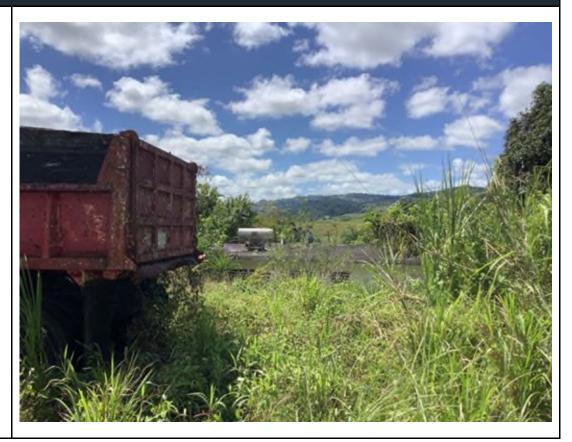
Photo Description: Trailer 2: Right side

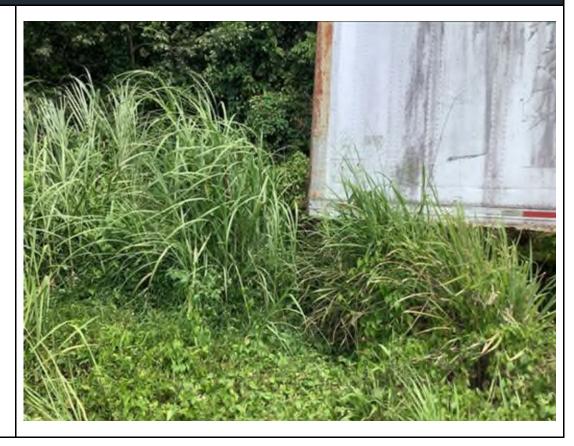
Photo Description: Water pump

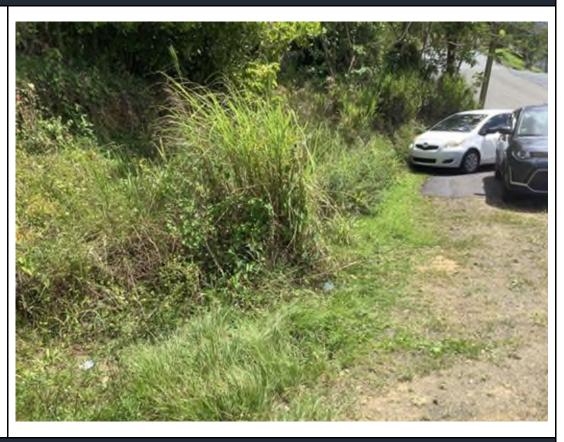
Photo Description: Underground powerr line from mainline to Trailer

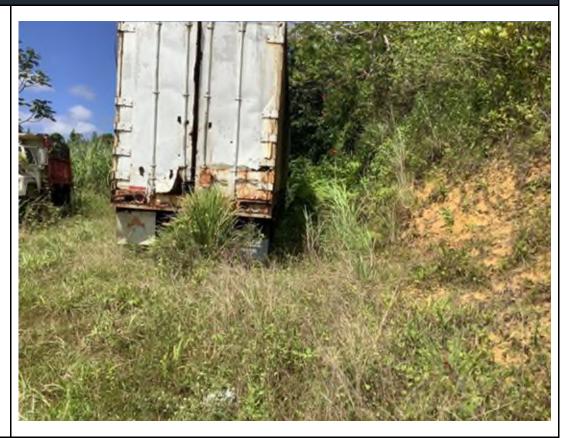
Photo Description: Underground power line from mainline to Trailer
