Environmental Assessment for HUD-funded Proposals

Project Identification: **SAN BLAS APARTMENTS**
#126 & #128 CALLE JOSE QUINTON (PR-14)
COAMO, PUERTO RICO

Preparer: **ARCH. JORGE L. SALA MORALES**
GS GROUP, LLC

Month/Year: **MAY 22, 2019**
REV 1 – JUNE 4, 2019
REV 2 – JUNE 17, 2019

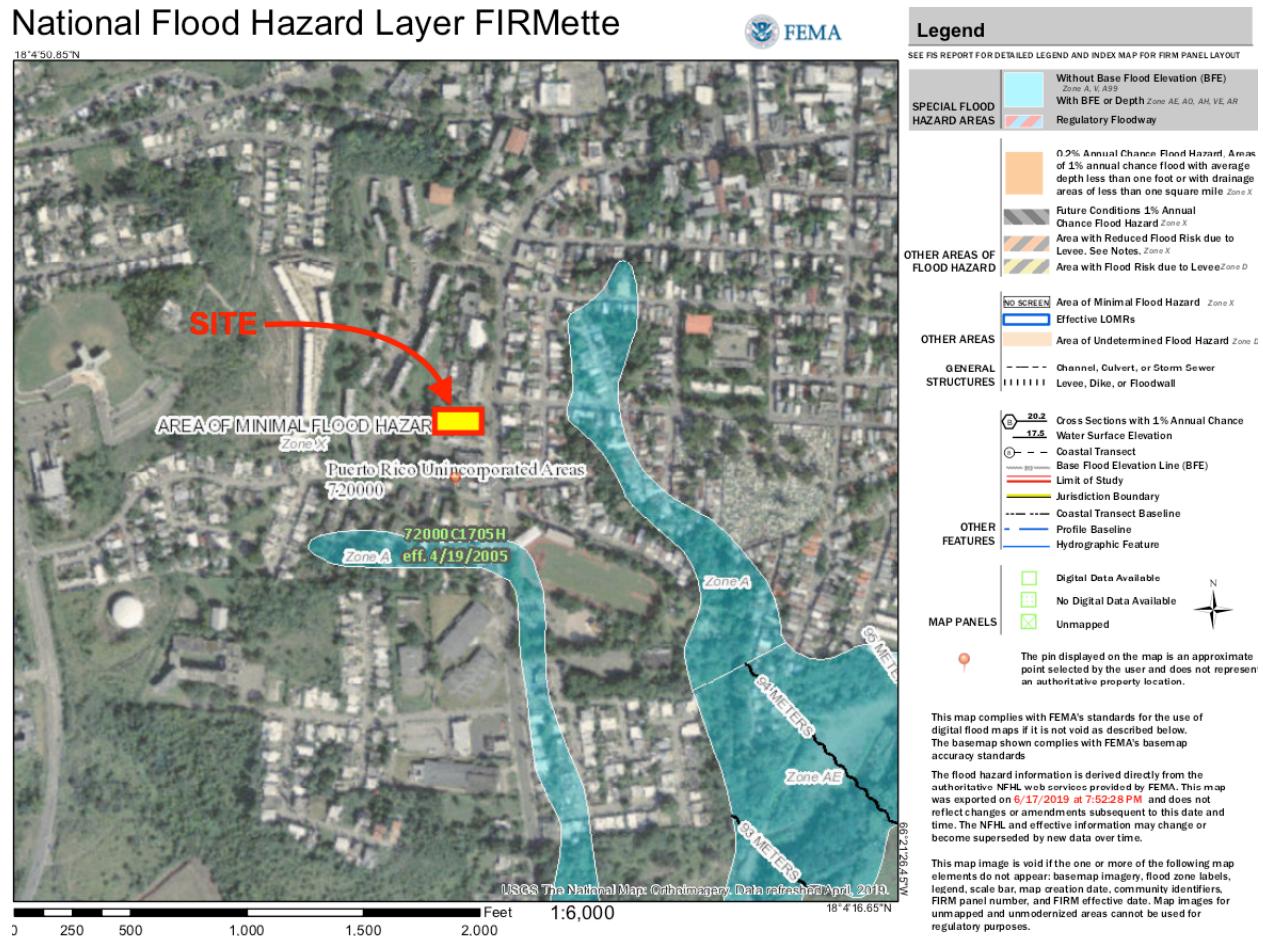
National Flood Hazard Layer FIRMette

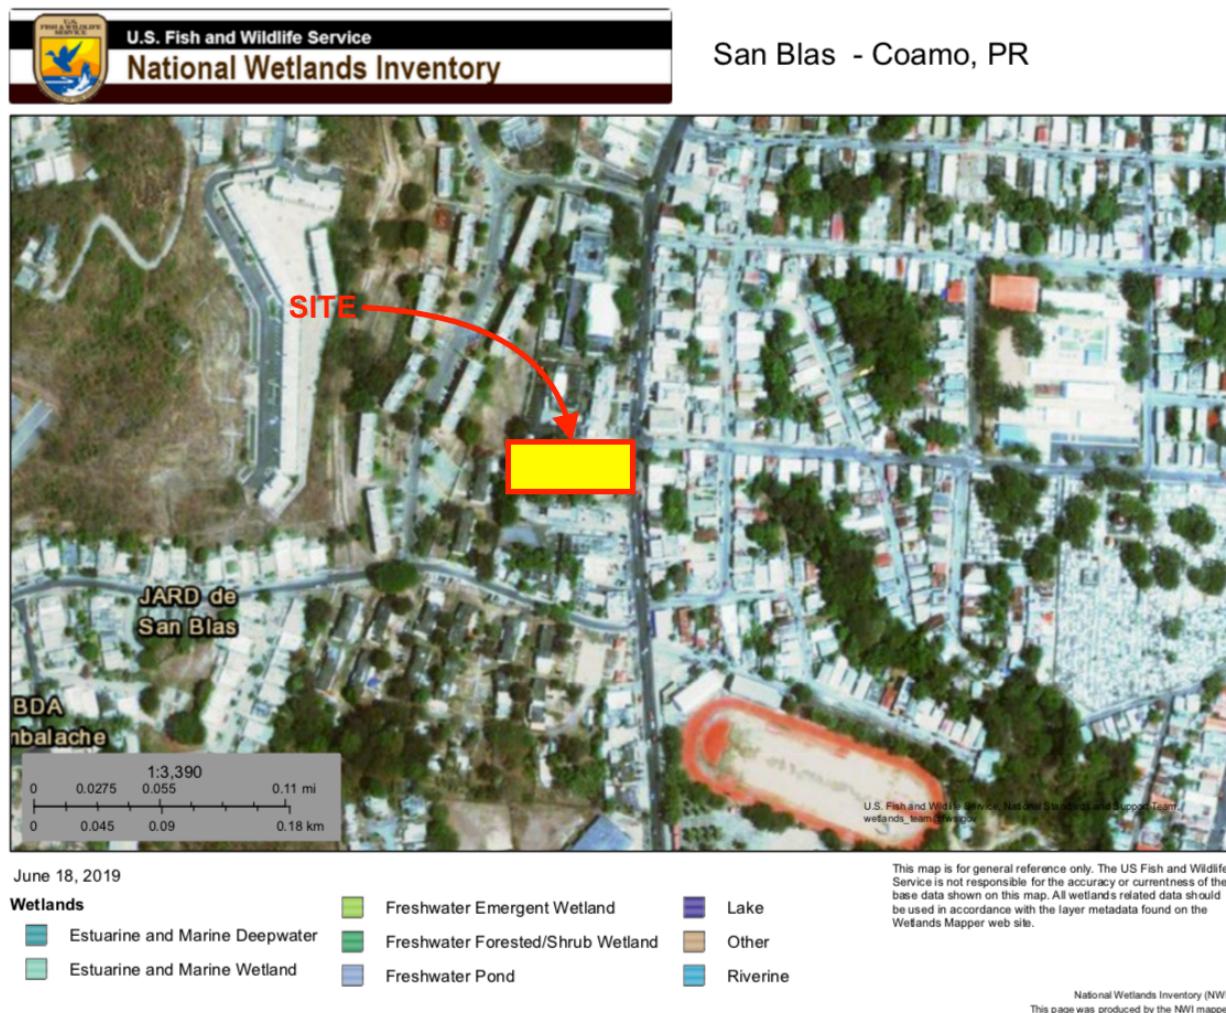
Exhibit No. 2

Wetland Protection – Wetlands Map

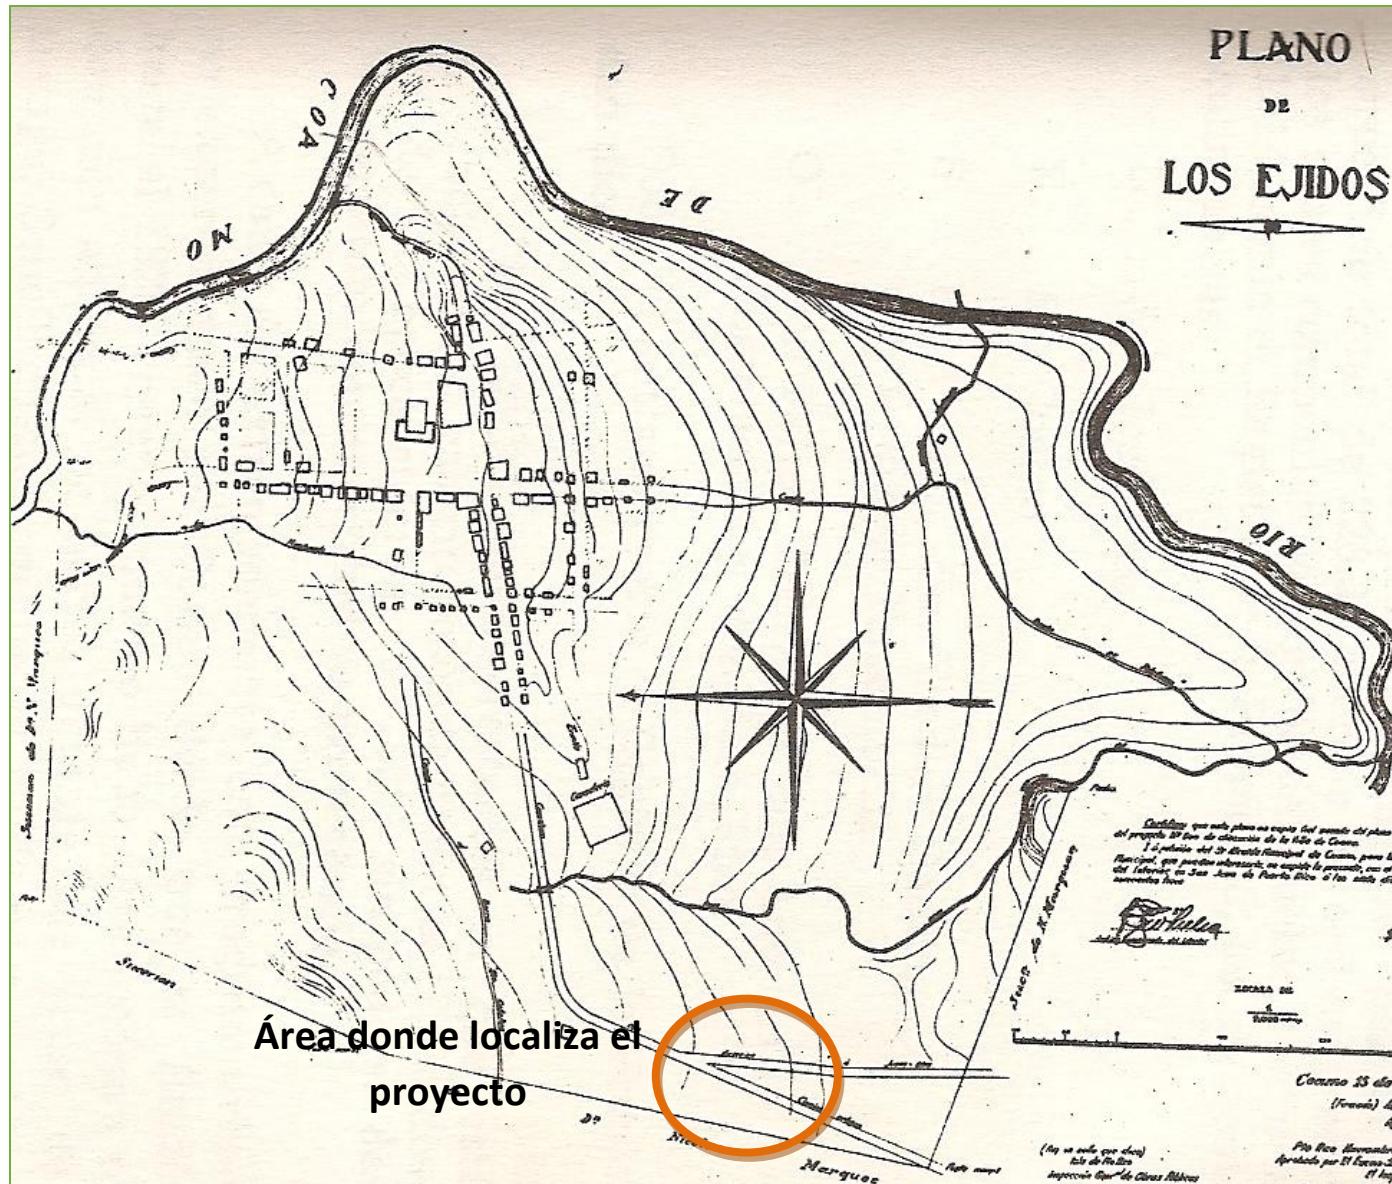
Figura 4: Plano del pueblo y los Ejidos de Coamo en 1870. Plano del agrimensor Augusto Braschi. Departamento de Obras Públicas de Puerto Rico. Se observa el área donde localiza el proyecto desocupada.

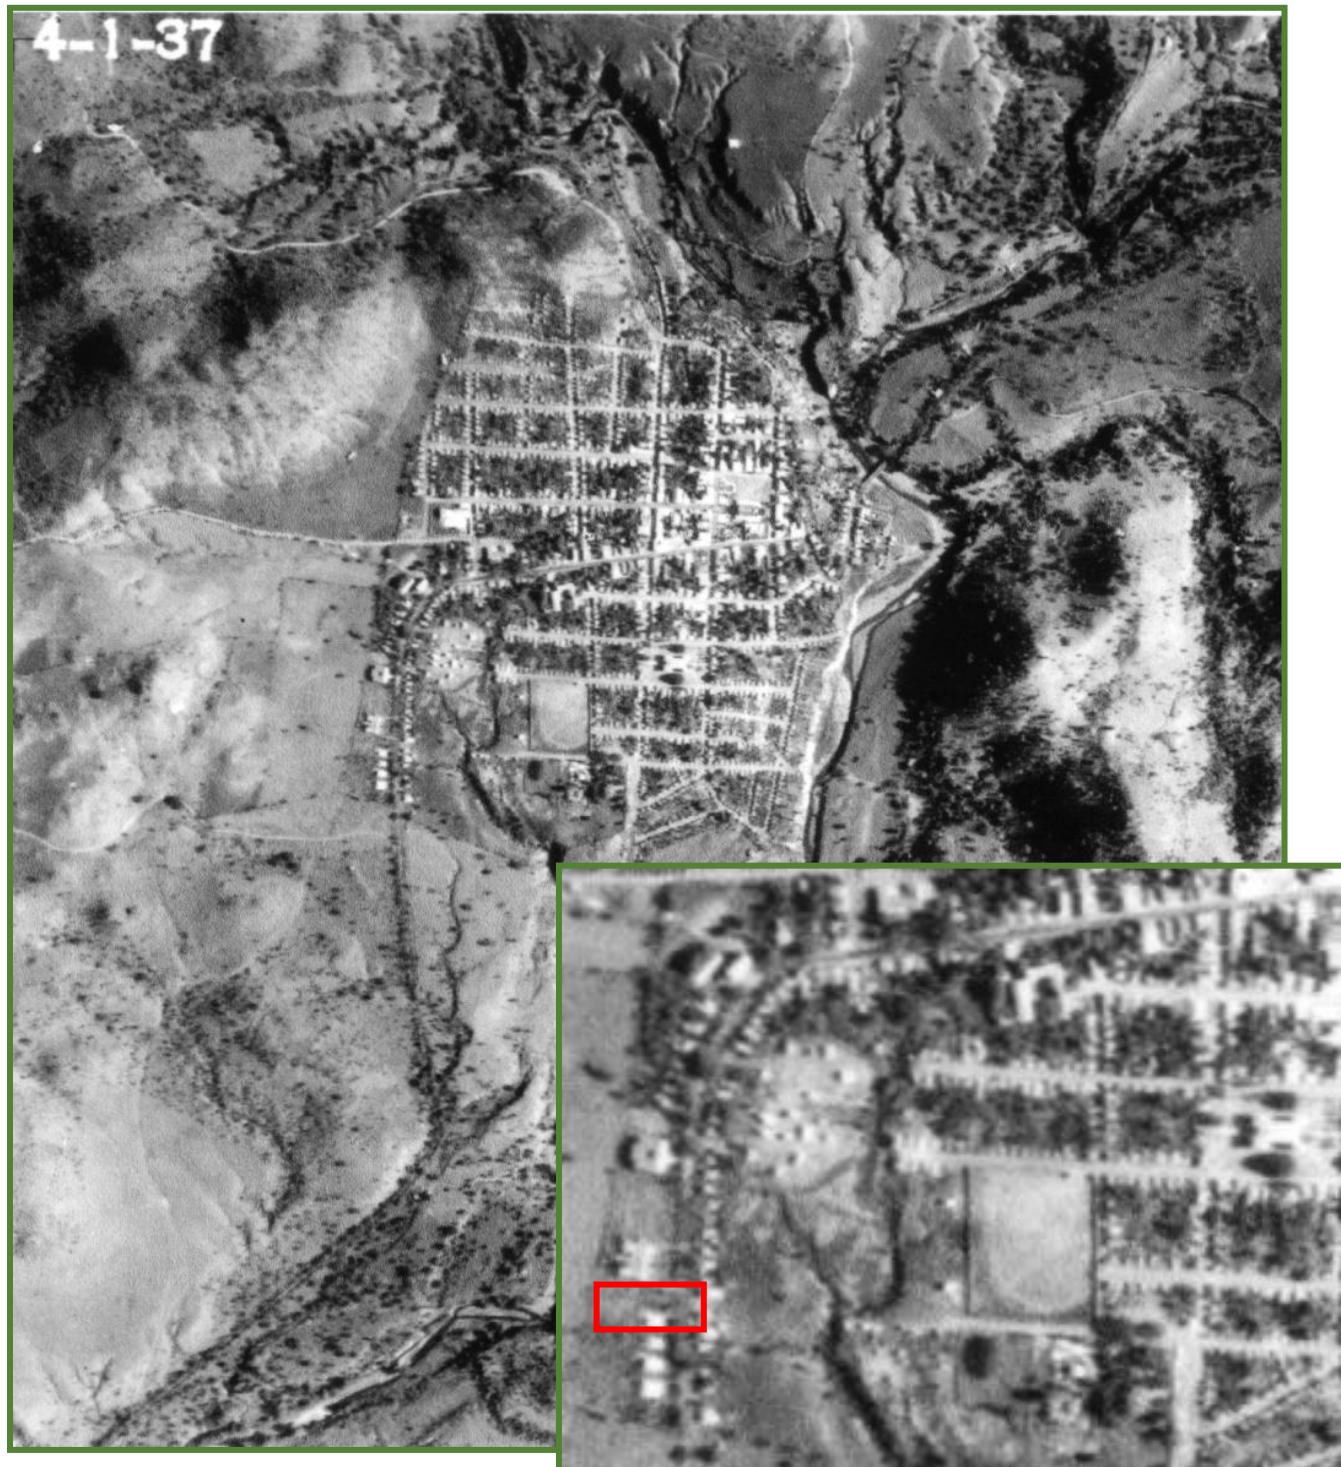
Figura 7: Fotografía aérea de 1937, Se observa el solar #128 ocupado por una estructura, el solar # 126 se observa todavía sin ocupar.

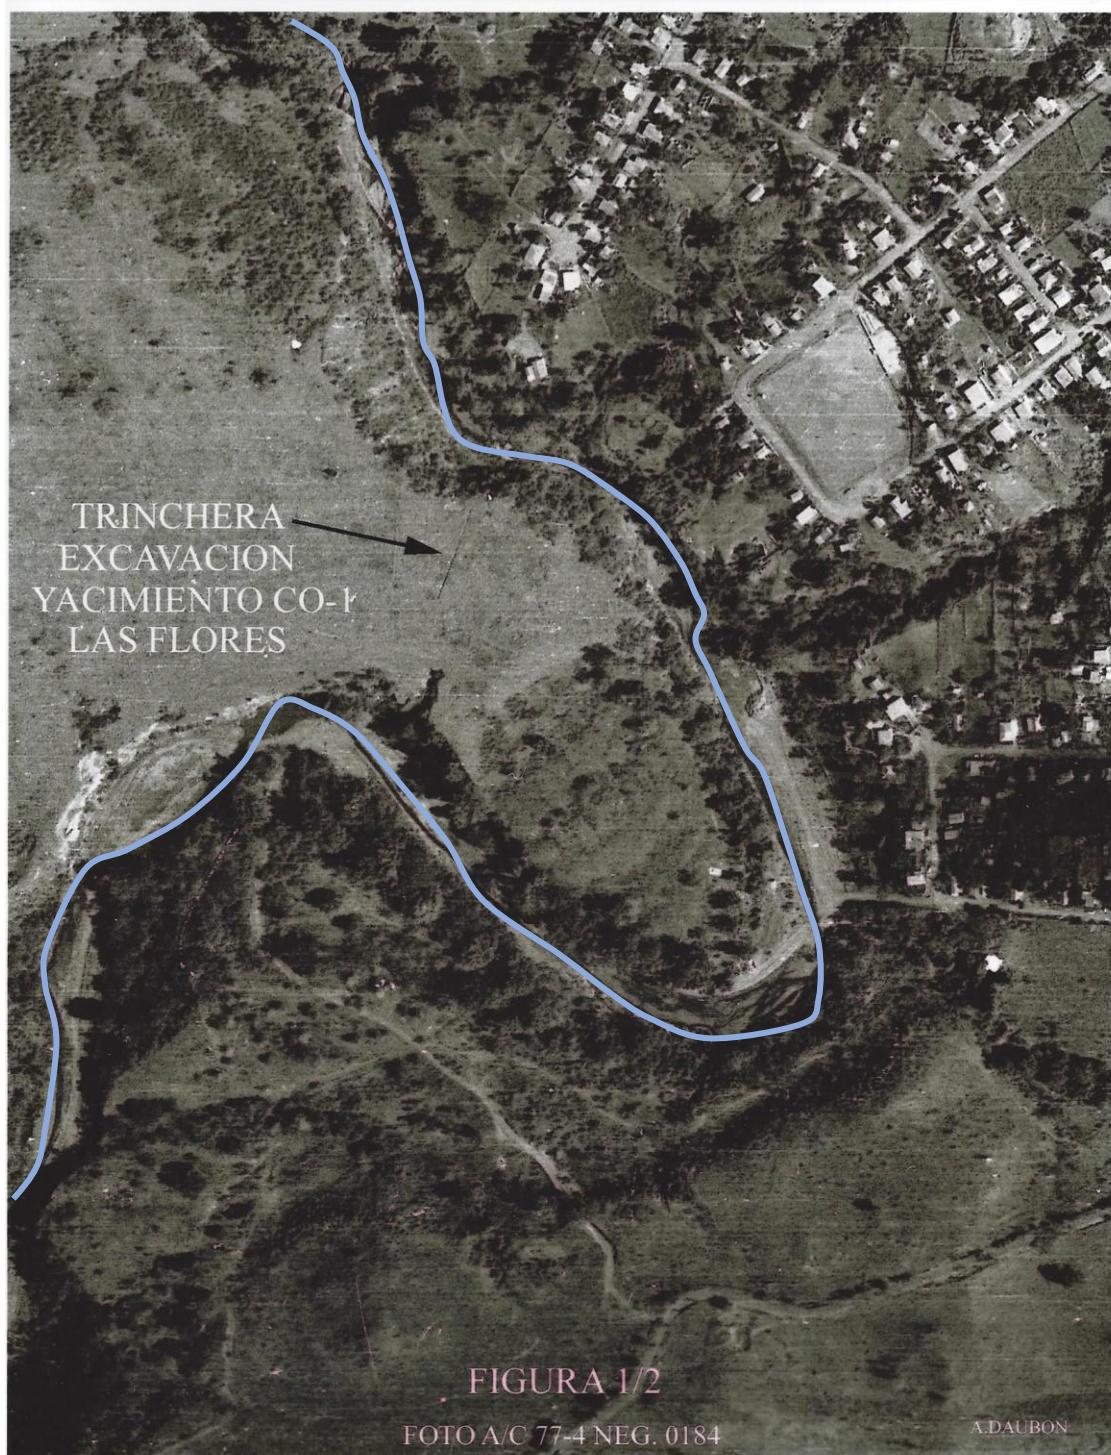
Figura 15: Fotografía aérea del yacimiento Las Flores en 1977. Se observa la trinchera de 60 metros que bisectó el yacimiento. Foto suministrada por el Arql. Antonio Daubón.

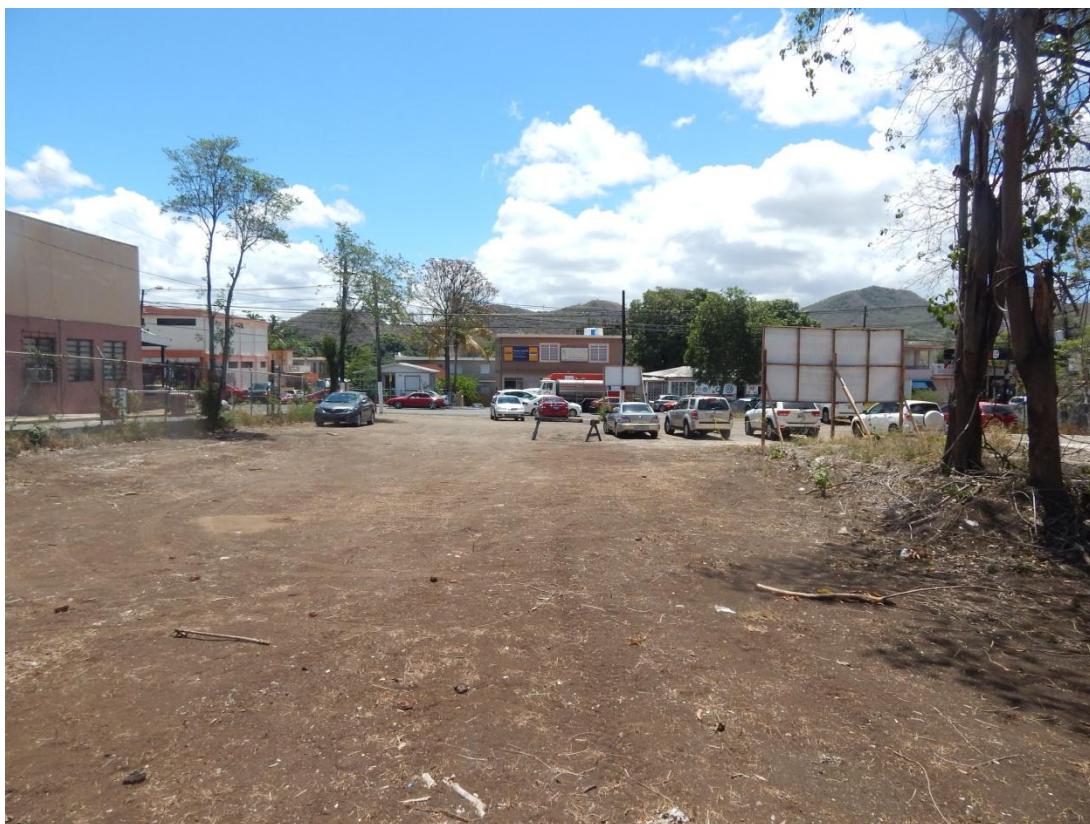
El recorrido /inspección de campo fue realizado el pasado viernes 14 de agosto de 2015. Durante el recorrido de campo se observa que los dos solares bajo evaluación son colindantes y están siendo utilizados como área de estacionamiento. Localizan frente al Laboratorio Clínico de Coamo en la calle José I. Quintón #126 y #128 (PR-14). Se observan en superficie los remanentes de una losa de hormigón que señala la huella de planta de una estructura demolida. El terreno presenta una topografía bastante llana, con una pendiente leve en dirección oeste-este. El predio presenta en el sector oeste varios árboles de quenepa. En el sector este presenta los remanentes de una losa de hormigón correspondiente a la casa de madera y techo de zinc que ubicaba en este solar. El suelo en la superficie se observa de matriz limosa. La superficie del terreno muestra que los solares fueron limpiados con maquinaria. Con esta limpieza realizada en el solar parte de la primera capa de suelo, unos 10 a 15 centímetros, ha resultado removida. Este corte en el terreno producto de la limpieza, se observa claramente cerca de los troncos de los árboles. Hacia el oeste los solares colindan con la Urb. Publica Las Palmas. En esta colindancia el desnivel del terreno es más evidente.

Foto 1: Vista oeste – este del solar bajo evaluación.

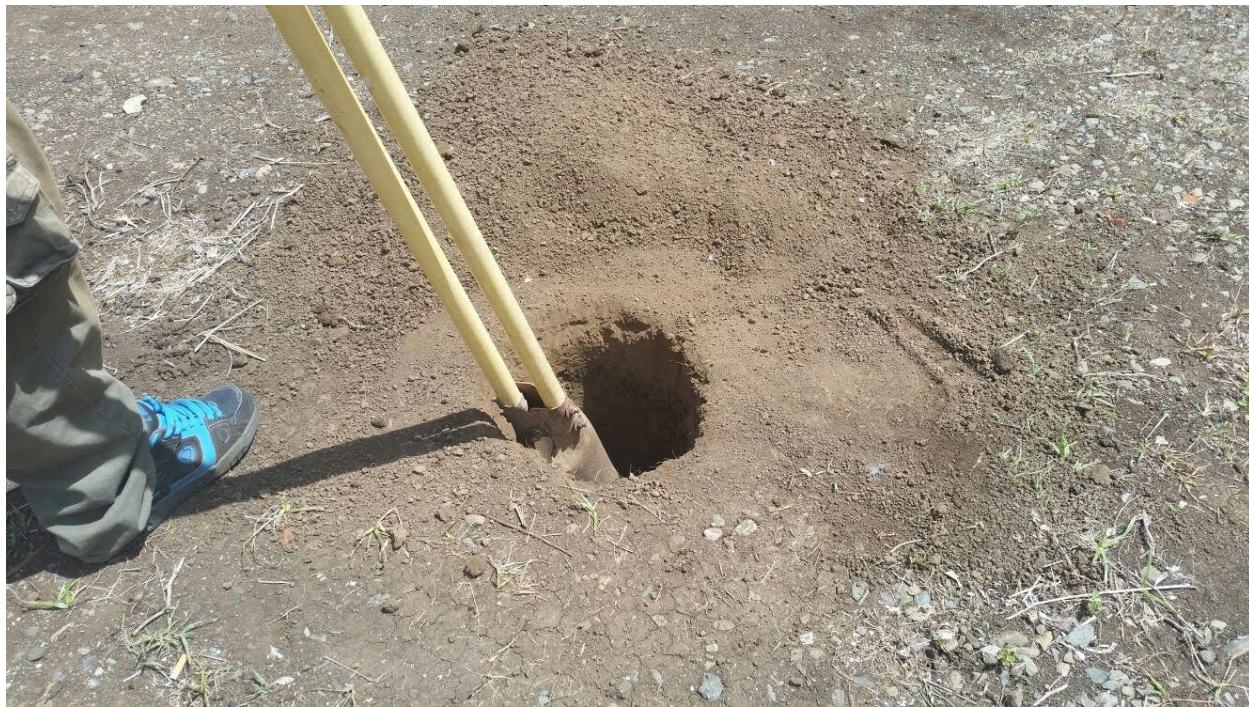
Foto 8: Excavación del suelo de matriz arcillosa 2.5 Y 4/4.

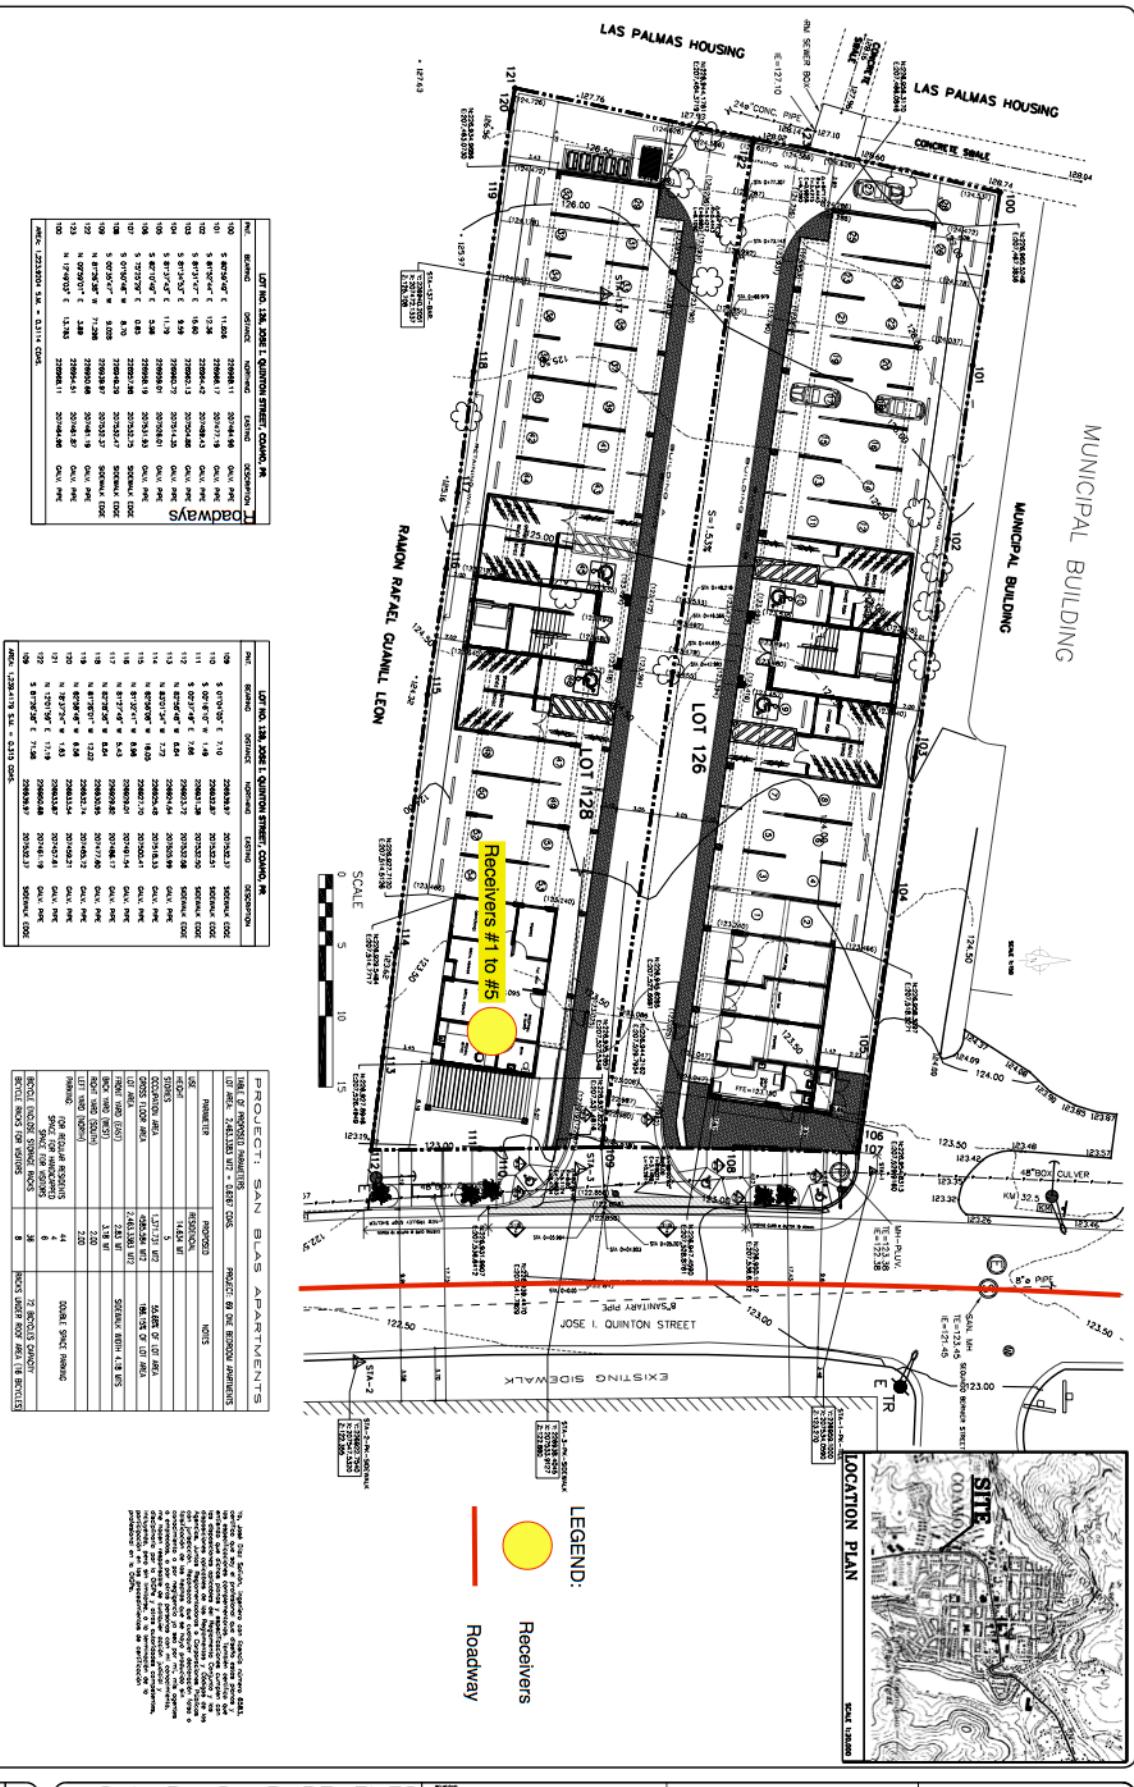
Figure 2 - Receivers Location Plan
Environmental Noise Study
San Blas Apartments - State Road PR-14 (José Quinton Street), Pueblo Ward, Coamo, PR
