## **ENVIRONMENTAL ASSESSMENT for HUD-funded Proposals**

**VIEWPOINT AT THE PARK**  
PARCELA B-1-A & B-1-B  
CALLE SEVILLA ESQ. ALHAMBRA  
HATO REY NORTE  
SANTURCE, PR

**ENVIRONMENTAL ASSESSMENT**

**Project Name:** VIEWPOINT AT THE PARK

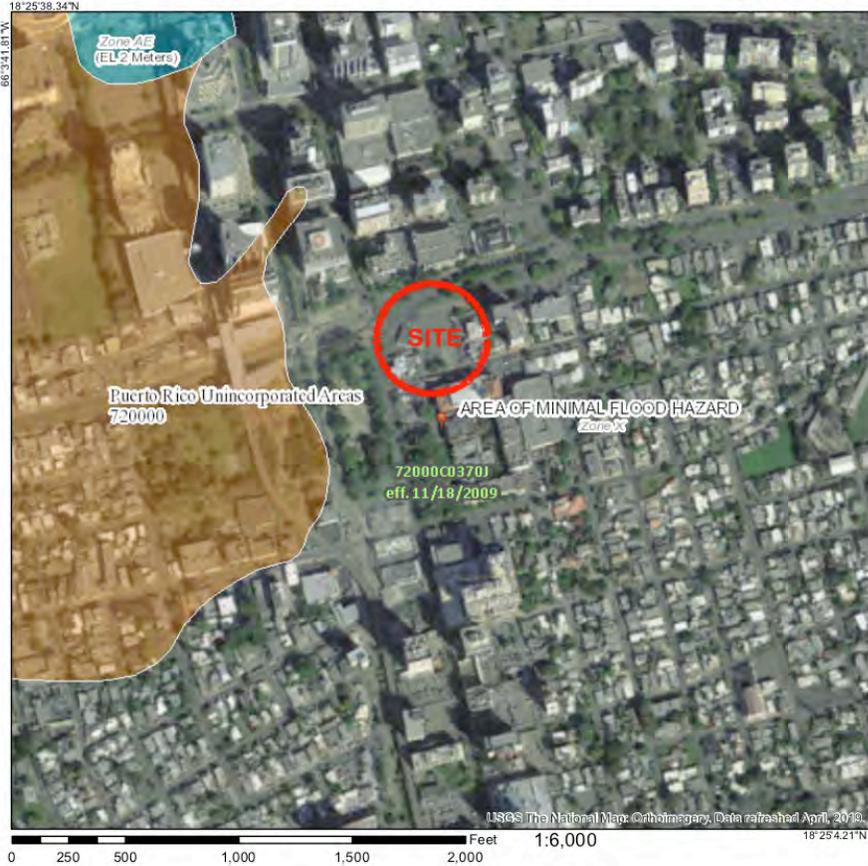
**Exhibit No. 1**  
**Floodplain Management - FEMA Firmette**

**National Flood Hazard Layer FIRMette**

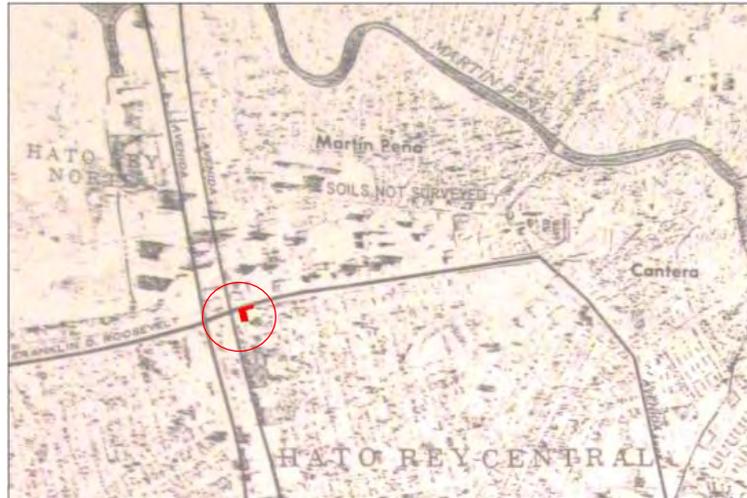
**Figura 4: Mapa de suelos de 1978 (Bochecciamp 1978)**

de suelo en el predio, para el proyecto *Plaza Mayor Development in San Juan*. Este desarrollo no se llevó a cabo. Para el presente proyecto, la compañía produjo un nuevo informe, con fecha del 28 de julio de 2016, que utilizó los resultados de las pruebas realizadas para el proyecto anterior.

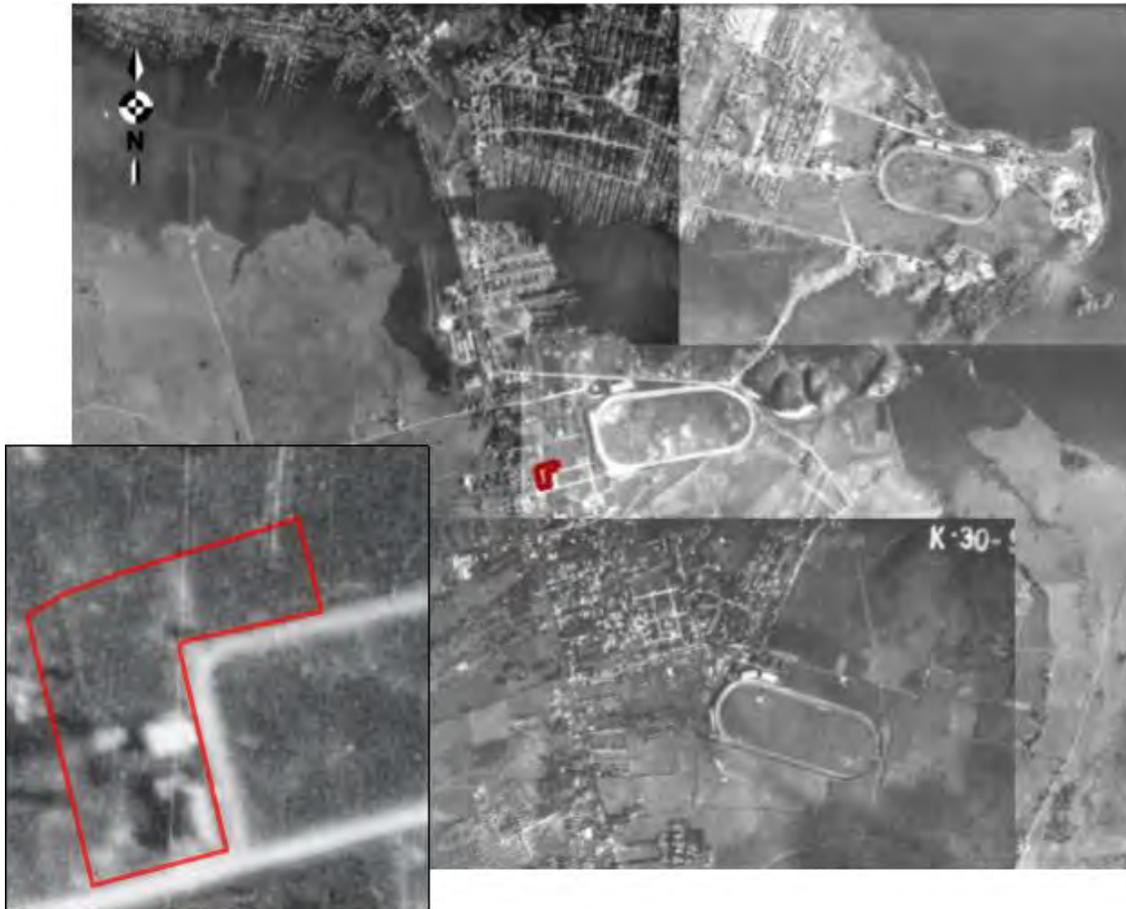
**Figura 10: Área del proyecto en la foto aérea de 1937, y acercamiento (ACT)**

En las primeras tres décadas del siglo XX, la zona donde ubica el proyecto sufrió un cambio significativo. En las fotos aéreas de 1936 y 1937 (Figura 10) se aprecia amplias áreas despobladas, particularmente en los márgenes de la carretera central. Llamam inmediatamente la atención tres hipódromos ubicados al este de la carretera central, muy cercanos entre sí. El área del proyecto se encuentra al norte de un desarrollo de viviendas, que aparece organizado en cuadrículas. Al norte, el Caño Martín Peña tiene un área amplia cenagosa alrededor, y está densamente poblado en el margen norte. En un acercamiento, se aprecia que las calles Sevilla y Alhambra ya existían, no así la Roosevelt. En el predio bajo estudio se observan tres estructuras, una rectangular que aparenta tener dos niveles, ubicada en la intersección de las calles mencionadas (Estructura 1), una rectangular, más pequeña, un poco al norte de la anterior (Estructura 2), y otra aún más pequeña, al noroeste (Estructura 3). En el resto del solar no se aprecian estructuras.

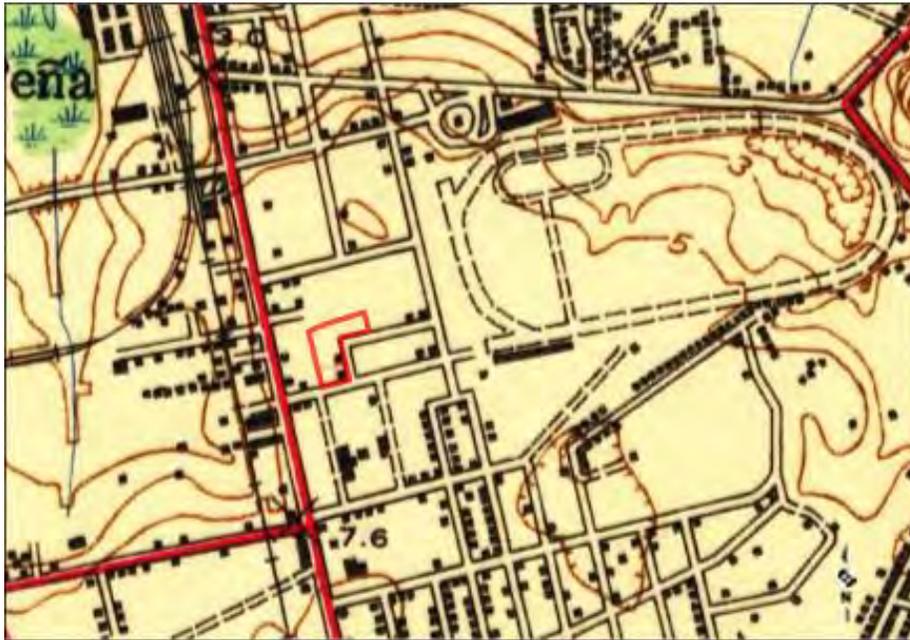
Figura 11: Cuadrángulo topográfico de 1941 (USGS)

La próxima representación gráfica del área es el cuadrángulo topográfico del USGS de 1941 (Figura 11). Aquí se observan condiciones similares a las de la foto aérea del 37. En el área del proyecto se observan las Estructuras 1 y 2, aledañas a la calle Sevilla. La tercera estructura no se encuentra en este plano, lo que sugiere que fue eliminada, o que se trataba de una estructura menor, como un pequeño almacén o garaje. En esta imagen se aprecia el trazado regular de las cuerdas al sur del

área bajo estudio, y la línea de tren (o tranvía), corriendo paralela y al oeste de la avenida Ponce de León. También hay otra línea que viene del oeste, por paralela a donde se encuentra la actual avenida Roosevelt -en este momento inexistente, y se integra a la vía principal. El hipódromo Las Monjas, ubicado a apenas 180 m al este del predio, sigue en existencia.

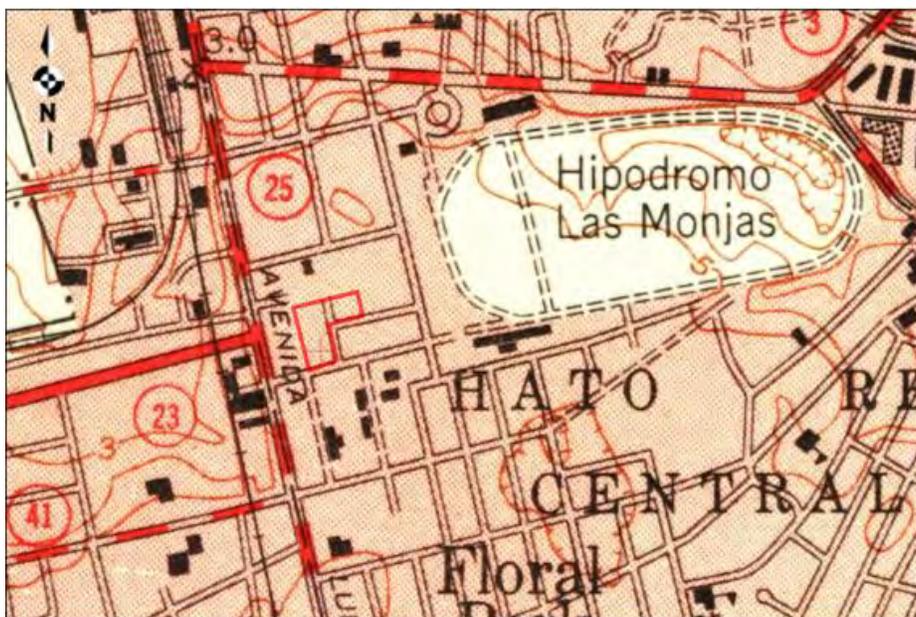
Figura 12: Cuadrángulo topográfico de 1948 (USGS)

El cuadrángulo de 1948 presenta algunas variaciones, sobre todo en la red vial (Figura 12). Aparece la avenida Roosevelt -entonces carretera 23- hacia el oeste de la Ponce de León, así como otras vías mayores, como la 41 y la 25 -que es la carretera central, y la 3, justo al norte del Hipódromo. Llama atención que la avenida central, actual Ponce de León, está designada como avenida Luis Muñoz Rivera. El desarrollo urbano al sur del predio está identificado como Floral Park, y el barrio como Hato Rey Central. En el predio del proyecto no se observan estructuras, pero esto se debe a que el plano solo señala estructuras mayores, probablemente institucionales. Lo que llama la atención, es que ahora la calle perpendicular a la Alhambra, continúa hacia el norte, cruzando de norte a sur el área del proyecto. El Hipódromo Las Monjas se aprecia ahora circundado por calles.

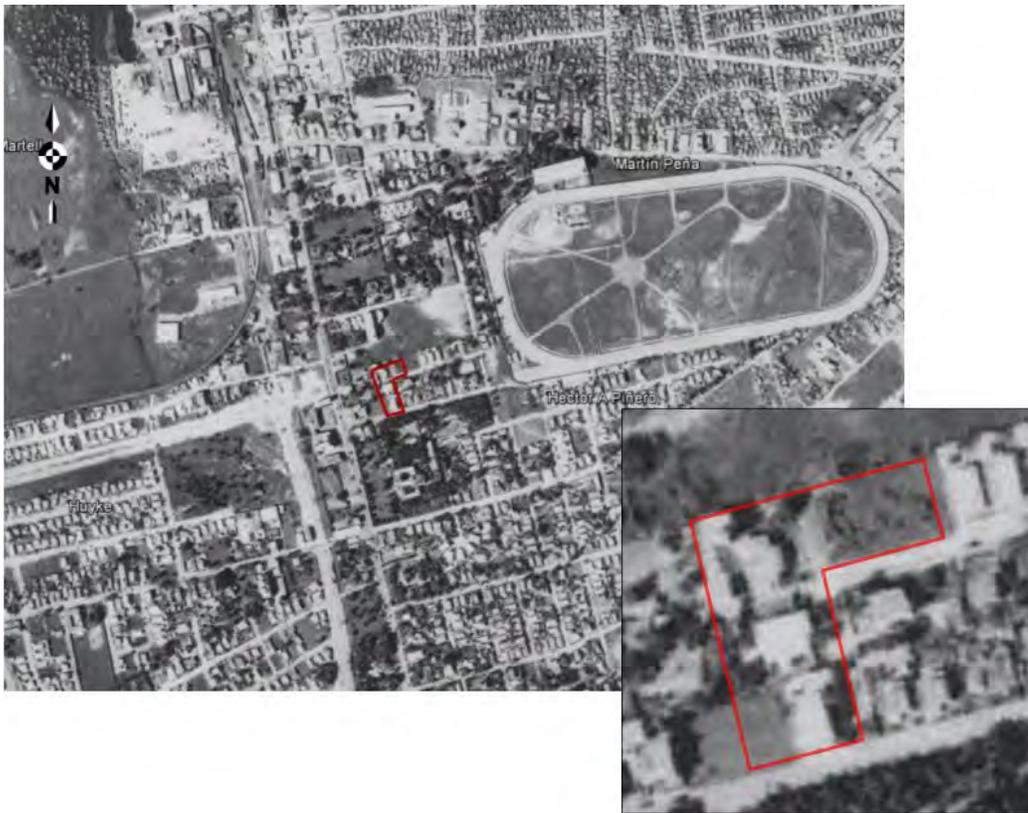
**Figura 13: Área del proyecto en la foto aérea de 1951, y acercamiento (ACT)**

En la foto aérea de 1951 (Figura 13) se aprecia que la zona se encuentra considerablemente más poblada, con patrones distintos al norte del Caño Martín Peña -donde hay estructuras mucho más pequeñas, distribuidas al azar con poca o ninguna área de patio-, y al sur, donde hay estructuras de mayor tamaño, y distribuidas más uniformemente. Las avenidas Roosevelt y Muñoz Rivera se distinguen por su anchura, mientras que la Ponce de León se observa más estrecha. En el predio bajo estudio se observan por lo menos cuatro (4) estructuras que ocupan toda la parte oeste. La estructura en el SE parece corresponder a la Estructura 1. La estructura 2 fue ampliada considerablemente, y la #3 no existe o fue integrada a la #2. Las dos nuevas estructuras, denominadas Estructuras 4 y 5, están ubicadas en el noroeste del predio. La estructura 4 es similar a las 1 y 2 en tamaño, mientras que la 5 se distingue por ser estrecha y alargada, y por estar ubicada justo en el perímetro noroeste de la propiedad. Se aprecia con claridad la extensión de la calle Sevilla, que cruza el predio de norte a sur, y otra calle, que lleva a la Estructura 4.

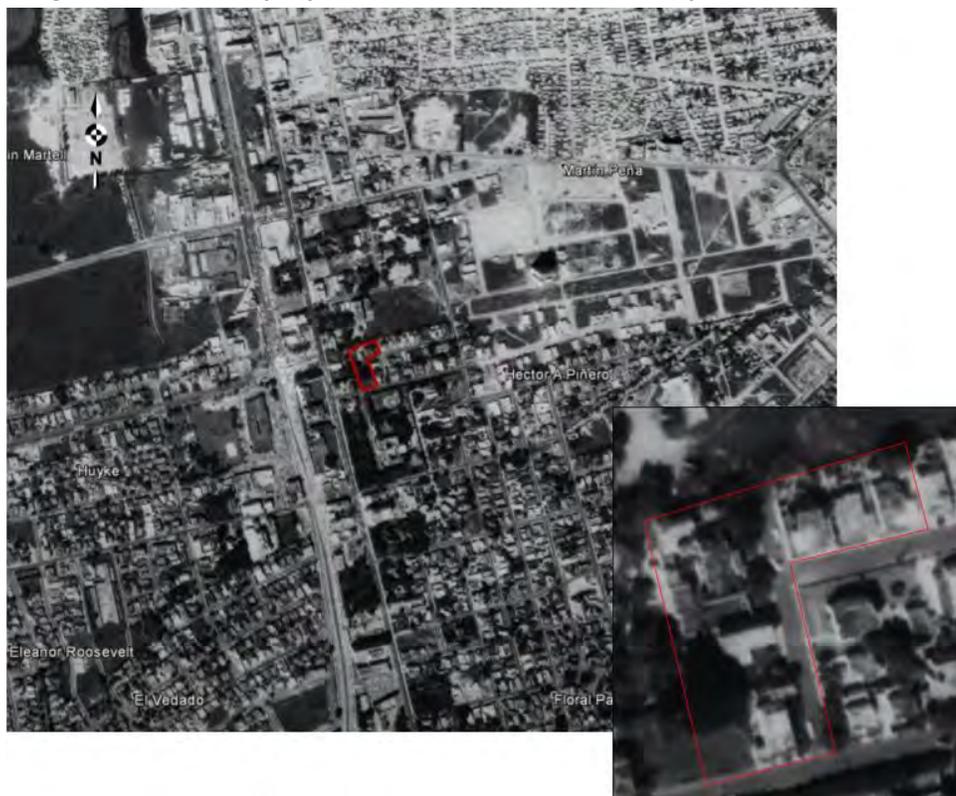
**Figura 14: Área del proyecto en la foto aérea de 1962, y acercamiento (ACT)**

En la foto aérea de 1962 (Figura 14) se aprecia el aumento en densidad poblacional al sur del área del proyecto y las diversas urbanizaciones que ya existen, como la antigua Floral Park, Roosevelt y El Vedado. El Caño Martín Peña aparece bordeado de pequeñas estructuras que cubren cada espacio disponible. El área que ocupaba el hipódromo se ha parcelado, y parece en proceso de desarrollo. Dentro del lote, se pueden apreciar las 1, 2, 4 y 5 en el oeste, y tres nuevas estructuras en el noreste (estructuras 6, 7 y 8). En este momento, prácticamente toda la superficie del área bajo estudio se encuentra cubierta por estructuras.

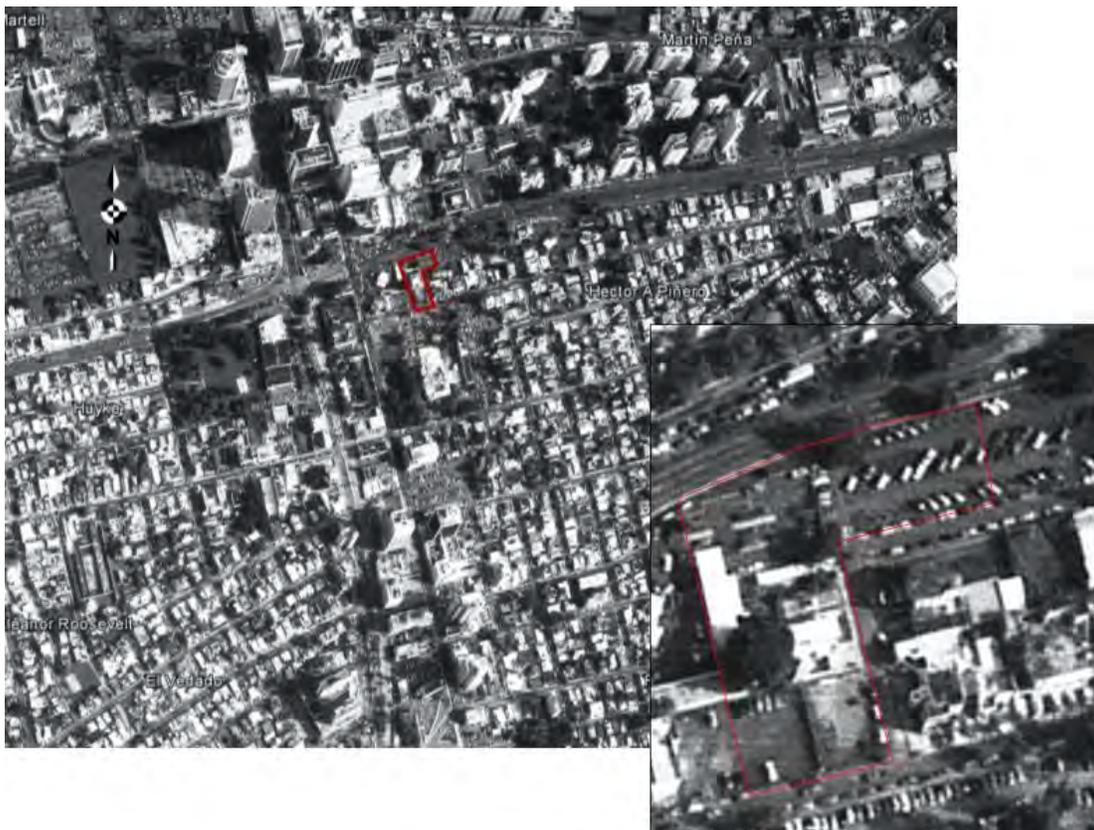
**Figura 15: Área del proyecto en la foto aérea de 1991, y acercamiento (ACT)**

En 1991, la zona en general es similar a como se encuentra hoy en día, con los edificios de la Milla de Oro al norte, la Roosevelt, y las urbanizaciones al sur (Figura 15). En el predio ya no aparecen las estructuras que estaban en el noreste, estructuras 6 a 8. Dicha área aparece ahora utilizada como estacionamiento. Del lado oeste, las únicas estructuras que permanecen son la 2 y la 5. La Estructura 2 parece haberse extendido un tanto, y al norte, casi adyacente, hay una nueva estructura rectangular y estrecha (Estructura 9). La Estructura 1, en existencia desde 1936, fue demolida. Parece quedar un solo muro en la parte central de la porción sur del predio. La Estructura 5, en existencia desde 1951, también fue demolida, posiblemente en parte por la construcción de la Roosevelt. La calle que cruzaba el área de N a S desaparece.

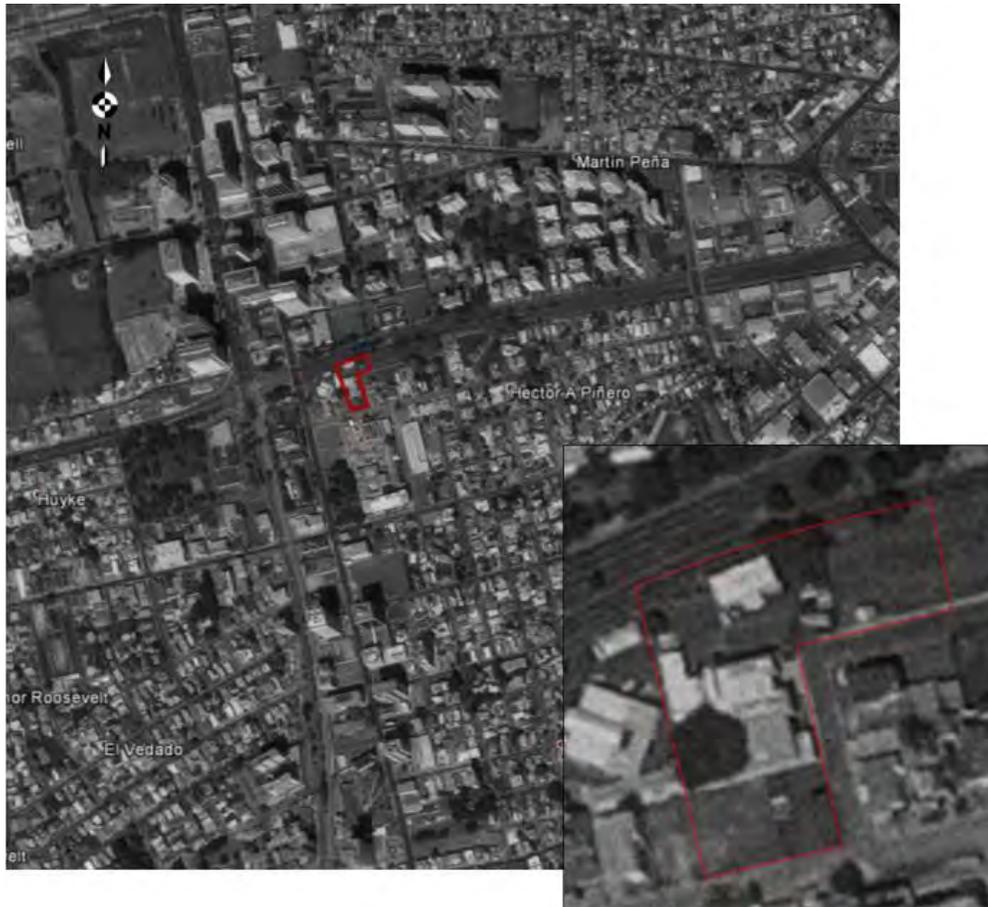
**Figura 16: Área del proyecto en la foto aérea de 1994, y acercamiento (GoogleEarth)**

Entre 1991 y 1994 se construye una nueva estructura al norte -la #10-, adyacente a la avenida Roosevelt. Las estructuras 2, 5 y 9 aparecen contiguas, formando una sola masa en la foto satelital de 1994 (Figura 16). La parte este del predio continúa vacante.

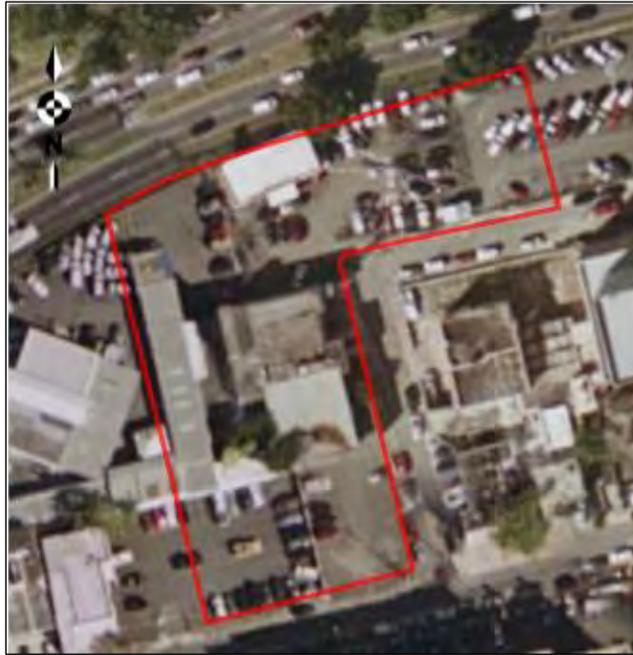
**Figura 17: Acercamiento al área del proyecto en la foto aérea de 2004 (GoogleEarth)**

Las condiciones en el lote continúan similares por la próxima década. En la foto aérea del 2004 (Figura 17) se aprecia con claridad la distribución de las estructuras aún existentes, la 2, 5 y 9. El resto del predio es utilizado como estacionamiento. Llama la atención que una porción de la parte NE del predio este siendo utilizada como parte del estacionamiento del predio colindante hacia el este, estando aparentemente separada del área bajo estudio al oeste, a la cual pertenece. De la misma forma, la Estructura 5 continúa hacia el predio colindante al oeste.

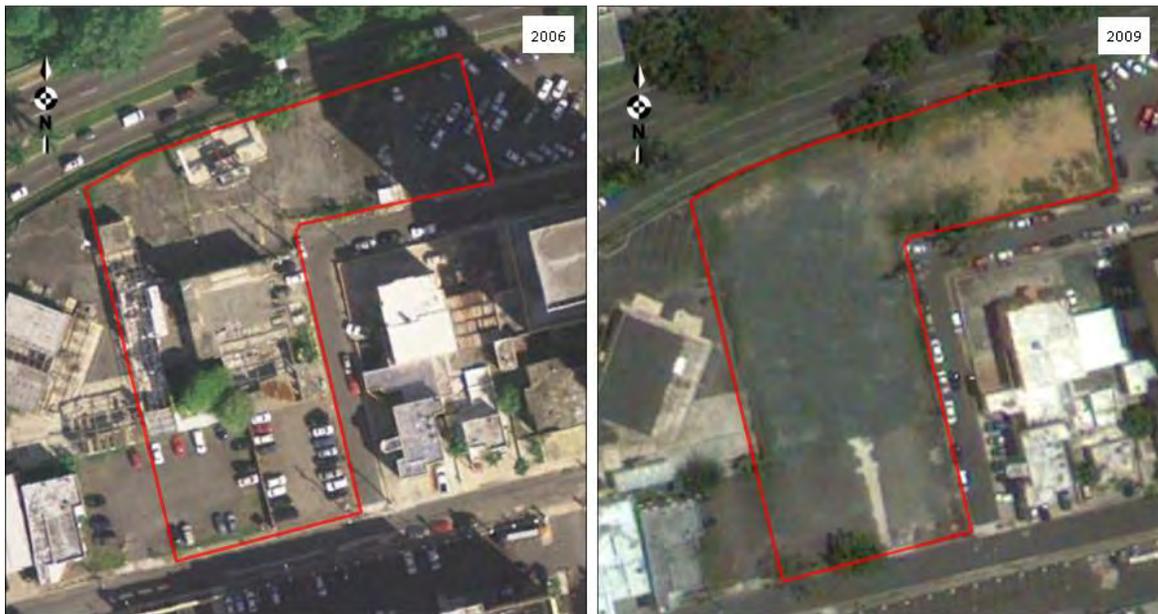
**Figura 18: Acercamiento al área del proyecto en las fotos aérea de 2006 y 2009 (GoogleEarth)**

En la foto de noviembre de 2006 se aprecia que las estructuras dentro del predio están siendo demolidas (Foto 18), y en la foto de junio de 2009 se observa al predio totalmente sin estructuras, como se encuentra en el presente (Foto 18). El solar aparece baldío, con pavimento en el suroeste, relleno de mogolla en el noroeste y tierra rojiza en el noreste. En las diversas fotos aéreas existentes hasta el presente, se observa que el área ha sido utilizada intermitentemente como estacionamiento.

En síntesis, la cartografía y fotos aéreas demuestran que a lo largo del siglo XX y principios del XXI, han existido por lo menos 10 estructuras distintas dentro del área del proyecto. Las estructuras más antiguas de las que se tiene constancia ya existían para 1936. Una de ellas se mantuvo en pie por más de 70 años, hasta el 2006, año en que se comenzaron a demoler todas las estructuras del lote. Otras estructuras tuvieron una vida mucho más corta, como las ubicadas al NE del lote, las 6, 7 y 8, en existencia en 1962, pero ya desaparecidas para 1991 y la #10, construida en algún momento entre 1991 y 1994, y demolida apenas 12 años después.

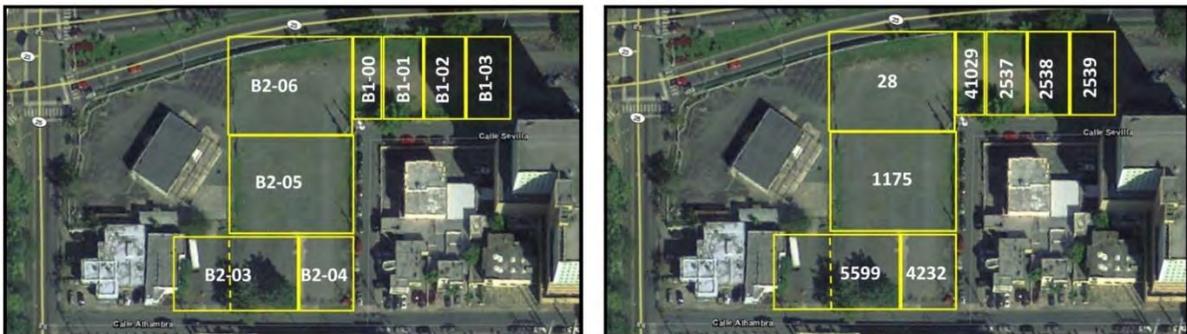
**Figura 27: Diagrama de ubicación de lotes y fincas en el área del proyecto**

A partir de estos datos se preparó la Figura 27, con el fin de determinar la ubicación y extensión de las estructuras descritas en cada finca y facilitar la comparación de las mismas con las macroestructuras (casas, edificios) visibles en las fotografías aéreas históricas y cuadrángulos topográficos.

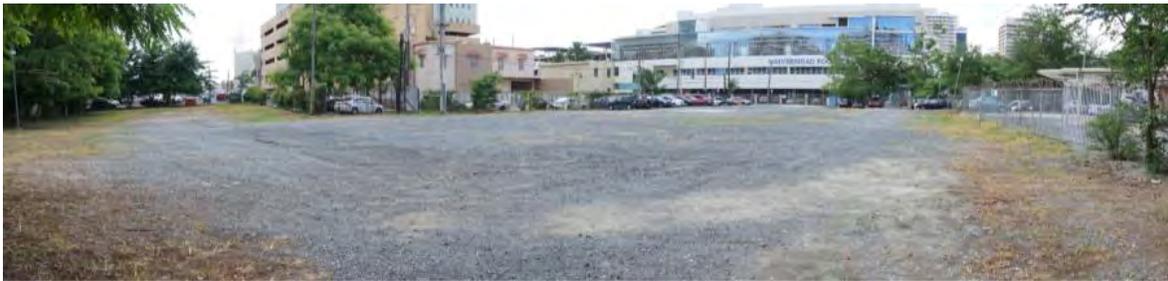
**Foto 1:** Vista panorámica del área bajo estudio, tomada desde la esquina noroeste

El área del proyecto se encuentra totalmente desprovista de estructuras, con la excepción de una pequeña caseta de madera al oeste de la entrada por la calle Alhambra (Foto 1). El predio está siendo utilizado como estacionamiento de la Universidad Politécnica, que se encuentra cruzando la calle Alhambra, al sur. En la calle Sevilla hay estructuras residenciales de dos niveles, y un estacionamiento multipiso (Foto 2).

La única infraestructura visible son postes de iluminación sobre bases pequeñas de hormigón, y postes de madera posiblemente con fibra óptica y postes de hormigón para electricidad. Todos están ubicados en el perímetro del lugar (Fotos 1 a 3).

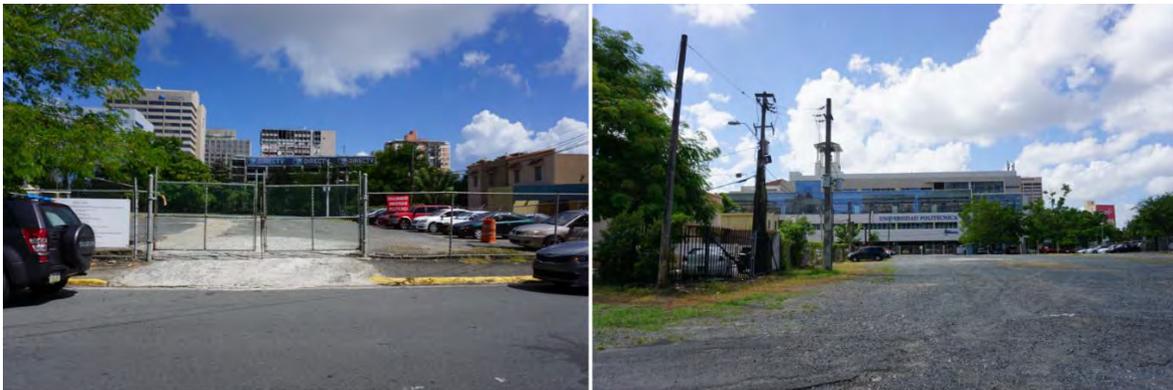
**Foto 2:** A la izquierda, vista general de acceso al predio por la calle Alhambra. Nótese área utilizada como estacionamiento y estructuras residenciales a la derecha de la foto. A la derecha, vista de la parte suroeste, mirando hacia el sur. Nótese el edificio de la Universidad Politécnica al Fondo, y los diversos tipos de postes a la izquierda de la imagen.

La parte suroeste del área bajo estudio tiene una parte pavimentada con asfalto, y una parte en hormigón. El resto de la zona está cubierta con mogolla (Foto 2). La parte noreste tiene relleno de mogolla y tierra con algo de grama (Foto 3). En el perímetro, sobre todo en el norte, hay árboles de diferentes tipos y tamaños.

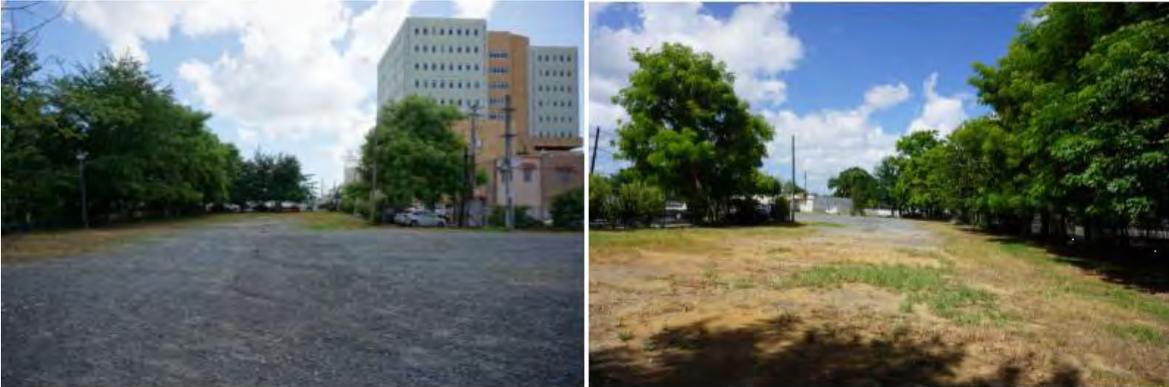
**Foto 3:** Vistas generales de la parte noreste del área bajo estudio. A la izquierda mirando al este y a la derecha, mirando al oeste. Nótese árboles en el límite norte del predio.

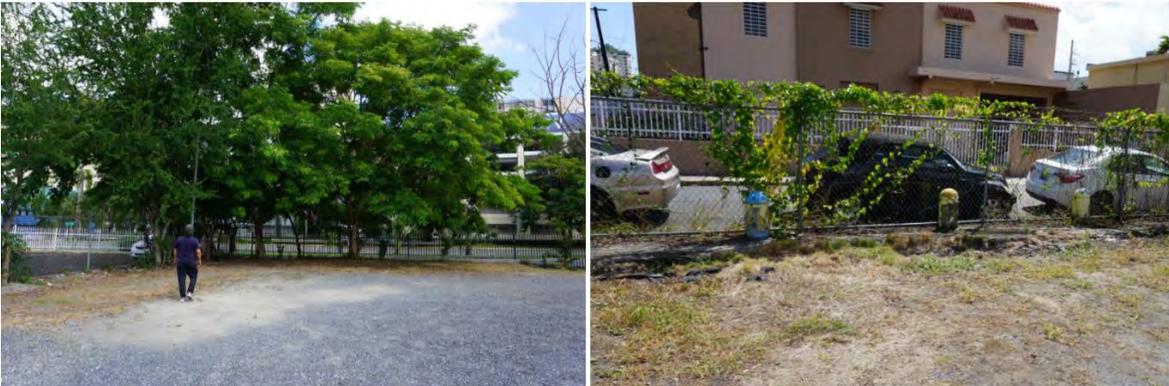
El predio está delimitado con una verja de alambre eslabonado, y con una verja de metal ornamental en un segmento del lado contiguo a la avenida Roosevelt. En el lado suroeste se observa una serie de bolardos para poner cadenas, lo que sugiere que había otro acceso por este lado (Foto 4).

**Foto 4:** A la izquierda, vista general de la esquina noroeste del predio, mirando hacia el noroeste. Nótese los tipos distintos de verja al norte y al oeste. A la derecha, detalle de los tres bolardos de hormigón ubicados en el límite sureste del área.

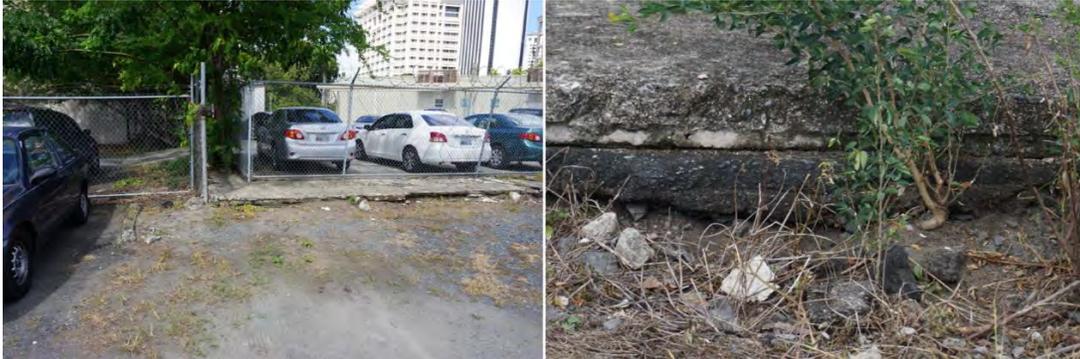
Del lado oeste del lote hay un segmento de una acera de hormigón estrecha, que termina en un pacillo que continúa hacia el predio al oeste. Un perfil de la acera se encuentra parcialmente expuesto, observándose una secuencia de varias capas: hormigón, dos capas de asfalto, tierra y otra capa de asfalto (Foto 5).

**Foto 5:** A la izquierda, detalle del límite oeste del área bajo estudio, donde hay un pasillo de acceso hacia el lote contiguo, mirando al oeste. A la derecha, detalle de la secuencia de superficies que se observa bajo la acera del límite oeste.

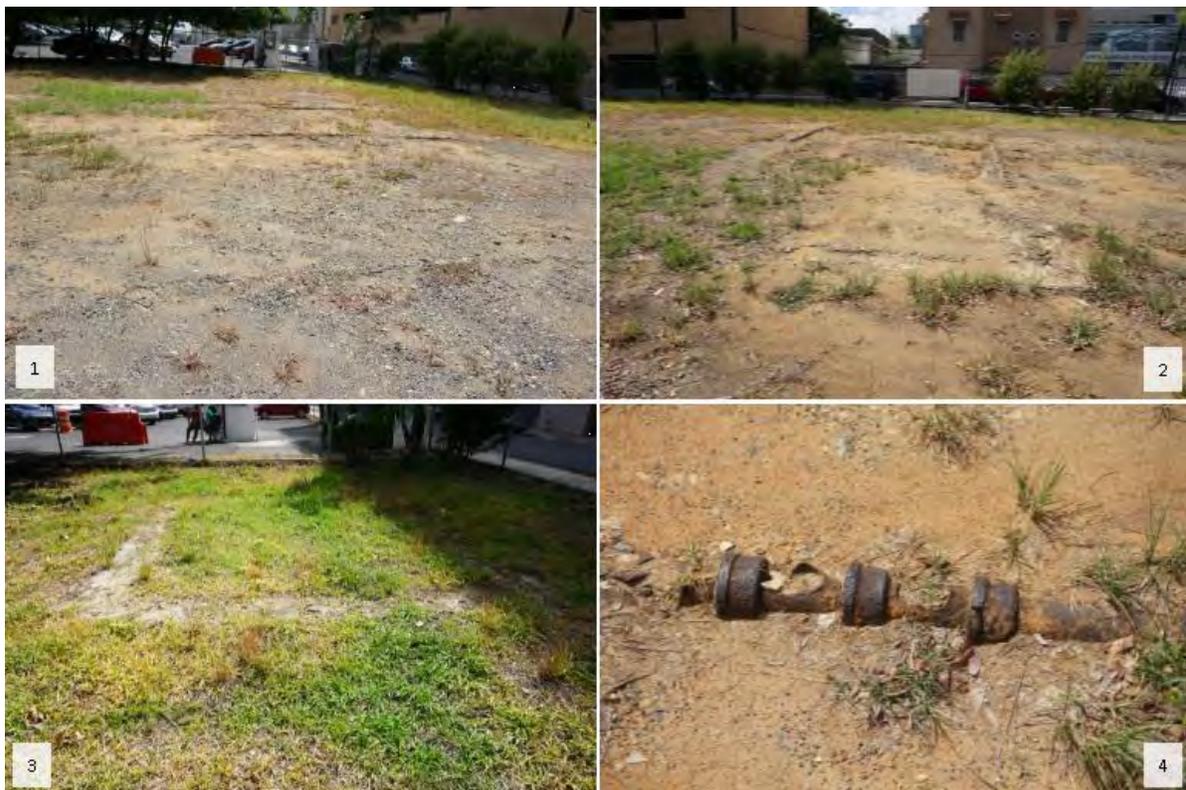
**Foto 6:** Detalles de improntas de estructuras en el noreste del área bajo estudio. 1-3: improntas de muros; 4: Detalle de tubería en hierro fundido

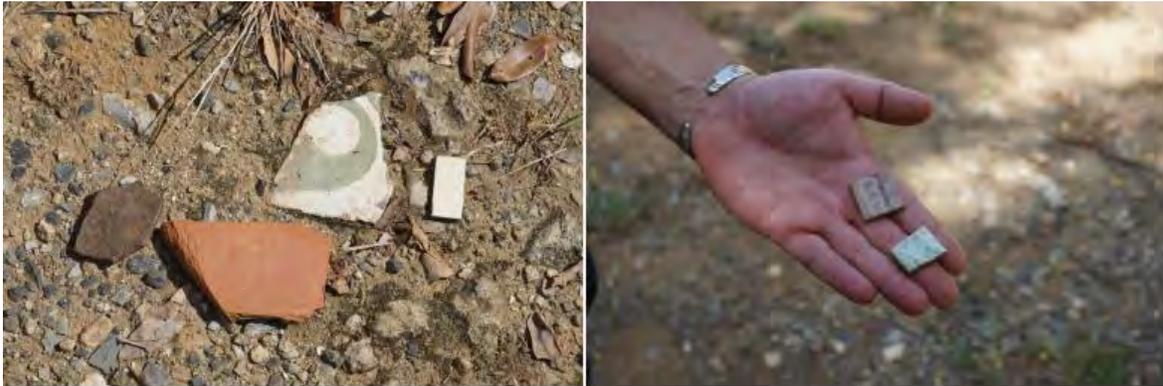
En la superficie de la parte noreste se pueden observar la impronta de muros en hormigón armado. También se observan algunos tubos en hierro colado, y restos artefactuales como losetas de piso y pared, y tejas.

**Foto 7:** Muestra de artefactos encontrados en superficie: fragmentos de losa de piso, teja y metal, y losas de pared.

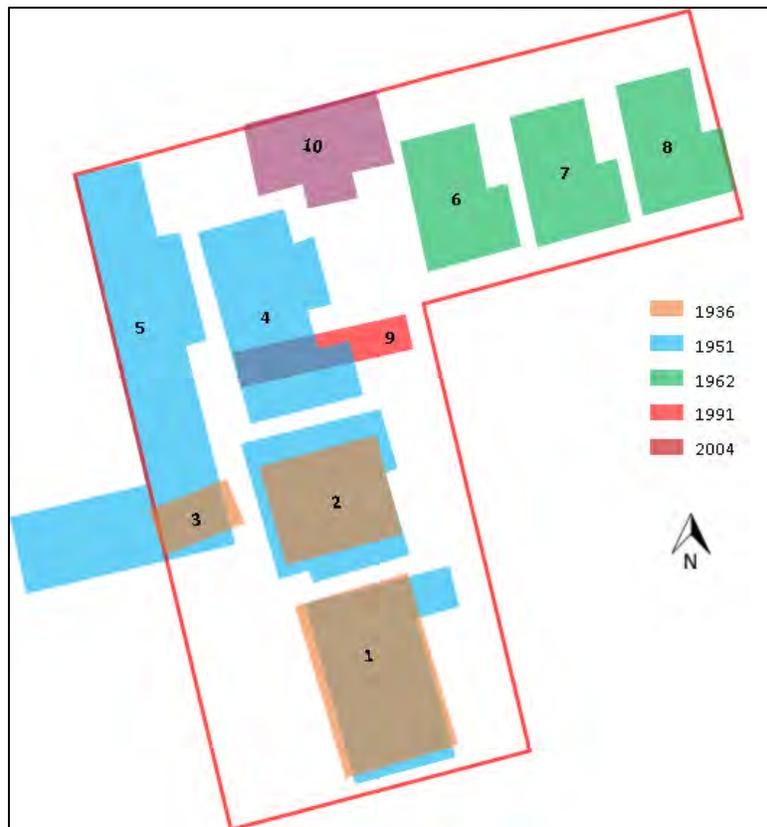
**Figura 29: Demarcación de estructuras construidas 1936 al 2004**

La Figura 29 muestra que el impacto no ha sido uniforme a través de toda el área de estudio. Hay una pequeña zona al sureste en la que no hay registro de construcciones, al menos durante los siglos XX y XXI. En el norte del predio sólo hay registro de un evento de ocupación, en contraste con la zona central, donde se identificaron varios eventos. Ahora bien, no todas las ocupaciones implican que las estructuras fueron demolidas y nuevas fueron construidas. Por ejemplo, la estructura ubicada en el sur o Estructura 1, que fue construida en algún momento antes de 1927, aparece ampliada o modificada en dos fotos satelitales posteriores: 1951 y 1994.

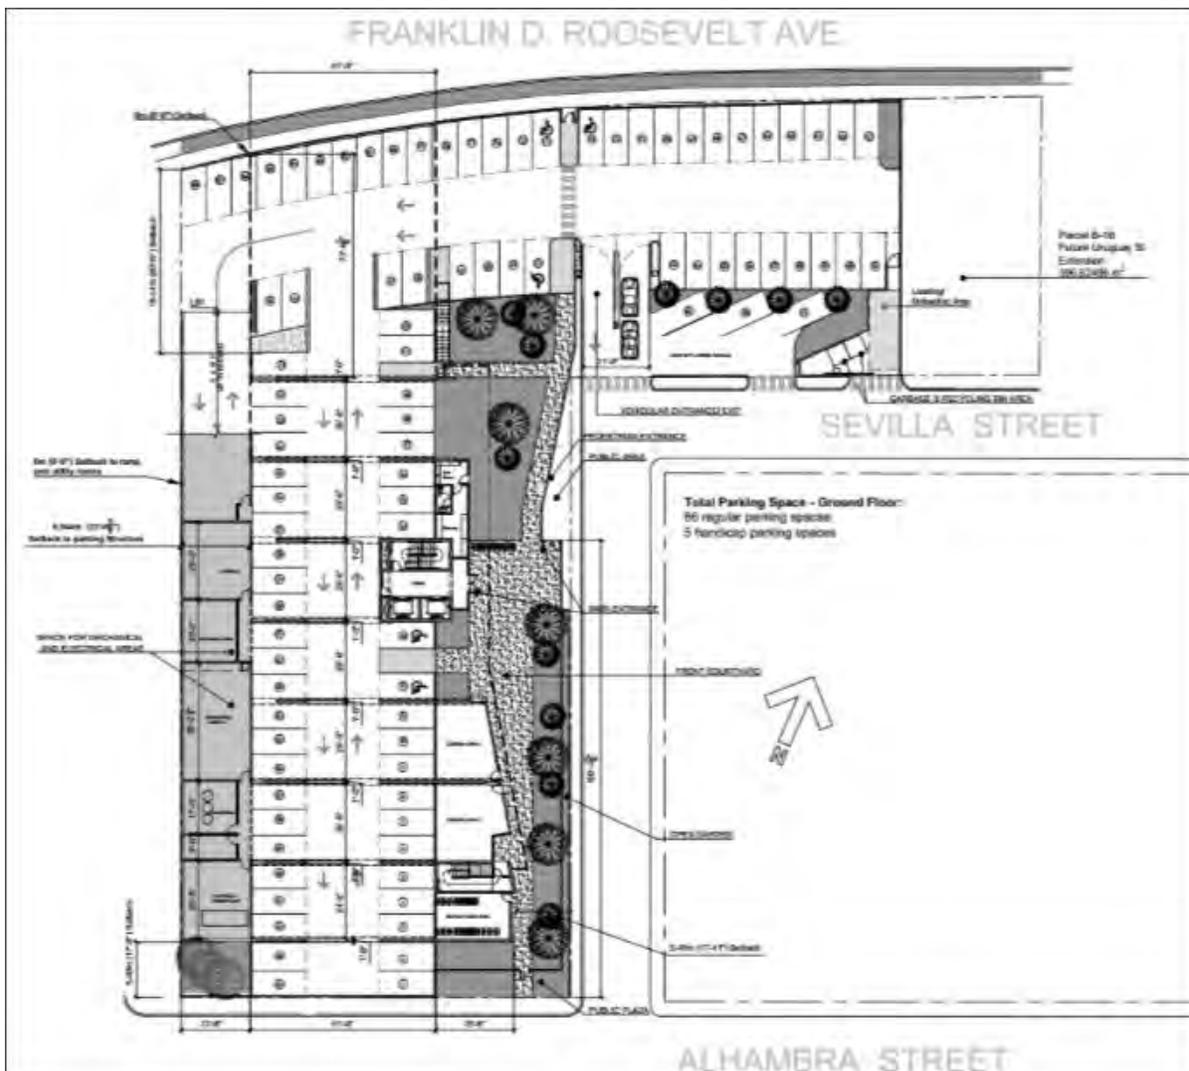
Figura 30: Plano de la primera planta del proyecto propuesto (EPA&A 2016)

El estudio de suelo de julio de 2016 recomienda que se utilice un cimiento de losa continua (“mat/slab foundation”) para el edificio. Este tipo de cimentación puede ser construida cerca de la superficie, por lo que no requiere excavaciones profundas. El estudio indica que también se puede utilizar zapatas aisladas (“spread footing”) de 12 x 12 pies (3.7 x 3.7 m) a una profundidad de 6 pies (1.8 m).

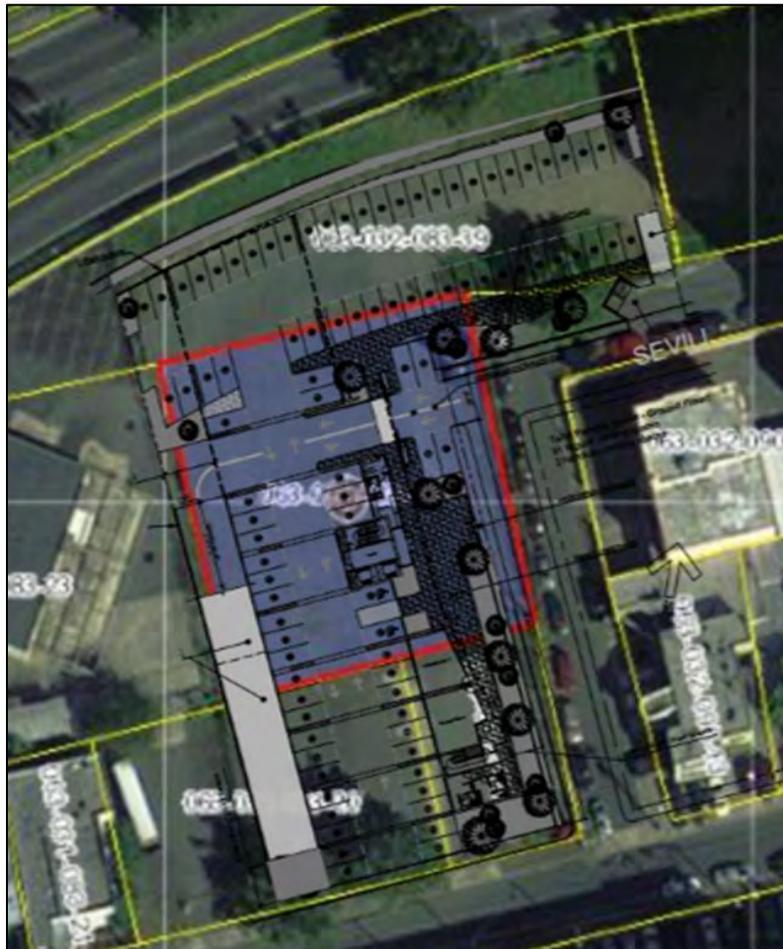
**Figura 31: Sobreimposición de plano del proyecto propuesto sobre foto satelital reciente**

La Figura 31 presenta una sobreimposición del plano del proyecto sobre la foto satelital reciente del predio bajo estudio. Se puede apreciar que el proyecto impactará la totalidad del predio.

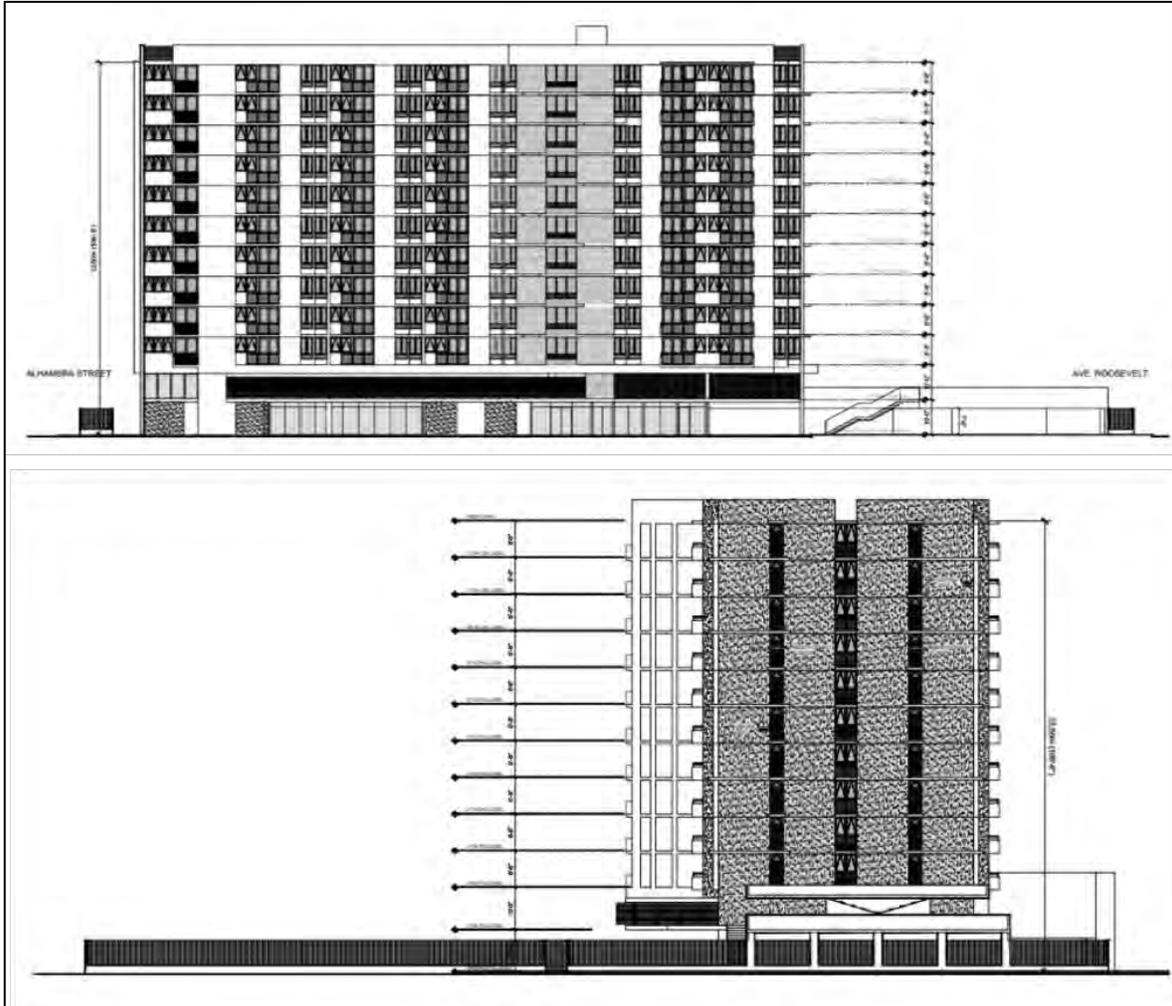
Figura 32: Elevaciones frontales (EPA&A 2016)

El edificio tendrá una altura de 26.4 m, sin contar los dos niveles de estacionamiento (Figura 32). En el área general donde ubica el proyecto hay edificios de alturas similares o mayores. En dicha área

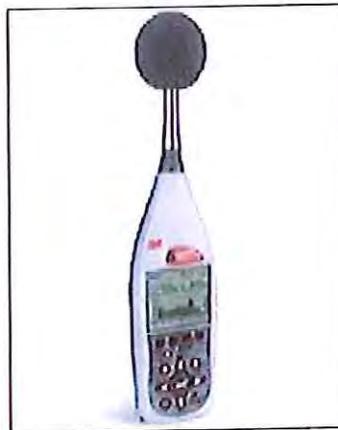
Figure #2- Sound Level Meter Photo

The noise survey was carried out using two (2) calibrated sound level meters which meets the "American National Standards Institute" (ANSI) specification for Type 1, sound level meters on its latest revision (See Figure #2). For this noise survey, two (2) calibrated Sound Pro Series DL Sound Level Meters manufactured by 3M (Quest Technologies) were used. Refer to Appendix 3 for data on calibration of the sound level meter instruments. The instruments are equipped with software and data logger and generate the data used to prepare this report. The raw data is included under Appendix 4.

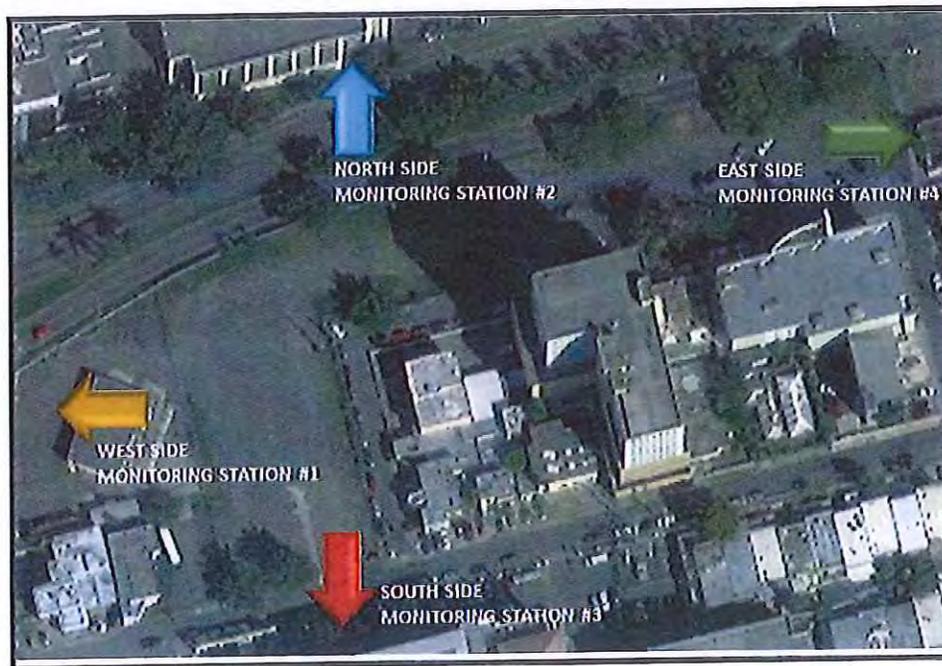
Figure #3- Monitoring Station Locations

- **Monitoring Station #1:** Located at View Point at Roosevelt Project West side adjacent to Ponce De Leon Avenue. Refer to Figure #3, the yellow arrow.
- **Monitoring Station #2:** Located at View Point at Roosevelt Project North side near Roosevelt Avenue. Refer to Figure #3, the blue arrow.
- **Monitoring Station #3:** Located at View Point at Roosevelt Project at South side adjacent to Alhambra Street. Refer to Figure #3, the red arrow.
- **Monitoring Station #4:** Located at View Point at Roosevelt Project at East side adjacent to Sevilla Street. Refer to Figure #3, the green arrow.

Sample	Monitoring Station (MS)	Time	Run Time	Description
1	1	10:01:49 pm	00:32:16	Located at View Point at Roosevelt Project at west side adjacent to Ponce De Leon Avenue.
2	2	10:00:23 pm	00:34:57	Located at View Point at Roosevelt Project at north side near to Roosevelt Avenue.
3	3	10:39:47 pm	00:30:06	Located at View Point at Roosevelt Project at south side adjacent to Alhambra Street.
4	4	10:37:31 pm	00:30:04	Located at View Point at Roosevelt Project at east side near Sevilla Street.

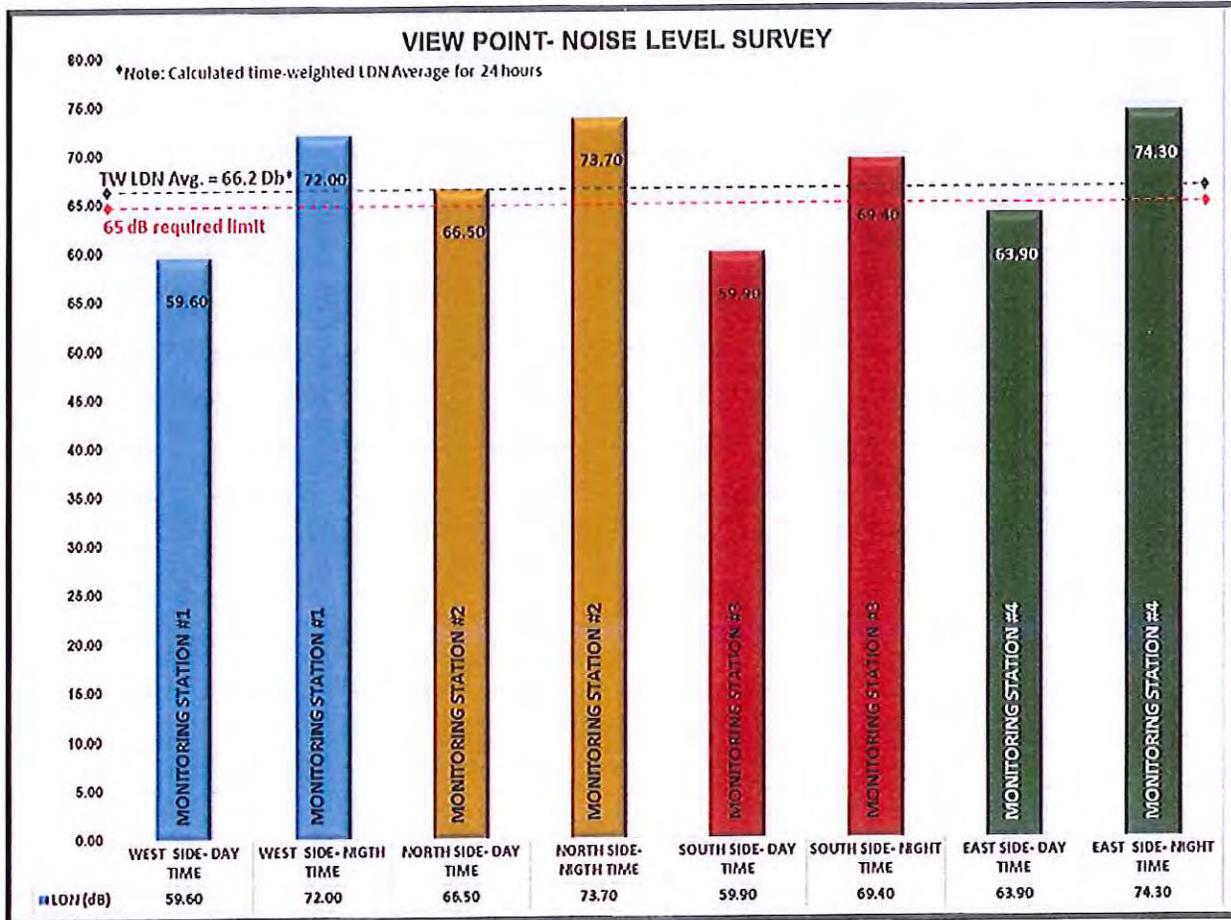
Figure #9- Monitoring Stations LDN Values.

Monitoring Stations (MS)	LDN
Monitoring Station 1	72.0 dB
Monitoring Station 2	73.7 dB
Monitoring Station 3	69.4 dB
Monitoring Station 4	74.3 dB
Average Nighttime LDN	72.4 dB

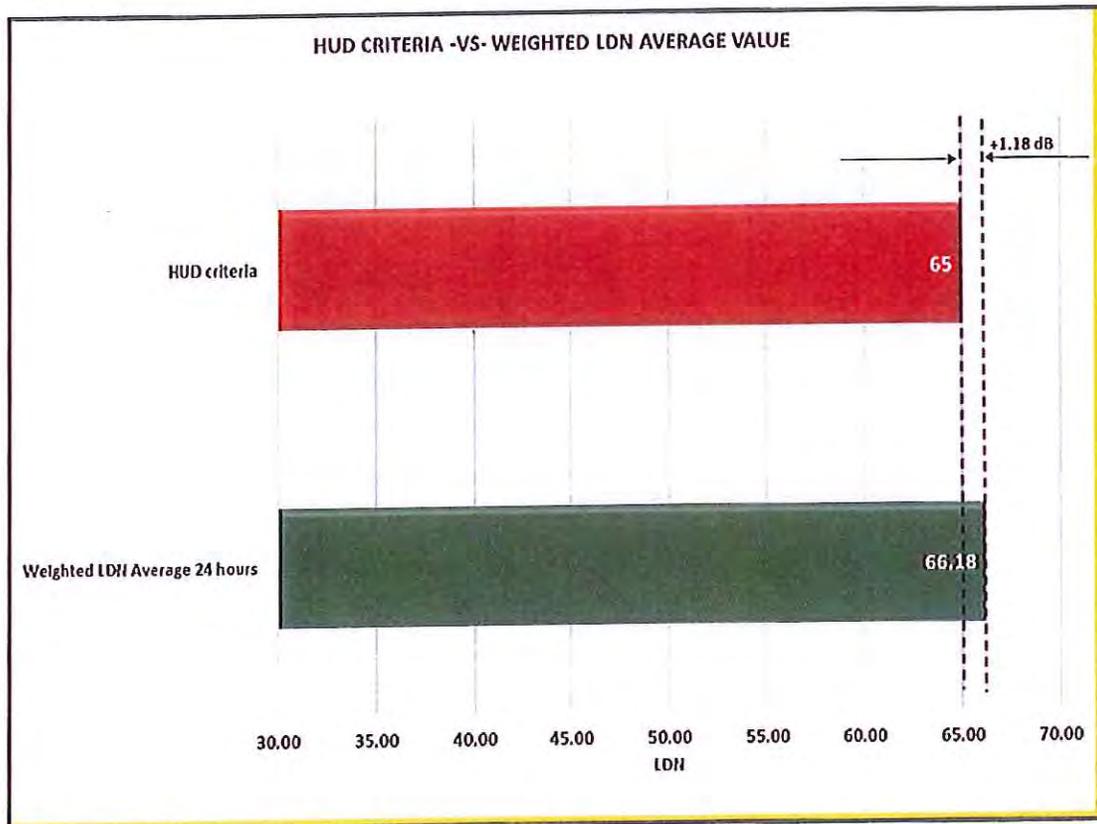
Figure #10- HUD Criteria -vs- Weighted LDN Average Value.

Based on the data collected during the noise survey at daytime and nighttime, the Calculated Time – Weighted LDN Average 24 hours is 66.2 dB reveal a LDN level normally unacceptable under the HUD criteria as these are higher than the HUD 65 decibels Acceptability Standard. This value represents 101.8% (+1.8%) of HUD Level criteria.
