**Environmental Review for Activity/Project that is
Categorically Excluded Subject to Section 58.5
Pursuant to 24 CFR 58.35(a)**

Project Name: PR-RGRW-03374-W-RE

This project (PR-RGRW-03374-W-RE) entails the award of a grant to Debbie Silva Mestre, an agricultural business, at Carretera 934 Km Hm 1.3, Bo. Ceiba Sur, Juncos, PR 00777. Tax ID Number: 253-014-126-38-000. Coordinates (18.210636, -65.916193). This project had an original CENST review which included the purchase of farm equipment including a UTV, computer, tractor, and implement (Broad fork, hoe, compost fork, grape hoe, and a sang hoe) for project cost of \$25,620.18. See attached CENST environmental review. This review includes a scope item previously considered as an EA level of review (storage container, solar system, equipment) which is now evaluated as CEST level of review in accordance with FR-6492-N-01 with a project cost of \$24,379.82. The project includes the purchase and installation of a warehouse (storage container), a solar system, a replacement cistern, and a new cistern in the southern portion of the project property. The Applicant has identified two potential locations for the warehouse, one location

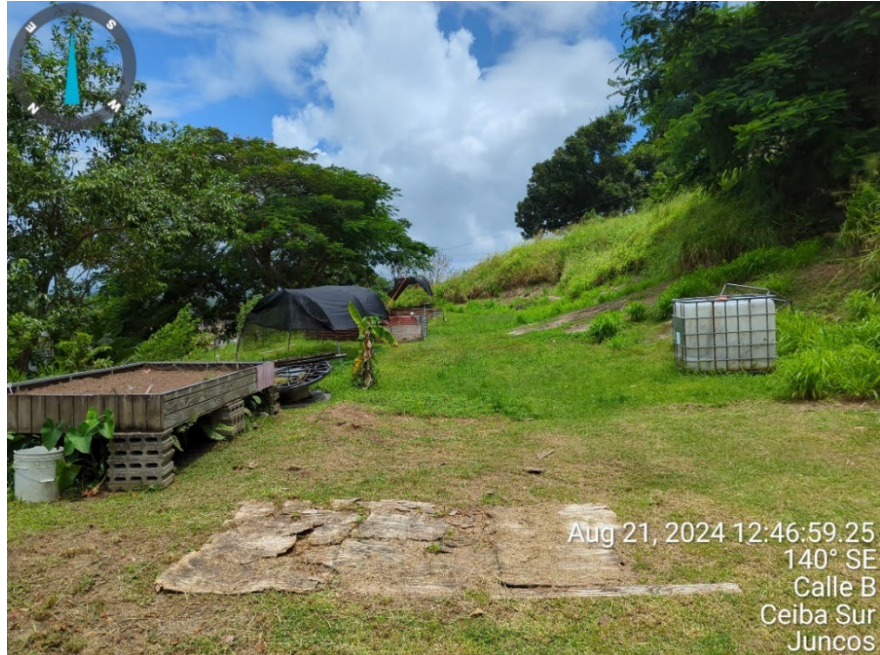
Description:
Overview of the project location for a freight container (option 1) (40x8x9.5ft) used as a warehouse on three concrete beams with metal anchor plates welded to the container. Crop area for recajo, an area where they used it for construction (mixing cement), and an unused cistern.

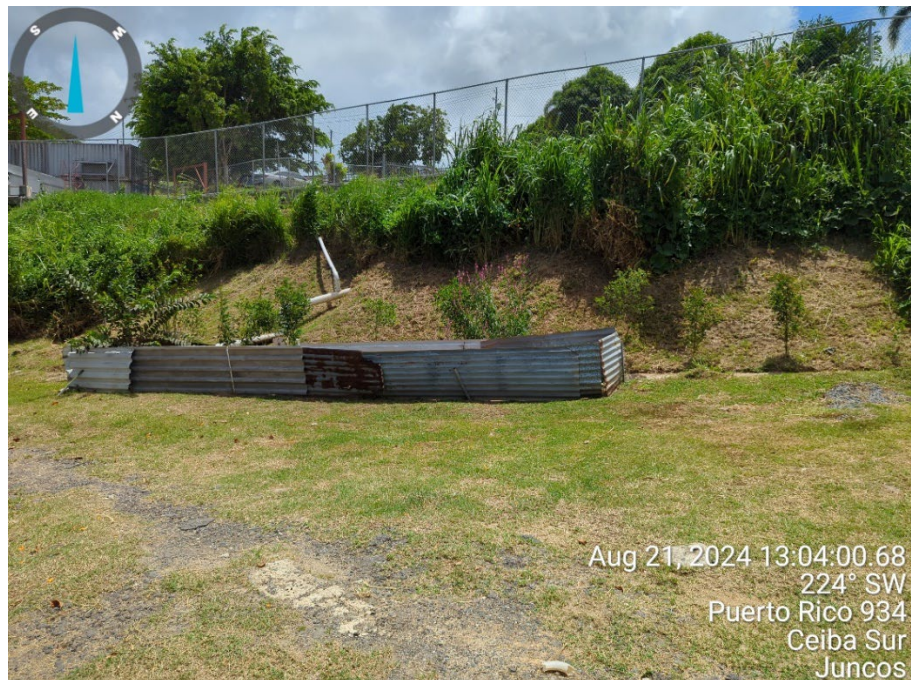
Photo #:
02

Description:
This alternative location for the freight container (option 2) will be used as a warehouse on three concrete beams with metal anchor plates welded to the container.

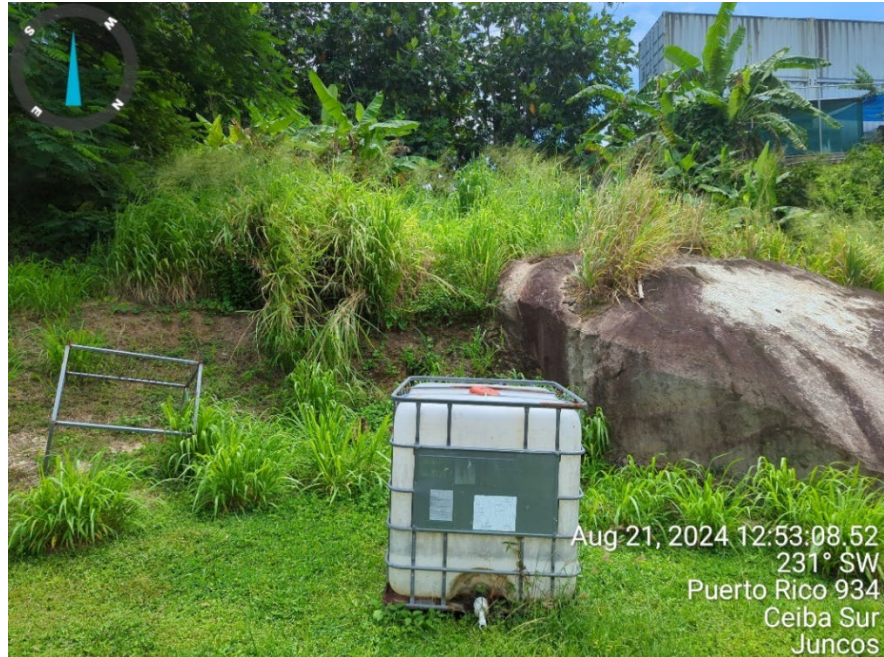
Overview of the project location for the new 600-gallon cistern and submersible water pump to provide water to the nearby crops. If the submersible water pump is not approved the applicant will install the cistern on a higher terrain behind the cistern pictured and at the side of the bolder.

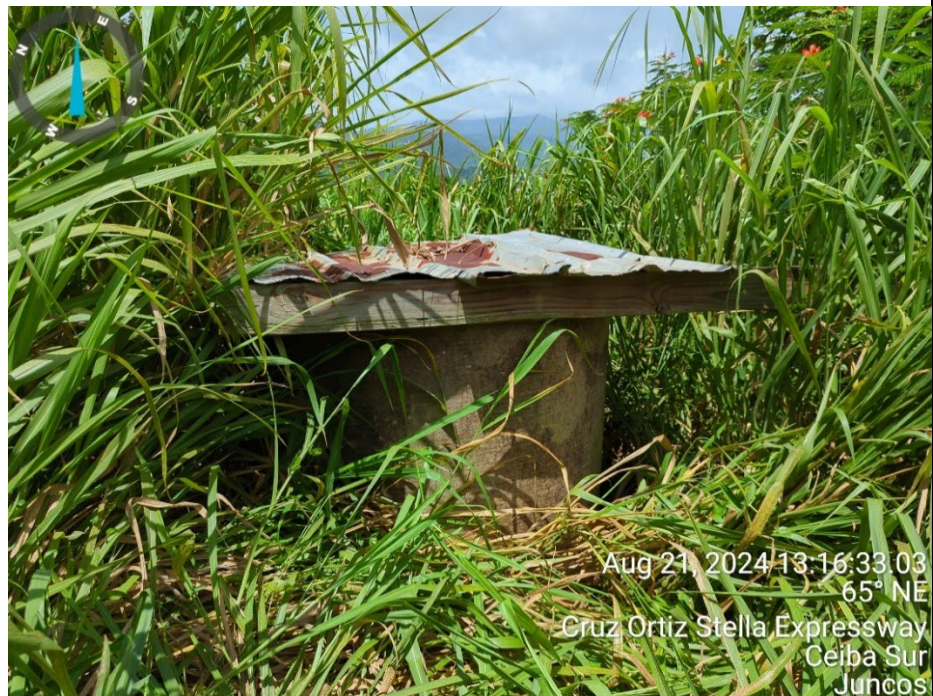
04 08/21/24

Overview of an existing cistern that provides water to the animals (pigs). The applicant is requesting a 600-gallon cistern to replace this one due to being broken; the aboveground water line is already installed. The area needs pruning. This is the project location of Replacement Cistern Option 1 and 2.

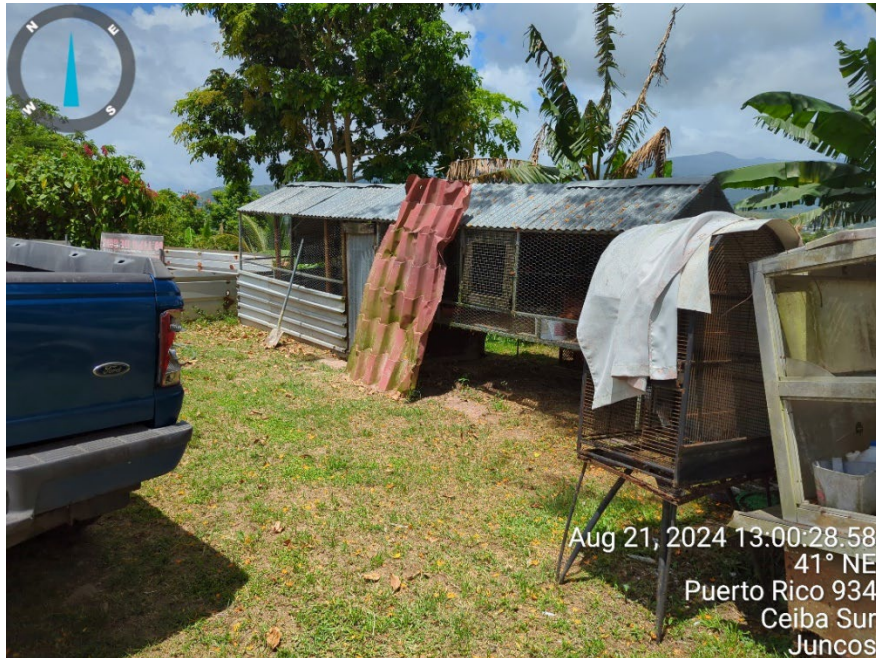
Description:
The applicant plans to use this area for six solar panels installed on an 8 by 8 ft concrete base with a metal frame on the ground. Alternately, on the roof of the chicken coop if the structure is reinforced.

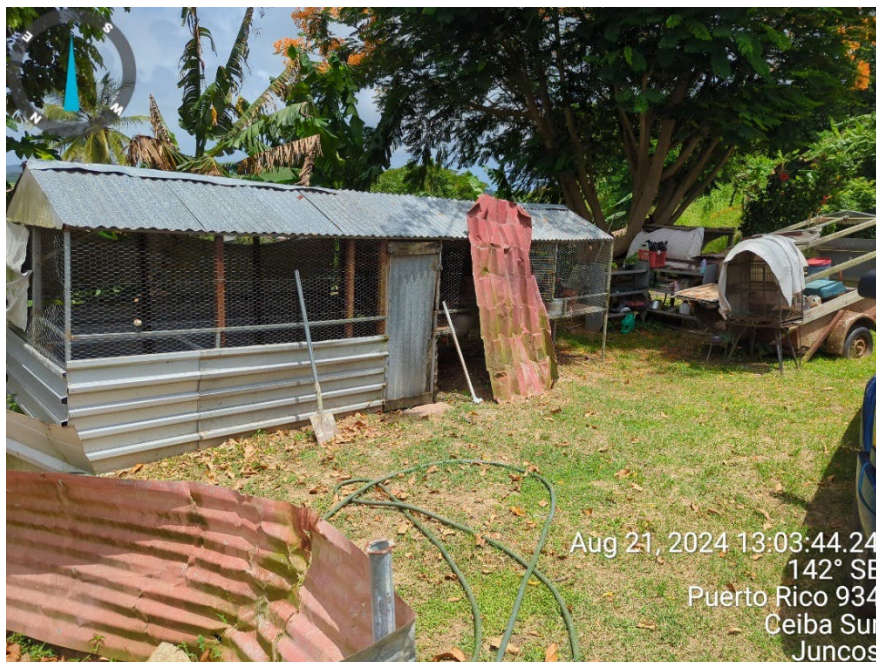
Photo #:
06

Description:
The applicant plans to use this area for six solar panels installed on an 8 by 8 ft concrete base with a metal frame on the ground. The applicant mentioned it can also be installed on the roof of the chicken coop if the structure is reinforced.

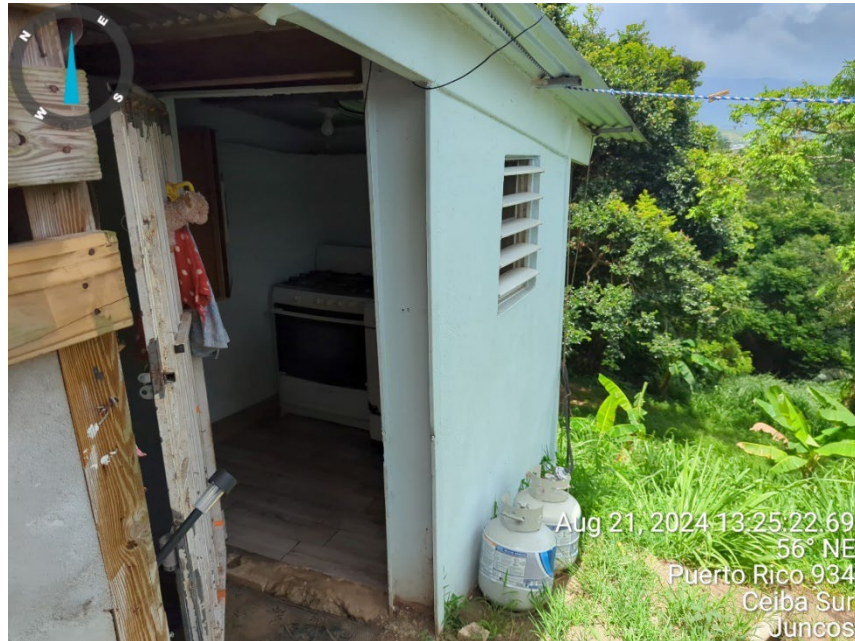
Photo #:
07

The solar panel system batteries will be stored inside the kitchen area. The picture shows two small (35-pound approx.) propane gas tanks.

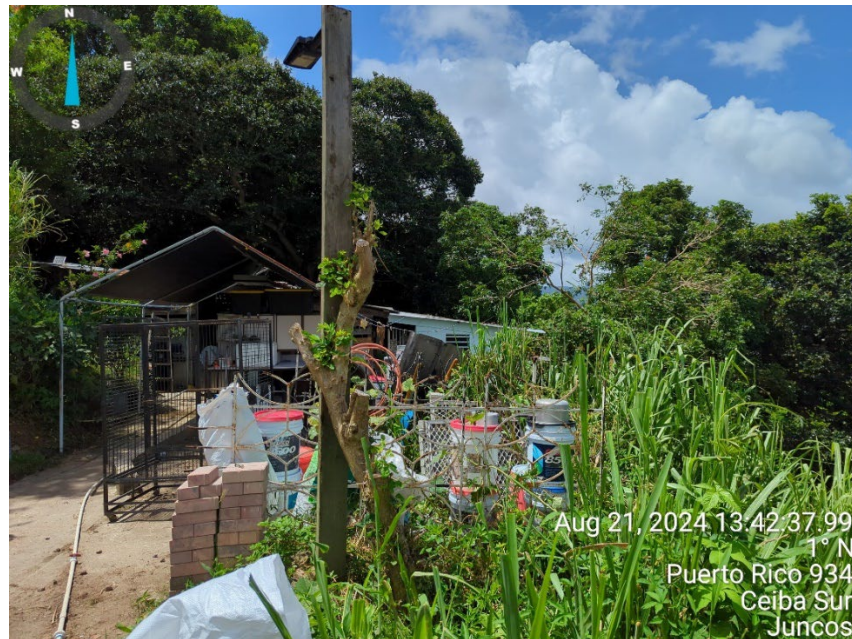
Photo #:

The solar panel system and the batteries will be connected through an underground cable. The picture shows the approximate direction of the underground cable.

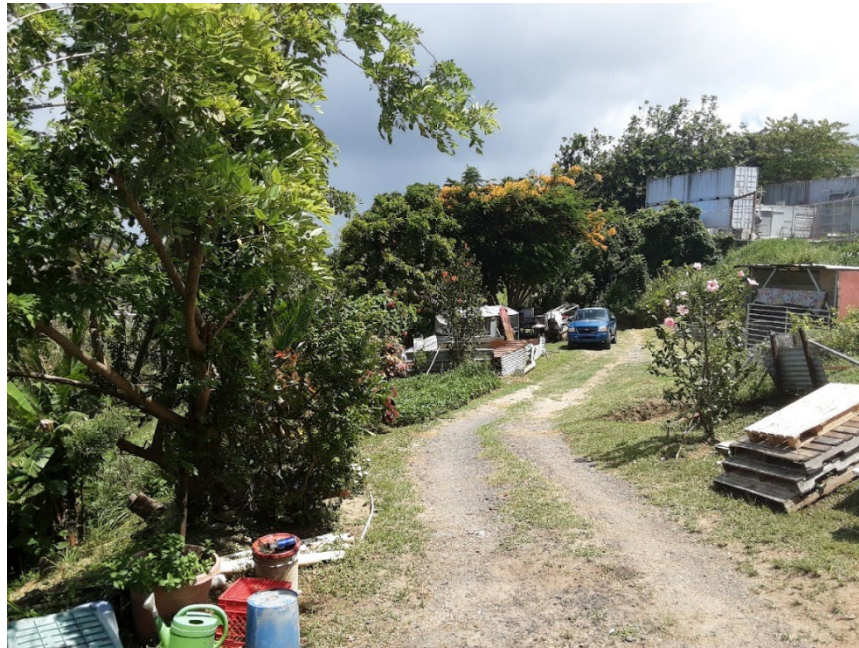
Description:
The solar panel system and the batteries will be connected through an underground cable. The picture shows the approximate direction of the underground cable.

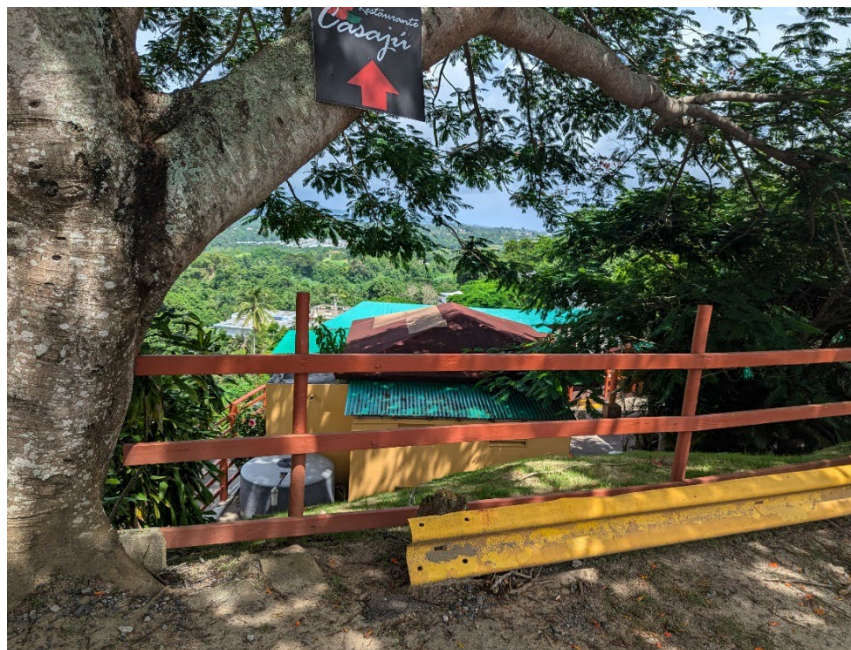
Photo #:
12

Description:
This picture is a closer overview of Restaurant Casaju, built in the 2000s, and has a direct view of the project location from the back of the restaurant.

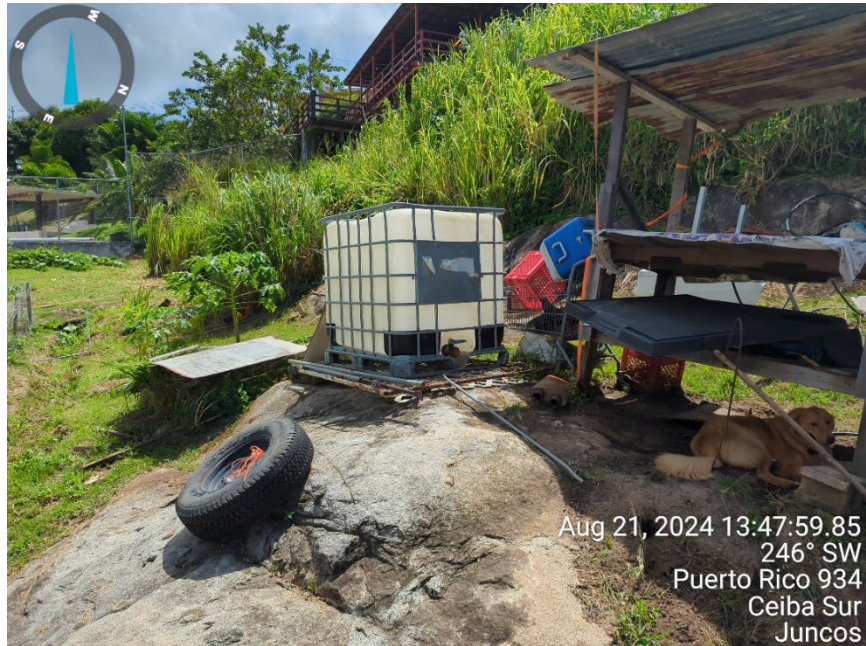
Description:
Overview of a broken cistern the applicant uses to store animal food because it is broken and a partial view of the back of Restaurant Casaju.

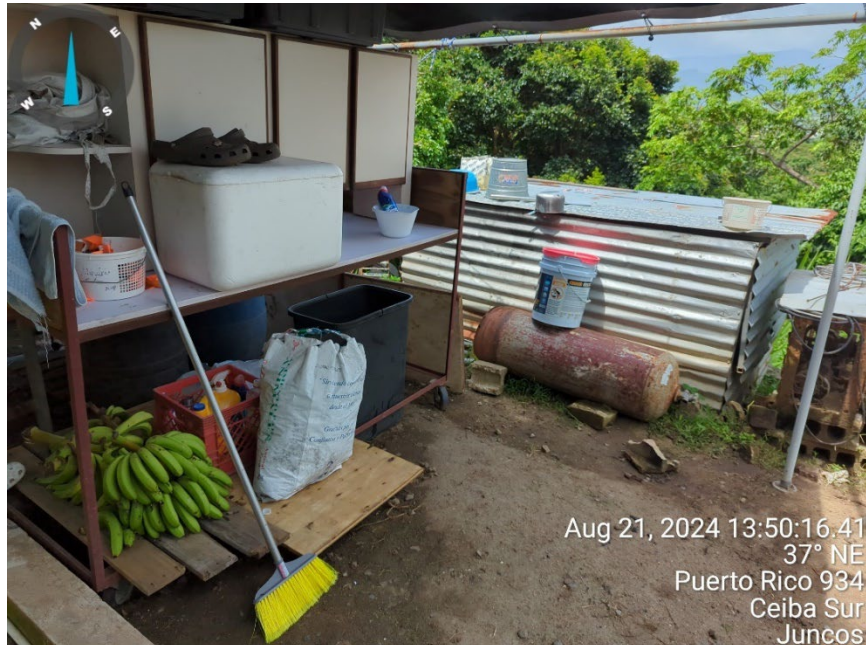
Photo #: 14
Date: 08/21/24

Description:
Overview of an unused propane gas tank usually used for the kitchen.

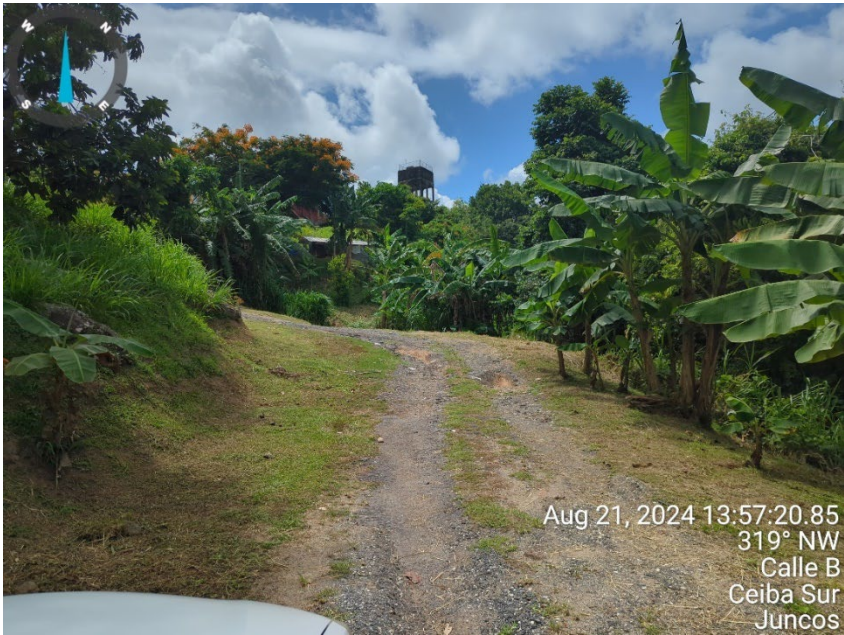
Photo #: 15	Date: 08/21/24

Photo Direction: Northwest		
Description: This picture overviews the access road conditions to get to the project areas. A four by four is needed to access it.

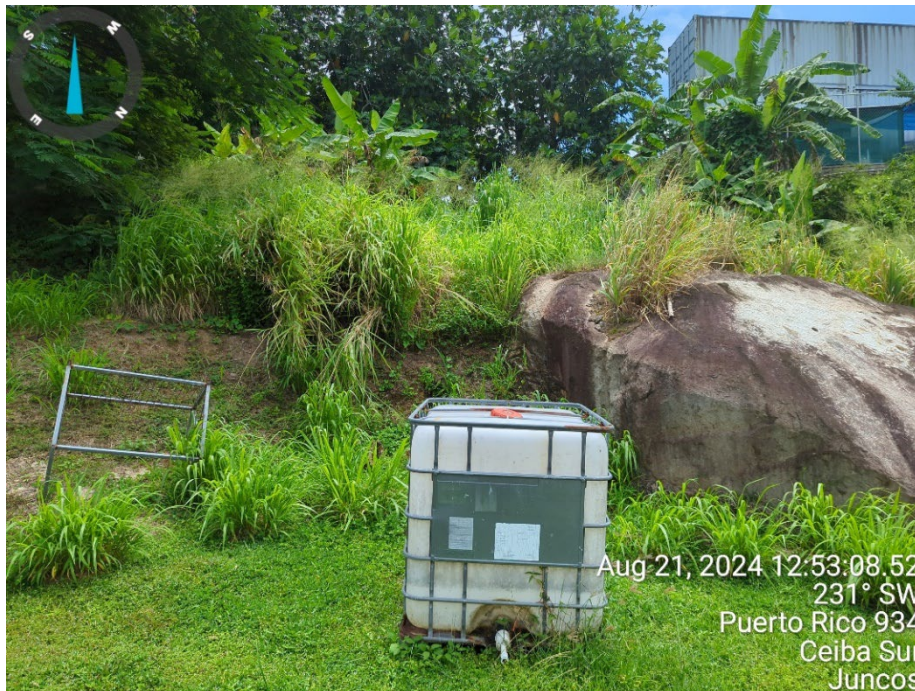
Photo #: 03	Date: 08/21/ 2024
Photo Direction: Southwest	
Description: Overview of the project location for a new 600-gallon cistern and submergible water pump to provide water to the nearby crops. If the submergible water pump is not approved the applicant will install the cistern on a higher terrain behind the cistern pictured and at the side of the bolder; the area will require basic pruning.

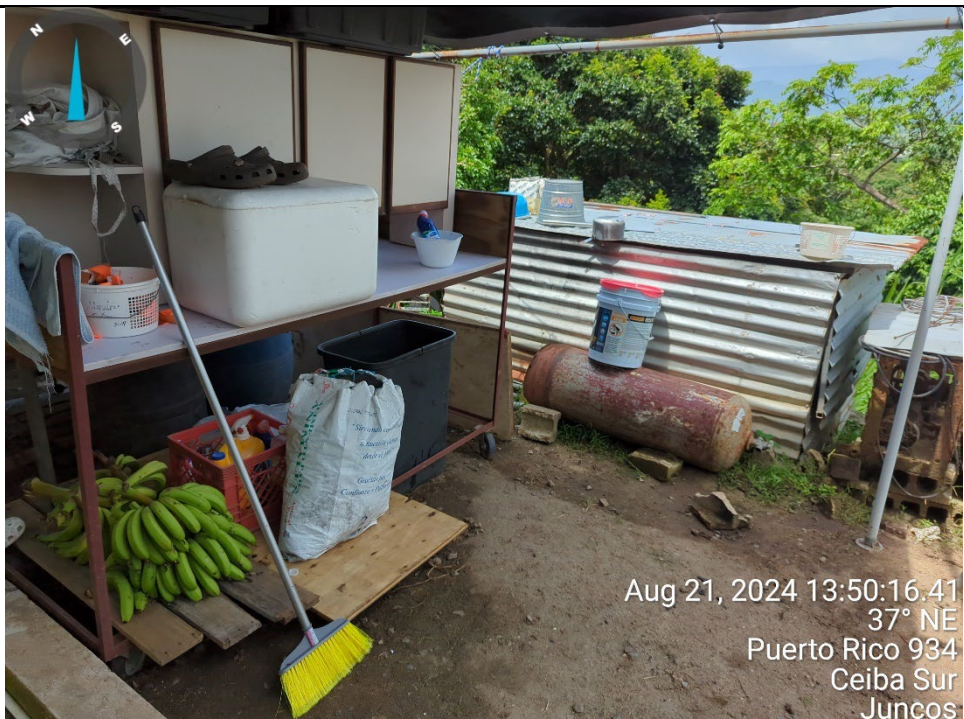
Photo #: 14	Date: 08/21/ 2024

Photo Direction: Northeast		
Description: Overview of an unused propane gas tank usually used for the kitchen.

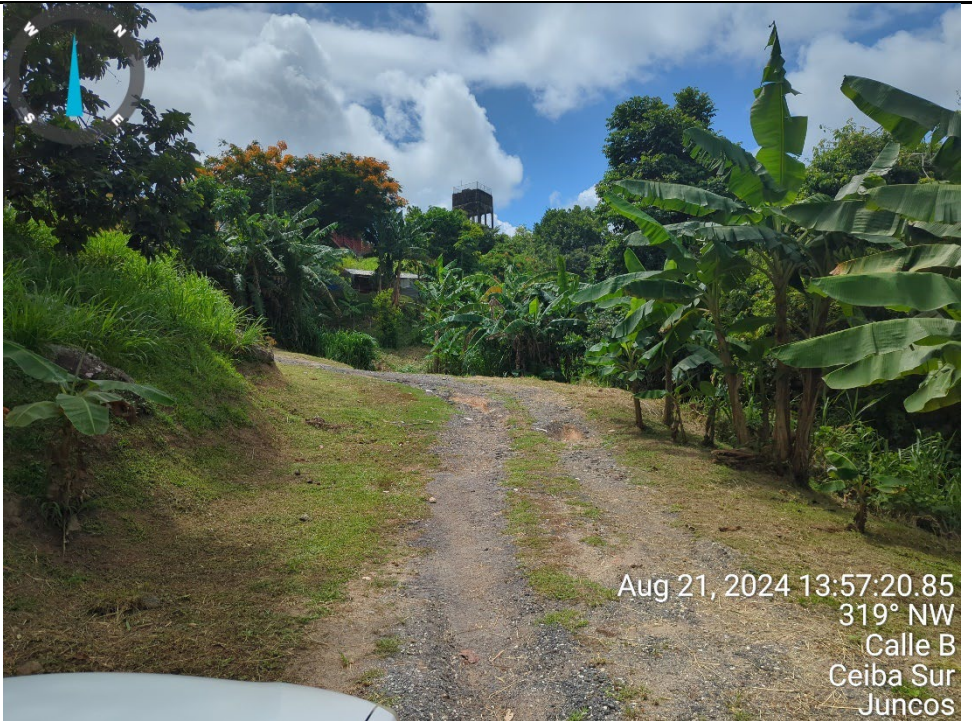
Photo #: 15	Date: 08/21/ 2024

Photo Direction: Northwest		
Description: This picture overviews the access road conditions to get to the project areas. A four by four is needed to access it.

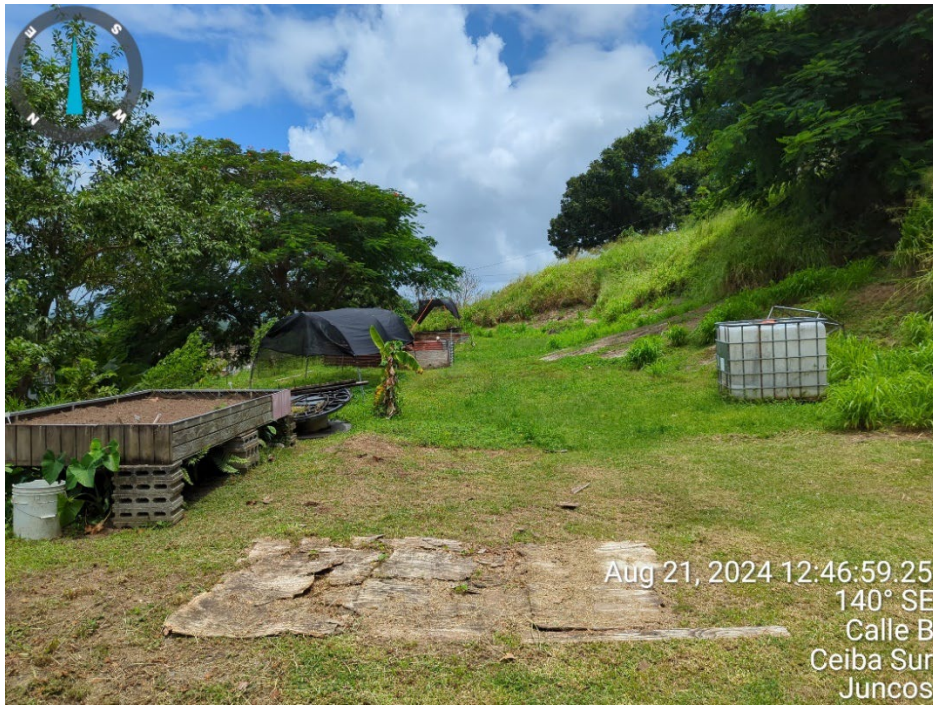
Photo #: 01	Date: 08/21/ 2024

Photo Direction: Southeast		
Description: Overview of the project location for a freight container (40x8x9.5ft) used as a warehouse on three concrete beams with metal anchor plates welded to the container. The picture shows the crop area for recajo, an area where they used it for construction (mixing cement), and an unused cistern.

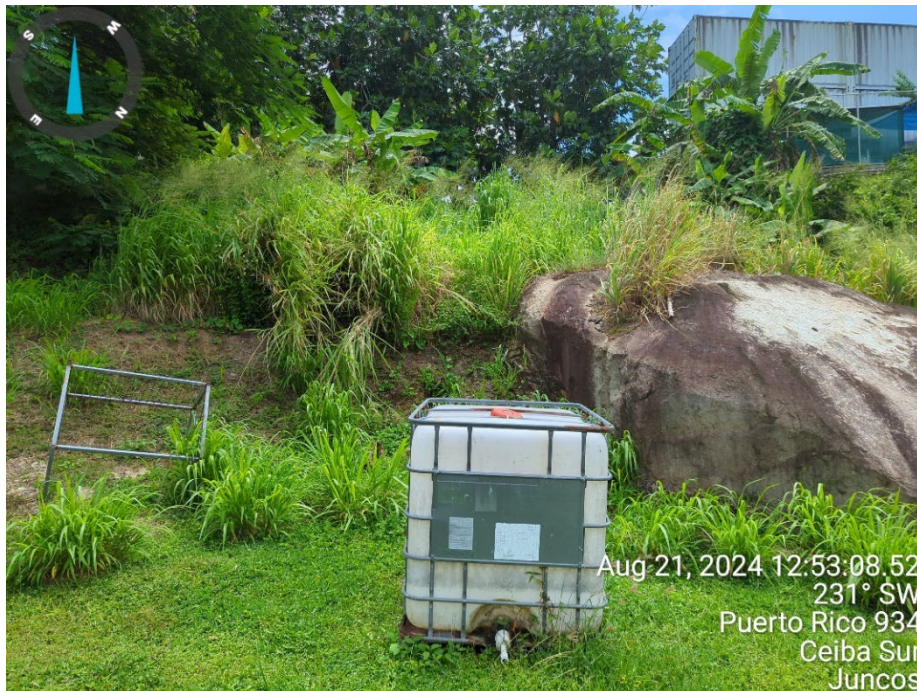
Photo #: 03	Date: 08/21/ 2024
Photo Direction: Southwest	
Description: Overview of the project location for a new 600-gallon cistern and submergible water pump to provide water to the nearby crops. If the submergible water pump is not approved the applicant will install the cistern on a higher terrain behind the cistern pictured and at the side of the bolder; the area will require basic pruning.

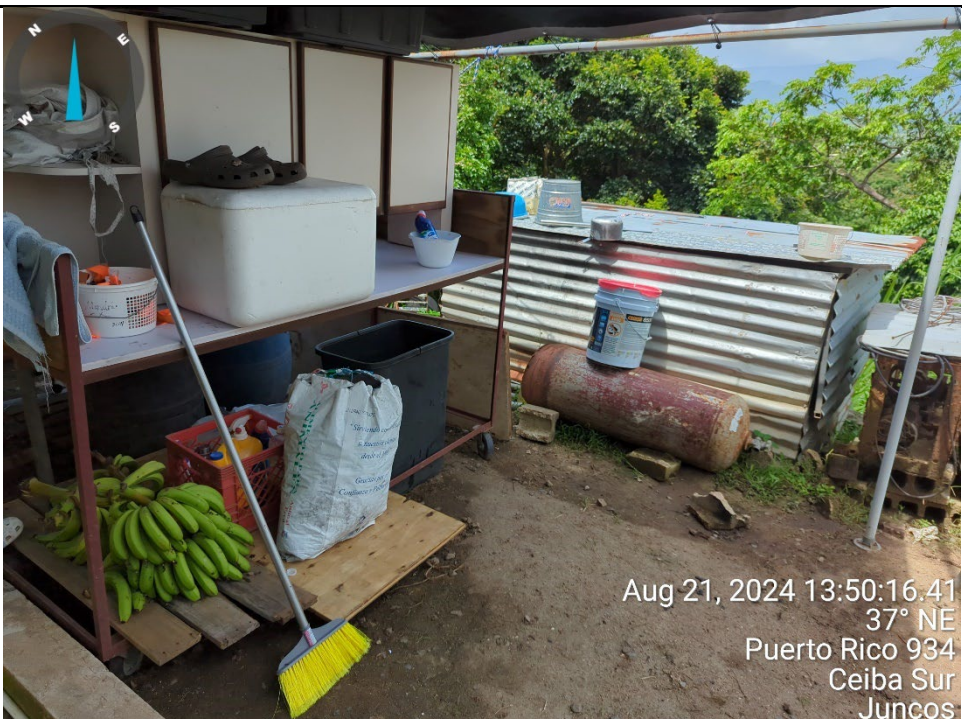
Photo #: 14	Date: 08/21/ 2024

Photo Direction: Northeast		
Description: Overview of an unused propane gas tank usually used for the kitchen.

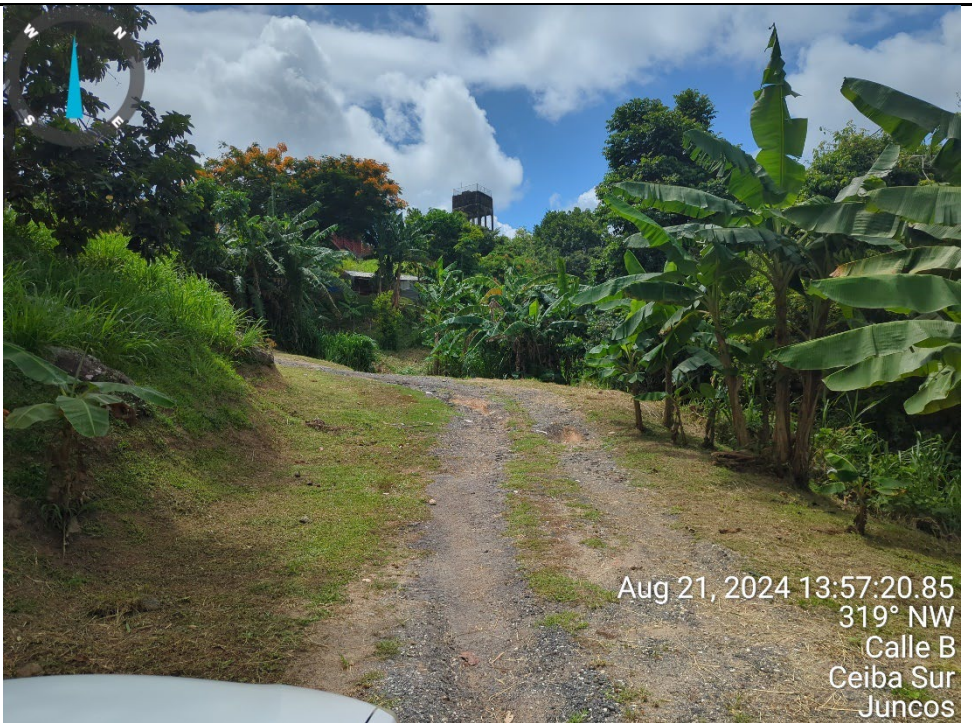
Photo #: 15	Date: 08/21/ 2024

Photo Direction: Northwest		
Description: This picture overviews the access road conditions to get to the project areas. A four by four is needed to access it.

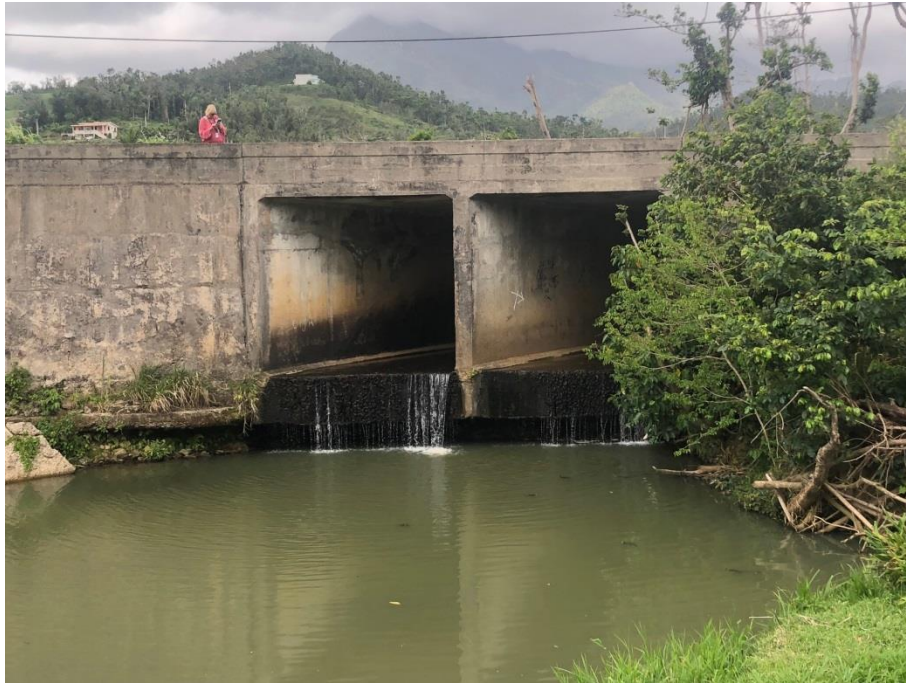
Figure 5. Poor design has resulted in scour and degradation below culvert and obstruction to fish passage.
