**ENVIRONMENTAL ASSESSMENT
DETERMINATIONS AND COMPLIANCE FINDINGS
FOR HUD-ASSISTED PROJECTS
24 CFR PART 58**

Centro de Distribución de Supermercados Econo Inc.
Canóvanas, PR.

Project Name: Econo Energy Project / IPGM-00375

TECHNICAL PROPOSAL – ENERGY FLOW

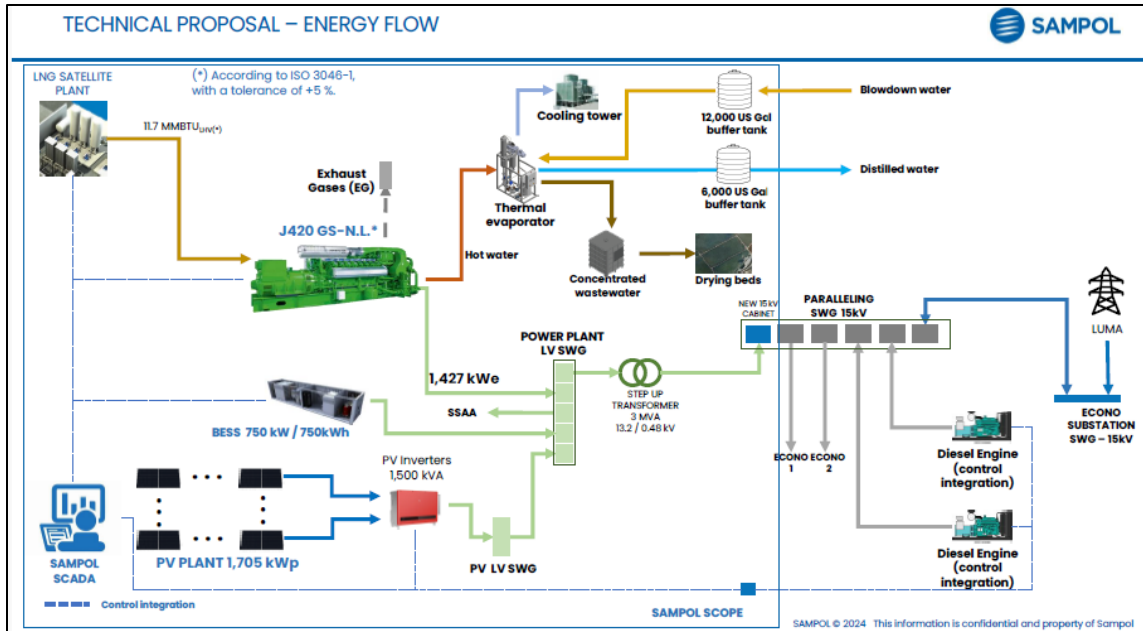
Figure 1 - Proposed material flow

The activity will involve excavations on the industrial site to construct foundations and installation of underground utilities. Underground water pipes from the existing cooling towers will be connected to the evaporator system and from the evaporator to the towers for recycling water. The ground impact at the site will be required for the gas engine (48.31 m²), the new battery system (45.52 m²), the dry cooler (15.79 m²), CW pumps (0.84 m²), HT pumps (0.84 m²), electrical container (45.52 m²), buffer tank (1.86 m²), evaporator (5.57 m²), blowdown buffer tank (29.73 m²), conditioned water buffer tank (14.86 m²), three drying beds (148.64 m²), and LNG regasification plant (195.10 m²), for a total area of 552.59 m². The estimated depth of bases for each of these areas is estimated at 0.3 meters (1 ft). Pipes connecting each of the project elements, including water pipes, electrical conduits, and any other underground lines, will also be installed at the depth of 0.3 meters (1 ft).

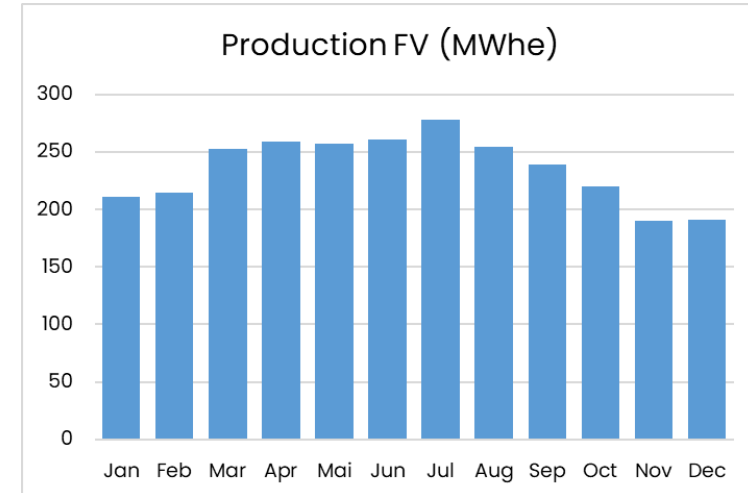
- **PV annual production estimation:** **2,825 MWh/year 0

*Number and power of modules and inverters to be defined during detailed engineering respecting nominal and peak power

** The production is estimated for year 0 and based on NREL databases. More accurate estimation need detailed engineering, ambient local conditions and O&M conditions

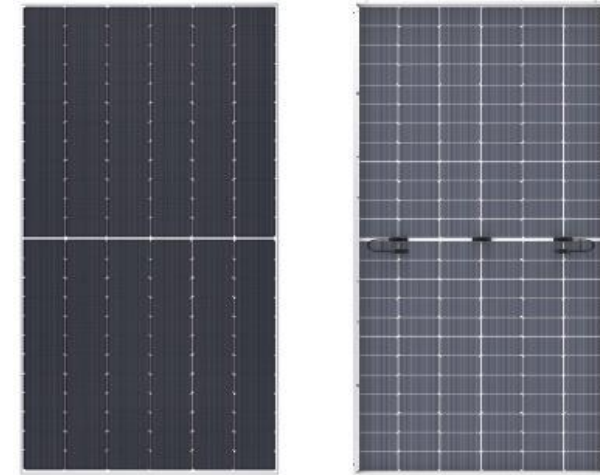
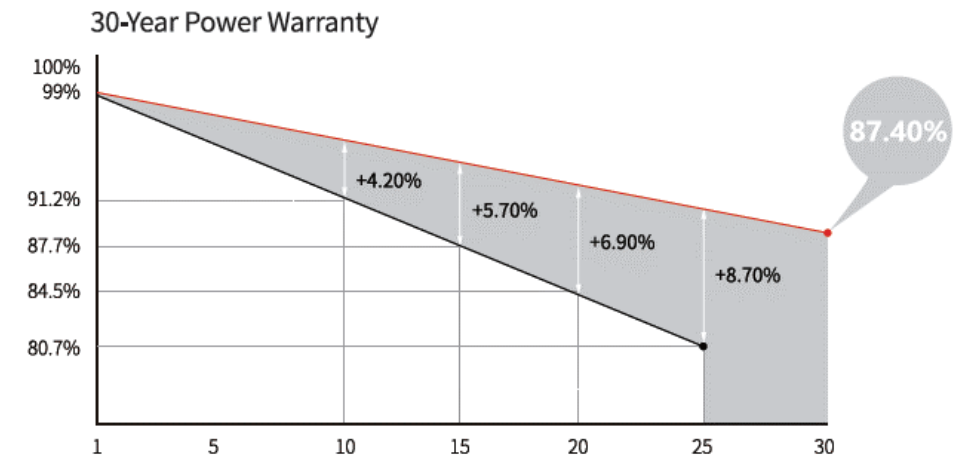
SOLAR PANEL		
Manufacture	LONGI	
Module type	LR7-72HGD-620M	
Cell material	Monocrystalline	
Module construction	Bifacial	
Power (STC)	620	Wp
Open Voltage (Voc)	52.77	V
Short Circuit Current (Isc)	14.85	A
Voltage at Maximum Power (Vmp)	44.33	V
Current at Maximum Power (Imp)	13.99	A
Efficiency	23%	
Dimension	2382 x 1134 x 30	mm
Weight	33.5	kg
J-BOX	IP68	
IEC 61701	Salt mist corrosion	
Materials and Processing Warranty	12	Years
Performance Warranty	30	years

PV INVERTER		
MANUFACTURE		GOODWE
Model		GW100KHT
Power AC output	kVA	100
DC Voltage in	V	1000
Number of MPP trackers		10
Efficiency		98.6%
Dimension	mm	1008 x 678 x 343

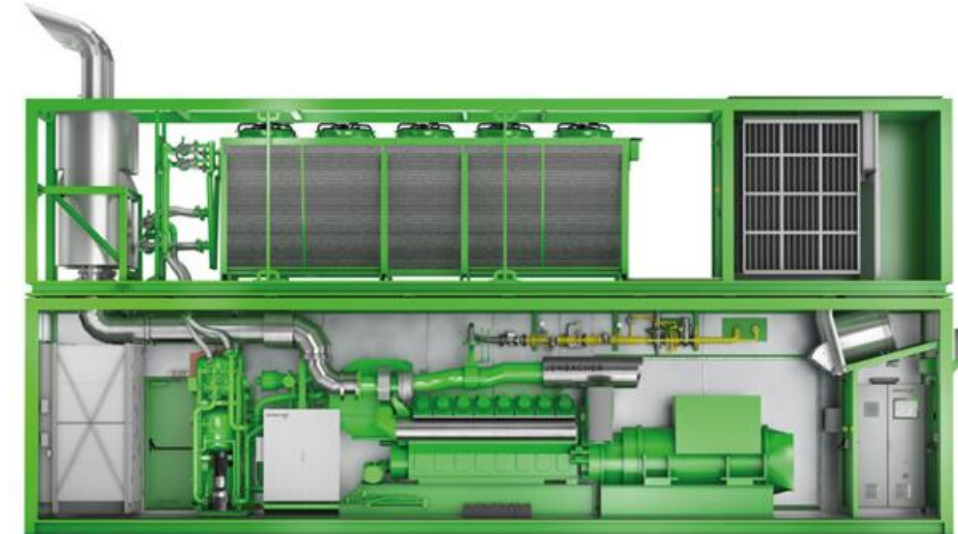
Engine Type	JGC 420 GS-N.L	
Fuel	Natural Gas	
Number of cylinder	20	
Mechanical power (on site)⁽ⁱ⁾	1,466	kWm
Rated power (on site)⁽ⁱⁱ⁾	1,427	kWe
Fuel gas consumption⁽ⁱⁱⁱ⁾	11.64	MMBtu_lhv
Nominal Efficiency (on site)	41.8	%
Voltage	480	V
Frequency	60	Hz

- (i) At nominal speed and standard reference conditions ICFN according to ISO 3046-1, respectively*
- (ii) At p. f. = 1.0 according to IEC 60034-1:2017*
- (iii) According to ISO 3046-1, respectively, with a tolerance of +5 %*

Ready to operate with **H2 up to 10%** per volume without losing any power
Ready to operate with **H2 up to 20%** per volume

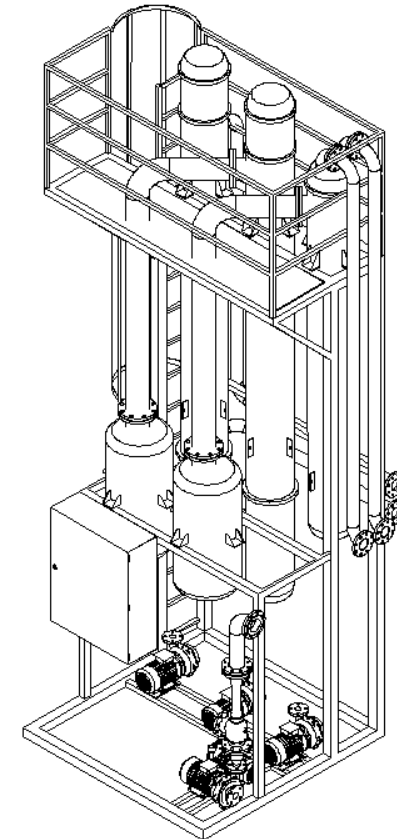
BRINE DRYING SYSTEM	
Inlet water	23 m ³ /day
Distilled water	22 m ³ /day
Concentrated wastewater	1 m ³ /day
Thermal consumption	362 kW
Electrical consumption	17 kW
Salt residue in distilled water	<4 ppm
Protection against corrosion	Yes
Auxiliary Natural Gas Heater	400 kW water heater protected against corrosion
Post treatment	pH and salinity control
Raw water buffer tank	12,000 Gal (2 days autonomy)
Threated water tank	6,000 Gal

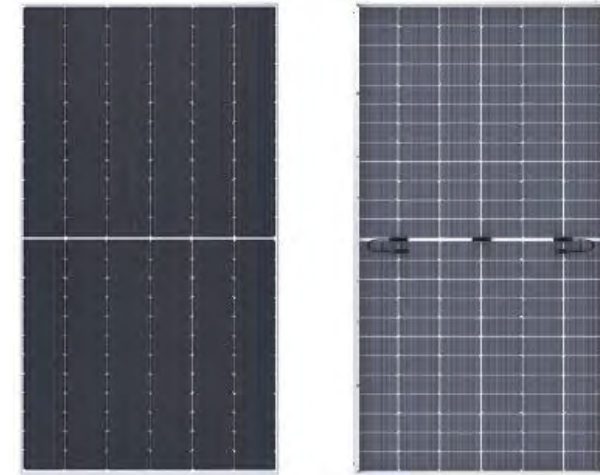
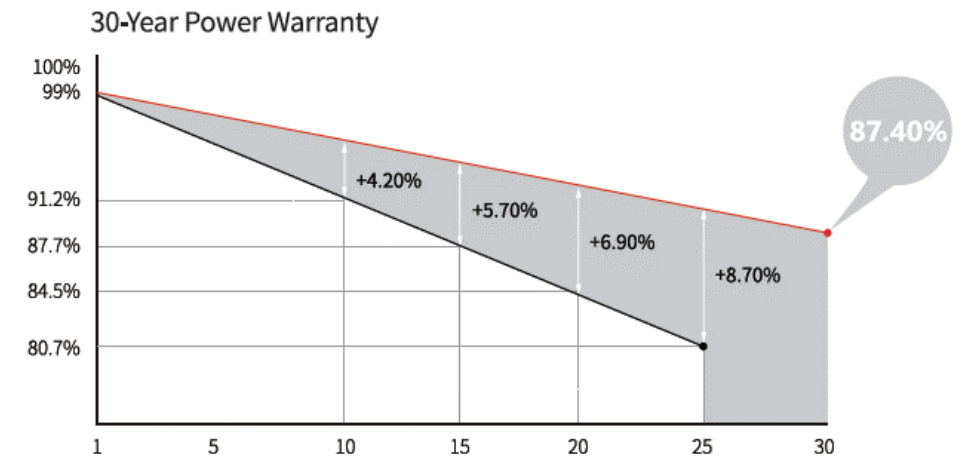
SOLAR PANEL		
Manufacture	LONGI	
Module type	LR7-72HGD-620M	
Cell material	Monocrystalline	
Module construction	Bifacial	
Power (STC)	620	Wp
Open Voltage (Voc)	52.77	V
Short Circuit Current (Isc)	14.85	A
Voltage at Maximum Power (Vmp)	44.33	V
Current at Maximum Power (Imp)	13.99	A
Efficiency	23%	
Dimension	2382 x 1134 x 30	mm
Weight	33.5	kg
J-BOX	IP68	
IEC 61701	Salt mist corrosion	
Materials and Processing Warranty	12	Years
Performance Warranty	30	years

PV INVERTER		
MANUFACTURE		GOODWE
Model		GW100KHT
Power AC output	kVA	100
DC Voltage in	V	1000
Number of MPP trackers		10
Efficiency		98.6%
Dimension	mm	1008 x 678 x 343

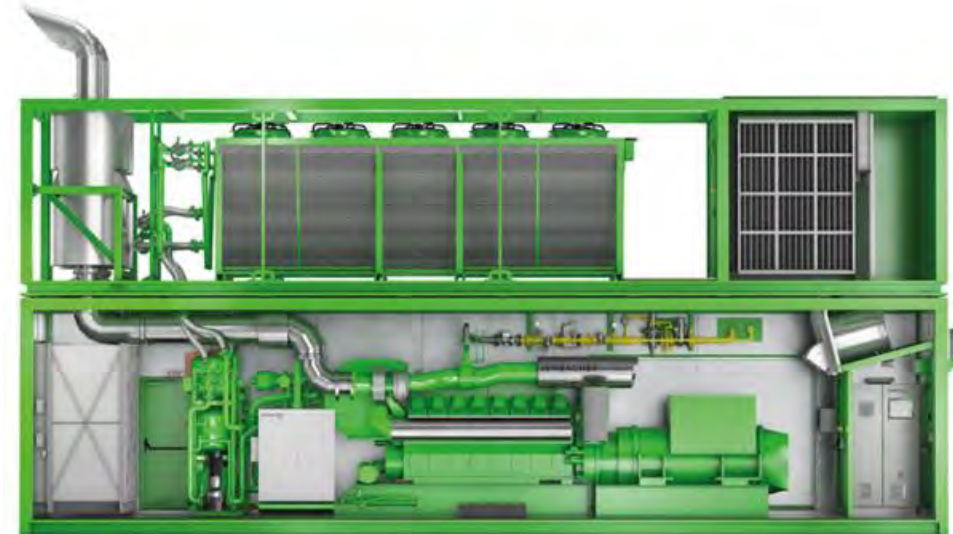
Engine Type	JGC 420 GS-N.L	
Fuel	Natural Gas	
Number of cylinder	20	
Mechanical power (on site)⁽ⁱ⁾	1,466	kWm
Rated power (on site)⁽ⁱⁱ⁾	1,427	kWe
Fuel gas consumption⁽ⁱⁱⁱ⁾	11.64	MMBtu_lhv
Nominal Efficiency (on site)	41.8	%
Voltage	480	V
Frequency	60	Hz

- (i) At nominal speed and standard reference conditions ICFN according to ISO 3046-1, respectively*
- (ii) At p. f. = 1.0 according to IEC 60034-1:2017*
- (iii) According to ISO 3046-1, respectively, with a tolerance of +5 %*

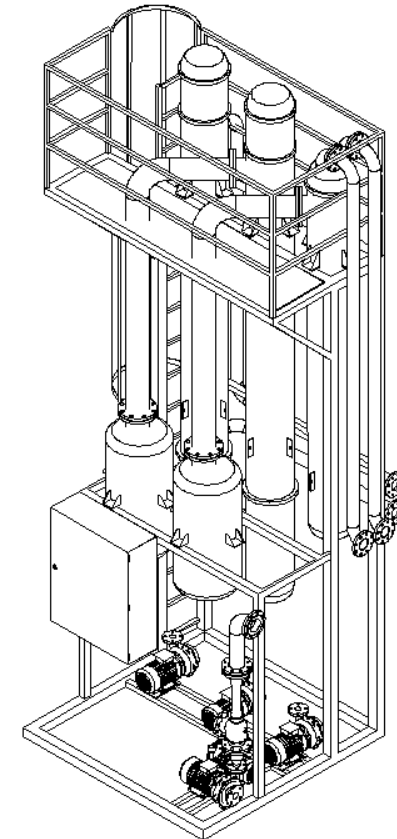
BRINE DRYING SYSTEM	
Inlet water	23 m ³ /day
Distilled water	22 m ³ /day
Concentrated wastewater	1 m ³ /day
Thermal consumption	362 kW
Electrical consumption	17 kW
Salt residue in distilled water	<4 ppm
Protection against corrosion	Yes
Auxiliary Natural Gas Heater	400 kW water heater protected against corrosion
Post treatment	pH and salinity control
Raw water buffer tank	12,000 Gal (2 days autonomy)
Threated water tank	6,000 Gal

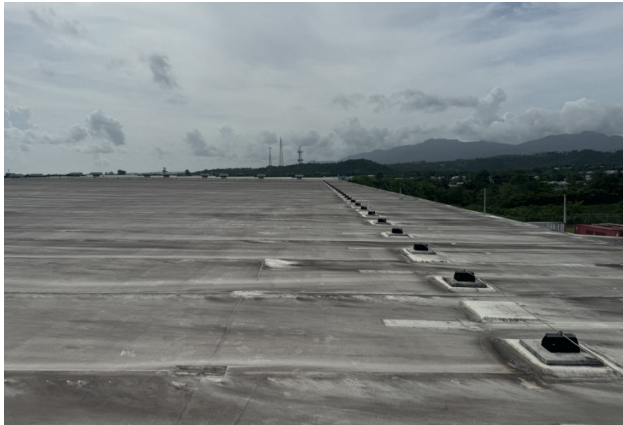
Rooftop where PV panels will be installed

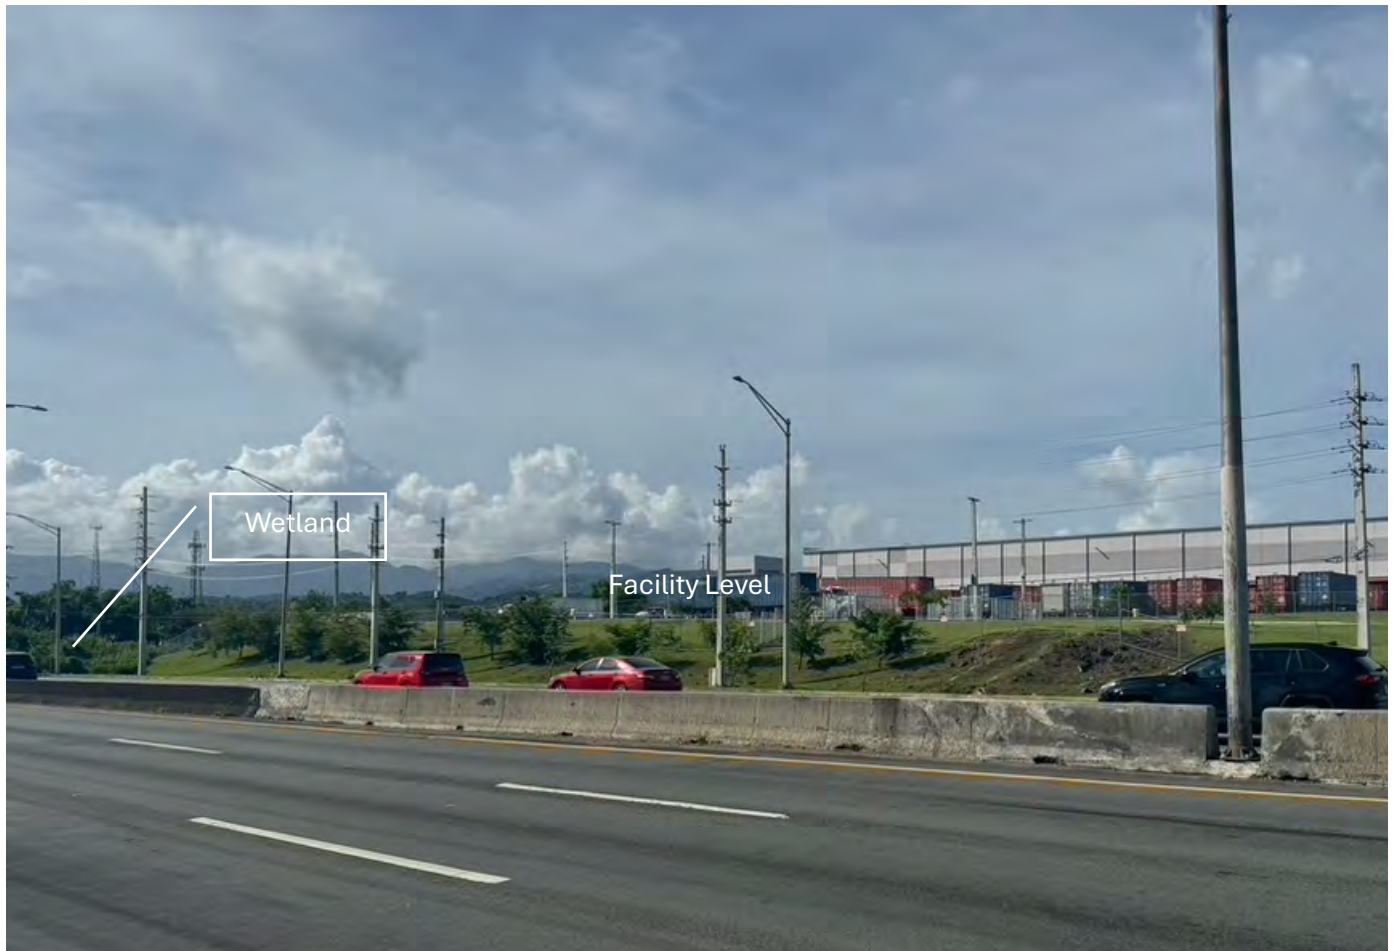
Photo showing the level of the facility compared to the level of the wetland.

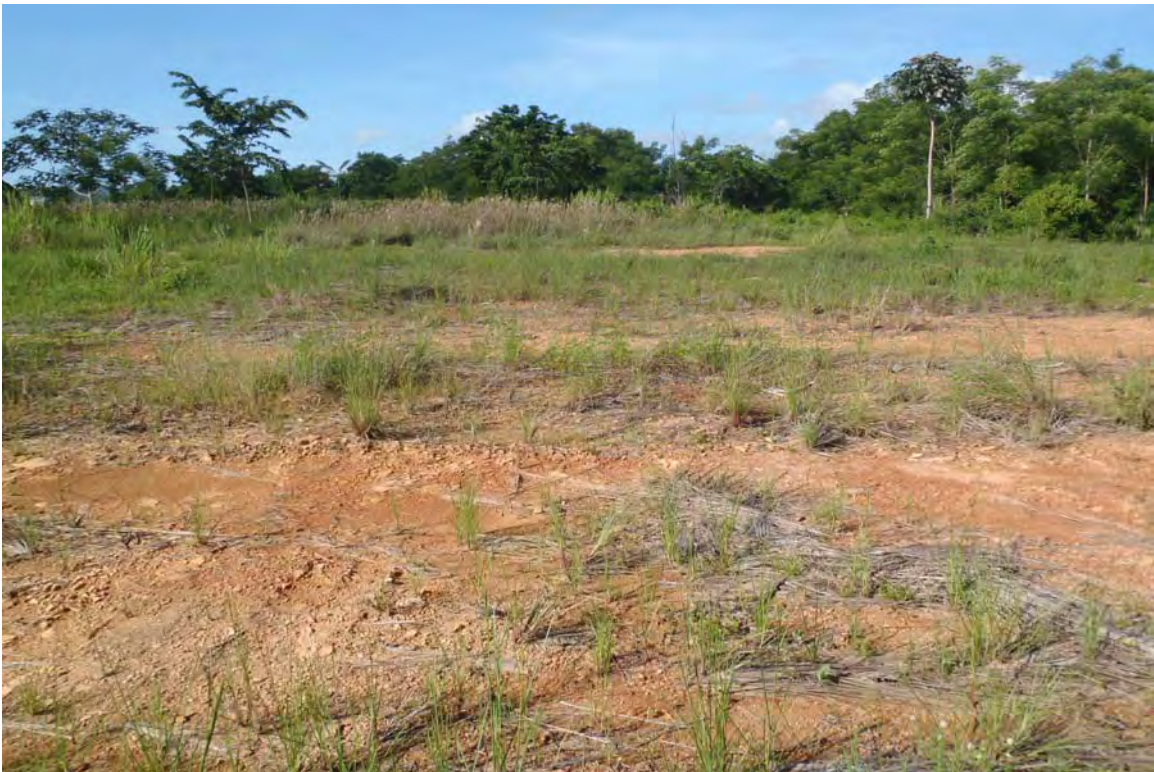
Photo 28. Another view of sampling point EC-14 area. Soil condition is shown.

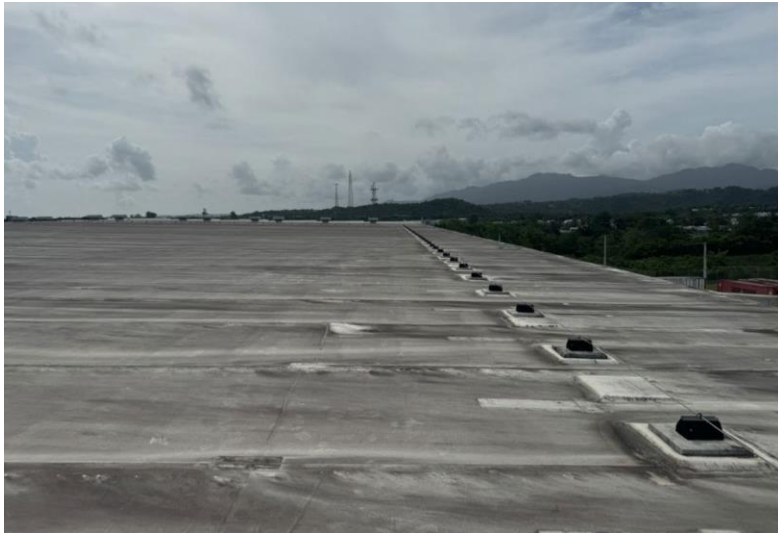
Rooftop where PV panels will be installed
