**Environmental Review for Activity/Project that is Categorically  
Excluded Subject to Section 58.5  
Pursuant to 24 CFR 58.35(a)**

**Project Name:** Estacionamiento y áreas circundantes de la plaza del mercado PR-CRP-001001

**Responsible Entity:** Puerto Rico Department of Housing (PRDOH)

**Description of the Proposed Project** [24 CFR 50.12 & 58.32; 40 CFR 1508.25]: This proposal aims to rehabilitate and improve the existing conditions of the surrounding areas of the Market Square. The new design

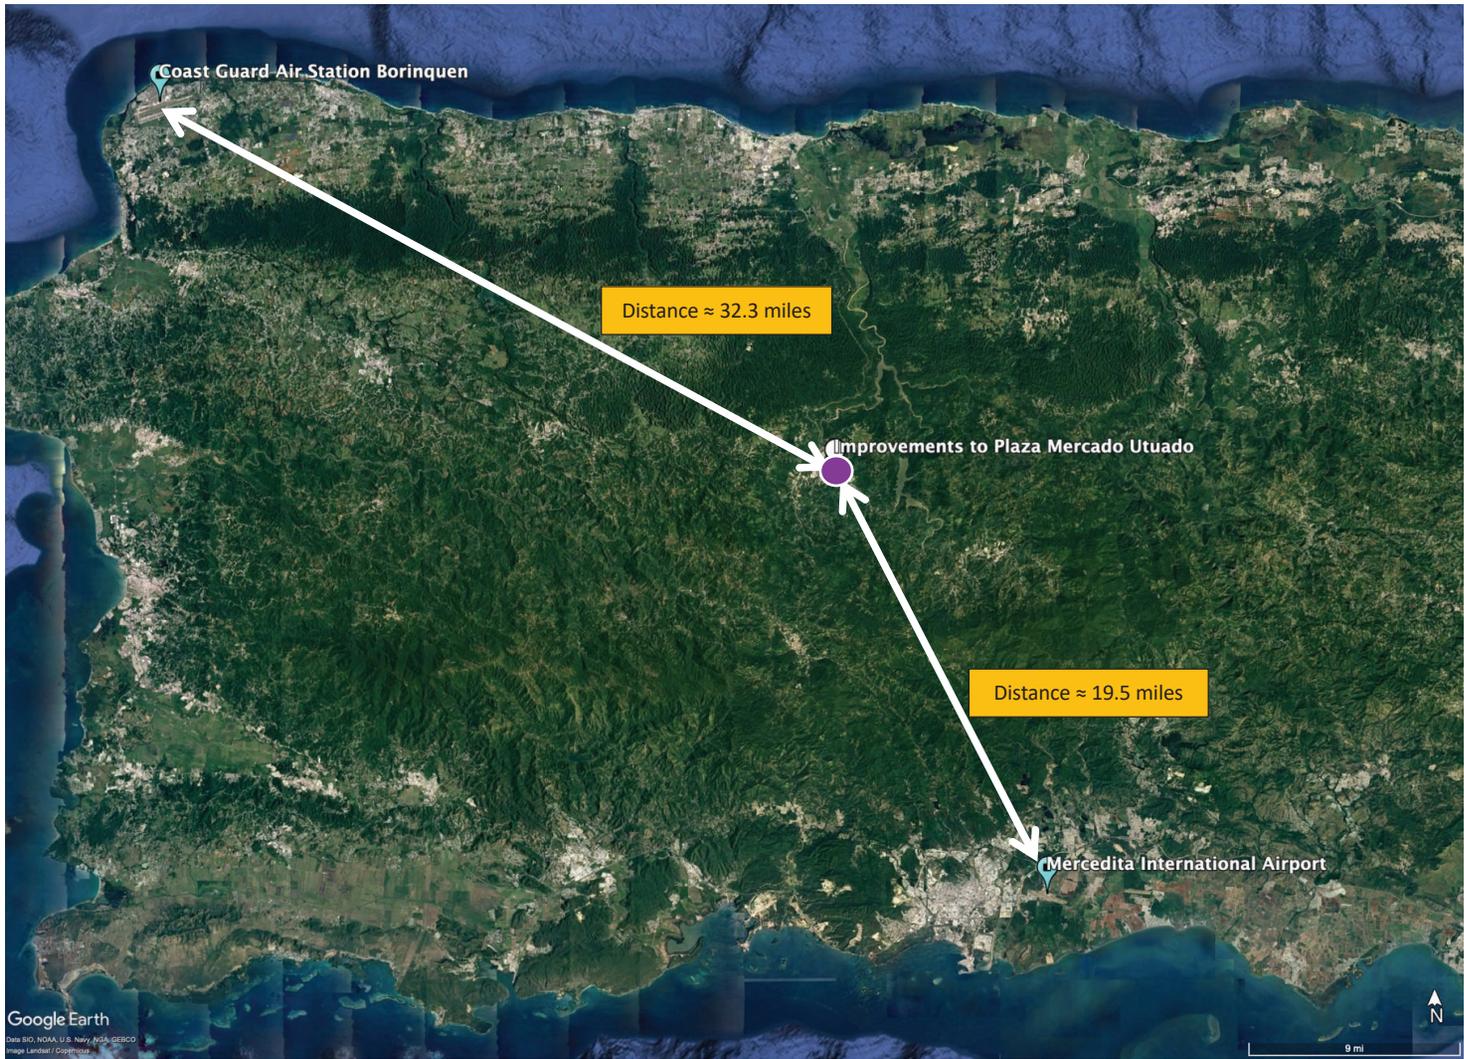
**Figure 1: Airport Hazards**

The closest civilian airport to the Project site is the Mercedita International Airport (PSE), located in Ponce, approximately 19.5 miles southeast of the project site. The closest military airport to the Project site is the Coast Guard Air Station at Borinquen Airport (BQN), located in Aguadilla, approximately 32.3 miles northwest of the project site. The project is not located within 15,000 feet of a military airport, or 2,500 feet of a civilian airport. The Project is in compliance with Airport Hazard requirements. See Figure 1 in Appendix B.

Compliance Factors: Statutes, Executive Orders, and Regulations listed at 24 CFR §58.5 and §58.6	Are formal compliance steps or mitigation required?	Compliance Determinations
<b>STATUTES, EXECUTIVE ORDERS, AND REGULATIONS LISTED AT 24 CFR 50.4 and 58.6</b>		
<b>Airport Hazards</b>  24 CFR Part 51 Subpart D	Yes    No <input type="checkbox"/> <input checked="" type="checkbox"/>	The closest civilian airport to the Project site is the Mercedita International Airport (PSE), located in Ponce, approximately 19.5 miles southeast of the project site. The closest military airport to the Project site is the Coast Guard Air Station at Borinquen Airport (BQN), located in Aguadilla, approximately 32.3 miles northwest of the project site. The project is not located within 15,000 feet of a military airport, or 2,500 feet of a civilian airport. The Project is in compliance with Airport Hazard requirements. See worksheet in Appendix A and Figure 1 in Appendix B.

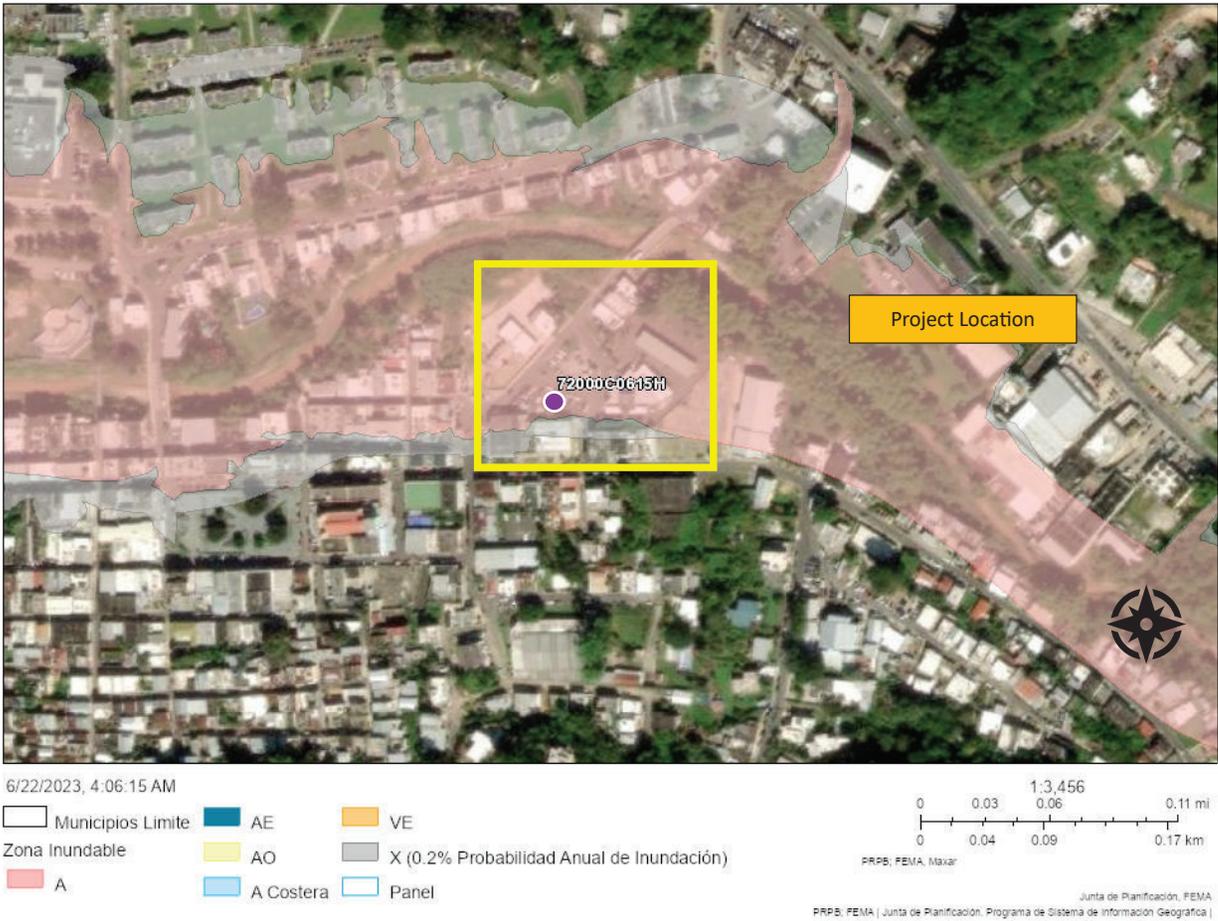
**Figure 06: Floodplain Management**

Per Floodplain Insurance Map 72000C0615H, effective date April 19, 2005, most of the north portion of the project is located within a Special Flood Hazard Area, or within the 1% annual chance of flood hazard zone. The middle southern section of this linear project is located within Zone X, or the 0.2% annual chance of flood hazard zone. The southern portion of the project area is located outside the flood zone.

<p>April 19, 2005 and flood hazard zone A per the Advisory Base Flood Elevation Map.</p> <p>An 8-Step evaluation was conducted for the project, and it was determined that the project will have no impacts on the floodplain due to the proposed improvements, as it will not expand the existing footprint. The 8-Step evaluation also concluded that there is no practicable alternative to locating the project outside the flood zone. This conclusion is based on: 1) the need to revitalize the parking and surrounding areas of the square plaza due to the aftermath of hurricanes; 2) the community's need for open recreational spaces for all ages; and 3) the necessity of ADA-compliant parking. Please refer to Appendix G for further details.</p> <p>Mitigation measures will be taken to minimize adverse impacts during construction and to restore and preserve natural and beneficial values. Best management practices are being employed during the design phase and will be implemented during the construction to appropriately minimize and remove debris from the floodplain area. The project would be implemented within the existing footprint of the property would not involve an increase in impervious surfaces. With these mitigations there will be no impact to the floodplain by incorporating mostly green open spaces. It will not have a significant impact on the actual runoff water behavior during weather events. The proposed use is in harmony with the surrounding developed area.</p> <p>The Project is in compliance with Floodplain Management requirements.</p> <p>Refer to worksheet in Appendix A, Figure 6 in Appendix B and supporting documentation in appendix G.</p>

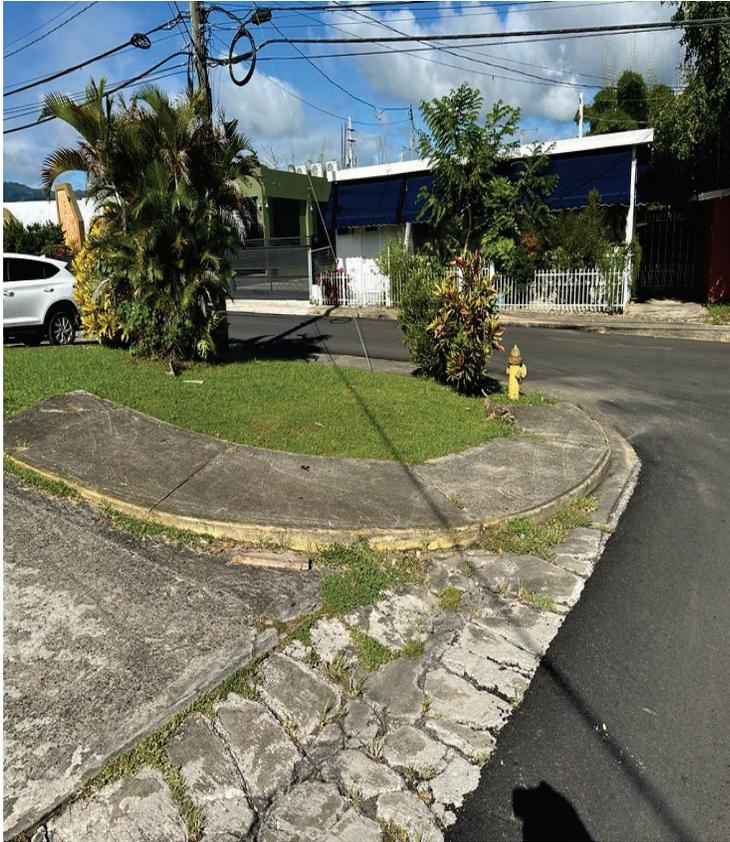
**Typical Concrete Yellow Curbs  
Painted with LBP  
Parking (North, East and South  
Plaza del Mercado de Utuado**

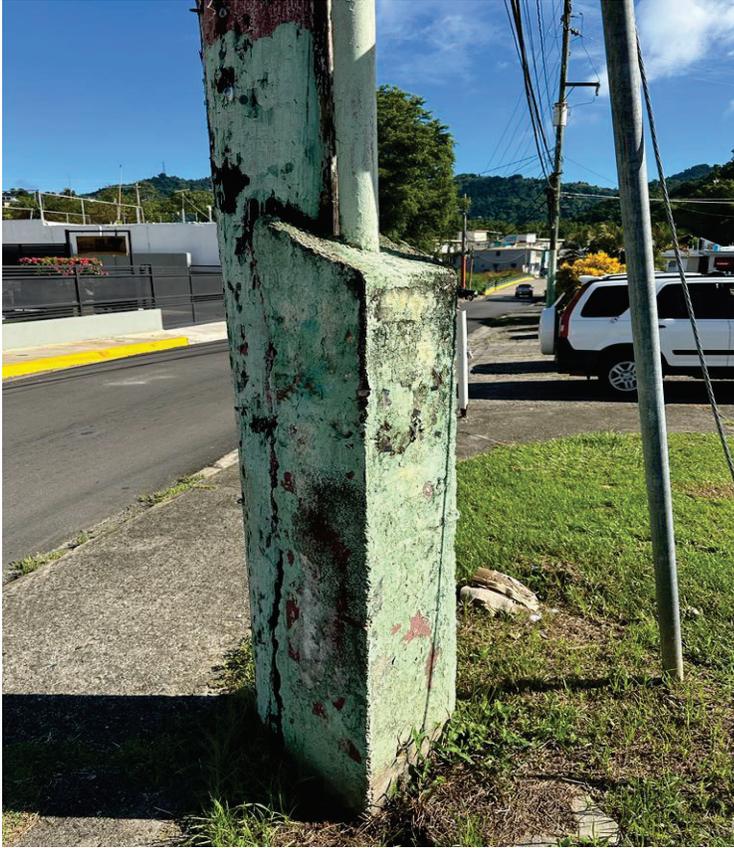
**Lt. Green Wood / Concrete / Metal  
Light Post  
Painted with LBP  
North Parking  
Plaza del Mercado de Utuado**

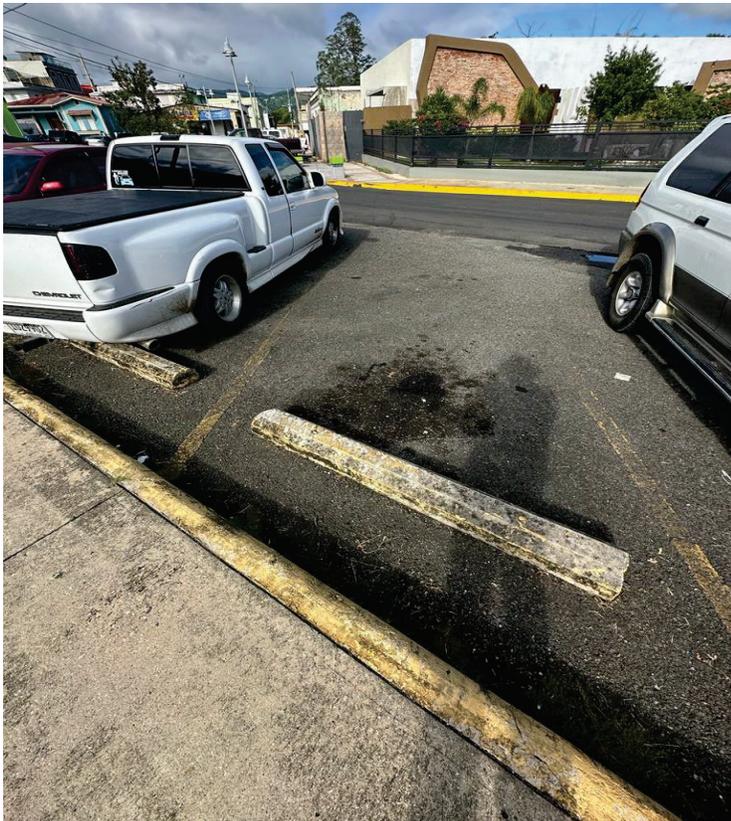
**Yellow Asphlt Floor Lines  
Painted with LBP  
East Parking  
Plaza del Mercado de Utuado**

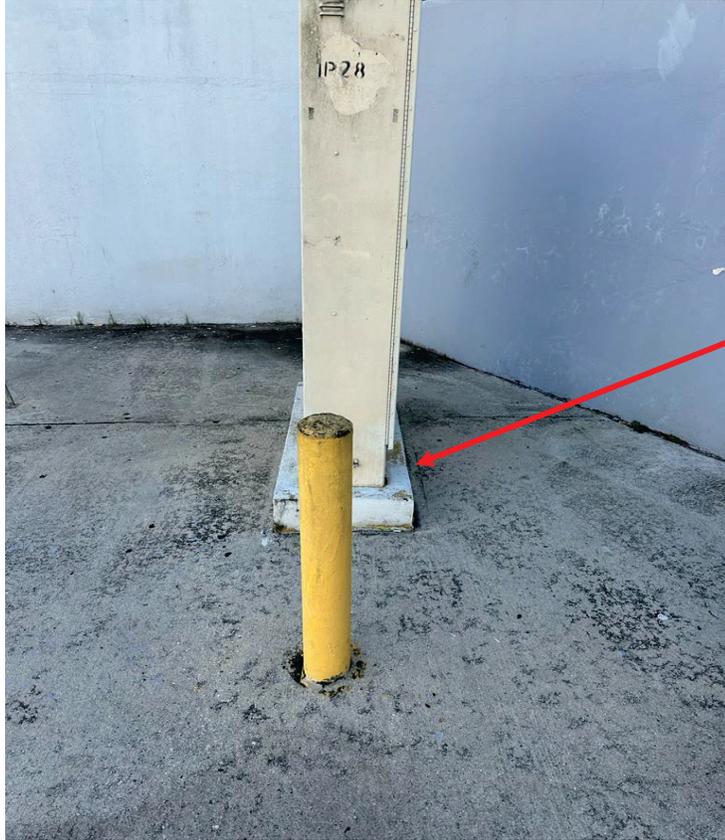
**Yellow Concrete Breaker Panel Base  
Painted with LBP  
Front of Building  
Plaza del Mercado de Utuado**

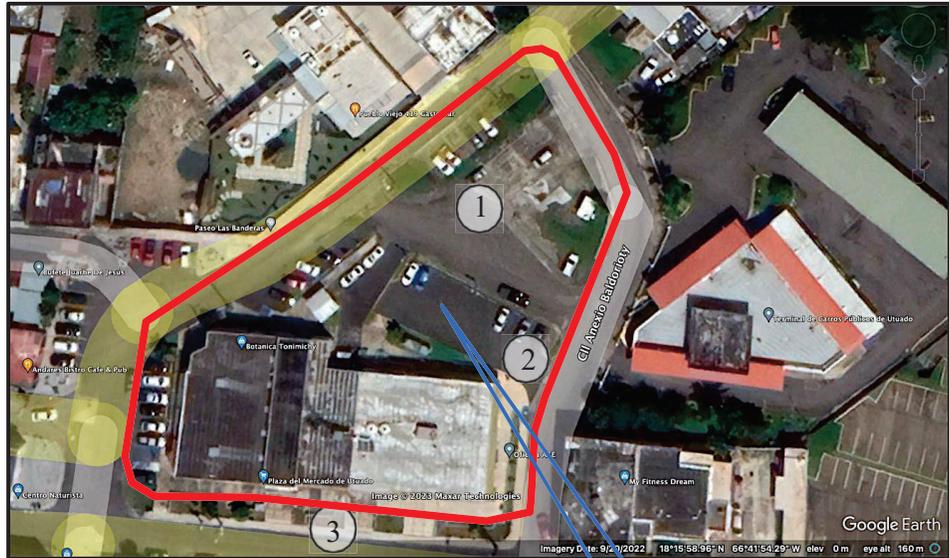
Figure 1. Project Site

1. Existing parking.
2. Sidewalks and existing ramps.
3. Surrounding of Plaza del Mercado.

The Municipality of Utuado in its recovery efforts after the impact of hurricanes Irma and María is seeking to provide the community with open spaces for recreation and mental distraction within urban areas. Since the hurricanes damaged the parking lot near the Plaza del Mercado, the Municipality of Utuado seeks to rehabilitate the parking area and, at the same time, provide the community with an open space for passive recreation. In addition, in case of emergency, these car parks can serve as a meeting point. By 1984, the most recent extension and improvement to the marketplace was completed. (Figure 1).

This proposal aims to rehabilitate and improve the existing conditions of the surrounding areas of the Market Square, (Figure 1). The new design proposed parking spaces (36 to 45 parking spaces) including two electric/hybrid charging spaces as well as accessible parking (ADA compliant). The project will also have green areas, new lighting, street furniture, solar-powered workstation-type tables with ports to recharge cell phones and connect laptops, game tables domino and chess, with umbrellas to create shade, architectural walls, with retractable roofs to separate the passive area of the Market Square and area for two food trucks. The new design will incorporate ADA compliance sidewalks and new solar light poles, (Figure 2).

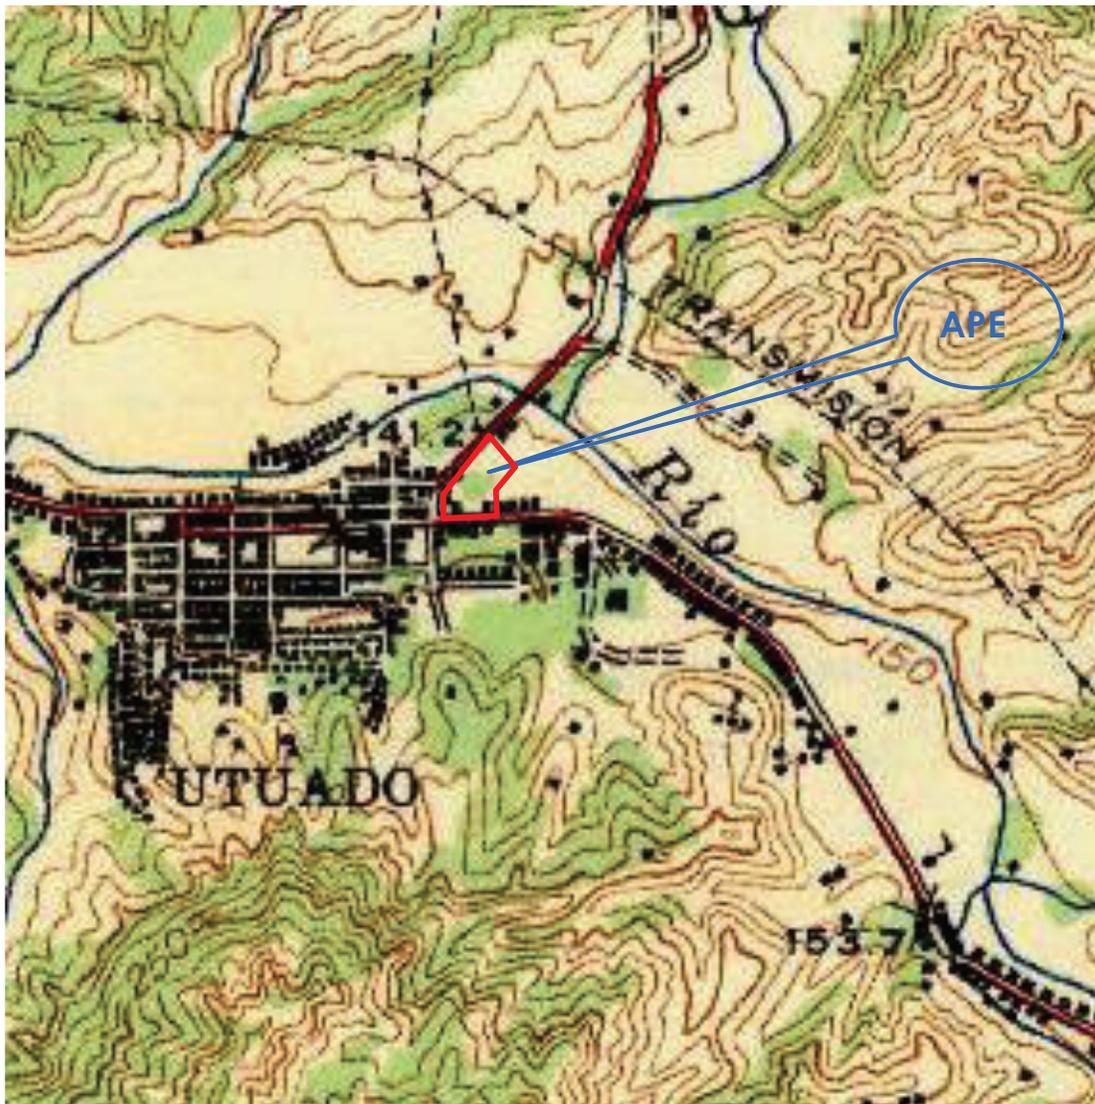
Figure 6: USGS Historical Topographic Quadrangle, 1946. The southern sector of the APE is observed with houses built and the northern sector is dedicated to crops. 1:30000.

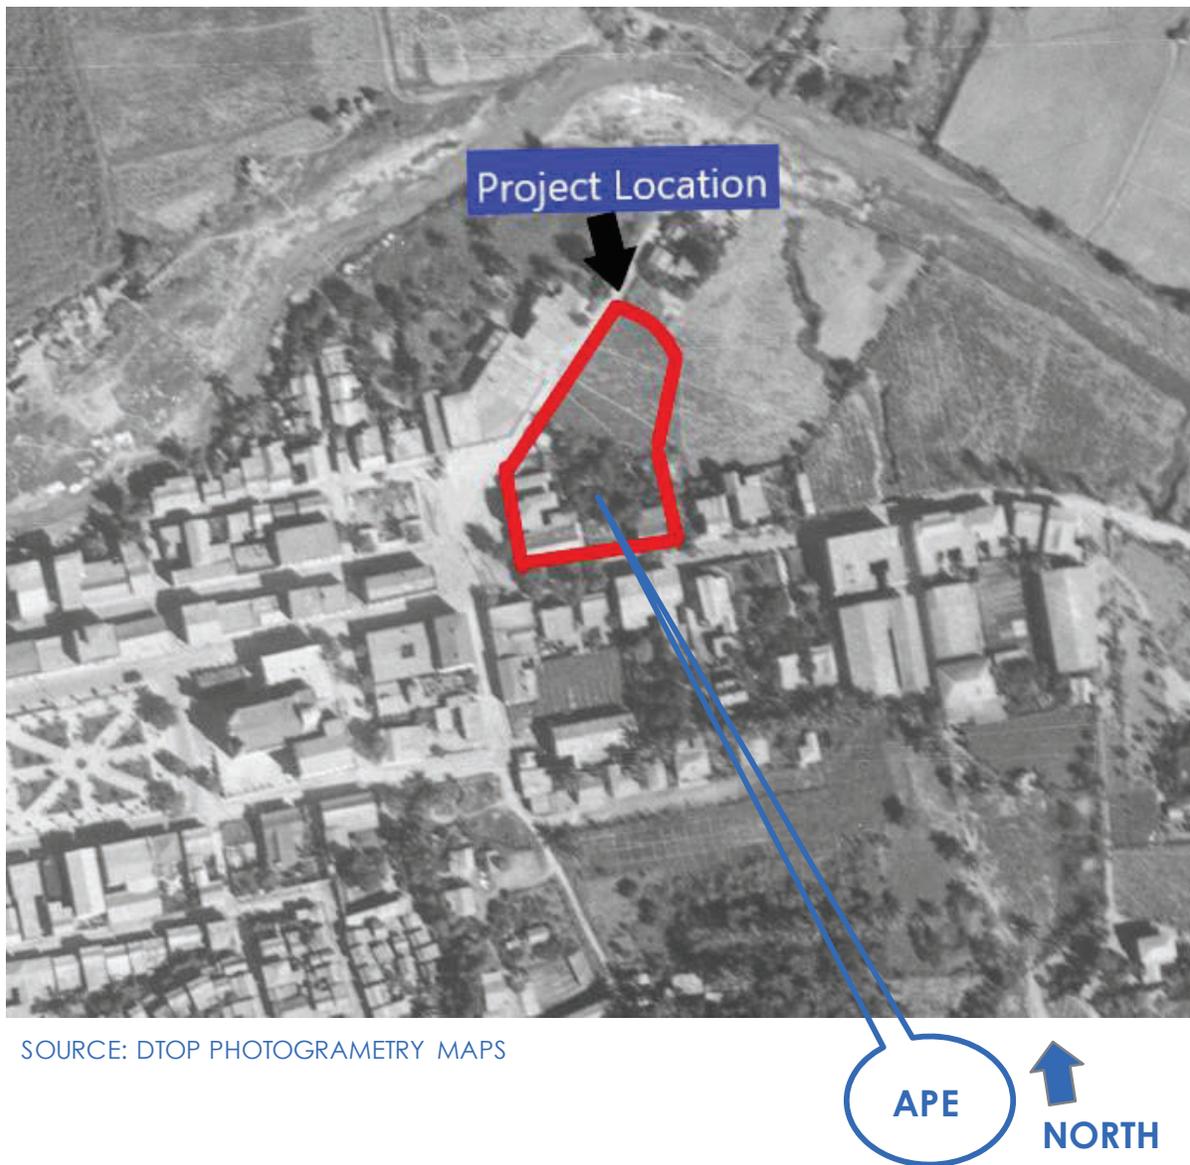
Figure 11: Aerial Photography, Utuado, Puerto Rico, 1931 showing APE. Houses can be seen in the southern section and sugarcane fields in the northern section of the APE.

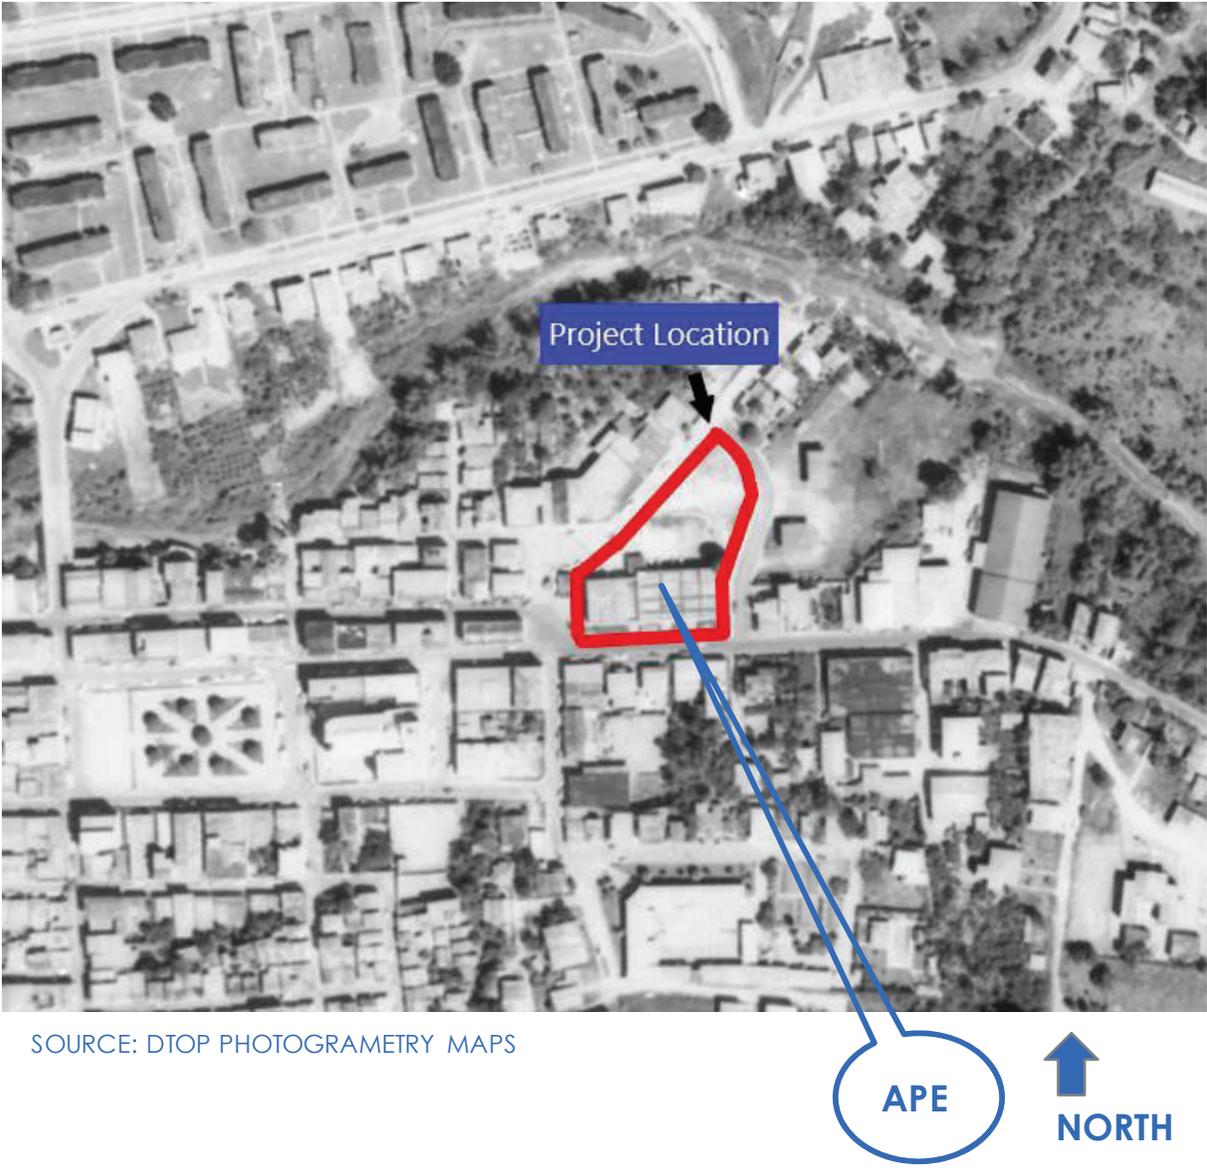
Figure 13: Aerial Photography, Utuado, Puerto Rico, 1963 showing APE. The building of the New Market Square (1959) can be seen. Residences and sugarcane fields were demolished.

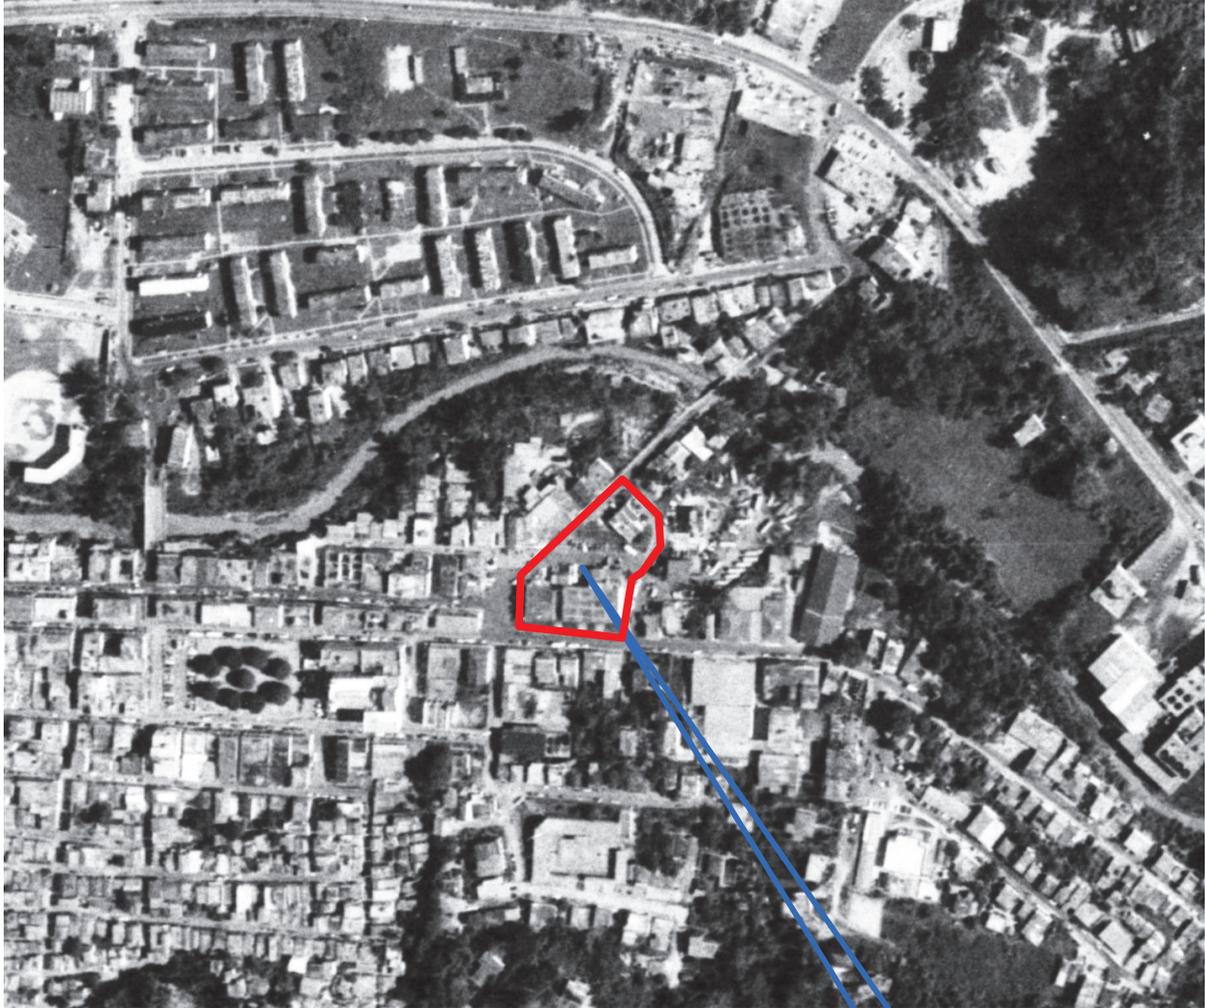
Figure 14: Aerial Photography, Utuado, Puerto Rico, 1980 showing APE. The building of the New Market Square is in the southern sector, and the building of the new Fire Station is already built in the northern sector of the APE plot.

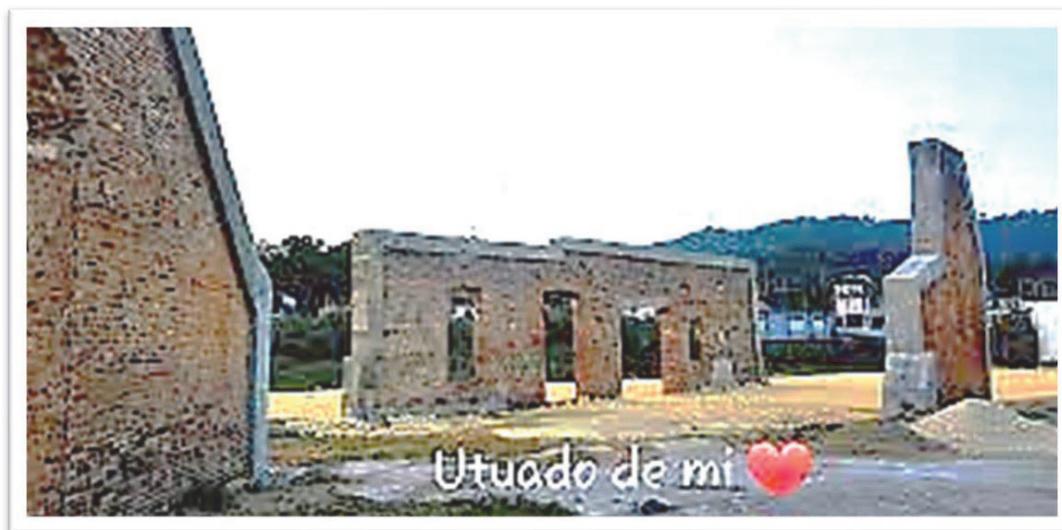
Figure 25: Ruins remnants from the Casella's Ice Plant located at the Plazuela of Utuado, Puerto Rico. July 26th. 2021.<sup>28</sup>

The historic ruins of the Casellas Ice plant are located 0.04 Miles to the North-northwest of Project APE. In 1999 a Phase IB study was conducted on the parcel where the Historic Ruins were located with negative results. After Hurricane Maria in September 2017, the historic ruins of the Casellas Ice Plant suffered considerable damage. Several walls collapsed and the historic ruins were reduced to some remnants of walls. Recently a project called Pueblo Viejo was built on the site.

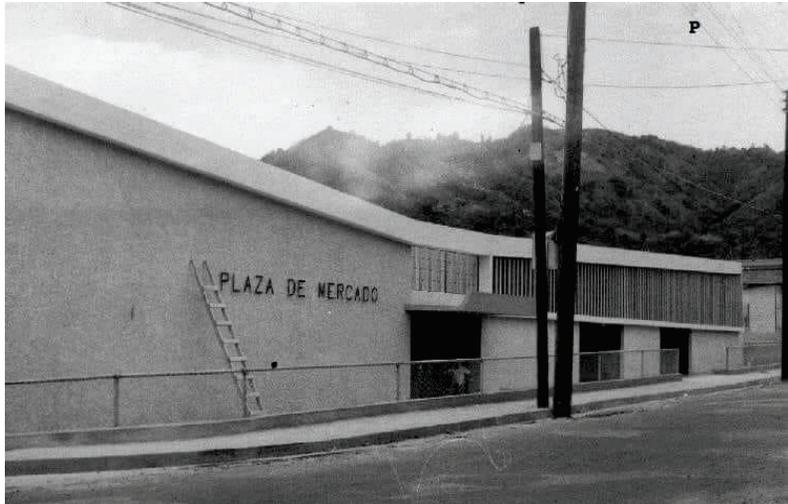
Figure 31: Plaza del Mercado, Utuado, Puerto Rico, 1959. (Lat: 18.265884, Lon: -66.698127). APE.

A metal roof structure can be observed in the North-East block of the APE, but it does not longer exist. It is the building in which the Fire Station was located. Based on the information brought forward in an interview by Mr. Elvin Maldonado Maestre, which is the Subdirector of Utuado Public Works Division, the 20<sup>th</sup> of October 2023, and the review of the aerial's photographs, the building did not appear in the 1963 aerial photograph.

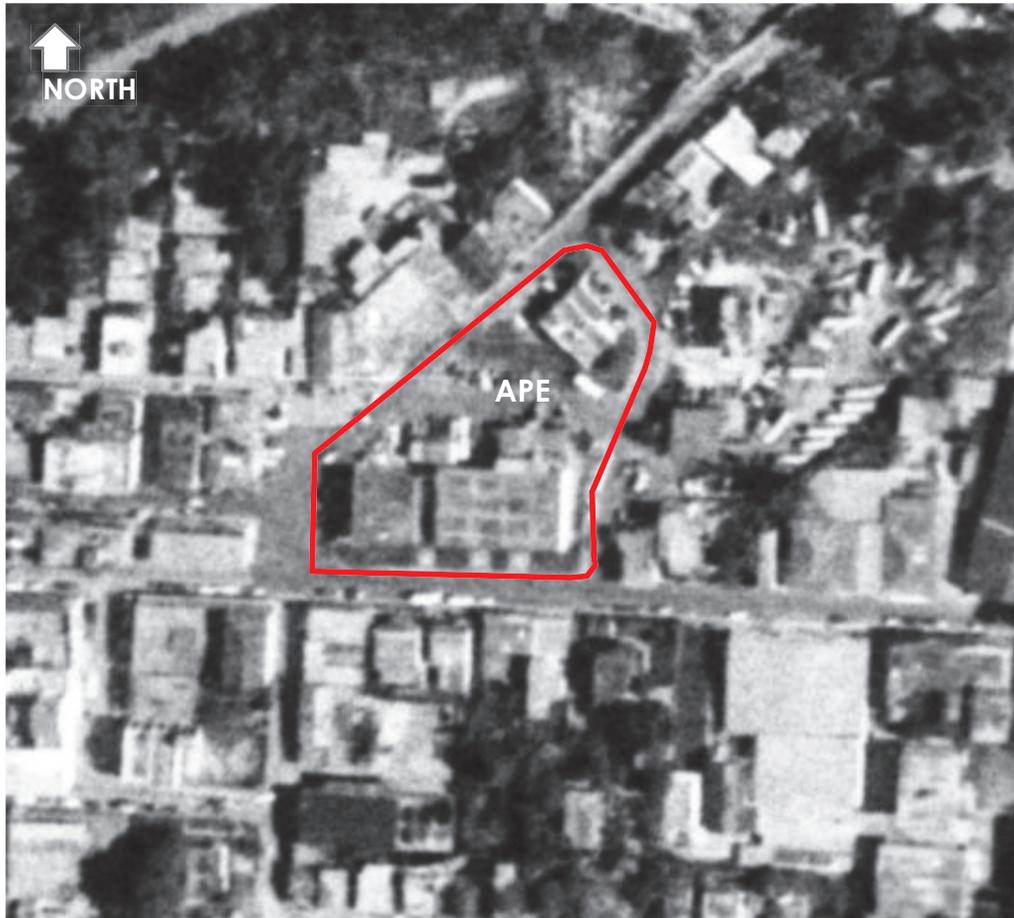
Figure 32: 1980, Utuado, Puerto Rico, Aerial photograph, Showing APE with Plaza del Mercado building. Source: DTOP, Photogrammetry

It can also be observed that before 1980, the entire parcel of land was divided into two blocks, in which an extension of the Santana Montalvo Street runs through connecting with the Anexo Baldorioty Street. (Figure 32). It eventually was turned into the Plaza de Mercado car parking lot.

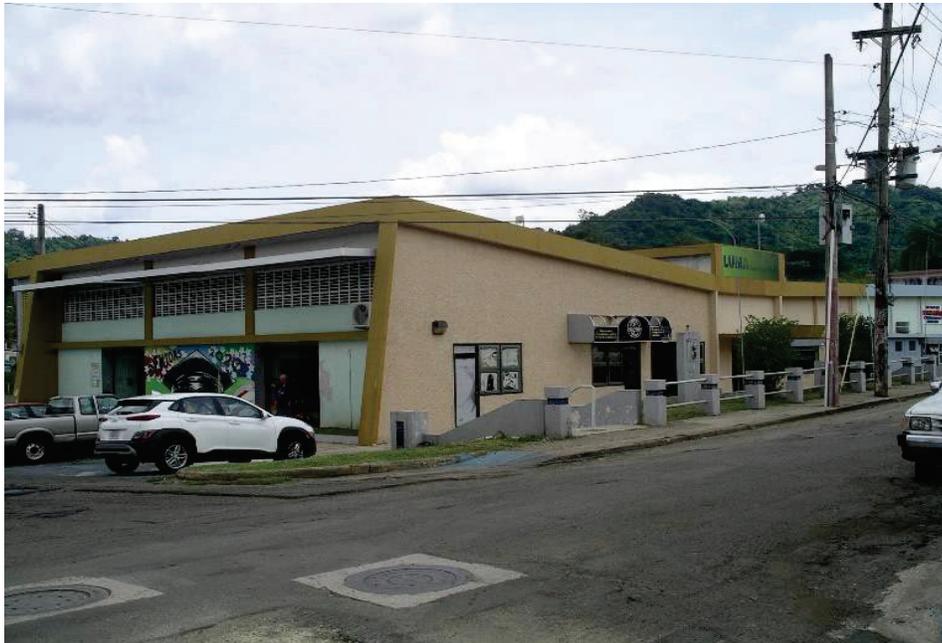
Figure 33: Plaza del Mercado, Utuado, Puerto Rico, Existing Conditions, 2023. APE.

The Plaza de Mercado building is an example which represents a modern solution of commercial buildings that tried to provide a practical commercial space where the farm industry could bring their fresh produce to the consumers in an organized and more sanitary way. This trend was promoted by the central and municipal administrations of Puerto Rico to impose new regulations for food produce management. (Figure 33).

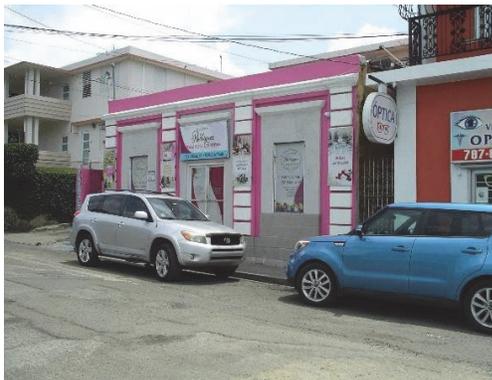
A. Contributing Visual/Indirect APE. Eligible property #01, Antonio R. Barceló Street, South view. Puerto Rico International Modern Style with North American Suburban Influences. ©1960. Materials: Reinforced Concrete. 232.86 Linear feet to APE (0.04 Miles) distance. Photo #13, (Lat:18.265503, Lon: -66.697675).

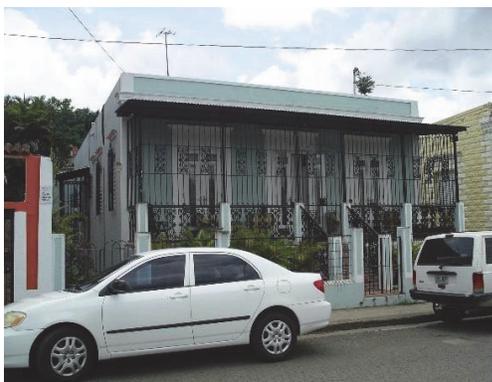
B. Contributing Visual/Indirect APE. Eligible property #02, Antonio R. Barceló Street, South-East view. Puerto Rico Vernacular Creole Style ©1900. Materials: masonry with concrete selective interventions and finishes. Building footprint with façade plane parallel with sidewalk. 175.29 Linear feet to APE (0.03 Miles) distance. Photo #15, (Lat: 18.265567, Lon: -66.697860).

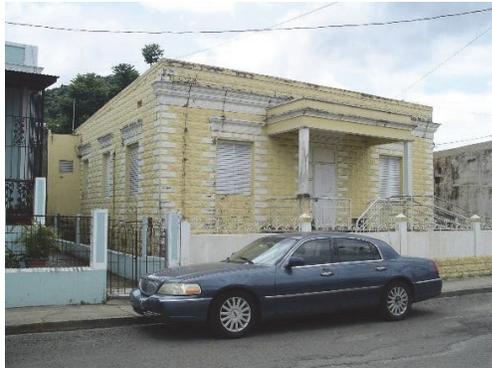
Figure 37. Properties on Antonio R. Barceló Street

D. Contributing Visual/Indirect APE. Eligible property #04, Antonio R. Barceló Street, South view. Puerto Rico Vernacular Creole Style ©1900. Materials: Molded concrete stone facing masonry construction. Setback building footprint with front balcony. 198.22 Linear feet to APE (0.04 Miles) distance. Photo #19, (Lat: 18.265545, Lon: -66.698252).

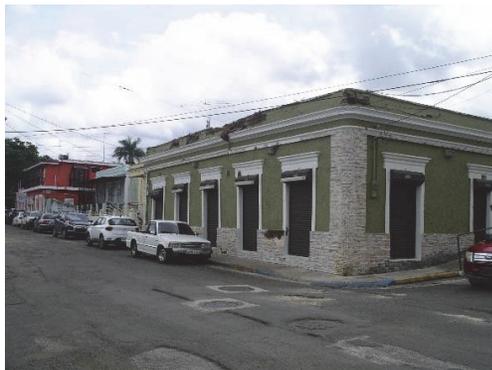
E. Contributing Visual/Indirect APE. Eligible property #05, Antonio R. Barceló Street, South-East view. Puerto Rico Storage Type Vernacular Creole Style ©1900. Materials: Masonry-rubblework construction. Building footprint with façade plane parallel with sidewalk. 216.86 Linear feet to APE (0.04 Miles) distance. Photo #20, (Lat: 18.265577, Lon: -66.698420).

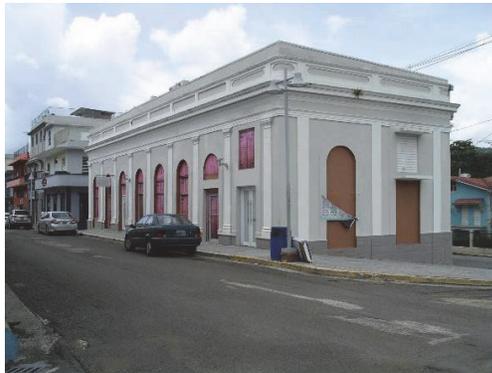
F. Non-eligible, contributing Visual/Indirect APE property, Antonio R. Barceló and corner of San Miguel Streets, South view. Puerto Rico Storage Type Creole Style. Materials: Reinforced concrete and masonry-rubblework construction. Building's footprints the entire corner with façade plane parallel with sidewalk. 300 Linear feet to APE (0.06 Miles) distance. Photo #29, (Lat: 18.265524, Lon: -66.698640).

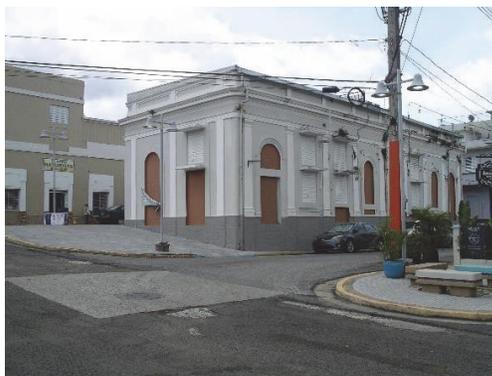
G. Contributing Visual/Indirect APE. Eligible property #06, Antonio R. Barceló and corner of San Miguel Streets, North-West view, South and East Facades. Puerto Rico Storage Type Creole Style with Neoclassical Influences, © 1900. Materials: Concrete and masonry-rubblework construction. Building's footprints the entire block with façade plane parallel with sidewalk, except on the East facade. 274.6 Linear feet to APE (0.05 Miles) distance. Photos #25-27, (Lat: 18.265763, Lon: -66.698757).

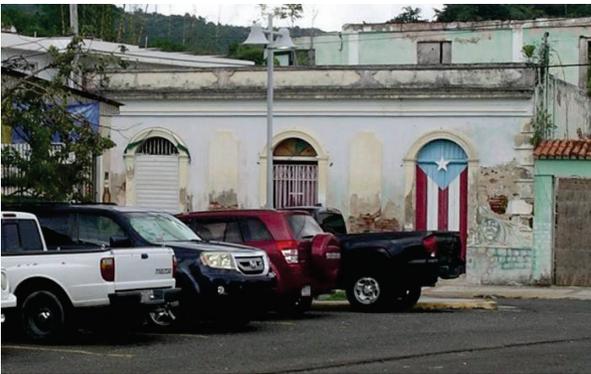
H. Contributing Visual/Indirect APE. Eligible property #07, San Miguel and corner of Dr. Cueto Street, West view, Vernacular Creole Style with Eastern North American Bungalow Influences, © 1900, Wood and metal roof construction, with corner balcony and property's footprint setbacks. 234.22 Linear feet to APE (0.04 Miles) distance. Photo #30, (Lat: 18.265942, Lon: -66.698691).

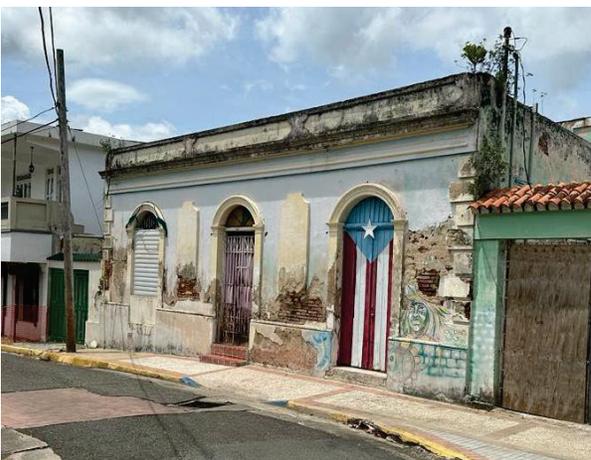
I. Contributing Visual/Indirect APE. Eligible property #08, Santana Montalvo Street, North view. Puerto Rico Vernacular Creole Style ©1900. Materials: Masonry-rubblework construction. Building footprint with façade plane parallel with sidewalk. 222.78 Linear feet to APE (0.04 Miles) distance. Photos #31-32, (Lat: 18.266222, Lon: -66.698648).

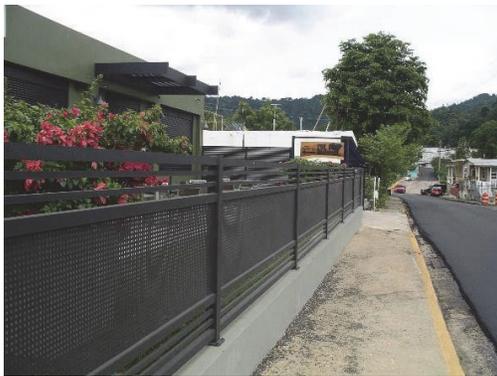
J. Contributing Visual/Indirect APE. Eligible property (Only the ruins remnants). Sabana Grande Street, North-West view. New construction with historic ruins remnants, integrated into the new building. Reinforced concrete construction. 150 Linear feet to APE (0.03 Miles) distance. Photos #37-39, (Lat: 18.266385, Lon: -66.698318).

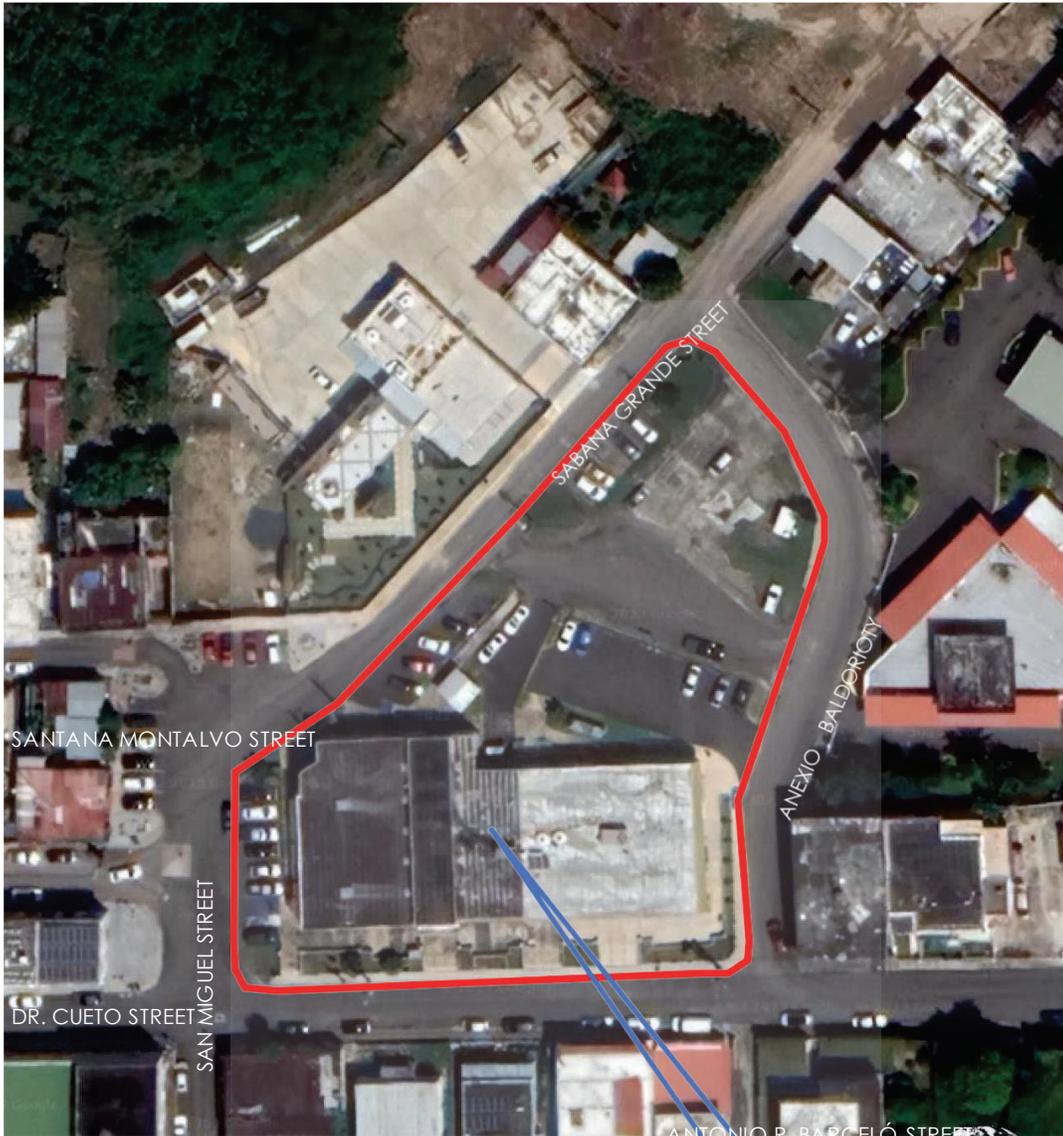
**Project (Parcel) Location – Area of Potential Effect Map (Aerial)**

- APE Size: 1.0728 Acres
- Longitude (North to South Axis): 344.88 linear feet.
- Width (East to West Axis): 336.48 linear feet.
- Coordinates: Lat: 18.265884, Lon: 66.698127

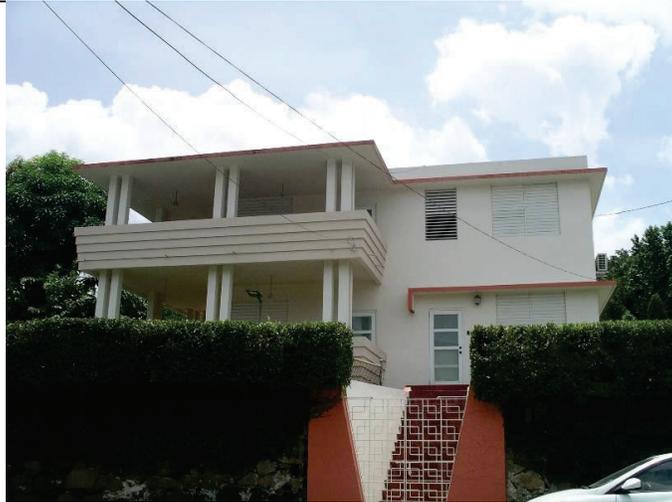
Photo: #13

Description: Antonio R. Barceló Street, South view. Eligible Property#01, Puerto Rico International Moderne Style with North American Suburban Influences, Visual APE.

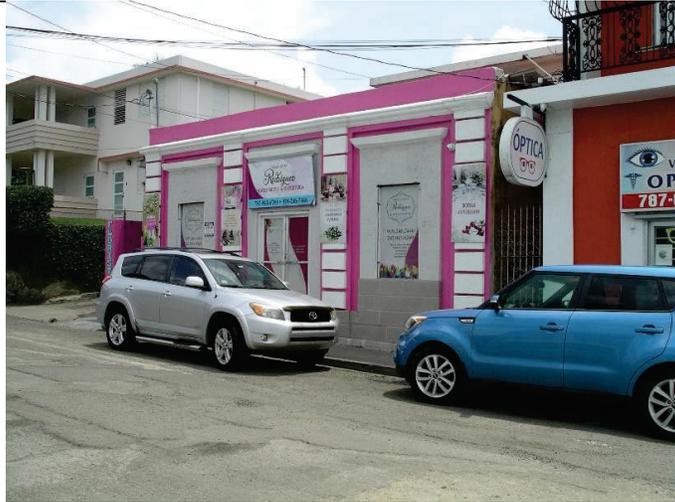
Photo: #15

Description: Antonio R. Barceló Street, South-East view, Eligible Property #02, Creole Style © 1930, Visual APE.

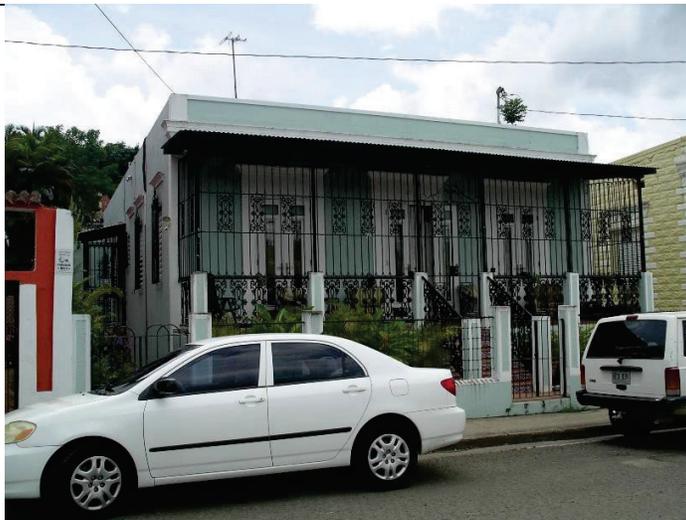
Photo: #18

C. Contributing Visual/Indirect APE. Eligible property #03, Antonio R. Barceló Street, South view. Puerto Rico Vernacular Creole Style ©1900. Materials: Masonry with concrete selective interventions and finishes. Setback building footprint with forged steel handrail in front balcony. 186.16 Linear feet to APE (0.03 Miles) distance. Photo #18, (Lat: 18.265563, Lon: -66.698122).

Description: Antonio R. Barceló Street, South view, Eligible Creole Style Property #03, Visual APE.

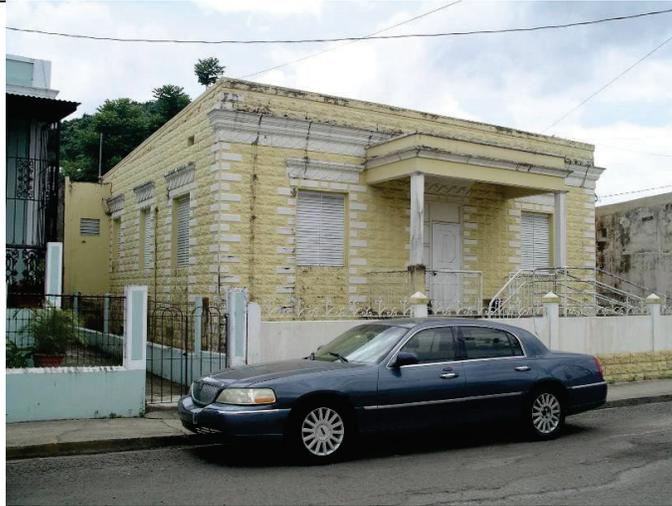
Photo: #19

Description: Antonio R. Barceló Street, South view, Eligible Creole Style Property #04, © 1930, Molded concrete stone-masonry construction, Visual APE.

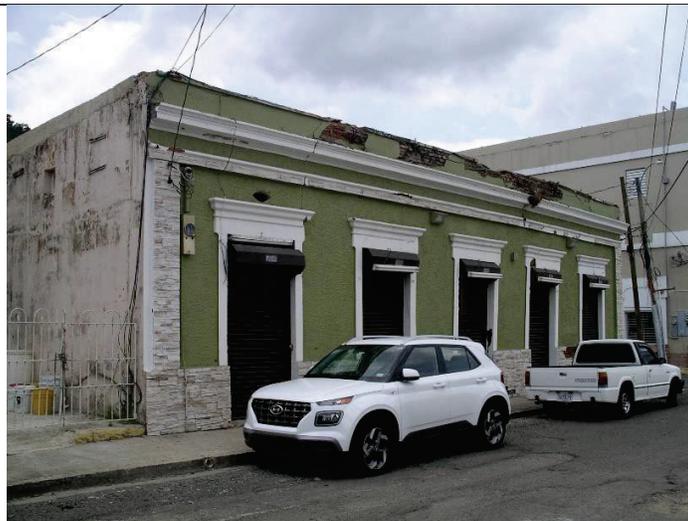
Photo: #20

Description: Antonio R. Barceló Street, South view, Eligible Property #05, Storage Type Creole Style, © 1930, Masonry-rubblework construction, Visual APE.

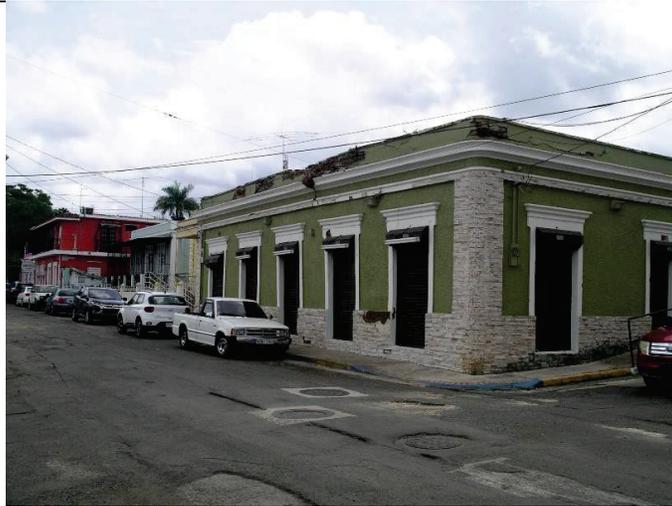
Photo: #21

Description: Antonio R. Barceló and corner of San Miguel Streets, South-East view, Eligible Property #05, Storage Type Creole Style, © 1930, Masonry-rubblework construction, Visual APE.

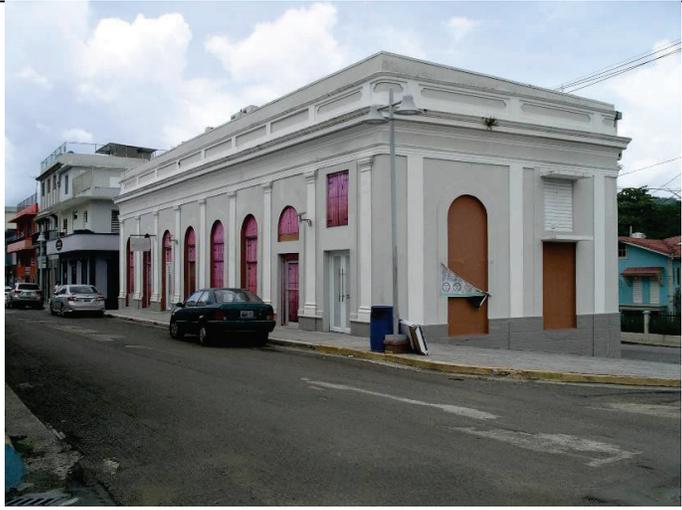
Photo: #25	Description: Antonio R. Barceló and corner of San Miguel Streets, North-West view, South and East Facades, Eligible Property #06, Storage Type Creole Style with Neoclassical Influences, © 1930, Concrete and Masonry-rubblework construction, Visual APE.	
Date: 09/12/23
