**Environmental Review for Activity/Project that is Categorically  
Excluded Subject to Section 58.5  
Pursuant to 24 CFR 58.35(a)**

**Project Name:** Estacionamiento y áreas circundantes de la plaza del mercado PR-CRP-001001

**Responsible Entity:** Puerto Rico Department of Housing (PRDOH)

**Description of the Proposed Project** [24 CFR 50.12 & 58.32; 40 CFR 1508.25]: This proposal aims to rehabilitate and improve the existing conditions of the surrounding areas of the Market Square. The new design

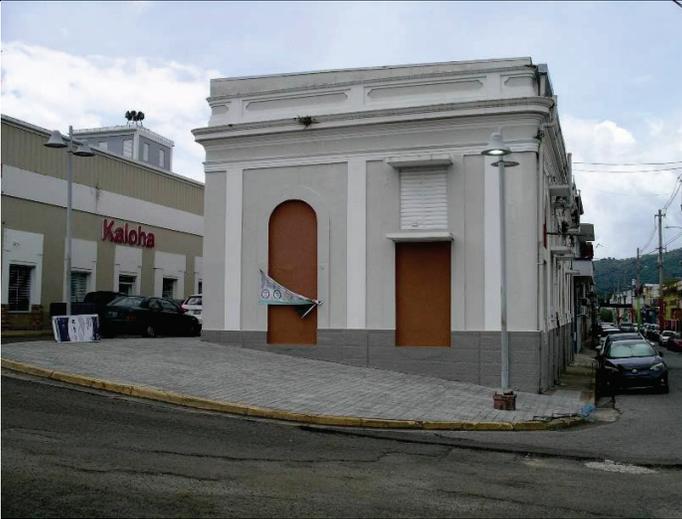
Photo: #26	Description: San Miguel Street, West view, East Facade, Eligible Property #06, Storage Type Creole Style with Neoclassical Influences, © 1930, Concrete and Masonry-rubblework construction, Visual APE.	
Date: 09/12/23

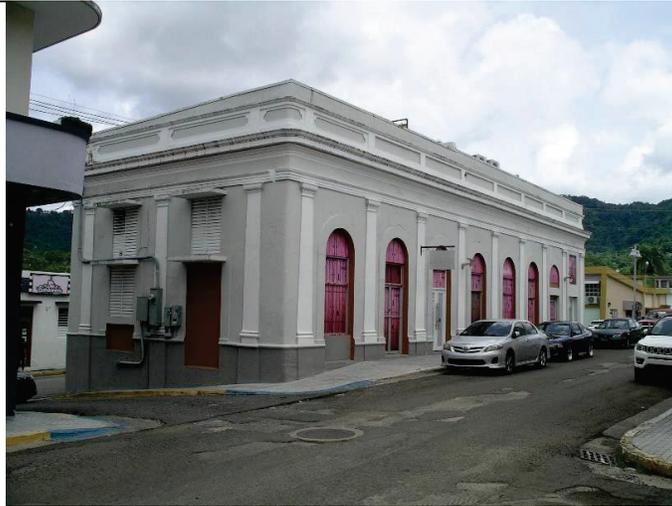
Photo: #27

Description: Antonio R. Barceló and corner of Progreso Street, North-East view, South and West Facades, Eligible Property #06, Storage Type Creole Style with Neoclassical Influences, © 1930, Concrete and Masonry-rubblework construction, Visual APE.

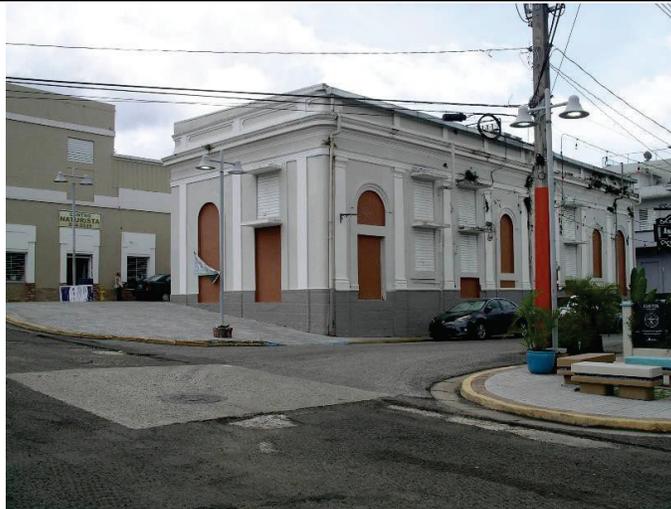
Photo: #28

Description: San Miguel and corner of Dr. Cueto Streets, South-West view, North and East Facades, Eligible Property #06, Storage Type Creole Style with Neoclassical Influences, © 1930, Concrete and Masonry-rubblework construction, Visual APE.

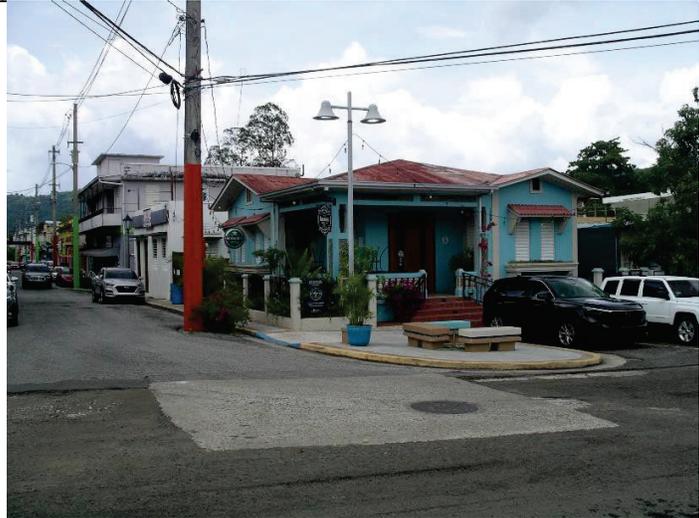
H. Contributing Visual/Indirect APE. Eligible property #07, San Miguel and corner of Dr. Cueto Street, West view, Vernacular Creole Style with Eastern North American Bungalow Influences, © 1900, Wood and metal roof construction, with corner balcony and property's footprint setbacks. 234.22 Linear feet to APE (0.04 Miles) distance. Photo #30, (Lat: 18.265942, Lon: -66.698691).

Photo: #30	Description: San Miguel and corner of Dr. Cueto Street, West view, Eligible Property #07, Vernacular Creole Style with Eastern North
Date: 09/12/23	American Bungalow Influences, © 1930, Wood and metal roof construction.

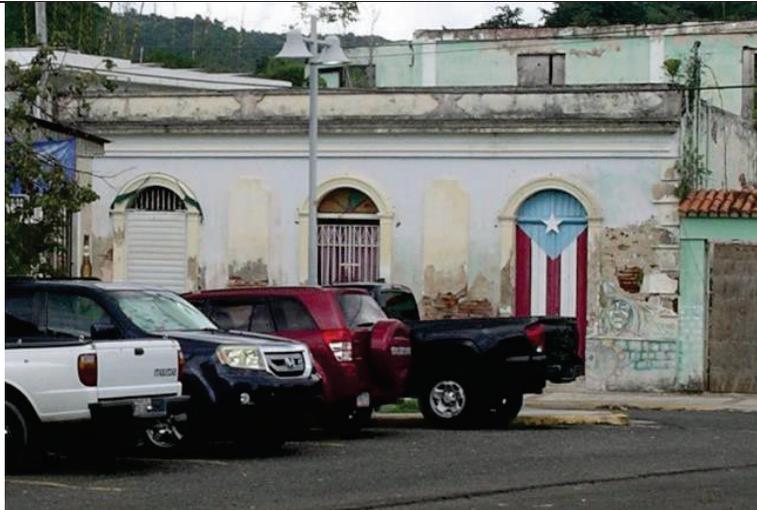
Photo: #31

Description: **Eligible property #08**, Santana Montalvo Street, North view. Puerto Rico Vernacular Creole Style ©1920-30. Materials: Masonry-rubblework construction. Building footprints with façade plane parallel with sidewalk. Visual APE.

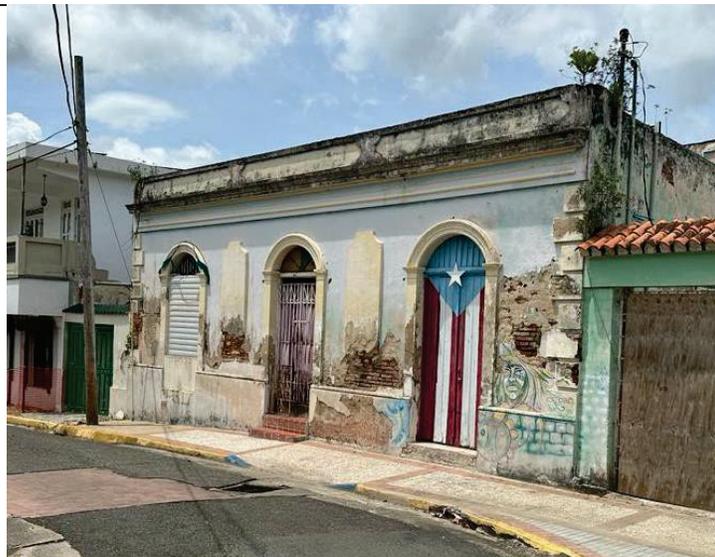
Photo: #32

Date: 09/12/23	Description <b>Eligible property #08</b> , Santana Montalvo Street, North view. Puerto Rico Vernacular Creole Style ©1920-30. Materials: Masonry-rubblework construction. Building front footprint with façade plane parallel with sidewalk. Visual APE.
----------------	--

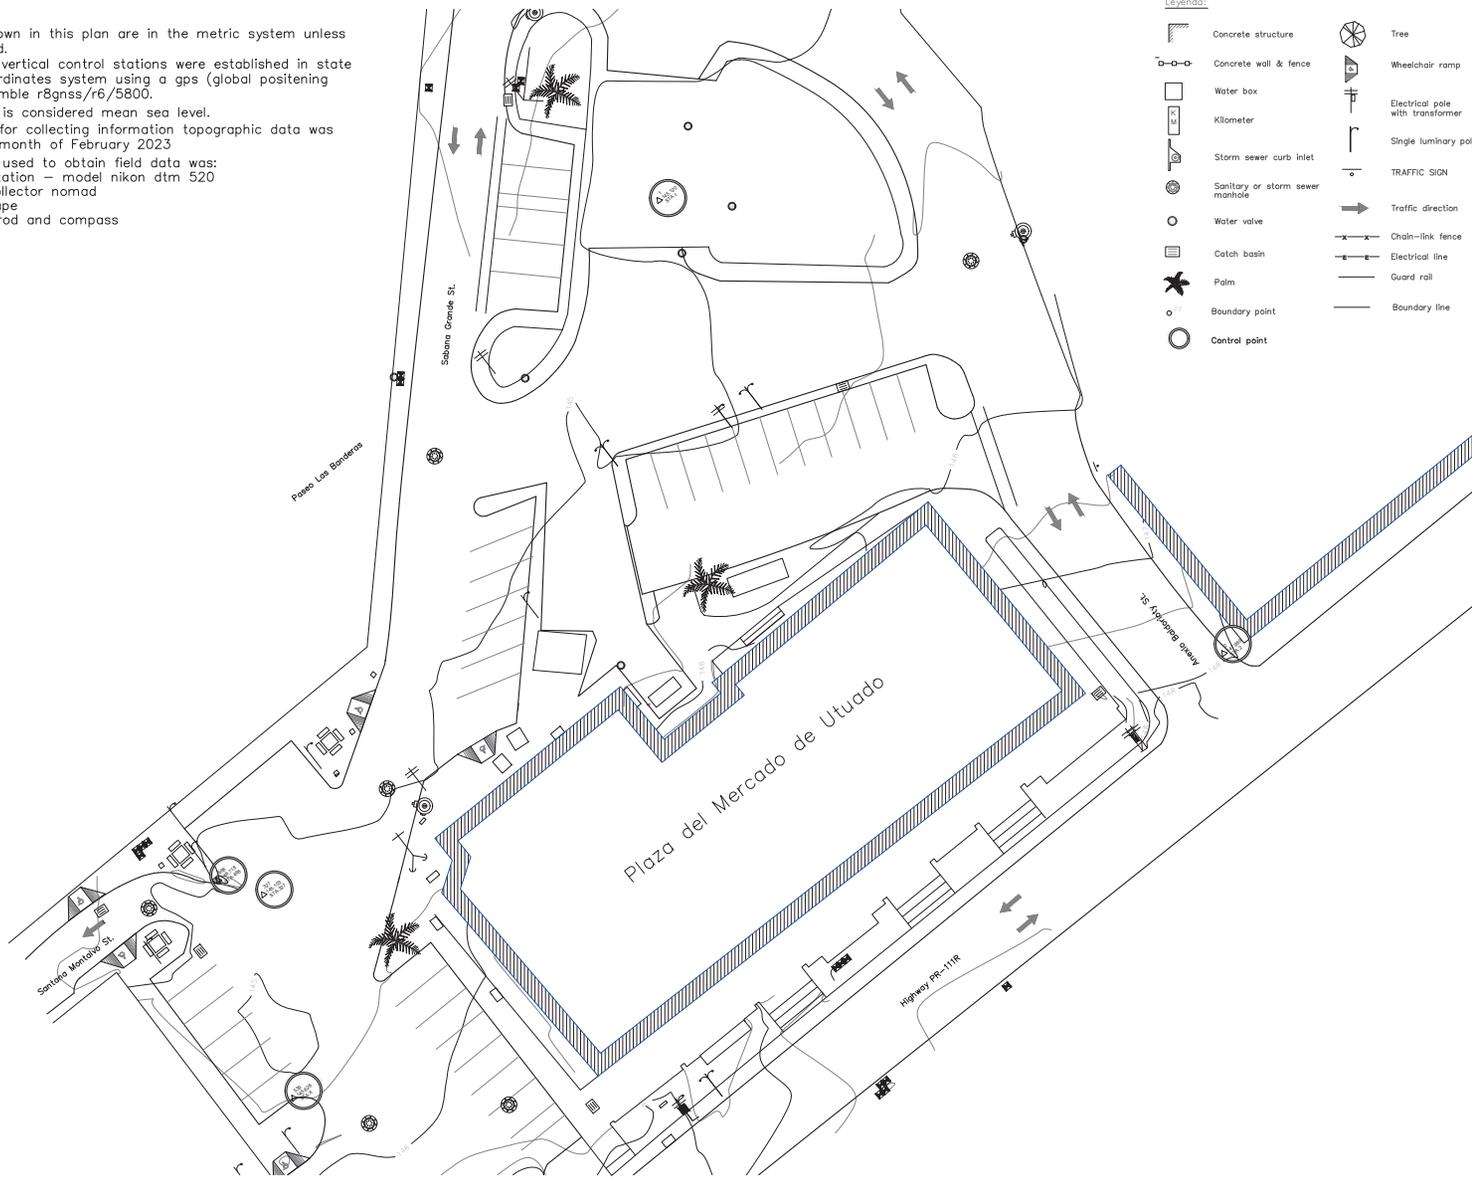
① SURVEY AND TOPOGRAPHICAL WORK  
1/16" = 1'-0"

1. All distance shown in this plan are in the metric system unless otherwise indicated.
2. Horizontal and vertical control stations were established in state plane nad 83 coordinates system using a gps (global positening system) model trimble r8gnss/r6/5800.
3. Vertical datum is considered mean sea level.
4. The field work for collecting information topographic data was performed in the month of February 2023
5. The equipment used to obtain field data was:
  - A - Total station - model nikon dtm 520
  - B - Data collector nomad
  - C - Steel tape
  - D - Prism, rod and compass

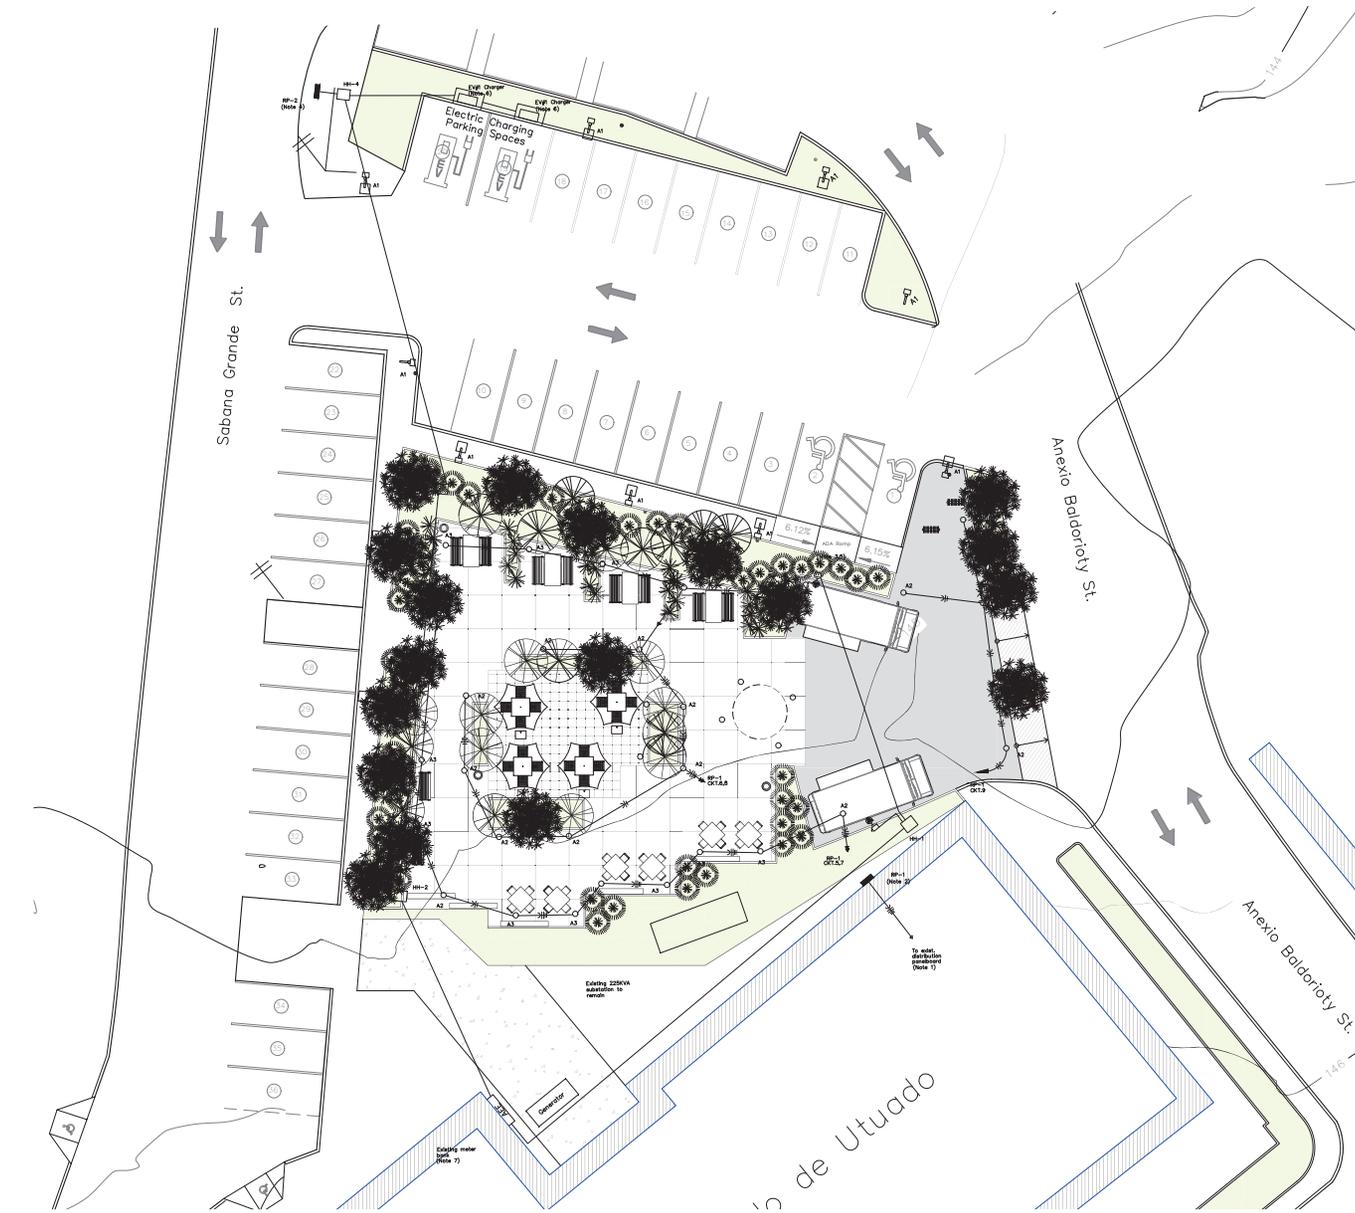
DATE	Agosto 2023
REV. DESC.	E-1

New Condition Electrical

- Contractor shall provide and install 4 # 2 x HHW and 1 # 6 TW ground cable in 1 1/2" Ø PVC SCH 40 conduit to be connected to new 100 AMP, 3 pole, 250V circuit breaker to be installed at existing distribution panelboard space position. Work to be field verified prior to start work, contractor shall provide all necessary breaker mounting kit for proper installation.
