**Environmental Review for Activity/Project that is  
Categorically Excluded Subject to Section 58.5  
Pursuant to 24 CFR 58.35(a)**

**Project Name:** PR-RGRW-03465-W

**HEROS Number:** 900000010466020

This project (PR-RGRW-03465-W) entails the award of a grant to Finca Brutal LLC, an agricultural business, at Carretera 112 Km 13 Camino Tamarindo, Bo. Rocha, Moca, PR 00676. Tax ID Numbers: 047-000-006-10 and 071-000-001-09-001. Coordinates (latitude 18.403054, longitude -67.051015). The project includes the purchase and construction of a new greenhouse, a new mobile electric fence, and solar panels, and the purchase of moveable equipment including an excavator, Pioneer 250 UTV, wire and poultry products, and wire and ruminant products. The property consists of gently to steeply sloping topography. Construction activities will occur on existing developed areas on the property and will not require substantial grading activities. The proposed greenhouse will be installed in the western portion of the project property along an existing internal roadway. The proposed greenhouse will be 160 square feet (sf) in size (20 feet [ft] by 8 ft). The greenhouse will be constructed on a 160-sf

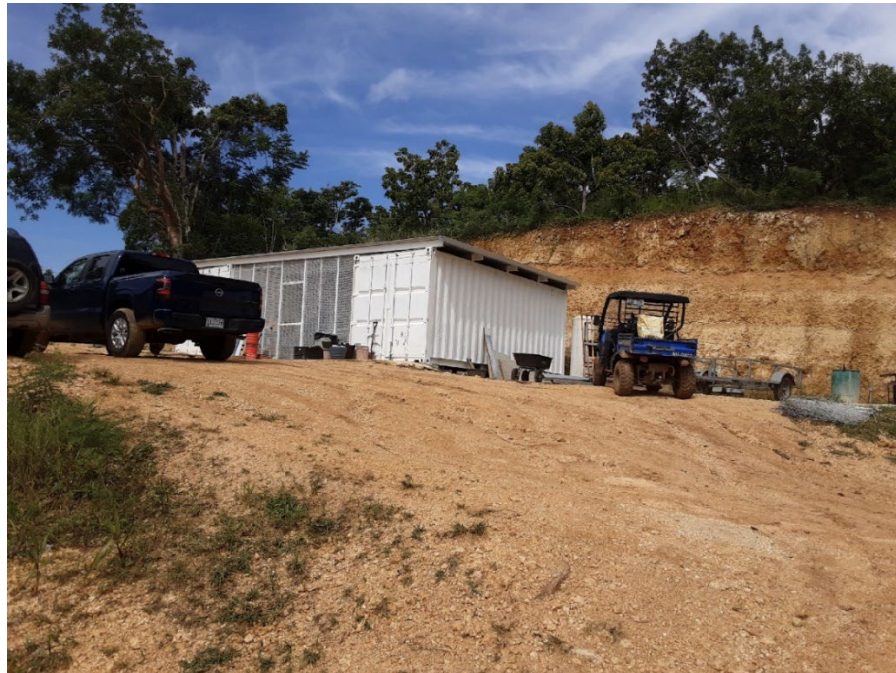
Overview of the warehouse where the solar panels will be installed on the roof. The batteries will be installed and secured inside the structure.

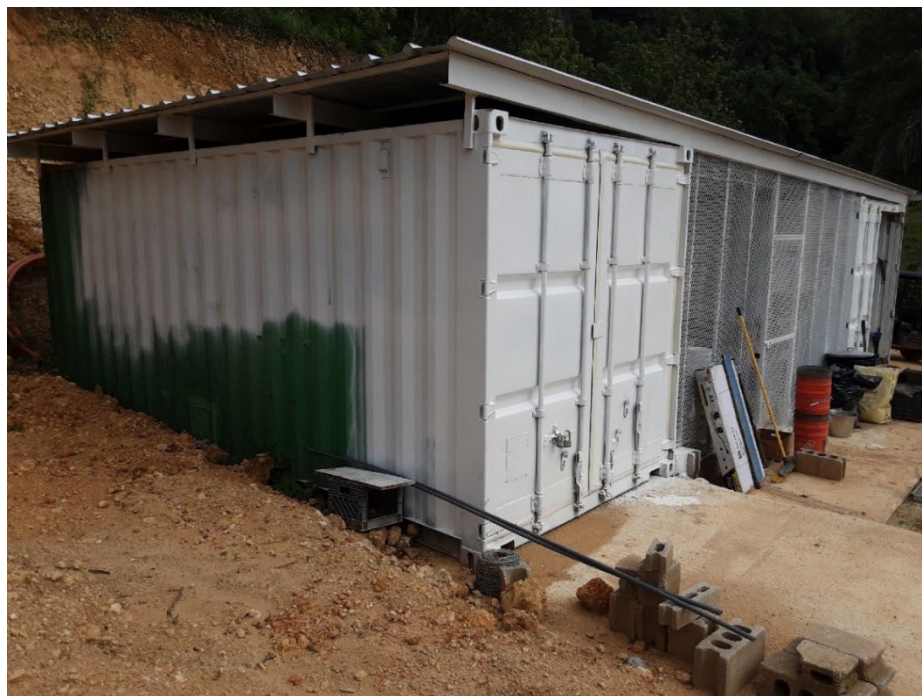
**Photo #:**  
02

Overview from the southeast corner of the warehouse where the solar panels will be installed. The batteries will be installed and secured inside the structure.

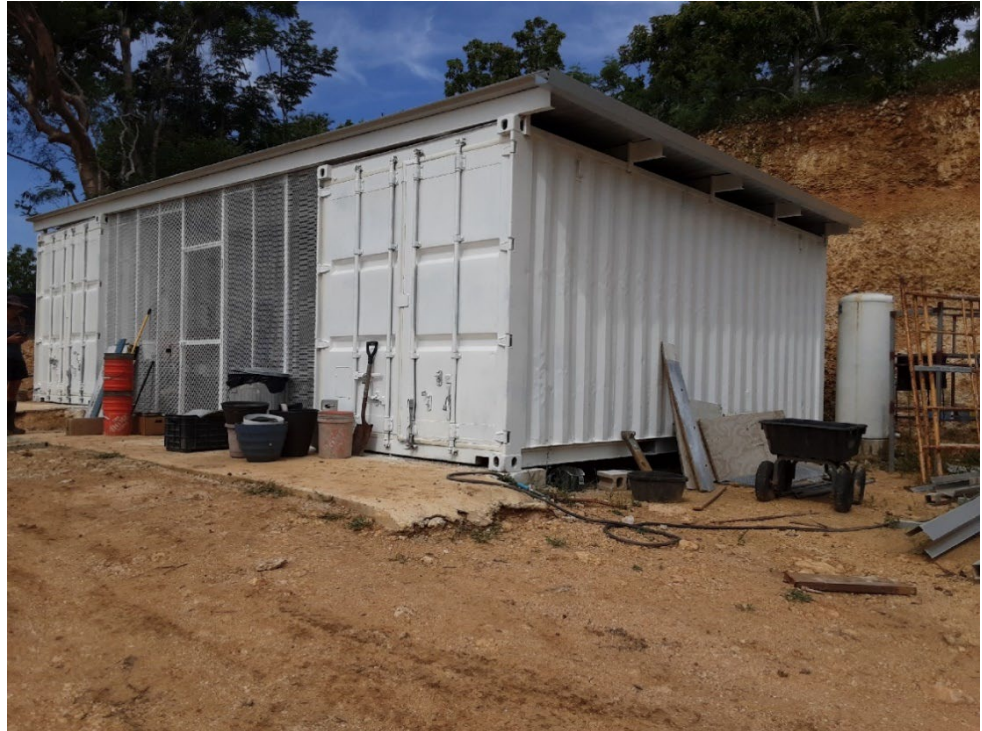
Overview from the northeast corner of the warehouse where the solar panels will be installed on the roof. The batteries will be installed and secured inside the structure.

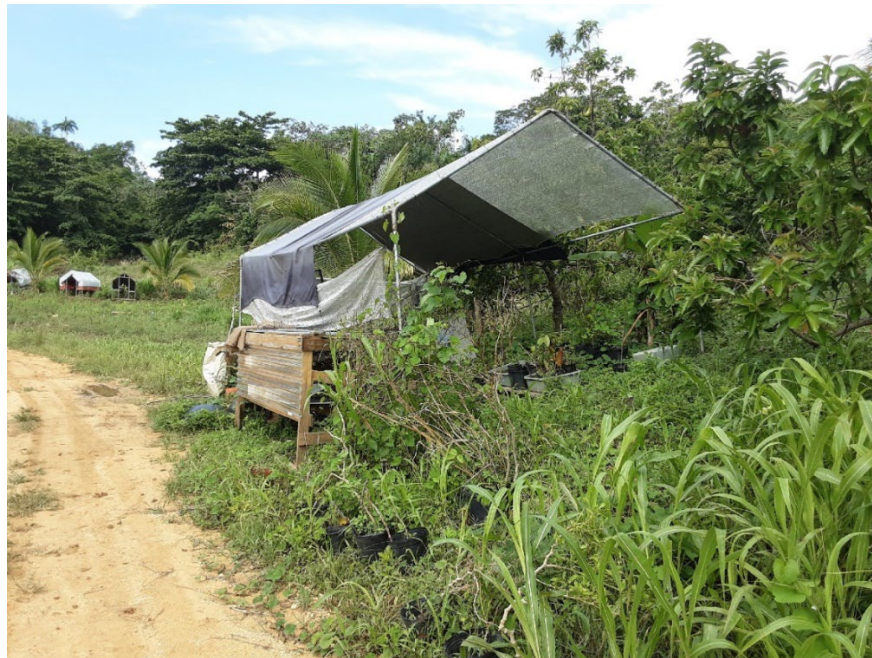
Photo #:  
04

Overview of the project location for a greenhouse nursery 20x8 ft on a wooden platform 2 ft deep, like a hardwood deck 20x8 ft. No tree clearing is needed to install it.

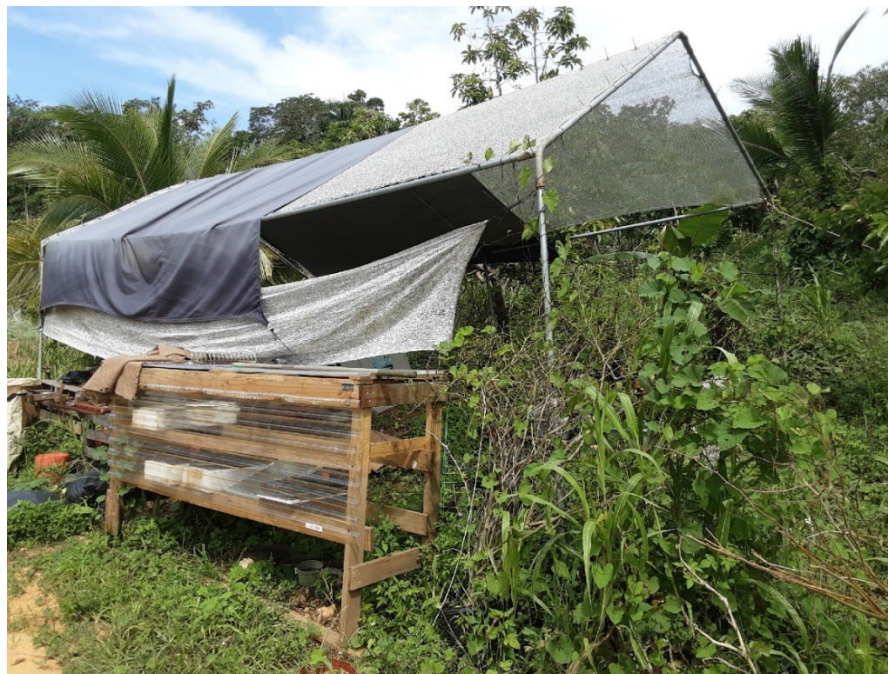
Overview of the project location for a greenhouse nursery 20x8 ft on a wooden platform 2 ft deep, like a hardwood deck 20x8 ft.

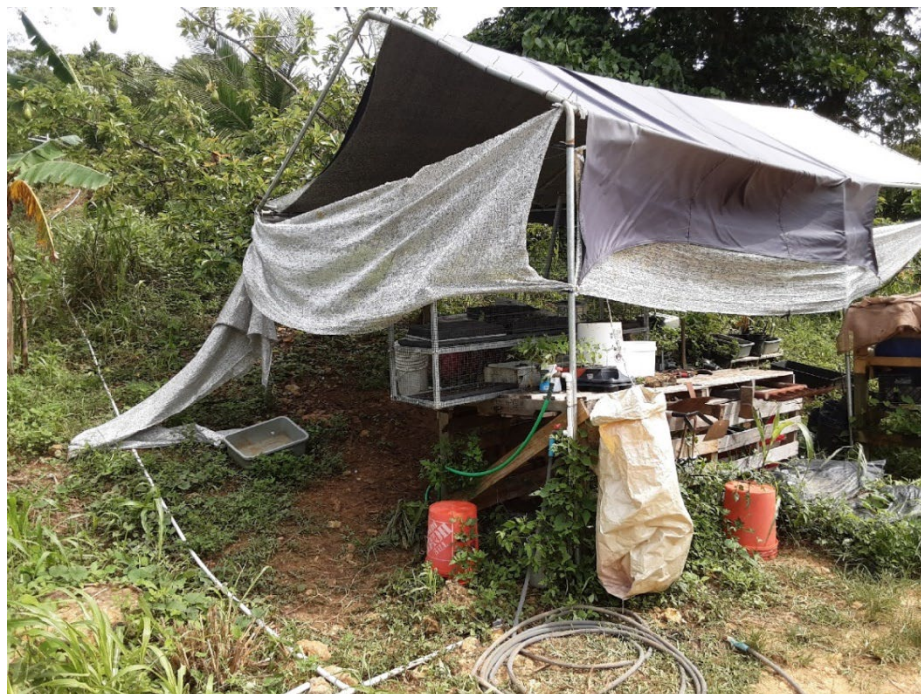
Overview of the project location for a greenhouse nursery 20x8 ft on a wooden platform 2 ft deep, like a hardwood deck 20x8 ft.

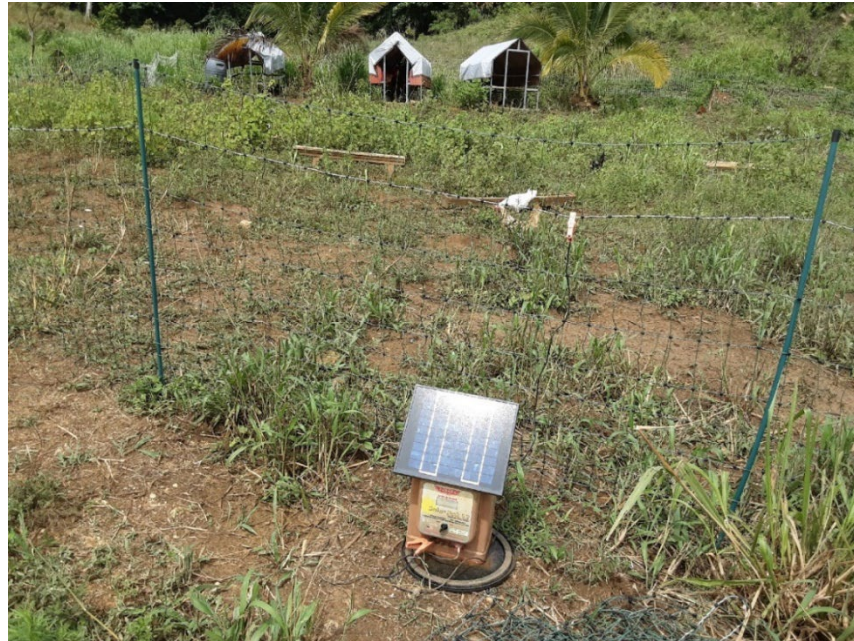
Overview of fence. According to the applicant, the applicant rotates them around the property to allow the soil and area pastured to rest.

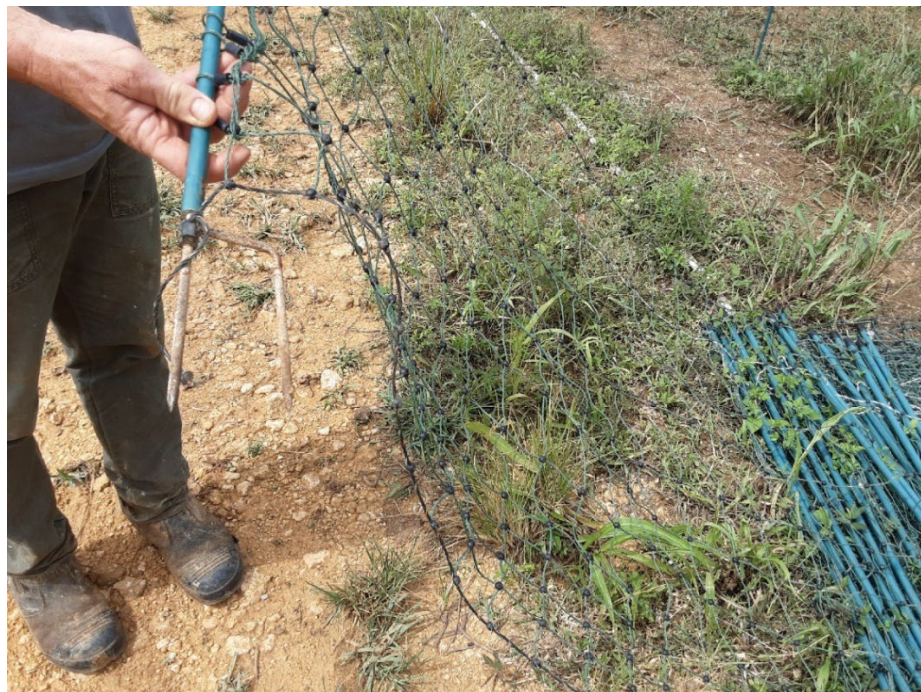
Photo #:

Close-up to the existing fence, the applicant is also requesting funds. The applicant explained the fence is easy to install and rotate, which will help the pastureland for the cattle.

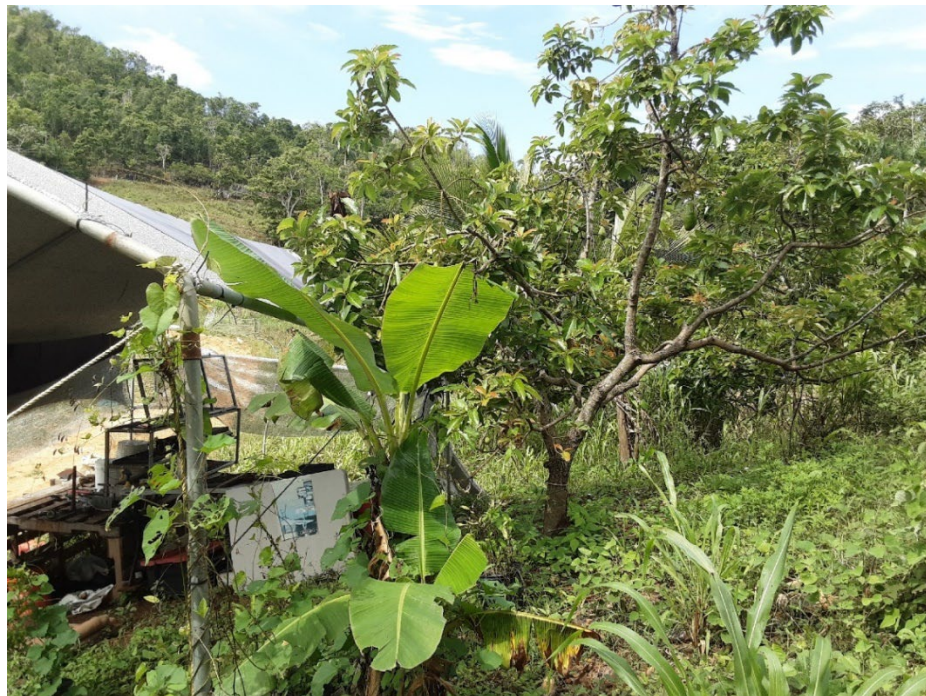
Overview of a tree and vegetation that needs to be trimmed but not removed, for the greenhouse nursery to be in place.

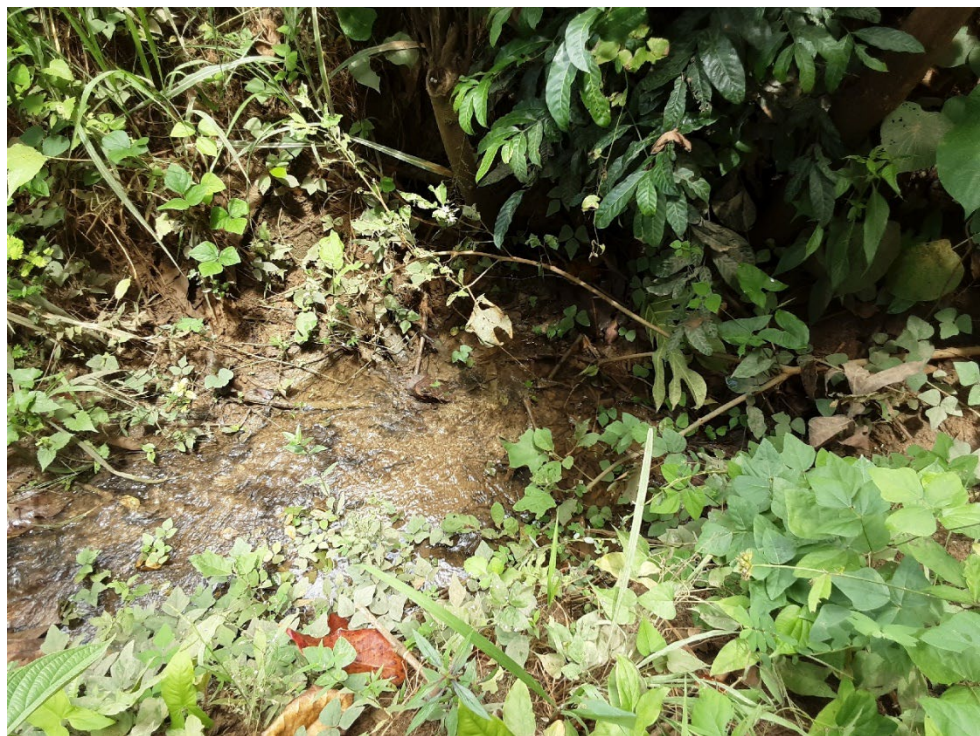
Photo #:

Overview of a natural sinkhole inside the property where a stream runs through. There is a cave on the adjacent property where the water is coming from.

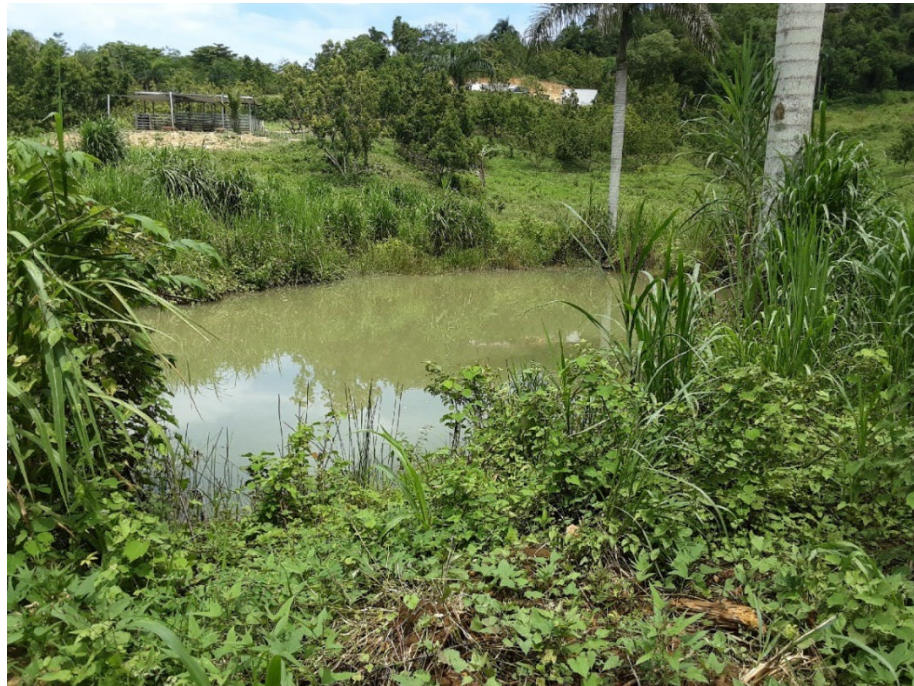
This picture shows the second pond on the applicant's property.

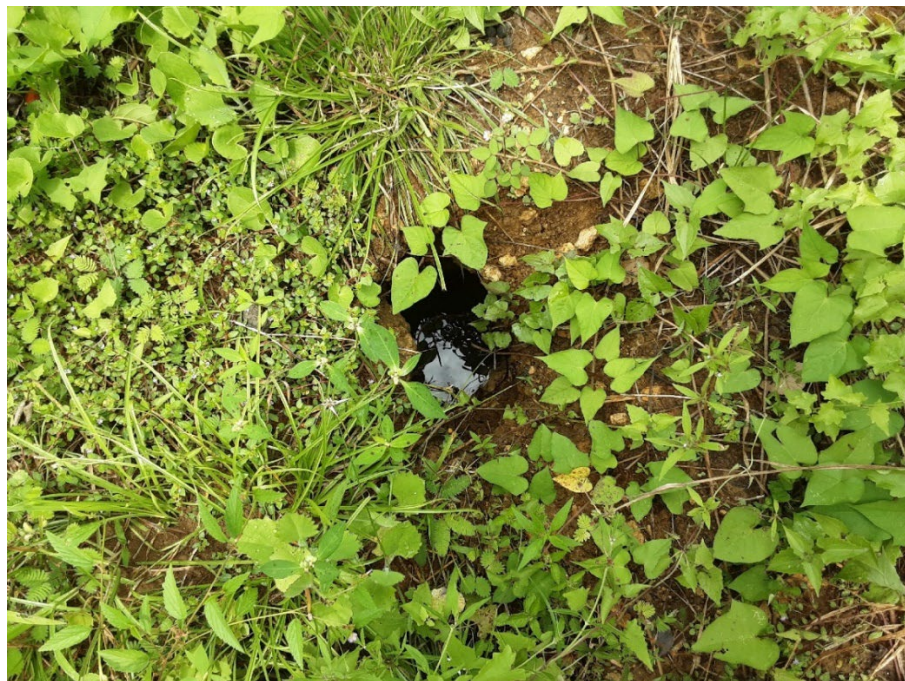
Overview of a natural sinkhole inside the property where a stream runs through. There is a cave on the adjacent property where the water is coming from.

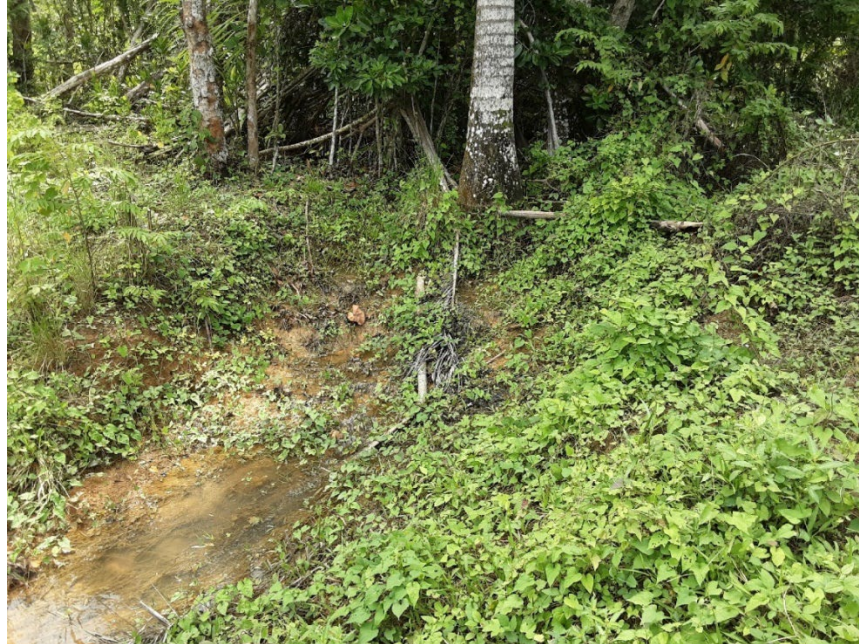
This picture shows spring water in the applicant's property that is probably connected to the cave on the adjacent property.

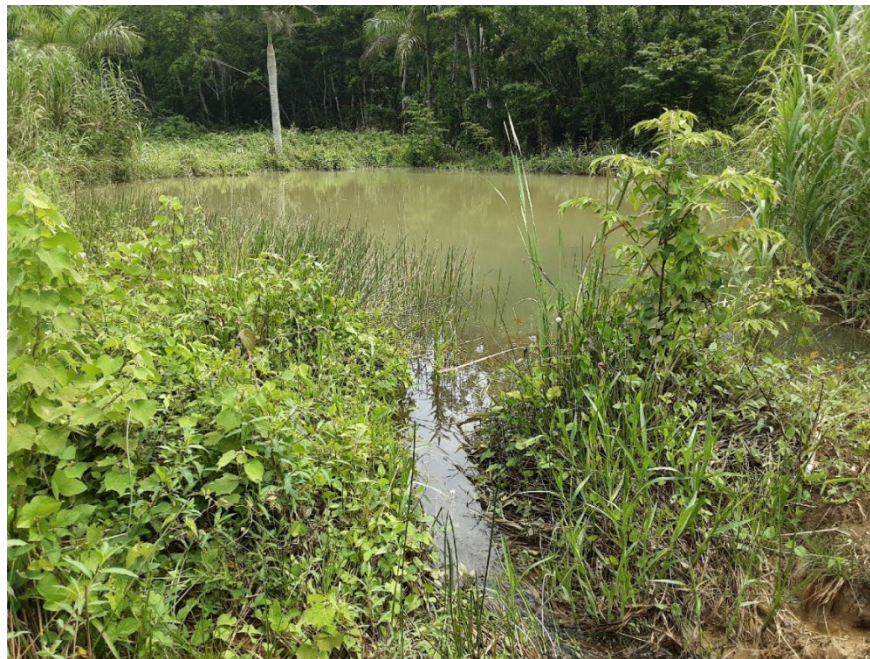
This picture shows the first pond on the applicant's property, probably connected to the cave on the adjacent property.

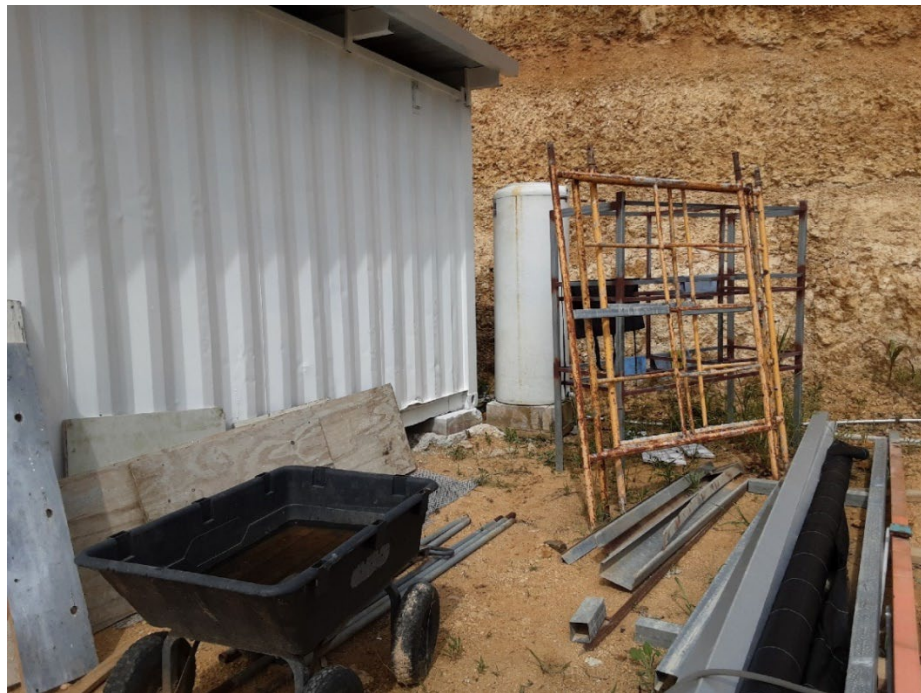
**Photo #:**  
16

**Description:**  
Overview of the warehouse where the solar panels will be installed on the roof. The batteries will be installed and secured inside the structure. There is also a gas tank.

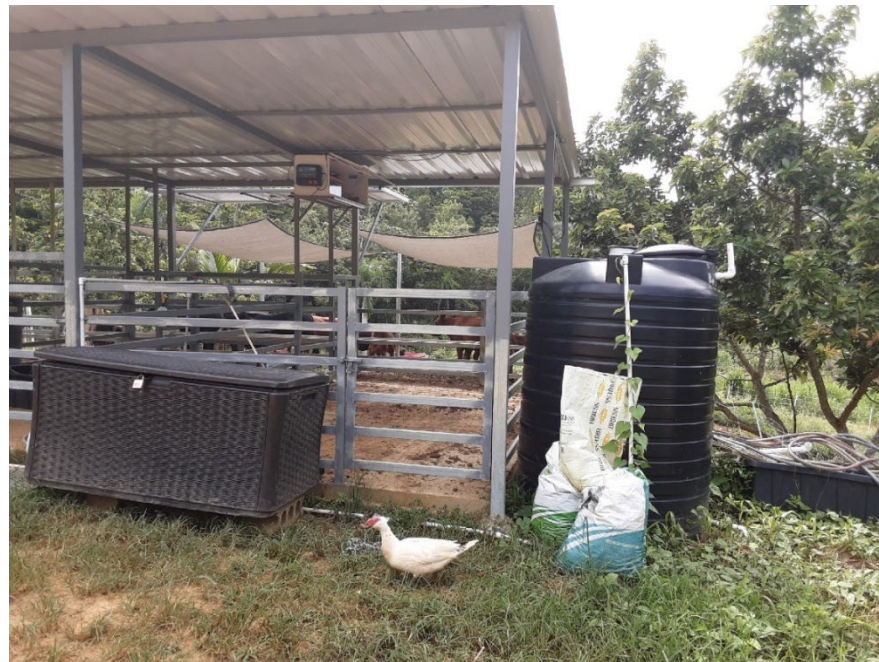
Overview of a 450-gallon cistern the applicant fills with potable water and rainwater.

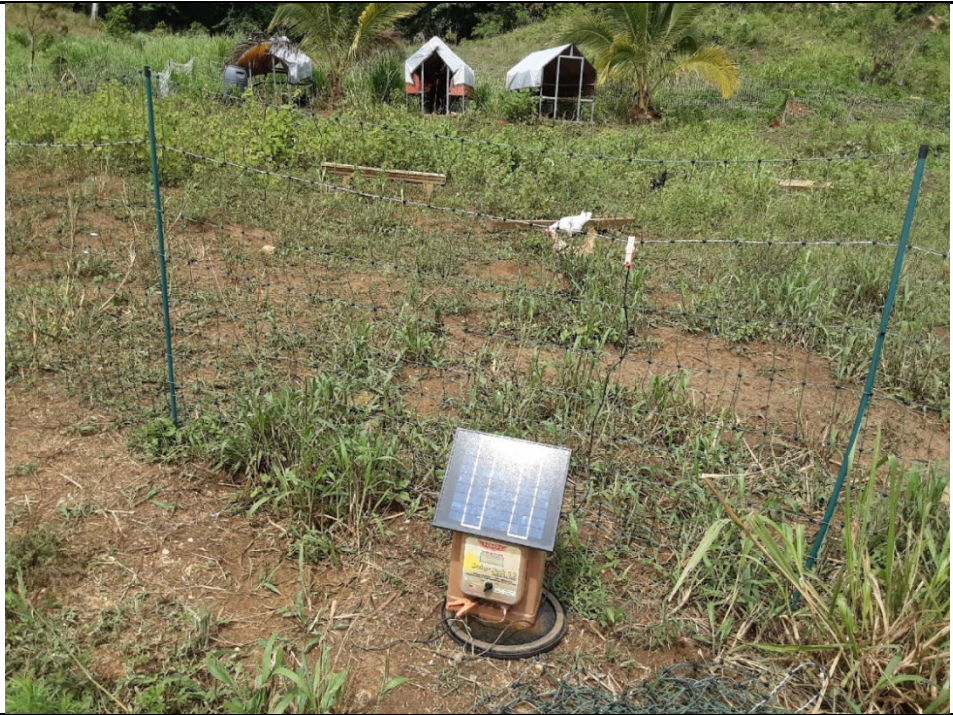
<b>Photo #:</b> 07	<b>Date:</b> 07/27/ 2024
<b>Photo Direction:</b> West, close-up	
<b>Description:</b> Overview of the location where the fence is. According to the applicant, the fences, old and the ones requested, can be rotated, and a solar battery electrifies them. The applicant rotates them around the property to allow the soil and area pastured to rest.

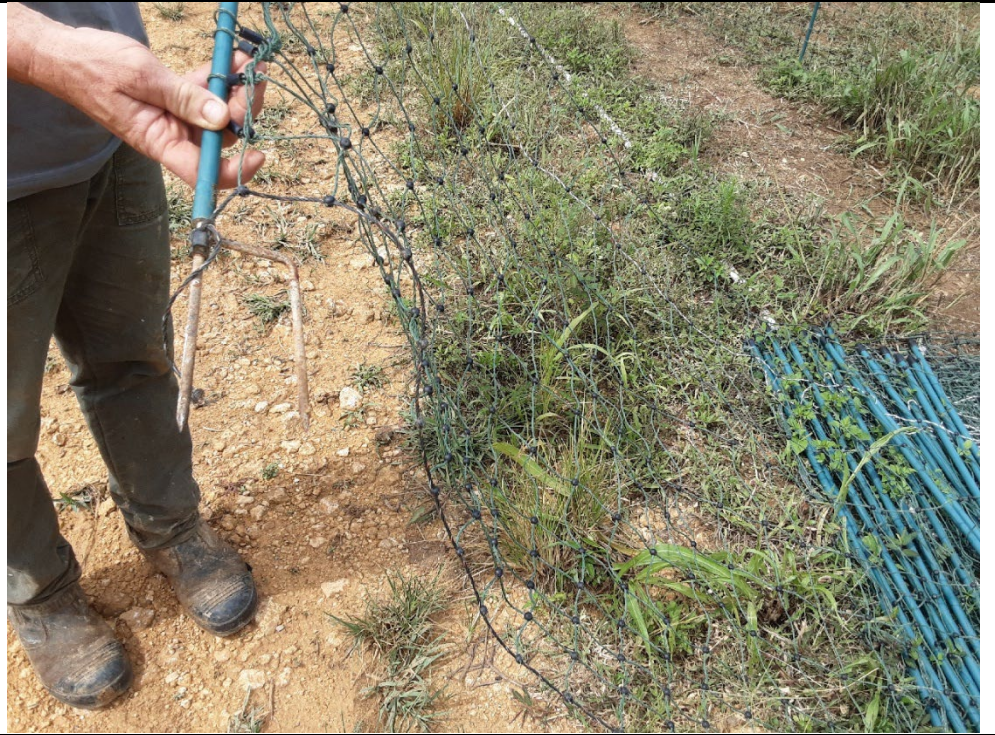
<b>Photo #:</b> 08	<b>Date:</b> 07/27/ 2024
<b>Photo Direction:</b> West, Close-up	
<b>Description:</b> Close-up to the existing fence, the applicant is also requesting funds. The applicant explained the fence is easy to install and rotate, which will help the pastureland for the cattle.

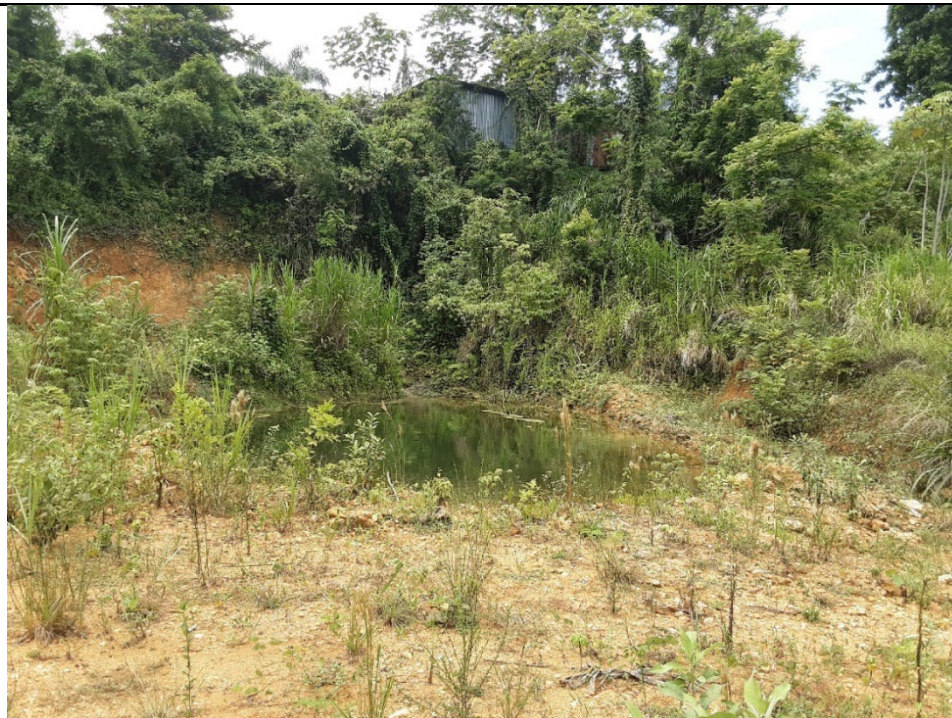
<b>Photo #:</b> 15	<b>Date:</b> 07/27/ 2024

<b>Photo Direction:</b> South		
<b>Description:</b> This picture shows the entrance of the cave on the adjacent property that is probably connected to the spring water ponds and natural sinkholes. The applicant mentioned the water might be getting contaminated by the junker south of the project location.

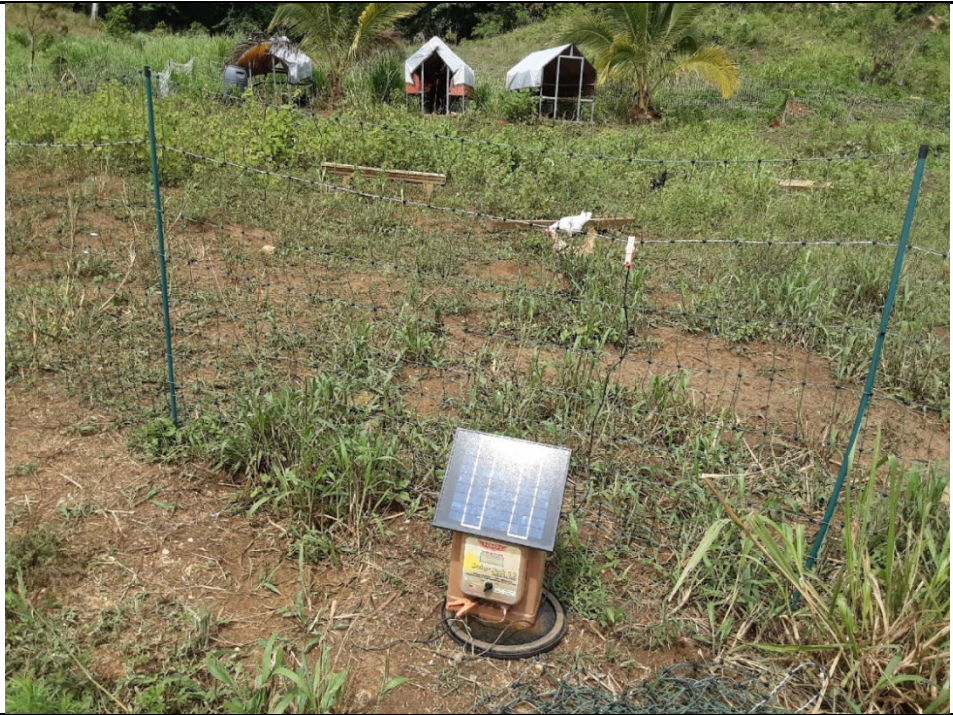
<b>Photo #:</b> 07	<b>Date:</b> 07/27/ 2024
<b>Photo Direction:</b> West, close-up	
<b>Description:</b> Overview of the location where the fence is. According to the applicant, the fences, old and the ones requested, can be rotated, and a solar battery electrifies them. The applicant rotates them around the property to allow the soil and area pastured to rest.

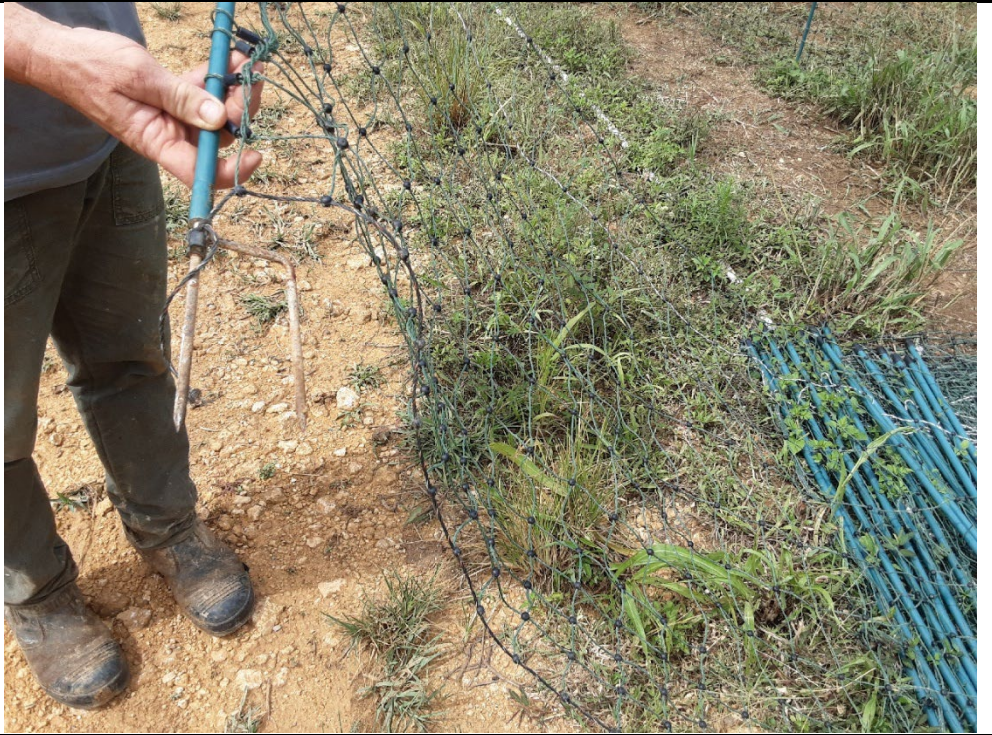
<b>Photo #:</b> 08	<b>Date:</b> 07/27/ 2024
<b>Photo Direction:</b> West, Close-up	
<b>Description:</b> Close-up to the existing fence, the applicant is also requesting funds. The applicant explained the fence is easy to install and rotate, which will help the pastureland for the cattle.
