Environmental Assessment Determinations and Compliance Findings for HUD-assisted Projects 24 CFR Part 58

Project ID: PR-RGRW-04095

Project Name: Finca la Buena Oportunidad LLC

The proposed activities for PR-RGRW-04095 consist of the installation and construction of a new 6" diameter (9" perforation) and 300 feet deep water well, a 25'x 106' greenhouse, a 20' trailer, a drip irrigation system and irrigation materials. It will be a new irrigation system that will supply water to the new greenhouse. The water to be used will come from existing cisterns and all the pipes will be above ground. No ground disturbance will be

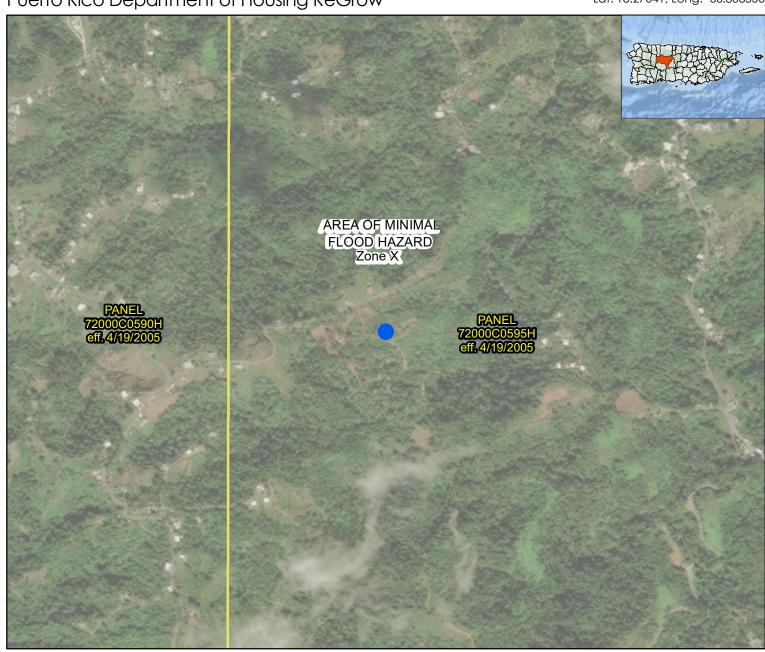
Flood Insurance Rate Map (FIRM) Puerto Rico Department of Housing ReGrow

Area of Minimal Flood Hazard Zone X

Floodplain Management Executive Order 11988, particularly section 2(a); 24 CFR Part 55	Yes No	The project is located in a Zone X, Panel 72000C0595H, 4/19/2005 (Figure 4). The site is not located in a Preliminary Firm or an Advisory Base Flood Elevation special flood hazard area. The project is in compliance with Executive Order 11988. See attached Flood Map (Figure 9).
Historic Preservation National Historic Preservation Act of 1966,	Yes No	The site was visited on October 4, 2023, by SOI-qualified archaeologist. Based on this definition and the nature and scope of the undertaking, the APE has been defined as the area potentially affected by ground-disturbing activities related to

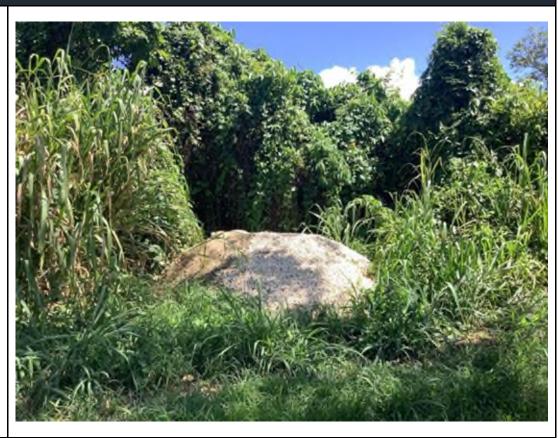
Photo Description: Main water well

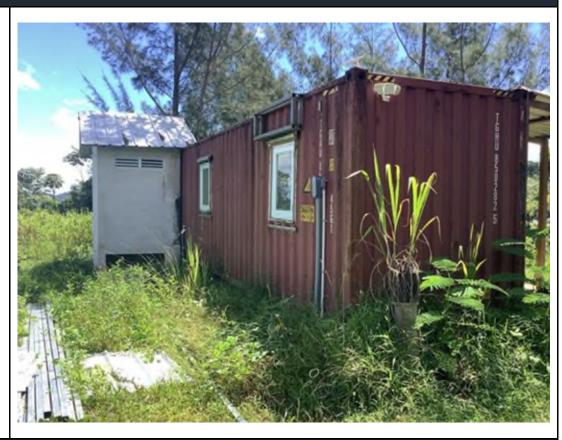
Architectural Details 20

Photo Description: 20ft trailer coodrinates: 18.276383, -66.808775
