Environmental Assessment

Determinations and Compliance Findings for HUD-assisted Projects

Project ID: PR-RGRW-04175

Project Name: Hacienda Cascada El Saltillo LLC

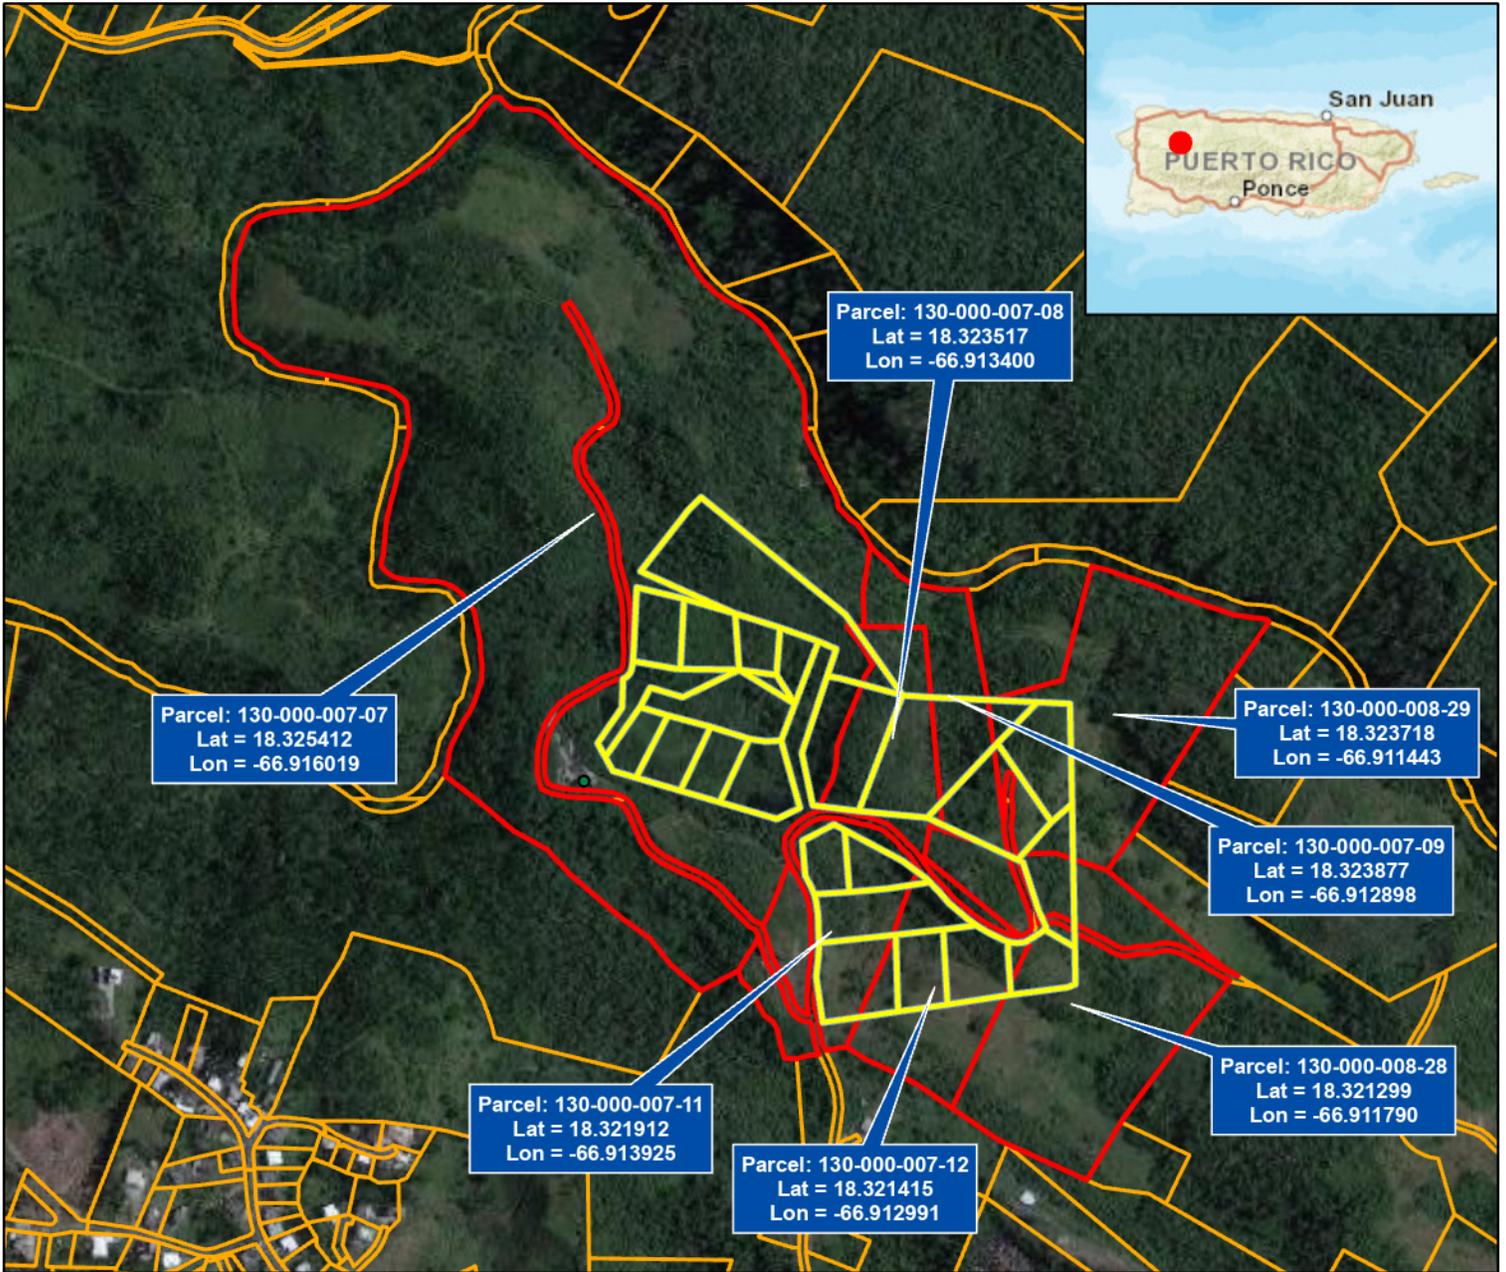
Figure 1
Location: Aerial Map
 Puerto Rico Department of Housing ReGrow

A site Map is included in Figure 1, illustrating the location of the new fence on the property. Photos of the location are included in Section 106 documentation, Appendix 1. Refer to Appendix 4 for Site Inspection Report.

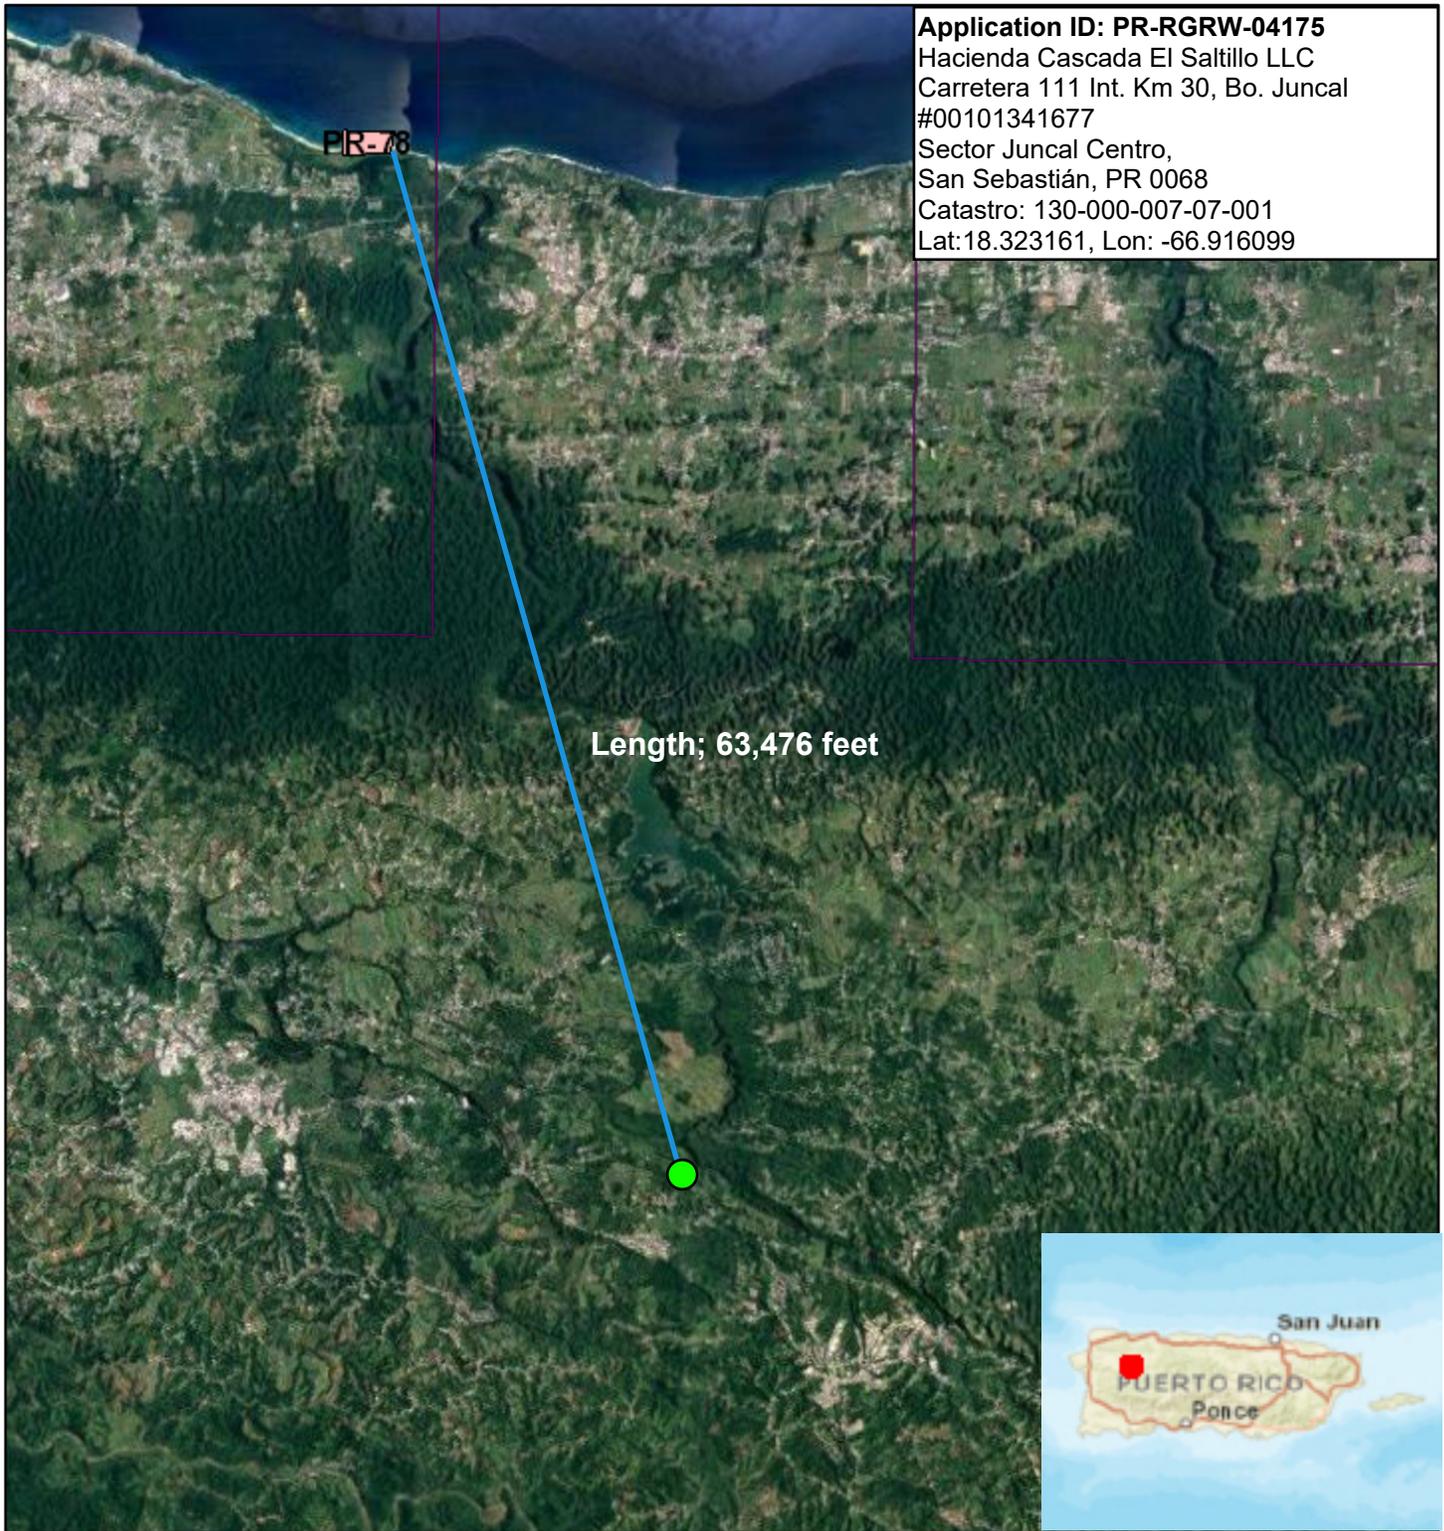
Figure 3 PR-RGRW-04175 CBRS

Compliance Factors: Statutes, Executive Orders, and Regulations listed at 24 CFR §58.5 and §58.6	Are formal compliance steps or mitigation required	Compliance determinations
STATUTES, EXECUTIVE ORDERS, AND REGULATIONS LISTED AT 24 CFR 58.6		
Airport Hazards 24 CFR Part 51 Subpart D	Yes No <input type="checkbox"/> <input checked="" type="checkbox"/>	This project is the installation of a new barbed wire fence and the purchase of plantain seeds and a tractor will have no impact on any Airports. The site is located 84,539 feet from the nearest major civil airport (Eugenio Maria de Hostos in Mayagüez) and 319,294 feet from the nearest military airport (Luis Muñoz Marín International Airport in San Juan). This topic is in compliance with the HUD's Airport Hazard regulations without further evaluation. See the attached Airport map Runway Protection Zone, Figure 2.
Coastal Barrier Resources Coastal Barrier Resources Act, as amended by the Coastal Barrier Improvement Act of 1990 [16 USC 3501]	Yes No <input type="checkbox"/> <input checked="" type="checkbox"/>	This project is not located in a CBRS Unit. The project is located 63,476 feet southeast of the nearest Coastal Barrier Resource System, PR-78. Therefore, this project has no potential to impact a CBRS Unit and is in compliance with the Coastal Barrier Resources Act. See the attached CBRS map, Figure 3.

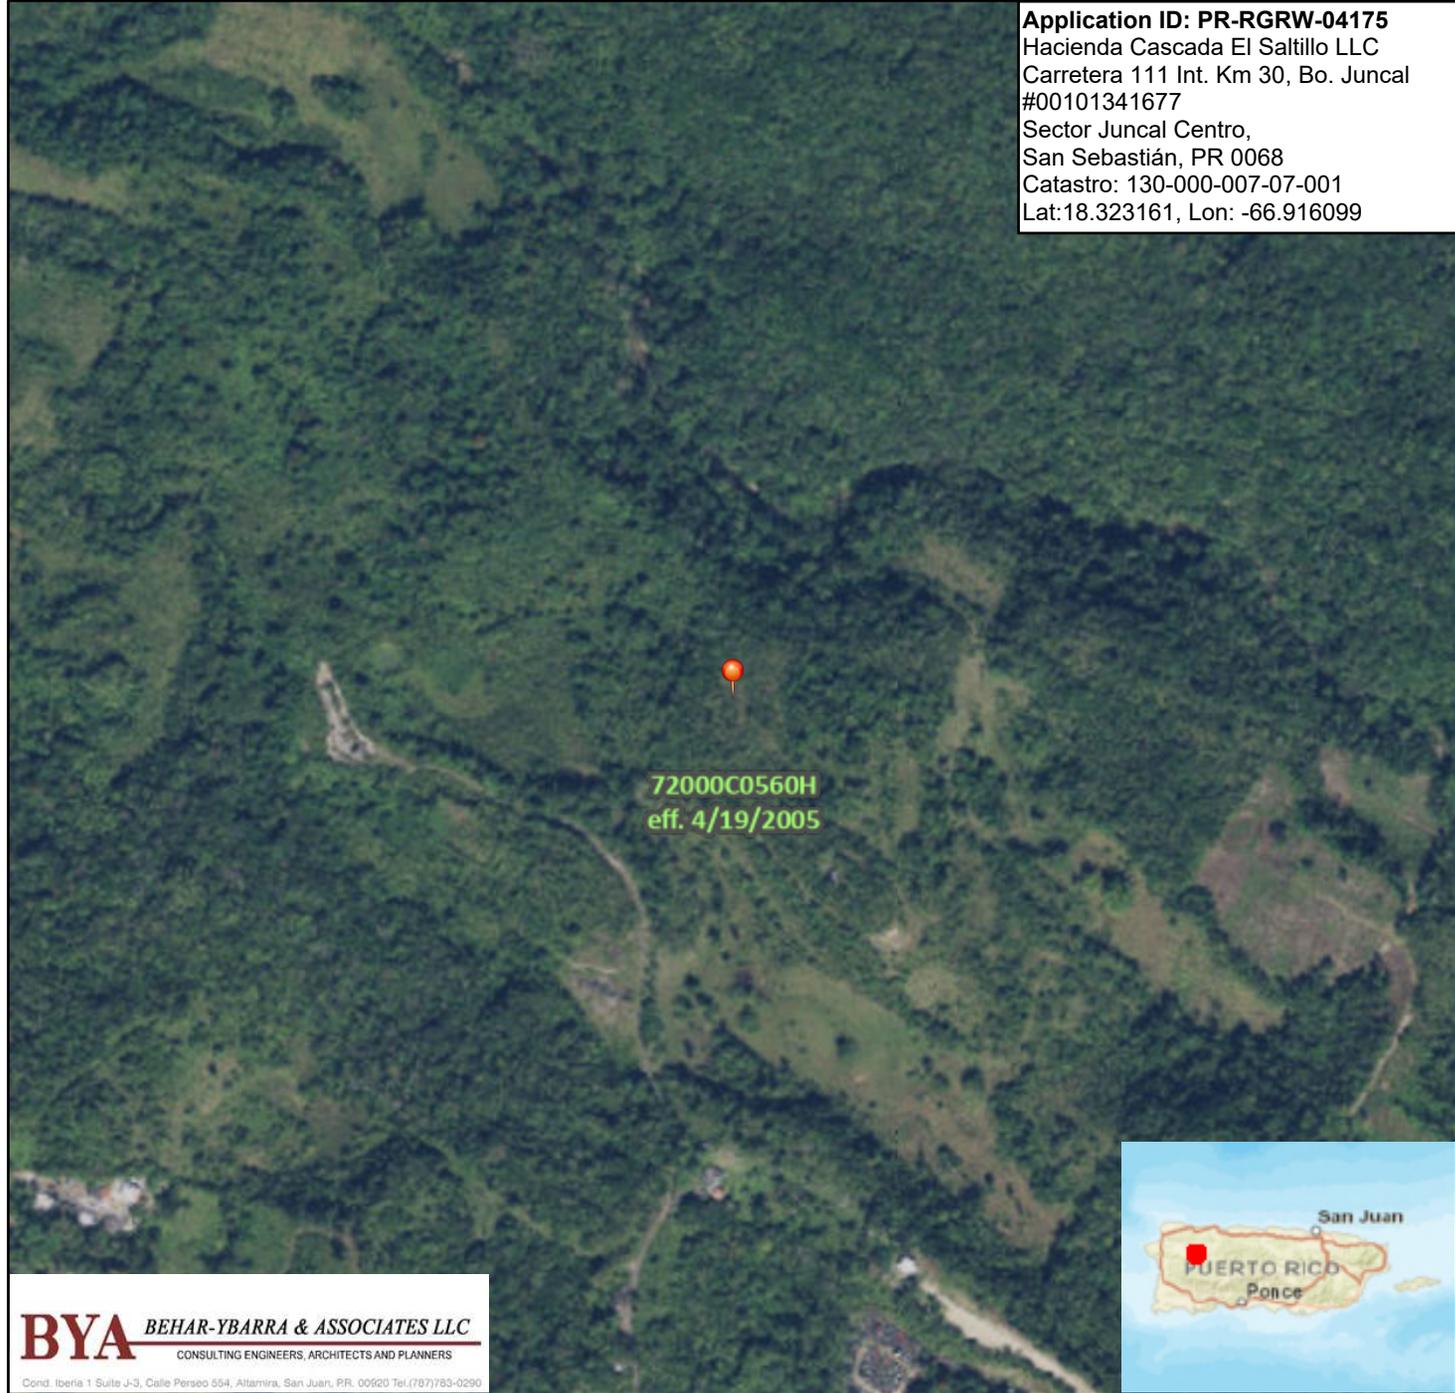
National Flood Hazard Layer FIRMette Figure 4

The flood hazard information is derived directly from the authoritative NFHL web services provided by FEMA. This map was exported on **10/16/2023 at 11:20 AM** and does not reflect changes or amendments subsequent to this date and time. The NFHL and effective information may change or become superseded by new data over time.

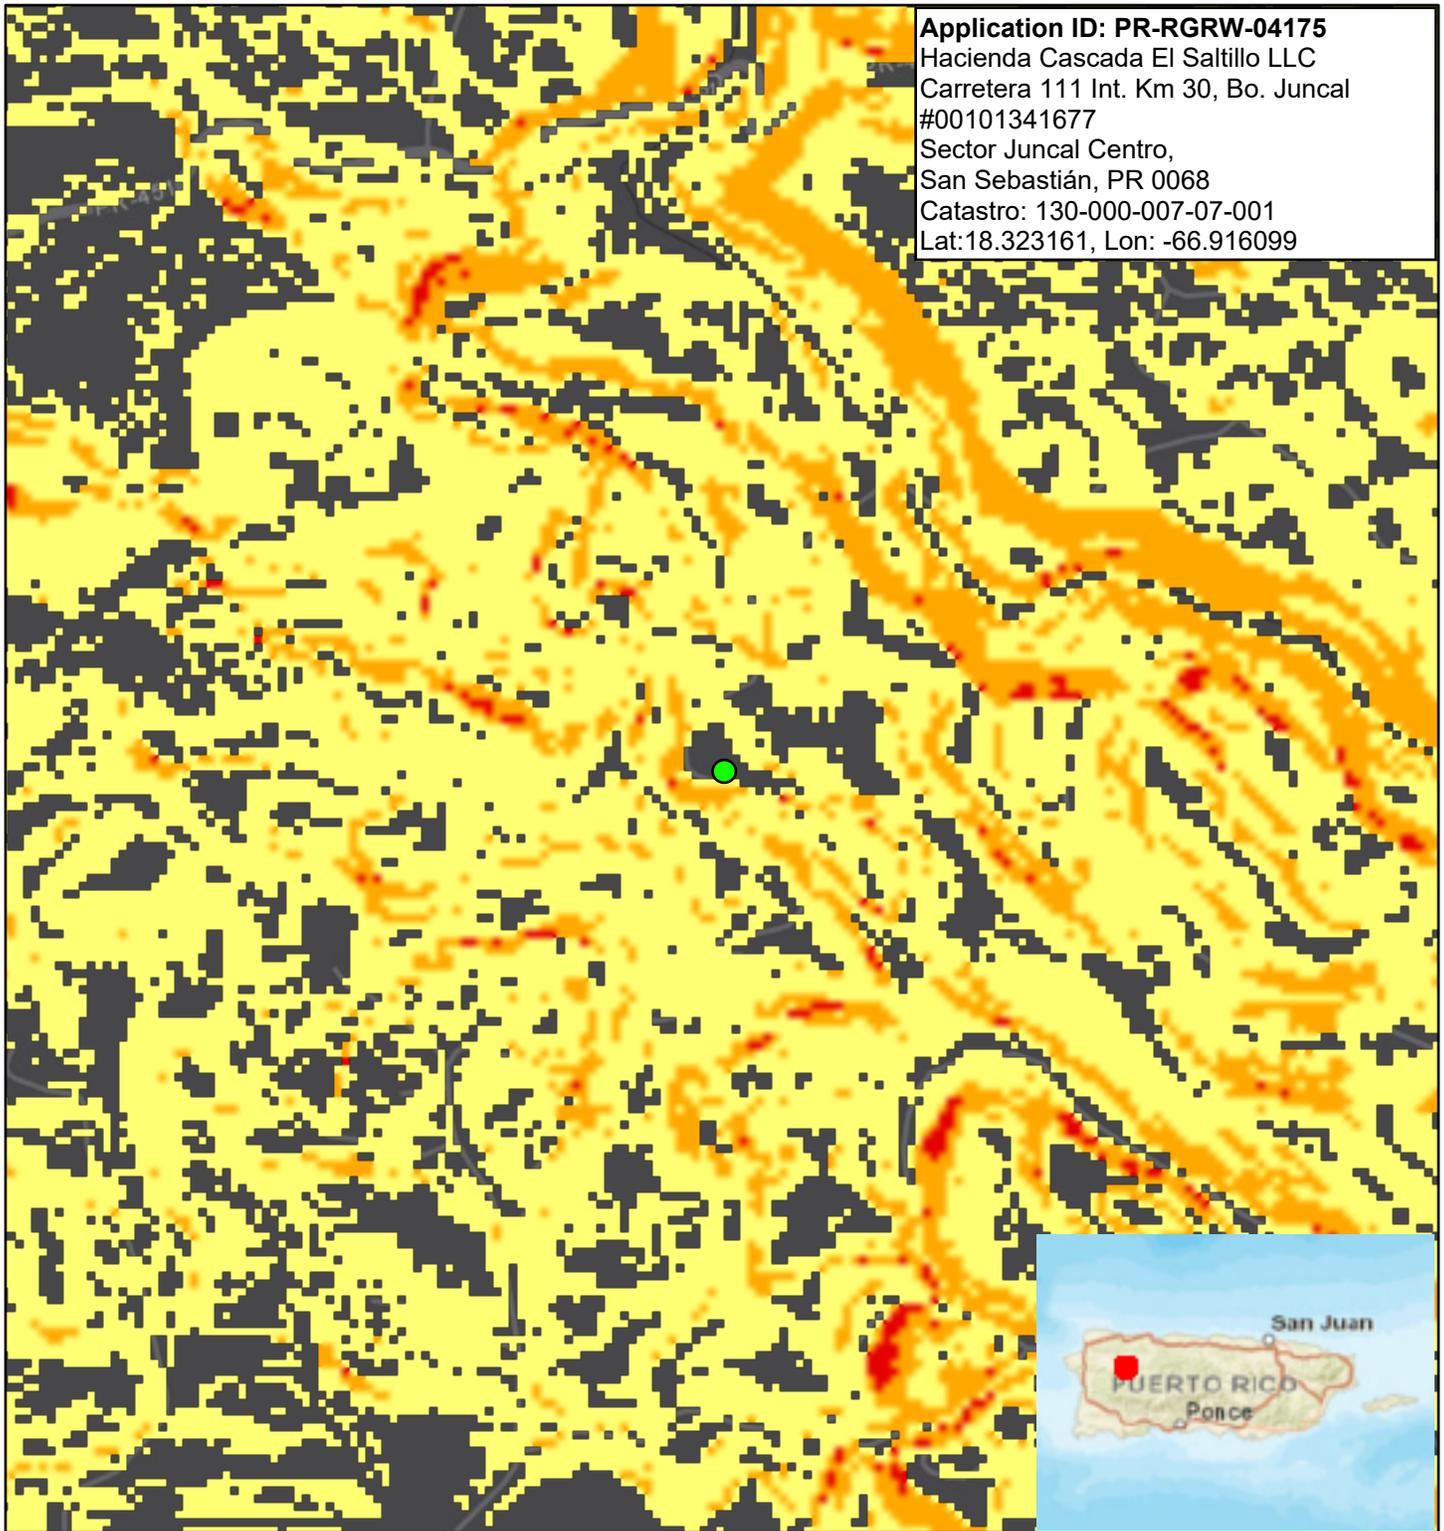
Figure 13

project. The project will not affect the drainage in the area. There will be little to no additional runoff associated with the project. See Landslide Susceptibility Map, Figure 13.
Hazards and Nuisances including Site Safety and Noise	2	There are no specific environmental hazards that have been identified for this site. The site is not in a high Noise Level area, nor will the project generate any additional noise. Additionally, the project does not include housing or such to where inhabitants would be affected.
Energy Consumption	2	The project consists of the installation of a new barbed wire fence and the purchase of plantain seeds and a tractor on an existing agricultural farm and will not require any expansion to existing power facilities.
Environmental Assessment Factor	Impact Code	Impact Evaluation

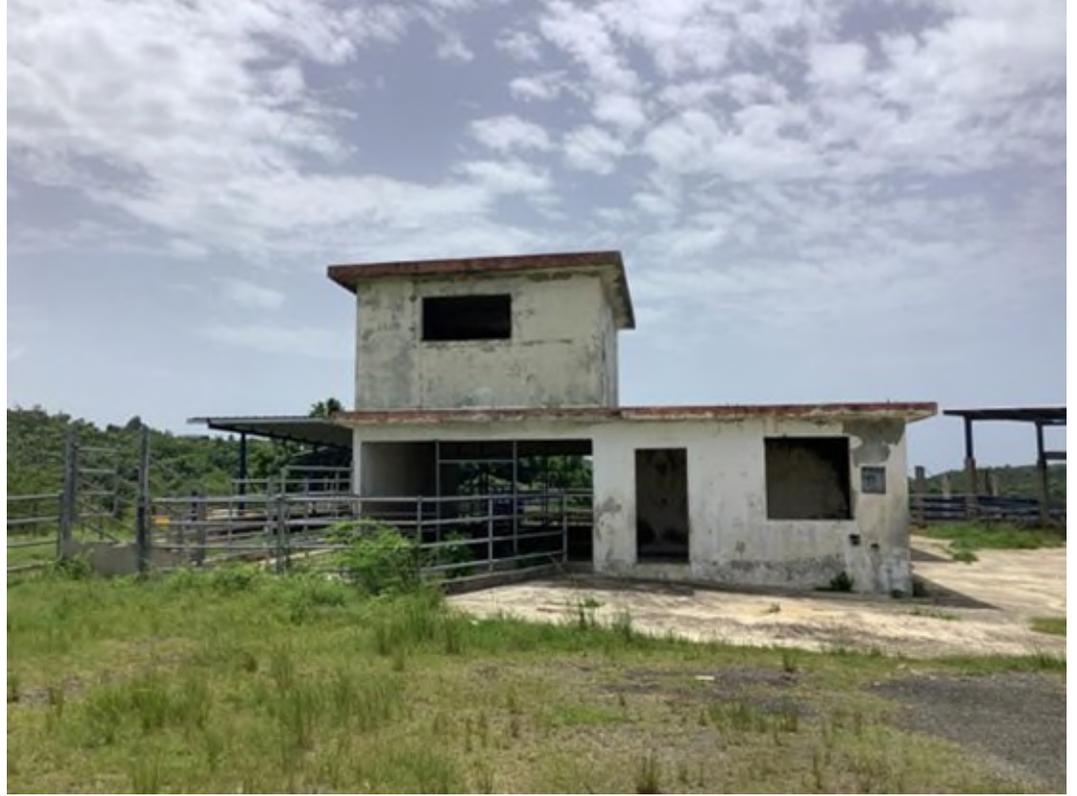
Architectural Details 2

Photo Description: Espeques

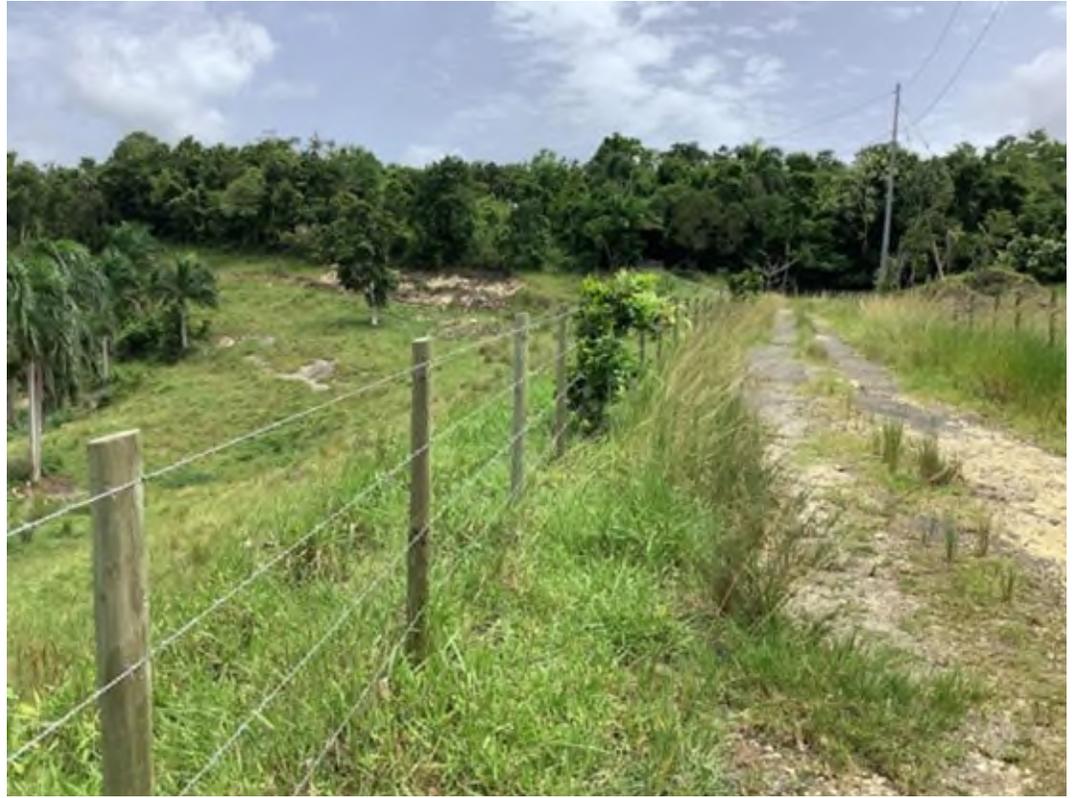
Architectural Details 14

Photo Description: Espeque Normal
2" ½ Depth: 6" to 8"

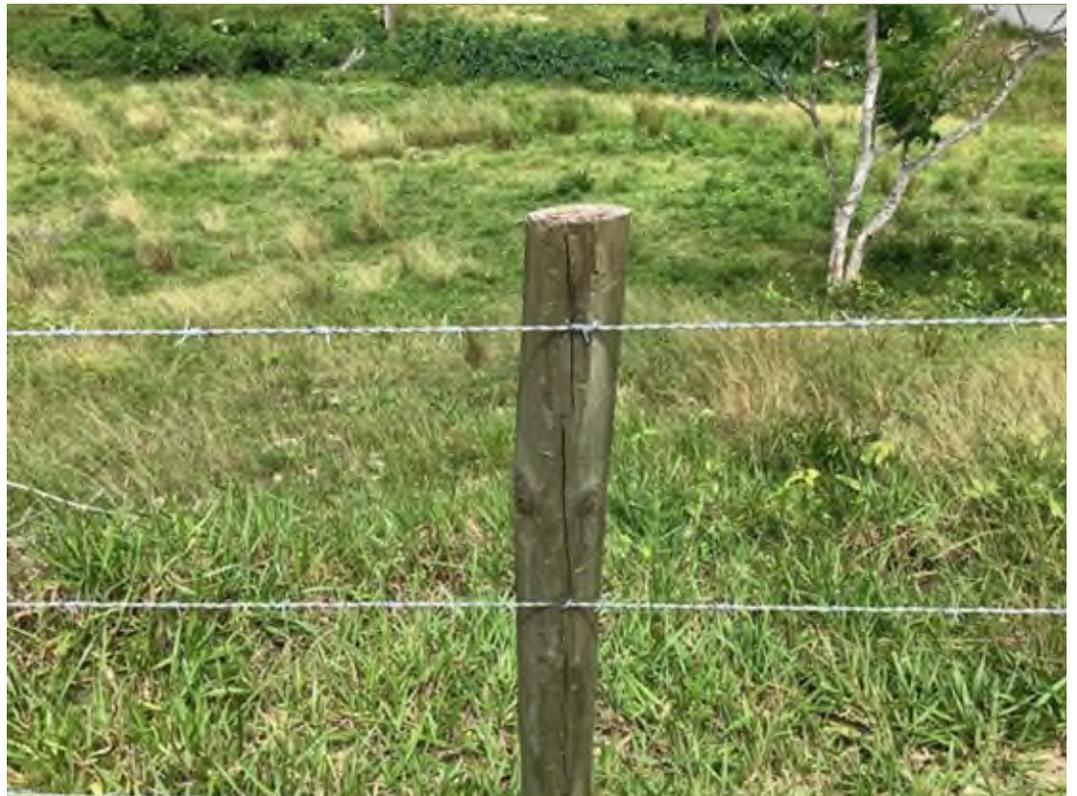
Architectural Details 15

Photo Description: Espeque Madrina
5" Depth: 12" to 18"

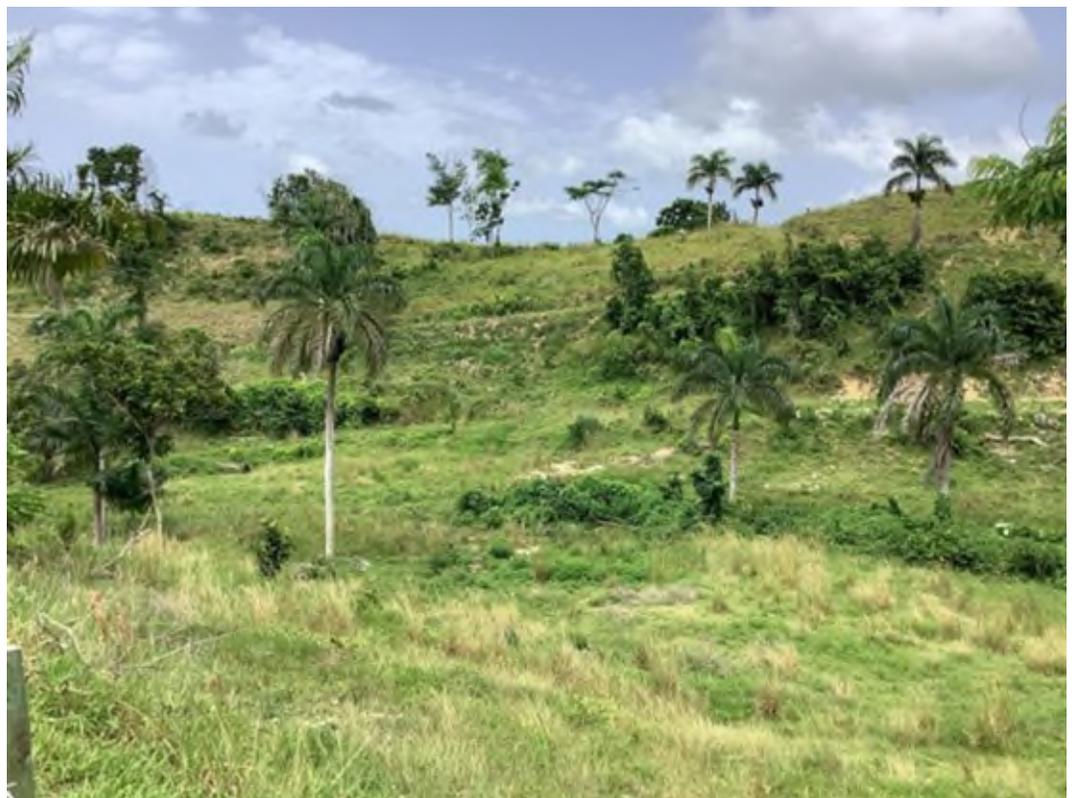
Architectural Details 19

Photo Description: Damaged fences
