Environmental Review for Activity/Project that is Categorically Excluded Subject to Section 58.5 Pursuant to 24 CFR 58.35(a)

Project Name: PR-RGRW-03822-W-RE

This project (PR-RGRW-03822-W-RE) entails the award of a grant to Hacienda Chile, an agricultural business, at Carretera 111 Bo. Caguana, Sector Jareales, Utuado, PR 00641. Tax ID Number: 160-000-009-23-000. Coordinates (18.283566, -66.772657). This project had an original CENST review which included the purchase of farm equipment including an UTV, loop handle, backpack blower, chain saw, pole pruner, pressure washer, evergreen organic, and 22" 7.25 B&S 163cc OHV RWD PP HW for project cost of \$24,201.44. See attached CENST environmental review. This review includes a scope item previously considered as an EA level of review (pulper and greenhouse) which is now evaluated as CEST level of review in accordance with FR-6492-N-01 with a project cost of \$25,661.73. The proposed project includes the purchase and installation of a new greenhouse and the purchase of a despulpadora (pulper). The new greenhouse is in the southeast area of the property. The greenhouse is approximately 1,200 square feet (ft) (48 ft by 30 ft) with a hei

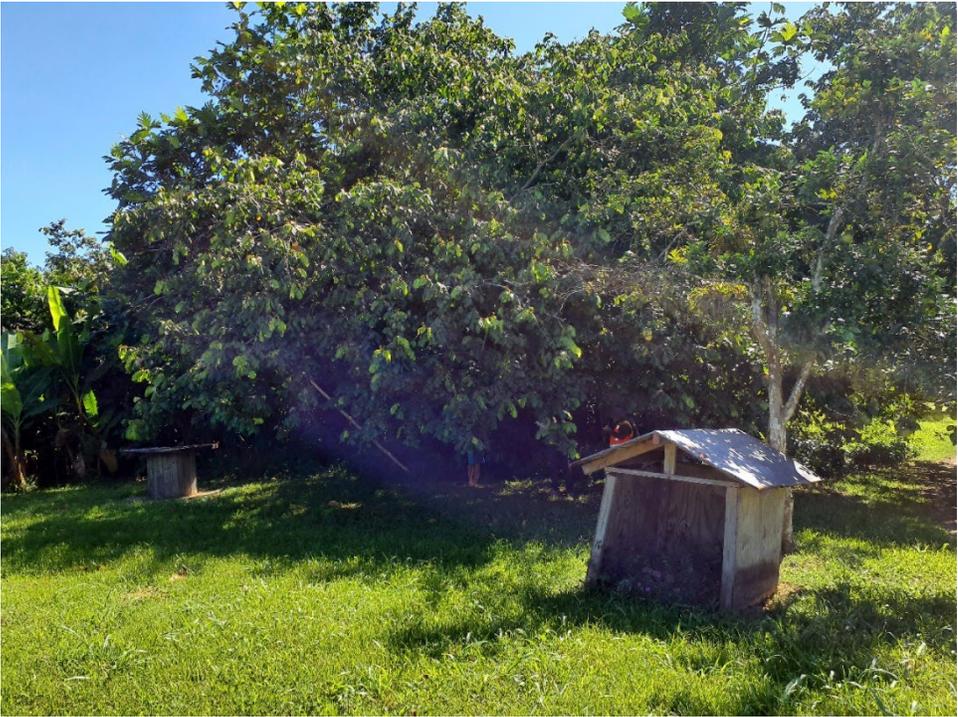
Photo #: 01	Date: 10/09/2 3	
Photo Direction: East

Description: This is an overview picture of the applicant's property and proposed project location for a 30x48ft greenhouse intended for drying coffee. This picture is facing east and depicts the layout of the land and various trees, including guava trees which applicant plans to clear. It also shows an old doghouse and spool which the applicant will be removing from the property.		
Photo #: 02	Date: 10/09/2 3	
Photo Direction: West

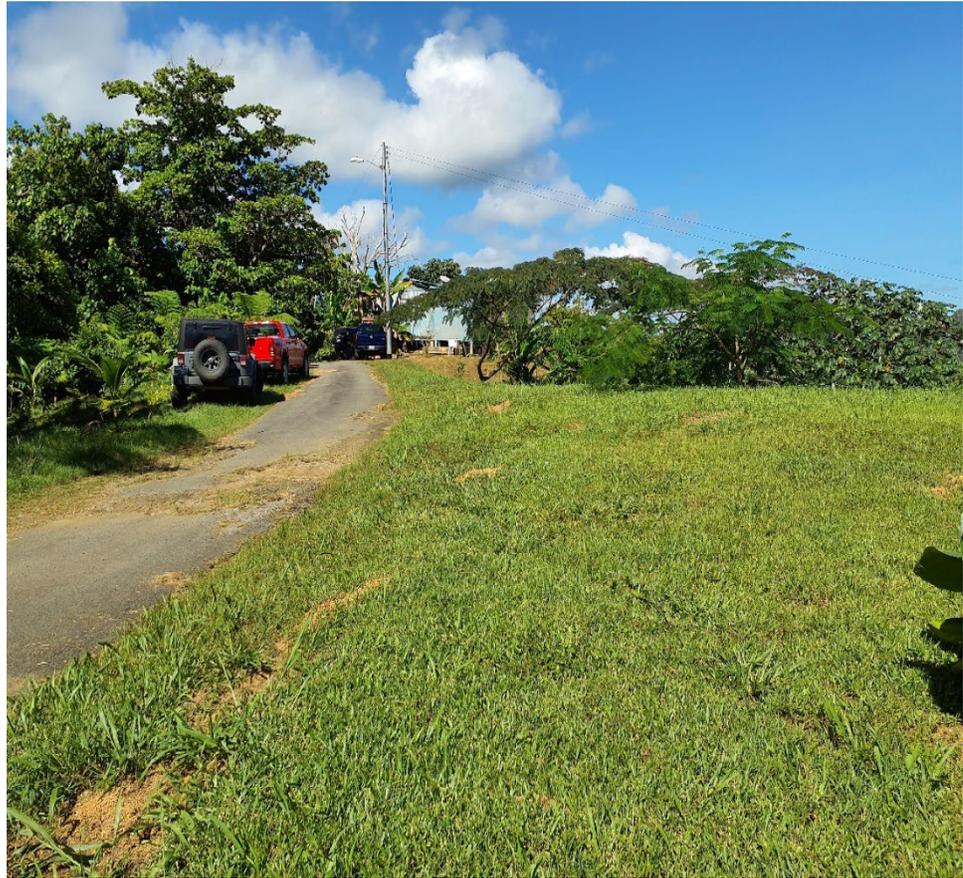
This is an overview picture of the applicant's property and proposed project location for a 30x48ft greenhouse intended for drying coffee. The picture is facing west and shows a light post and power lines (not being used for the project), as well as the layout of the land and various trees. SWCA staff and applicant's vehicles are also visible in this picture. A pre-existing structure (old house damaged by Hurricane Maria) is slightly visible in the background.

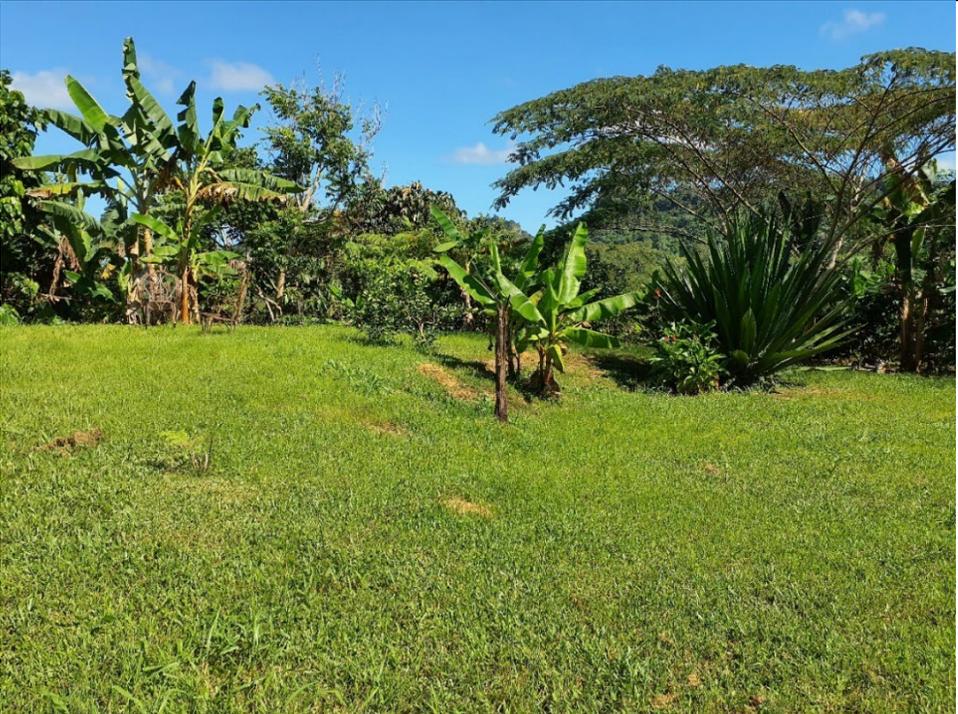
Photo #: 03	Date: 10/09/23

Photo Direction: North		
Description: This is an overview picture of the applicant's property and proposed project location for a 30x48ft greenhouse intended for drying coffee. This picture is facing north and shows the layout of the land and various trees on the property.		
Photo #: 04	Date: 10/09/23

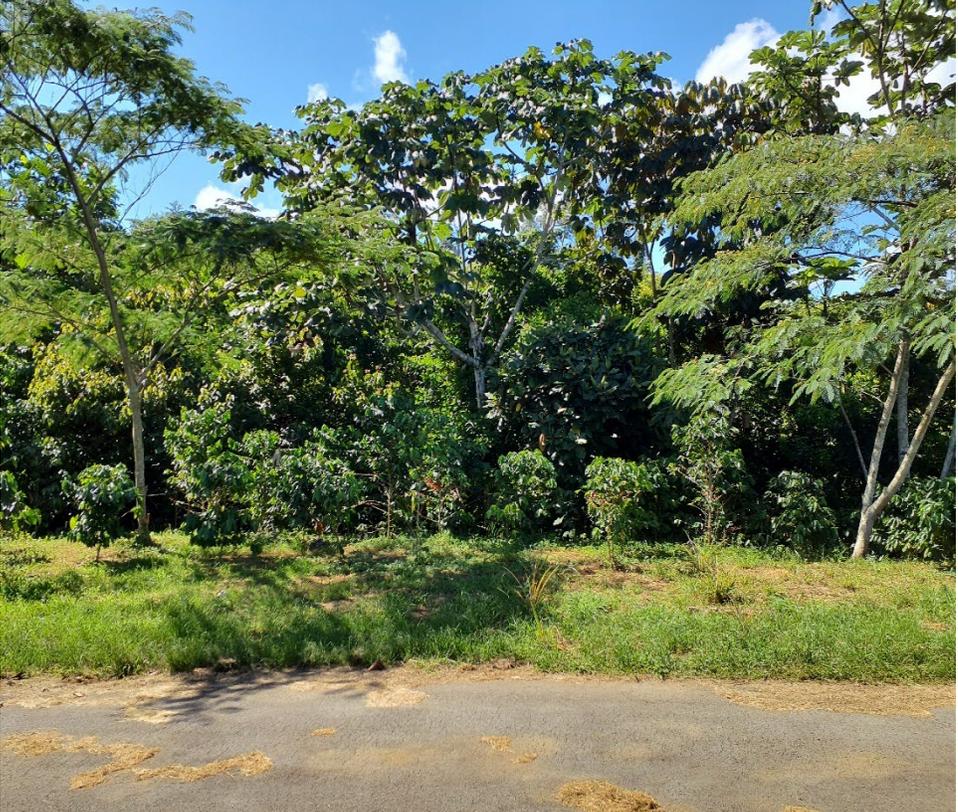
Photo Direction: South		
Description: This is an overview picture of the applicant's property and proposed project location for a 30x48ft greenhouse intended for drying coffee. This picture faces north and shows the layout of the land, various trees, and the community road adjacent to the proposed project location.

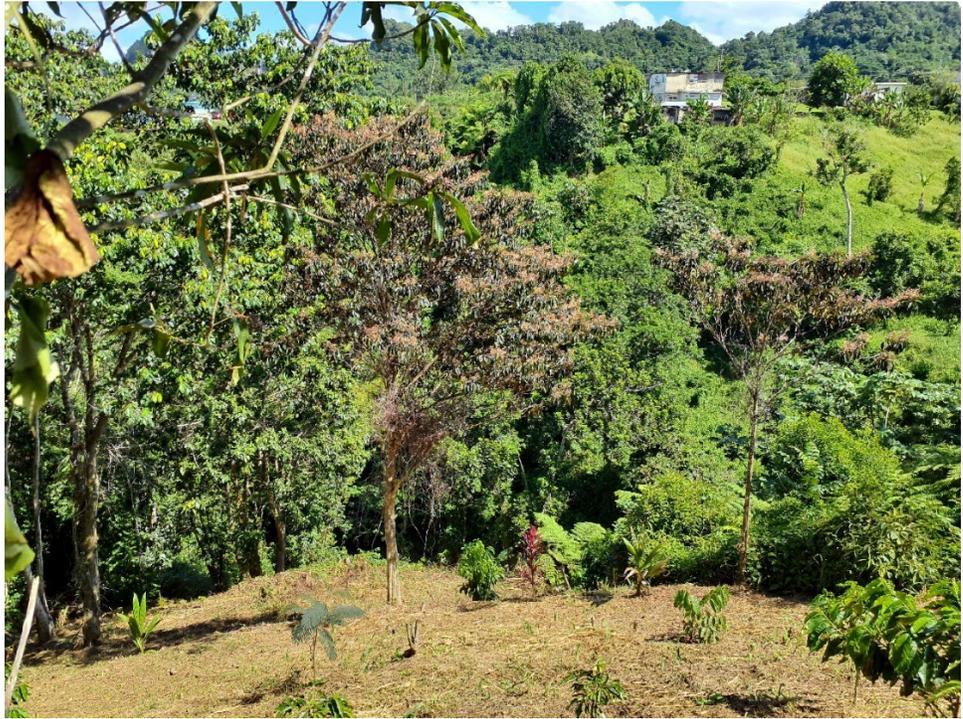
Photo #: 05	Date: 10/09/23
Photo Direction: North, Northeast	
Description: This picture is facing north northeast and depicts the view toward a nearby creek (Río Tanamá). The property is upland from the creek and the creek is not visible from the project location. This picture also shows the properties with potential direct line of sight to proposed greenhouse location.

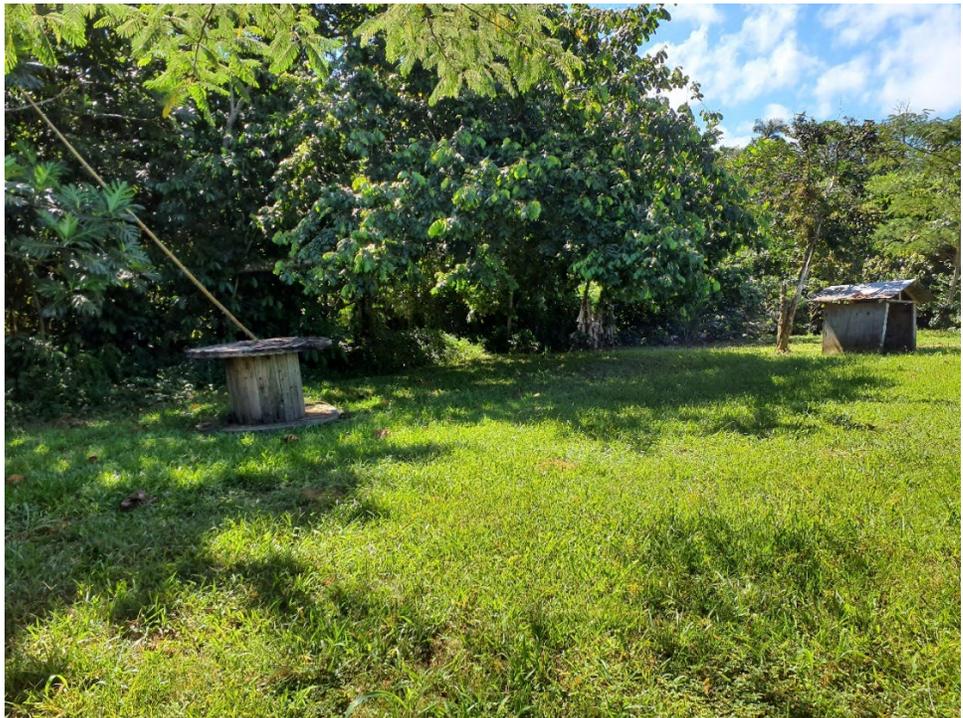
Photo #: 06	Date: 10/09/23
Photo Direction: Southeast	
Description: This picture faces southeast from the northwest corner of the proposed project location for a 30x48ft greenhouse intended for drying coffee. It depicts the layout of the land and various trees, including guava trees that applicant will be clearing. A spool and a doghouse which the applicant intends to remove are also visible in this picture.

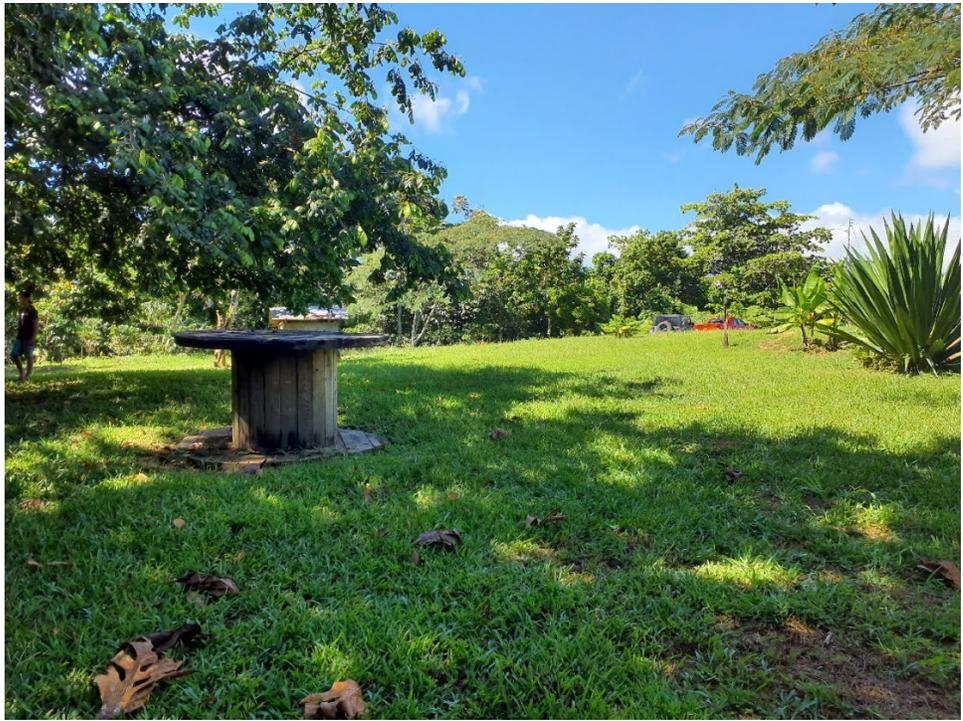
Photo #: 07	Date: 10/09/23
Photo Direction: South, Southwest	
Description: This picture faces south southwest from the northeast corner of the proposed project location for a 30x48ft greenhouse intended for drying coffee. It depicts the layout of the land, vegetation, and an old spool which the applicant intends to remove. SWCA staff vehicles are also visible in the background.

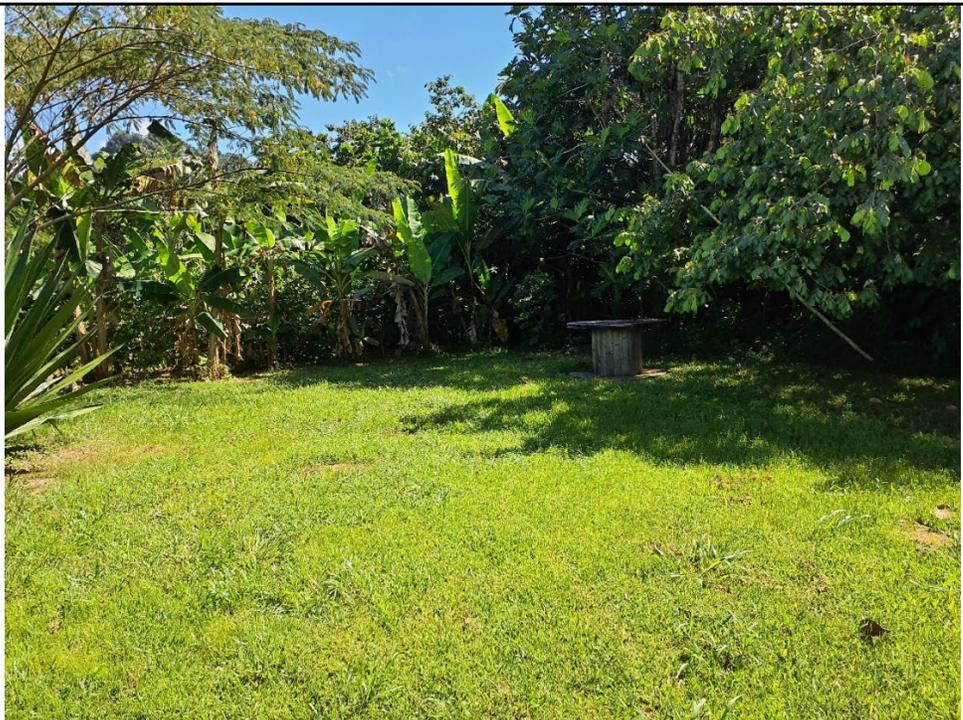
Photo #: 08	Date: 10/09/23
Photo Direction: Northeast	
Description: This picture faces northeast from the southwest corner of the proposed project location for a 30x48ft greenhouse intended for drying coffee. It depicts the layout of the land, various trees, and an old spool which the applicant intends to remove.

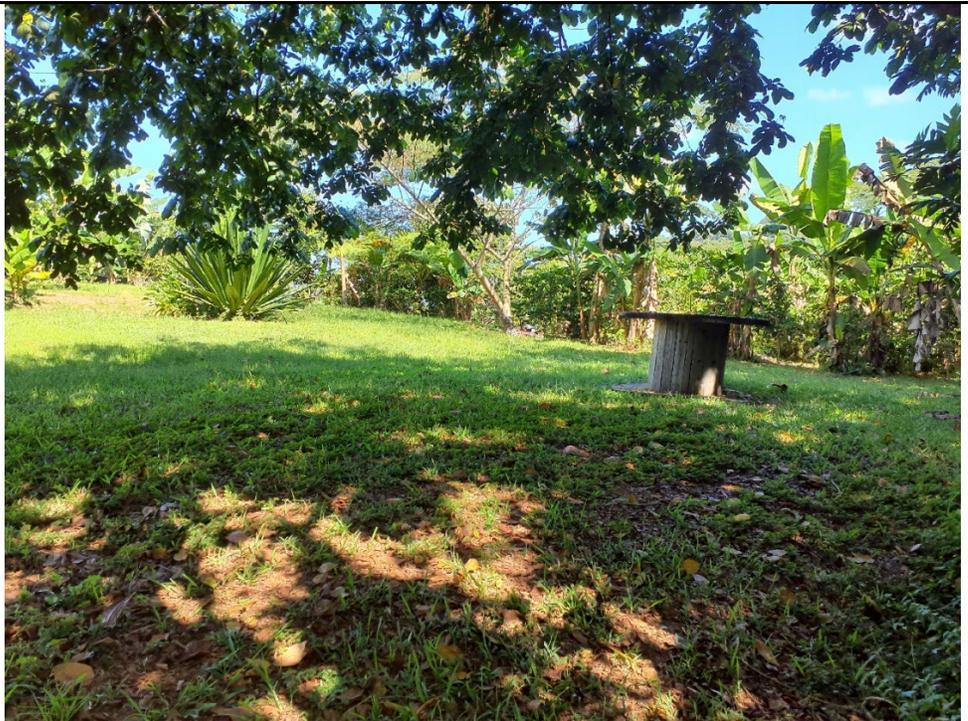
Photo #: 09	Date: 10/09/23
Photo Direction: North, northwest	
Description: This picture faces north northwest from the southeast corner of the proposed project location for a 30x48ft greenhouse intended for drying coffee. It depicts the layout of the land, various trees and other vegetation, and an old spool which the applicant intends to remove.

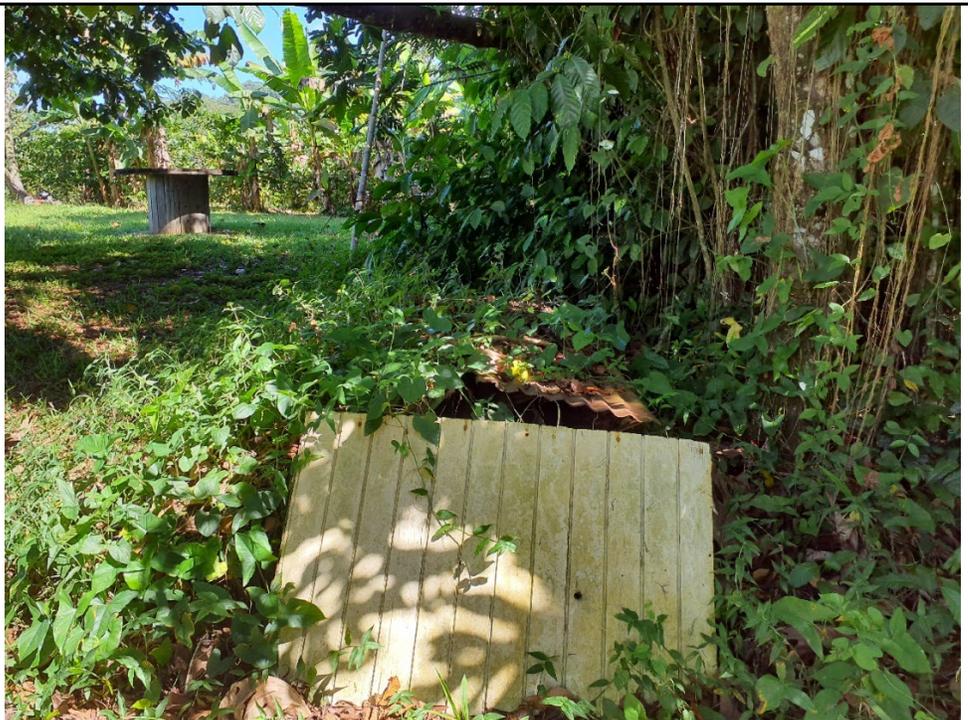
Photo #: 10	Date: 10/09/23
Photo Direction: Northeast/Close-up	
Description: This picture is a close-up (facing northeast) of construction materials and debris left behind by Hurrican Maria (zinc and wooden panels) which applicant intends to remove from property.

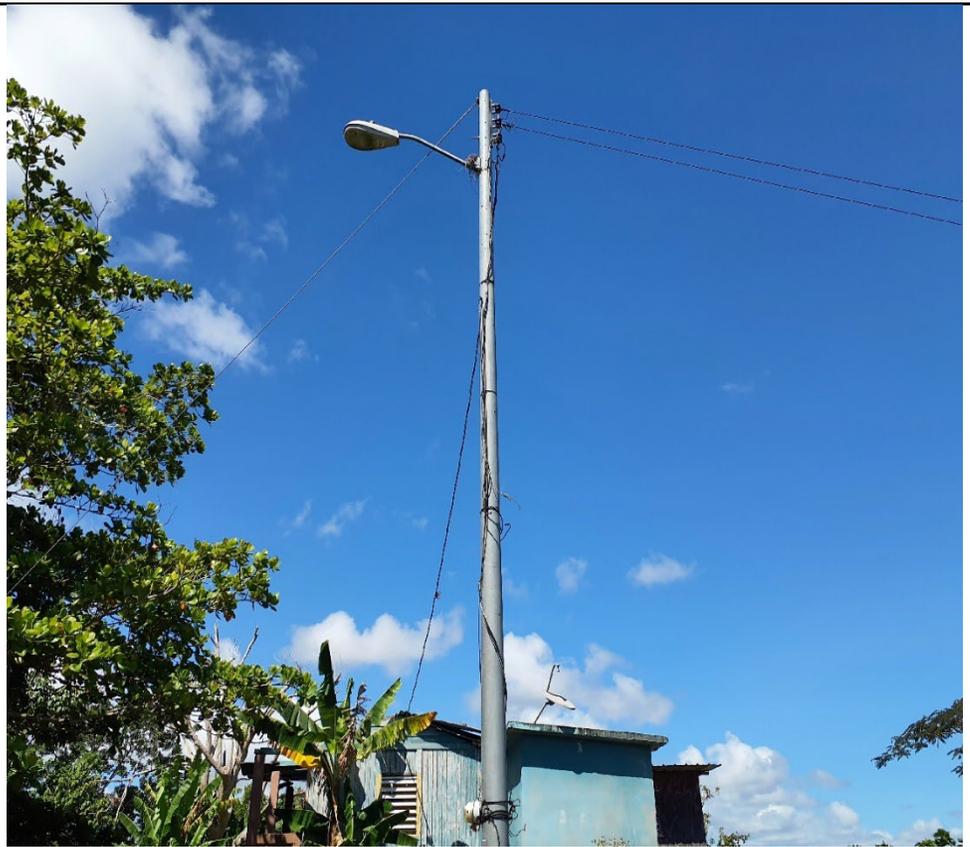
Photo #: 11	Date: 10/09/23
Photo Direction: West	
Description: This picture faces west and depicts a partially dilapidated bird nest (possibly a Gray Kingbird nest) on a light post (light post not in service). The nest does not appear to be currently in use. A pre-existing structure (house that was severely damaged by Hurricane Maria), as well as various trees, are also visible in this picture.

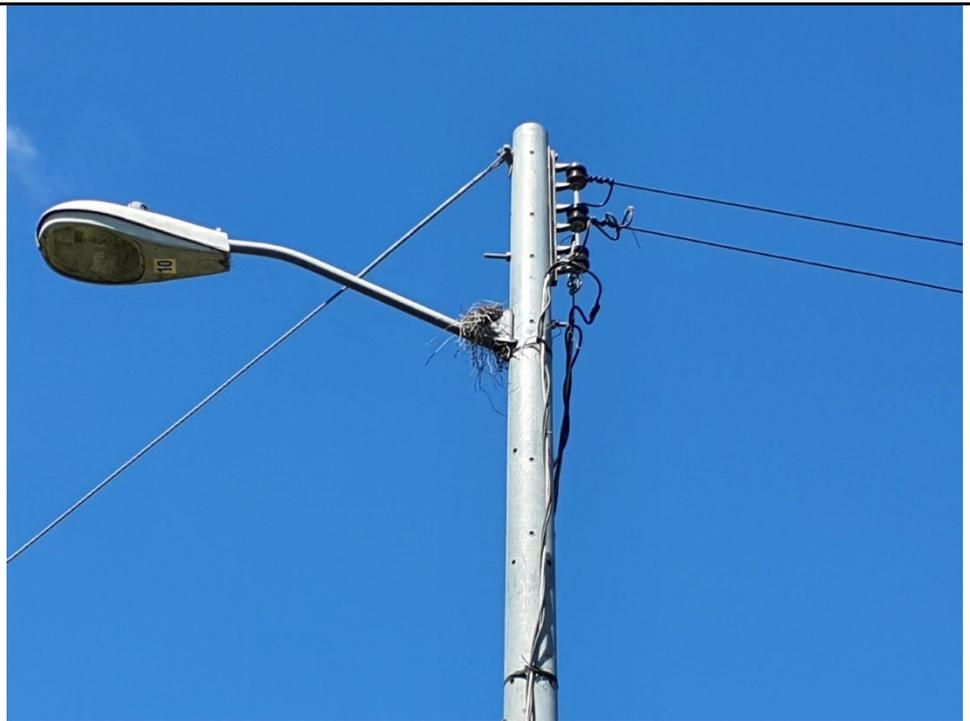
Photo #: 12	Date: 10/09/23
Photo Direction: Close-up	
Description: This is a close-up picture of the partially dilapidated bird nest on the light post. The nest does not appear to be currently in use and the light post/electricity is not currently in service.

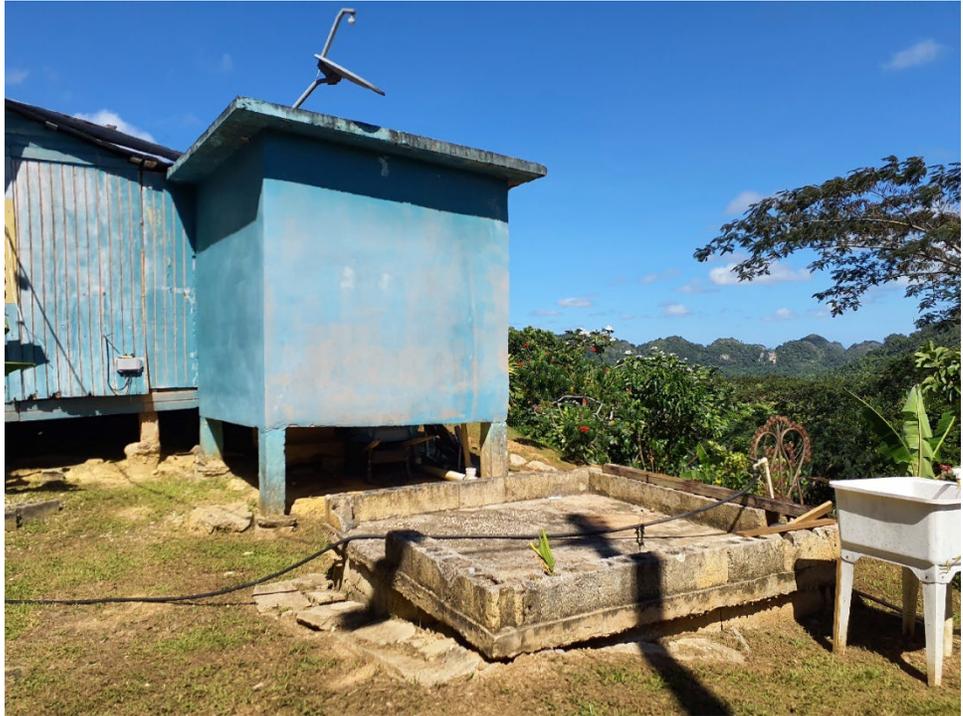
Description:
This picture is facing northwest and shows a partially above-ground septic tank and pre-existing structure (old house severely damaged by Hurricane Maria). The picture also shows a hand wash station (not currently in use/connected to water) as well as various trees, vegetation, and mountains in the background).

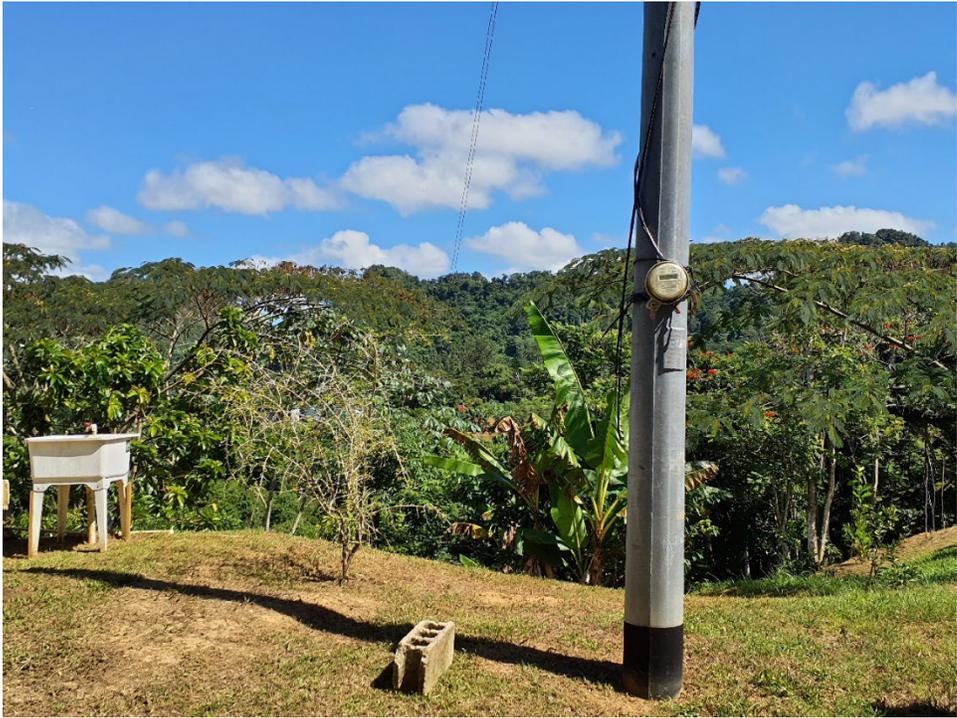
Photo #: 14	Date: 10/09/23
-----------------------	--------------------------

Description:
 This picture faces northeast and depicts the current available electric source but the applicant does not intend to use electricity for the proposed project. It also shows the landform, vegetation and mountains in the background, a cinder block, and a hand-wash station that is not currently in use or hooked up to water.

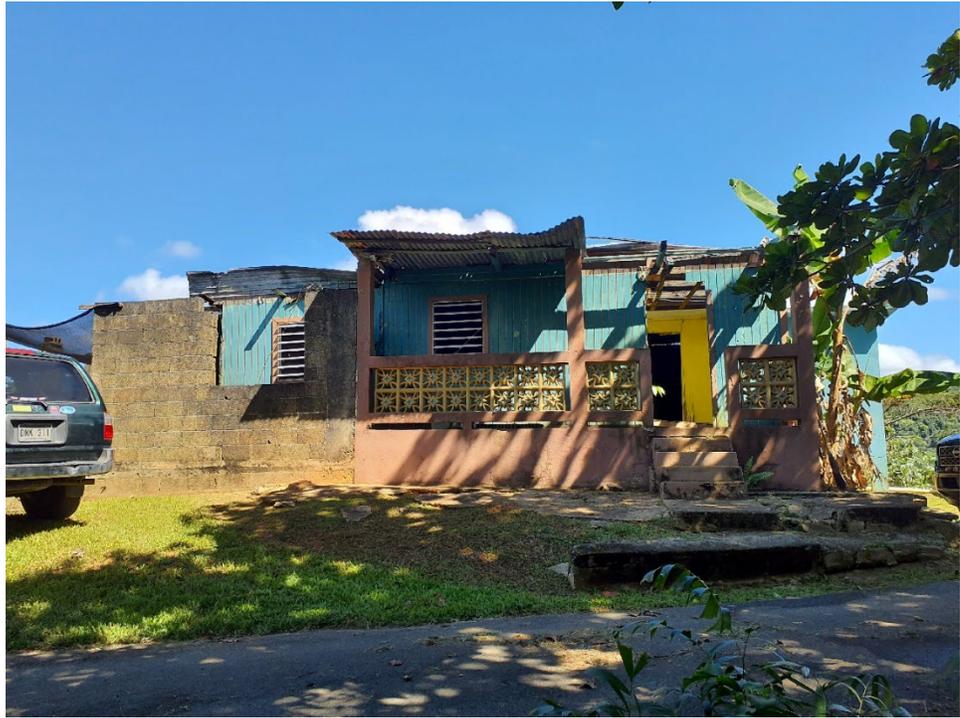
Photo #: 15	Date: 10/09/23
Photo Direction: North

Description:
 This picture is facing north and depicts a pre-existing structure. The applicant believes the structure was built in ~1950. The structure was severely damaged by Hurricane Maria. The community road, applicant's vehicle, and several trees are also visible in this picture.

Are abandoned vehicles or electrical equipment present?	No	Comment:
Is other potential environmentally hazardous debris on the parcel?	No	Comment:
Is there non-environmentally hazardous debris on the parcel?	No	Comment:
Are any leaks, soil stains, or stressed vegetation present associated with any of the above or separately?	No	Comment:
Are there any pungent, foul or noxious odors?	No	Comment:
Are there any potentially hazardous trees that could fall?	No	Comment:
Are any bird nests visible?	Yes	Comment: Partially dilapidated nest on light pole- potential Gray Kingbird nest- not currently in use. Outside of project location
Are there any animal burrows visible?	No	Comment:
Are there any buildings in direct visual sight of the project locations?	Yes	Comment: Structure built ~1950 and was severely damaged by Hurricane Maria.

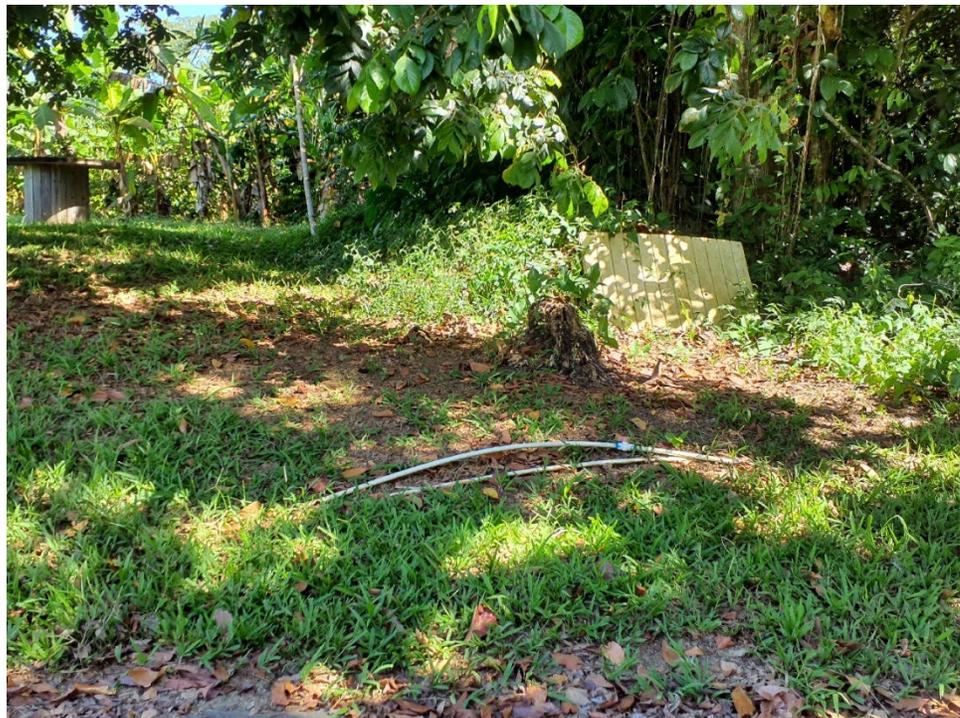
Photo #: 16	Date: 10/09/23
-----------------------	--------------------------

Description:
 This is a close-up picture of a partially exposed water line. The buried portion of the line is buried 6 inches deep. This picture also shows an old spool, and old construction material and debris which applicant intends to remove. The landform and various trees, including guava trees which applicant plans to clear, are also visible in this picture.

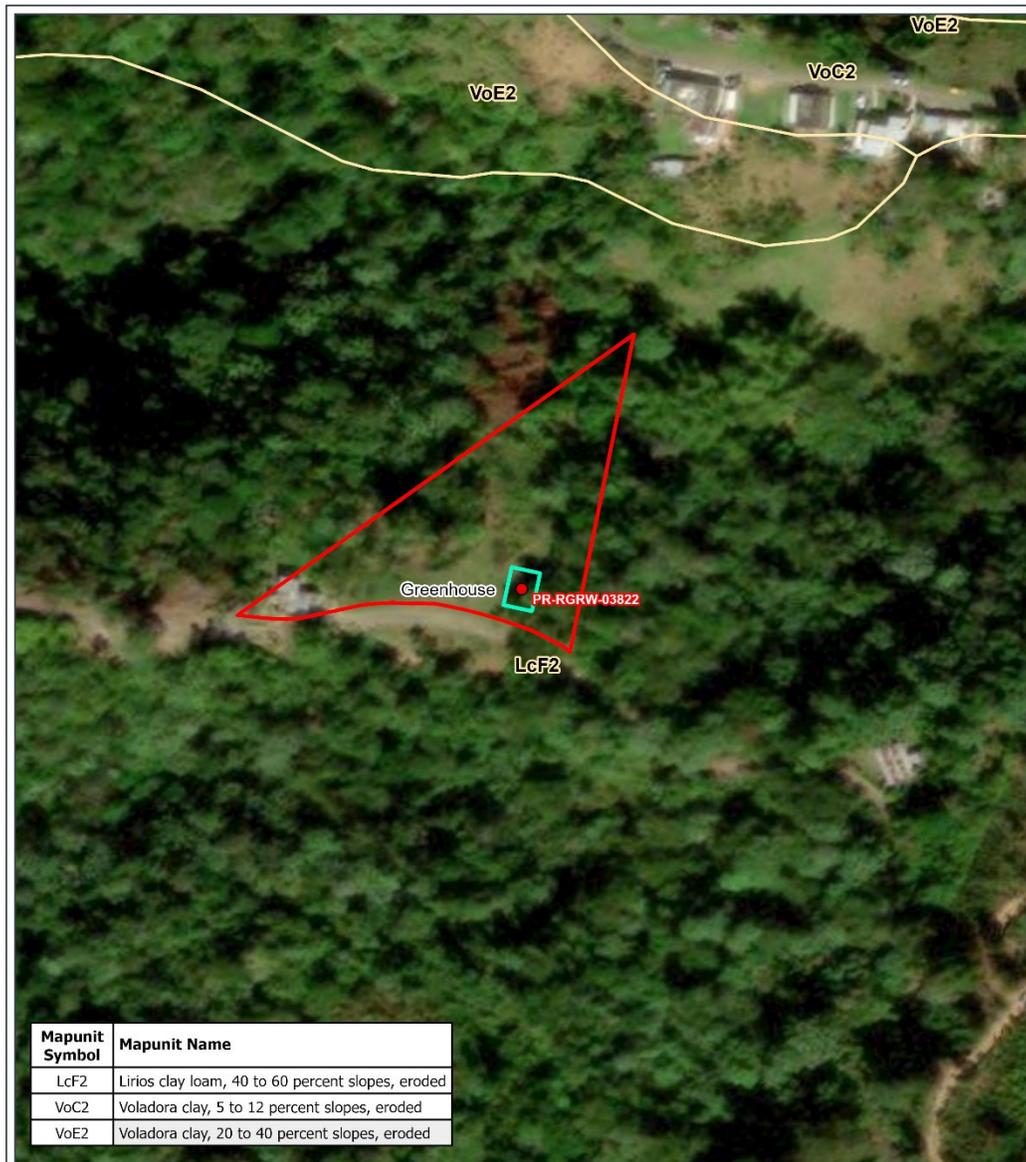
Project (Parcel) Location – Soils Map

Mapunit Symbol	Mapunit Name
LcF2	Lirios clay loam, 40 to 60 percent slopes, eroded
VoC2	Voladora clay, 5 to 12 percent slopes, eroded
VoE2	Voladora clay, 20 to 40 percent slopes, eroded

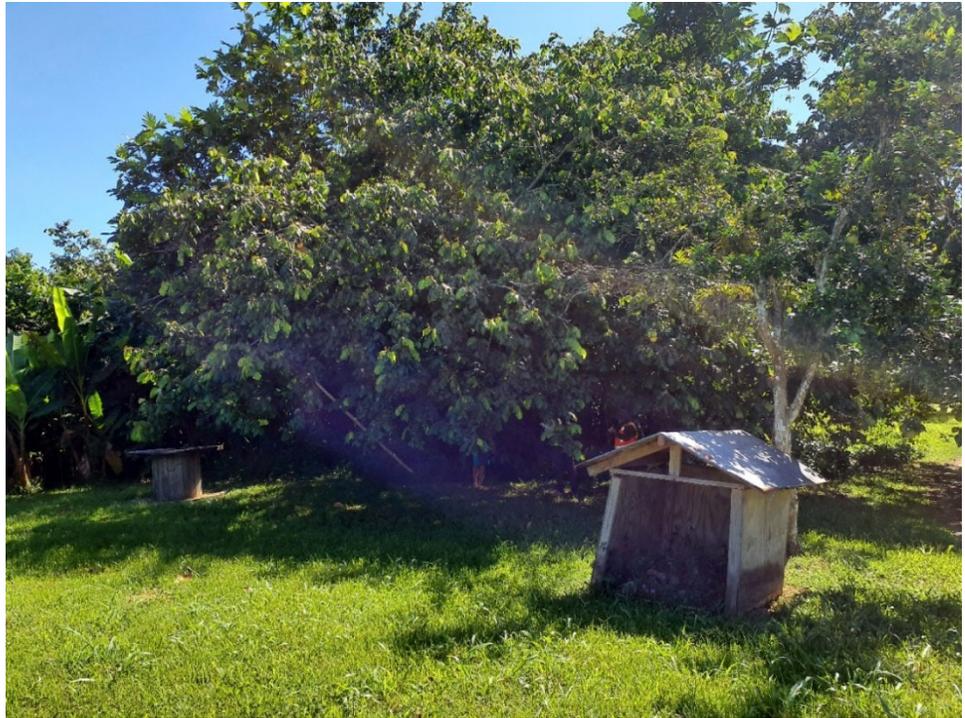
Photo #: 01	Date: 10/09/23
Photo Direction: East	
Description: Overview of the applicant's property and proposed project location for a 30x48ft greenhouse intended for drying coffee. This picture is facing east and depicts the layout of the land and various trees, including guava trees which applicant plans to clear. It also shows an old doghouse and spool which the applicant will be removing from the property.

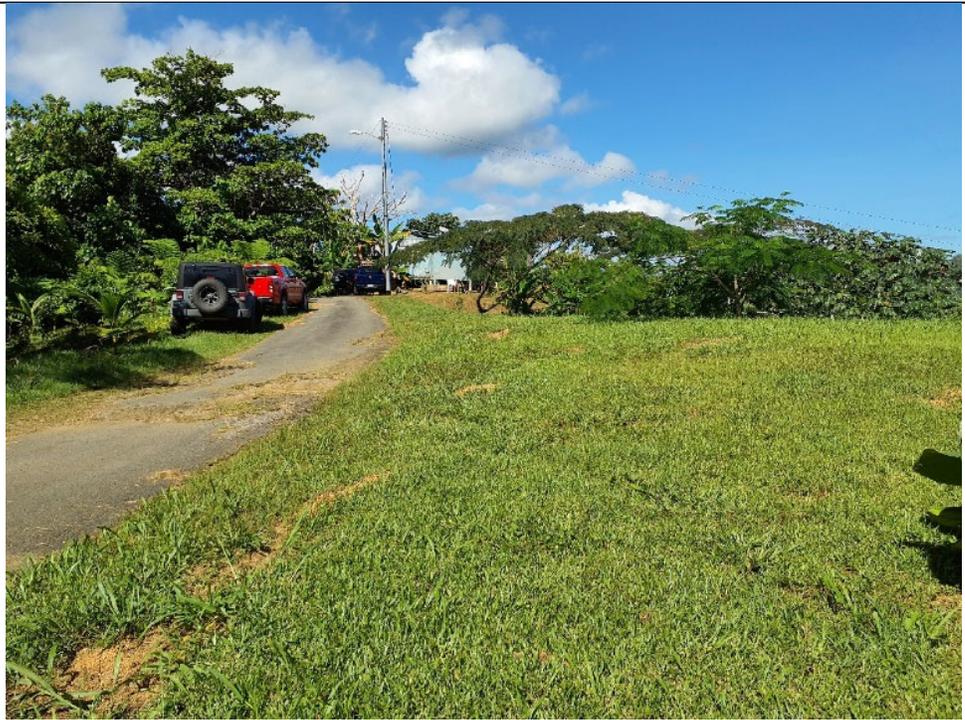
Photo #: 02	Date: 10/09/23
Photo Direction: West	
Description: Overview of the applicant's property and proposed project location for a 30x48ft greenhouse intended for drying coffee. The picture is facing west and shows a light post and power lines (not being used for the project), as well as the layout of the land and various trees.

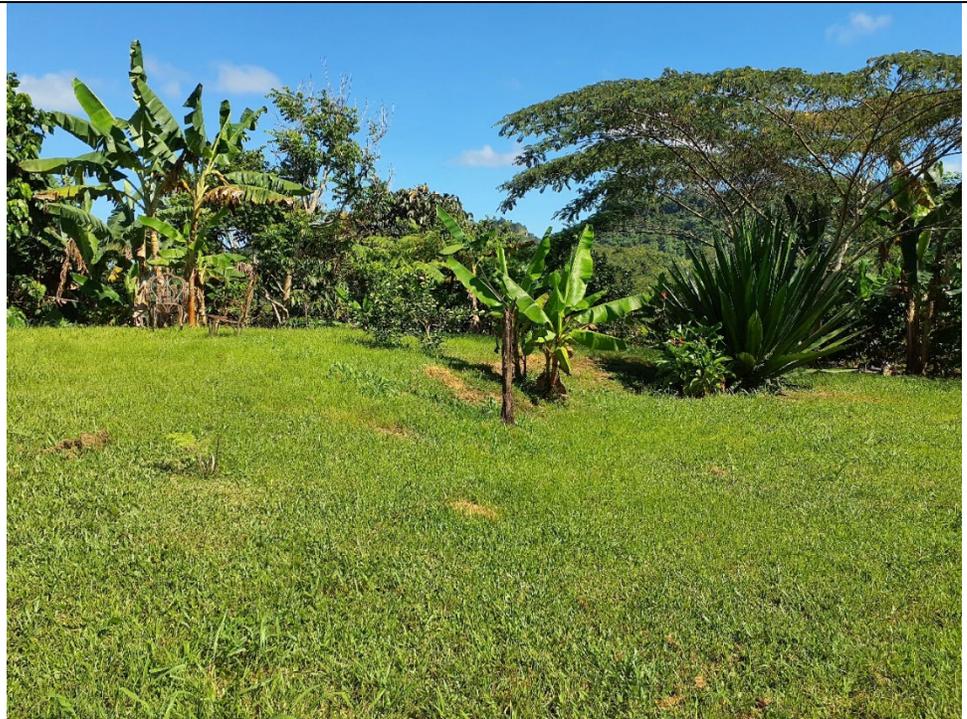
Photo #: 03	Date: 10/09/23
Photo Direction: North	
Description: This is an overview picture of the applicant's property and proposed project location for a 30x48ft greenhouse intended for drying coffee. This picture is facing north and shows the layout of the land and various trees on the property

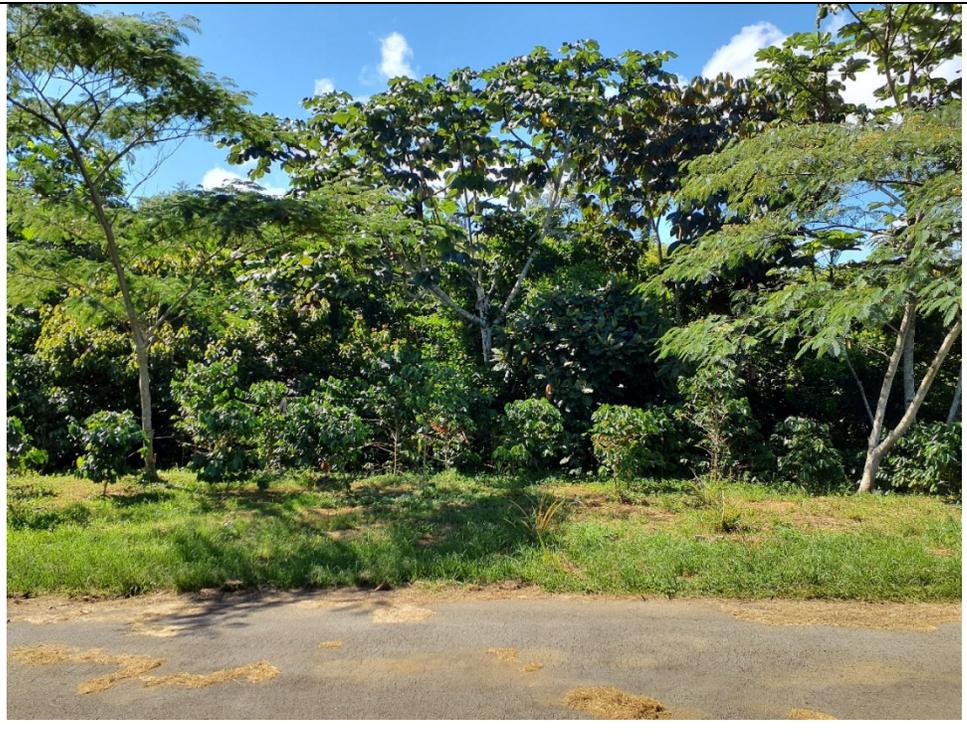
Photo #: 04	Date: 10/09/23
Photo Direction: South	
Description: This is an overview picture of the applicant's property and proposed project location for a 30x48ft greenhouse intended for drying coffee. This picture faces north and shows the layout of the land, various trees, and the community road adjacent to the proposed project location.

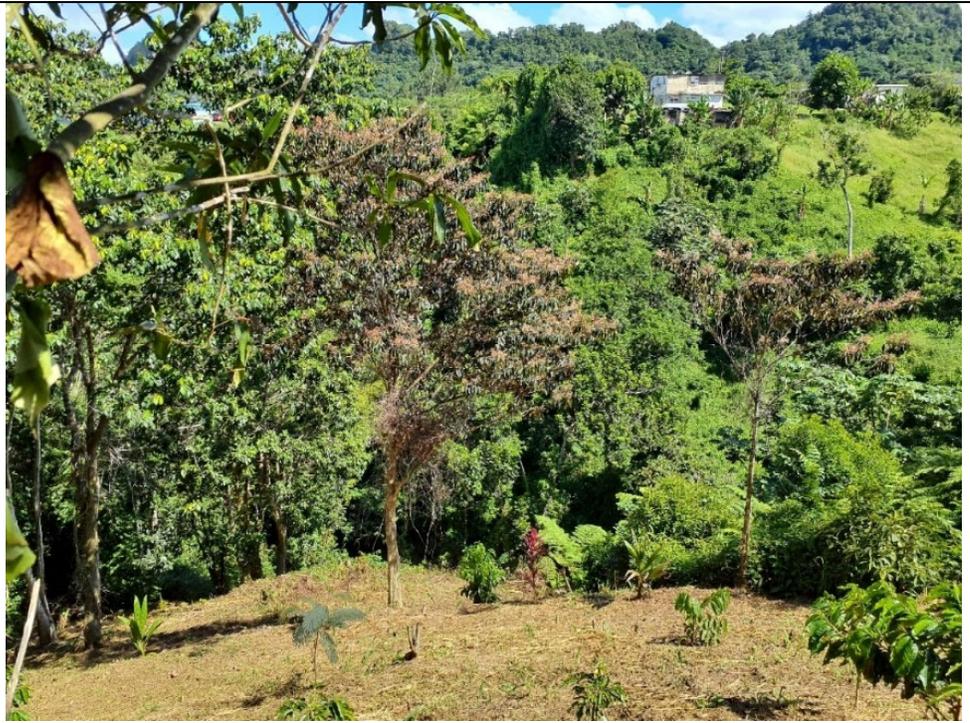
Photo #: 05	Date: 10/09/23
Photo Direction: North	
Description: This picture is facing north northeast and depicts the view toward a nearby creek (Río Tanamá). The property is upland from the creek and the creek is not visible from the project location. This picture also shows the properties with potential direct line of sight to proposed greenhouse location.

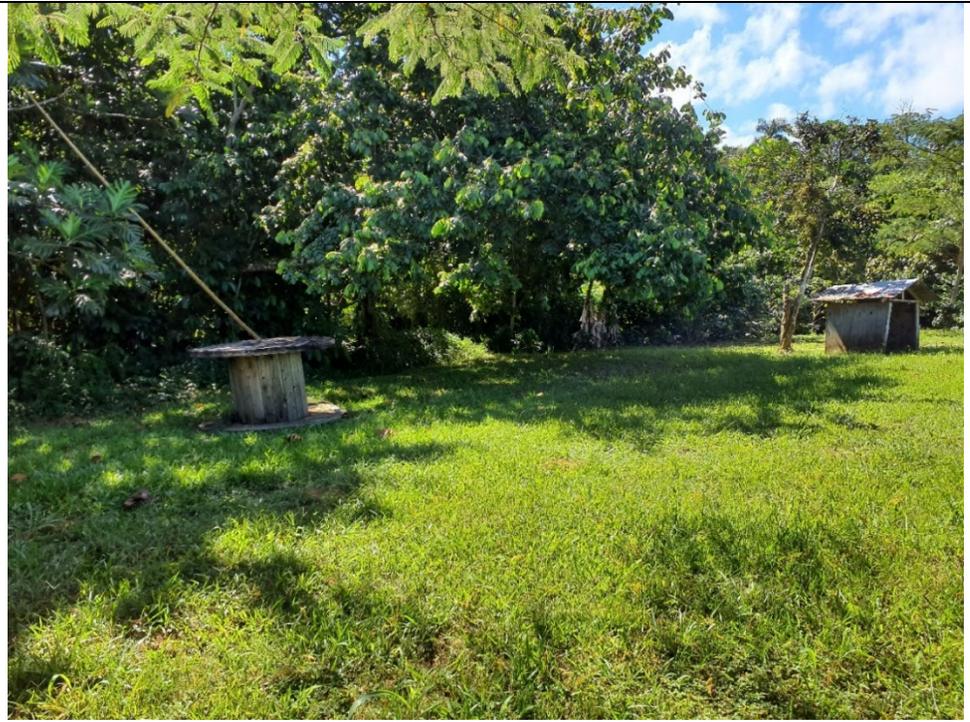
Photo #: 06	Date: 10/09/23
Photo Direction: Southeast	
Description: This picture faces southeast from the northwest corner of the proposed project location for a 30x48ft greenhouse intended for drying coffee. It depicts the layout of the land and various trees, including guava trees that applicant will be clearing. A spool and a doghouse which the applicant intends to remove are also visible in this picture.

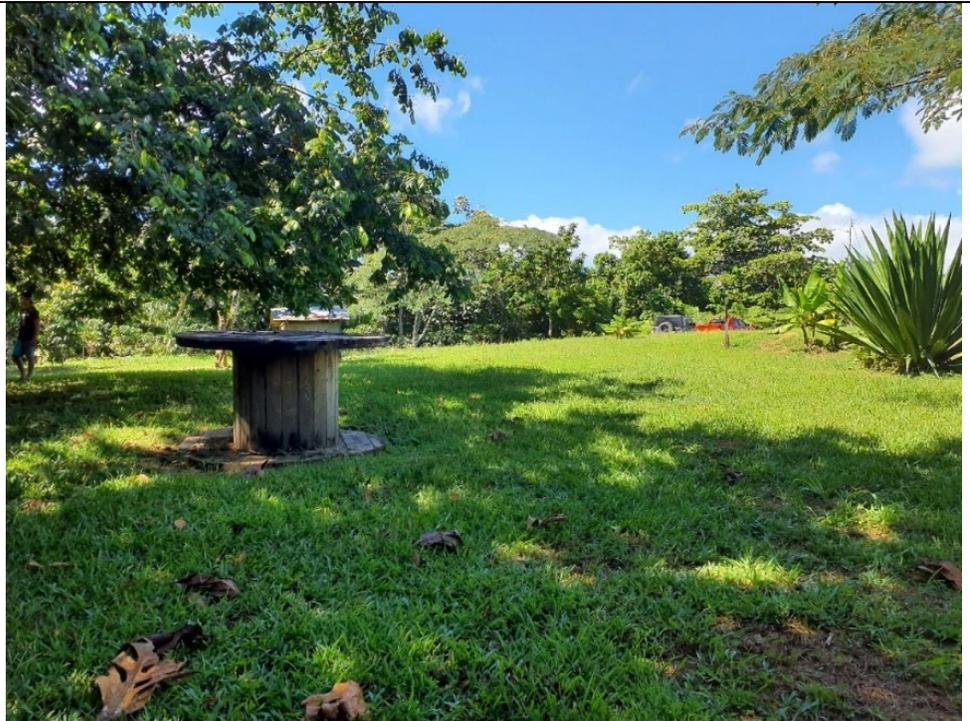
This picture faces south southwest from the northeast corner of the proposed project location for a 30x48ft greenhouse intended for drying coffee. It depicts the layout of the land, vegetation, and an old spool which the applicant intends to remove. SWCA staff vehicles are also visible in the background.

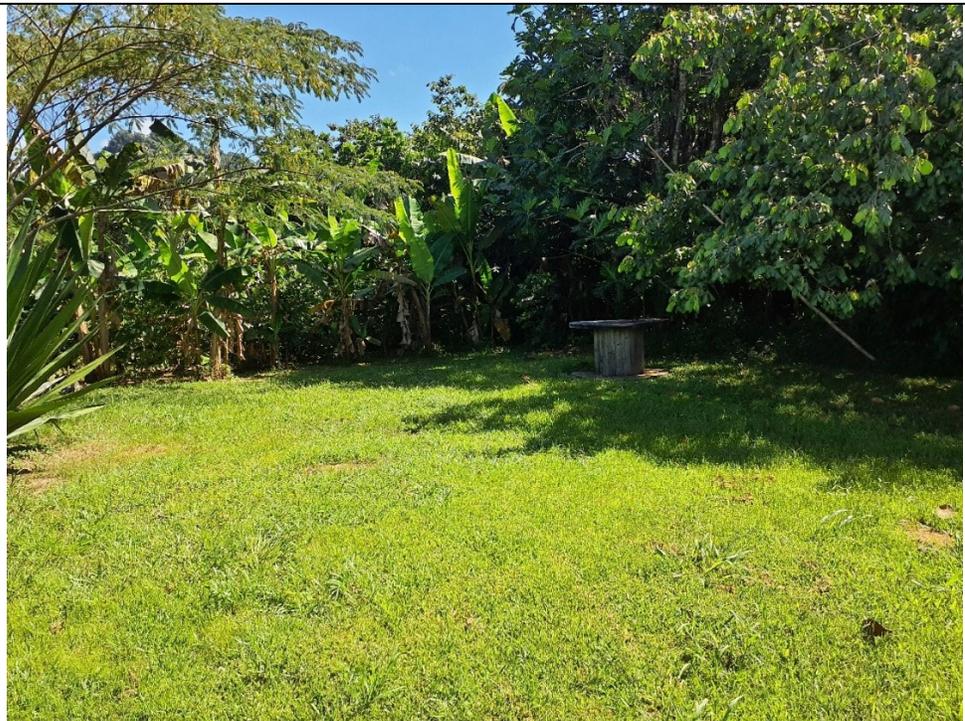
This picture faces northeast from the southwest corner of the proposed project location for a 30x48ft greenhouse intended for drying coffee. It depicts the layout of the land, various trees, and an old spool which the applicant intends to remove.

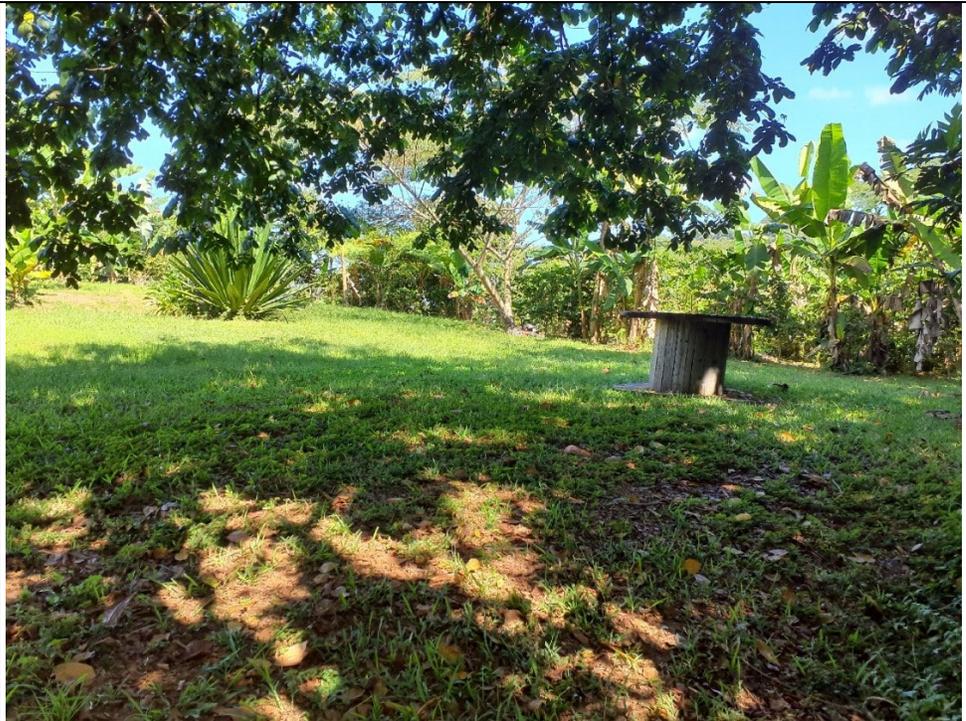
Description:
This picture faces north northwest from the southeast corner of the proposed project location for a 30x48ft greenhouse intended for drying coffee. It depicts the layout of the land, various trees and other vegetation, and an old spool which the applicant intends to remove.

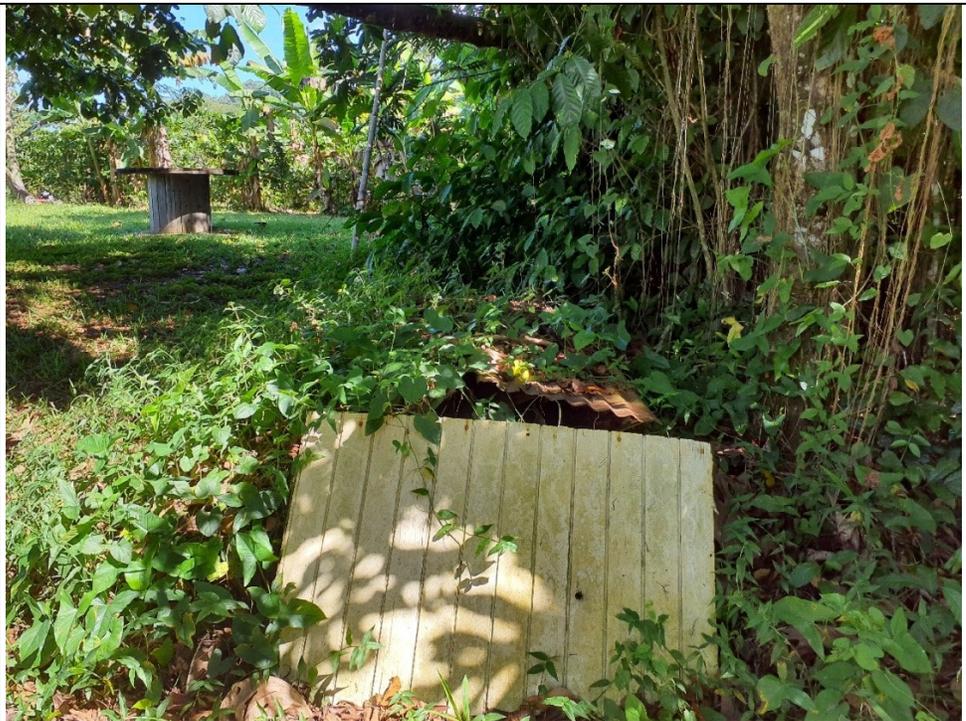
Description:
This picture is a close-up (facing northeast) of construction materials and debris left behind by Hurricane Maria (zinc and wooden panels) which applicant intends to remove from property.
