Environmental Review for Activity/Project that is Categorically Excluded Subject to Section 58.5 Pursuant to 24 CFR 58.35(a)

Project Name: PR-RGRW-03822-W-RE

This project (PR-RGRW-03822-W-RE) entails the award of a grant to Hacienda Chile, an agricultural business, at Carretera 111 Bo. Caguana, Sector Jareales, Utuado, PR 00641. Tax ID Number: 160-000-009-23-000. Coordinates (18.283566, -66.772657). This project had an original CENST review which included the purchase of farm equipment including an UTV, loop handle, backpack blower, chain saw, pole pruner, pressure washer, evergreen organic, and 22" 7.25 B&S 163cc OHV RWD PP HW for project cost of \$24,201.44. See attached CENST environmental review. This review includes a scope item previously considered as an EA level of review (pulper and greenhouse) which is now evaluated as CEST level of review in accordance with FR-6492-N-01 with a project cost of \$25,661.73. The proposed project includes the purchase and installation of a new greenhouse and the purchase of a despulpadora (pulper). The new greenhouse is in the southeast area of the property. The greenhouse is approximately 1,200 square feet (ft) (48 ft by 30 ft) with a hei

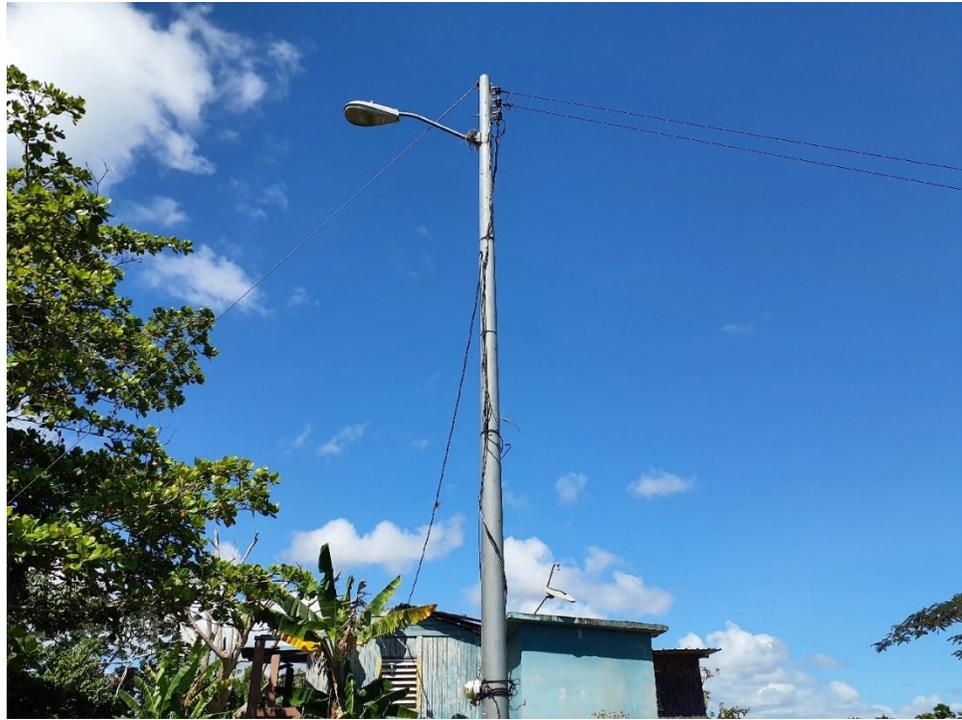
Description:
This picture faces west and depicts a partially dilapidated bird nest (possibly a Gray Kingbird nest) on a light post (light post not in service). The nest does not appear to be currently in use. A pre-existing structure (house that was severely damaged by Hurricane Maria), as well as various trees, are also visible in this picture.

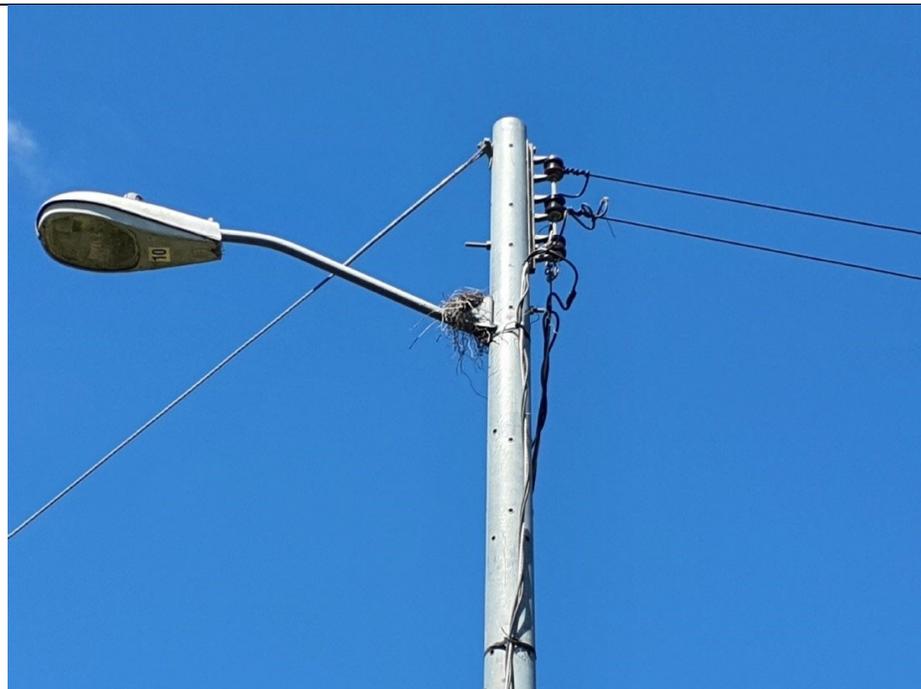
Description:
This is a close-up picture of the partially dilapidated bird nest on the light post. The nest does not appear to be currently in use and the light post/electricity is not currently in service.

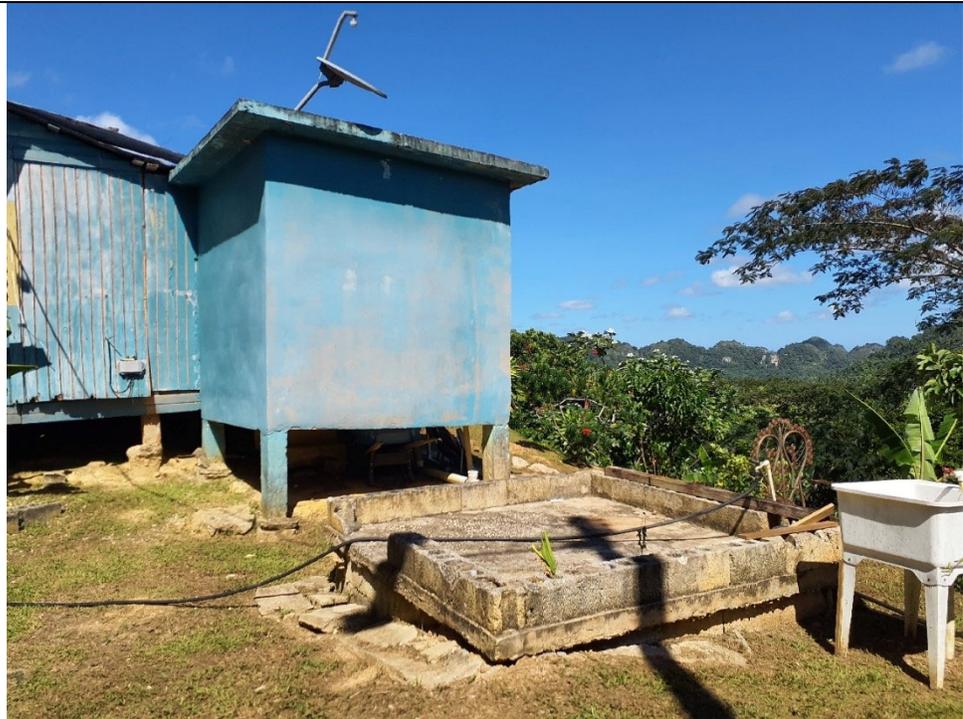
Photo #: 13	Date: 10/09/23
Photo Direction: Northwest	
Description: This picture is facing northwest and shows a partially above-ground septic tank and pre-existing structure (old house severely damaged by Hurricane Maria). The picture also shows a hand wash station (not currently in use/connected to water) as well as various trees, and vegetation).

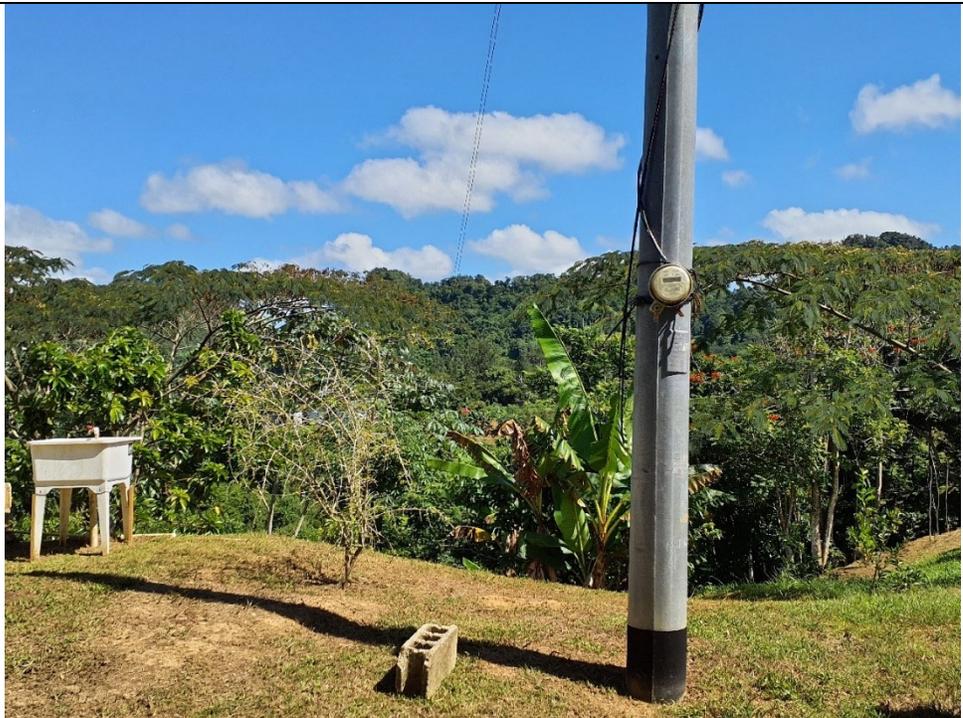
Photo #: 14	Date: 10/09/23
Photo Direction: Northeast	
Description: This picture faces northeast and depicts the current available electric source but the applicant does not intend to use electricity for the proposed project. It also shows the landform, vegetation, the mountains in the background, a cinder block, and a sink that is not in use.

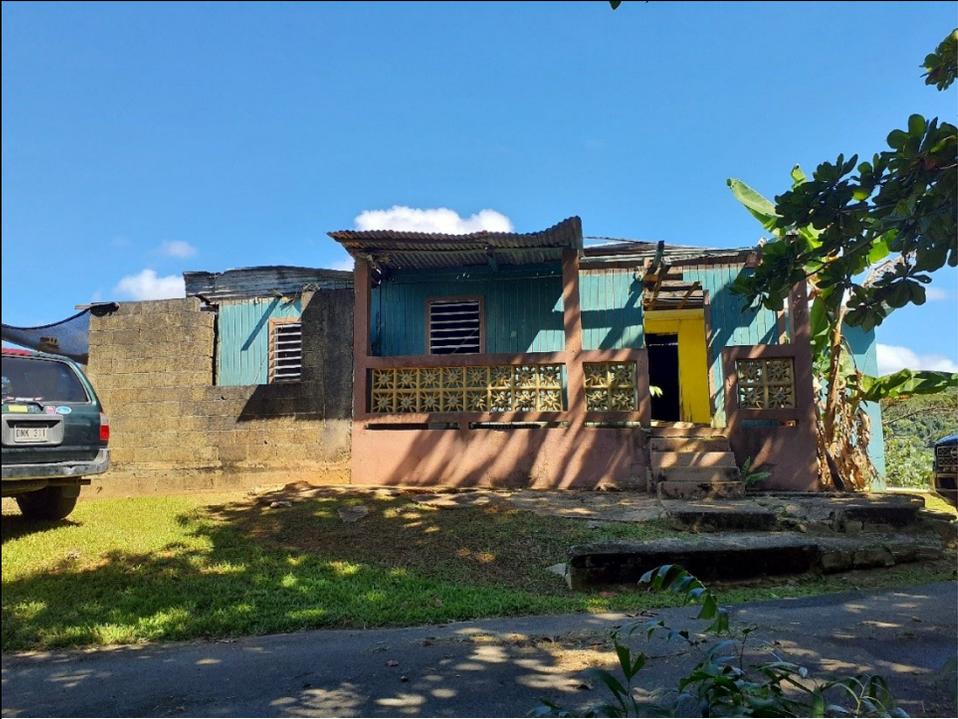
<p>Photo #: 15</p>	<p>Date: 10/09/23</p>

<p>Photo Direction: North</p>		
<p>Description: This picture is facing north and depicts a pre-existing structure. The applicant believes the structure was built in ~1950. The structure was severely damaged by Hurricane Maria. The community road, applicant's vehicle, and several trees are also visible in this picture.</p>		
<p>Photo #: 16</p>	<p>Date: 10/09/23</p>

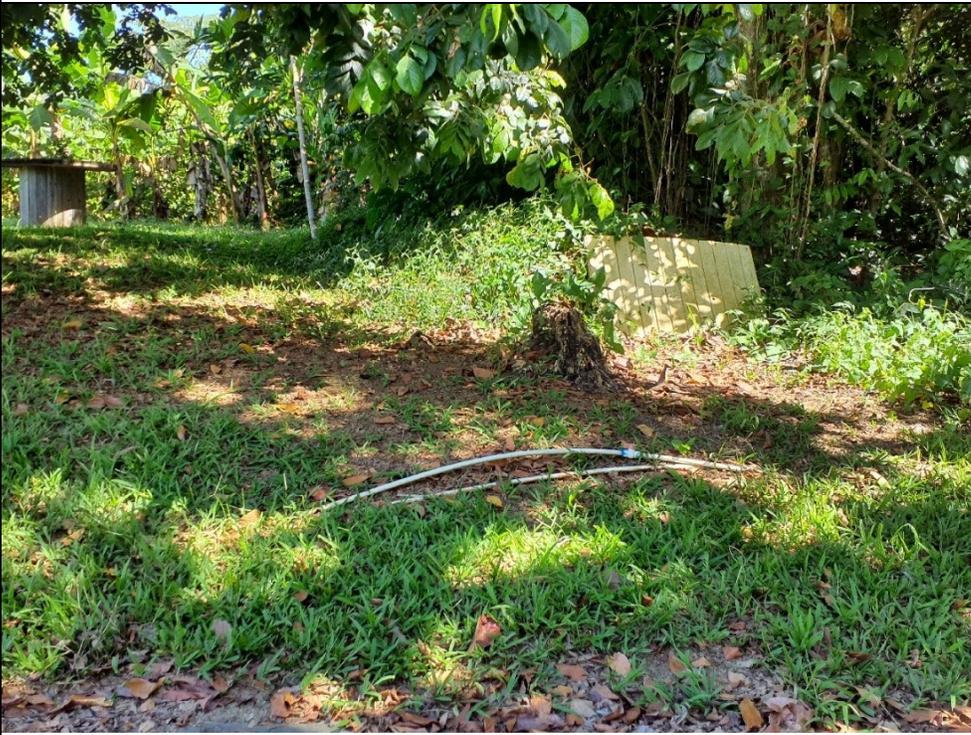
<p>Photo Direction: Close-up</p>		
<p>Description: This is a close-up picture of a partially exposed water line. The buried portion of the line is buried 6 inches deep. This picture also shows an old spool, and old construction material and debris which applicant intends to remove. The landform and various trees, including guava trees which applicant plans to clear, are also visible in this picture.</p>

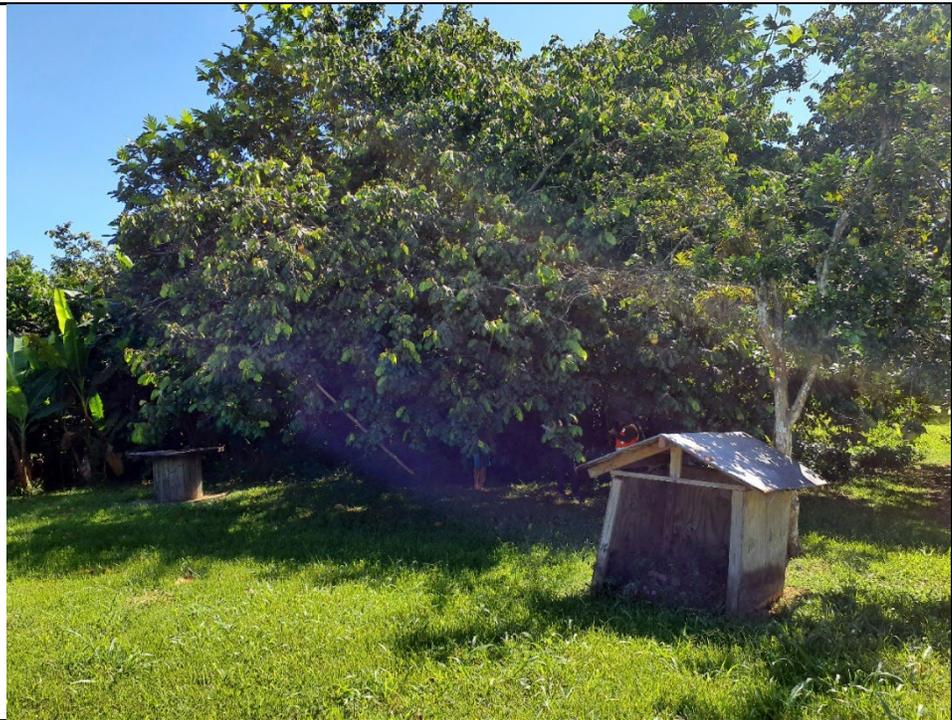
Photo #: 01	Date: 10/09/23
Photo Direction: East	
Description: This is an overview picture of the applicant's property and proposed project location for a 30x48ft greenhouse intended for drying coffee. This picture is facing east and depicts the layout of the land and various trees, including guava trees which applicant plans to clear.

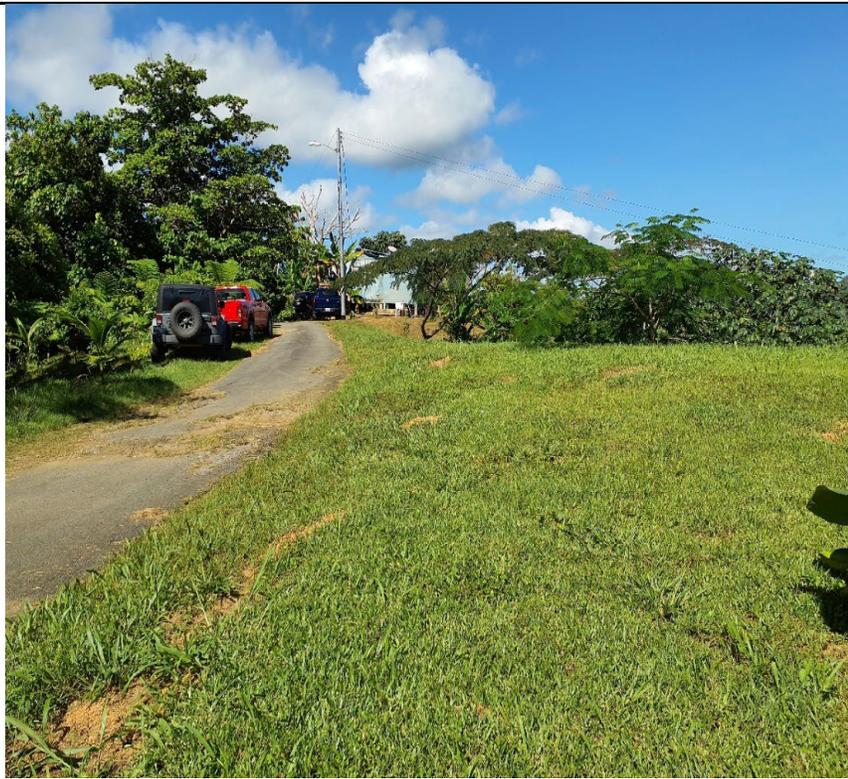
Photo #: 02	Date: 10/09/23
Photo Direction: West	
Description: This is an overview picture of the applicant's property and proposed project location for a 30x48ft greenhouse intended for drying coffee. The picture shows a light post and power lines (not being used for the project), as well as the layout of the land and various trees. A pre-existing structure is slightly visible in the background.

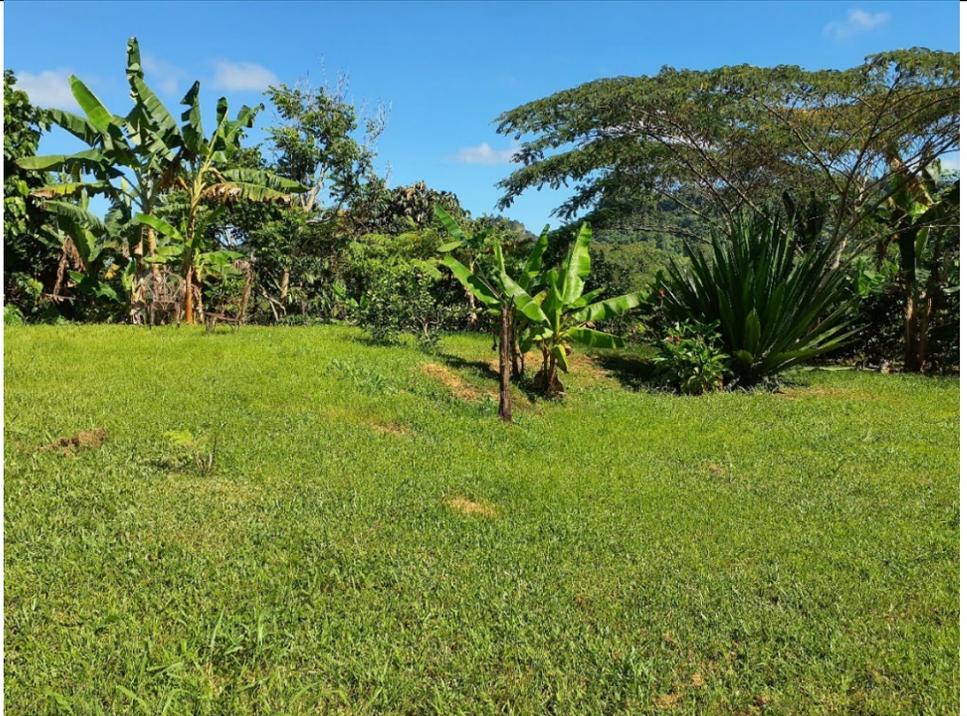
Photo #: 03	Date: 10/09/23

Photo Direction: North		
Description: This is an overview picture of the applicant's property and proposed project location for a 30x48ft greenhouse intended for drying coffee. This picture is facing north and shows the layout of the land and various trees on the property.

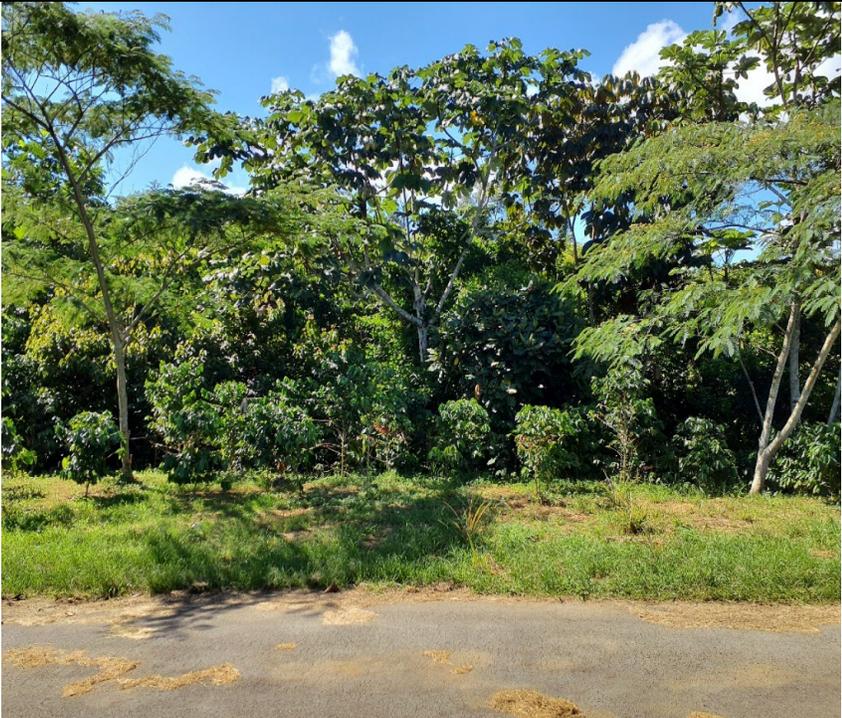
Photo #: 04	Date: 10/09/23

Photo Direction: South		
Description: This is an overview picture of the applicant's property and proposed project location for a 30x48ft greenhouse intended for drying coffee. This picture faces north and shows the layout of the land, various trees, and the community road adjacent to the proposed project location.

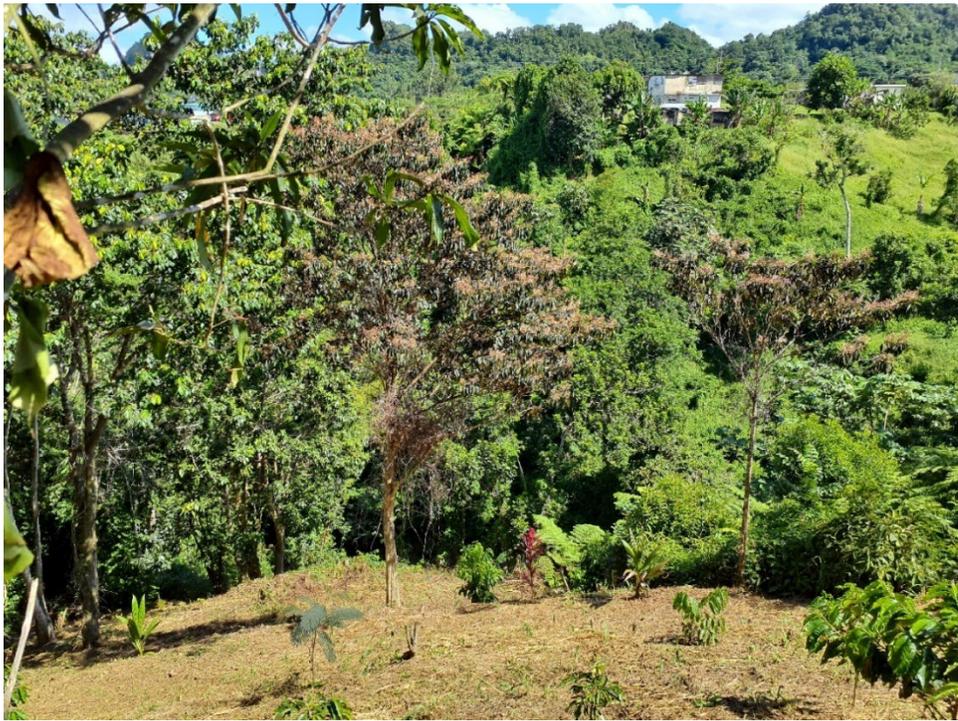
Photo #: 05	Date: 10/09/23

Photo Direction: North, Northeast		
Description: This picture is facing north northeast and depicts the view toward a nearby creek (Río Tanamá). The property is upland from the creek and the creek is not visible from the project location. This picture also shows the properties with potential direct line of sight to proposed greenhouse location.

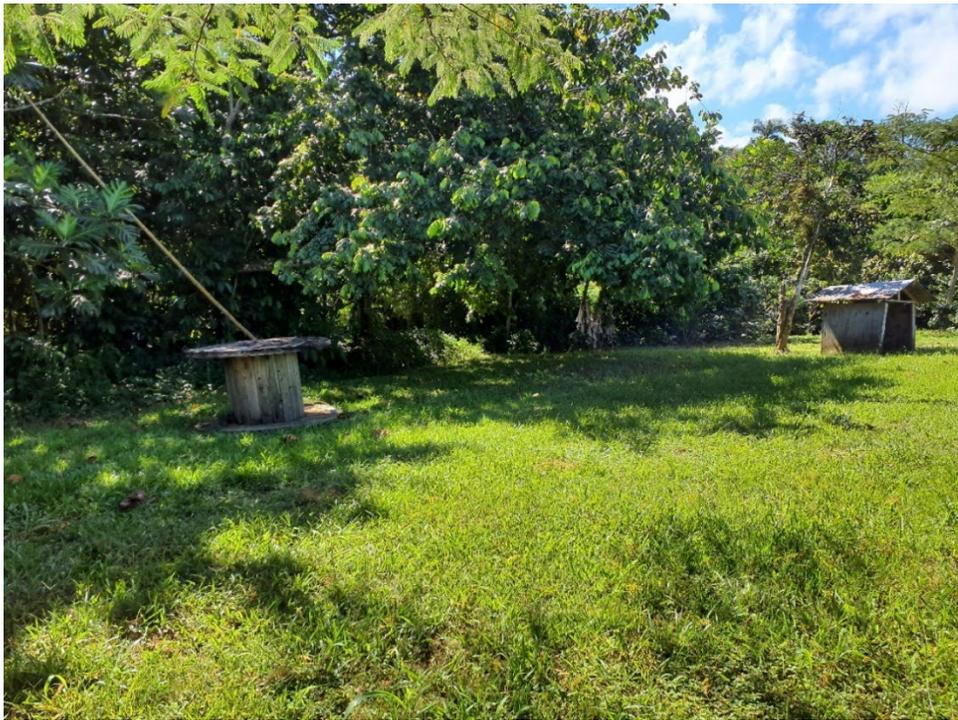
Photo #: 06	Date: 10/09/23

Photo Direction: Southeast		
Description: This picture faces southeast from the northwest corner of the proposed project location for a 30x48ft greenhouse intended for drying coffee. It depicts the layout of the land and various trees, including guava trees that applicant will be clearing. A spool and a doghouse which the applicant intends to remove are also visible in this picture.

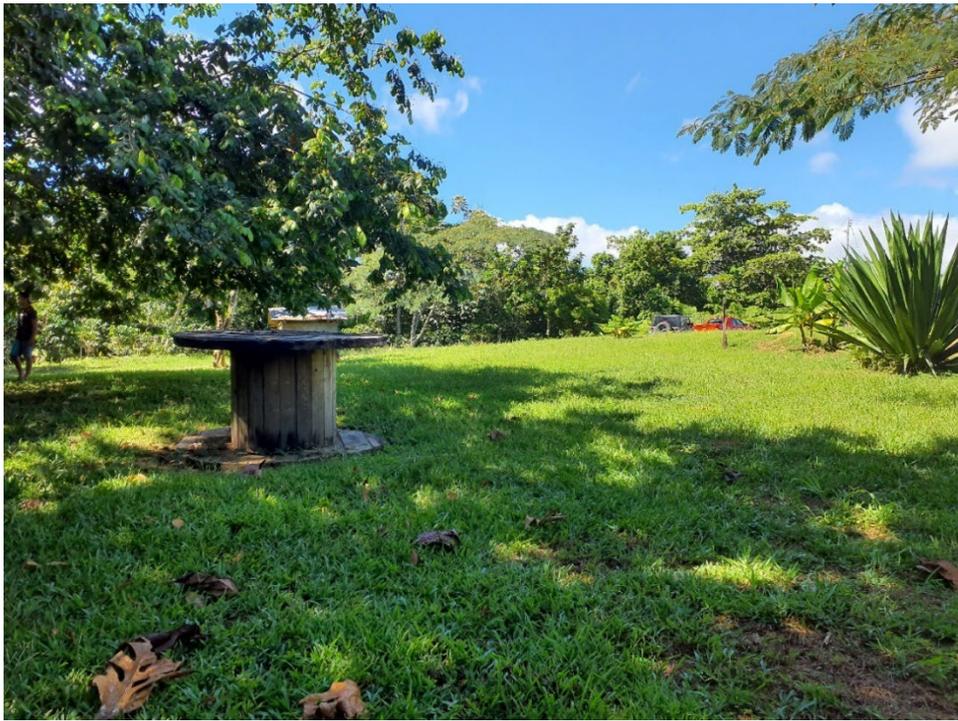
Photo #: 07	Date: 10/09/23

Photo Direction: South, Southwest		
Description: This picture faces south southwest from the northeast corner of the proposed project location for a 30x48ft greenhouse intended for drying coffee. It depicts the layout of the land, vegetation, and an old spool which the applicant intends to remove. SWCA staff vehicles are also visible in the background.

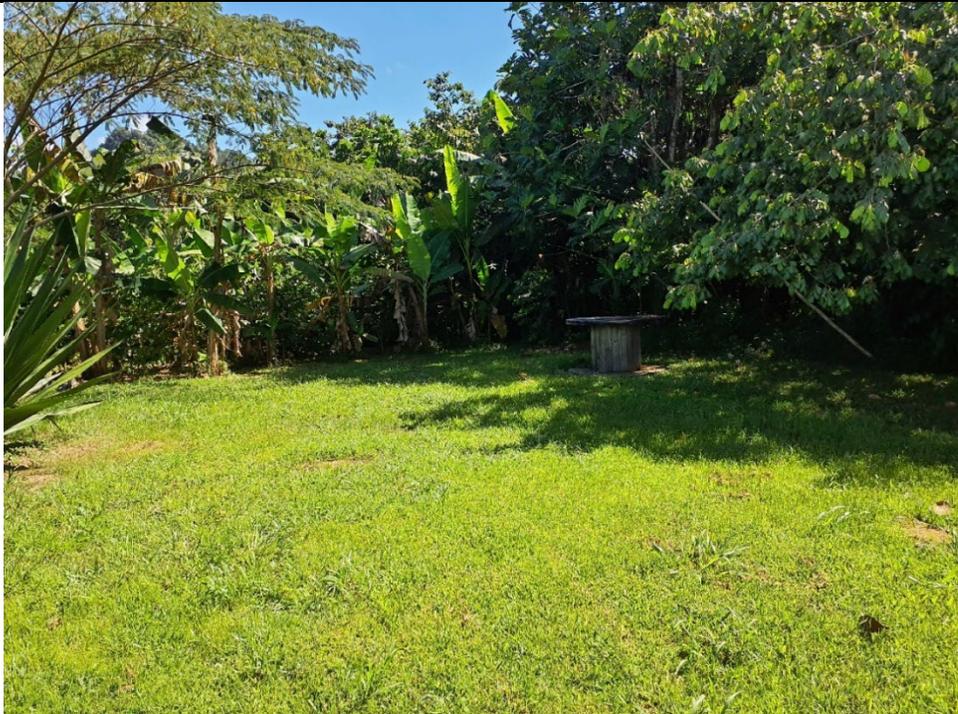
Photo #: 08	Date: 10/09/23

Photo Direction: Northeast		
Description: This picture faces northeast from the southwest corner of the proposed project location for a 30x48ft greenhouse intended for drying coffee. It depicts the layout of the land, various trees, and an old spool which the applicant intends to remove.

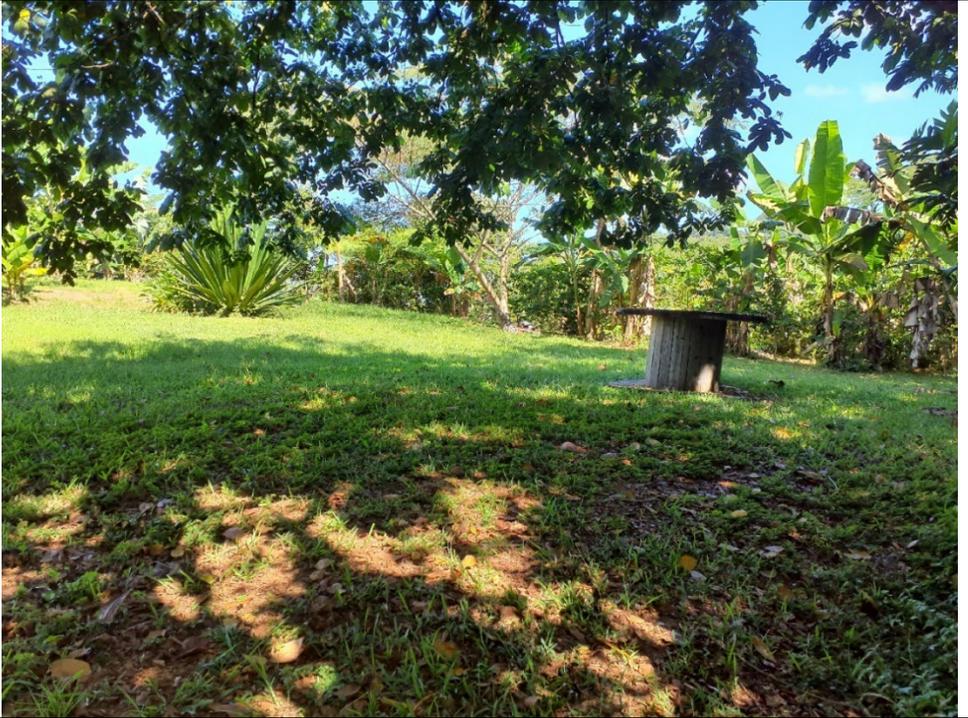
Photo #: 09	Date: 10/09/23

Photo Direction: North, northwest		
Description: This picture faces north northwest from the southeast corner of the proposed project location for a 30x48ft greenhouse intended for drying coffee. It depicts the layout of the land, various trees and other vegetation, and an old spool which the applicant intends to remove.

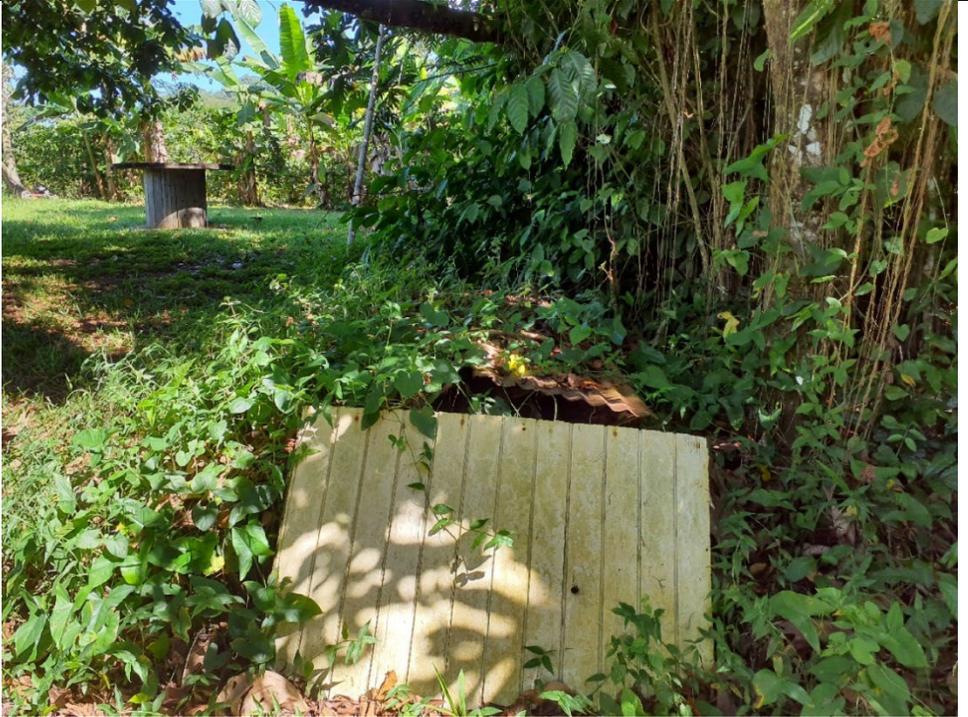
Photo #: 10	Date: 10/09/23

Photo Direction: Northeast/Close-up		
Description: This picture is a close-up (facing northeast) of construction materials and debris left behind by Hurrigan Maria (zinc and wooden panels) which applicant intends to remove from property.

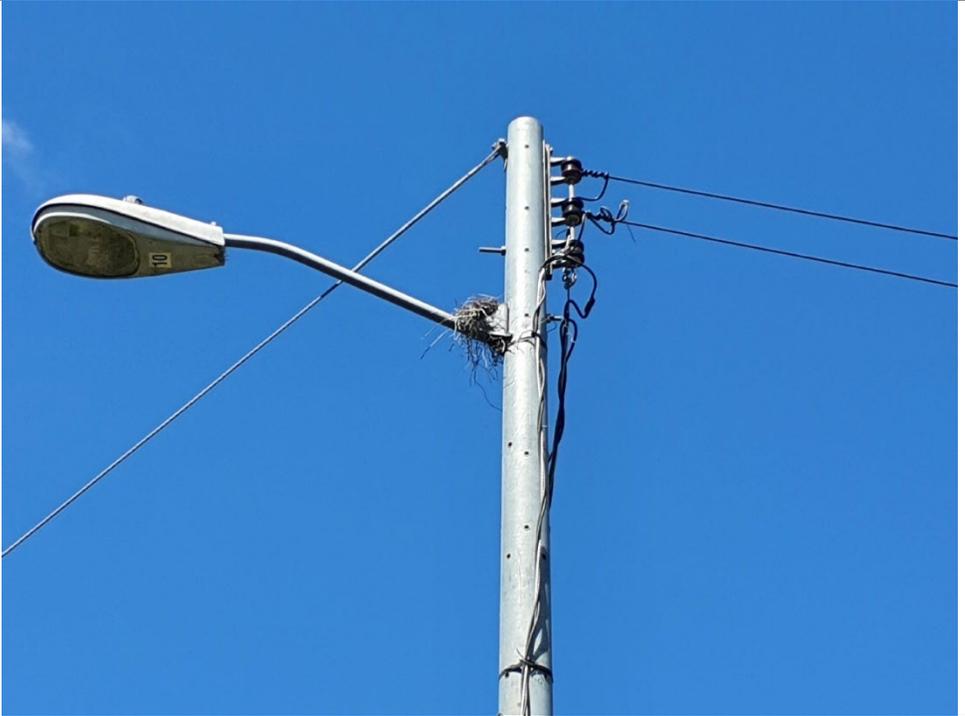
Photo #: 11	Date: 10/09/23

Photo Direction: Close-up		
Description: This is a close-up picture of the partially dilapidated bird nest on the light post. The nest does not appear to be currently in use and the light post/electricity is not currently in service.

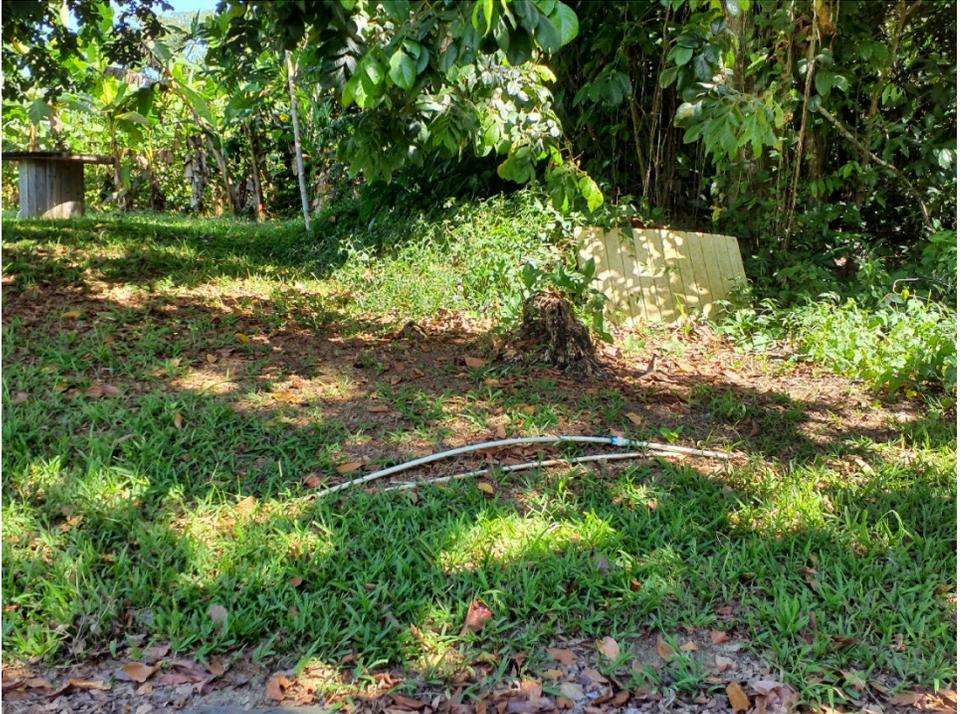
Photo Direction: Close-up		
Description: This is a close-up picture of a partially exposed water line. The buried portion of the line is buried 6 inches deep. This picture also shows an old spool, and old construction material and debris which applicant intends to remove. The landform and various trees, including guava trees which applicant plans to clear, are also visible in this picture.
