Environmental Assessment

Project ID: PR-RGRW-01778

Project Name: Huertos de Puerto Rico LLC

Responsible Entity: Puerto Rico Department of Housing

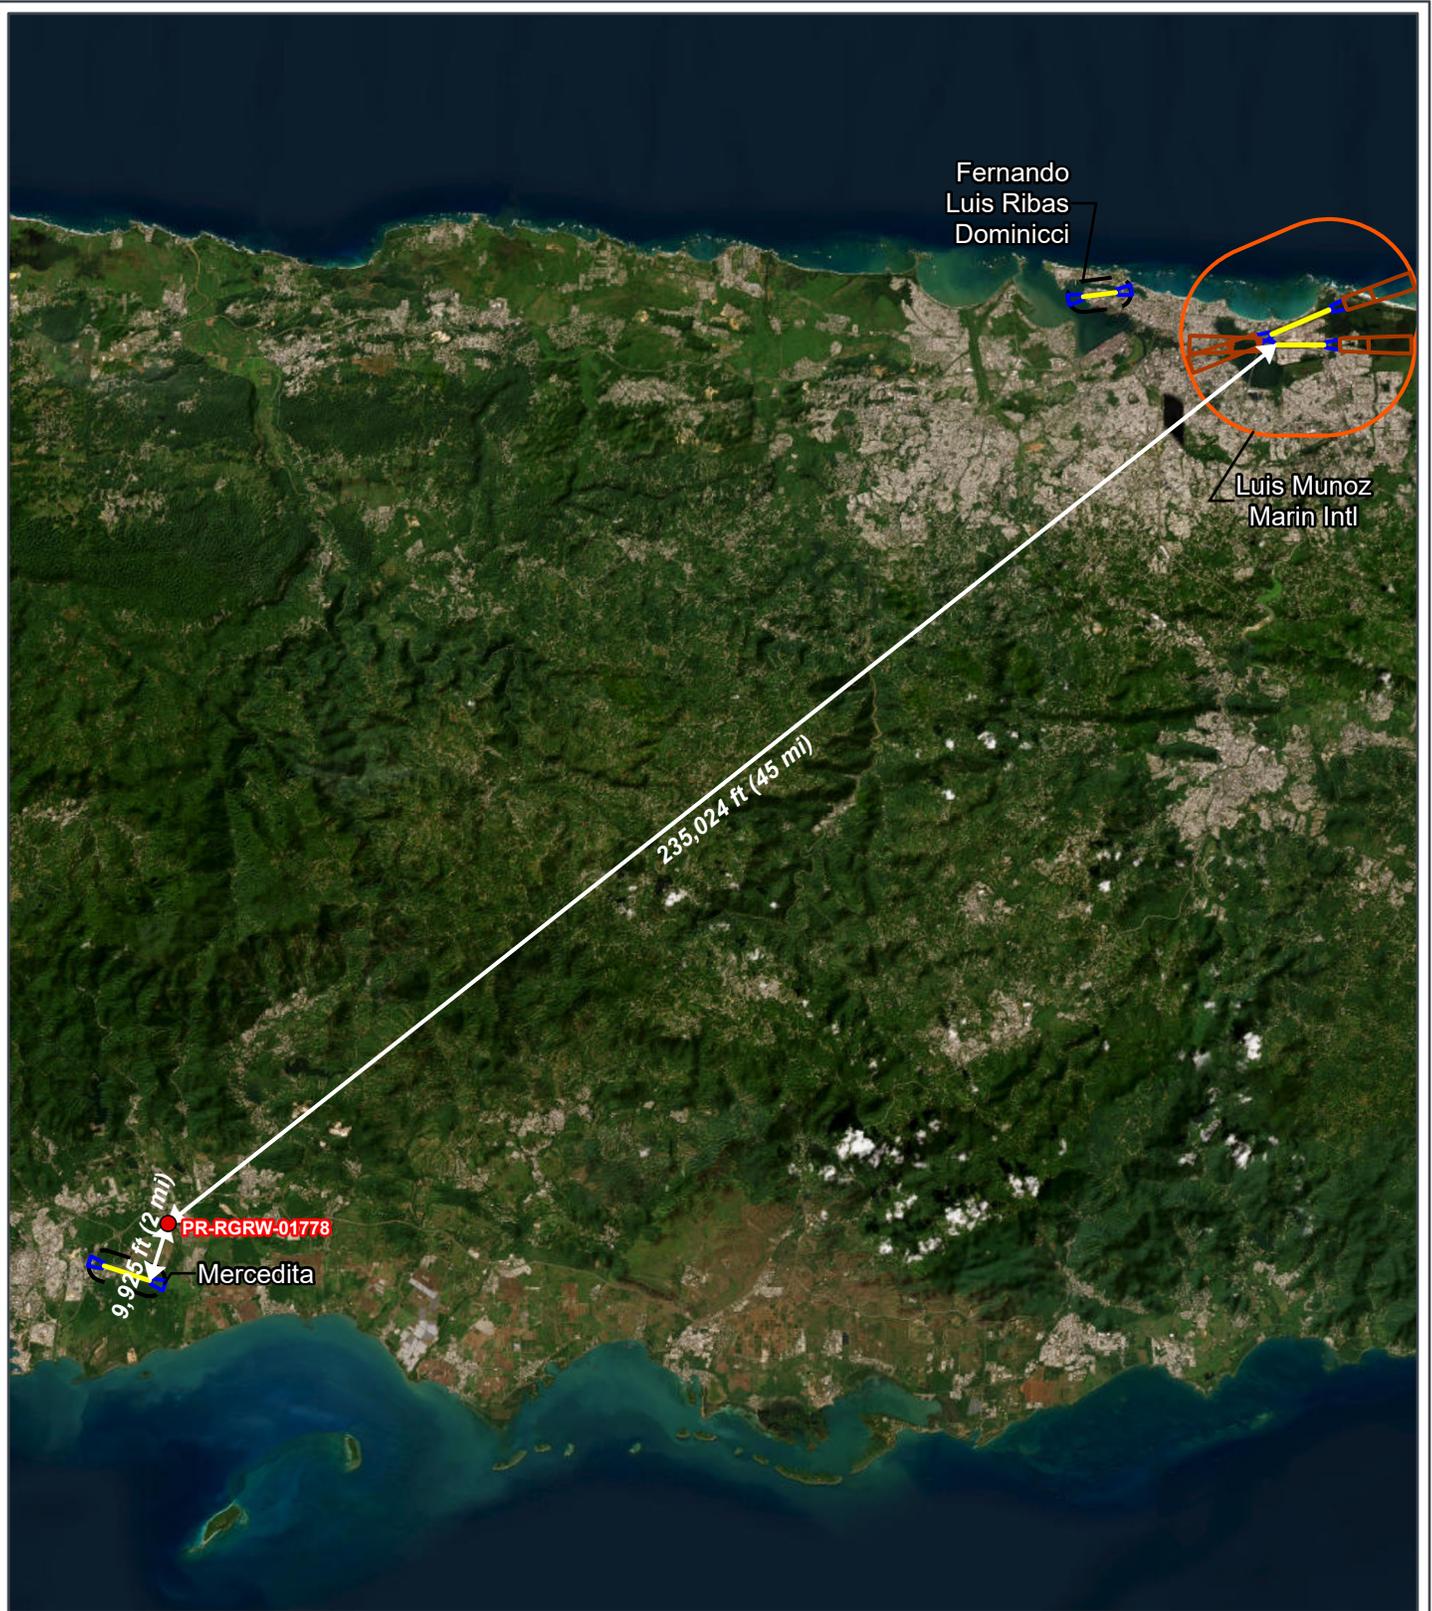
**Figure B 1-1:
Airport Hazards Map**

The project site is not within 2,500 feet (ft) of a civil primary or commercial service airport or within 15,000 ft of a military airport. The nearest civil primary or commercial service airport, Mercedita, is located 9,925 ft (2 miles) from the project site. The nearest military airport, Luis Munoz Marin International Airport, is located 235,024 ft (45 miles) from the project site. No further evaluation is required. The project is in compliance with airport hazards requirements.

| Compliance Factors: Statutes, Executive Orders, and Regulations listed at 24 CFR §58.5 and §58.6 | Are formal compliance steps or mitigation required? | Compliance Determinations |
|--|---|---|
| Airport Hazards 24 CFR Part 51 Subpart D | Yes No <input type="checkbox"/> <input checked="" type="checkbox"/> | <p>The project site is not within 2,500 feet (ft) of a civil primary or commercial service airport or within 15,000 ft of a military airport. The nearest civil primary or commercial service airport, Mercedita, is located 9,925 ft (2 miles [mi]) from the project site. The nearest military airport, Luis Munoz Marin International Airport, is located 235,024 ft (45 mi) from the project site. No further evaluation is required. The project is in compliance with airport hazards requirements.</p> <p>The Airport Hazards Partner Worksheet and Airport Hazards Map (Figure B 1-1) are provided in Appendix B, Attachment 1.</p> |

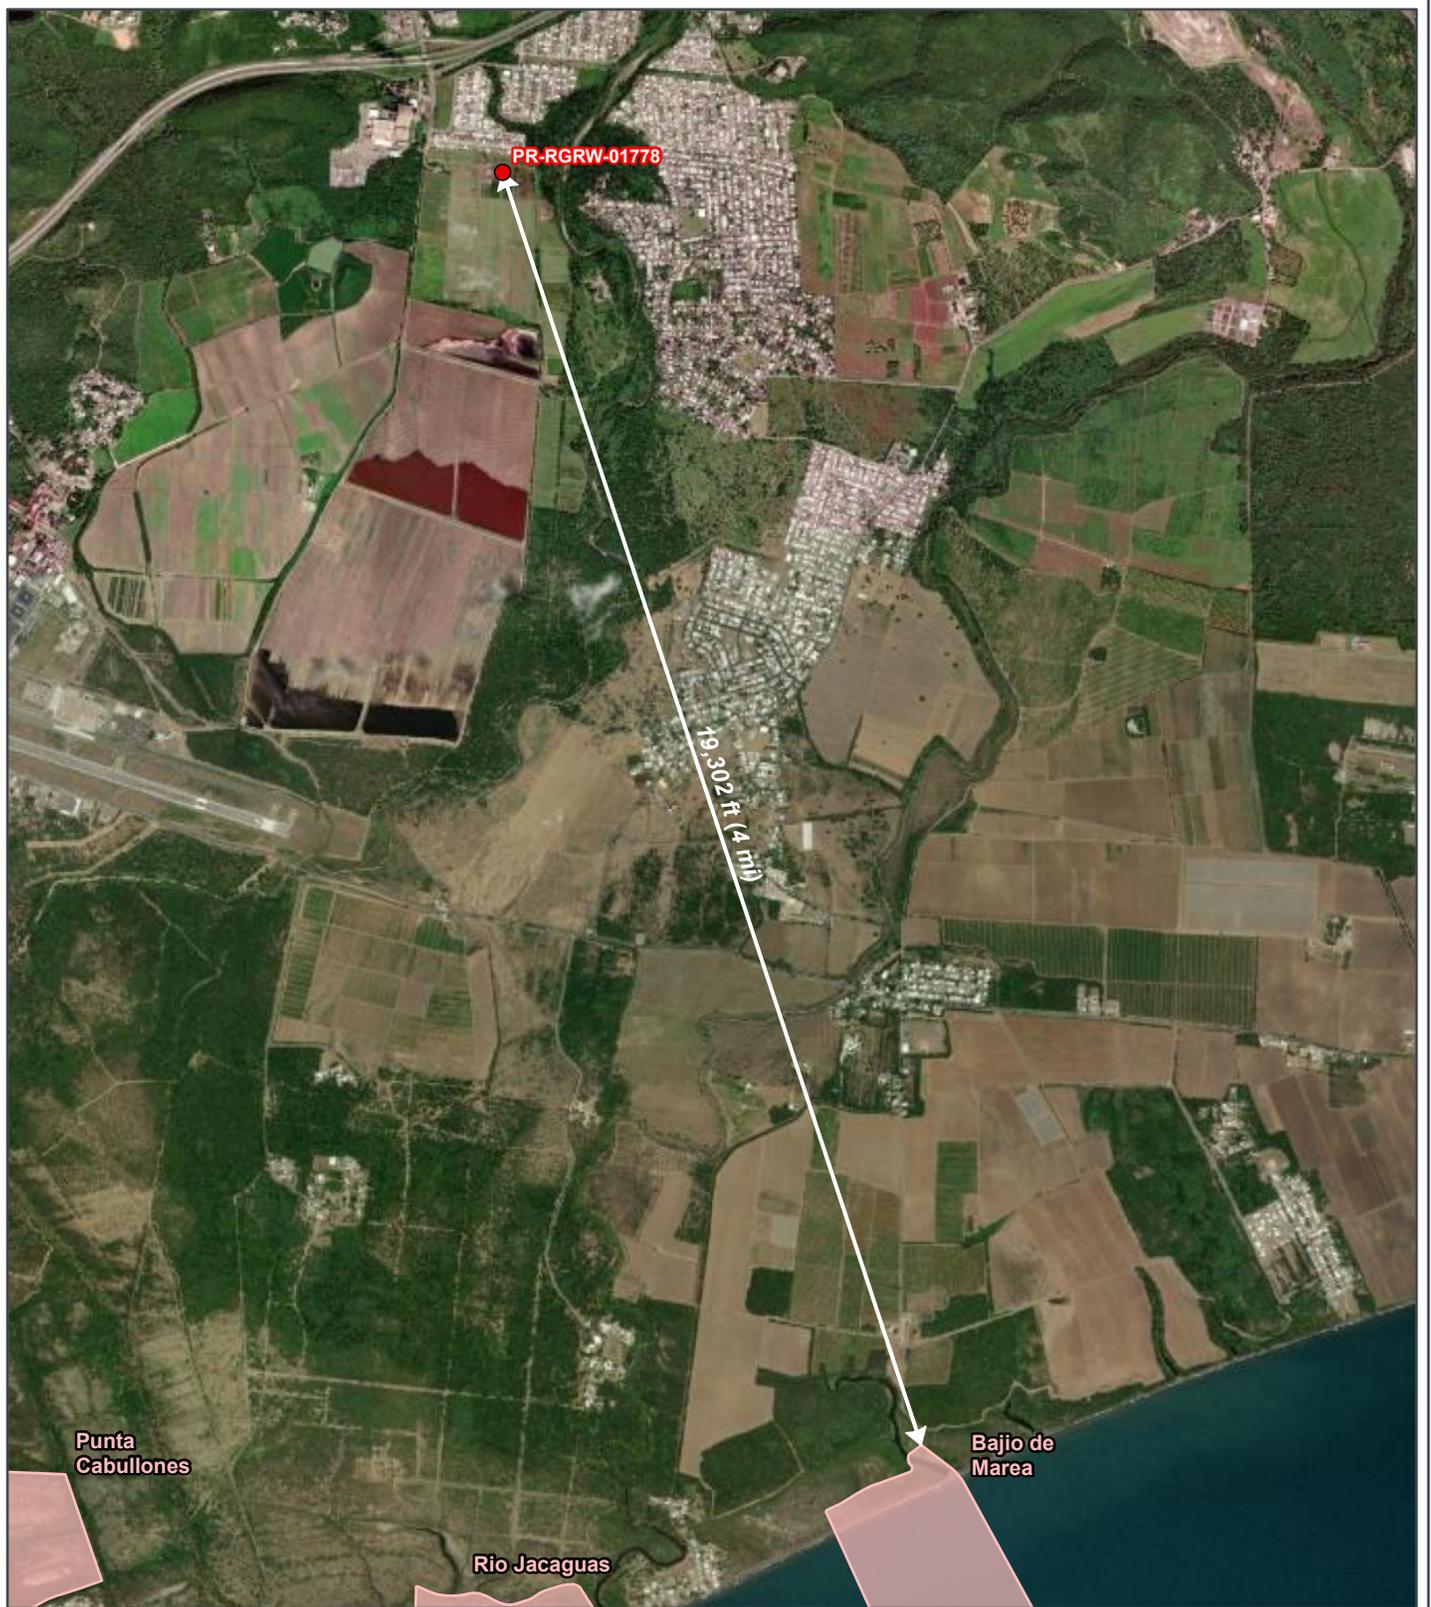
Figure B 2-1: Coastal Barrier Resources Map

The project site is not located in a Coastal Barrier Resource Systems Unit (CBRS) or Otherwise Protected Area (OPA). The closest CBRS unit, Bajio de Marea, is located 19,302 feet (4 miles) from the project site. No further evaluation is required. The project is in compliance with the Coastal Barrier Resources Act.

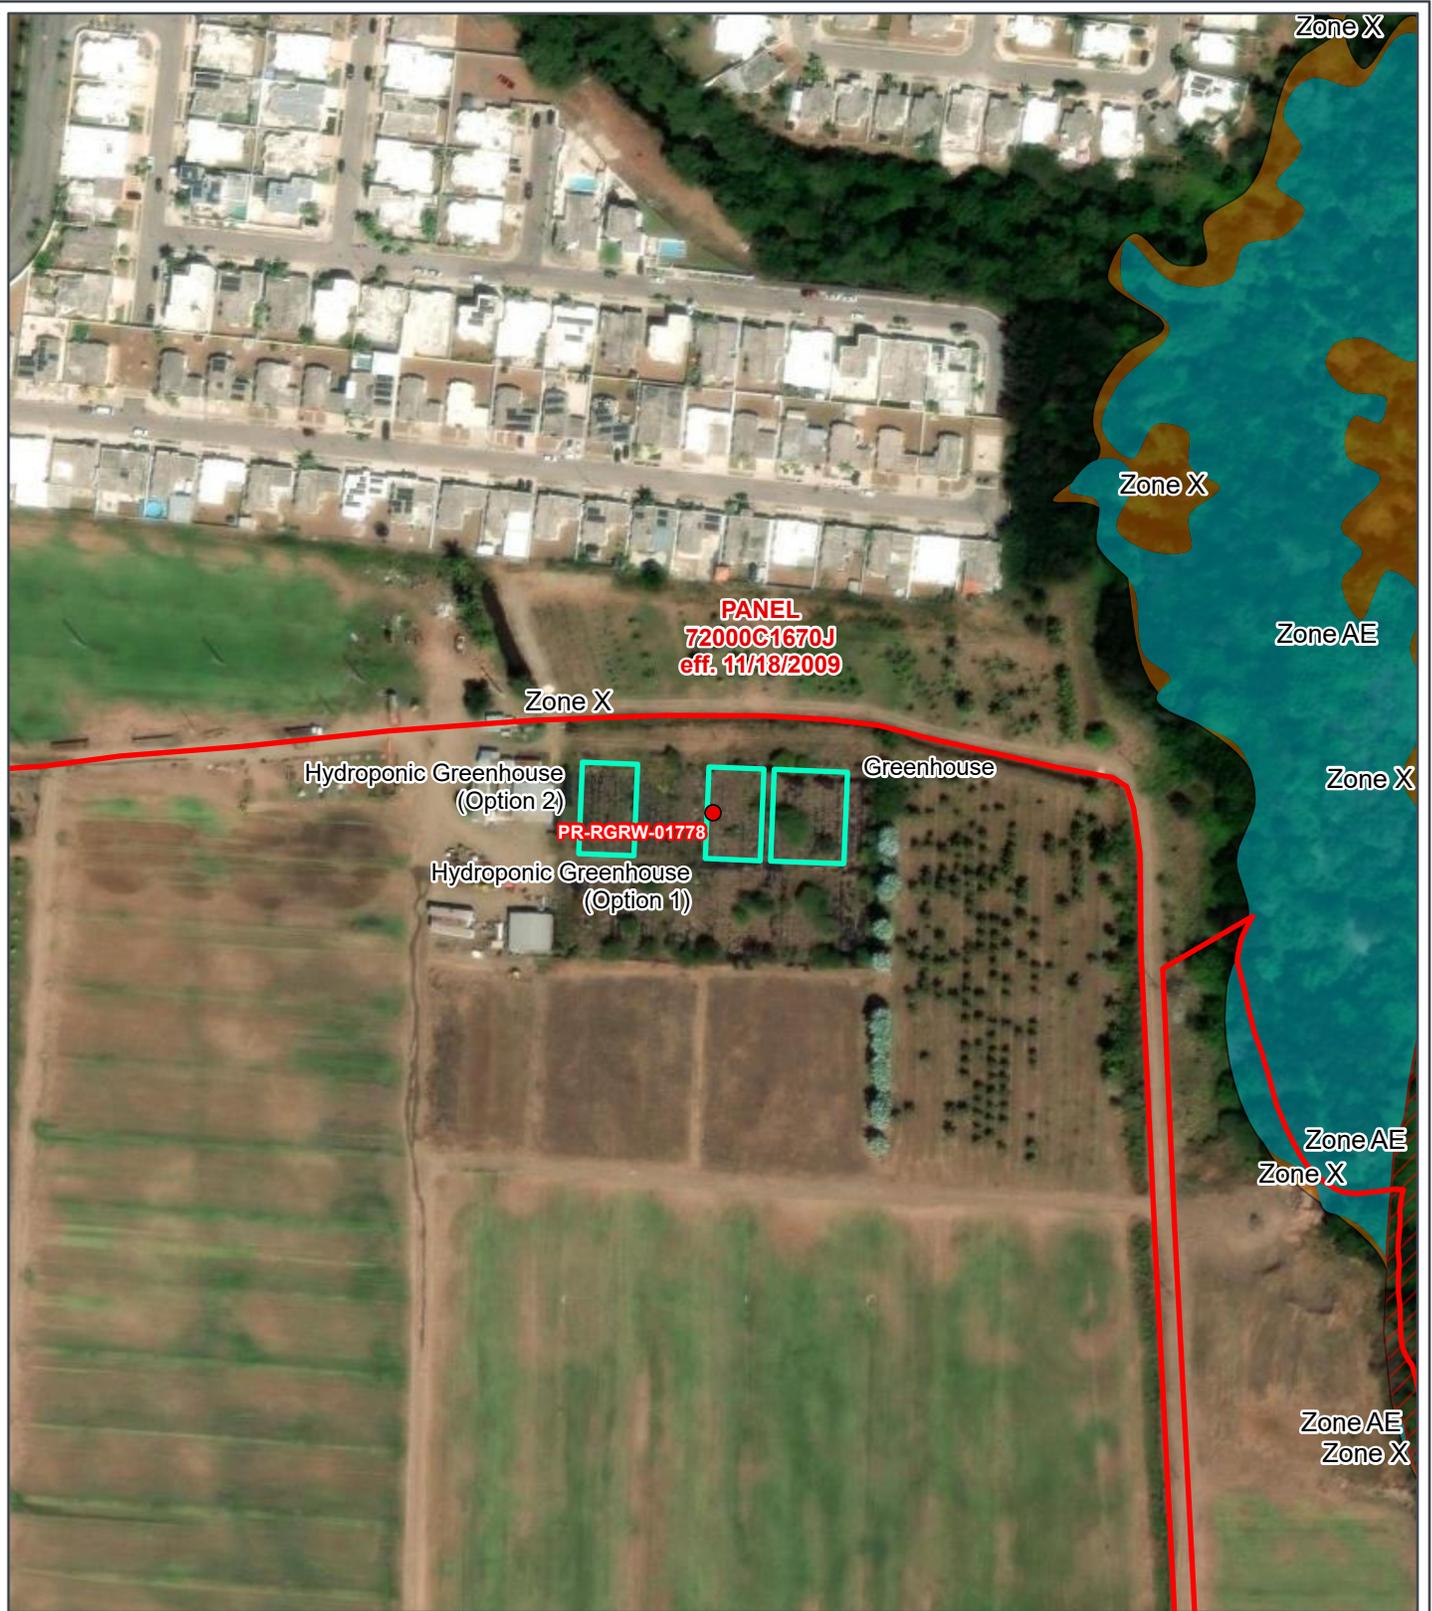
Figure B 3-1: Flood Insurance Rate Map (FIRM)

A review of the FEMA Flood Insurance Rate Map (FIRM), Community Panel 72000C1670J (effective date 11/18/2009), shows the project site is in Flood Zone X, which is not in a Special Flood Hazard Area (SFHA). Flood insurance is not required. No further evaluation is required. The project is in compliance with the Flood Disaster Protection Act and National Flood Insurance Reform Act.

| <p>Flood Insurance</p> <p>Flood Disaster Protection Act of 1973 and National Flood Insurance Reform Act of 1994 [42 USC 4001-4128 and 42 USC 5154a]</p> | <p>Yes No</p> <p><input type="checkbox"/> <input checked="" type="checkbox"/></p> | <p>A review of the FEMA Flood Insurance Rate Map (FIRM), Community Panel 72000C1670J (effective date 11/18/2009), shows the project site is in Flood Zone X, which is not in a Special Flood Hazard Area (SFHA). Flood insurance is not required. No further evaluation is required. The project is in compliance with the Flood Disaster Protection Act and National Flood Insurance Reform Act.</p> <p>The Flood Insurance Partner Worksheet and FIRM (Figure B 3-1) are provided in Appendix B, Attachment 3.</p> |

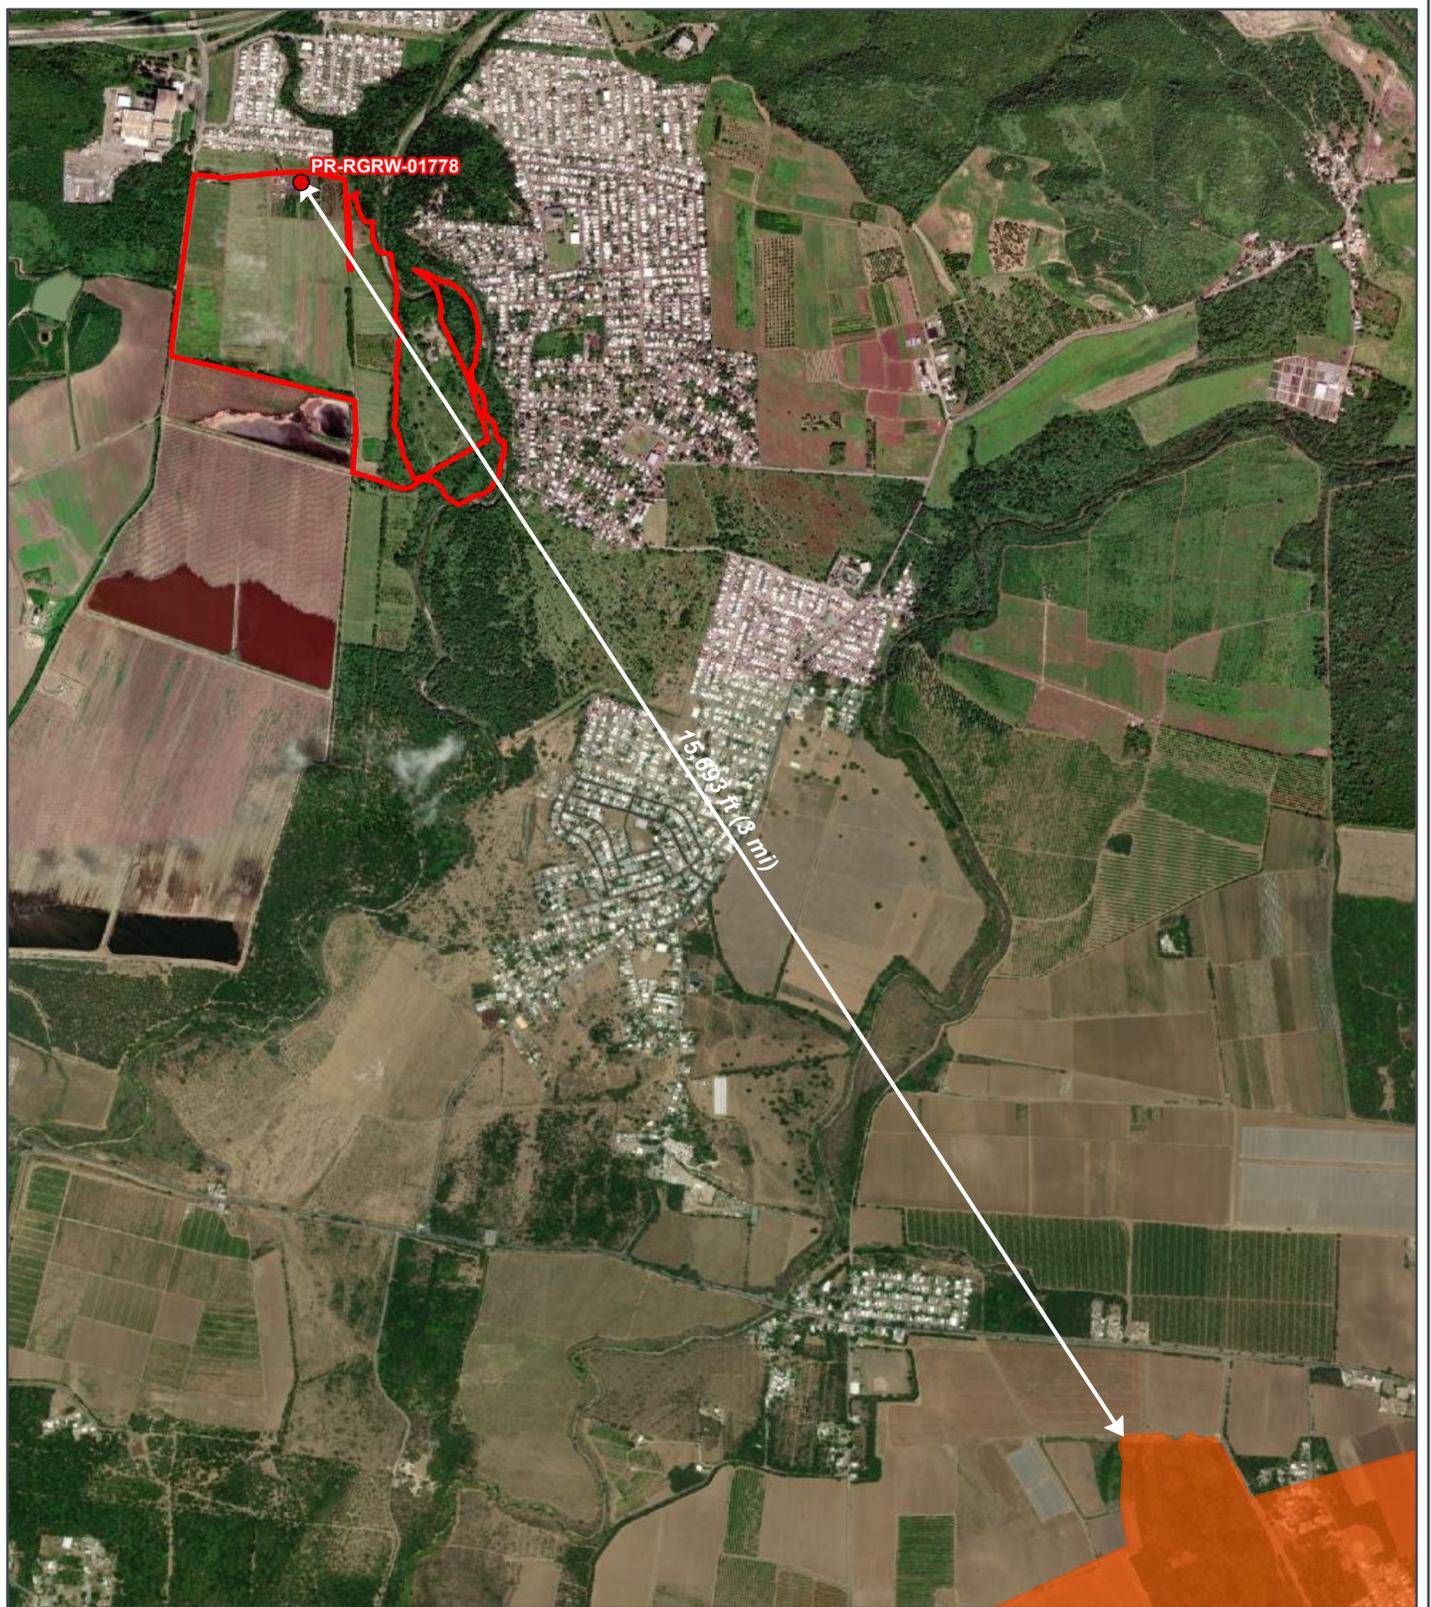
Figure B 5-1: Coastal Zone Management Map

The project site is not located within the Puerto Rico Coastal Management Zone. The closest coastal zone area is located 15,693 feet (3 miles) from the project site. No further evaluation is required. The project is in compliance with the Coastal Zone Management Act.

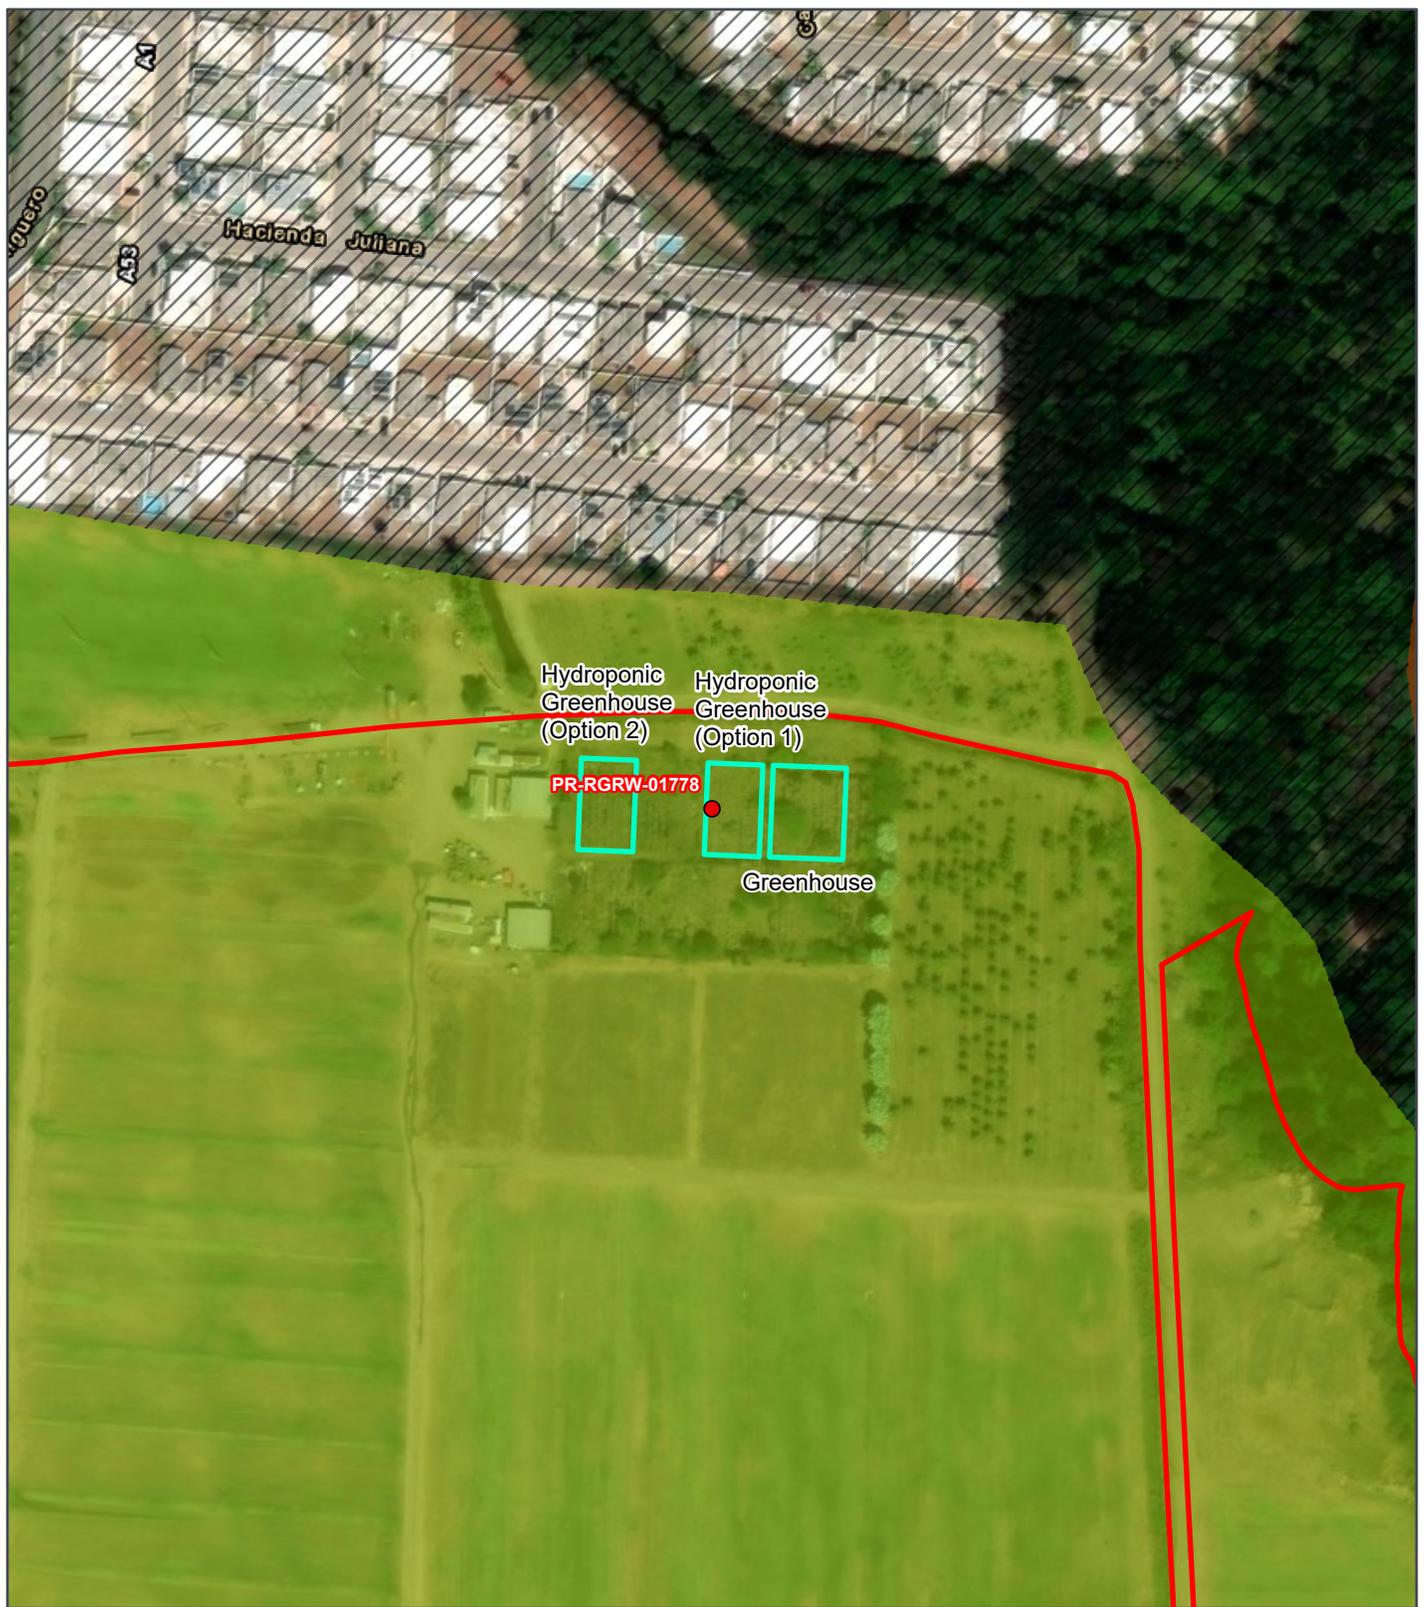
**Figure B 9-1:
Prime Farmland Map**

This project does not include any activities that could potentially convert agricultural land to non-agricultural use. No prime farmland or farmlands of statewide importance are within the project area. Although the project includes new construction, the project is exempt from review under the Farmland Protection Policy Act (FFPA) as the project is limited to construction of on-farm structures needed for farm operations. No further review is required. The project is in compliance with the Farmland Protection Policy Act.

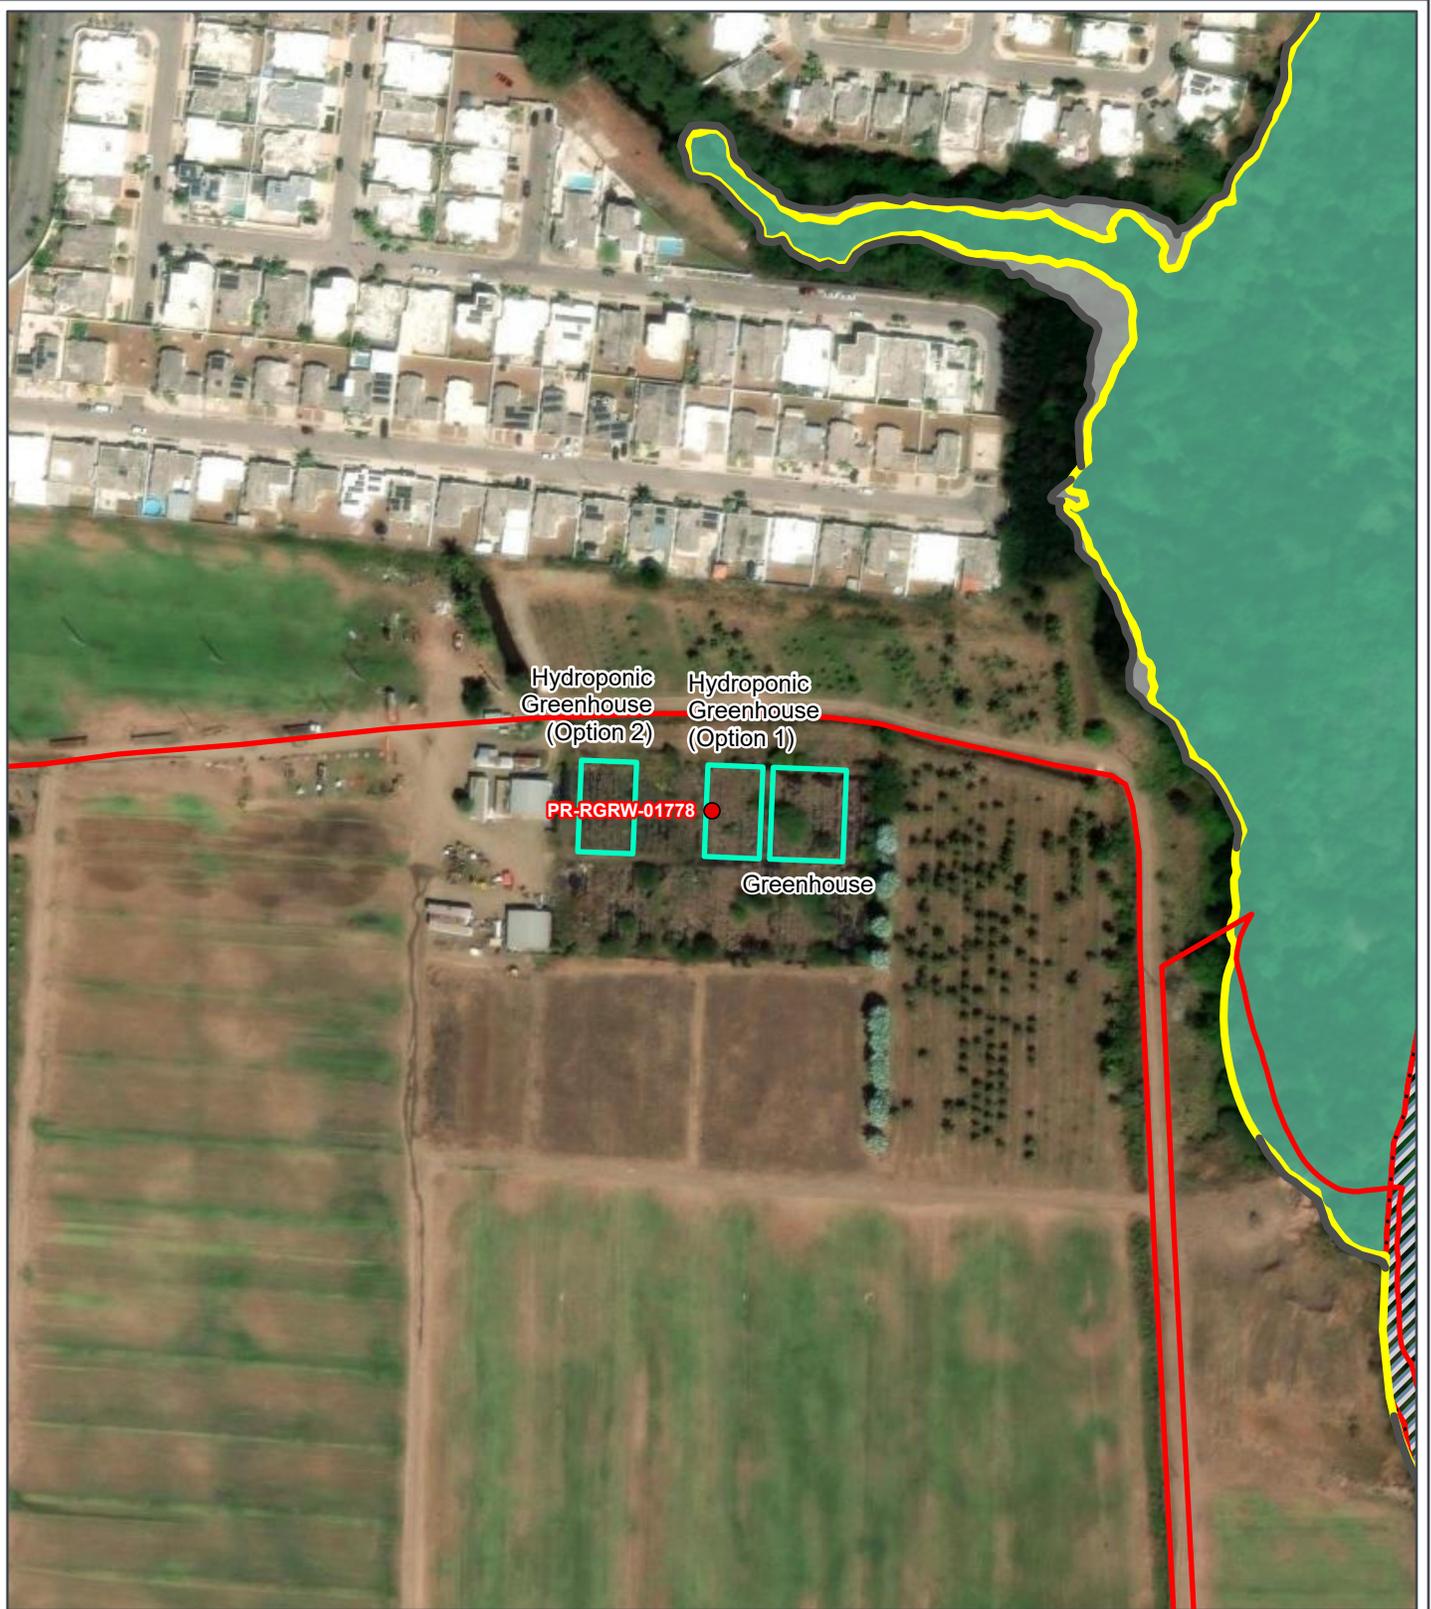
**Figure B 10-1:
Advisory Base Flood
Elevation For 100-Year
Floodplain Map**

A review of the Advisory Base Flood Elevation (ABFE) map, Community Panel 72000C1670J (effective date 11/18/2009), shows the project site is in Flood Zone X. The project is not located in the 100-year floodplain or ABFE special flood hazard area; therefore, no further action is required. The project is in compliance with Executive Order 11988.

| <p>Floodplain Management</p> <p>Executive Order 11988, particularly section 2(a); 24 CFR Part 55</p> | <p>Yes No</p> <p><input type="checkbox"/> <input checked="" type="checkbox"/></p> | <p>A review of the Advisory Base Flood Elevation (ABFE) map, Community Panel 72000C1670J (effective date 11/18/2009), shows the project site is in Flood Zone X. The project is not located in the 100-year floodplain or ABFE special flood hazard area; therefore, no further action is required. The project is in compliance with Executive Order 11988.</p> <p>The Floodplain Management Partner Worksheet and ABFE Floodplain Map (Figure B 10-1) are provided in Appendix B, Attachment 10.</p> |

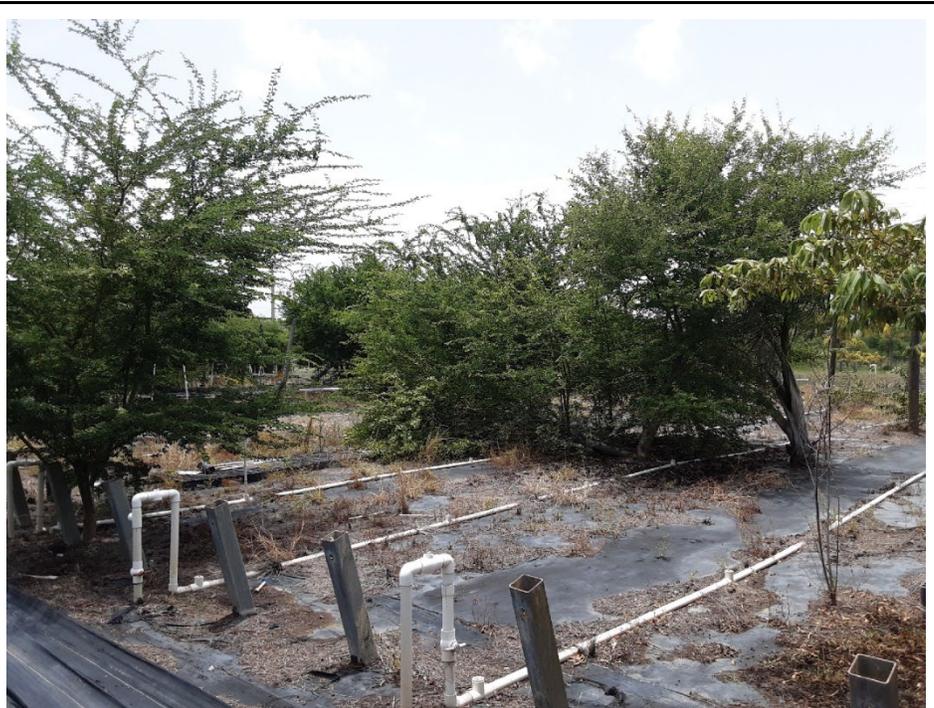
02

Overview of the site location for hydroponic Greenhouse 2, Option 2, southeast corner.

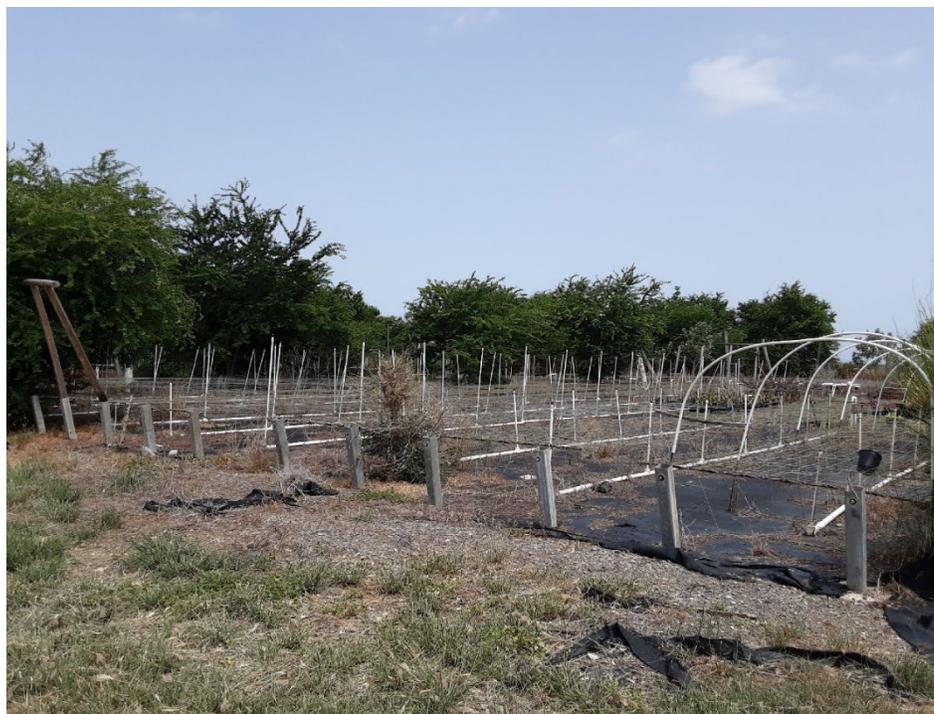
Overview of the site location for hydroponic Greenhouse 2, Option 1, southwest corner.

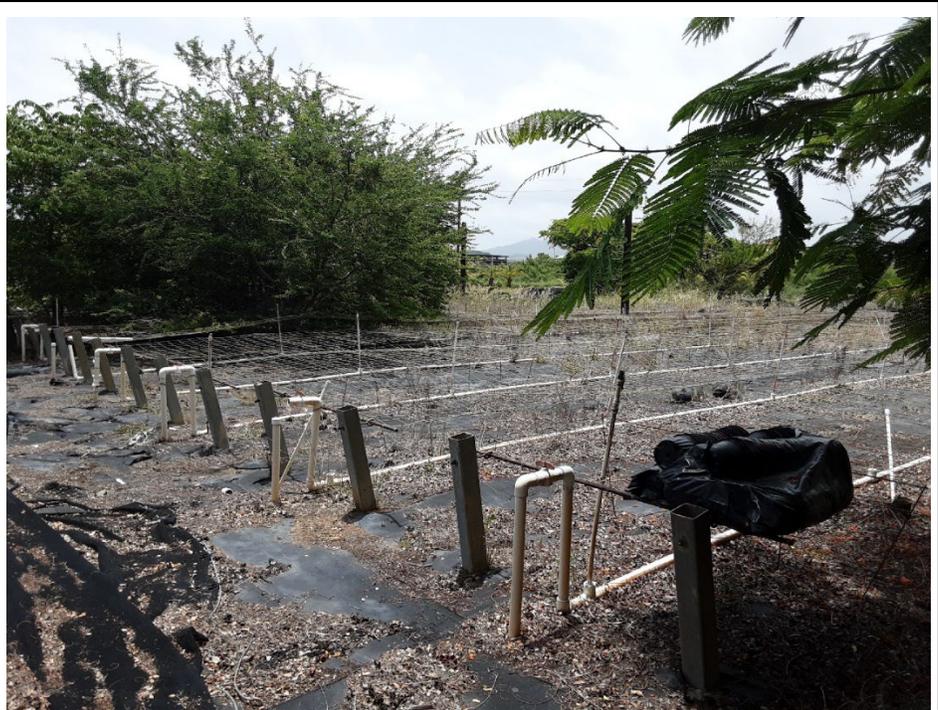
Photo #:
04

Overview of the site location for the shade Greenhouse 1, southeast corner.

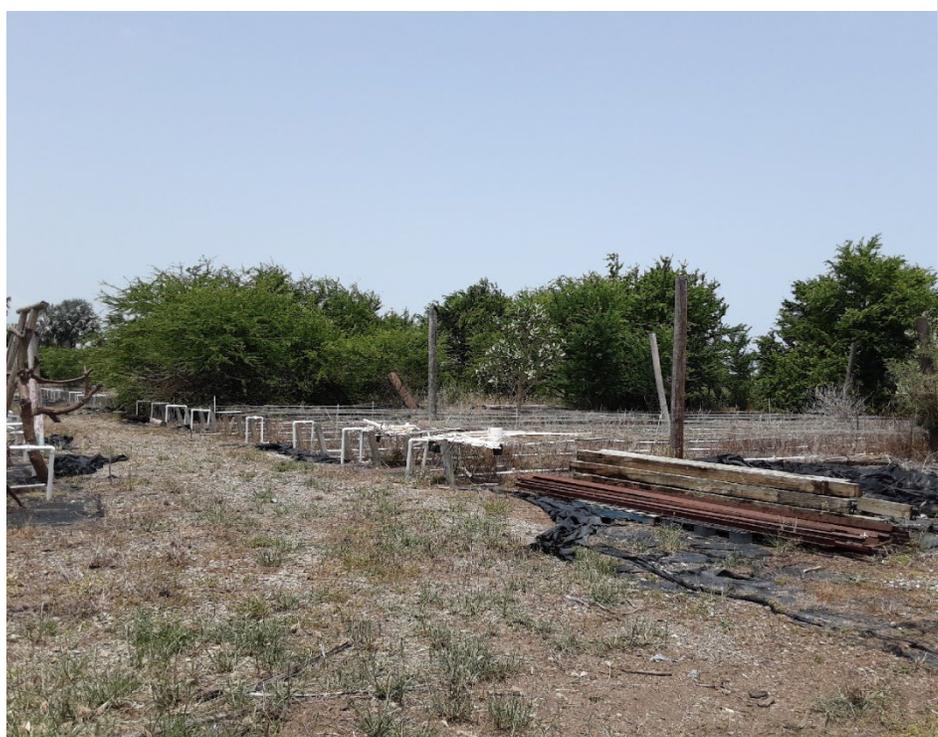
Overview of the location of the shade Greenhouse 1, and both Options for hydroponic Greenhouse 2.

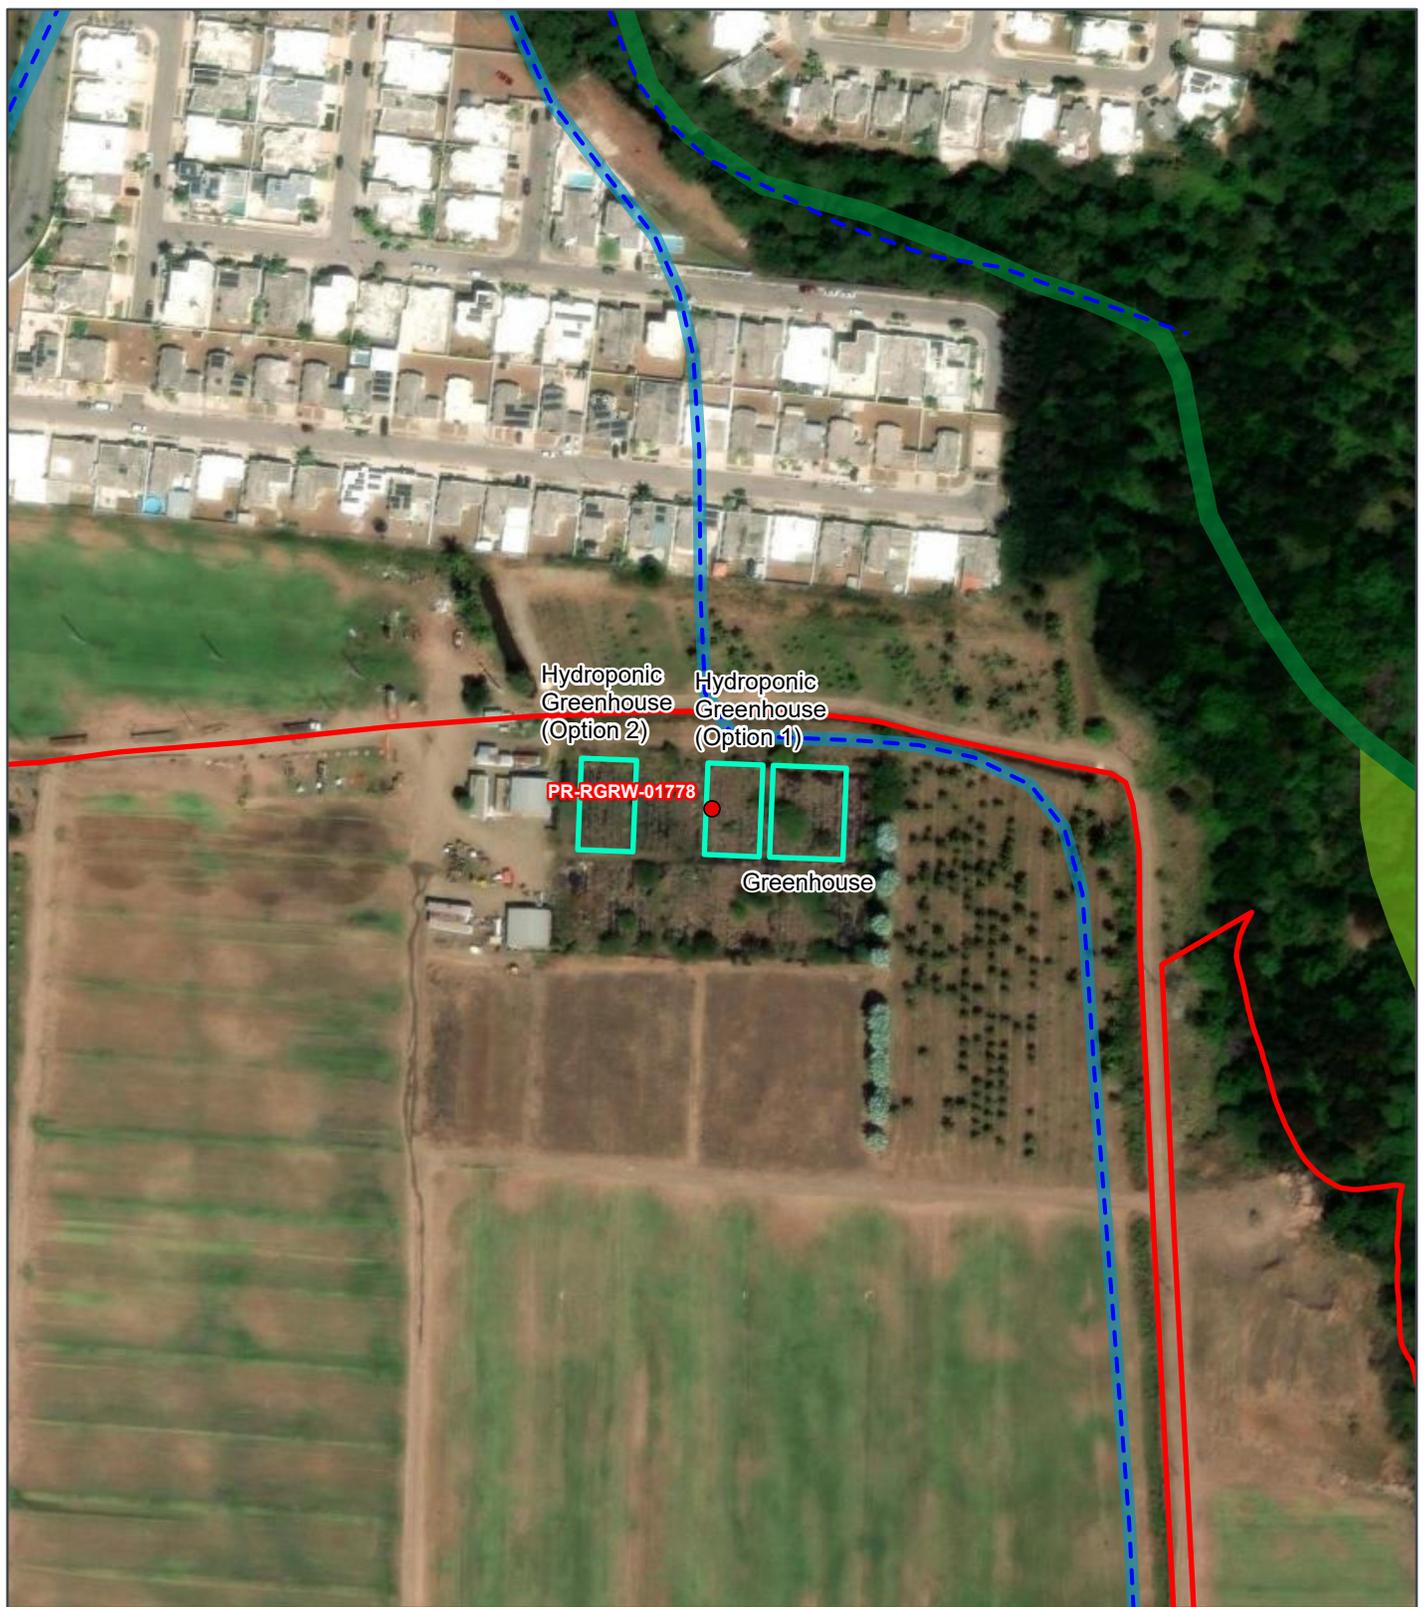
A riverine wetland (shown as an NHD stream on Figure B 14-1) is located approximately 24 feet north of both greenhouses at its closest point, and will not be affected by project activities; therefore, an 8-step decision making process is not required. Note- the NWI online webmapper, accessed on July 26, 2023, shows this NHD stream is a riverine wetland.

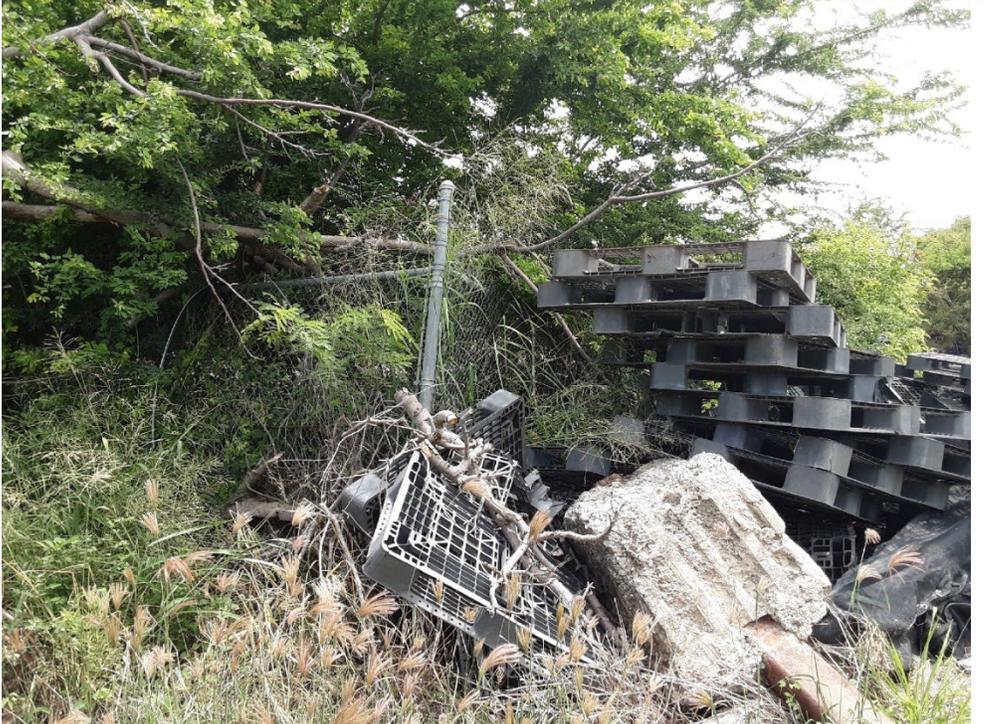
| Description: The picture taken from the northeast corner overviews the southwest area of the project location for a greenhouse 100x80ft and it shows the debris and the fallen tree both left after Hurricane Maria. | | |

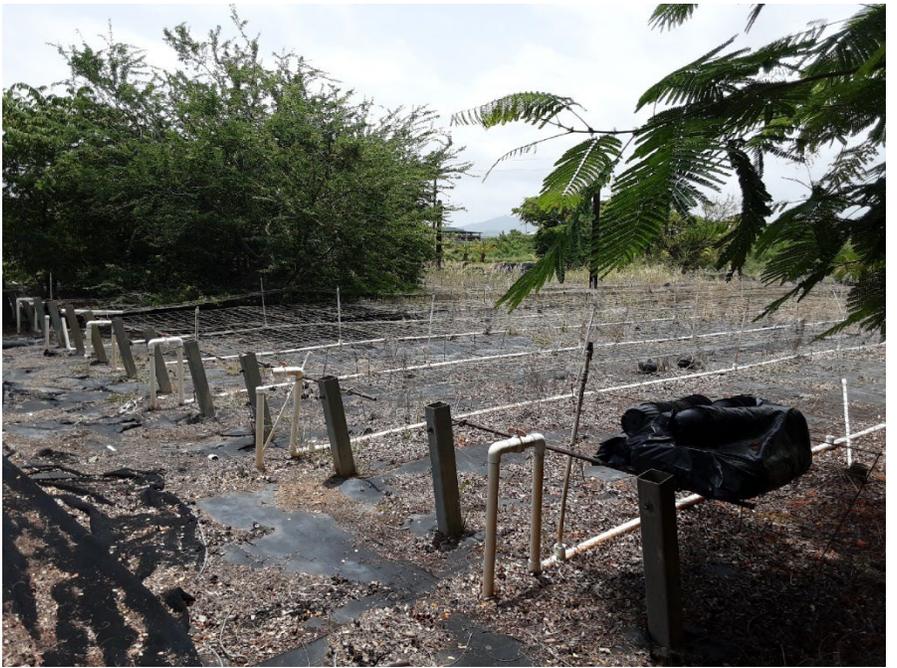
| Photo #: 02 | Date: 07/21/ 2023 | |

| Description: The picture taken from the southeast corner overviews the northwest area of the project location for a greenhouse 100x80ft and it shows the area after Hurricane Maria; the Hurricane took off the roof but left the irrigation system, the ground cover, and part of the tables. Before Maria, the property was a greenhouse administered by Sucesión Serrallés II. | | |

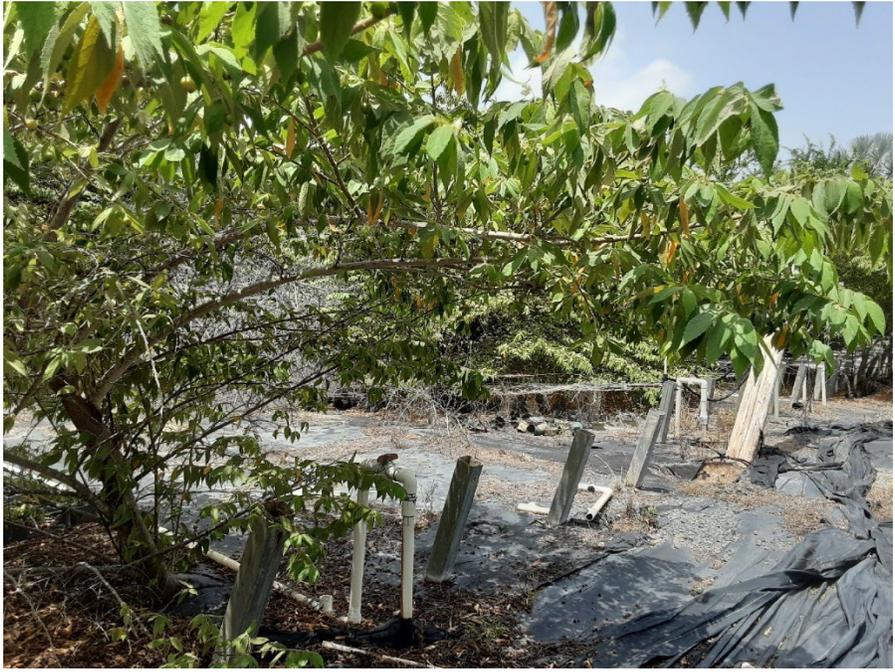
| Description: The picture taken from the southwest corner overviews the northeast area of the project location for a greenhouse 100x80ft and it shows the area after Hurricane Maria; the Hurricane took off the roof but left the irrigation system, the ground cover, and part of the tables. Before Maria, the property was a greenhouse administered by Sucesión Serrallés II. | | |
