Environmental Assessment

Project ID: PR-RGRW-01778

Project Name: Huertos de Puerto Rico LLC

Responsible Entity: Puerto Rico Department of Housing

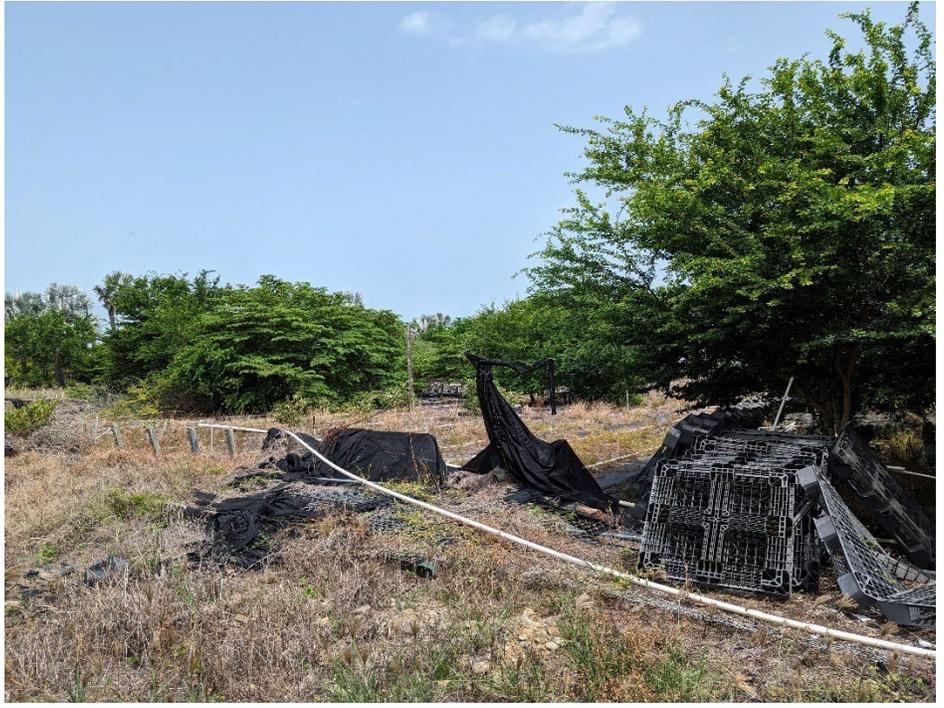
| Photo #: 04 | Date: 07/21/ 2023 | |

| Description: The picture taken from the northwest corner overviews the southeast area of the project location for a greenhouse 100x80ft and it shows the area after Hurricane Maria with the above-ground pipes used for the irrigation system, the ground cover already pulled aside, and plastic pallets. | | |

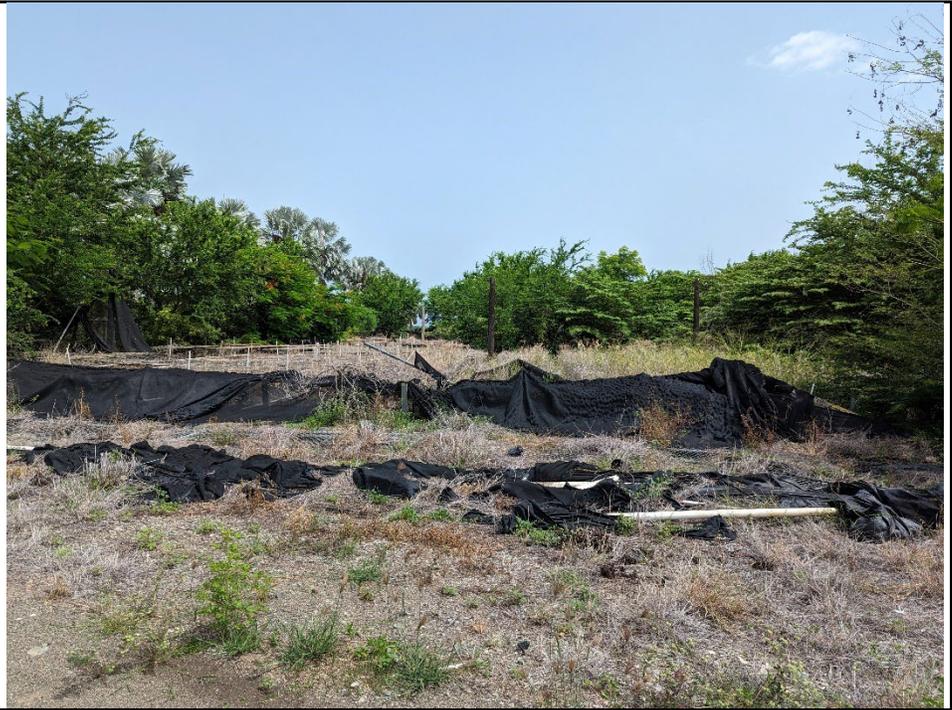
| Description: The picture taken from the dirt road south of the ditch overviews the south area of the project location for a greenhouse 100x80ft and it shows the pipes used for the irrigation system, the ground cover already pulled aside, and overgrown vegetation. | |

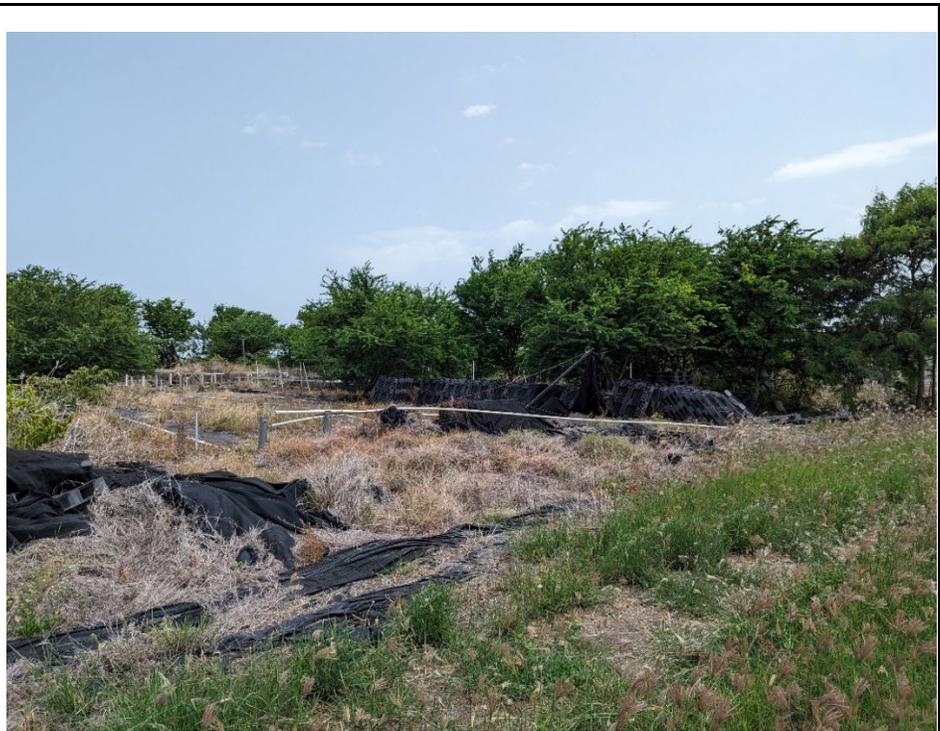
| Description: The picture taken from the northeast corner overviews the southwest area of the project location option 1 for a greenhouse-hydroponic 100x60ft it shows the ground cover already pulled aside, a partial view of the tables used for the previous greenhouse established before Hurricane Maria, and the overgrown vegetation. | |

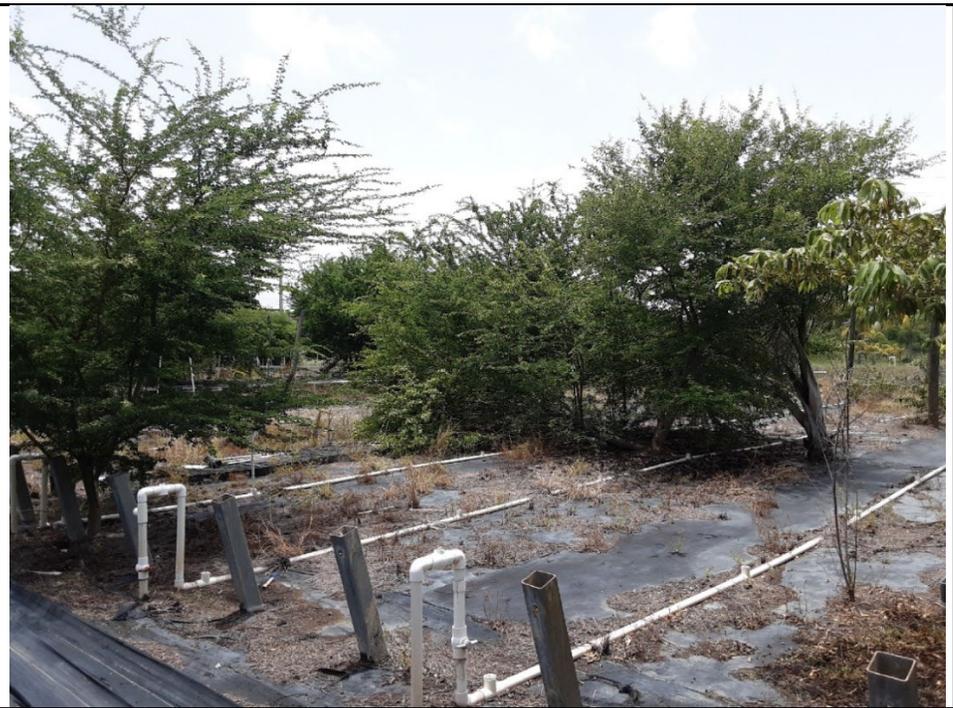
| Description: The picture taken from the southeast corner overviews the northwest area of the project location option 1 for a greenhouse-hydroponic 100x60ft and it shows the ground cover, the irrigation system, the metal posts for the tables, and the overgrown vegetation. | |

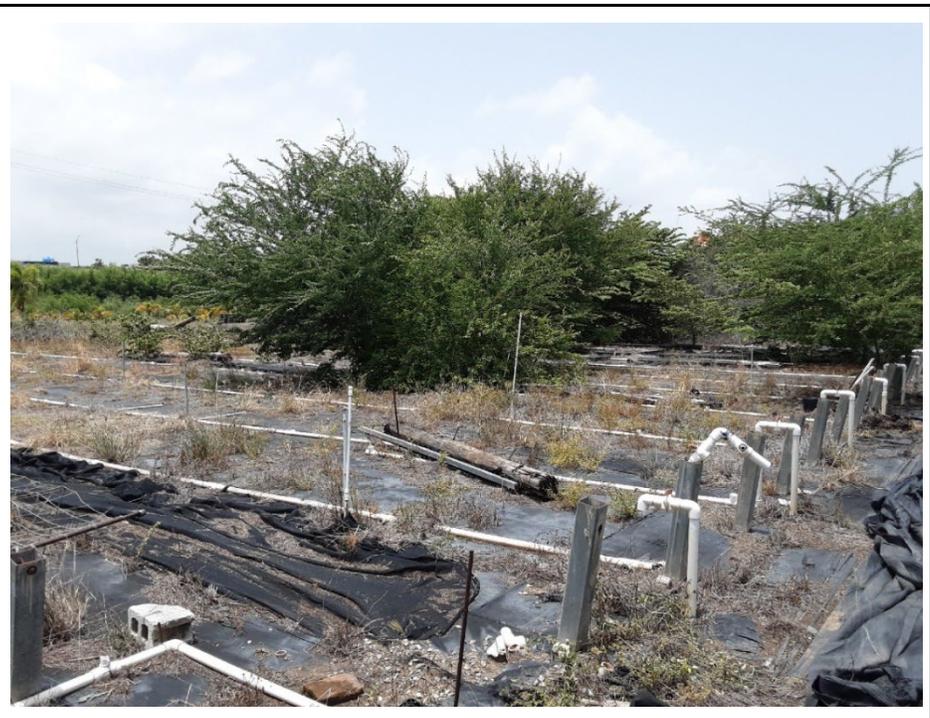
| Description: The picture taken from the southwest corner overviews the northeast area of the project location option 1 for a greenhouse-hydroponic 100x60ft and it shows the ground cover, the irrigation system, the metal posts for the tables, hardwood poles for the previous roof taken away by Hurricane Maria, and the overgrown vegetation. | |

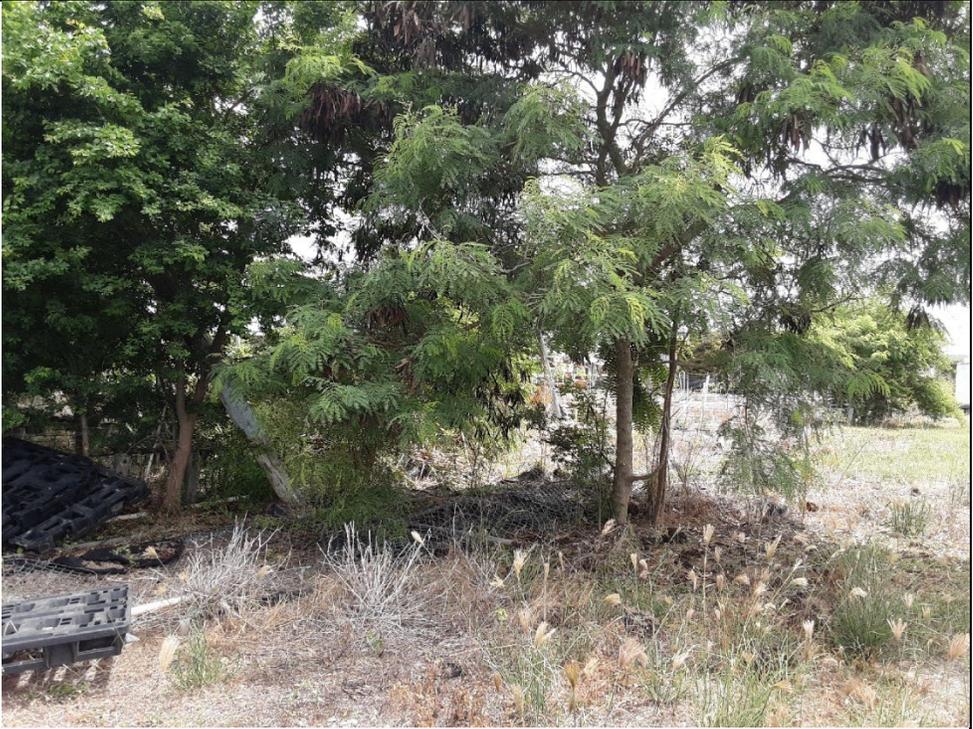
| Photo #: 09 | Date: 07/21/ 2023 | |

| Description: The picture taken from the northeast corner overviews the southwest area of the project location option 1 for a greenhouse-hydroponic 100x60ft and it shows the ground cover, the irrigation system, the posts for the tables, and the overgrown vegetation. | | |

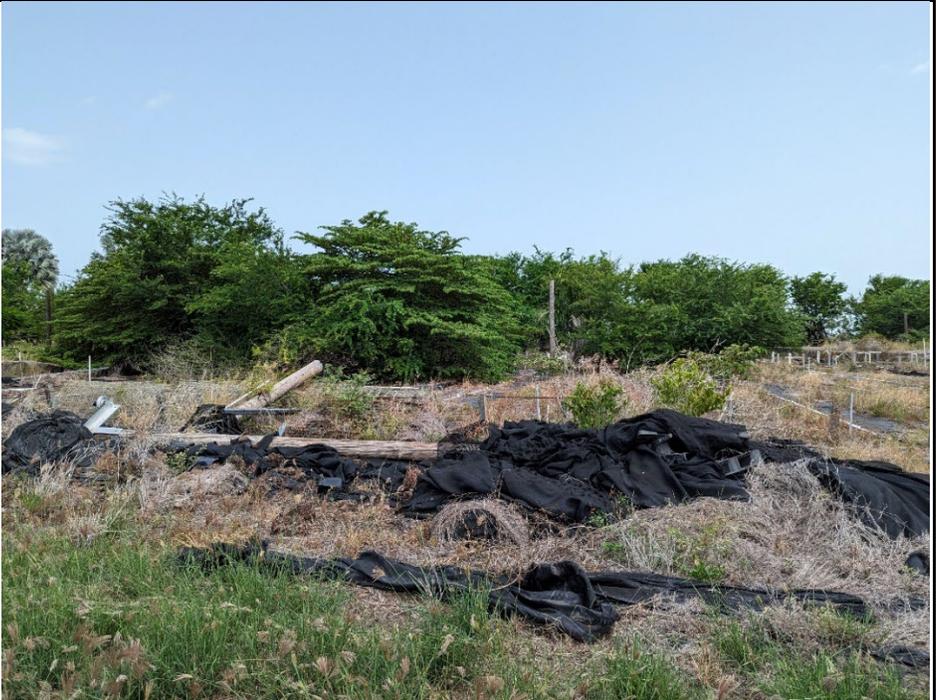
| Photo #: 10 | Date: 07/21/ 2023 | |

| Description: The picture taken from the northwest corner overviews the southeast area of the project location option 1 for a greenhouse-hydroponic 100x60ft and it shows the ground cover pulled aside, the irrigation system, hardwood poles for the previous roof destroyed by Hurricane Maria, and the overgrown vegetation. | | |

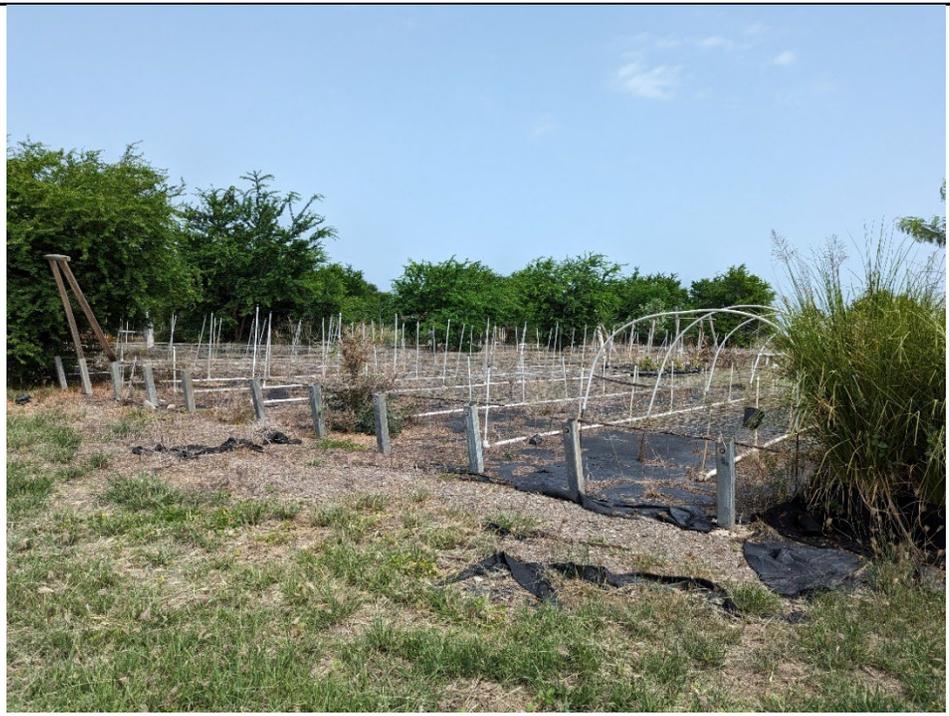
Description:
The picture taken from the southeast corner overviews the northwest area of the project location option 2 for a greenhouse-hydroponic 100x60ft and it shows the ground cover pulled aside, the irrigation system, the metal posts for the tables, and the overgrown vegetation.

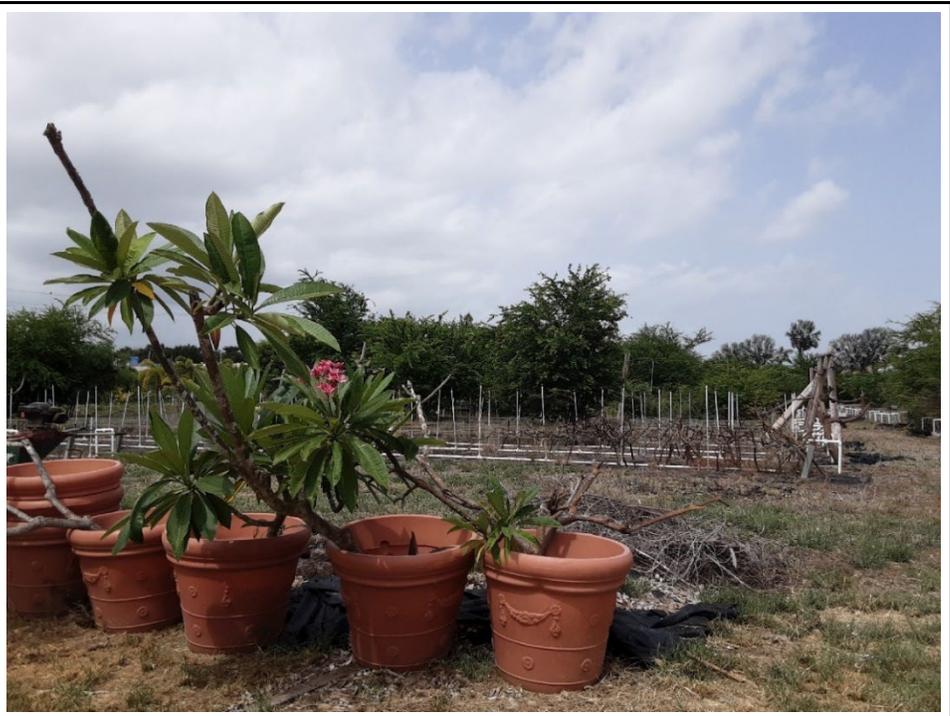
Description:
The picture taken from the parking area overviews the option 2 area of the project location for a greenhouse-hydroponic 100x60ft and it shows the overgrown vegetation, the irrigation system, and pots dividing the parking lot and areas where the greenhouses were located.

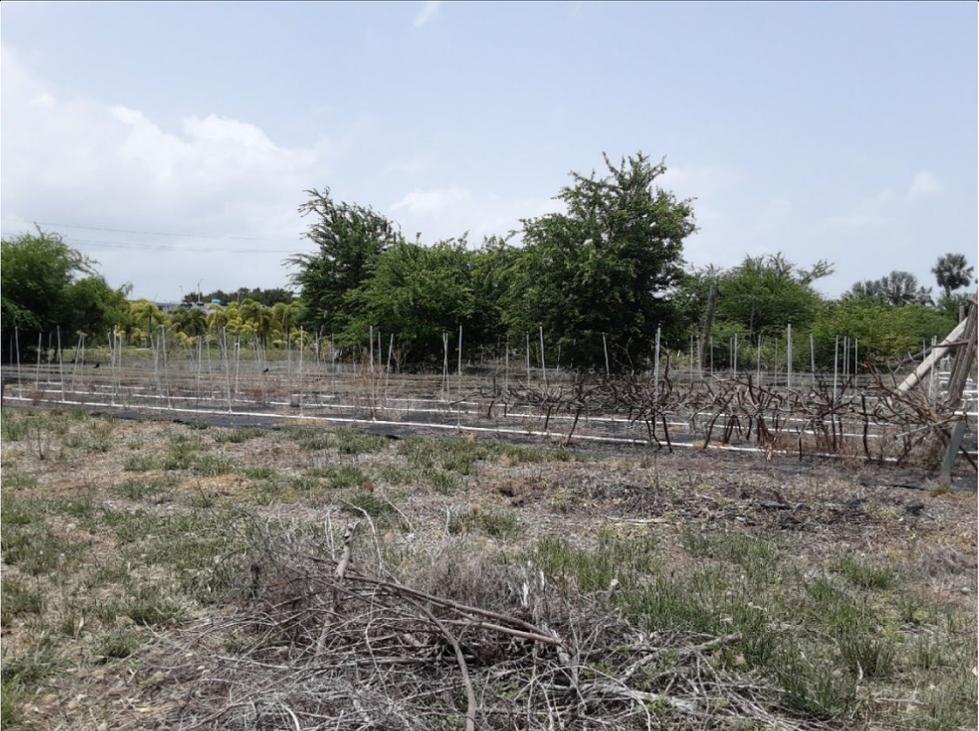
| Description: The picture taken from the parking area overviews option 2 for the project location of a greenhouse-hydroponic 100x60ft showing the overgrown vegetation and the irrigation system. | | |

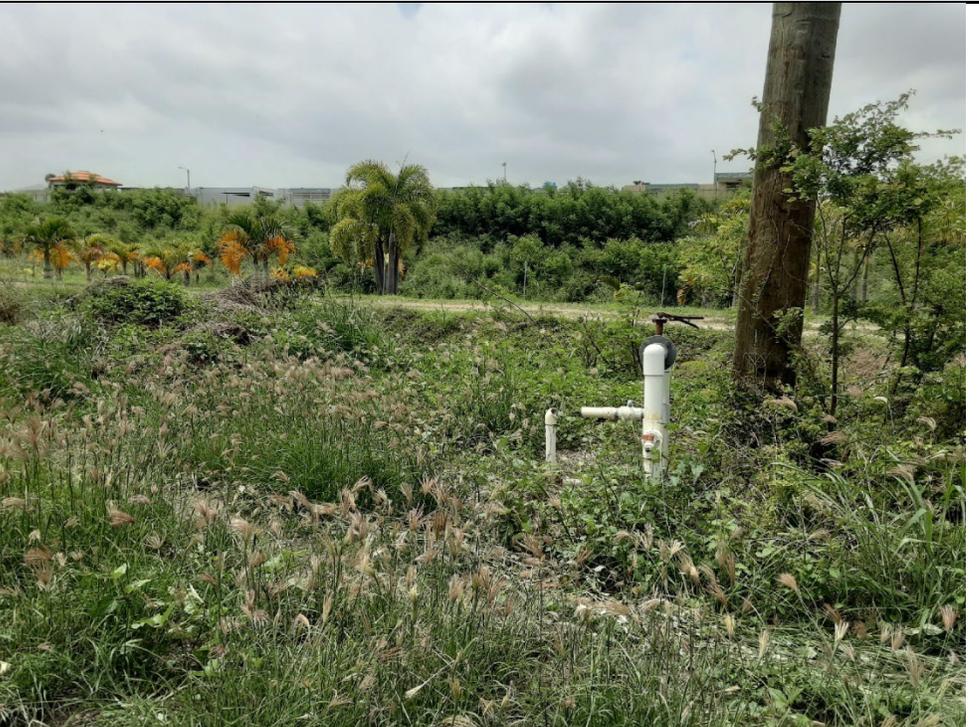
| Photo #: 14 | Date: 07/21/ 2023 | |

| Description: This picture overlooks the connection for the irrigation system between the dirt road (south) and a ditch (north) on the northeast corner of the proposed location for a 100x80ft greenhouse. | | |

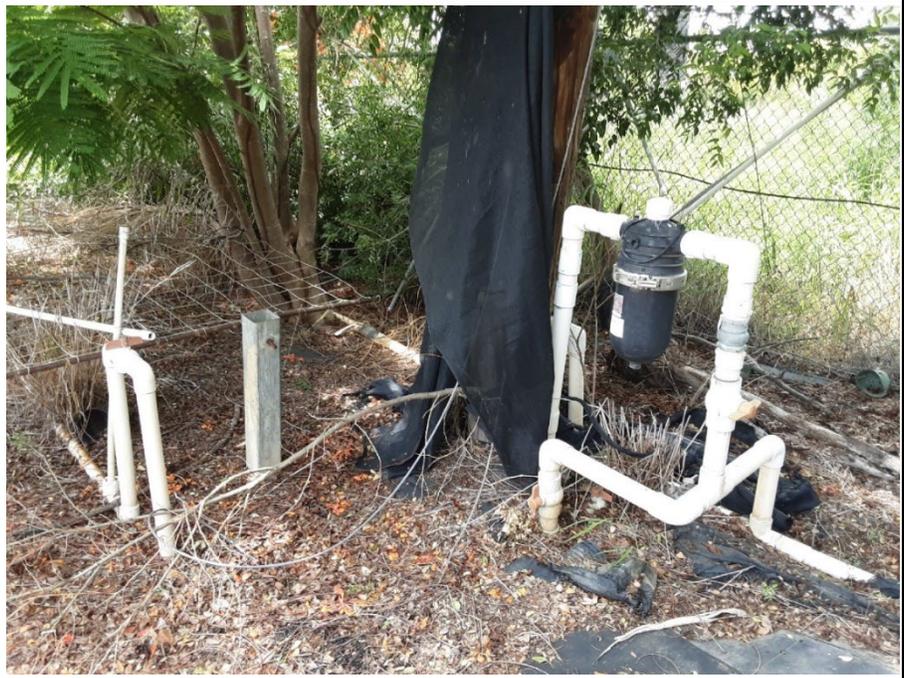
| Description: The picture is a close-up of the water valve used to direct the water through the areas selected by the applicant to cultivate. The picture also shows a partial view of the tables already in place when the applicant leased the property. All this was installed before the applicant leased the property by the Sucesión Serrallés II which used to run a greenhouse nursery. | |

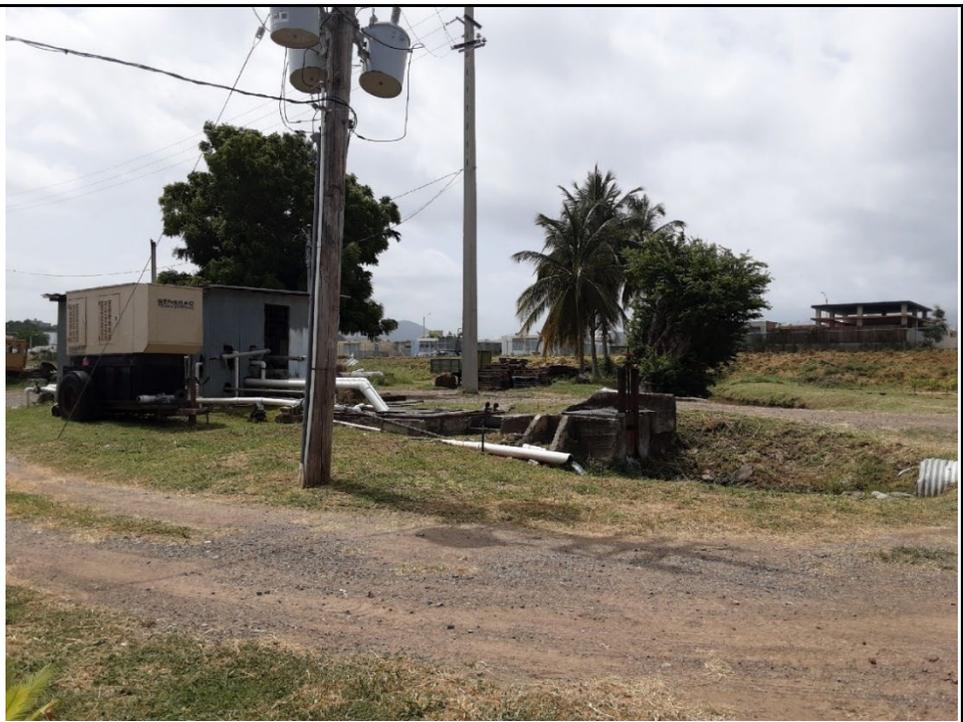
| Description: The picture presents the area where the water pump is located; the water comes from the water well and from a lake inside the property. The picture also shows the transformer where the electricity is generated from the electric company GENERA. | |

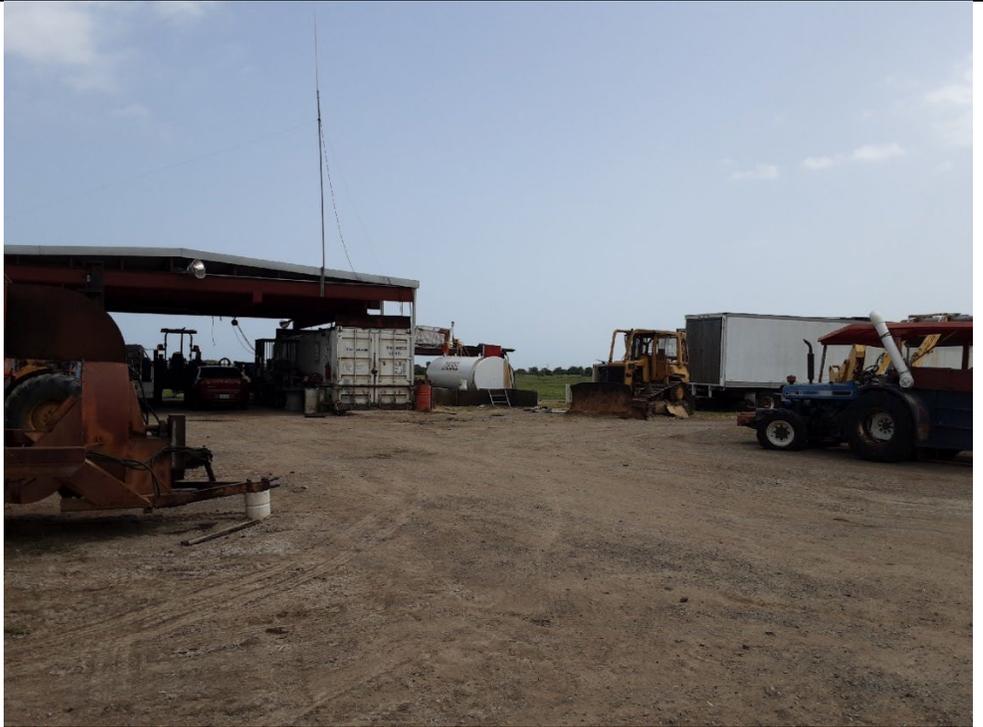
| Description: This picture overviews the parking area with a mechanic shop, a diesel tank in used, drums, multiple freight containers, and heavy machinery. | | |

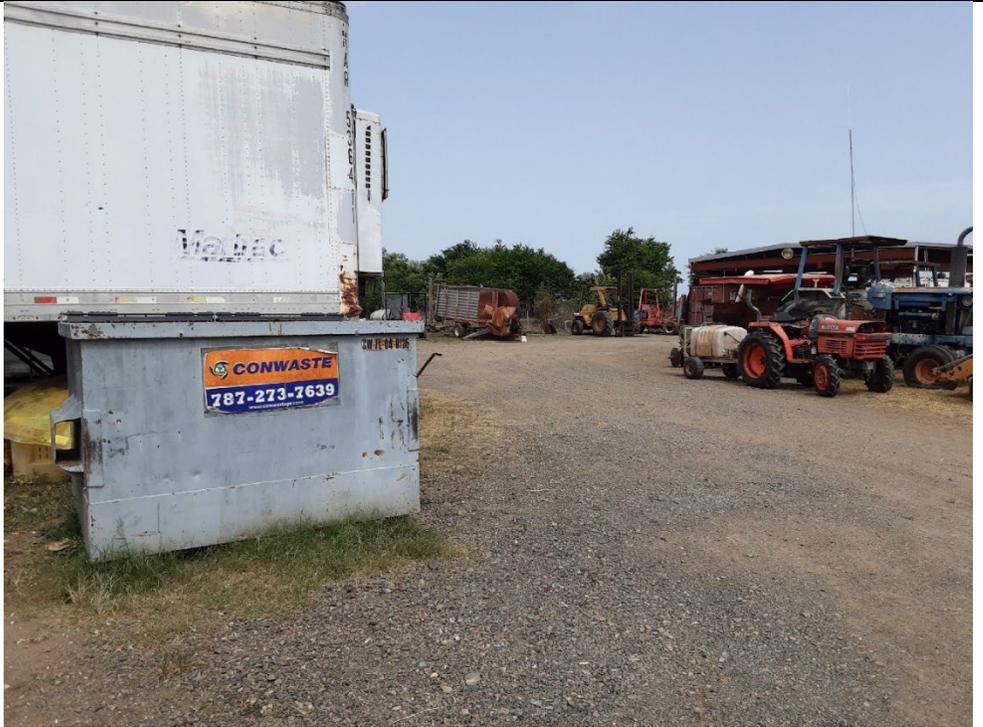
| Photo #: 18 | Date: 07/21/ 2023 | |

| Description: This picture overviews the parking area with multiple freight containers, a waste container, and heavy machinery. | | |

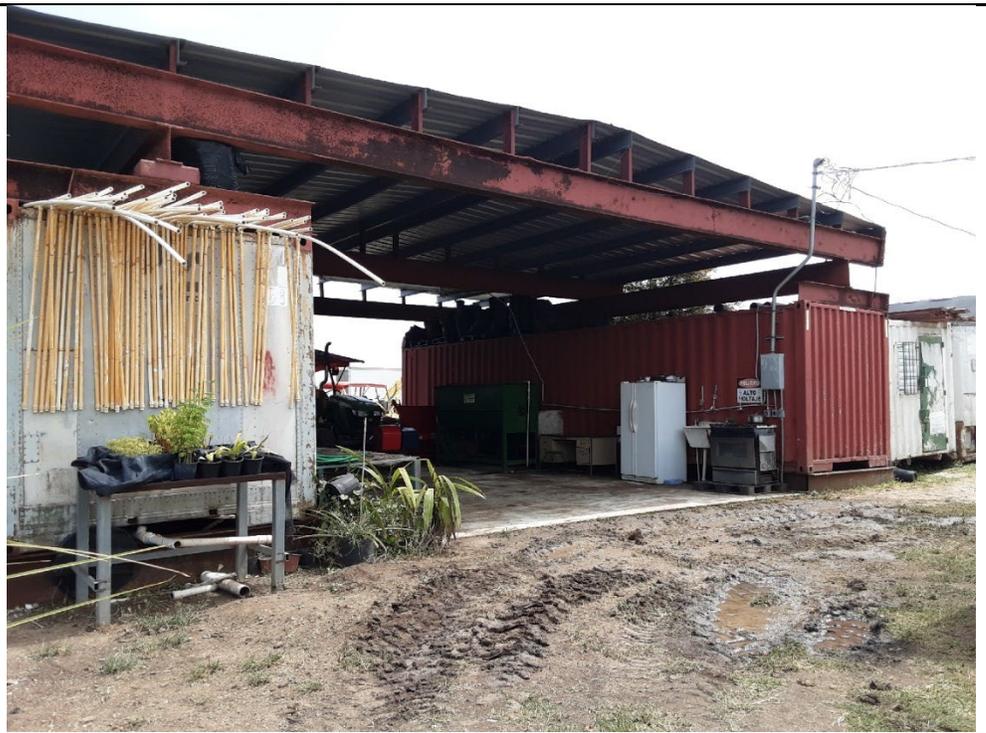
| Description: This picture presents the warehouse the applicant plans to use as a workspace; this area has a potable water connection from PRASA (AAA, in Spanish) and electricity. | |

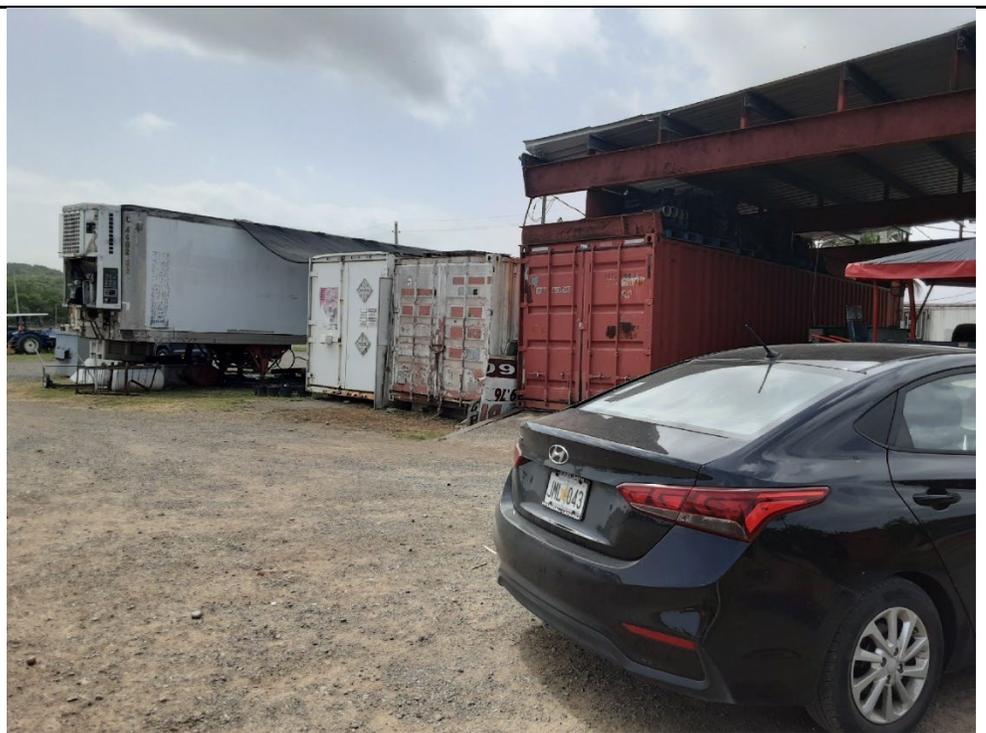
| Description: This picture overviews the parking area with multiple freight containers, a partial view of the warehouse that will be used as a workspace, and the applicant's vehicle. | |

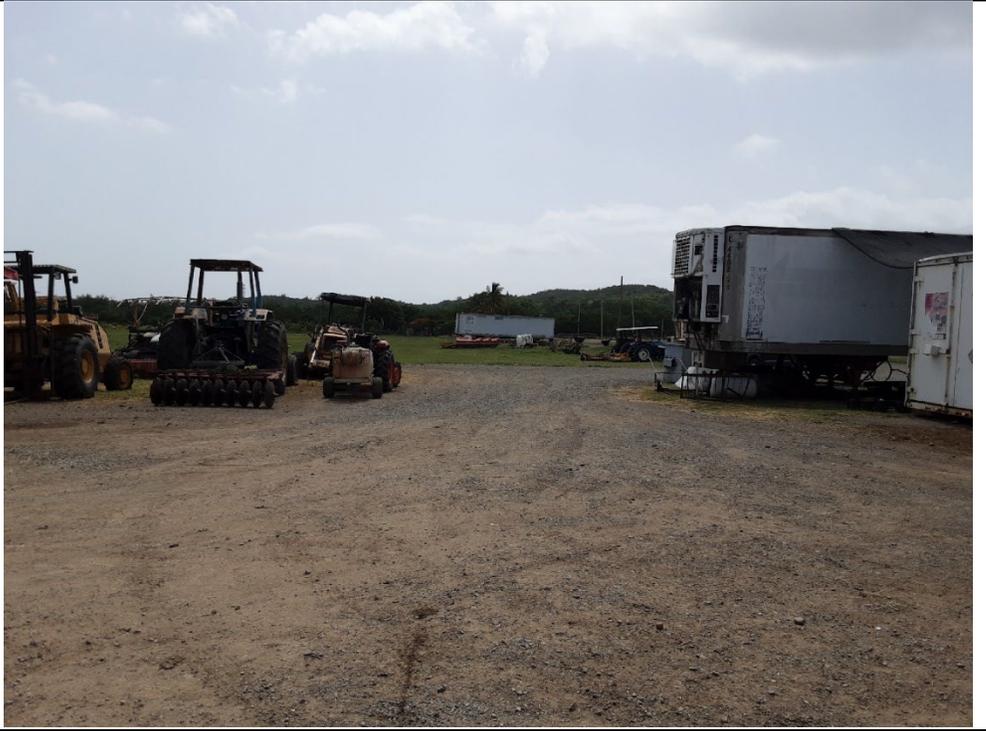
| Photo #: 21 | Date: 07/21/ 2023 | |

| Description: This picture overviews the parking area with multiple freight containers and heavy machinery. This area belongs to Sucesión Serrallés II and is used for the general mechanical and cleaning operation for different properties. | | |
