Environmental Assessment

Determinations and Compliance Findings for HUD-assisted Projects

Project ID: PR-RGRW-01721

Project Name: José Ángel Feliciano Rivera

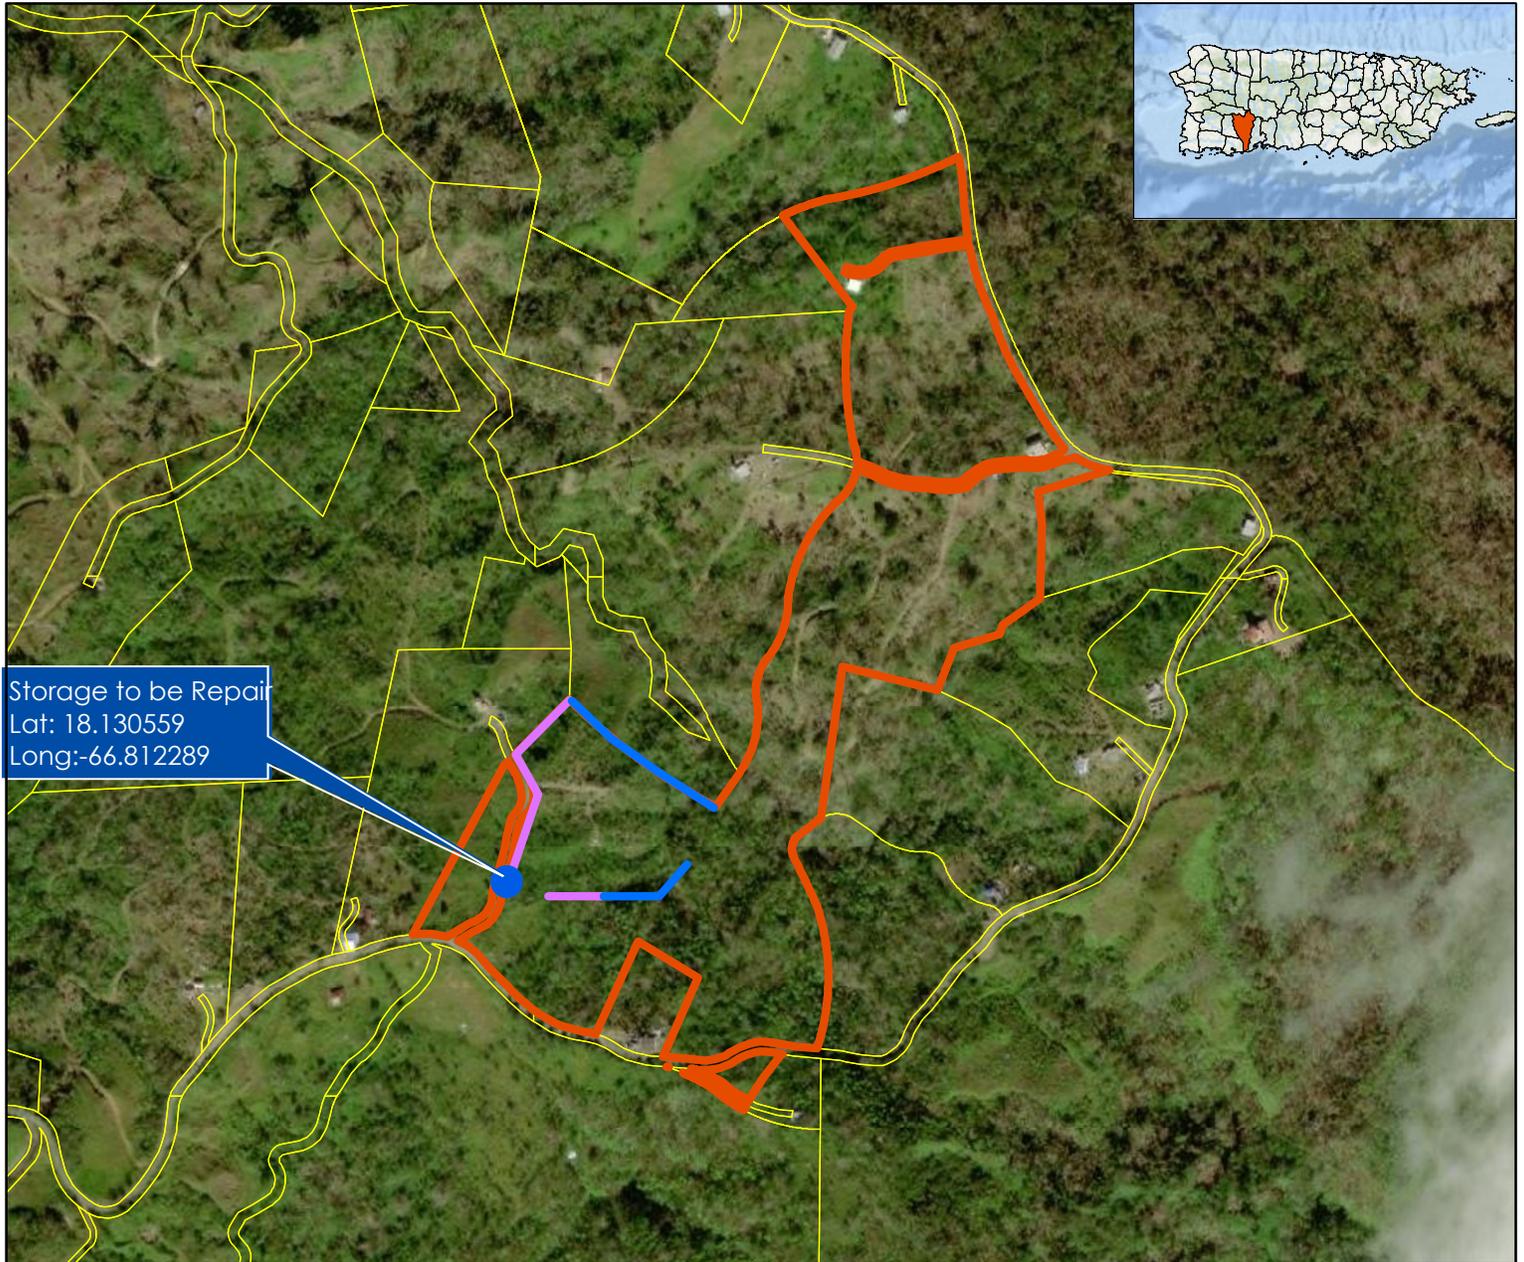
Figure 1.1: Location Aerial Map

- Storage to be Repair
- New Fence
- Fence to be Repair
- Parcel-01721
- CRIM_PARCELS

A site Map is included in Figure 1.1 and 1.2, illustrating the location of the storage, fence, coffee grinder and coffee toaster on the property. Photos of the location are included in Section 106 documentation, Appendix 1. Refer to Appendix 3 for Site Inspection Report.

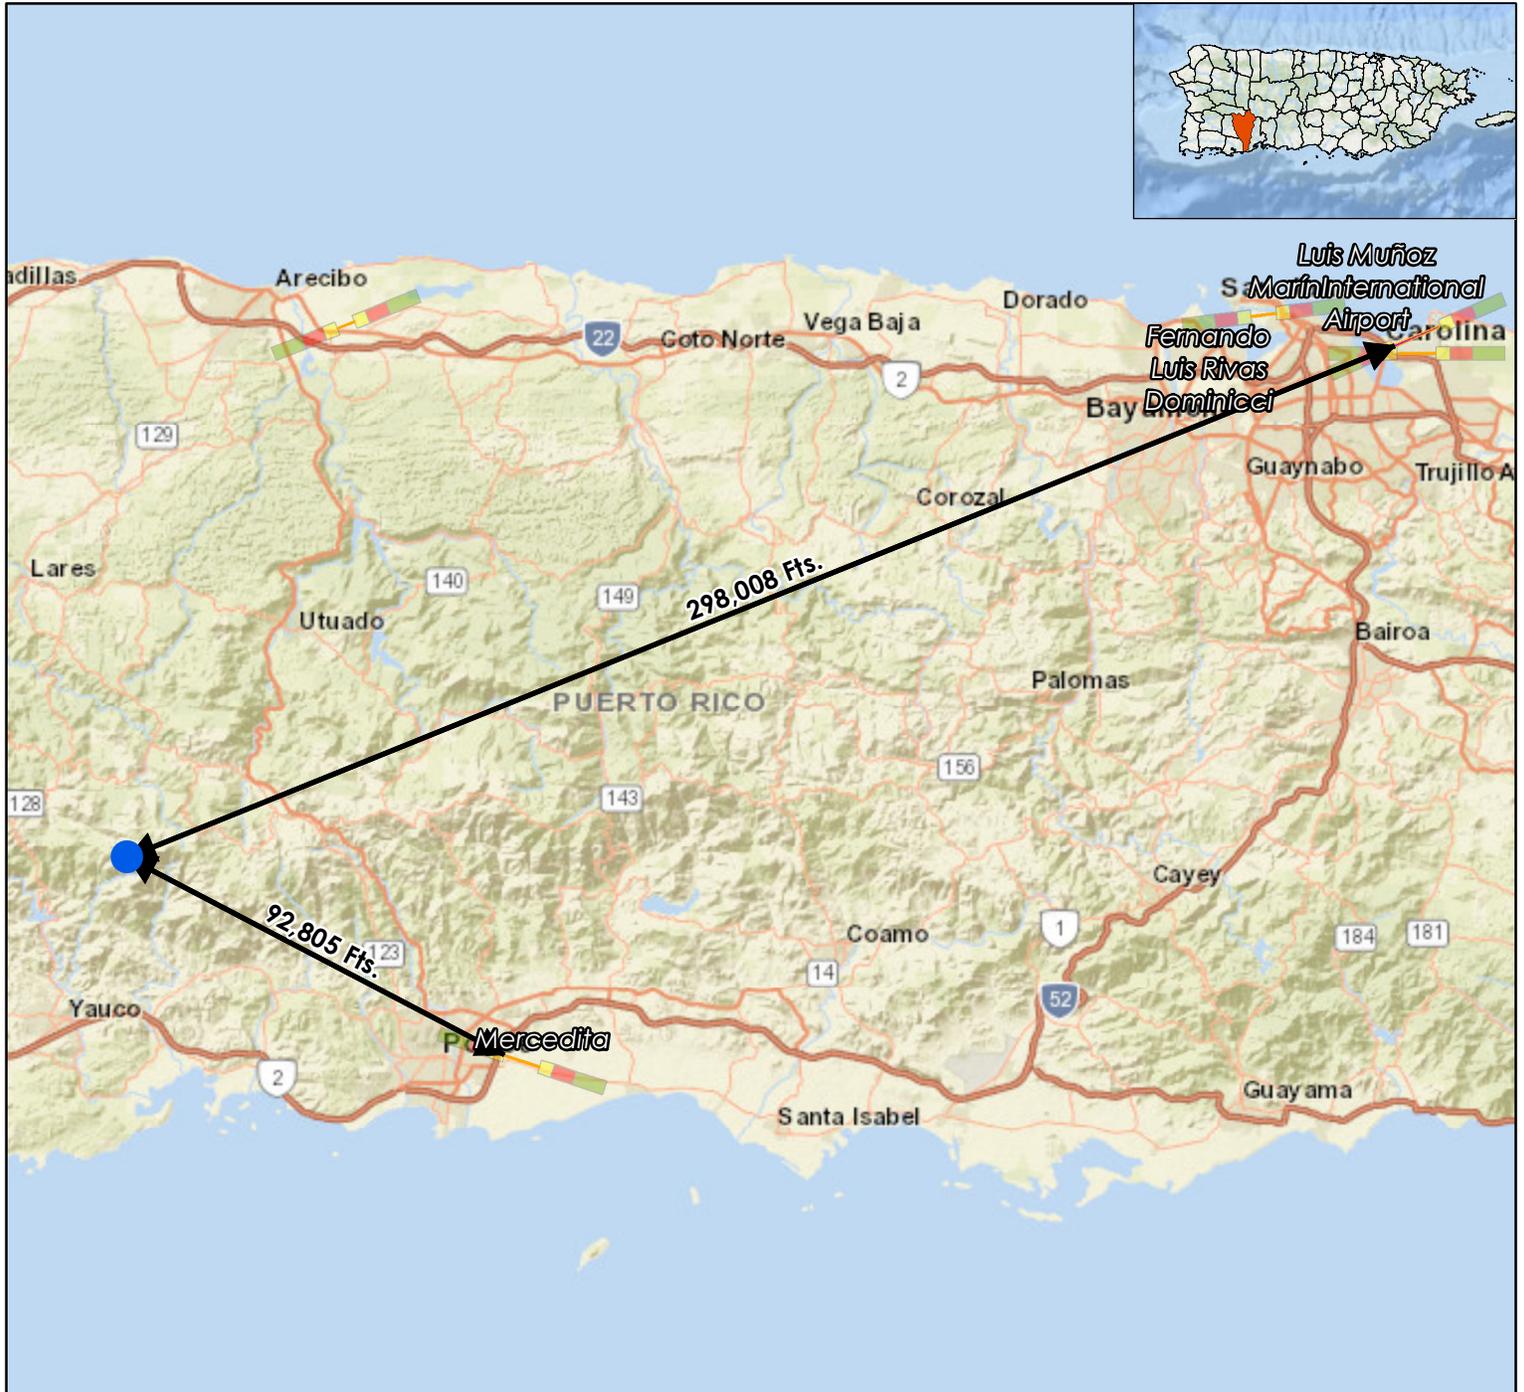
Figure 2.1: Airports

- PR-RGRW-01721
- SJU Military Runaway
- Civil Runaway
- Accident Potential Zone**
- APZ 1
- APZ 2
- Clear Zone

Airport maps Runway Protection Zone, Figures 2.1 and 2.2.
<p>Coastal Barrier Resources</p> <p>Coastal Barrier Resources Act, as amended by the Coastal Barrier Improvement Act of 1990 [16 USC 3501]</p>	<p>Yes No</p> <p><input type="checkbox"/> <input checked="" type="checkbox"/></p>	<p>This project is not located in a CBRS Unit. The site where the installation of the fence and the repair of the storage will take place is located 57,177 feet northwest of the nearest Coastal Barrier Resource System, PR-58P. The site where the coffee toaster and grinder machine will be is located 28,986 feet northeast of the nearest Coastal Barrier Resource System, PR-59.</p> <p>Therefore, this project has no potential to impact a CBRS Unit and is in compliance with the Coastal Barrier Resources Act. See the attached CBRS maps, Figures 3.1 and 3.2.</p>
<p>Flood Insurance</p> <p>Flood Disaster Protection Act of 1973 and National Flood Insurance Reform Act of 1994 [42 USC 4001-4128 and 42 USC 5154a]</p>	<p>Yes No</p> <p><input type="checkbox"/> <input checked="" type="checkbox"/></p>	<p>The project is located in Zone X. For the location of the fence and storage the Panel is 72000C1070H, 4/19/2005 on the FEMA FIRM and for the location of the coffee grinder and toaster the Panel is 72000C1615H, 4/19/2005 on the FEMA FIRM. The project does not require flood insurance or is excepted from flood insurance. See attached Flood Maps, Figures 4.1 and 4.2. The project is in compliance with the Flood Insurance without further evaluation.</p>

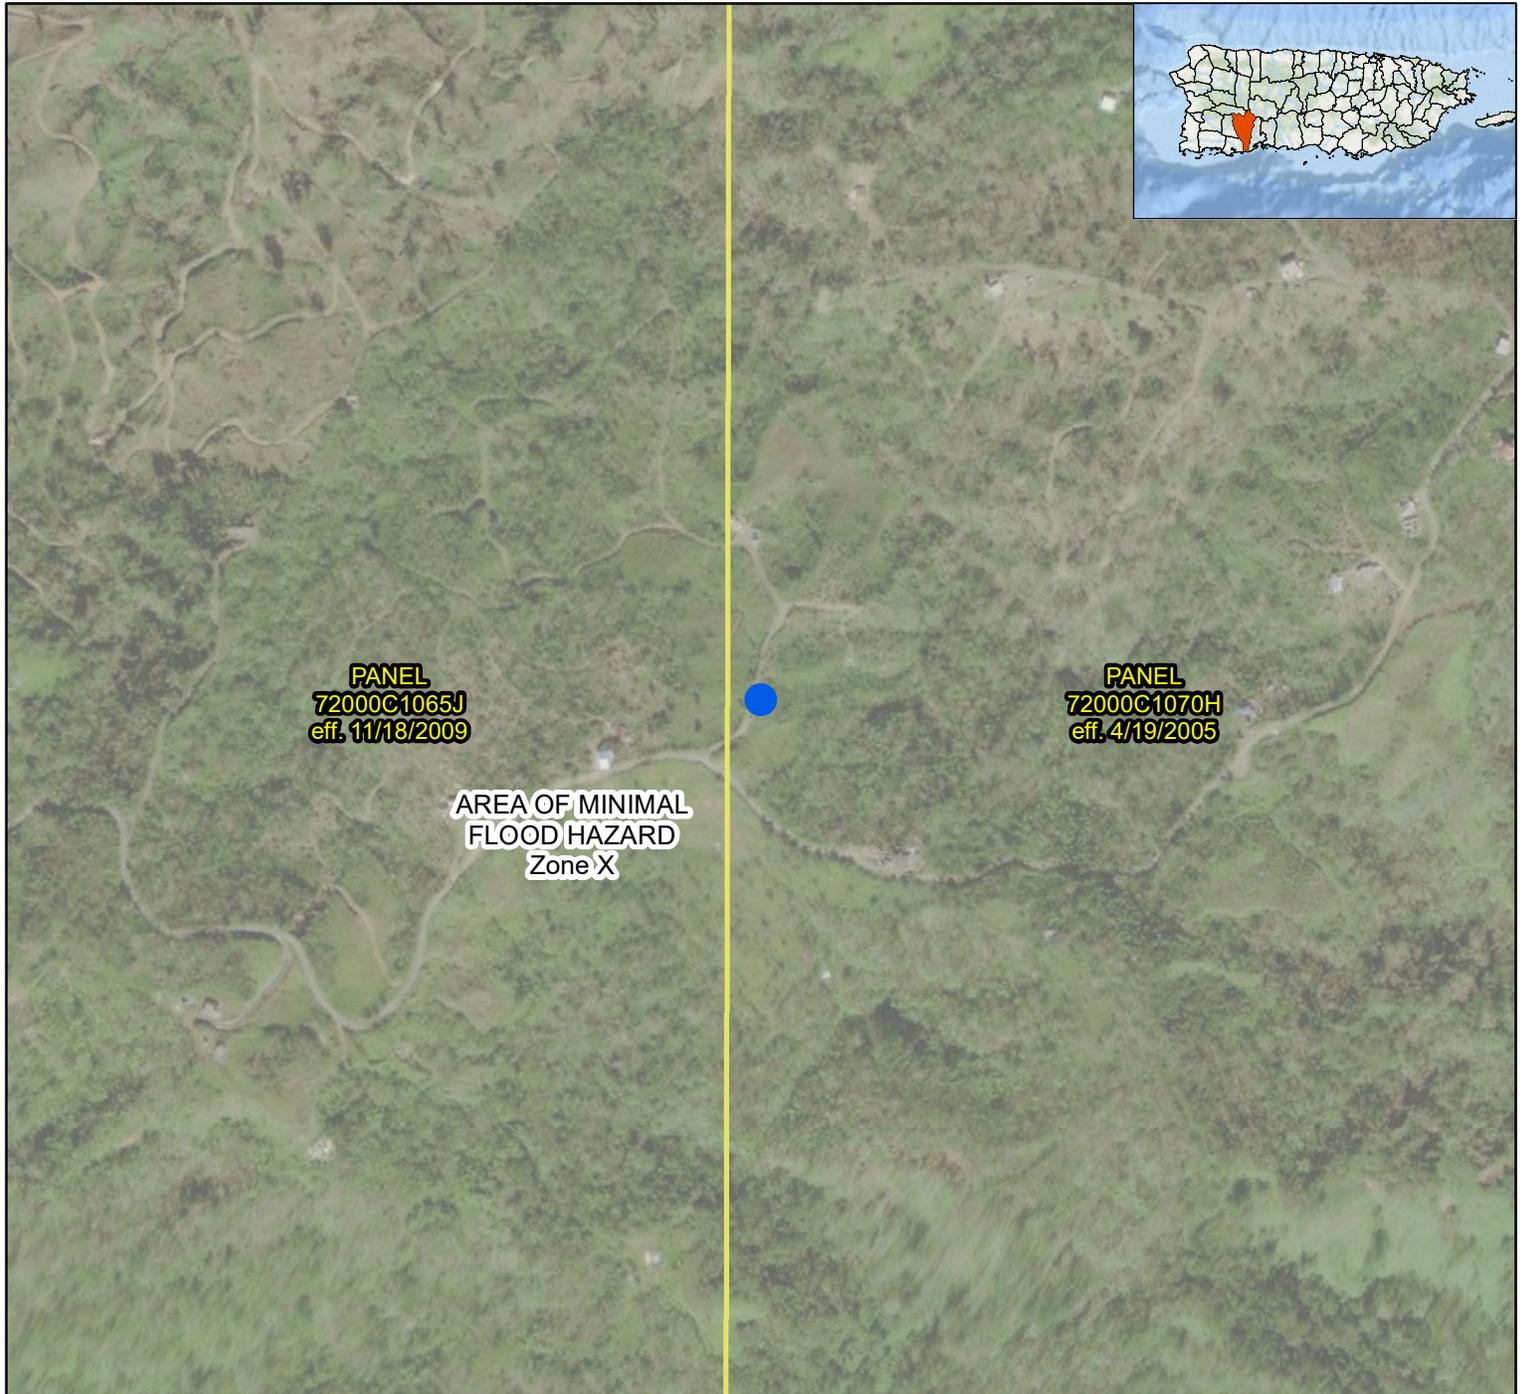
Figure 4.1: Flood Insurance Rate Map

- PR-RGRW-01721
- Area of Minimal Flood Hazard *Zone X*
- FIRM Panel

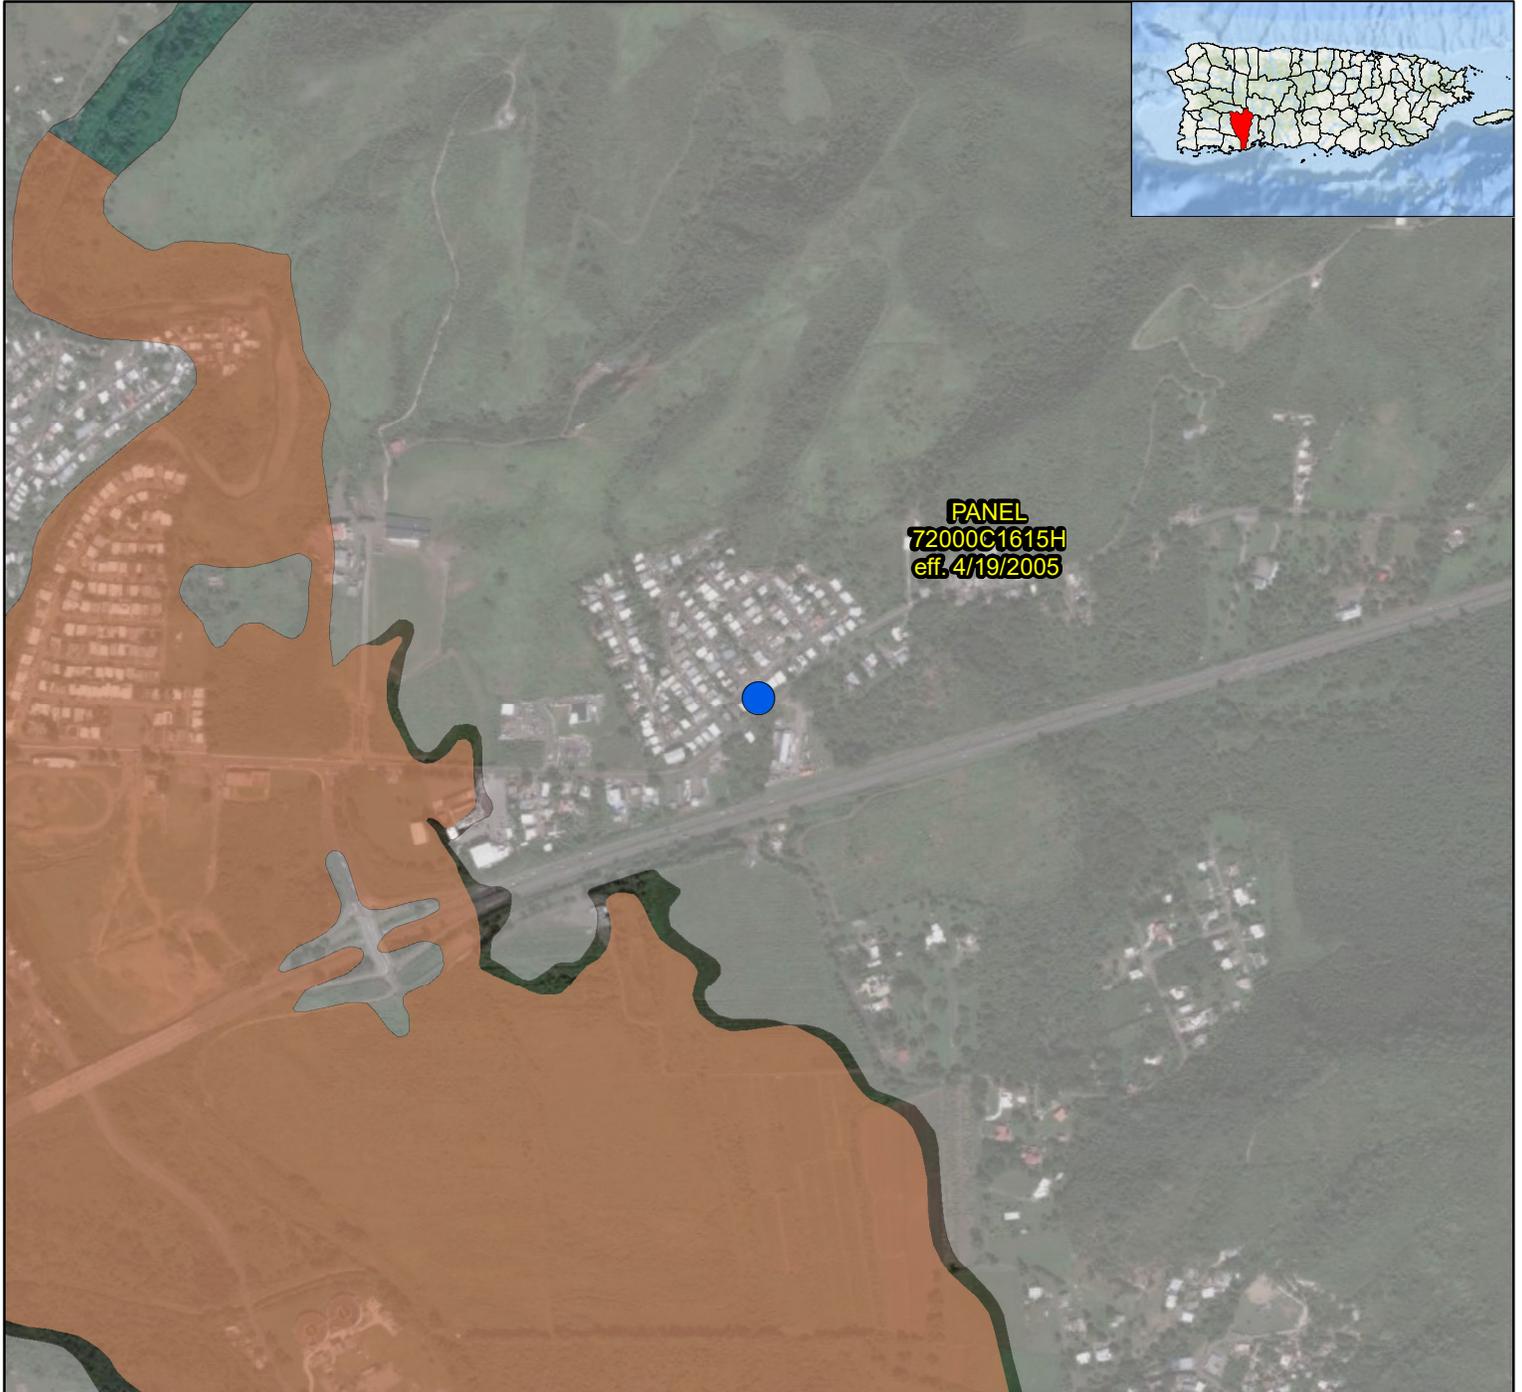
Figure 4.2
Flood Insurance Rate Map
 Puerto Rico Department of Housing ReGrow

- PR-RGRW-01721
- Zone AE
- Zone X - Area of Minimal Flood Hazard *Zone X*
- Zone A *Zone A, V, A99*
- FIRM Panel

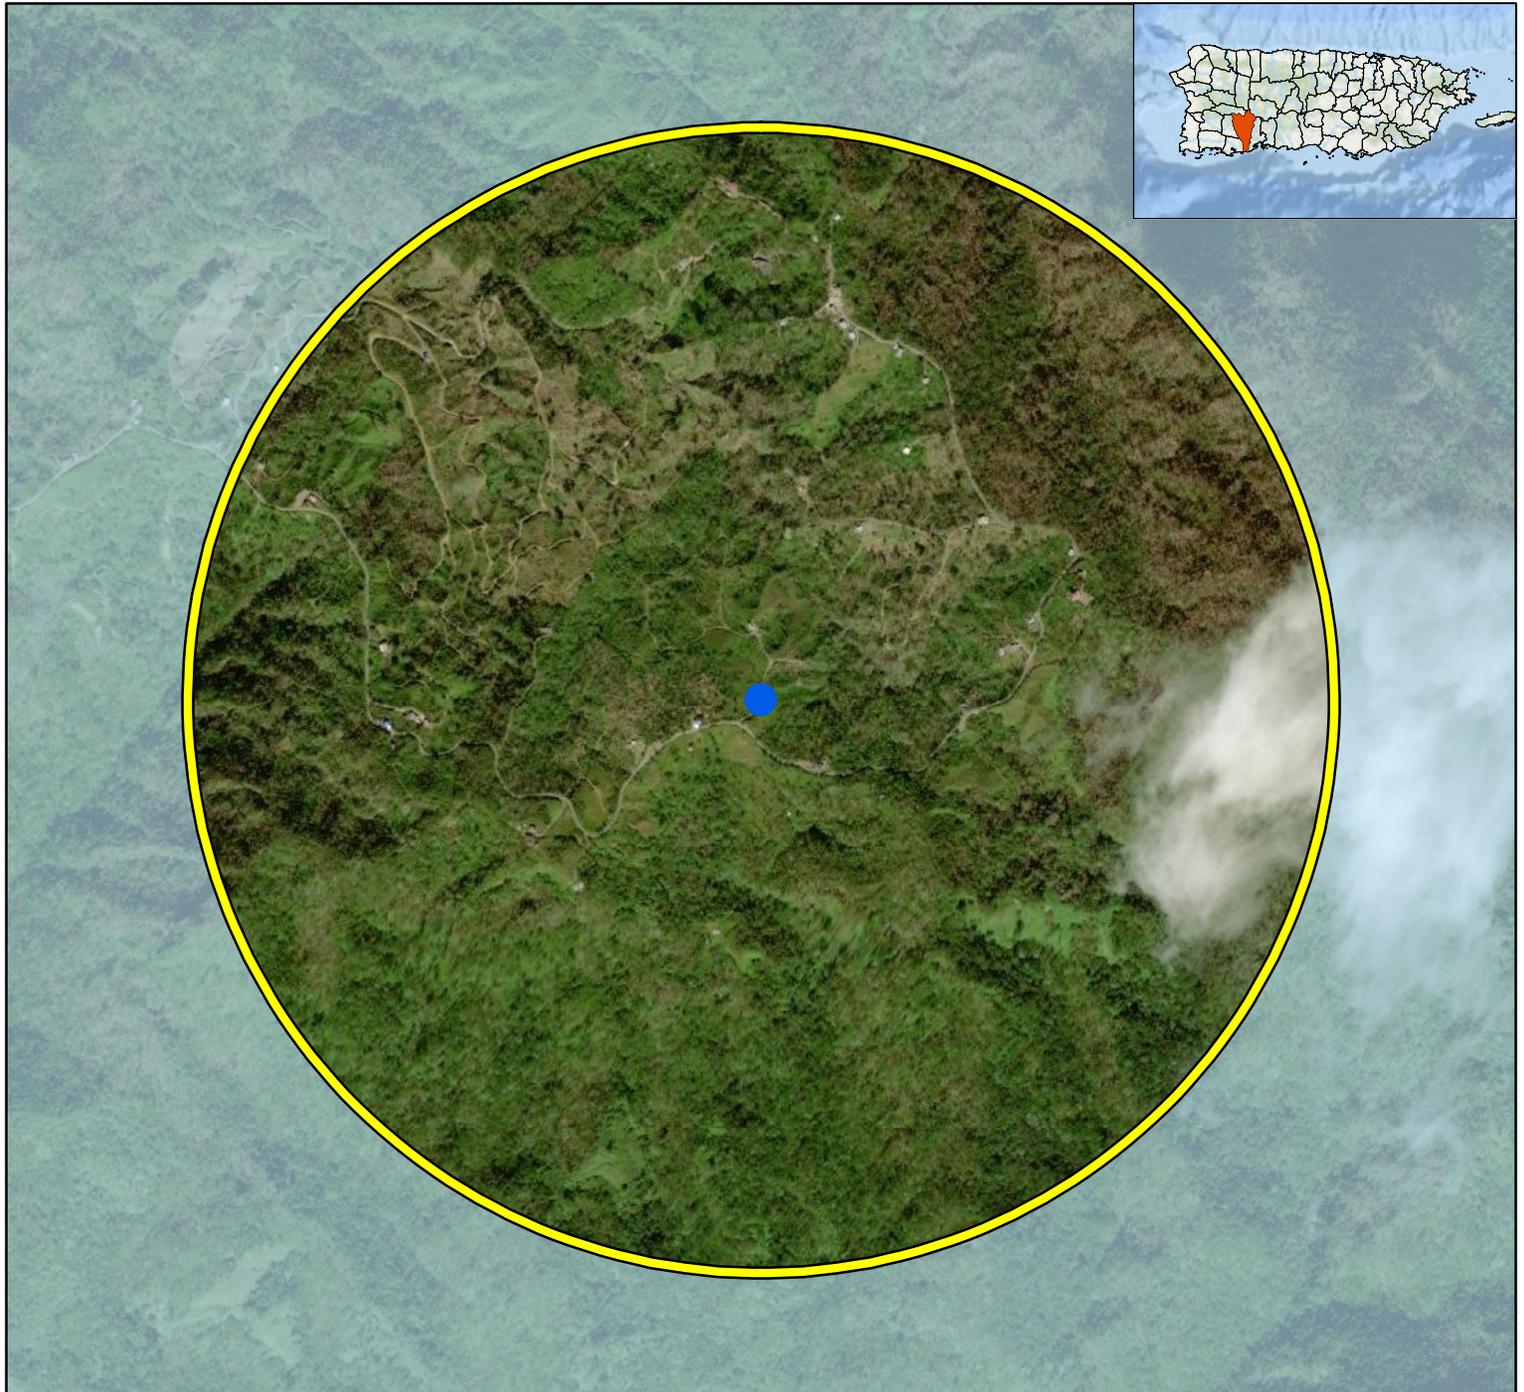
Figure 6.1: Toxic and Hazardous Facilities

- PR-RGRW-01721
- 3,000 Fts. Buffer
- FACILITY INTERESTS
- ICIS
- NCDB
- NPDES
- NPDES MAJOR
- ▲ RCRA
- ▲ RCRA ACTIVE
- ▲ RCRA INACTIVE
- ▲ RCRA LQG

<p>Contamination and Toxic Substances</p> <p>24 CFR Part 58.5(i)(2)</p>	<p>Yes No</p> <p><input type="checkbox"/> <input checked="" type="checkbox"/></p>	<p>This project consists of the purchase of materials to repair an existing 12 feet x 8 feet storage, the repair of a fence, and the installation of new sections of the fence and the purchase of 200-gallon cistern, a coffee toaster machine, and a coffee grinder machine for an agricultural project. A visual site inspection of the project area and property (both locations) was conducted and on-site or nearby toxic, hazardous, or radioactive substances that could affect the health and safety of project occupants or conflict with the intended use of the property were not found. According to what was observed in the site inspection and what was searched on the NEPASSIT page, there are no sites of environmental concern identified within 3,000 feet near the storage and fence location.</p>

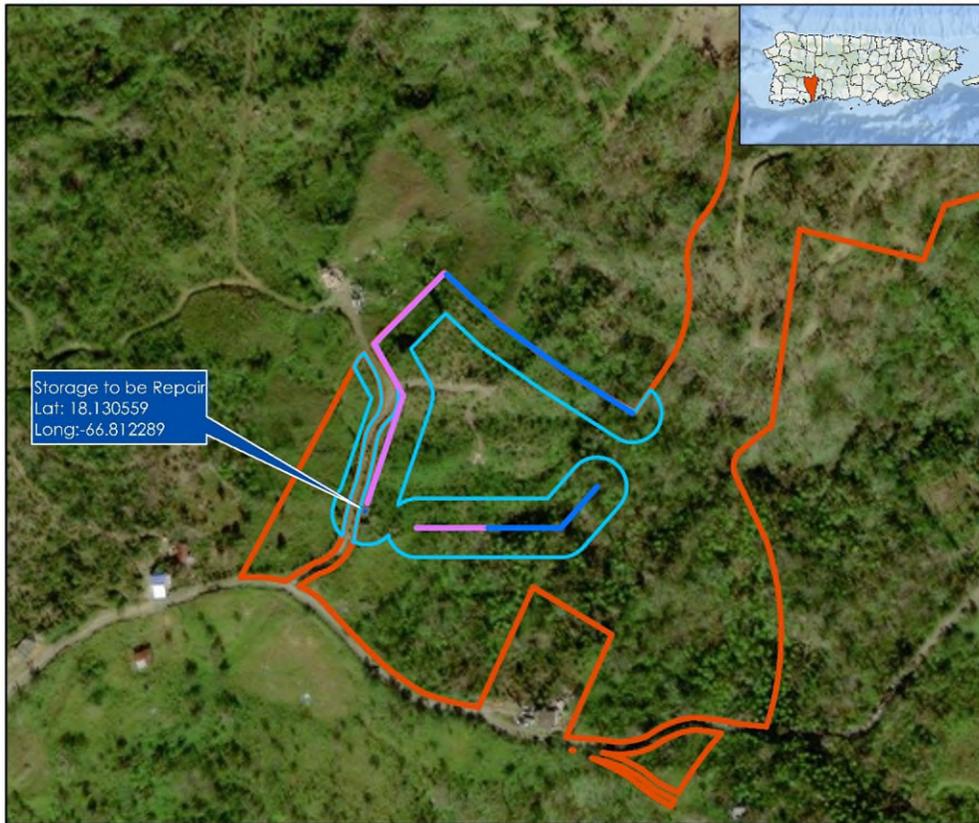
- New Fence 01721
- Fence to be Repair
- Area of Potential Effect (15 Mts.)
- Storage to be Repair
- Parcel-01721

The Area of Potential Effect (APE) has been defined as the area potentially impacted by ground disturbing activities related to the repair of an existing storage and the installation of a fence. Based on this definition and the nature and scope of the Undertaking, the Program has determined that the direct APE for this project is the location of the storage and fence plus a 15-meter buffer and the visual APE is the viewshed of the proposed project.

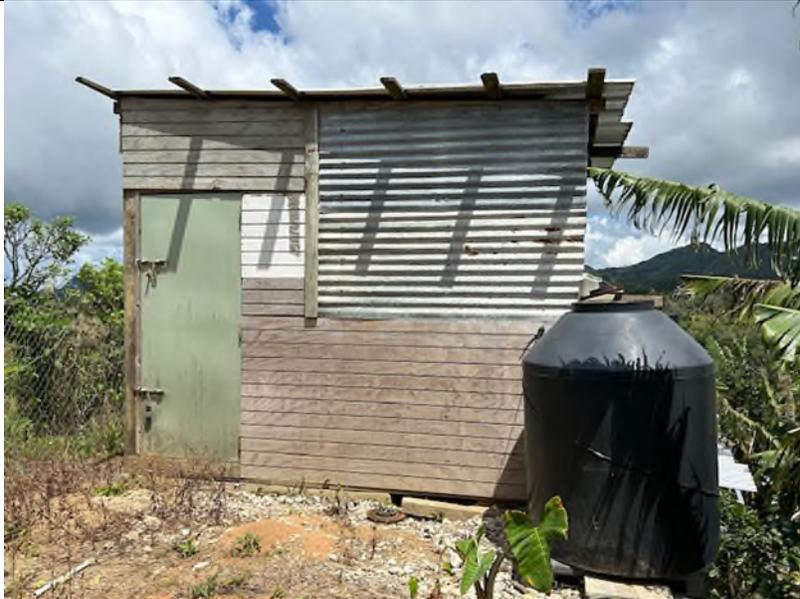
Photo #:1

Description (include direction): Area of the storage to be repair, looking north.

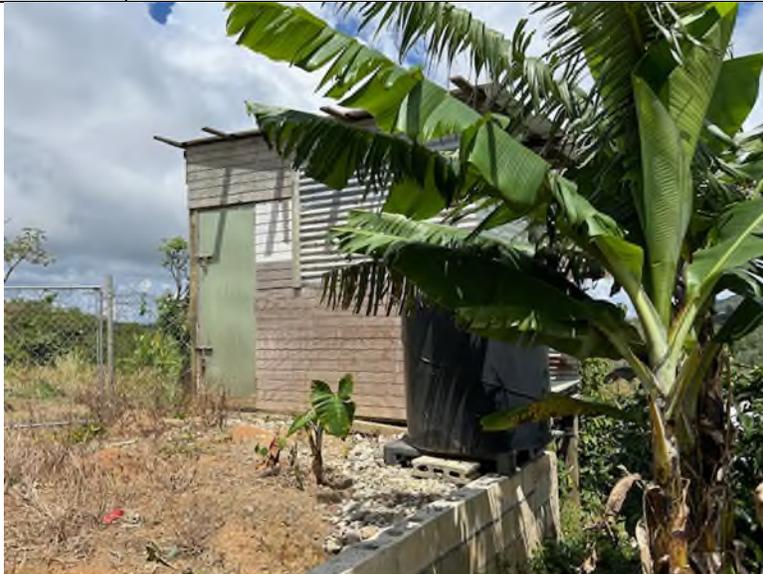
Photo #:2

Description (include direction): Area of the storage to be repair, looking northwest.

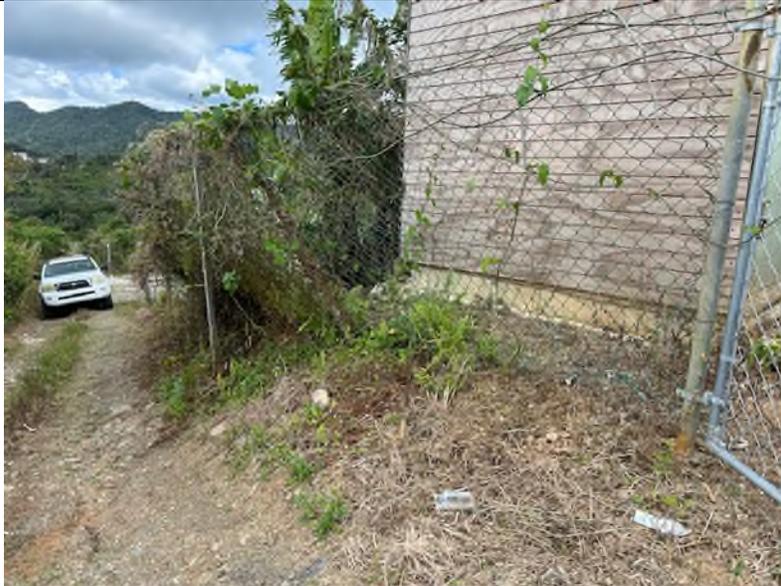
Photo #:3

Description (include direction): Area where the fence will be repaired, looking northeast.

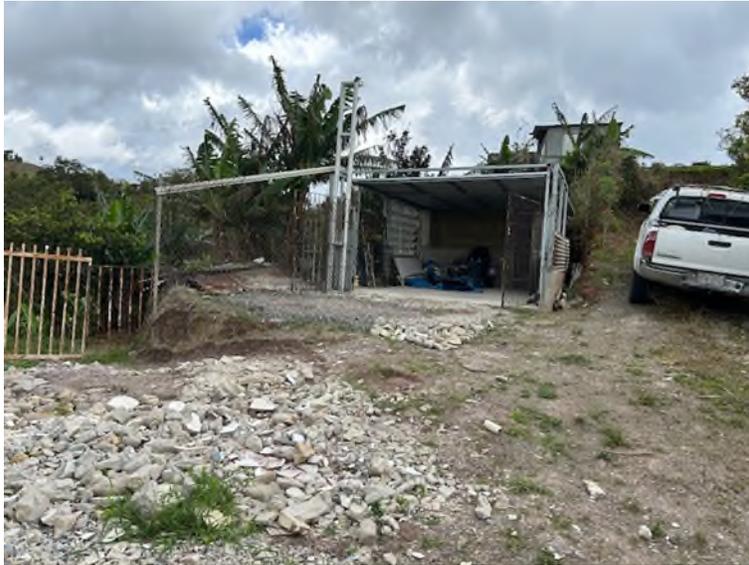
Photo #:4

Description (include direction): Area where the fence will be repaired, looking southwest.

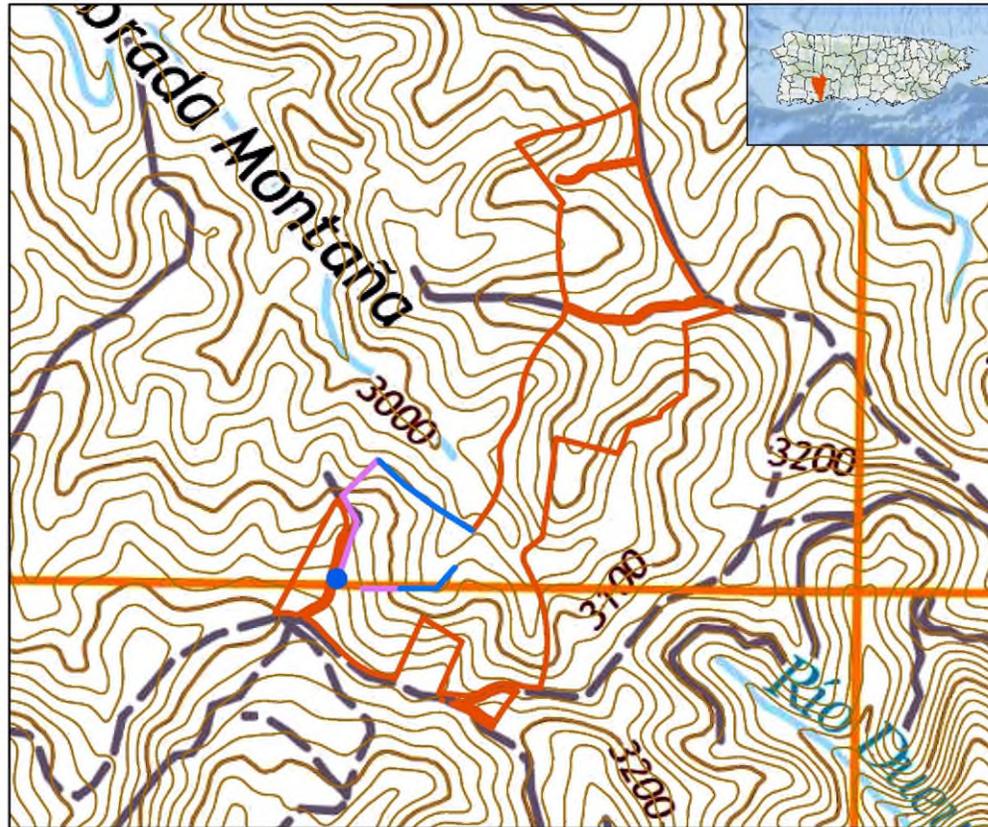
Location: USGS Topographic Map
Puerto Rico Department of Housing ReGrow

- Legend:**
- Storage to be Repair
 - New Fence
 - Fence to be Repair
 - Parcel-01721
 - Contour Interval 20 Feet
