**Environmental Review for Activity/Project that is Categorically  
Excluded Subject to Section 58.5  
Pursuant to 24 CFR 58.35(a) (3)(iii)**

**Project Name:** Multifunctional Recreation Center of Municipality of Trujillo Alto

**Application ID:** PR-CRP-001058

**Project Location:** Urban Area, Intersection PR-8860 and PR-181, St. Just ward, Trujillo Alto, PR 00976.  
**Coordinates (lat / long):** 18.35882992 °, -66.00141529°.  
**Cadaster No.:** 115-050-749-02

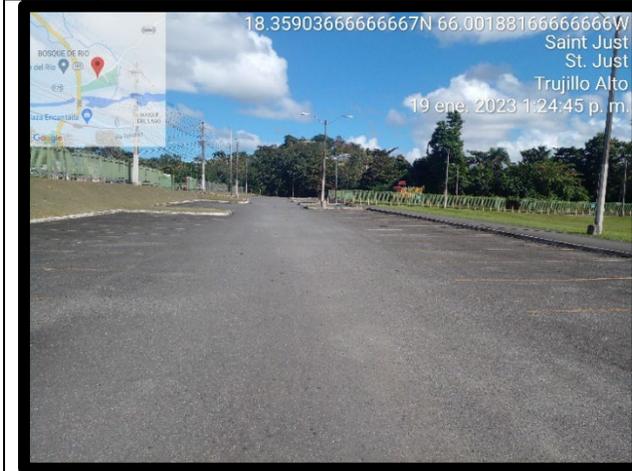
### 1.0 Project Location

#### NORTH FACADE

- Walking track for exercise and, or to enjoy the landscapes.
- Construction of multiple rest areas
- Construction of additional access of the complex.

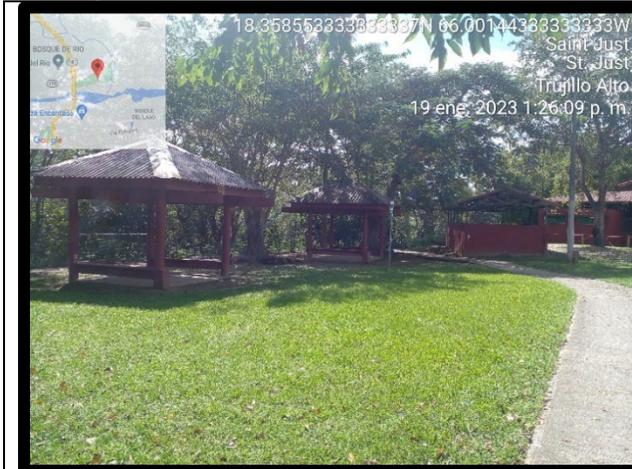
### 2.0 Project Location

#### SOUTH FACADE

- Gazebo area for activities, birthdays, baptisms, celebrations, and similar family activities.
- Outdoor space for activities such as festivals, town festivals, among others.
- Dog Park.

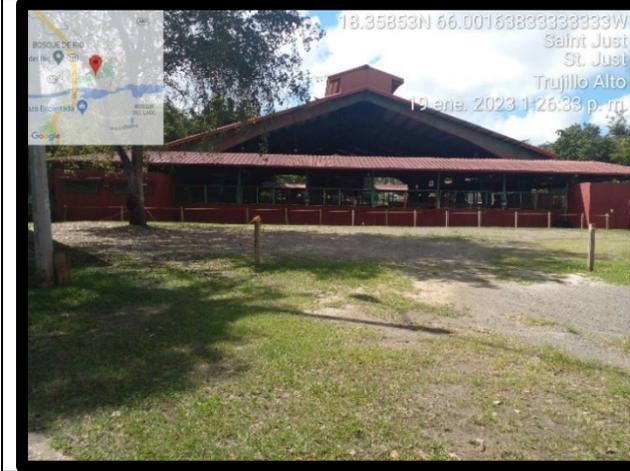
#### 4.0 Project Location

#### EAST FACADE LOOKING WEST

- Center for Community Resilience, Security and Emergency.
- Colosseum-type structure for massive activities of all kinds, such as: shows, massive citizen services, massive vaccination events and detention tests, family market, pet vaccination, equestrian activities, and equine therapy for the development of skills in children with disabilities.

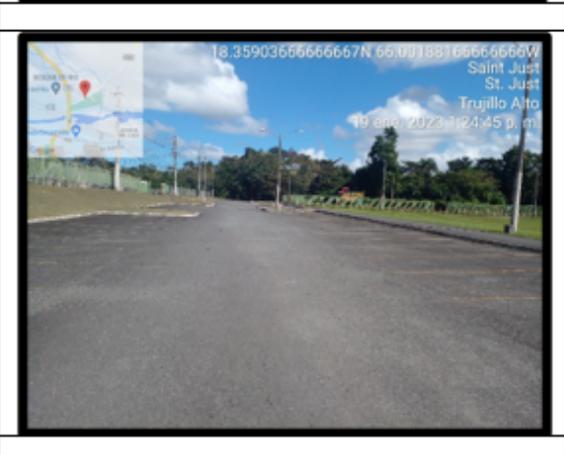
<p><b>Hazardous substances a in relation to the identified uses. Visual inspection did not identify any significant use or generation of hazardous substances on the Property. No manufacturing, fabrication or assembly operations are carried out on the property.</b></p>

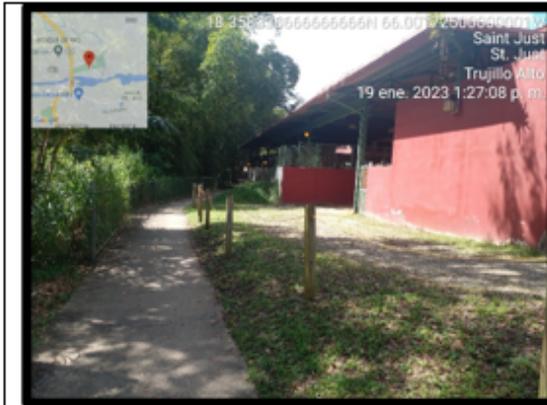
<p><b>Stench</b> No strong, pungent, or noxious odors that could indicate the possibility of contamination were observed or reported.</p>

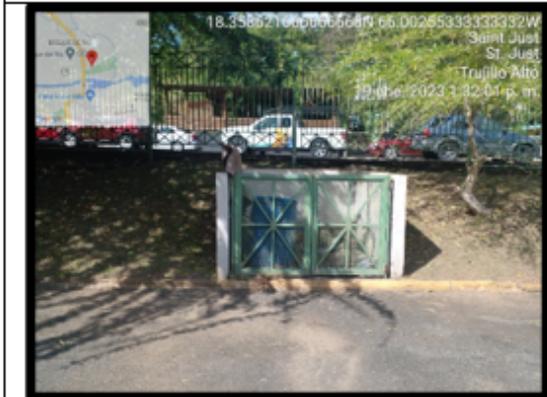
**Liquid Pools**  
**No pools containing liquids that could be dangerous substances.**

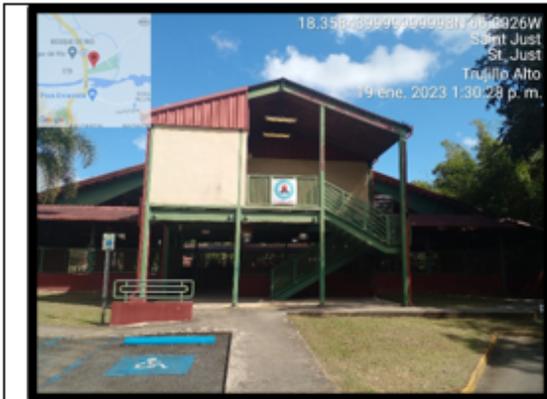
**Drums and Hazardous Substances Containers.**  
**Drums containing liquids that could be dangerous substances were not installed observed or reported on or adjacent to the Property.**

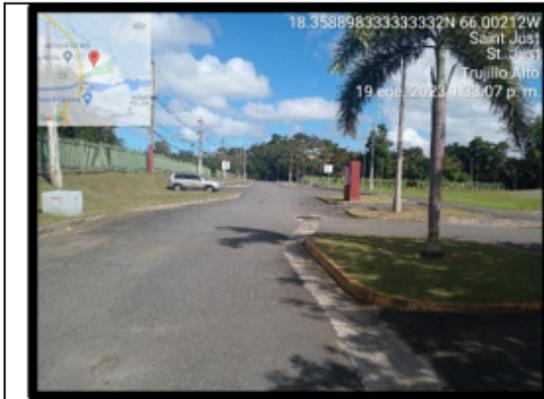
**Drains and Sumps**  
No evidence of sinkholes was observed.

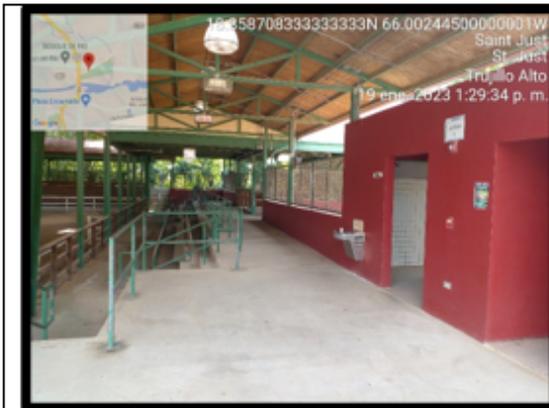
**Floor and pavement stained.**  
No significantly stained soil or pavement was observed or reported at the Property other than silty areas that caused by disuse.

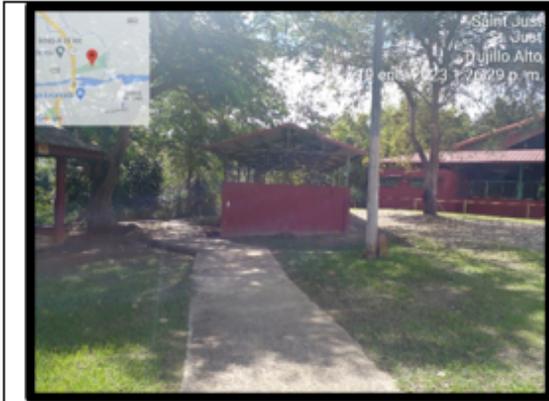
**Stressed vegetation**  
No areas of stressed vegetation were observed or reported on or adjacent to the Property.

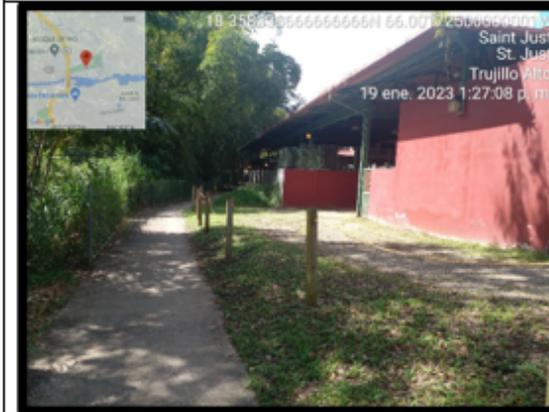
**solid waste**  
**Not observe any areas that appear to have been filled or graded suggesting the presence of debris, including but not limited to construction debris, demolition debris, or other.**

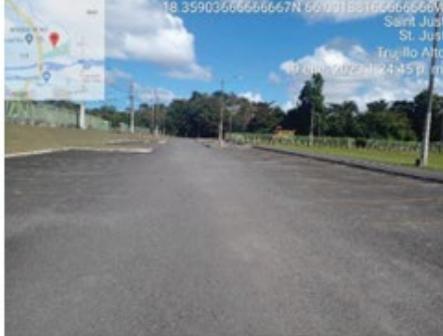
### 1.0 Project Location

#### NORTH FACADE

- Walking track to exercise or appreciate landscapes.
- Construction of multiple rest areas

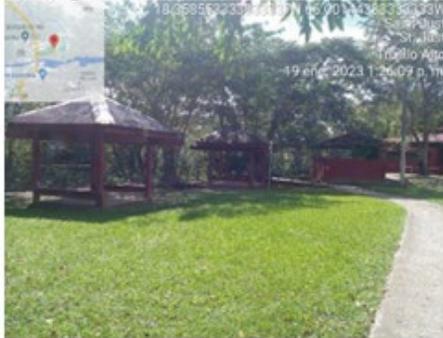
### 2.0 Project Location

#### SOUTH FACADE

- Gazebo area for activities, birthdays, baptisms, celebrations, and similar family activities.
- Outdoor space for activities such as festivals, town festivals, among others
- Dog Park.

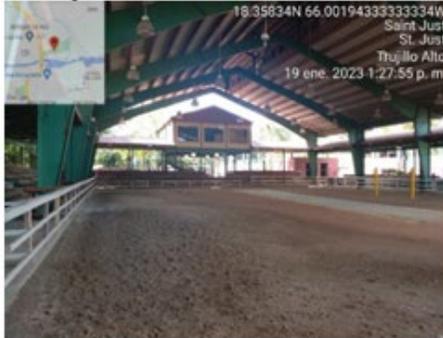
### 3.0 Project Location

#### INTERIOR VIEW

- Center for Community Resilience, Security and Emergency.
- Colosseum-type structure for massive activities of all kinds, such as: shows, massive citizen services, massive vaccination events and detention tests, family market, pet vaccination, equestrian activities, and equine therapy for the development of skills in children, with disabilities and paso fino skills, as initially authorized.

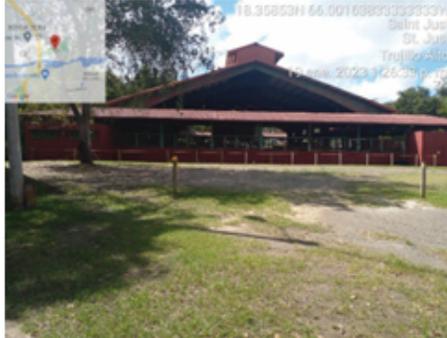
#### 4.0 Project Location

#### EAST FACADE LOOKING WEST

- Center for Community Resilience, Security and Emergency.
- Colosseum-type structure for massive activities of all kinds, such as: shows, massive citizen services, massive vaccination events and detention tests, family market, pet vaccination, equestrian activities, and equine therapy for the development of skills in children. with disabilities and paso fino skills, as initially authorized.

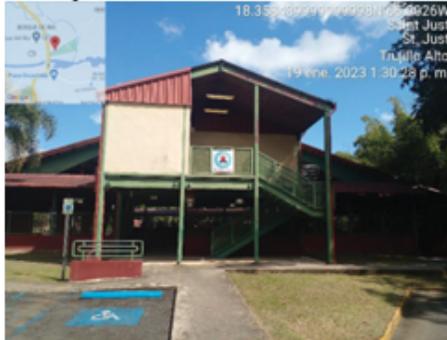
#### 5.0 Project Location

#### WEST FACADE LOOKING EAST

- Center for Community Resilience, Security and Emergency.
- Colosseum-type structure for massive activities of all kinds, such as: shows, massive citizen services, massive vaccination events and detention tests, family market, pet vaccination, equestrian activities, and equine therapy for the development of skills in children. with disabilities and paso fino skills, as initially authorized.

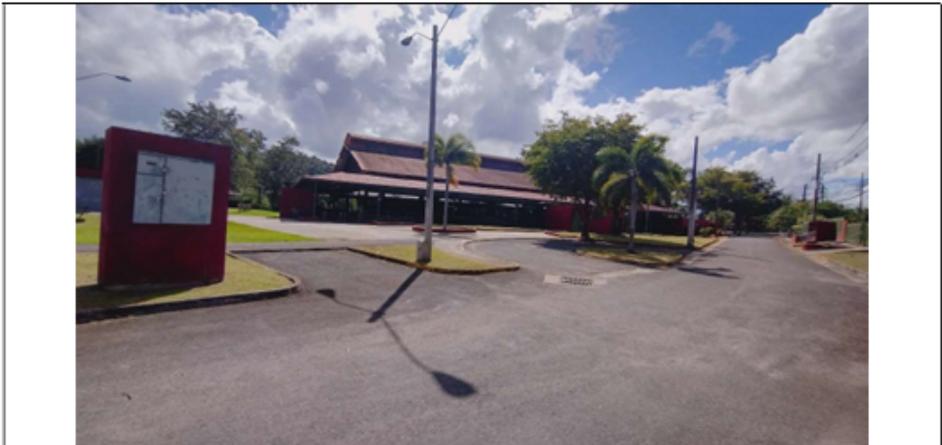
<b>Photo #:</b> 1	<b>Description:</b> View of inside of the existing Equestrian Park in Trujillo Alto. The photo was taken from the northern area of the project, looking southwest.
<b>Date:</b> 1-23-2023

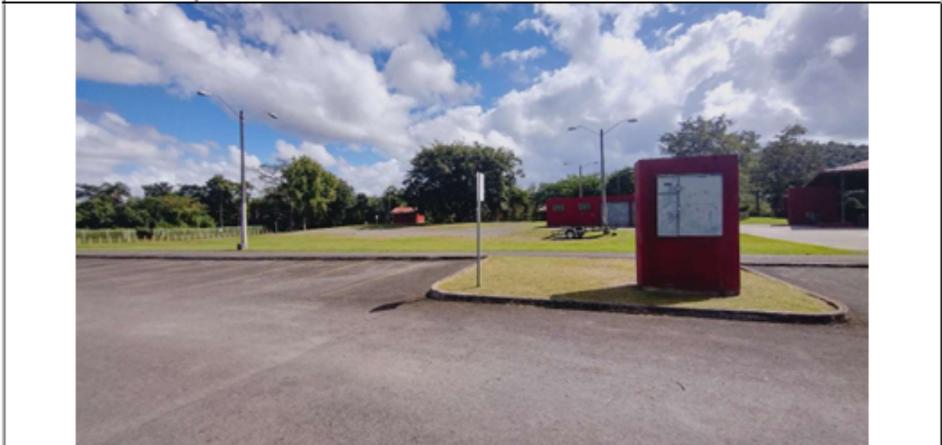
<b>Photo #:</b> 2	<b>Description:</b> View from inside of the existing Equestrian Park in Trujillo Alto. The photo was taken from the northern area of the project, looking south.
<b>Date:</b> 1-23-2023

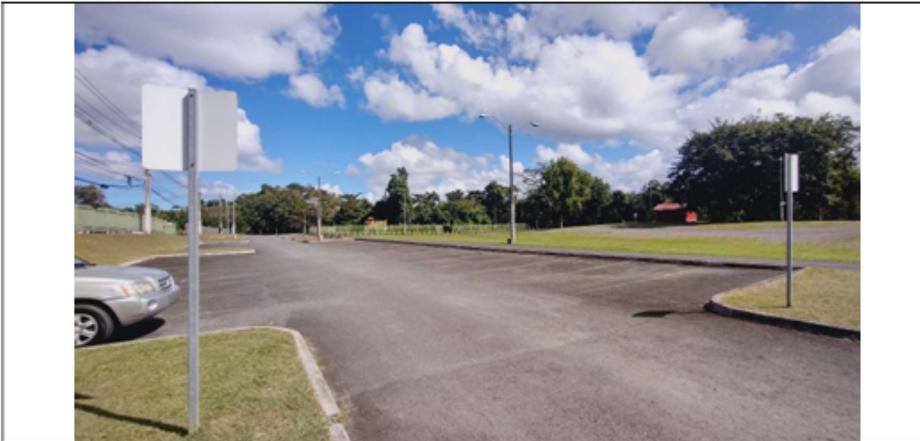
<b>Photo #:</b> 3	<b>Description:</b> View from inside of the existing Equestrian Park in Trujillo Alto. The photo was taken from the northeast area of the project, looking northeast.
<b>Date:</b> 1-23-2023

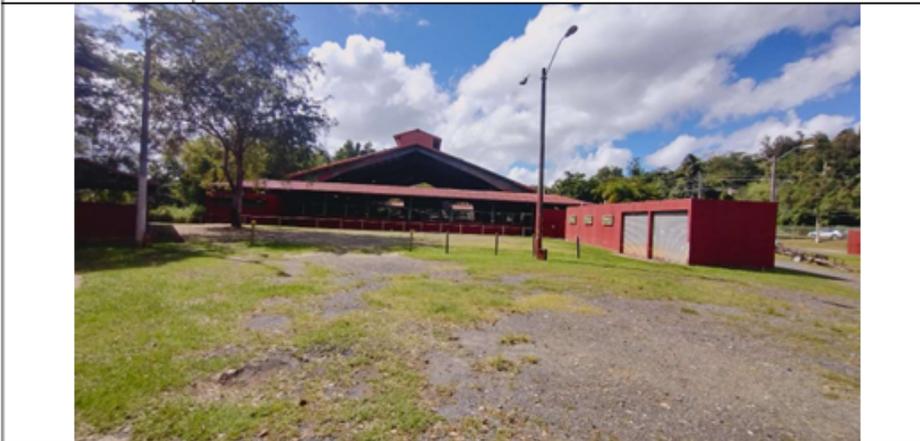
<b>Photo #:</b> 4	<b>Description:</b> View from inside of the existing Equestrian Park in Trujillo Alto. The photo was taken from the eastern area of the project, looking west.
<b>Date:</b> 1-23-2023

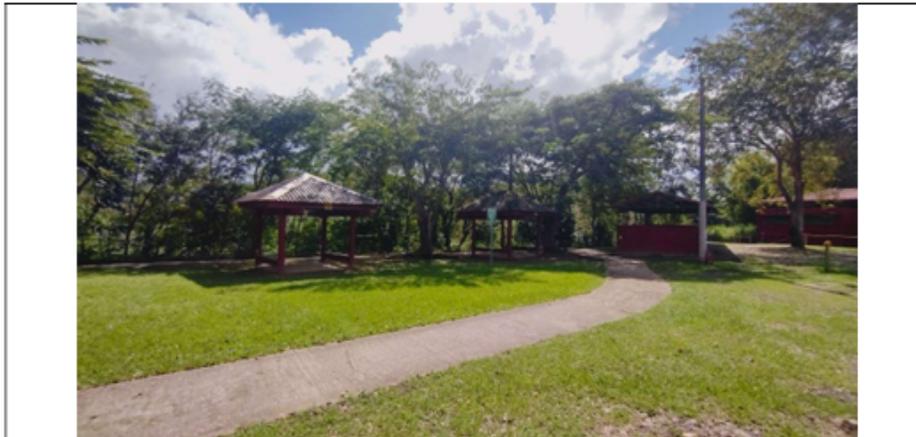
<b>Photo #:</b> 5	<b>Description:</b> View from inside of the existing Equestrian Park in Trujillo Alto. The photo was taken from the eastern area of the project, looking southwest.
<b>Date:</b> 1-23-2023

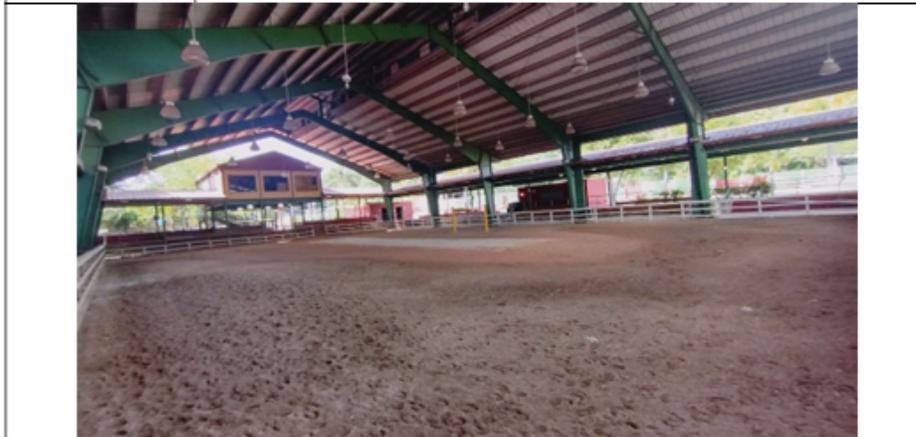
<b>Photo #:</b> 6	<b>Description:</b> View from inside of the existing Equestrian Park in Trujillo Alto. The photo was taken from the center area of the project, looking northwest.
<b>Date:</b> 1-23-2023
