**Environmental Review for Activity/Project that is Categorically
Excluded Subject to Section 58.5
Pursuant to 24 CFR 58.35(a)**

Project Name: Nuevo Estacionamiento Plaza del Mercado y Centro Urbano (PR-CRP-001142)

Project Location: Comercio Street Yauco, PR (Lat: 18.03534545, Lon: -66.85207347)

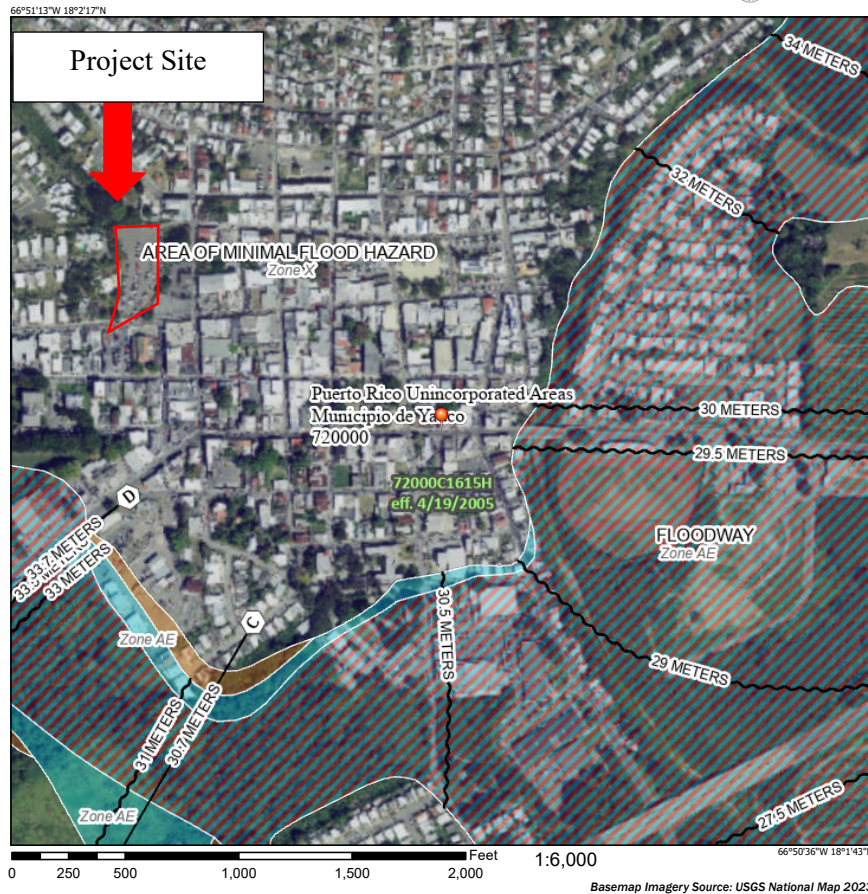
National Flood Hazard Layer FIRMette

The flood hazard information is derived directly from the authoritative NFHL web services provided by FEMA. This map was exported on 12/27/2023 at 2:12 PM and does not reflect changes or amendments subsequent to this date and time. The NFHL and effective information may change or become superseded by new data over time.

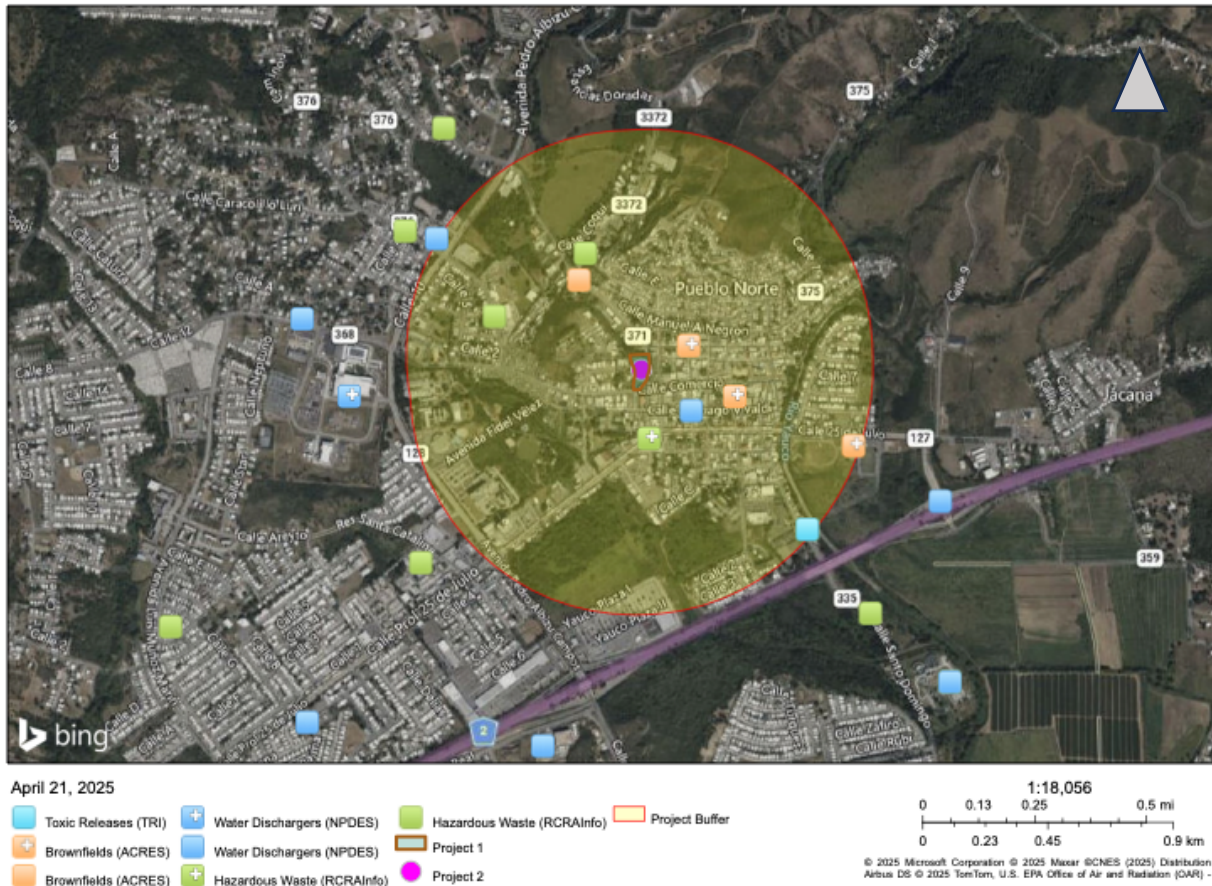
Attachment 7A: Toxics Map with 3,000 ft buffer

ID	EPA Facility	Distance from Project Site	Direction from Project Site	Description	Compliance Status
1	RCRA	1,637 ft	NW	ESSO STANDARD OIL CO - PR CO-408	No violation
2	RCRA	789 ft	SE	ESSO STANDARD OIL CO PR 2P-397	No violation
3	CWA	400 ft	SE	Municipality of Yauco	Unknown
4	RCRA	823 ft	SE	PREPA - YAUCO TECHNICAL OPERATIONS OFFICE	No violation
5	CWA	2,600 ft	NW	SARTORIUS STEDIM FILTERS, INC. - MB	No violation
6	RCRA	2,800ft	NW	FARMACIA EL AMAL 36	No violation

<p>suspected materials were observed, consequently no samples were taken. A site inspection was completed on October 18, 2023. No evidence of hazardous materials, contamination, toxic chemicals and gases, or radioactive substances were observed during the site inspection. Thus, there are no environmental concerns identified at the site. A review of nearby regulated sites using the EPA tool ECHO identified six (6) sites within a 3,000-foot radius of the project site. One of the sites had reporting violations three years ago. Potential impacts of these nearby regulated sites were evaluated, considering factors such as pollution sources, emissions, and compliance information as well as distance to the project site. See attachment 6B for further information. Based on distance from the project site and absence of a significant violation, it was determined that these sites will not impact the project.</p> <p>The project does not involve long-term occupancy, only improvements of an existing parking (open parking). In accordance with CPD-23-103, this exemption means that radon considerations are not applicable to this analysis.</p> <p>Based on the above information, the project complies with Contamination and Toxic Substances requirements and a lead-based paint hazard mitigation plan will be required.</p> <p>For further details, please refer to the supporting documentation in Attachments 7A-D.</p>

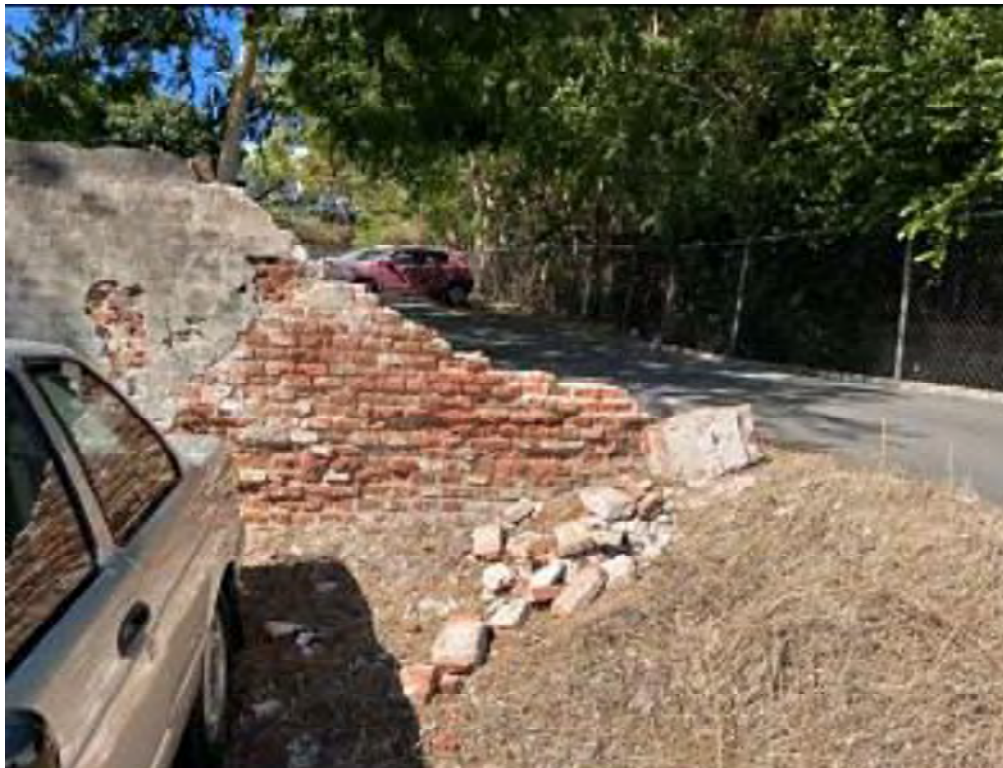
These are remnants of a rubblework construction that is in the north-east perimeter and whose distance from center of Direct APE is 180 Linear Feet, (0.04 miles). It was probably part of the existing property wall which remains in the south of Mattei Lluveras Street and in which an art mural has been painted. It can be eligible under Criteria C that could embody the distinctive characteristic of a type, period and method of construction. (Figures 29 -30), and (Photos #39, 42, and 49).

Figure 29. Existing rubble works remnants at the north-east of the Direct APE site. View towards the east.
 Source: Applied Engineer Group.

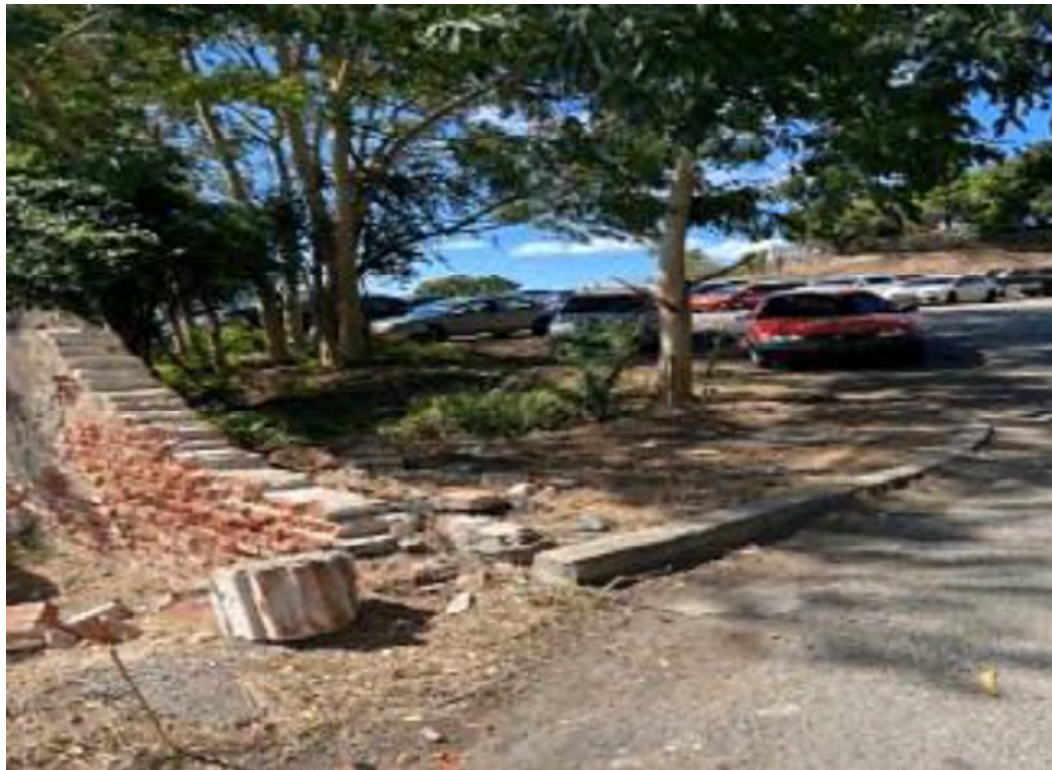
Figure 30. Existing rubble works remnants at the north-east Direct APE site. View towards the south-east.
 Source: Applied Engineer Group.

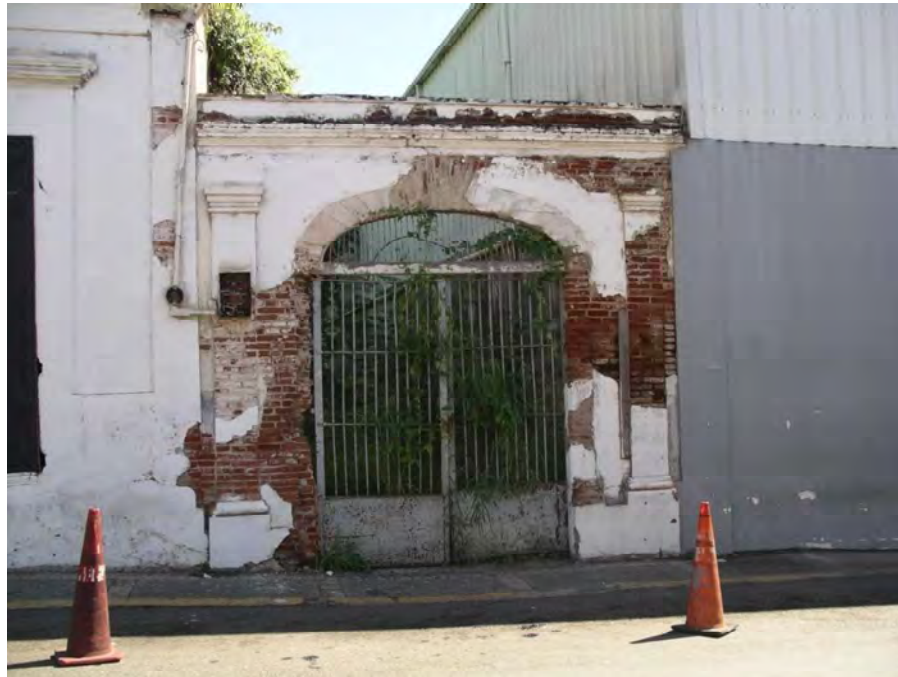
Figures 32. Private property on Fernando Pacheco Street. Side porch access area with elliptical (Carpnel) arch.

Located within the east boundaries of the proposed project Visual APE, whose distance from center of the Direct APE is 240 Linear Feet, (0.04 miles), it is a contributing property, included in the JP/ICP Historic Zone-District of Yauco, Puerto Rico. It can be eligible under Criteria C that could embody the distinctive characteristic of a type, period and method of construction. (Figures 31 to 33).

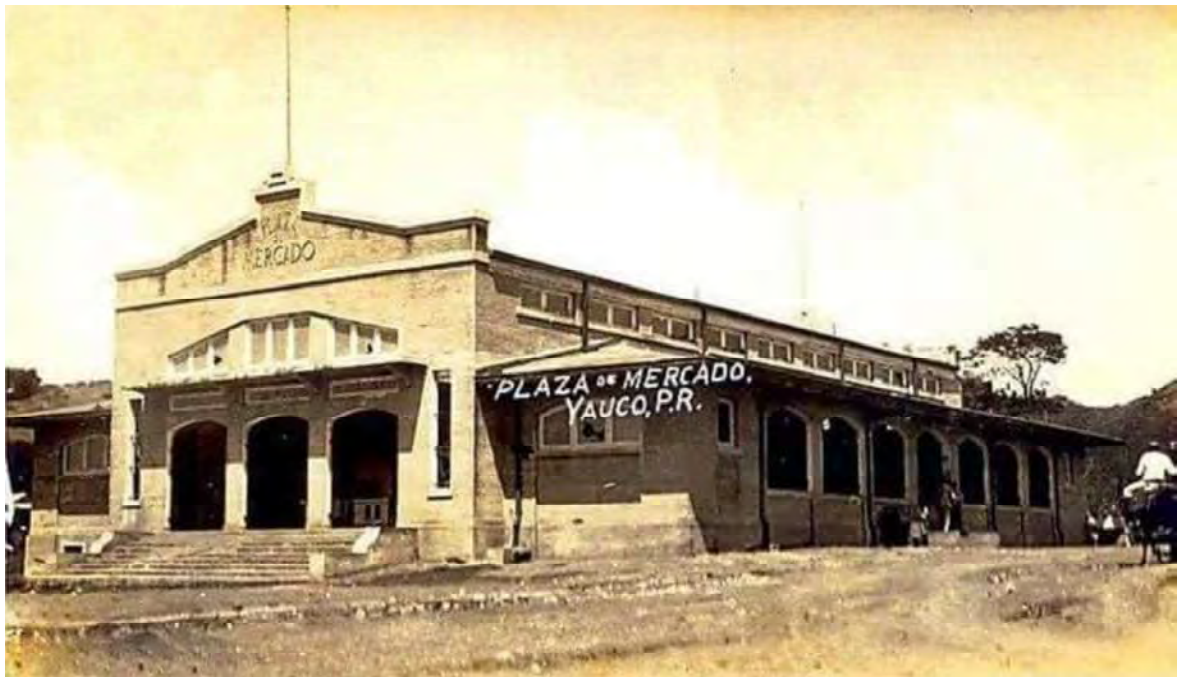
Figure 34. Plaza del Mercado (Market Square) de Yauco, Puerto Rico, 1925.¹⁶

Between 1950 and 1960 it was remodeled, changing its glass pediment from one complete piece to one with three segments. In addition, the corrugated metal roofs were replaced by flat reinforced concrete roofs. Located within the south boundaries of the proposed project Visual APE whose distance from the center of the Direct APE is 370 Linear Feet, (0.07 miles). It is a contributing listed property, and part of the JP/ICP Historic Zone-District of Yauco, Puerto Rico. (Figures 34 to 36).

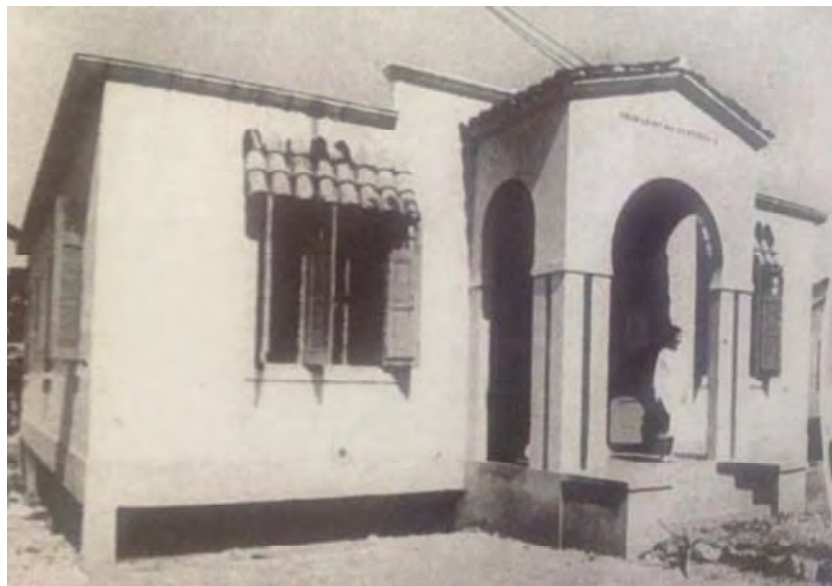
Figure 37. Public Health Unit of Yauco Puerto Rico, 1937. ¹⁹

This public health unit was one of two models built in Puerto Rico by the Puerto Rico Reconstruction Administration. As a public health unit, it was part of the preventive health and health education system established in 1926 by the Insular Department of Health in cooperation with the Rockefeller Foundation. On October 14th, 2021, the Public Health Unit in Yauco was included in the National Register of Historic Places, MP100007078.

Located within the south boundaries of the proposed project Visual APE, whose distance from center of the Direct APE is 362 Linear Feet, (0.07 miles), it is a contributing listed property, and part of the JP/ICP Historic Zone-District of Yauco, Puerto Rico. (Figures 37 to 39).

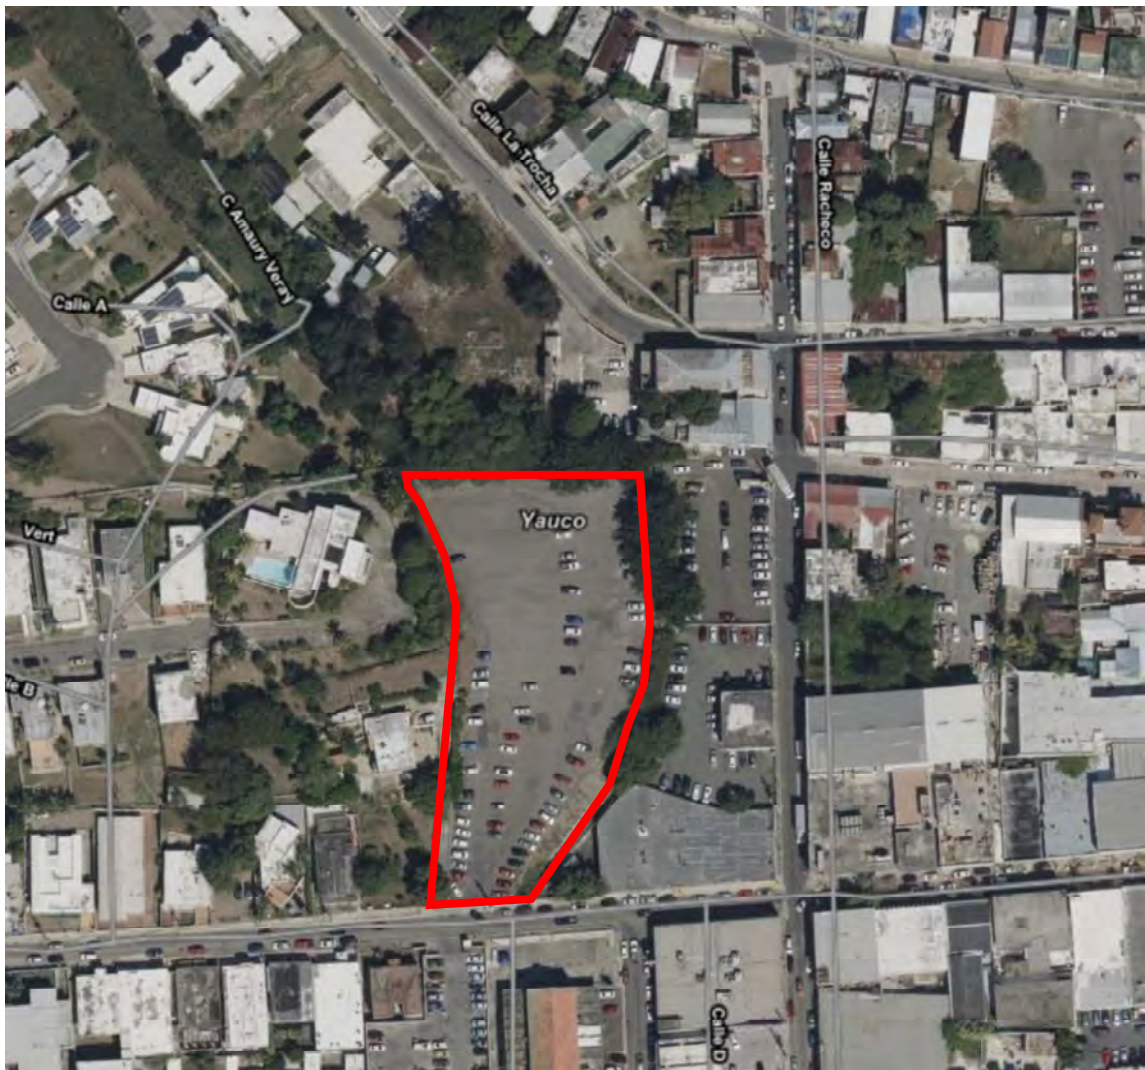
Figure 44. Coordinates: 18.03534545, Lon: -66.85207347.
 Not to Scale. Source: Google Earth, 2024.

Project (Parcel) Location- Soils Map

Map Unit Symbol	Map Unit Name	Acres in AOI	Percent of AOI
Ua	Urban land	2.0	100.0%
Totals for Area of Interest		2.0	100.0%

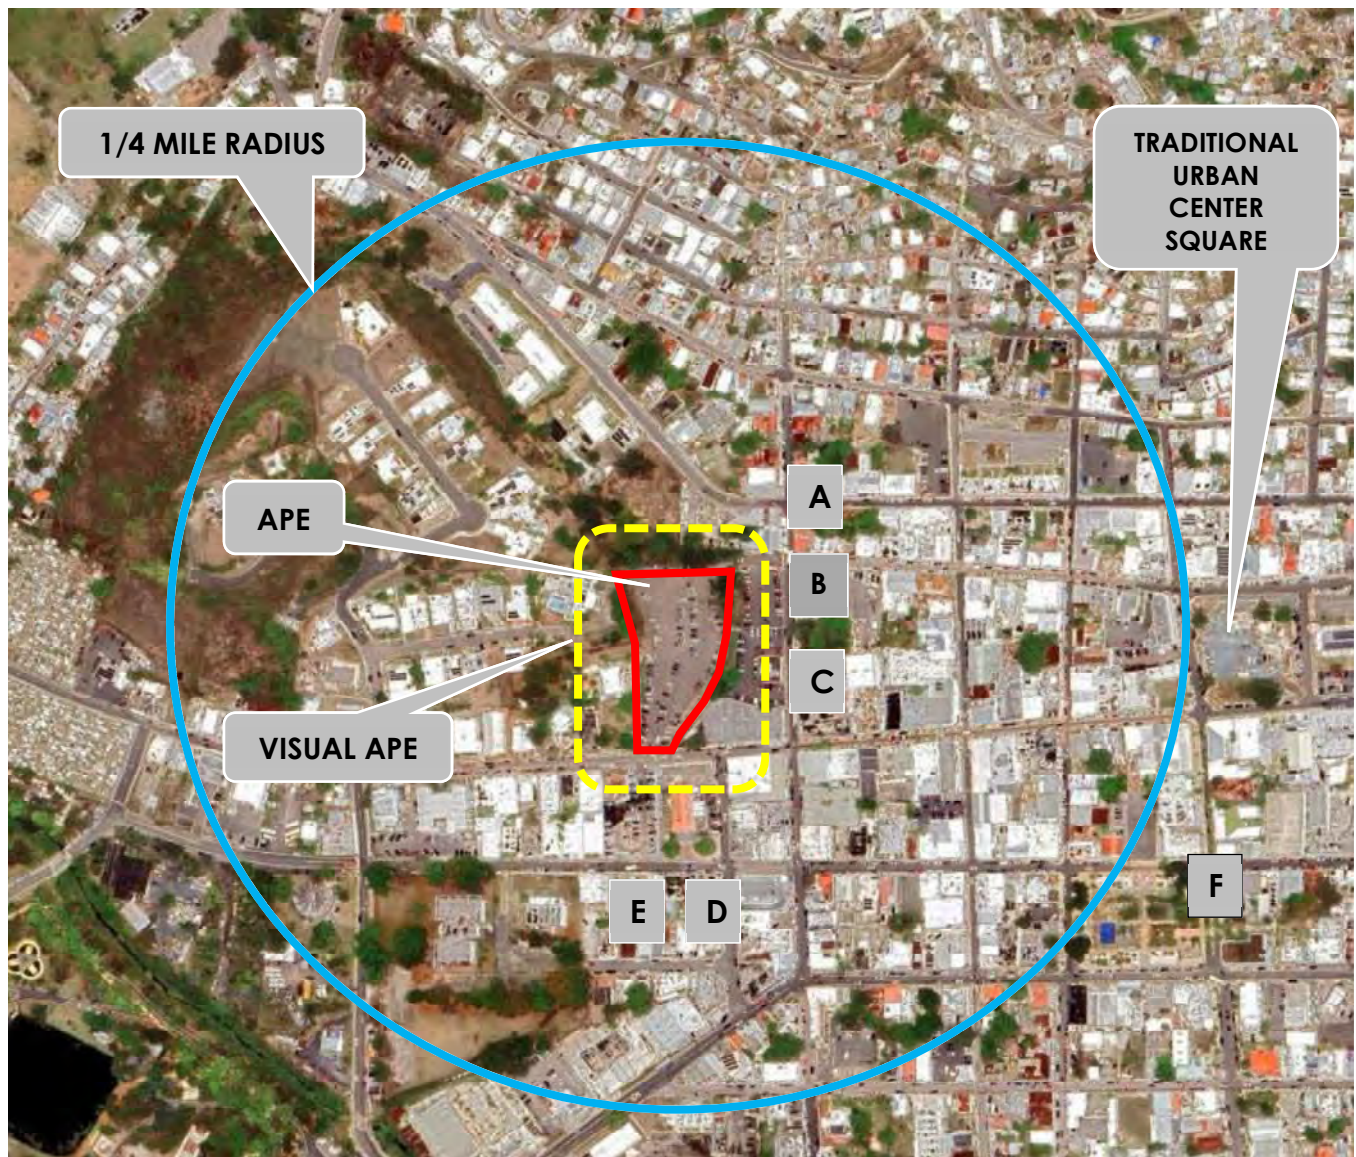
Figure 45. Coordinates: 18.03534545, Lon: -66.85207347.
 Not to Scale. Source: Source: Google Earth, 2024.

Project (Parcel) Location with Known Cultural Resources- Aerial Map

- A. Yauco Art and Historic Museum, ca. 1880.
- B. Rubbleworks remnants.
- C. Private Residence, ca. 1890.
- D. Market Square, 1925.
- E. Public Health Unit, 1937.
- F. Historic Zone/District, (Figure 24).

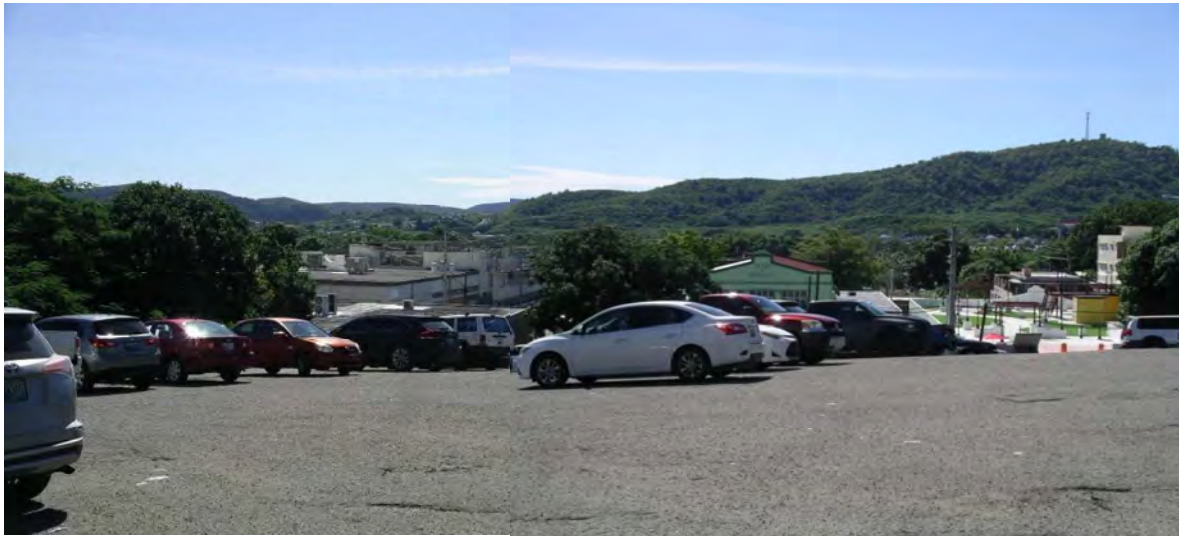
Photo: 23

Description: APE. South view showing the parking and towards the Comercio Street.

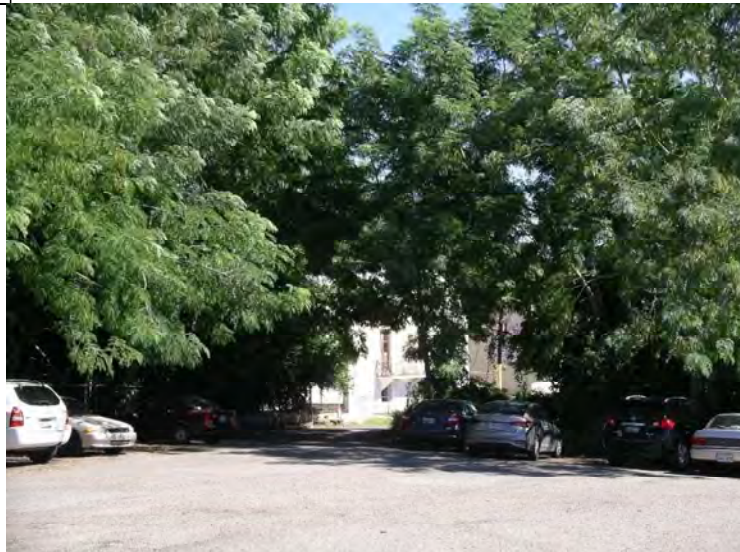
Photo: 24

Description: APE. East view towards north-east parking egress on Mattei Lluveras Street.

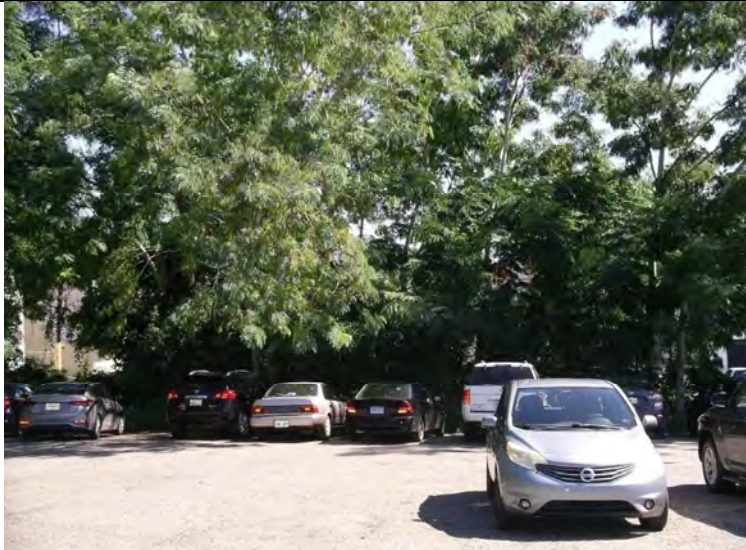
Photo: 25	Description: APE. East view towards the north-east area of the parking project.
Date:19/Nov/24

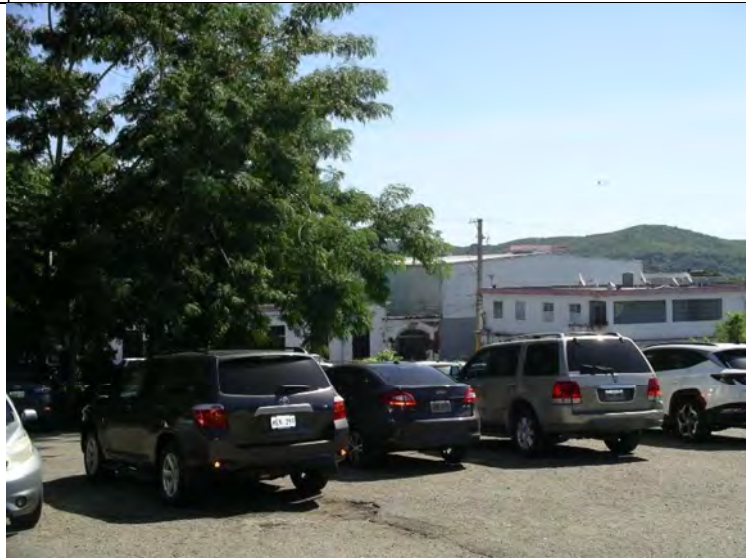
Photo: 26	Description: APE. South-east view towards the project parking area and partially viewed of the Fernando Pacheco Street urban profile. (Visual/APE).
Date:19/Nov/24

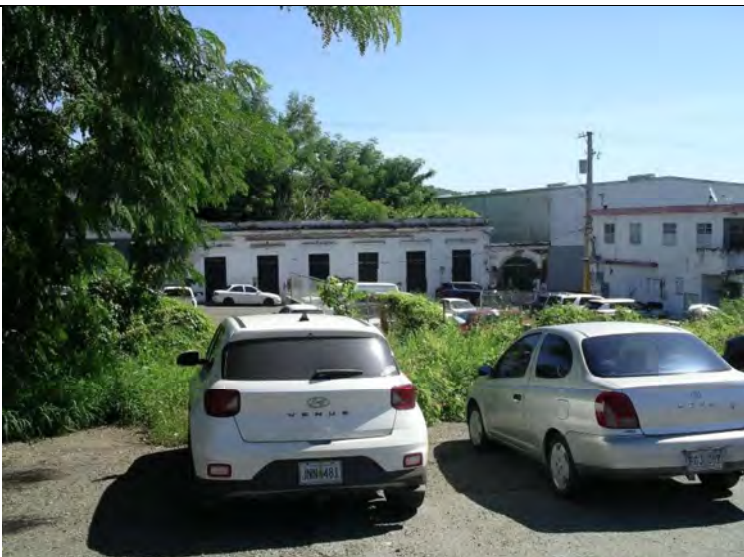
Photo: 27	Description: APE. East view from the project parking area and partially viewshed of the Fernando Pacheco Street urban profile. (Visual/APE).
Date:19/Nov/24

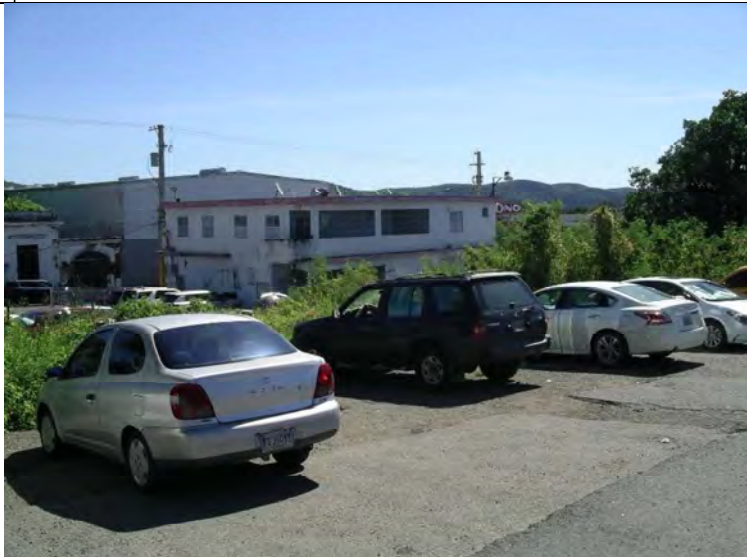
Photo: 28	Description: APE. East view from the project parking area and partially viewshed of the Fernando Pacheco Street urban profile (Visual/APE).
Date:19/Nov/24

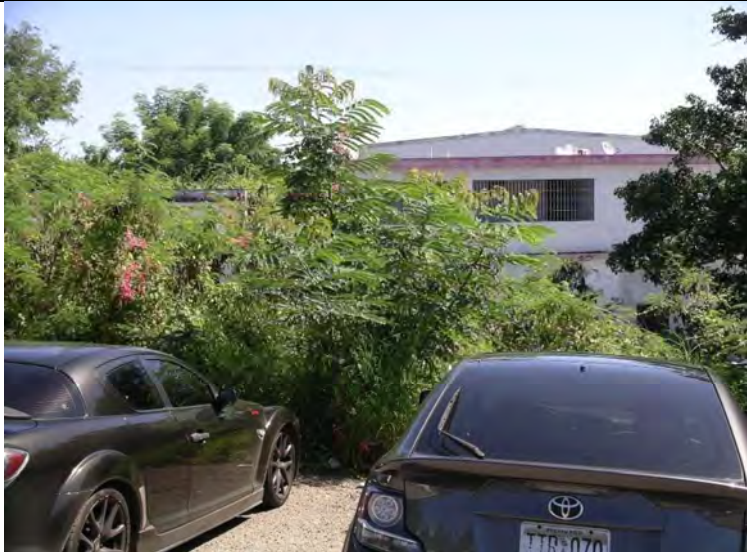
Photo: 29	Description: APE. East view from the project parking area and partially viewshed of the Fernando Pacheco Street urban profile (Visual/APE).
Date:19/Nov/24

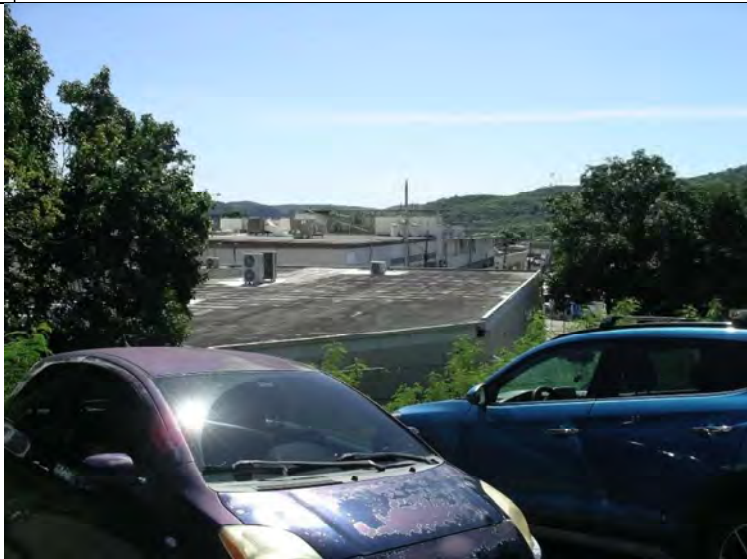
Photo: 30	Description: APE. South-east view from the project parking area and partially viewshed of the Fernando Pacheco Street and partial Historic Zone/District urban profile (Visual/APE).
Date:19/Nov/24

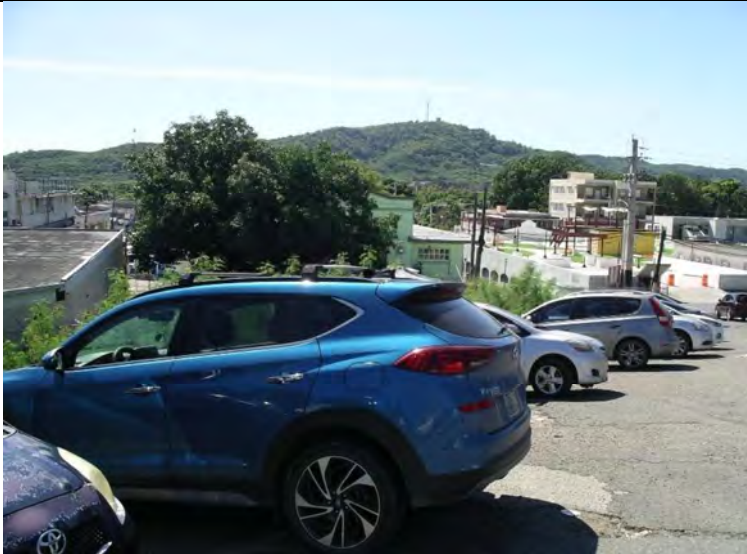
Photo: 31	Description: APE. South view from the project parking towards the Comercio Street partial Historic Zone/District urban profile. (Visual/APE).
Date:19/Nov/24

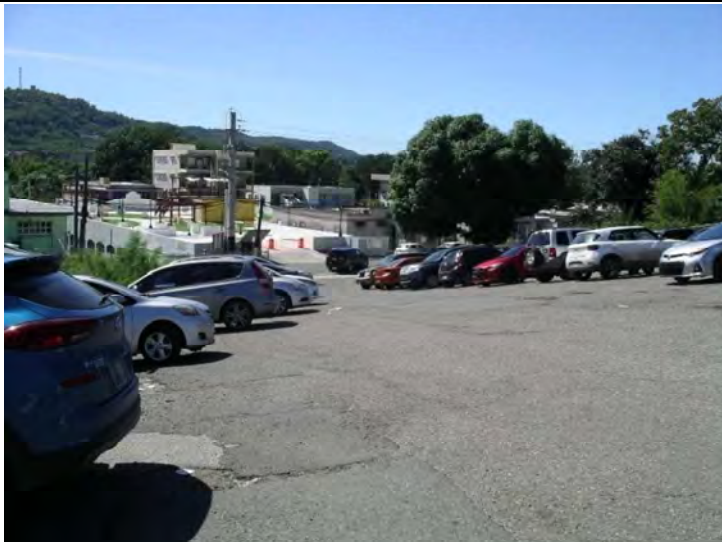
Photo: 32	Description: APE. South view from the project parking main entrance and towards the Comercio Street partial Historic Zone/District urban profile. (Visual/APE).
Date:19/Nov/24

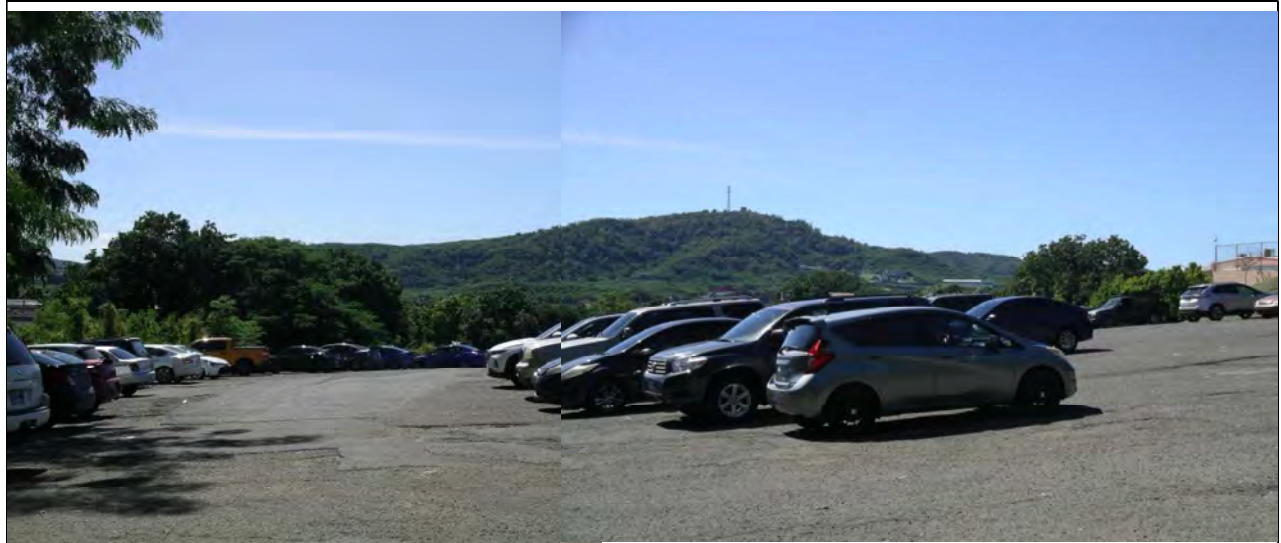
Photo:33	Description: APE. South view from north area of the parking project.
Date:19/Nov/24

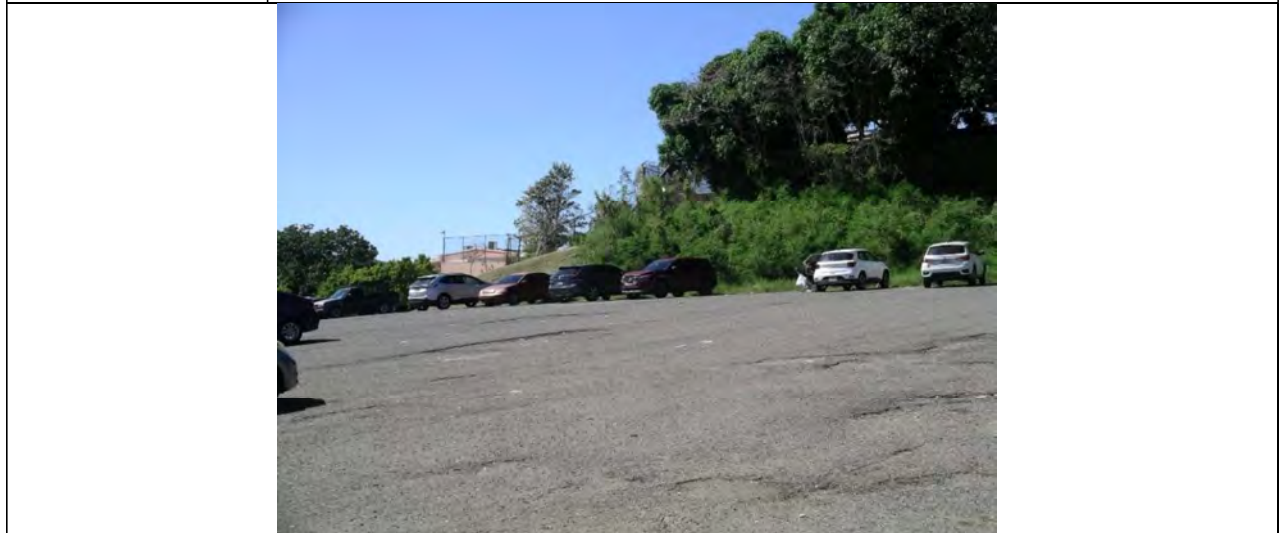
Photo: 34	Description: APE. South-west view from north area of the parking project.
Date:19/Nov/24

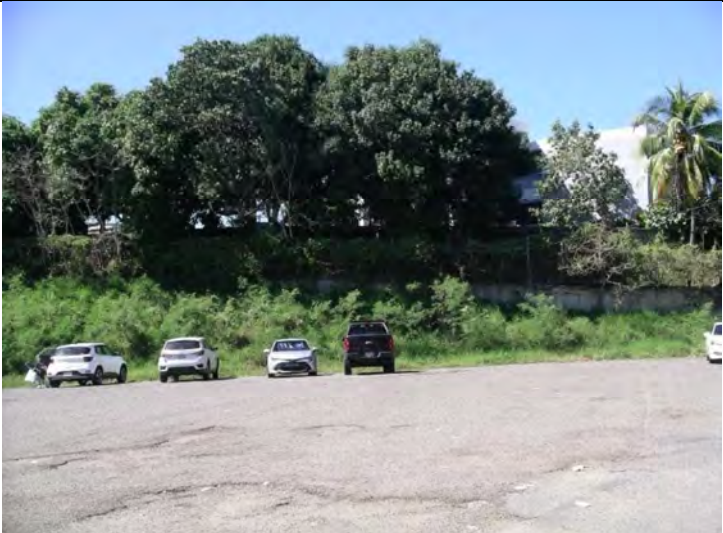
Photo: 35	Description: APE. West view from north area of the parking project.	
Date:19/Nov/24

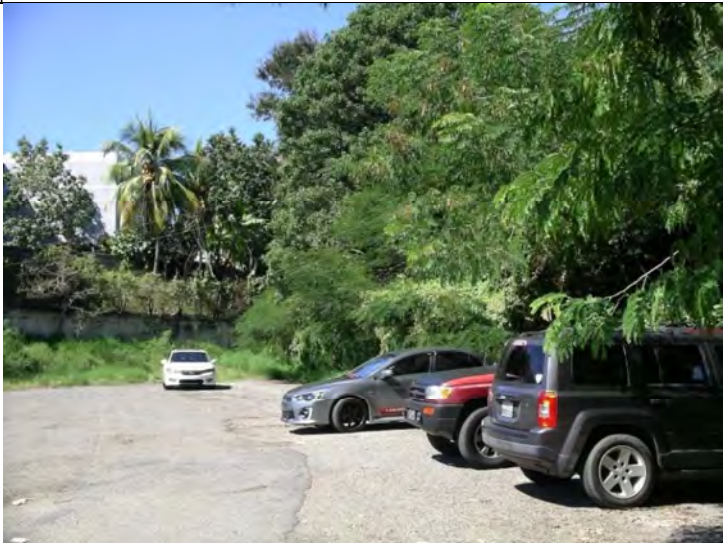
Photo: 36	Description: APE. West view from north area of the parking project.	
Date:19/Nov/24

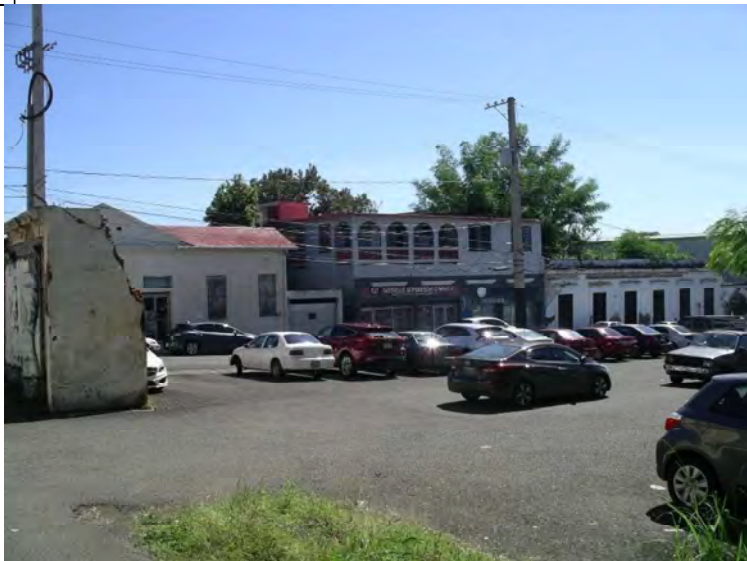
Photo: 40	Description: Visual/APE. South-east view towards Fernando Pacheco Street Historic Zone/District urban profile.
Date:19/Nov/24

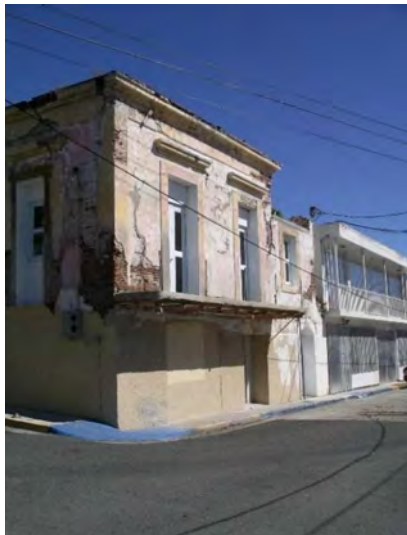
Photo: 39	Description: Visual/APE. North-east view towards the corner of Fernando Pacheco and Mattei Lluveras Street in the Historic Zone/District. Contributing vacant property.
Date:19/47v/24

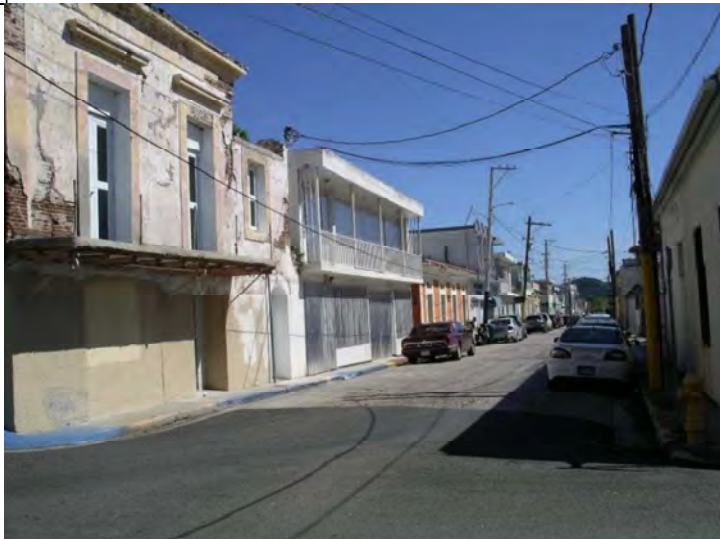
Photo: 48	Description: Visual/APE. East view towards Mattei Lluveras Street in the Historic Zone/District.
Date:19/Nov/24

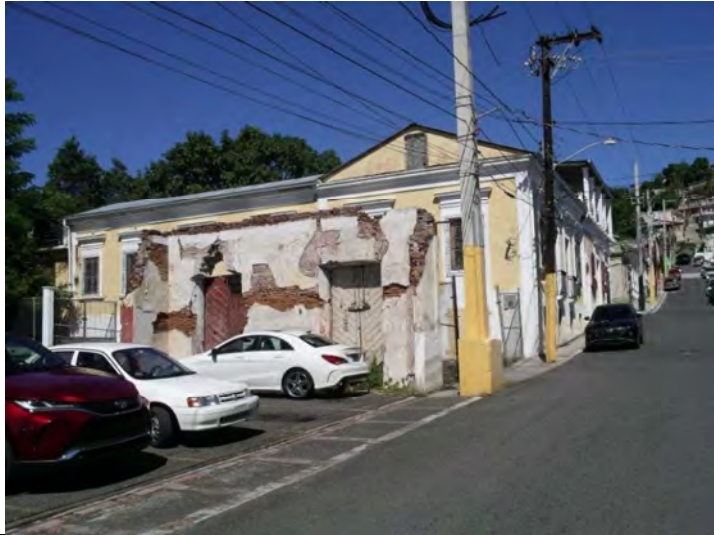
Photo: 49

Description: Visual/APE. North view towards the corner of Fernando Pacheco and Mattei Lluveras Street in the Historic Zone/District. Historic property remnants. (Mural painted on the opposite side).

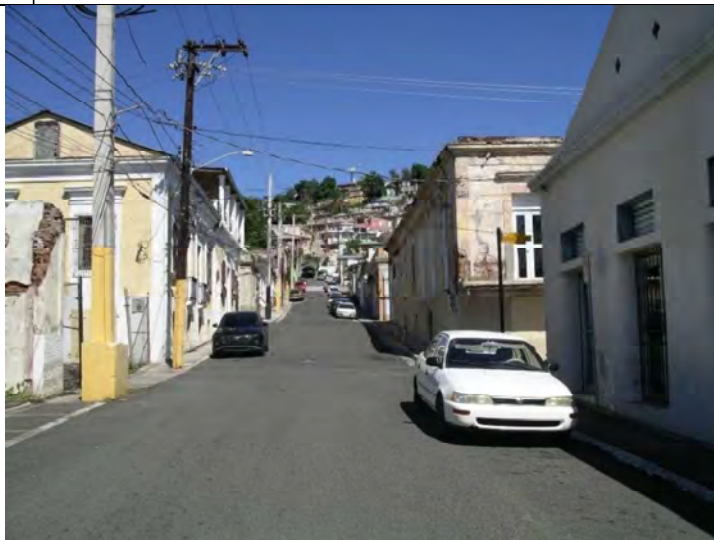
Photo: 50

Description: Visual/APE. North view towards Fernando Pacheco Street in the Historic Zone/District.

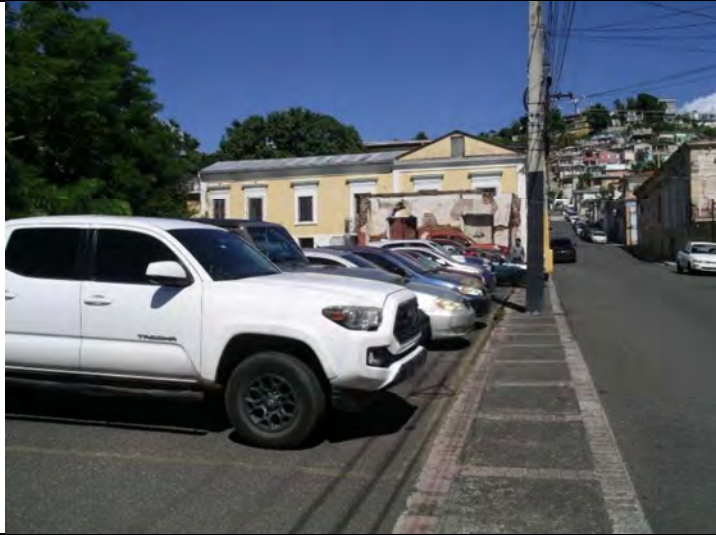
Photo: 51

Description: Visual/APE. North view towards Fernando Pacheco Street in the Historic Zone/District where another parking area is located. (Not part of the APE).

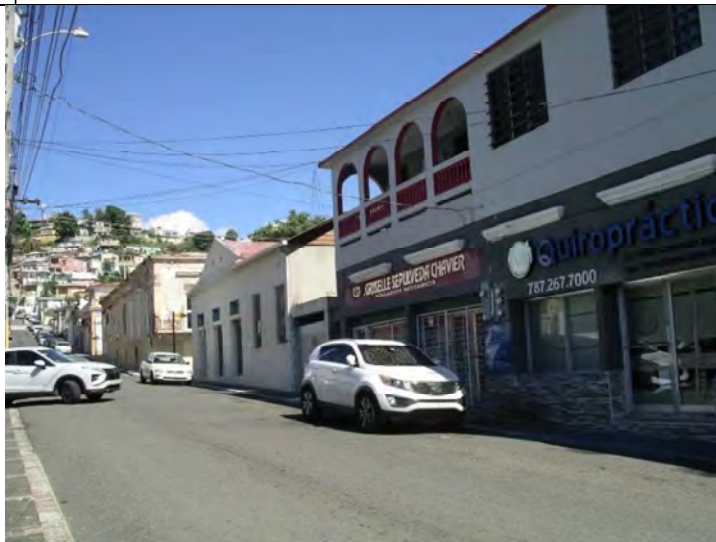
Photo: 52

Description: Visual/APE. North view towards Fernando Pacheco Street in the Historic Zone/District.

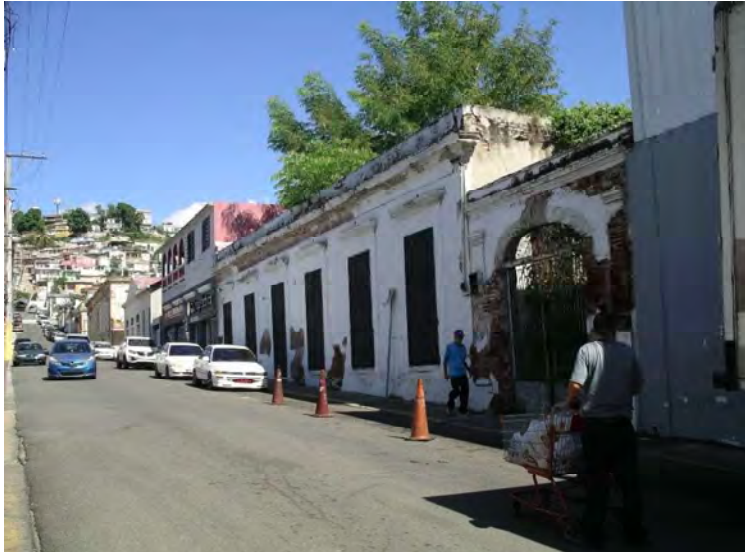
Photo: 57	Description: Visual/APE. North view towards Fernando Pacheco Street in the Historic Zone/District.
Date:19/Nov/24

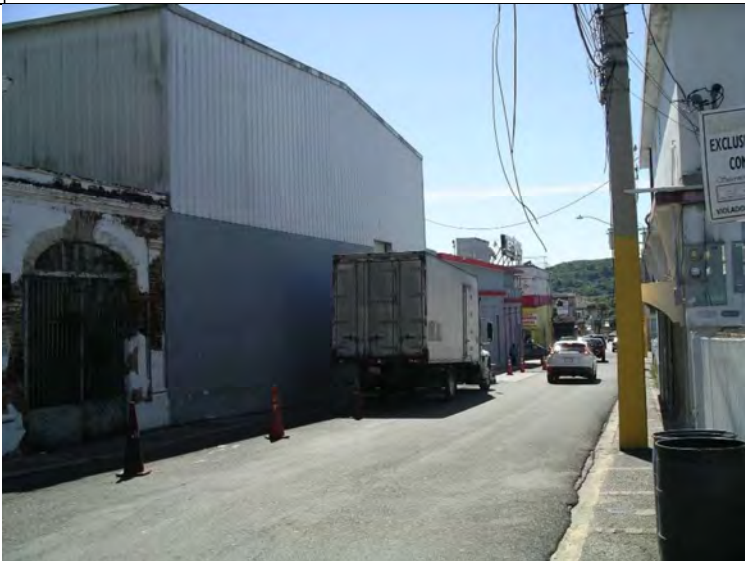
Photo: 58	Description: Visual/APE. South view on Fernando Pacheco Street in the Historic Zone/District. Non-contributing property.
Date:19/Nov/24
