Environmental Review for Activity/Project that is Categorically Excluded Subject to Section 58.5

Project Name: *PR-CRP-000369 Plaza de Armas*

Responsible Entity: PUERTO RICO DEPARTMENT OF HOUSING (PRDOH)

The project scope of work (SOW) comprises the improvements of the historic Plaza de Armas and the surrounding sidewalks. The Plaza de Armas is located in the heart of Old San Juan, in front of Casa Alcaldía in San Francisco Street.

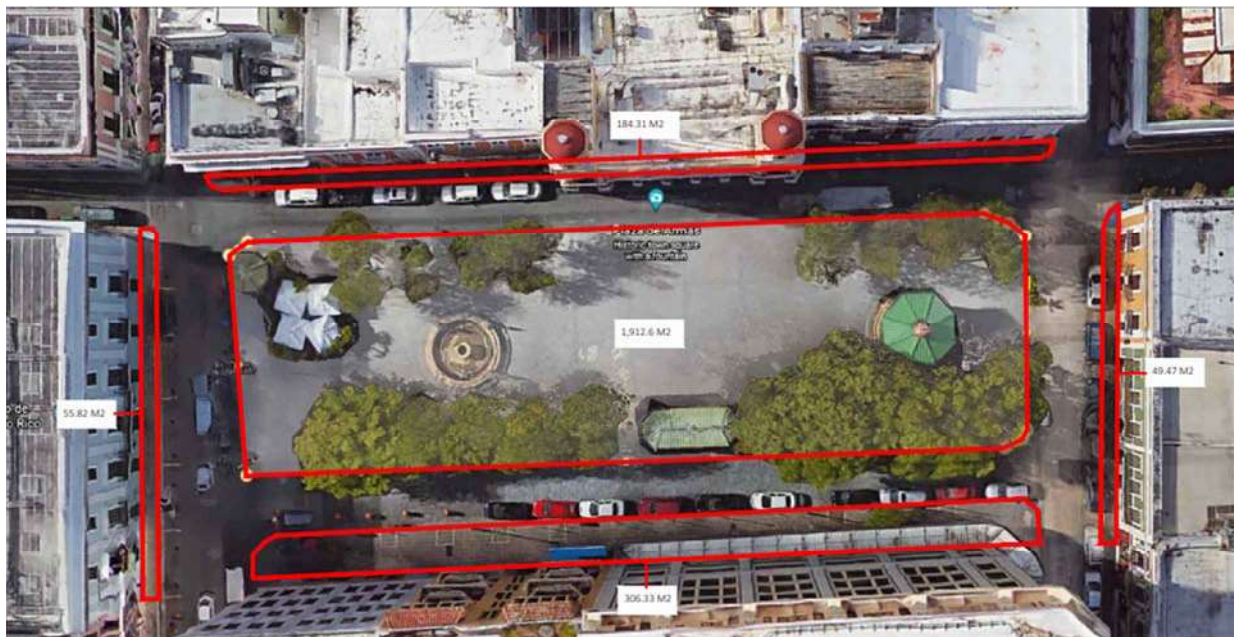
Below you can see the area designated by the Municipality of San Juan in the Scope of Work for the project.

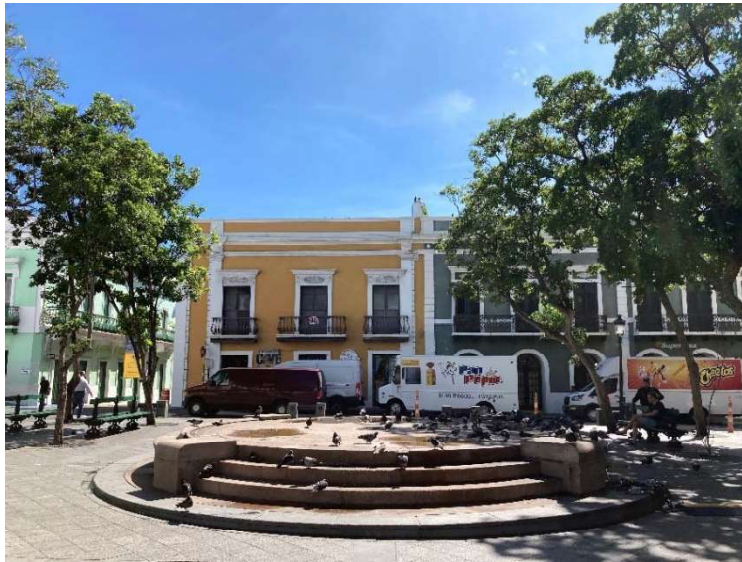
The improvements consist of restoring and replacing the existing features of the Plaza. The Plaza and its surrounding sidewalks consist of **16,000 sfs** of pavements. **Without any excavation process**, damaged tiles will be removed and replaced without impacting the underlying concrete slab with **new granite tiles**. Nonetheless we have commissioned a **Phase 1A Archeological Study**. In the two existing commercial venue structures, we will make improvements to the metal roof and lighting systems since these were affected by the Hurricanes. Mechanical repairs will be done to the existing water fountain and its pump.

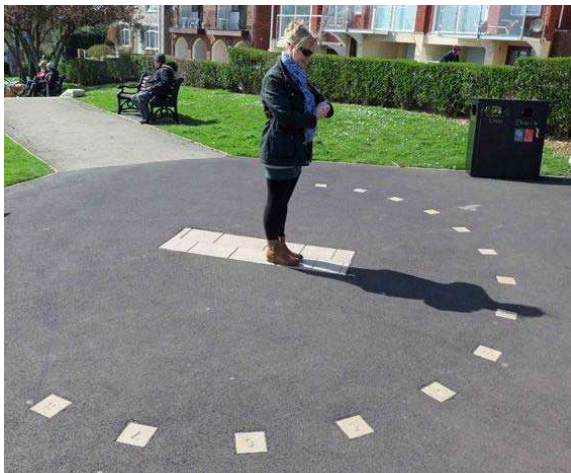
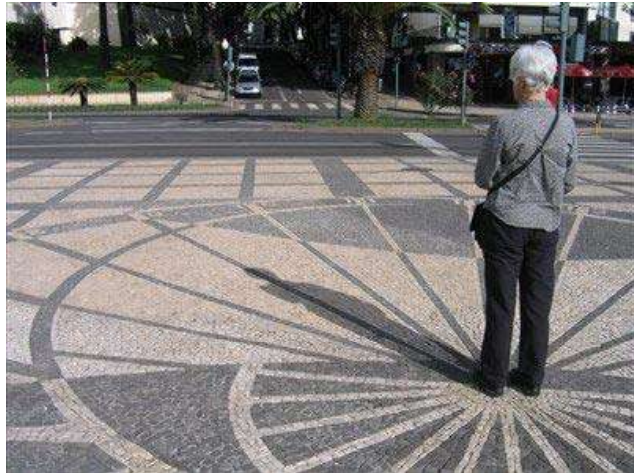
Proposed New Interactive Sun Dial

We propose an interactive Human Sun Dial where the 90's Gazebo and concrete base stood. This implies that the existing concrete base to the east of the Plaza would be demolished and properly disposed of. The Sun Dial would be placed in the exact footprint of the base, facing north, and would be composed of the same granite tiles with bronze inlays in the pavement indicating the hours and months. **No protruding obstacles will be present.** The following images as references and pages 11 & 1, A-3.0/3.1 of Construction Drawings Set.

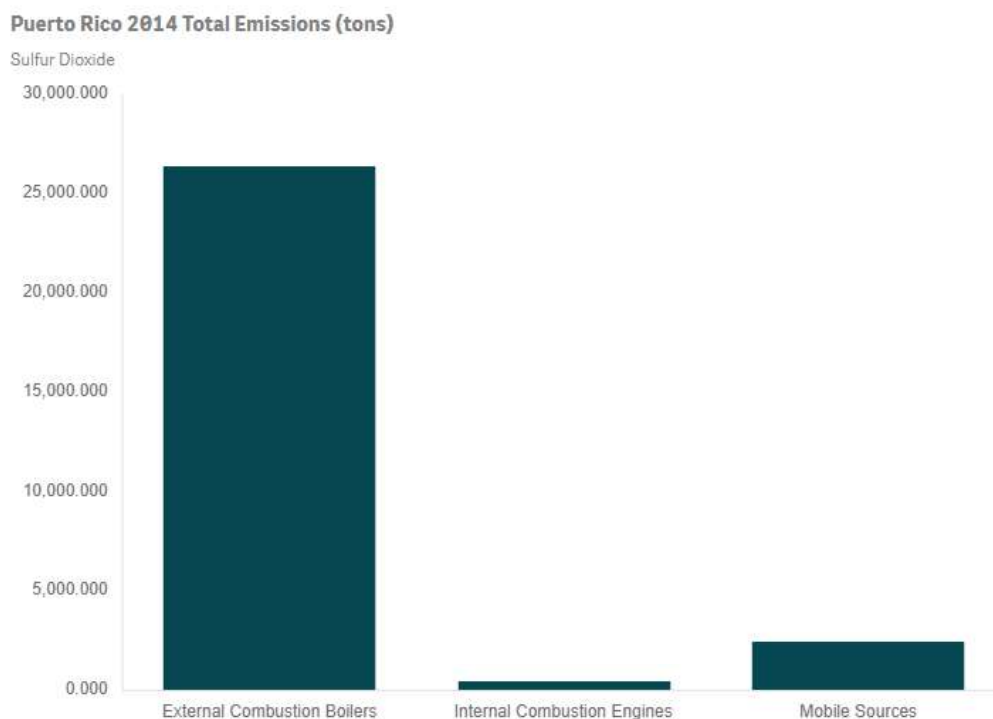
Figure #3: NEI 2014 SO₂ Emission based on process

Emissions inventory and source emission rate data serve as the foundation for modeling and other required analyses. Sulfur dioxide emissions come from anthropogenic sources such as fossil fuel combustion and biogenic sources such as volcanic activity. Anthropogenic emissions of SO₂ in Puerto Rico are mainly due to combustion of fossil fuels by external combustion boilers (~90 %), internal combustion engines (~1.6%) and transportation-related sources (~8.4%) based on 2014 EPA National Emission Inventory (USEPA, 2014), shown in Figure #3.

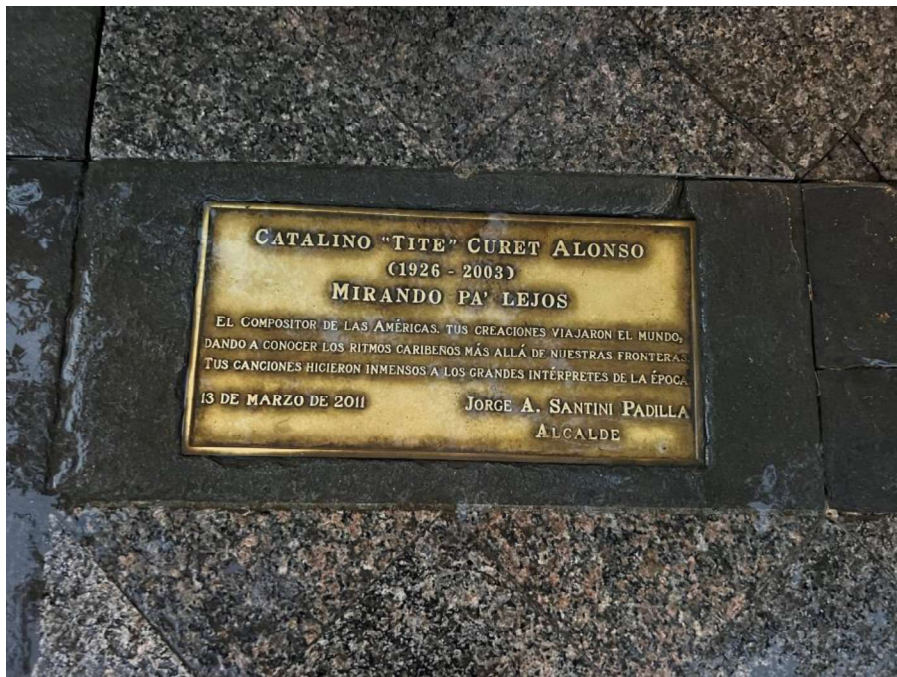
Plaza de Armas- South Side – Metal Statue with Lead Based Paint

Plaza de Armas- South Side – Metal Statue Plaque with Lead Based Paint

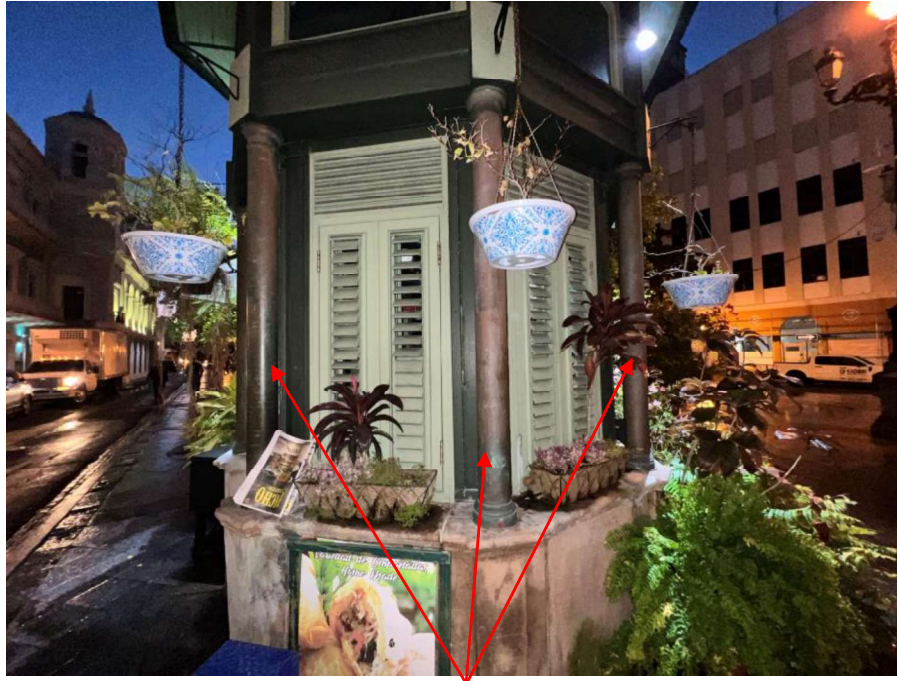
Plaza de Armas- Kiosk #1- Exterior- Metal Columns with Lead Based Paint

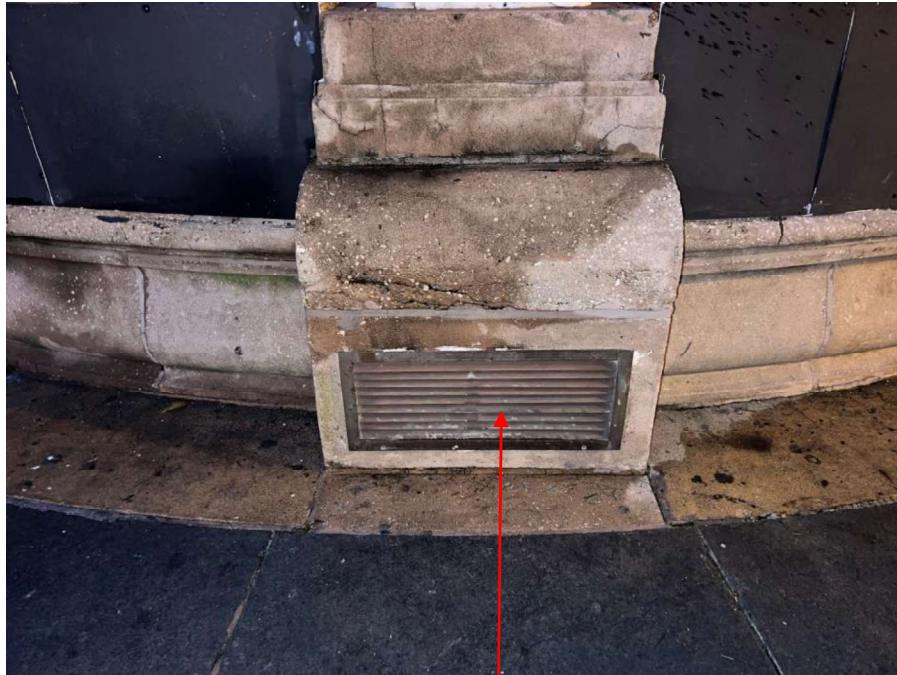
Plaza de Armas- Water Fountain- Metal Grate with Lead Based Paint

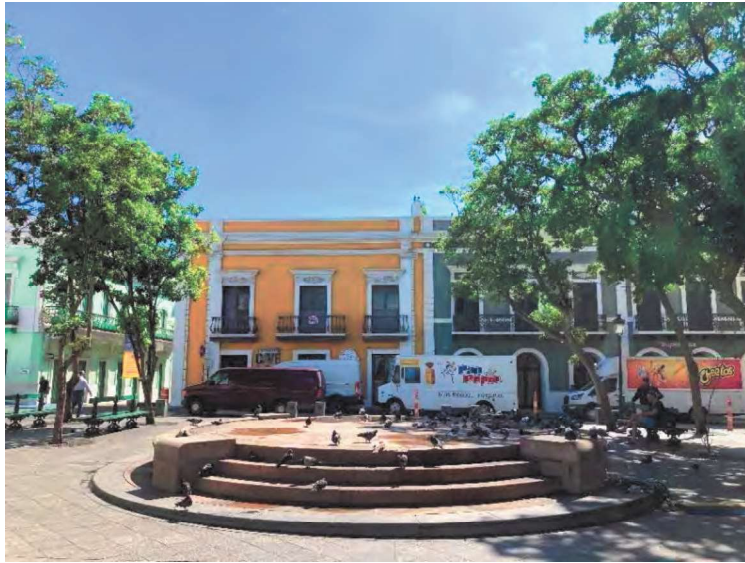
After Hurricane Maria the existing Gloriette was heavily damaged. The MASJ uninstalled it afterwards (2018) to avoid any accidents or hazards. This existing structure was designed amid 1986/90. The proposed Pavillion pays homage to the old structure with a new design and a light structure that will withstand events such as hurricane winds or earthquakes.

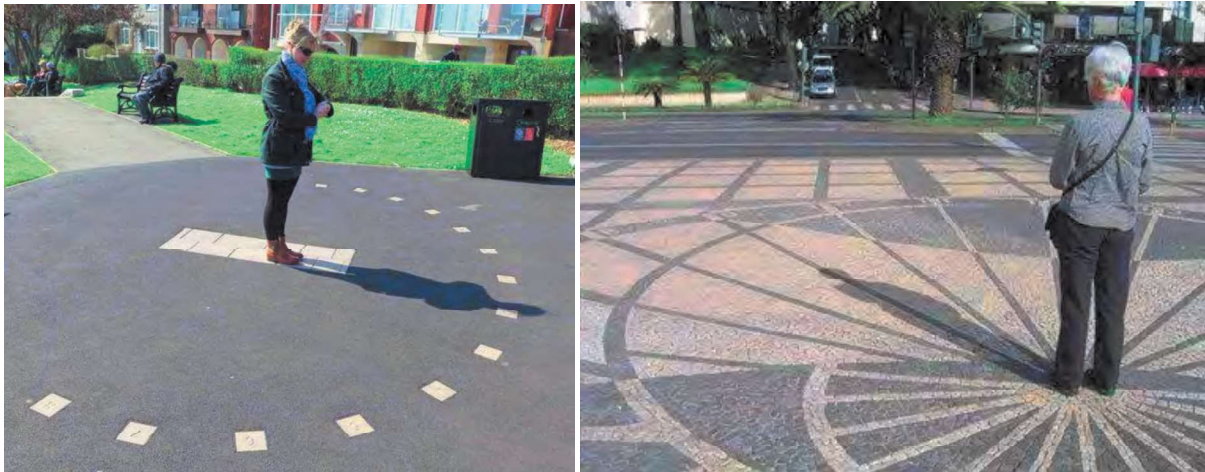
As an alternative to the Pavilion Structure, we propose an interactive Human Sun Dial instead. This implies that the existing concrete base to the east of the Plaza would be demolished. The Sun Dial would be placed in the exact footprint of the base and would be composed of the same granite tiles with bronze inlays in the pavement indicating the hours and directions. **No protruding obstacles will be present.** See image as reference.

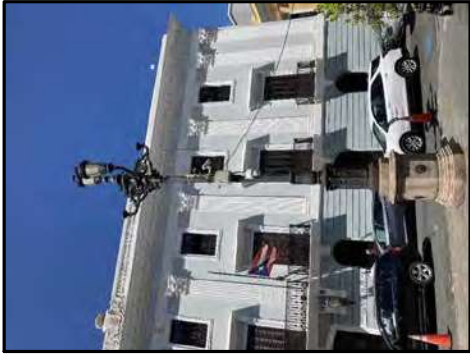
EXISTING LAMP
POST PALACIO
GRUPO JARENO TO
BE RESTORED, SEE
DWG A-1.0

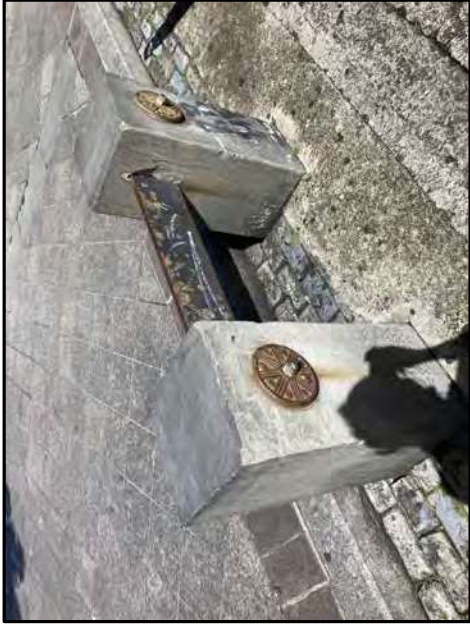
EXISTING LAMP
POST PALACIO
GRUPO JARENO TO
BE RESTORED, SEE
DWG A-1.0

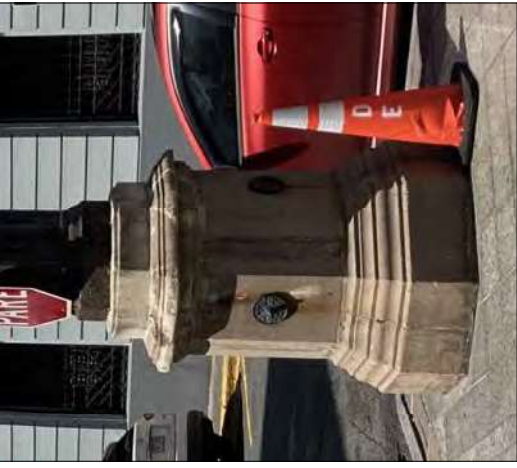
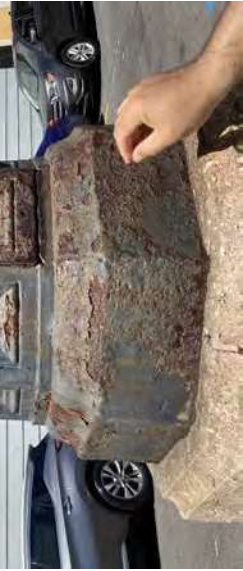
RESTORE POLE AND LAMP ACCORDING
SECTION 05-01-00 "RESTORATION OF
METALS", SECTION 099600 "HIGH
PERFORMANCE COATING" AND SECTION
049000 "STONE MASONRY RESTORATION
& CLEANING" OF TECH. SPECS. SEE
ELECTRICAL DWGS.

EXISTING METAL POLE AND CONCRETE BASE

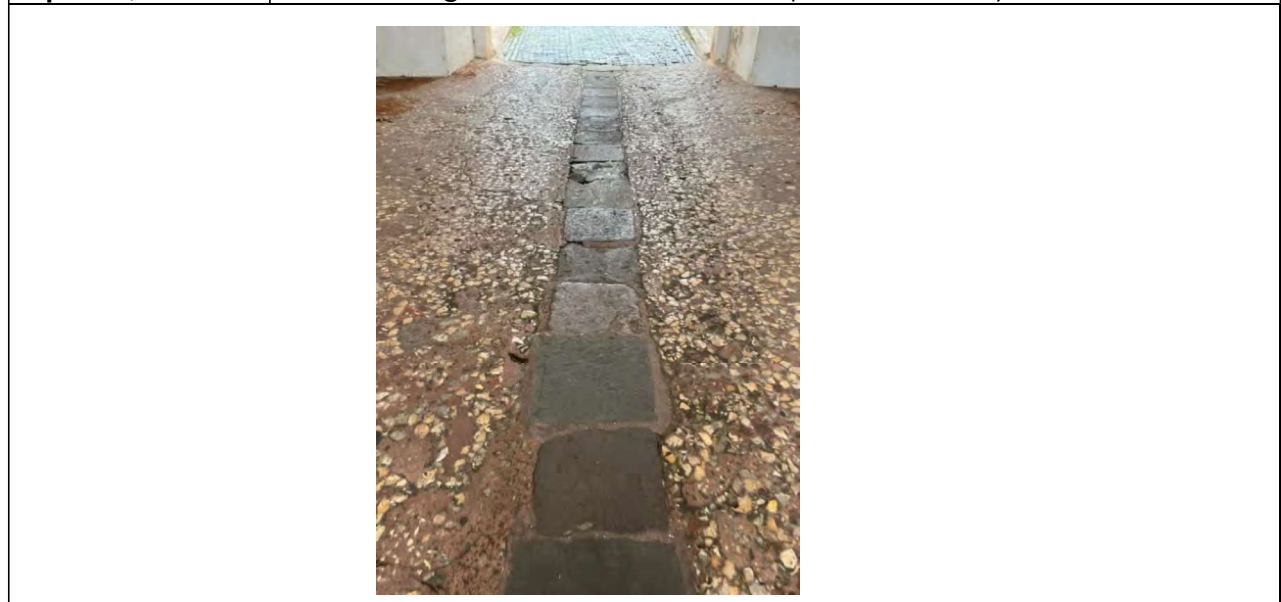
Photo #: 02	Description (include direction): towards east
Date: April 23,2023	Pavement construction detail

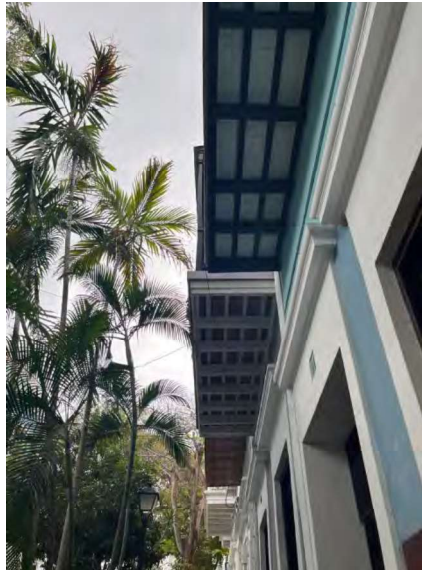
Photo #: 06	Description (include direction): towards east
Date: April 23, 2023	Caleta de San Juan Balconies construction details

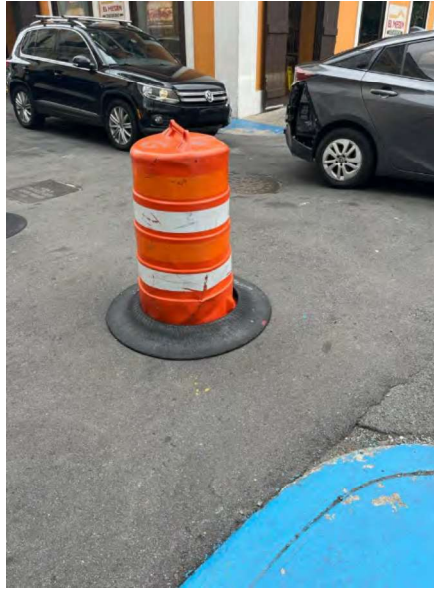
Photo #: 17	Description (include direction): towards northwest Junction of San Francisco and San José Street -tar pavement and actual conditions
Date: April 23, 2023

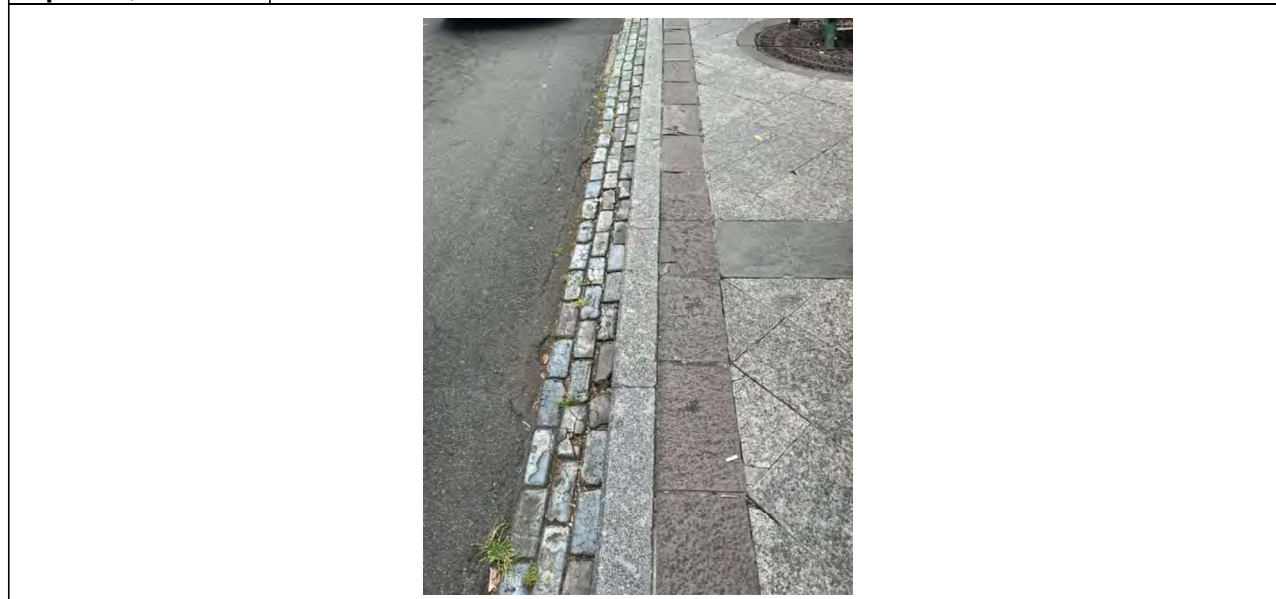
Photo #: 24	Description (include direction): towards east
Date: April 23, 2023	Detail of different pavement treatments and finishes at San Francisco Street and Plaza de Armas

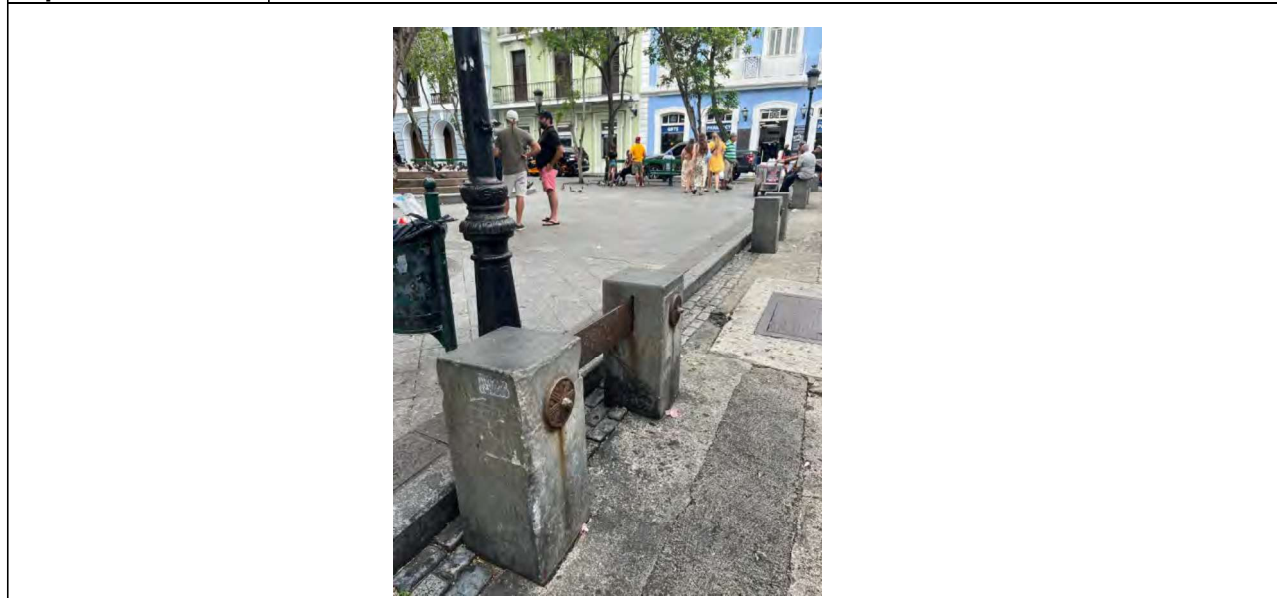
Photo #: 38	Description (include direction): towards northwest Parking posts at the limits of the paved Plaza de Armas
Date: April 23, 2023

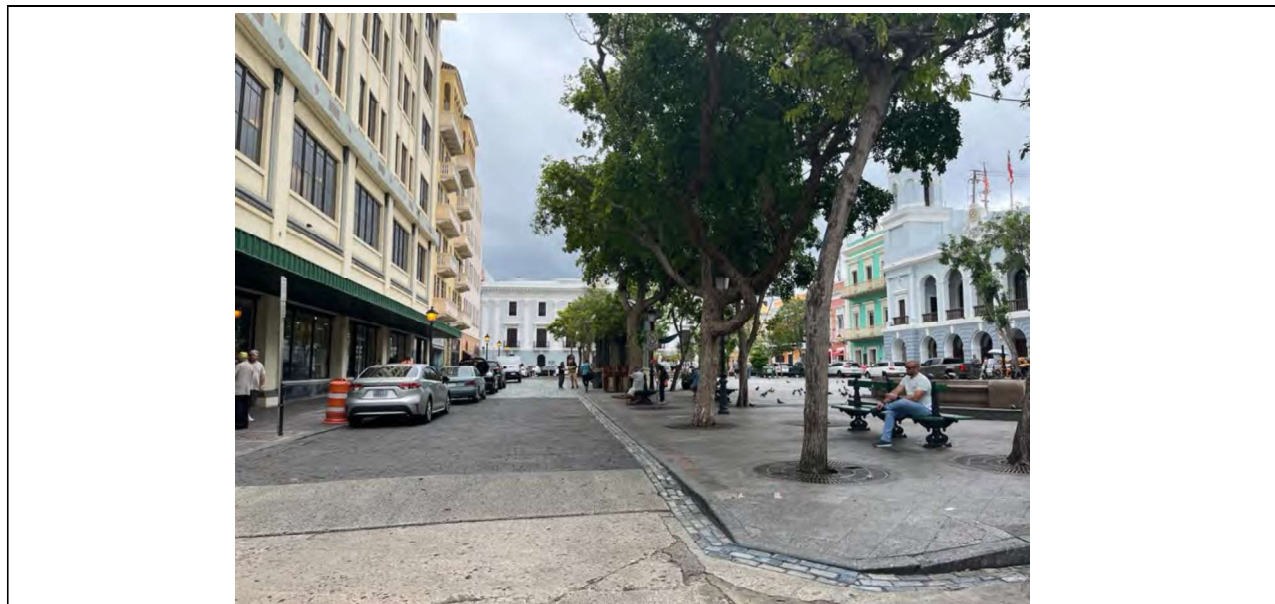
Photo #: 45	Description (include direction): towards west
Date: April 23, 2023	Marshalls at the left and Plaza de Armas at the right, the Department of State is at the background.

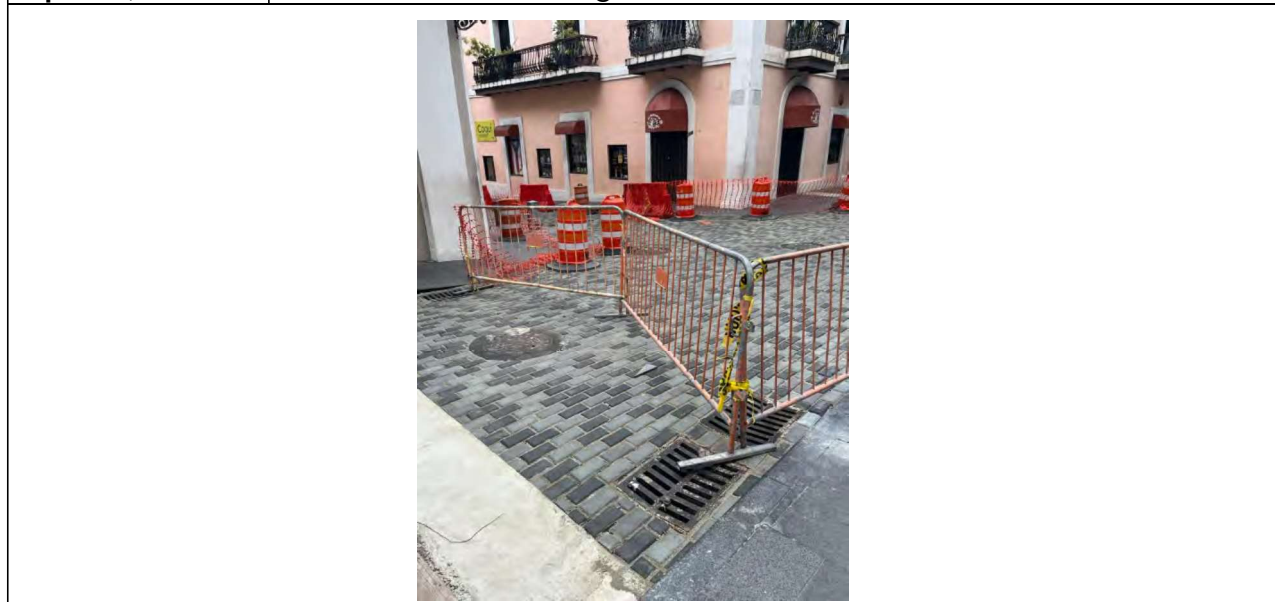
Photo #: 46	Description (include direction): towards southeast
Date: April 23, 2023	Pavement treatment to the south adjacent to the Marshalls store.

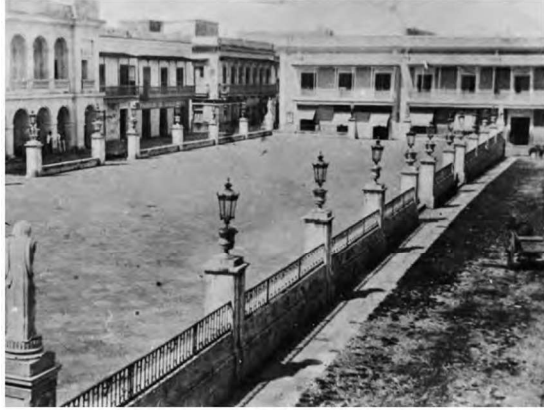
Así lucía la Plaza de Armas en 1898, sobre el nivel de las calles aledañas. >Foto Suministrada 1898: looking towards northeast
El Vocero

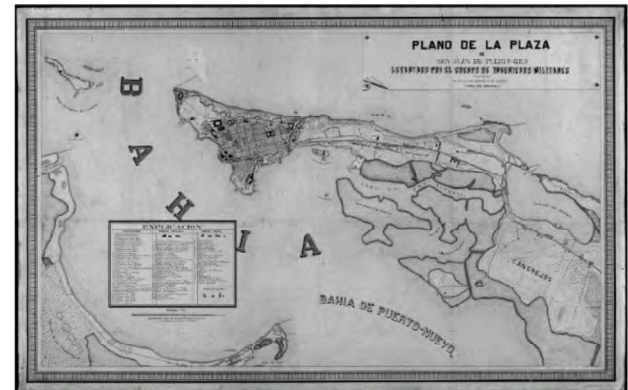
9. Plan of the Plaza de San Juan de Puerto Rico, F. Roldán y Navarro, 1867. Archivo Cartográfico y Estudios Geográficos del Centro Geográfico del Ejército, España.

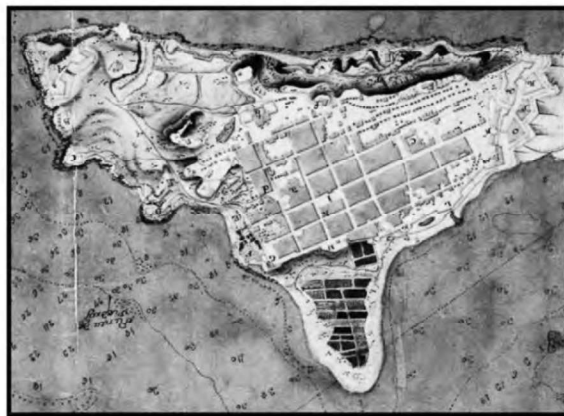
Plan of San Juan, 1776, Ramón de Villalonga. Archivo Cartográfico y Estudios Geográficos del Centro Geográfico del Ejército, Spain.

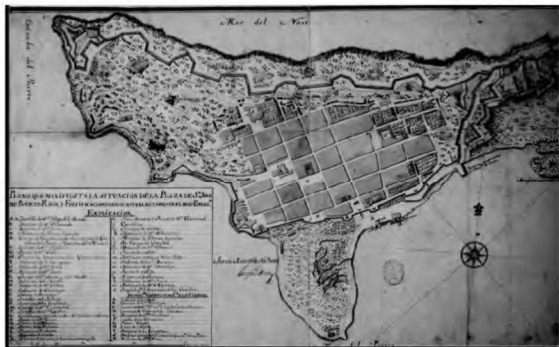
Plan of San Juan, Engineer Juan Francisco Mestre, 1792. Archivo Cartográfico y Estudios Geográficos del Centro Geográfico del Ejército, Spain.

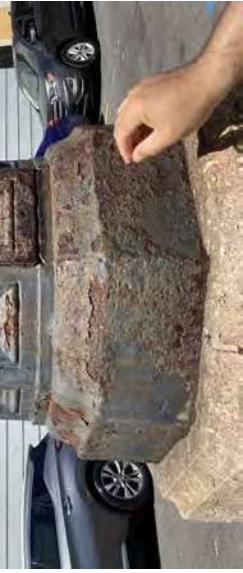
RESTORE POLE AND LAMP ACCORDING
SECTION 05-01-00 "RESTORATION OF
METALS", SECTION 099600 "HIGH
PERFORMANCE COATING" AND SECTION
049000 "STONE MASONRY RESTORATION
& CLEANING" OF TECH. SPECS. SEE
ELECTRICAL DWGS.

EXISTING METAL POLE AND CONCRETE BASE

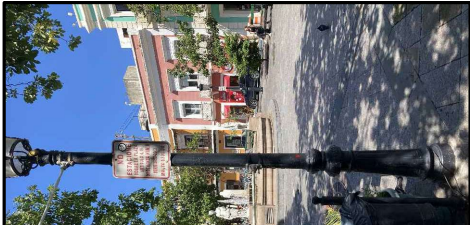
EXISTING LAMP
POST PALACIO
GRUPO JARENO TO
BE RESTORED, SEE
DWG A-1.0.

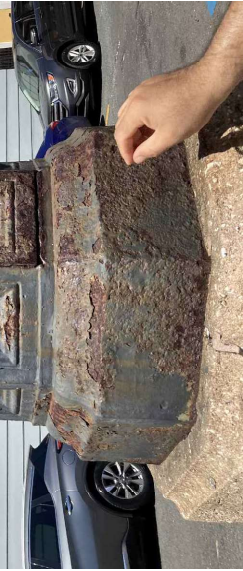
RESTORE POLE AND LAMP ACCORDING SECTION 05-01-00 "RESTORATION OF METALS", SECTION 099600 "HIGH PERFORMANCE COATING" AND SECTION 049000 "STONE MASONRY RESTORATION & CLEANING" OF TECH. SPECS. SEE ELECTRICAL DWGS.

EXISTING METAL POLE AND CONCRETE BASE

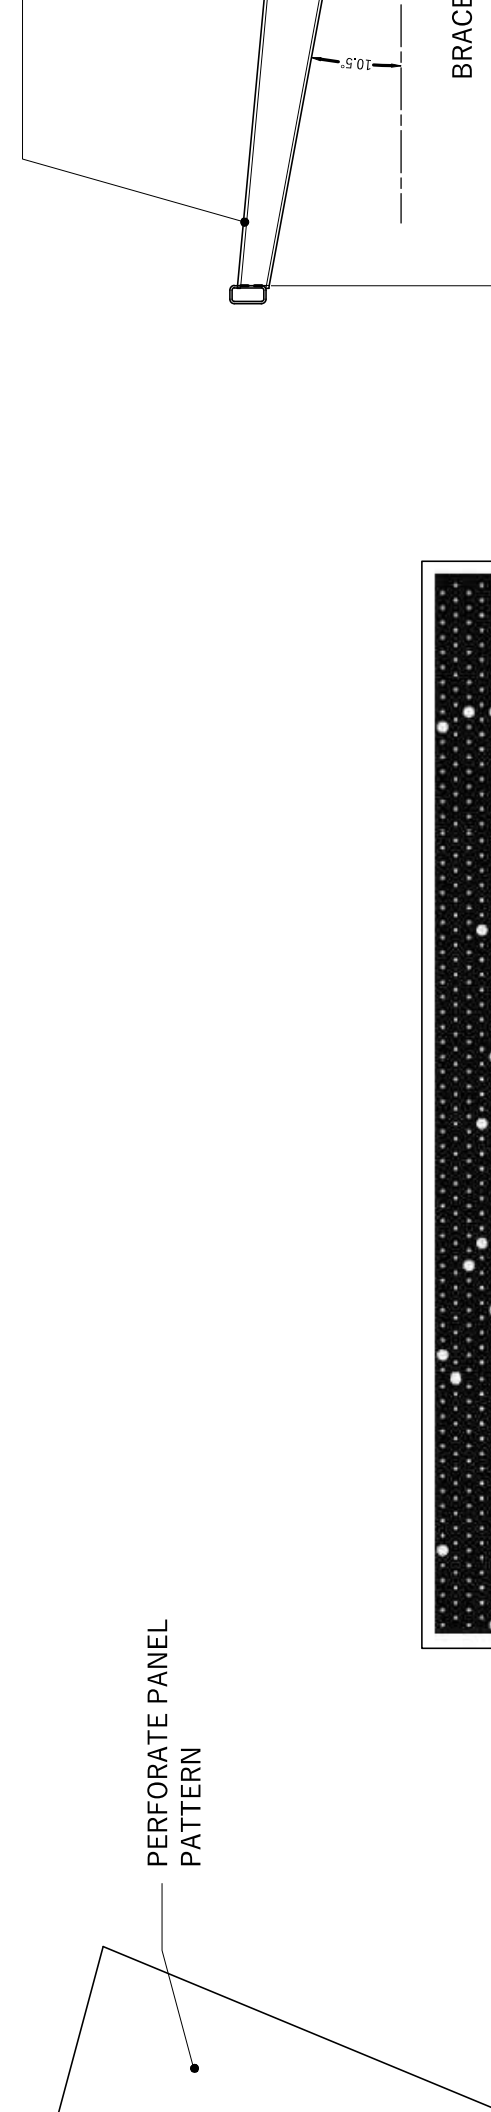
1
A-3.1

NOTE:
SEGMENTS ARE EQUAL ALL AROUND
