**Form 2-5 Statutory Checklist**  
**Environmental Review for Activity/Project that is**  
**Categorically Excluded Subject to Section 58.5**  
**Pursuant to 24 CFR 58.35(a)**

**Project Name:** Plaza Salvador Brau, (PR-CRP-000448)

**Responsible Entity:** PUERTO RICO DEPARTMENT OF HOUSING (PRDOH)

The rehabilitation and renovation of the Plaza Salvador Brau, comprises 1,384 square meters, The undertaking will repair damages caused by hurricanes Irma and Maria and improve the plaza to recover and foster its public uses. The work will renovate electrical infrastructure and replace lampposts and existing pavement with flamed granite tiles. Still, it will retain the pattern of the tiles that signals the footprint of the demolished seventeenth-century San Francisco church. Existing bollards and trashcans in the south sidewalk will be replaced with new models, short concrete fences around the planters will be renovated, handrails located in the steps between the plaza and the San Francisco church slightly elevated atrium will also be replaced, and the existent wood and iron benches will be substituted with curved concrete prefabricated benches. Trees will be replanted to compensate for

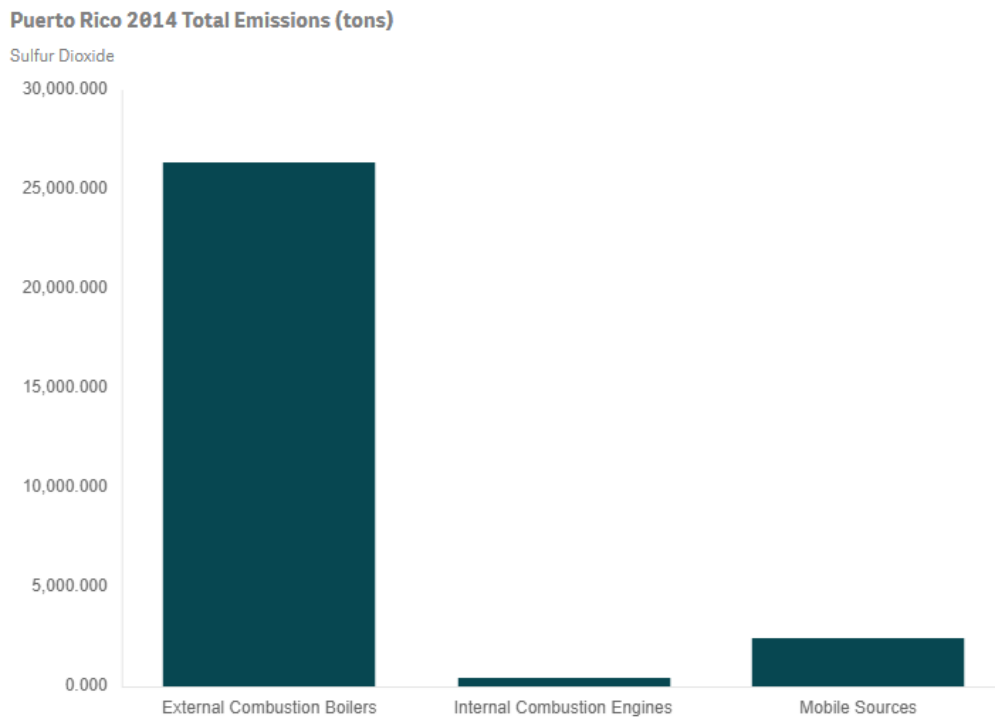
Figure #3: NEI 2014 SO<sub>2</sub> Emission based on process

Emissions inventory and source emission rate data serve as the foundation for modeling and other required analyses. Sulfur dioxide emissions come from anthropogenic sources such as fossil fuel combustion and biogenic sources such as volcanic activity. Anthropogenic emissions of SO<sub>2</sub> in Puerto Rico are mainly due to combustion of fossil fuels by external combustion boilers (~90 %), internal combustion engines (~1.6%) and transportation-related sources (~8.4%) based on 2014 EPA National Emission Inventory (USEPA, 2014), shown in Figure #3.
