Environmental Review for Activity/Project that is Categorically Excluded Subject to Section 58.5

Project Name: *PR-CRP-000955 Puente Iluminado (puente Klumb Ave Gandara)*

Responsible Entity: Puerto Rico Department of Housing (PRDOH)

It crosses over the Gándara Ave., Río Piedras Ward, San Juan, P.R., Coordinates: Lat 18.401131°, Lon -66.050738°, Cadaster EXC-TMP-146-00 (see Location Map at Attachment A of this report.)

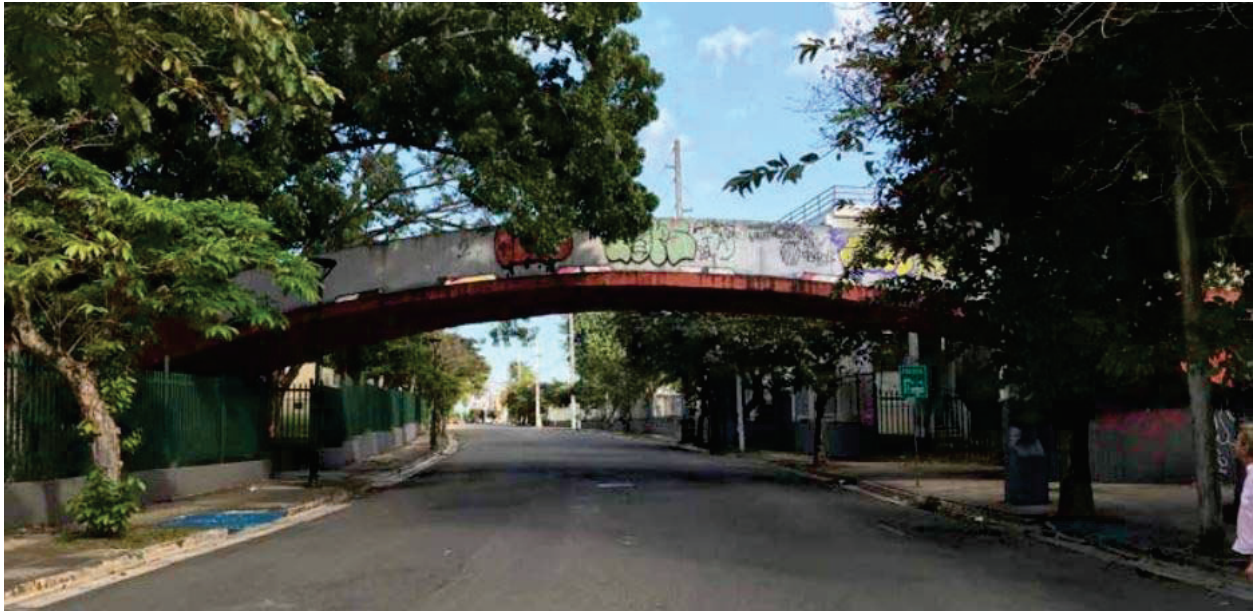
Infrastructure systems of water, sanitary sewer, electricity, and storm sewer are present in the existing site. Below some photos of the existing bridge conditions:

Bridge side view from Ave. Gándara looking East

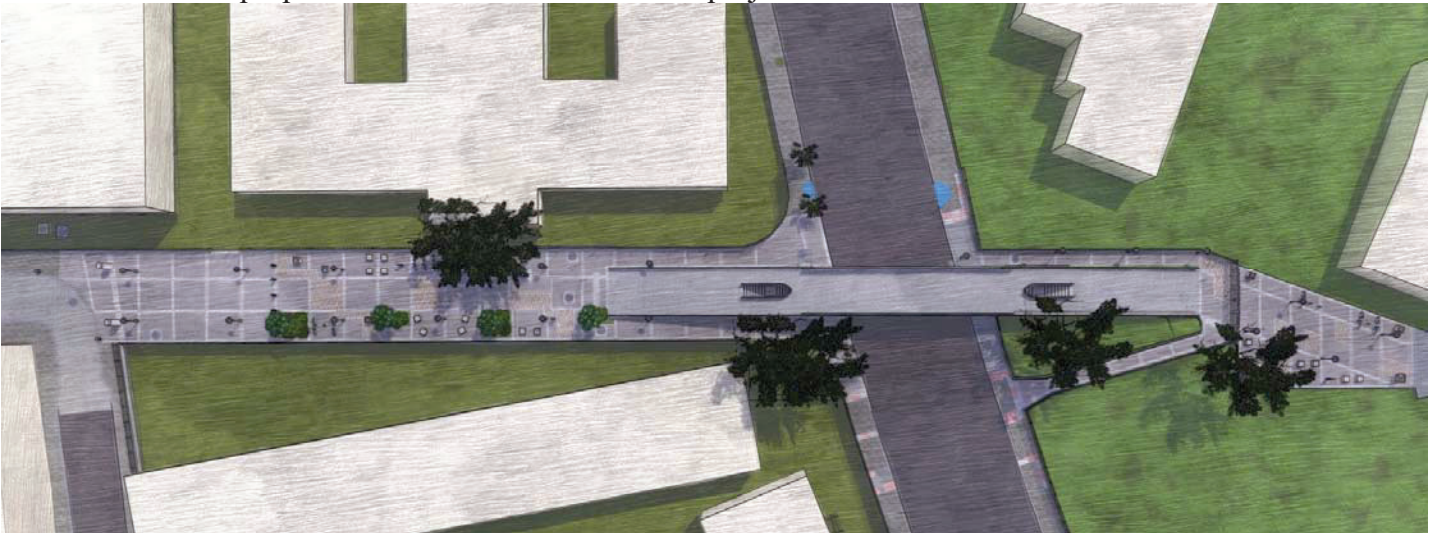
Below is a proposed rendered Site Plan for this project:

All the areas in this project have already been impacted. It is not proposed to expand the footprint of the improvement project outside of the existing footprint of the already impacted areas of the Bridge and its surroundings.

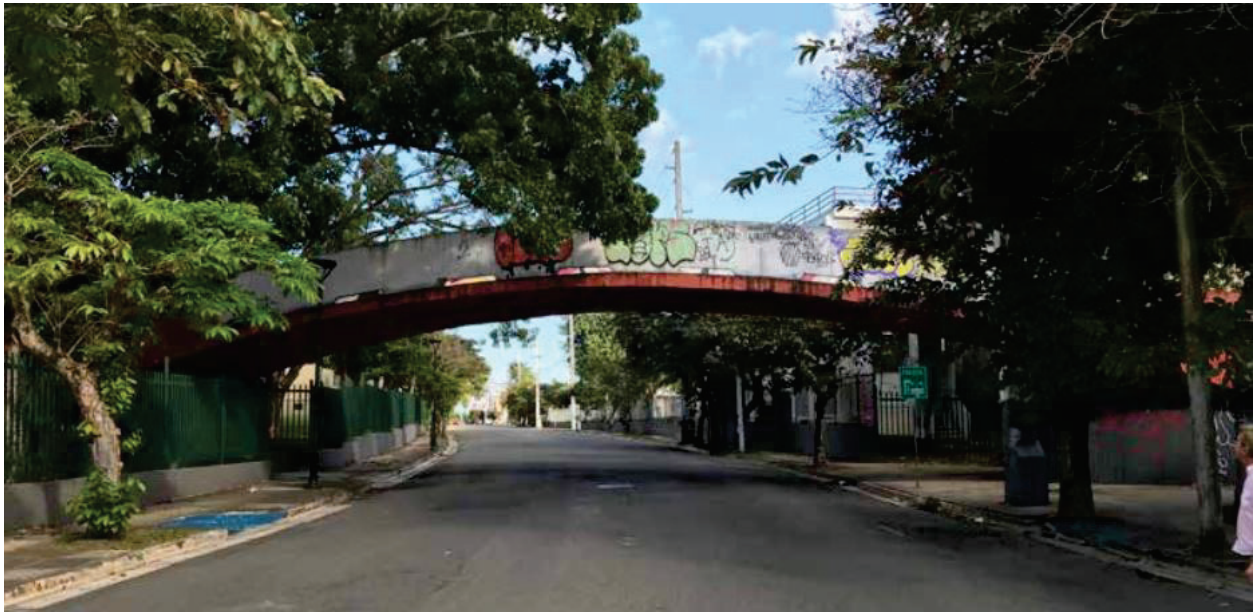
Parcel ID: EXC-TMP-146-00

Attachment III: Flood Insurance Flood Disaster Protection Act of 1973 and National Flood Insurance Reform Act of 1994 [42 USC 4001-4128 and 42 USC 5154a]

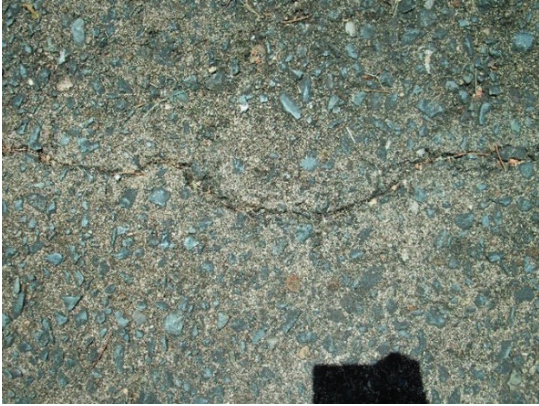
Figure 1

Damaged topping exposed aggregate concrete floor surface.

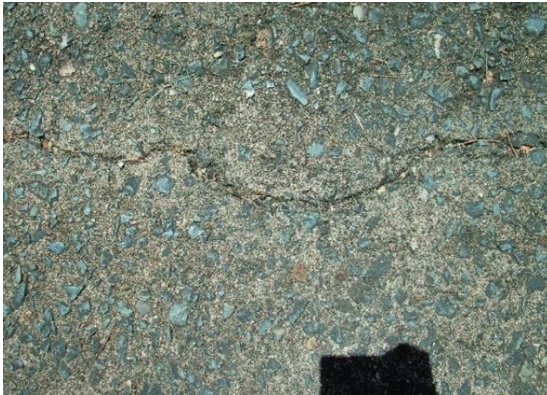
Figure 1

Damaged topping exposed aggregate concrete floor surface. Existing depth varies from 2-3".

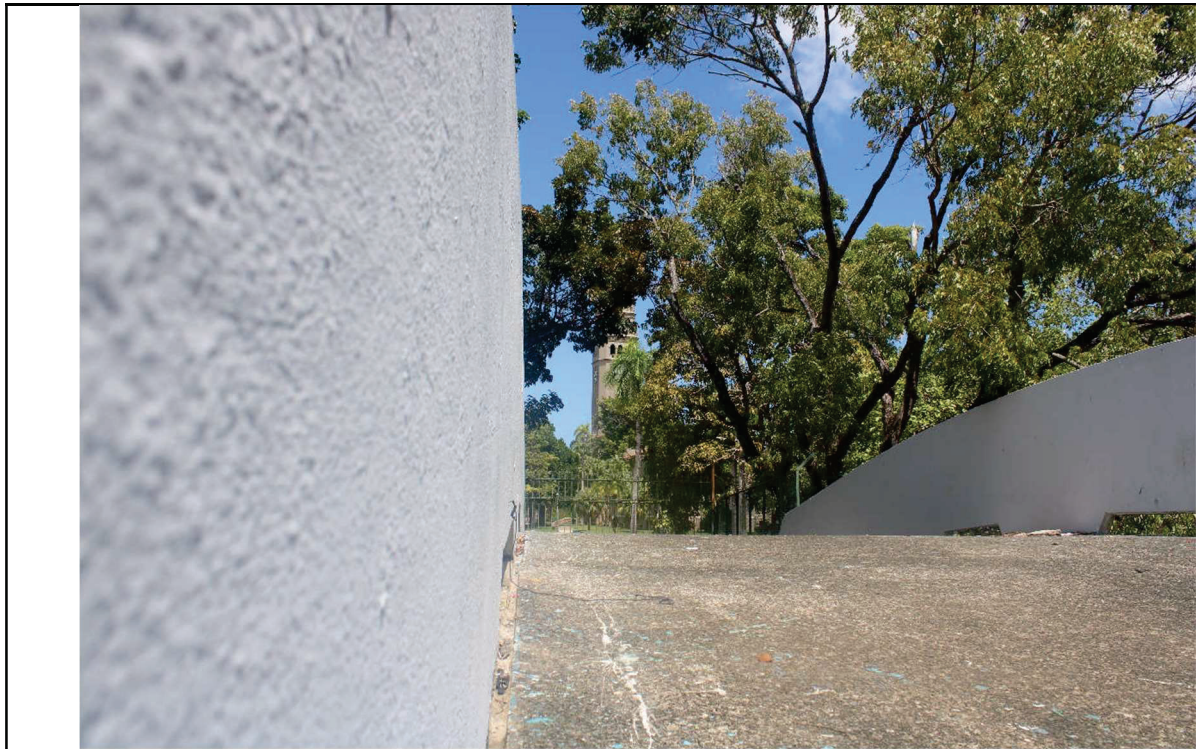
Photo #20 3/17/2024	Details of wall and pavement surfaces.

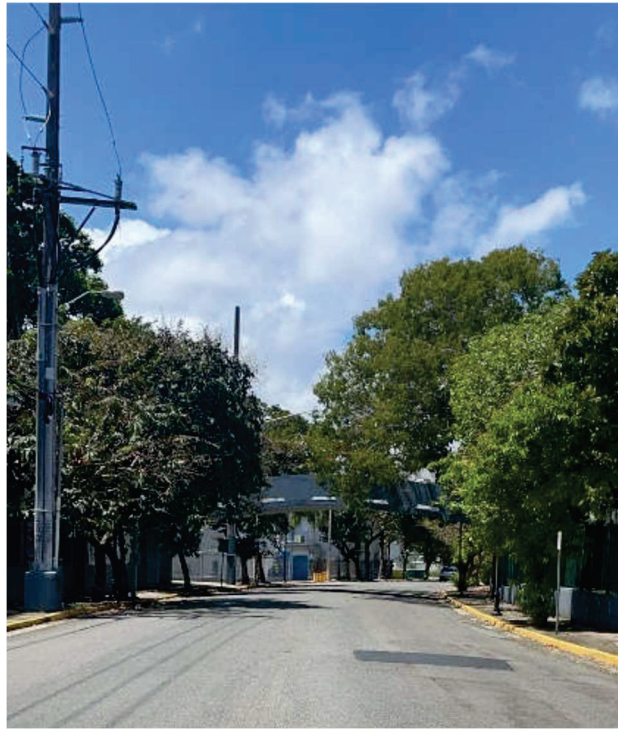
Figure 11. View of the bridge from Jose N. Gándara Ave, towards west, 2024. (Source: Hernández, Zuleyka and Torres, Maritza, Puente Henry Klumb, CRP-000955, Puerto Rico 2017 Disaster Recovery, CDBG-DR Program, City Revitalization Program (CRP), Section 106 NHPA Effect Determination, 2023)

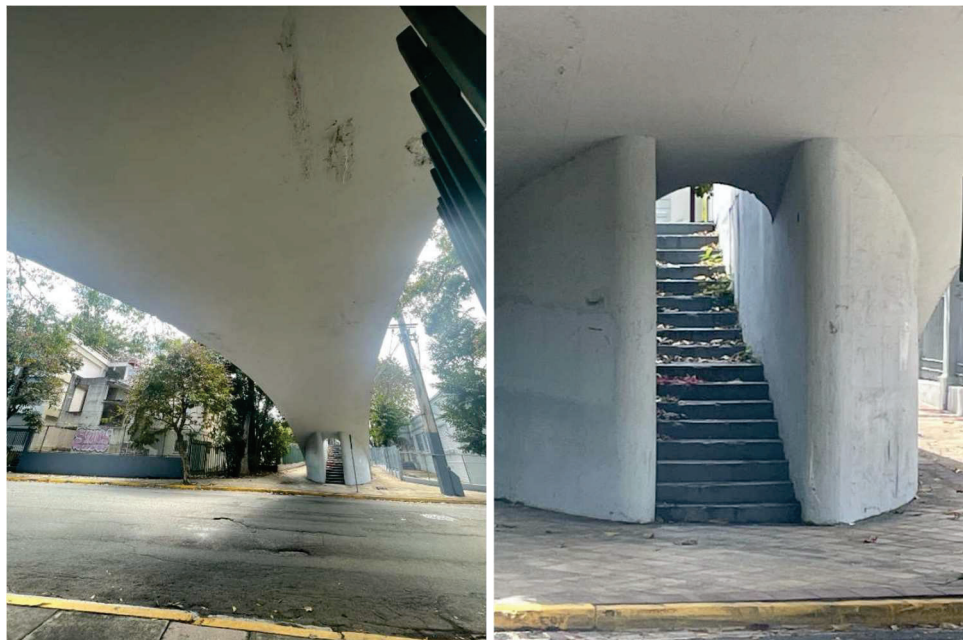
Figure 12. Left, details of the roof, looking south from sidewalk on José N.Gándara Avenue. Right, Stairways and concrete foundations in direction to UPR Campus 2024. (Source: Hernández, Zuleyka and Torres, Maritza, Puente Henry Klumb, CRP-000955, Puerto Rico 2017 Disaster Recovery, CDBG-DR Program, City Revitalization Program (CRP), Section 106 NHPA Effect Determination, 2023)
