**Environmental Review for Activity/Project that is Categorically Excluded Subject to Section 58.5  
Pursuant to 24 CFR 58.35(a)**

**Project Name:** Rehabilitación Plaza de la Revolución de Lares – Plaza Pública (PR-CRP-001088)

**Responsible Entity:** Puerto Rico Department of Housing (PRDOH)

**State/Local Identifier:** Puerto Rico/Municipality of Lares

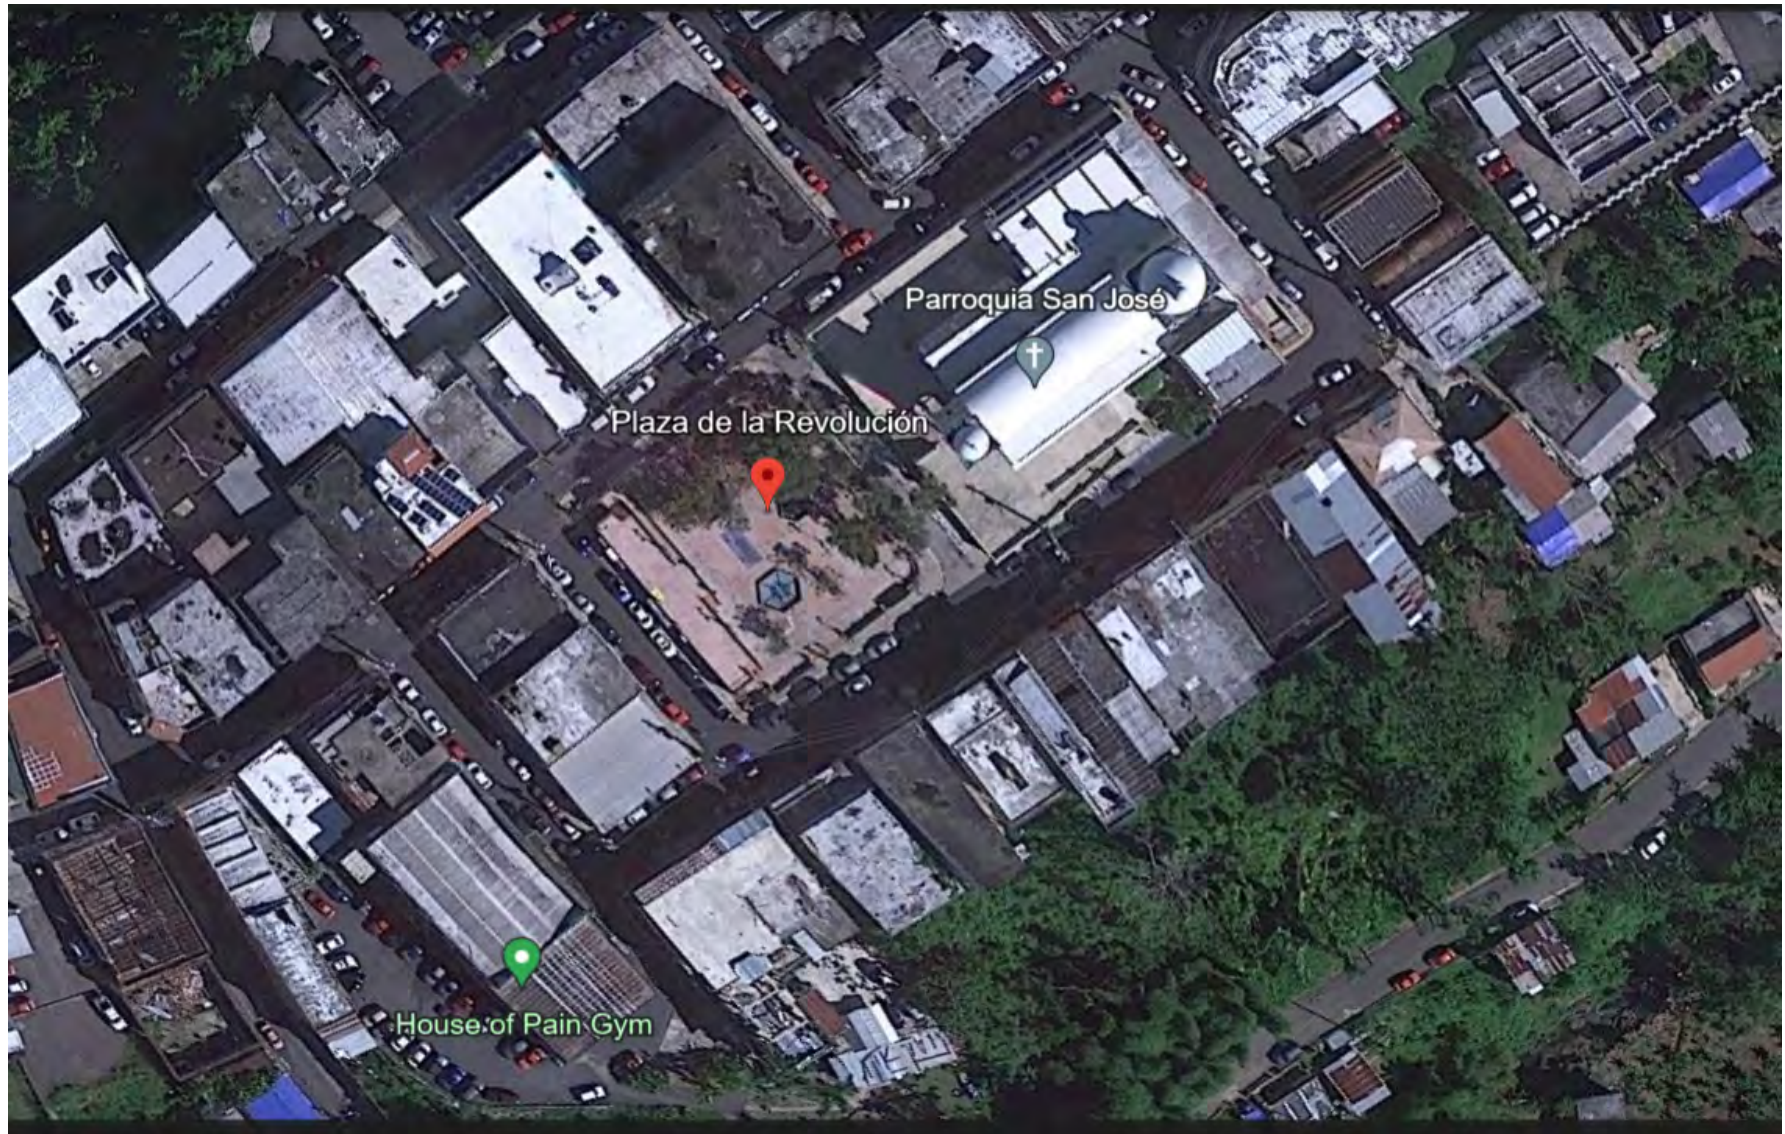
**Site Location: Plaza de la Revolución Lares, Street A, Lares, Puerto Rico, 00669**

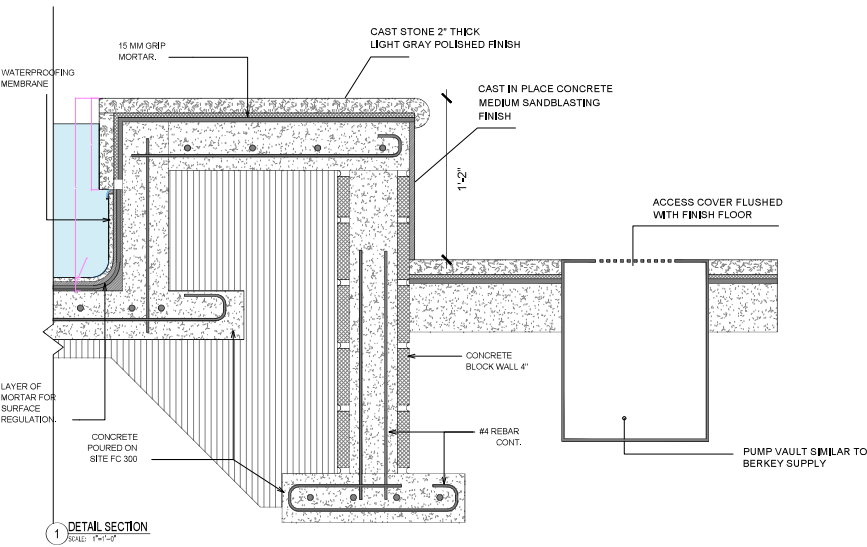
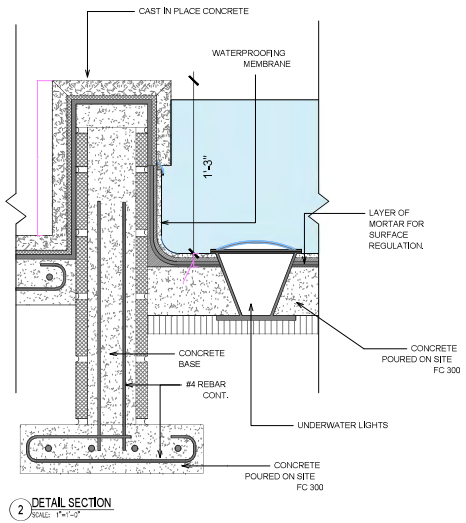
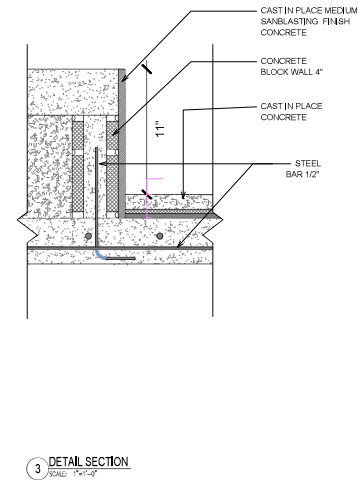
NEW WATER FOUNTAIN  
SCALE: 3/8"=1'-0"

- NOTAS:
- INTERIOR OF THE FOUNTAIN IN RUBBED CONCRETE, PAINT WITH TWO COATS OF EPOXY PAINT FINISH WITH MOSAIC TILES.
  - FROM JET FOUNTAIN NOZZLES BRASS CONSTRUCTION 12" DISPLAY HEIGHT SIMILAR OR EQUAL TO FOUNDLINER.COM

2. New design for the Public Plaza:
  - a. Removal of the existing fountain. A provision will be made for a future time capsule in this space.
  - b. Construction of a new fountain near the Ramón Emeterio Betances bust.
