**Environmental Review for Activity/Project that is Categorically Excluded
Subject to Section 58.5
Pursuant to 24 CFR 58.35(a)**

Project Name: Revitalization of Plaza Buenos Aires (PR-CRP-000772)

Responsible Entity: Puerto Rico Department of Housing (PRDOH)

Grant Recipient (if different than Responsible Entity): Municipality of Arecibo

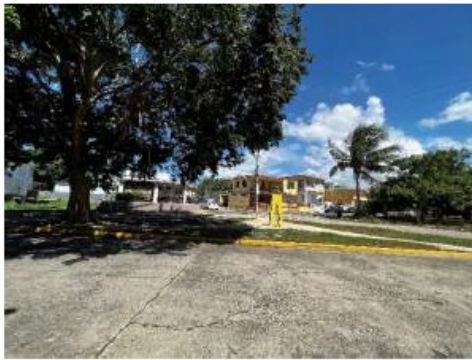
Photo 1. View of Central Plaza Area with Tree Canopy

The project area, located within Arecibo's Traditional Urban Center (TUC), encompasses approximately 0.47 acres bordered by Mirta Silva, Antonio González, José (Cheo) González, and Juan R. Figueroa Streets. The inspection confirmed that the proposed work involves both substantial repair and new construction, including the rehabilitation of plaza infrastructure, installation of stormwater management systems, and redesign of green spaces. Visual observations and aerial imagery analysis indicate prior development occurred in phases from 1931 to 1972, with much of the plaza now paved or landscaped. Despite this, the soil disturbance from past development appears limited, with an estimated maximum depth of 24 inches.
