**Environmental Review for Activity/Project that is Categorically
Excluded Subject to Section 58.5
Pursuant to 24 CFR 58.35(a)**

Project Name: V. Suárez & Co., Inc. Solar Photovoltaic System (IPGM-00161)

Responsible Entity: Puerto Rico Department of Housing (PRDOH)

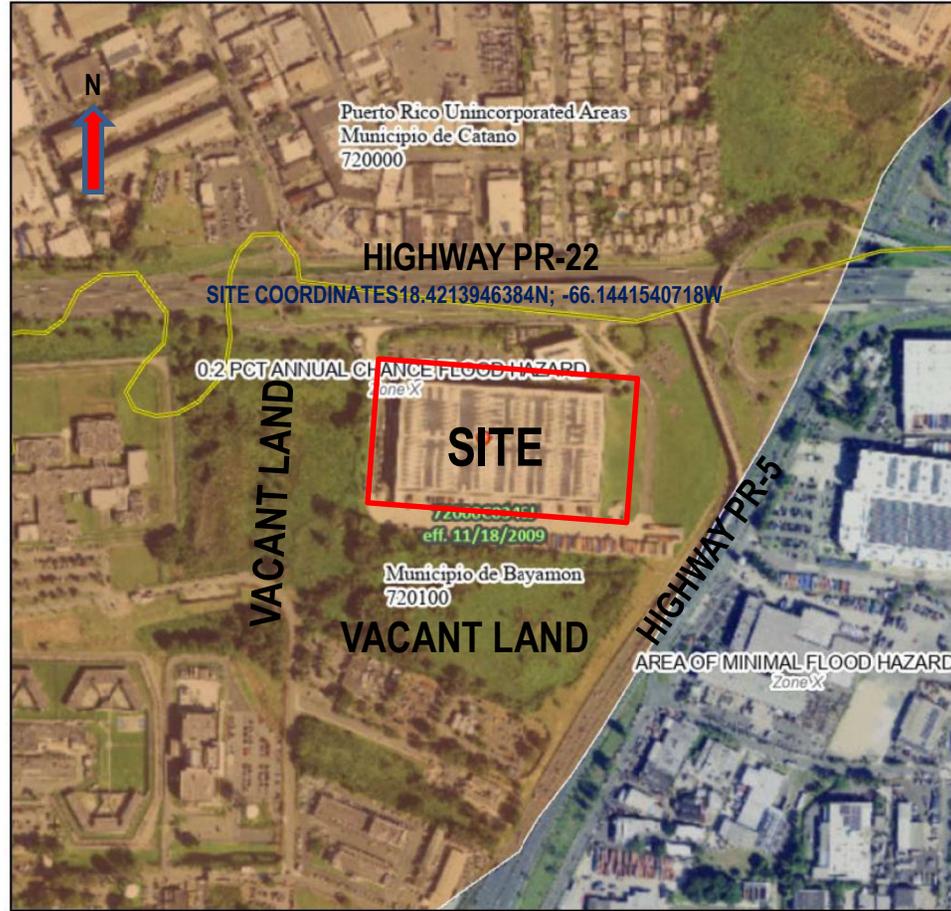
National Flood Hazard Layer FIRMette

The flood hazard information is derived directly from the authoritative NFHL web services provided by FEMA. This map was exported on 5/23/2024 at 10:30 AM and does not reflect changes or amendments subsequent to this date and time. The NFHL and effective information may change or become superseded by new data over time.

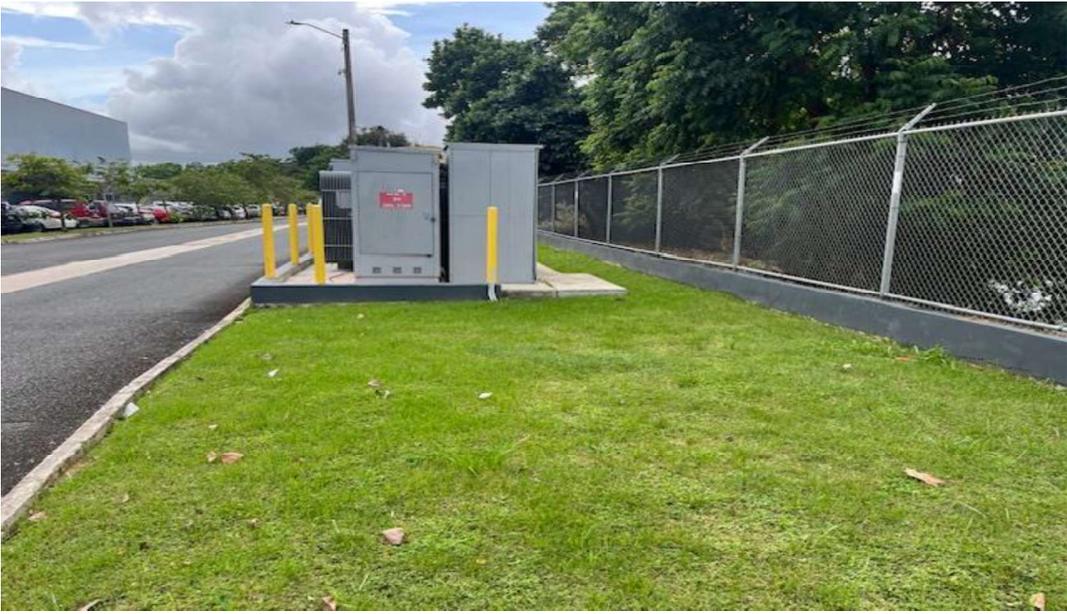
Photo No.: 1	Date: 10/29/2024

Direction Photo Taken: South		
Description:		
Luma pad mounted transformer

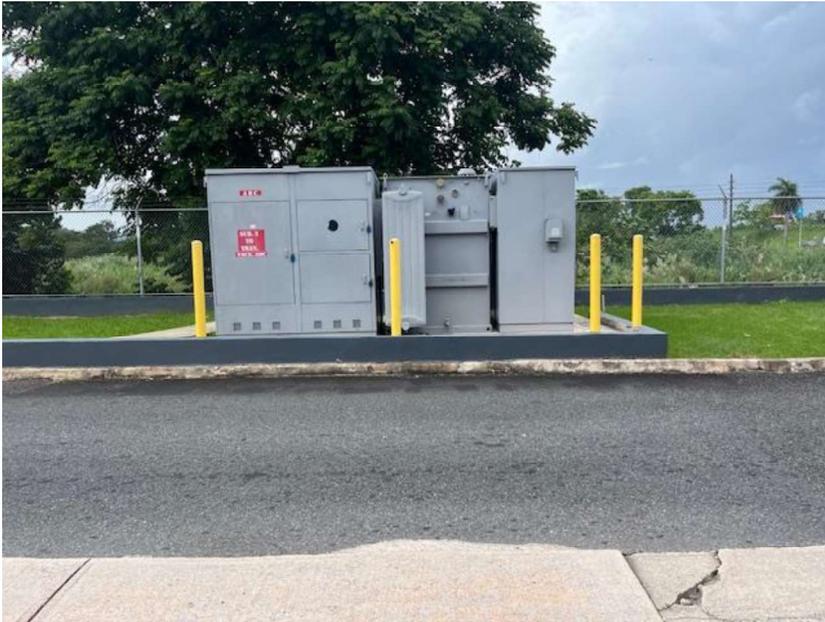
Photo No.: 2	Date: 10/29/2024

Direction Photo Taken: West		
Description:		
Luma pad mounted transformer

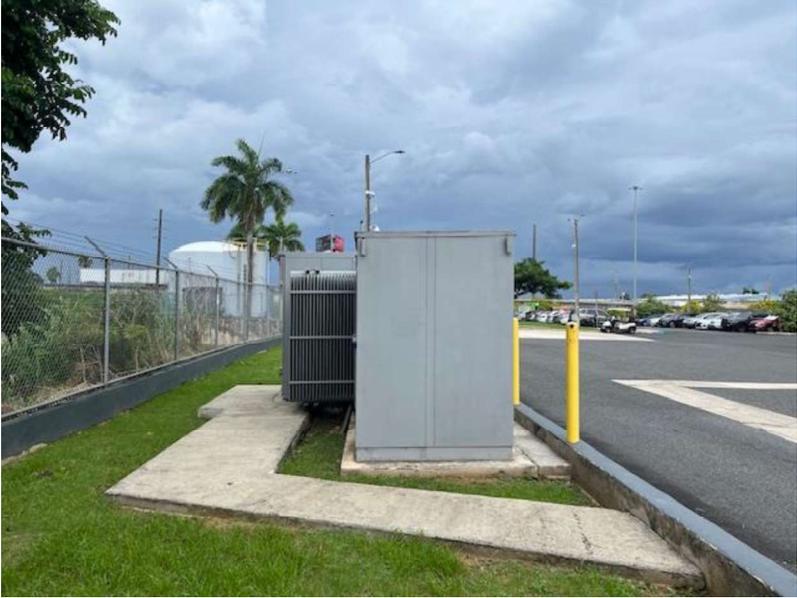
Photo No.: 3	Date: 10/29/2024

Direction Photo Taken: North		
Description: Luma pad mounted transformer.		
Photo No.: 4	Date: 10/29/2024

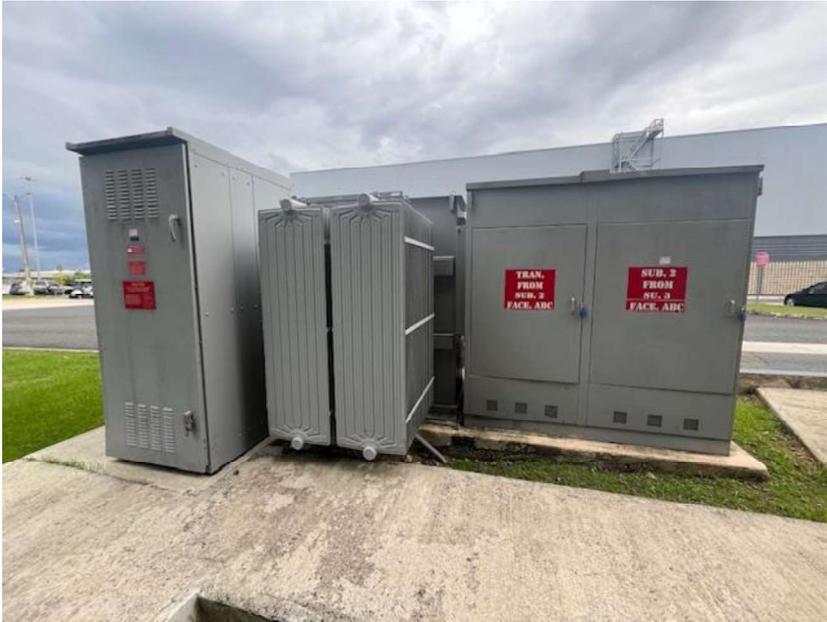
Direction Photo Taken: East		
Description: Luma pad mounted transformer.

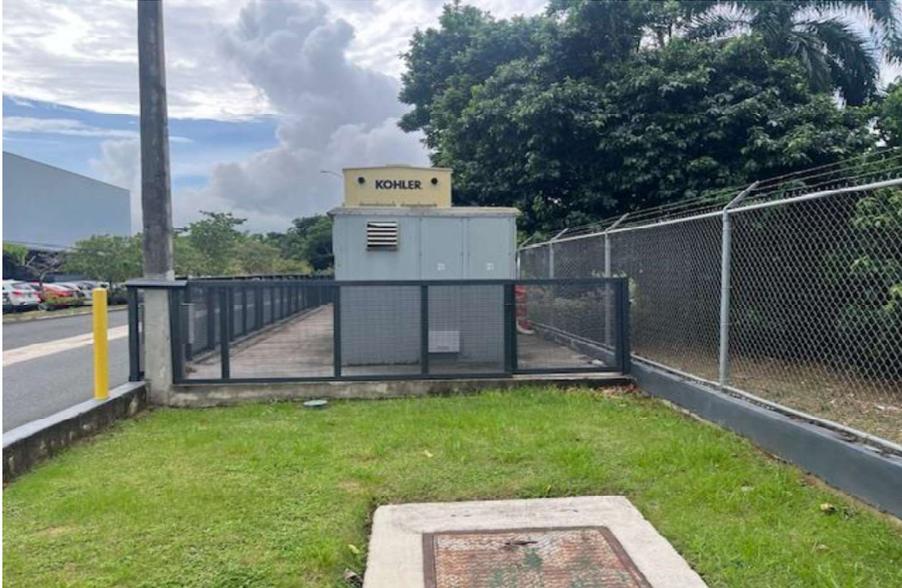
Photo No.: 5	Date: 10/29/2024

Direction Photo Taken: South		
Description:		
Battery bank for former solar panel system.		
Photo No.: 6	Date: 10/29/2024

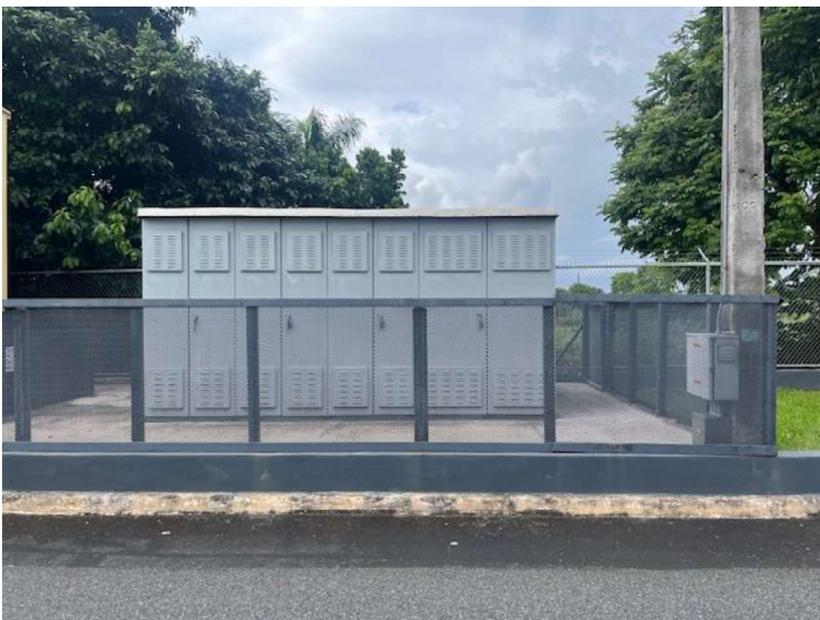
Direction Photo Taken: West		
Description:		
Battery bank for former solar panel system.

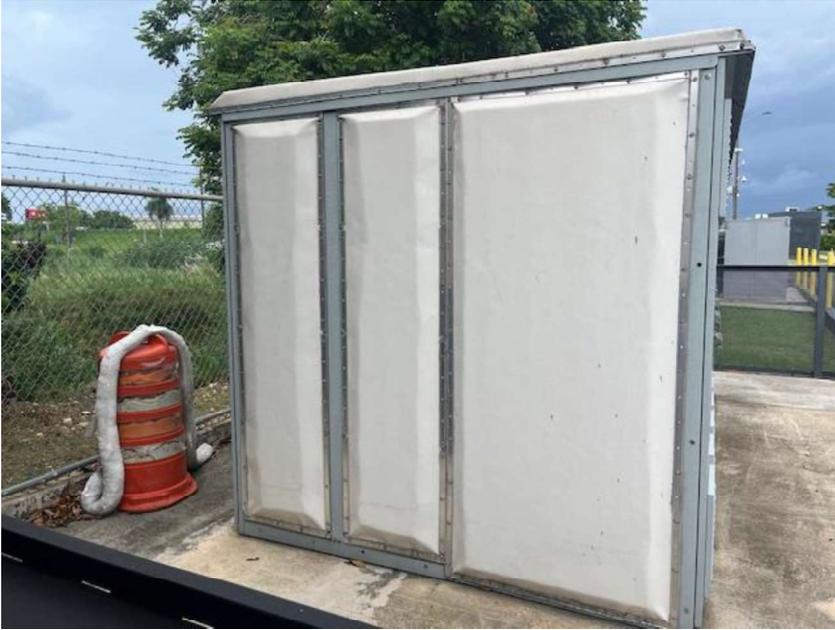
Photo No.: 7	Date: 10/29/2024

Direction Photo Taken: North		
Description: Battery bank for former solar panel system.

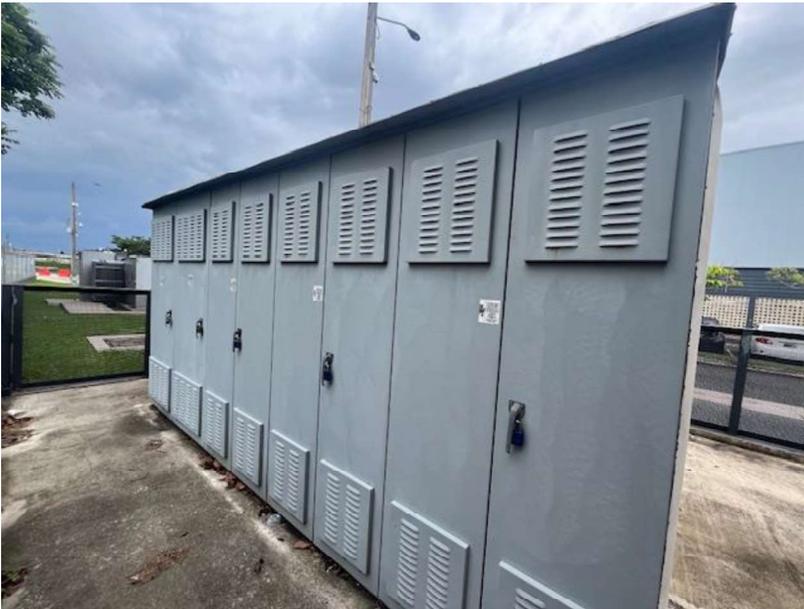
Photo No.: 8	Date: 10/29/2024

Direction Photo Taken: Northeast		
Description: Battery bank for former solar panel system.

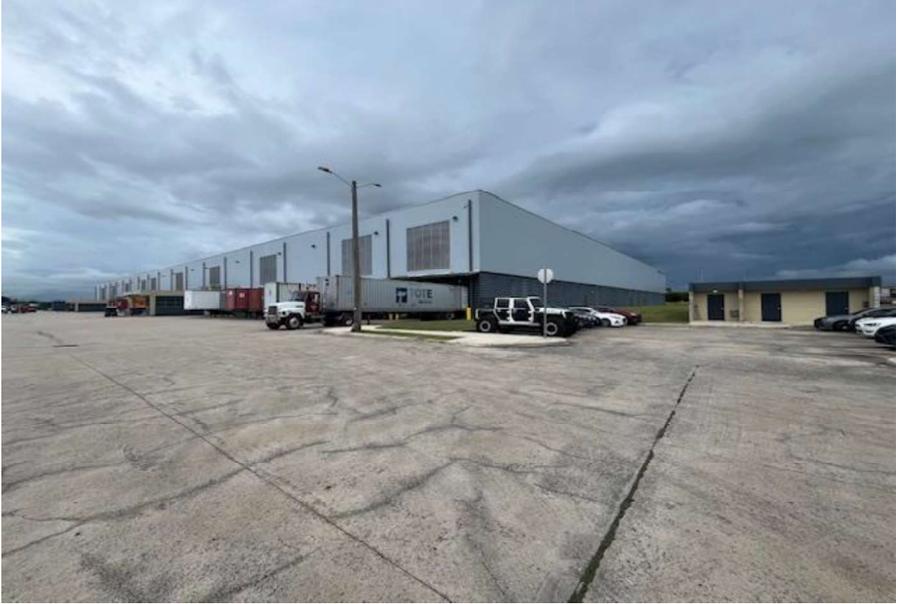
Photo No.: 13	Date: 10/29/2024

Direction Photo Taken: Northwest		
Description:		
Southeast corner of distribution building.

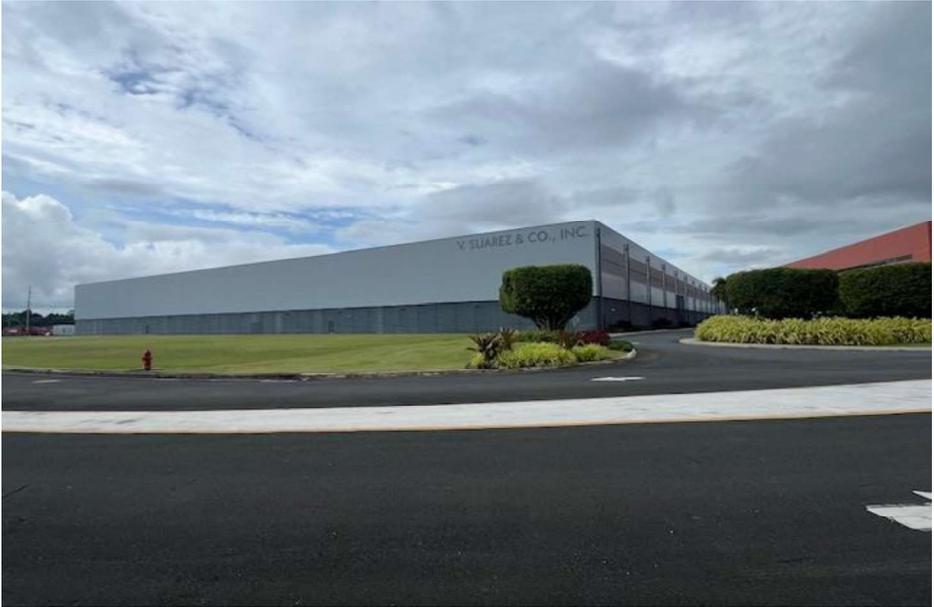
Photo No.: 14	Date: 10/29/2024

Direction Photo Taken: Southwest		
Description:		
Northeast corner of distribution building.

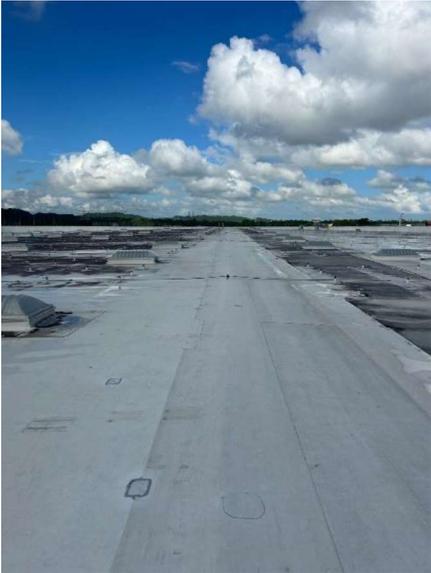
Photo No.: 17	Date: 10/3/2024

Direction Photo Taken: West		
Description:		
Current condition of building roof.

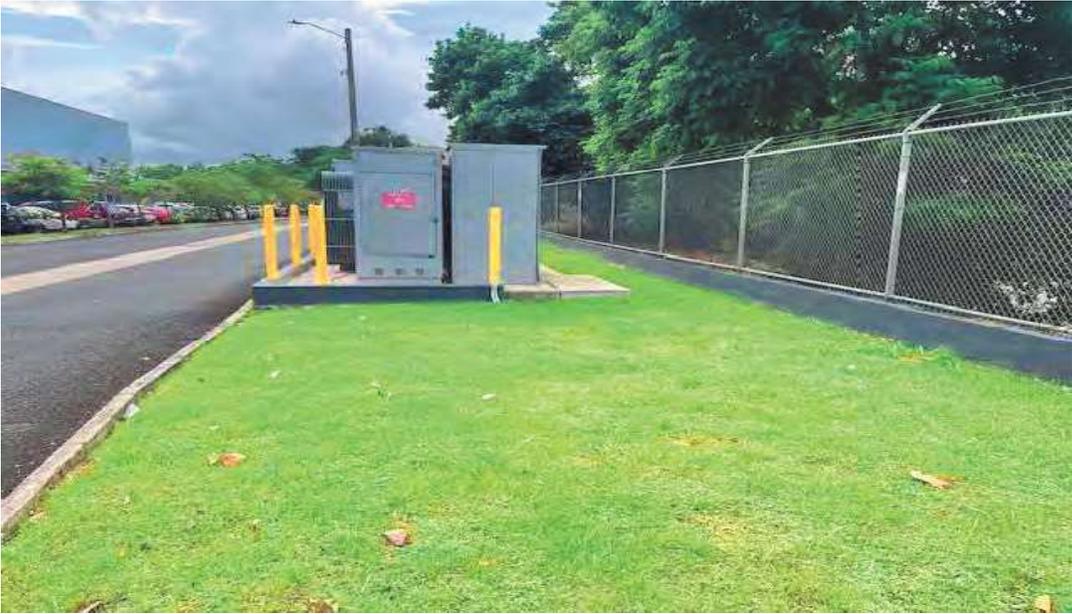
Photo No.: 1	Date: 10/29/2024

Direction Photo Taken: South		
Description:		
Luma pad mounted transformer

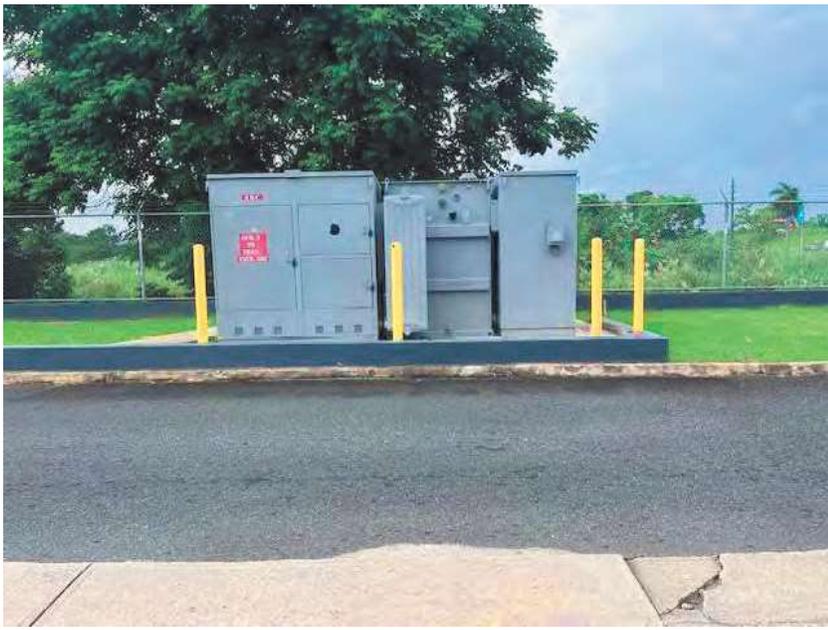
Photo No.: 2	Date: 10/29/2024

Direction Photo Taken: West		
Description:		
Luma pad mounted transformer

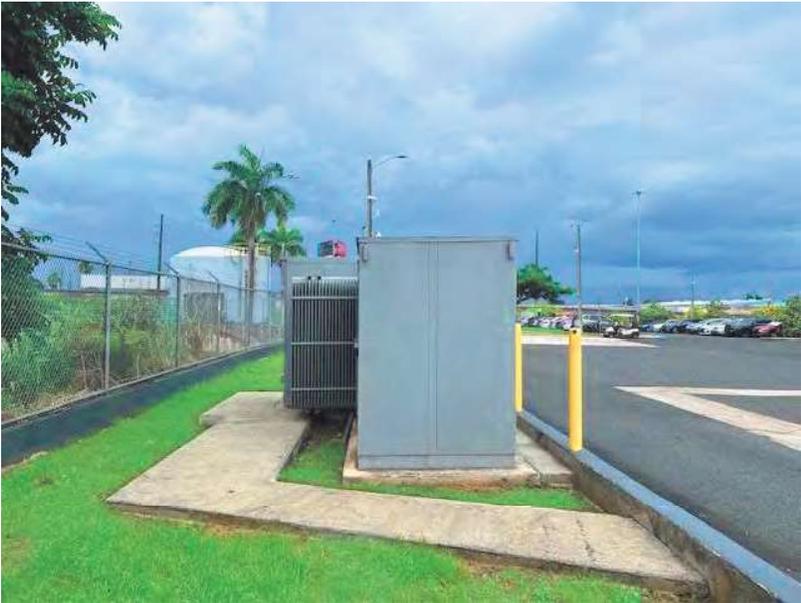
Photo No.: 3	Date: 10/29/2024

Direction Photo Taken: North		
Description: Luma pad mounted transformer.		
Photo No.: 4	Date: 10/29/2024

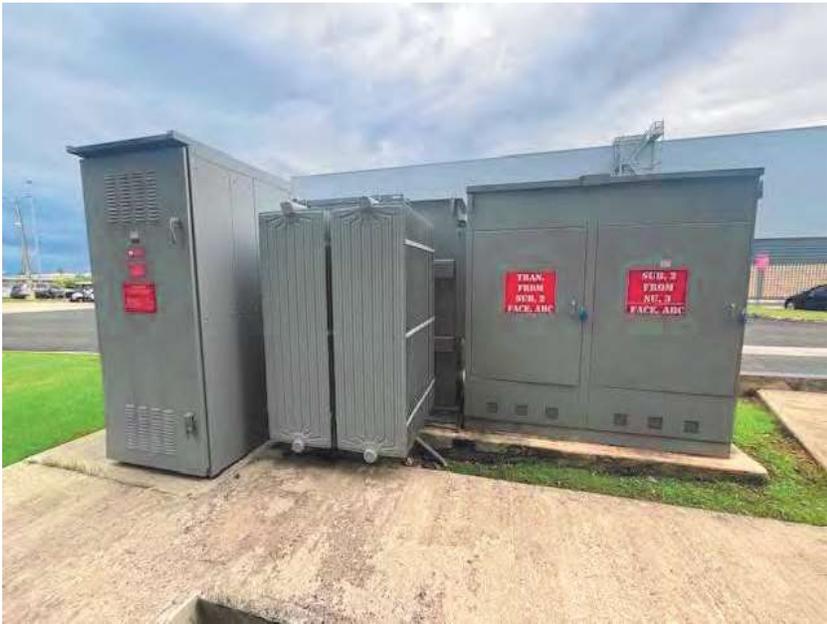
Direction Photo Taken: East		
Description: Luma pad mounted transformer.

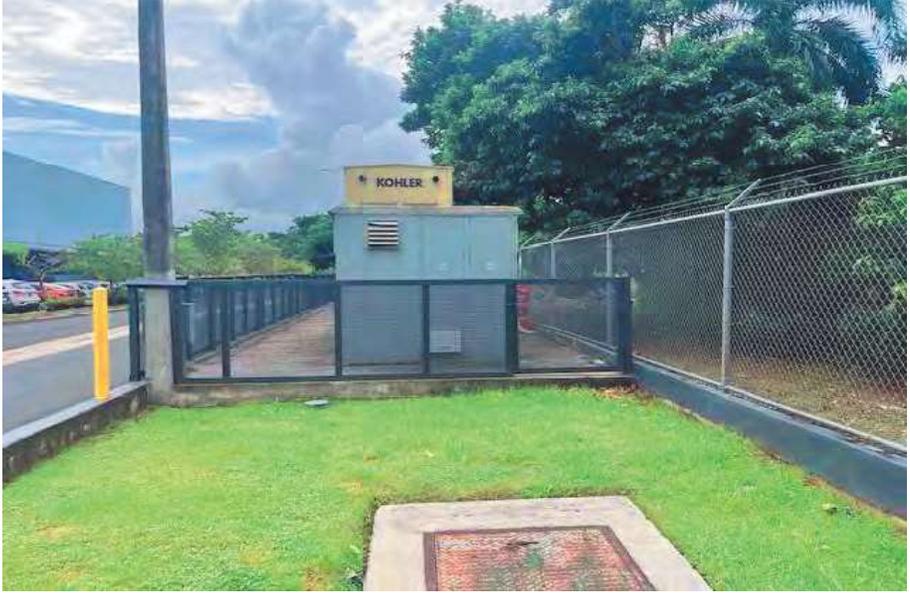
Photo No.: 5	Date: 10/29/2024

Direction Photo Taken: South		
Description: Battery bank for former solar panel system.		
Photo No.: 6	Date: 10/29/2024

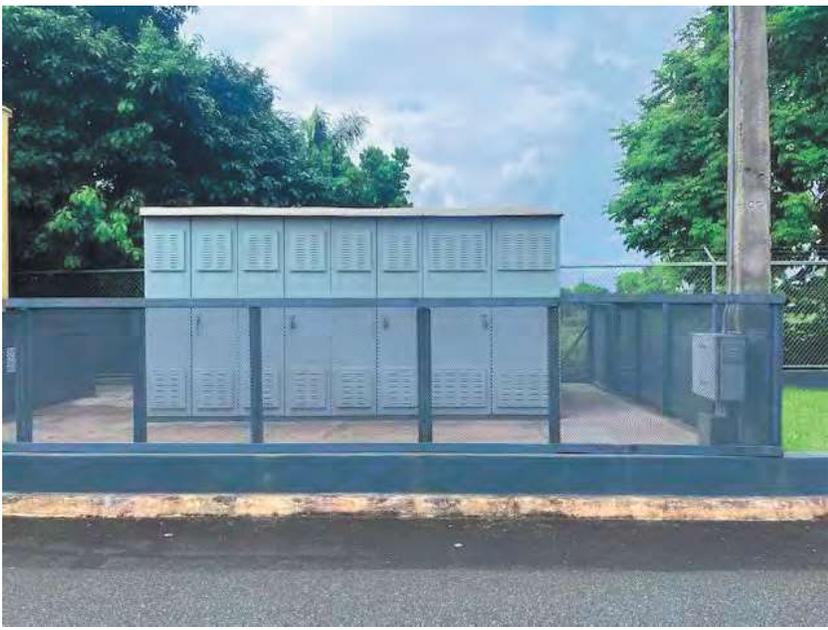
Direction Photo Taken: West		
Description: Battery bank for former solar panel system.

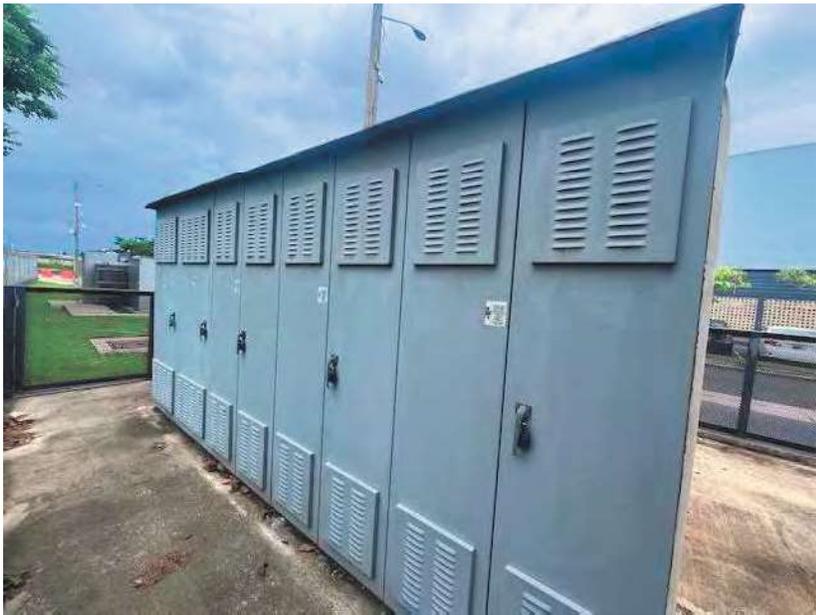
Photo No.: 8	Date: 10/29/2024

Direction Photo Taken: Northeast		
Description:		
Battery bank for former solar panel system.

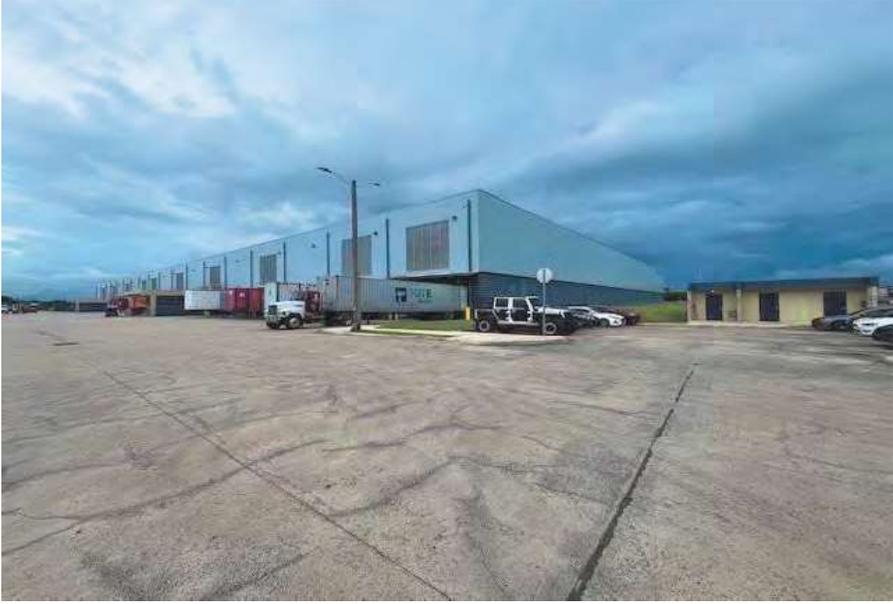
Photo No.: 13	Date: 10/29/2024

Direction Photo Taken: Northwest		
Description: Southeast corner of distribution building.

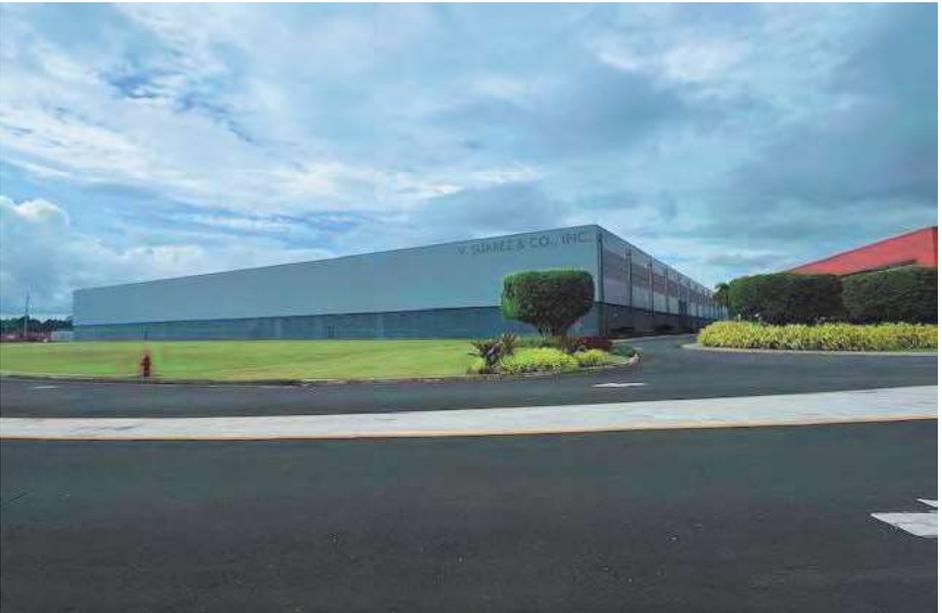
Photo No.: 14	Date: 10/29/2024

Direction Photo Taken: Southwest		
Description: Northeast corner of distribution building.

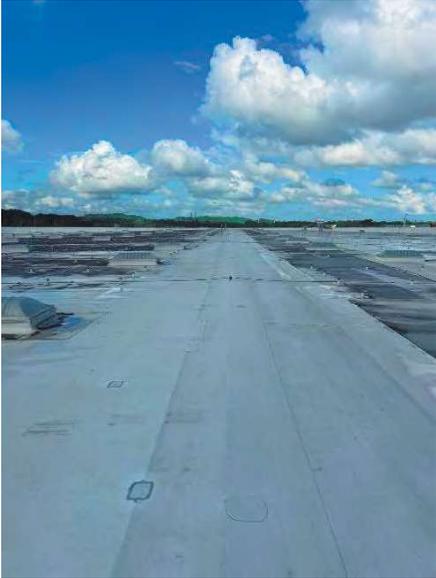
Photo No.: 17	Date: 10/3/2024

Direction Photo Taken: West		
Description:		
Current condition of building roof.

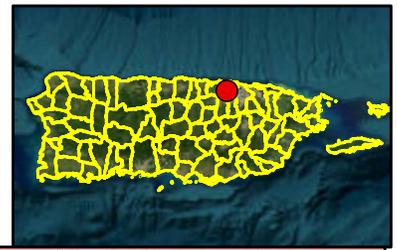
Attachment 17A
Advisory Base Flood Elevation
IPGM-00161

Project Footprint	AE-Floodway	 Scale: 1:3,000 1 inch equals 250 feet
A	Coastal A Zone and Floodway	
AO	Zone - BFE Boundary	Spatial Reference: NAD 1983 StatePlane Puerto Rico Virgin Islands FIPS 5200 Feet Source: ABFE data obtained from FEMA (https://hazards-fema.maps.arcgis.com/apps/webappviewer/index.html?id=8b0adb51996444d4879338b5529aa9cd) Esri Imagery Basemap service
AE	1% Annual Chance Flood	
Coastal A Zone	0,2% Annual Chance Flood	
VE	Advisory Base Flood Elevation	
X, 0,2% Annual Chance Flood Zone	Streamline	
A-Floodway

According to the FEMA Flood Insurance Rate Map (FIRM) from FEMA's National Flood Hazard Layer (panel 72000C0345J, effective 11/18/2009) (Attachment #4), the project site is located outside of the 100-year floodplain but is entirely within the 500-year floodplain. Preliminary FIRMs Flood Zones have not been developed for this area (Attachment #5). According to the Advisory Base Flood Elevation (ABFE) map, the project site is almost entirely within the 500-year floodplain, with a portion located within the 100-year A zone (Attachment #6).

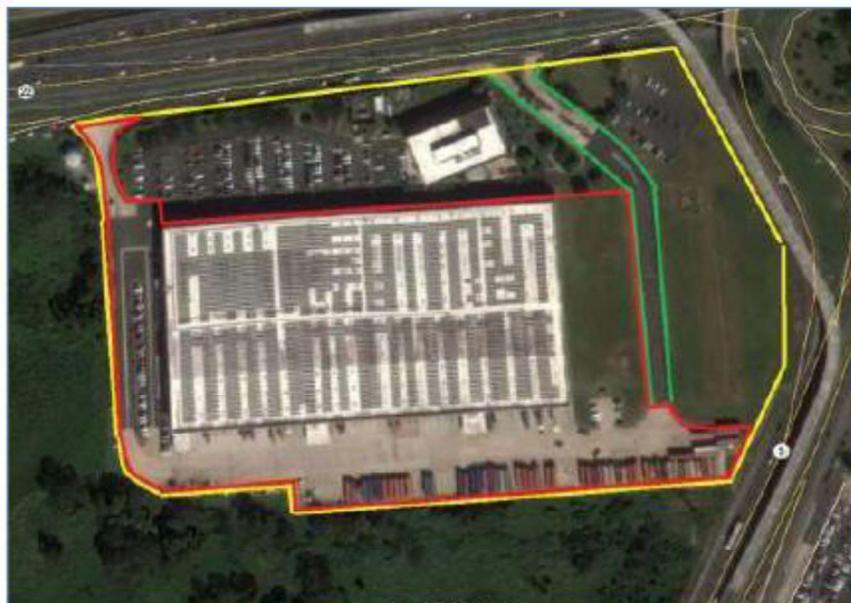
SITE PLAN

The subject parcel has adequate location and physical features for warehouse use. Overall, it is a competitive site. The following images illustrate the subject site. It is the site within the red line boundaries on the second image.

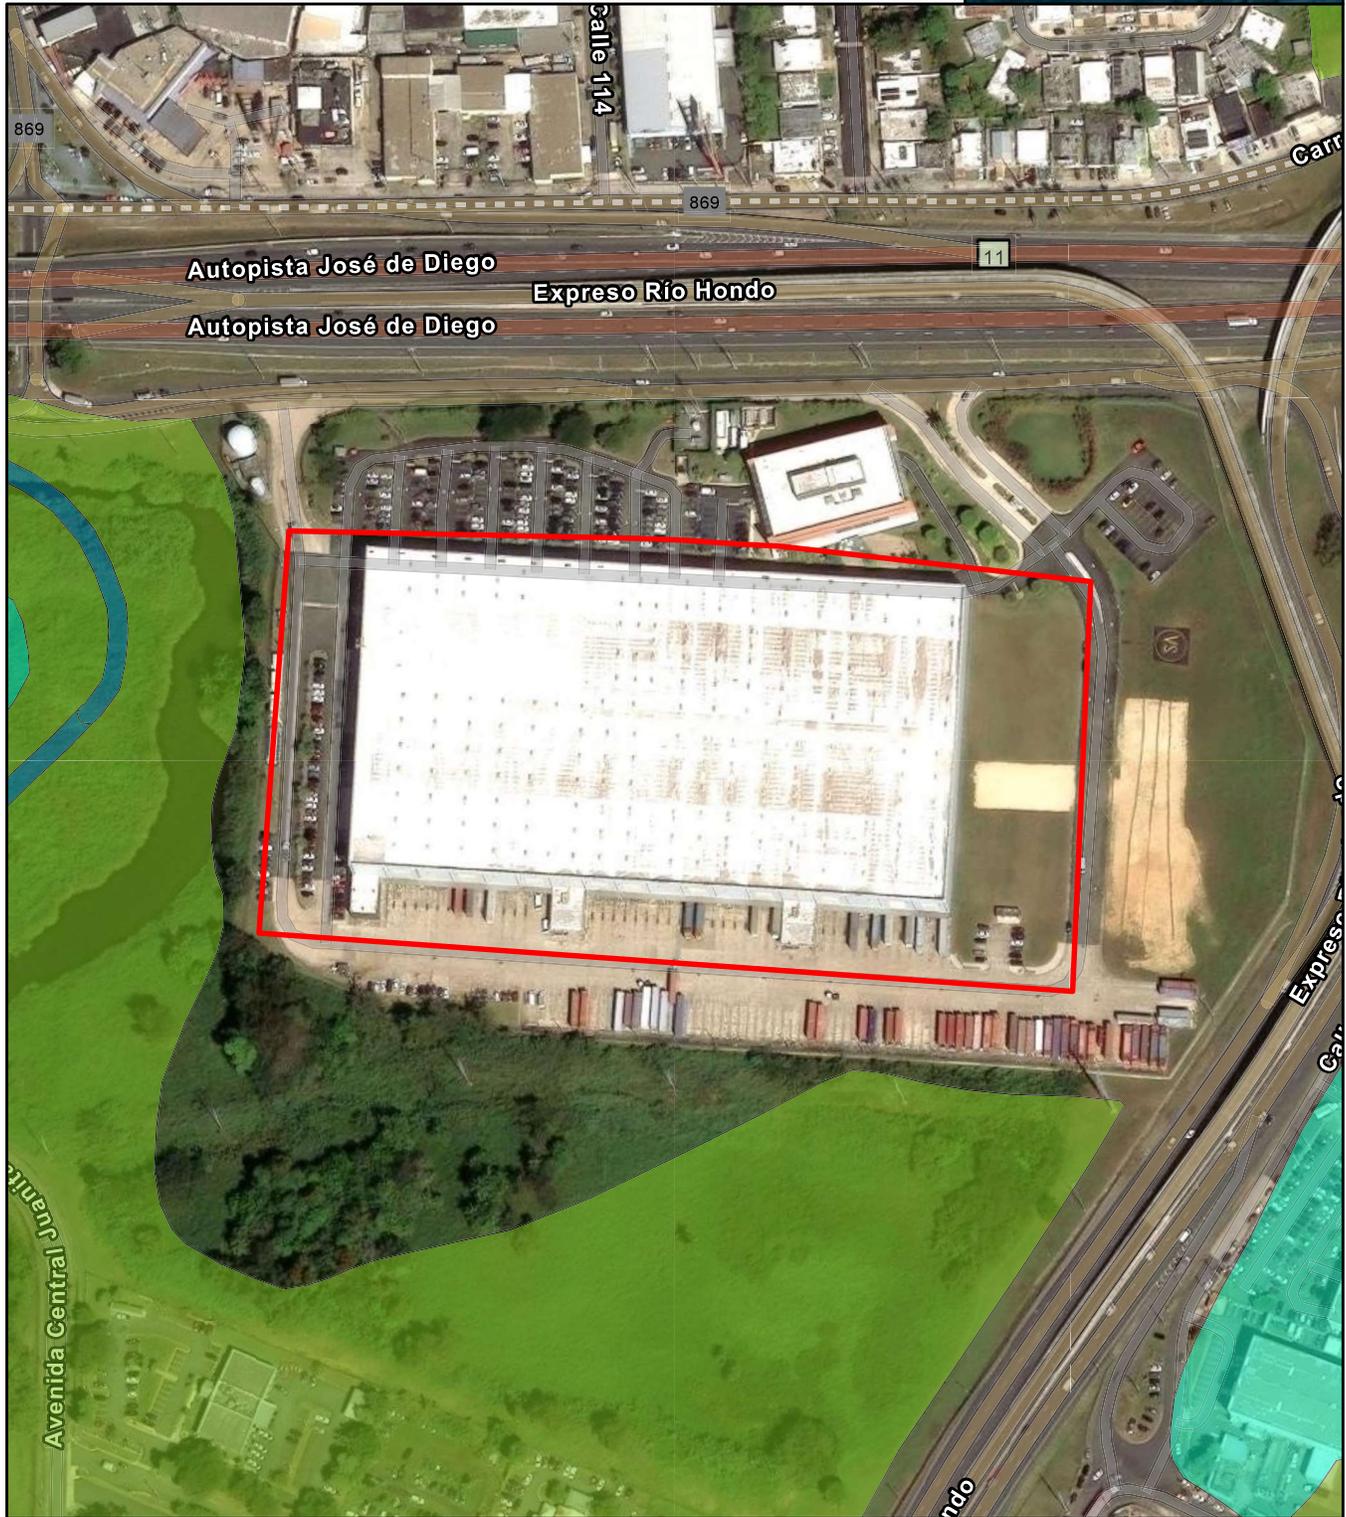
ATTACHMENT #7

Project Points	Freshwater Forested/Shrub Wetland	Scale: 1:3,000 1 inch equals 250 feet Source: Wetlands data obtained from USFWS (https://fwsprimary.wim.usgs.gov/wetlands/Rico Virgin Islands FIPS apps/wetlands-mapper/); Esri Imagery Basemap service
Project Footprint	Freshwater Pond	
Estuarine and Marine Deepwater	Lake	
Estuarine and Marine Wetland	Other	
Freshwater Emergent Wetland	Riverine

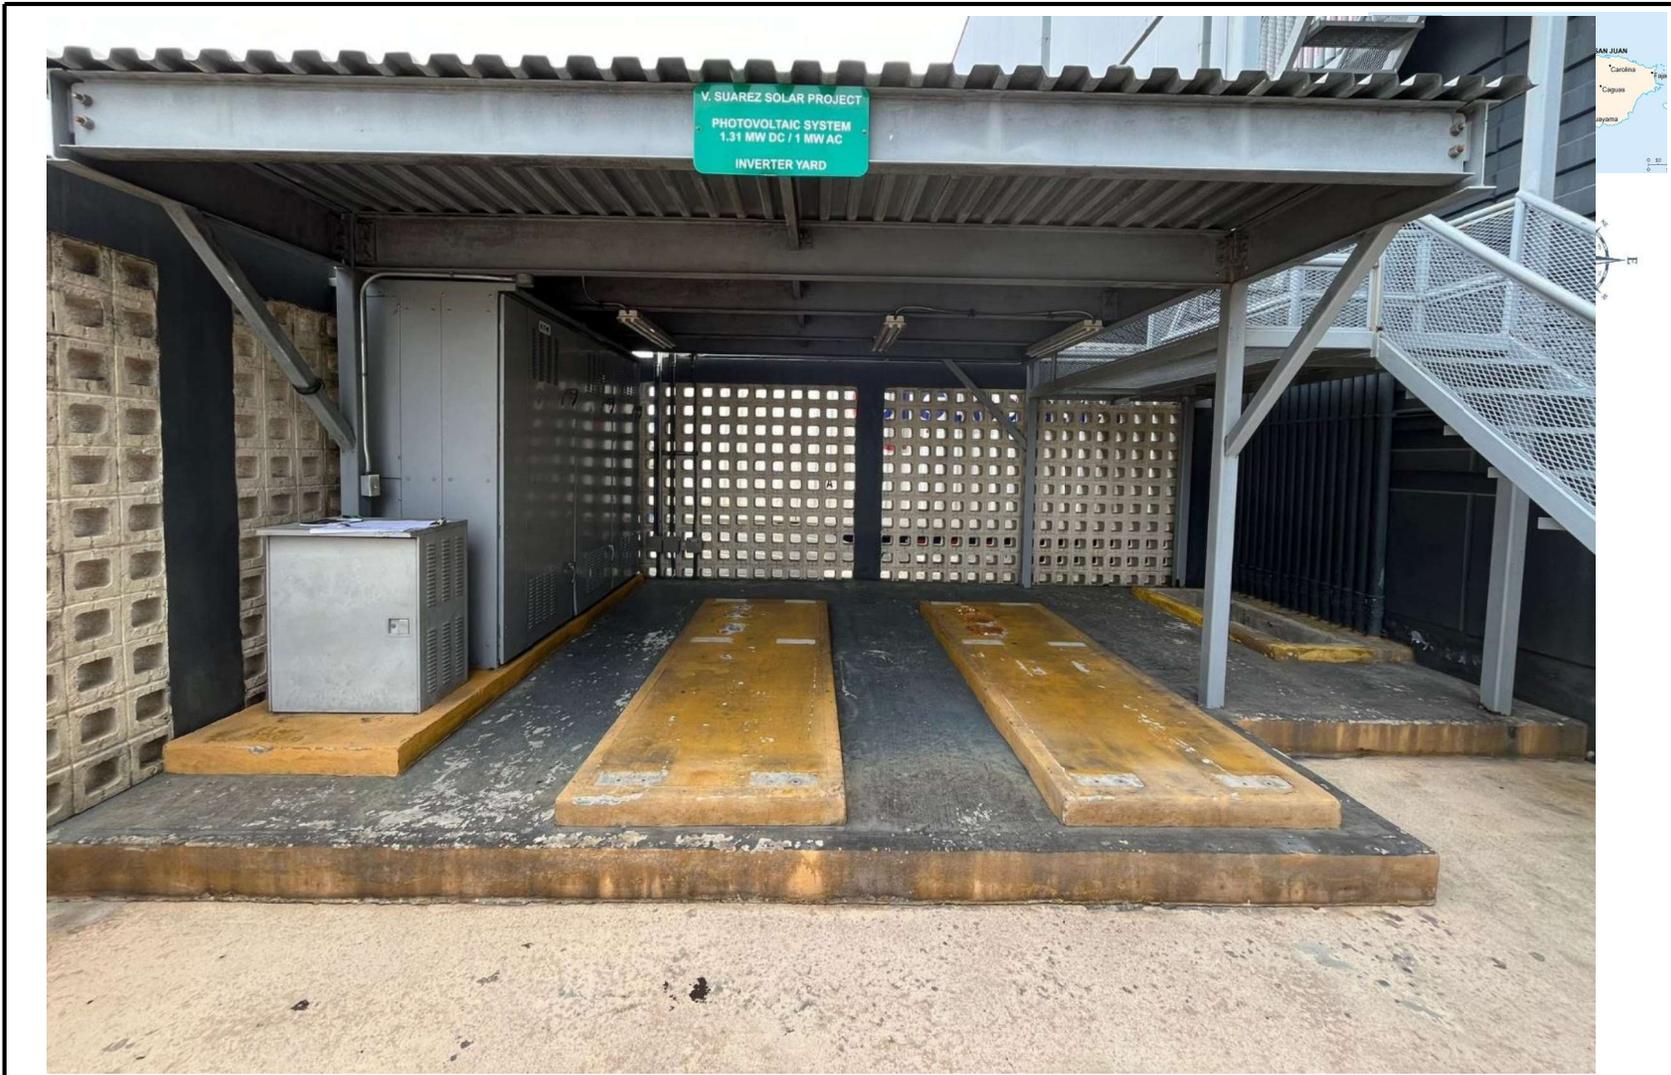
STORM WATER DRAINAGE MAP
 SOLAR PHOTOVOLTAIC SYSTEM
 V. SUÁREZ & CO., INC.
 300 LUCHETTI INDUSTRIAL PARK, PR-5, BAYAMÓN, PR
 PROJECT ID IPGM-00161
 SITE COORDINATES 18.4213946384N; -66.1441540718W

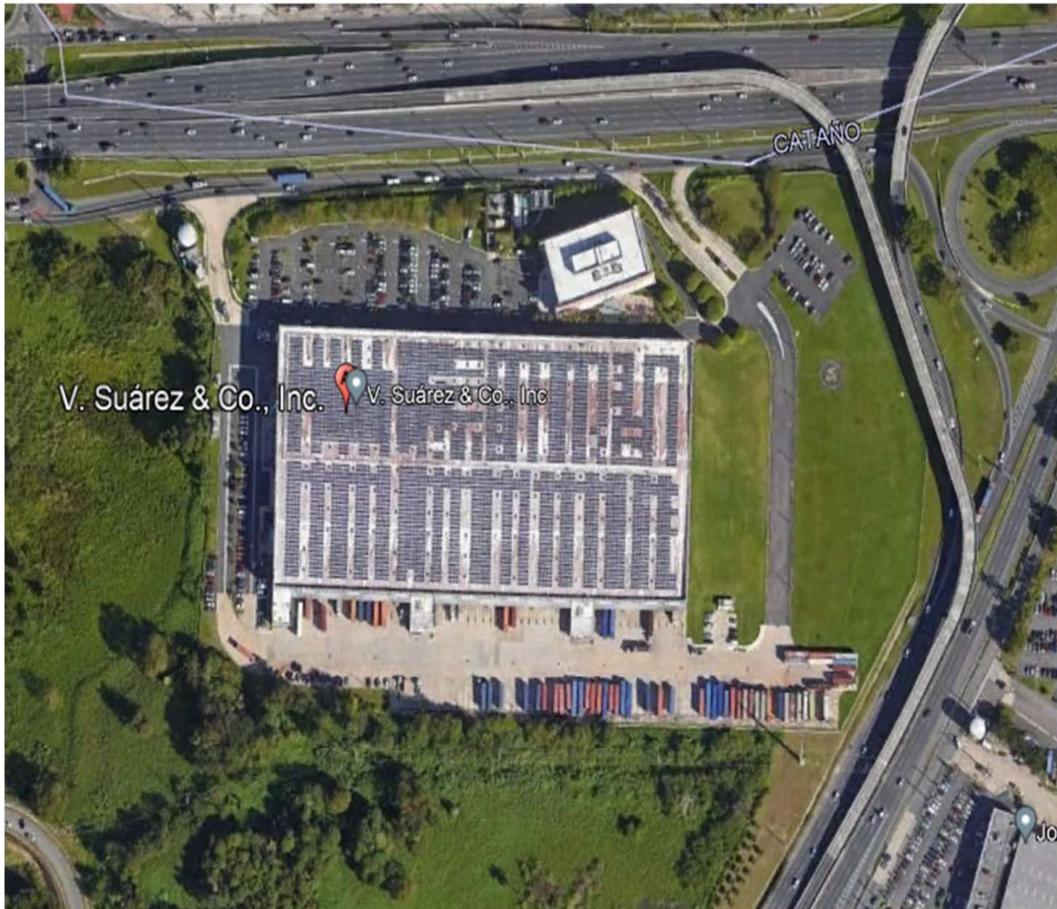
The system proposed is composed of 25 inverters installed at roof level and combined in the main pv switchboard, along with a battery system to comply with the ATRs and the relay/protection required. From this main switchgear will connect supply side in the line side of the 2,500 KVA Substation (13.2 KV to 480 volts). The Point of Connection is at 480 volts.
