Environmental Assessment Determinations and Compliance Findings for HUD-assisted Projects 24 CFR Part 58

Project Name: Revitalización de la Plaza Pública de la Ciudad entre Montañas
(PR-CRP-000640)

Responsible Entity: Puerto Rico Department of Housing

State/Local Identifier: Puerto Rico / Utuado

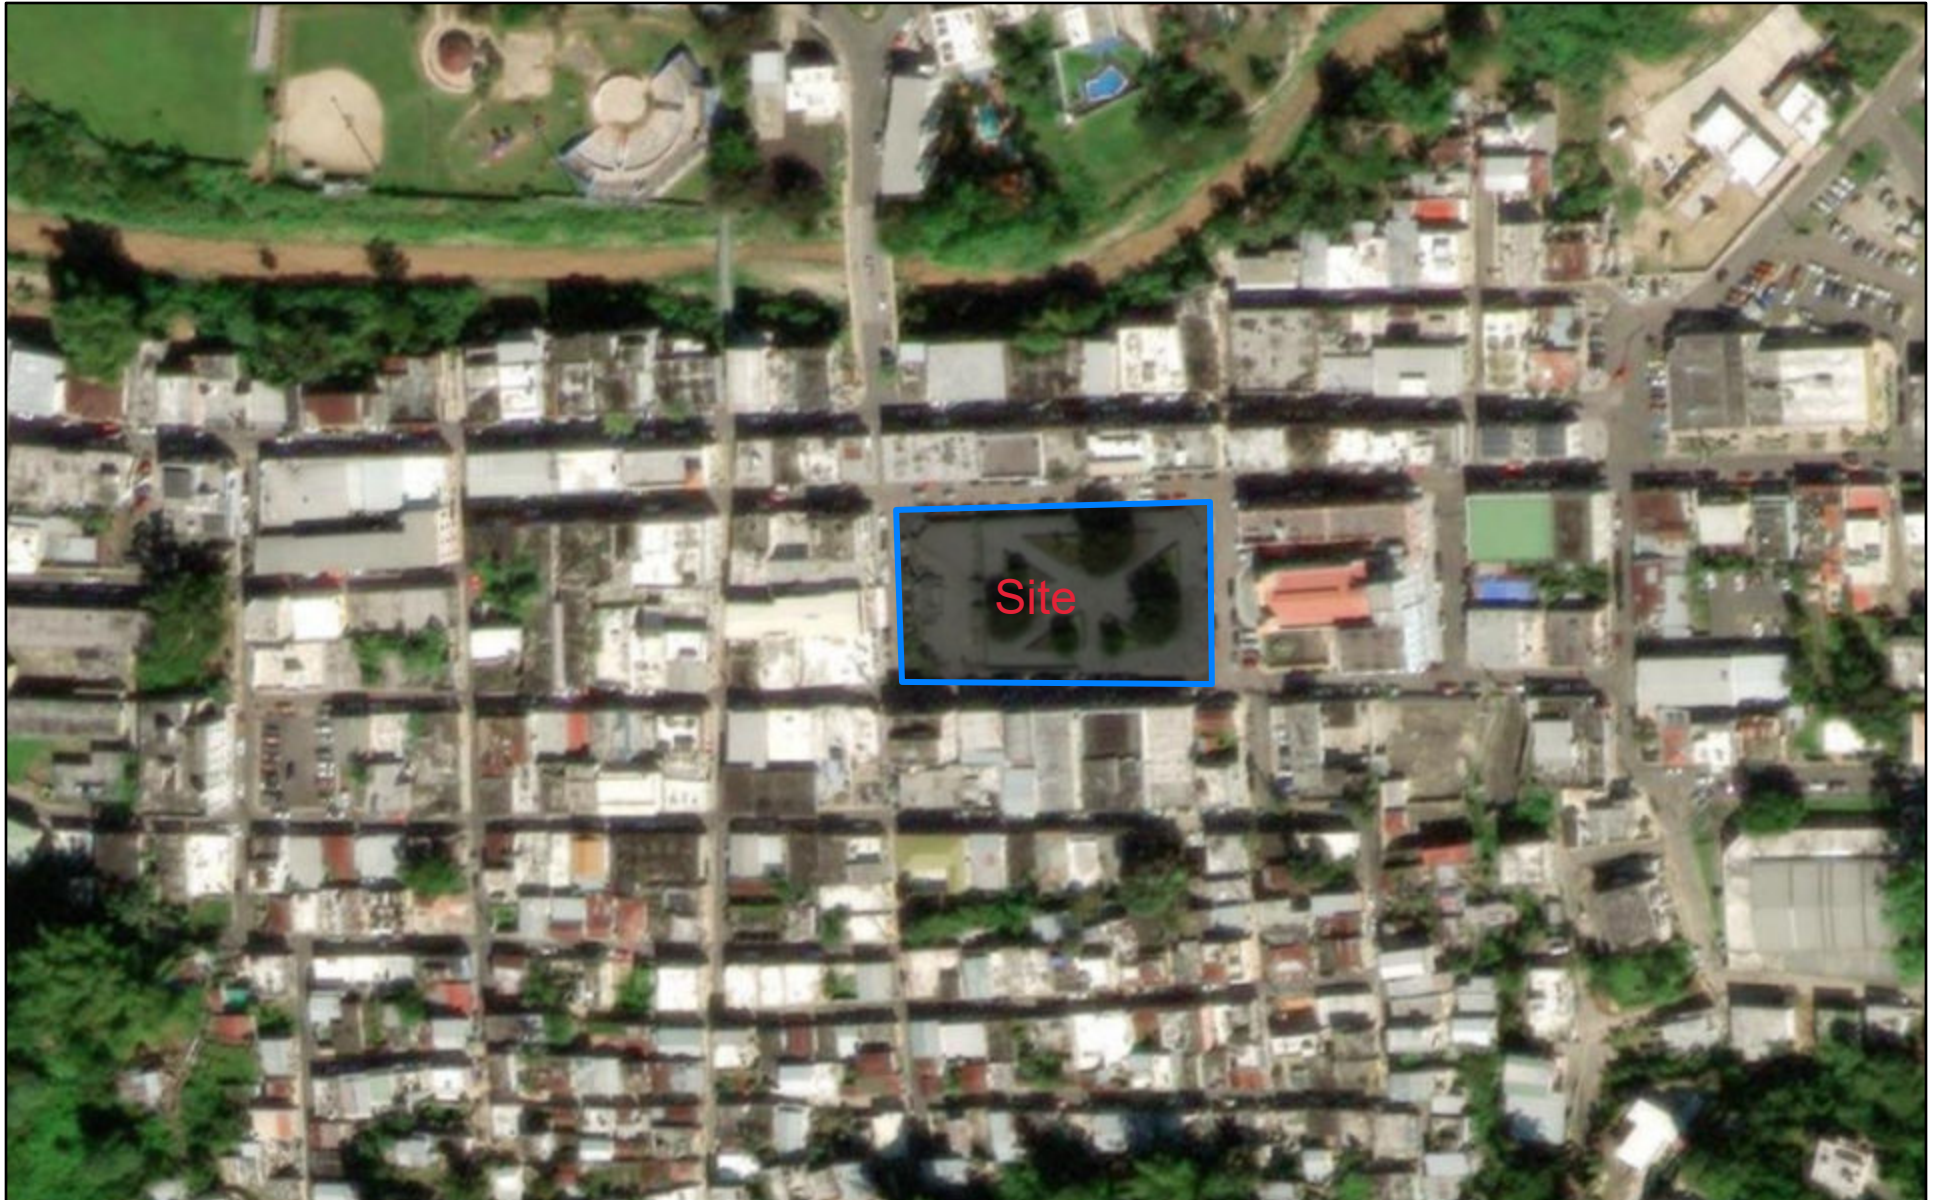
Figure 1 Location Map

Project Location: Antonio R. Barceló St., Dr. Barbosa St., Dr. Betances St. and Sánchez
López Streets, Utuado, Puerto Rico, 00641; cadaster number: 188-048-051-01
(Plaza) and coordinates 18.26532, -66.69994. Refer to Figure 1 in Appendix B.

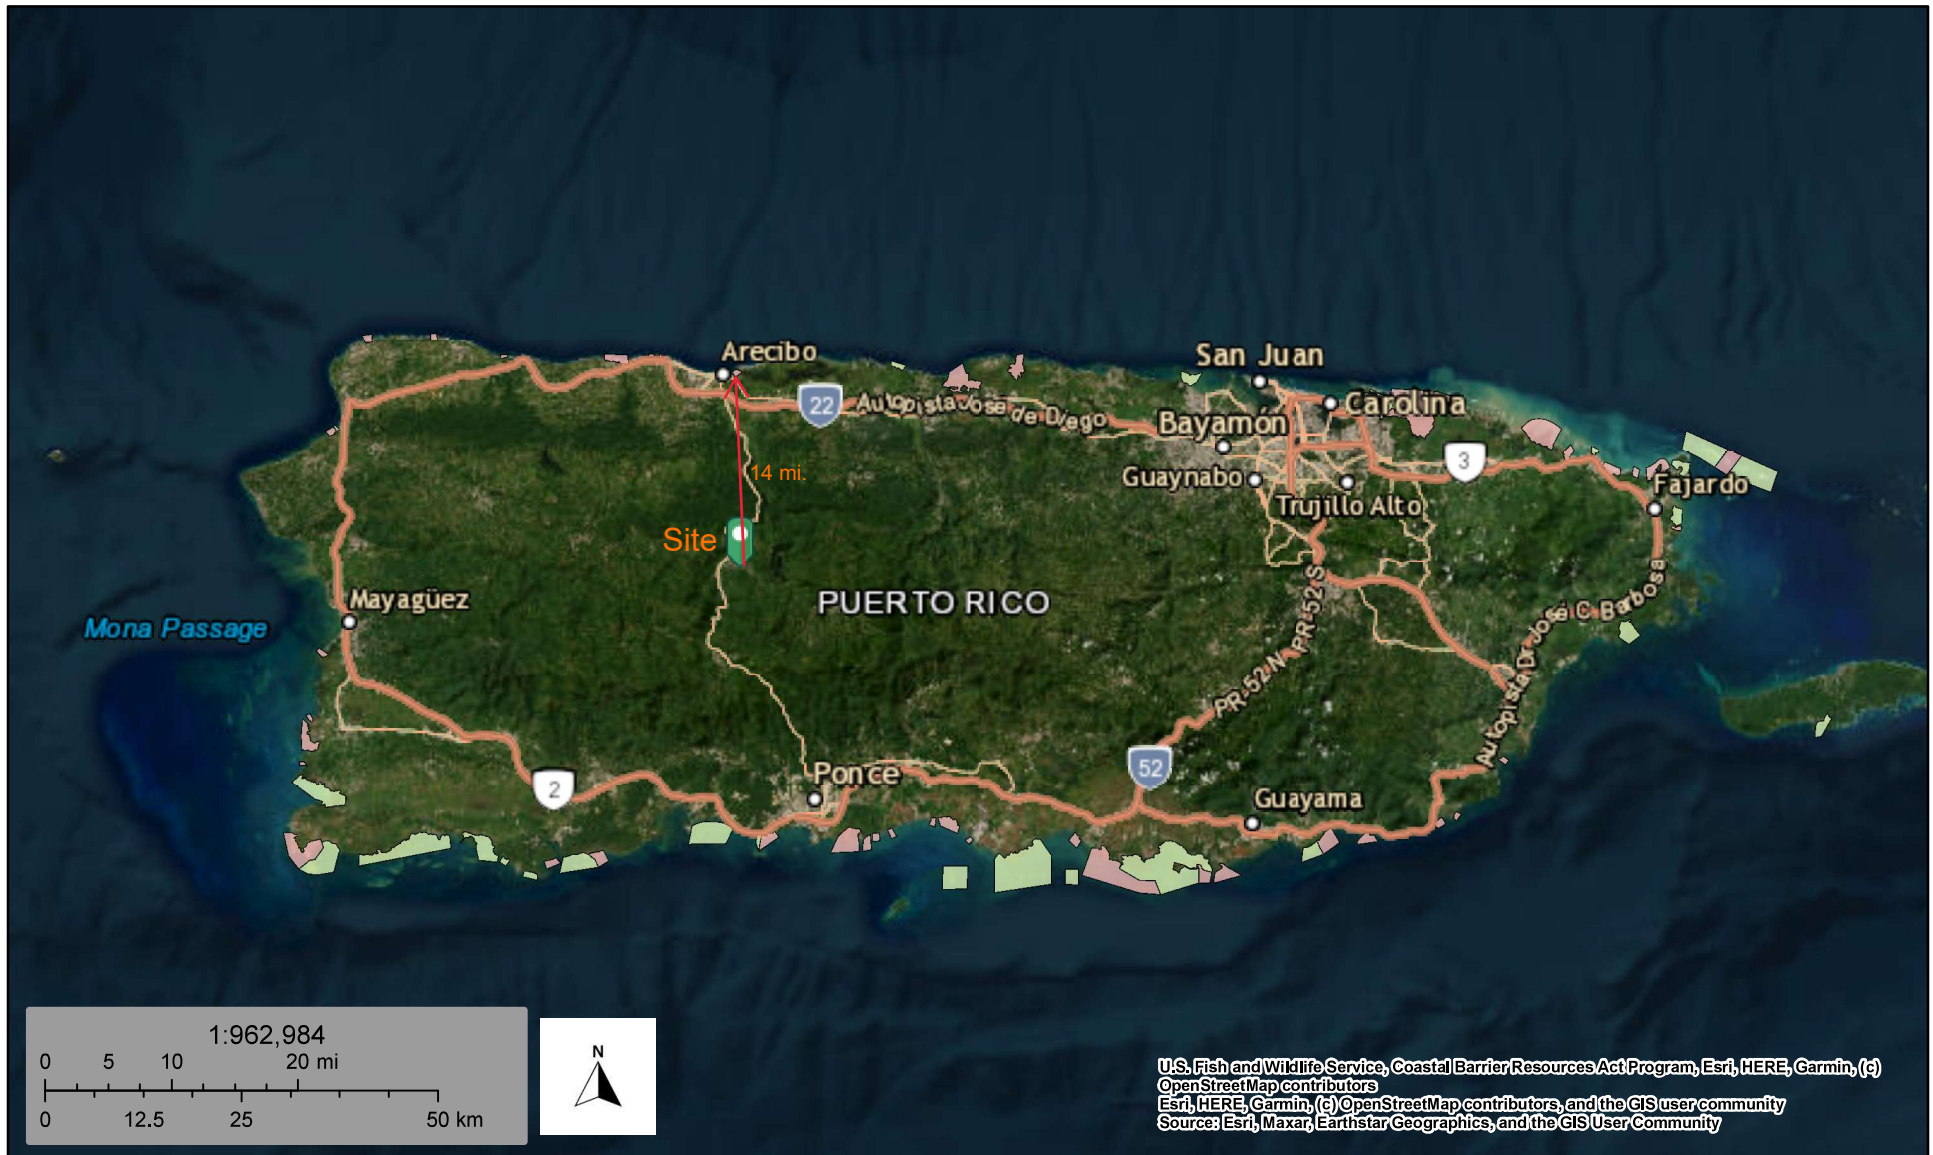
Figure 3 PR-CRP-000640 Revitalización de la Plaza Pública de la Ciudad entre Montañas

The Project is in compliance with Coastal Barrier Resources Coastal Barrier Resources Act, as amended by the Coastal Barrier Improvement Act of 1990 [16 USC 3501]. Refer to Figure 3 in Appendix B.

<p>Coastal Barrier Resources</p> <p>Coastal Barrier Resources Act, as amended by the Coastal Barrier Improvement Act of 1990 [16 USC 3501]</p>	<p>Yes No</p> <p><input type="checkbox"/> <input checked="" type="checkbox"/></p>	<p>The Project site is not located in or adjacent to a CBRS Unit. The nearest unit is approximately 14.0 miles to the north.</p> <p>The Project is in compliance with Coastal Barrier Resources Coastal Barrier Resources Act, as amended by the Coastal Barrier Improvement Act of 1990 [16 USC 3501]. Refer to worksheet in Appendix A and Figure 3 in Appendix B.</p>
<p>Flood Insurance</p> <p>Flood Disaster Protection Act of 1973 and National Flood Insurance Reform Act of 1994 [42 USC 4001-4128 and 42 USC 5154a]</p>	<p>Yes No</p> <p><input type="checkbox"/> <input checked="" type="checkbox"/></p>	<p>Within the FIRM map, the site is only partially within the 500-year flood zone as indicated on Flood Insurance Rate Map (FIRM) Panel no. 72000C0615H, revised on April 19, 2005. Although flood insurance is recommended, it is not required.</p> <p>The project is in compliance with the Flood Disaster Protection Act of 1973 and National Flood Insurance Reform Act of 1994 [42 USC 4001-4128 and 42 USC 5154a]. Refer to worksheet in Appendix A and Figure 4 in Appendix B.</p>

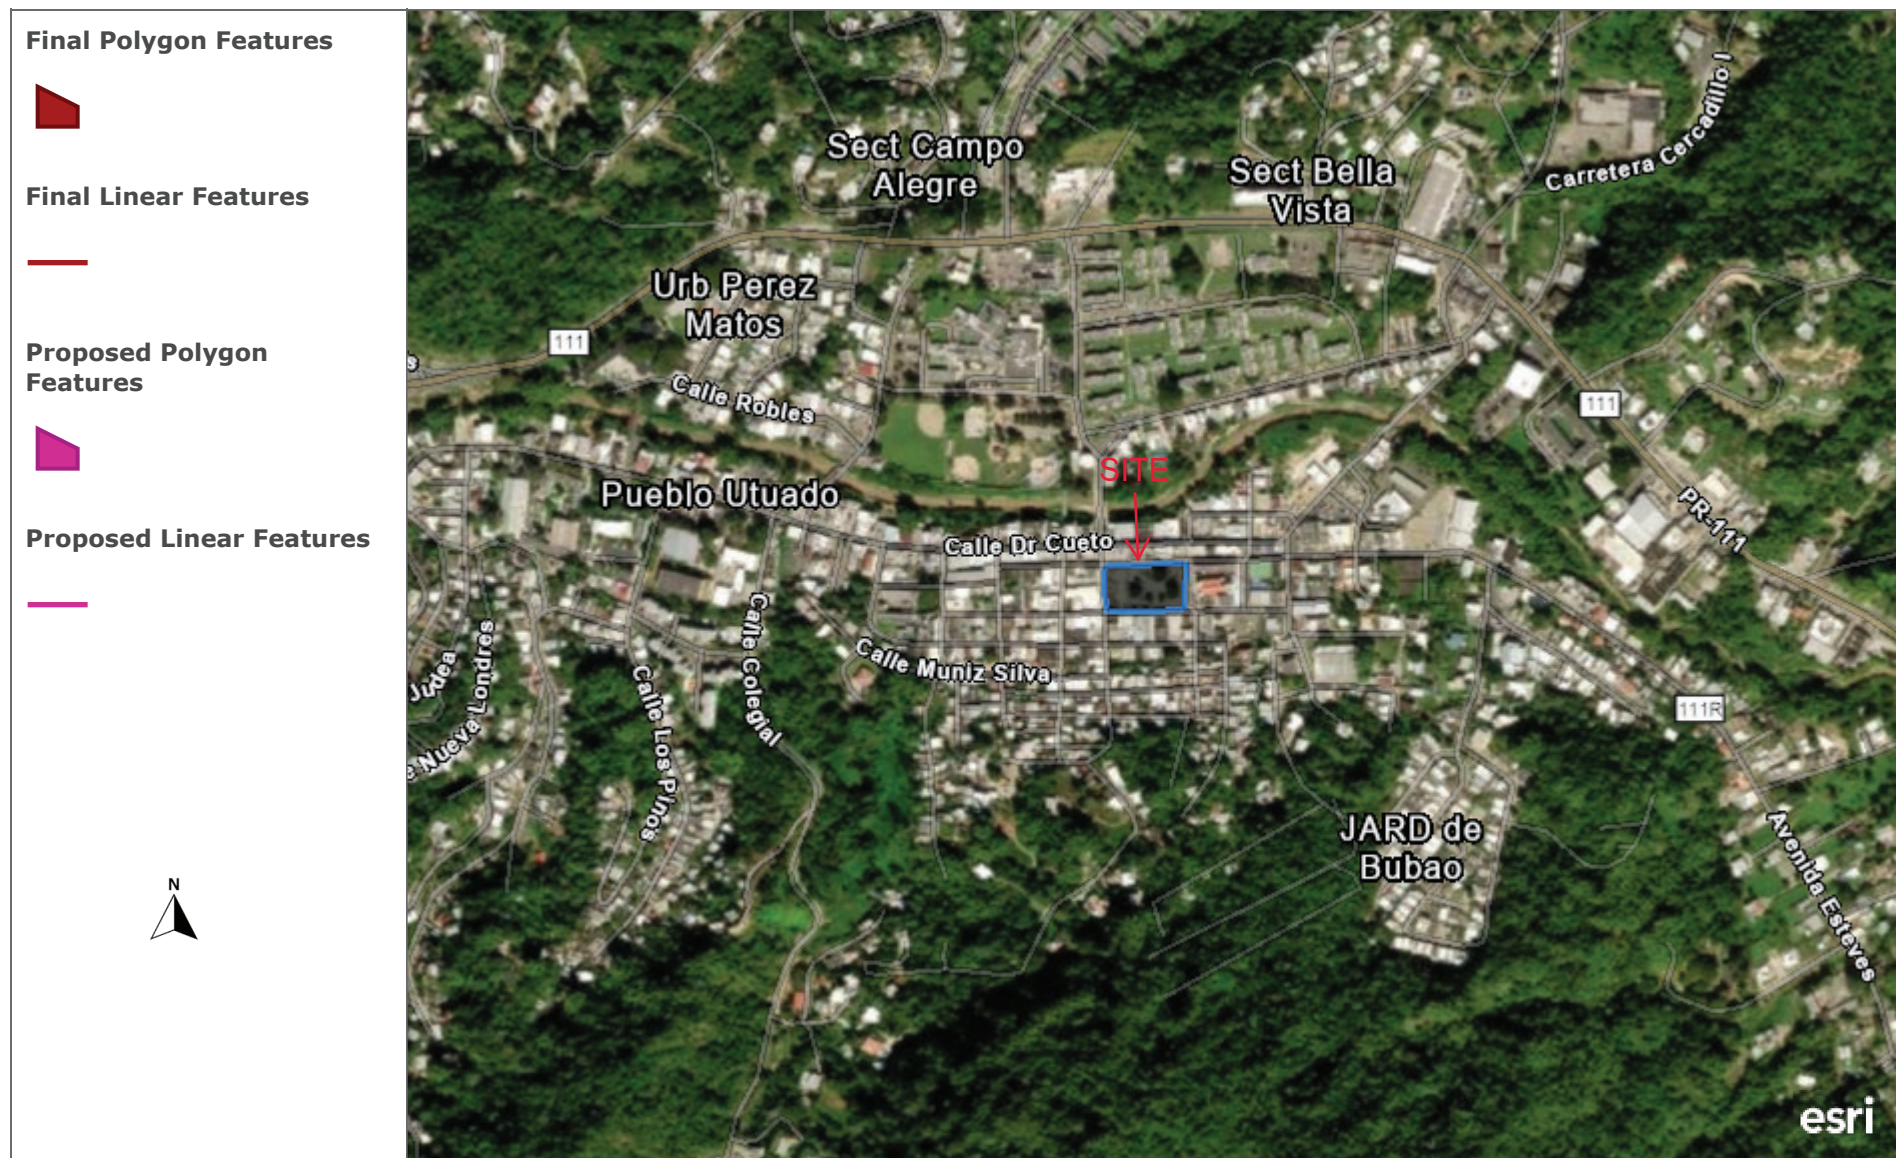
Figure 8 Critical Habitat for Threatened & Endangered Species [USFWS]

A specific geographic area(s) that contains features essential for the conservation of a threatened or endangered species and that may require special management and protection.

<p>The Project will have no potential to affect species or habitats due to the nature of the activities involved in the project. Based on the nature of the project, scope of work, information available, and a careful analysis of the Project Site, and IPaC species list, it was determined that it would not be likely to adversely affect federally listed species for any of the listed species. On December 14, 2023, the USFWS determined that the proposed action qualifies for the blanket clearance letter.</p> <p>The proposed activities are covered by the USFWS Blanket Clearance Letter for Federally sponsored projects, Housing and Urban Development of January 14 of 2013, Item 10. If a Puerto Rican Boa is encountered, work will cease until it moves off the site or, failing that, the Puerto Rico Department of Natural and Environmental Resources (PRDNER) Rangers will be notified for safe capture and relocation of the animal, in accordance with the USFW Puerto Rican Boa Conservation Measures guidelines and the July 27, 2023, Amended Programmatic Biological Opinion.</p> <p>The project is in compliance with the Endangered Species Act of 1973, particularly section 7; 50 CFR Part 402. Refer to worksheet in Appendix A, Figure 8 in Appendix B, and Appendix D Endangered Species (including the IPaC Report).</p>

The project is in compliance with the Endangered Species Act of 1973, particularly section 7; 50 CFR Part 402. Refer to Figure 8 in Appendix B, and Appendix D Endangered Species (including the IPaC Report).

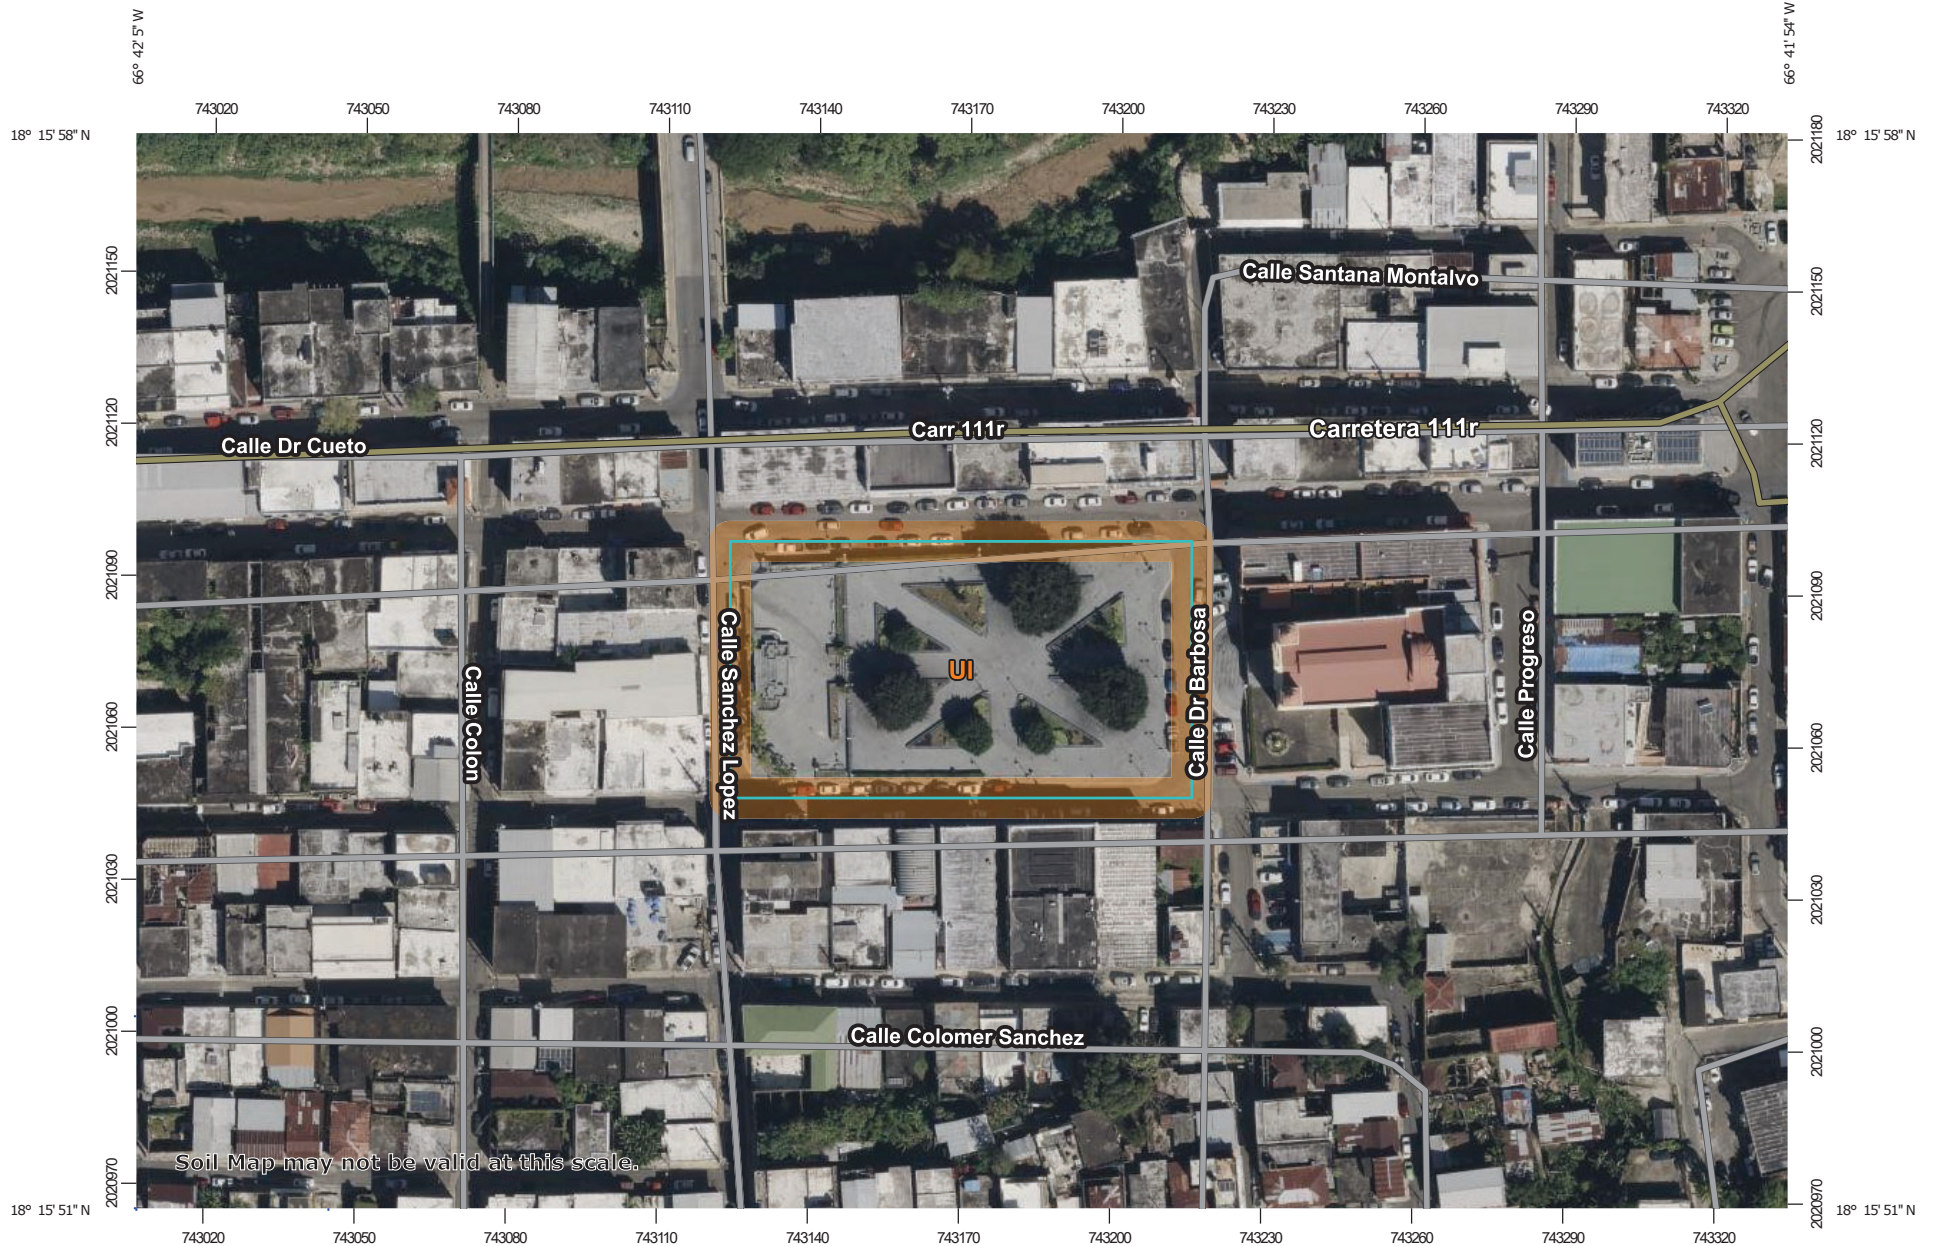
Figure 10 Farmlands Map

The project is compliance with the Farmland Protection Policy Act of 1981, particularly sections 1504(b) and 1541; 7 CFR Part 658. Refer to Figure 10 in Appendix B.

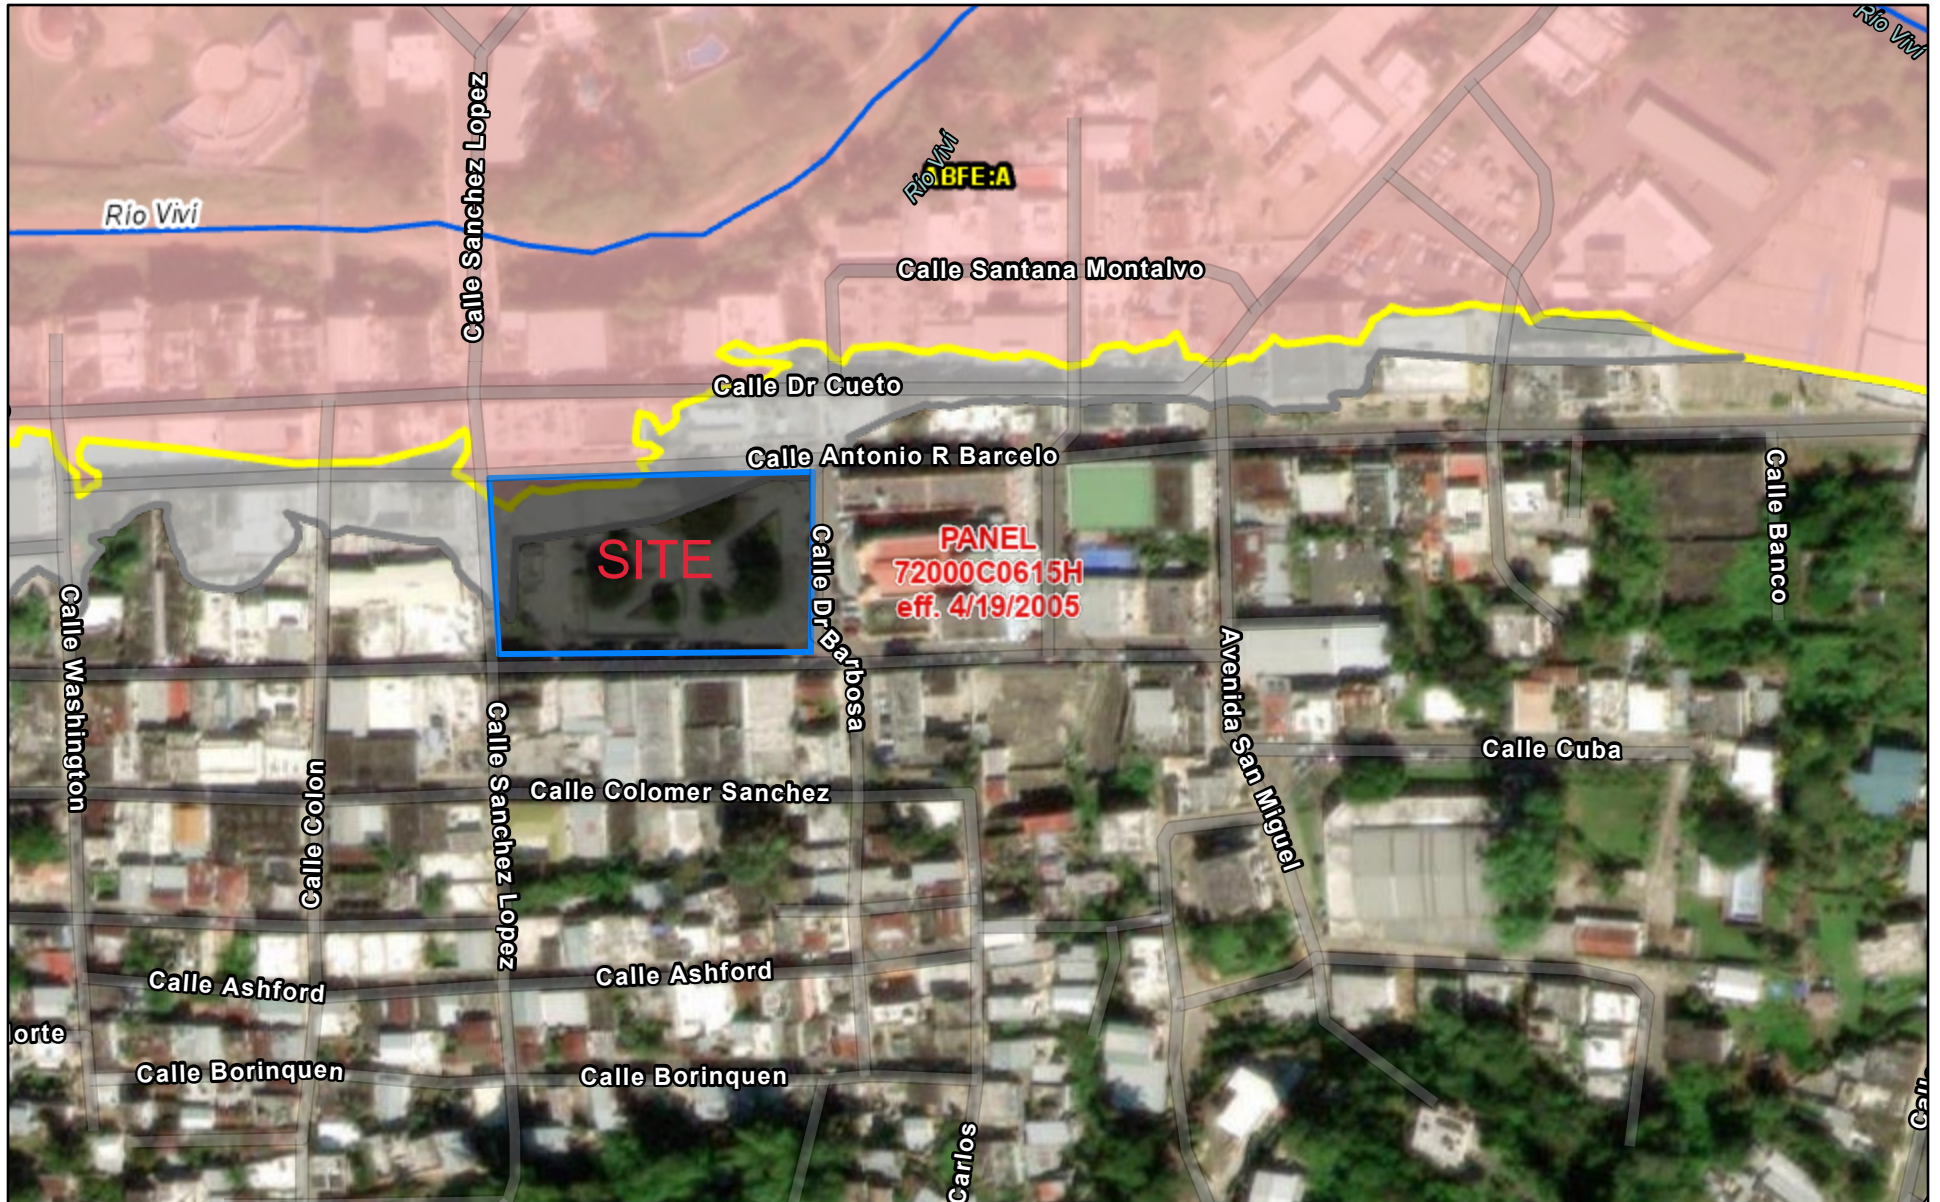
Figure 11 Floodplain Management Map

Within the FIRM map, the site is only partially within the 500-year flood zone as indicated on Flood Insurance Rate Map (FIRM) Panel no. 72000C0615H, revised on April 19, 2005. Although flood insurance is recommended, it is not required.

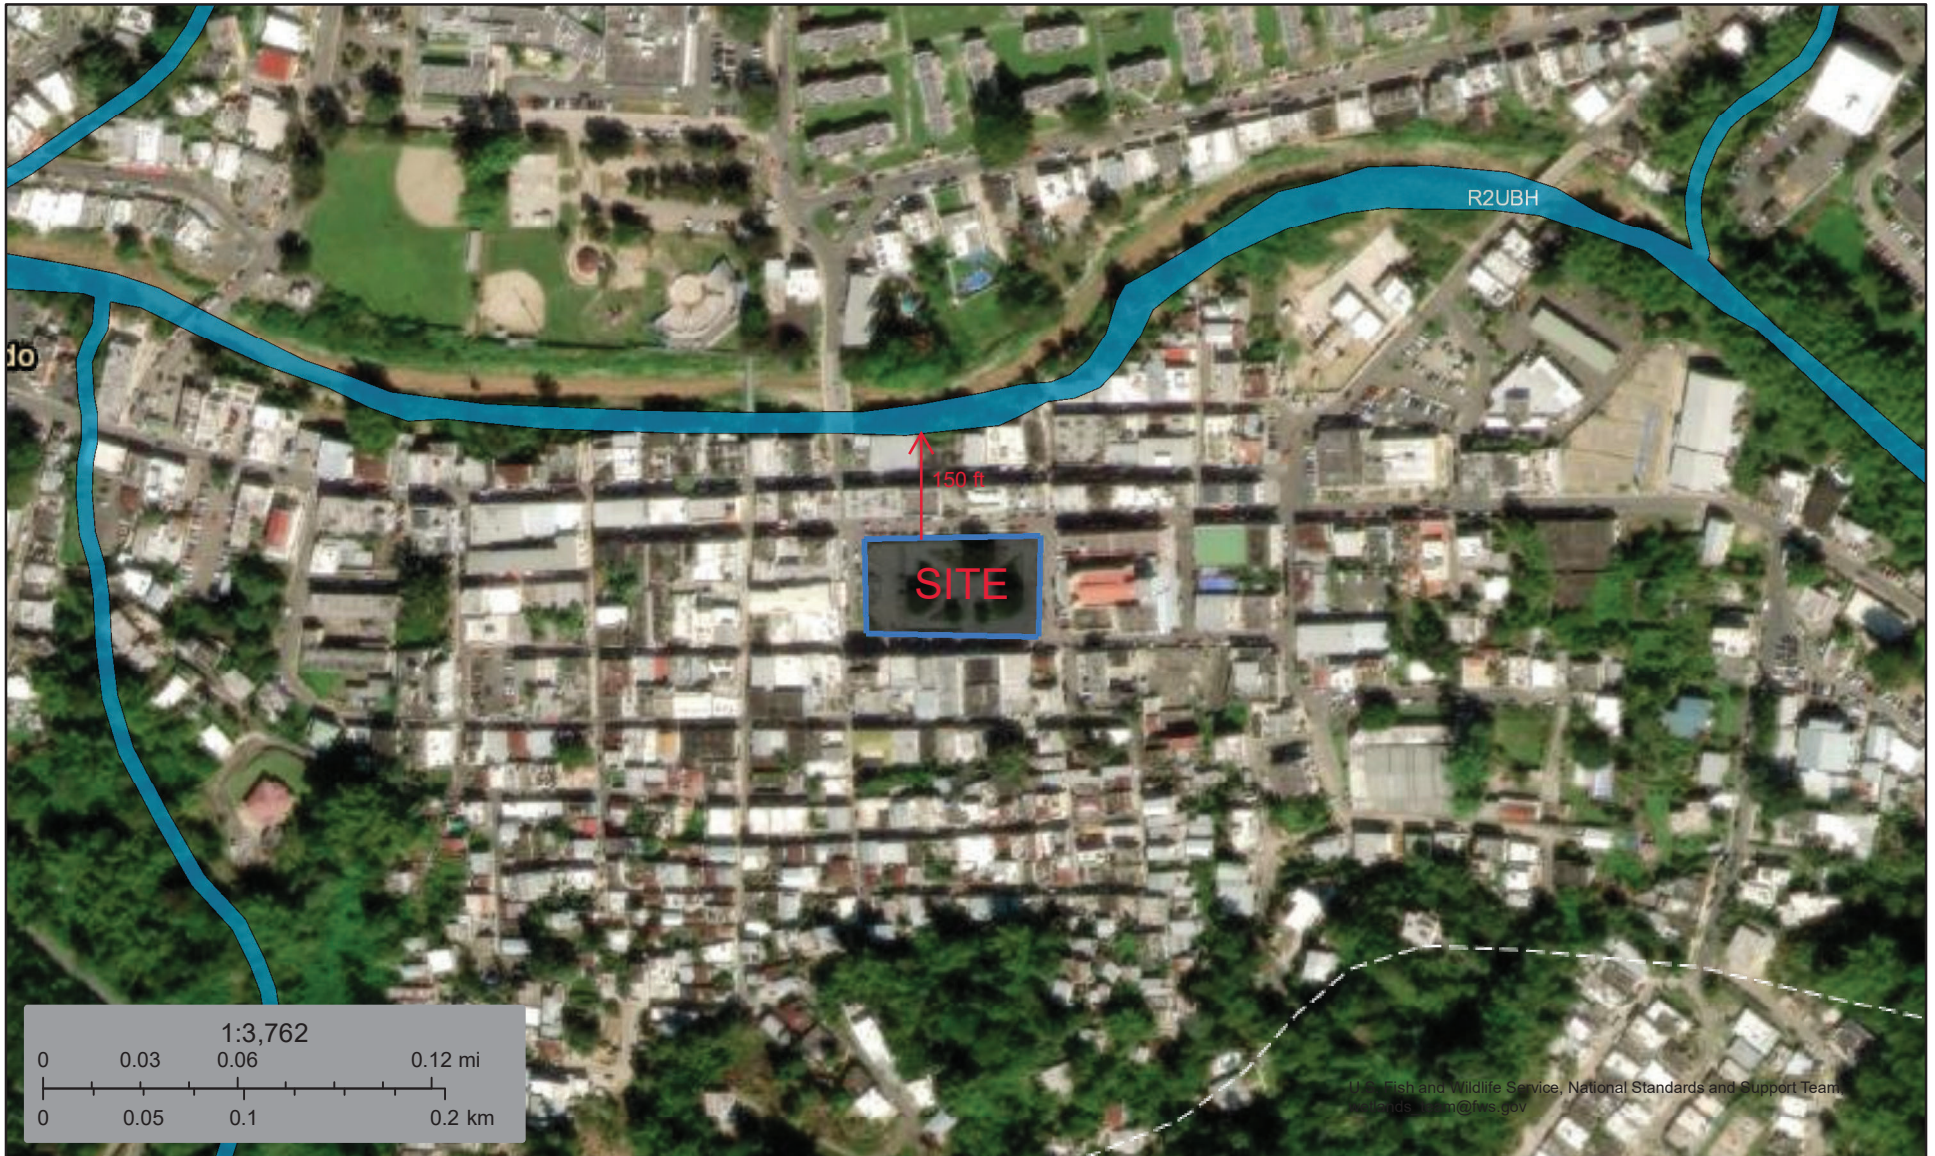
Figure 13 PR-CRP-000640 Revitalización de la Plaza Pública de la Ciudad entre Montañas
Dr Betances St, Utuado PR 00641
Coordinates 18.26532, -66.69994

Refer to Figure 13 in Appendix B.

<p>Sole Source Aquifers</p> <p>Safe Drinking Water Act of 1974, as amended, particularly section 1424(e); 40 CFR Part 149</p>	<p>Yes No</p> <p><input type="checkbox"/> <input checked="" type="checkbox"/></p>	<p>There are no EPA sole source aquifers in Puerto Rico. Furthermore, the project consists of activities that are unlikely to have an adverse impact on groundwater.</p> <p>The project complies with Sole Source Aquifer regulations, Safe Drinking Water Act of 1974, as amended, particularly section 1424(e); 40 CFR Part 149. Refer to worksheet in Appendix A and Figure 12 in Appendix B.</p>
<p>Wetlands Protection</p> <p>Executive Order 11990, particularly sections 2 and 5</p>	<p>Yes No</p> <p><input type="checkbox"/> <input checked="" type="checkbox"/></p>	<p>The National Wetlands Inventory (NWI) mapping shows no wetlands located within or adjacent to the project site.</p> <p>The project complies with Wetland Protection regulations and Executive Order 11990. Refer to worksheet in Appendix A and Figure 13 in Appendix B.</p>

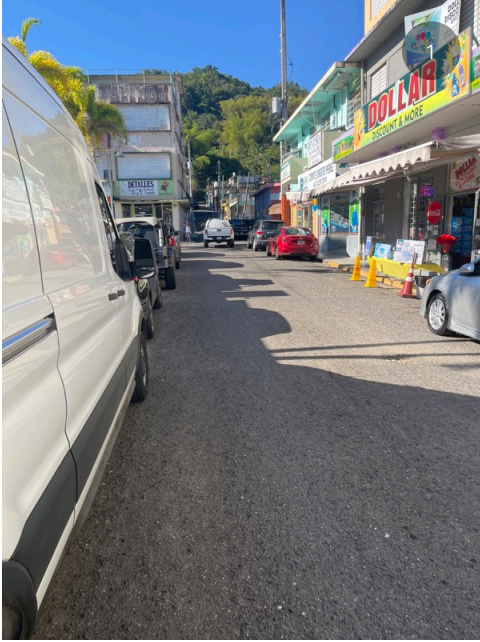
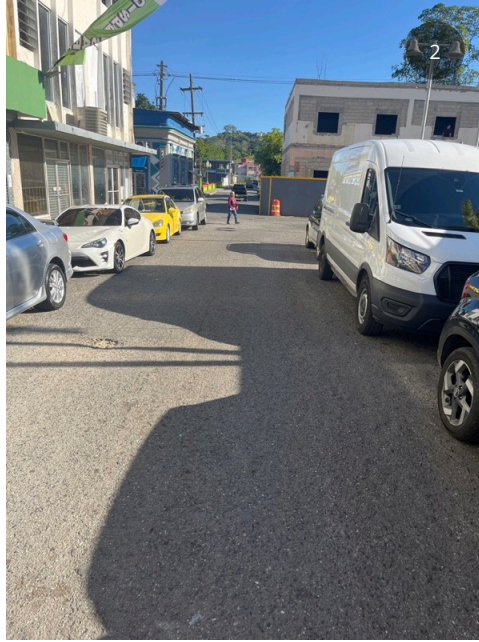
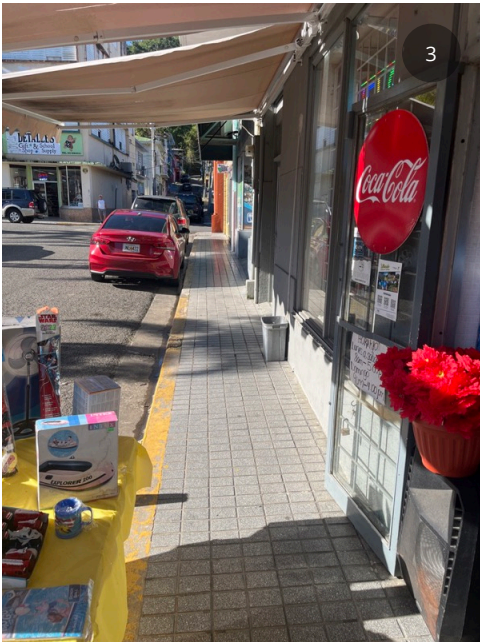
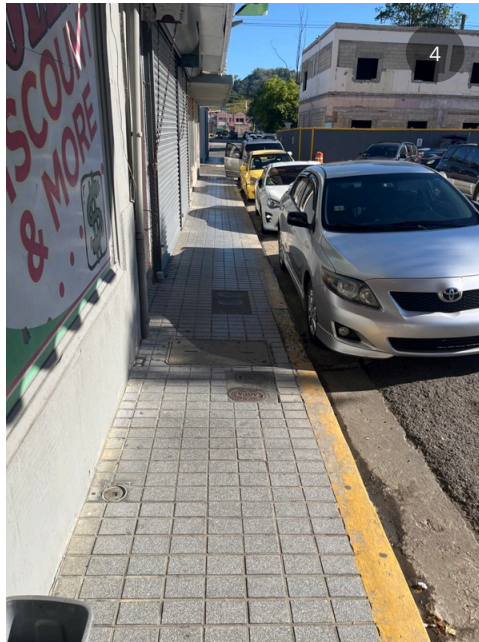
GENERAL VIEWS: C. SANCHEZ LOPEZ

No SACM visible at the moment of the inspection.

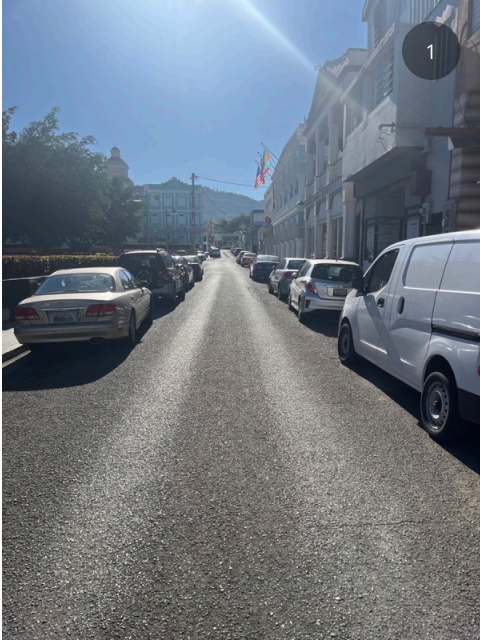
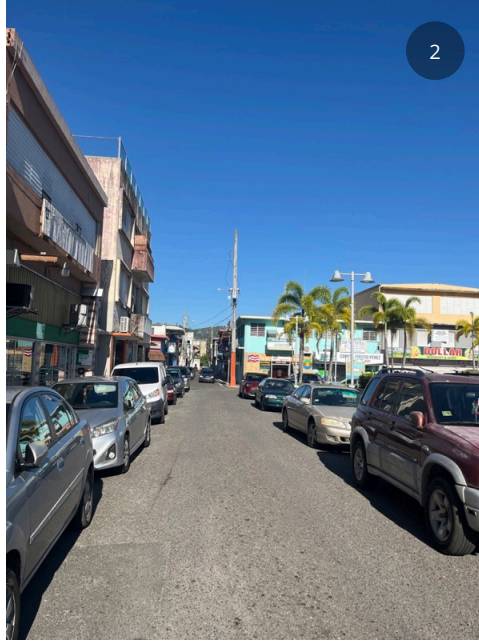
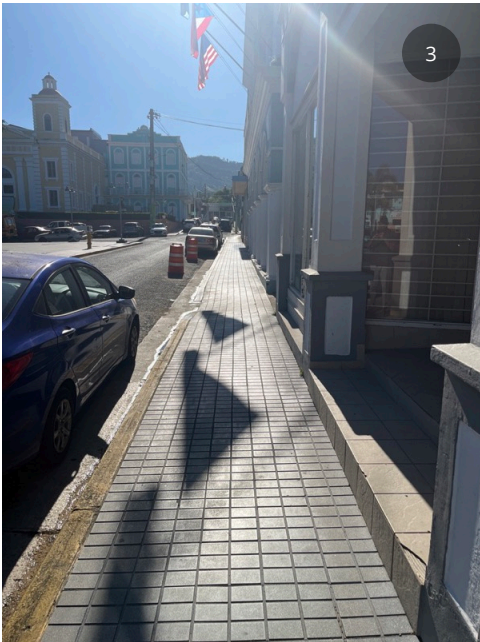
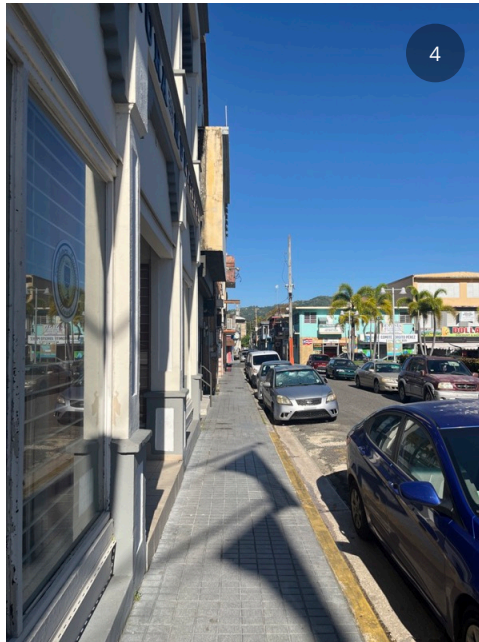
GENERAL VIEWS: C. DR. BETANCES

SACM VISIBLES?

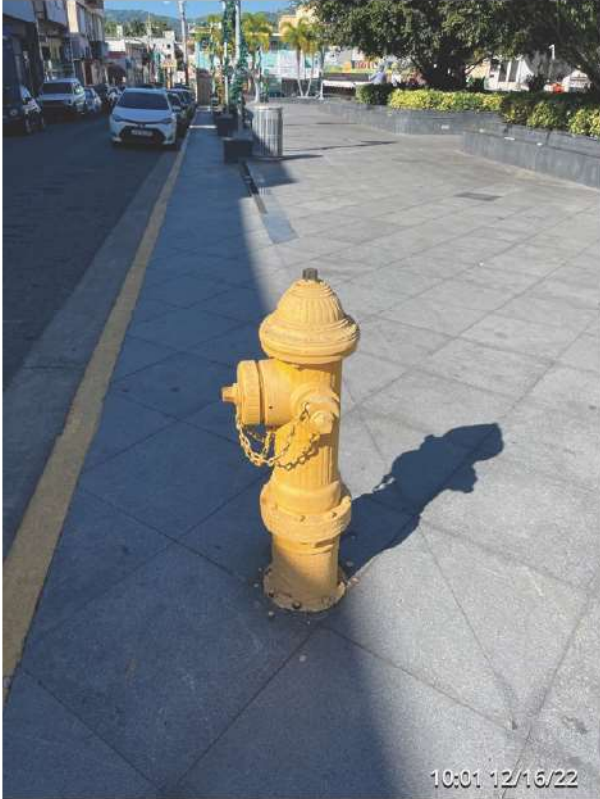
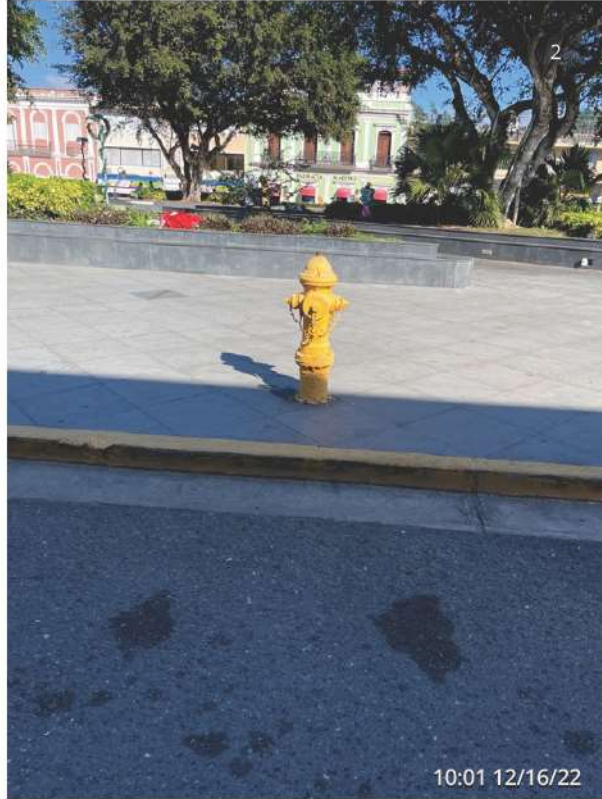
LBP DETECTED? FIRE HYDRANT

LBP was found on the fire hydrant components. Data from XRF analyzer testing is included in **Attachment 3 and 4** with positive readings marked in red or bold. **Attachment 5** includes the approximated location of identified LBP or lead-glazes at the subject structure. Representative Pictures\Photograph Log of identified LBP surfaces and/or lead-glazed ceramic components within the structure are provided in the **Attachment 6**.

Exterior, Readings #74 & #75, yellow steel fire hydrant, 1.6 - 1.0 mg/cm².

(Qty. 1 unit)

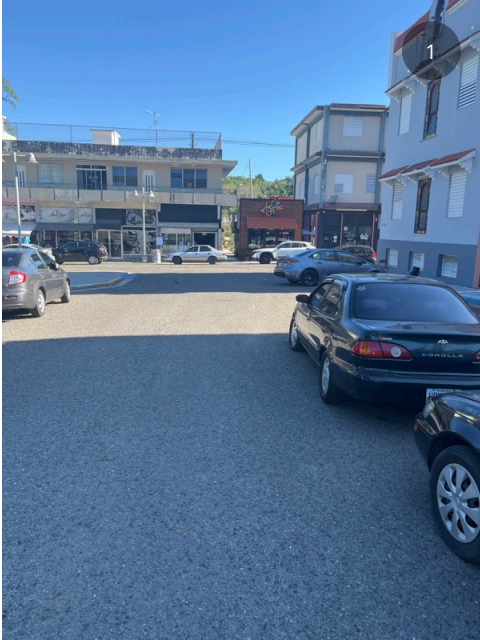
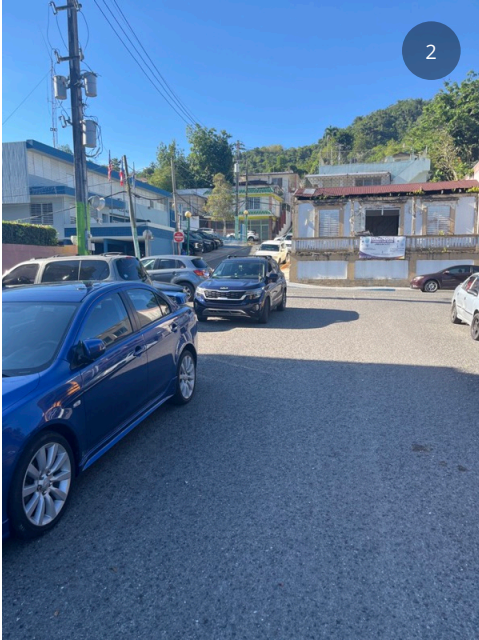
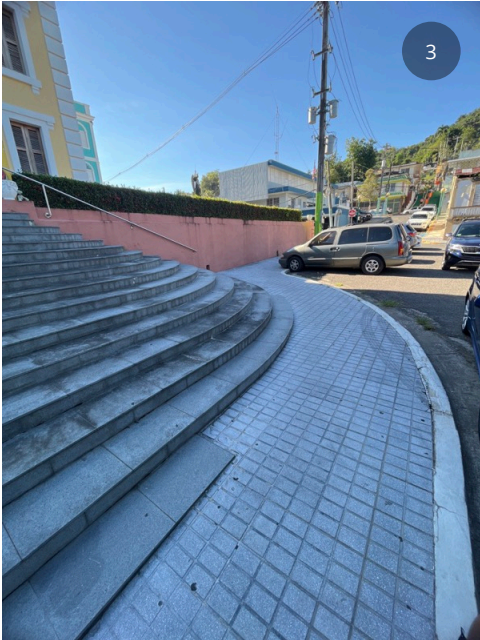
GENERAL VIEWS: C. DR. BARBOSA

Inspection of lead and asbestos on sidewalks/streets surrounding Plaza de Utuado.

No LBP detected at the moment of the inspection.

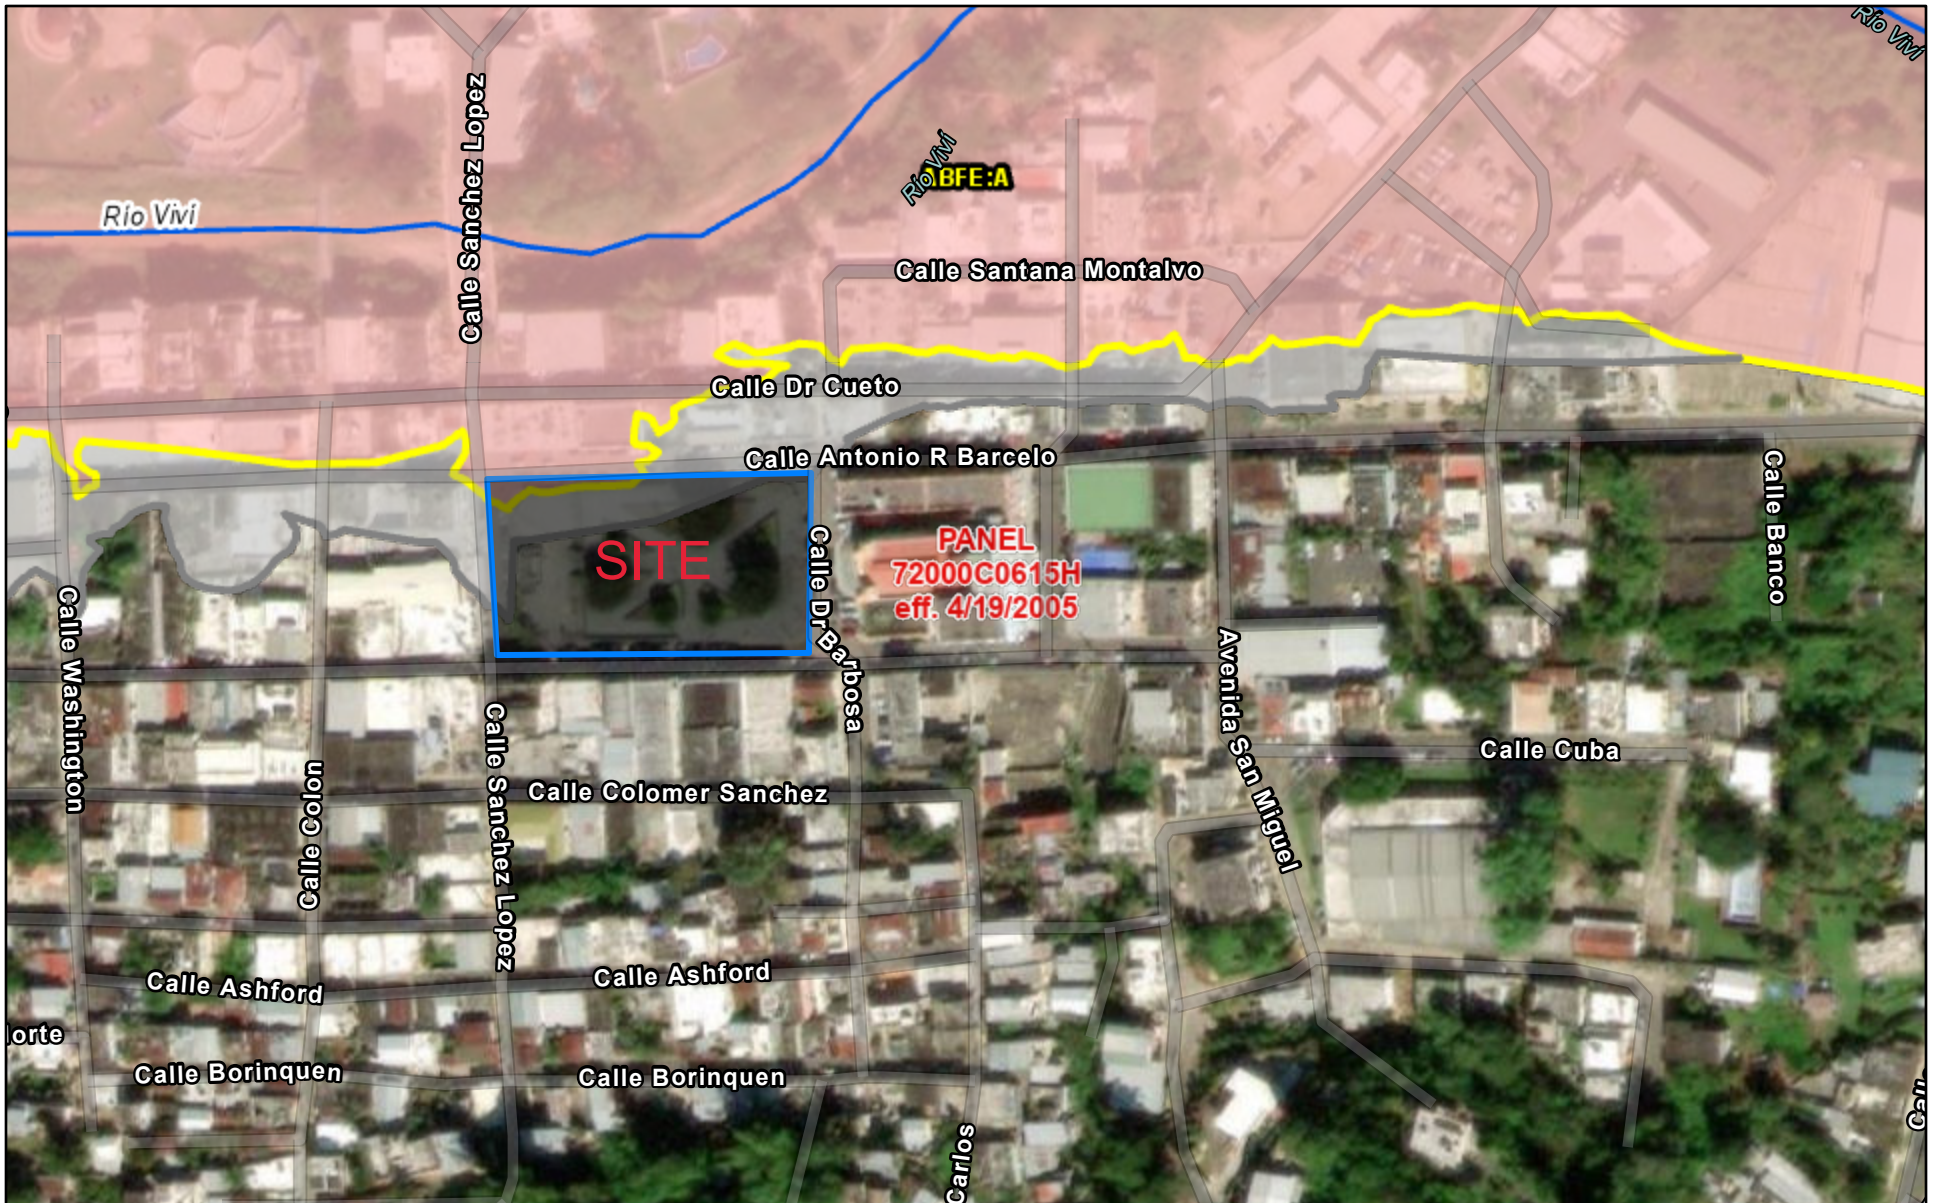
National Flood Hazard Layer FIRMette

The flood hazard information is derived directly from the authoritative NFHL web services provided by FEMA. This map was exported on **3/22/2022 at 7:25 PM** and does not reflect changes or amendments subsequent to this date and time. The NFHL and effective information may change or become superseded by new data over time.
