Environmental Assessment Determinations and Compliance Findings for HUD-assisted Projects 24 CFR Part 58

Project Name: Revitalización de la Plaza Pública de la Ciudad entre Montañas
(PR-CRP-000640)

Responsible Entity: Puerto Rico Department of Housing

State/Local Identifier: Puerto Rico / Utuado

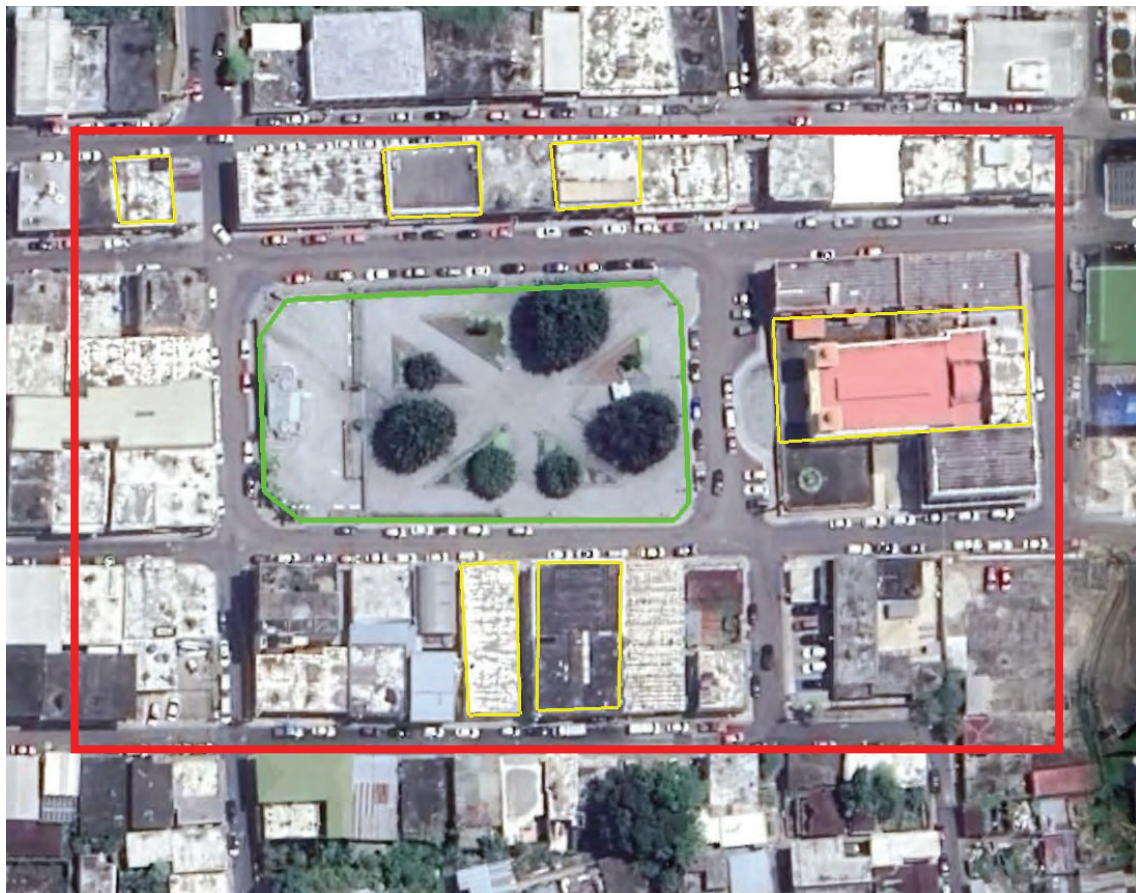
Project (Parcel) Location – Area of Potential Effect Map (Aerial)

(Green) APE / Direct Effect

(Yellow) Indirect Effect

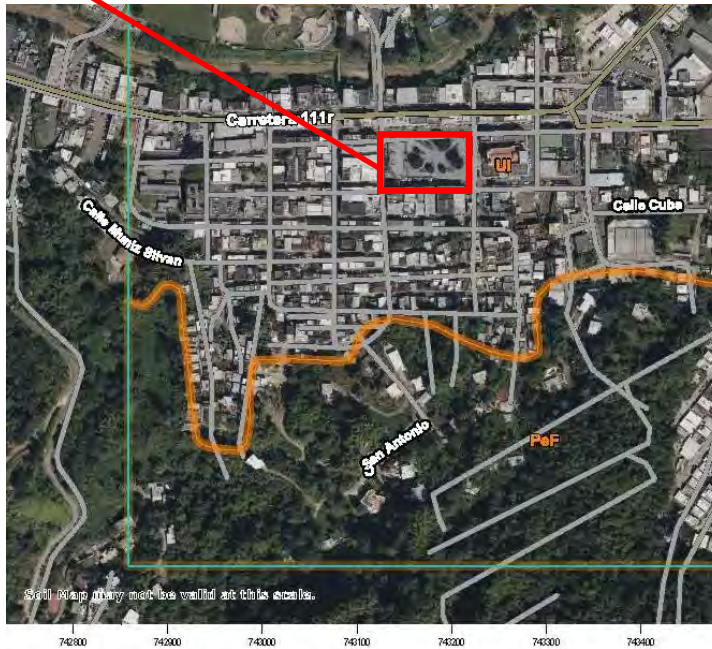
Project (Parcel) Location with Soil Types

Map Scale: 1:5,040 if printed on A landscape (11" x 8.5") sheet
0 50 100 200 300 Meters
0 200 400 800 1200 Feet
Map projection: Web Mercator Corner coordinates: WGS84 Edgetics: UTM Zone 19N WGS84

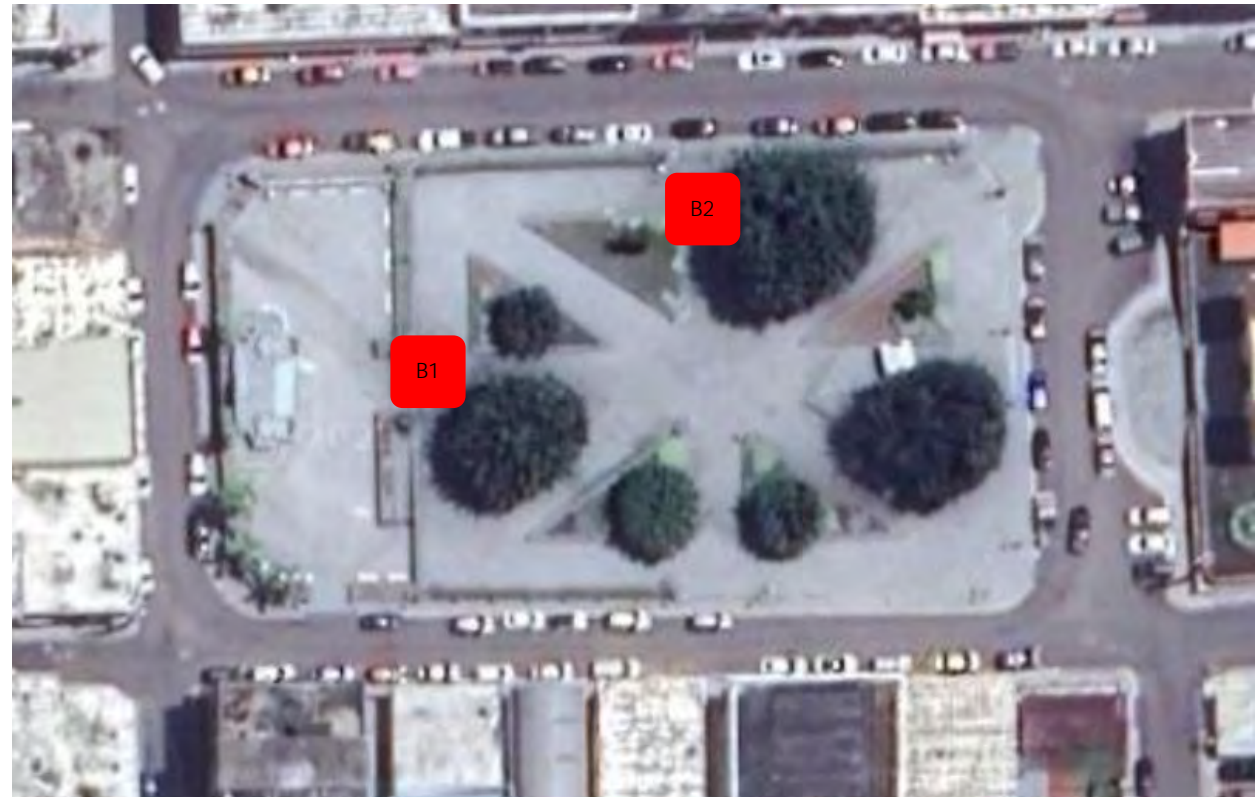
Boring Locations

The evaluation is concentrated in the following items for the proposed project development:

- a) Bearing Capacity of footings
- b) Type of footing and depth of embedment
- c) Site Preparation
- d) General Filling Operations
- e) Archeological mitigation plan

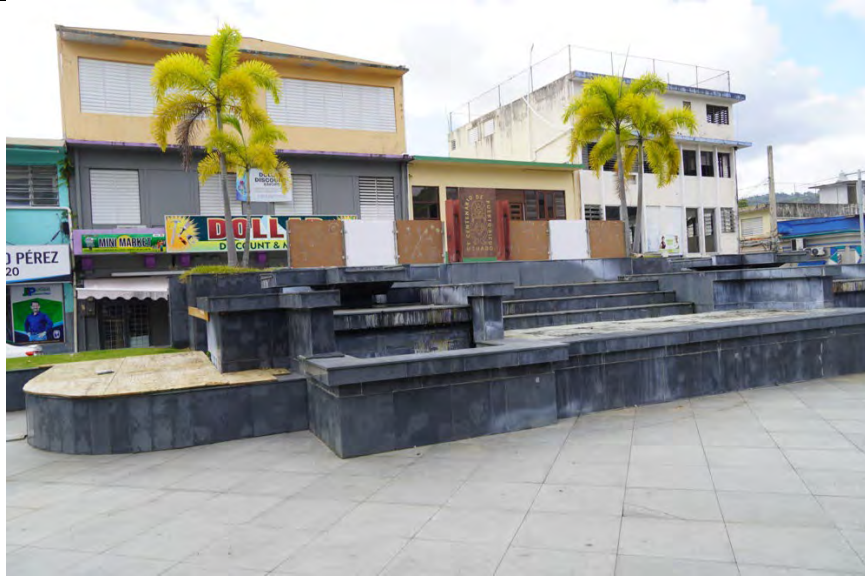
Photo #: 3	Description (include direction):
Date: 02/19/23	Public Square Fountain looking west

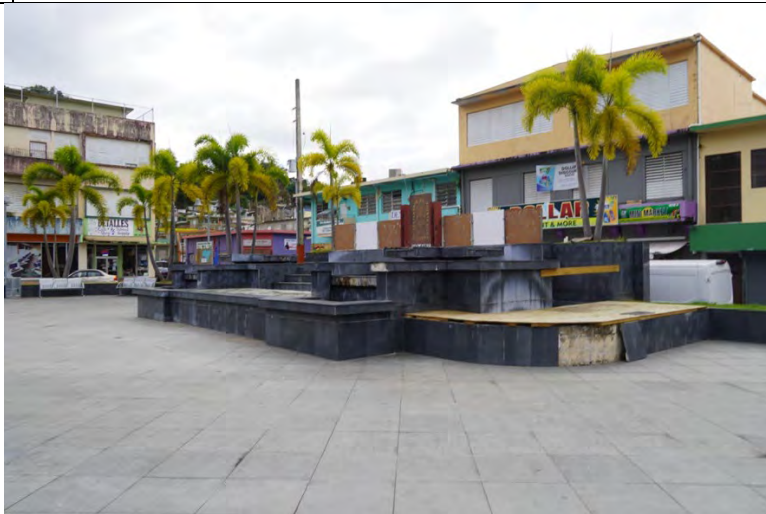
Photo #: 4	Description (include direction):
Date: 02/19/23	Public Square Fountain looking Southwest – Existing Condition

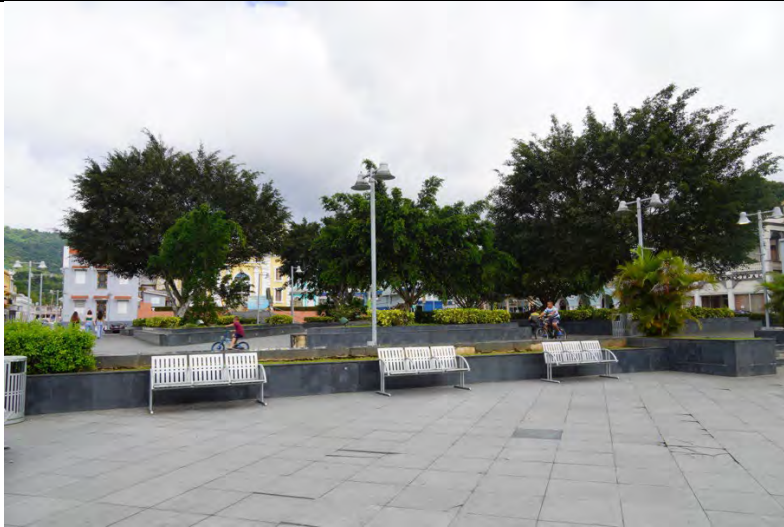
Photo #: 5	Description (include direction):
Date: 02/19/23	Public Square Benches looking east

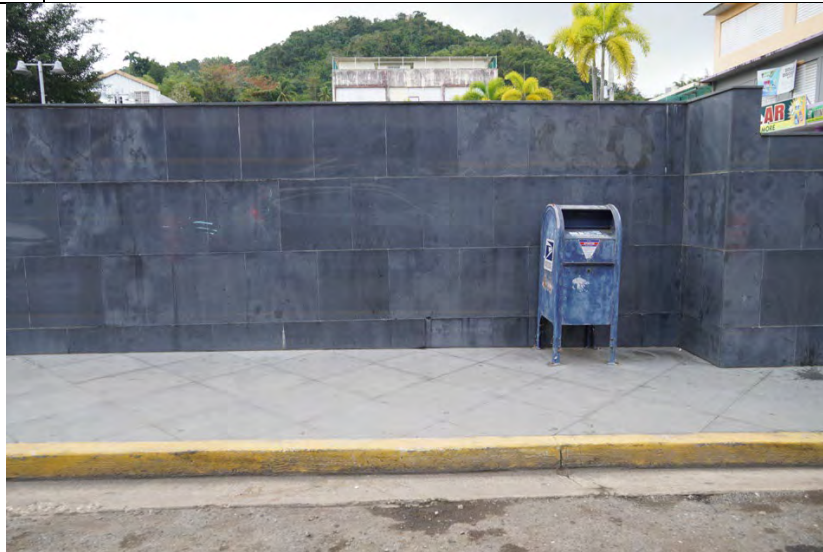
Photo #: 6	Description (include direction):
Date: 02/19/23	Public Square, Fountain back wall looking south

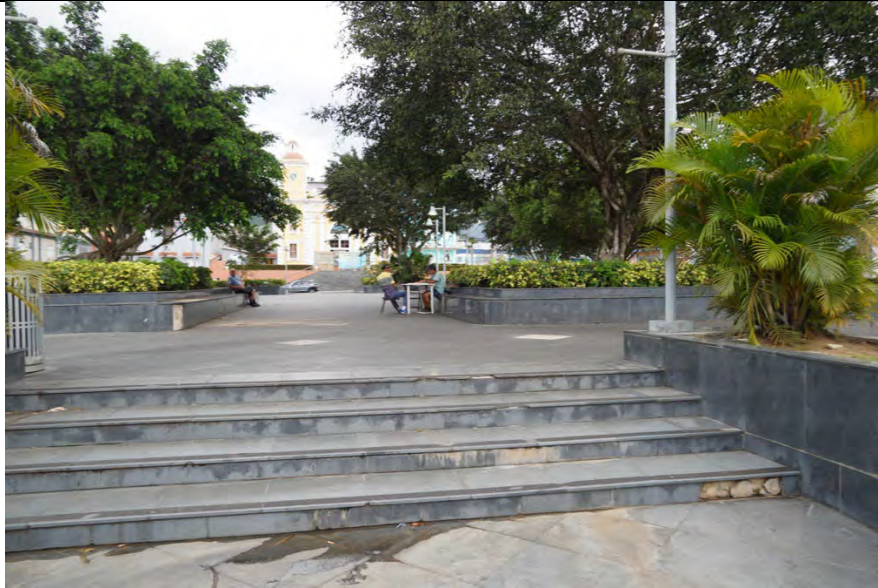
Photo #: 9	Description (include direction):
Date: 02/19/23	Public Square, center stairs, looking out east

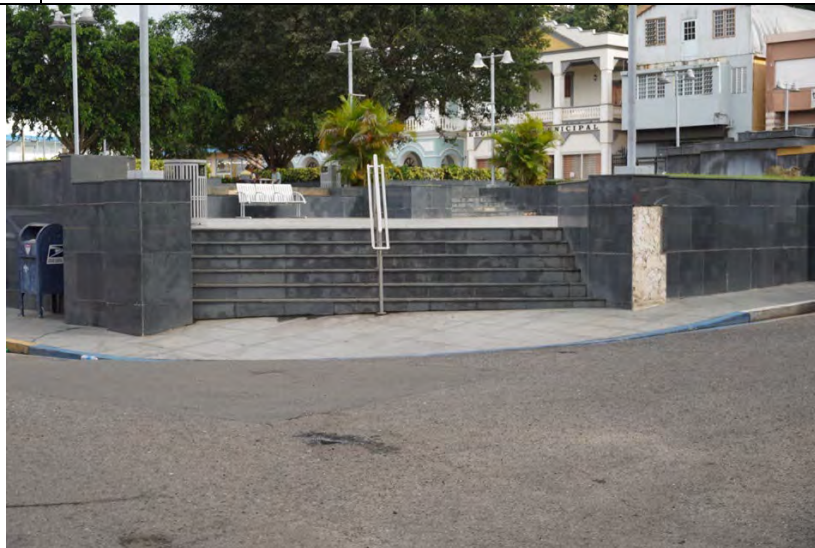
Photo #: 10	Description (include direction):
Date: 02/19/23	Public Square, northwest access stair looking south

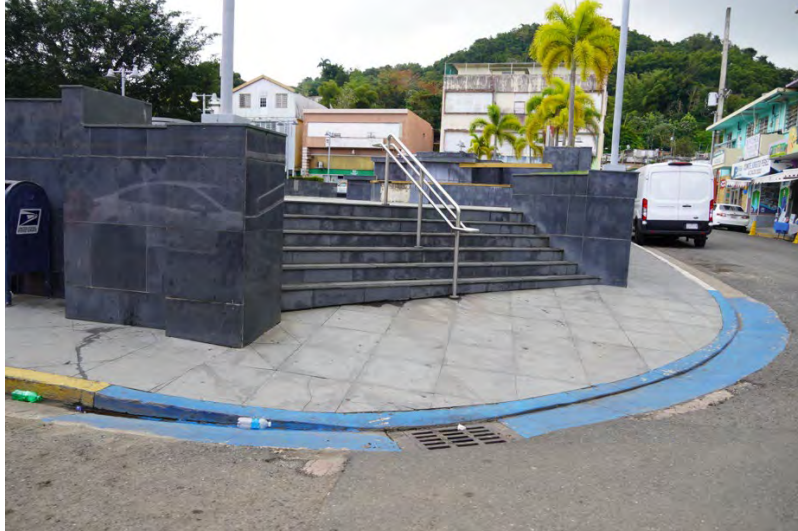
Photo #: 11	Description (include direction):
Date: 02/19/23	Public Square, northwest access stair looking south

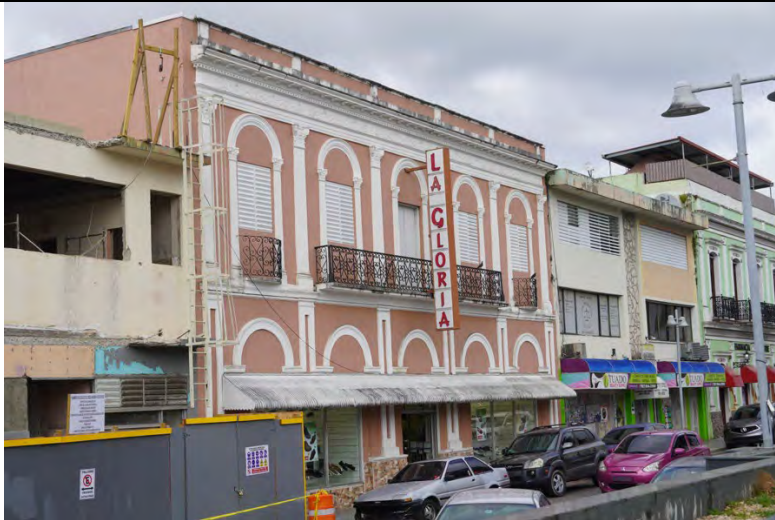
Photo #: 12	Description (include direction):
Date: 02/19/23	La Gloria is a two stories commercial building built circa, 1860, it's an eligible historical property under criterion C, and it's 482 feet away from APE.

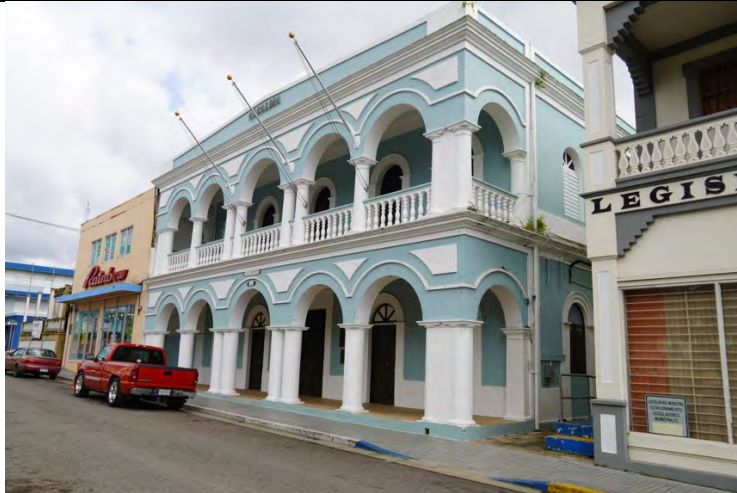
Photo #: 17	Description (include direction): Utuado Town Hall existing structure was built circa 1929, it's an eligible historical property under criteria A and C, and it's 423 feet away from APE.
Date: 02/19/23

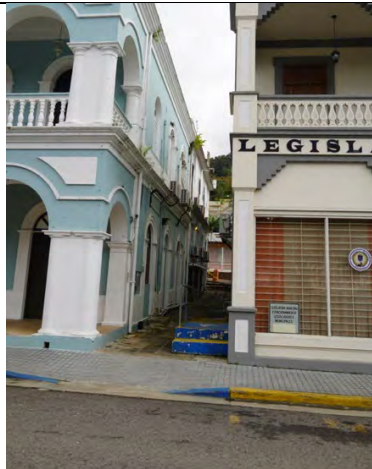
Photo #: 18	Description (include direction): Utuado Town Hall right side elevation facing west.
Date: 02/19/23

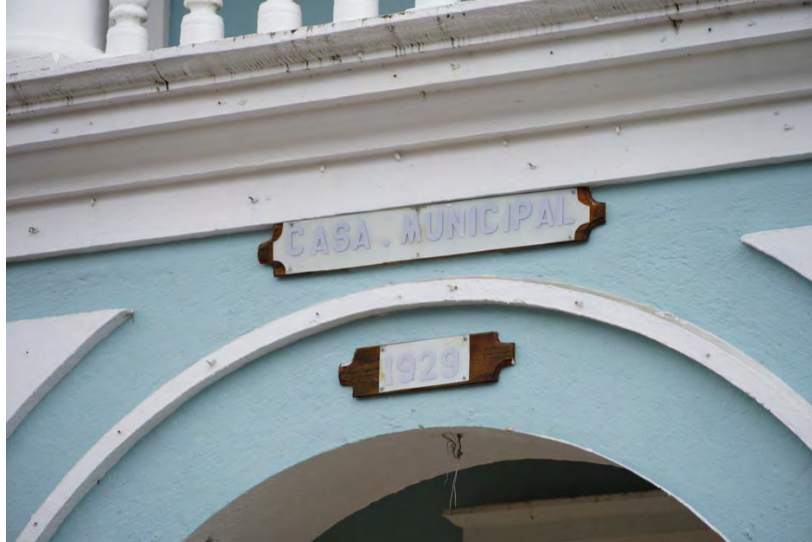
Photo #: 19	Description (include direction): The main Façade of Utuado Town Hall, in the lower-level date of construction plaque.
Date: 02/19/23

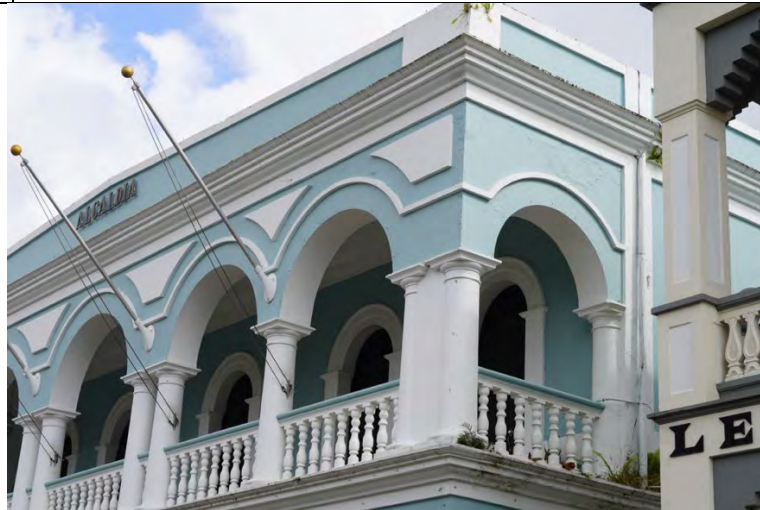
Photo #: 20	Description (include direction): Utuado Town Hall, Façade detail
Date: 02/19/23

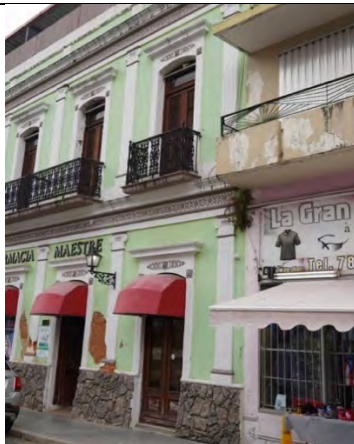
Photo #: 22	Description (include direction): Main Façade, Maestre Pharmacy is a two-story commercial building built circa 1860, it's an eligible historical property under criterion C, and it's 407 feet away from APE.
Date: 02/19/23

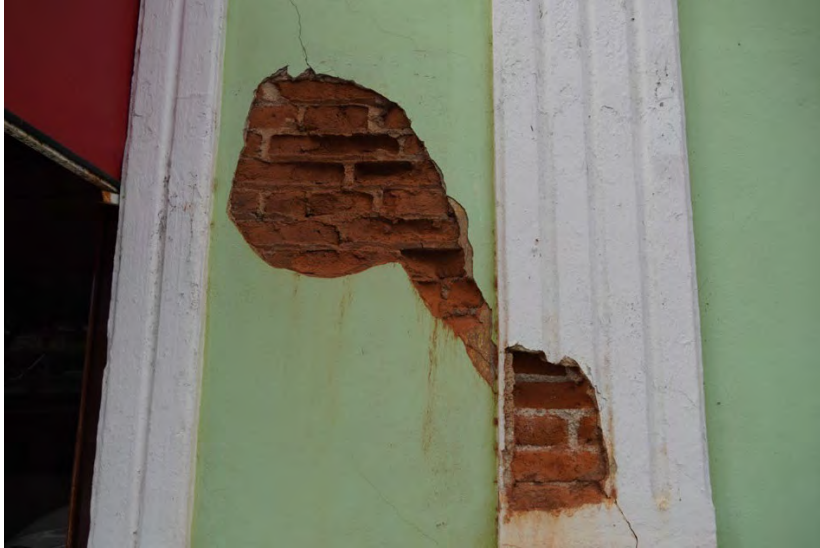
Photo #: 23	Description (include direction):
Date: 02/19/23	Exposed Bricks in the main Façade of Maestre Pharmacy,

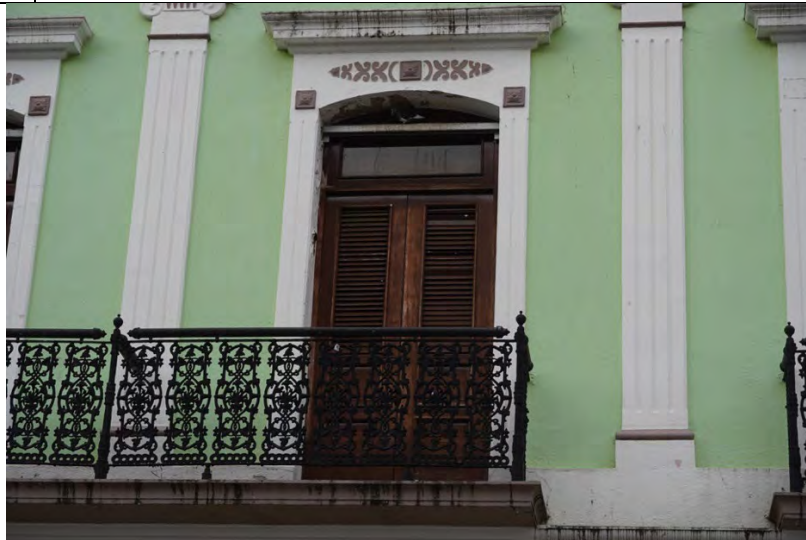
Photo #: 24	Description (include direction):
Date: 02/19/23	Façade detail of Maestre Pharmacy,

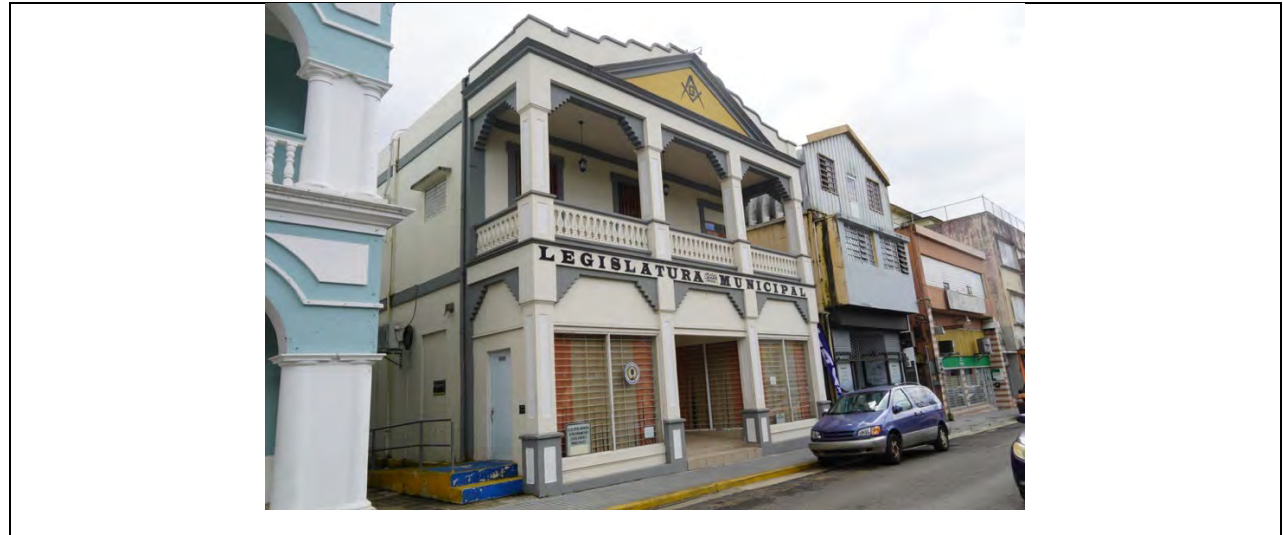
Photo #: 25	Description (include direction):
Date: 02/19/23	Looking out south from Public Square, Masonic Lodge of Utuado is facing north. The Loggia was built circa 1920, it's an eligible historical property under criterion A, and it's 10 feet away from APE.

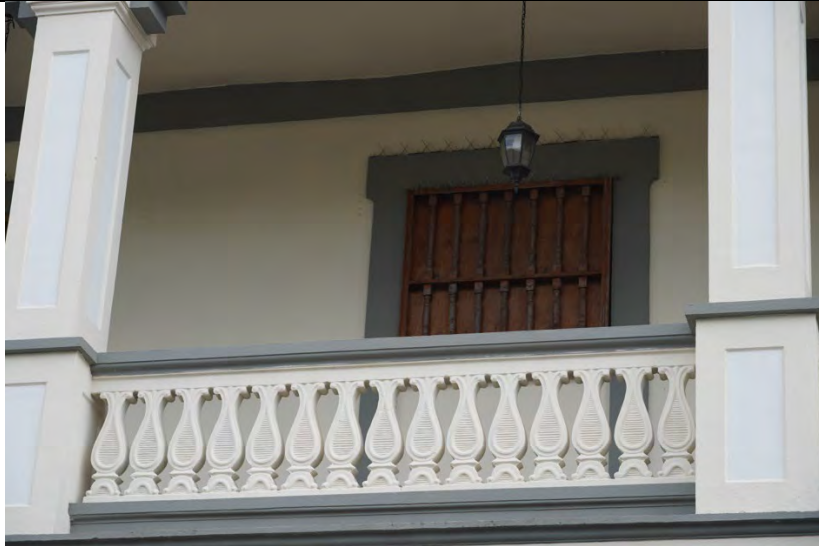
Photo #: 27	Description (include direction):
Date: 02/19/23	Main Façade, Masonic Lodge of Utuado, Upper-level concrete baluster railing detail.

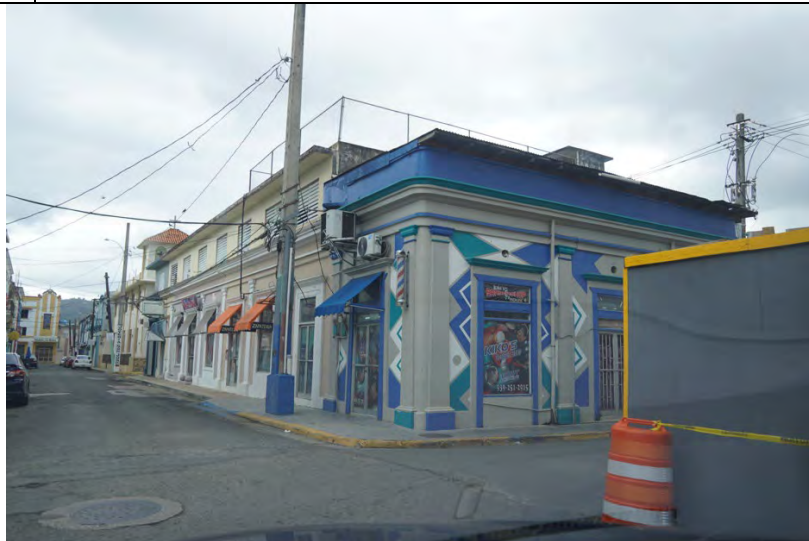
Photo #: 28	Description (include direction):
Date: 02/19/23	Looking out west from Public Square, Residence of Don Damián Torres - built circa 1899, it's an eligible historical property under criterion A, and it's 377 feet away from APE.

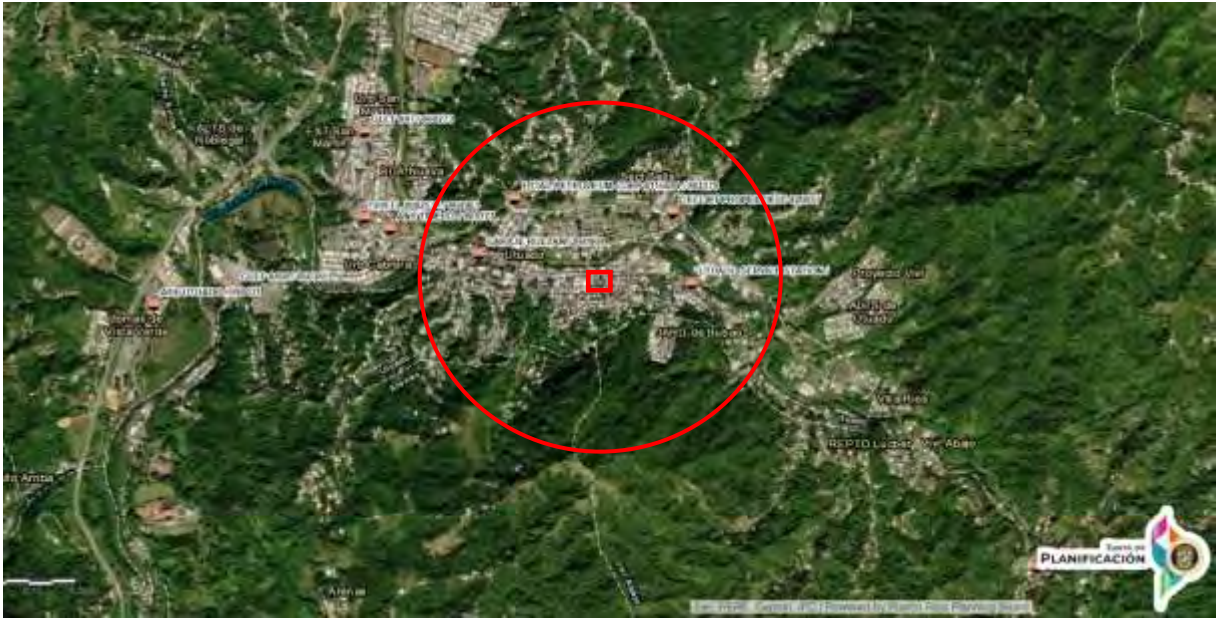
Revitalization of the Public Plaza of the City between Mountains
PR-CRP-000640
Municipality of Utuado
Antonio R. Barceló Street, Utuado, Puerto Rico 00641
18.26537, -66.69995°

○ UST 0.5 mi Radius (approx.) □ Site

Therefore, the project is in compliance with the Contamination and Toxic Substances requirements, 24 CFR Part 50.3(i) & 58.5(i)(2). Refer to Figure 7 in Appendix B, and report in Appendix C.

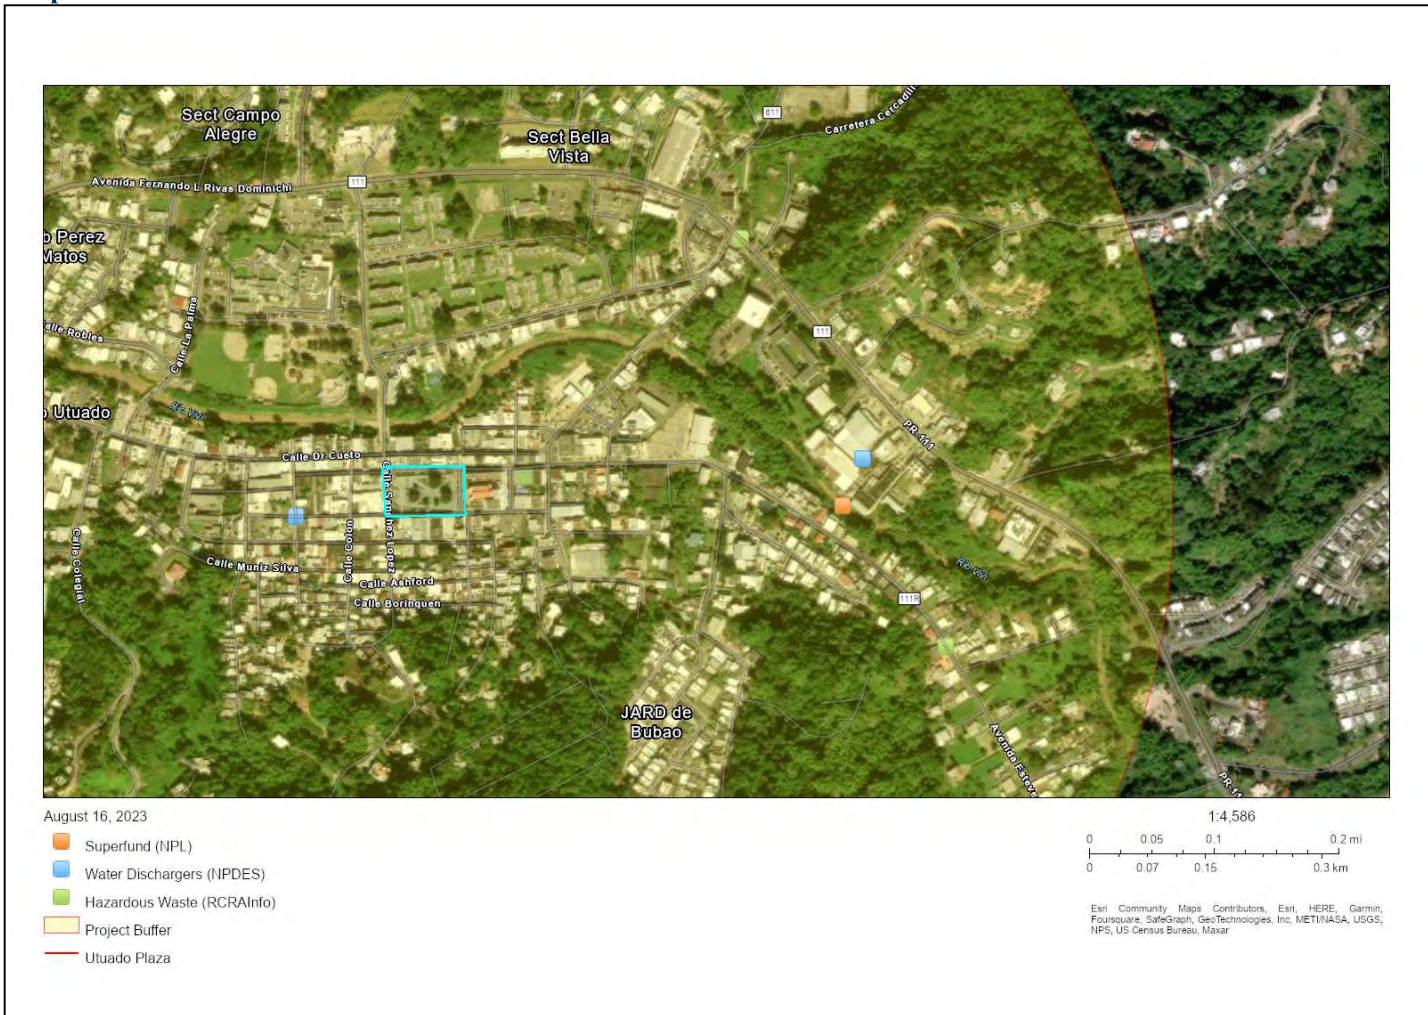
Map

**Supporting Documents for Exhibit 6a
NEPAssist Identified
Facilities within 3,000 ft**

Geographic coordinates:

LINE
 (18.265648,-66.700500,18.265648,-66.699539,18.265134,-66.699530,18.265085,-66.699513,18.265069,-66.700500,18.265640,-66.700543,18.265623,-66.700440)
 with buffer 3000 feet
