Hurricane Maria Effects on Puerto Rico Electric Power Infrastructure

ABSTRACT This paper discusses the effects of Hurricane Maria on Puerto Rico's electric grid. Arguably, the most significant effect of Hurricane Maria on Puerto Rico was the electric power outage that initially affected the entire island and lasted more than ten months. Although the damage to the conventional electric power generation infrastructure was relatively minor, both the transmission and distribution portions of the grid suffered much worse damage than that observed during other hurricanes that affected the U.S. in the past decade. This extensive damage added to logistical limitations and the island orography were important factors that contributed to an extremely slow restoration process leading to a very low resilience for the island's power grid. This paper describes all these aspects in detail and supports the explanation of the hurricane effects with photographic evidence collected during a damage assessment conducted in the early December 2017 when about half of the electricity customers were still without service. This paper concludes by exploring some lessons from these observations including pote

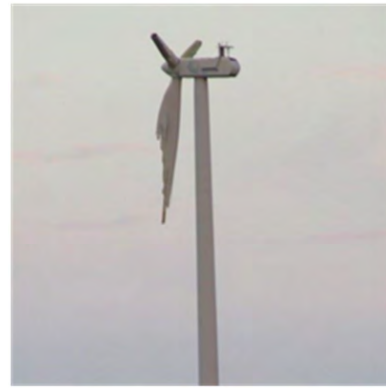
FIGURE 2. A damaged wind turbine with two of its blades broken at their neck and the third blade delaminated. (Photo: A. Kwasinski).

Renewable energy sources are also part of the generation mix in Puerto Rico. The effect of Hurricane Maria on these power generation systems are discussed in detail in [8]. At the time Hurricane Maria affected Puerto Rico there were two main wind farms operating in the island. With an installed capacity of 95 MW, Santa Isabel is the largest of the two wind farms. This wind farm had no damage from Hurricane Maria. However, the second wind farm in Punta Lima, had all of its 13 wind turbines damaged. Two failure modes could be observed in these wind turbines. As Fig. 2 shows some blades of the wind turbines experienced delamination, and other blades broke at their neck. The surviving blades configuration suggest that the wind turbines were feathered, and their rotors were blocked from rotating. However, due to the wind farm geographic location in the northeastern quadrant of the hurricane, the 1.8 MW wind turbines in this farm experienced the strongest winds generated by the storm with maximum sustained winds of no less than 125 mph. The wind farm in Santa Isabel experienced instead more moderate winds, which helped its wind turbine survive the storm.

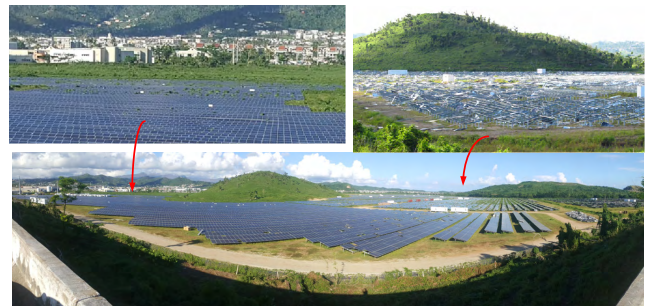
FIGURE 3. The PV "farm" at Humacao. The bottom image, facing north, shows a general view of this facility. A hill at the center of this image may have protected the central area of this facility. A detail on the top and right of this general view shows the nearly completed expanded area from the eastern side, facing west, towards the central hill. The detail on the top left shows damage west of the hill as seen looking from the south of the facility. (Photo: A. Kwasinski).

fashion at the premises of 8,500 PREPA's customers [9]. The five utility-scale PV plants experienced different damage during Hurricane Maria. While the PV plant in Loíza was practically undamaged, the PV plant in Humacao experienced significant damage, as Fig. 3 shows. The other utility-scale PV plants in Isabela, Salinas and Guayama experienced light to moderate damage, although none of them were as severely damaged as the PV plant in Humacao, which is located near Hurricane Maria landfall point. At that time, about a third of this PV system was been expanded to make the total plant capacity reach almost 100 MW, which would had make it the largest PV power generation facility in the island. However, the expanded area was almost completed destroyed by the storm. Although the other two areas (operating before Maria) had much less damage, about 50% of such area still suffered considerable damage. As Fig. 3 suggests, a hill located north of the central area of this PV facility may have protected the less damaged areas from the prevalent north-south hurricane winds. The failure mode in all of these PV plants was PV modules blown away by the wind. A detail description of

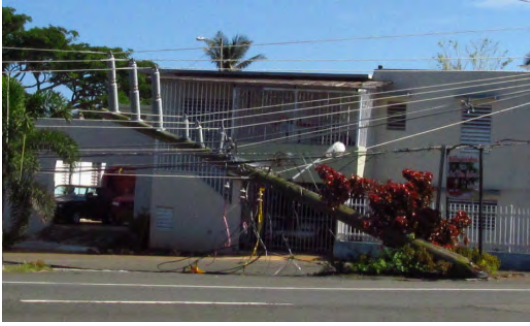
FIGURE 4. A fallen transmission wooden pole. (Photo: A. Kwasinski).

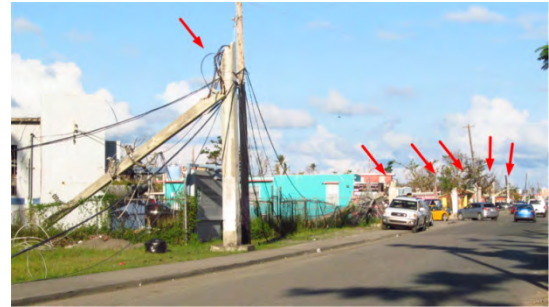
FIGURE 5. Multiple broken concrete poles in Punta Santiago. (Photo: A. Kwasinski).

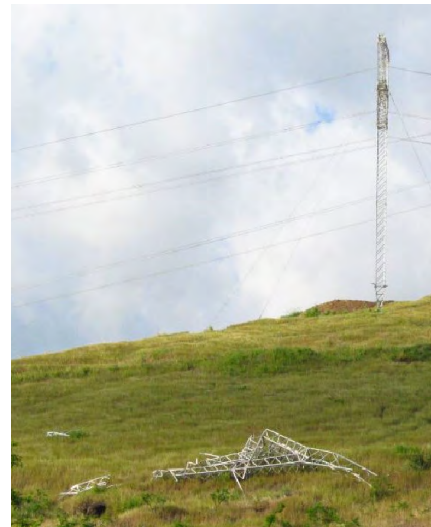
FIGURE 6. One of the many fallen transmission towers in Puerto Rico. (Photo: A. Kwasinski).

Transmission lines in Puerto Rico presented important vulnerabilities. In addition of having many structures installed in difficult to access mountainous locations with thick vegetation, reports indicated that only 15 % of the lines could withstand wind forces caused by a Category 4 hurricane [11]. As a result, almost all transmission lines in the eastern half of the island experienced severe damage. Although preliminary reports suggested that 55% of the transmission towers fell [12] later reports indicated that 847 transmission structures had fallen due to Maria [13], which is consistent with the observations made during a damage assessment in early December of 2017. In comparison, hurricanes Gustav and Ike caused the failure of Entergy's 260 structures and 980 structures, respectively, over a much larger area than that occupied by Puerto Rico. Many monopole structures, including wooden and concrete poles (see Fig. 5) broke due to the effects of strong winds and flying debris or fallen vegetation. Arguably, the most critical failures were those observed in 230 kV structures, such as the one in Fig. 6. A detailed view in Fig. 7 shows fractured braces in this lattice tower. Failures in the 230 kV structures were exacerbated by the vulnerable PREPA's grid layout shown in Fig. 1 with a significant portion of the generation assets located south of the island and the largest demand center located across the mountainous inland region on the northern coast of the island.

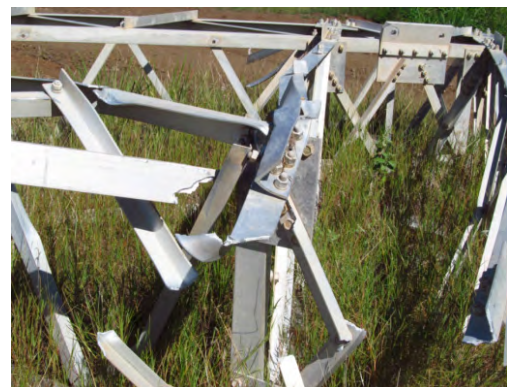
FIGURE 7. Detail of damage in a transmission tower with fractured braces. (Photo: A. Kwasinski).

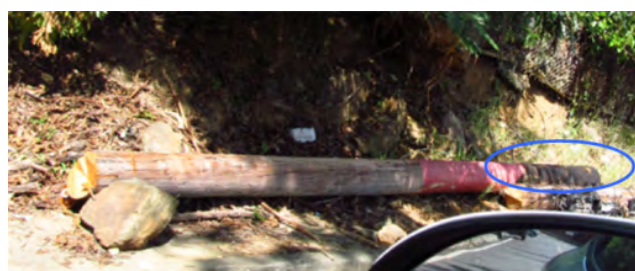
FIGURE 9. A 30 ft long fallen pole with an oval showing its buried portion. This buried portion measured approximately 3.7 ft., which is less than the 5 ft. 6 in. used in a utility in Florida [22]. (Photo: A. Kwasinski).

and through the natural increase of wind speed at higher elevations. Additional contributing factors for pole failures included overloaded poles and poles installed at a time with less demanding wind speed withstanding requirements.

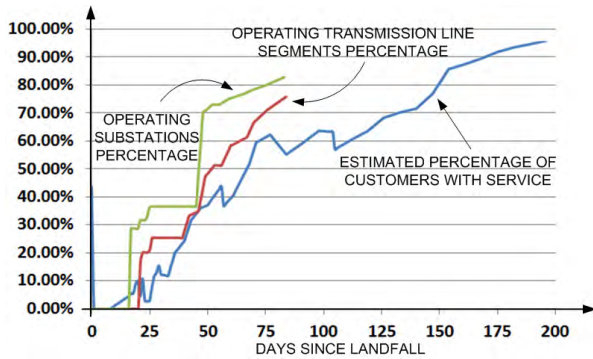
FIGURE 10. Electric system restoration process progression, adapted from [24].

Figure 10 shows the restoration process of the transmission lines, substations and approximate service restoration percentage with respect to the estimated percentage of customers with electricity based on data from [18]. The fact that these curves are not monotonically increasing or decreasing is explained in most cases by seasonal variations in power demand and lines that failed after they were brought back to service. Such occurrence is usually caused by weakened vegetation from the hurricane that eventually fall on the line or by human errors. Another cause for loss of load in Puerto Rico during the restoration process was operating failures in PREPA's main power plants, such as in Cambalache, San Juan and Palo Seco. In Fig. 10, the island is considered as a whole in order to be able to compare its values with those in [18] and [20]. In these works, past hurricane outage statistics are

Figure 10 can be used to calculate Puerto Rico’s electric power system resilience based on metrics presented in [20]. Since the outage data provided in [19] until January 3rd, 2018 was not indicated with respect to the total number of customers but, instead, it was calculated with respect to the peak load, the percentage of customers without service in Fig. 10 had to be estimated from the percentage of peak load information. Typically, the fewer, larger and more critical loads are restored before the far more numerous smaller and less critical residential loads. Hence, outage data specified with respect to the peak load is usually less than that indicated with respect to the total number of customers. This is also demonstrated by these data set. On January 3rd, 2018 when outage data was first indicated both with respect to peak load and total number of customers, the former was 12.40 percentage points higher than the latter. In order to take a conservative estimation, half of this difference is considered for estimating the outage data from the time Hurricane Maria made landfall to the end of 2017. Additionally, although for the first few weeks outage data were published on a daily basis, during the last months reports were issued every few days up to a week. Thus, missing data was estimated with a linear interpolation considering the data points in [19].

To place Puerto Rico’s grid resilience metric into context, power outage data shown in Fig. 10 is compared to those from hurricanes that affected the continental U.S. from 2004 to 2011 based on the local intensity indexes in [18]. During Maria, Puerto Rico was under at least tropical storm winds for 24 hours. Weather data also suggests that an average of 120 mph winds is a conservative estimate of the average highest sustained winds observed in the island. Additionally, the area variable A in [18] is considered here equal to 1 because all of the island sustained at least tropical storm winds. Likewise, H in [18] is taken equal to 1 due to storm surge and flooding information for the island. Based on these values, the calculations indicated in [18] yield a local tropical cyclone intensity index (LTCII) for maximum outage incidence, $LTCII_{MOI}$, of 2,520.45 and an LTCII for 95% restoration time, $LTCII_{T_{95}}$, of 37.82. With these values, the expected maximum outage incidence is of 99.5 % (matching actual performance) and the expected time required to restore service to 95% of the customers is approximately 20.5 days. The average deviation of this dataset with respect to the regression curve of the 95% restoration time vs. $LTCII_{T_{95}}$ is of 1.8 days although it is possible to observe that almost all of the points do not deviate by more than 10 days from the 95% restoration time regression curve. Such deviations are normal because, as explained in [18] restoration times are significantly influenced by human decisions and processes. Hence, an alternative approach is to consider T_e in (1) equal to the expected 95 % restoration time from [18]. Hence, when T_e is taken equal to 20.5 days, Puerto Rico’s Hurricane Maria grid resilience equals 0.045. Such extremely low value is expected because it took 192 days to restore service to 95% of PREPA’s customers, whereas in none of the previous hurricanes that affected the continental U.S. power outages extended for more than a few weeks (e.g., about two months in some flooded areas in New Orleans due to the time it took for the flooded waters to recede or be pumped away after Hurricane Katrina).

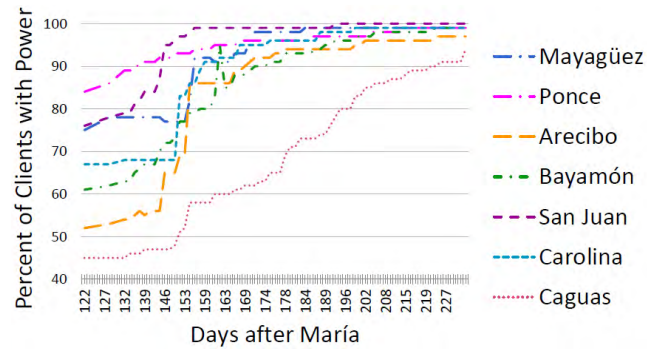
FIGURE 11. Final electric system restoration process by region [24].
