Environmental Assessment Determinations and Compliance Findings for HUD-assisted Projects 24 CFR Part 58

Project Name: PR- CRP-000892 Lajas Recreational Sports Complex

Responsible Entity: Puerto Rico Department of Housing

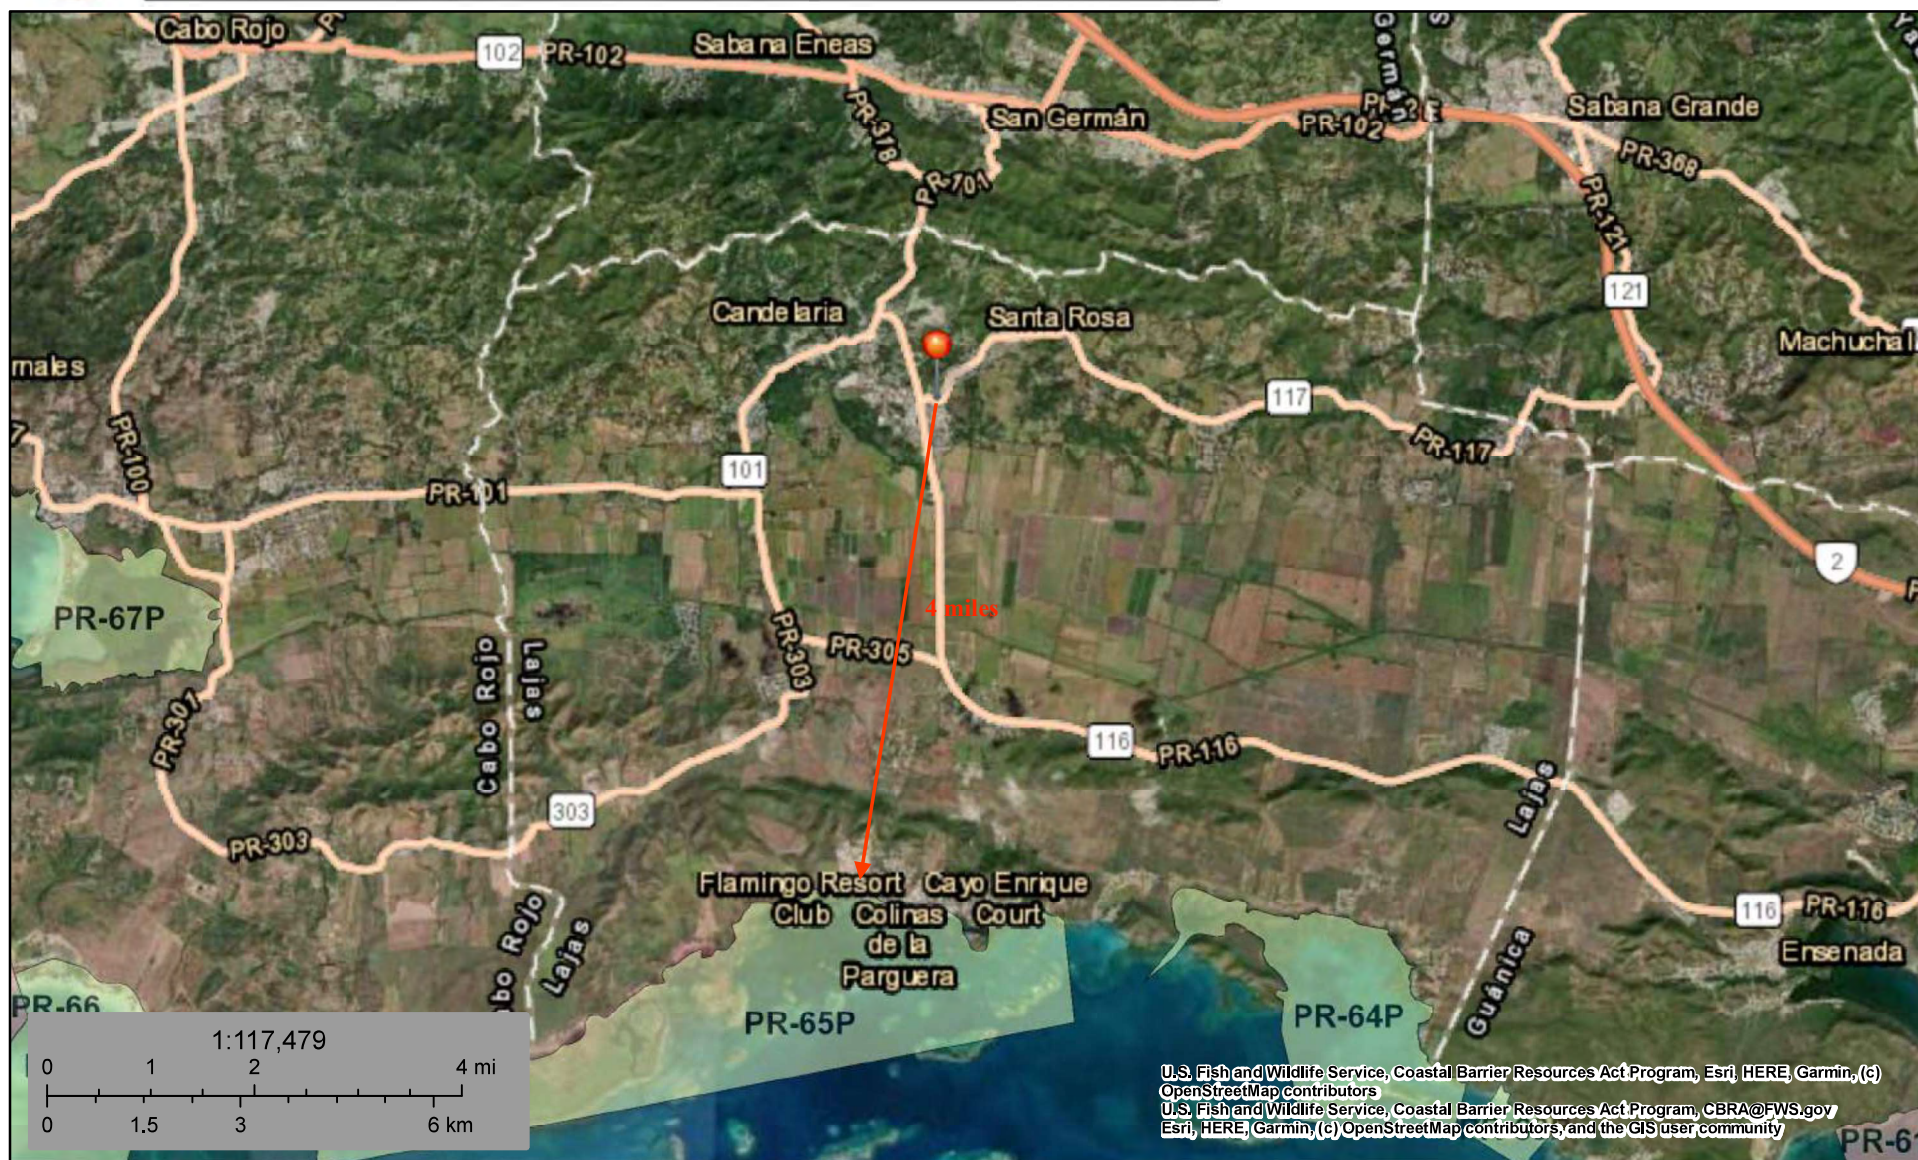
Figure 4- Coastal Barrier Map
PR-CRP-000892
Lajas Recreational Sport Complex
Carr. 117 Km. 0.2, Bo. Santa Rosa
Lajas, PR 00667
18.042252; -67.050132

Improvement Act of 1990 [16 USC 3501]		no potential to impact a CBRS Unit and is in compliance with the Coastal Barrier Resources Act. Refer to worksheet in Attachment A and Figure 4 in Attachment B.
Flood Insurance Flood Disaster Protection Act of 1973 and National Flood Insurance Reform Act of 1994 [42 USC 4001-4128 and 42 USC 5154a]	Yes No <input type="checkbox"/> <input checked="" type="checkbox"/>	The proposed project site is within FEMA designated as Zone X (Area of no or minimal flood hazard). Reference: Flood Insurance Rate Map Panel No. 72000C1570H Effective Date: April 19, 2005, FEMA Flood Map Service Center - https://msc.fema.gov/portal/home The project is in compliance with the Flood Disaster Protection Act of 1973 and National Flood Insurance Reform Act of 1994 [42 USC 4001-4128 and 42 USC 5154a]. Refer to worksheet in Attachment A, Figure 10a in Attachment B
Clean Air Clean Air Act, as amended, particularly section 176(c) & (d); 40 CFR Parts 6, 51, 93	Yes No <input type="checkbox"/> <input checked="" type="checkbox"/>	The project's municipality or air quality management district is in attainment status for all criteria pollutants. Project does not include new construction or conversion of land use facilitating the development of public, commercial, or industrial facilities or five or more dwelling units. Municipalities in nonattainment or maintenance areas include Arecibo, Bayamón, Cataño, Guaynabo, Salinas, San Juan, and Toa Baja. This project is in compliance with the Clean Air Act, as amended, particularly section 176(c) & (d); 40 CFR Parts 6, 51, 93. Refer to worksheet in Attachment A and Figure 5 in Attachment B.

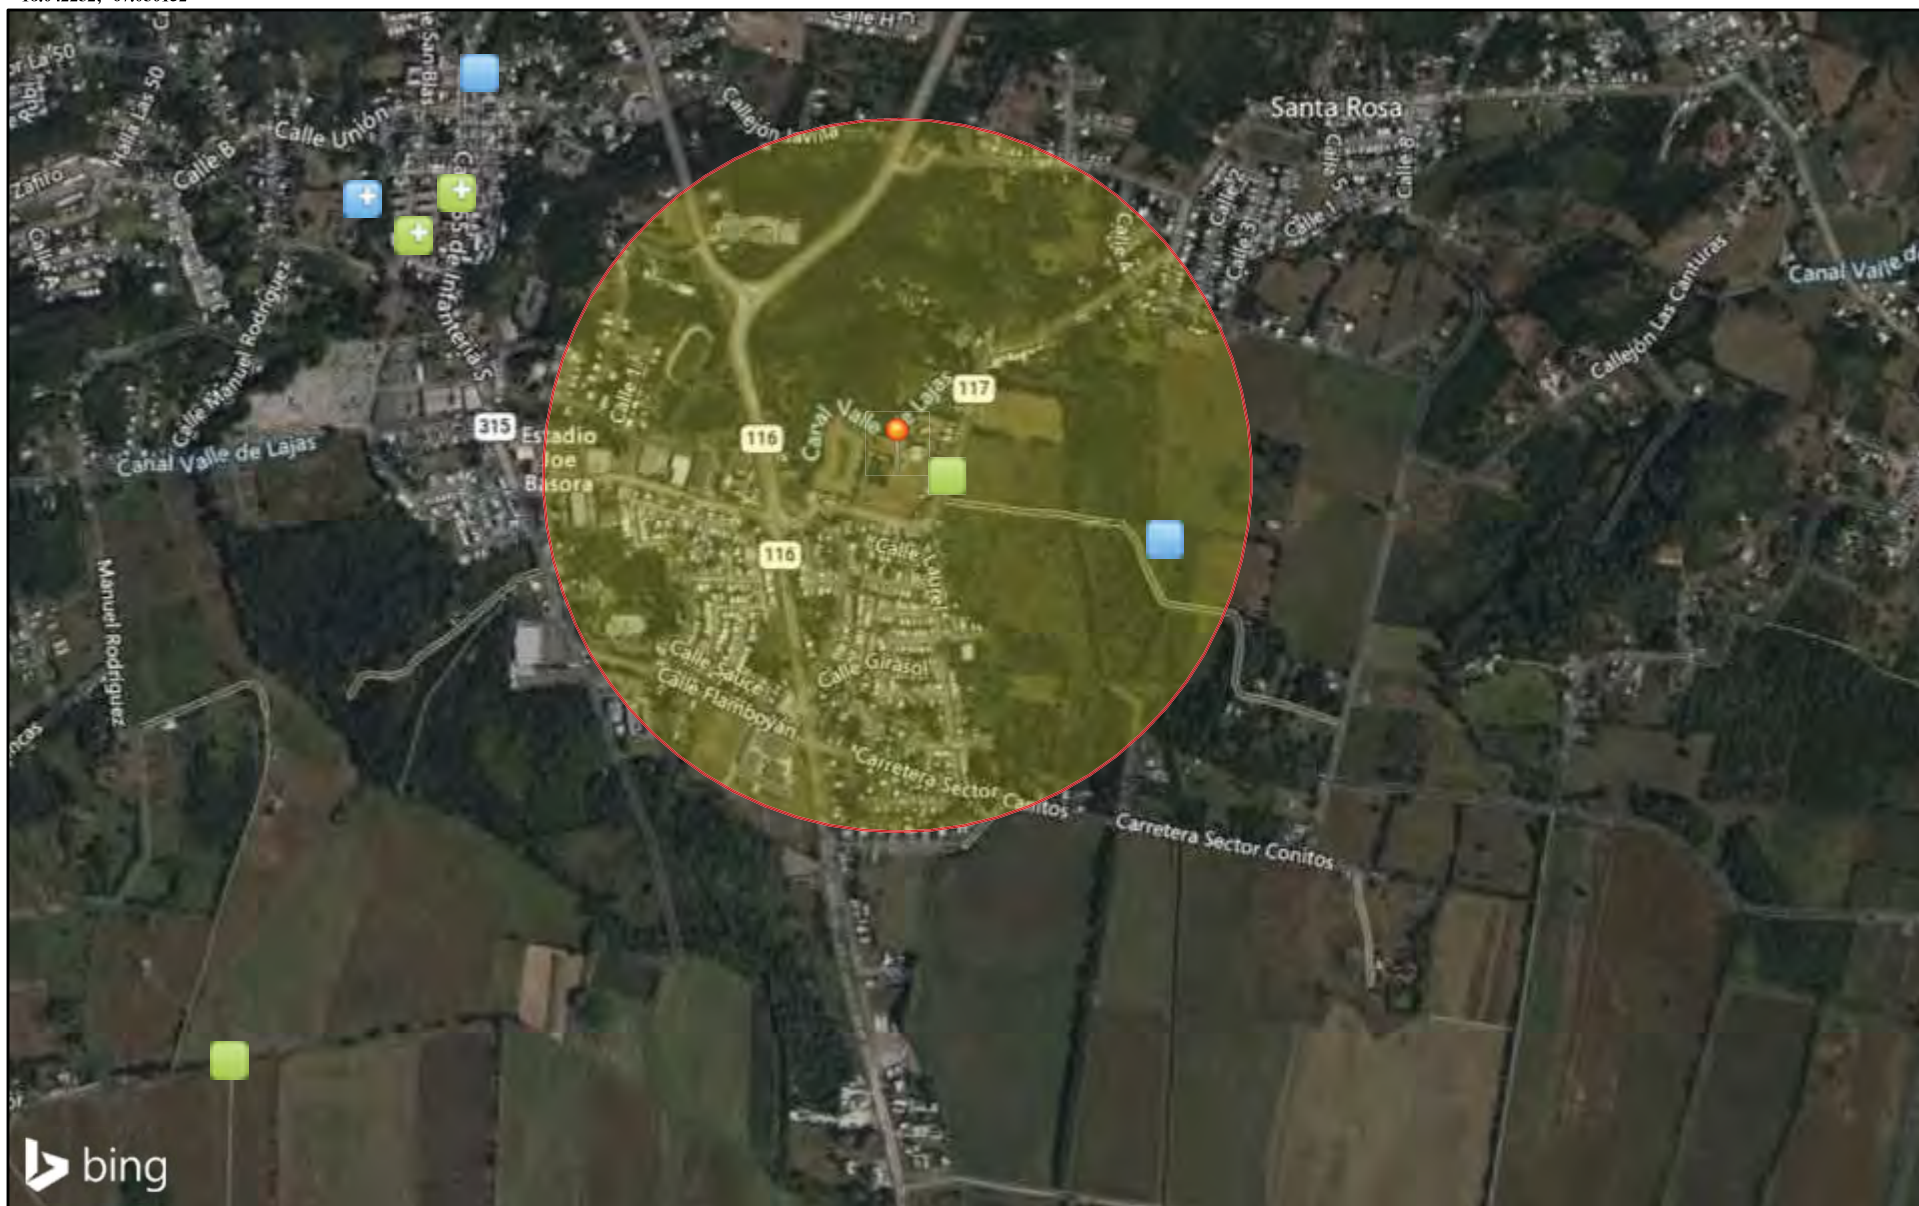
Figure 7- Toxic Substances Map
 PR-CRP-000892
 Lajas Recreational Sport Complex
 Carr. 117 Km. 0.2, Bo. Santa Rosa
 Lajas, PR 00667
 18.042252; -67.050132

<p>3,000 feet of the project site, one (1) RCRA site was identified, PRASA Reparto del Valle STP at 165 ft distance from project. This site has no reported or any EPA formal or informal action reported for the last five years.</p> <p>PRASA WTP Lajas Filter Plant was identified for a wastewater NPDES permit at 1,960 ft distance. This site did not report or any EPA formal or informal action for the past five years, except a discharge violation reported on the second quarter of year 2024. ECHO Facility Reports are included in Attachment C.</p> <p>The Phase I Environmental Site Assessment conducted revealed that no recognized environmental conditions (RECs) were identified in connection with the subject site. See report in Attachment E.</p> <p>The project will not involve residents or increase in occupancy of any structure. There would be no increase in risk associated with the proposed project. Therefore, the project is in compliance with the Contamination and Toxic Substances requirements, 24 CFR Part 50.3(i) & 58.5(i)(2).</p> <p>Refer to worksheet in Attachment A, Figure 7 in Attachment B, NEPA Assist Reports in Attachment C and Phase I ESA in Attachment E.</p>

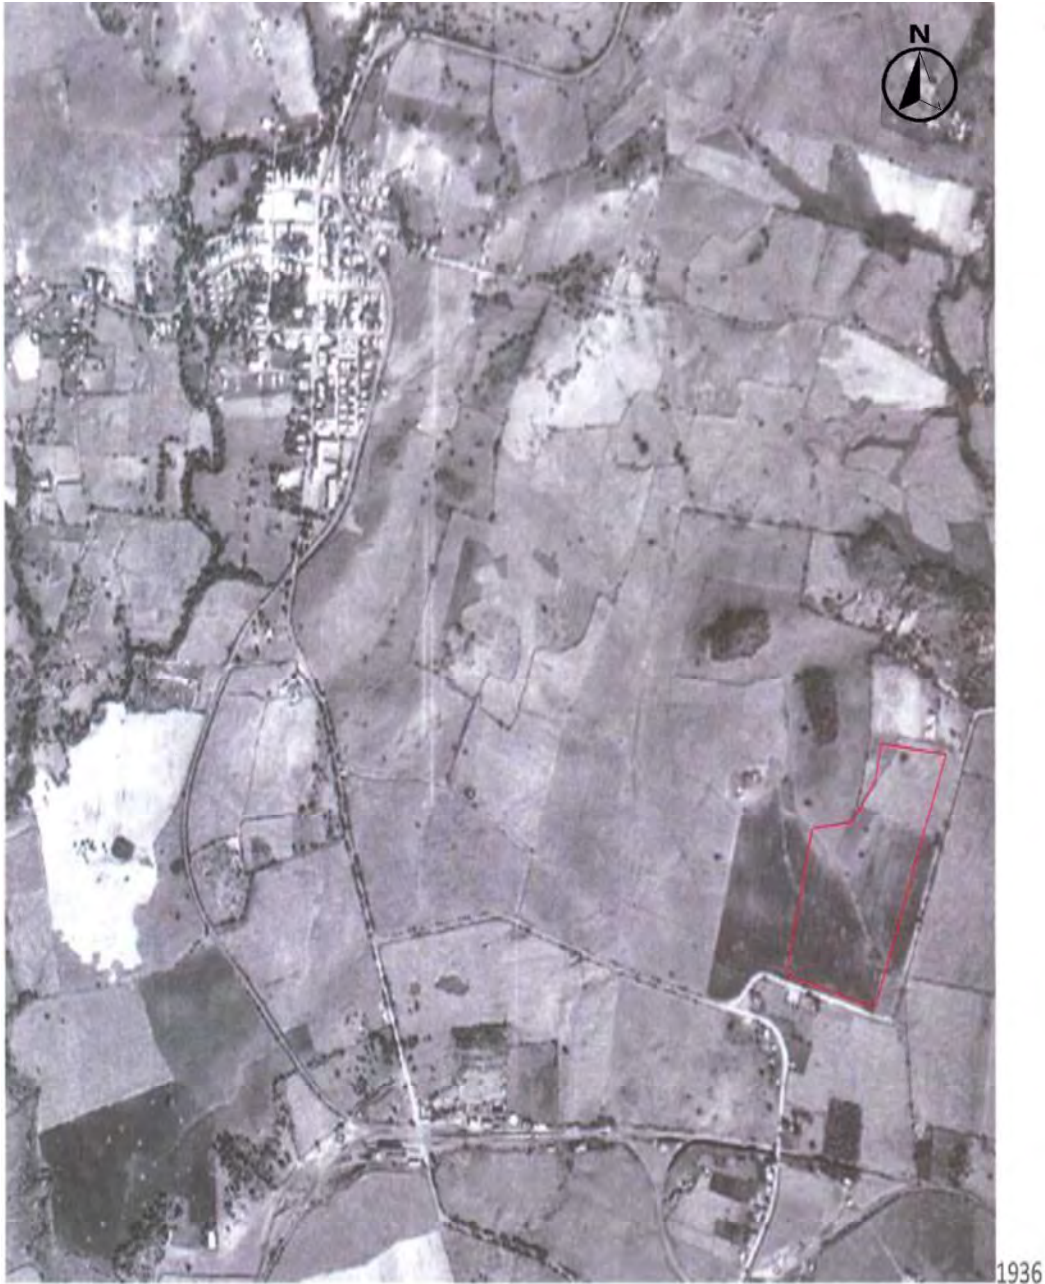
Figura 23: Fecha de Vuelo: Feb./ 13/ 1936; Autoridad de Carreteras y Transportación – Oficina de Fotogrametría - Minillas, San Juan (Escala – ampliada) Foto Área 1936 – Escala: 1:18,000 núm. Rollo K-6, núm. Foto 530

Se observa en la Figura 23 un camino de tierra de acceso desde la hoy Carr. PR – 117 al Este y cruzando hacia N-O va la llamada “Casa de Habitación” en la Estancia de Juan Cancio Ortiz luego de la Fa. Nazario. Posiblemente luego en 1957, sobre el Canal de Riego se construyó el “Puente” que aún existe (hoy día detrás o al Norte de la Capilla en la Academia San Luis, ver figura 24) y servía de acceso a la “Casa Habitación”. El mismo se encuentra dentro del APE pero no dentro de la propiedad investigada. Se observa al N-E del terreno la siembra de Caña. Al Este no se observa la Grúa/Cañera.

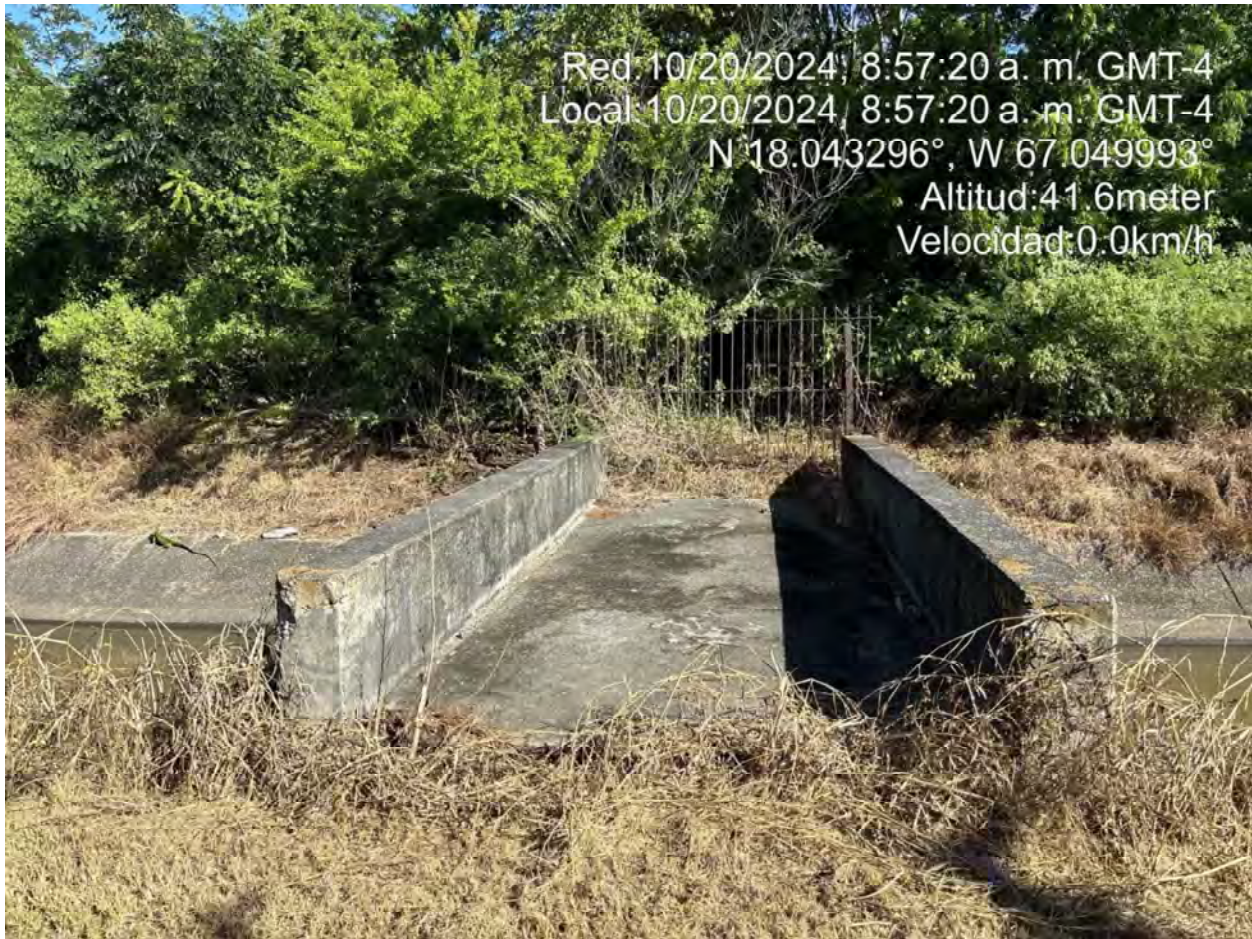
Figura 24: Puente sobre el Canal de Riego (ca. 1957), al Norte de la Capilla que servía de acceso peatonal y vehicular entre las Fincas de la Fa. Nazario Mendoza.

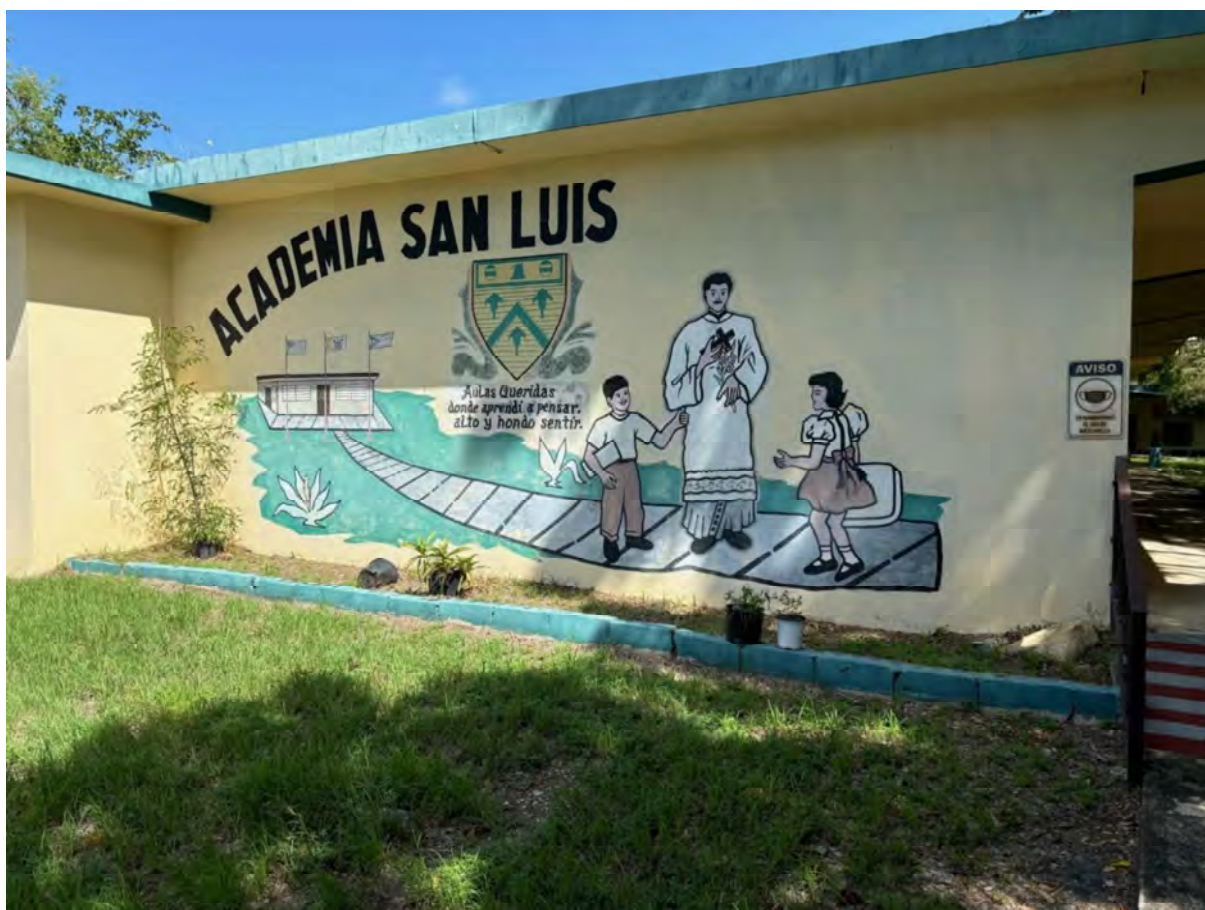
Figura 36: Fachada principal del Edificio en “L”, (1ra sección) de Sur a Norte, pre-fabricado colocado en 1987.

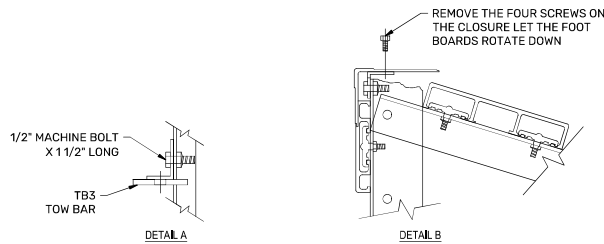
3 ALUMINUM TRANSPORTABLE BENCH DETAILS
SCALE: N/A

BLEACHER TOW UNITS AREA NOT FOR HIGHWAY USE. THEY ARE ONLY TO BE MOVED ON LEVEL SURFACES AT A MAXIMUM OF 5 MILES PER HOUR. E&D SPECIALTY STANDS INC. IS NOT RESPONSIBLE FOR ANY DAMAGE TO THE BLEACHER OR OTHER PROPERTY THAT MAY OCCUR FROM THE MOVING OF THE BLEACHER. IT IS THE RESPONSIBILITY OF THE OWNER TO INSPECT BEFORE OPENING IT TO THE PUBLIC. TOW BAR AND WHEELS TO BE REMOVED BEFORE USE.

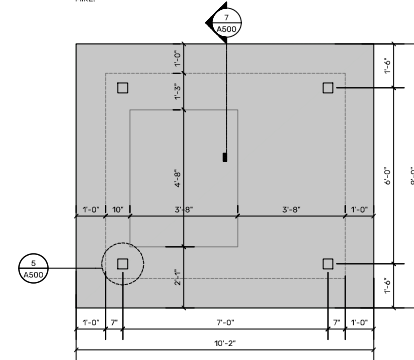
4 PITCHING MACHINE FLOOR PLAN
SCALE: 3/16" = 1'-0"

1. PROPOSED EQUIPMENTS SHALL BE INSTALLED FOLLOWING MANUFACTURER RECOMMENDATION.
2. IRON MIKE (S) ITEMS ARE SPECIFIED FOR QUALITY FUNCTIONING REQUIREMENTS AND MATERIAL SUBMITTED FOR APPROVAL. THE APPROVED EQUAL MUST BE DETERMINED BY A/E. CONTRACTOR MUST SUBMIT SPECIFICATIONS OF SUBSTITUTE EQUIPMENT FOR APPROVAL OF THE A/E.
3. EQUAL OR SIMILAR

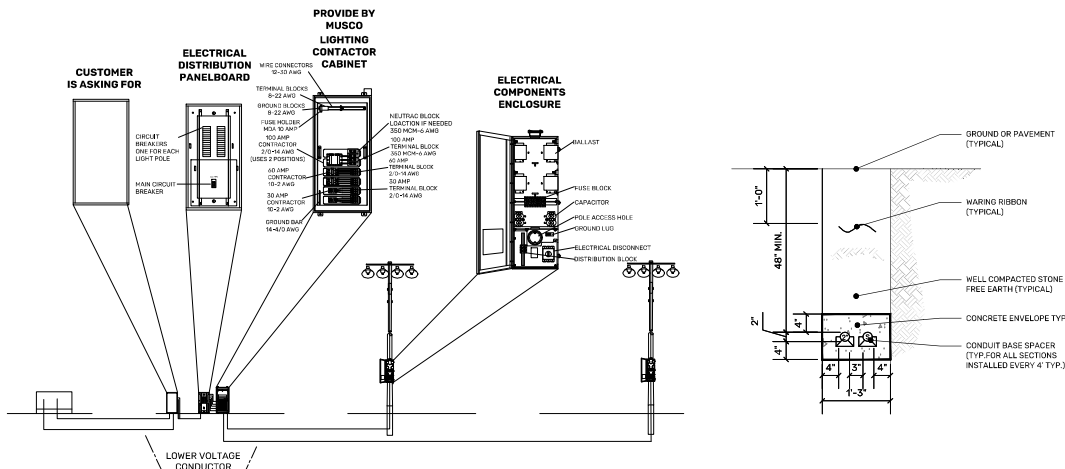
2 GENERAL ELECTRICAL DETAIL
SCALE: N.T.S

16. ALL LIGHTING FIXTURE SHALL BE WIRED AS PER ARTICLE 410 OF N.E.C..
17. THE PANEL BOARD SHALL BE PROVIDED WITH A FACTORY INSTALLED GROUND BUS FOR CONNECTING GROUND THE GREEN WIRE IN ALL P.V.C. CONDUITS.

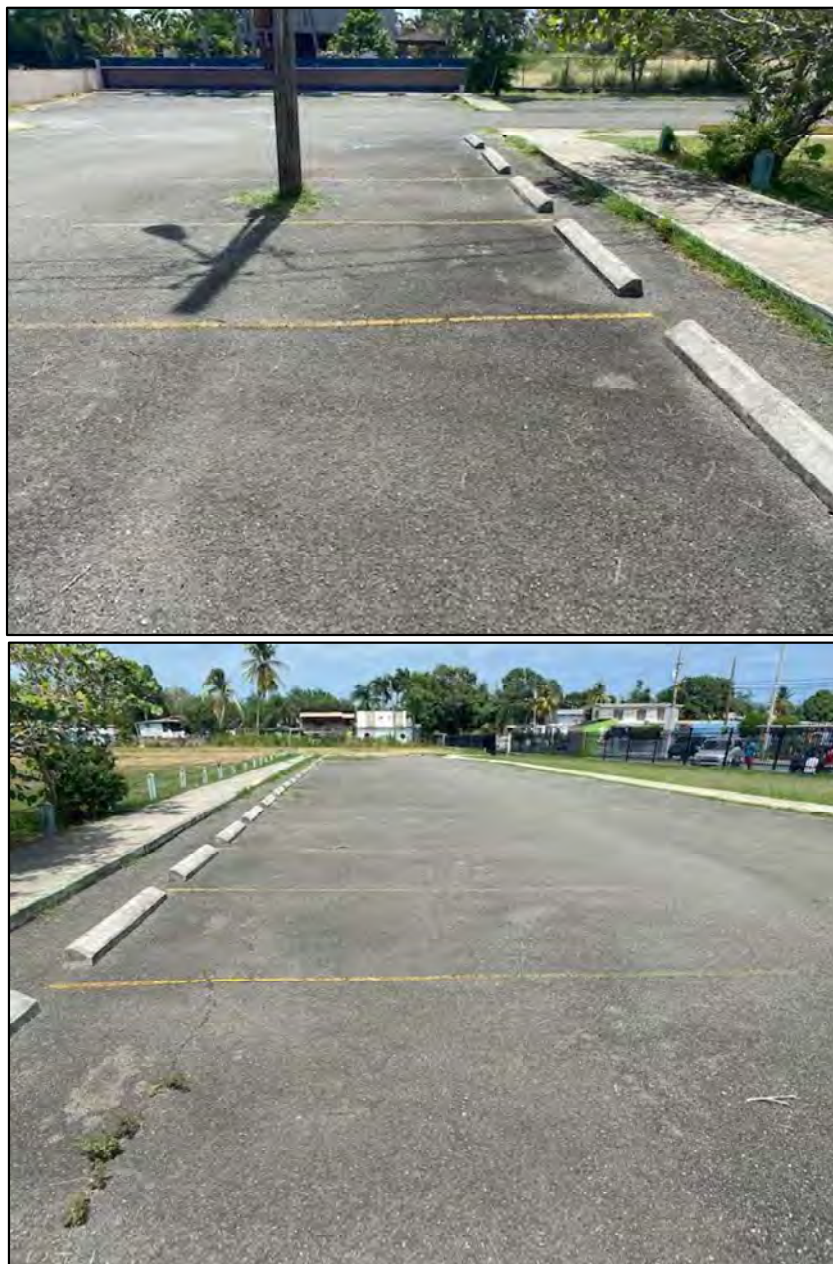
Positive LBP, Yellow traffic lines.

- Environmental Site Assessment (ESA) Phase I Study - Former San Luis Academy (September 2023) See Attachment E.
- Lead Based Paint (LBP) Survey Report - Lajas Sport Center/Academia San Luis (June 2023)
The LBP inspection found positive components with Lead Based Paint (LBP) only at yellow parking lines. See Attachment G.
- Asbestos Containing Materials (ACM) Survey Report - Lajas Sport Center/Academia San Luis (June 2023)

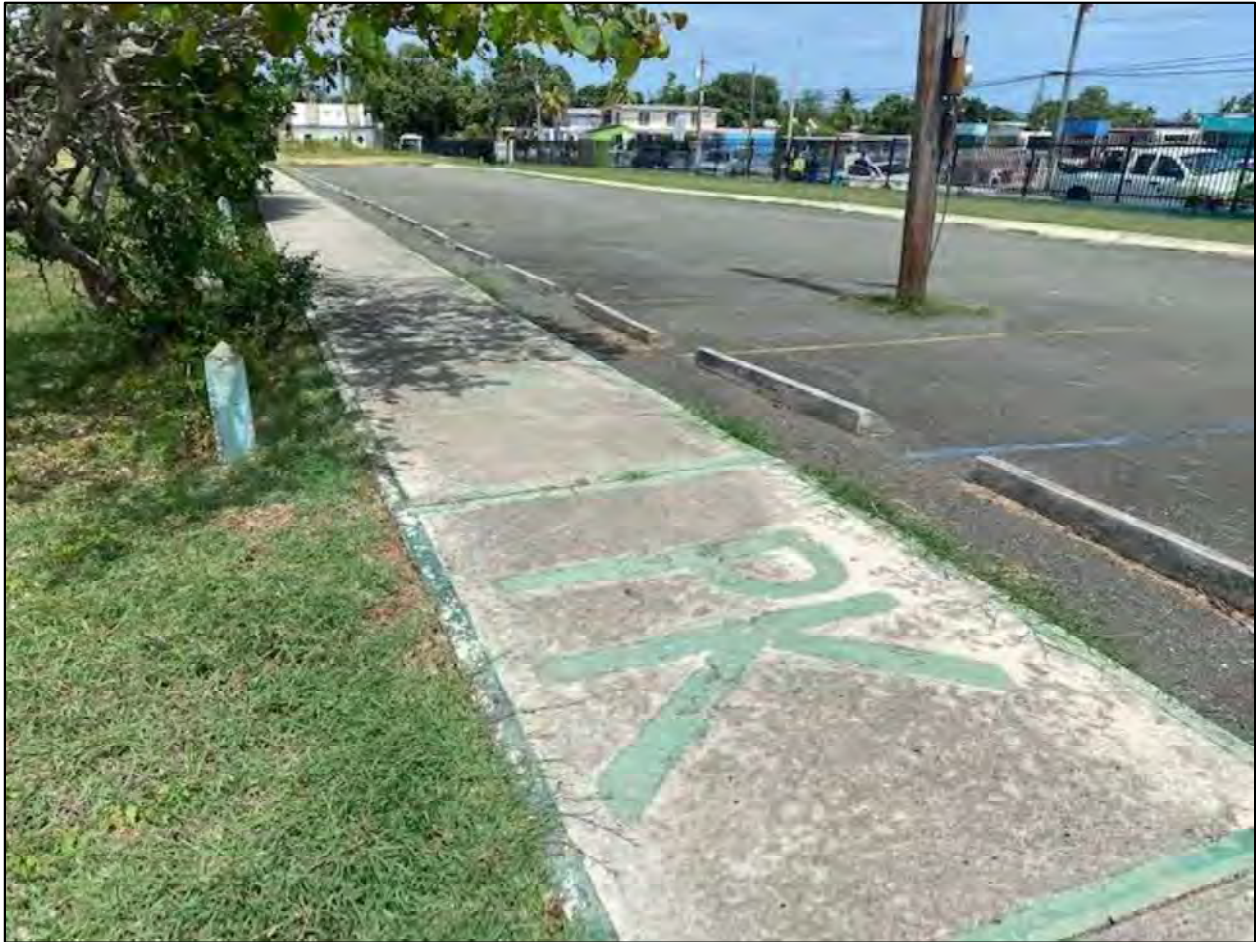
Positive LBP, Yellow traffic lines.
