Environmental Assessment

Determinations and Compliance Findings for HUD-assisted Projects

Project Name: Lote B, Guayama - Monserrate Apartments

Project ID: PR-SIH-00029B #02

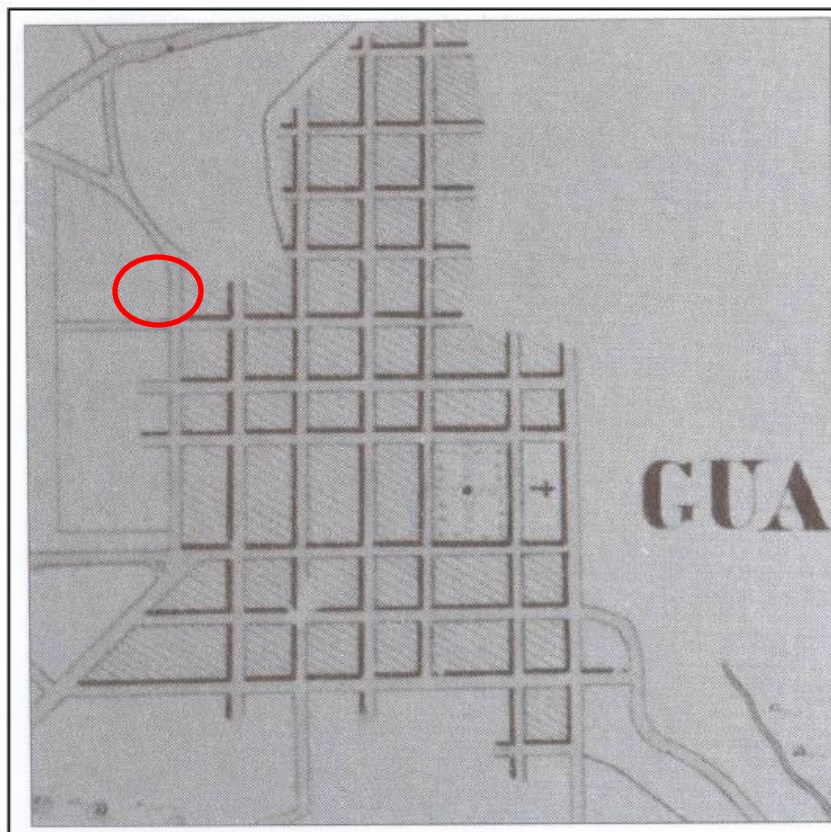
Figure 1: Casco Urbano de Guayama, ca. 1853 (Sepúlveda 2005, vol 2: 25)

The project area is located in the northwestern section of the traditional urban center of Guayama, about 0.18 mi northwest of its town square. A 19th century map of the urban center suggests that this area was already part of the town's grid by 1853 (Figure 1). By 1884, the block where the project is located was developing, as shown in Figure 2.

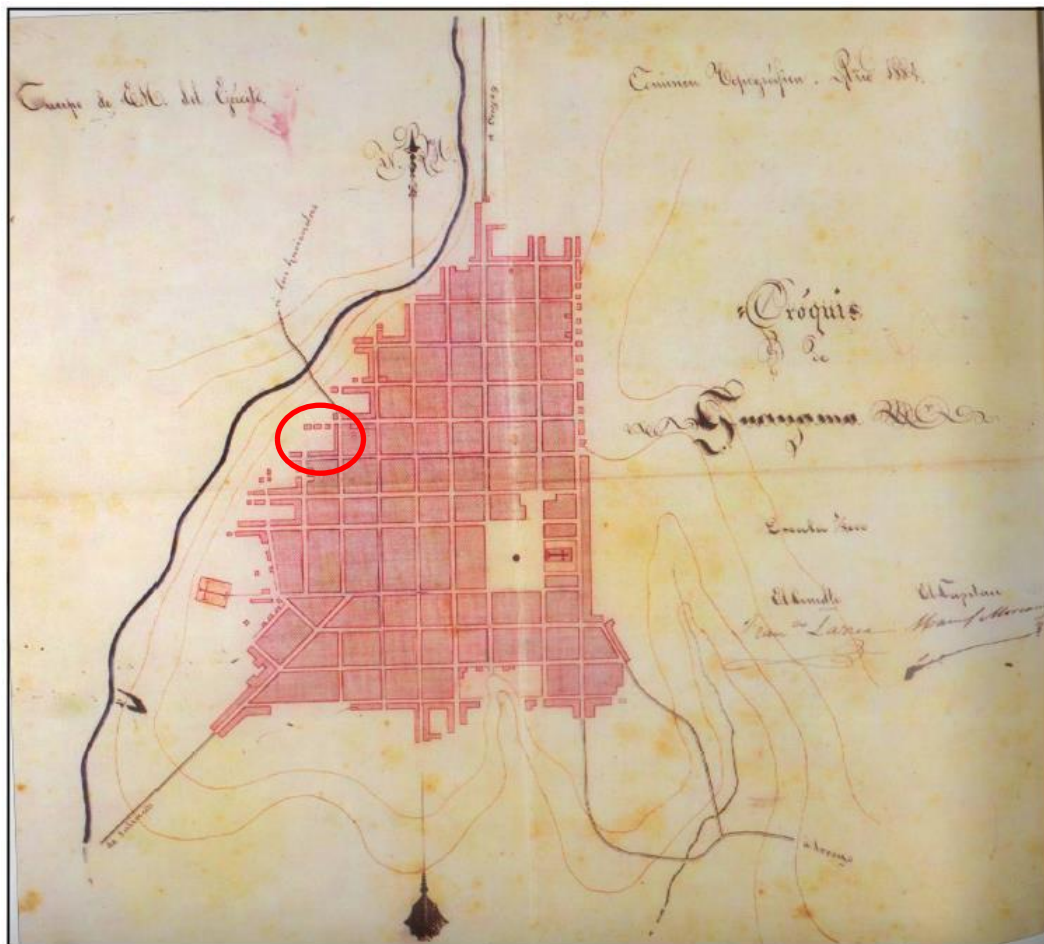
Figure 2: Casco Urbano de Guayama en 1884, Francisco Larea y Liso y Manual Mariano y Vivó (Sepúlveda 2005, vo 3: 182)

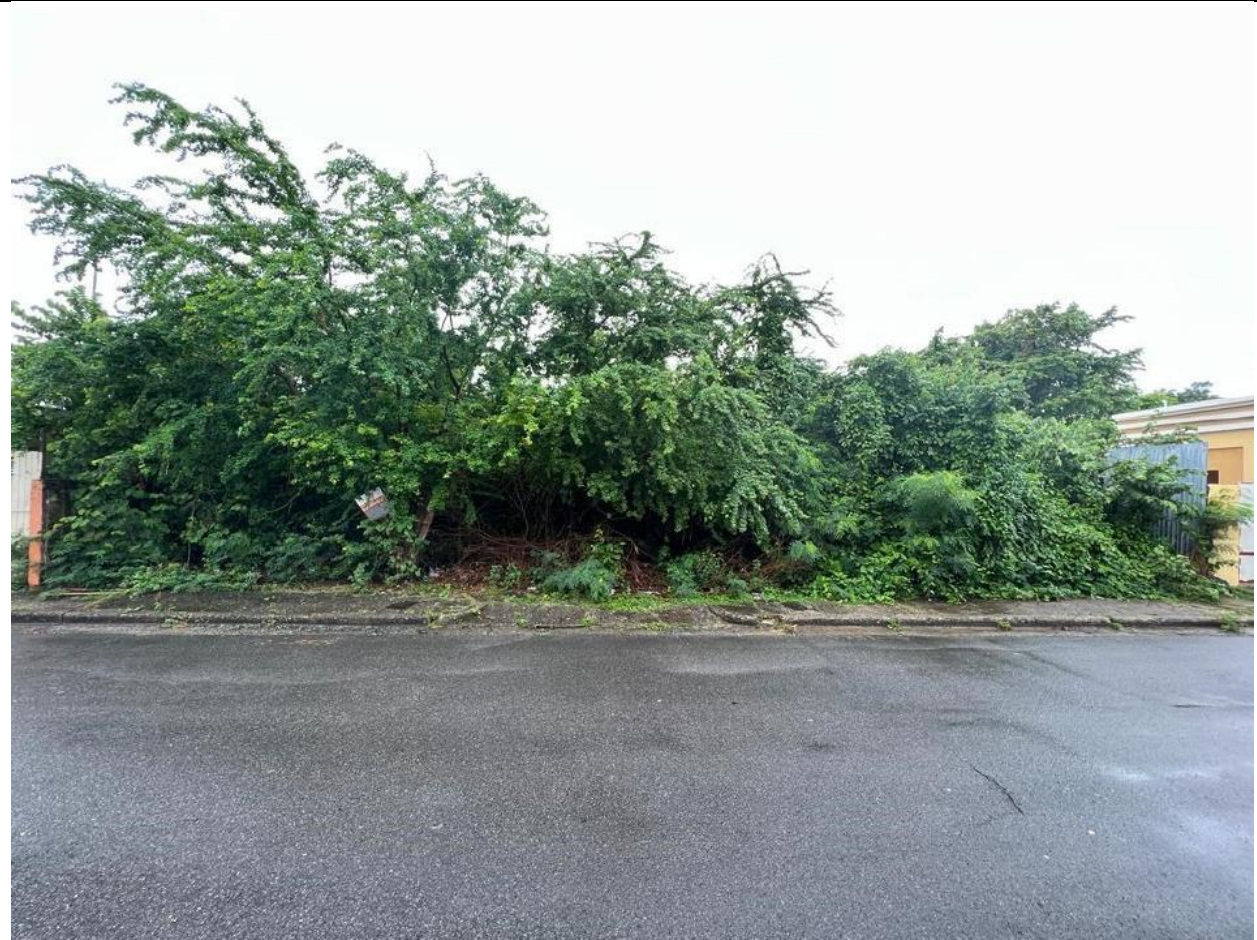
Photo #: 1

Description (include direction): Closeup of the project APE, facing west from the east side of Calle Monserrate.

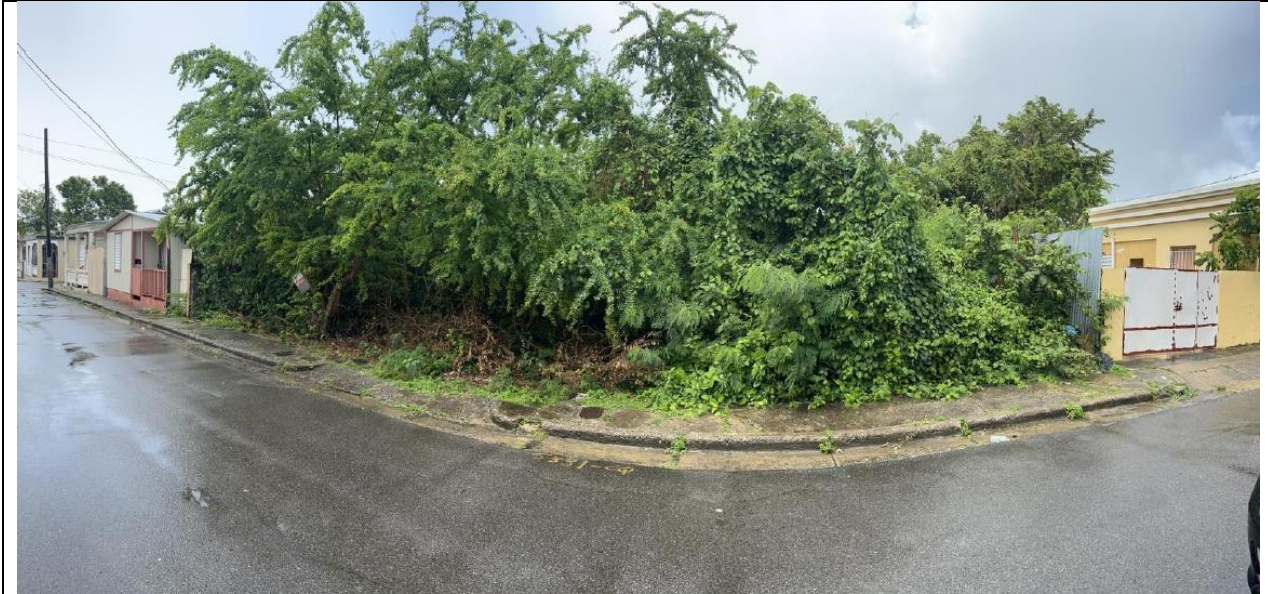
Photo #: 2

Description (include direction): Overview of the project APE, facing west from the east side of Calle Monserrate. Slightly distorted by the panoramic view, however the adjacent properties are visible for context.

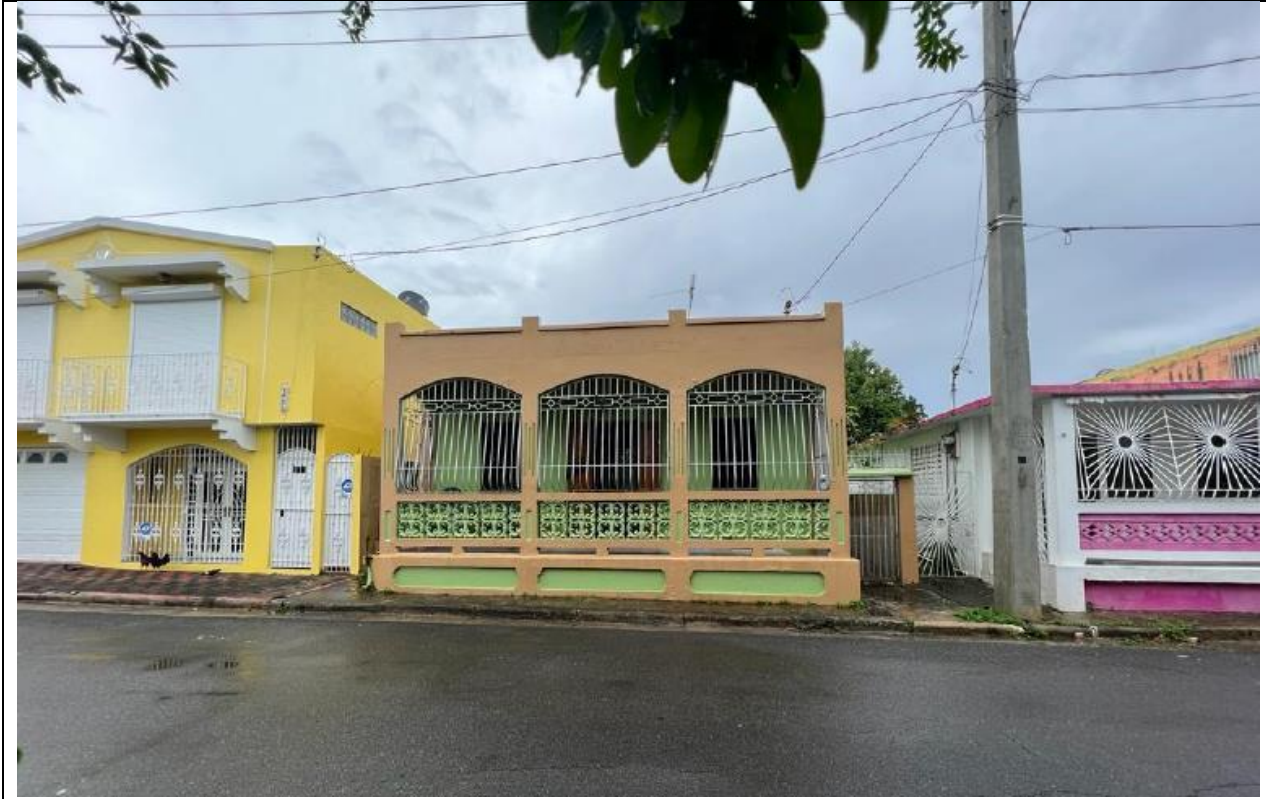
Photo #: 3

Description (include direction): Overview of the properties along the east side of Calle Monserrate, facing west from in front of the project APE.

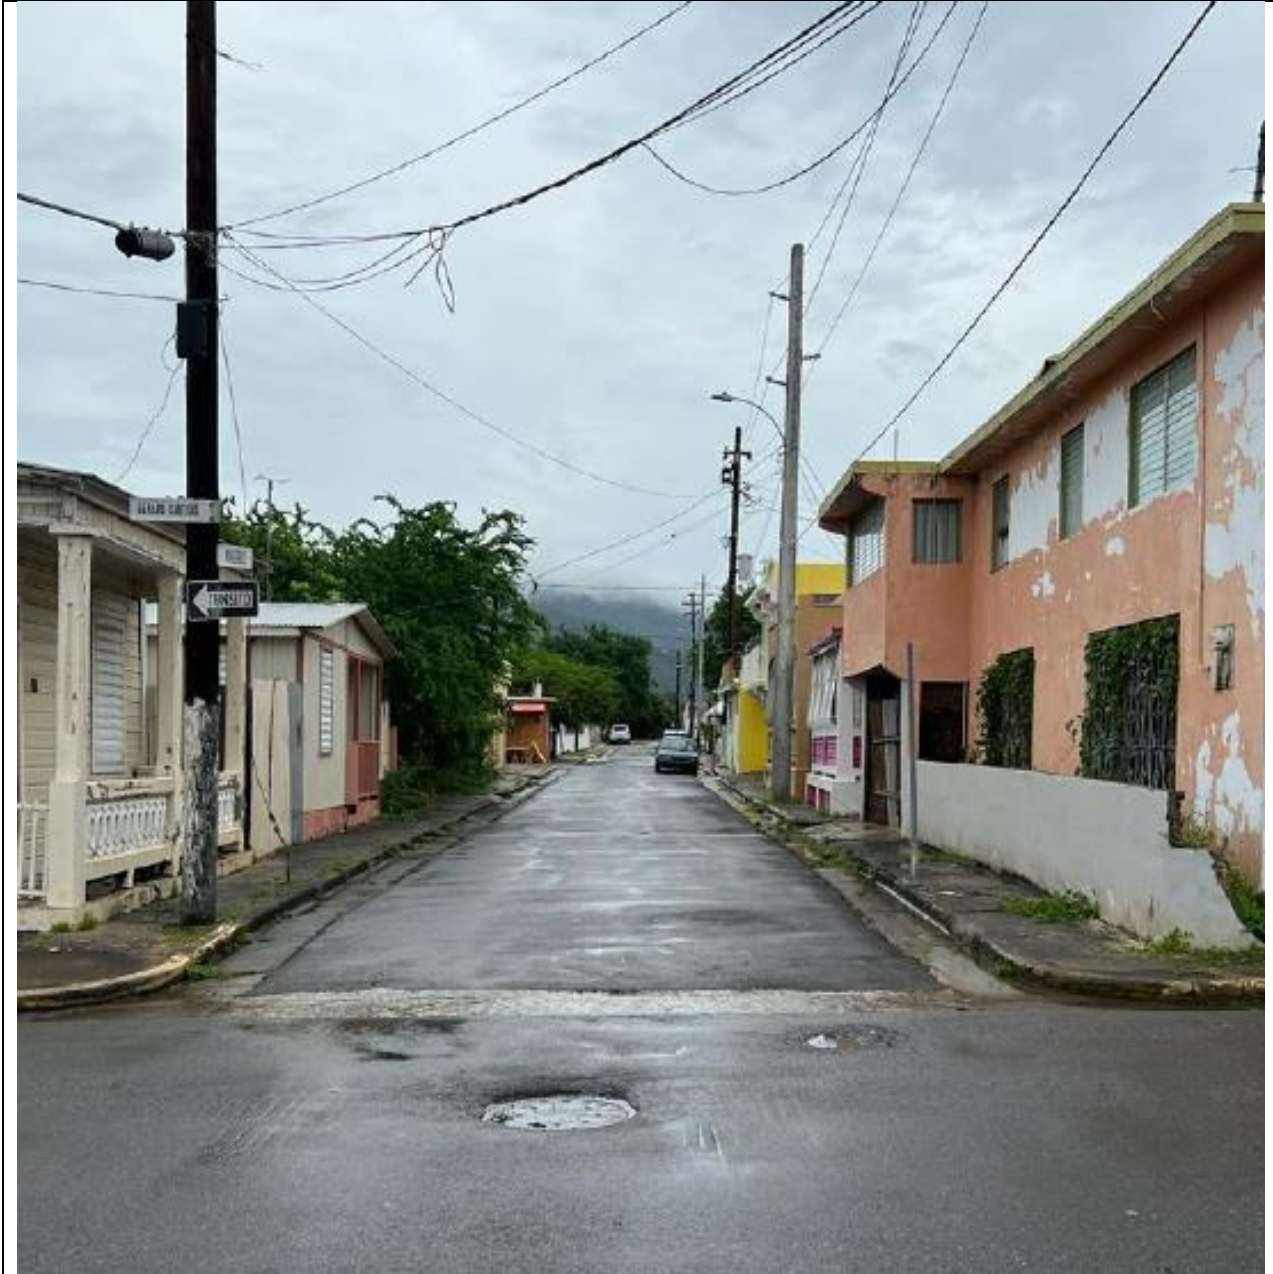
Photo #: 5

Description (include direction): Calle Monserrate street view taken from its intersection with Calle Genaro Cautiño Insúa, facing north. Note the project area to the left in the background.

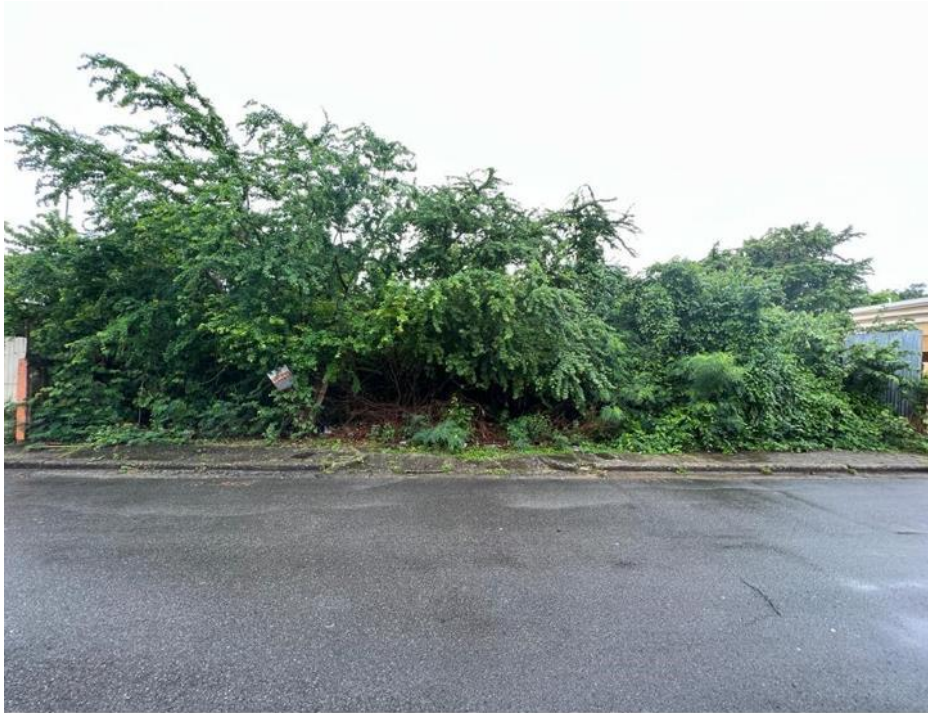
Photo 1: Project APE, facing west from the east side of Calle Monserrate (10/2022)

According to the Section 106 NHPA Effect Determination Form, completed by architectural historian Lauren B. Poche and archaeologist Sharon Meléndez Ortiz, the possibility of finding remains of previous occupations within the direct project's area of potential effect is high. Historical cartographic resources evidenced that the area of Guayama where the project is located was already part of the town's grid by the second half of the 19th century, and that there were several occupations since the 1930s. Thus, there is potential to find remnants of previous occupations dating from the 19th or early 20th centuries.
