ENVIRONMENTAL ASSESSMENT for HUD-funded Proposals

Project Identification: **SABANA VILLAGE
977 CALLE JUAN PEÑA REYES
SABANA LLANA WARD
SAN JUAN, PUERTO RICO**

Preparer: **ARCH. JORGE SALA
GS GROUP, LLC**

Month/Year: **MARCH 19, 2019
REV 1 – JUNE 4, 2019
REV 2 – JUNE 29, 2019**

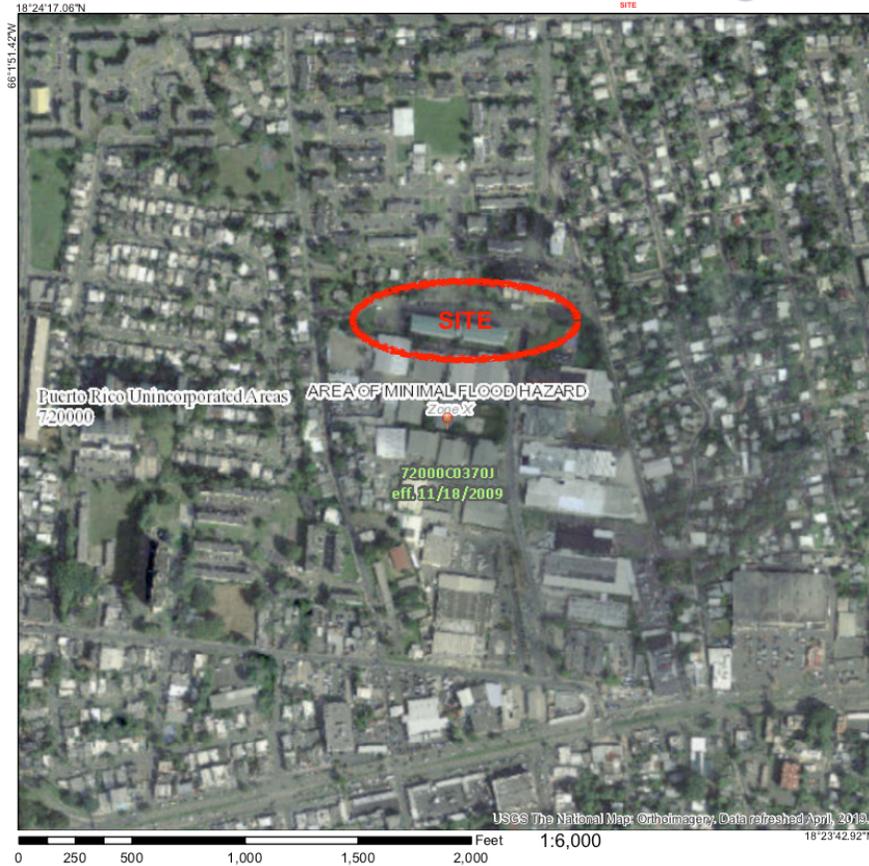
Exhibit No. 1
Floodplain Management - FEMA Firmette

National Flood Hazard Layer FIRMette

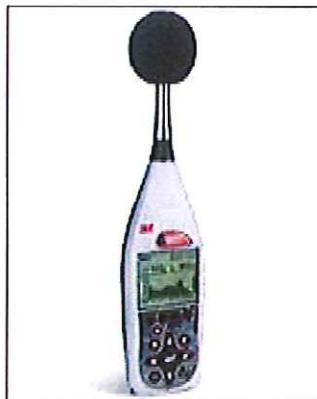
Figure #2- Sound Level Meter Photo

The noise survey was carried out using two (2) calibrated sound level meters which meets the "American National Standards Institute" (ANSI) specification for Type 1, sound level meters on its latest revision (See Figure #2). For this noise survey, two (2) calibrated Sound Pro Series DL Sound Level Meters manufactured by 3M (Quest Technologies) were used. Refer to Appendix 3 for data on calibration of the sound level meter instruments. The instruments are equipped with software and data logger and generate the data used to prepare this report. The raw data is included under Appendix 4.

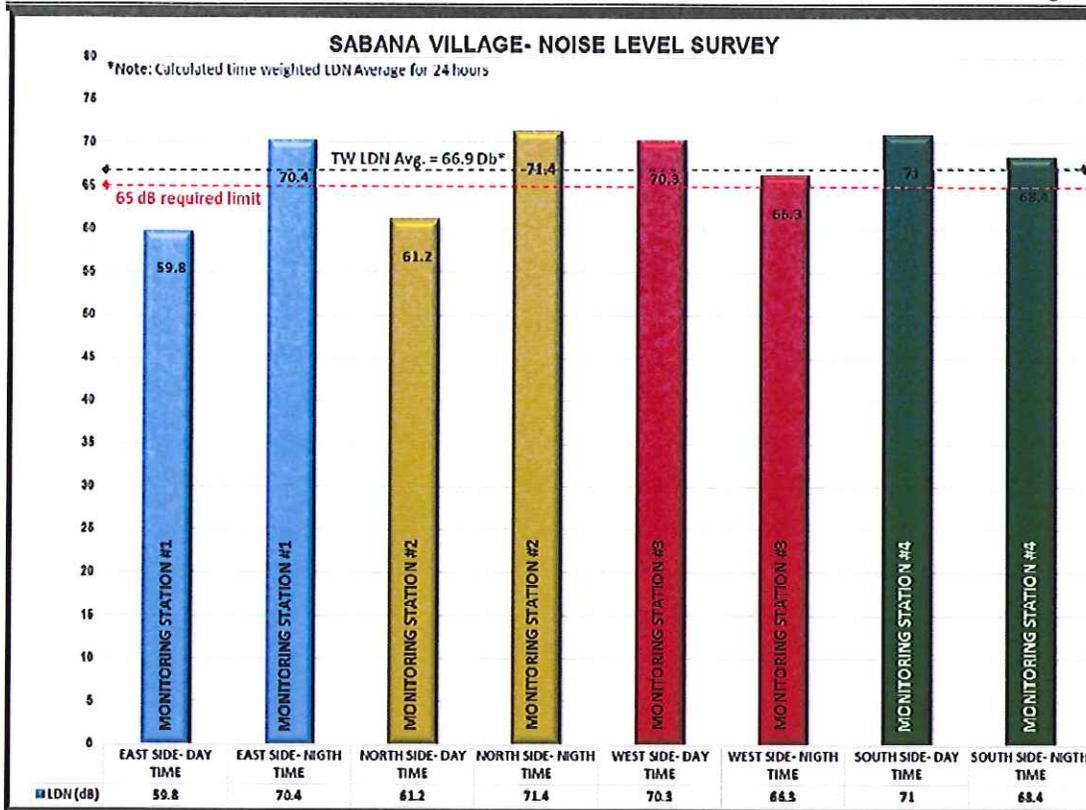
Figure #9- Monitoring Stations LDN Values.

Monitoring Stations (MS)	LDN
Monitoring Station 1	70.4 dB
Monitoring Station 2	71.4 dB
Monitoring Station 3	66.3 dB
Monitoring Station 4	68.4 dB
Average Nighttime LDN	69.1 dB

The LDN represents the 24 hours average sound level. For daytime period the Time – Weighted Average LDN is 65.6 dB. For nighttime period the Time – Weighted Average LDN is 69.1 dB.

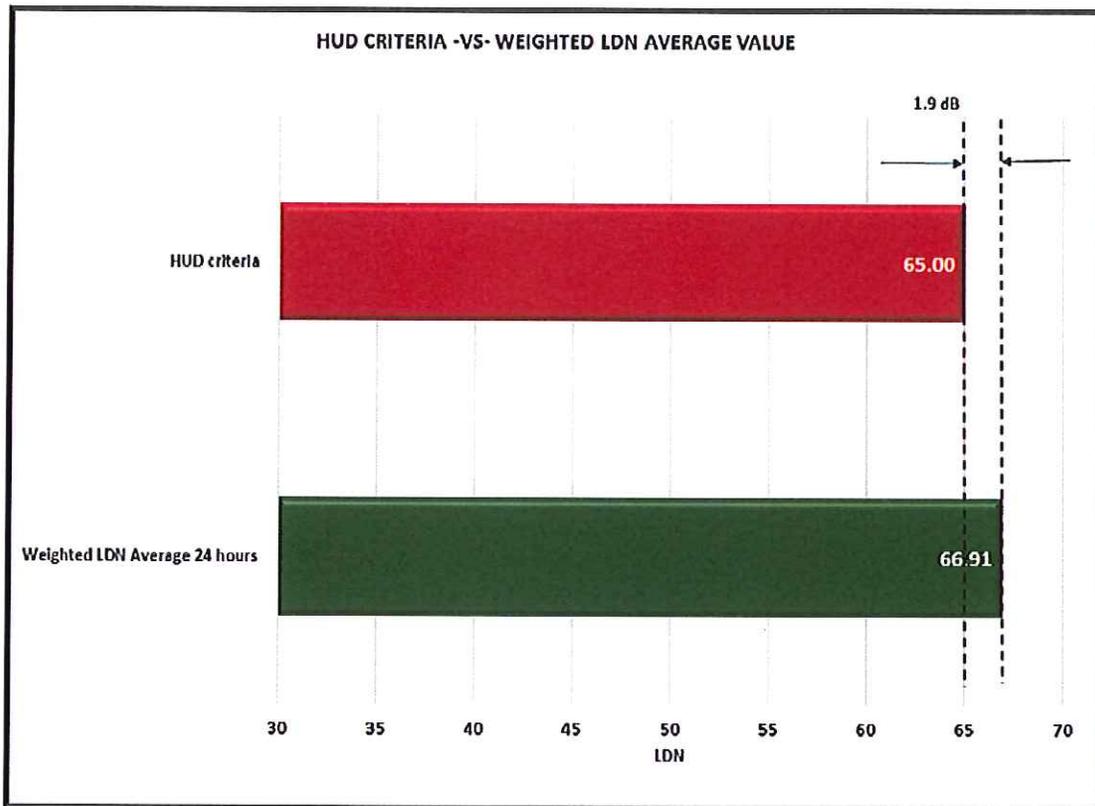
Figure #10- HUD Criteria -vs- Weighted LDN Average Value.

Based on the data collected during the noise survey at daytime and nighttime, the Calculated Time – Weighted LDN Average ^{24 hours} is 66.9 dB reveal a LDN level normally unacceptable under the HUD criteria as these are higher than the HUD 65 decibels Acceptability Standard. This value represents 102.9% of HUD criteria.

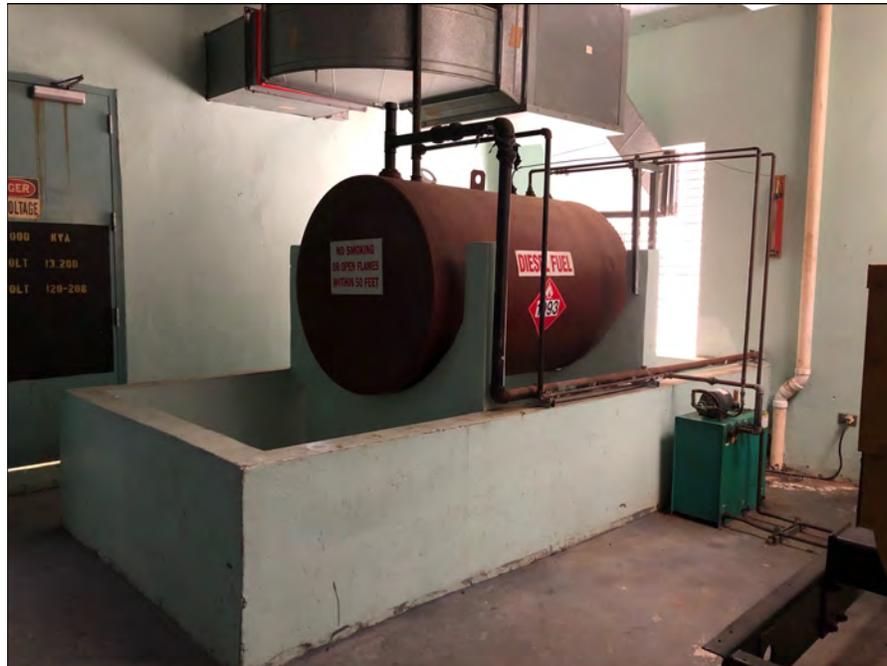
FACILITY: Sabana Village Apartments
LOCATION: #856 Juan Pérez Reyes St. Sabana Llana, San Juan, PR
SUBJECT: Diesel AST.

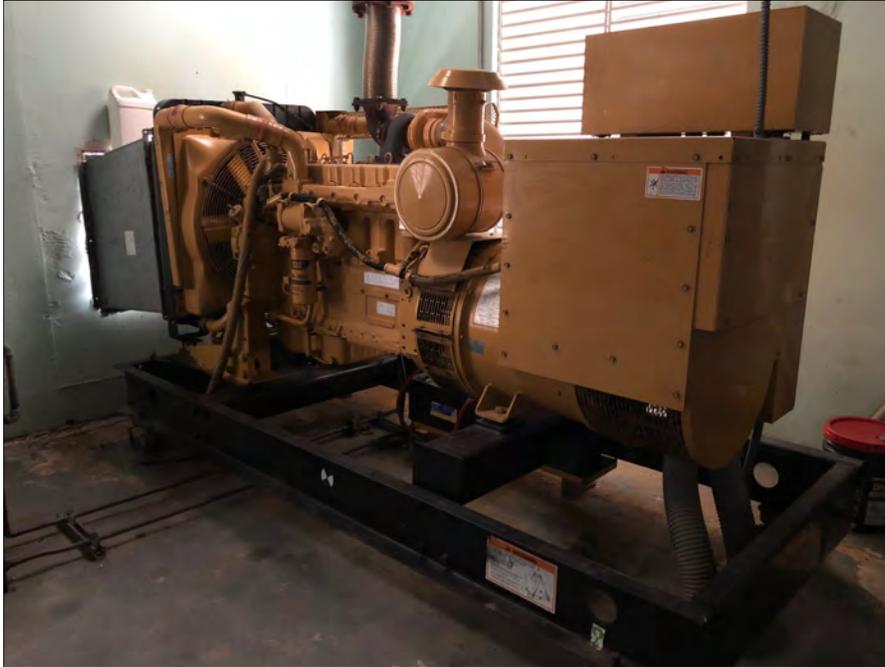
FACILITY: Sabana Village Apartments
LOCATION: #856 Juan Pérez Reyes St. Sabana Llana, San Juan, PR
SUBJECT: Electric generator.

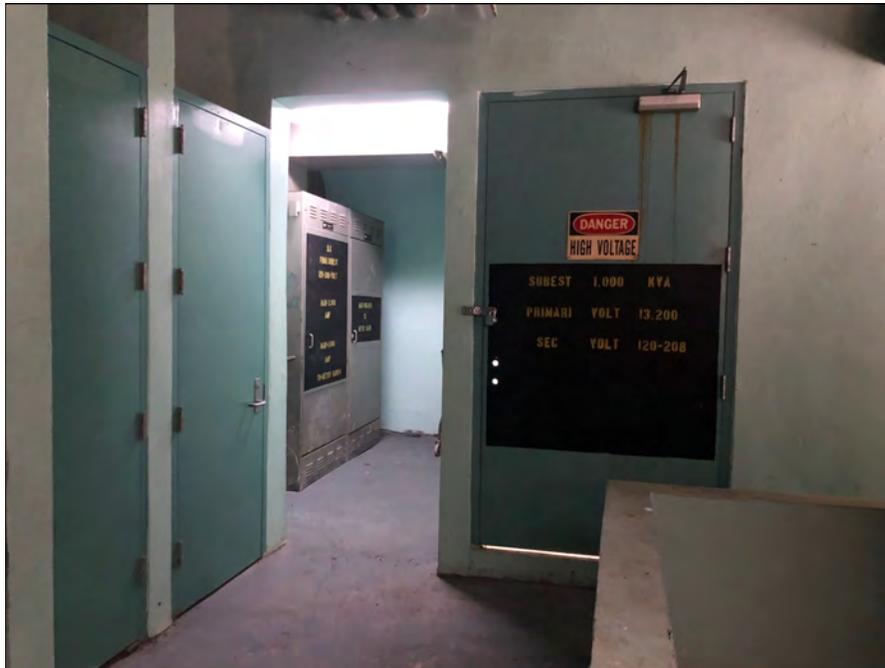
FACILITY: Sabana Village Apartments
LOCATION: #856 Juan Pérez Reyes St. Sabana Llana, San Juan, PR
SUBJECT: Electrical panels.

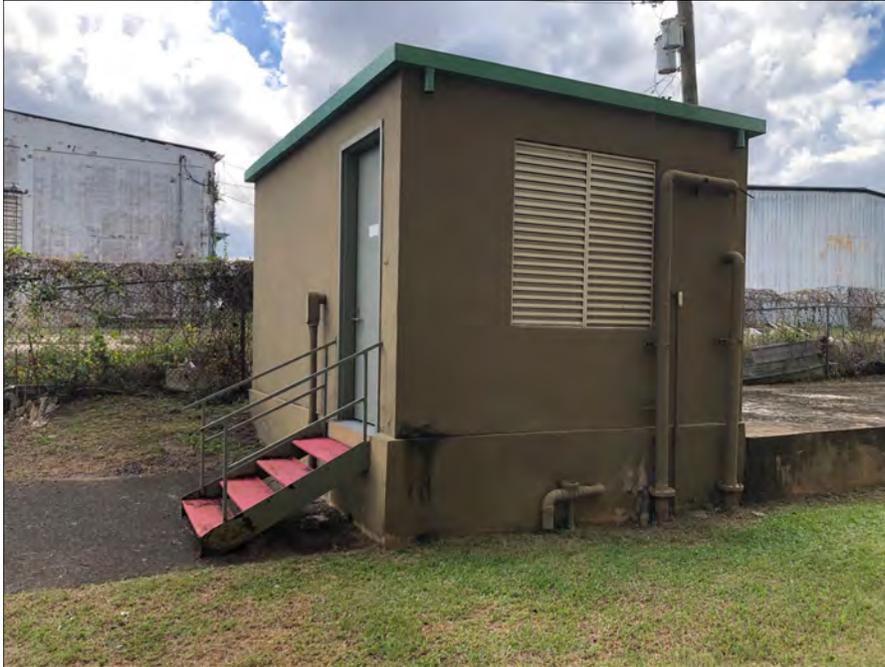
FACILITY: Sabana Village Apartments
LOCATION: #856 Juan Pérez Reyes St. Sabana Llana, San Juan, PR
SUBJECT: Water cistern pump station.

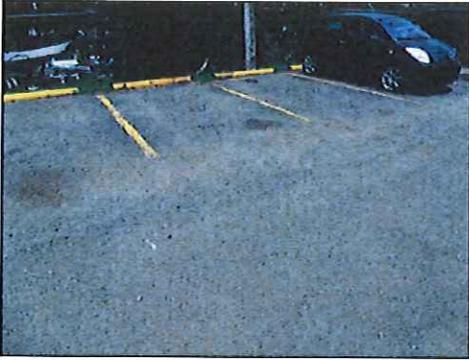
Exterior Parking Area
Lead based painted parking pavement marking

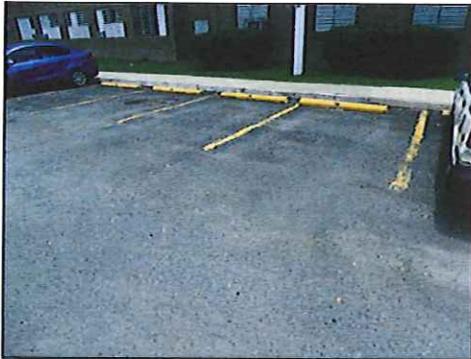
Exterior Parking Area
Lead based painted parking pavement marking
