# **Environmental Assessment**

## **Determinations and Compliance Findings for HUD-assisted Projects**

**Project ID:** PR-RGRW-01190

**Project Name:** AGROEDUC, INC.

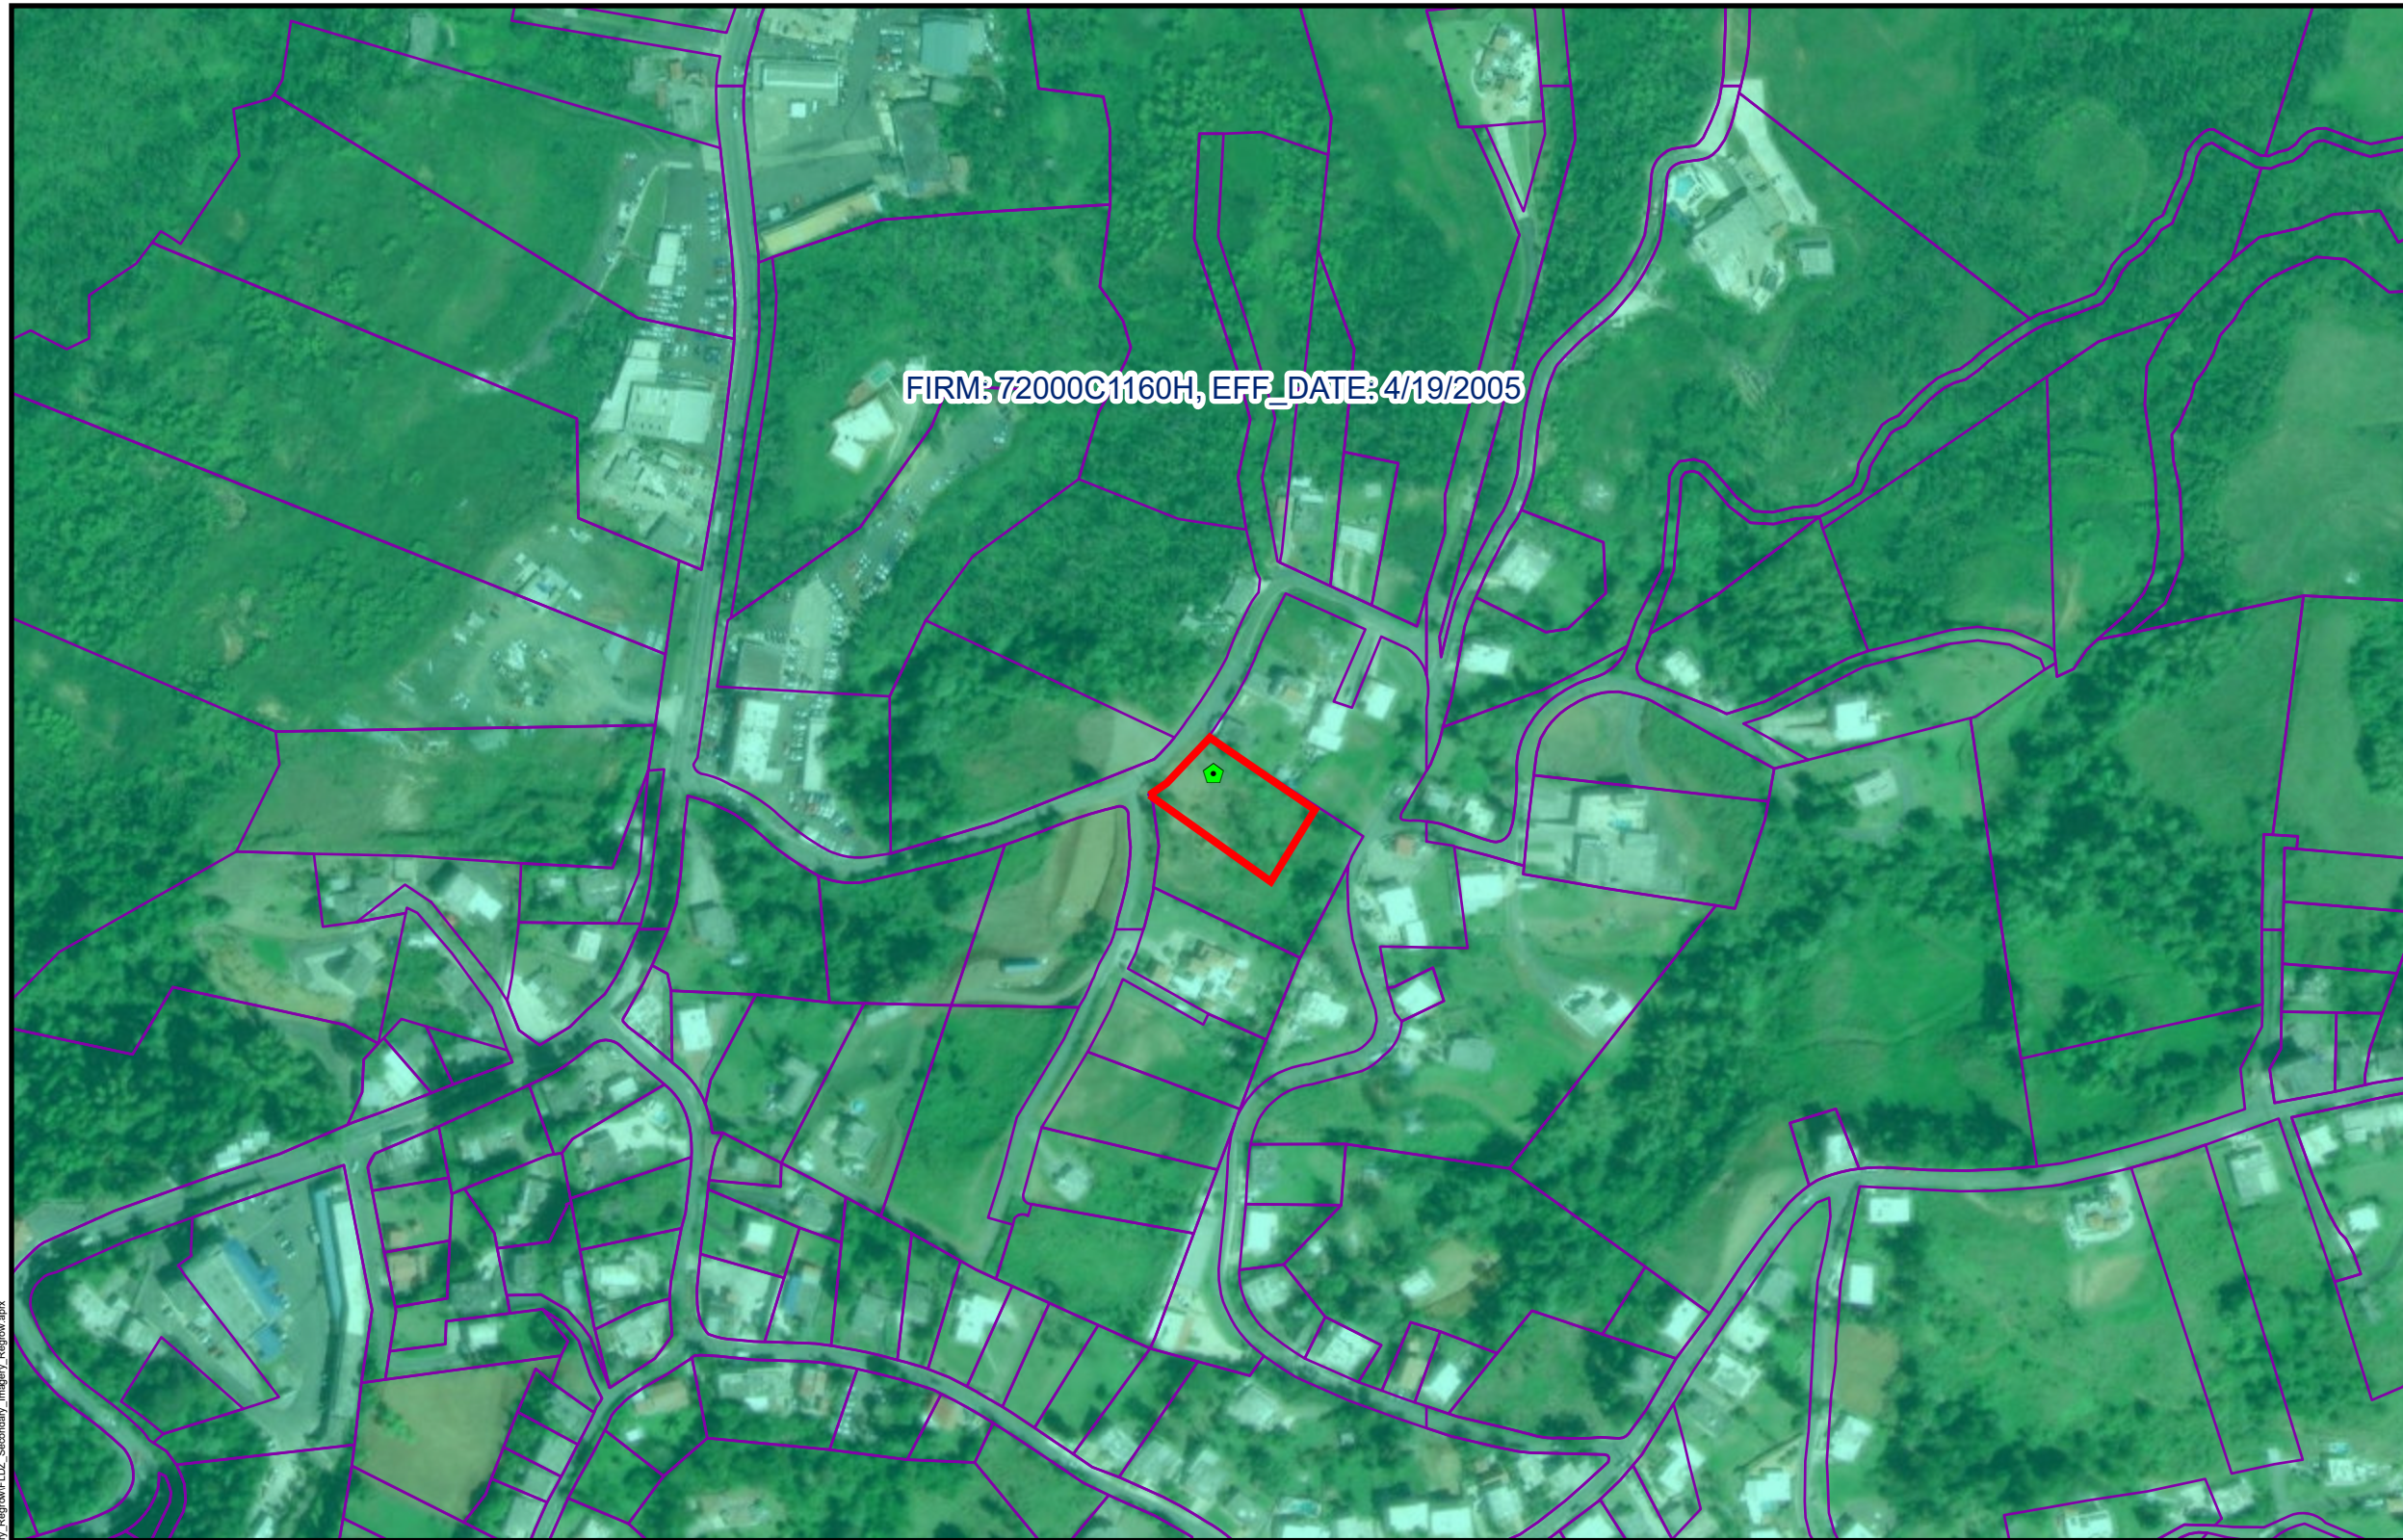
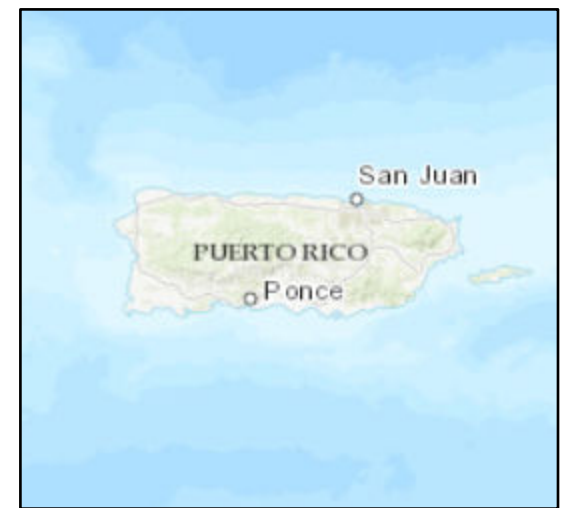
**Figure 4: FLOOD INSURANCE RATE MAP  
 APPLICANT ID: PR-RGRW-01190**

FIRM: 72000C1160H, EFF\_DATE: 4/19/2005

airport. The project is in compliance with Airport Hazards requirements. Refer to Figure 2 in <b>Appendix B.</b>
<p><b>Coastal Barrier Resources</b></p> <p>Coastal Barrier Resources Act, as amended by the Coastal Barrier Improvement Act of 1990 [16 USC 3501]</p>	<p>Yes No</p> <p><input type="checkbox"/> <input checked="" type="checkbox"/></p>	<p>Puerto Rico has various Coastal Barrier Resources Systems (CBRS). The project is in the central region of Puerto Rico. The distance to the nearest CBRS unit is 80,102 feet. Therefore, this project has no potential to impact a CBRS Unit and is in compliance with the Coastal Barrier Resources Act. Refer to Figure 3 in <b>Appendix B.</b></p>
<p><b>Flood Insurance</b></p> <p>Flood Disaster Protection Act of 1973 and National Flood Insurance Reform Act of 1994 [42 USC 4001-4128 and 42 USC 5154a]</p>	<p>Yes No</p> <p><input type="checkbox"/> <input checked="" type="checkbox"/></p>	<p>The Project site is located in Zone X, area of minimal flood hazard, as per Floodplain Insurance Rate Map (FIRM) 72000C1160H, effective date April 19, 2005. This project is in compliance with Floodplain Insurance requirements. (See Figures 4 and 5 in <b>Appendix B.</b>)</p>

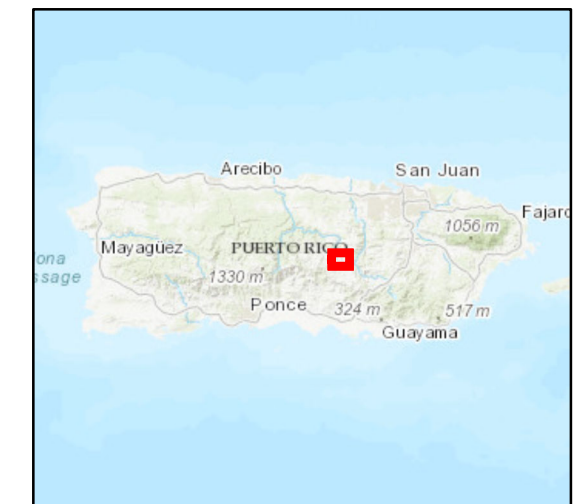
**Figure 8: TOXIC CHEMICALS AND GASES, HAZARDOUS MATERIALS, CONTAMINATION, AND RADIOACTIVE SUBSTANCES**  
**APPLICANT ID: PR-RGRW-01190**

- Project Parcel
- RCRA
- Toxic Release Inventory Site
- NPDES
- Superfund Site
- Brownfield Sites
- 3000 Ft Buffer NPDES
- 3000 Ft Buffer TRI
- 3000 Ft Buffer Superfund
- 3000 Ft Buffer RCRA
- 3000 Ft Buffer Brownfield

The Betterroads Asphalt LLC facility, 2,638 ft southwest of project site, is a CAA listed site. As a CAA site is considered an operating site with no violations over the last 3 years. According to ECHO report the site is also considered an inactive RCRA site.

As a CWA site, Coloco have been under the Significant/Category I Noncompliance status over the last 3 years. PR Asphalt is a General Permit Covered Facility with several violations over the last 3 years period, currently under the "No Violation Identified" status. Latest violation identified is from the 3<sup>rd</sup> quarter period of year 2023. Since 1<sup>st</sup> quarter of year 2022 to the 2<sup>nd</sup>

<p>quarter of 2023 this facility was under the “Significant/Category I Noncompliance” status due to “Failure to Report DMR - Not Received”.</p> <p>Predicting the impact of the noncompliance of these regulated facilities on the project area is difficult since the noncompliance status is due to the failure to submit the DMR report. However, given the distance and the hydraulic gradient of the area, these CWA sites should have no effect on project area.</p> <p>The Betterrecycling Corporation is a General Permit Covered Facility under the Terminated status since the 4<sup>th</sup> quarter of 2021.</p> <p>With these conditions, the proposed activities, and the distance between the sites and the proposed project location, there would not be any impacts to the project site. See ECHO reports in <b>Appendix C</b>.</p> <p>Refer to Figures 8 and 9 in <b>Appendix B</b> and the Site inspection report and photos in <b>Appendix A</b>. The project is in compliance with Contamination and Toxic Substances.</p>
