Environmental Assessment

Determinations and Compliance Findings for HUD-assisted Projects

Project Name: PR-CRP-000670 Multi-use Center Autonomous Municipality of Moca

Responsible Entity: Puerto Rico Department of Housing (PRDOH)

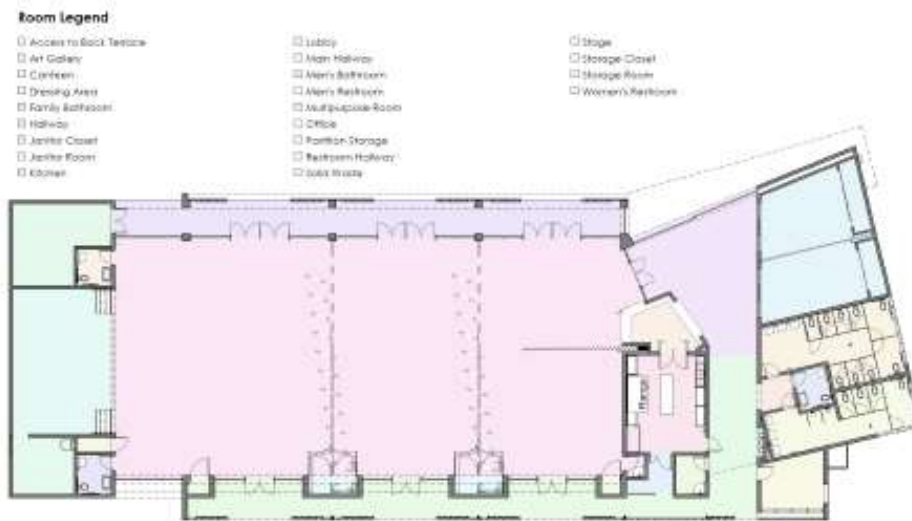
The main undertaking of this project is the building of the 10,970ft² multiuse center. A detailed room legend is provided here for reference.

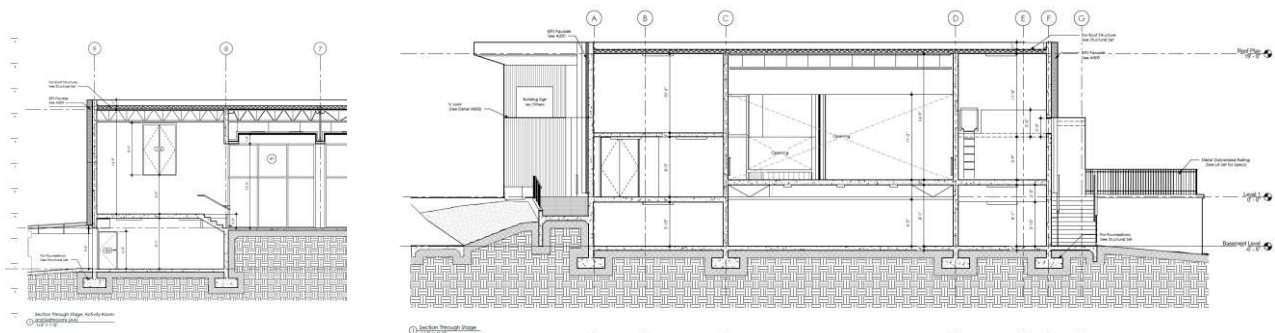
Proposed Building sections showing basement.

The site has an approximated 2.5-meter grade change in its long axis. Therefore, a partial basement is proposed on the south side of the building (shown below) to accommodate additional storage space, adding an additional 1 630 ft². The ground disturbance for this excavation will be 58 feet long by 21 feet wide with a maximum of 5 feet below the existing grade.

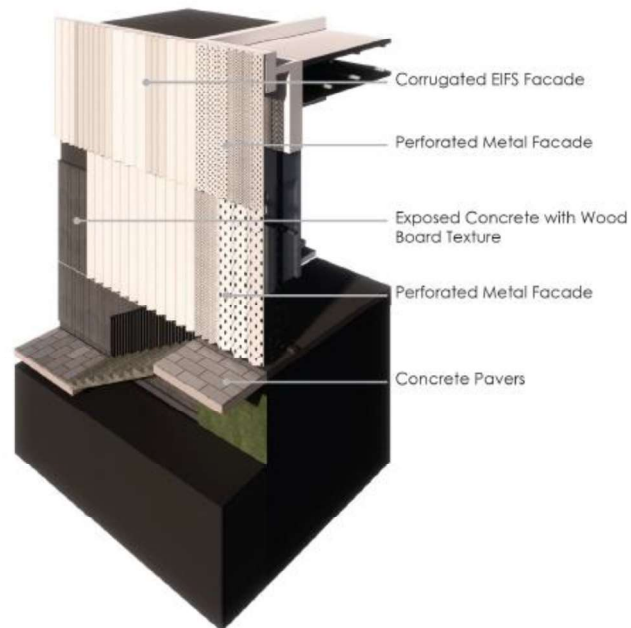
Wall Section Detail

values. Where the building has glass openings, a custom perforated metal façade serves as both a shade cover and impact protection.

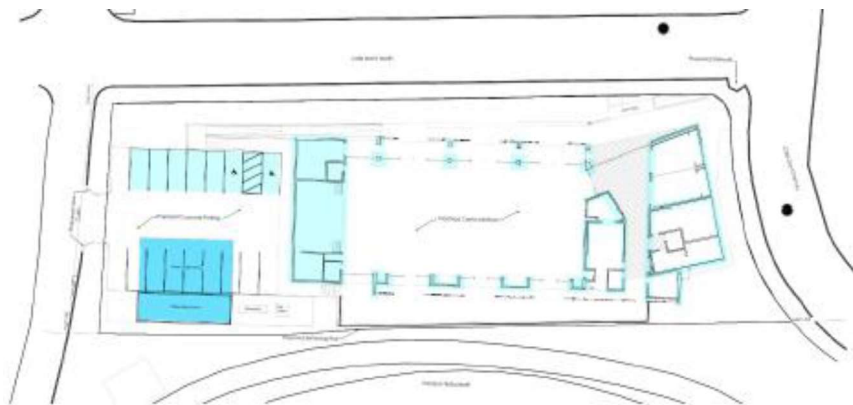
Ground Floor Plan

Lastly, ground disturbances are several. The basement will be excavated 2' - 6" deep for the footings (shown below in light blue). Geotechnical studies revealed expansive soils that need to be improved as part of this project, these amended soils will be reused as fill. There will be excavations for footings, stormwater retention and a cistern. Footing and stormwater management excavations will be limited to 1.5 meters (5 feet) below the existing grade. The underground cistern will be located southeast of the site and the excavation will be about 50 feet by 40 feet with 10 feet in depth (shown below in dark blue).

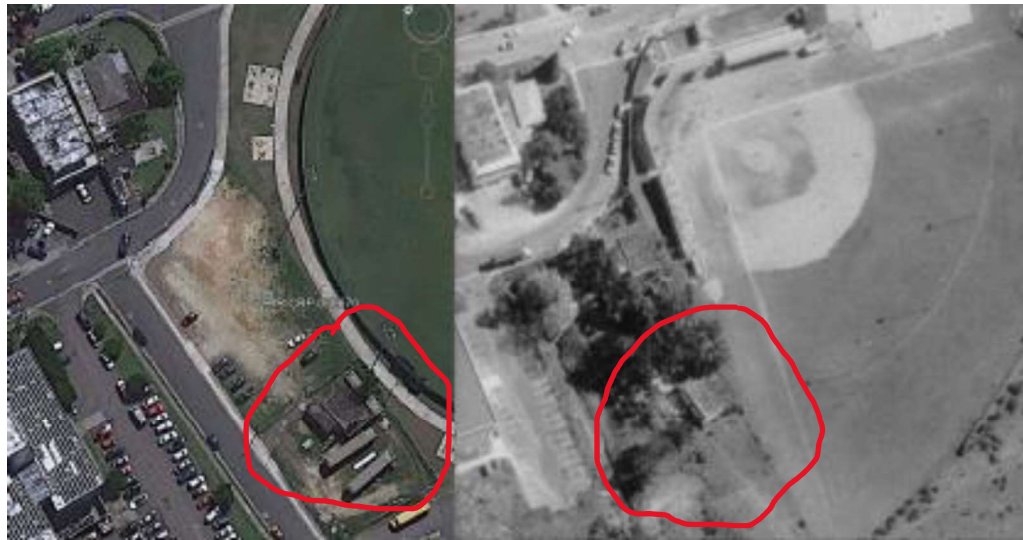
Details of 2023 and 1975 aerial imagery indicating the extant building on the property. Approximate APE marked in Red.

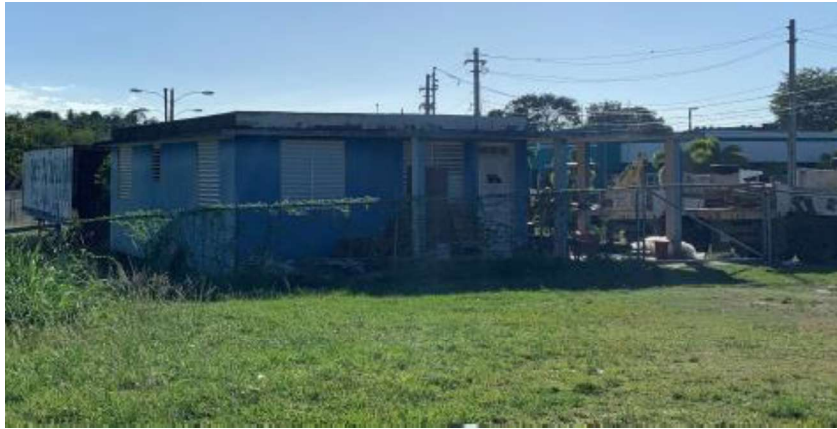
The house has slab on grade concrete foundation, concrete walls, and a flat concrete roof with overhangs. The façade faces north and has a projecting L-shaped front porch to the right side supported by five simple concrete columns. The front door appears original, is to the right side of the façade wall, and is made of wood with recessed rectangular panels. A three light wood and glass transom is above the entrance door. The windows are metal jalousies.

Extant building on the property, view southeast.

The building is first present in 1975 aerial imagery, not visible in 1958. The 1975 footprint does not include the L-shaped front porch which was added between 1993 and 2004. Historic topographic maps were also reviewed to try and further narrow the date of construction; a house is present to the north on the 1964 (1967, ed) Mocha topographic map on USGS topoview.com, likely one that is visible in 1975, however the subject property is not depicted. Therefore, a date of circa 1970 has been determined for this property.
