Environmental Assessment Determinations and Compliance Findings for HUD-assisted Projects 24 CFR Part 58

Project Name: Gallery Plaza (PR-CRP-000981)

Project Location: PR-472 and Juan González Street, Isabela, Puerto Rico, 00662

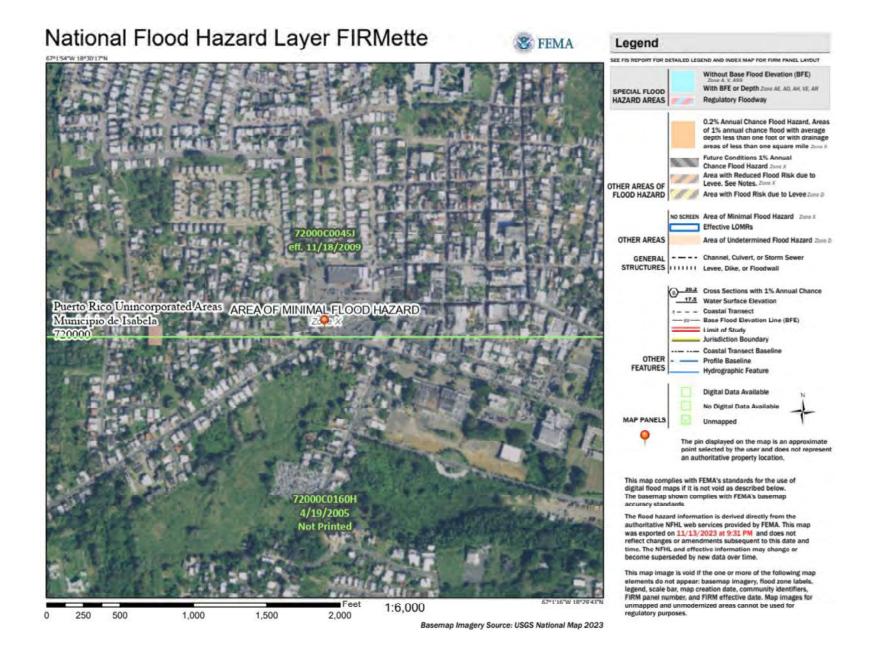
FEMA - Firmette

Flood Insurance Flood Disaster Protection Act of 1973 and National Flood Insurance Reform Act of 1994 [42 USC 4001-4128 and 42 USC 5154a]	Yes No	The project is located in an Area of Minimal Flood Hazard, classified as Zone X Unshaded, per FEMA Flood Insurance Rate Map (FIRM) Number 72000C0045J and 72000C0160H, revised on November 18, 2009. Since the site is outside a FEMA-designated Special Flood

CTATHTEC EVECUTIVE ORD	EDC AND DEC	Hazard Area, flood insurance is not required. The project is in compliance with Flood Disaster Protection Act of 1973 and National Flood Insurance Reform Act of 1994. See FIRMette in Exhibit 4.
	EKS, AND REG	ULATIONS LISTED AT 24 CFR 50.4 & 58.5
Clean Air Clean Air Act, as amended, particularly section 176(c) & (d); 40 CFR Parts 6, 51, 93	Yes No	The site is within the Municipio of Isabela, which is in attainment district for all EPA list of NAAQS criteria pollutants for all Puerto Rico Municipalities. The proposed activity will not exceed any of the de minimis or threshold emissions levels of non-attainment and maintenance level pollutants or exceed the screening levels established by the state or air quality management district. The nearest nonattainment municipality, Arecibo, which is in nonattainment for Lead (2008 standard), is about 108,500 feet to the east from the site.

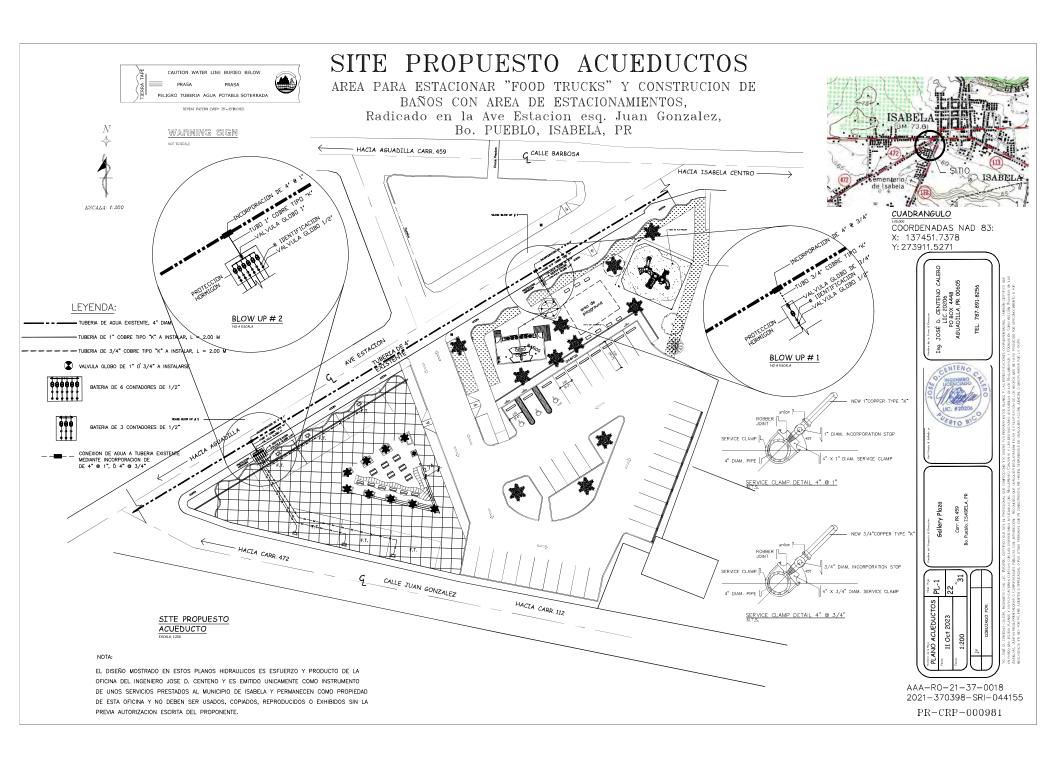
NOTAS GENERALES PARA SISTEMA DE ACUEDUCTOS

- 1- TODAS LAS CONEXIONES SERAN REALIZADAS POR UN MAESTRO PLOMERO O BAJO LA SUPERVICION DIRECTA DE ESTE.
- 2- TODAS LAS ACOMETIDAS DE LA BATERIA DE CONTADORES SERAN DE 1/2"ø.

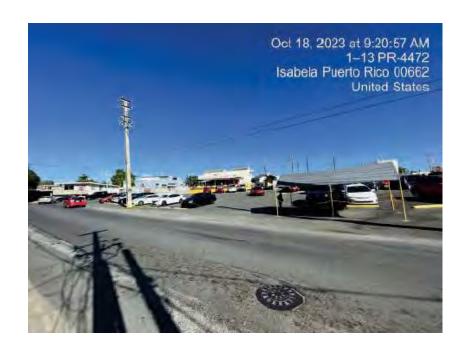
View from Highway PR-472 (west) within the site and view towards the east.

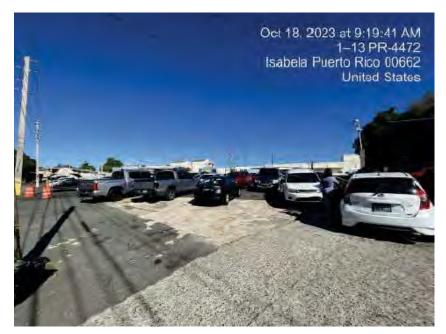
View from C. Juan Gonzalez Street to site.

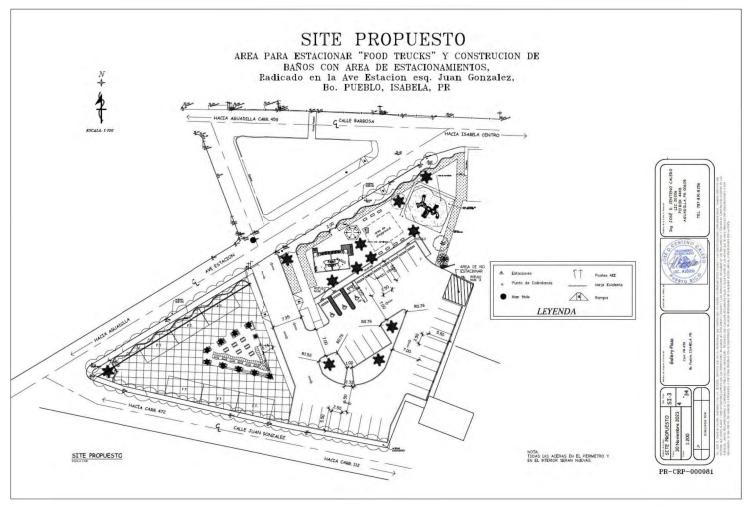
Figure 3: Poposed Site Plan, 13/October/2023 Set of Plans.

- 3. Demolition and Removal Activities: The proposed scope of work includes removing objects such as parking islands, stoppers, and pavement that currently obstruct the site. Additionally, the project involves demolishing concrete islands located in the north, south, and central areas to facilitate the new construction activities. These demolition efforts will involve ground-disturbing activities, with excavation depths potentially reaching up to 3 feet below ground level. In addition, the project proposes the demolition of an existing structure located on the northwest side of the parking area. However, the expected depth of the ground disturbance resulting from this activity is not specified in the provided plans.

The activities detailed above are visually represented in the following figure:

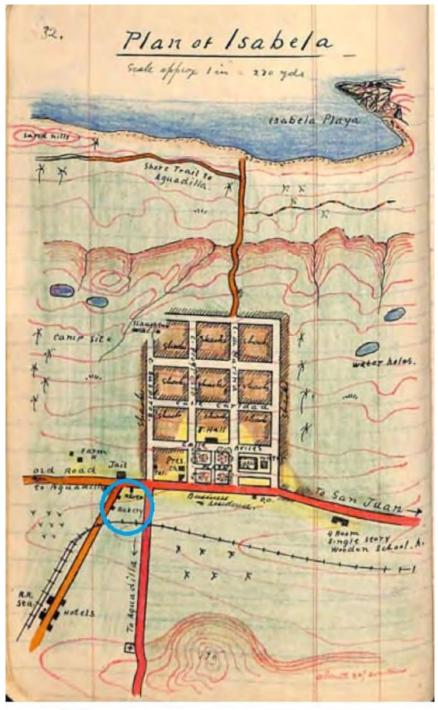
Figure #4 "Plan of Isabela," illustrated town map from Armstrong's notebooks. Image sourced from: https://doi.org/10.18737/M7D38

The historic map is from the year 1904 and shows the urban center drawn in color as it was at the time. The historic map, titled Plan of Isabela c1904 (Figure #4) shows two buildings in the area of the direct APE adjacent to the urban center, one of them marked as a bakery. Aerial Imagery from the year 1930 shows us that the area adjacent to the Traditional Urban Center has been developed. Inside the direct APE at least four structures can be noted (Figure #5). The 1941 USGS topographic (Figure #6), due to scale does not show all the buildings individually but instead represents them as a large black rectangle but it does depict the single track, standard gauge railroad line that borders the southern perimeter of the Direct APE. The 1950 (Figure #7) aerial image shows Inside the direct APE at least seven structures can be noted covering most of the plot, including an apparent L shaped building in the center. More vegetation is evident in the form of trees to the northeast of the plot, but all the same buildings appear to still be on site, the L shape building is in fact two buildings on an L shape form. The 1960 USGS topographic quadrangle map (Figure #8) shows four structures to the northwest of the plot along the street. They probably represent the buildings already there since 1950, although their visual representation is not accurate to what the aerial imagery shows. The single track, standard gauge railroad line that bordered the Direct APE to the south is no longer present in the 1960 USGS topographic quadrangle map. Aerial imagery from the year 1993 (Figure #9) shows that at least two to three more buildings were erected on the direct APE. The northern building that formed the L shape structures expanded to the west doubling its size and absorbing a building that existed there. The only undeveloped area of the direct APE seems to be used as a parking lot. The 2009 aerial imagery (Figure #10) shows that all buildings but the three to the west were demolished and the entire east side of the plot has been used as a parking lot. In the remaining buildings was the northwestern side of the L shape structures that was previously expanded. Sometime after that but before 2011 the rest of the buildings were demolished, and the entire plot of the direct APE was asphalted. To this date it is used as a parking lot and nowadays has few food trucks parked on site.

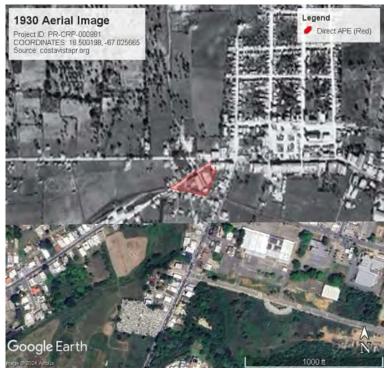
Figure #5 The image above showcases the projects Direct APE over the 1930 aerial image sourced from costavistapr.org. This website is no longer available.

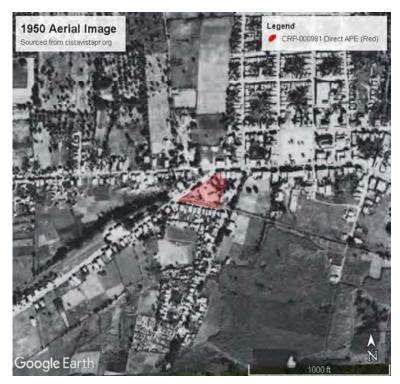
Figure #7 The image above showcases the projects Direct APE over the 1950 aerial image sourced from costavistapr.org. This website is no longer available.

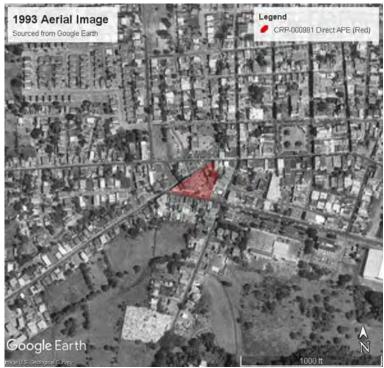
Figure #9 The image above showcases the projects Direct APE over the 1993 aerial image sourced from Google Earth.

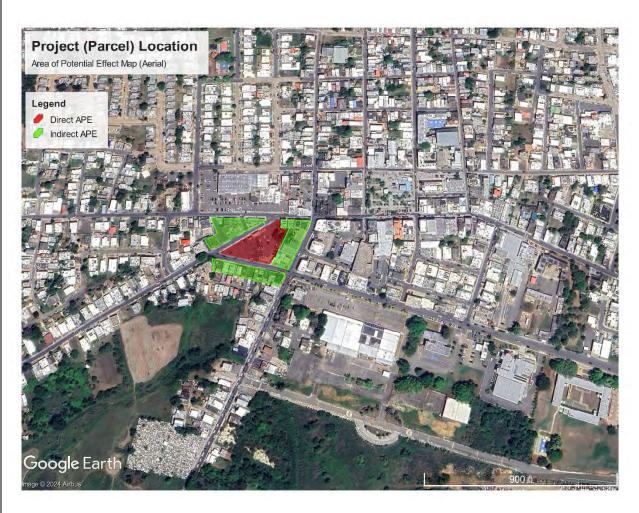
Figure 2

Description: Google Earth 2024 Aerial image of the APE (red) and the indirect APE surrounding it (green),

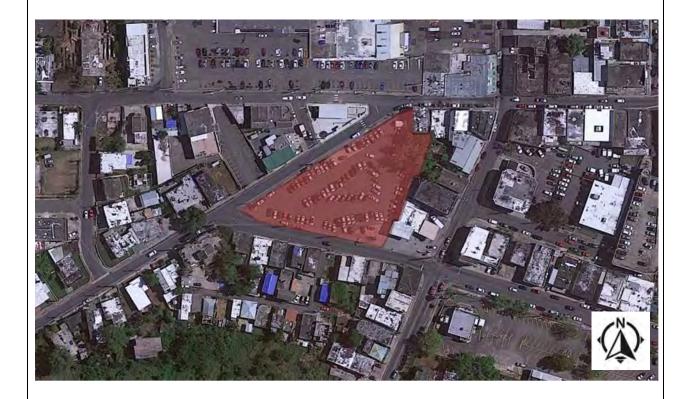
Figure 3

Description: Detailed aerial image from Google Earth 2023. The project will be located two blocks away from the historic urban center of the town. Between PR-472 east, in the south is C. Juan Gonzalez Street, to the east is Agustín Ramos Calero Avenue and to the north is C. Celso Barbosa Street.

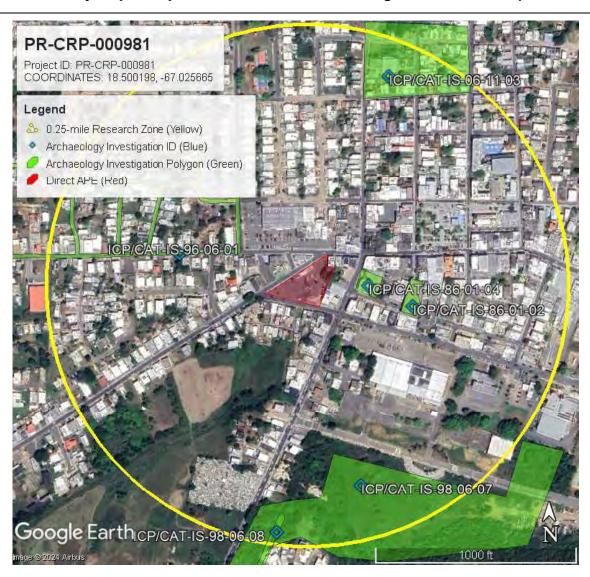
Figure 8

Description: The image above focuses on the archaeology projects within the area of potential effect, highlighting archaeological projects identified both around the site and within the potential impact zone.

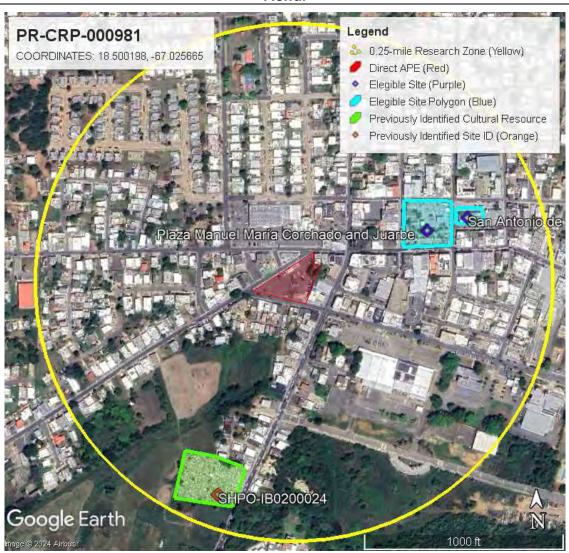
Figure 10

Description: The image above showcases all previously recorded cultural resources within this project APE or its vicinity. The image was sourced from USGS Historical Topographic Map Explorer.

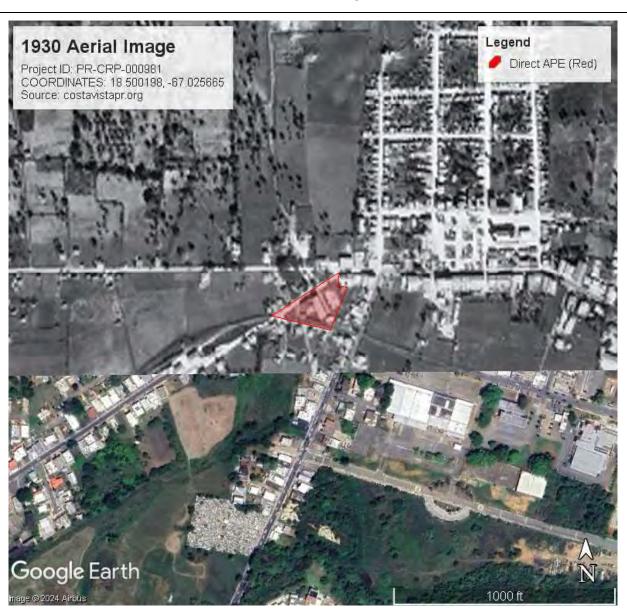
Figure 13

Description: The image above showcases the projects Direct APE over the 1930 aerial image sourced from costavistapr.org. This website is no longer available.

According to the 13/October/2023 set of plans, before the first intervention, there were properties inside of the proposed site dating back to 1930 (See Figure 13) and in the 2009 aerial image (See Figure 16) we can see that the properties were removed to create a parking space. We can conclude that there was an intervention done in the years leading up to 2010 in the proposed site.

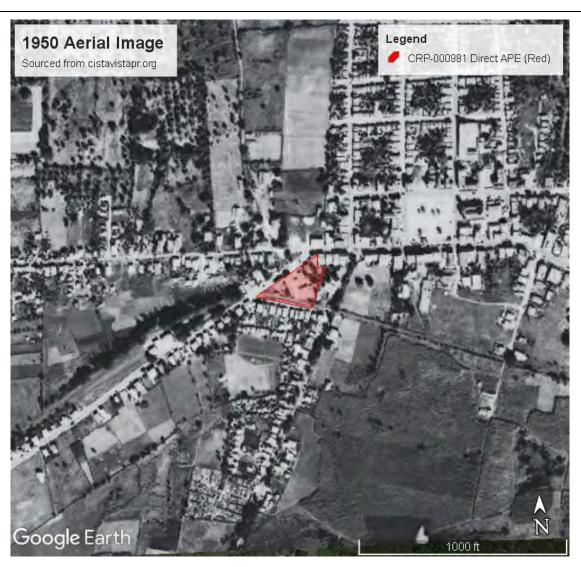
Figure 14

Description: The image above showcases the projects Direct APE over the 1950 aerial image sourced from costavistapr.org. This website is no longer available.

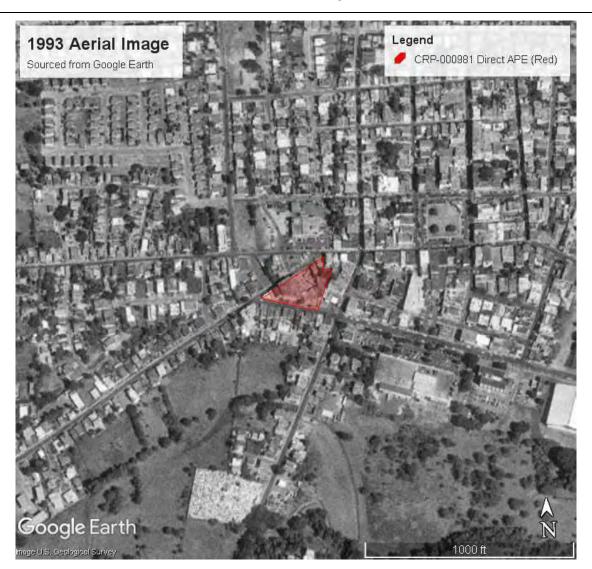
Figure 15

Description: The image above showcases the projects Direct APE over the 1993 aerial image sourced from Google Earth.

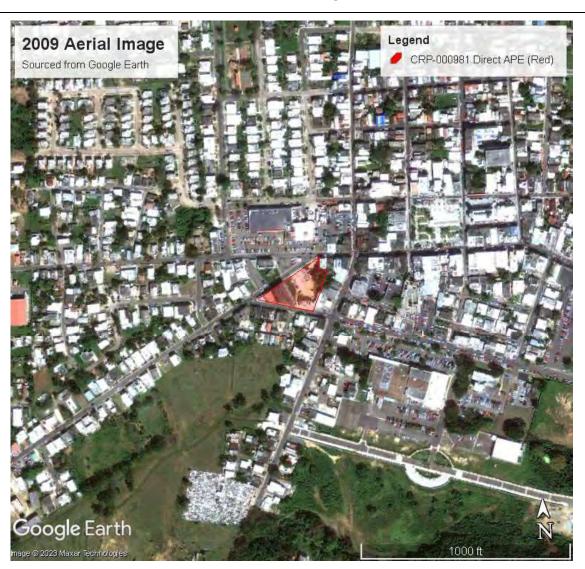
Figure 16

Description: The image above showcases the projects Direct APE over the 2009 aerial image sourced from Google Earth.

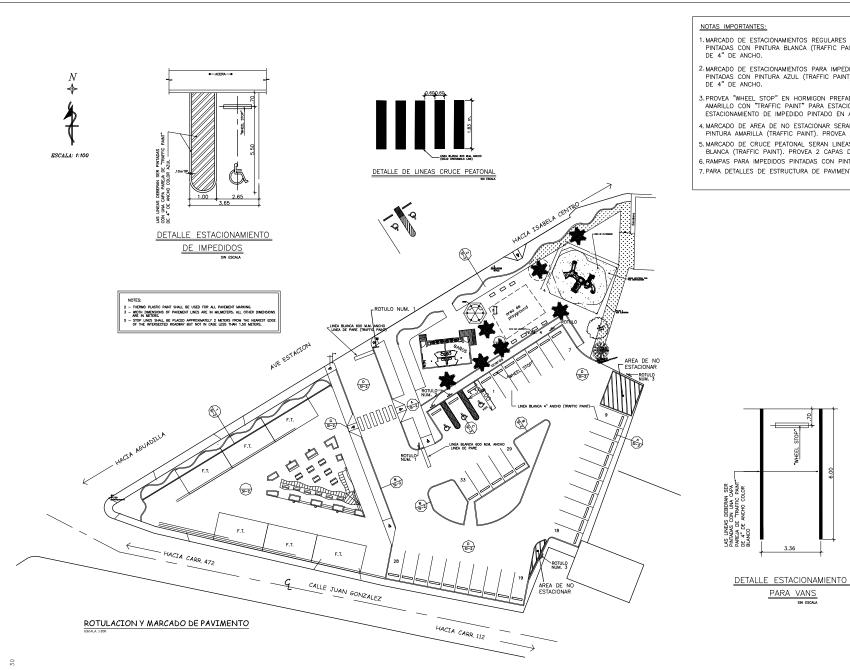
- 1.MARCADO DE ESTACIONAMIENTOS REGULARES SERAN LINEAS PINTADAS CON PINTURA BLANCA (TRAFFIC PAINT), PROVEA 2 CAPAS
- 2. MARCADO DE ESTACIONAMIENTOS PARA IMPEDIDOS SERAN LINEAS PINTADAS CON PINTURA AZUL (TRAFFIC PAINT), PROVEA 2 CAPAS
- 3. PROVEA "WHEEL STOP" EN HORMIGON PREFABRICADO PINTADOS DE AMARILLO CON "TRAFFIC PAINT" PARA ESTACIONAMIENTO REGULAR Y PARA ESTACIONAMIENTO DE IMPEDIDO PINTADO EN AZUL CON "TRAFFIC PAINT".
- 4. MARCADO DE AREA DE NO ESTACIONAR SERAN LINEAS PINTADAS CON PINTURA AMARILLA (TRAFFIC PAINT). PROVEA 2 CAPAS DE 4" DE ANCHO.
- 5. MARCADO DE CRUCE PEATONAL SERAN LINEAS PINTADAS CON PINTURA BLANCA (TRAFFIC PAINT). PROVEA 2 CAPAS DE 2 PIES DE ANCHO.
- 6, RAMPAS PARA IMPEDIDOS PINTADAS CON PINTURA AZUL (TRAFFIC PAINT)
- 7, PARA DETALLES DE ESTRUCTURA DE PAVIMENTO VEA HOJA 8/10
