# **Environmental Assessment Determinations and Compliance Findings for HUD-assisted Projects 24 CFR Part 58**

**Project Name:** Mejoras Plaza Pública José Ramón Figueroa Rivera (PR-CRP-000127)

**Responsible Entity:** Puerto Rico Department of Housing (PRDOH)

**Grant Recipient** (if different than Responsible Entity): Municipality of Villalba

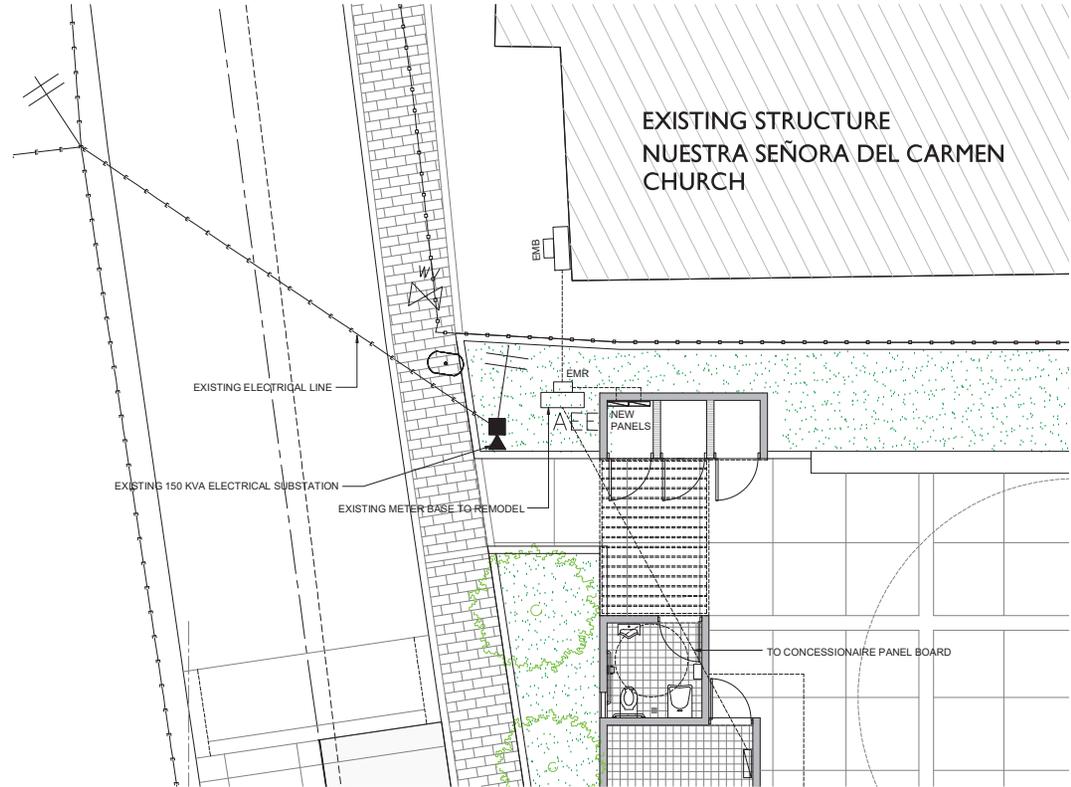
**PROPOSED ELECTRICAL SITE DISTRIBUTION**  
 SCALE 3/32" = 1'-0"

**ONE LINE DIAGRAM**  
 SCALE 1/4" = 1'-0"

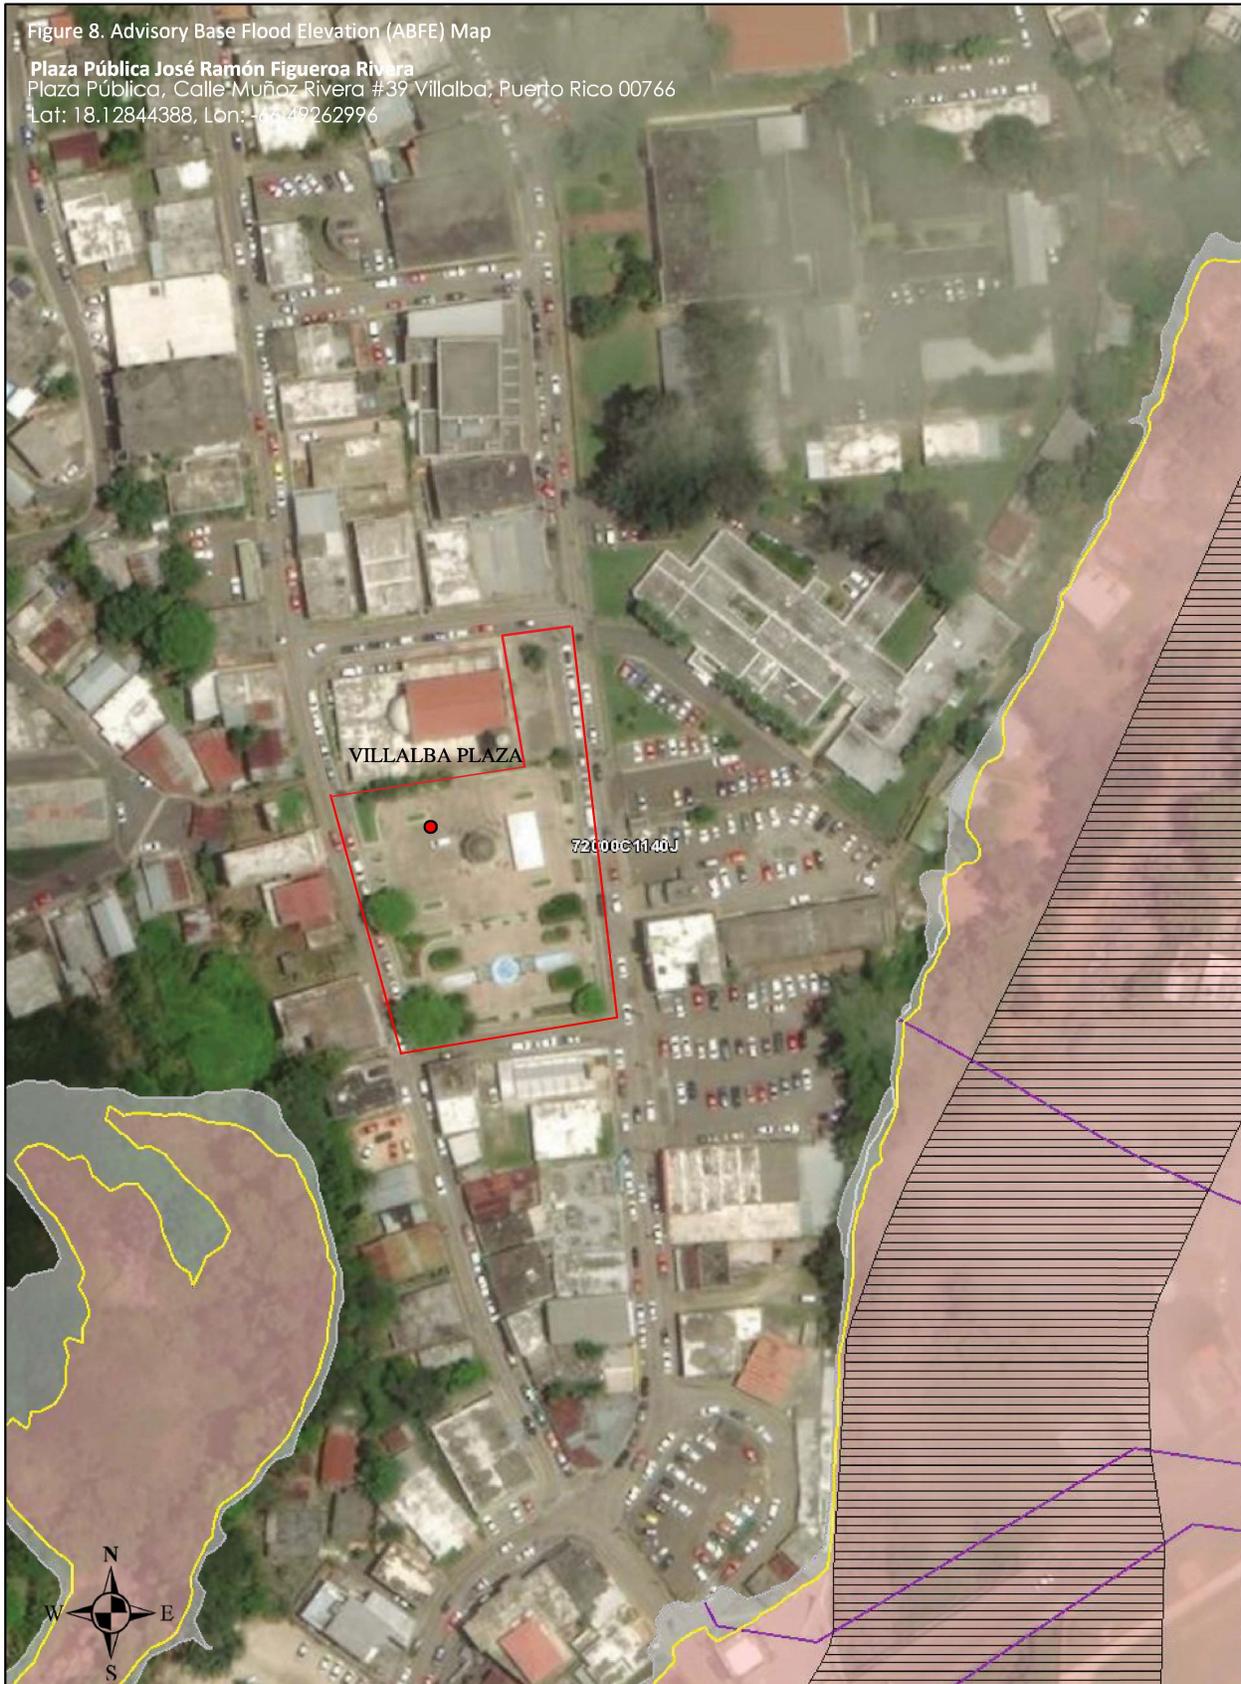
Figure 8. Advisory Base Flood Elevation (ABFE) Map

**Plaza Pública José Ramón Figueroa Rivera**  
 Plaza Pública, Calle Muñoz Rivera #39 Villalba; Puerto Rico 00766  
 Lat: 18.12844388, Lon: -66.49262996

The proposed project is not located in a Federal Flood Risk Management Standard (FFRMS) floodplain. The presence of the location in a FFRMS floodplain was assessed using the best available data and the FEMA-defined 0.2 Percent-Annual-Chance Floodplain Approach (0.2PFA). The project site is not within the 0.2 percent chance of flood, nor is there any hydrologic or hydraulic data to indicate the likelihood of flooding at the project site. The Project site is not in the 100-year Special Flood Hazard Area (SFHA), as indicated on the FEMA Recommended Base Flood Level Maps (Advisory Maps), Map from December 11, 2018. The project site is within the Zone X area of minimal flood hazard. The project is not considered a critical action under 24 CFR Part 55. The Project is in compliance with Executive Order 11988, particularly section 2(a); 24 CFR Part 55, as amended by Executive Order 13690. See Appendix B, Figure 8, and Figure 5

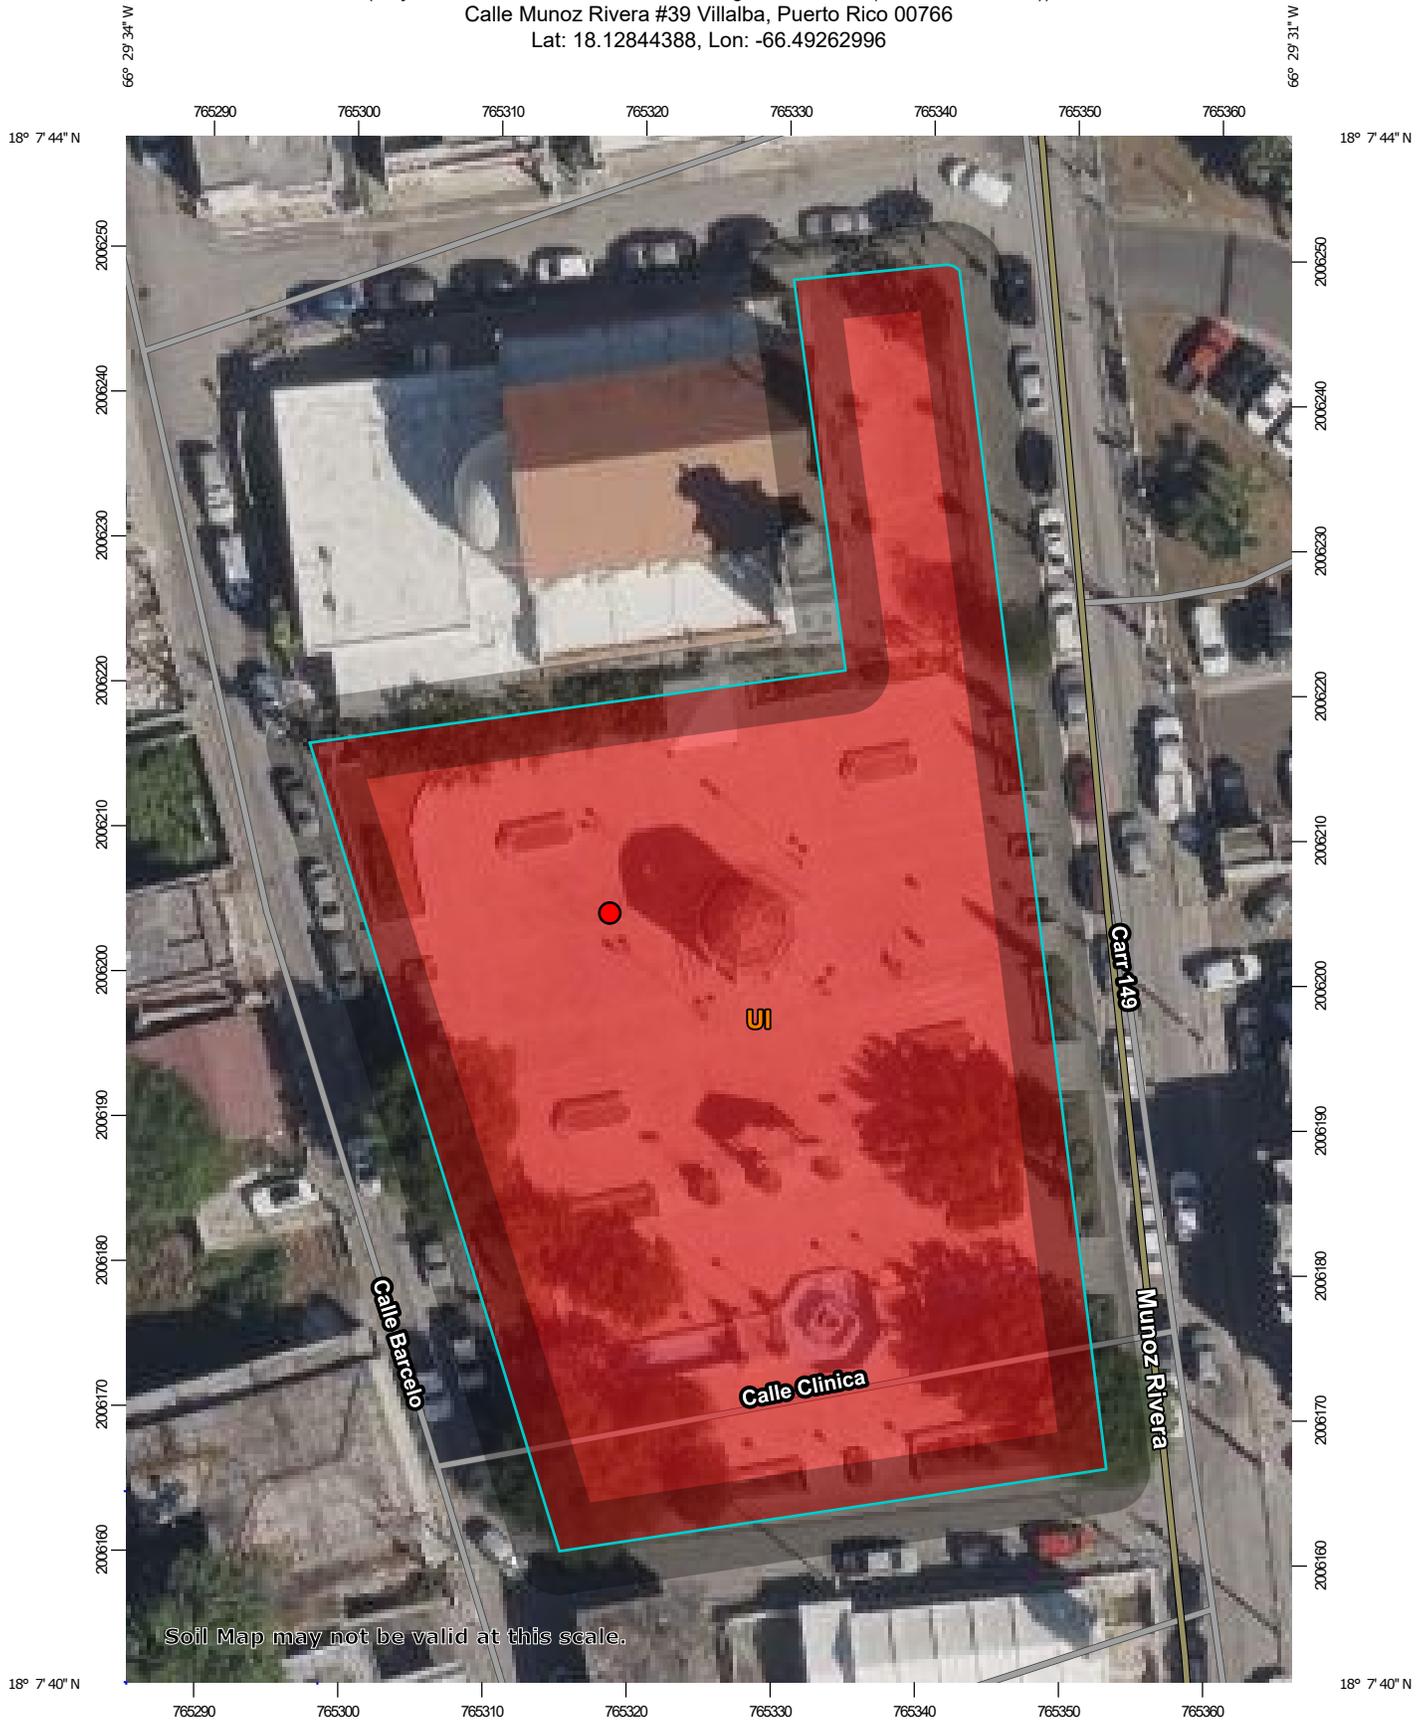
Figure 9. Farmland Classification—Ponce Area, Puerto Rico Southern Part  
 (Mejoras Plaza Publica Jose Ramon Figueroa Rivera (PR-CRP-000127))  
 Calle Munoz Rivera #39 Villalba, Puerto Rico 00766  
 Lat: 18.12844388, Lon: -66.49262996

Farmland Classification—Ponce Area, Puerto Rico Southern Part  
 ((Mejoras Plaza Publica Jose Ramon Figueroa Rivera (PR-CRP-000127)))

See Appendix B, Figure 9.

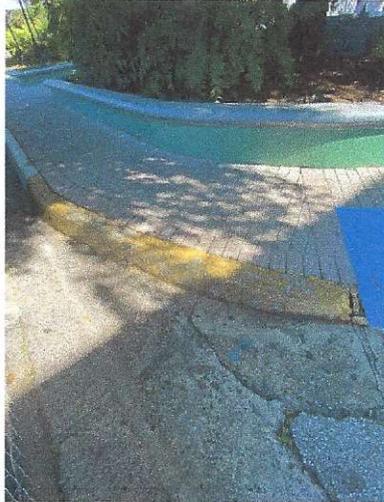
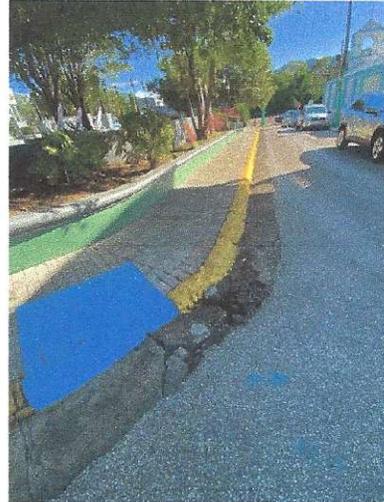
Curves at Southwest Area (Approximately 30 lineal feet)\*

**\*The Quantification of the areas is only an estimated. The Contractors shall estimate the amount of materials to be abated**

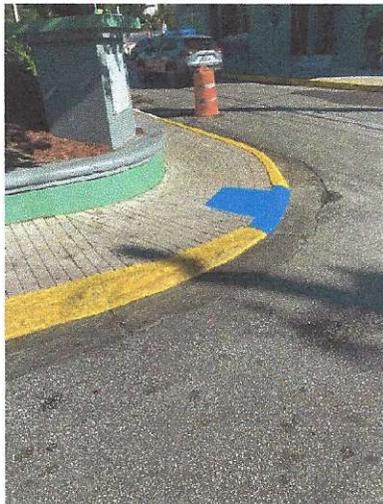
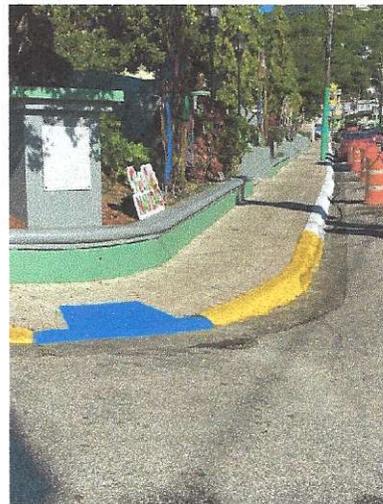
Curves at Southeast Area (Approximately 30 lineal feet)\*

**\*The Quantification of the areas is only an estimated. The Contractors shall estimate the amount of materials to be abated**

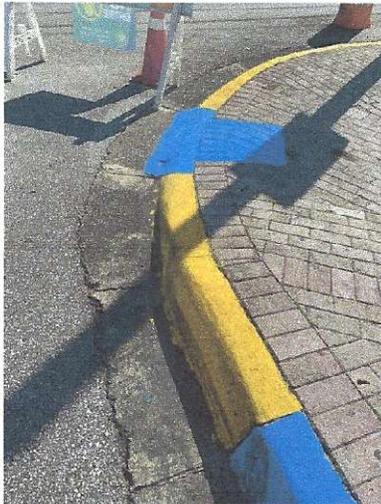
Curves at Northeast Area (Approximately 24 lineal feet)\*

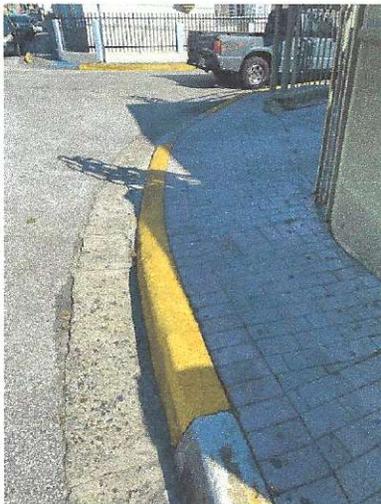
Curves at Northeast Area (Approximately 20 lineal feet)\*

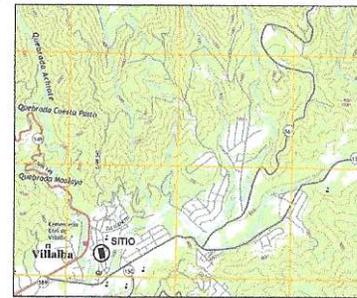
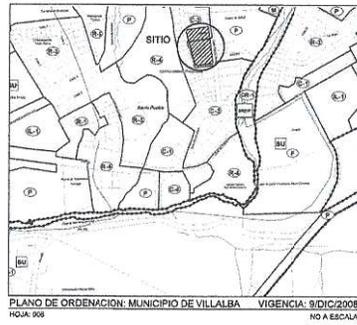
Título  
**PLANO DE MENSURA Y TOPOGRAFIA**

- NOTAS:**
- EL CONTROL HORIZONTAL HA SIDO REFERENCIADO AL SISTEMA DE COORDENADAS PUERTO RICO NAD\_83(2011) (EPSG:2010.0000).
  - TODAS LAS DISTANCIAS ESTAN EXPRESADAS EN METROS, O DE OTRA FORMA ESPECIFICADA.
  - LA INFORMACION ILUSTRADA EN ESTE PLANO REPRESENTA EL RESULTADO DE LA MENSURA REALIZADA EN LA FECHA INDICADA Y SOLO PUEDE SER CONSIDERADA COMO UNA INDICACION DE LAS CONDICIONES GENERALES EXISTENTES EN ESE MOMENTO.
  - EL INTERVALO DE LAS LINEAS DE CONTORNO ES DE 0.50 METRO.

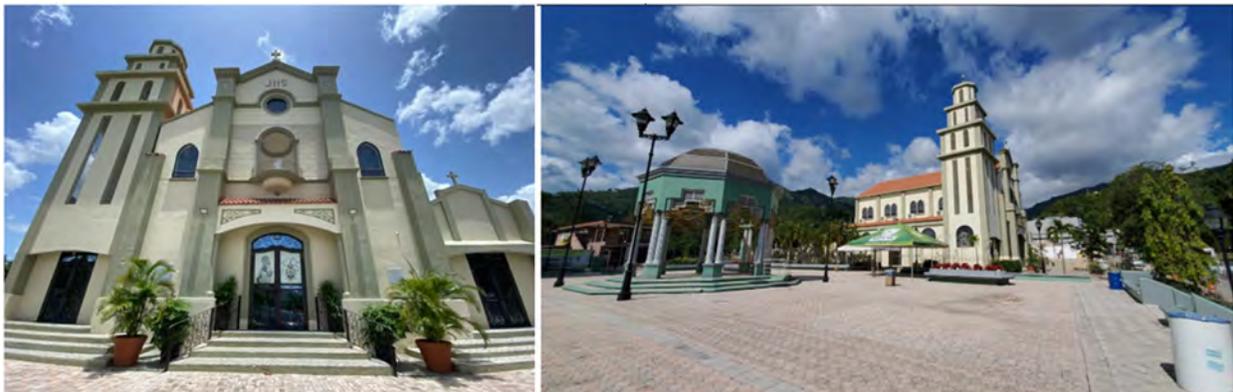
**Figure 5: Villalba’s Catholic Paric Façade (left) and Upper East Section of the Plaza (right)** (Lizardi Pollock and Vega 2023: 21 and 34)

There are six (6) known historic properties within the APE (refer to Figure 8). Two (2) of the historic properties are located within the project’s direct APE: the Plaza Pública José Ramón Figueroa itself, built circa 1923, and the Parroquia Nuestra Señora del Carmen de Villalba, built in 1928 (Figure 5).

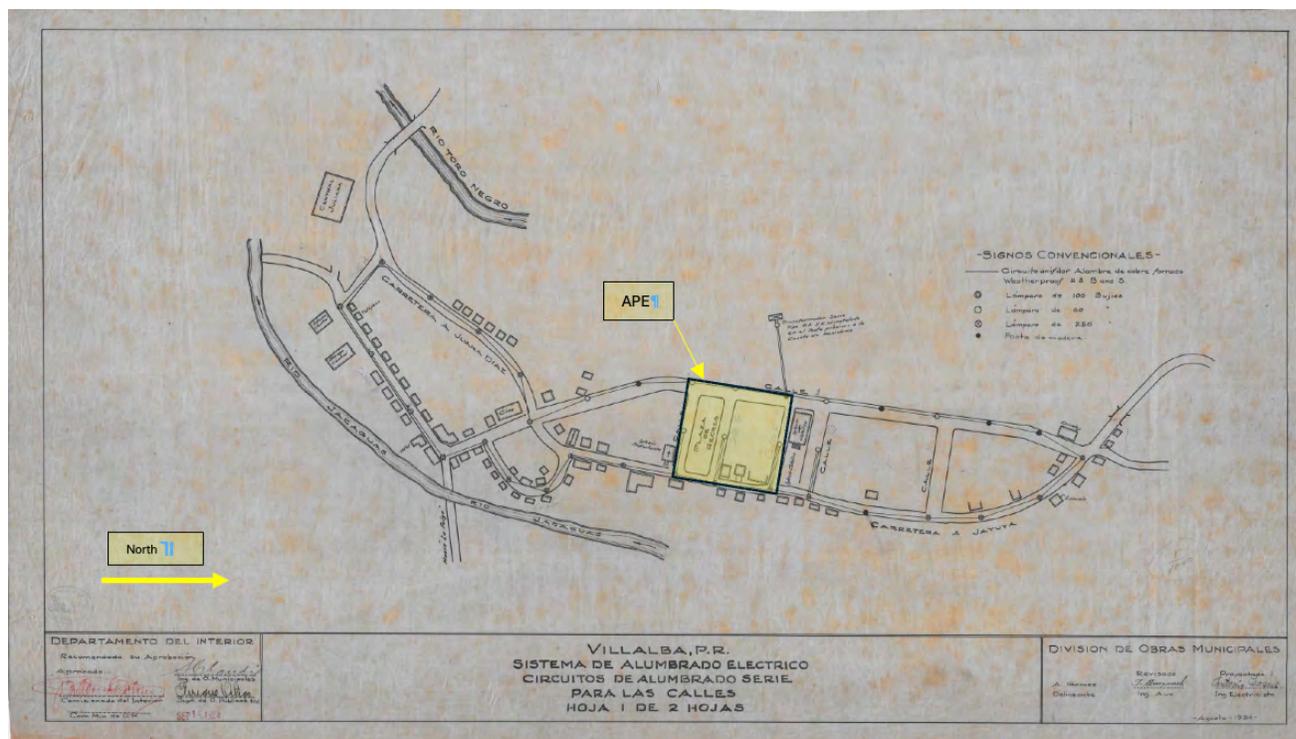
**Figure 11.** Villalba PR. Plan del Sistema de Alumbrado Eléctrico. División de Obras Municipales. 1924. Retrieved from Archivo Digital Nacional.

In 1924, and probably on the initiative of one of the wealthy residents, such as Walter McKown Jones, electric lighting was installed in the town. The plan drawn up by the Municipal Public Works Division of the Department of the Interior in 1924 identified the footprint of the Plaza and its surroundings (see Figure 11) by that time. The esplanade was a rectangular space oriented east to west between the current Muñoz Rivera and the Barceló streets. The Antolín Castillo Street and a Presbyterian (now evangelical) church, established in 1905 and occupying a concrete building in the southeast corner, flanked the south of the Plaza. The current Presbyterian church building is probably not the same as the one identified in 1924. The current one is made of concrete and has a concrete gabled roof and a central bell tower where its entrance is located. This entrance exhibits an arched lintel with an archivolt, flanked by two columns with capital but without a base. The architectural traits of this central element suggest this is the oldest part of the temple, probably built in the 1930s.

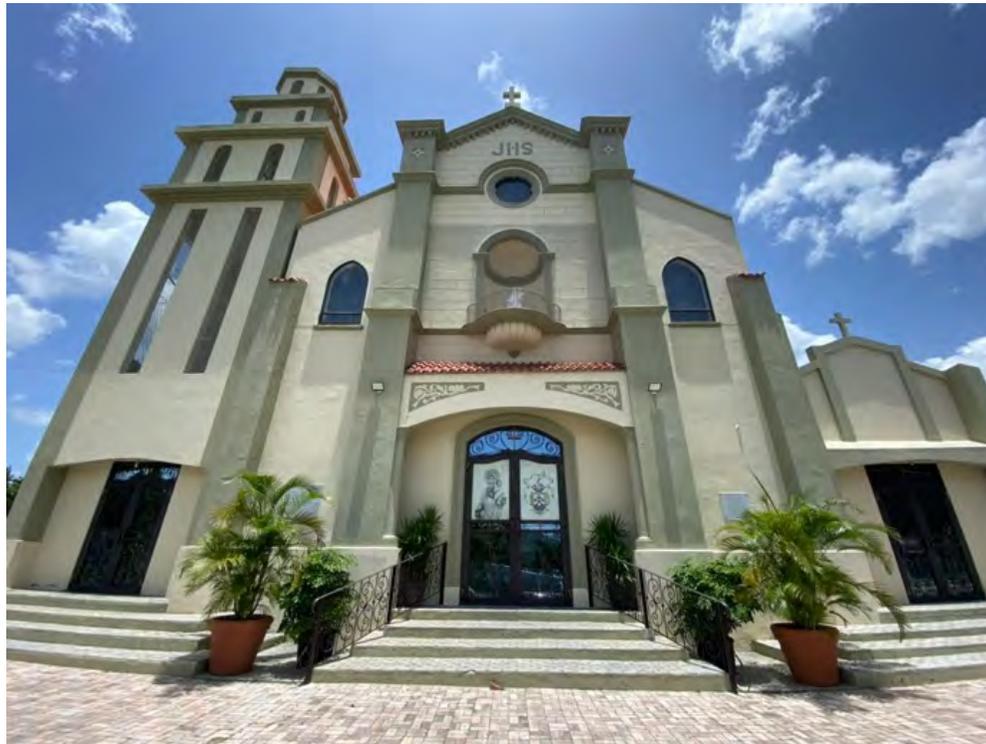
**Figure 14.** Villalba’s catholic parish façade, actual.

The 1928-29 church designed by Porrata Doria faces east, like the original wooden one. It has three bays, and an exedra covered by a semi-dome shelters the main altar. It is topped with a gabled wood and metal roof, with decorative corbels on the interior walls. Despite being an eclectic design that combines Spanish revival, neoclassical and neo-Gothic elements, the Porrata Doria design exhibits a strict symmetry in all its elevations. The church entrance is framed by two concrete buttresses, a short entrance tympanum covered by a short overhanging eave with clay shingles on top, flanked by two pseudo-Romanic columns. Over it, there is a niche with a sculpture of the Virgen del Carmen, flanked by two ogival windows, above an oculus with stained glass, a roof crowned by denticles and cornice, and a simple Latin cross. The lateral elevations are equally symmetrical, segmented by buttresses, paired ogival stained glass windows between them, and an access tympanum in the center. The 1989 renovation ended the symmetry conceived by Porrata Doria, adding a stepped bell tower on the left side of the façade and a new nave, although lower than the clerestory windows. On the left side of the façade, a building that serves as an extension of the Church's interior space and as a parish house was annexed. The wrought metal fences that surrounded the atrium and perimeter of the temple were replaced by others of more modern design, thus maintaining the separation between the building and the Plaza. (Figure 14).

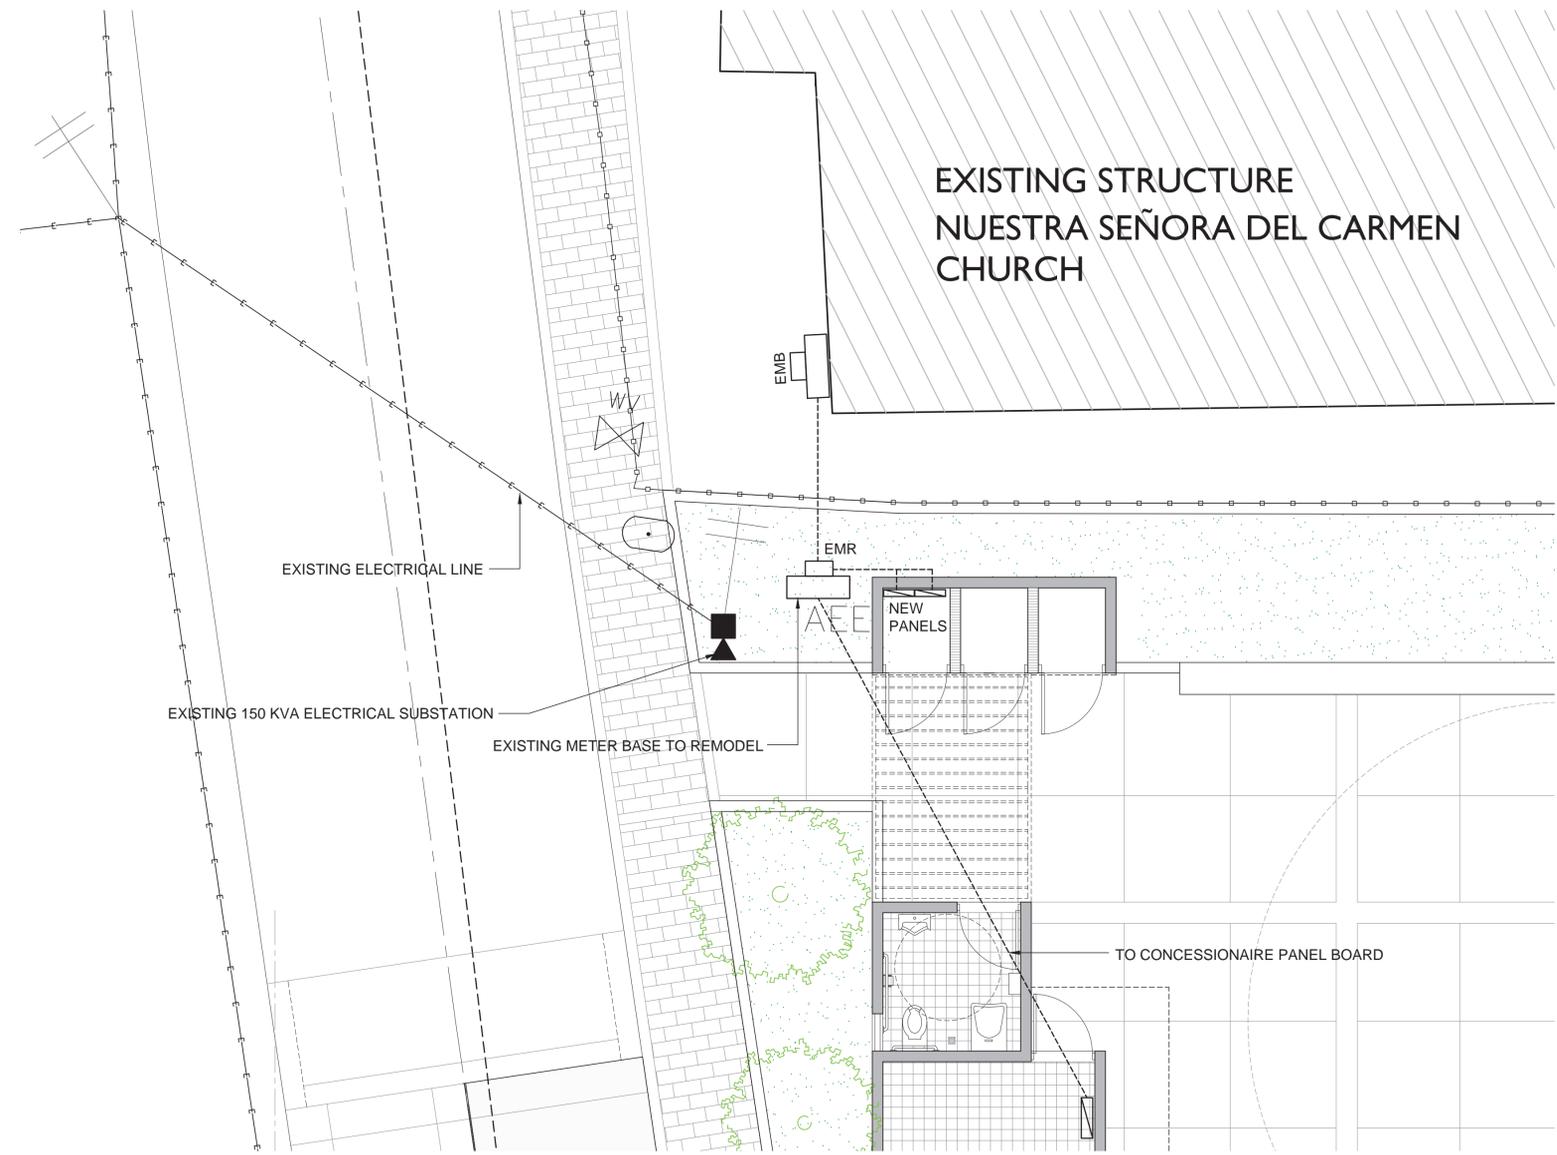
12. 200A 3PH 120/240V PANELBOARDS TO SERVE PUBLIC AREA. SEE SCHEDULE FOR DETAIL.
13. 100A 3PH 120/240V PANELBOARDS FOR CONCESSIONARY. SEE SCHEDULE FOR DETAIL.

14. SECONDARY FEEDER CONSISTING OF 4#3/0 THAN AND 1C#2 IN 2" CONDUIT. USE PVC SHC 40 FOR UNDERGROUND AND RGS EXPOSED.
