# **Environmental Assessment**

**Project ID:** PR-RGRW-02735

**Project Name:** Agrojibaro LLC

**Responsible Entity:** Puerto Rico Department of Housing

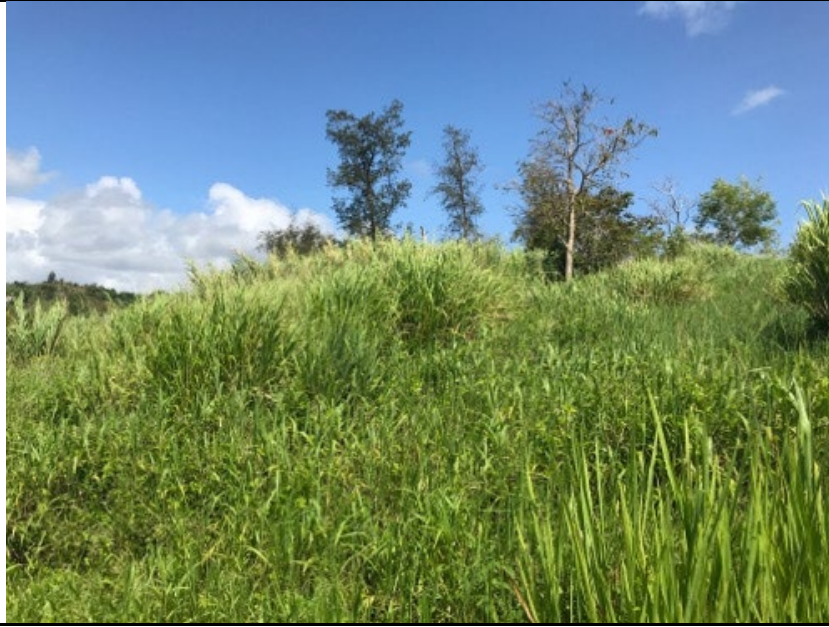
**Scope Of Work**

Photo Description: Scope of work 1: construction of a greenhouse

The scope of work for this project includes the purchase of a tractor and two greenhouses. The applicant plans to purchase and install two greenhouses for the crop of recaó. The Scope of Work 1 (SOW-1) is the installation of a 100-foot (ft) x 32 ft metal greenhouse structure with plastic and saran cover. The greenhouse will be anchored to the ground with 2 inches diameter pillars. Greenhouse front and side pillars are reinforced by a ratchet fixed to the ground to a maximum depth of 3 ft and attached to the top of each pillar with Galvanized Cord. Lateral and central pillar spacing varies depending on the greenhouse size. In average, lateral pillar spacing is 8 ft and central pillar spacing is 15 ft. The proposed greenhouse will require at least 34 posts. The greenhouse will be

installed on bare soil, no ground cover or concrete pad is included as part of the SOW. The structure is proposed to be installed on an available space area with approximate dimensions of 120 ft x 60 ft, located at coordinates 18.301694, -65.936497. Clearing and grading activities are required.

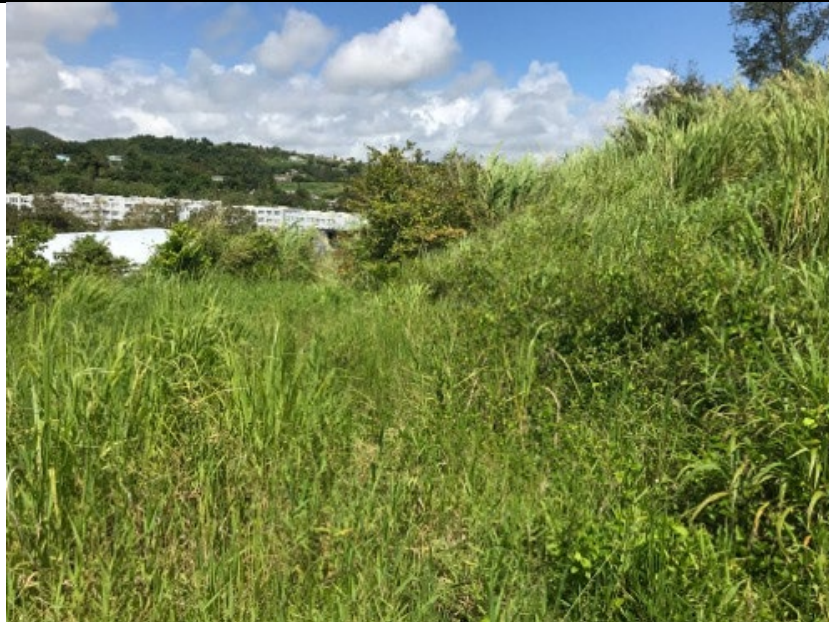
**Scope Of Work**

Photo Description: Scope of work 1: construction of a greenhouse

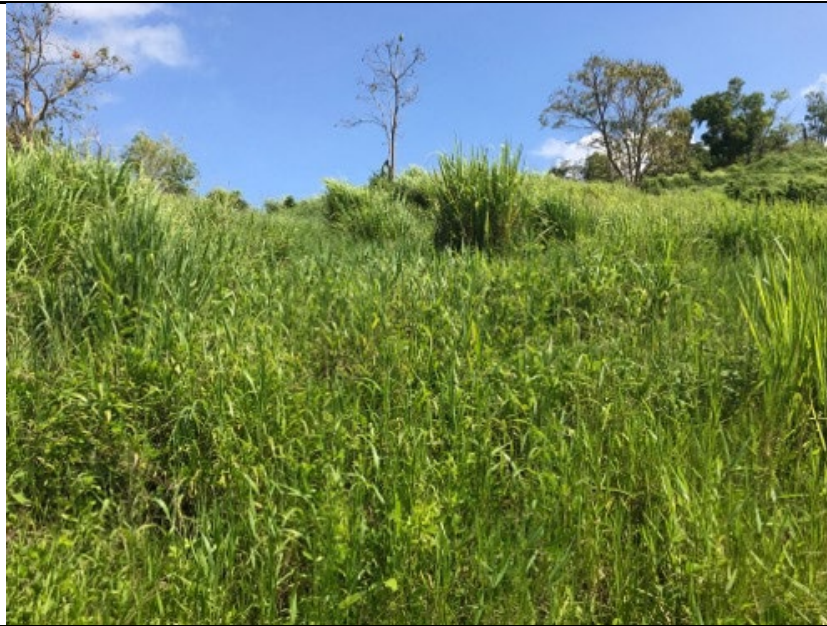
**Scope Of Work**

Photo Description: Scope of work 1: construction of a greenhouse

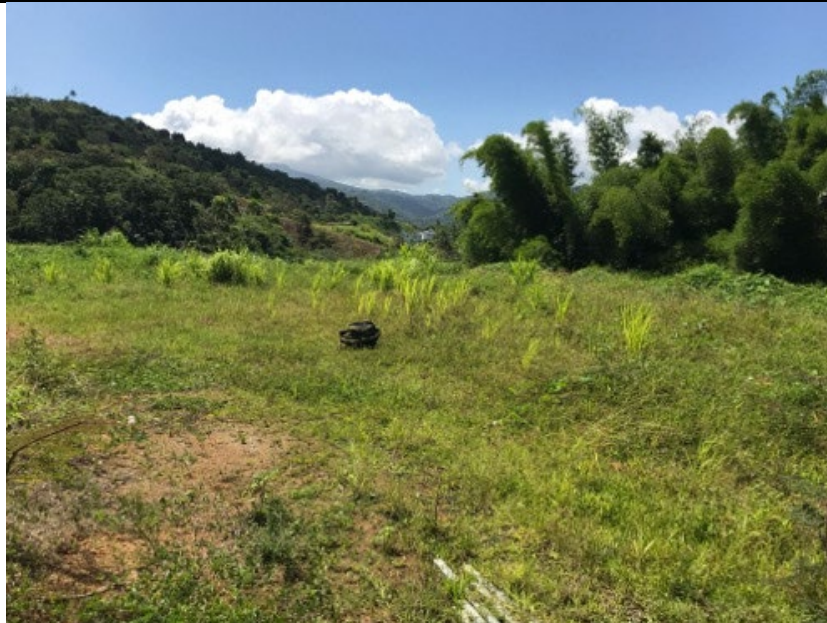
**Scope Of Work**

Photo Description: Scope of work 2: construction of a greenhouse

The Scope of Work 2 (SOW-2) is the installation of a second 100 ft x 32' metal greenhouse structure with plastic and saran; the greenhouse will be anchored to the ground with 2 inches diameter pillars. Greenhouse front and side pillars are reinforced by a ratchet fixed to the ground to a maximum depth of 3 feet and attached to the top of each pillar with Galvanized Cord. Lateral and central pillar spacing varies depending on the greenhouse size. In average, lateral pillar spacing is 8 ft and central pillar spacing is 15 ft. The proposed greenhouse will require at least 34 posts. The greenhouse will be installed on bare soil, no ground cover or concrete pad is included as part of the SOW. This greenhouse will be located at coordinates 18.301403, -65.936221, adjacent to the back of the existing greenhouse. The available space for the installation of the new structure is approximately 110 ft x 50 ft. Clearing and grading activities are required.

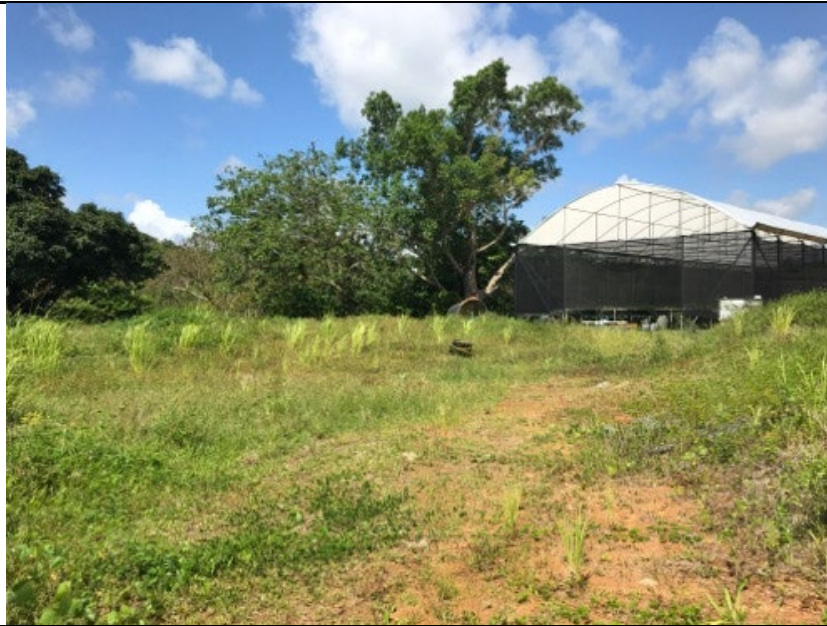
**Scope Of Work**

Photo Description: Scope of work 2: construction of a greenhouse

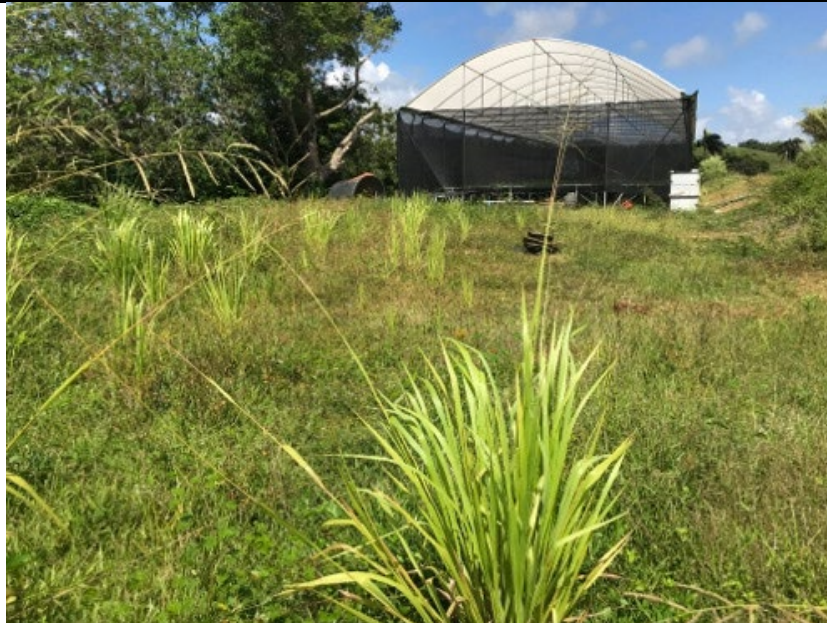
**Scope Of Work**

Photo Description: Scope of work 2: construction of a greenhouse

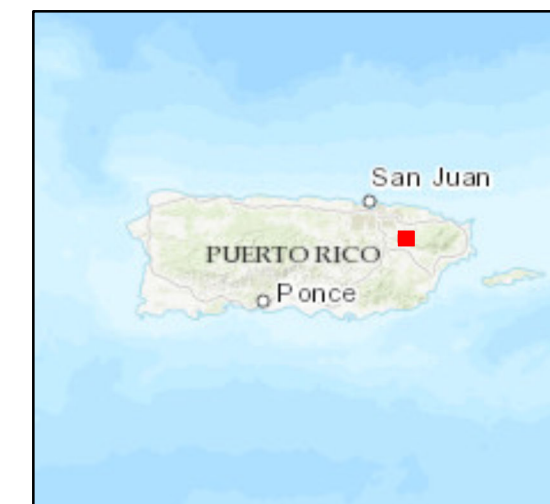
**Figure 4: FLOODPLAIN MANAGEMENT  
APPLICANT ID: PR-RGRW-02735**

- Legend**
- Project Parcel
  - Parcels
  - FIRM Panels
  - Floodway
  - 100 Yr Floodzone
  - 500 Yr Floodzone
  - Area Of Minimal Flood Hazard
  - Unmapped for Floodplain
  - Area of Potential Effect

<p><b>Flood Insurance</b></p> <p>Flood Disaster Protection Act of 1973 and National Flood Insurance Reform Act of 1994 [42 USC 4001-4128 and 42 USC 5154a]</p>	<p>Yes    No</p> <p><input type="checkbox"/>   <input checked="" type="checkbox"/></p>	<p>The Project site is located in Zone X, area of minimal flood hazard, as per Floodplain Insurance Map panels 72000C0765J and 72000C0770J, both with effective date November 18, 2009. This project is in compliance with Floodplain Insurance requirements. (See Figures 4 and 5 in <b>Appendix B.</b>)</p>

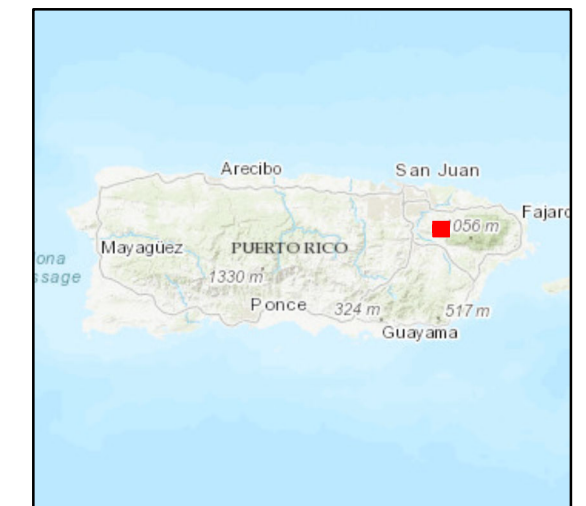
**Figure 6: ADVISORY BASE FLOOD ELEVATION**  
**APPLICANT ID: PR-RGRW-02735**

- Legend**
- ◆ Project Parcel
  - Parcels
- Legend**
- PuertoRico\_ABFE\_1PCT  
Advisory Base Flood Elevation (zoom in to make visible)
- 
- Flood Hazard Boundary (zoom in to make visible)  
Limit of Moderate Wave Action (LMWA)
- ▲
- Flood Hazard Extent
- 1% Annual Chance Flood
  - 0.2% Annual Chance Flood
- Zone/BFE Boundary
- 
- Flood Hazard Area (zoom in to make visible)
- Flood Hazard Zone
- A
  - AO
  - AE
  - Coastal A Zone
  - VE
  - X 0.2% Annual Chance Flood
  - A-Floodway
  - AE-Floodway
  - Coastal A Zone and Floodway
- Area of Potential Effect

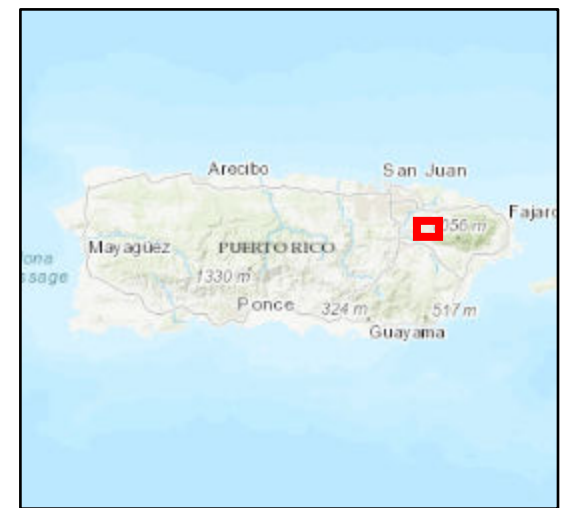
**Figure 8: TOXIC CHEMICALS AND GASES, HAZARDOUS MATERIALS, CONTAMINATION, AND RADIOACTIVE SUBSTANCES**  
**APPLICANT ID: PR-RGRW-02735**

- Legend**
- Project Parcel
  - AIR
  - NPDES
  - RCRA
  - Toxic Release Inventory Site
  - Superfund Site
  - Brownfield Sites
  - 3000 Ft Buffer AIR
  - 3000 Ft Buffer NPDES
  - 3000 Ft Buffer TRI
  - 3000 Ft Buffer Superfund
  - 3000 Ft Buffer RCRA
  - 3000 Ft Buffer Brownfield

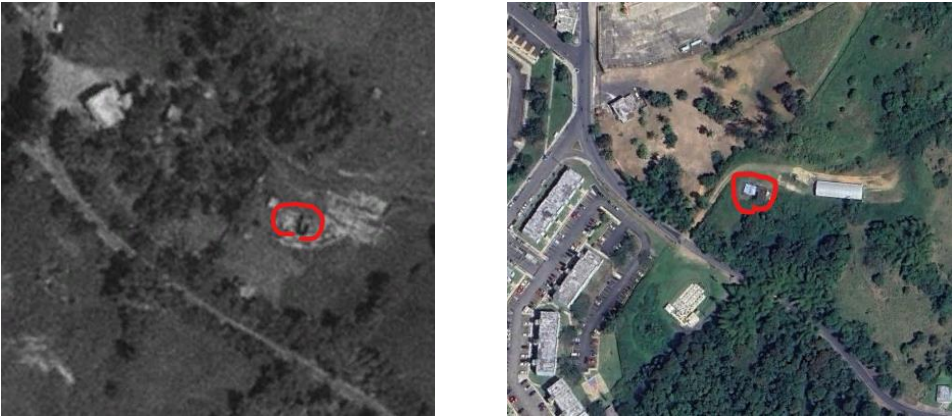
**Figures 1 & 2.** Detail of 1994 aerial image and of 2023 aerial image indicating the location of the building on the property.

The building on the property is used for storage and it is located west of the existing greenhouse. The two-story building has a concrete slab on grade foundation, reinforced concrete walls, and flat roof with overhangs. An addition on the right side has a metal roof over a wood frame structure. The building has metal double doors in front, has missing windows, and some of the openings are covered with concrete blocks. The second level is recessed from the front elevation, has no fenestrations or staircase to reach it.

The proposed project is located in a rural mountainous terrain. The property lies northeast of Route PR-853 in Carolina, near the limit with the town of Trujillo Alto to the west. A circa 1985 building that is the applicant's house, is located north of the APE geocoordinates. The building, shown below, appears on a 1994 aerial image shown below left, but not on a 1977 aerial image. A metal roof addition on the right side of the building appears in the 2023 aerial image shown below right.
