# Environmental Review for Activity/Project that is Categorically Excluded Subject to Section 58.5 Pursuant to 24 CFR 58.35(a)

Project Name: Mejoras en la Plaza de La Música (PR-CRP-000054)

**Description of the Proposed Project** [24 CFR 50.12 & 58.32; 40 CFR 1508.25]: The proposed project involves the rehabilitation and enhancement of the Plaza de Música, located at Guillermo Esteves St, Carr 141 Km 0.0, Bo. Pueblo, in the municipality of Jayuya, Puerto Rico. A project location map can be found in **Appendix A**. The site, covering 288.75 square meters, is designated as Commercial Intermedio (C-I) under zoning regulations and Suelo Urbano (SU) under the land use plan classification. The project

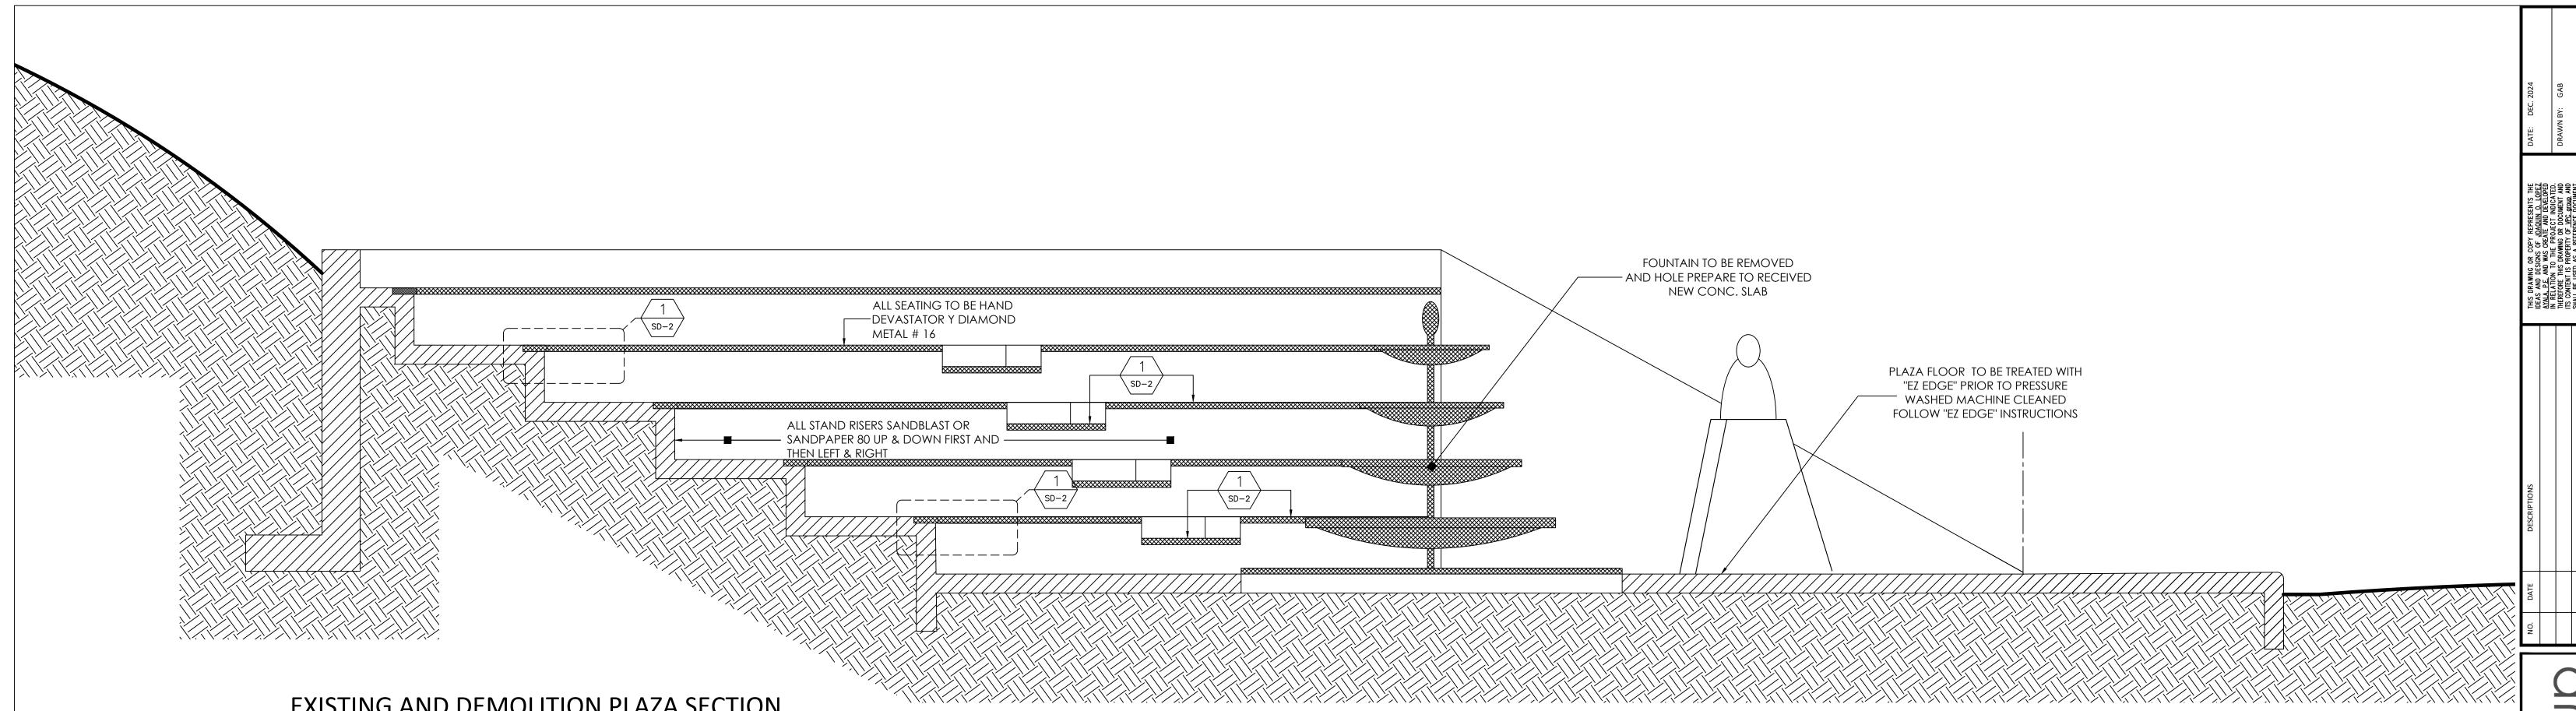
# EXISTING AND DEMOLITION PLAZA SECTION SCALE: 1/2"=1'-0"

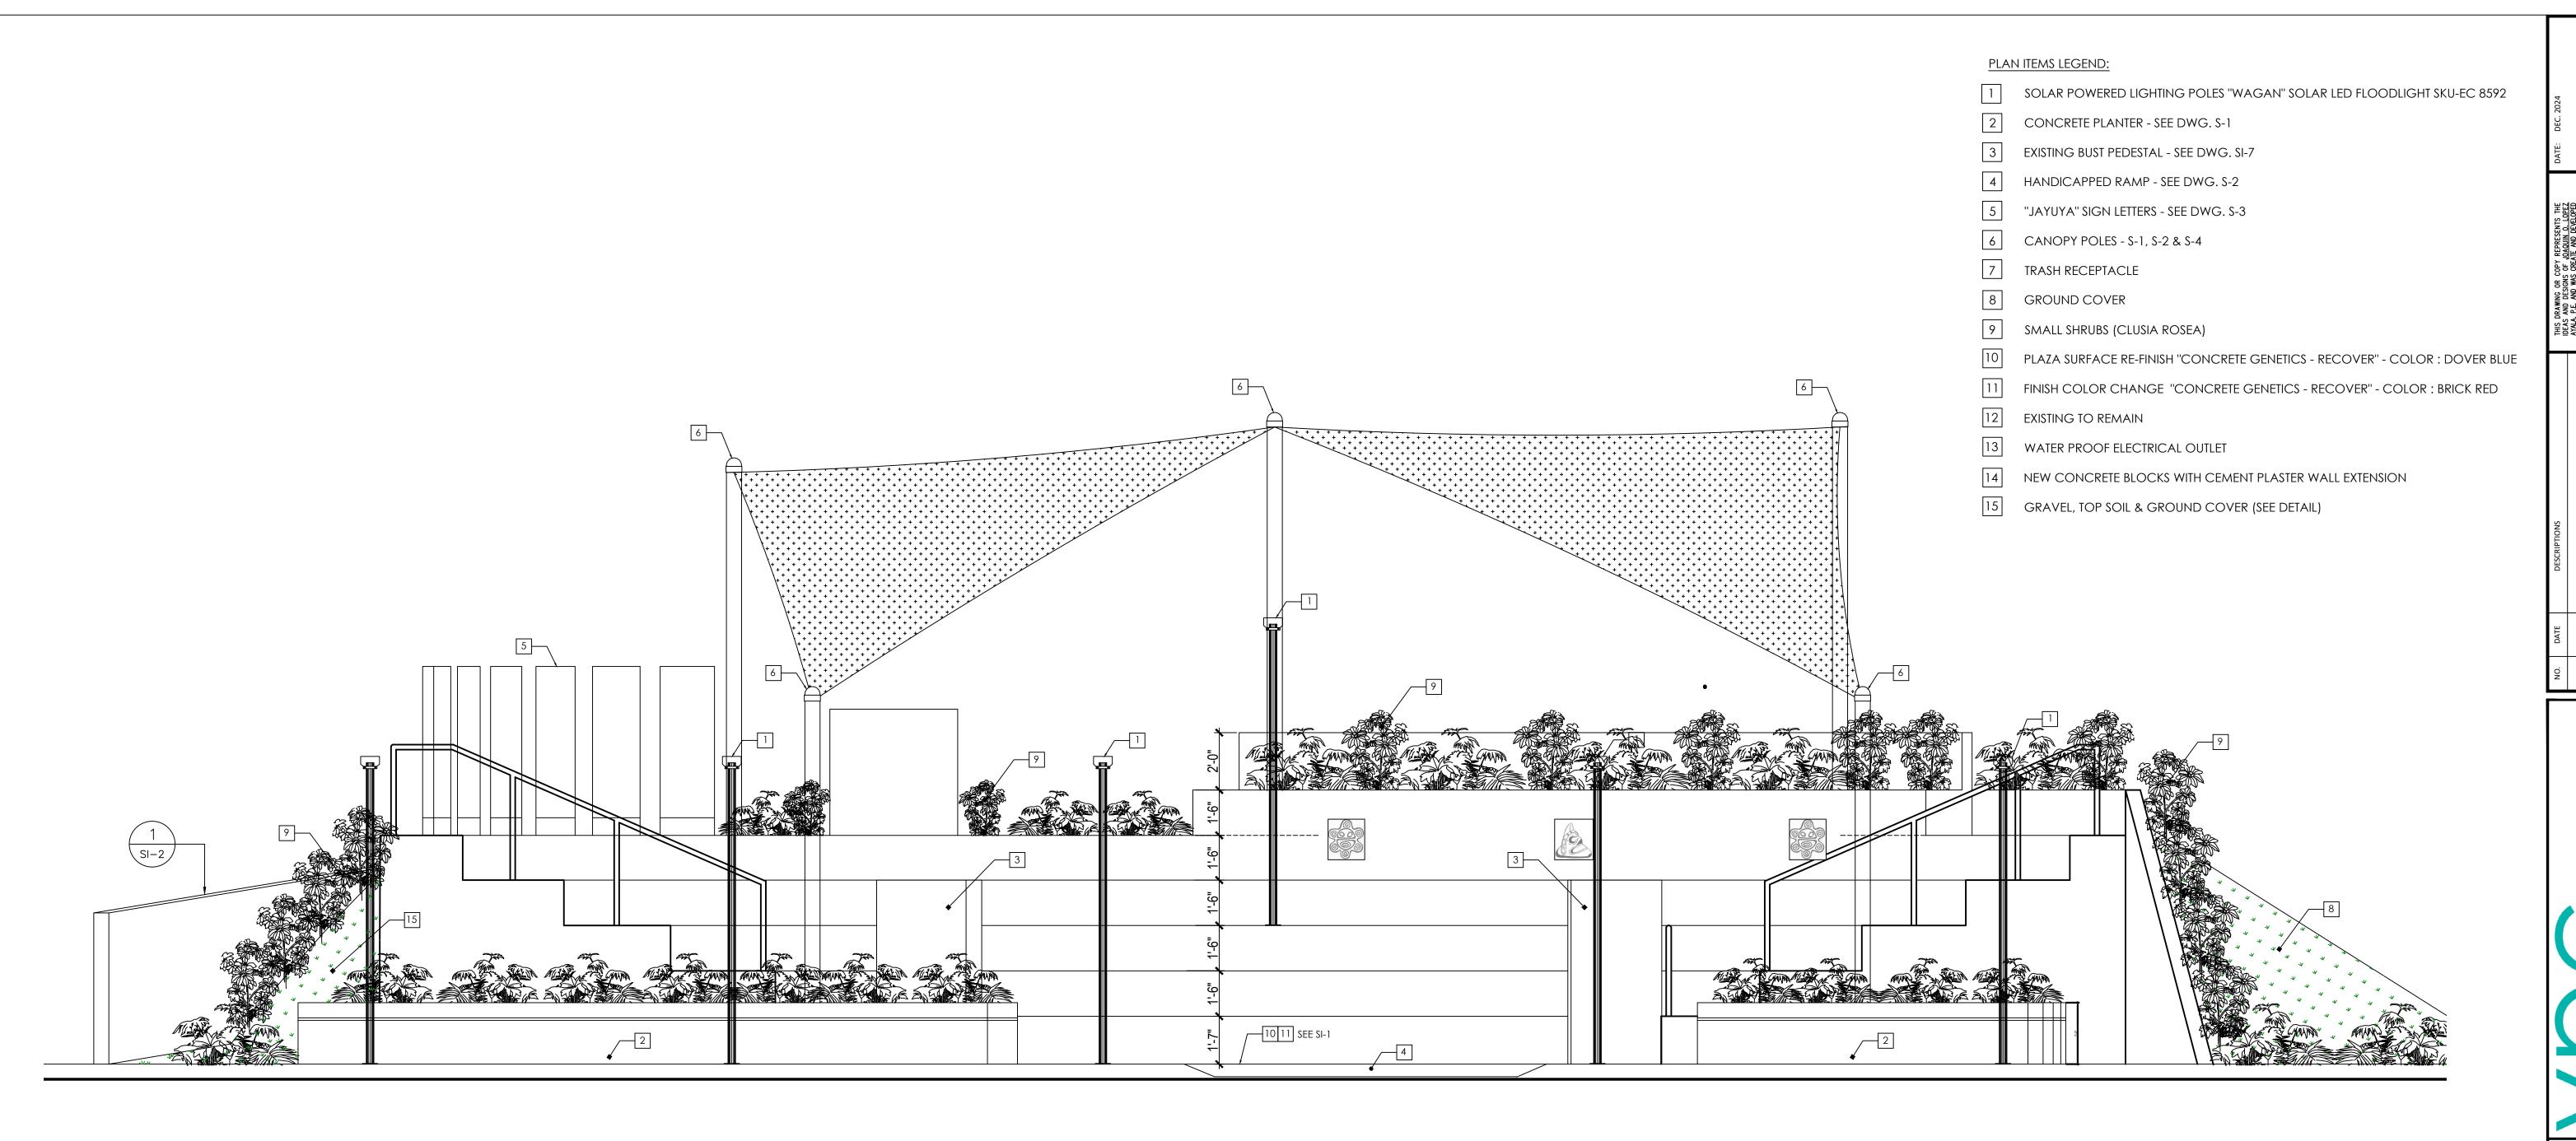
# PROPOSED PLAZA MAIN ELEVATION

SCALE: 3/8"=1'-0"

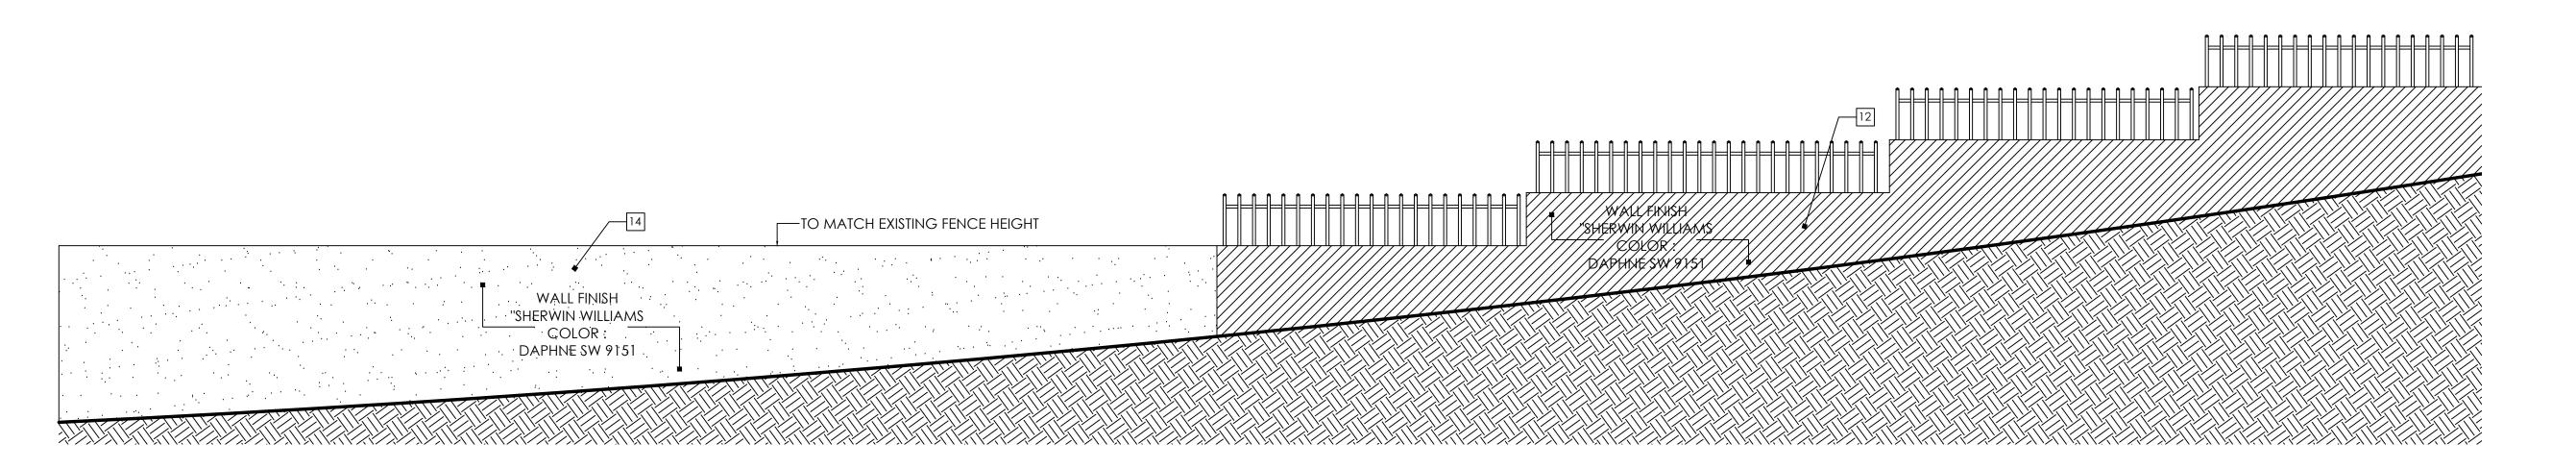
SIDE PROPERTY FENCE ELEVATION

SCALE: 3/8"=1'-0"

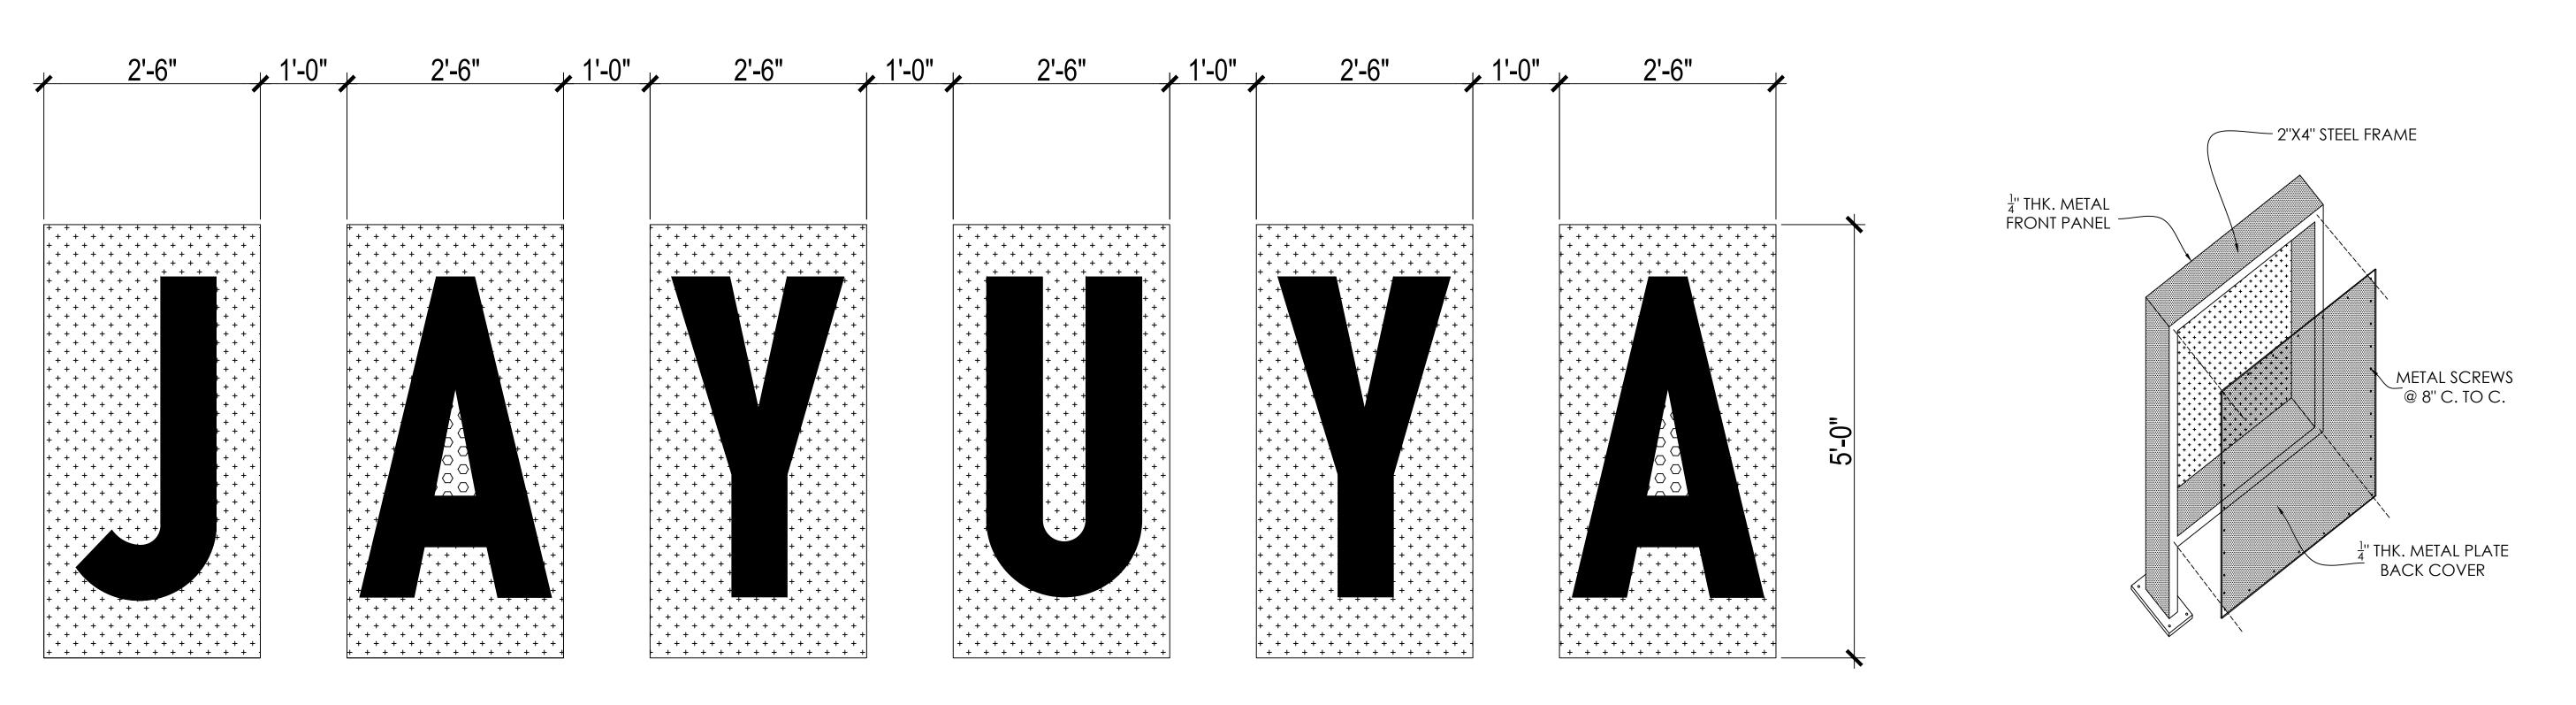
# SIGN LETTERS ELEVATION

SCALE: 1"=1'-0"

1-THE CONTRACTOR SHALL SUBMIT SHOP DRAWING PRIOR TO MANUFACTURE.

2-SUBMIT ANCHOR DETAIL PRIOR TO INSTALLATION.

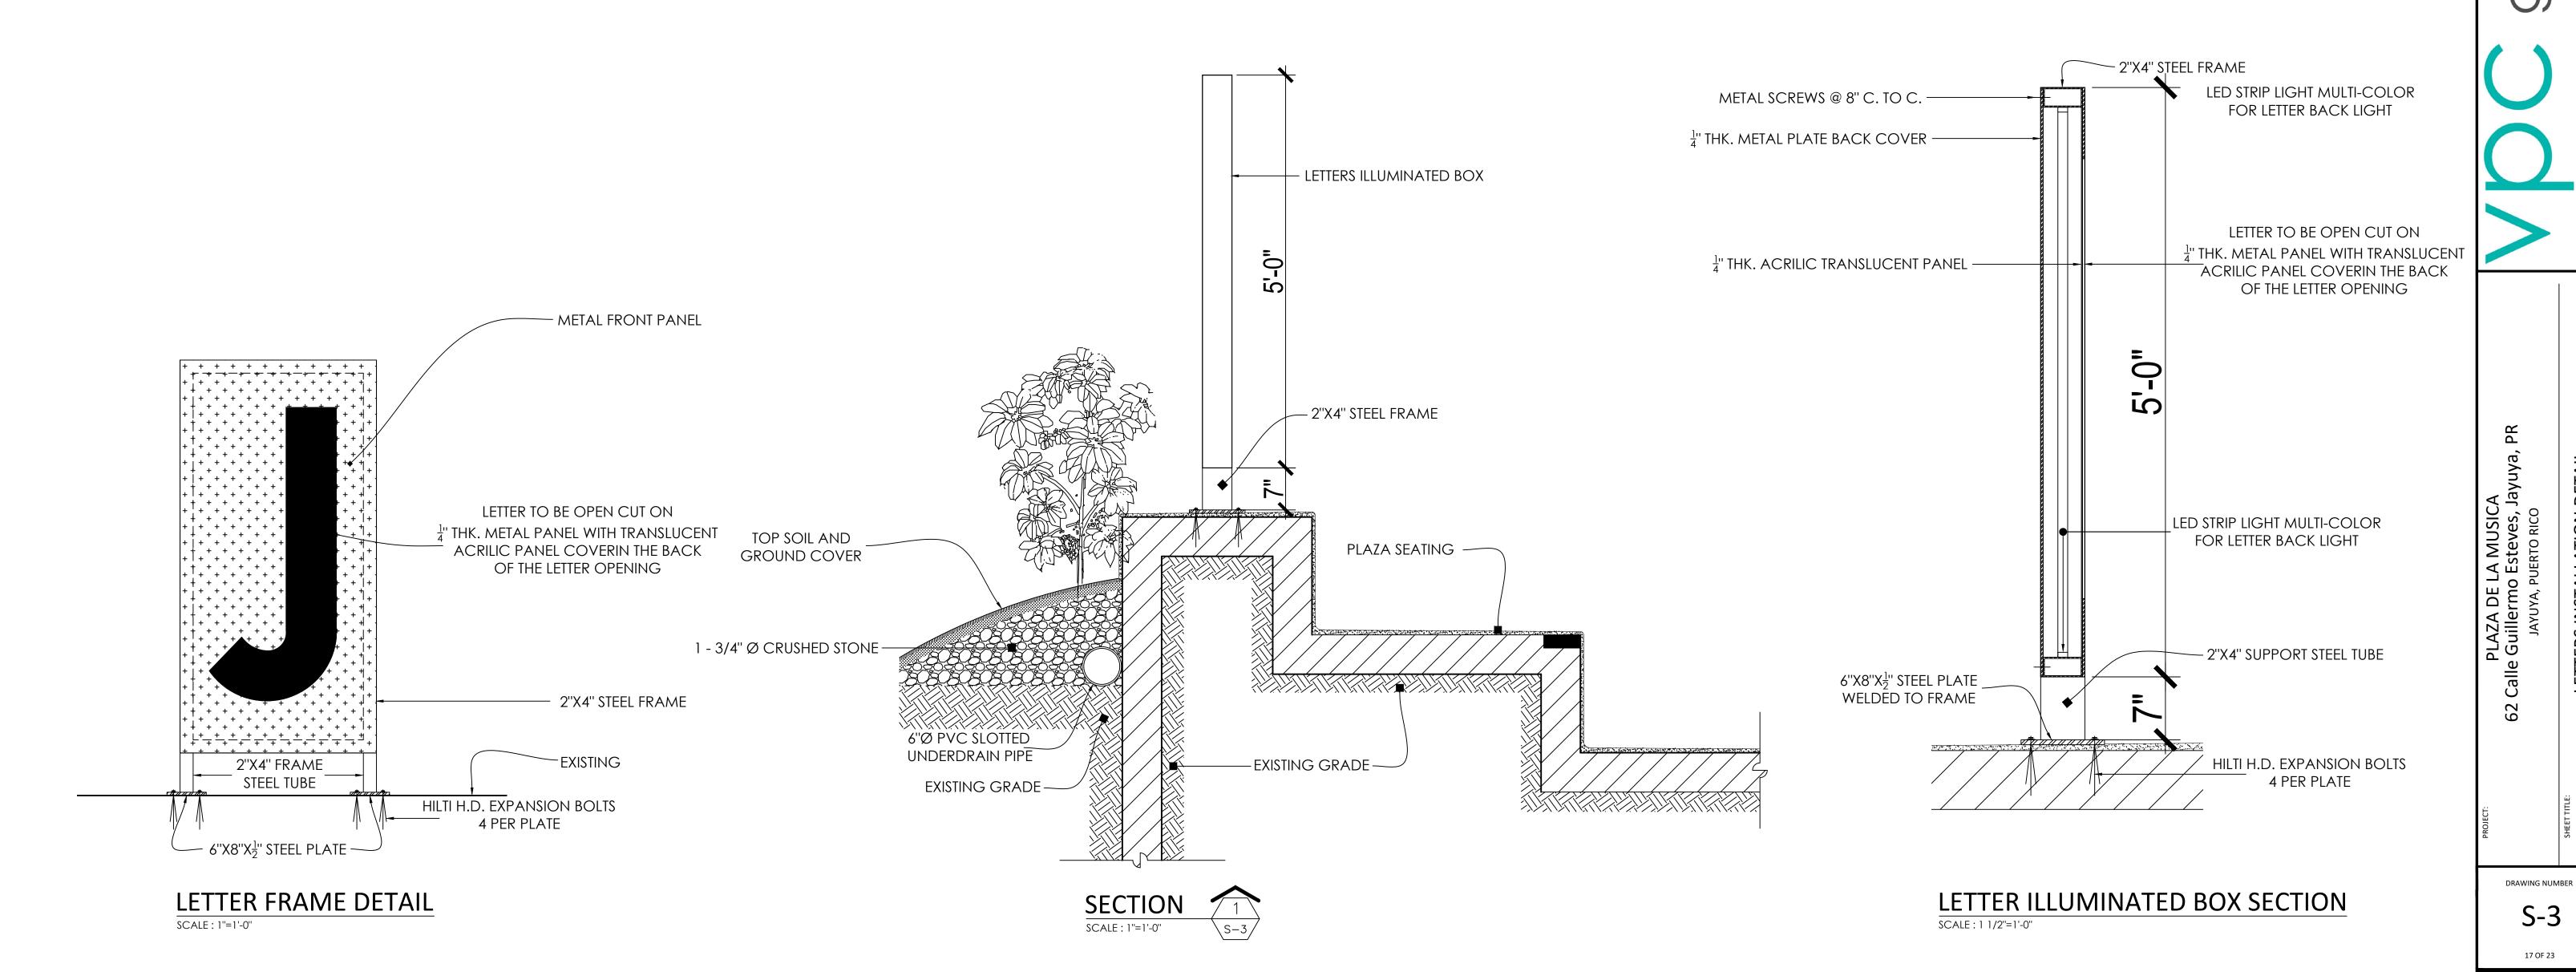
LETTER ILLUMINATED BOX

NOTE: FOR ADDITIONAL INFORMATION SEE SECTION ON THIS DRAWING

SCALE: 1 1/2"=1'-0"

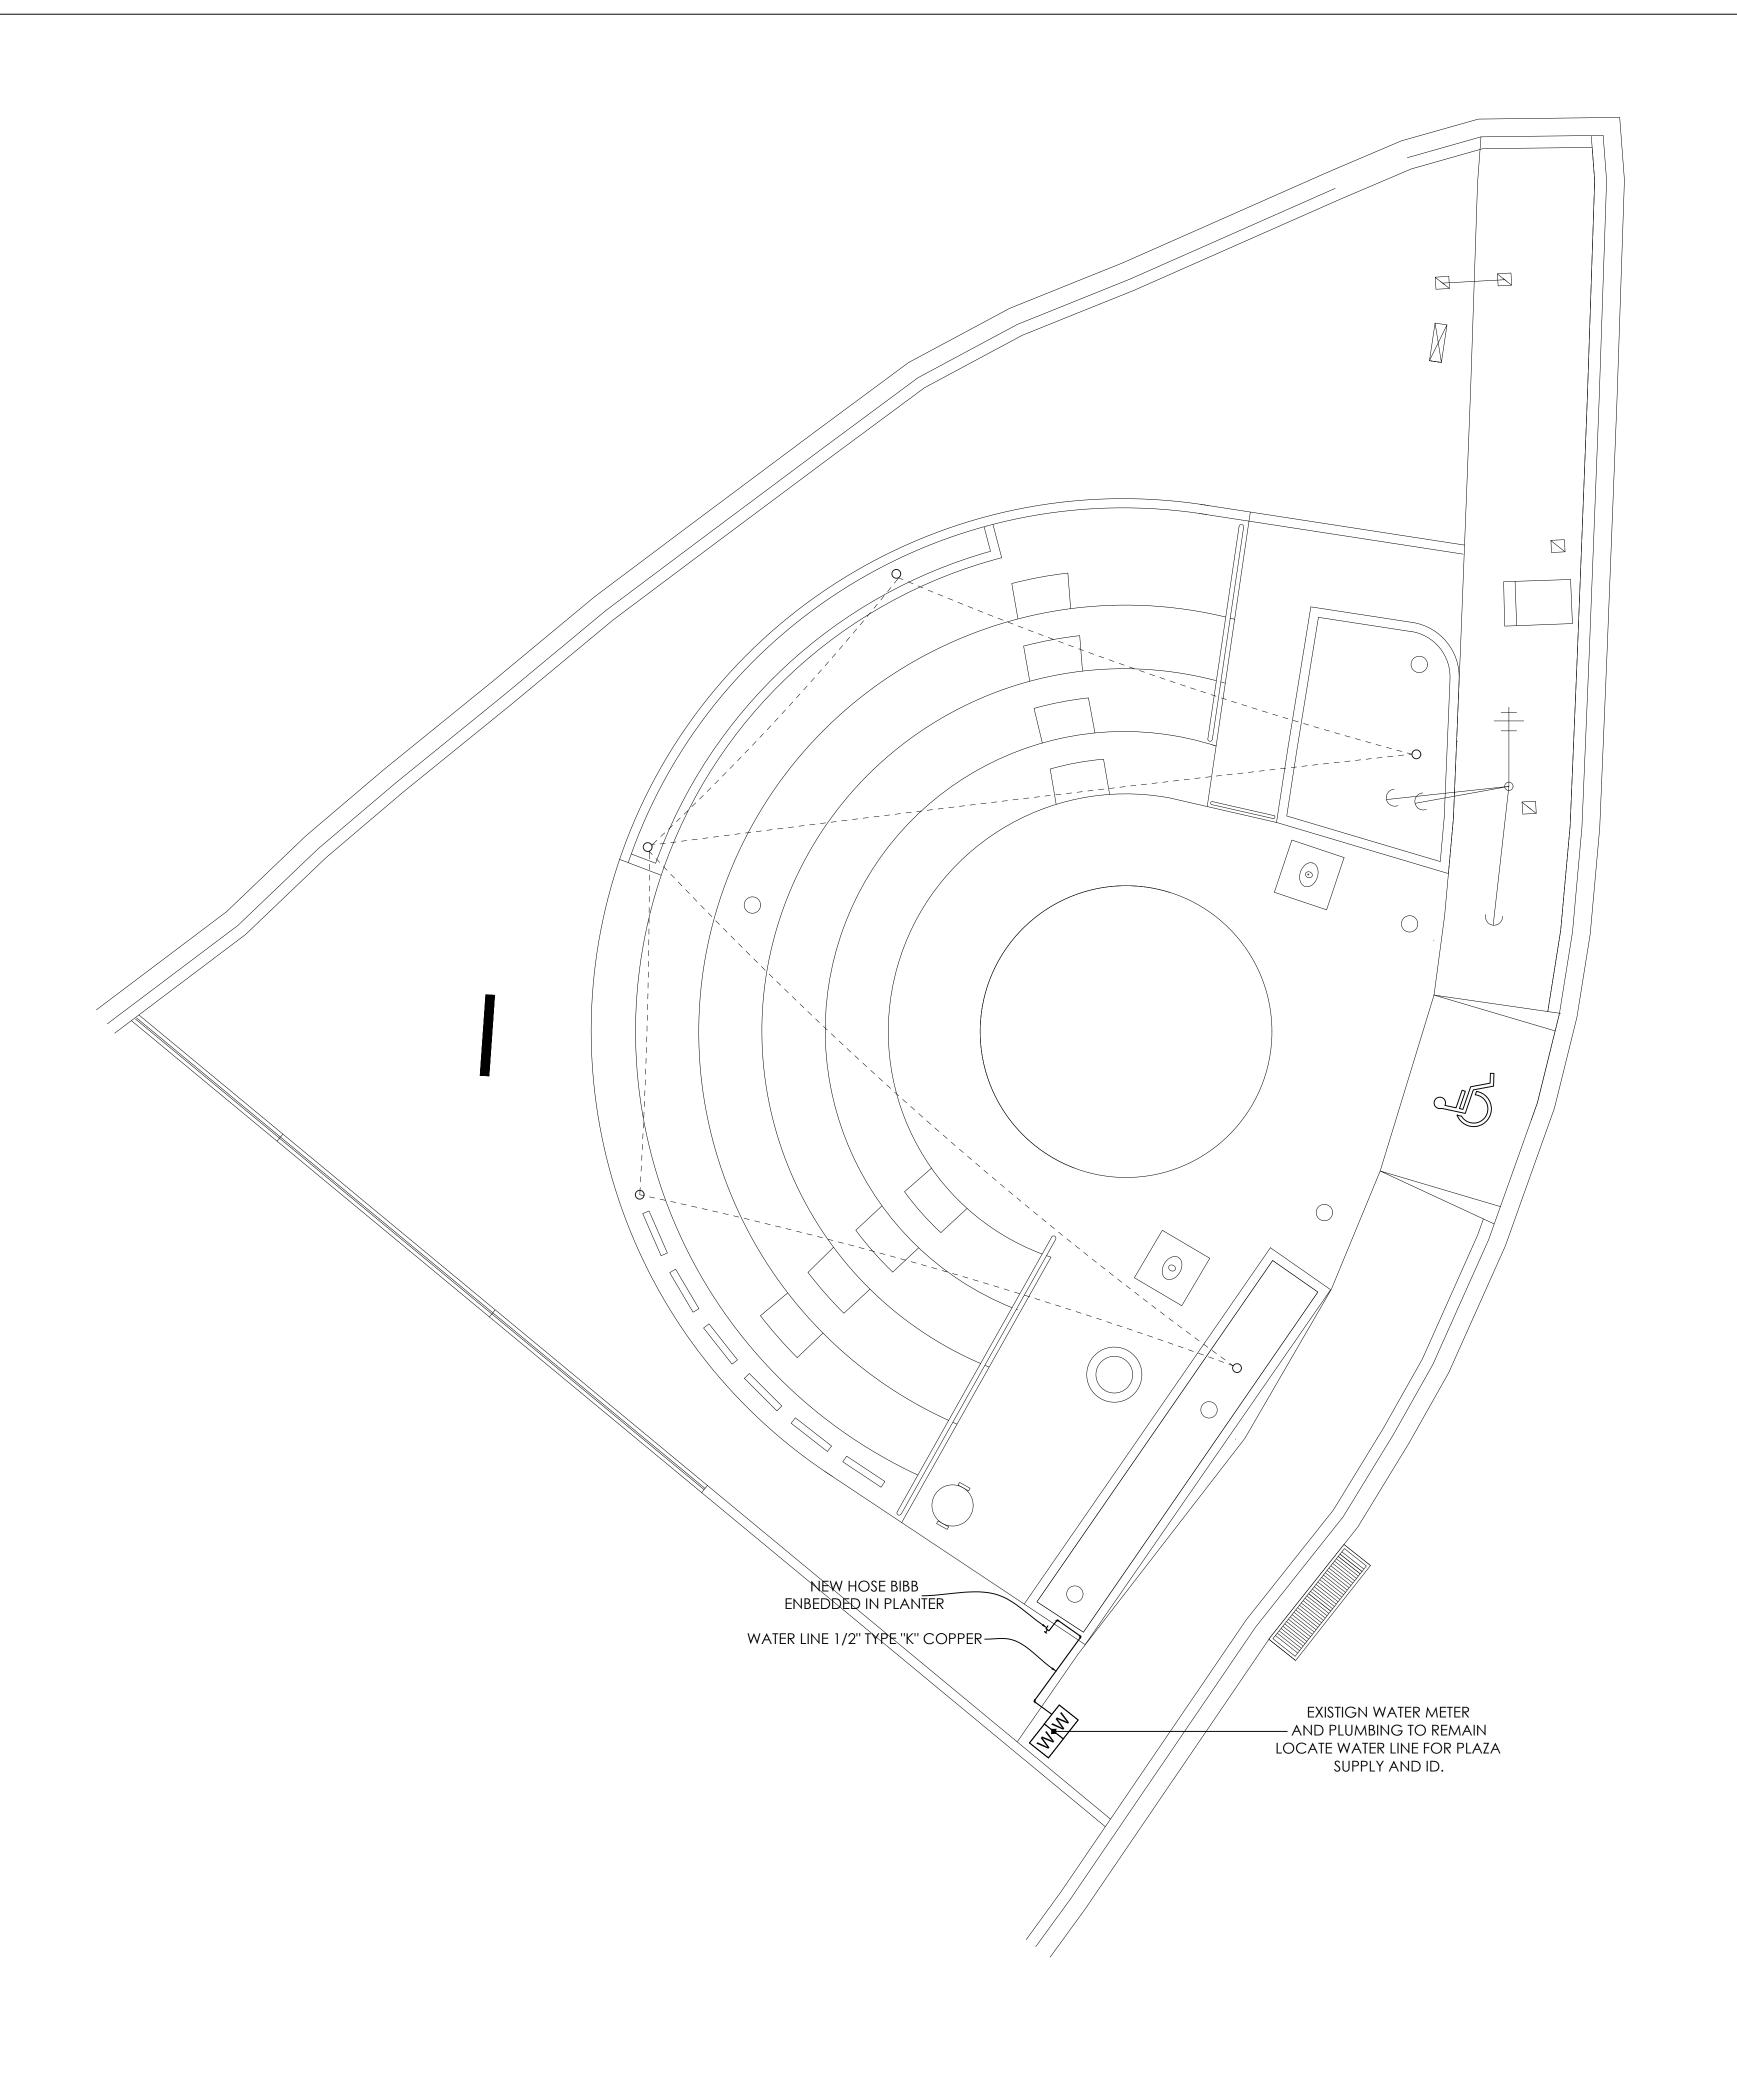
SITE PLUMBING LAYOUT
SCALE: 3/16"=1'-0"

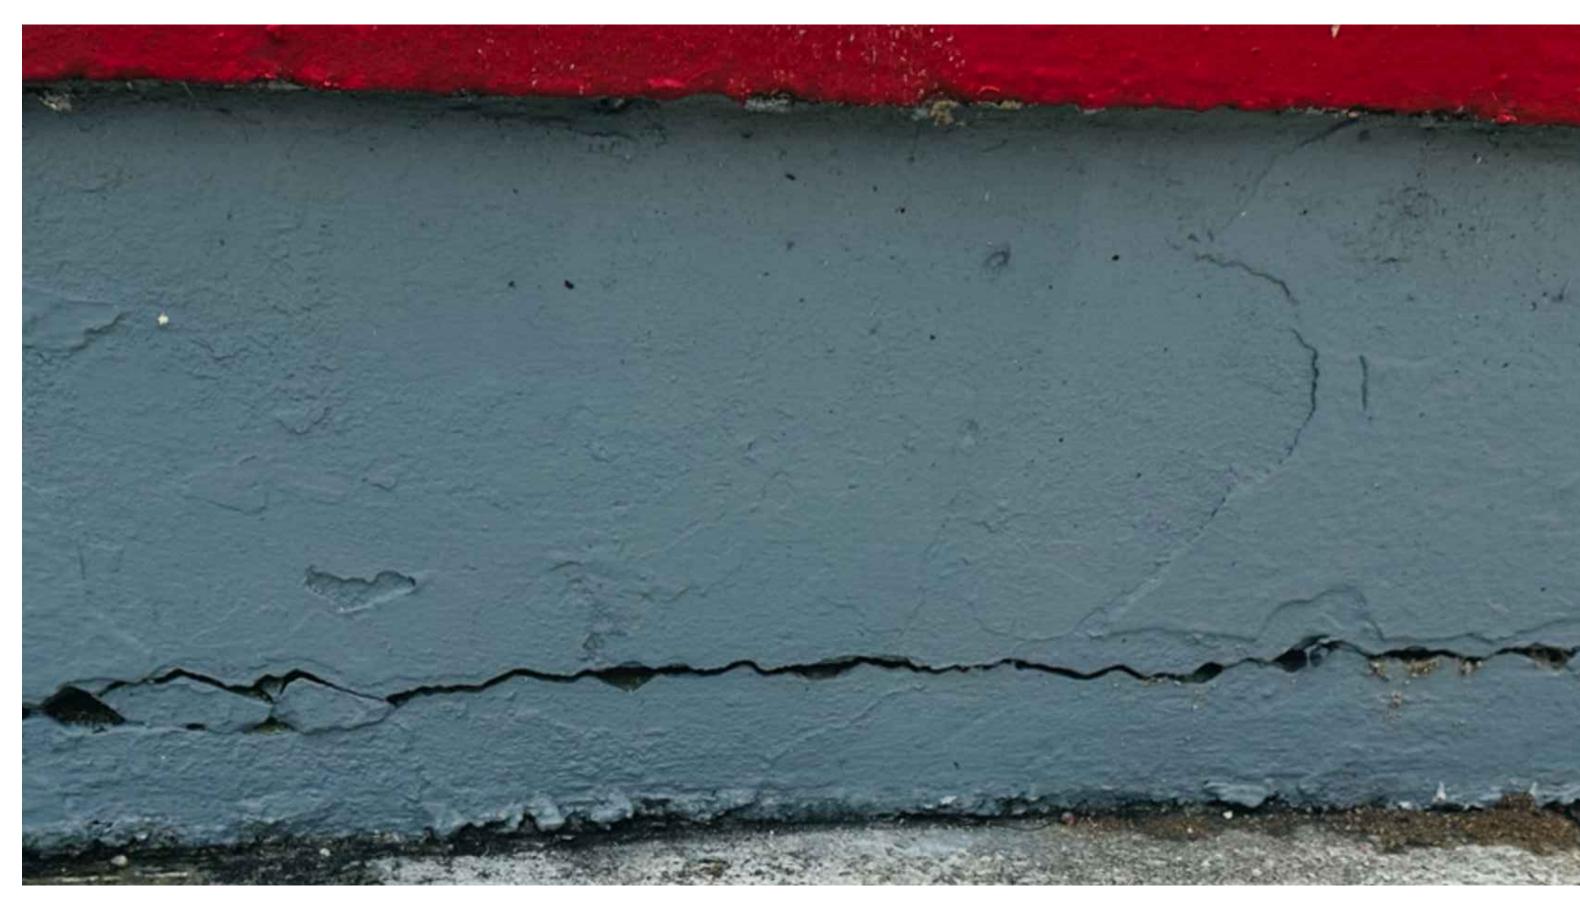
PH-9
Existing conditions of the plaza (broken concrete and deterioration)

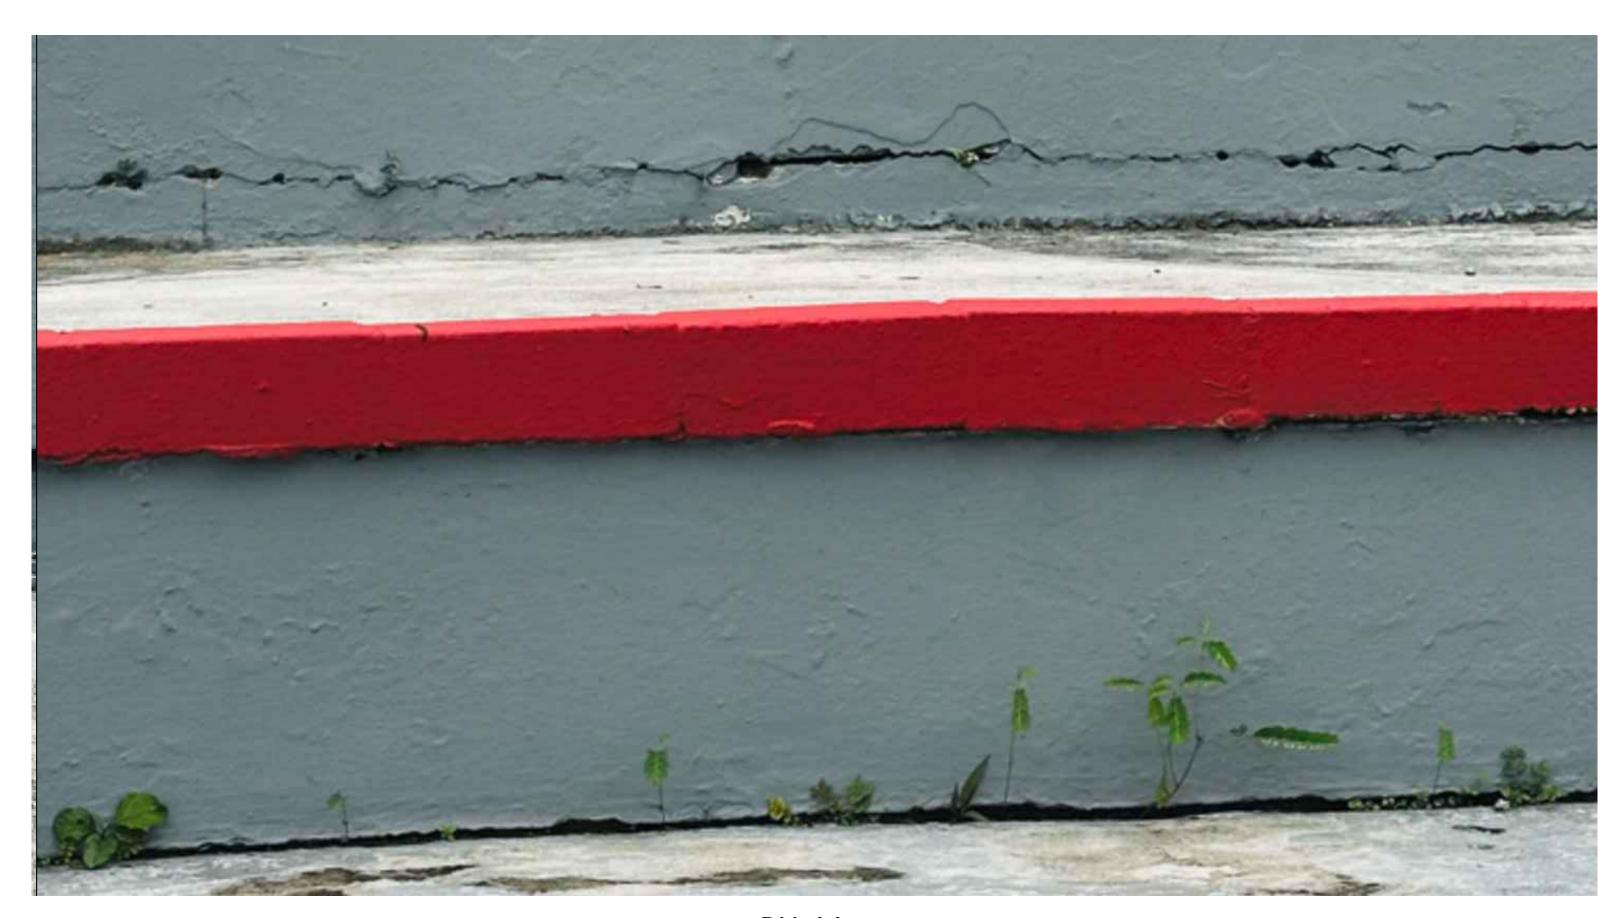
PH-11
Existing conditions of the plaza (broken concrete and deterioration)

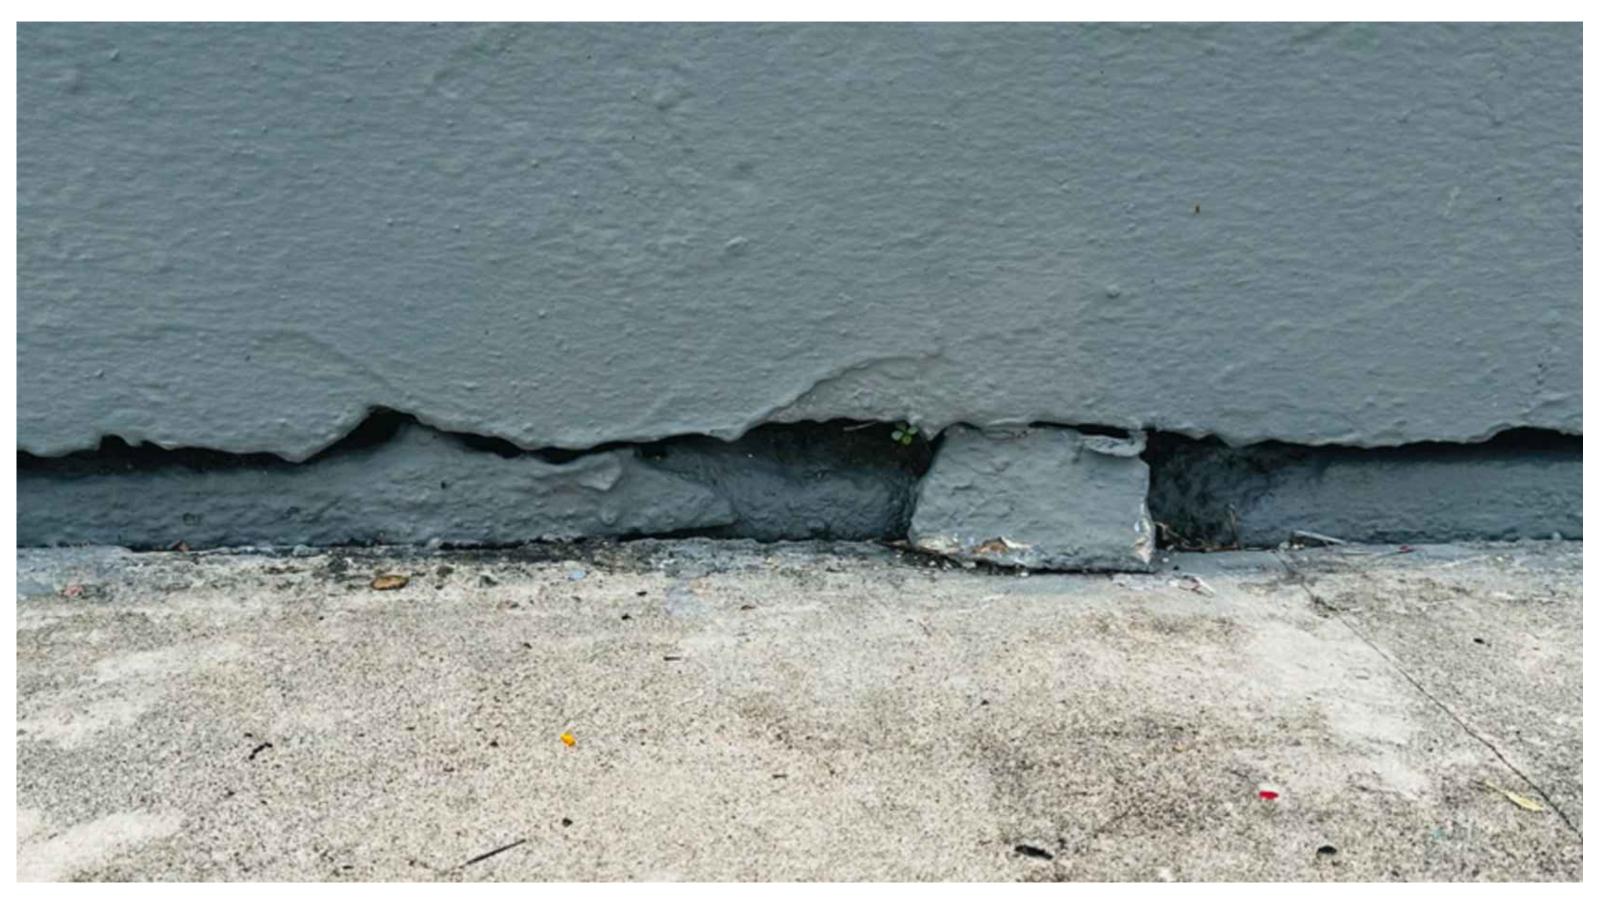
PH-10
Existing conditions of the plaza (broken concrete and deterioration)

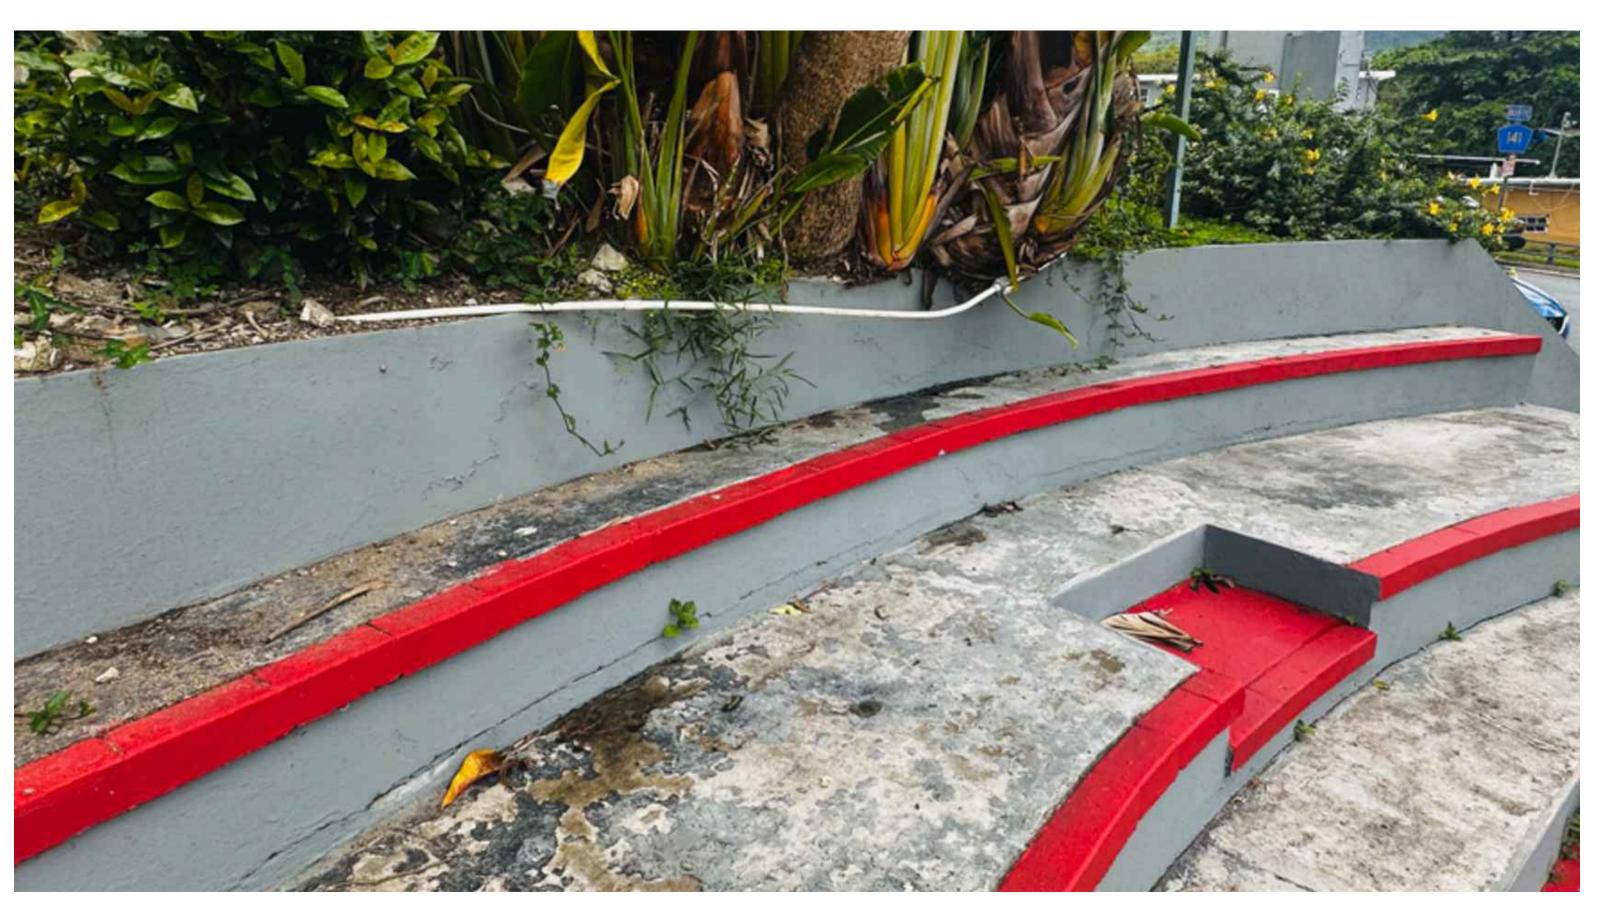
PH-12 Existing conditions of the plaza (broken concrete and deterioration)

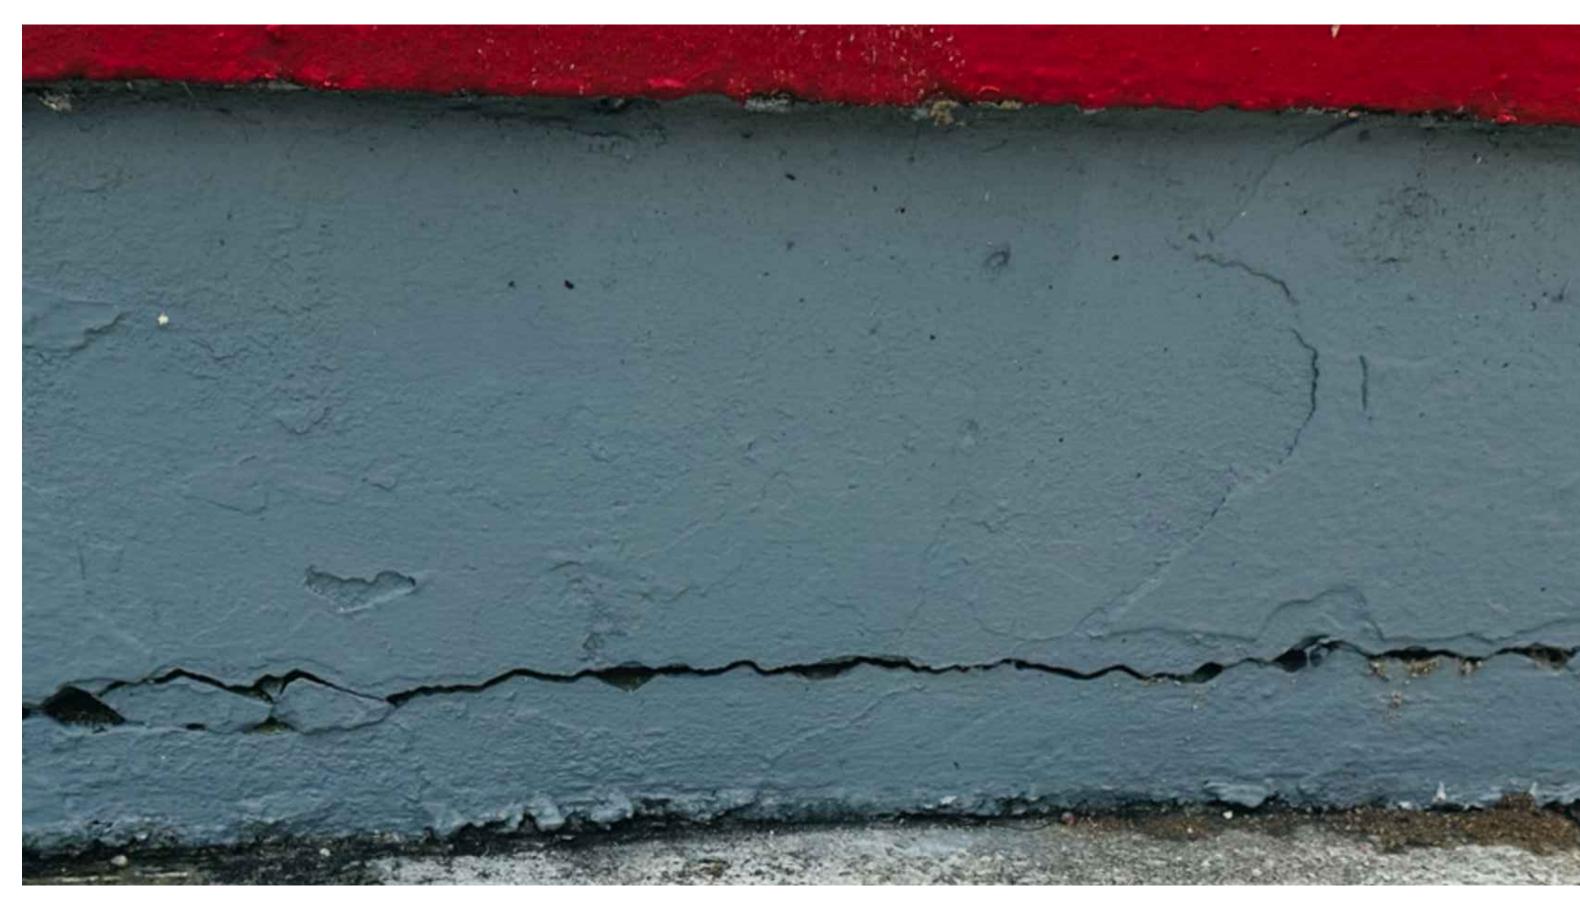
PH-9
Existing conditions of the plaza (broken concrete and deterioration)

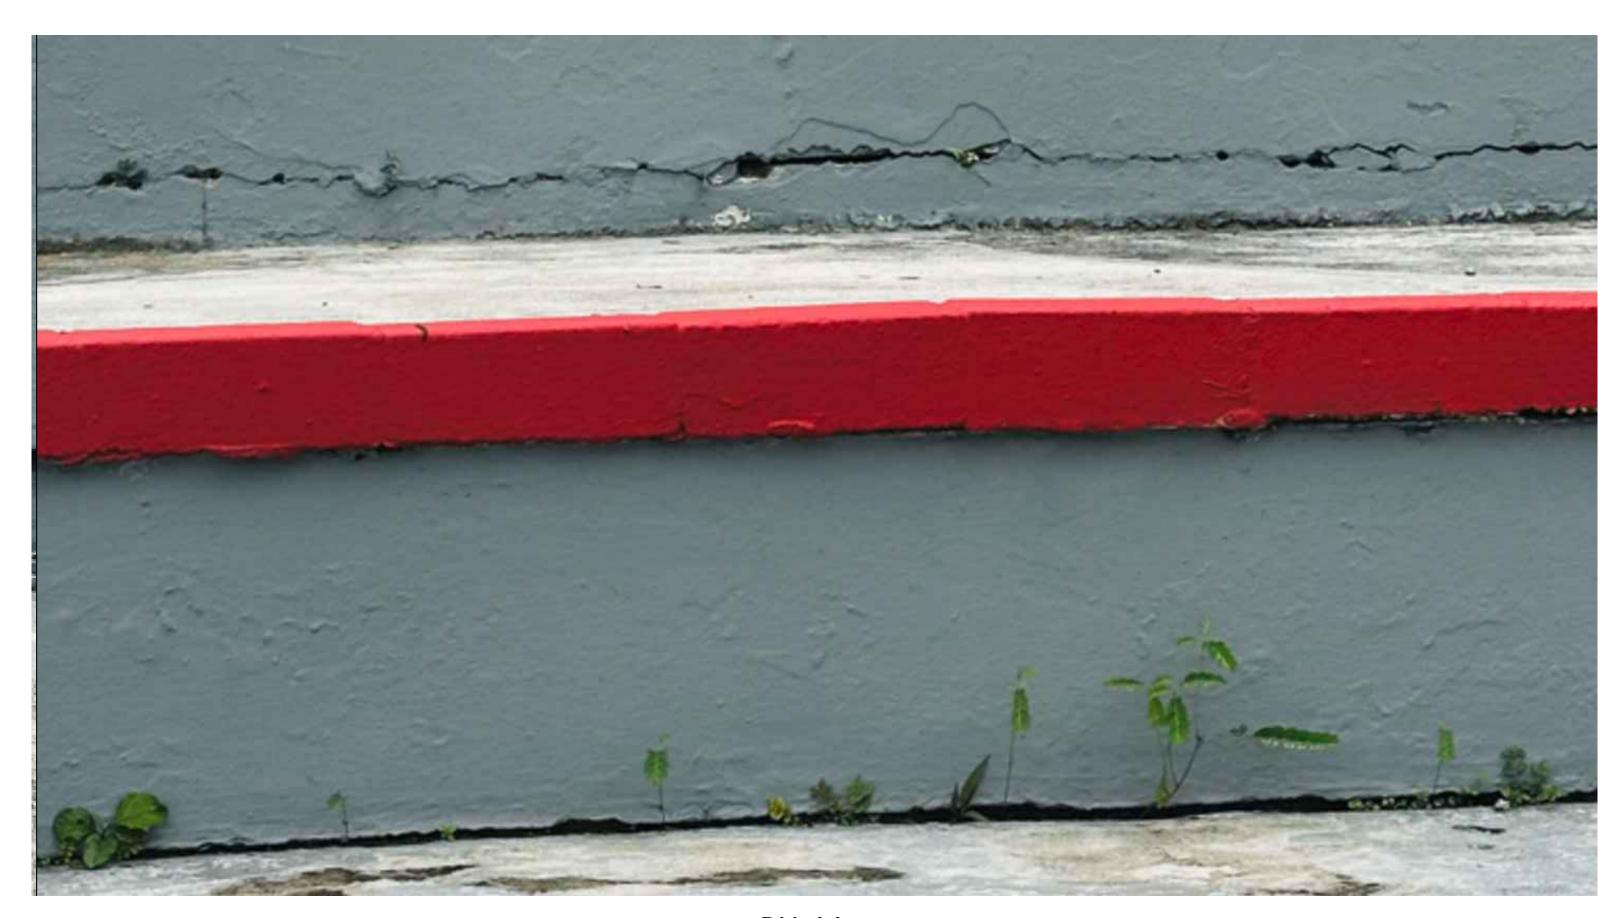
PH-11
Existing conditions of the plaza (broken concrete and deterioration)
