# Environmental Review for Activity/Project that is Categorically Excluded Subject to Section 58.5 Pursuant to 24 CFR 58.35(a)

Project Name: Mejoras en la Plaza de La Música (PR-CRP-000054)

**Description of the Proposed Project** [24 CFR 50.12 & 58.32; 40 CFR 1508.25]: The proposed project involves the rehabilitation and enhancement of the Plaza de Música, located at Guillermo Esteves St, Carr 141 Km 0.0, Bo. Pueblo, in the municipality of Jayuya, Puerto Rico. A project location map can be found in **Appendix A**. The site, covering 288.75 square meters, is designated as Commercial Intermedio (C-I) under zoning regulations and Suelo Urbano (SU) under the land use plan classification. The project

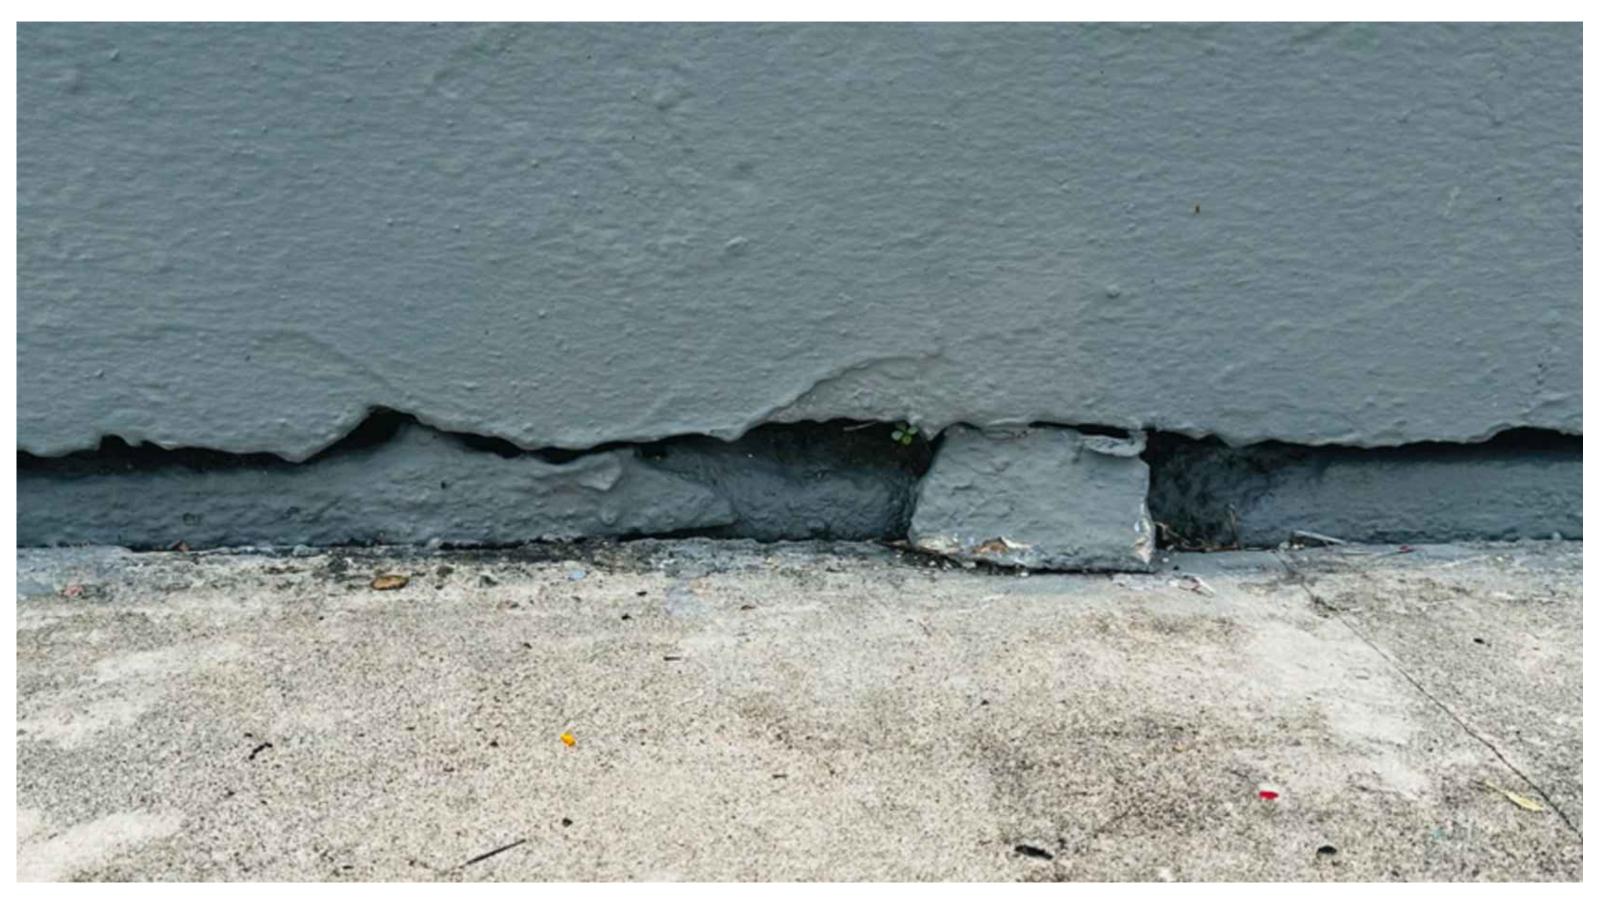
PH-10
Existing conditions of the plaza (broken concrete and deterioration)

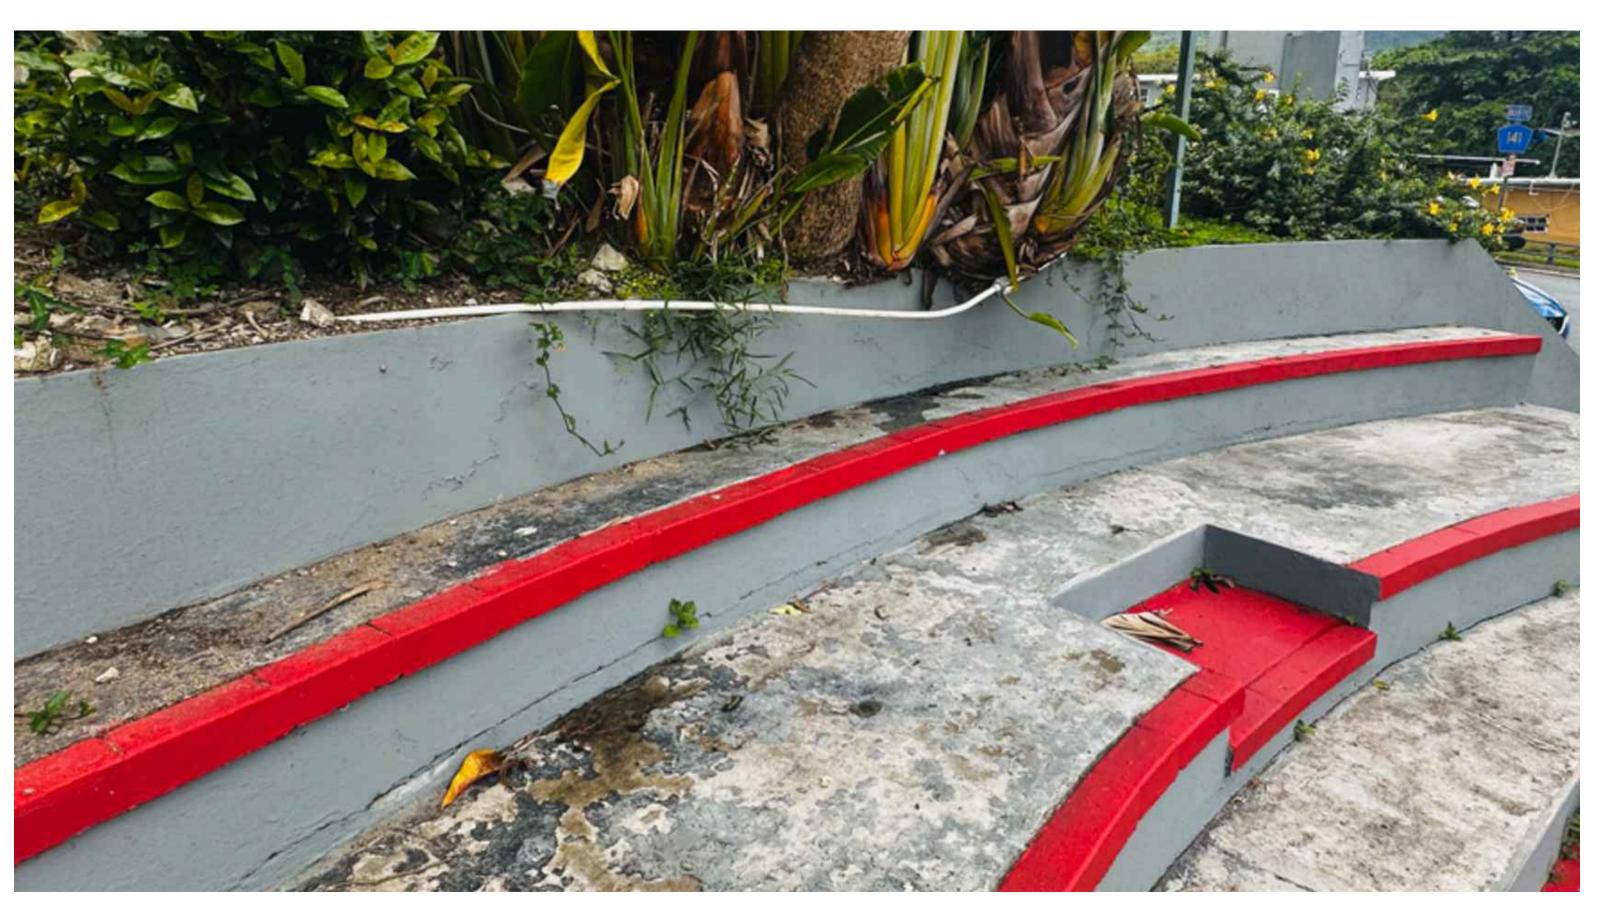
PH-12 Existing conditions of the plaza (broken concrete and deterioration)
