Environmental Review for Activity/Project that is Categorically Excluded Subject to Section 58.5

Project Name: PR-CRP-000720 Revitalización y Restauración del Centro Urbano

Project Location: Maricao Urban Center, Maricao, PR.
Public Plaza (18.180775, -66.979881);
Kiosks (18.18104368, -66.97977998);
Small Plaza (18.18139782, -66.98022663);
Roundabout Intersection (18.183654, -66.981702)

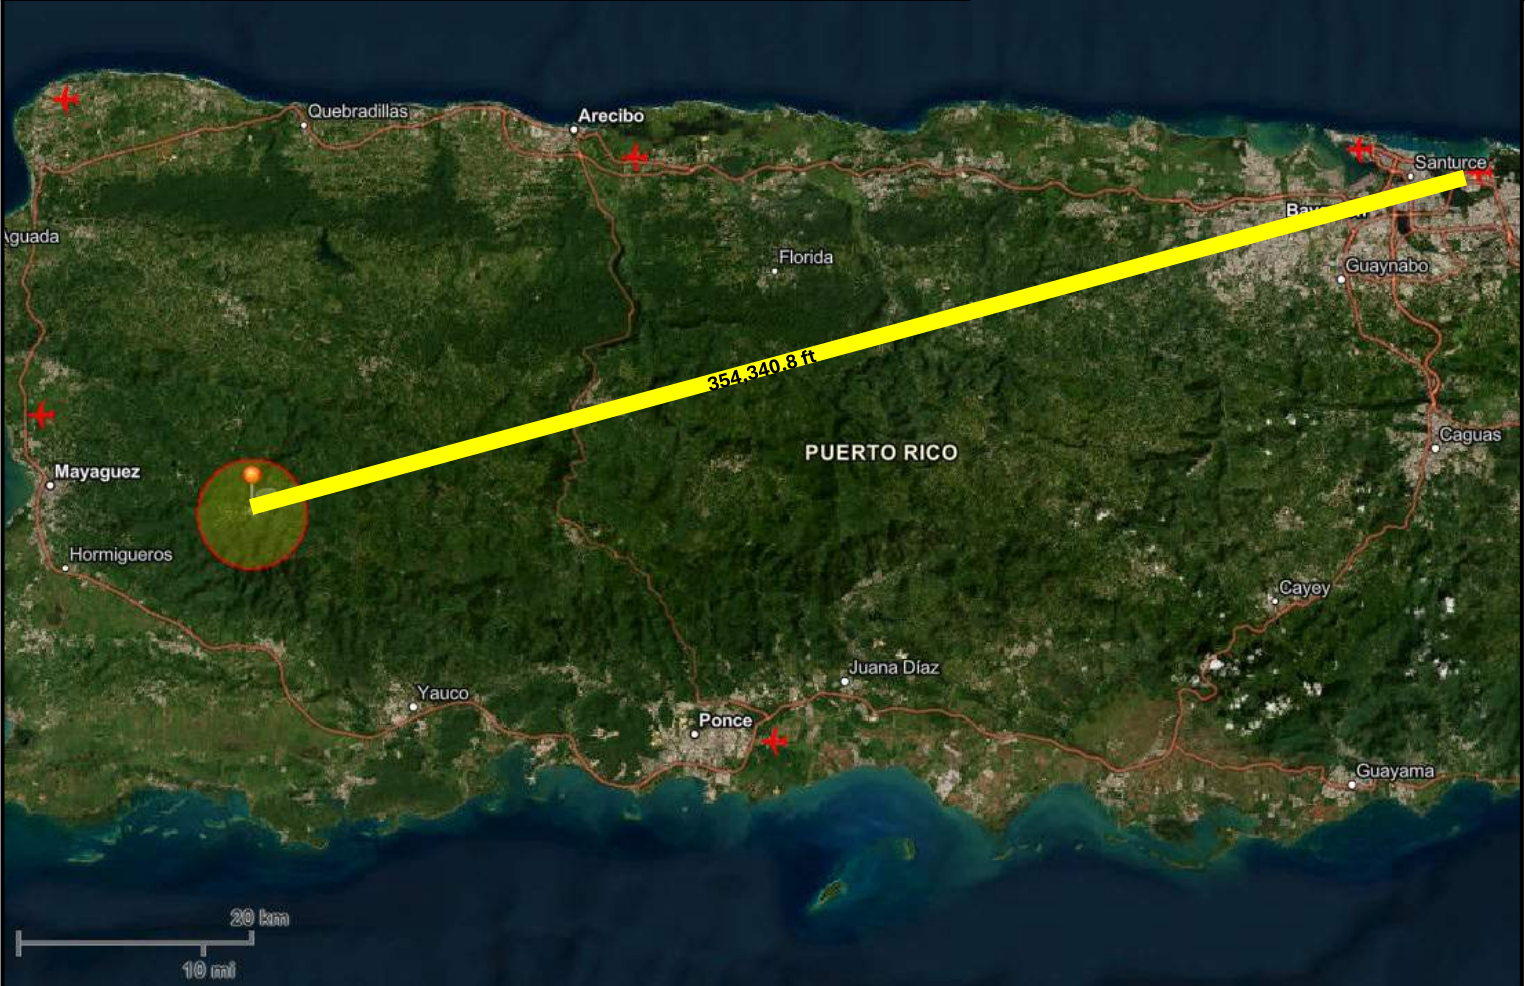
Distance to the nearest Military Airport, Muñiz ANG Base, PR
Air National Guard, Carolina, Puerto Rico is 354,340.8 feet.

The project site is located approx. 67,872.31 feet from the Eugenio Maria de Hostos Airport and 354,340.8 feet from the Muñiz ANG Base, PR Air National Guard, Carolina, Puerto Rico. The project site is not within 15,000 feet of a military airport or 2,500 feet of a civilian airport. The project is not within an APZ or RPZ/CZ; therefore, the proposed project is consistent with DOD Guidelines for APZ. The project is in compliance with Airport Hazards requirements.

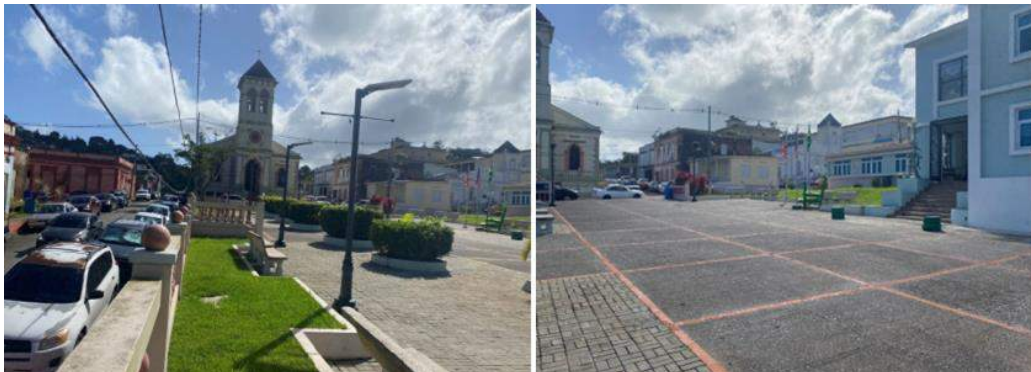
Photo 2: General views of the Town Square (from Hernández Miranda and Medina Carrillo 2023: 30)

- Remodeling the town square (Figure 3-in purple) (Area 2). This task includes the elimination of architectural barriers, replacement of the flooring and seats, addition of a new stage platform. The new stage will be 30 ft by 20 ft and will require excavations between 2 and 4 ft deep.

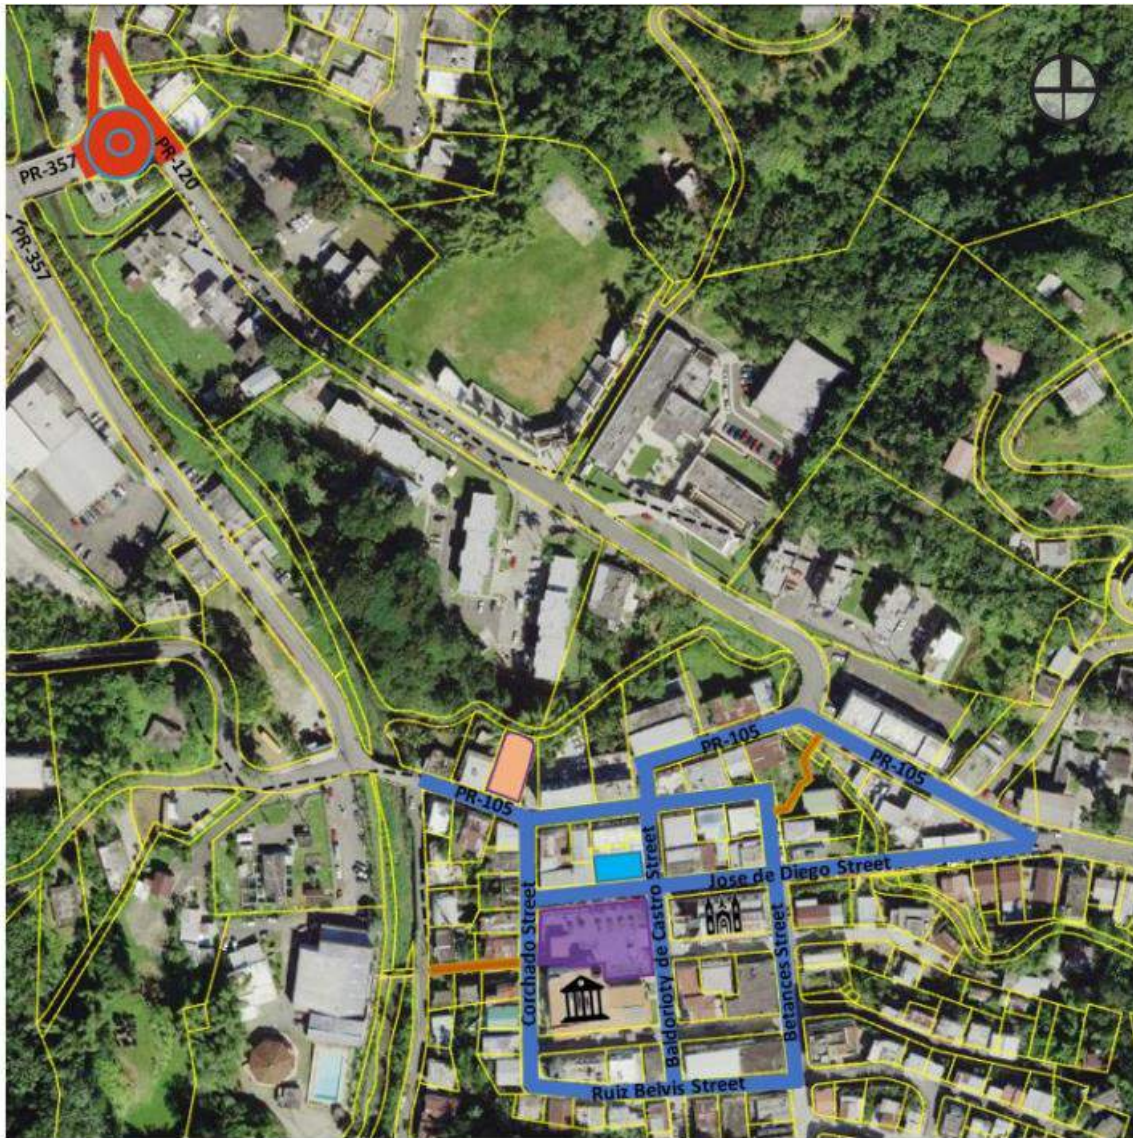
Figure 3: Project Parcels Location
(from Hernández Miranda and Medina Carrillo 2023: 22)

- Improve the intersection of PR-357 with PR-120 (Figure 3-in red) (Area 5). The existing roundabout will be demolished, and a three-way intersection will be built in its place, along with parking spaces for the surrounding recreational public areas, and new eco-friendly lighting.
- New green areas and gardens. This project also contemplates spaces for green areas and gardens. The anticipated maximum depths of ground disturbance for grubbing of areas destined for trees and vegetation will range from 1.5' to 2'-0".
- Replacement of lighting. Eco-friendly lighting will replace the current lighting throughout the project's urban area. The anticipated maximum depths of ground disturbance for the bases of the new lighting poles will range from 6'-0" to 7'-6".
