Environmental Review for Activity/Project that is Categorically Excluded Subject to Section 58.5 Pursuant to 24 CFR 58.35(a)

Project Name: Coliseo Arquelio Torres (PR-CRP-000879)

The municipality of San Germán proposes the repair of the Arquelio Torres Coliseum. No major alterations or demolitions to the structure of the coliseum are contemplated.

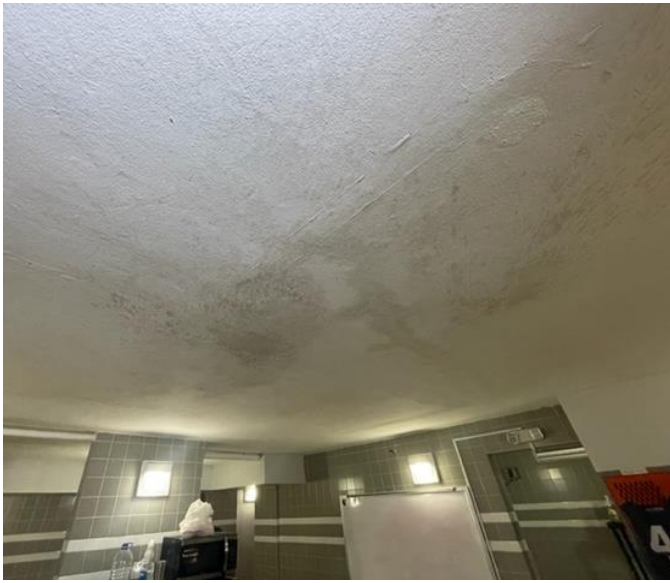
**General Condition of
Home Dressing Area/Lockers
Visible Mold on Concrete Ceiling**

Generally, remediation activities needed include replacement of wooden components (doors) and cleaning and sanitization of the entire space. Upon completion of remediation activities an HVAC control program should be established to maintain the temperature/humidity in the appropriate thermal comfort range.

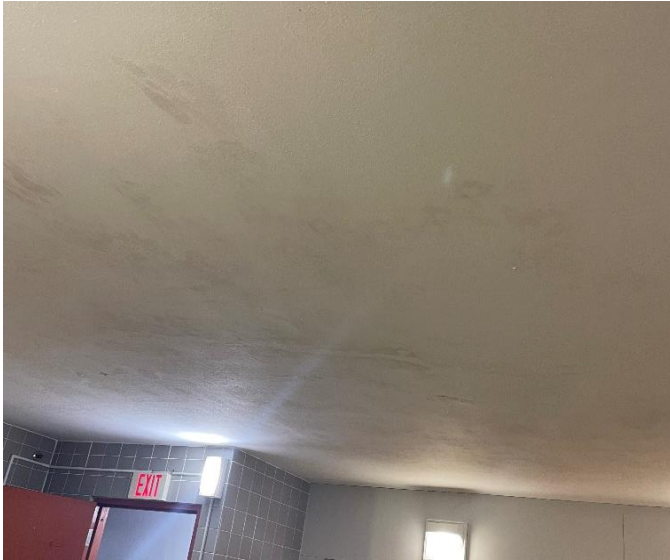
**General Condition of
Visitor Dressing Area/Lockers
Visible Mold on Concrete Ceiling**

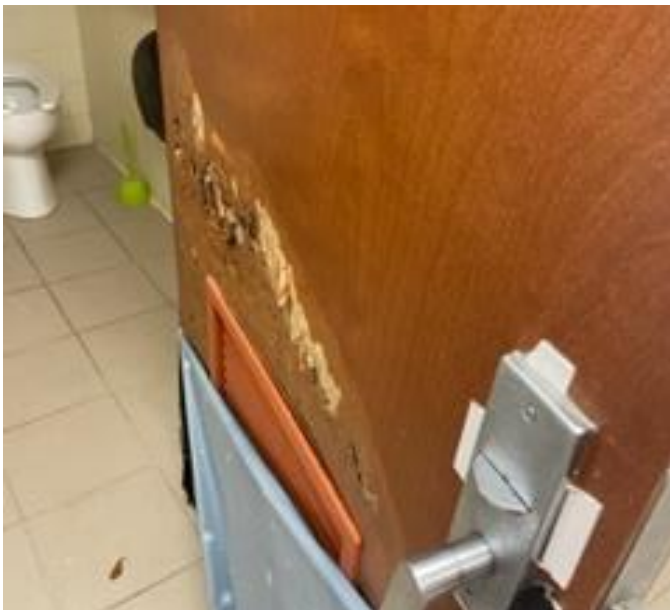
**General Condition of
VIP Room- Bathroom
Water-Damaged Wooden Door**

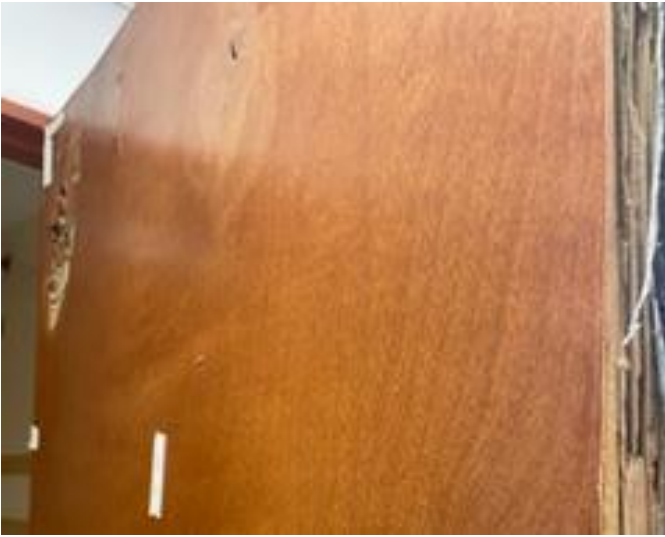
**VIP Room- Bathroom
Water-Damaged Wooden Door**

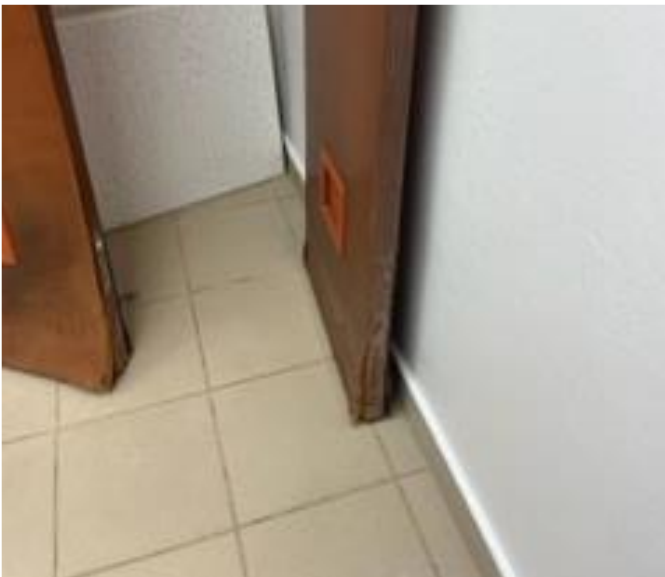
**General Condition of
VIP Room- Bathroom
Wood Doors with Visible Water Damage**

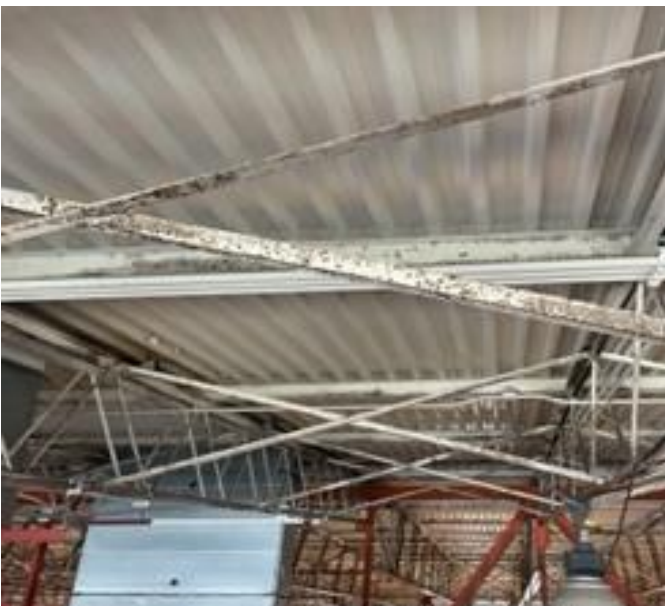
Visible Mold on Metal Ceiling Beams

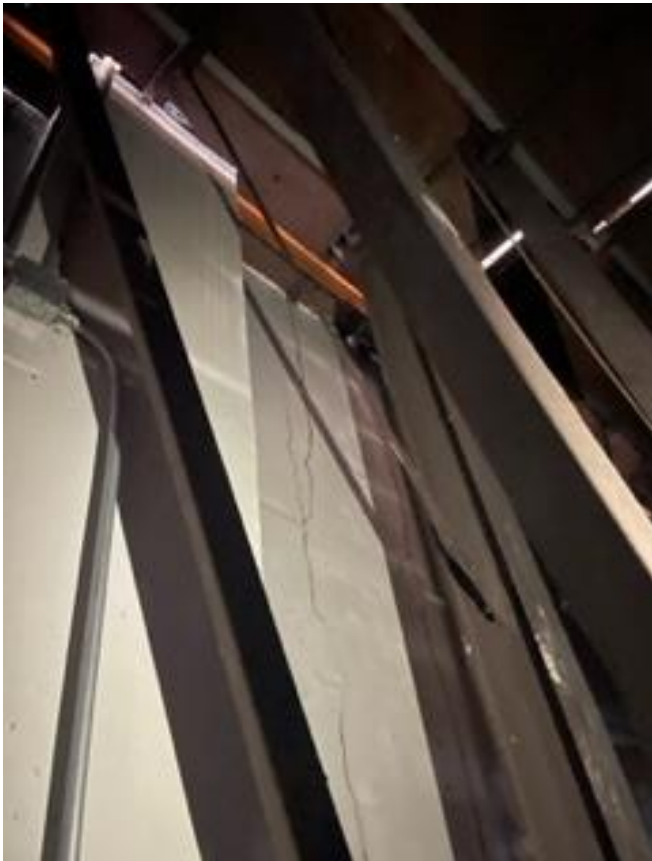
**Traces of Water Leaks on
Concrete Walls
Back of Bleachers Area**

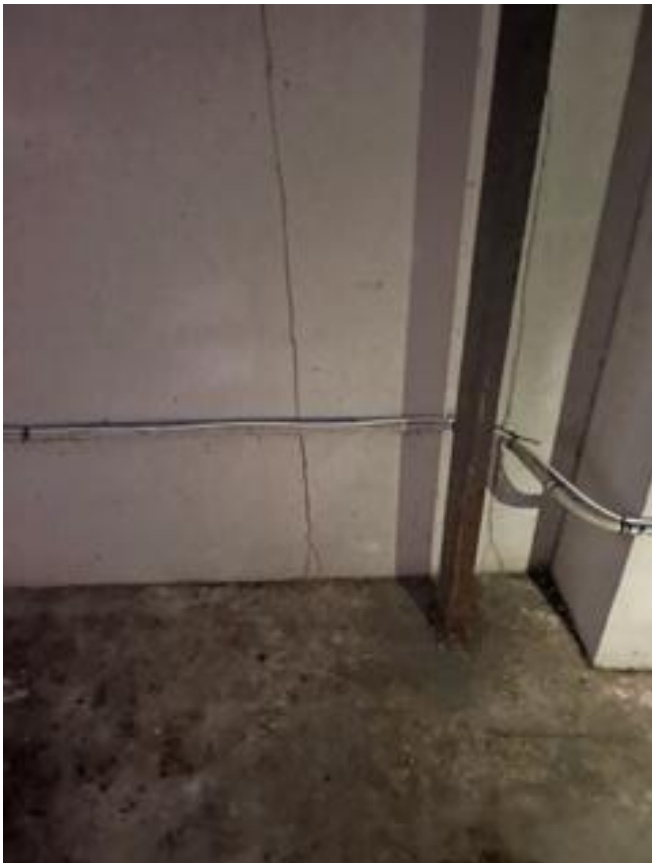
**Visible Water Intrusion
Concrete Walls on the Back of
Bleachers Area**

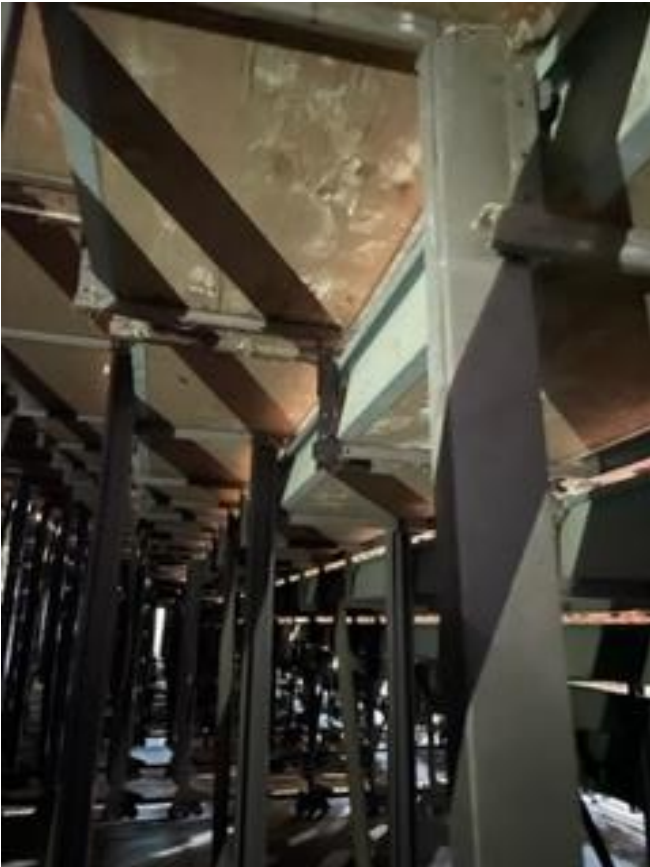
Area under Bleachers
Damages caused by water leaks are visible

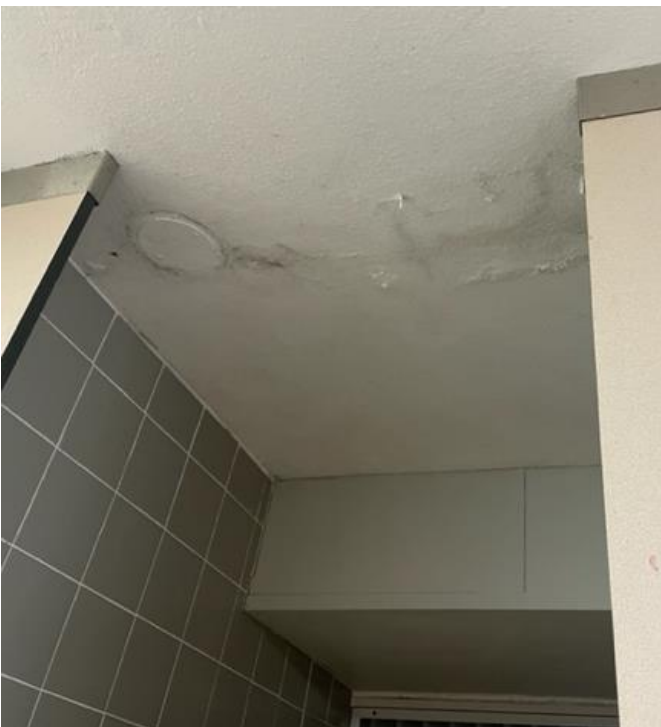
Deteriorated Concrete Ceiling
Women Bathroom- East Side

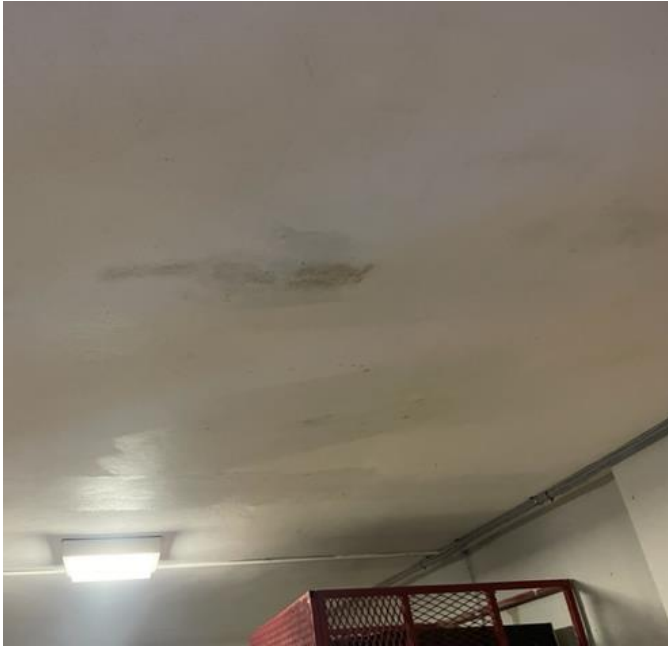
**Mold Races on Concrete Ceiling
Women Bathroom- East Side**

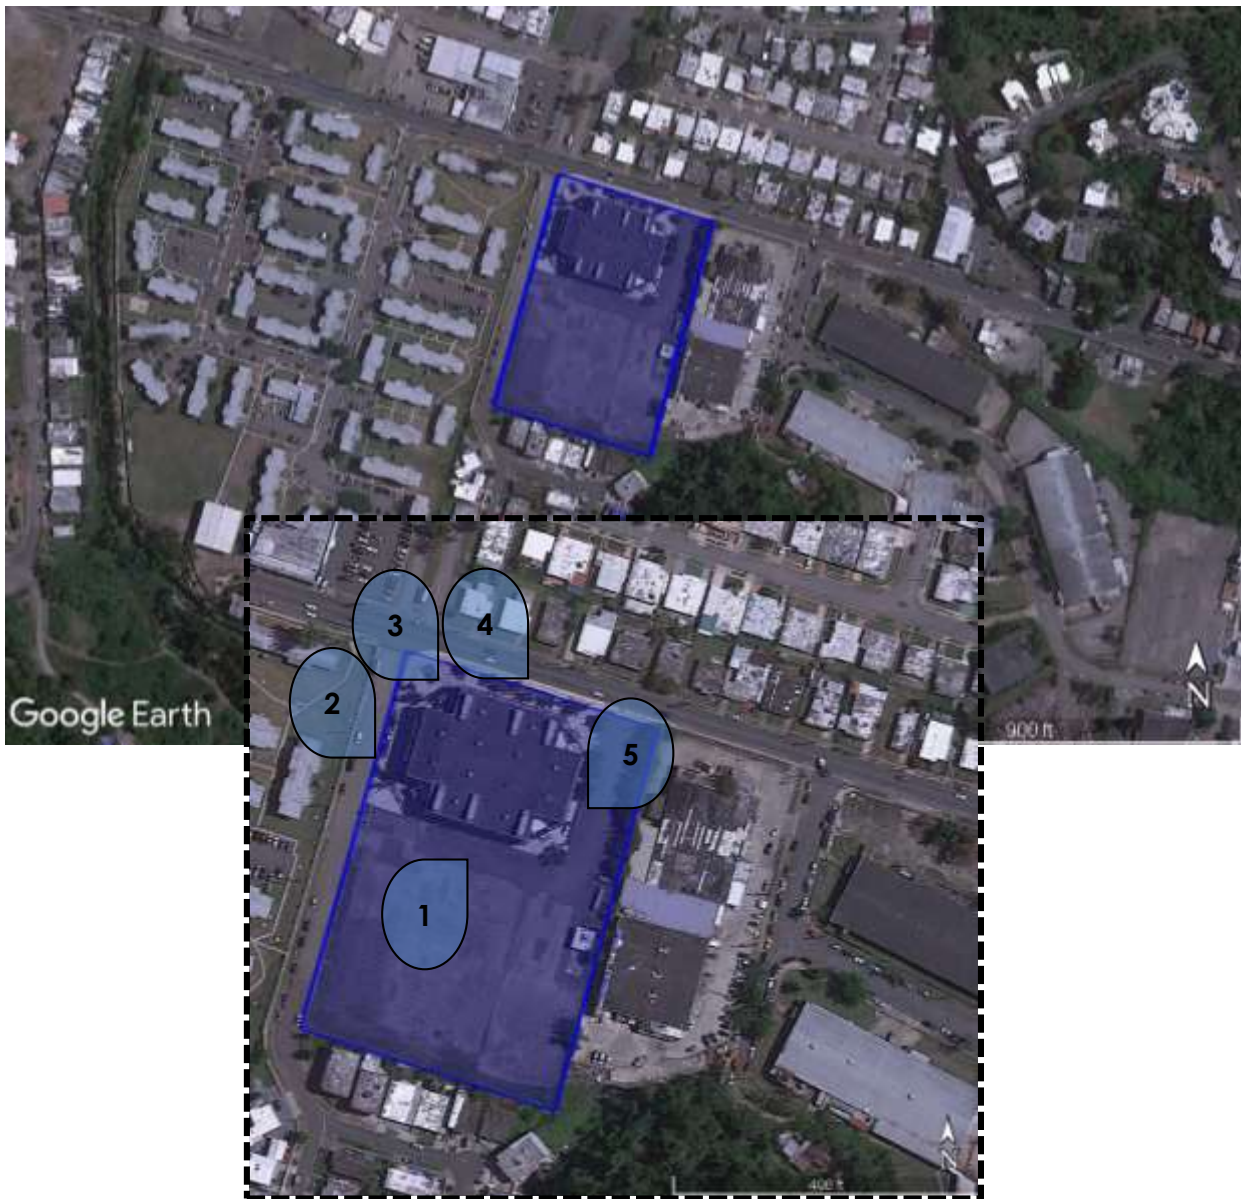
Figure 18. Photograph Key

Description: The photo key depicts the locations and orientations of the photographs taken along and around the exterior of Coliseo Arquelio Torres, Puerto Rico. The photographs provide views of existing conditions along the avenue to visually document the project's area of potential effect.
