Environmental Review for Activity/Project that is Categorically Excluded Subject to Section 58.5

Project Name: Hotel Ojo de Agua (PR-CRP-000493)

Responsible Entity: Puerto Rico Department of Housing

Project Location: 24 Parque Street, Rincón, PR 00677 (See attachment 1)

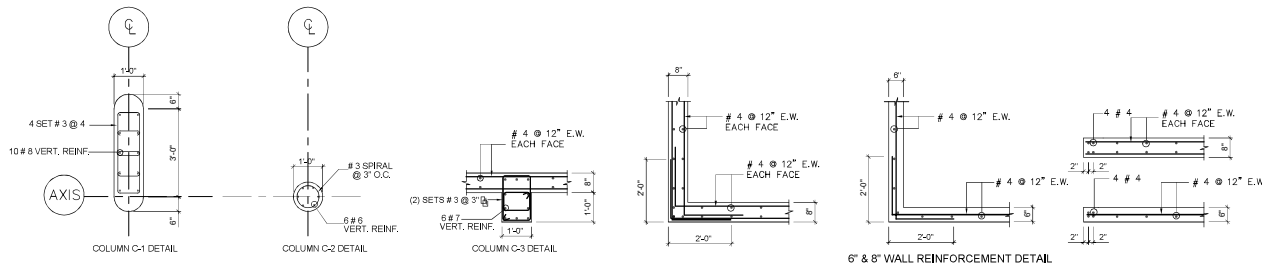
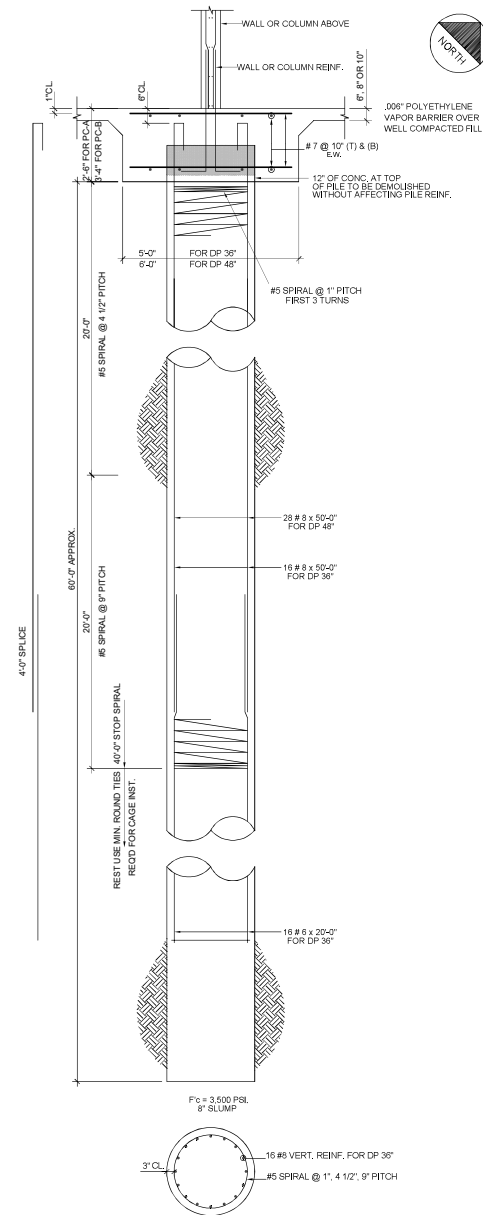
FOUNDATION PLAN SCALE: 3/16" = 12"
FOR PC-A, PC-B & PC-C

DP - 36 FOR PC-A, PC-B & PC-C DETAIL
SCALE: 1/2" = 1'-0"

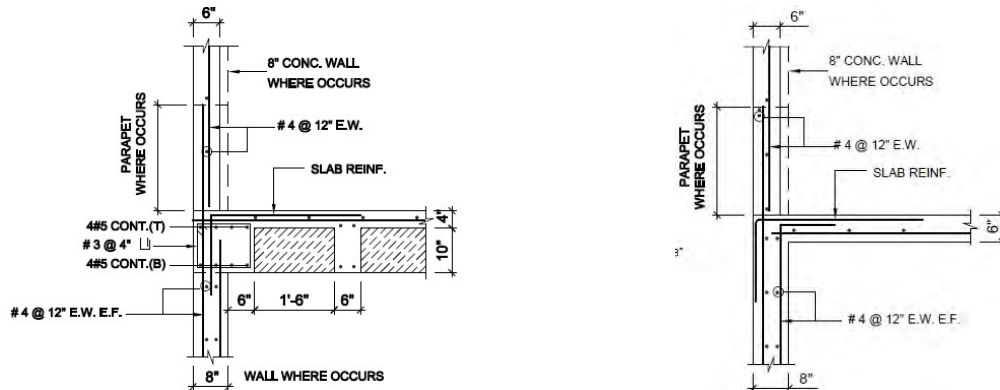
The building consists of 6" and 8" concrete shear walls for its earthquake lateral load resisting system.

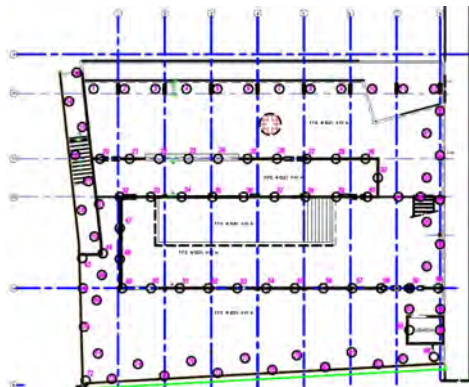
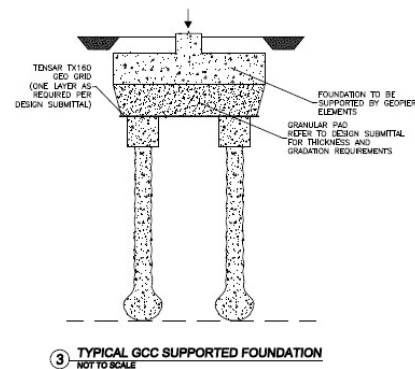
Foundations and Ground Floor Concrete Slab

The ground floor is a cast in place structural reinforced concrete slab over continuous footings and grade beams supported by a GEOPIERS foundation system.
