## **Environmental Assessment Determinations and Compliance Findings for HUD-assisted Projects 24 CFR Part 58**

**Project Name:** Mejoras Intersección Rotonda PR-693 y PR-698 (PR-CRP-000557)

**Responsible Entity:** Puerto Rico Department of Housing (PRDOH)

**Grant Recipient** (if different than Responsible Entity): Municipality of Dorado

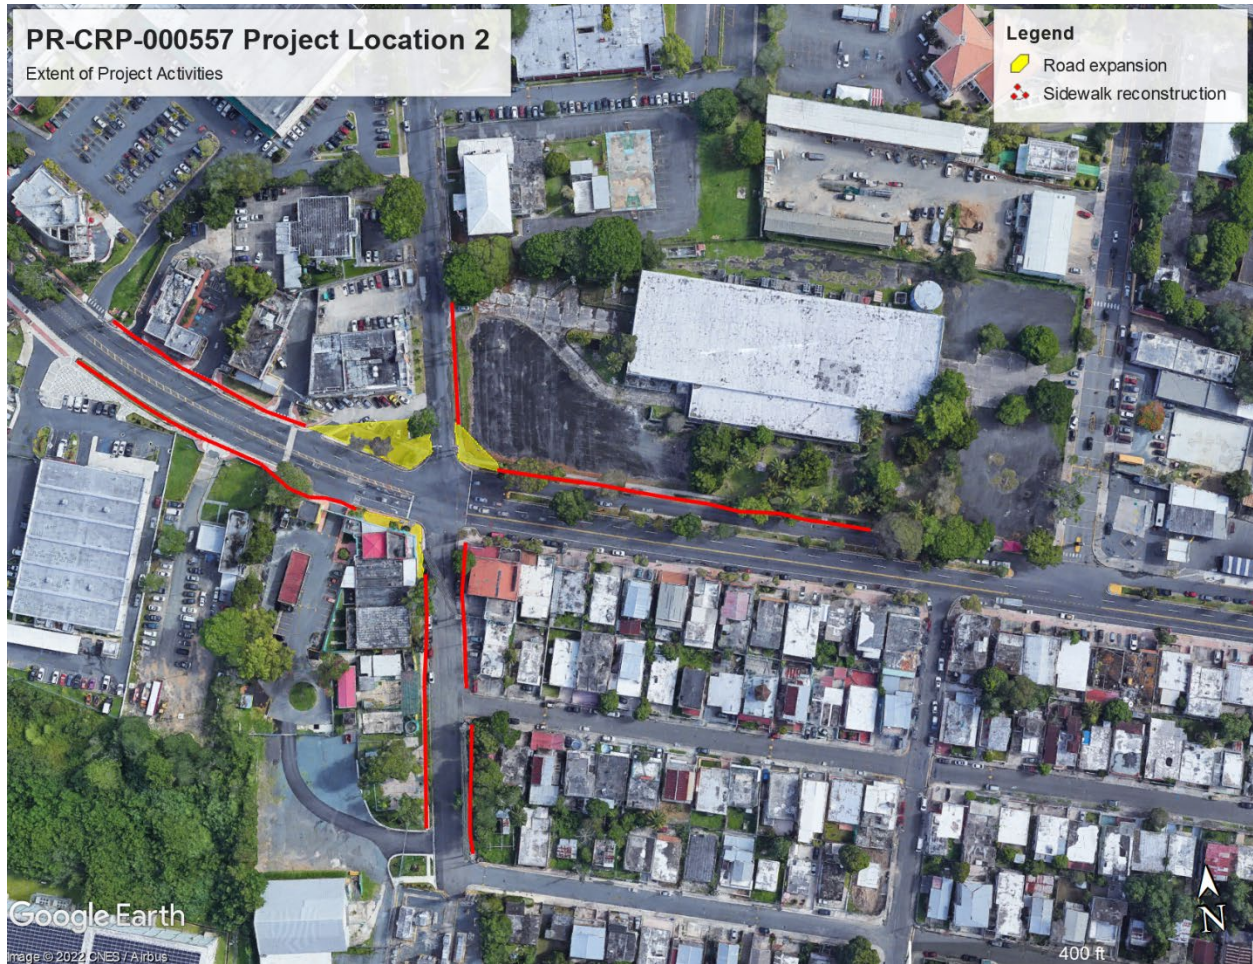
Figure 2 – Aerial photograph of project area with estimated areas of impact

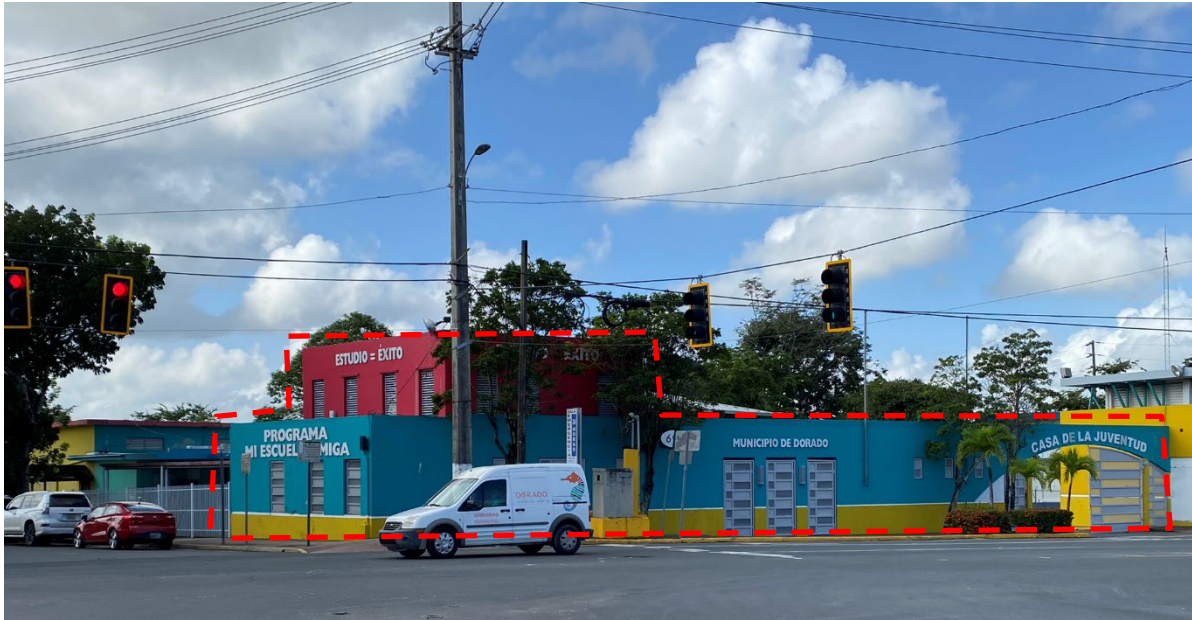
Figure 5- Photos with buildings to be demolished

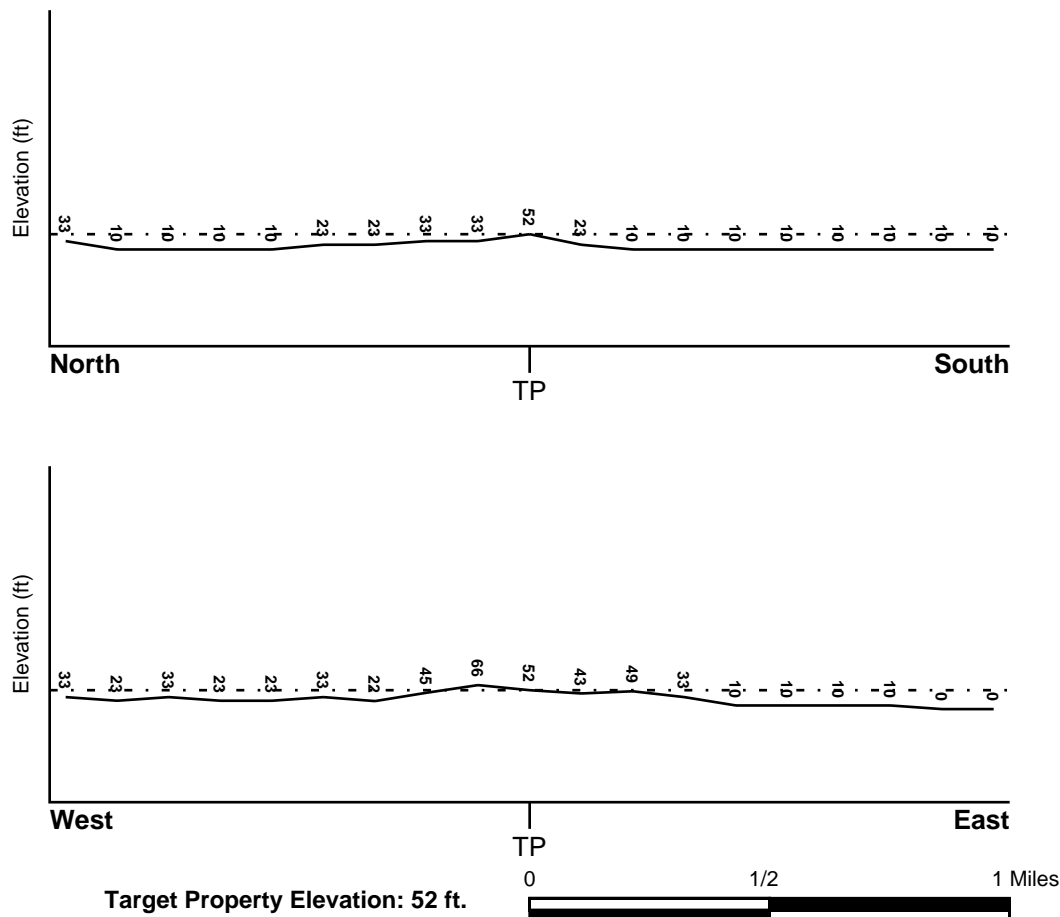
### SURROUNDING TOPOGRAPHY: ELEVATION PROFILES

General Topographic Gradient: General SSW

Source: Topography has been determined from the USGS 7.5' Digital Elevation Model and should be evaluated on a relative (not an absolute) basis. Relative elevation information between sites of close proximity should be field verified.

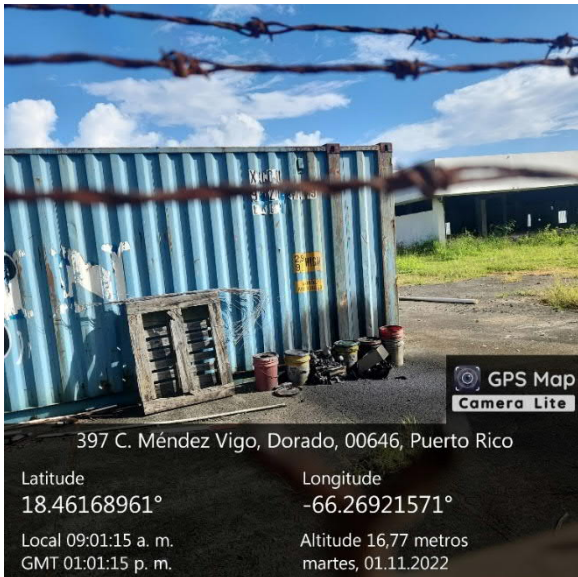
<p>Photograph ID: 2</p> <p>Comments: Former Playtex Industrial Parking Oil Spill is Observed.</p>

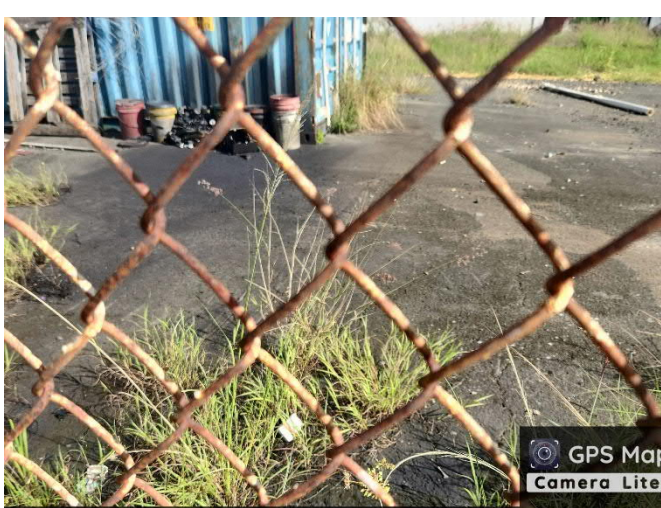
<p>423 C. Méndez Vigo, Dorado, 00646, Puerto Rico</p> <p>Latitude 18.46168358° Longitude -66.26915984°</p> <p>Local 09:02:44 a. m. Altitude 16,77 metros GMT 01:02:44 p. m. martes, 01.11.2022</p>	<p>Photograph ID: 3</p> <p>Comments:</p> <p>Former Playtex Industrial Parking Oil Spill is Observed.</p>

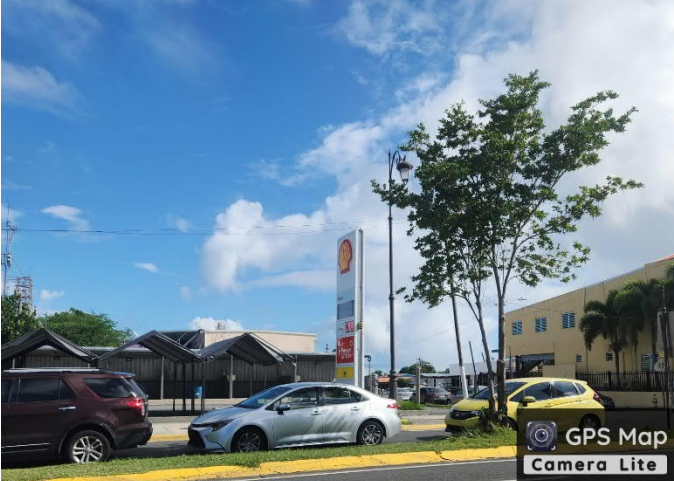
<p>363 C. Méndez Vigo, Dorado, 00646, Puerto Rico</p> <p>Latitude 18.46106921° Longitude -66.26725723°</p> <p>Local 09:39:09 a. m. Altitude 16,77 metros GMT 01:39:09 p. m. martes, 01.11.2022</p>	<p>Photograph ID: 13</p> <p>Comments:</p> <p>Shell Gas Station PR-693 Km. 6.9 Marginal Street Urb. Martorell UST ID 86-0861.</p>

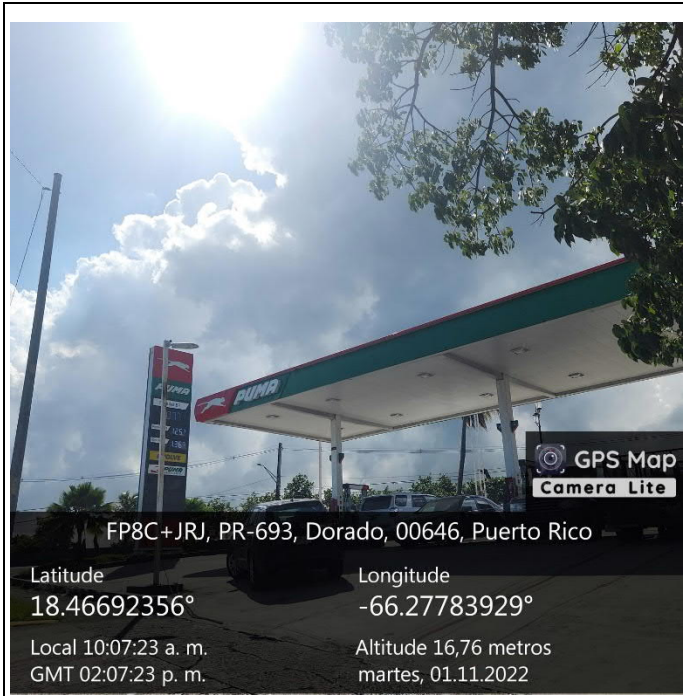
<p>FP8C+JRJ, PR-693, Dorado, 00646, Puerto Rico</p> <p>Latitude 18.46692356°</p> <p>Longitude -66.27783929°</p> <p>Local 10:07:23 a. m. GMT 02:07:23 p. m.</p> <p>Altitude 16,76 metros martes, 01.11.2022</p>	<p>Photograph ID: 14</p> <p>Comments:</p> <p>Puma Gas Station PR-693 #2 Street Urb. Dorado del Mar UST ID 92-0091.</p>
--	--

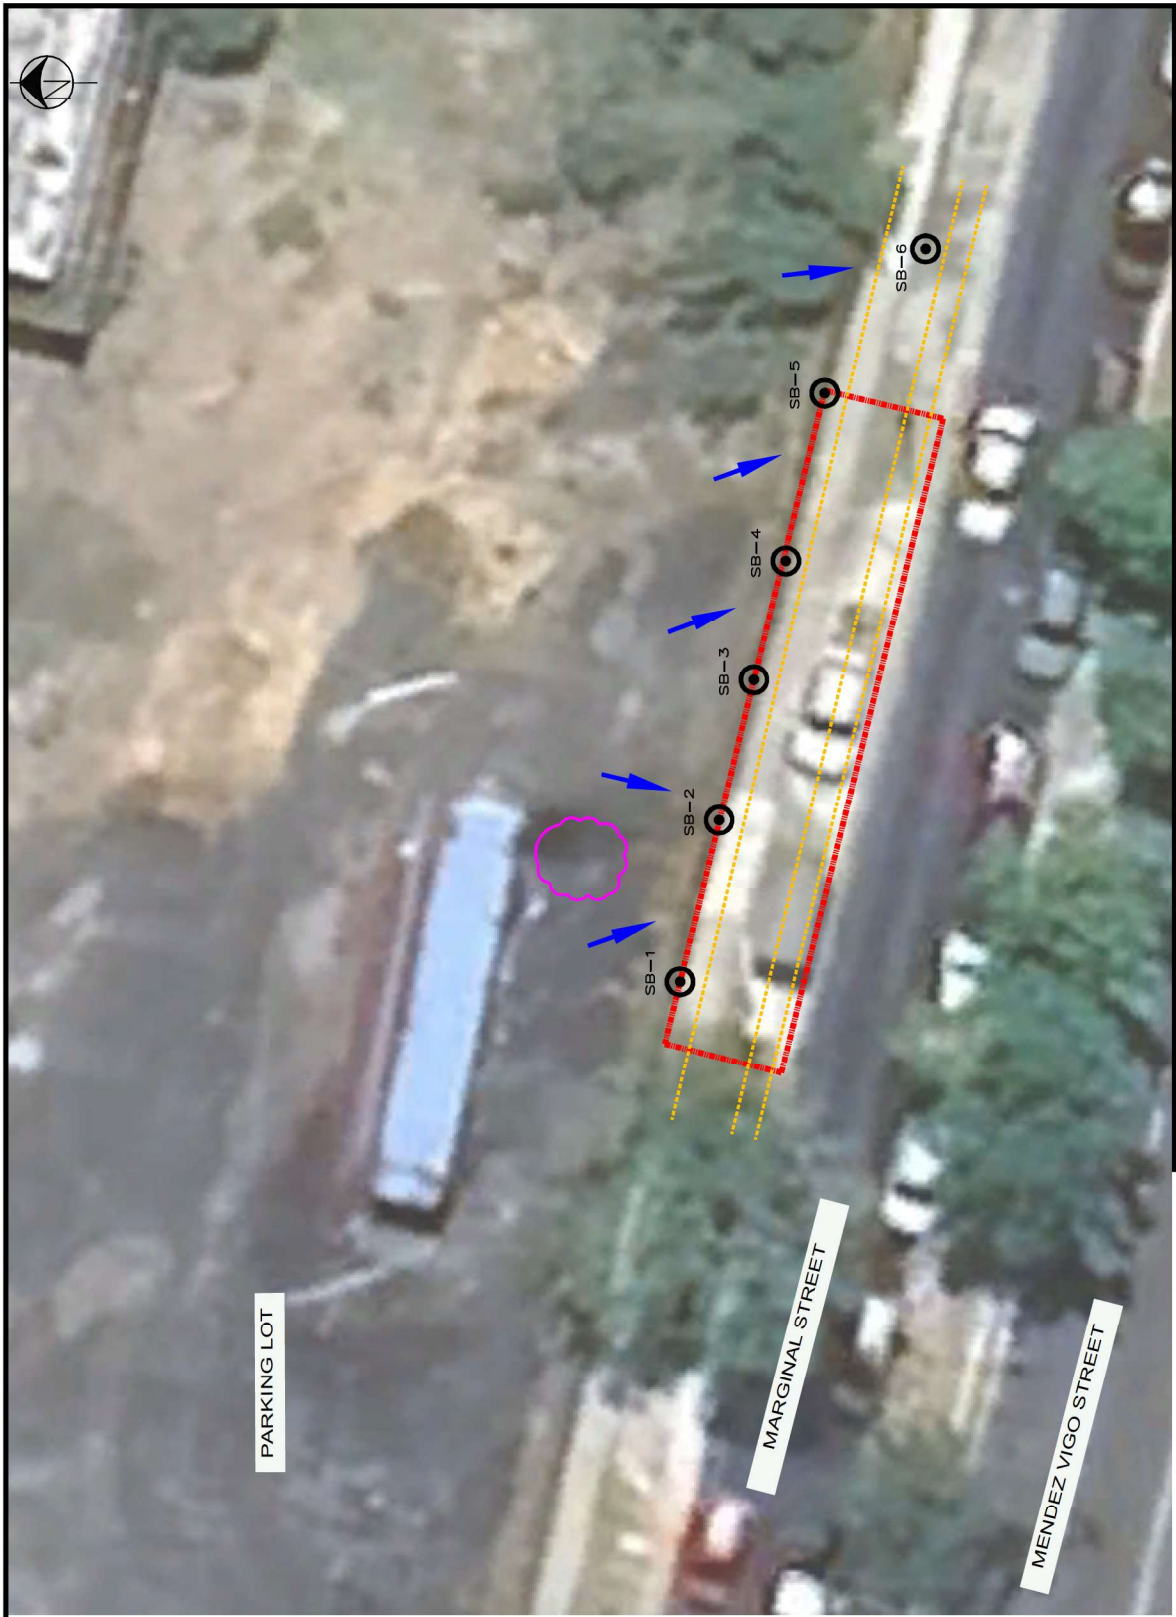
- AREA OF CONCERN
- SB-1
- SOIL BORING APPROXIMATE LOCATION
- PAILS AND OIL STAINS, ON THE ASPHALT OF ADJOINING PARKING LOT APPROXIMATE LOCATION
- APPROXIMATE UNDERGROUND UTILITIES MARKED IN THE FIELD
- ESTIMATED SURFACE DRAINAGE FLOW PATTERN

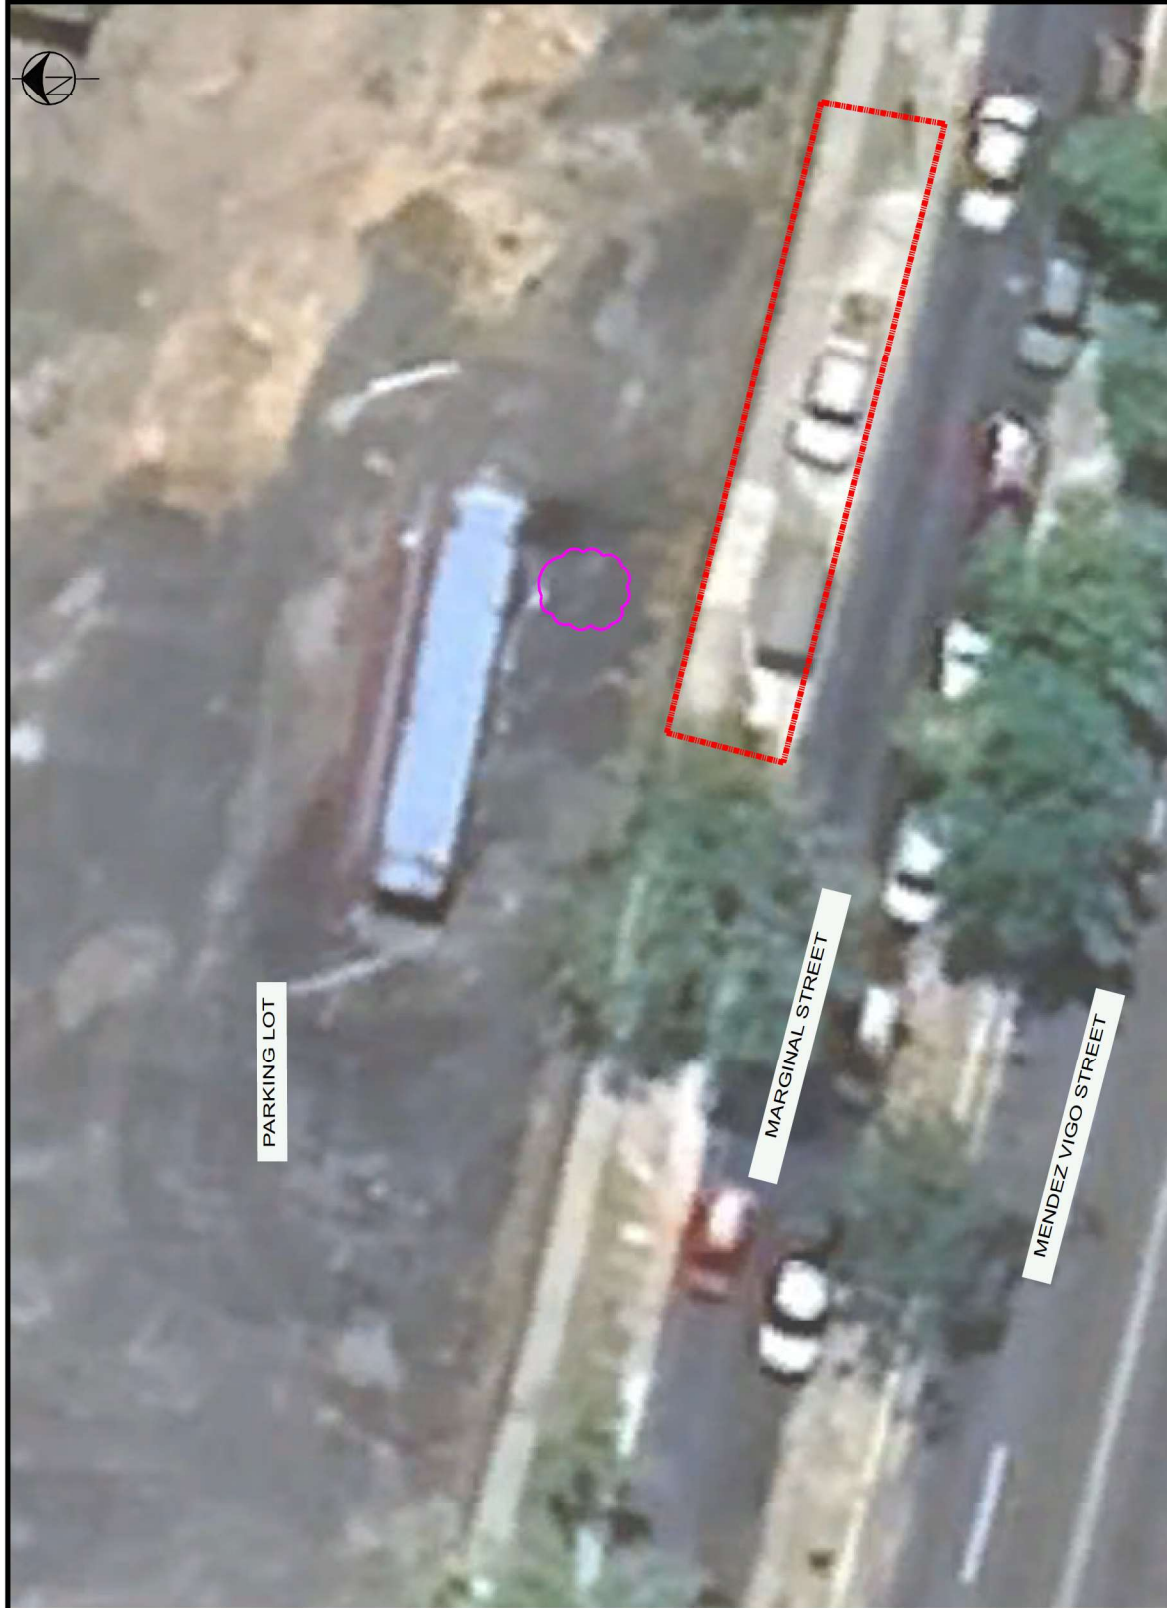
FIGURE 2

ALL LOCATIONS SHOWN ARE APPROXIMATE AND ARE ACCOMMODATED TO FIT THIS FIGURE  
SOURCE: GOOGLE EARTH, MAY 10, 2023, AREA OF CONCERN PROVIDED BY MOD IN THE RFP

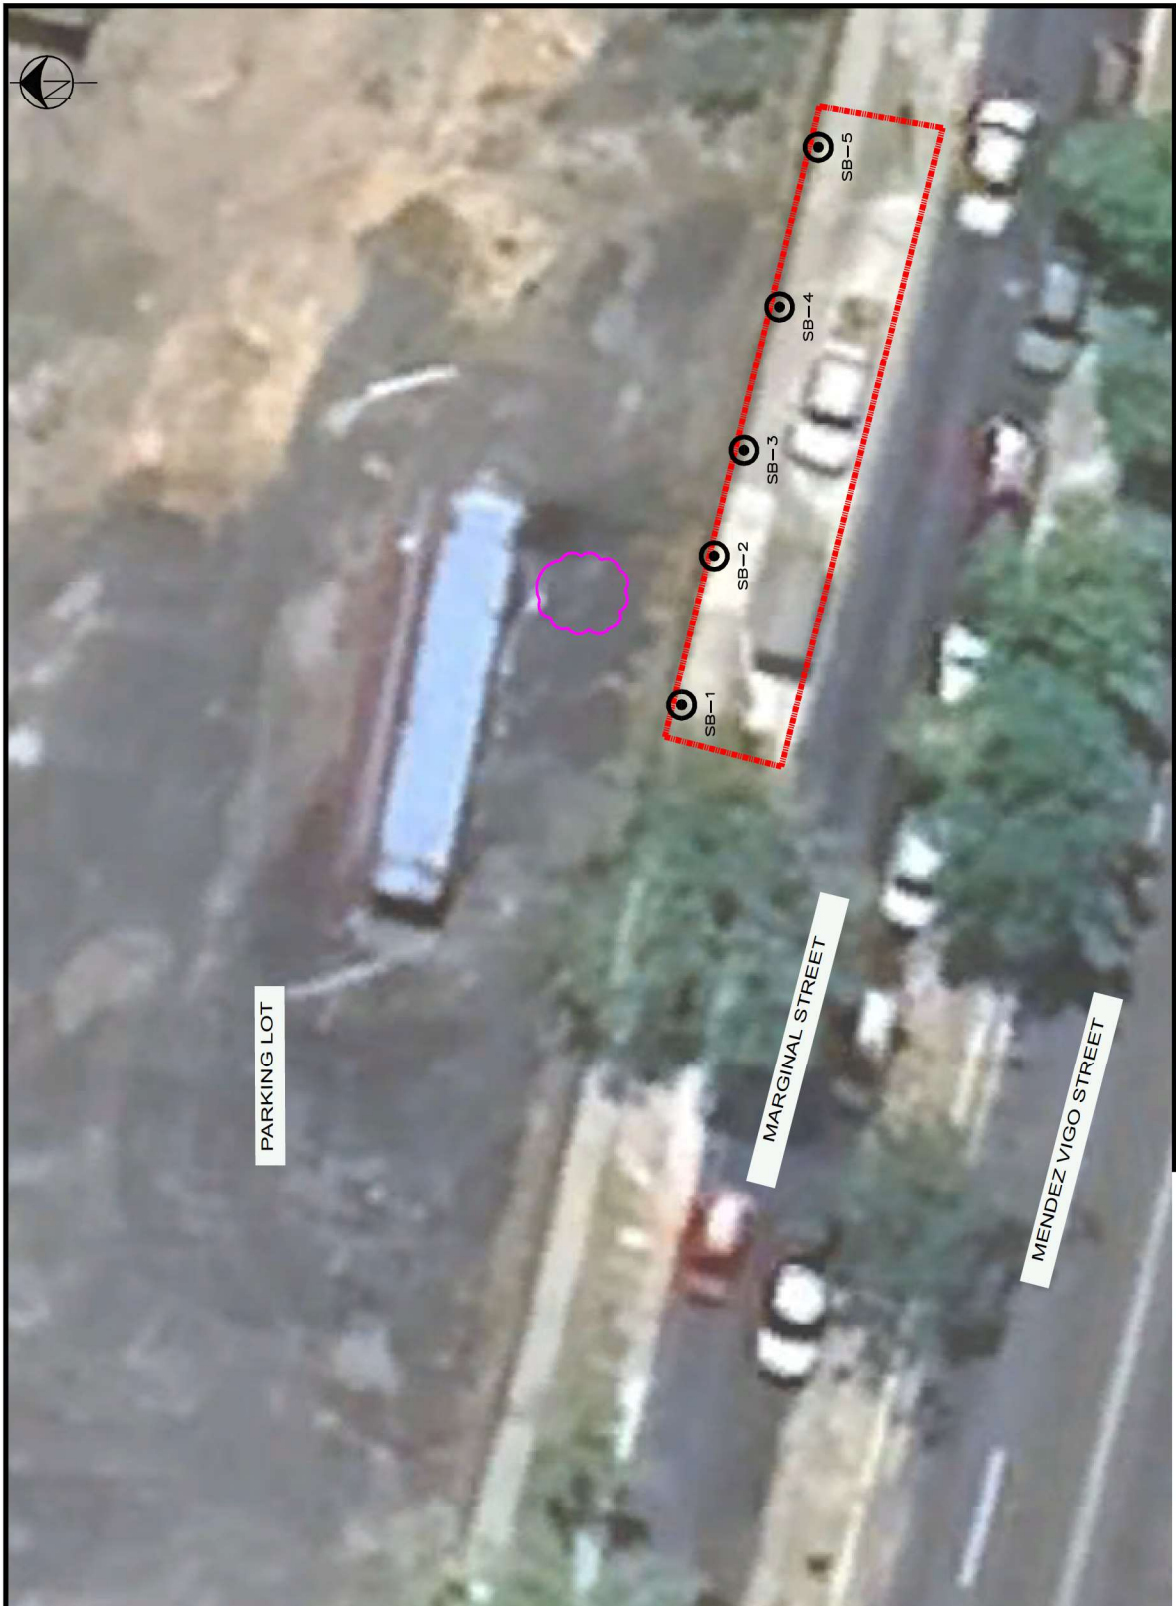
- ▬ AREA OF CONCERN
- SB-1 PROPOSED SOIL BORING APPROXIMATE LOCATION
- PAIRS AND OIL STAINS, ON THE ASPHALT OF ADJOINING PARKING LOT APPROXIMATE LOCATION

As part of the proposed assessment activities, **5** soil borings will be drilled. The approximate locations of the proposed soil borings are presented in **Figure 3**. However, these proposed boring locations may change, based upon site conditions encountered during the site activities. We note that the locations included in this figure are approximate and subject to modification based upon site observations and due to site conditions encountered.

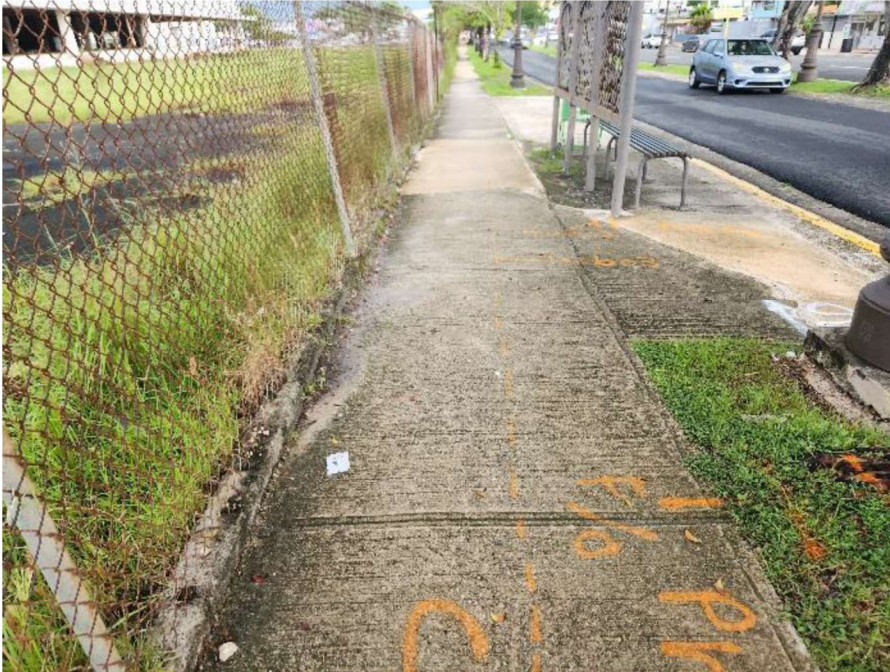
Photograph 1: Underground utilities marked in the area (see yellow lines)

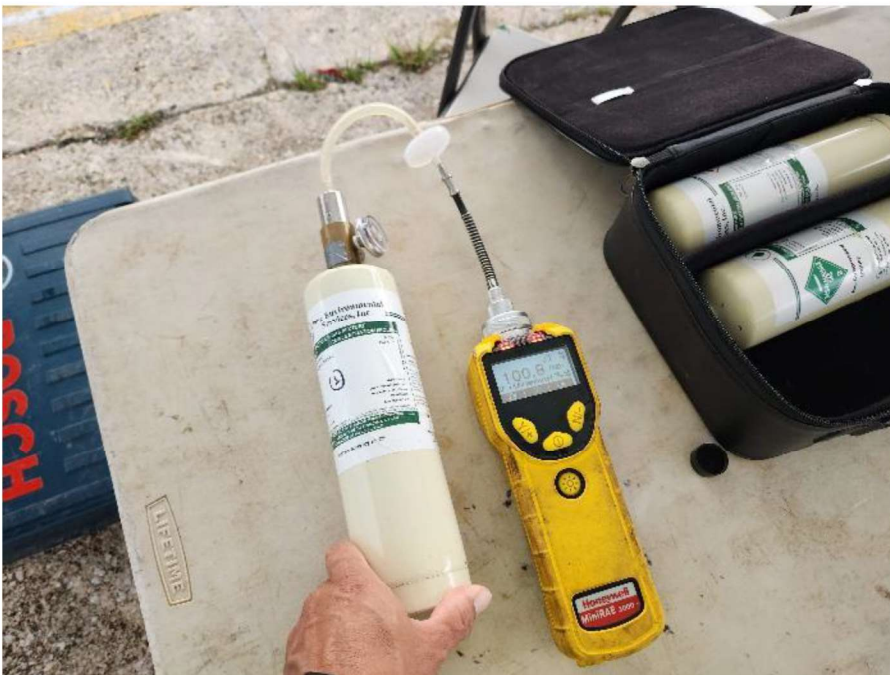
Photograph 2: PID calibration.

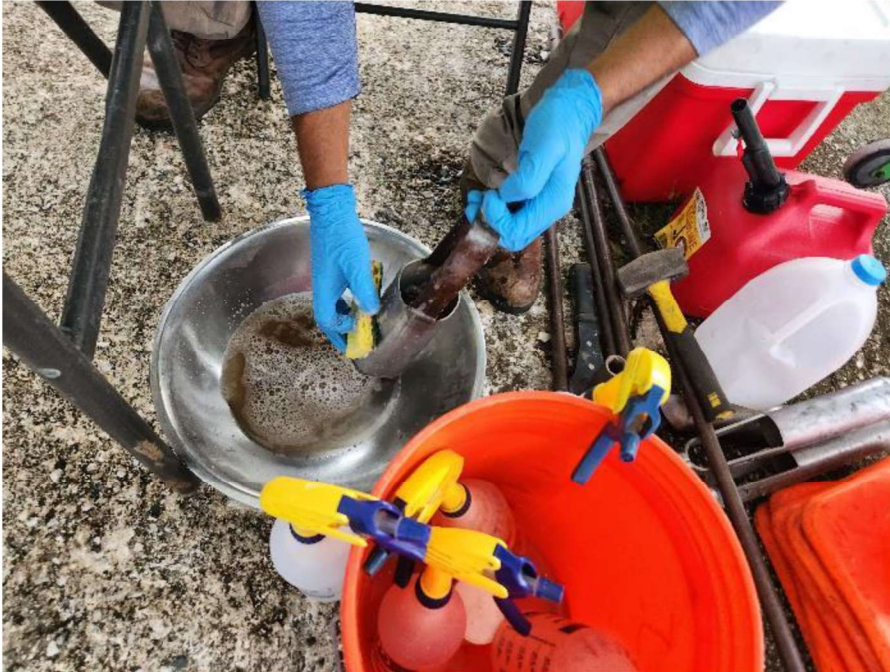
Photograph 3: Equipment decontamination process

fresh water rinse. No additional decontamination will be required if the equipment appears visually clean. If evident contamination is observed after hot water/steam cleaning, the equipment will be decontaminated by scrubbing or brushing with a detergent.

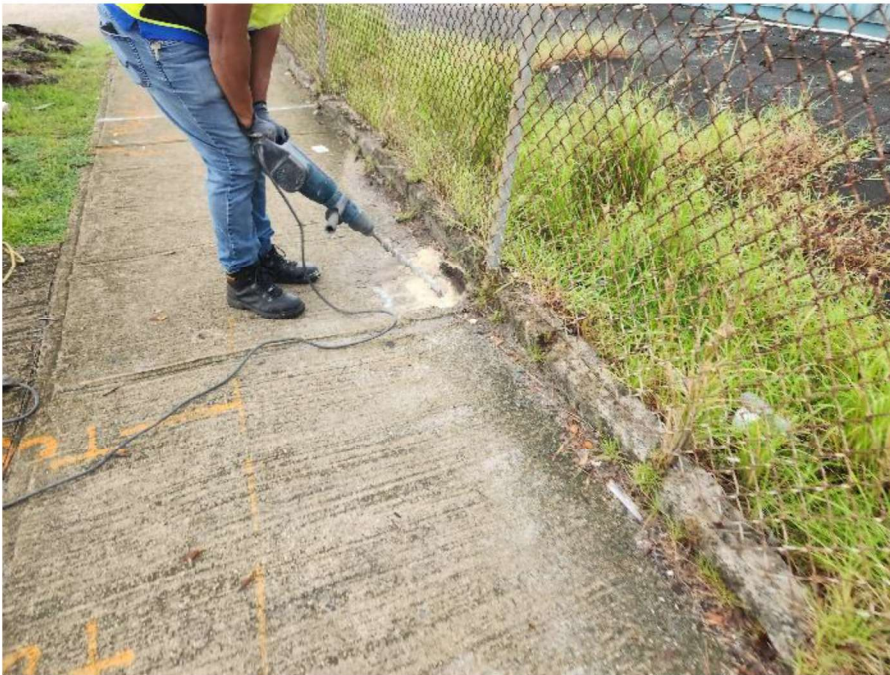
Photograph 4: Concrete breaking at SB-1.

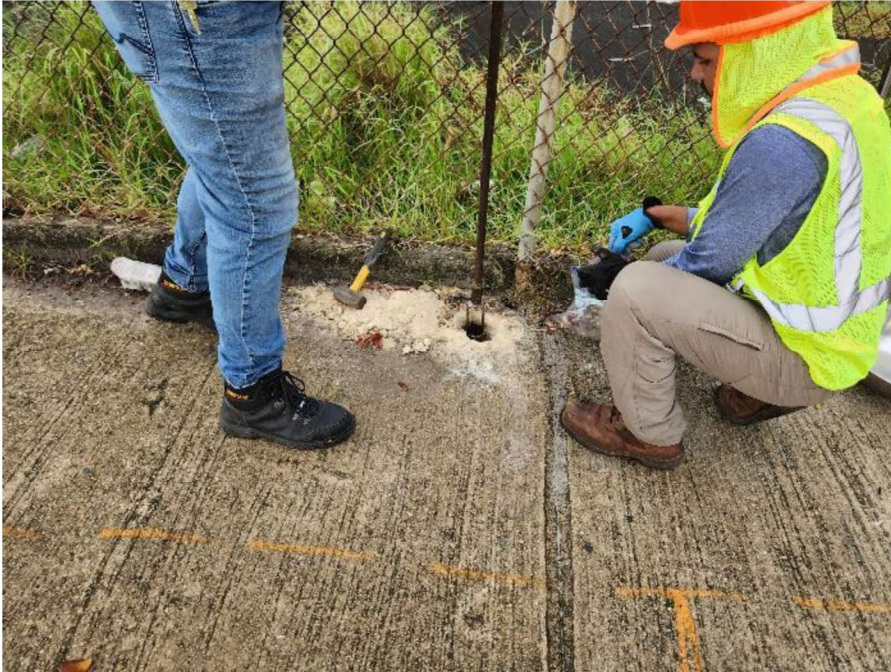
Photograph 5: Soil drilling using a hand auger at SB-1.

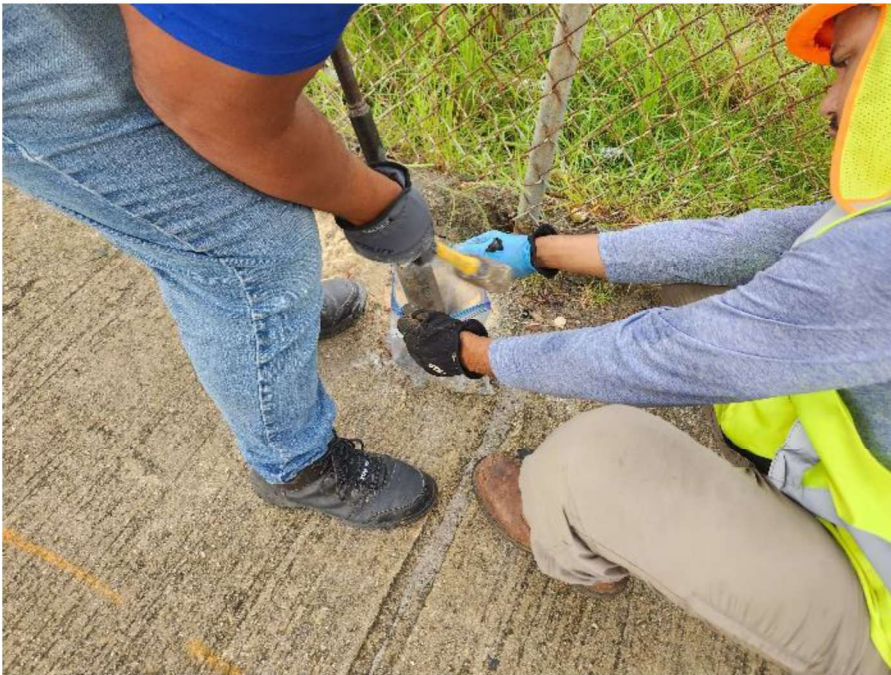
Photograph 6: Soil sample collected at SB-1.

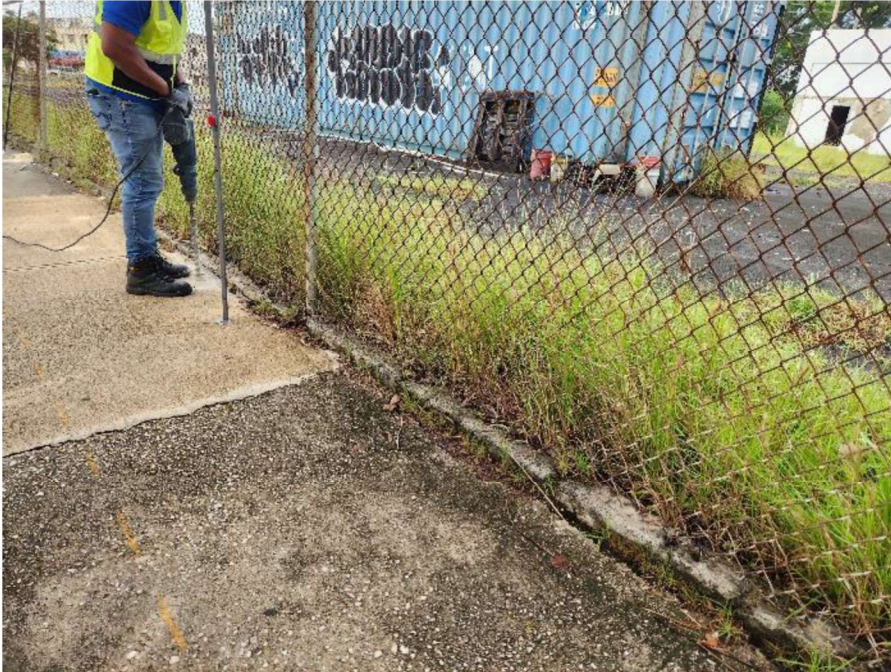
Photograph 7: Concrete breaking at SB-2.

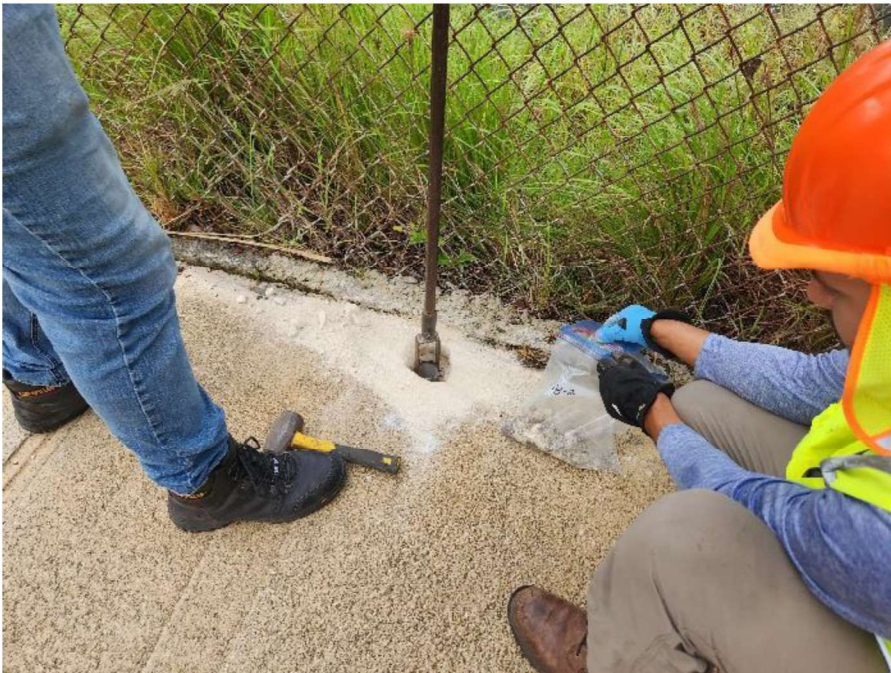
Photograph 8: Soil drilling using a hand auger at SB-2.

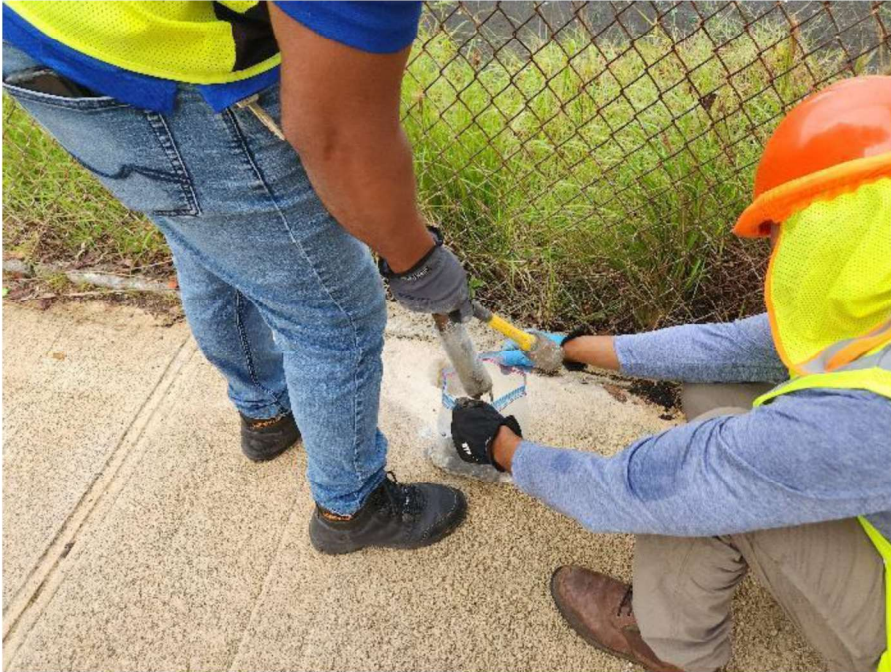
Photograph 9: Soil sample collected at SB-2.

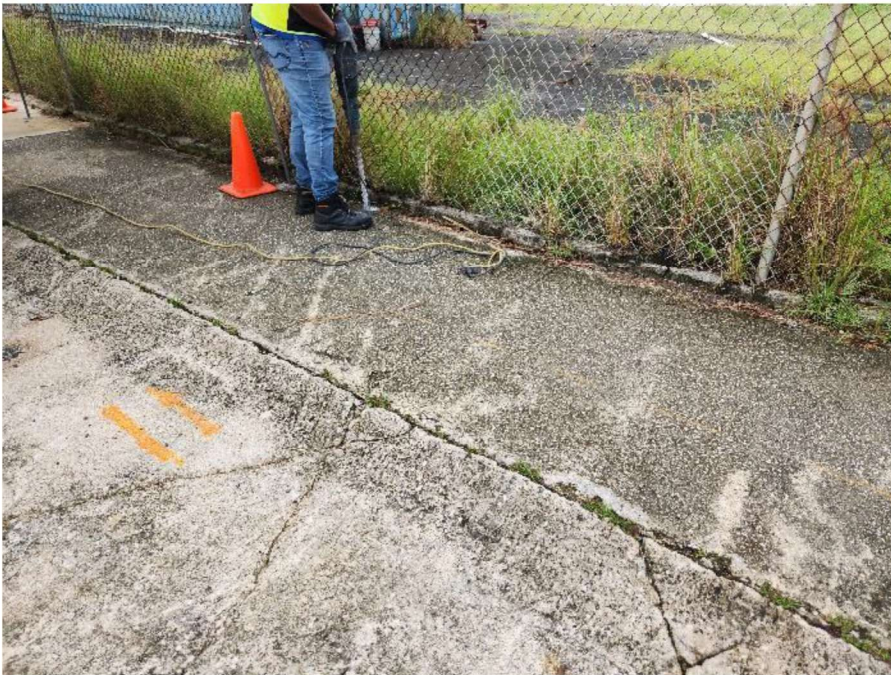
Photograph 10: Concrete breaking at SB-3.

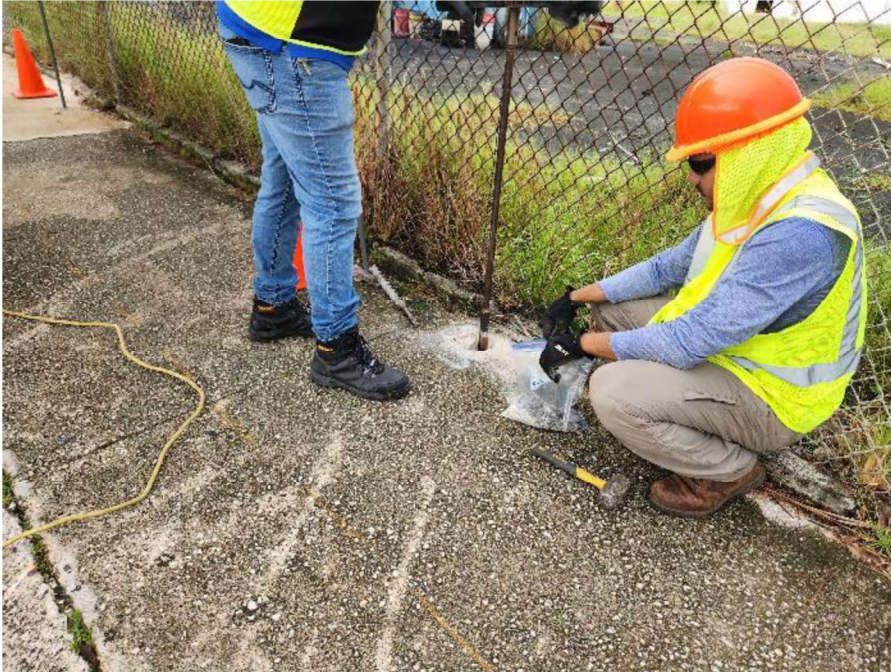
Photograph 11: Soil drilling using a hand auger at SB-3.

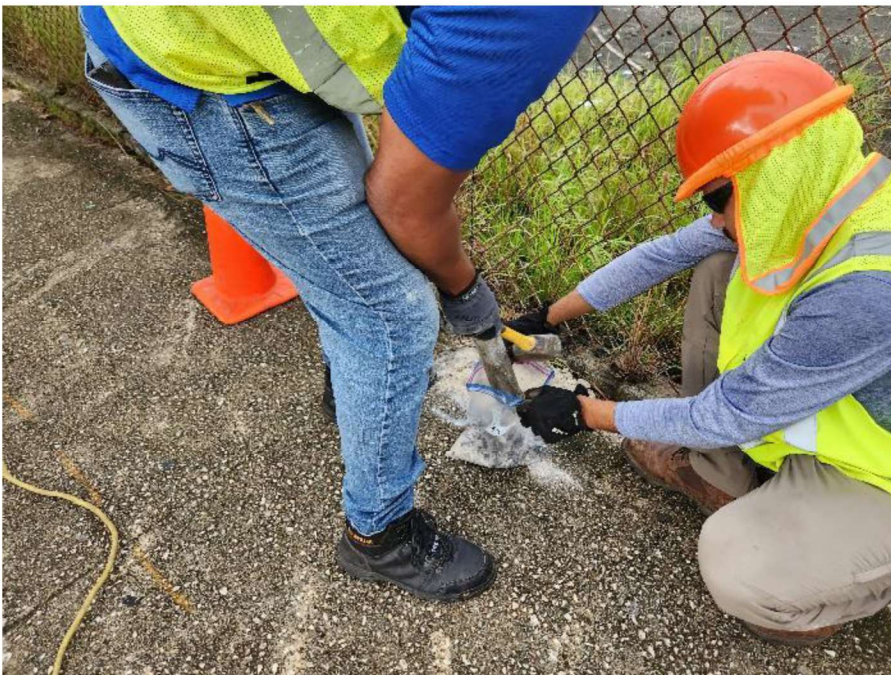
Photograph 12: Soil sample collected at SB-3.

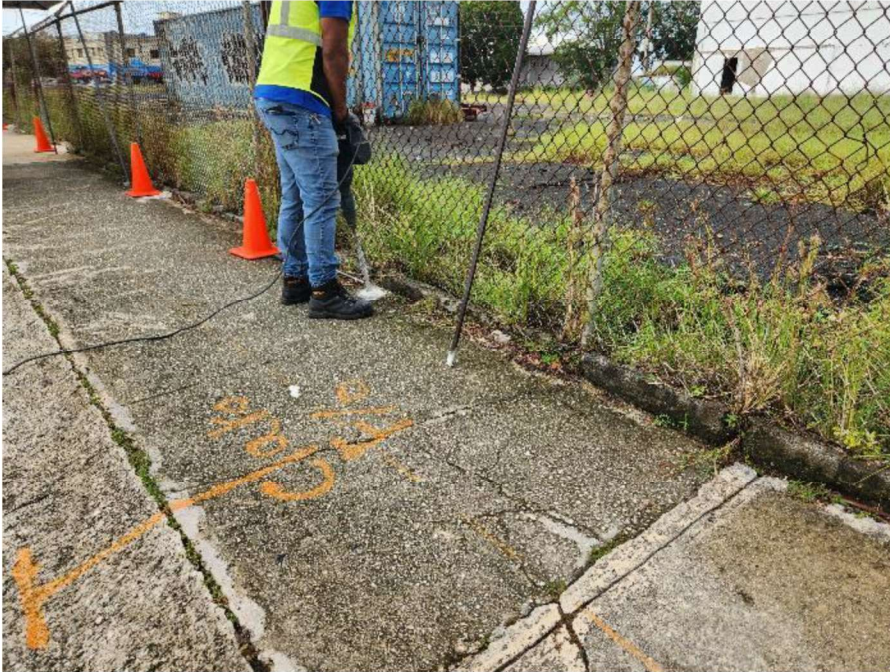
Photograph 13: Concrete breaking at SB-4.

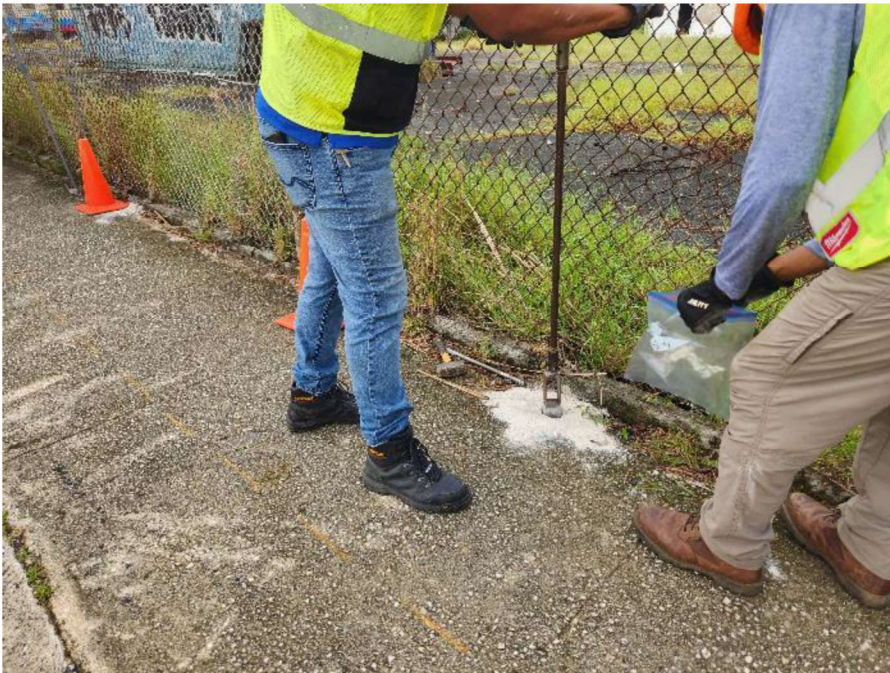
Photograph 14: Soil drilling using a hand auger at SB-4.

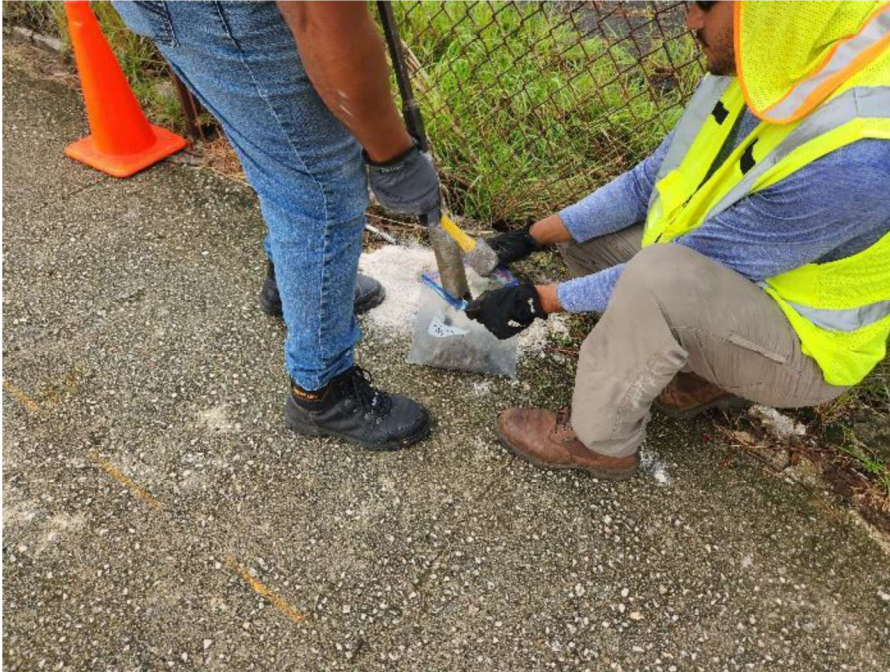
Photograph 15: Soil sample collected at SB-4.

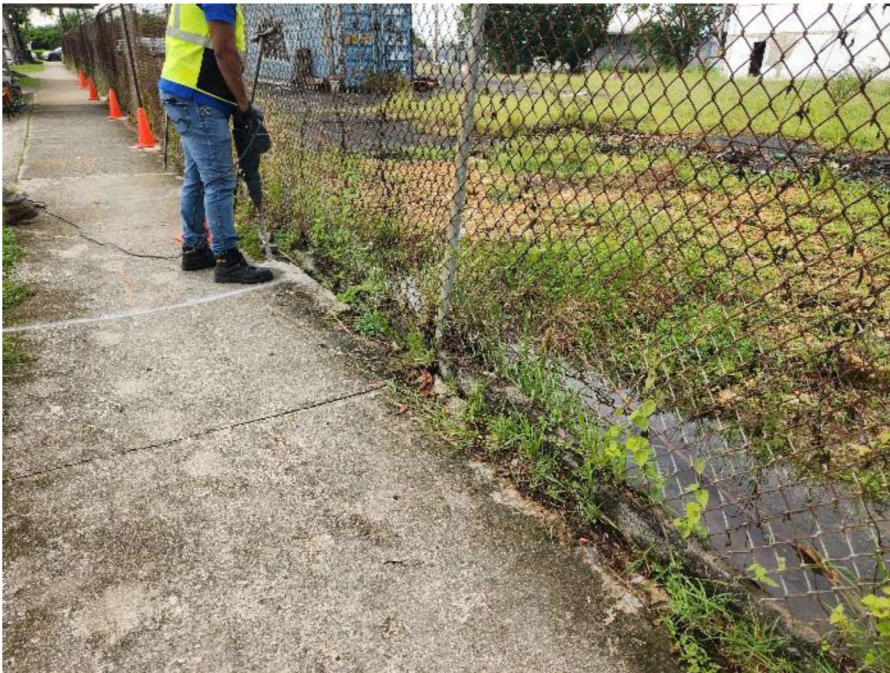
Photograph 16: Concrete breaking at SB-5.

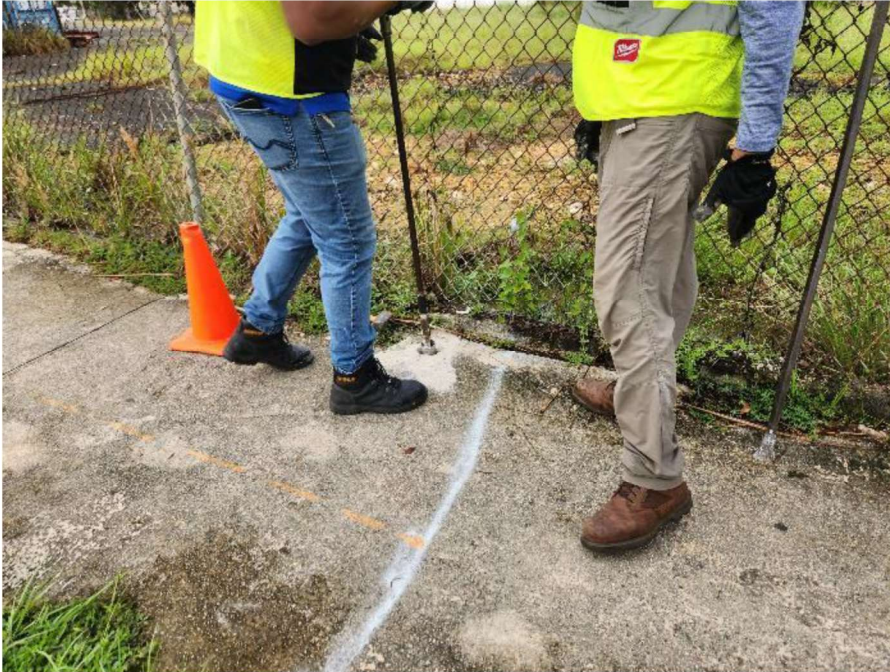
Photograph 17: Soil drilling using a hand auger at SB-5.

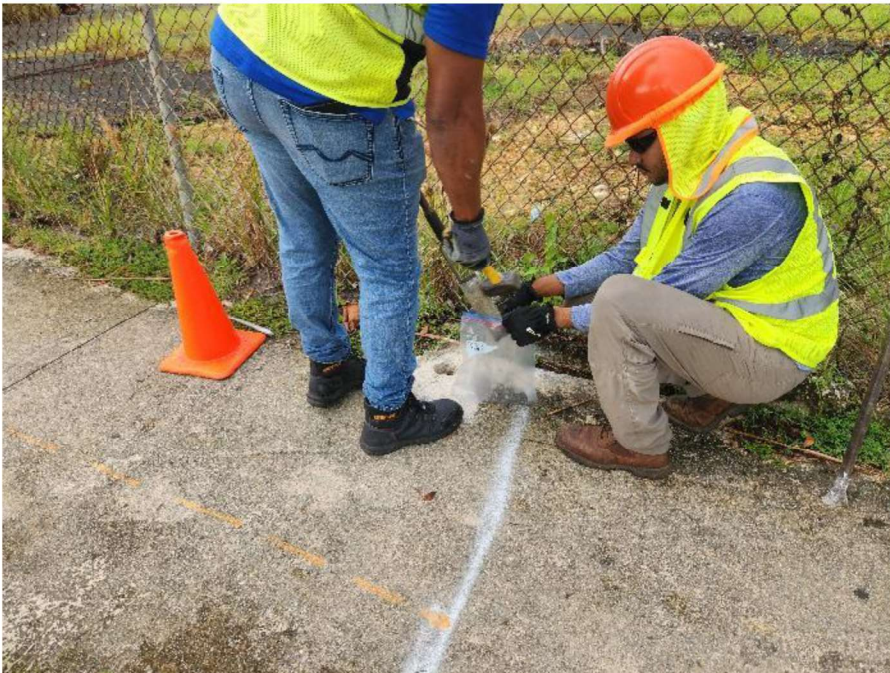
Photograph 18: Soil sample collected at SB-5.

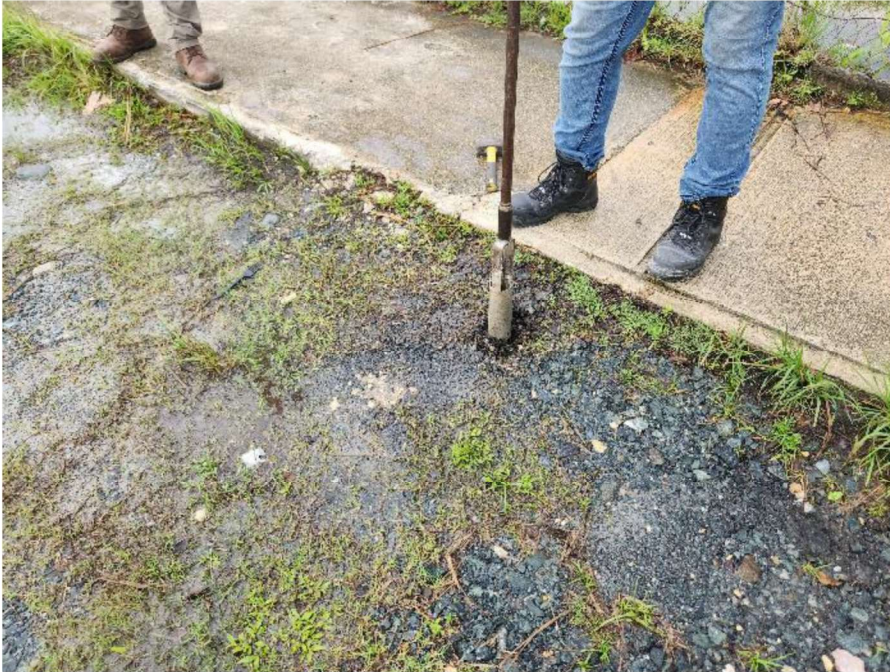
Photograph 19: Soil drilling using a hand auger at SB-6.

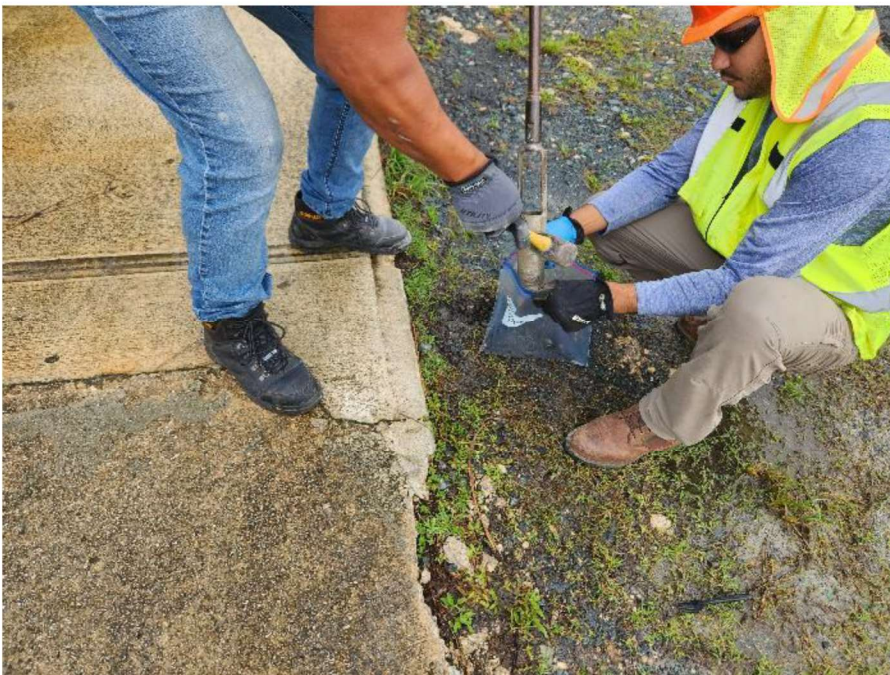
Photograph 20: Soil sample collected at SB-6.
