## **Environmental Assessment Determinations and Compliance Findings for HUD-assisted Projects 24 CFR Part 58**

**Project Name:** Mejoras Intersección Rotonda PR-693 y PR-698 (PR-CRP-000557)

**Responsible Entity:** Puerto Rico Department of Housing (PRDOH)

**Grant Recipient** (if different than Responsible Entity): Municipality of Dorado

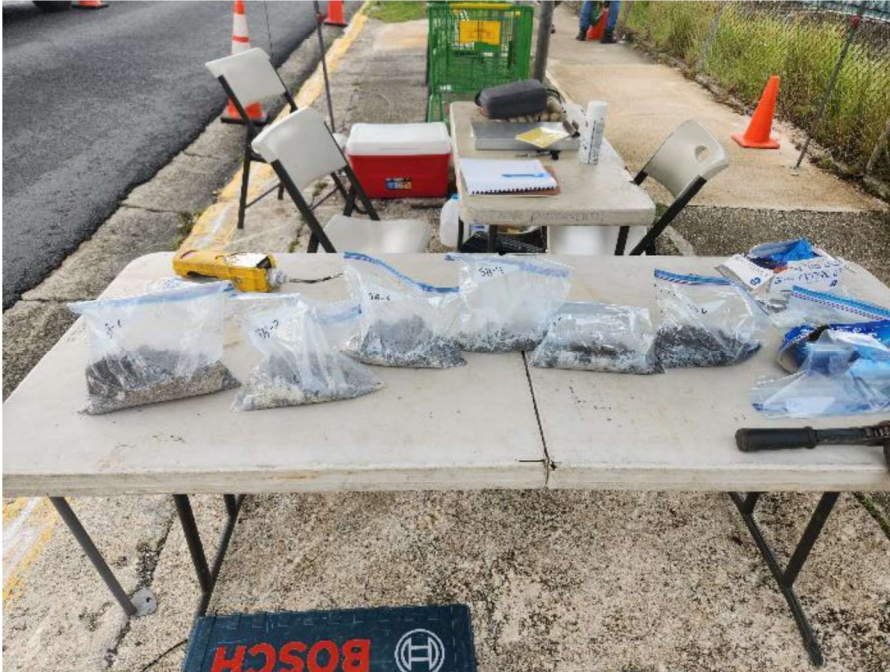
Photograph 21: Soil samples collected placed in dedicated zip lock bags.

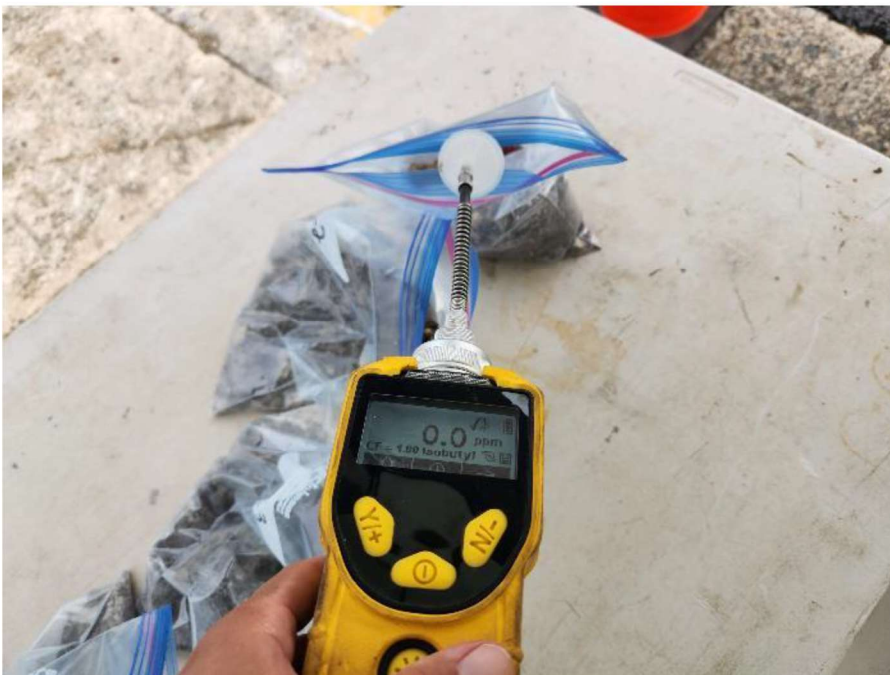
Photograph 22: PID screening in soil sample SB-1. PID = 0.0 ppm.

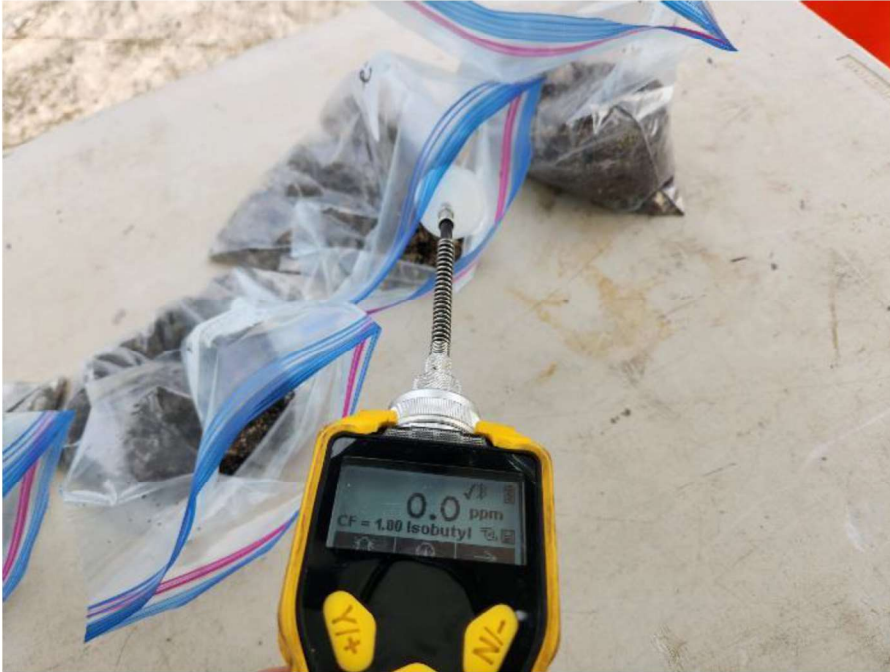
Photograph 23: PID screening in soil sample SB-2. PID = 0.0 ppm.

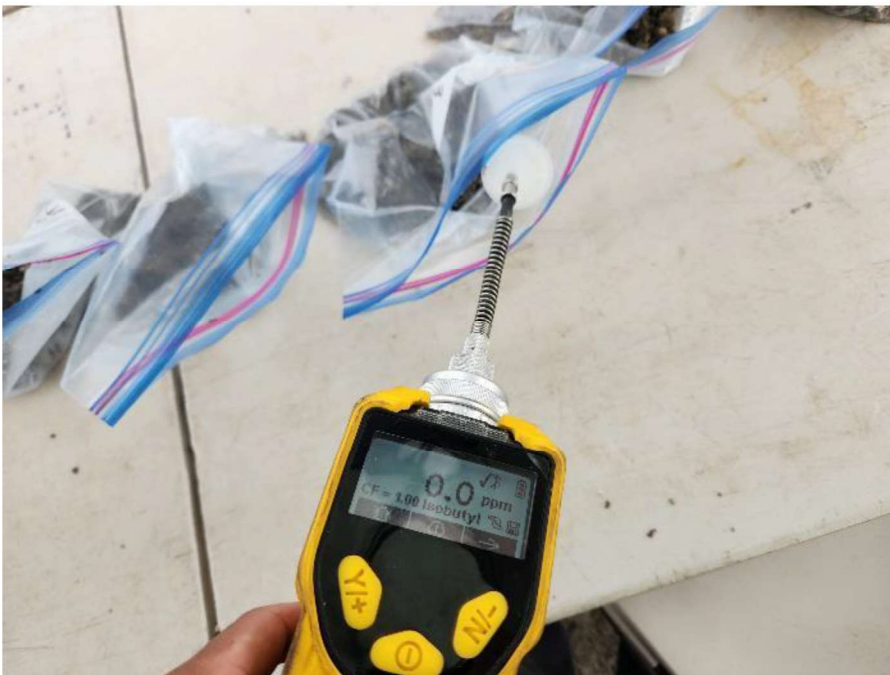
Photograph 24: PID screening in soil sample SB-3. PID = 0.0 ppm.

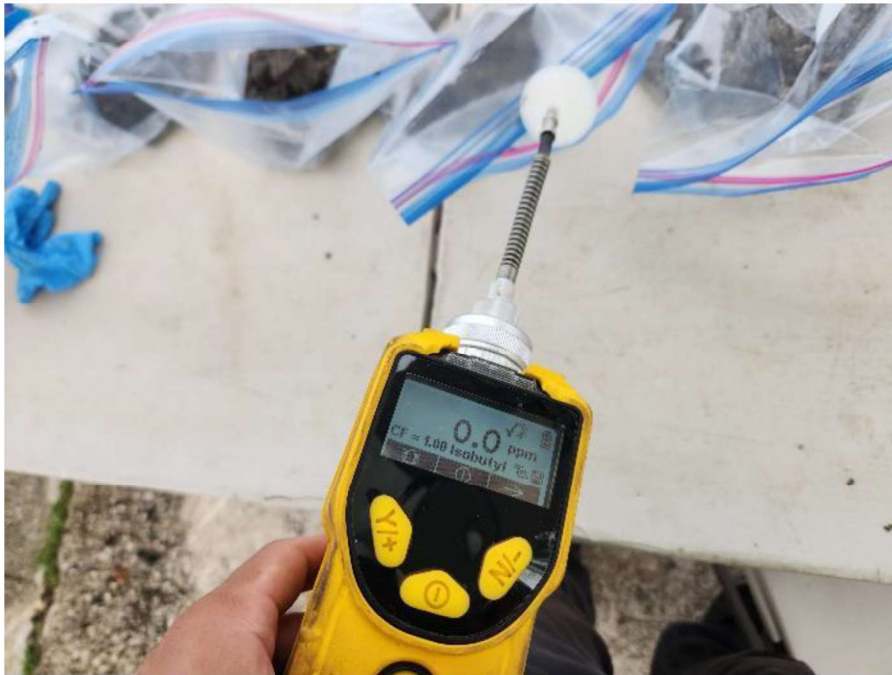
Photograph 25: PID screening in soil sample SB-4. PID = 0.0 ppm.

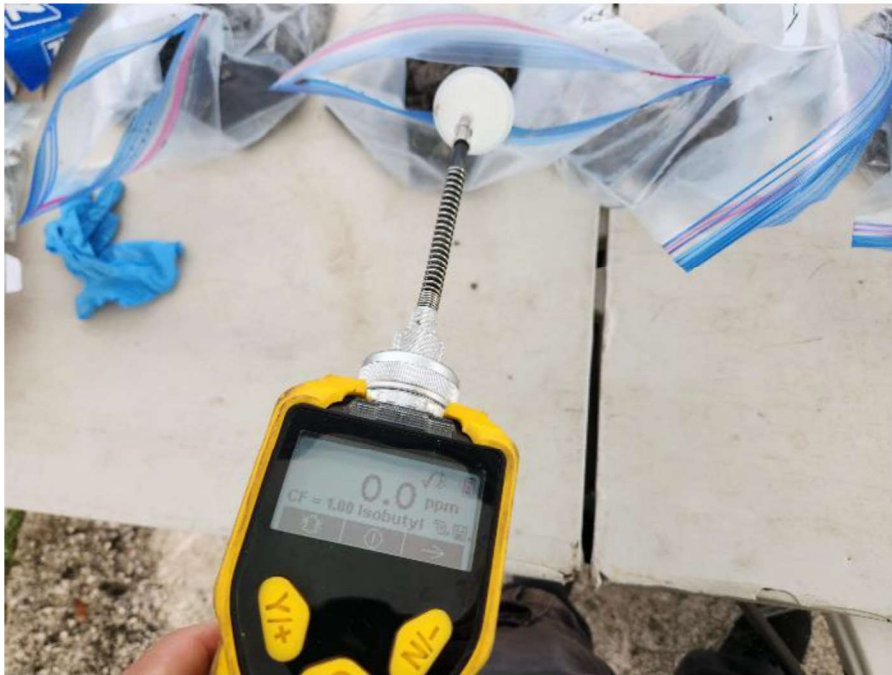
Photograph 26: PID screening in soil sample SB-5. PID = 0.0 ppm.

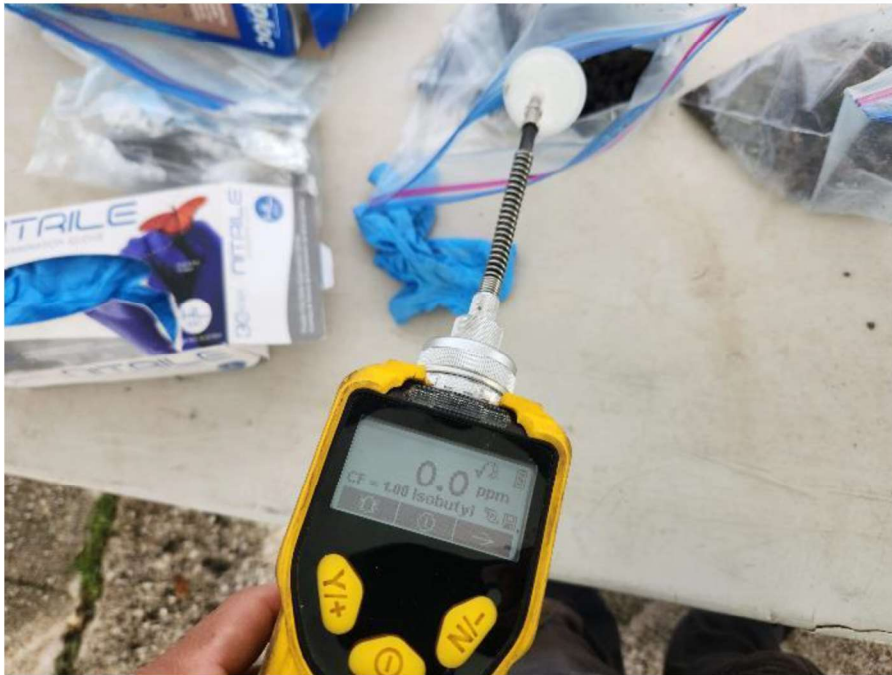
Photograph 27: PID screening in soil sample SB-6. PID = 0.0 ppm.

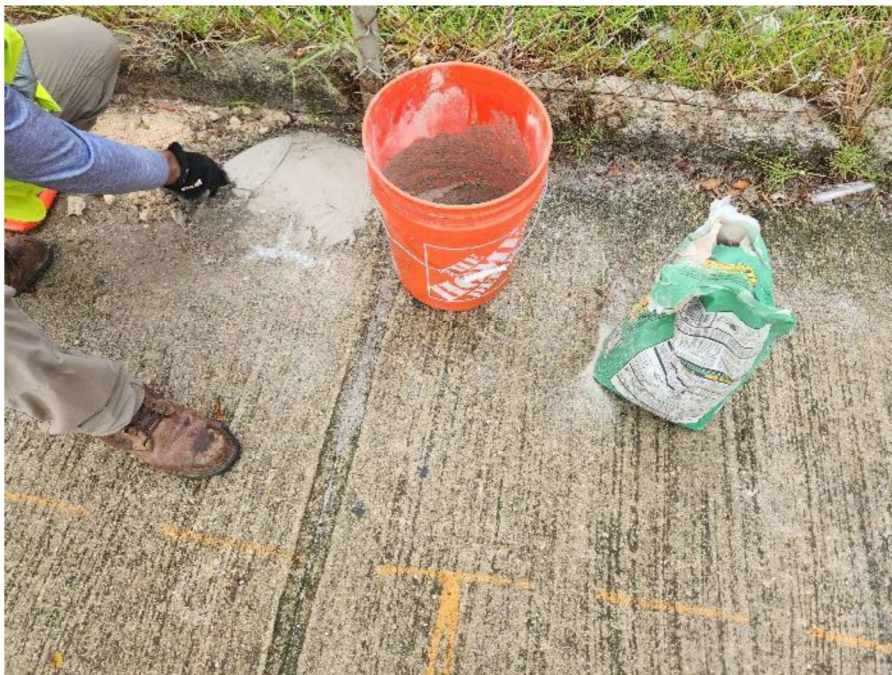
Photograph 28: Cement grouted at SB-1.

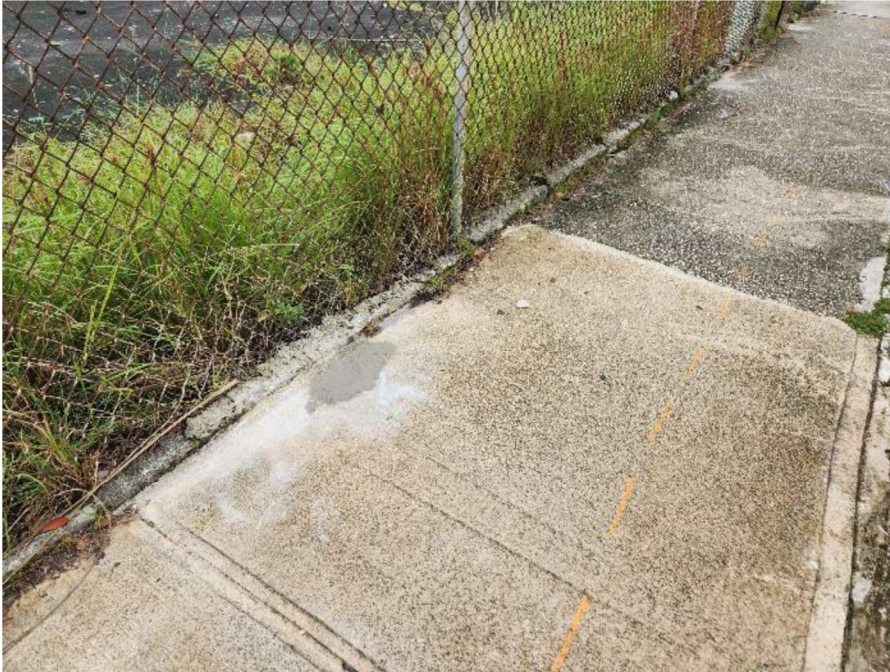
Photograph 29: Cement grouted at SB-2.

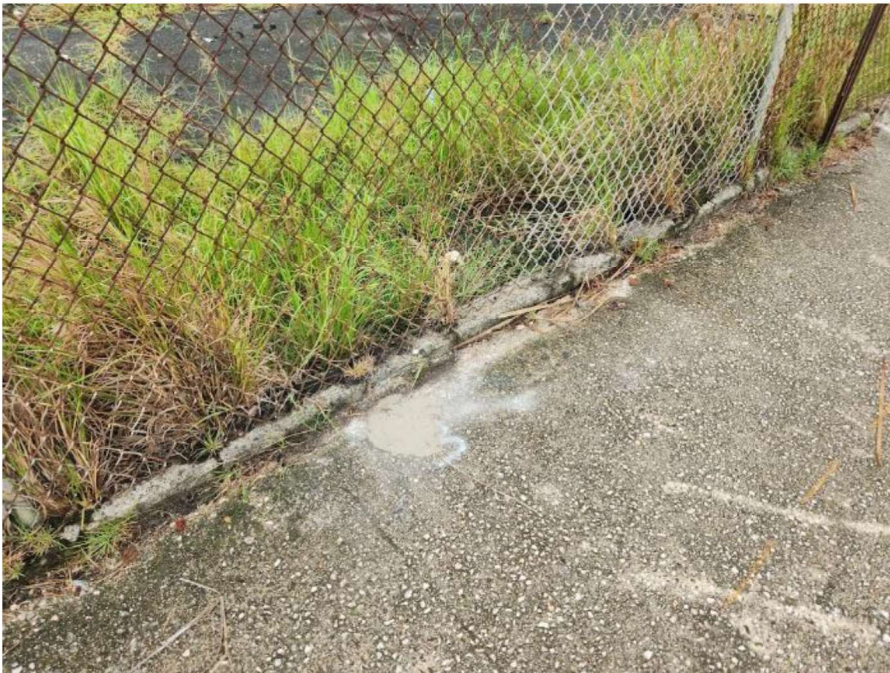
Photograph 30: Cement grouted at SB-3.

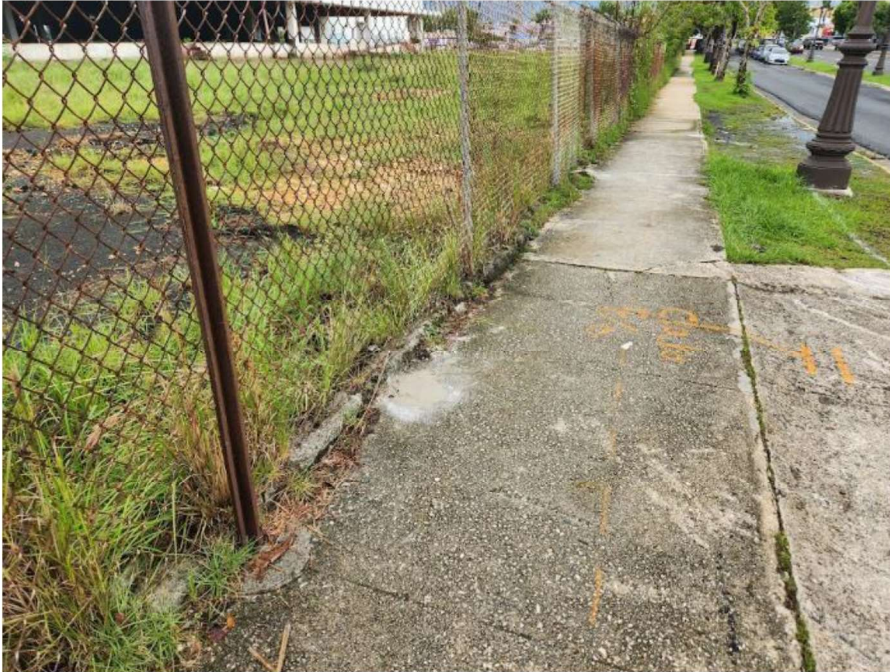
Photograph 31: Cement grouted at SB-4.

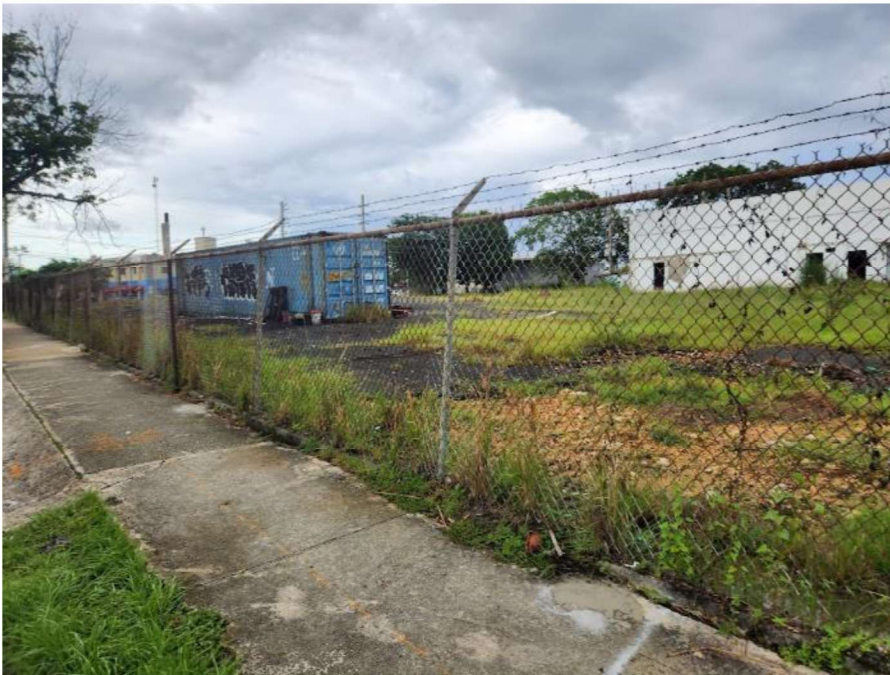
Photograph 32: Cement grouted at SB-5.

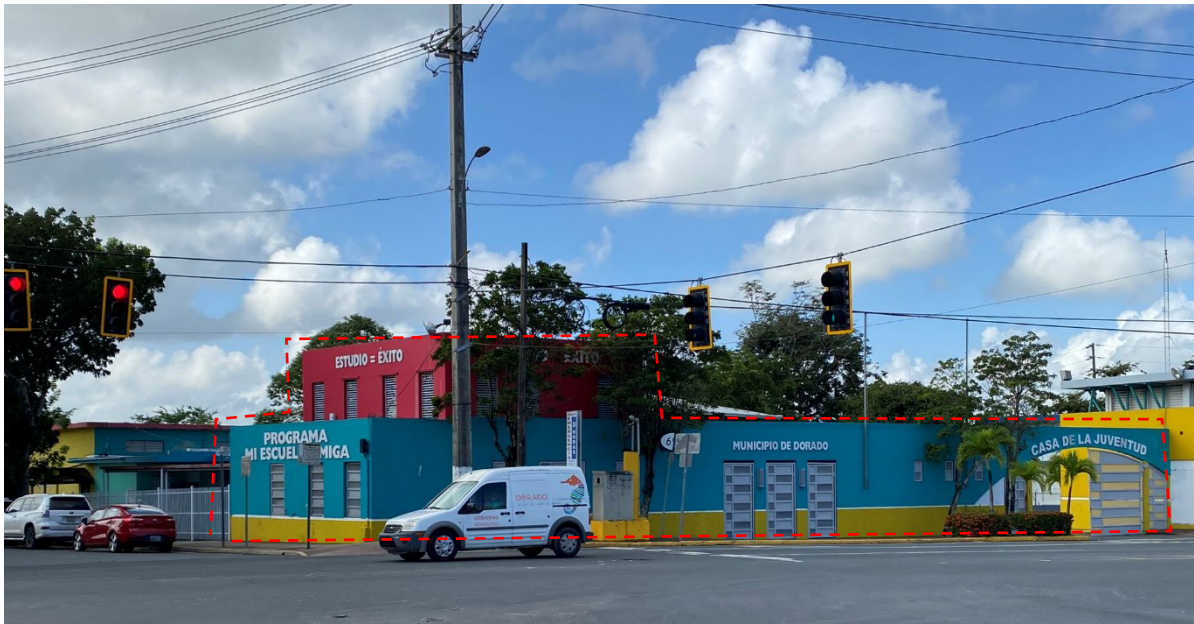
Figure 1- Photos with buildings to be demolished

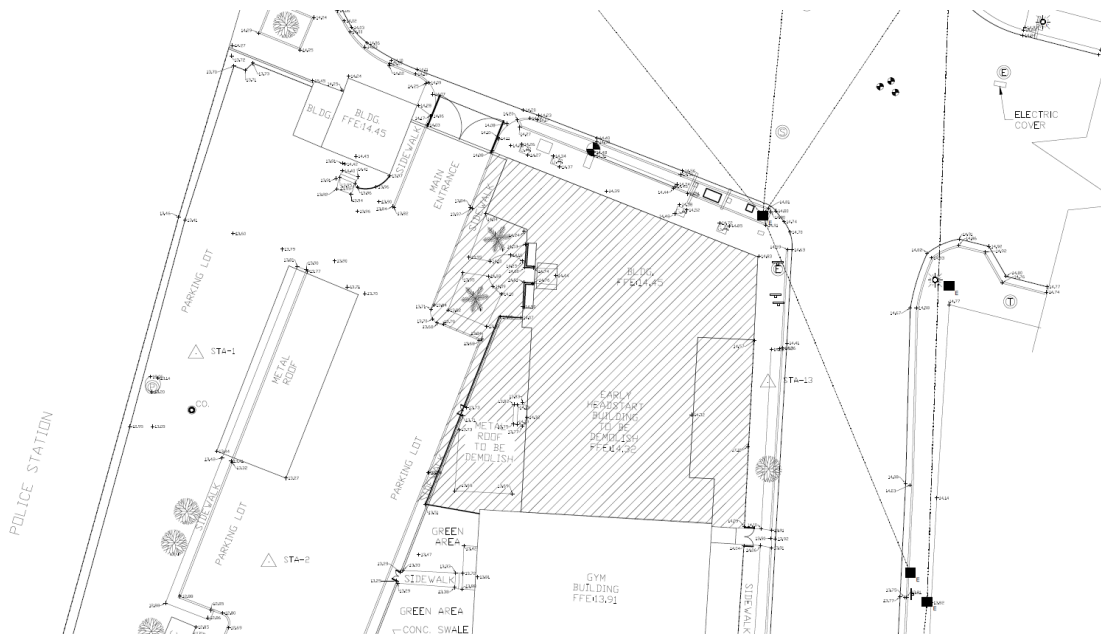
Figure 2 – Detail of drawing showing demolition area in municipal-owned property

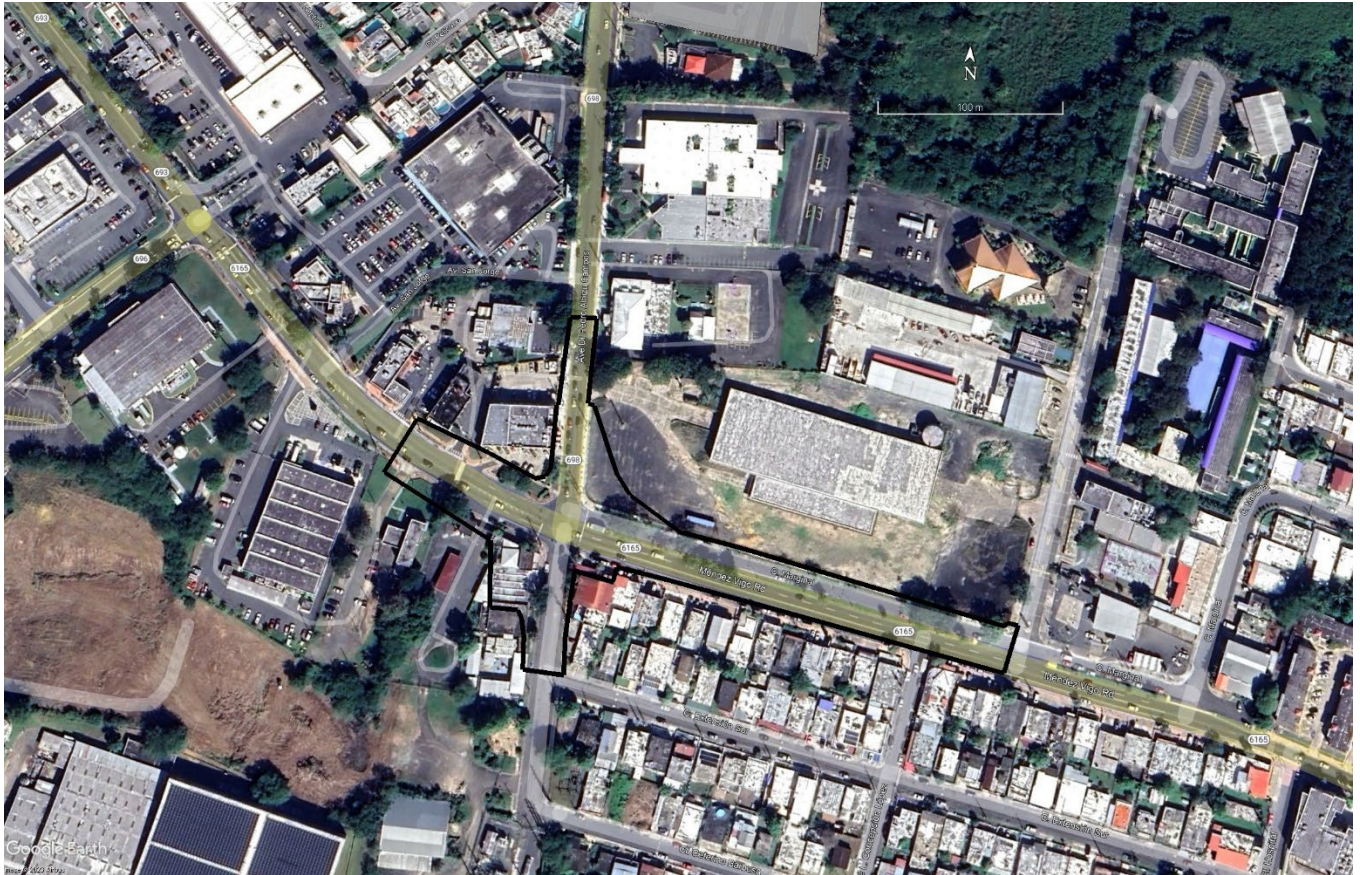
*Figure 1 Location of limits of the project in google earth satellite image 2023 (source: google earth system accessed June 2023)*

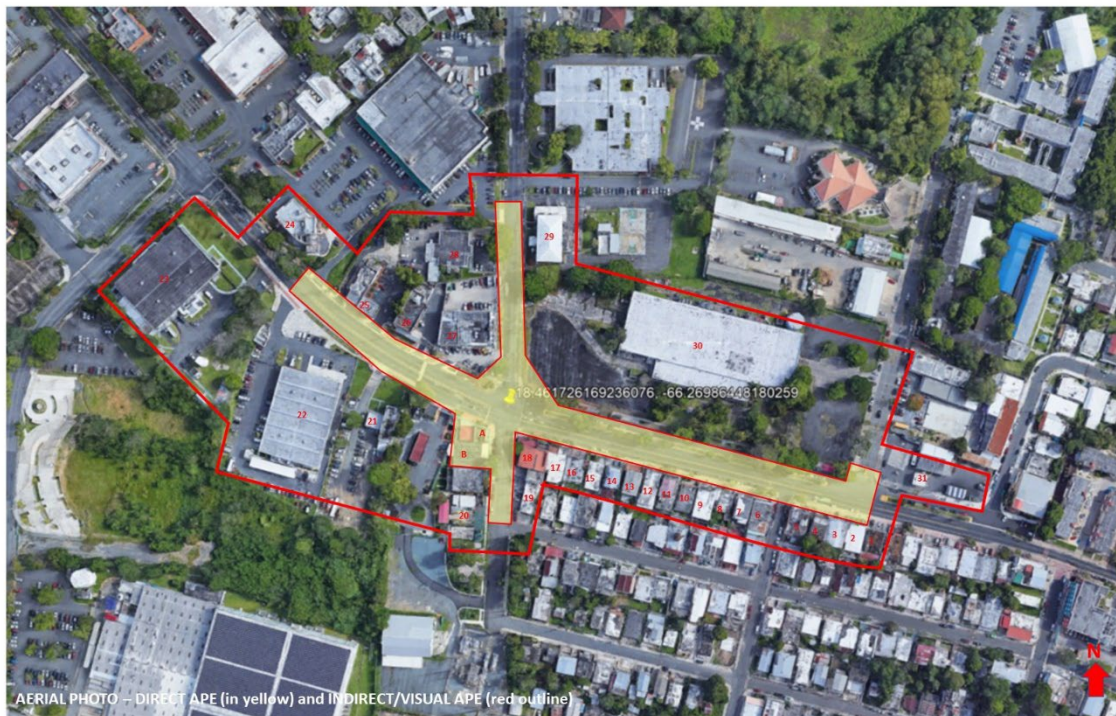
*Figure 3 Area of Potential Effect limits. The yellow area is the Direct APE and the red line shows the Indirect /Visual APE. Images of the properties within the Indirect APE are shown in Table 3 (Source: Google Earth, defined by Arch. Marla Lopez)*

As defined in 36 CFR §800.16(d), the area of potential effects (APE) is the geographic area or areas within which an undertaking may directly or indirectly cause changes in the character or use of historic properties if any such properties exist. Based on this definition and the nature and scope of the Undertaking, the Program has determined that the Direct APE for this project as described in the construction documents, covers 340 meters along PR 693 (from intersection of PR 693 with Pedro J. Ridos Street (east), to intersection of PR693 with entrance to Dorado District Police Station (west), and 195 meters along PR 698 (from intersection of PR698 with the with the first entrance to parking lot of the Dorado Diagnostic and Treatment Center (north), to intersection of PR 698 with South Extension St. (south)). The roundabout will be built in the intersection of both roads and will include parts of lots to the north to be acquired. The Indirect/Visual APE is the viewshed of the proposed project which has been defined as the surrounding properties along the Direct APE (see Figure 3).

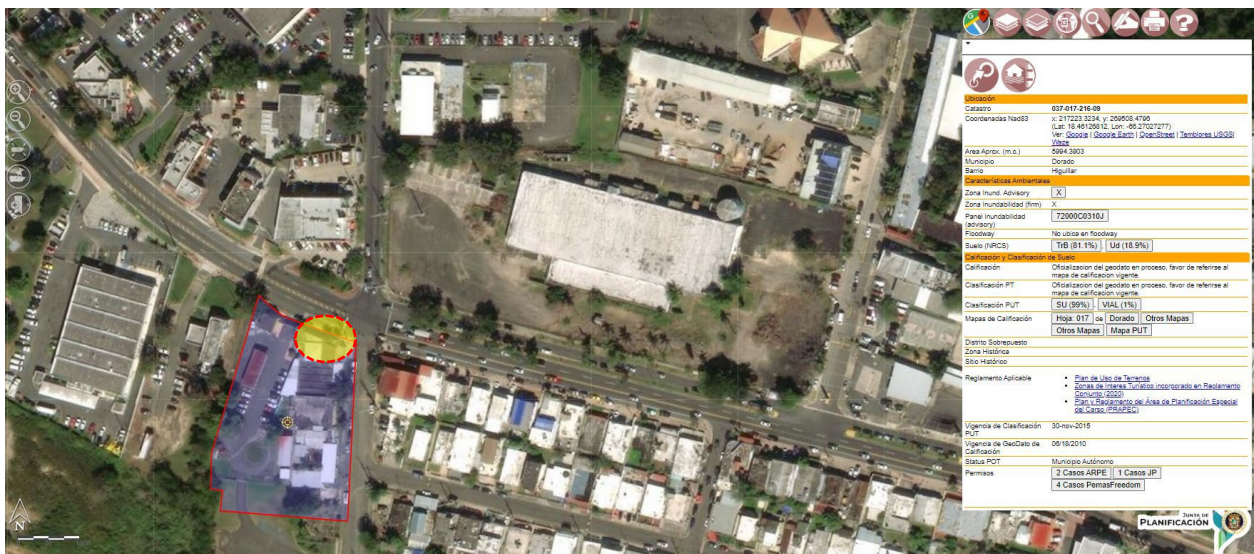
*Figure 2.1.1 Location of Mi Escuela Amiga within the parcel.*

The Mi Escuela Amiga building is a two-story reinforced concrete building, built approximately c.2000-2004 (according to topographic maps and aerial photos) and consisting of:

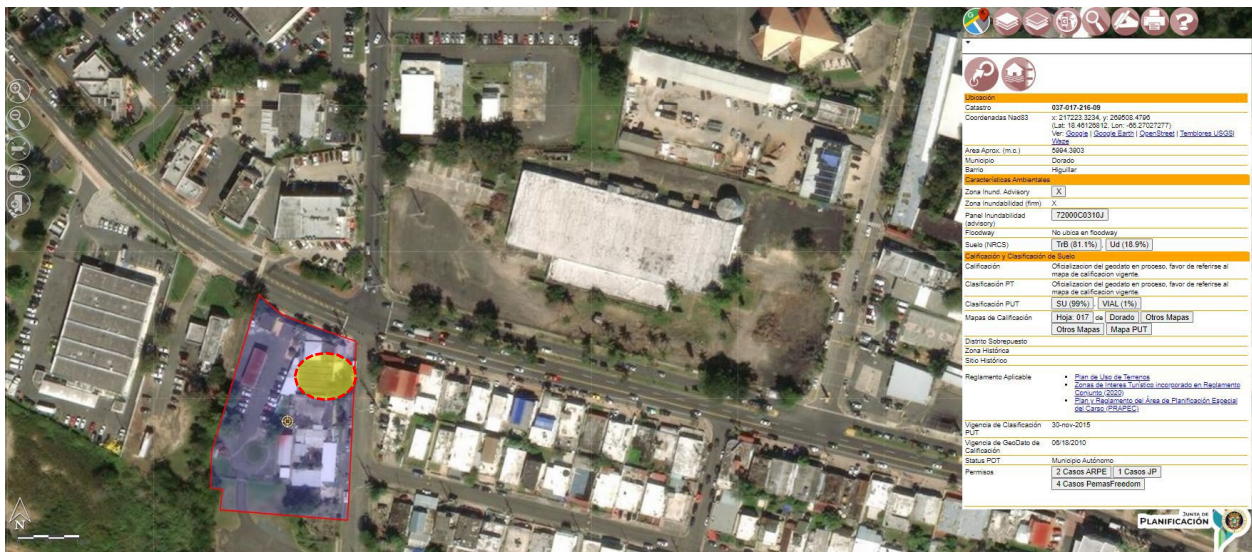
Figure 2.1.2- Location of Paraiso Infantil Building within the parcel.

The Paraiso Infantil building is a one-story reinforced concrete building, built approximately c.1980s (according to topographic maps and aerial photos) and consisting of:

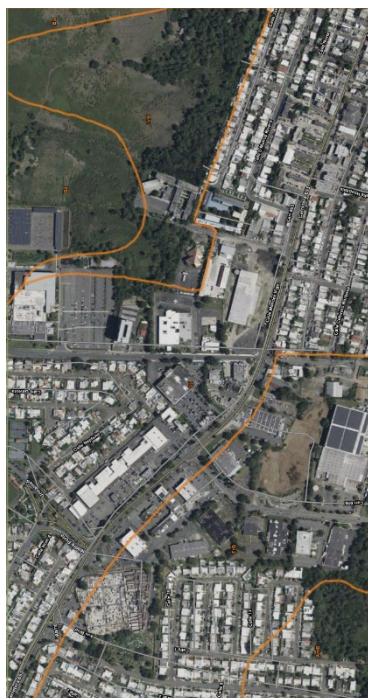
Map Unit Symbol	Map Unit Name
AmB	Almirante clay, 2 to 5 percent slopes
Ba	Bajura clay, 0 to 2 percent slopes, frequently flooded
TrB	Torres loamy sand, 2 to 5 percent slopes
Ud	Urban land-Durados complex

Figure 4 Soil data downloaded from the Web soil data base  
(Source: <https://www.nrcs.usda.gov/>)

As for known archaeological sites identified on the Dorado Municipality, most are located along the coast or along the riverbanks of La Plata River. Also, in the karst area that begins at the end of the norther coastal plain (mogotes) investigations have detected settlements and possible ceremonial sites in the caves of the area. The project is located within the geological the northern coastal plain The soils are characteristic of these plains as Almirante Clay, Bajura Clay and Torres loamy sand, Bu most of the area is classified as Urban Land Durados complex (Figure 4).

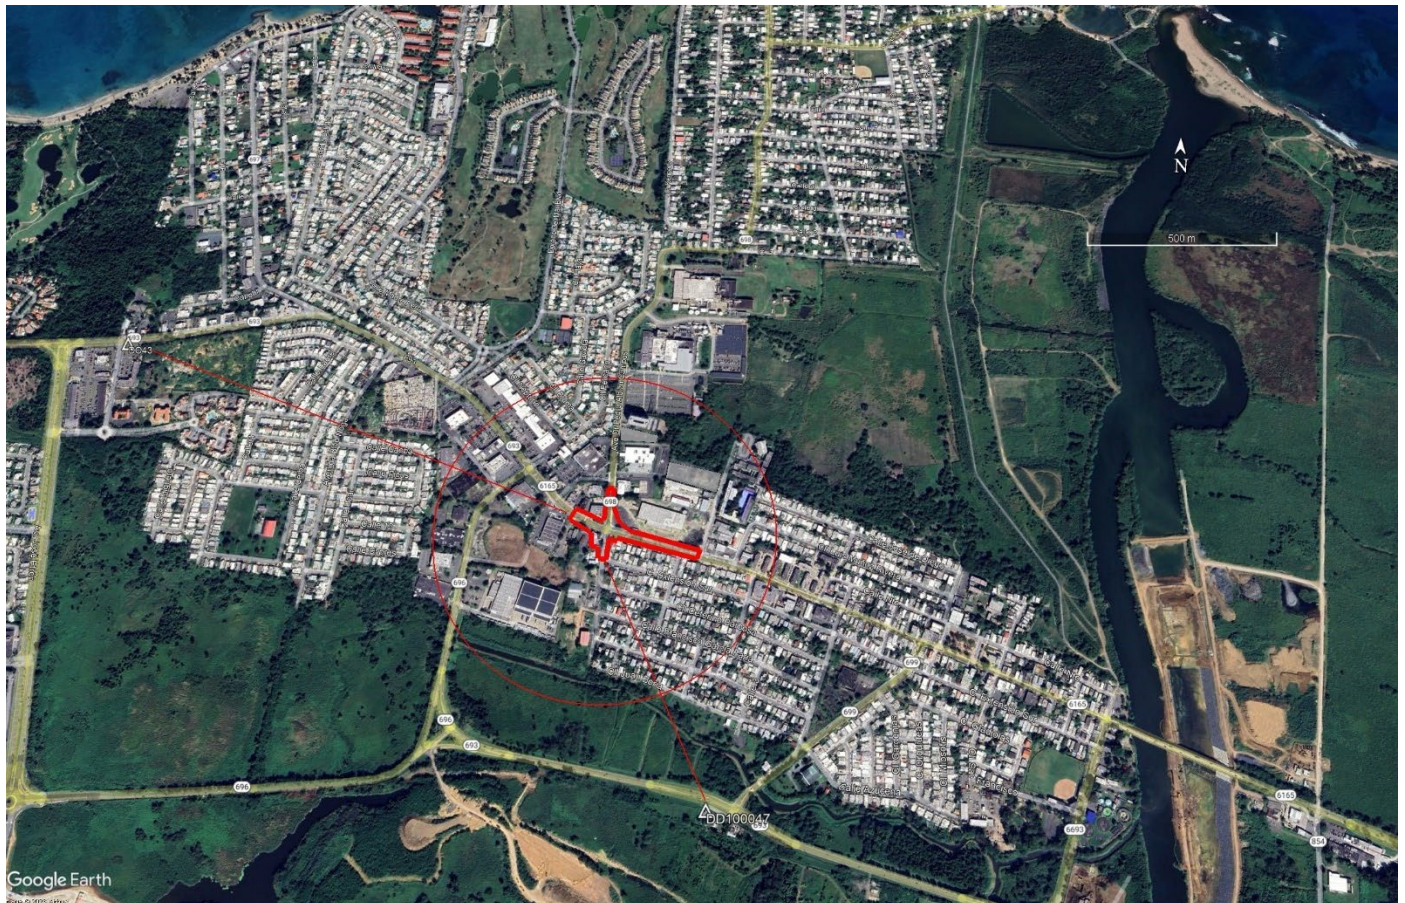
Figure 5 Archaeological sites nearest to the undertaking are located outside the 0.25-mile buffer zone

Existing information on previously identified historic properties has been reviewed to determine if any such properties are located within or near the APE of this undertaking. The review of this existing information, by the PM archaeologist shows that there are no known archaeological sites located within or near the APE. The nearest archaeological sites are located outside of the 400 mts buffer zone considered for this project DO 100040 is the remains of a site located to the north and discovered as scattered material during an investigation described below. (Figure 5) The other is located 700 mts to the south (Dorado 100047). The "Plaza de Recreo" (Townsquare) is located approximately 600 mts to the east and Casa del Rey is in the same street but approx. 800 mts to the east along the main road.

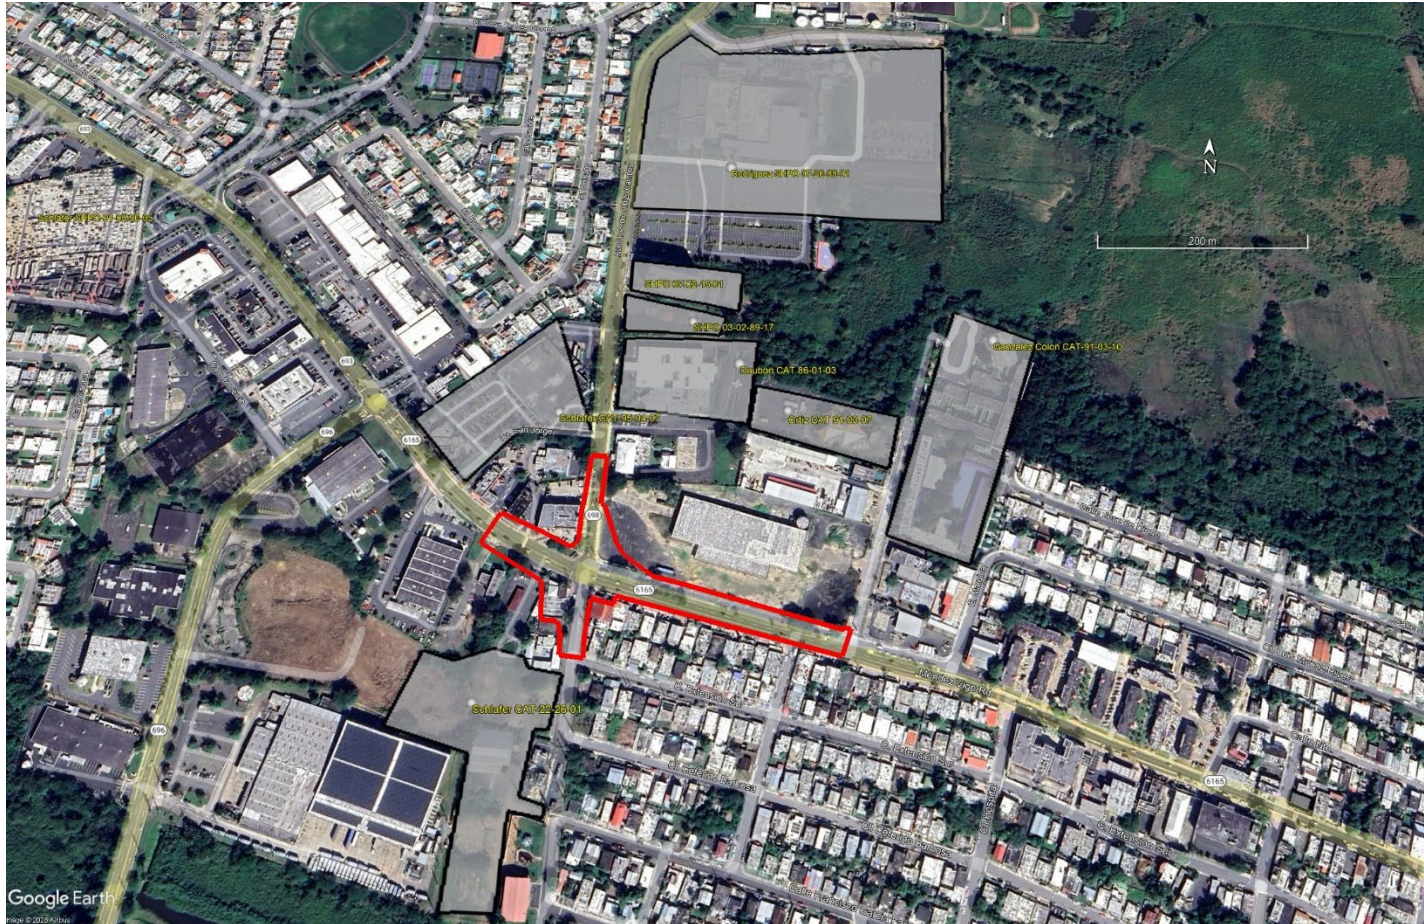
Figure 6 Location of the archeological investigations in the SHPO and CAT archives near the undertaking (Source: SHPO and CAT 2022)

archives for Dorado. The ICP/ CAT archive shows 161 investigations. From SHPO archive only two are in the Pueblo ward, both for the Plaza de los Artesanos located 385 mts approx. of the east end of the project over the Mendez Vigo Street (PR 693). (Figure 6) The Phase I archaeological investigation was negative but during the Monitory they found three historic elements (latrine, foundations, and garbage) dated to early XX century. The other investigations nearby are located at Higuillar ward. The two-Phase IA\_IB archaeological assessments for the Centro de Envejecientes, located 100 and 120 mst to the north end of the project over PR 698. Dated 1989 and 2015 both were negative.

In the CAT archive we found five archaeological investigations near the project, all with a negative result. The nearest ones are CAT-95-04-07 by Ethel Schlafer that is located at the north of the west end of the project. This was made for a Grande Supermarket. To the north of PR 693 and east of PR 698 south of the Centro de envejecientes that we already have mentioned we have three projects (Daubón, CAT-86-01-03, Ortiz CAT 91-03-07m and González CAT 91-03-10) All have a negative result. Ortiz mentioned in his 1991 project that he did a project in 1989 for the Academia Paraiso that limits with the project he was doing, but we don't find it on the maps. To the south of the project Ethel Schlafer performs the lates project in 2022, at 20 mts to the south of the south end of the project in PR 698. This project also has a negative result (Figure 6).

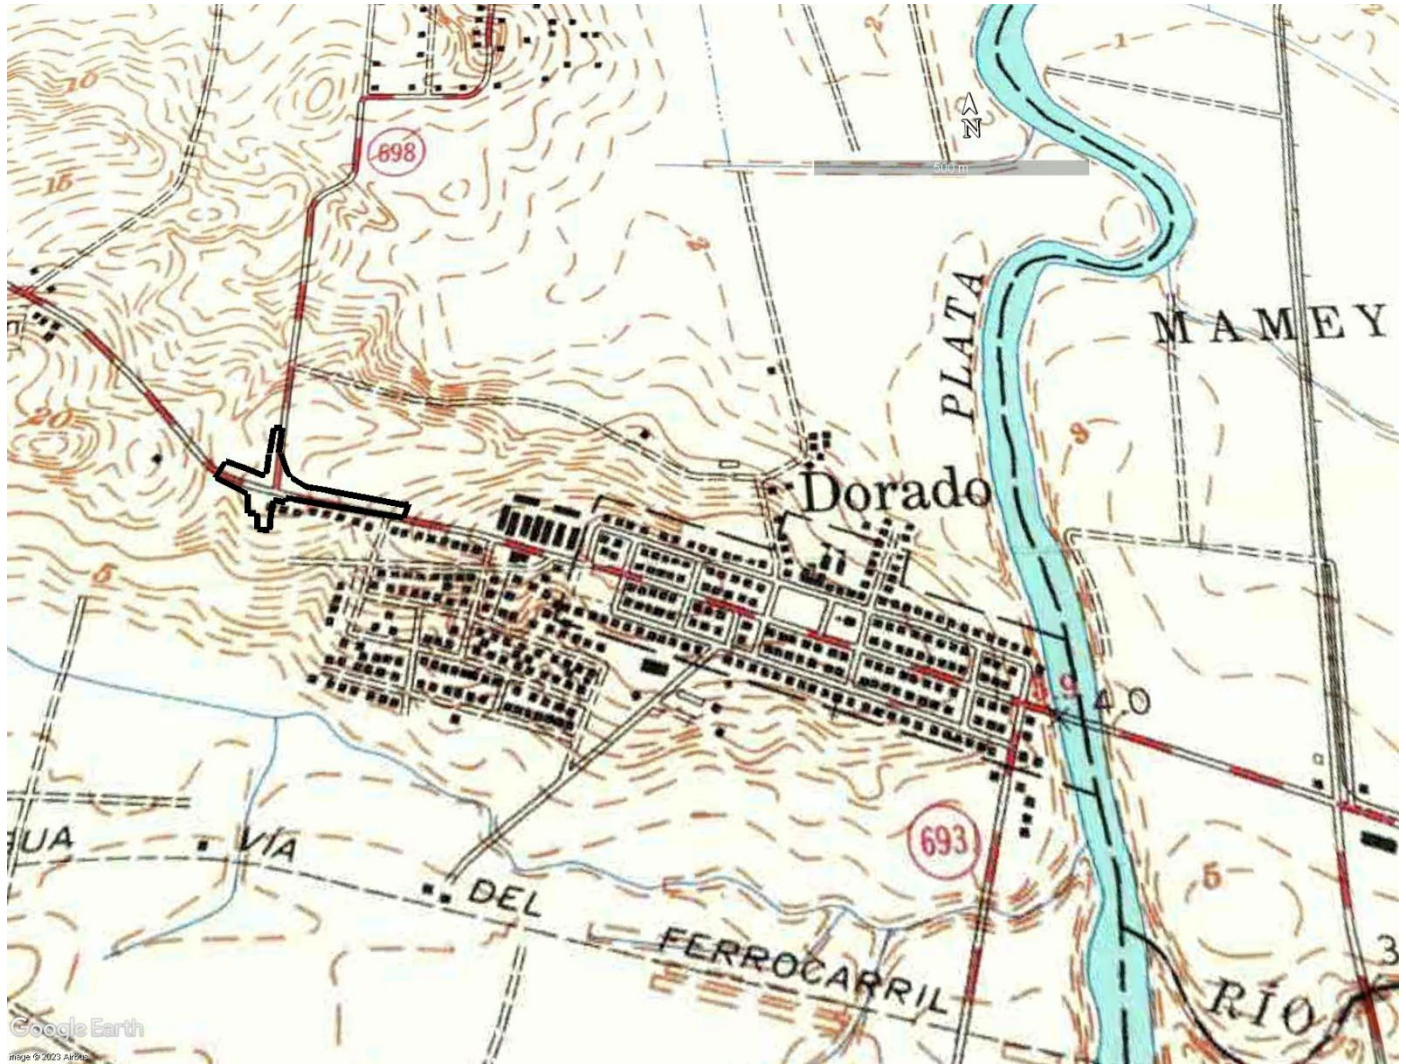
Figure 16 1958 USGS Quadrangle. In this map we can see the town growing to the west. At the south of PR 693 houses are appreciated all the way to the intersection with PR. 698. (Source: <https://ngmdb.usgs.gov/topoview/> accessed mayo 2023)

In 1958 we can notice a change with an expansion of the city to the West. According to the USGS Quadrangle published for that date. The area known as Martorell shows a set of large buildings near the town to the north, To the south and west is the first development. Also, along the road some buildings are observed. Some of them in the area to the south of the east part of the undertaking including the area where the roundabout is proposed.

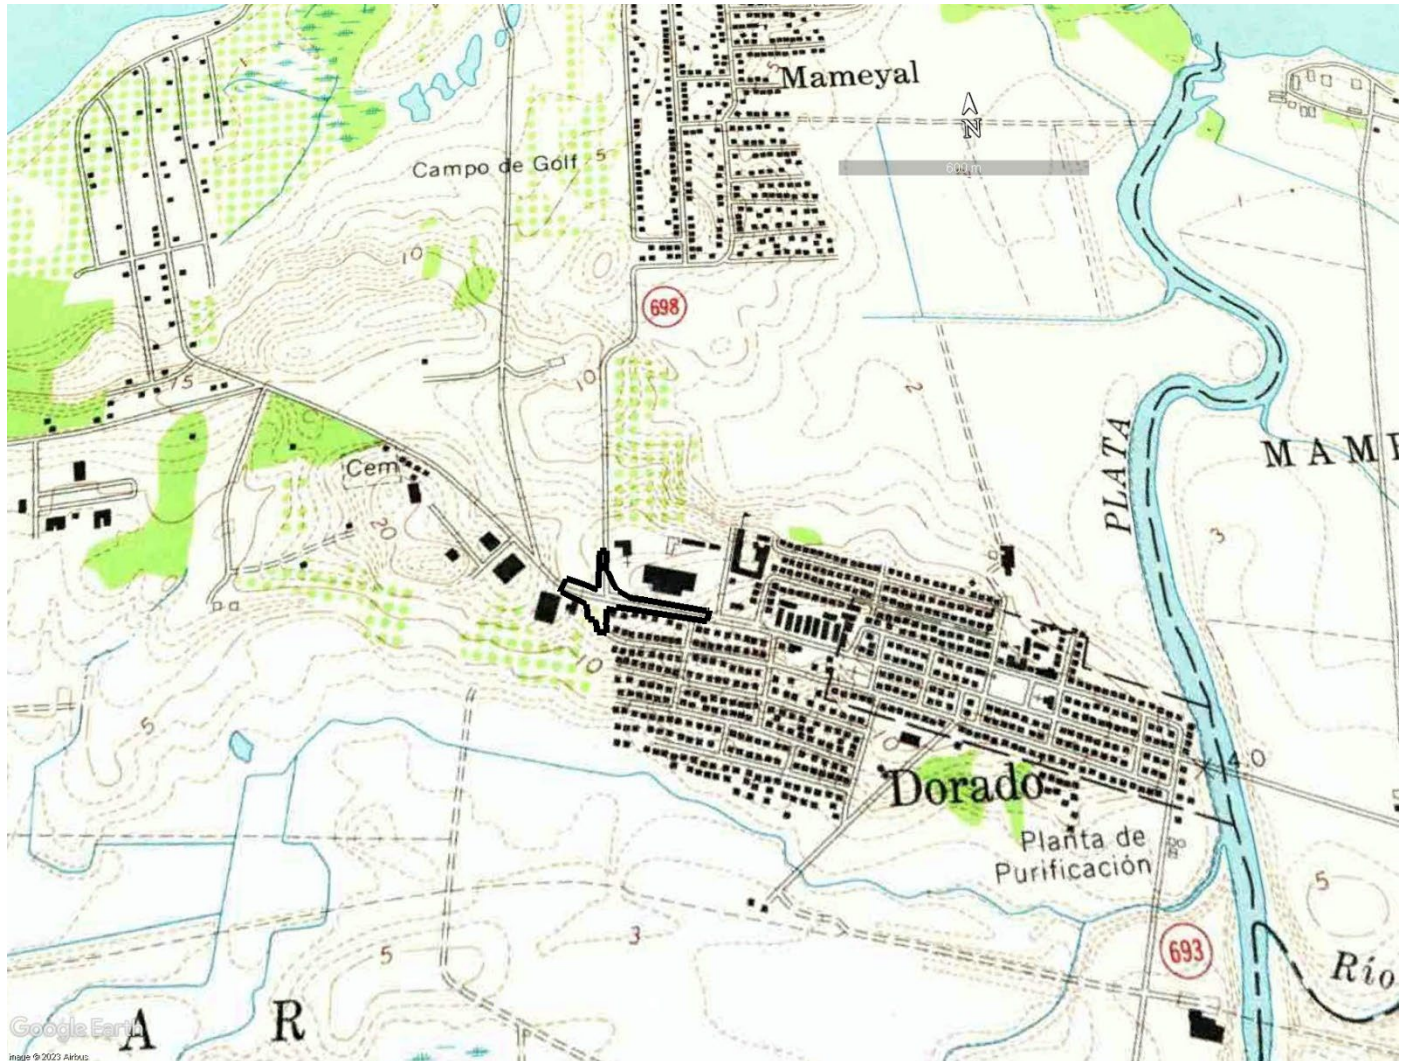
Figure 17 Fragment of 1969 USGS Quadrangle showing the undertaking. Buildings to the northeast and southwest of the intersection are shown. The church to the north.

Then in 1969 we can appreciate that additional large buildings appear to the north of PR 693 and west of PR 698. A church is located to the north of this corner. To the west and to the area of the cemetery some large buildings are shown along the south part of the road (Figure 8). No changes in the 1994 and 2022 satellite images.

From that perspective we can conclude the area remains as farmland until the late 1950's or early 1960's when the town begin its expansion to the west. PR 698 to the North was built, according to the images, between 1950 and 1958. To the south the portion that includes the undertaking is not shown until 1968.

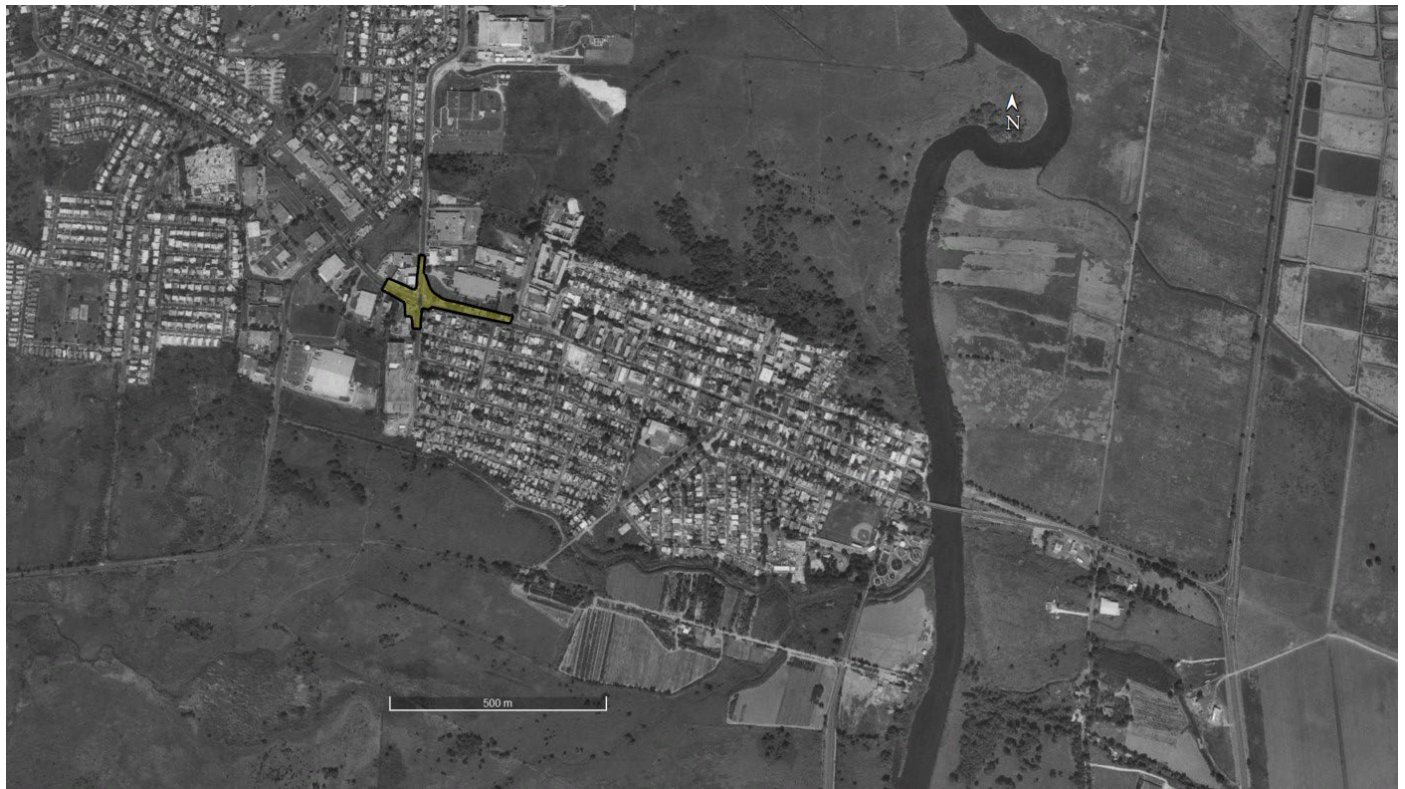
*Figure 18 Fragment of the 1994 aerial photo showing the undertaking (Source: Google Earth accessed June 2023)*

CostaVis aerial photo of 1950 shows the urban core's, west limit, up to NorthSt. The following aerial photo, 1994 shows development along the four corners of intersection PR693 with PR698: northeast, Commercial Center/Dorado Health Center; southeast, commercial, and residential properties; southwest, San Antonio Head Start complex; northwest, no. 410 Commercial Center. (See Figures 15).

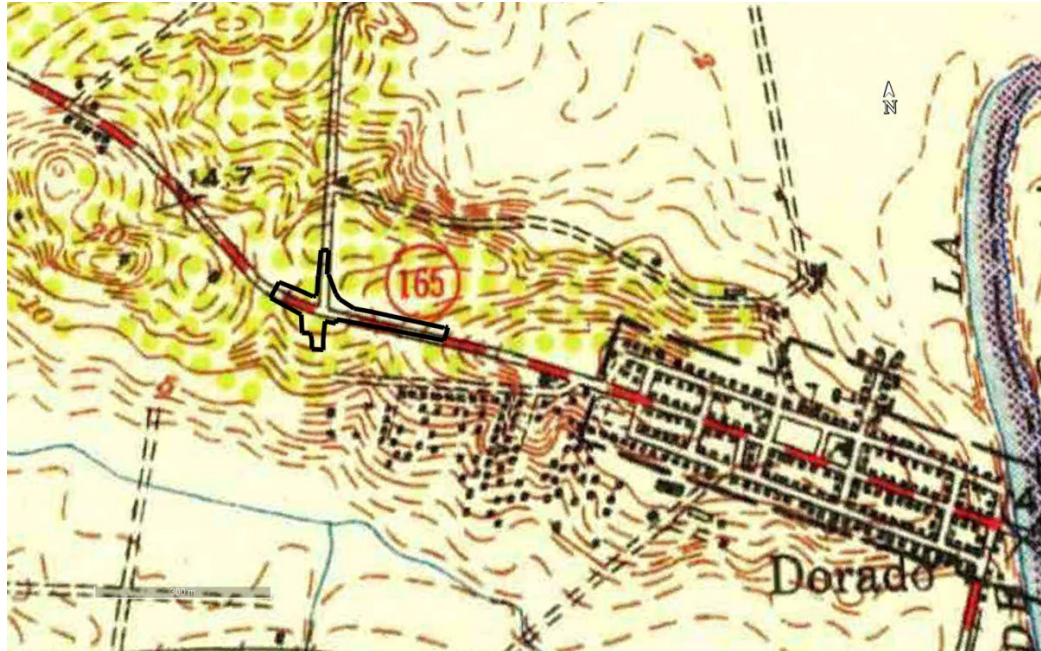
Figure 19 USGS Historical Topographic Map, 1953

Historic topographical maps of the area are the USGS Vega Alta, PR maps from 1940 (the earliest map), 1940, 1946 (no changes in the area from 1940 map), 1953, 1958, 1969, and 1983. (See Figures 19 & 20)

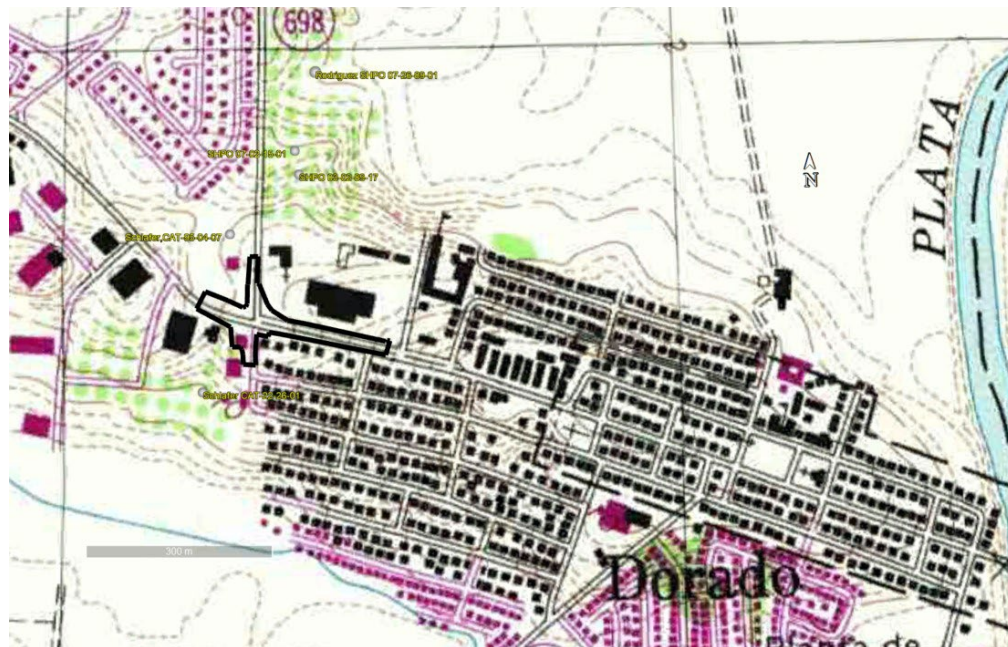
Figure 20 USGS Historical Topographic Map, 1982
