## **Environmental Assessment Determinations and Compliance Findings for HUD-assisted Projects 24 CFR Part 58**

**Project Name:** Mejoras Intersección Rotonda PR-693 y PR-698 (PR-CRP-000557)

**Responsible Entity:** Puerto Rico Department of Housing (PRDOH)

**Grant Recipient** (if different than Responsible Entity): Municipality of Dorado

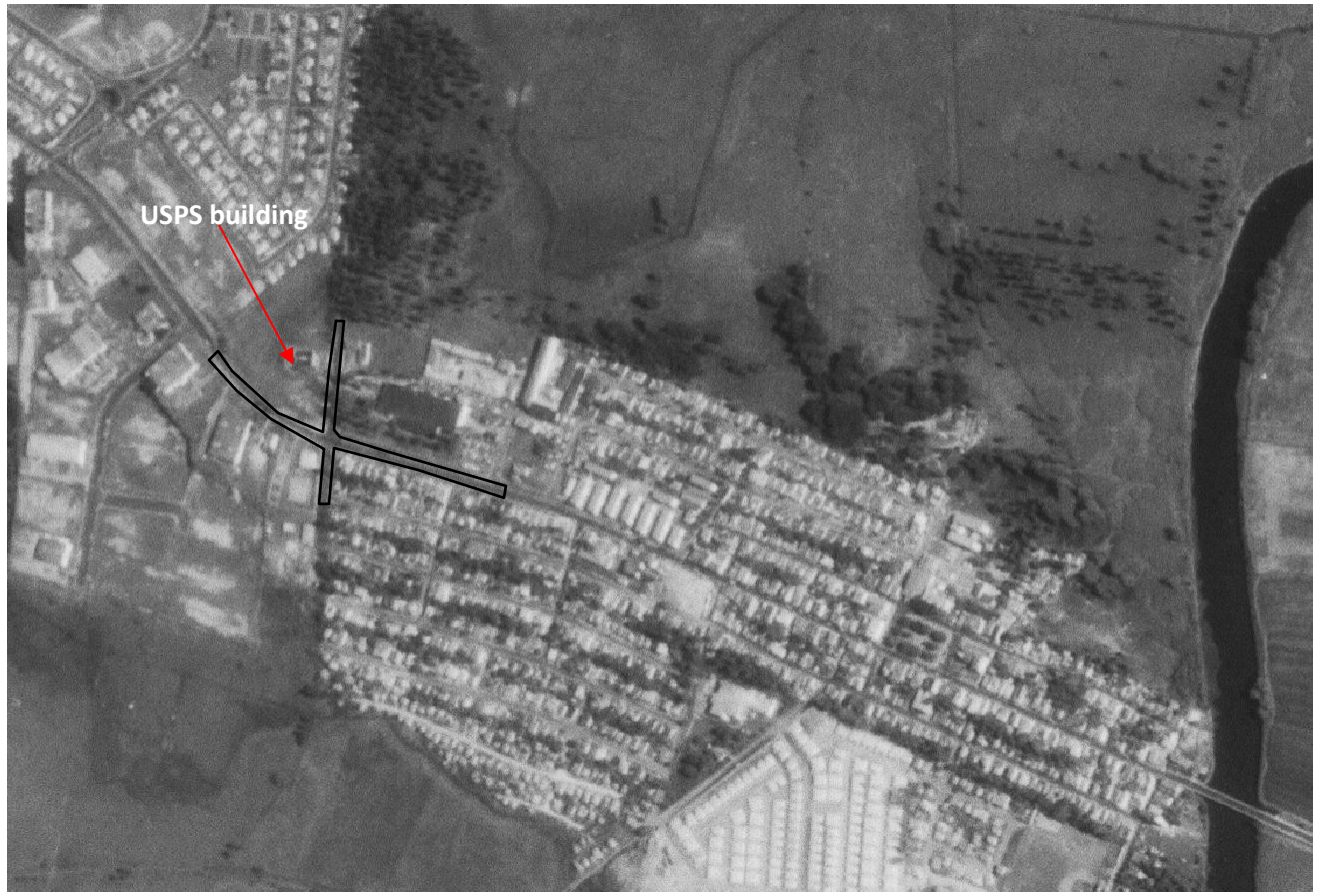
*Figure 21 USGS Earth Explorer Aerial of 1977, DI# ARH770100050248*

USGS Earth Explorer from 1977 shows the United State Postal Service building, northwest of the intersection. (See Figure 21).

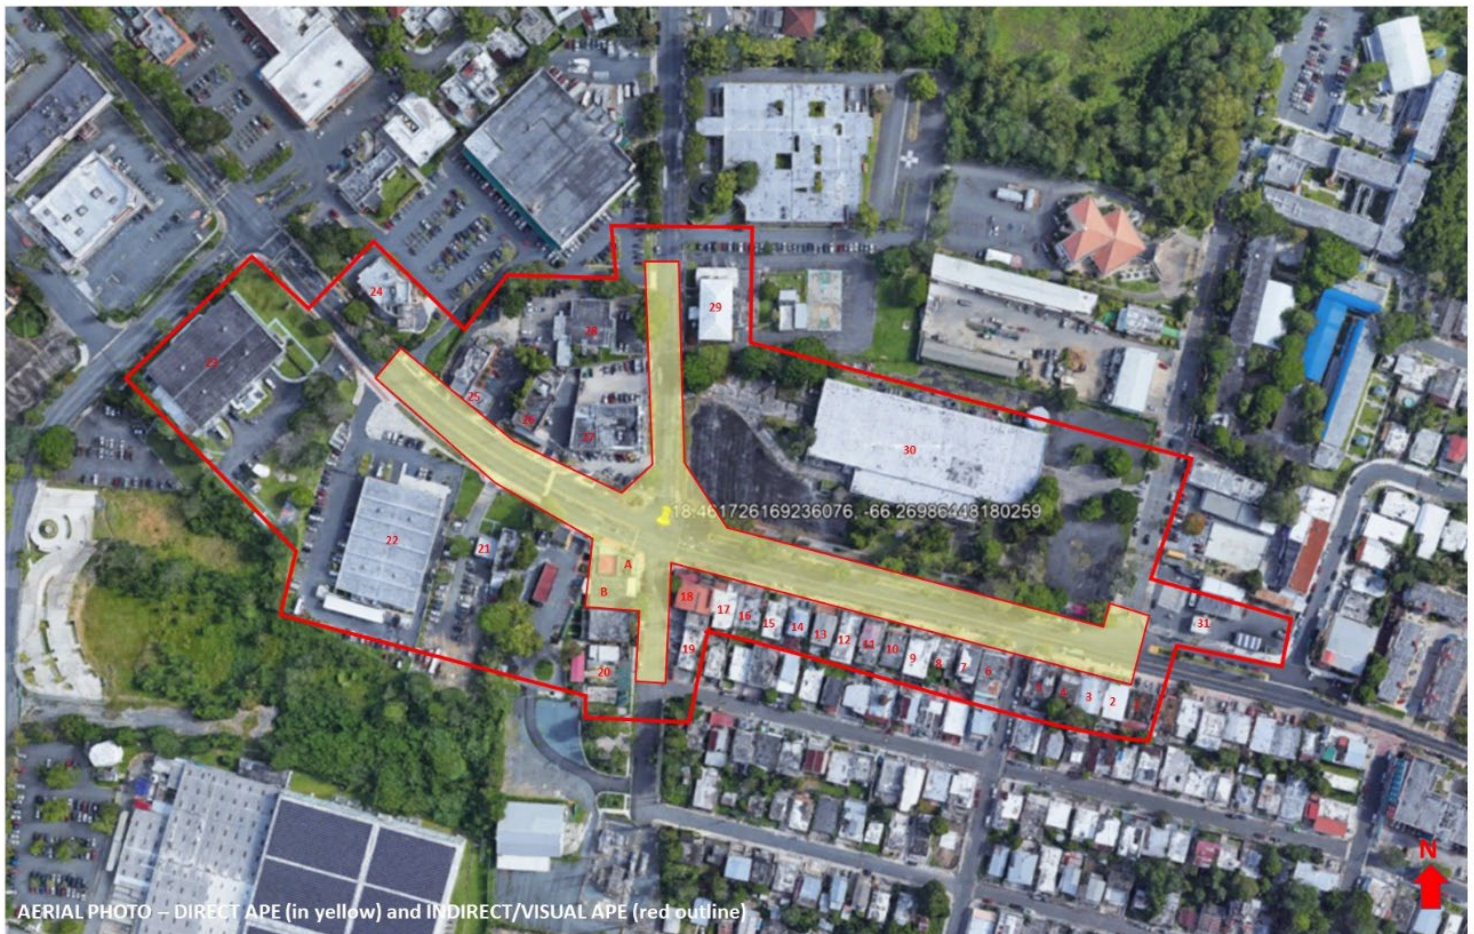
*Figure 23 Direct and Indirect APE*

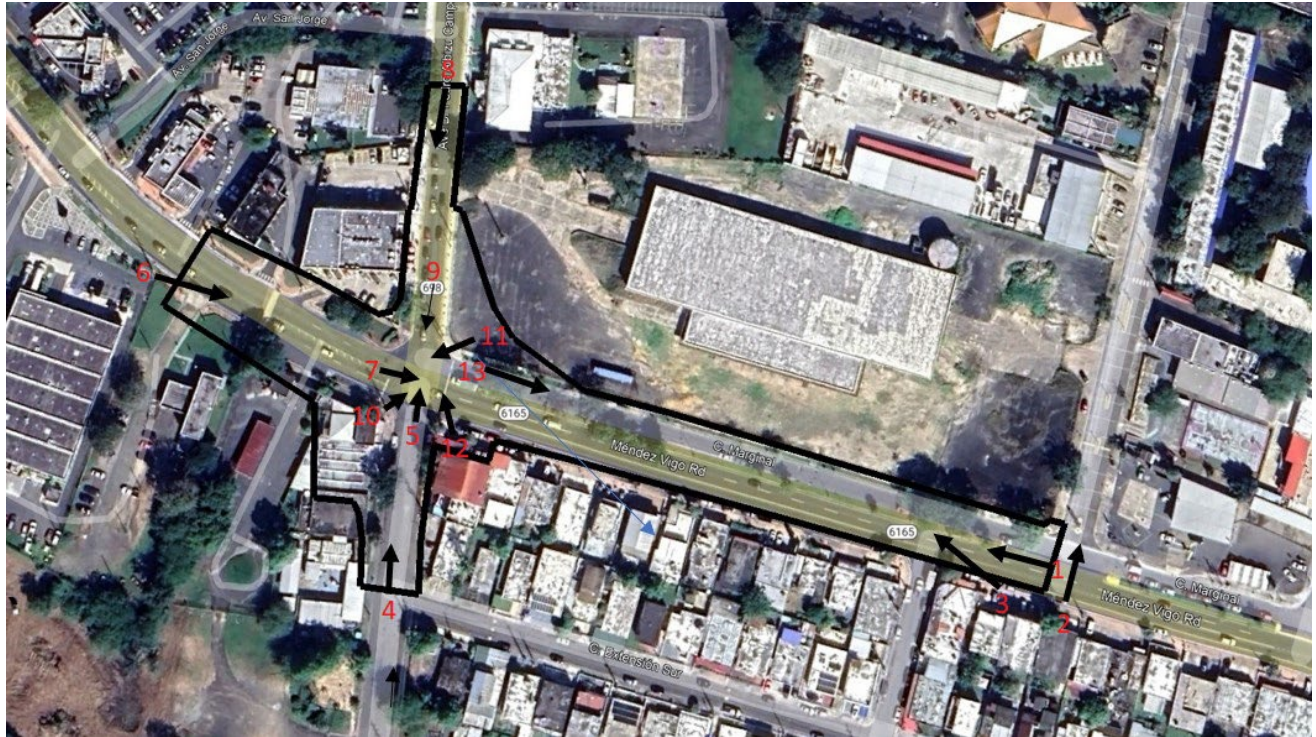
General Key Photo map

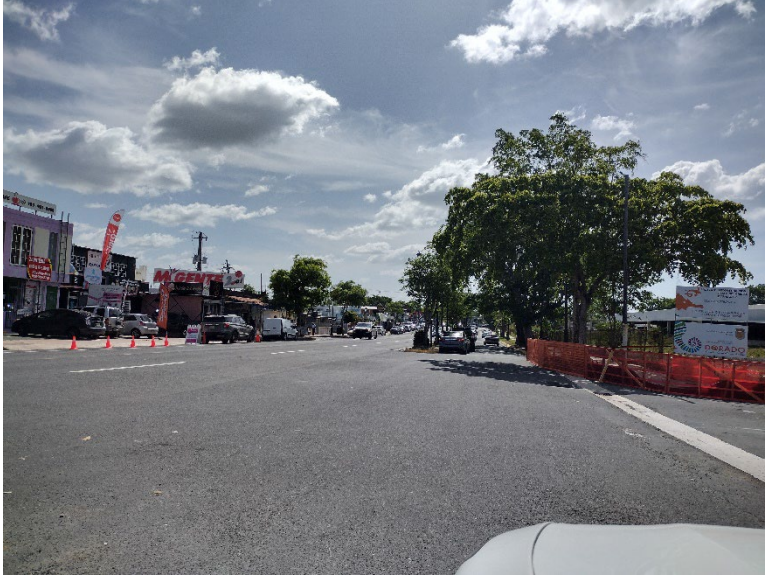
**Photo #: 1**

**Description (include direction): View of PR 693 from the east limit of the undertaking looking to the west**

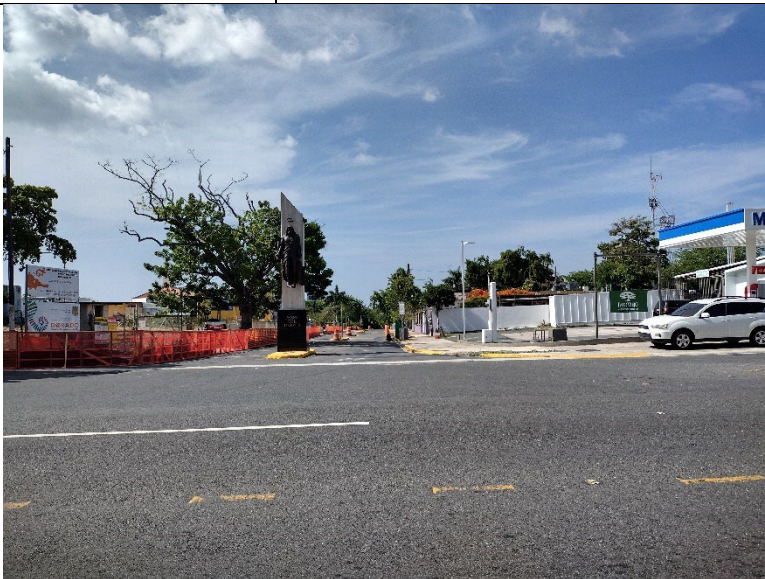
**Photo #: 2**

**Description (include direction): View of the East limit of the undertaking from the south sidewalk to the north.**

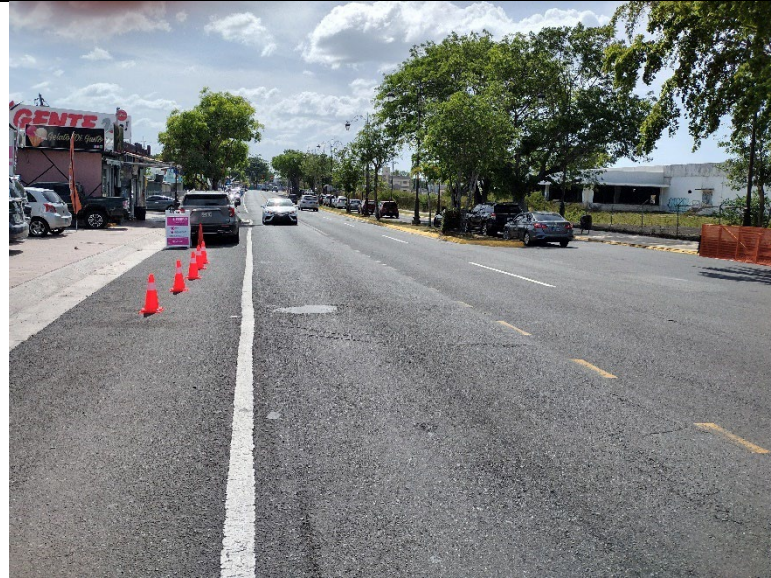
**Photo #: 3**

**Description (include direction): View of the PR.693 from the south sidewalk to the west. Showing the two south lanes**

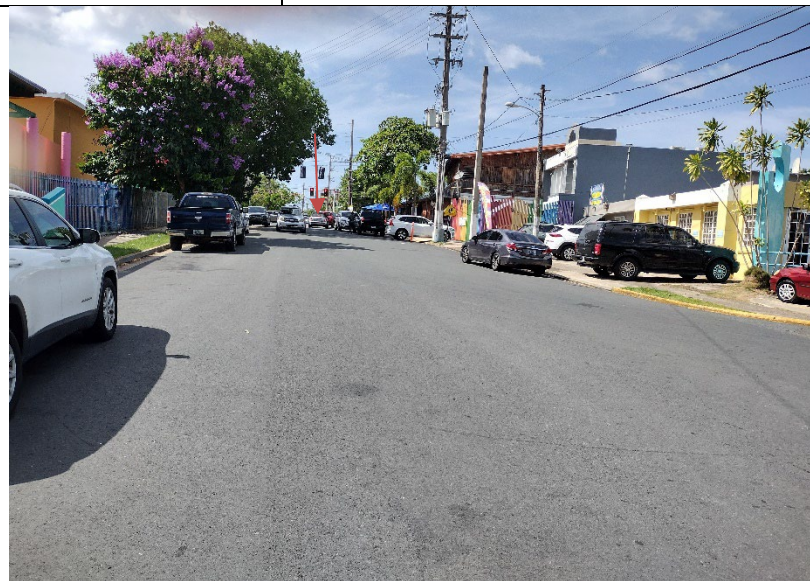
**Photo #: 4**

**Description (include direction): View from the south limit of the undertaking in PR 698 to the intersection with PR 693 (red arrow). To the left the buildings of the Head Start.**

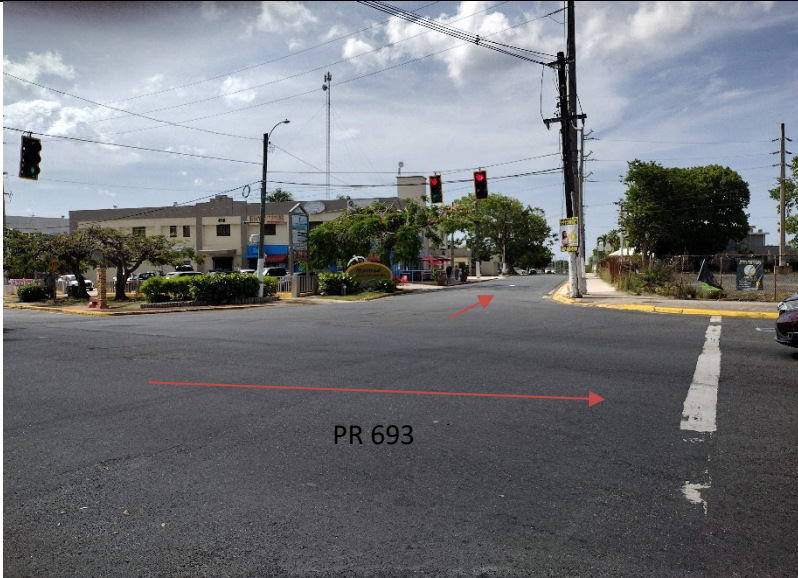
Photo #: 5

Description (include direction): View to the north from the south side of the intersection.

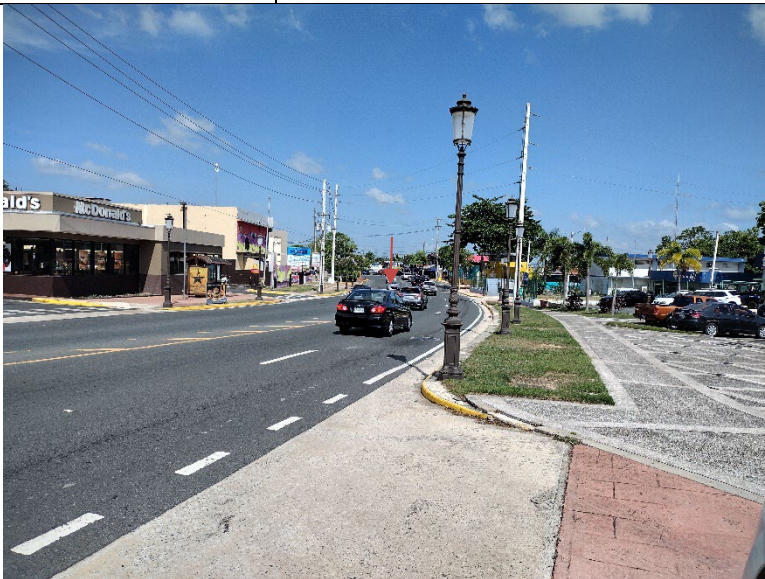
Photo #: 6

Description (include direction): PR 698 from the west. To the right is the Police Headquarters.

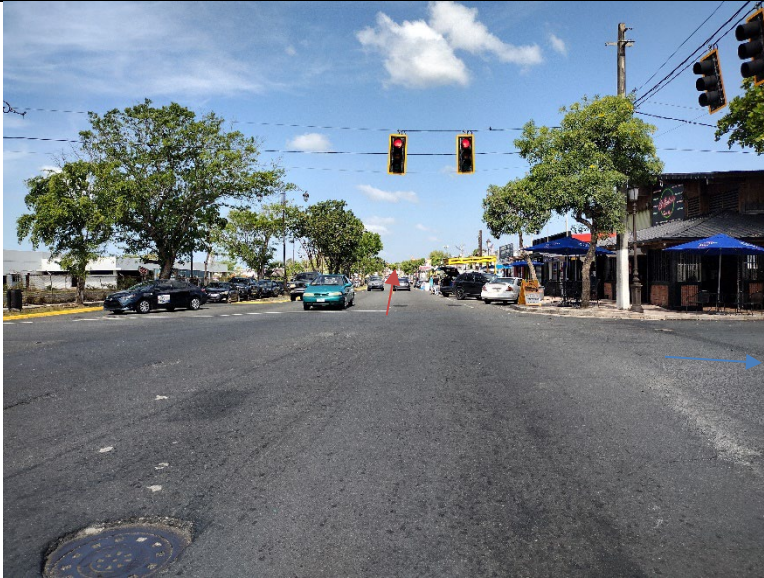
Photo #: 7

Description (include direction): View of the intersection to the east from PR 698 south lanes

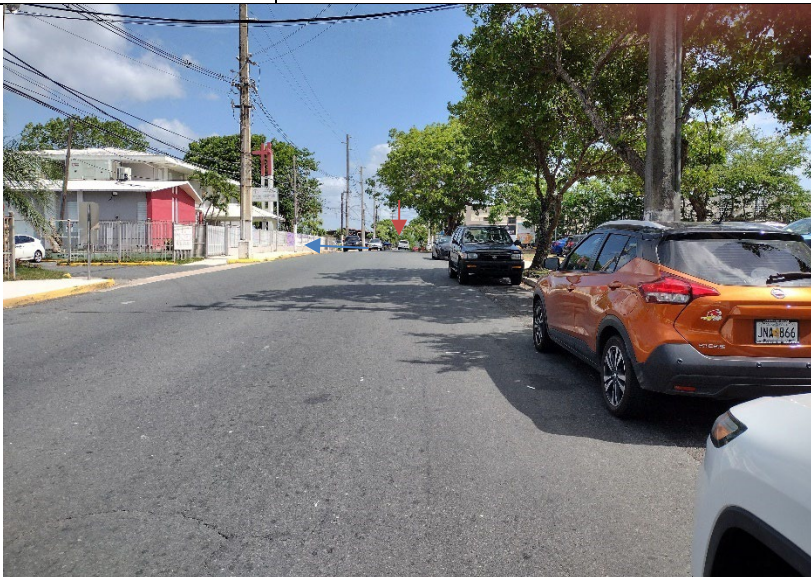
Photo #: 8

Description (include direction): View from the north limit of the project. Blue arrow shows the school, red arrow the intersection.

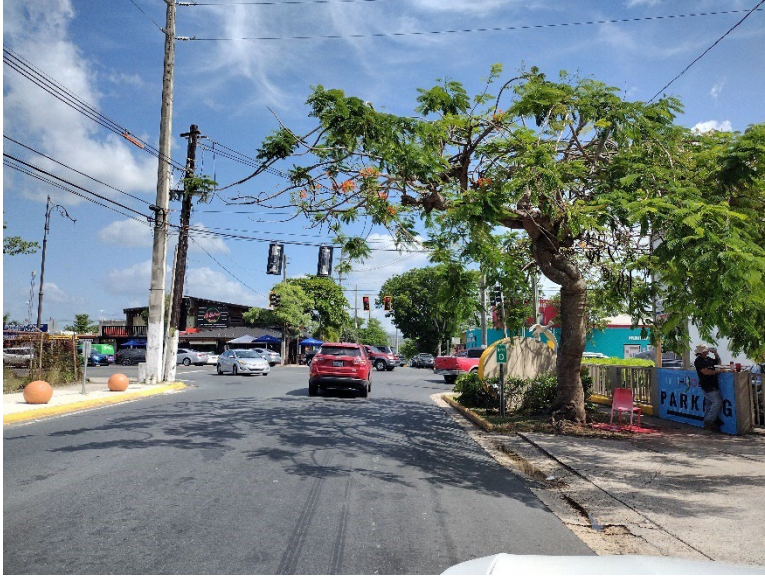
**Photo #: 9**

**Description (include direction): View of the intersection from PR 698 north to south. To the right Hijole Restaurant. Crossing the intersection to the right Escuela Amiga**

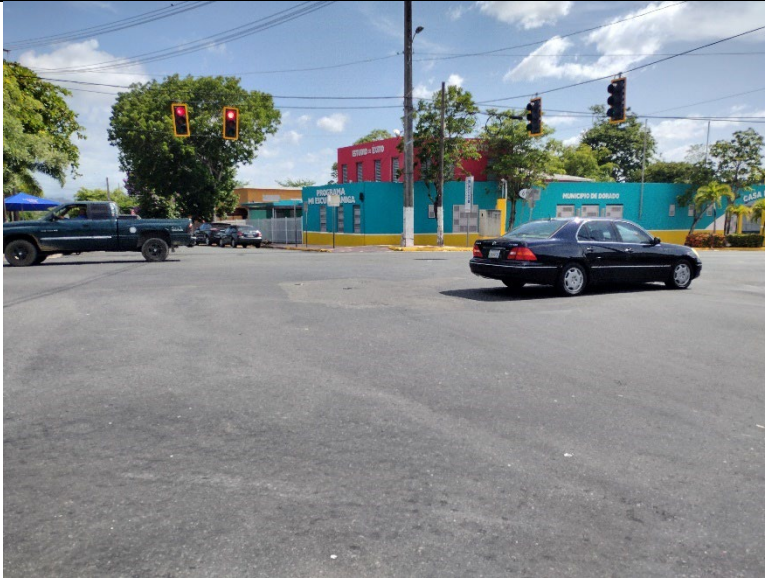
**Photo #: 11**

**Description (include direction): View from the northeast corner of the intersection to Escuela Amiga**

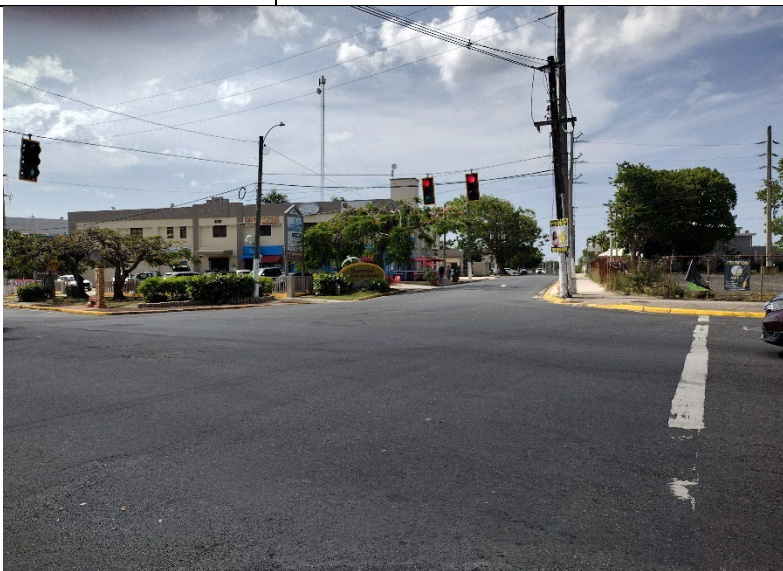
**Photo #: 12**

**Description (include direction): View of the intersection from the southeast corner to the north.**

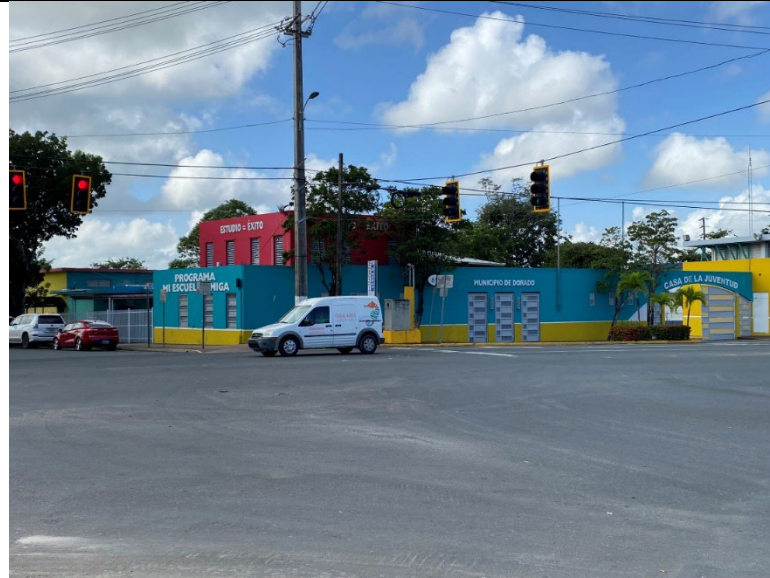
Photo #: A1

Description (include direction): Looking at the southwest corner of intersection PR-693 and PR-698

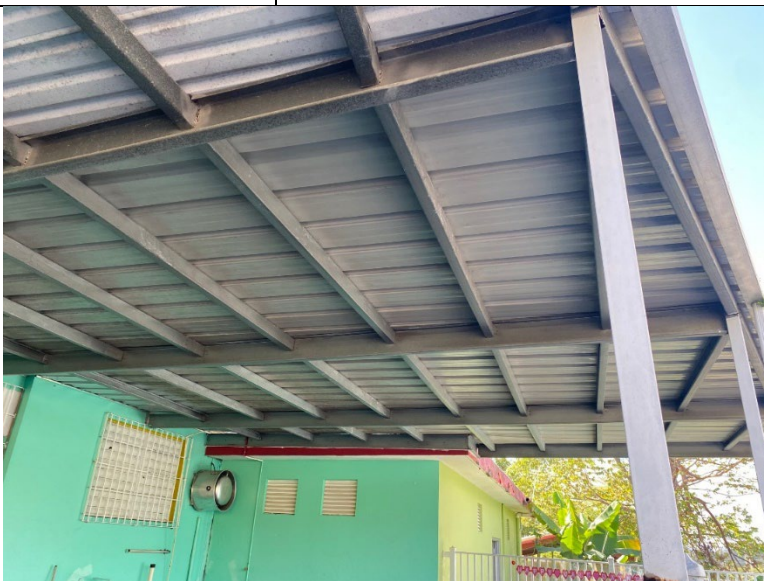
Photo #: B16

Description (include direction): Paraiso Infantil (Building 2) covered patio roof detail (west)

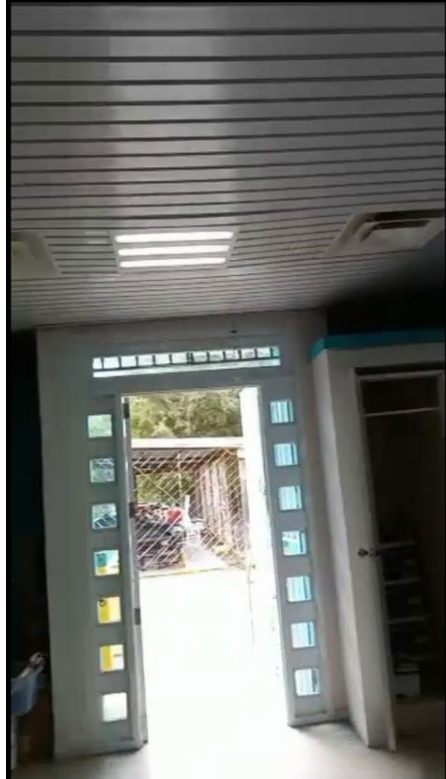
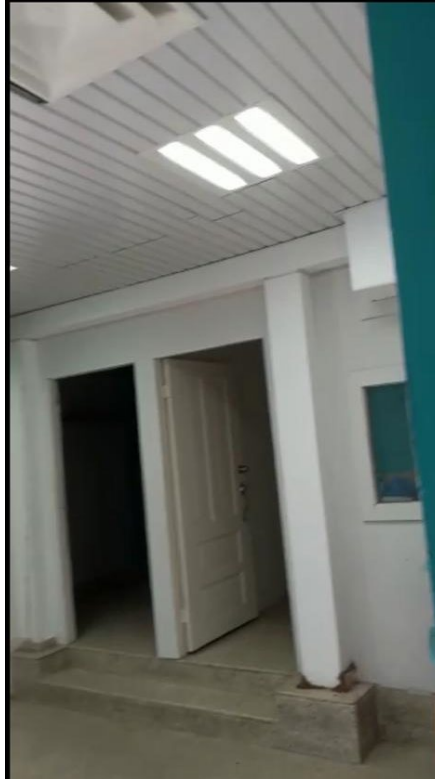
Photo #: B17

Description (include direction): Paraiso Infantil (Building 2) covered patio (west). Photo taken by Municipality of Dorado.

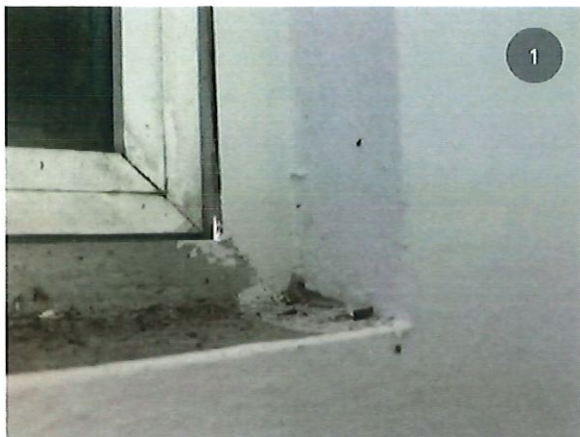
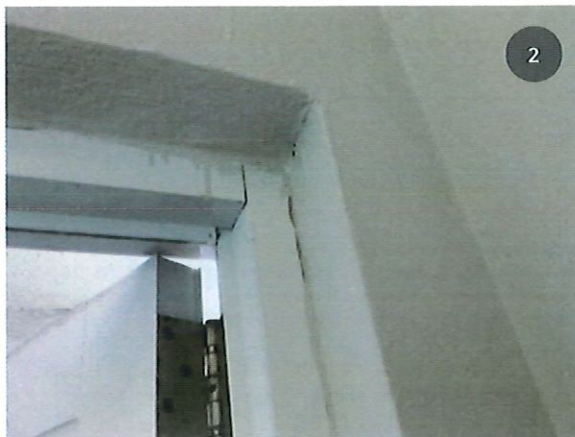
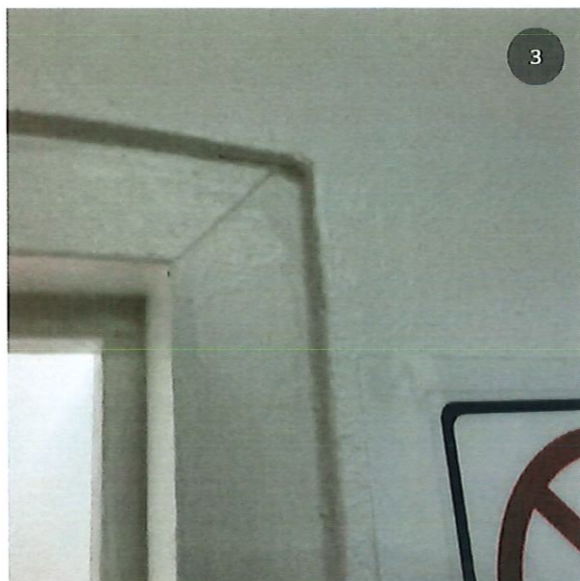
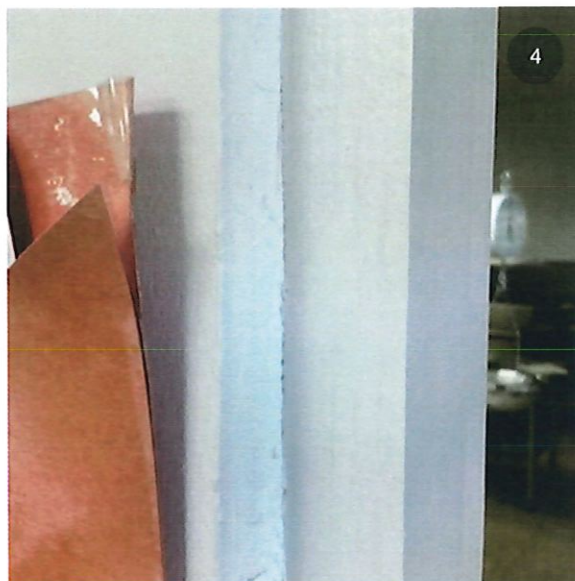
## WINDOW/DOOR CAULKING:

SACM caulking was not found visible at the moment of the inspection.

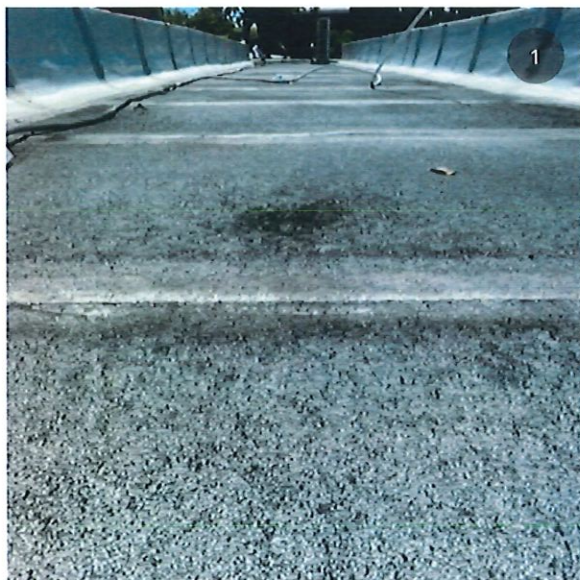
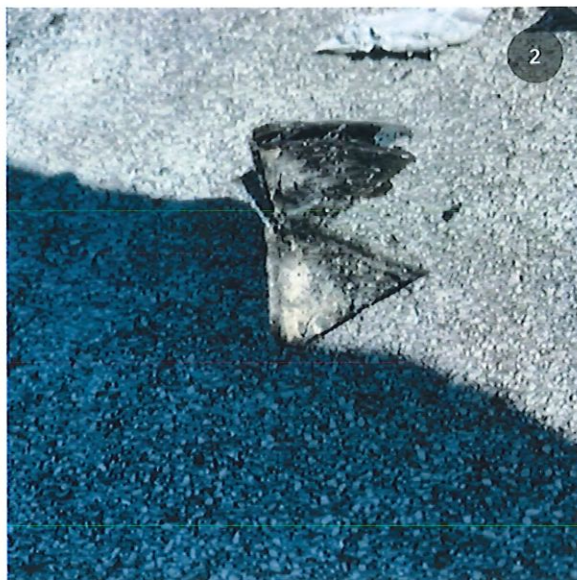
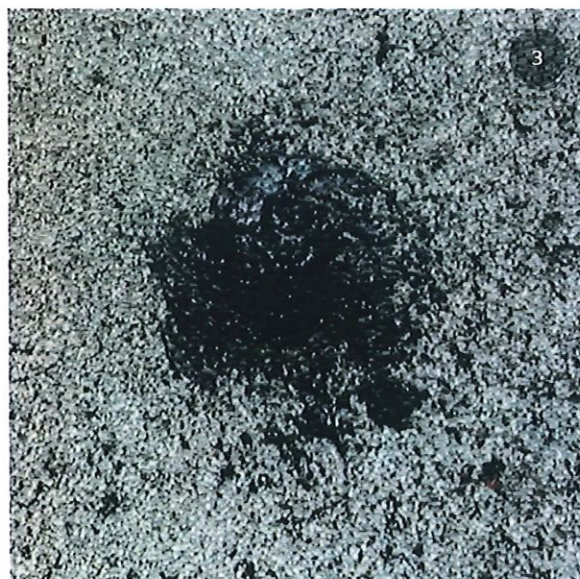
## SACM VISIBLE? ROOF TOP

Condition: acceptable

EHSEAD-HA1-EO-#01, #02 & #03 **Asbestos was not detected**

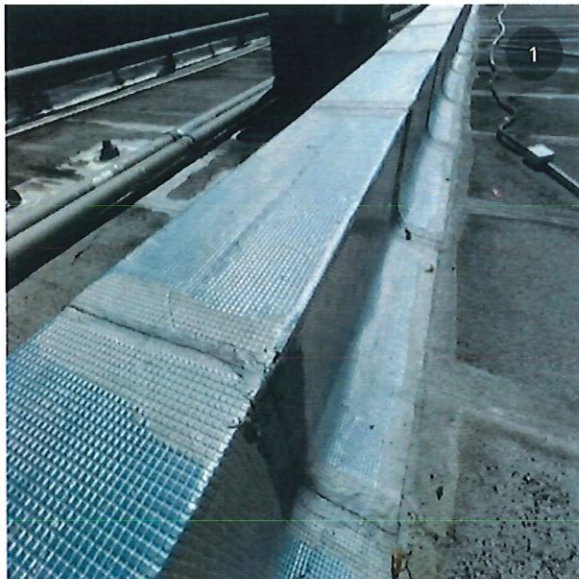
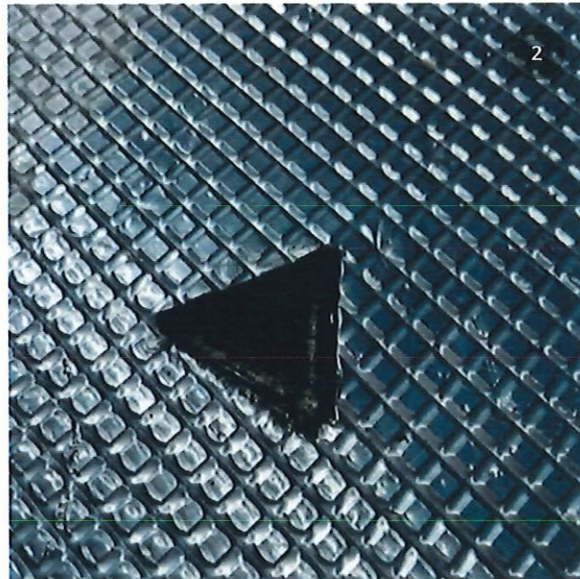
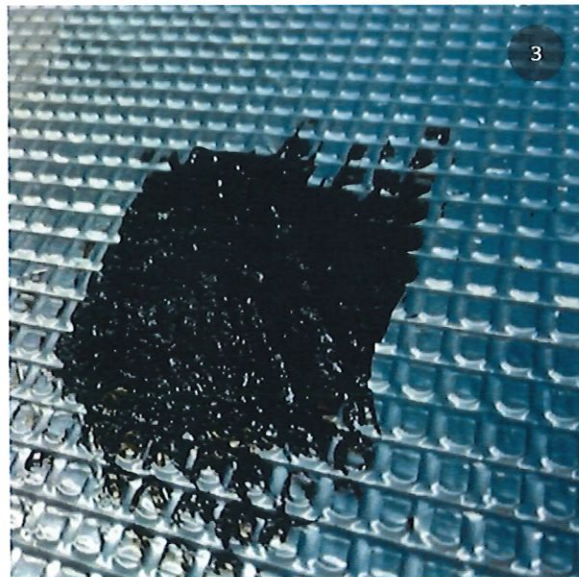
## SACM VISIBLE? ROOF TOP

Condition: acceptable

EHSEAD-HA2-EO-#04, #05 & #06 **Asbestos was not detected**

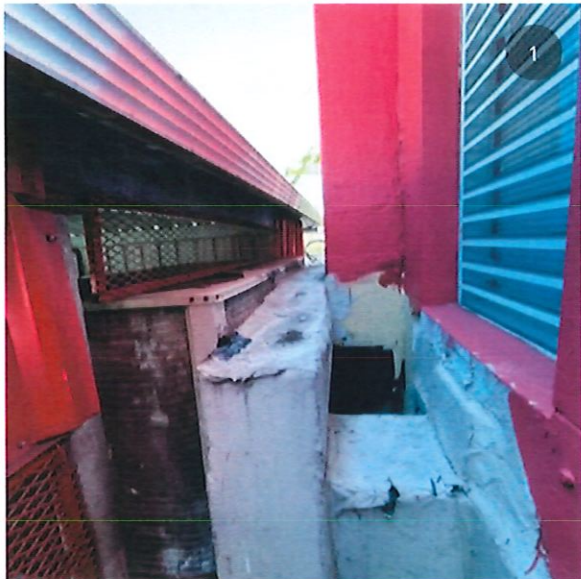
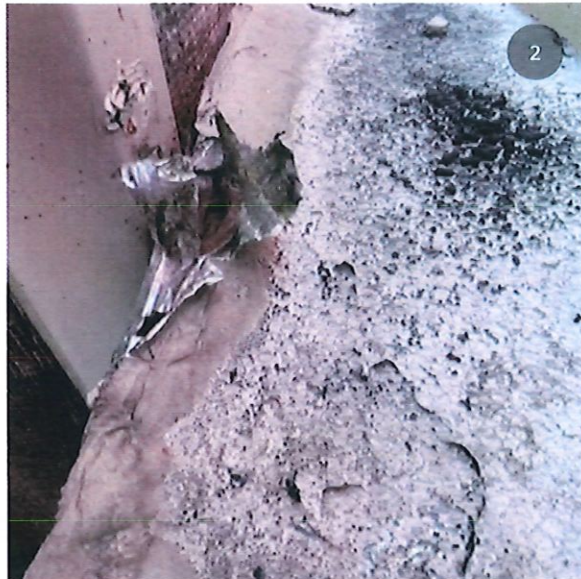
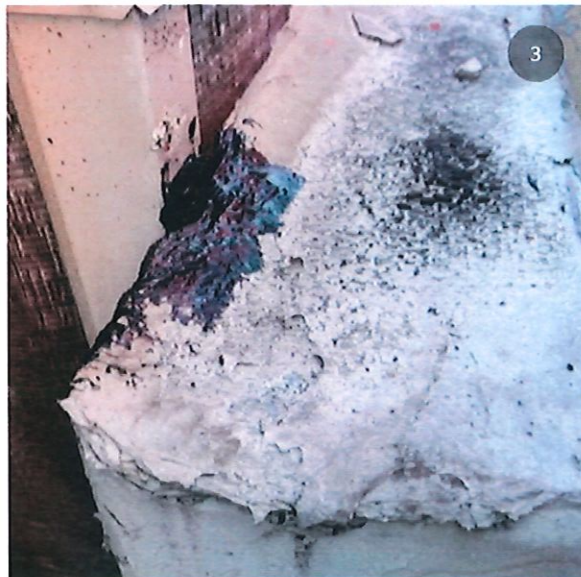
## SACM VISIBLE? ROOF TOP A/C DUCT

Condition: acceptable

EHSEAD-HA3-EO-#07, #08 & #09 **Asbestos was not detected**

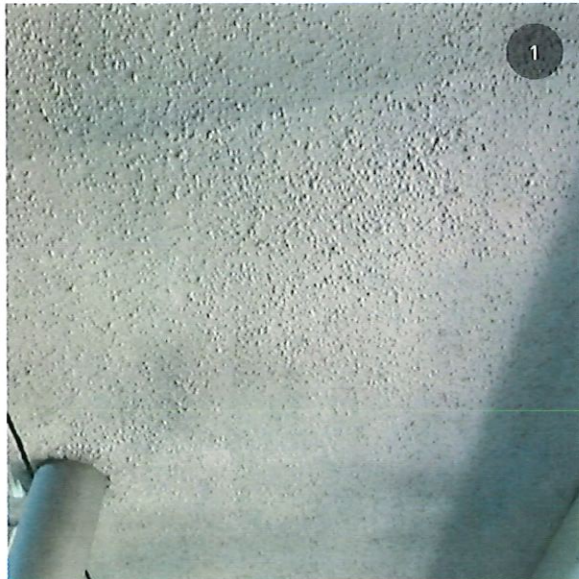
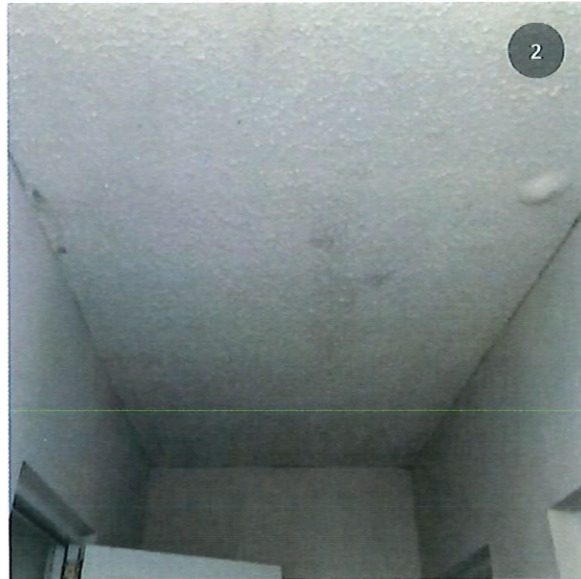
**SACM VISIBLE? INTERIOR BUILDING 1, ROOM 1 (ROOM 1), ROOM 2 (ROOM 2), ROOM 3 (ROOM 3), ROOM 4 (ROOM 5), STAIRS AREA (ROOM 4) BATHROOM 1 (ROOM 6) BATHROOM 2 (ROOM 7)**

Condition: acceptable

EHSEAD-HA4-EO-#10, #11 & #12 **Asbestos was not detected**

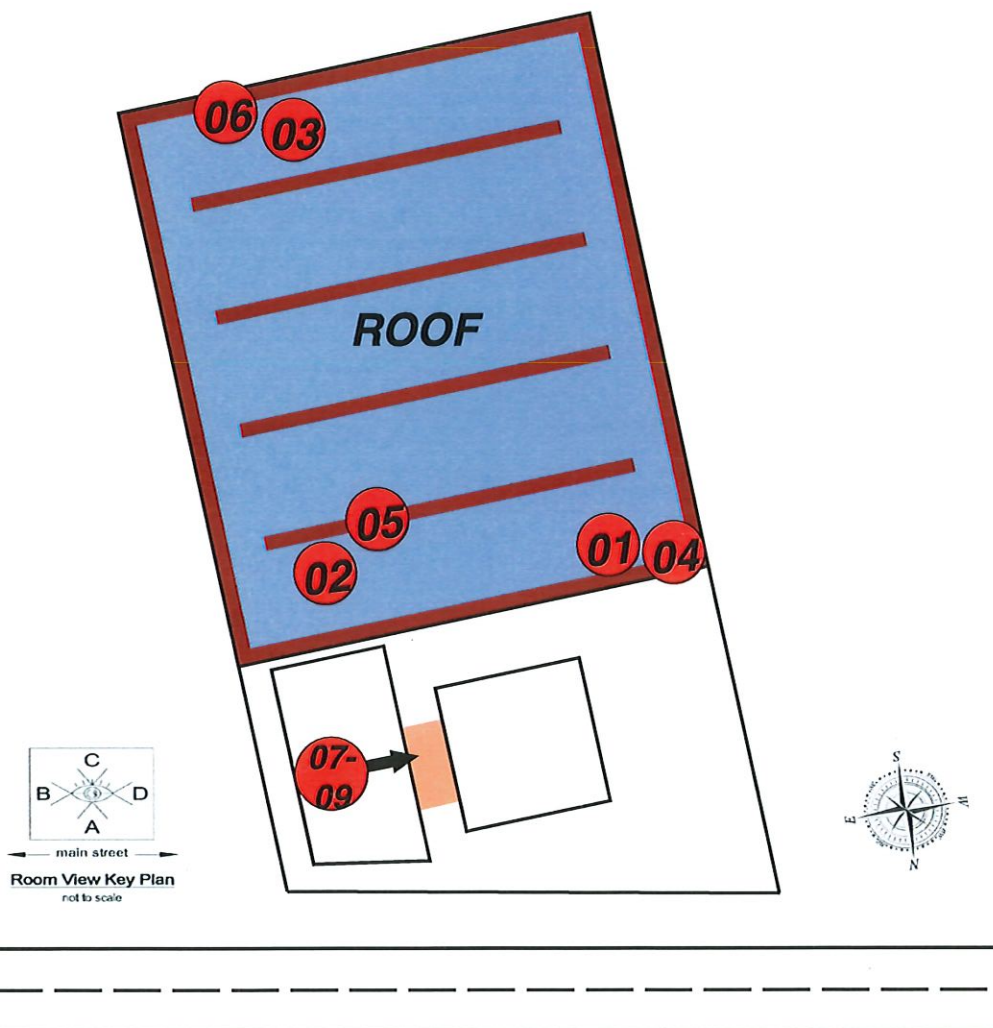
➔ **AREA WHERE SAMPLES WERE TAKEN**

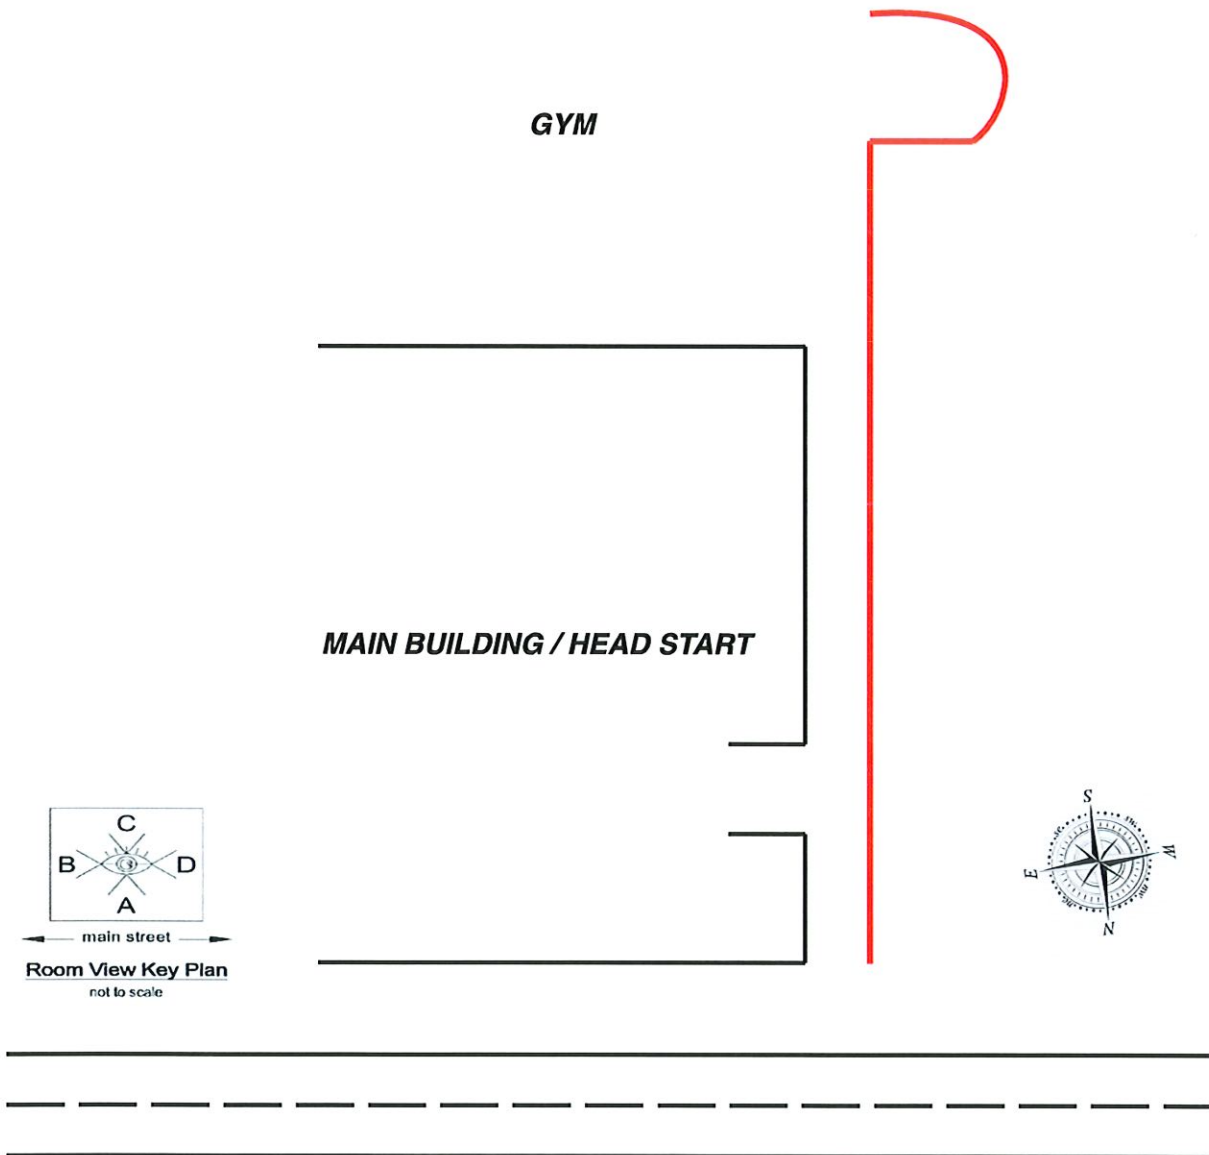
➔ **POSITIVE YELLOW LEAD-BASED PAINT CONCRETE CURB**

LBP was found on the ***exterior concrete curbs located in the parking lot (about 165 Ft2)***. The data from XRF analyzer testing is included in **Attachment 3 and 4** with positive readings marked in red or bold. **Attachment 5** includes the approximated location of identified LBP or lead-glazes at the subject structure. Representative Pictures\Photograph Log of identified LBP surfaces and/or lead-glazed ceramic components within the structure are provided in **Attachment 6**.

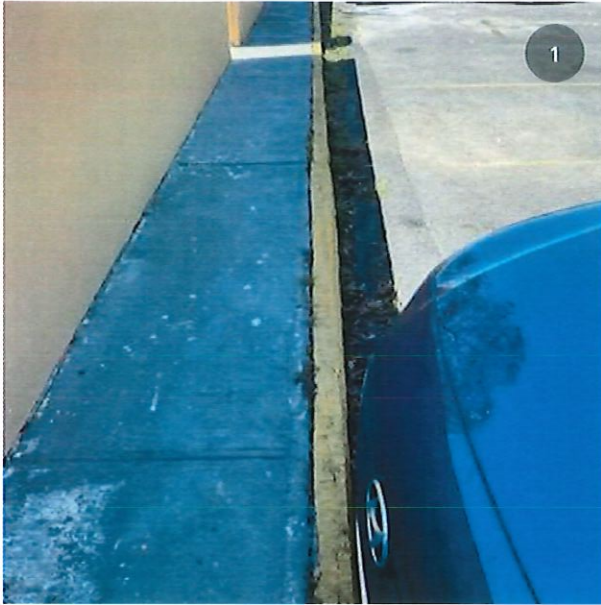
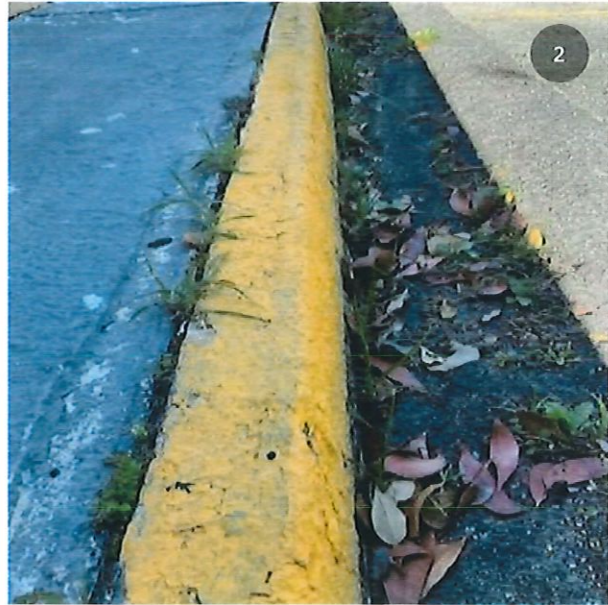
## LBP DETECTED? PARKING LOT

Exterior, Readings from #09 to #12, yellow concrete curb, between 1.5 to 4.7 mg/cm<sup>2</sup>, (qty. 165 LF Approx.)

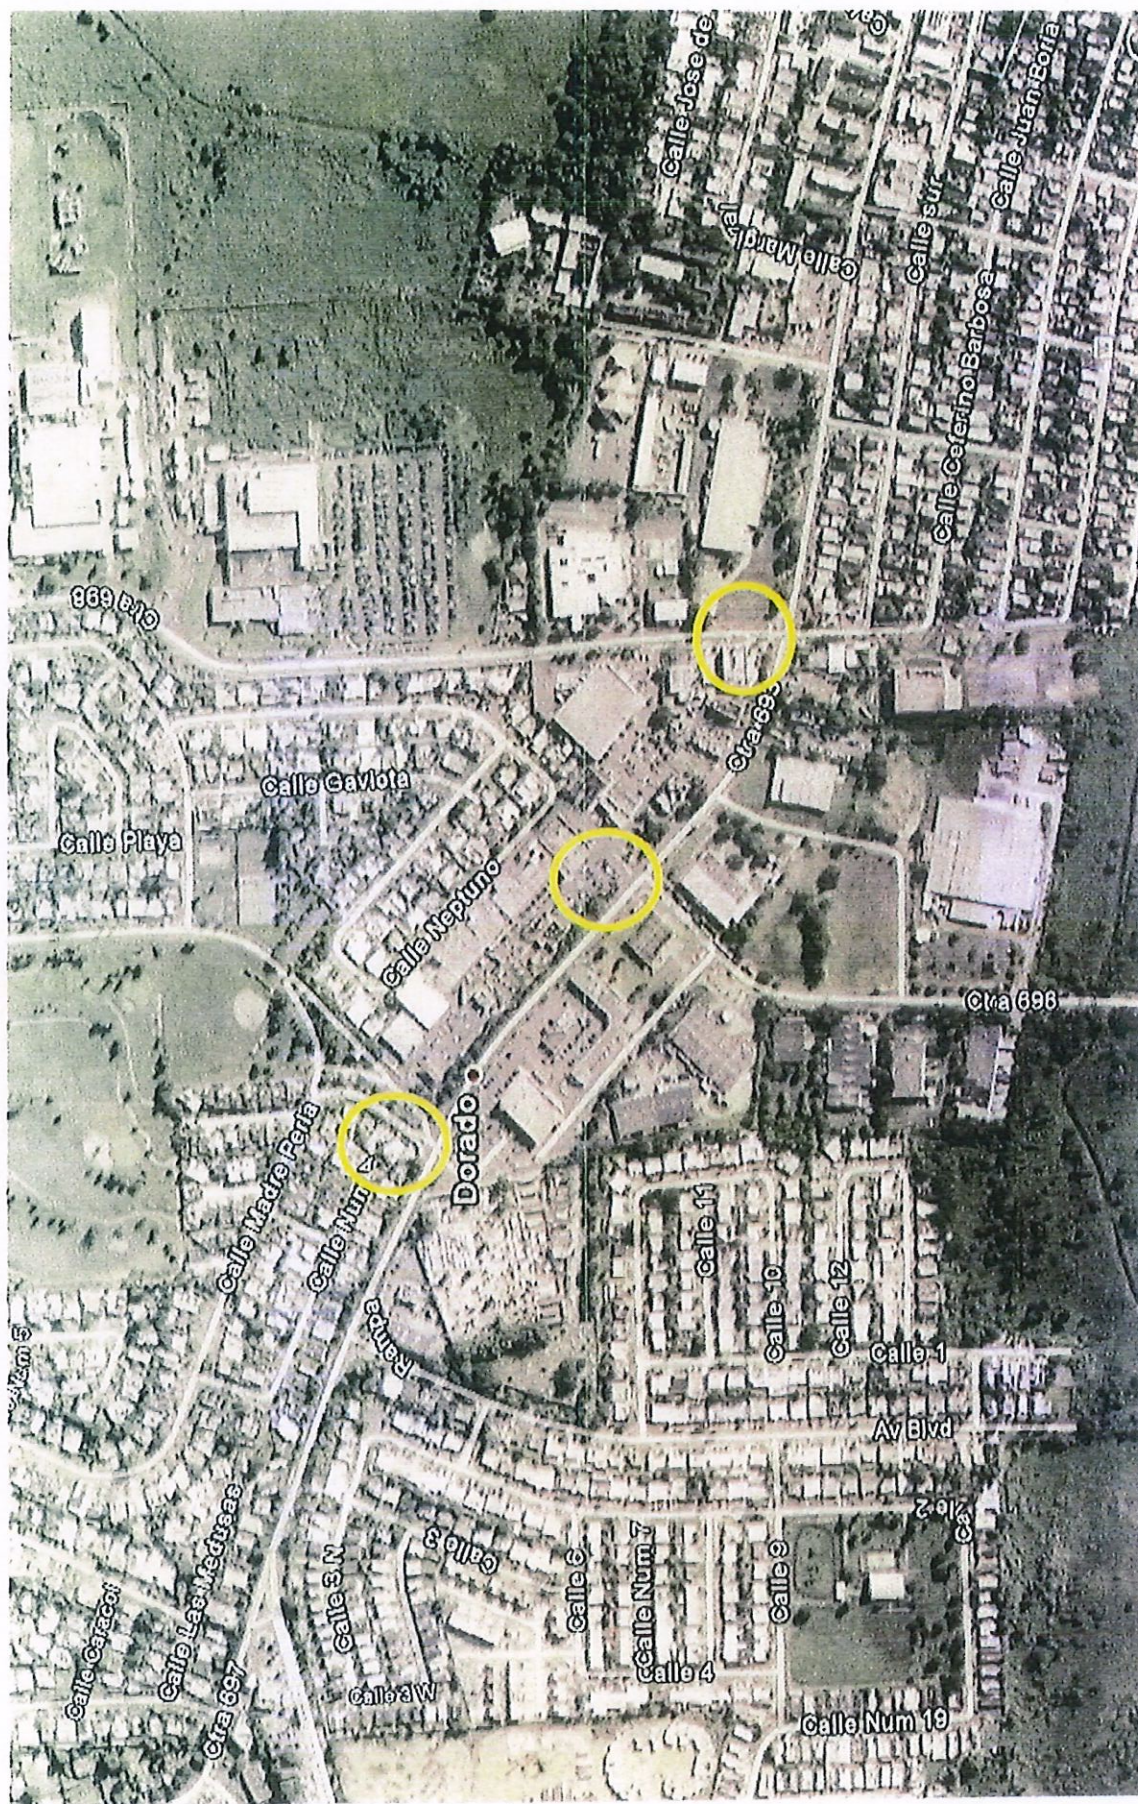
LOCALIZACIÓN DE LAS INTERSECCIONES A ESTUDIARSE  
FIGURA 1

A petición de la Autoridad de Carreteras y Transportación en su comunicación del 11 de febrero de 2009, se añade la Intersección de la Avenida Boulevard con la Carretera PR-693 al **Estudio para Determinar Mejoras Operacionales de Tránsito, Intersección Carretera PR-693 con PR-696 y PR-698**, en el Municipio de Dorado, Puerto Rico. La Figura Núm. 1 muestra las intersecciones a estudiarse.

El objetivo de este informe es estudiar la circulación de vehículos en las Intersecciones Avenida Boulevard con la Carretera PR-693, las Carreteras PR-696 con PR-693 y PR-698 con PR-693. Se analizará la capacidad de estas tres (3) intersecciones y se determinarán las mejoras operacionales necesarias para obtener un flujo de vehículos seguro y eficiente.
