## **Environmental Assessment Determinations and Compliance Findings for HUD-assisted Projects 24 CFR Part 58**

**Project Name:** Mejoras Intersección Rotonda PR-693 y PR-698 (PR-CRP-000557)

**Responsible Entity:** Puerto Rico Department of Housing (PRDOH)

**Grant Recipient** (if different than Responsible Entity): Municipality of Dorado

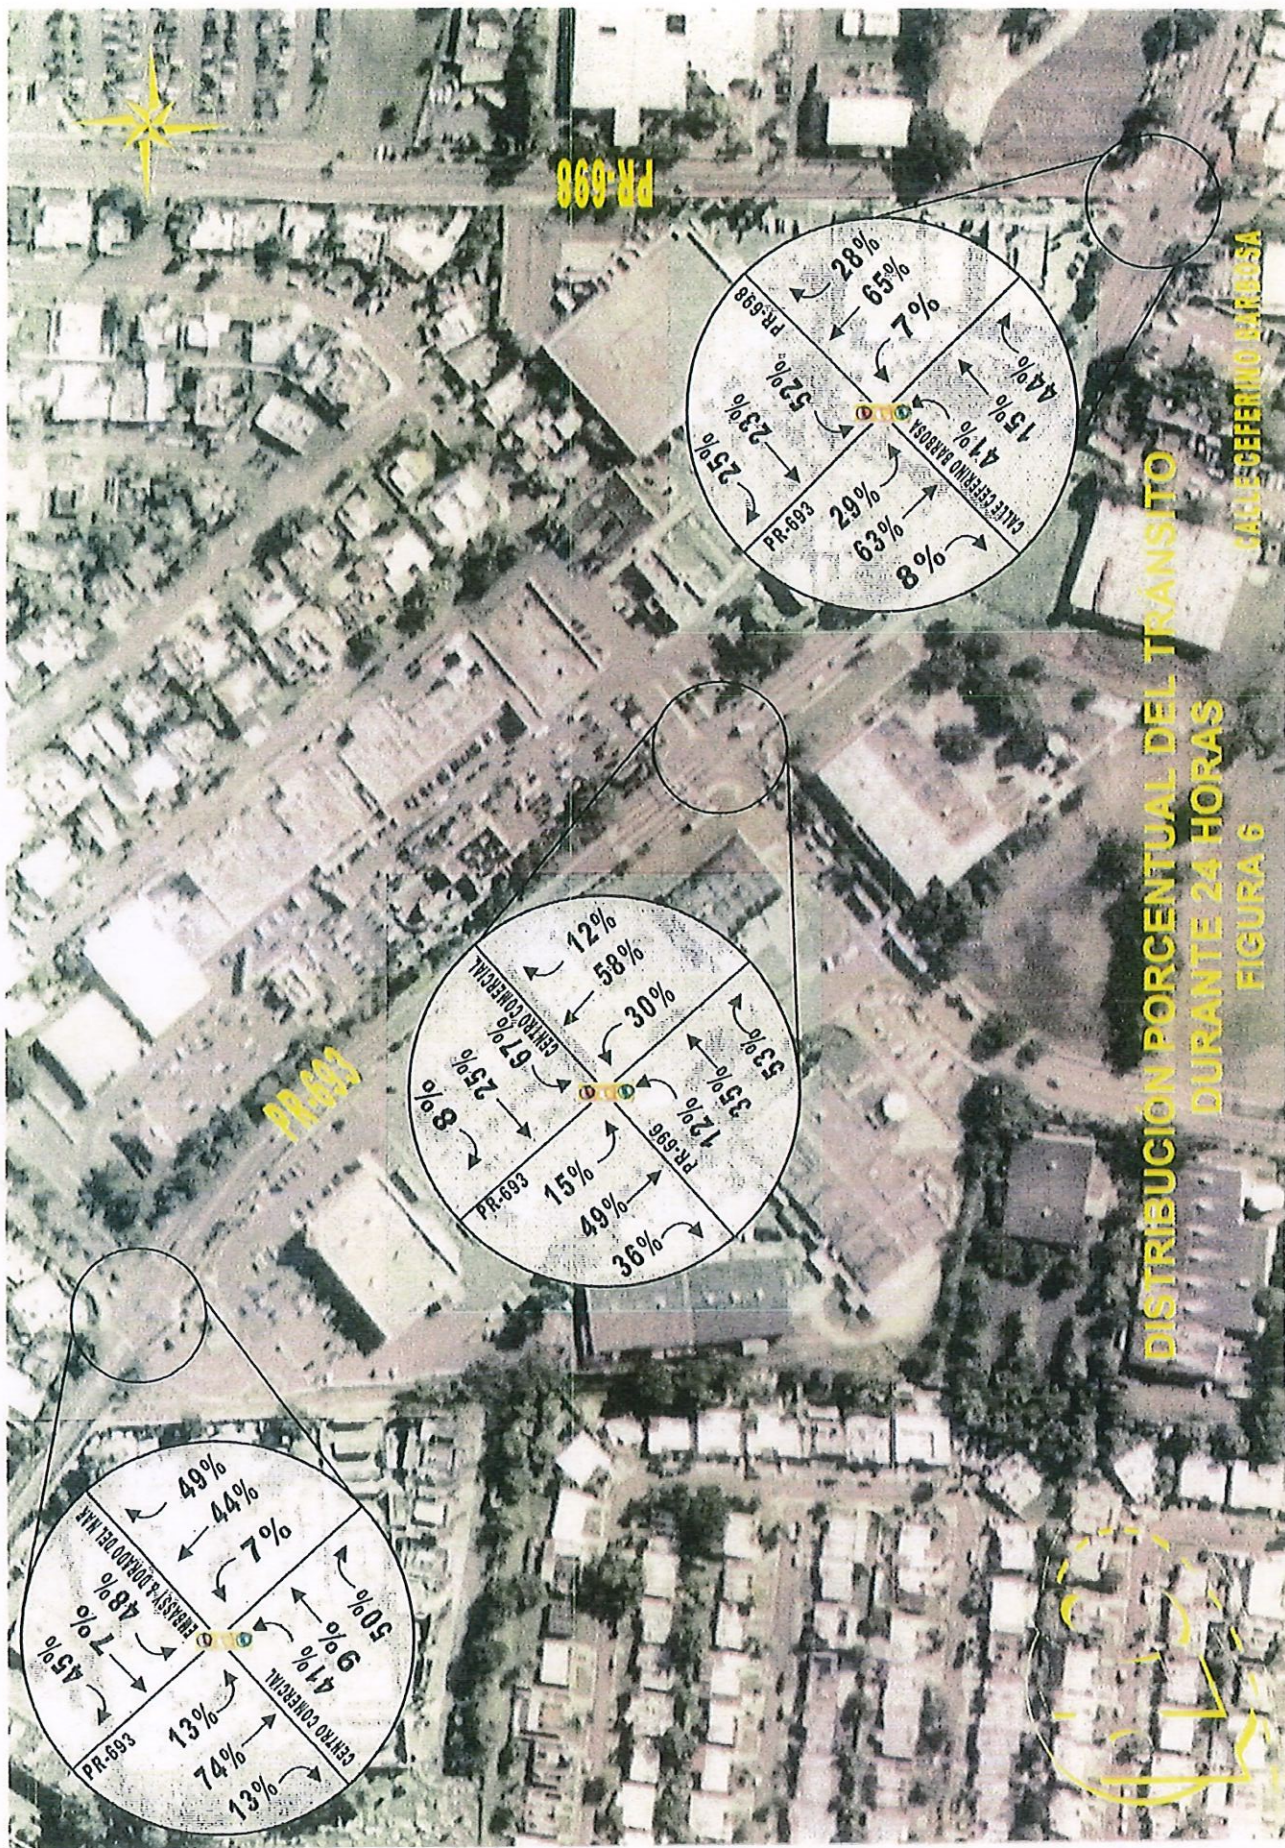
**Figura 7: Gráfica de Volumen vs Tiempo  
Intersección Ave. Boulevard y Carretera PR-693**

En la Figura Núm. 7 se presenta la gráfica de volumen de vehículos por accesos y tiempo (durante 24 horas), para la Intersecciones Avenida Boulevard & la Carretera PR-693.

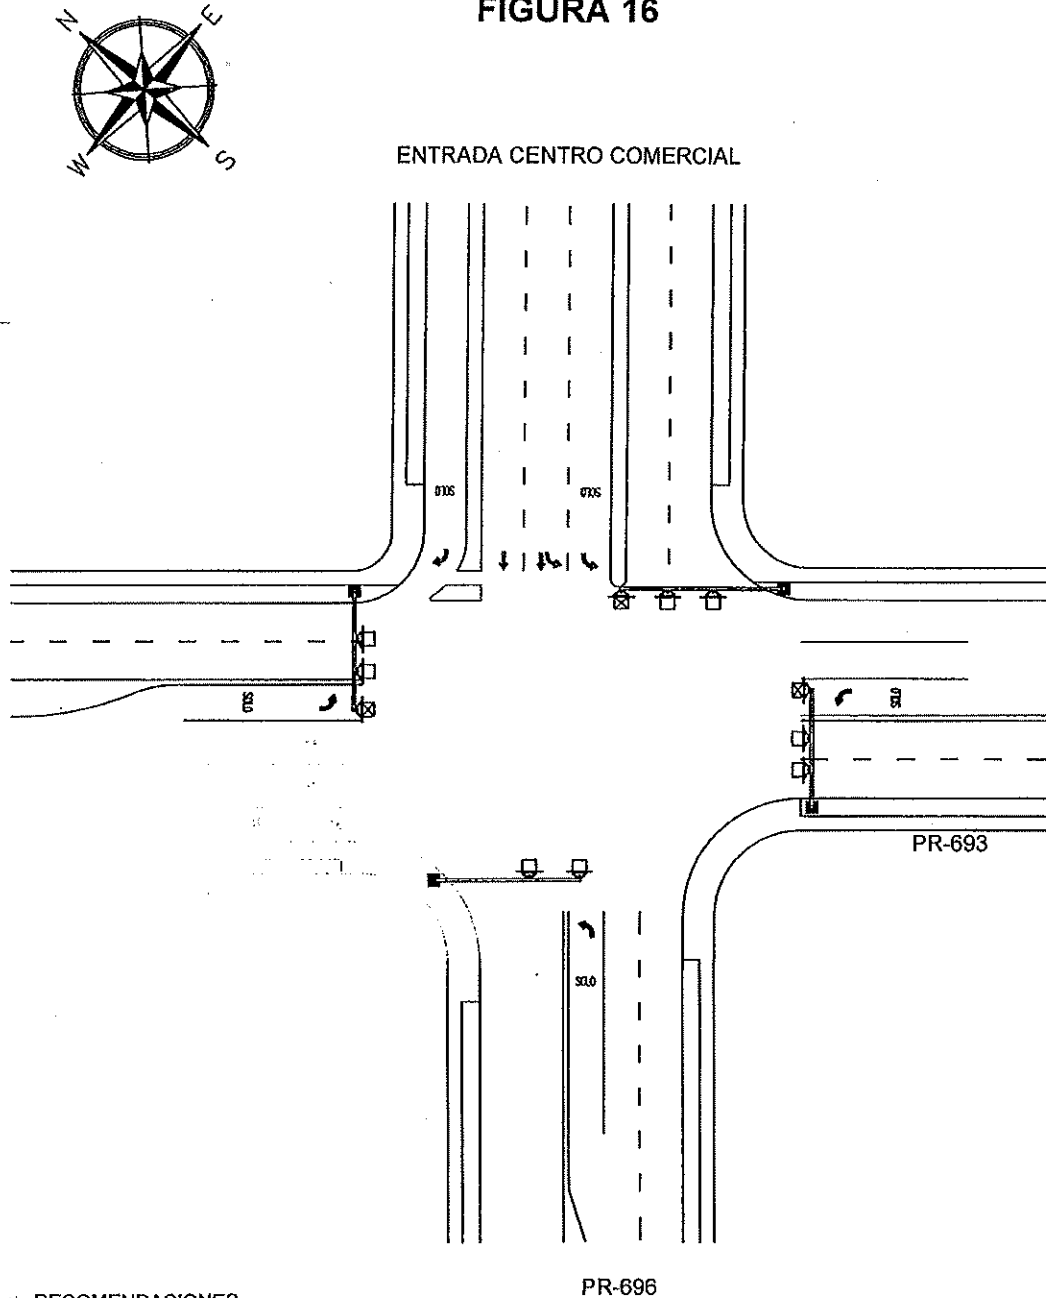
**FIGURA 16**

**RECOMENDACIÓN #2: ACCESO OESTE**  
**INTERSECCIÓN ENTRADA A CENTRO COMERCIAL Y**  
**CARRETERAS PR-696 & PR-693**

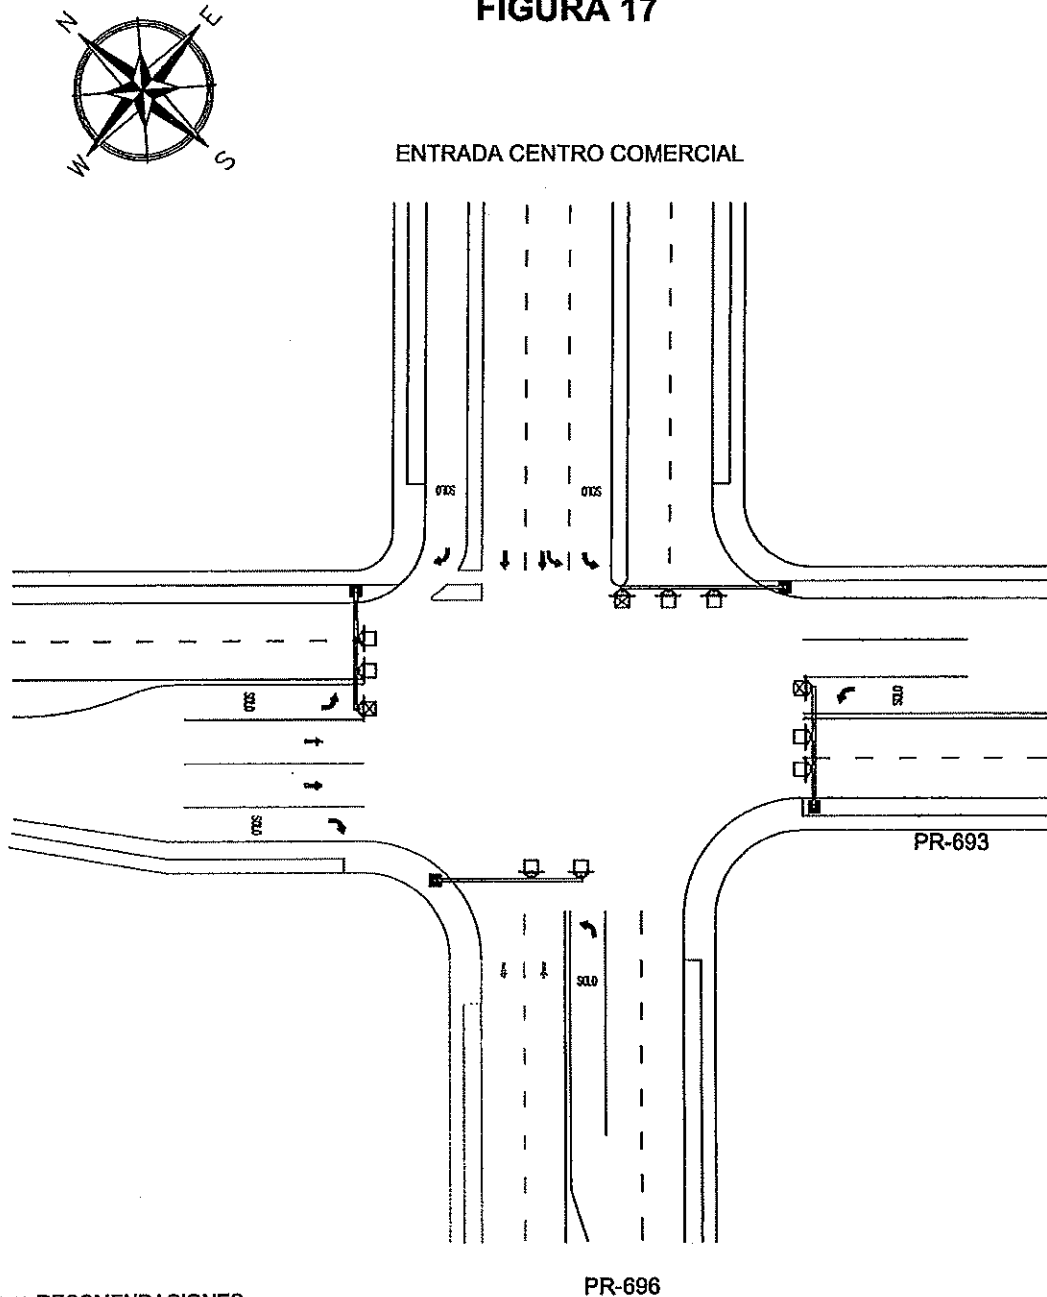
FIGURA 17

# RECOMENDACIÓN #3: ACCESO SUR INTERSECCIÓN ENTRADA A CENTRO COMERCIAL Y CARRETERAS PR-696 & PR-693

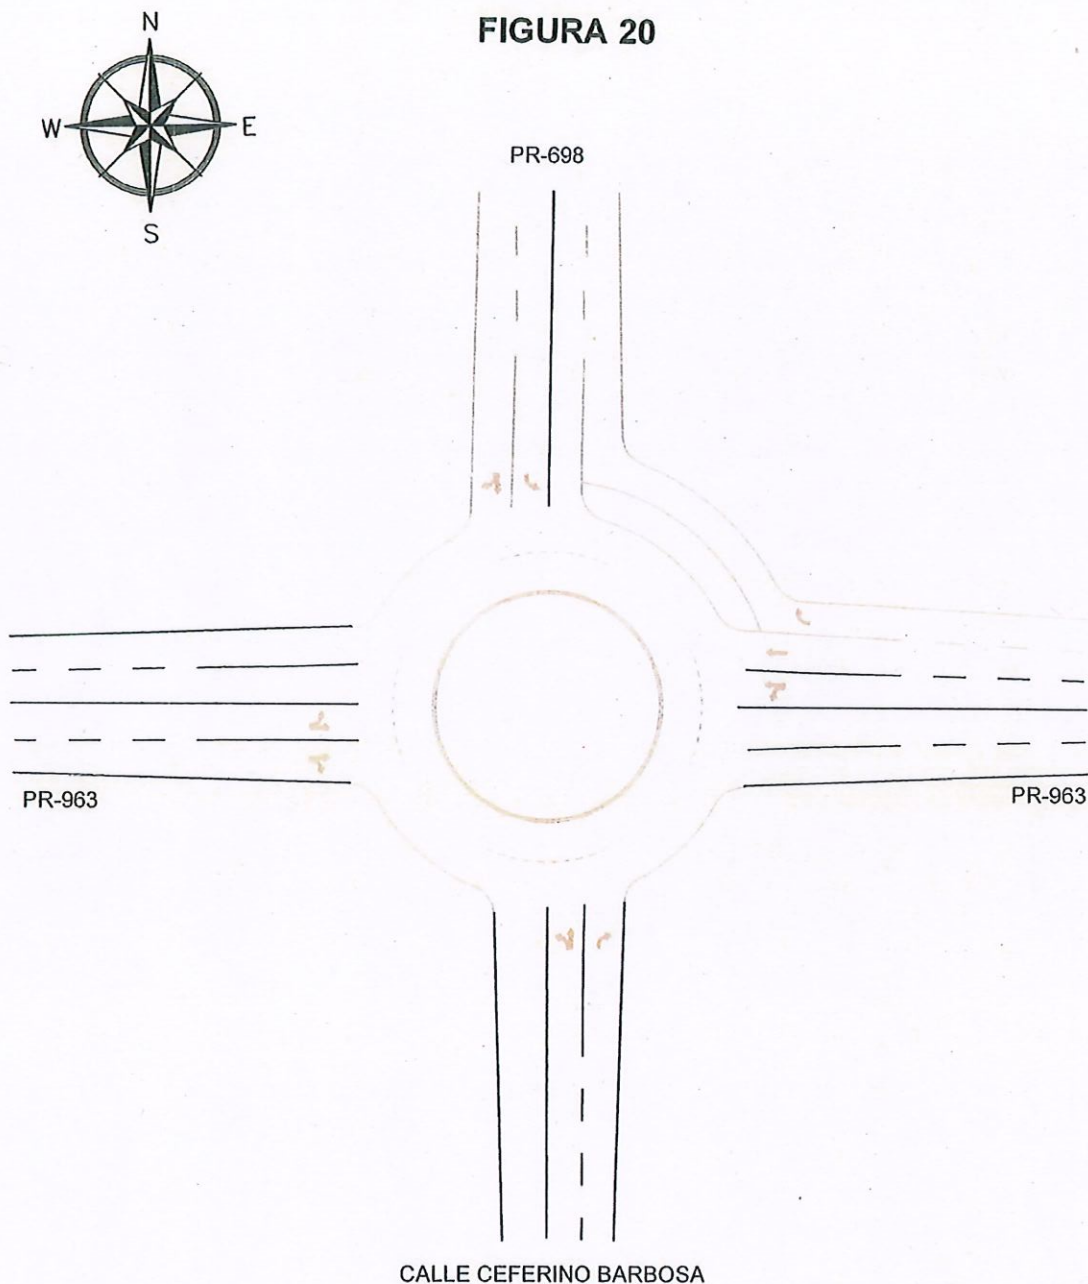
**FIGURA 20**

**RECOMENDACIÓN #1: ROTONDA**  
**INTERSECCIÓN CARRETERA PR-698,**  
**CALLE CEFERINO BARBOSA & CARRETERA PR-693**

Reconstrucción de aceras y encintados para hacer mejoras geométricas tipo rotonda en la vía pública existente en la intersección de la carretera PR-693 y la PR-698, en Dorado.
